**PHASE IB
FIELD INVESTIGATION**

BRONX RIVER PEDESTRIAN GREENWAY

BRONX, NEW YORK

**NYSDOT PIN # X027.05
NYSOPRHP # 05PR01491**

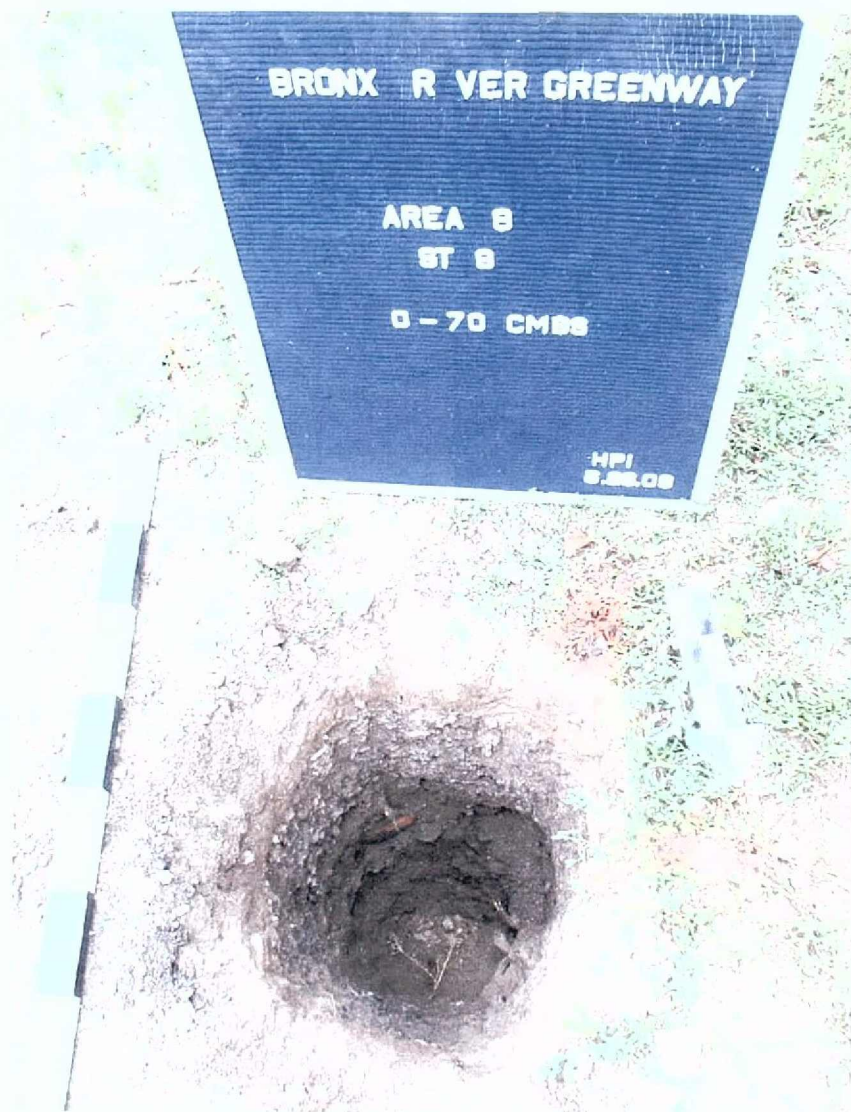
Bronx River Greenway Phase IB
Photograph 1: Photograph of ST 8-8, facing south.

To the south of East 177th Street, STs 8-10 through 8-12, and 7-1 through 7-7 were completed (Figures 4 and 5; Photograph 1). STs were generally shallower than those excavated to the north as concrete obstructions were encountered immediately beneath fill (Appendix A). Again, no definitively historical period deposits or precontact material was encountered in this Area (Appendix B).

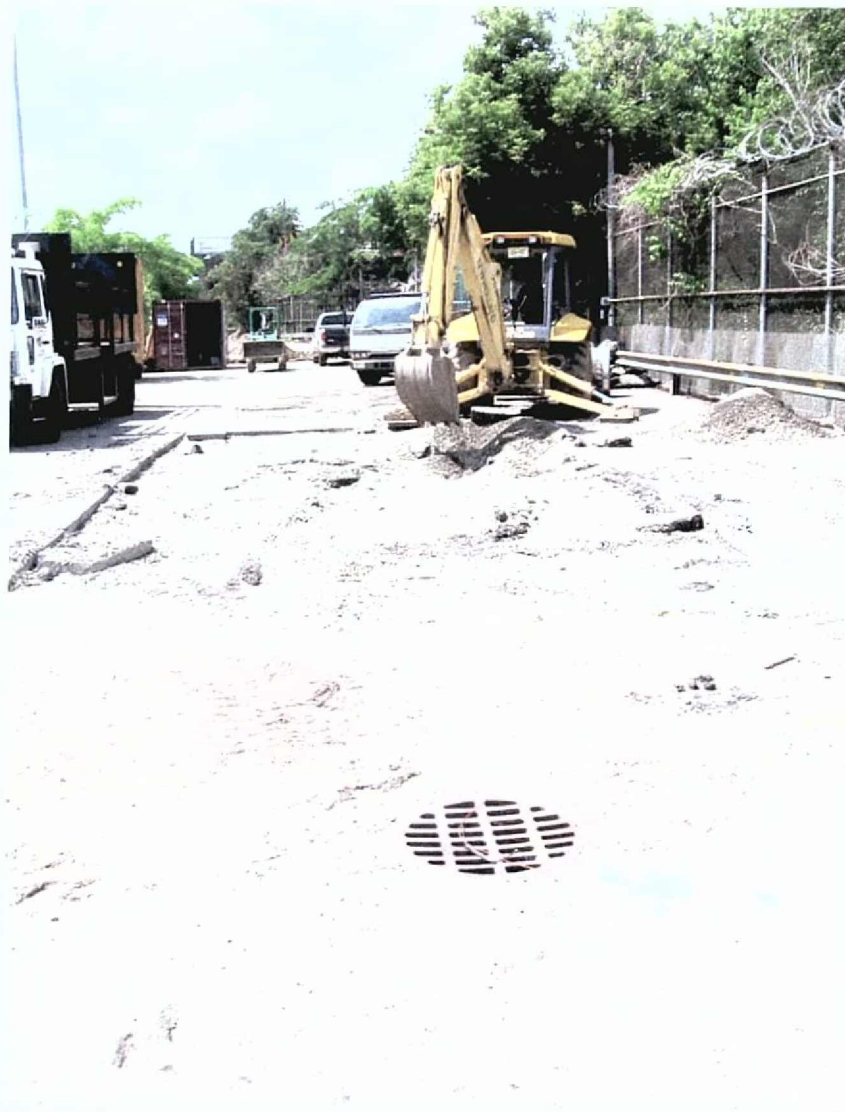
Bronx River Greenway Phase IB
Photograph 2: Location of Trench E, prior to excavation.

Trench E was excavated in the paved parking lot that lies between the MTA Bus Depot parking lot to the east – and out of the APE – and the unpaved land uphill of the Bronx River to the west (Figure 4). The trench was originally planned to be excavated fairly close to East 177th Street, but it was shifted to the south by 10 meters in order to avoid unmapped drainage culverts that would have otherwise been in the center of the trench (Photograph 2).

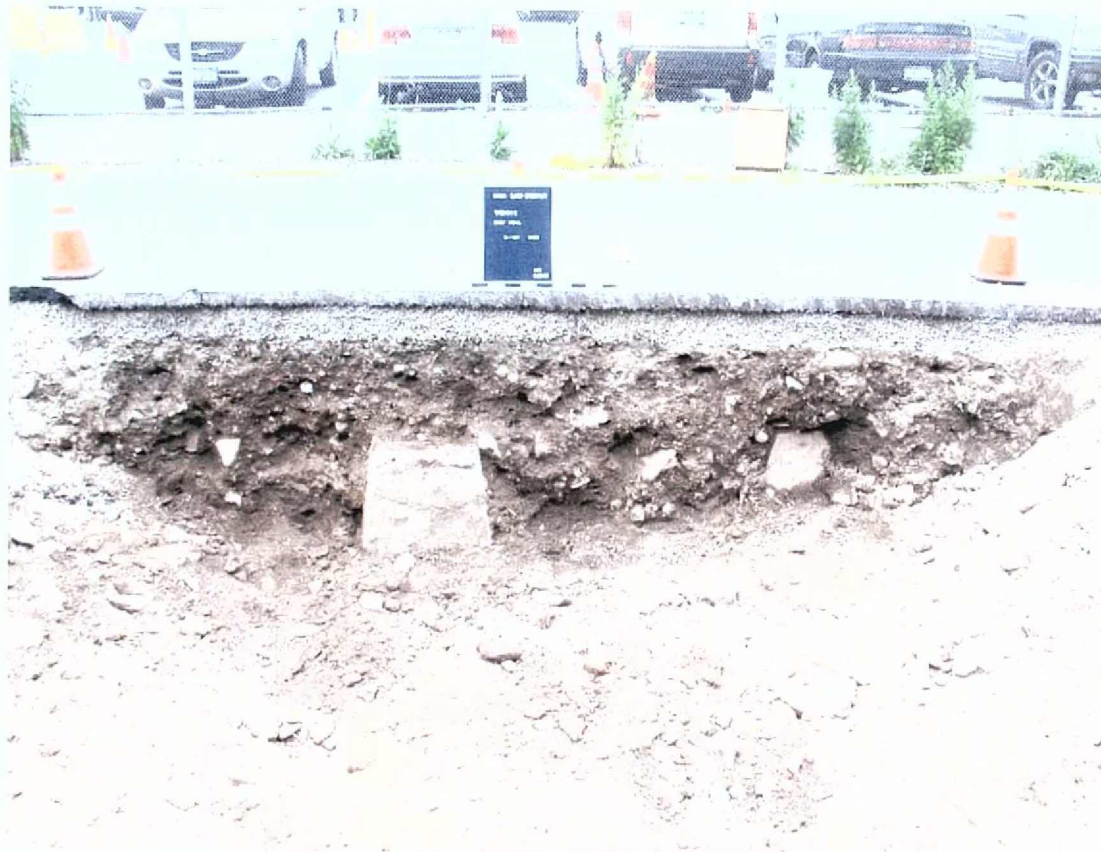
Bronx River Greenway Phase IB
Photograph 3: Photograph and profile of Trench E, east wall.

Trench E encountered multiple fill levels throughout (Photograph 3; Appendix B). Boulder fill was found beneath more modern fill down to about nine feet below grade (2.75 meters). A pocket of late 19th to early 20th century fill, containing bottles (e.g., an Albert Krumenaker lager bottle dating to between 1893 and 1913), whiteware, and a piece of salt-glazed stoneware, was encountered along the western portion of the trench (Appendix B). However, it was not entirely distinct from the mixed 19th and 20th century deposits around it. The mixing of artifacts was probably due to the presence of several large subsurface features. A poured concrete pier, possibly a base of a former parking lot lamp or similar feature, was observed in eastern wall of the trench (Photograph 3). Fill levels around this contained mixed 19th and 20th century material, with an extensive collection of bottles dating to the early 20th century (Appendix B). Most of the material appeared to have been associated with Starlight Park, built in 1918, or possibly dumping that occurred prior to this. There was an obvious lack of domestic resources and architectural debris, other than a few bricks. No evidence of undocumented mill remains or 18th century material was recovered.

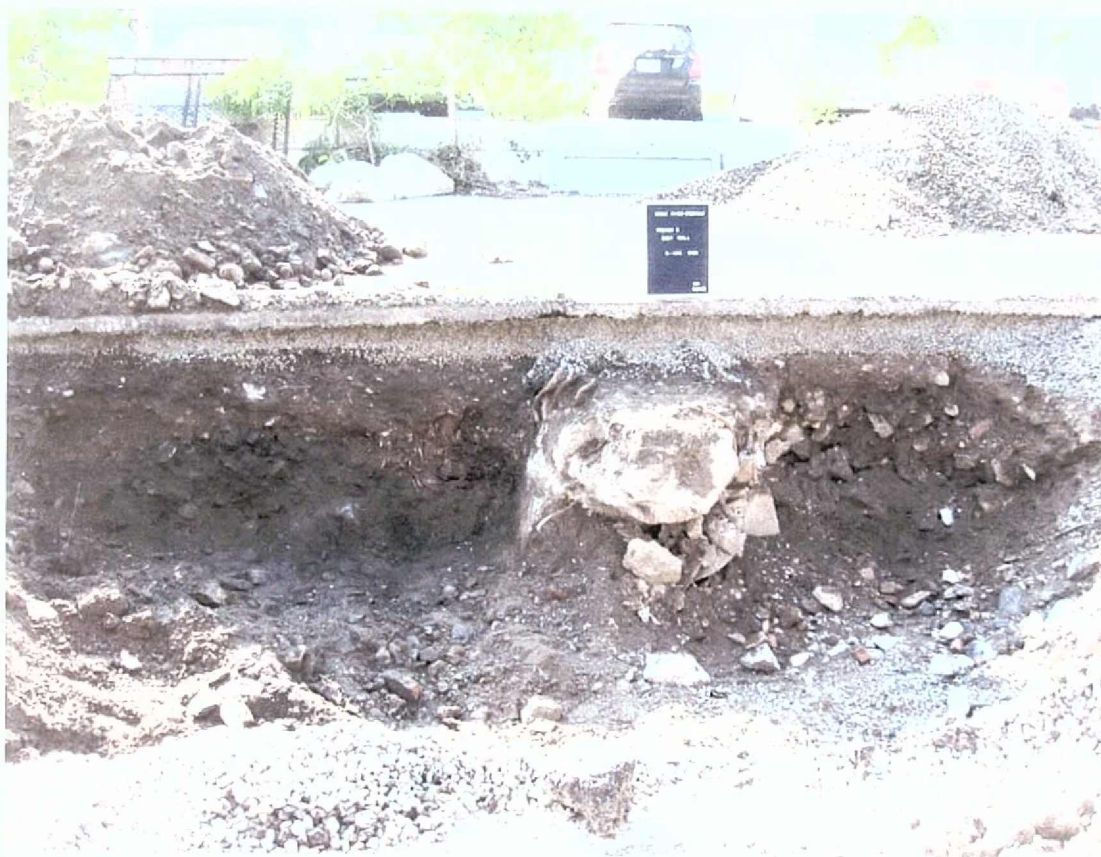
Bronx River Greenway Phase IB
 Photograph 4: Photograph and profile of Trench D, east wall.

South of this, Trench D was also excavated in the parking lot, west of the MTA Bus Depot parking area and east of the Bronx River (Figure 5). Concrete piers reinforced with rebar were encountered in both the eastern and western wall of the trench (Photograph 4). These appeared to be either lamp post bases or structure supports, but were clearly of 20th century origin. Multiple fill levels were encountered, and there was fairly modern (mid-to-late 20th century) material encountered throughout the trench, such as rubber and plastic, as well as a spark plug dating to the late 1960s (Appendix B). After the trench was excavated to about 1.65 meters (5.4 feet) in depth, and all mapping and photographs were completed, a deeper narrow trench was excavated from north to south through the center of the trench (Photograph 5). This revealed the presence of an unmapped sewer pipe, measuring roughly 90 cm (3 feet) in diameter. Original excavations for the installation of the pipe clearly disturbed the upper levels, as did the installation of the two reinforced concrete piers. No undisturbed artifact deposits were encountered.

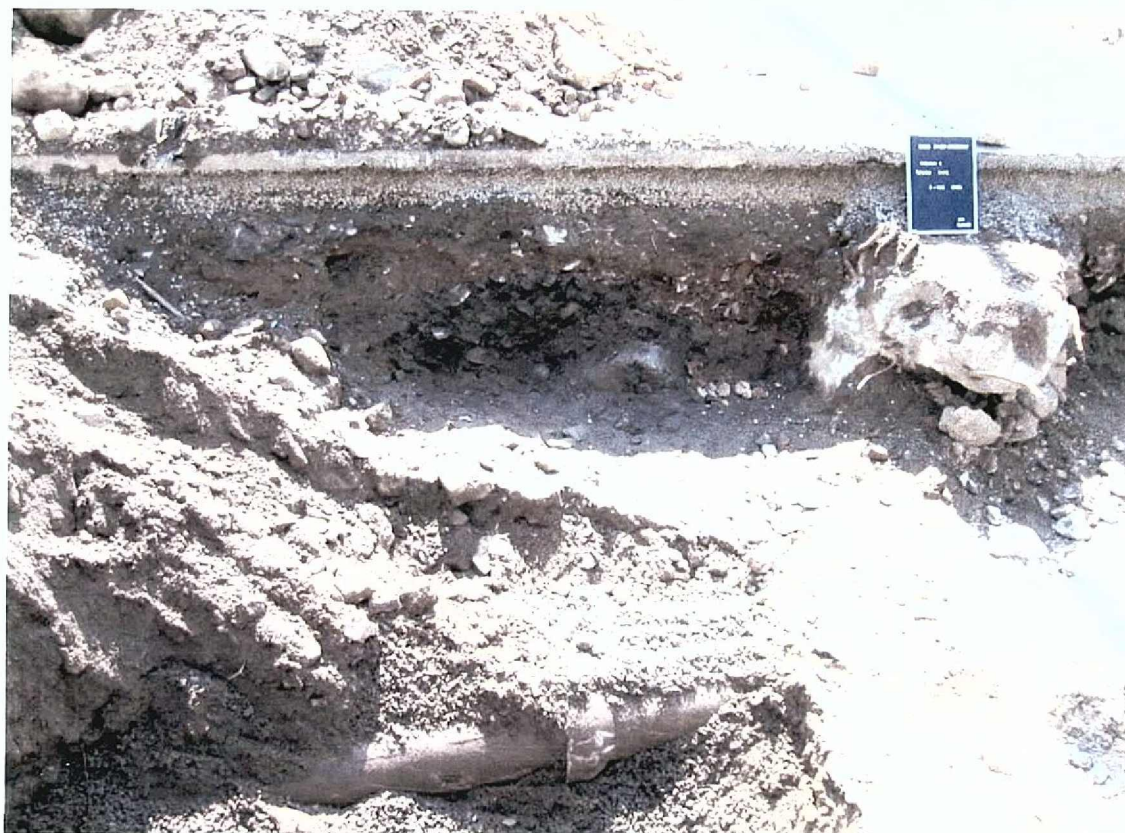
Photograph 5: Plan view of Trench D, sewer pipe in center of trench.

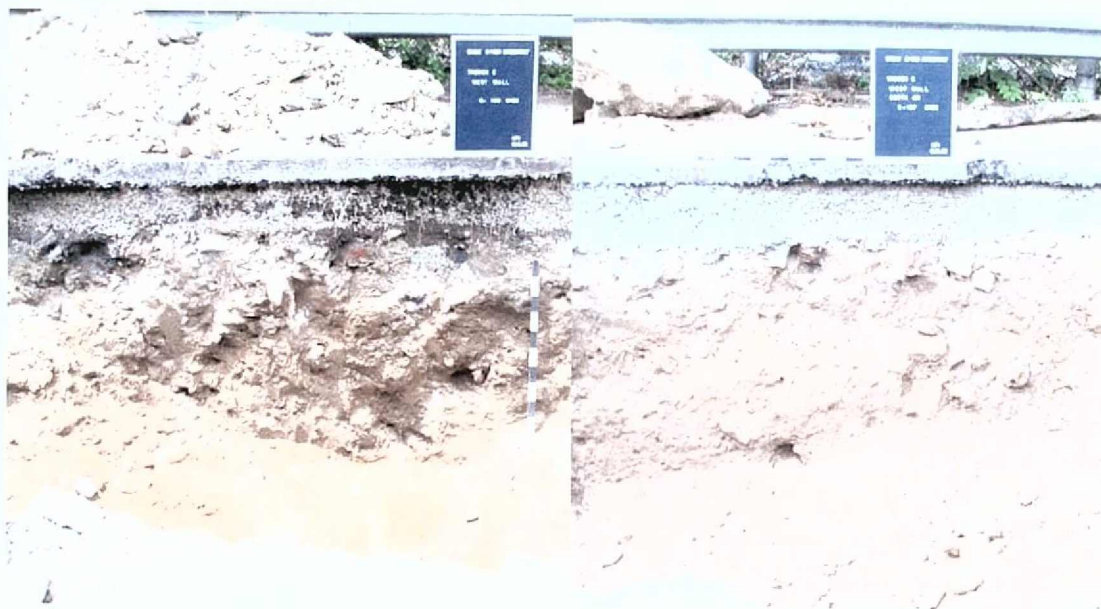
Photograph 6: Photograph and profile of Trench C, west wall.

Beneath the uppermost level of pavement, a layer of gravel bedding, and a layer of 20th century fill, evidence of an earlier poured cement drive or walkway was encountered along the eastern portion of the trench (Appendix A). The location and presence of 20th century material immediately above it suggests that it was a walkway or internal road affiliated with Starlight Park (ca. 1918-1940s), and was covered over when the Cross Bronx Expressway was constructed. Beneath this were mixed deposits of late 19th and early 20th century material predating the 1940s that included brick, bone, bottle glass, and cut stone pavers measuring roughly 18x12.5x10cm (7x5x4ins) (Appendix B). One possible feature was identified; a pocket of distinct soil with red and yellow bricks, as well as a shoe, that was observed emanating from the western wall (Photograph 6). The feature was interpreted as a discrete dumping episode, probably dating to the 20th century demolition of Starlight Park. Beneath and slightly north of this discrete dumping episode was a rusting 12.7cm (5ins) water pipe jutting out of the west wall, indicating that at least a portion of the trench had previously been excavated and disturbed for the installation of municipal water (Photograph 6).

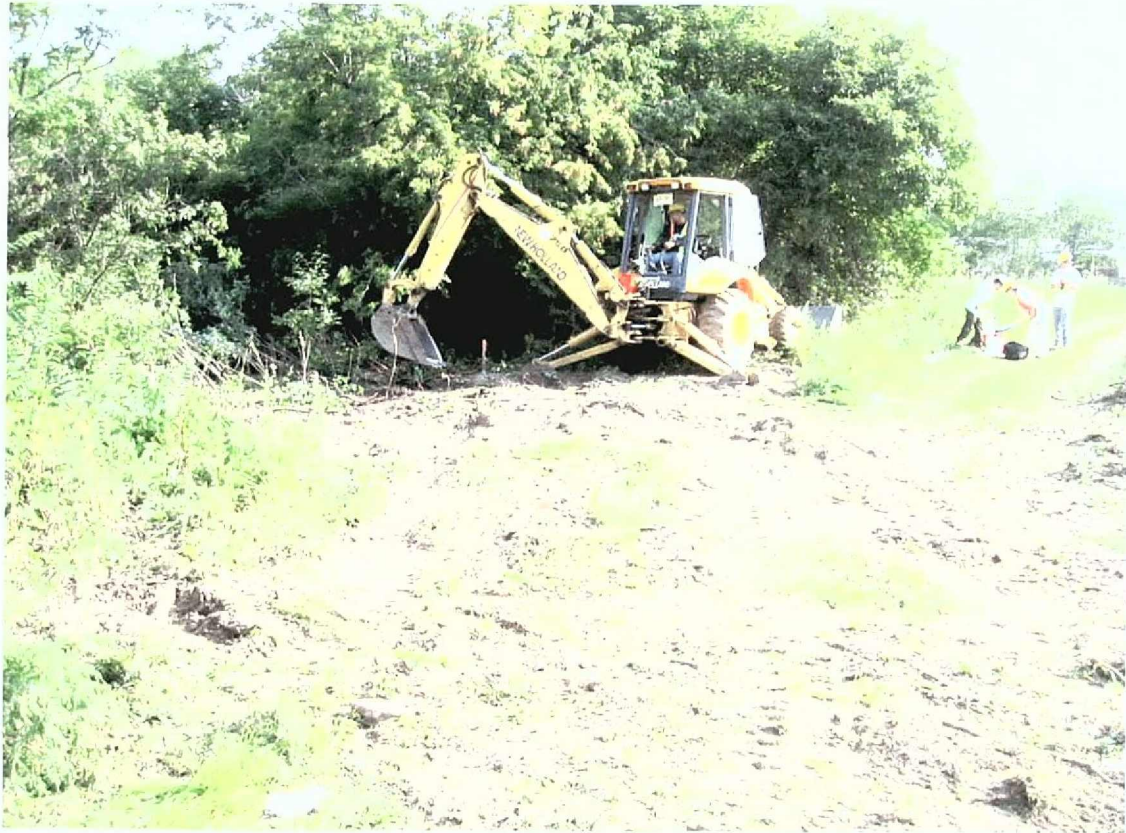
Bronx River Greenway Phase IB
Photograph 7: Location of Trench B, prior to excavation.

The relocated Trench B was placed southwest of the West Farms Bus Depot parking lot between mature trees (Photograph 7; Figure 7). The uppermost fill level contained dozens of plexiglass sheets and modern debris. Beneath this, along the eastern edge of the trench, were a poured cement walkway and the eastern wall of the pool that was built as part of Starlight Park (ca. 1918). Excavations extended to 1.5 meters (5 feet) below grade, in an attempt to get beneath the level of disturbance by the pool to see if intact precontact or historical features were present. Several additional cement and fill levels were noted, and wood planks, which probably served as forms for the poured concrete, were observed up against the cement pool wall (Photograph 8). No undisturbed precontact or historical deposits were encountered, as the pool depth extended below the depth of proposed impacts, and beyond the depth of the trench (Figure 7; Photographs 8 and 9). The poured-cement pool wall still bore evidence of its turquoise paint.

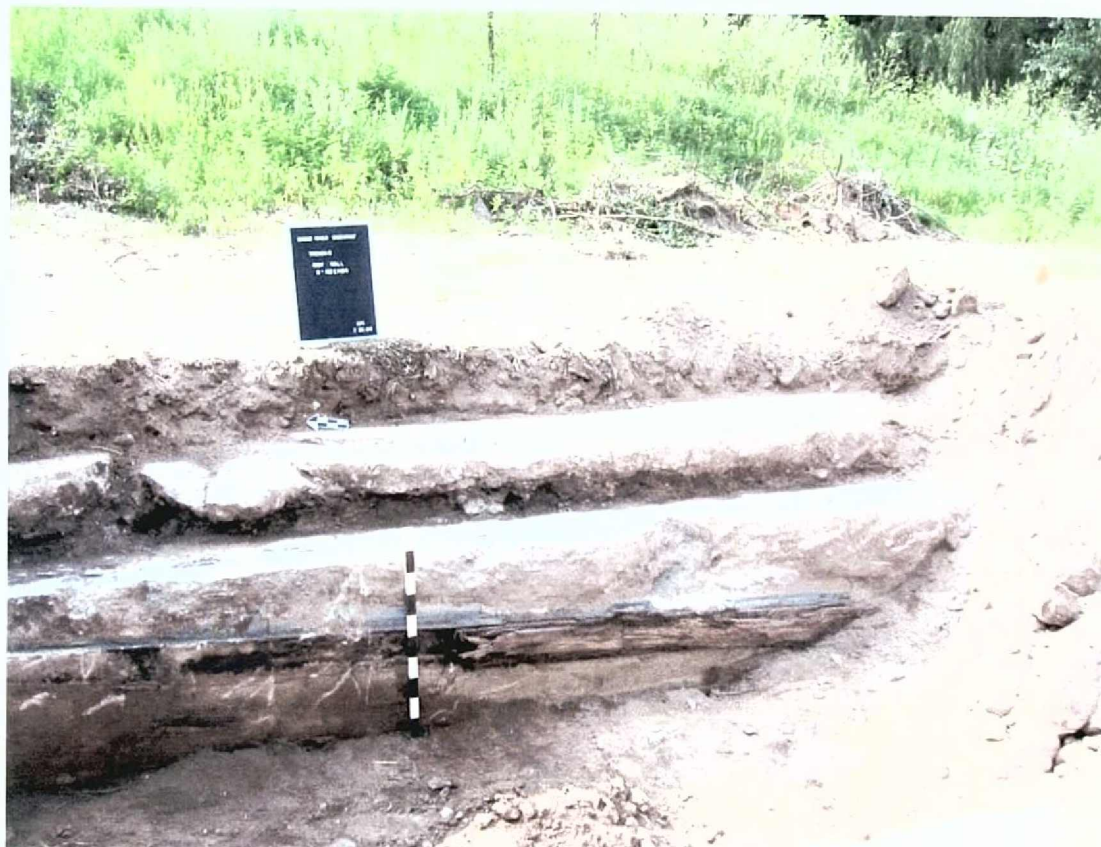
Bronx River Greenway Phase IB
 Photograph 8: Photograph and profile of Trench B, east wall

Backfill in the pool's concavity consisted of concrete slabs from the pool's demolition, bottles, whiteware, sheet metal, plastic, bone, iron, ceramic floor and wall tiles, wood planks, and a few bricks (Appendix B; Photograph 10). Most of the material appeared to be associated with the site's use as an amusement park. No undisturbed intact features or deposits were encountered. The artifacts generally dated from the late 19th through mid-20th century, suggesting that the fill layers did not represent evidence of historic occupation, but rather dumping and other earthmoving episodes associated with the demolition of Starlight Park and possibly the construction of the Cross Bronx Expressway immediately to the north.

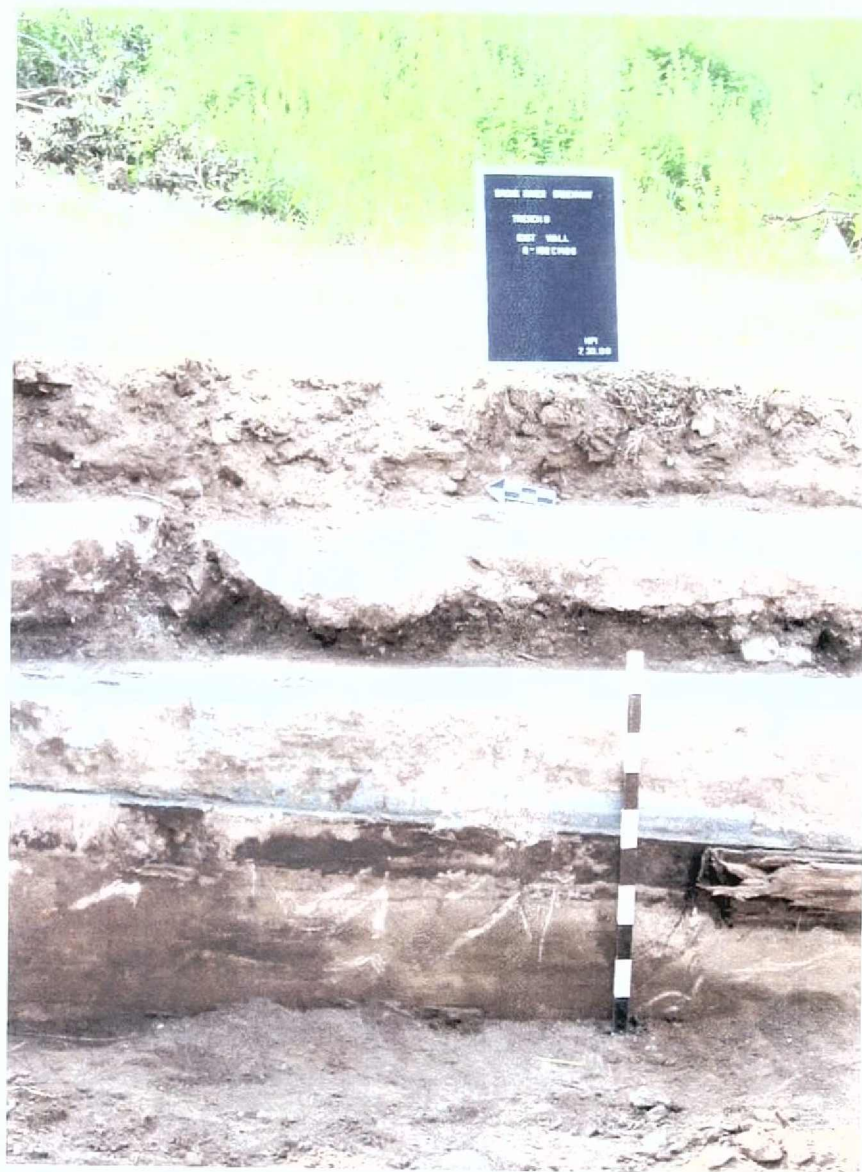
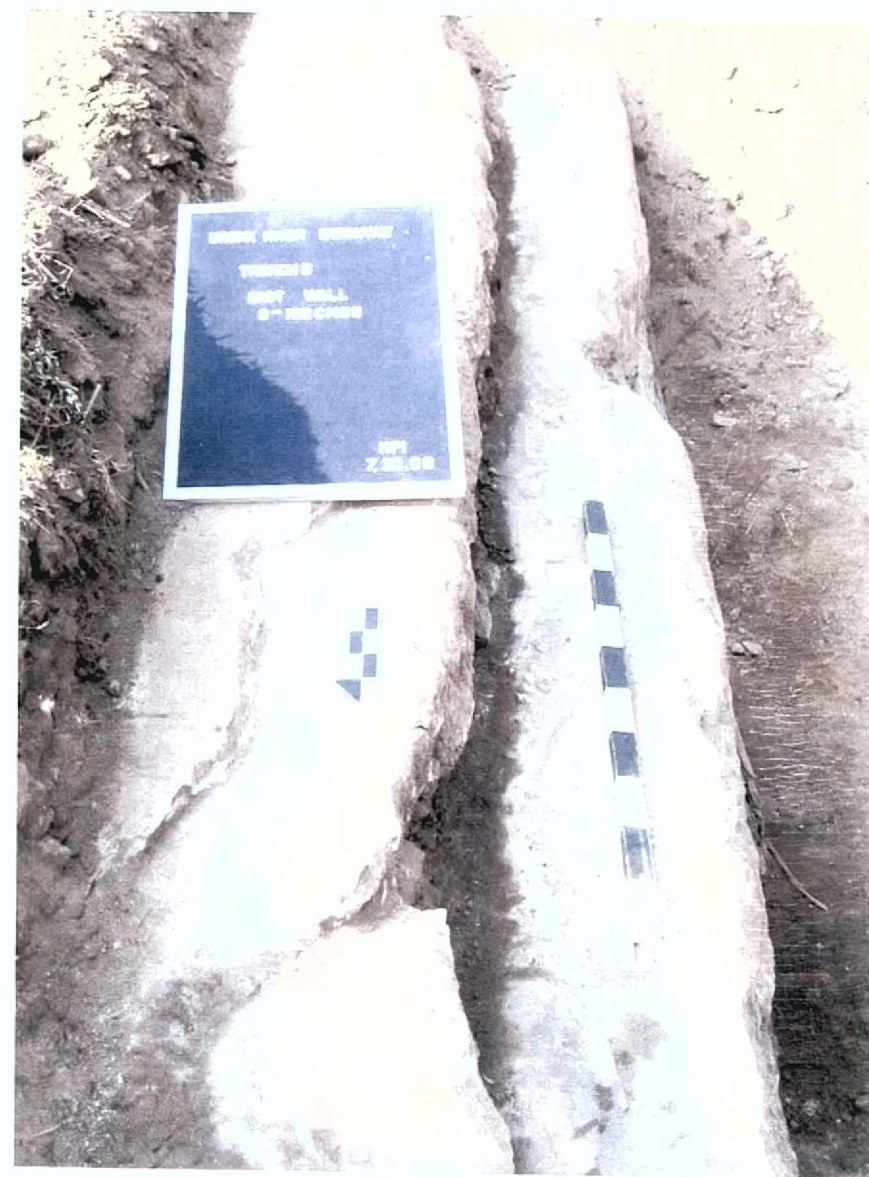
Bronx River Greenway Phase IB
 Photograph 9: Trench B east wall close up, profile view and plan view.

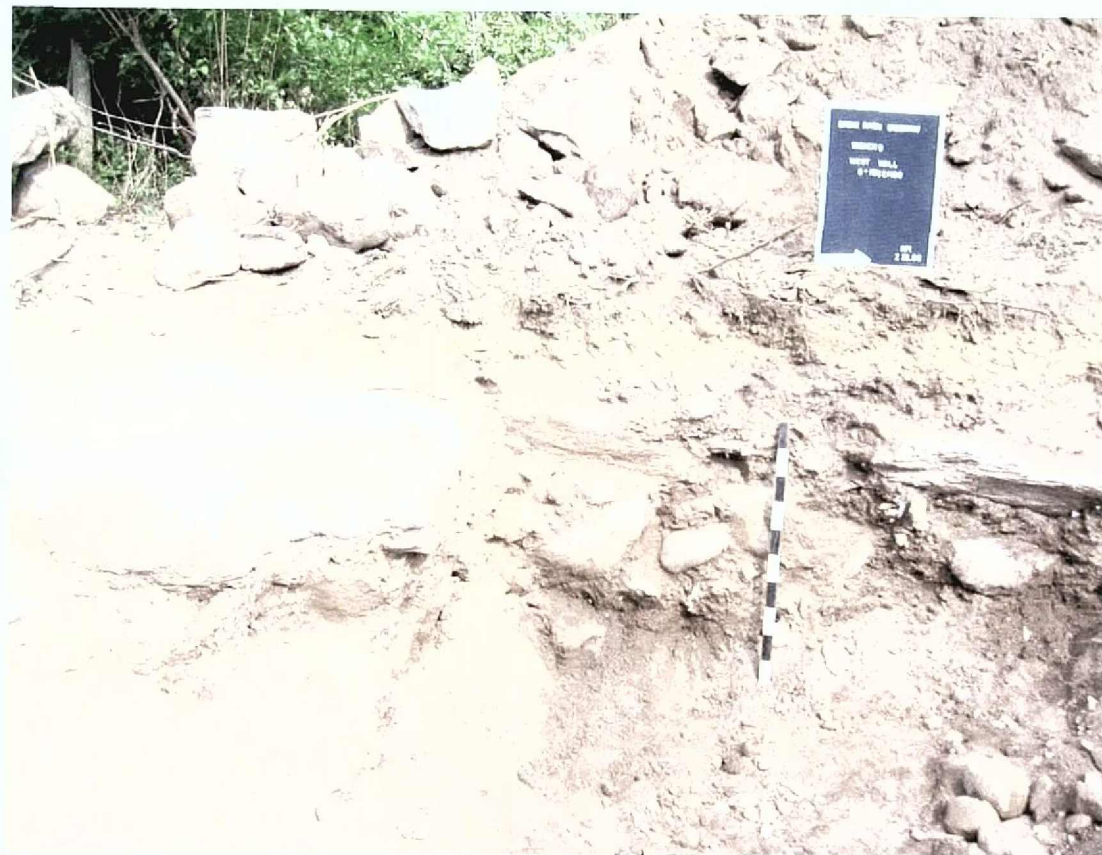
Bronx River Greenway Phase IB
 Photograph 10: Photograph and profile of Trench B, west wall

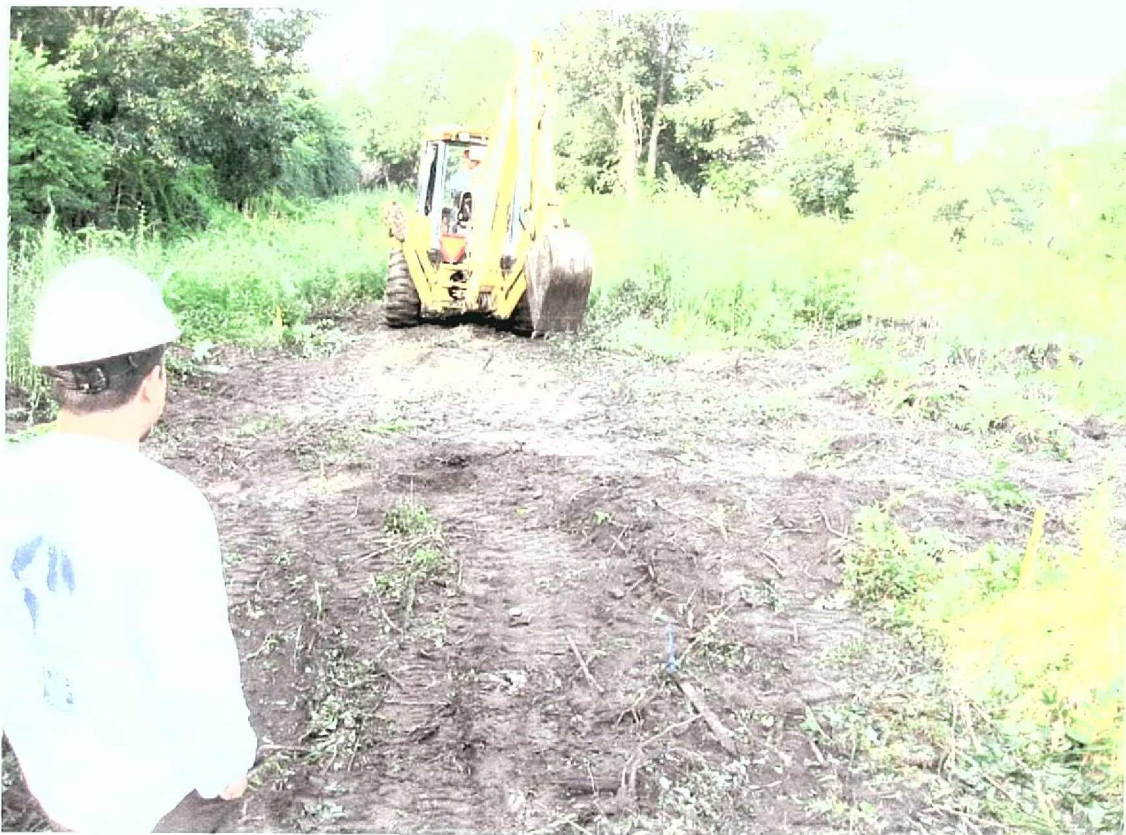
Bronx River Greenway Phase IB
Photograph 11: Location of Trench A, prior to excavation.

After the STs were completed, and a NYS DEP permit was obtained, Trench A was excavated in Area 4. The trench was placed mid-way between the Bronx River to the west and AMTRAK railroad tracks to the east (Figure 11;

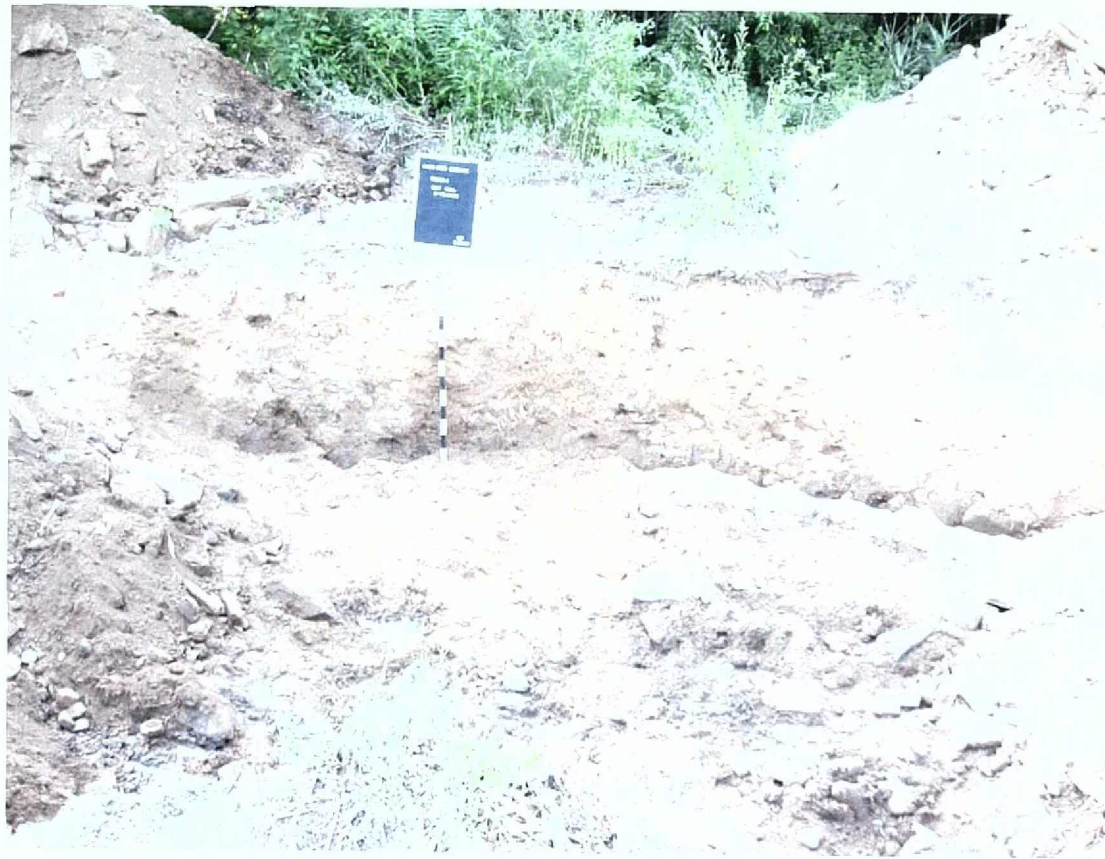
Level 3, Moist 10 YR
3/1 gravelly sand
mottled with 10 YR 5/2
sand

Photograph 12: Photograph and profile of Trench A, east wall

Photograph 11). Excavations to 1.5 meters (5 feet) below grade found multiple fill levels, as shown on Photographs 12 and 13.

Artifacts were noted in many of the fill layers, and included railroad related debris (metal spikes, wood planks, a sign-post base, etc.) limited architectural debris (red brick, smaller cut stones, concrete chunks, etc.) and an extremely limited amount of domestic debris (a rubber bicycle seat cover, whiteware, and several bottles; see Appendix B). Within the trench, there was no evidence of any intact features, or remnants of a factory that once stood near this location. The trench stratigraphy clearly reflected extensive disturbance, probably from the construction of the railroad tracks. The artifacts dated from the 20th century, suggesting that the fill layers did not represent evidence of historic occupation, but rather dumping or other earthmoving episodes associated with non-site specific activities.

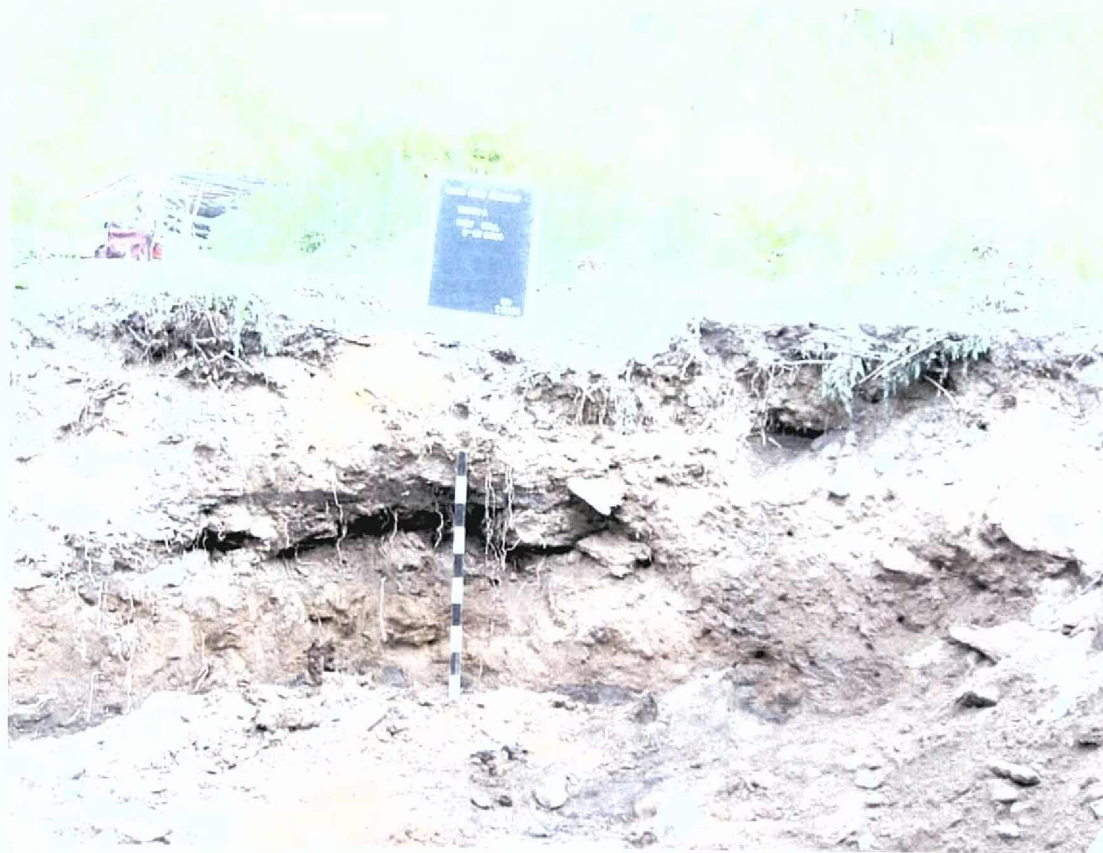
Bronx River Greenway Phase IB
Photograph 13: Photograph and profile of Trench A, west wall
