U.S. Army Corps of Engineers
New York District

**RECORDATION OF SIX (6) VESSELS
IN CONNECTION WITH THE
NEW YORK AND NEW JERSEY HARBOR NAVIGATION STUDY
UPPER AND LOWER BAY
PORT OF NEW YORK AND NEW JERSEY
STATEN ISLAND, RICHMOND COUNTY, NEW YORK
ELIZABETH, UNION COUNTY AND
BAYONNE, HUDSON COUNTY, NEW JERSEY**

**VOLUME I: FINAL REPORT
FEBRUARY 2008**

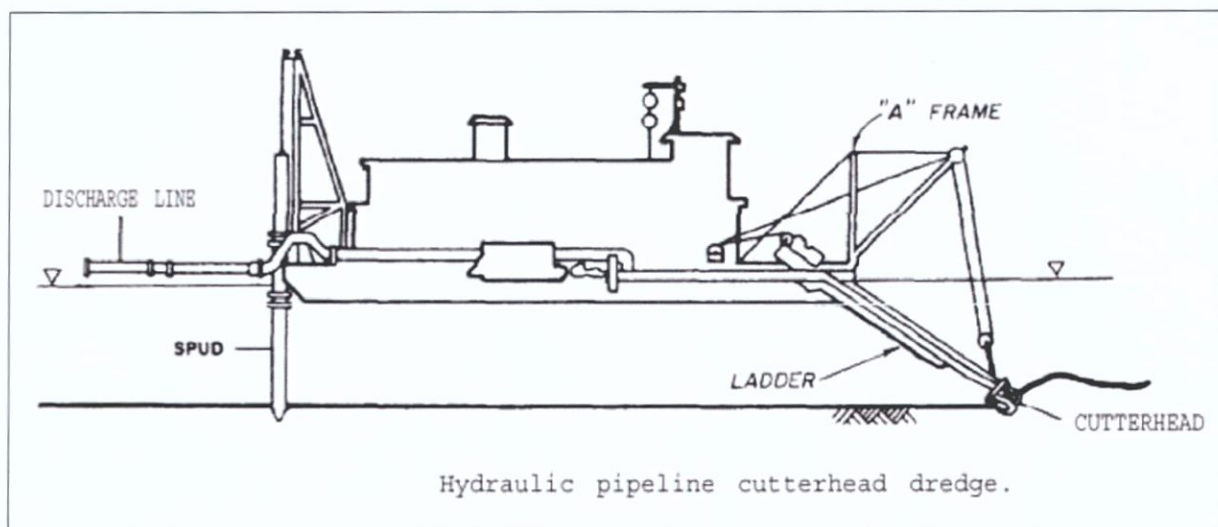
Figure 4-05. Basic cross section of a cutterhead dredge showing locations of major machinery components (as presented at www.globalsecurity.org/military/systems/ship/dredge-cutterhead-pics.html).

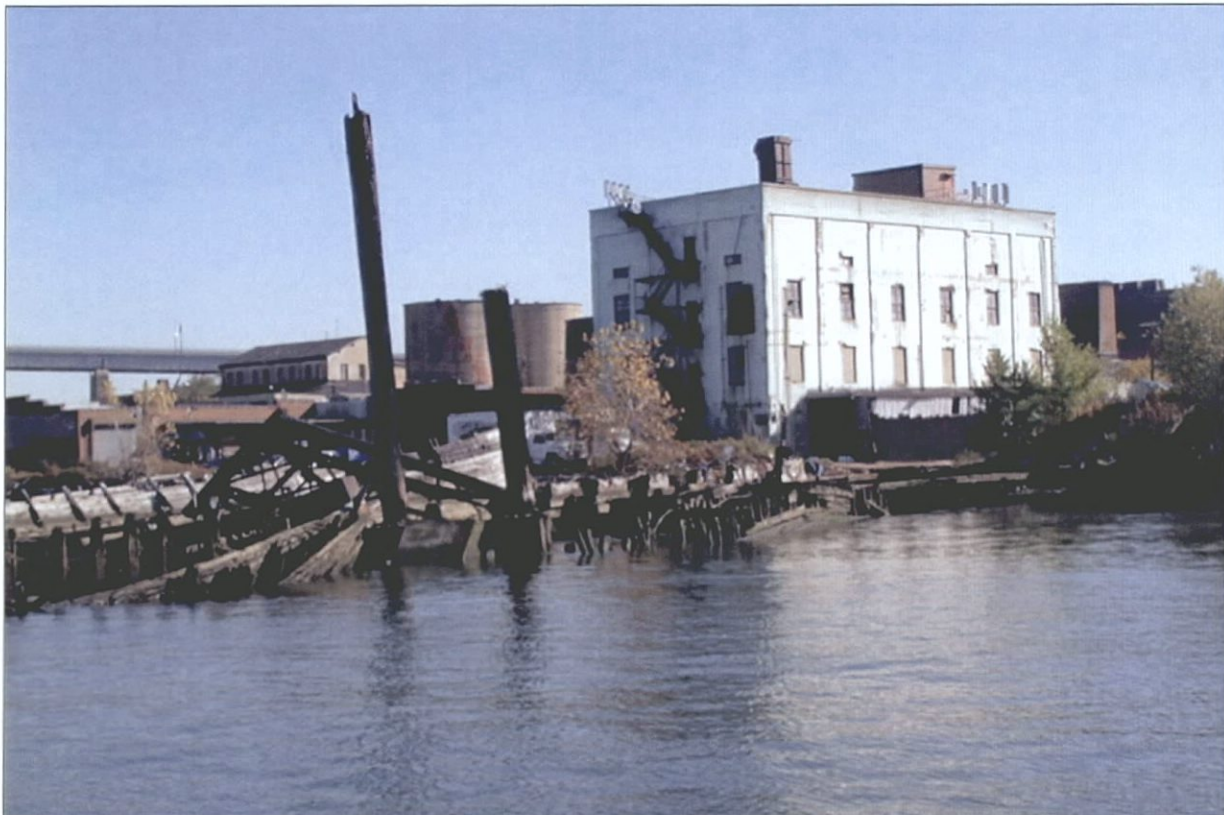
Figure 4-24. V36 starboard side, looking forward. View to the south.

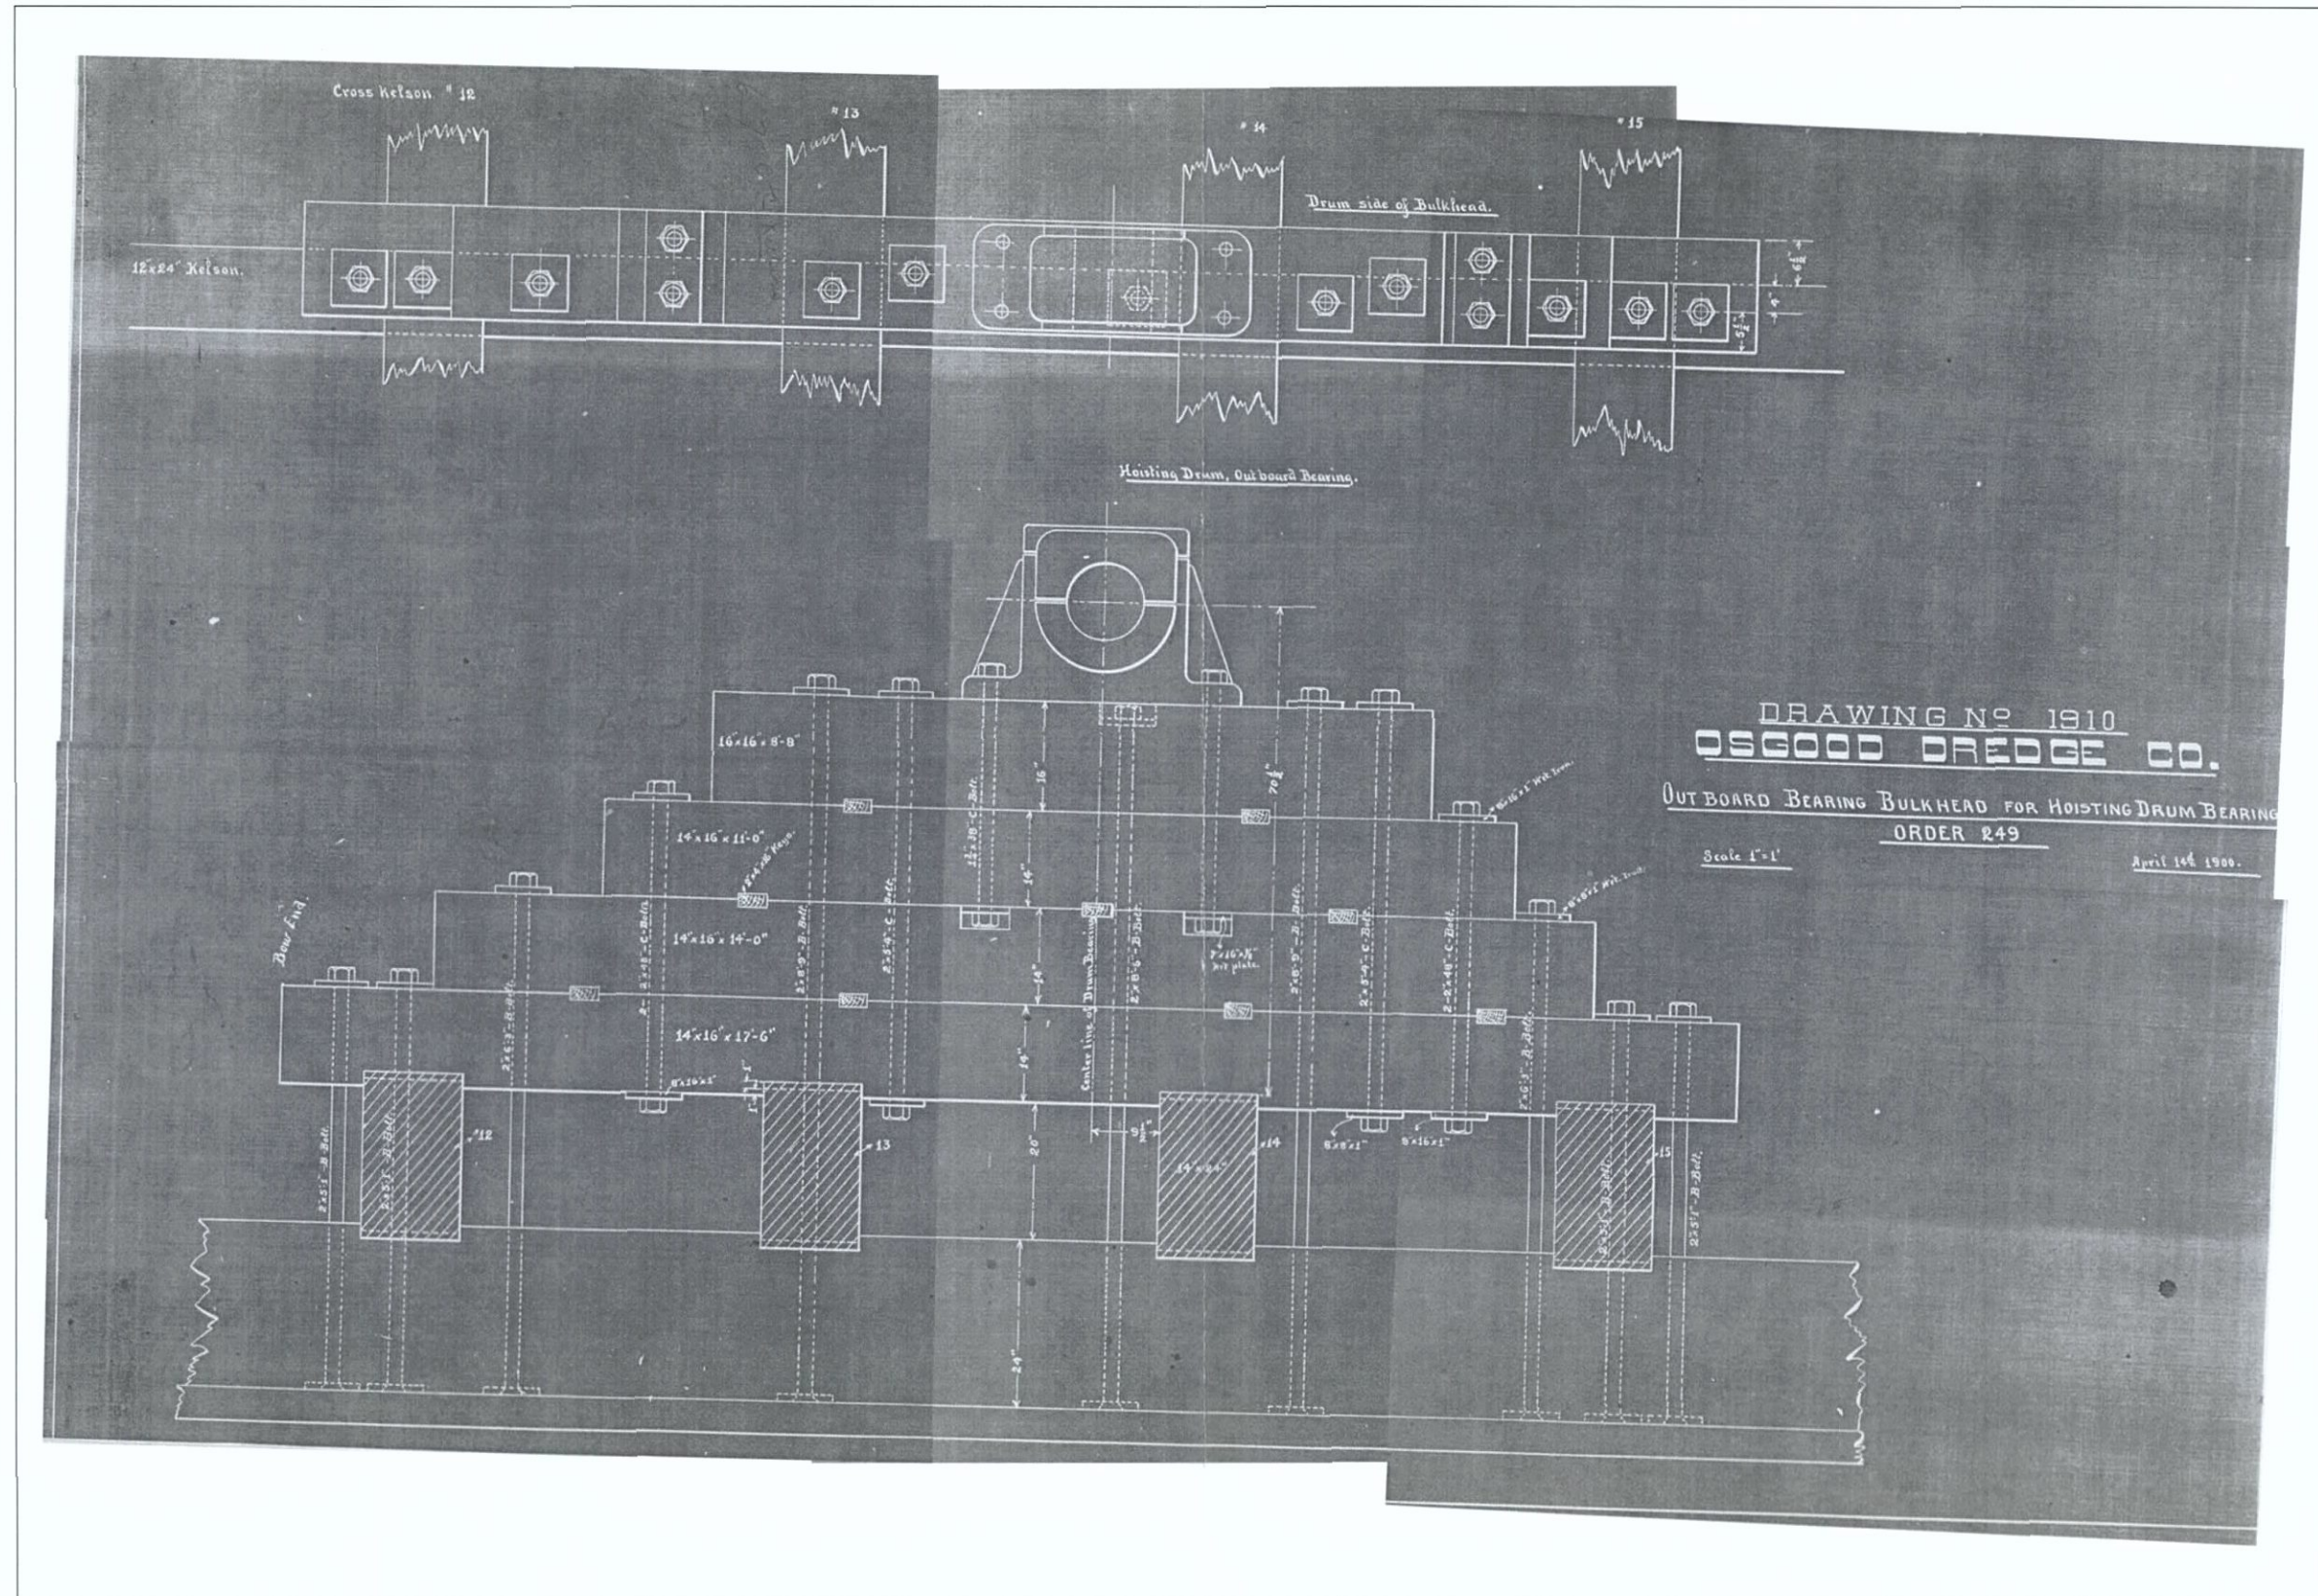
Figure 4-30. Bearing bulkhead profile of Osgood dredge, circa 1900 (courtesy of Mystic Seaport Ship Plans Library).

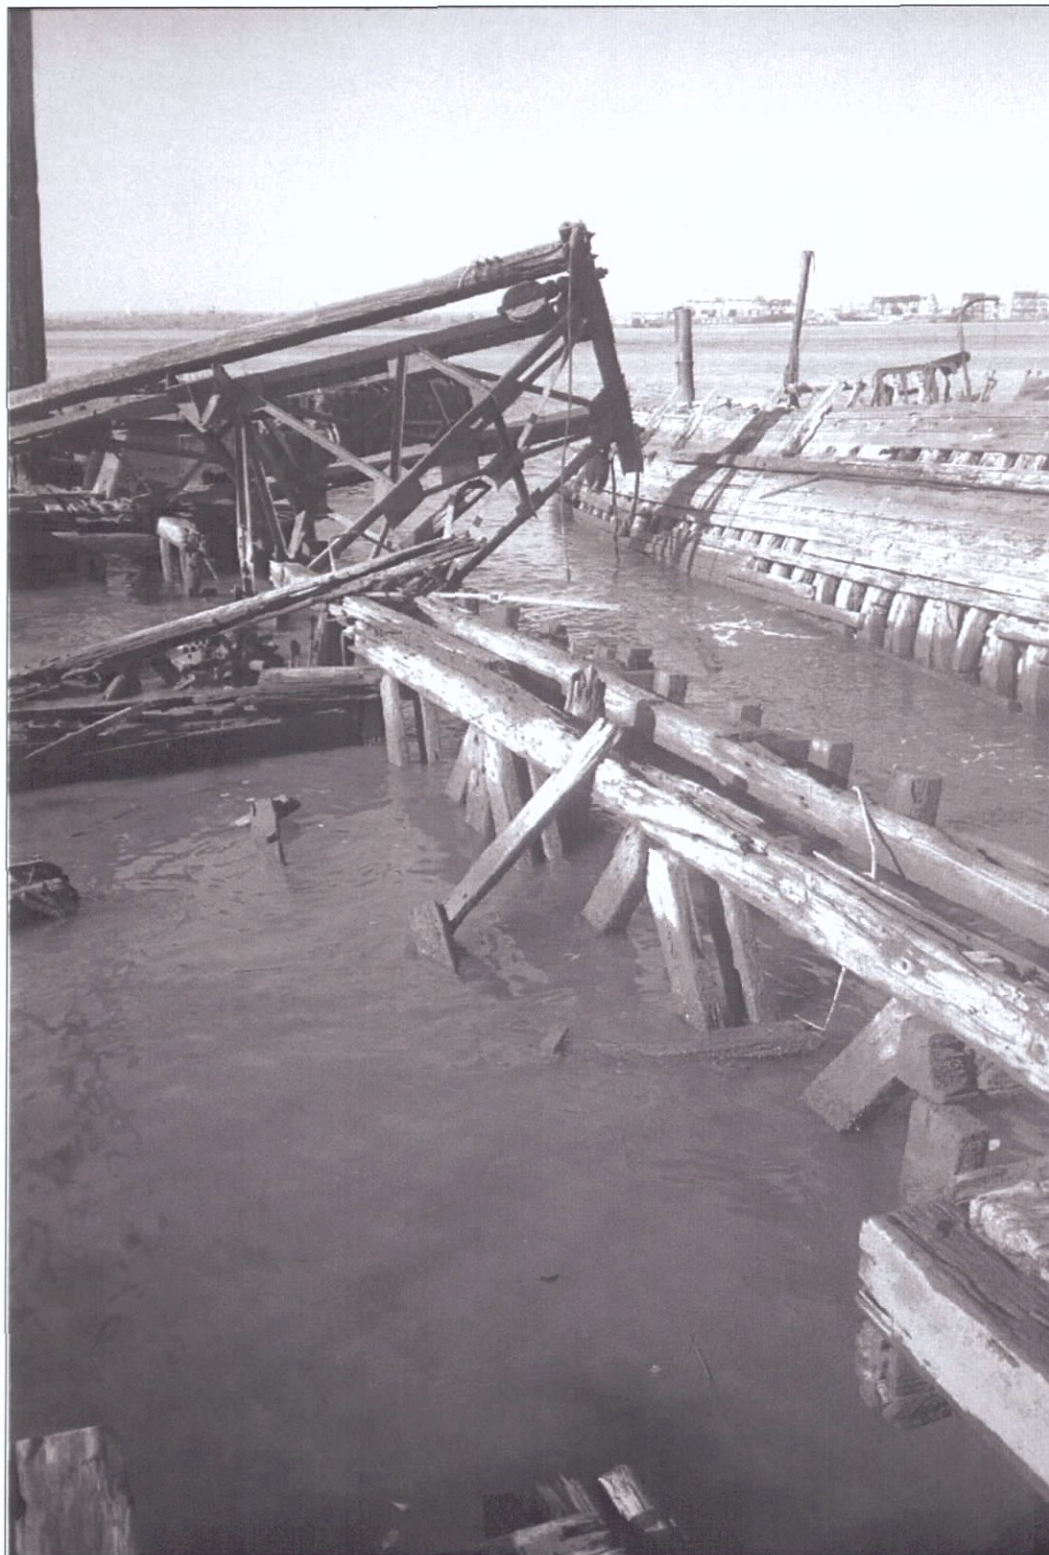
Figure 4-31. Port side framing. Note aft bulkhead, center left. View to the north (aft).

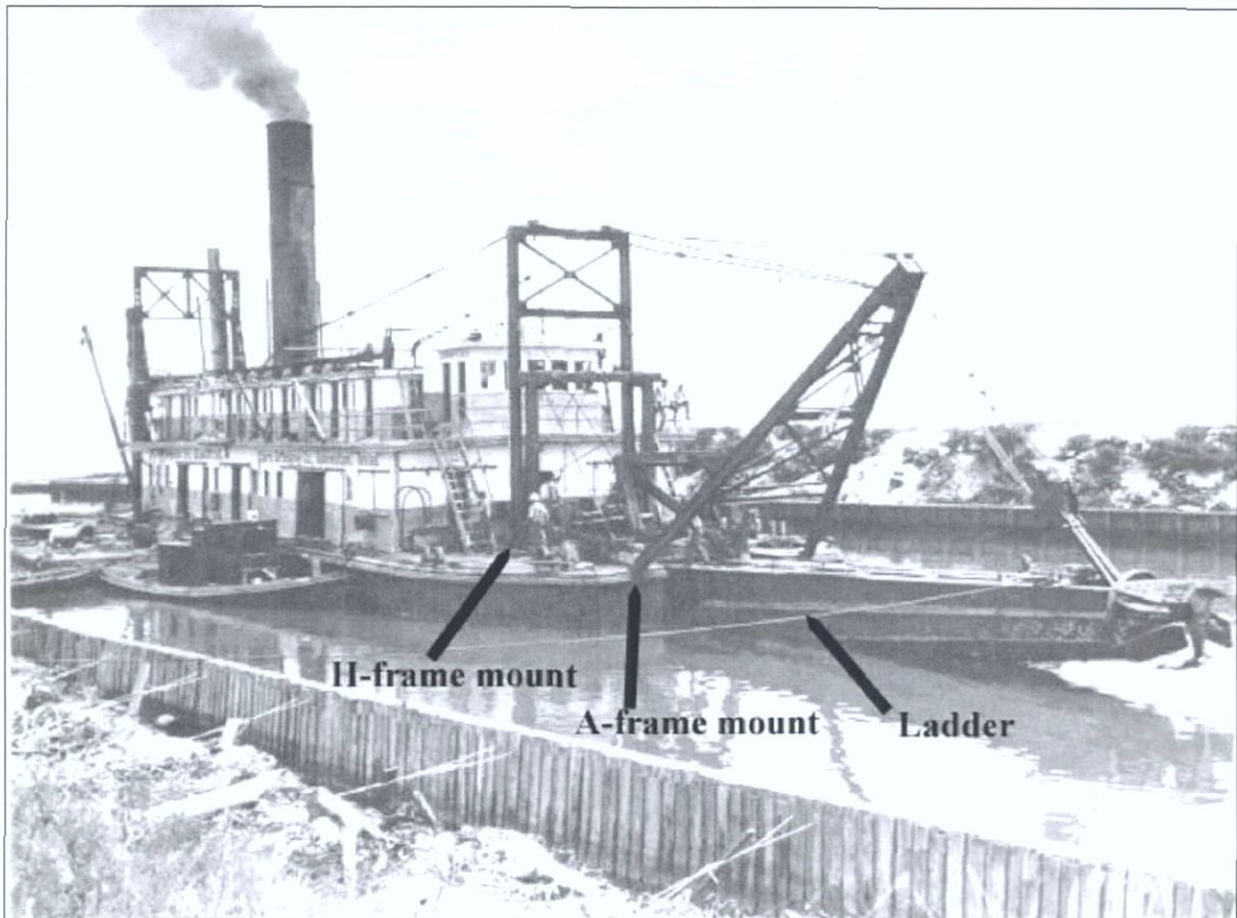
Figure 4-38. Early-twentieth-century suction dredge, showing locations of machinery observed on the deck of V36 (photo courtesy of the Florida Photographic Collection).

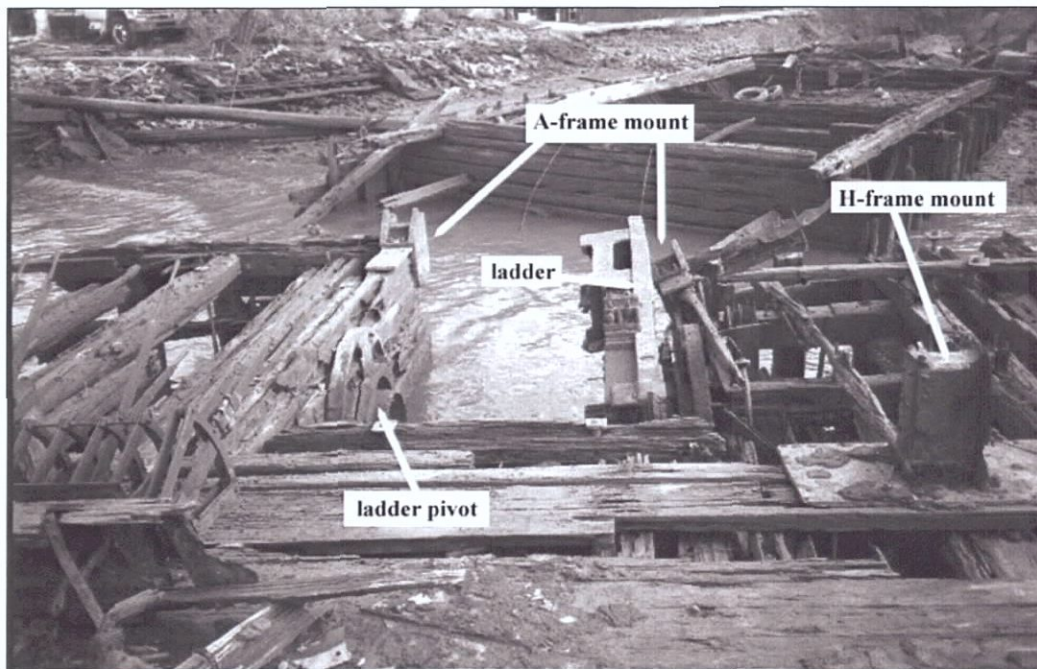
Figure 4-39. Forward hull extensions of V36, showing locations of machinery remnants. View to the south (forward).

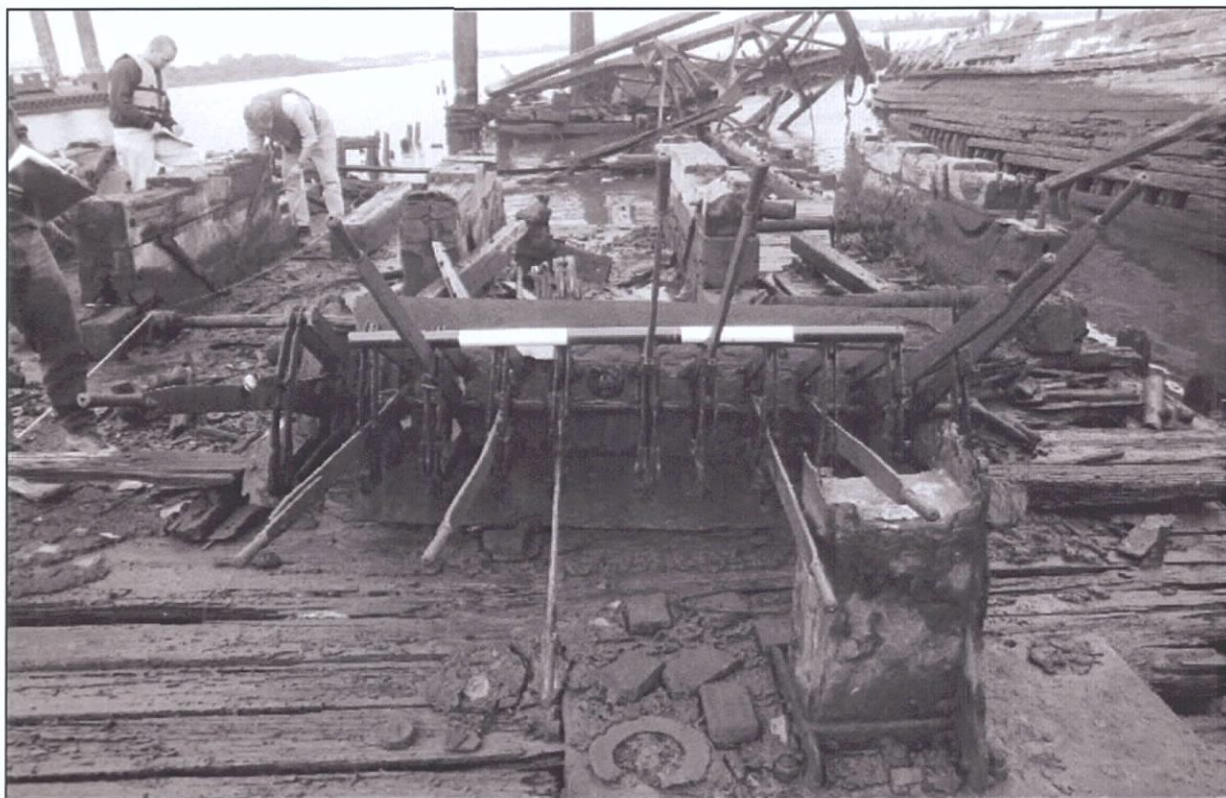
Figure 4-50. Main deck, showing machinery mounts. View to the north (aft).

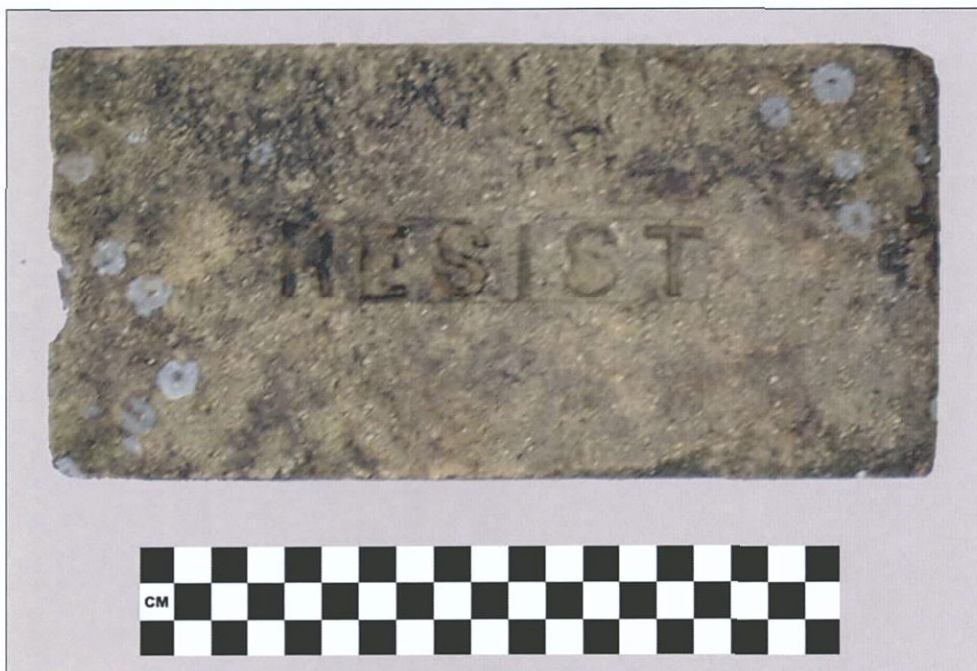
Figure 4-66. "RESIST" firebrick from V36.

The date ranges of the identified bricks suggest a date of installation between 1935 and 1942. While it is certainly possible the vessel was built somewhere between those dates, the presence of the bricks is not conclusive evidence of a date of construction, as the bricks may have been salvaged and reused, or taken from an existing stockpile, indicating a construction date later than that of the bricks, or the bricks may have been replacements installed during an equipment upgrade or boiler replacement, in which case an earlier build date is indicated.

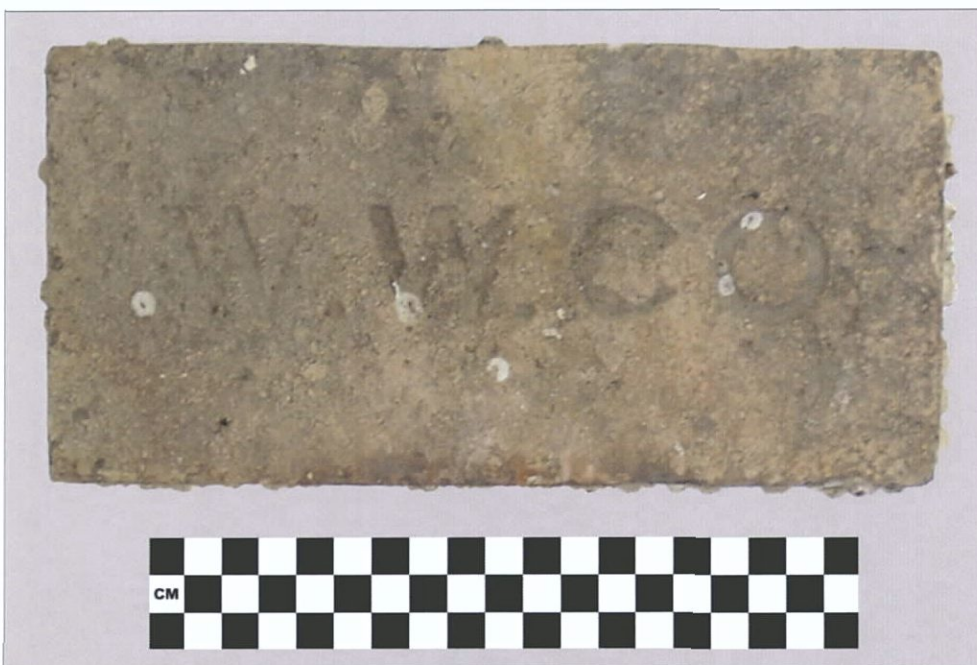
Figure 4-67. "W.W.C.O." firebrick from V36.

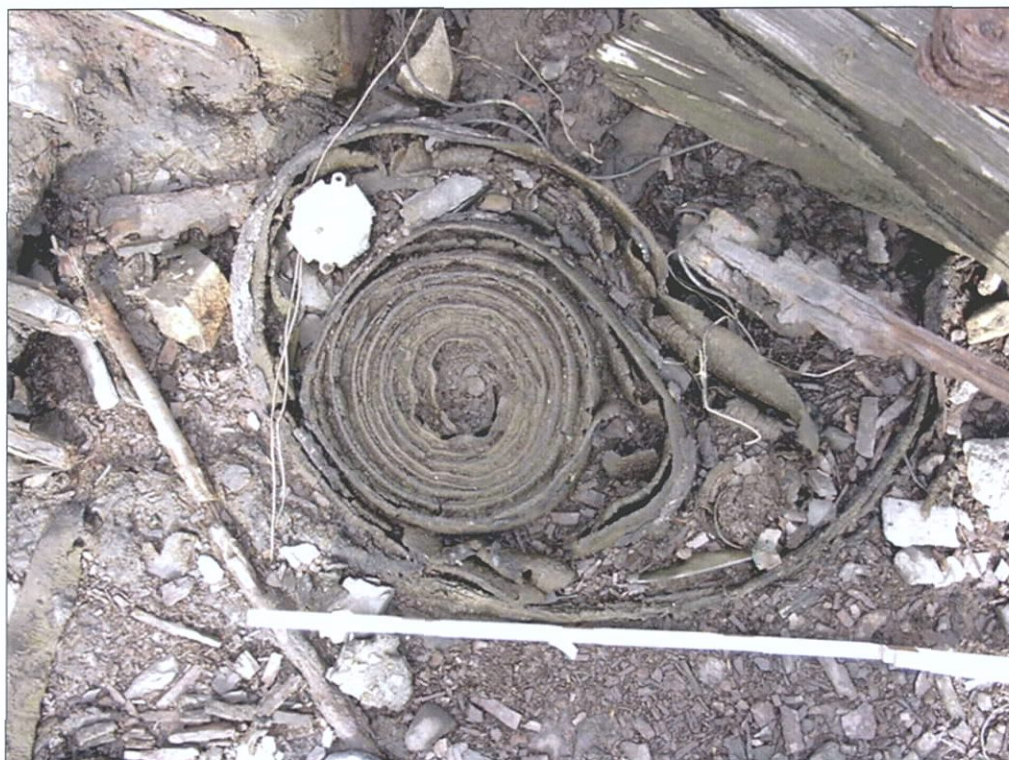
Figure 4-71. Canvas and rubber belt noted coiled *in situ* on the deck of V36.

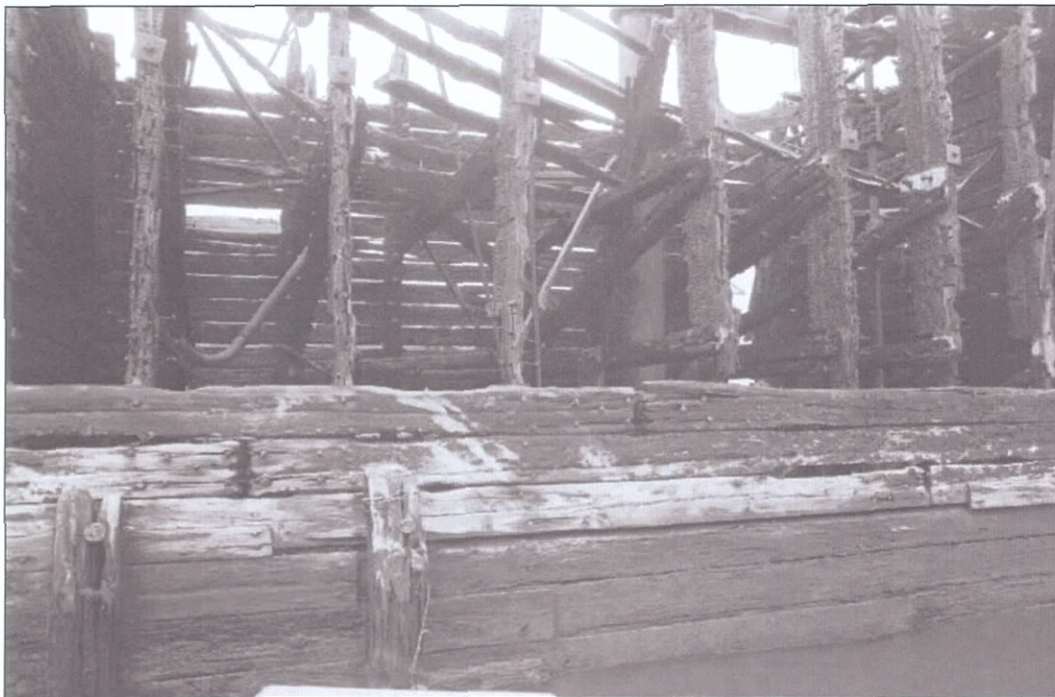
Figure 5-45. View starboard wing showing placement of watertight bulkheads, noted at opposite ends of photograph. View to the west.

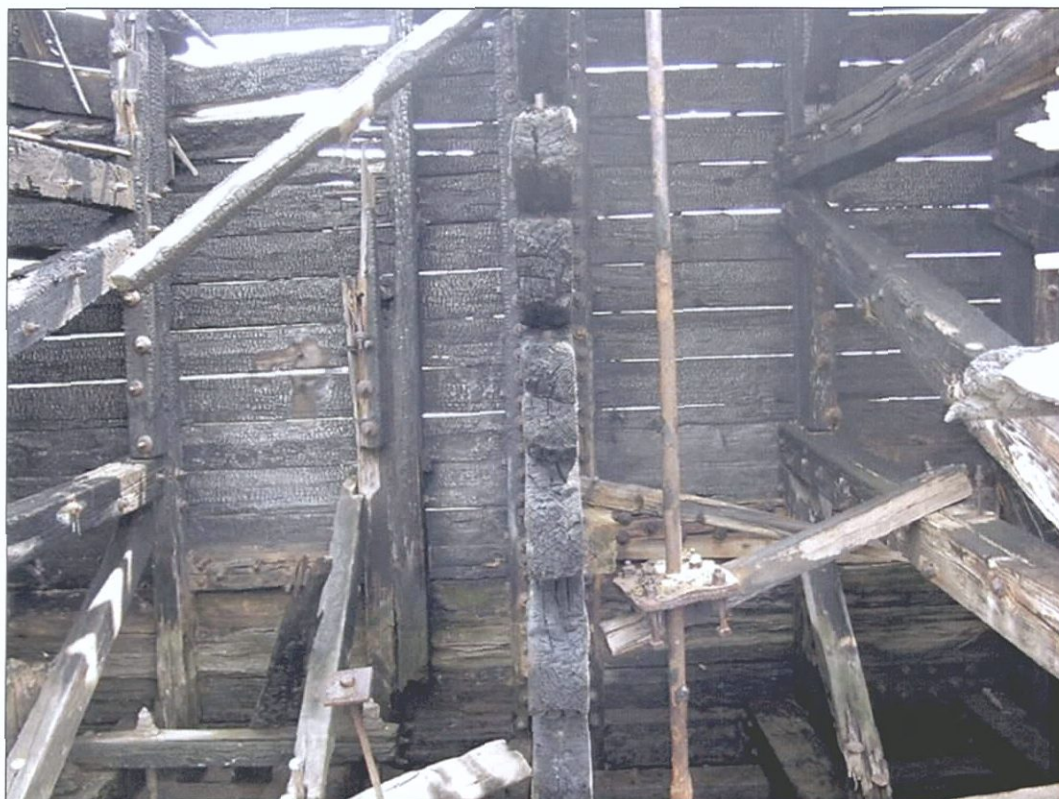
Figure 5-46. Bulkhead timbers. View to the east (starboard).

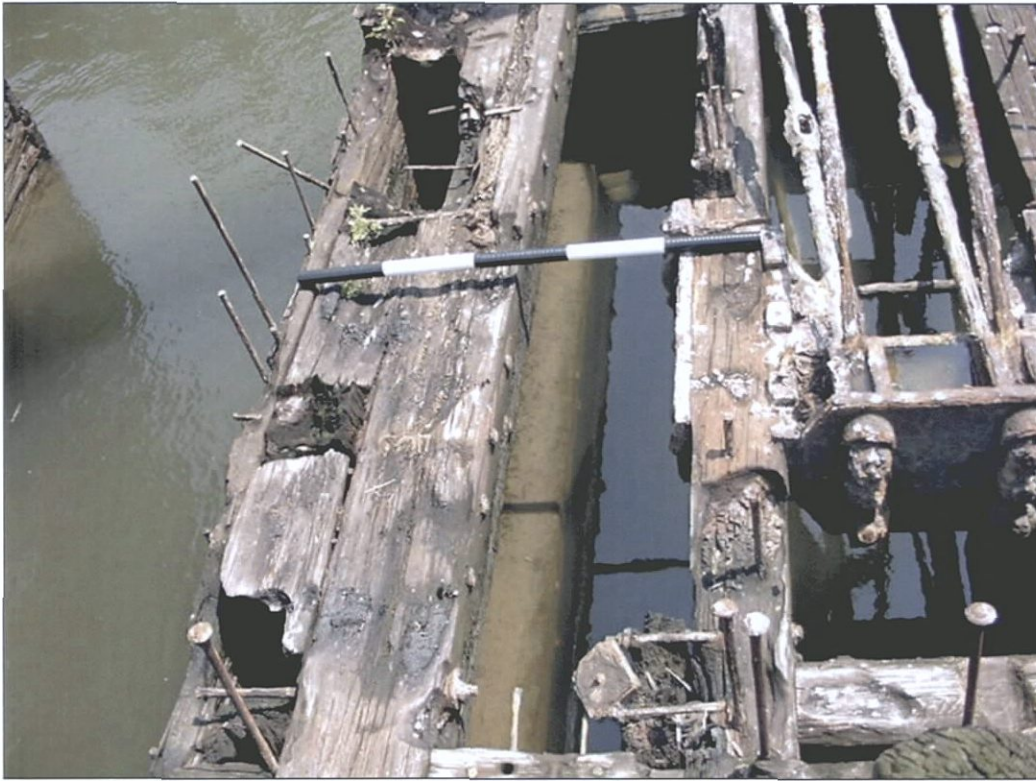
Figure 5-53. Vessel end frames on northern exposed end of V1. Note spacing and chocks. View to the east.

The outer hull is supported by a series of regularly spaced vertical frames extending from the end bottom log to the deck level. The scantlings vary according to location; the frames of the vessel ends are of considerably heavier dimension than those that make up the sides of the vessel. It should also be noted that the side frames continue past the main deck level to become frames for the outboard side of the wings. The end frames are 12 inches molded and 10 inches sided, and placed on 42-inch centers (Figure 5-53). A chock measuring 12 inches molded and 10 inches sided fills the space between each frame (Figure 5-54). The side frames total 18 inches in a molded dimension and are made up of two futtocks edge fastened rather than side by side. The outboard futtock measures 10 × 5 while the inner member measures 8 × 5. The side frames are located on the outboard side of each deck beam, again with the exception of the bulkhead locations, which employ a different vertical reinforcement that will be discussed below. The space between the frame and the next deck beam is filled with a chock at deck beam level (see Figure 5-54). The inner futtock extends to just above main deck level, where it terminates in a bevel cut, with the remaining futtock forming the frame of the wing structure (Figures 5-55 and 5-56). Several feet above the main deck the inner futtock is added again to support the wing framing structure.

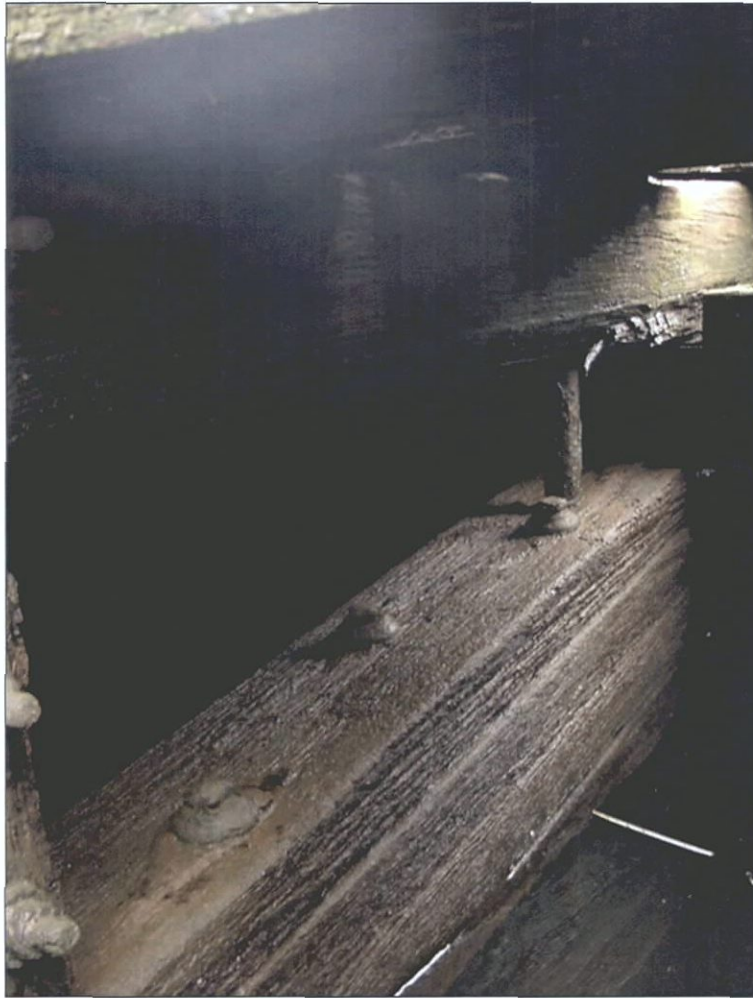
Figure 5-57. Main 16-inch laminated arched truss (T1). View from port toward vessel centerline (east).

The tremendous weight of the vessel sitting in the drydock is distributed equally to the surrounding water via a series of diagonal and arched trusses. A total of eight timbers, including one large curved laminated truss, make up each truss system. There is one located at each deck beam, again with the exception of the transverse bulkhead locations. The largest member, a giant curved laminated beam consisting of four 4-inch by 10-inch timbers fastened together to form one 16-inch beam, extends from the lower side of the main hull across the central bulkhead (Figure 5-57). It is fastened to each deck stanchion and rests on the aforementioned chock placed directly below the deck beam.

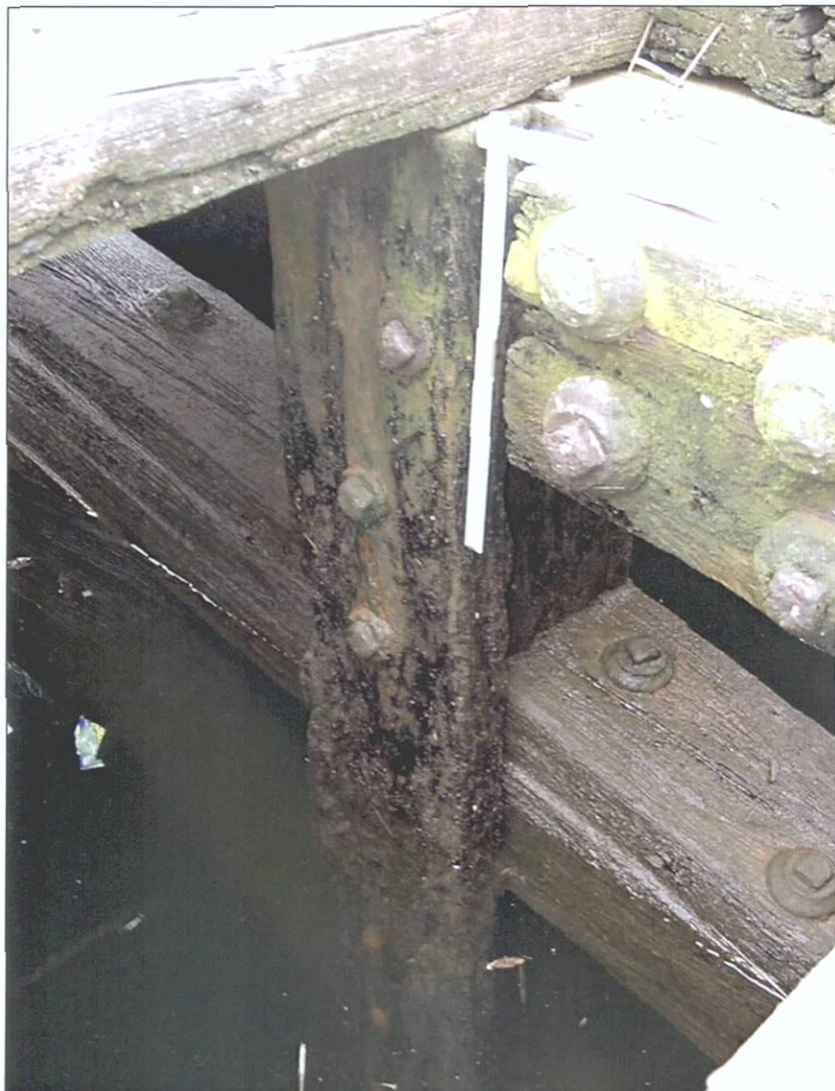
Figure 5-58. Main 16-inch laminated arched truss (T1). View toward southeast (aft starboard corner).

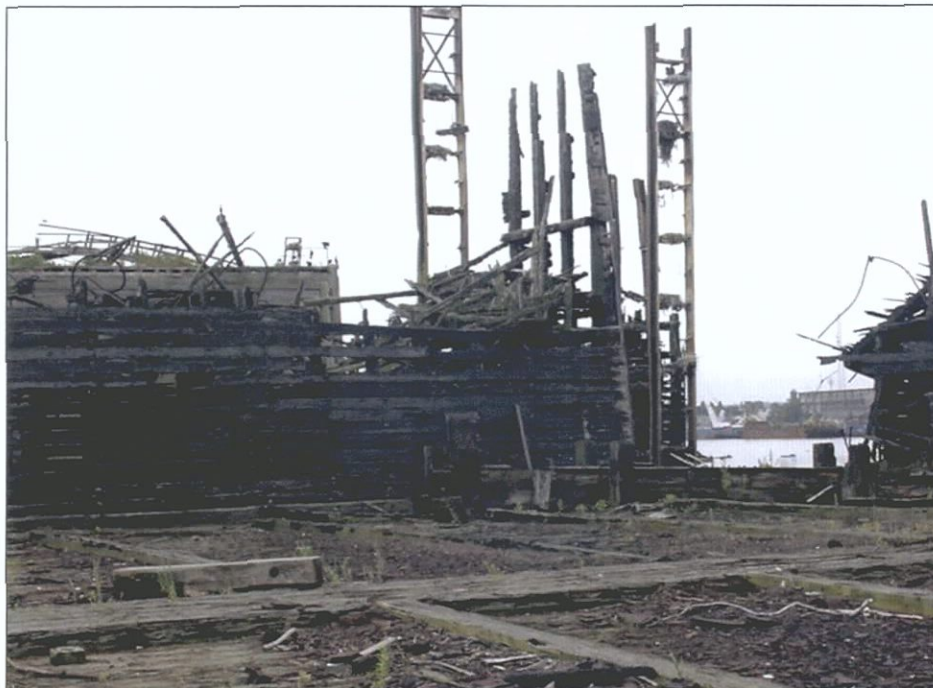
Figure 5-86. Main deck looking starboard (southeast). Note location of drains, bottom center.

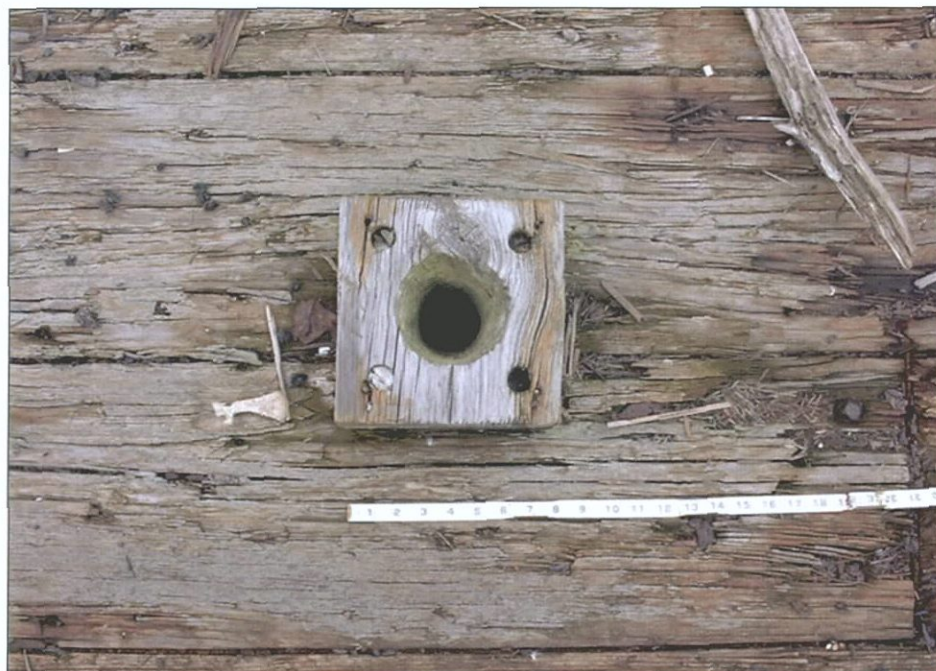
Figure 5-87. Deck fitting with tapered hole.

Also observed at various places close to the centerline but most often on the side of each bilge block stringer opposite the drain is a square fitting with a circular tapered hole of unknown function (Figures 5-86, lower left, and 5-87). Measuring 9 inches square and 2 inches tall, with a 3-inch diameter hole tapering to 2 inches at the bottom, it would appear some kind of receiver fitting for a vertical pole.

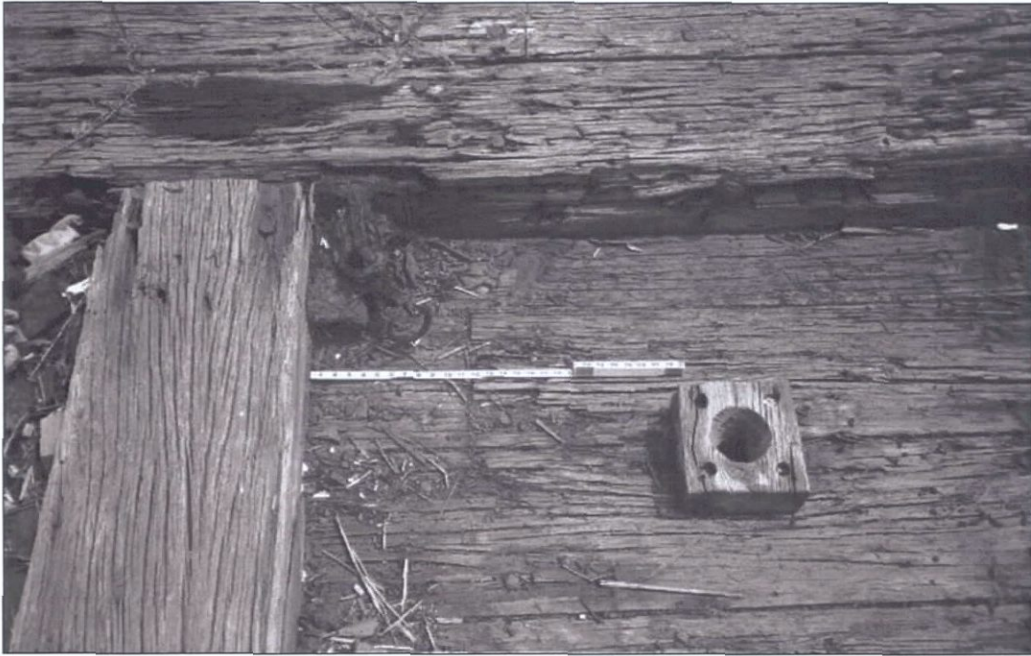
Figure 5-88. Square deck fitting in relation to bilge block and keel block stringers.

Also present, although highly deteriorated, are several hook-and-eye fittings, perhaps part of the bilge block track system (Figures 5-88 and 5-89).

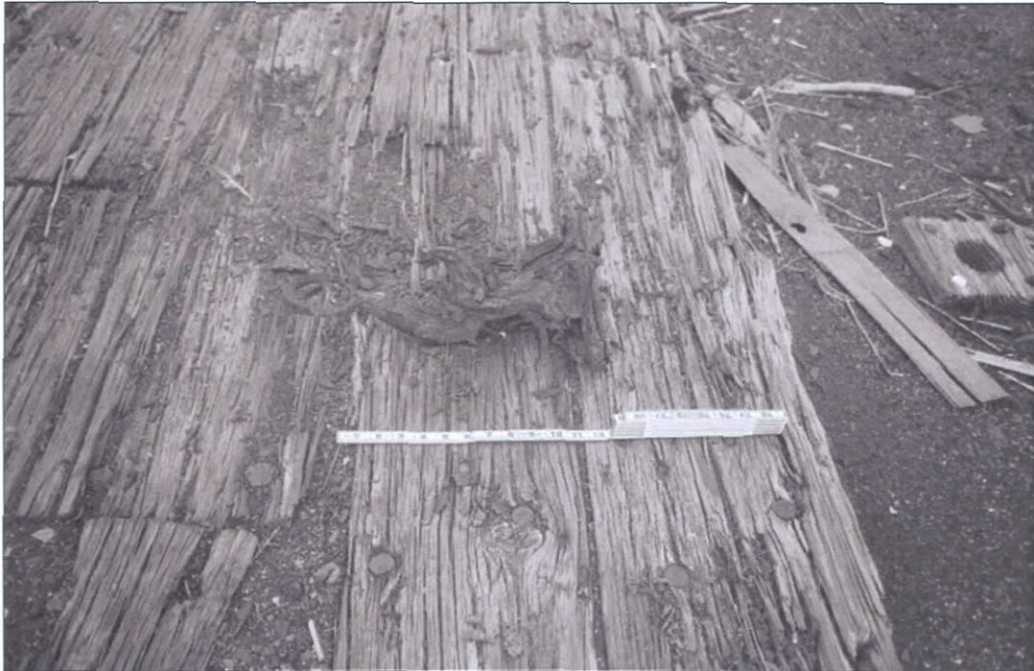
Figure 5-89. Loose hook and eye, highly deteriorated and concreted.

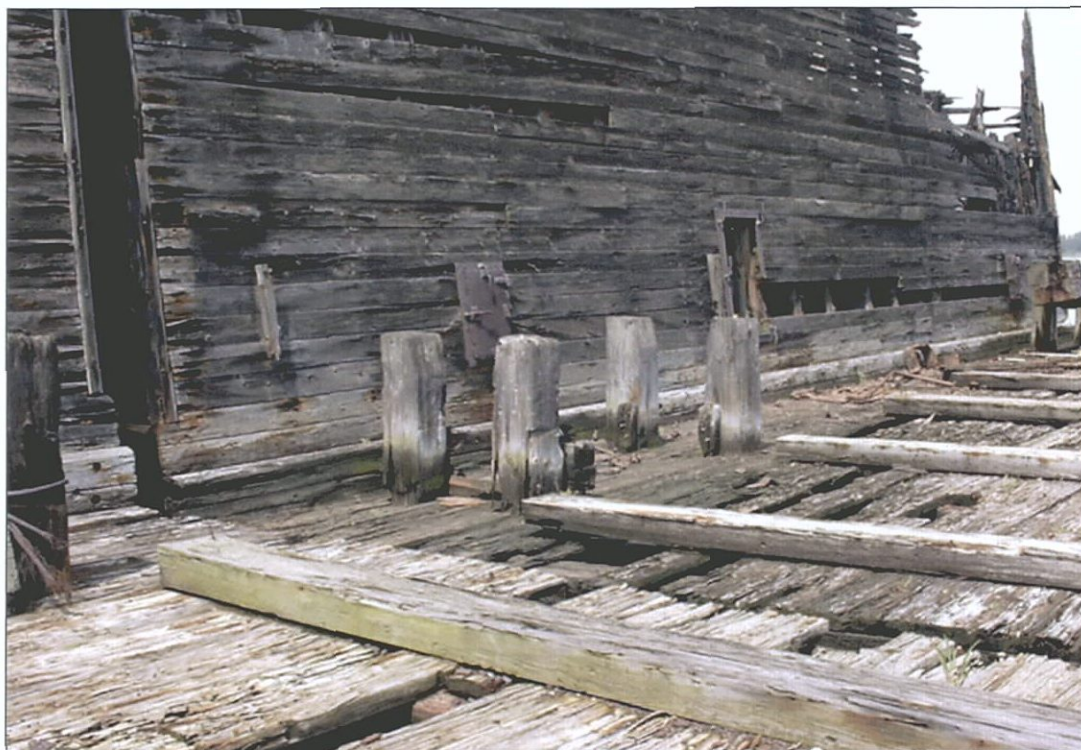
Figure 5-134. Port wing showing hatch locations. View to the northwest (port).

There are several access hatches in the inner face of each wing (Figures 5-134 and 5-135). These allowed access to the inner wing structure and machinery below the upper (middle) deck. The center hatch, which is also the largest of the three, is 26 inches wide by 60 inches tall, with the overall frame 45 inches by 69 inches. It exactly spans one wing frame interval and is fastened with carriage bolts to the adjacent planking. The hatch dogs, now rusted in place, have handles 9 inches in length. The outer two hatches, both identical to each other and smaller than the center hatch, still retain their doors, which are dogged in place and rusted shut (Figures 5-136 and 5-137). The small hatches measure 45 inches tall by 31 inches wide overall, with an opening and hatch size of 39 inches tall by 25 inches wide. It is centered between frames and fastened to the planks with carriage bolts.

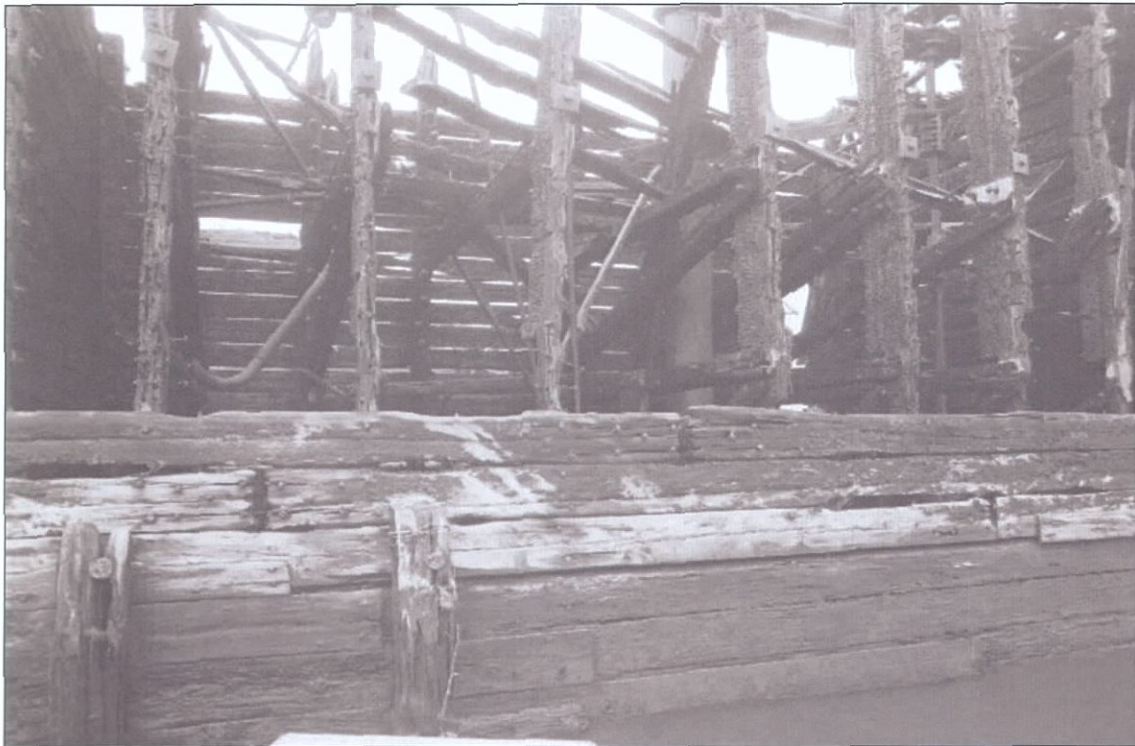
Figure 5-148. Remnants of starboard wing, showing pump, valve, and floodgate actuator rods.

The dock is flooded through the use of gravity. Floodgates in the outer hull and between each compartment opened via manually operated handwheels concentrated in one area on the top deck of the dock and connected via a series of rotating shafts and universal joints. Flooding is controlled to the various sets of interconnected compartments by adjustments to the floodgates (Figure 5-148).
