U.S. Army Corps of Engineers
New York District

**RECORDATION OF SIX (6) VESSELS
IN CONNECTION WITH THE
NEW YORK AND NEW JERSEY HARBOR NAVIGATION STUDY
UPPER AND LOWER BAY
PORT OF NEW YORK AND NEW JERSEY
STATEN ISLAND, RICHMOND COUNTY, NEW YORK
ELIZABETH, UNION COUNTY AND
BAYONNE, HUDSON COUNTY, NEW JERSEY**

**VOLUME I: FINAL REPORT
FEBRUARY 2008**

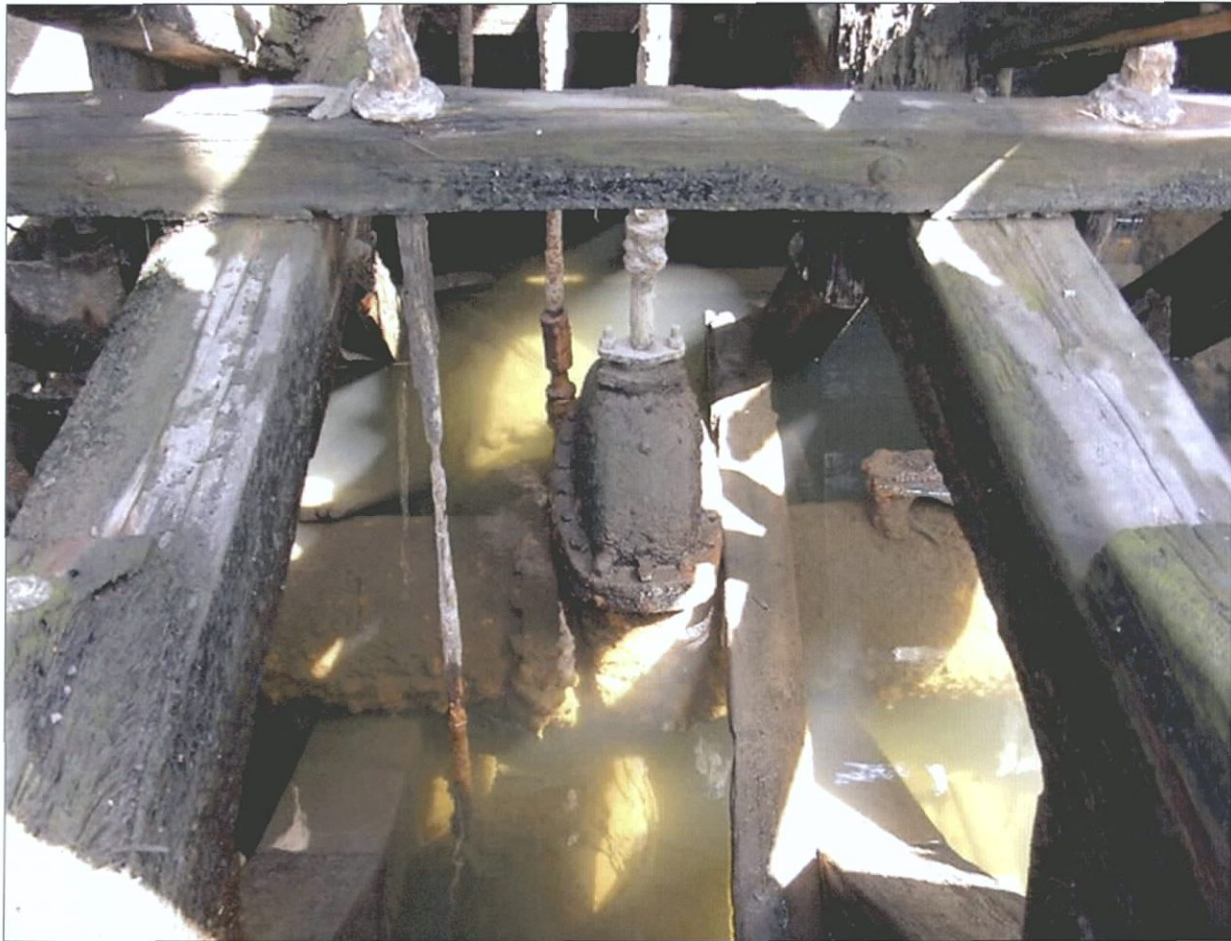
Figure 5-151. Gate valves in inlet (below) and outlet (center) pipes. Port side, view to the west.

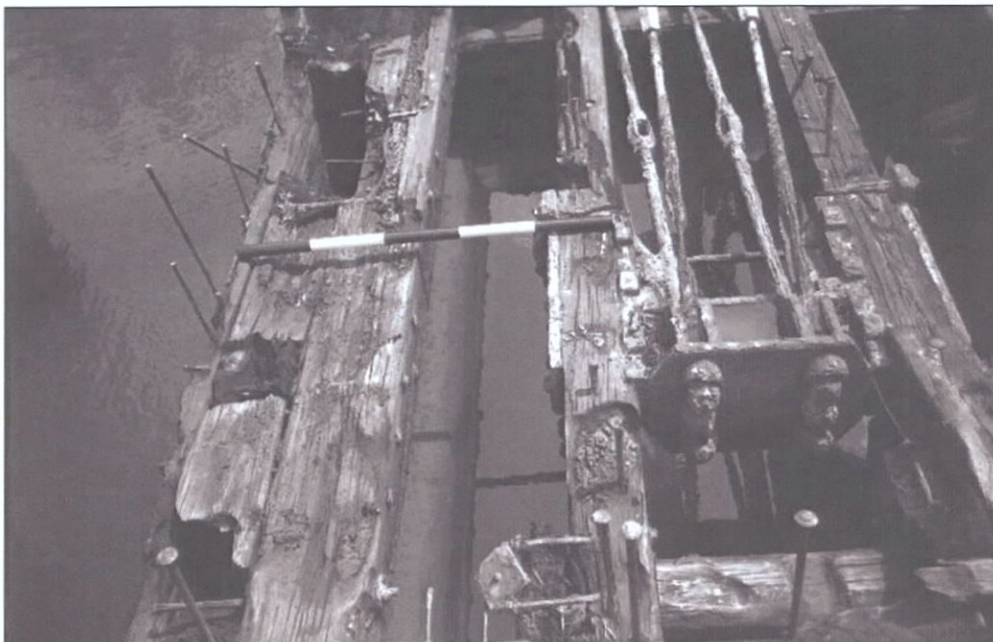
Figure 5-169. Turnbuckle anchor. Starboard forward, view to the east (starboard).

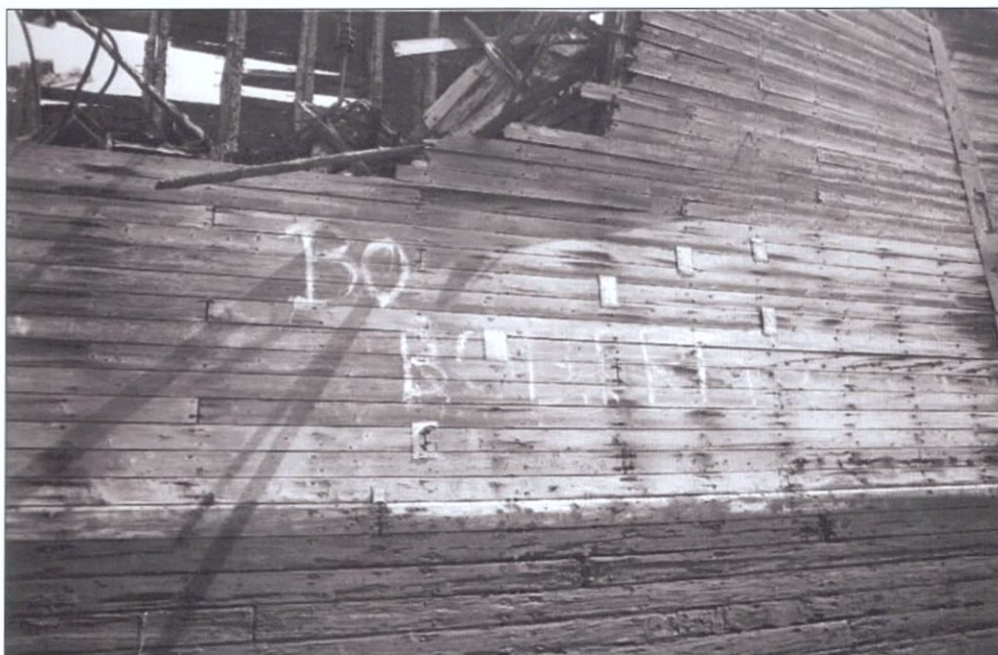
Figure 5-170. Port wing showing tin patches covering plank joints. View to the southeast (starboard).

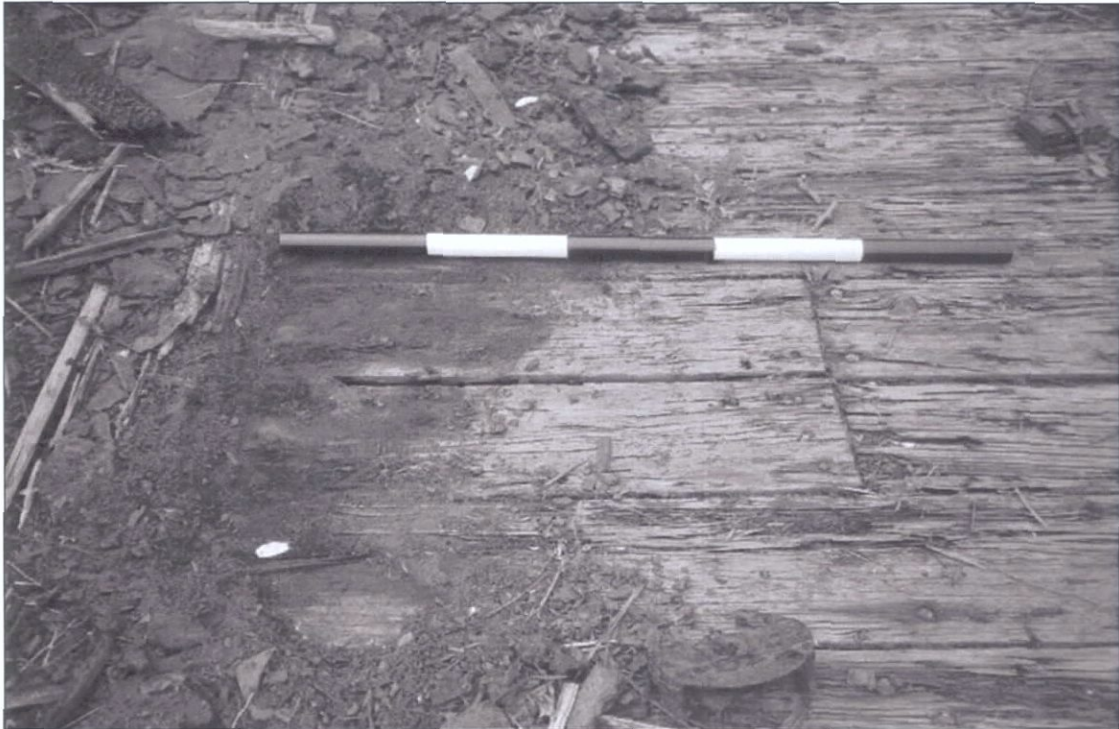
Figure 5-171. Small section of replaced deck plank on main deck. Note different fasteners on patch.

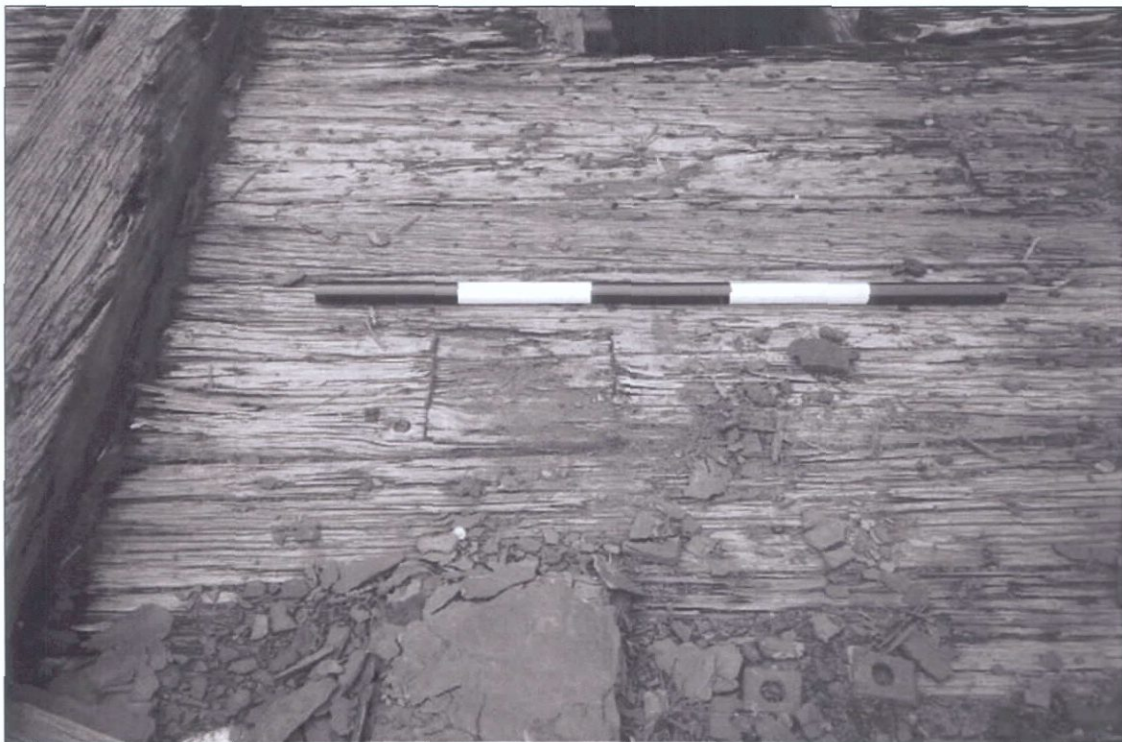
Figure 5-172. Small plug repair on main deck.

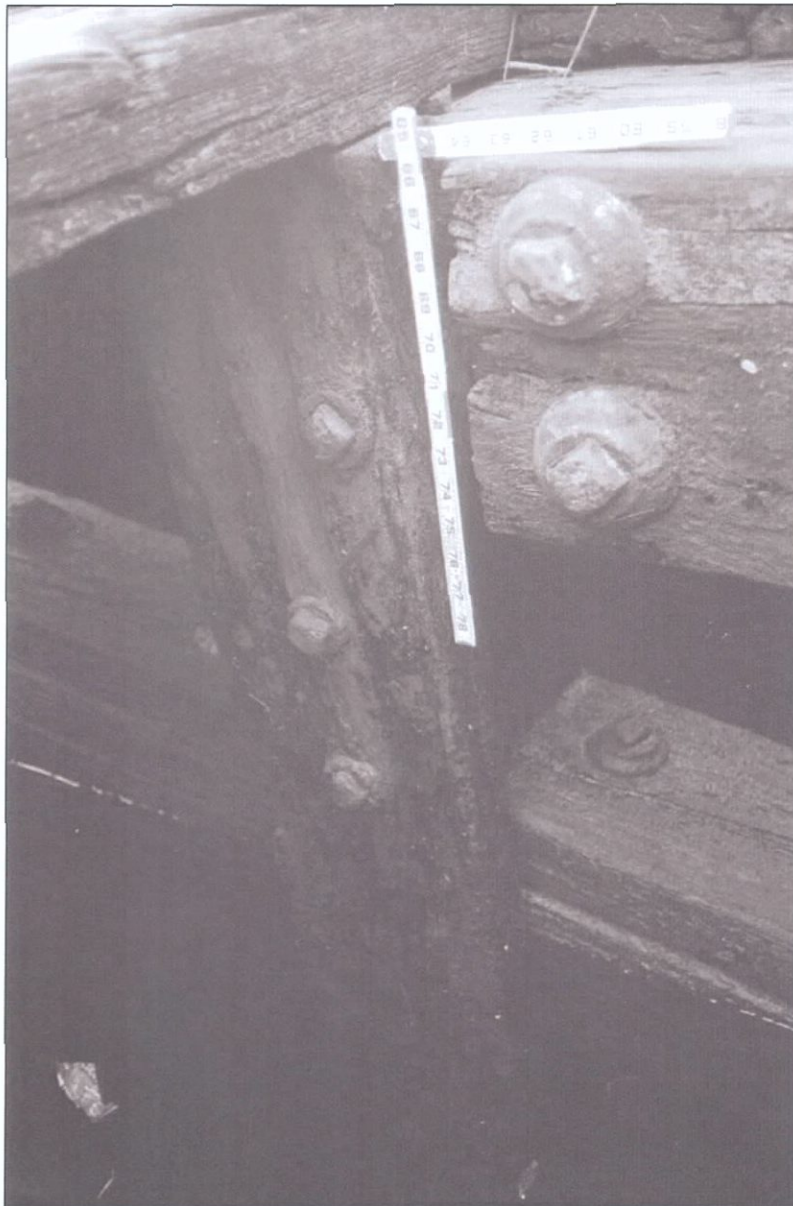
Figure 5-173. Truss and stanchion showing 1-inch and 5/8-inch bolts.

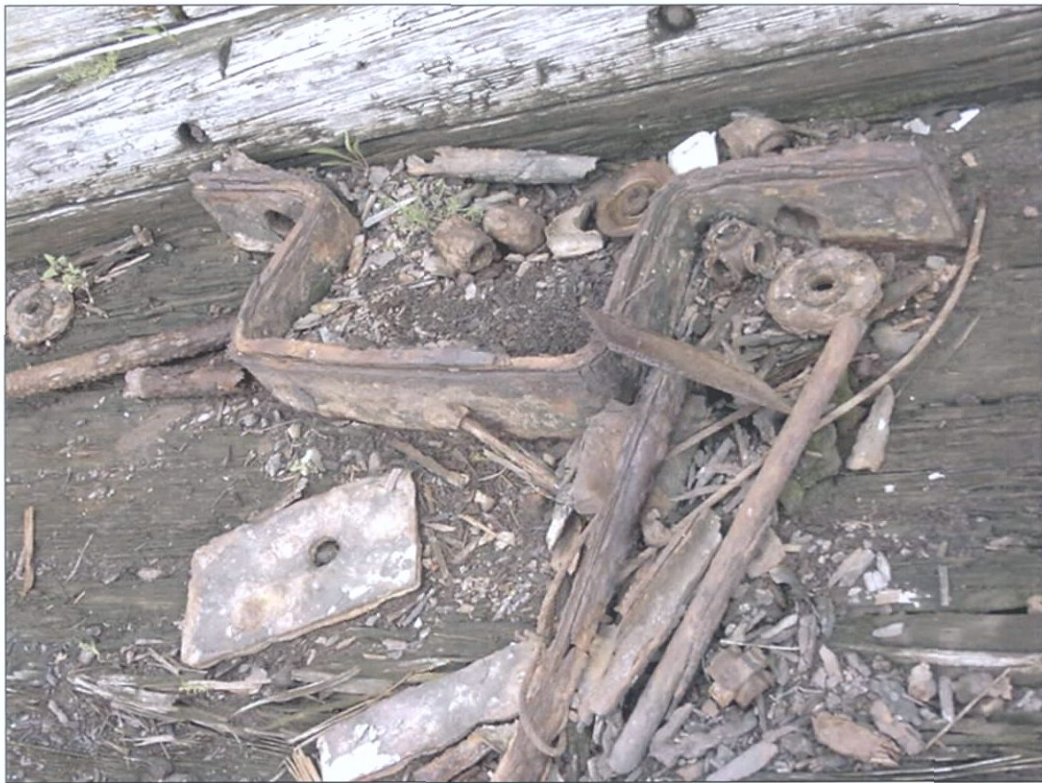
Figure 5-182. Pile of debris including coupling cinch plate, various pipes, and flanges relating to the railing. The piece of iron with the hole in it is a temporary tie down welded to the side of the vessel being repaired.

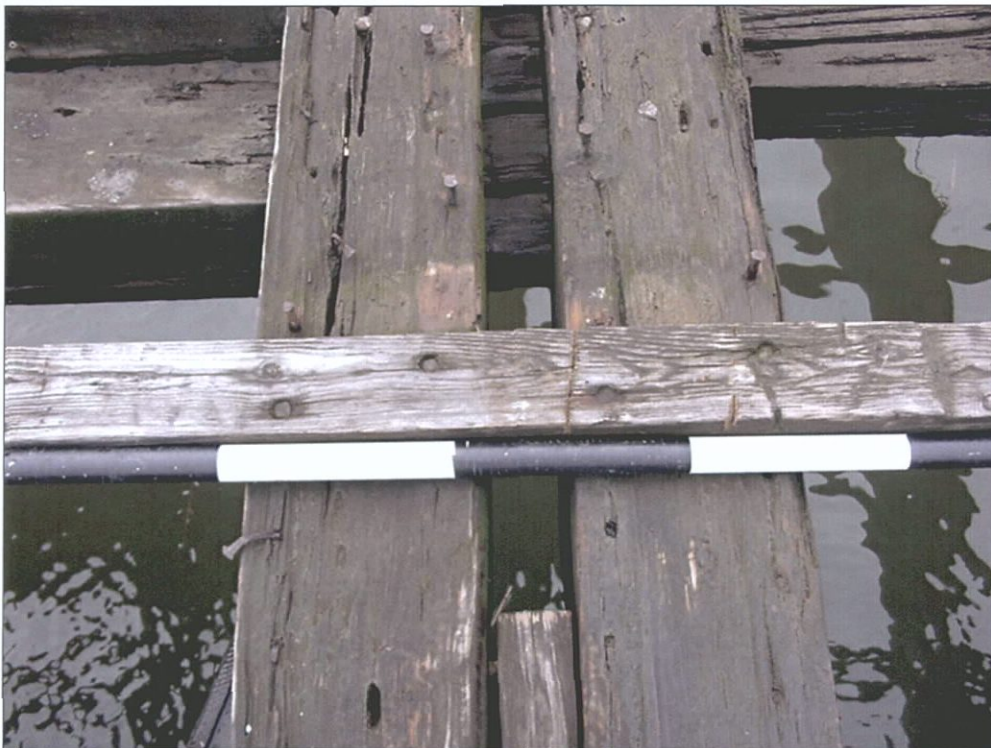
Figure 6-83. Single remaining deck plank just starboard of forward hatch. Note rose head spikes and fastener pattern.

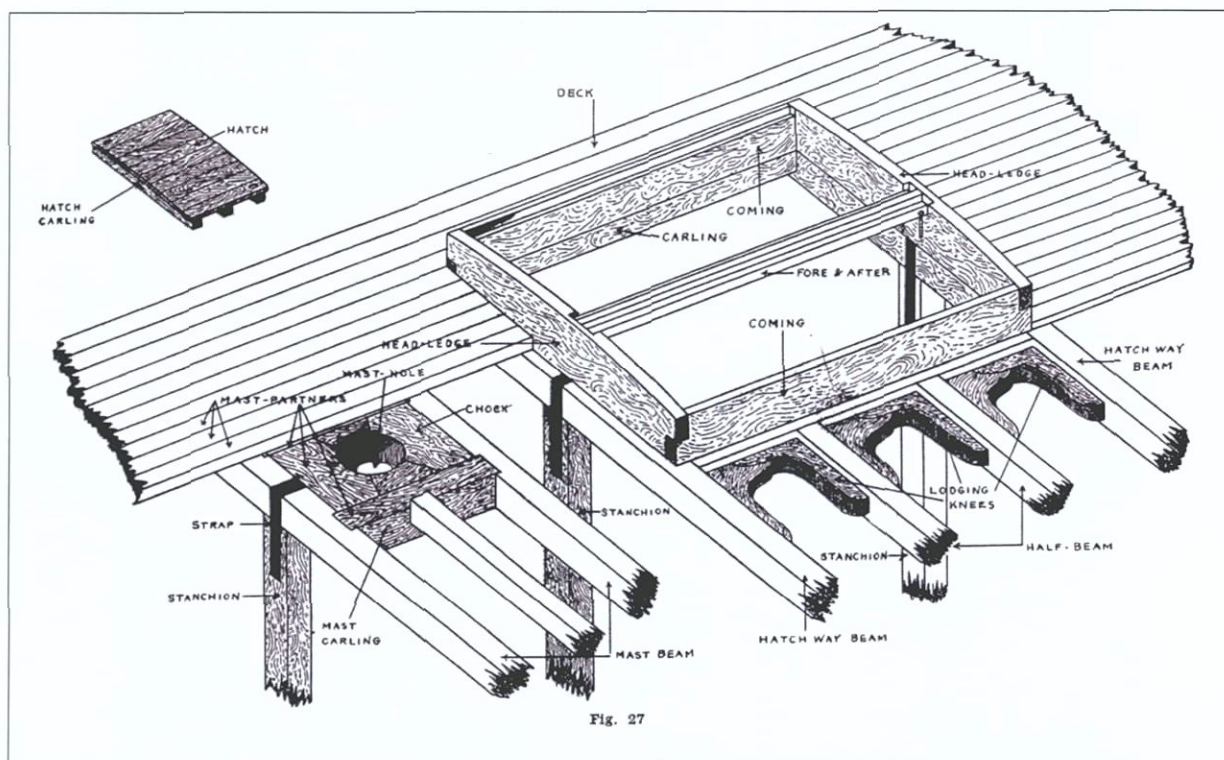
Figure 6-92. Illustration of common method of framing deck mast hole of typical wooden sailing vessels in the early twentieth century. Note use of lodging knees, which are absent in the *Thurlow* (as presented in Desmond 1918).

No lodging knees were noted in the construction of hatch or mast hole framing.

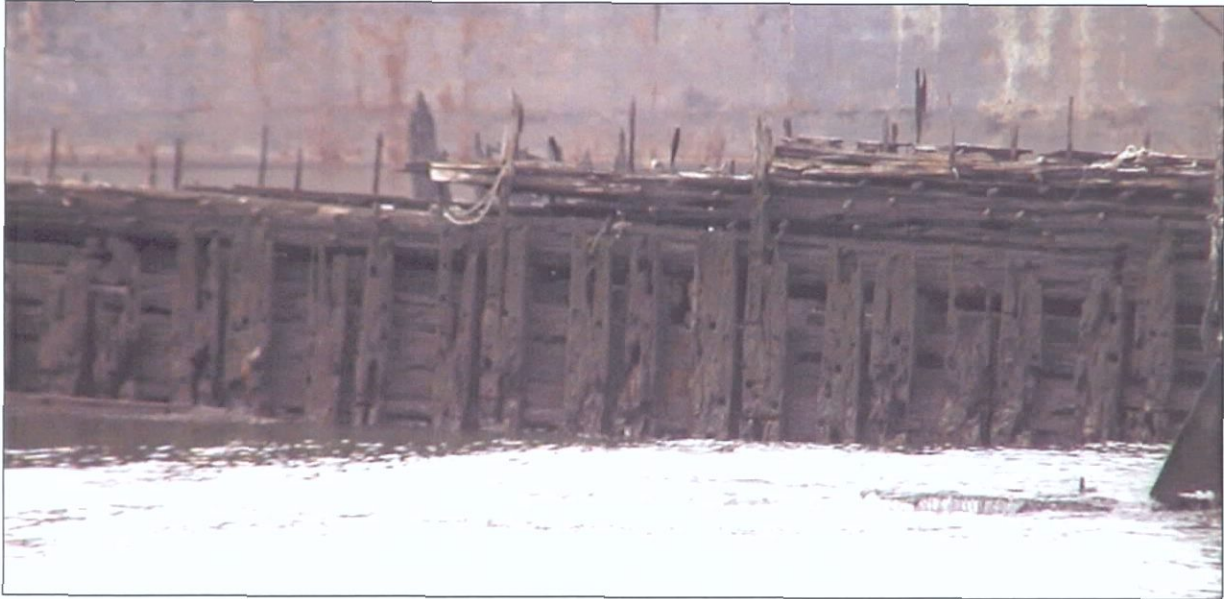
Figure 6-105. Port side, amidships, showing arrangement of futtocks and frames. View to the southwest.

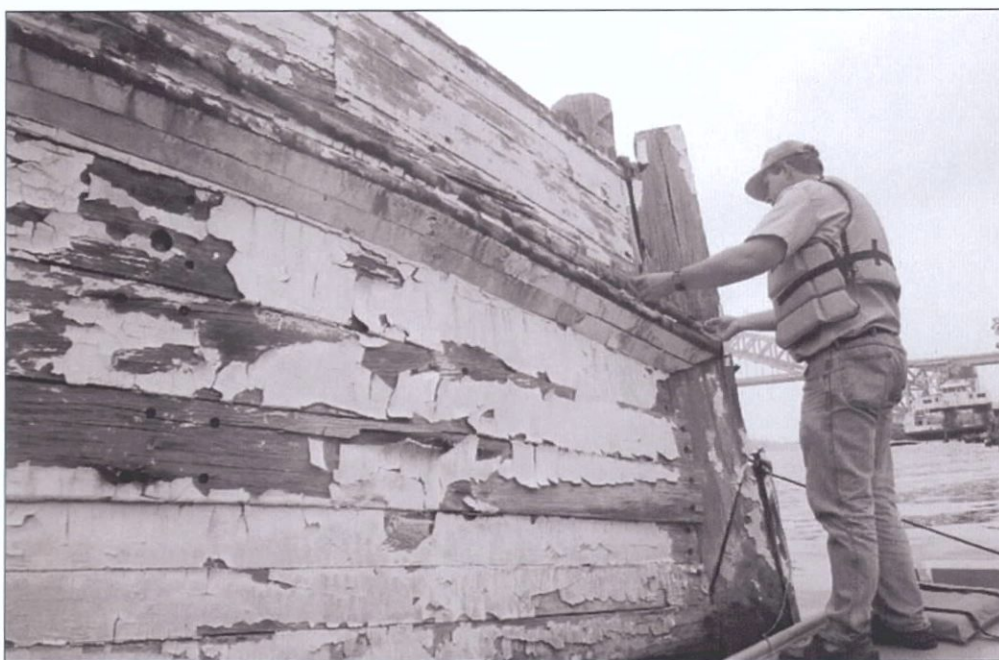
Figure 7-55. Starboard side of bow, showing main rub rail construction. View to the southeast.

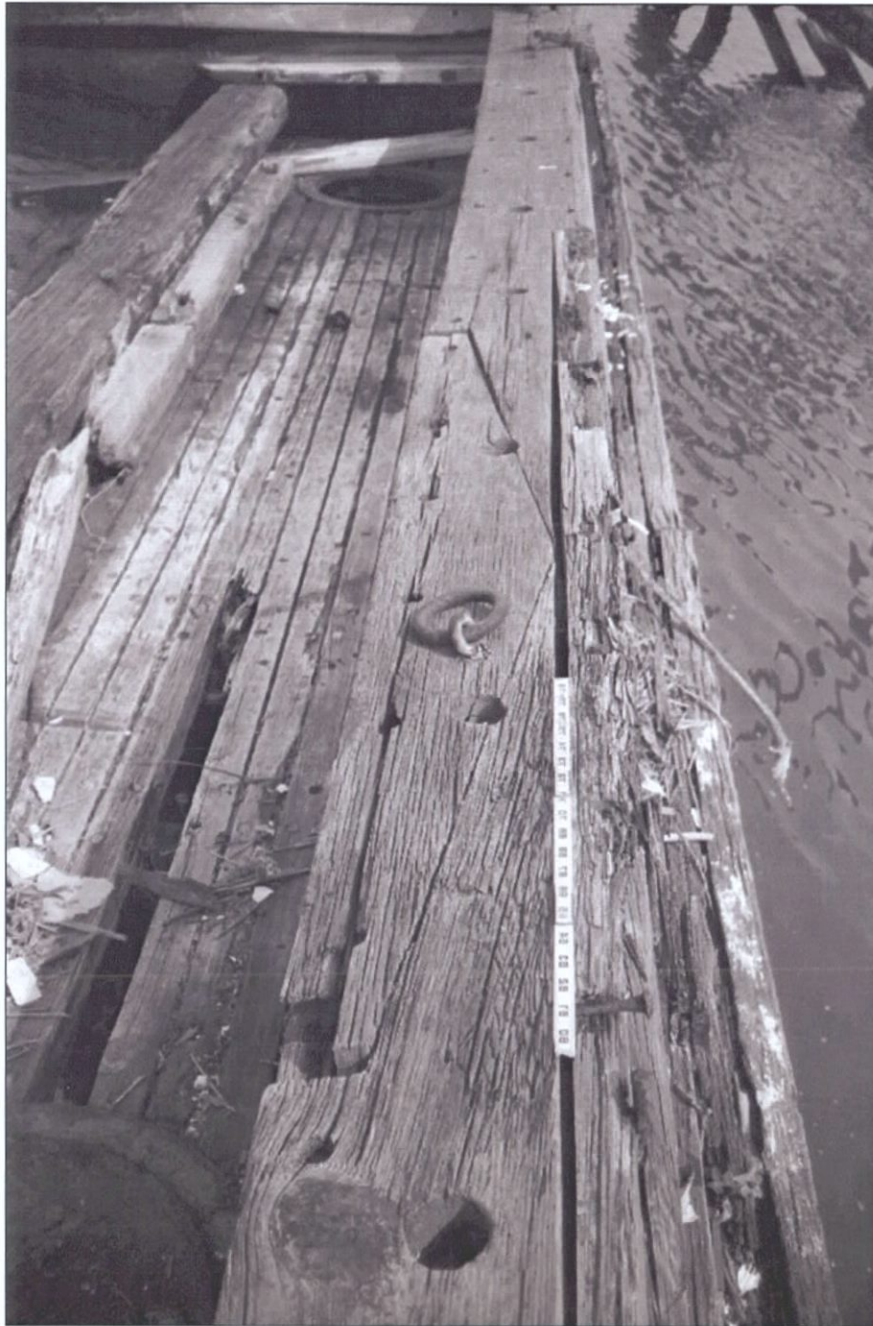
Figure 7-104. Scarph joint used to join sections of the starboard rail.

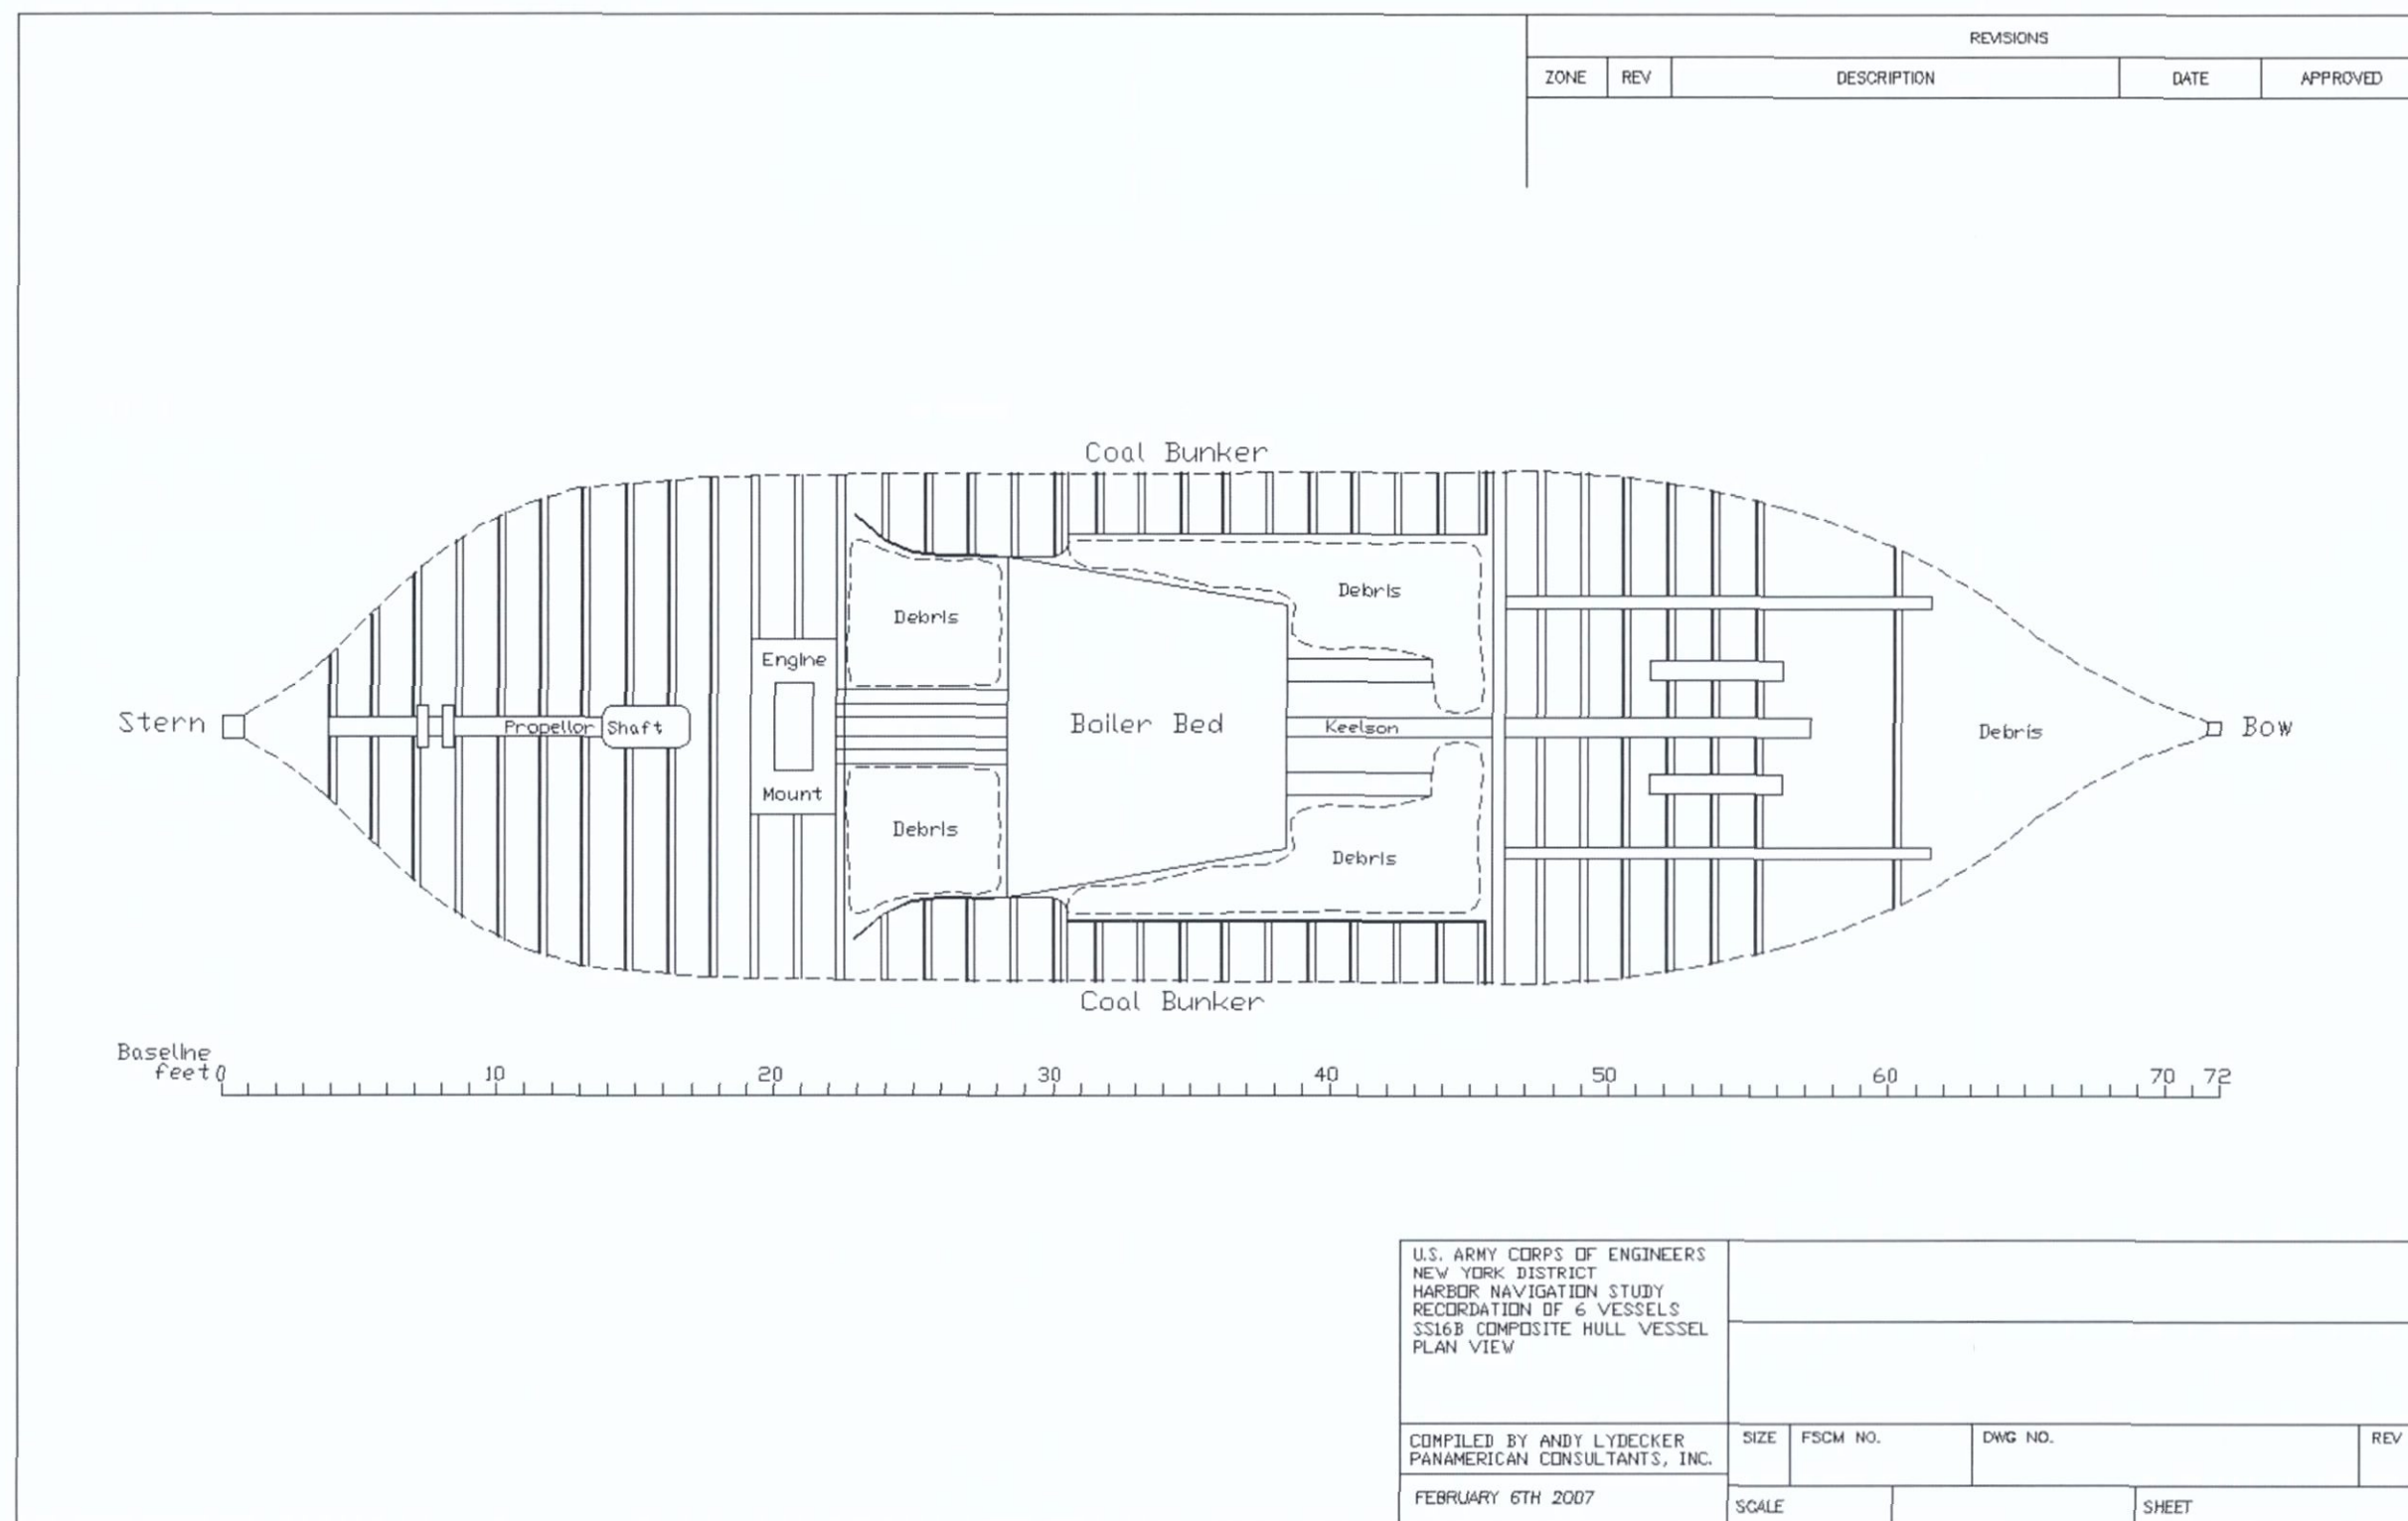
Figure 8-18. Plan view of SS16b.

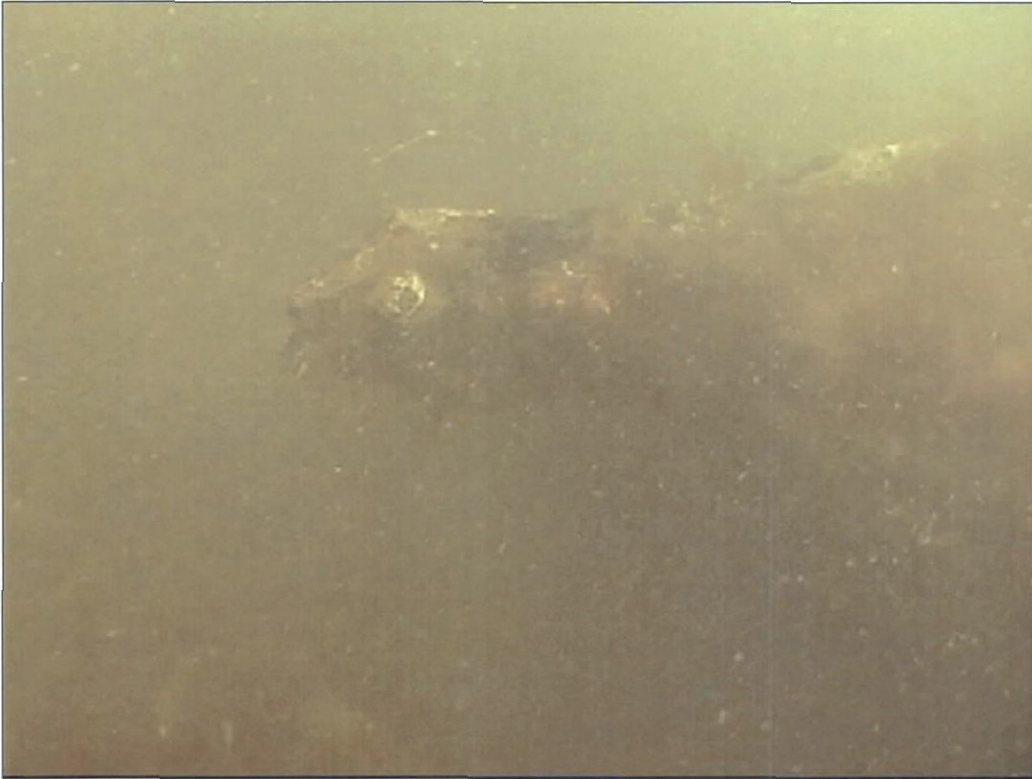
Figure 8-19. Video frame of deteriorated iron framing of SS16b.

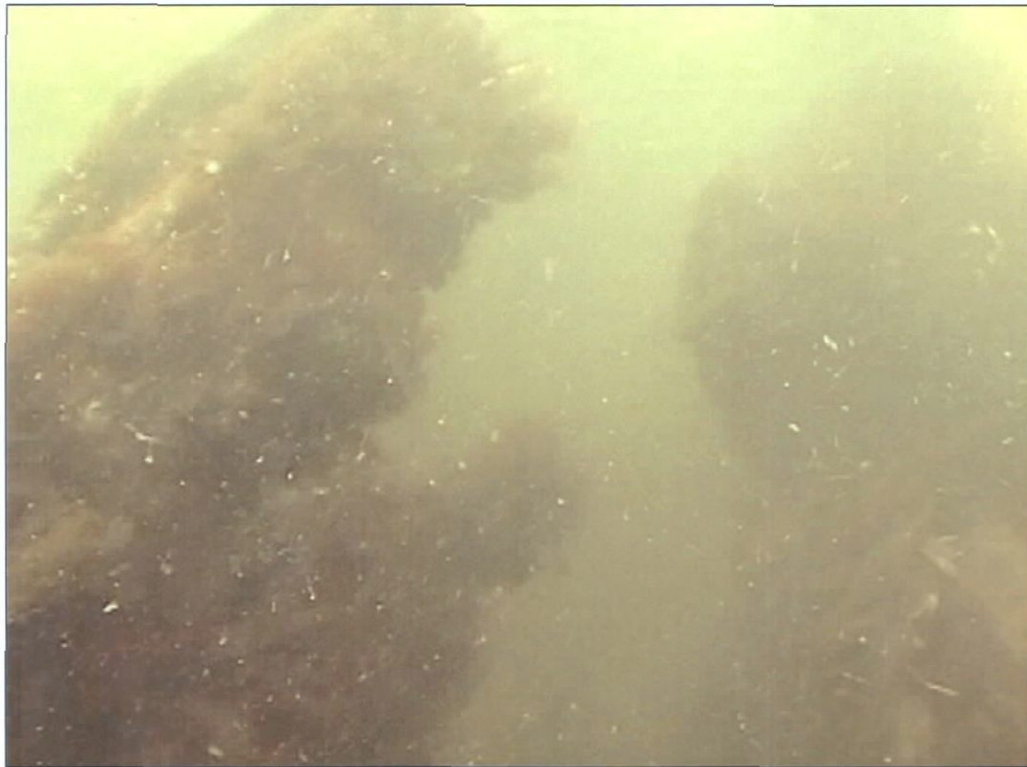
Figure 8-20. Video frame showing deteriorated hull planking.

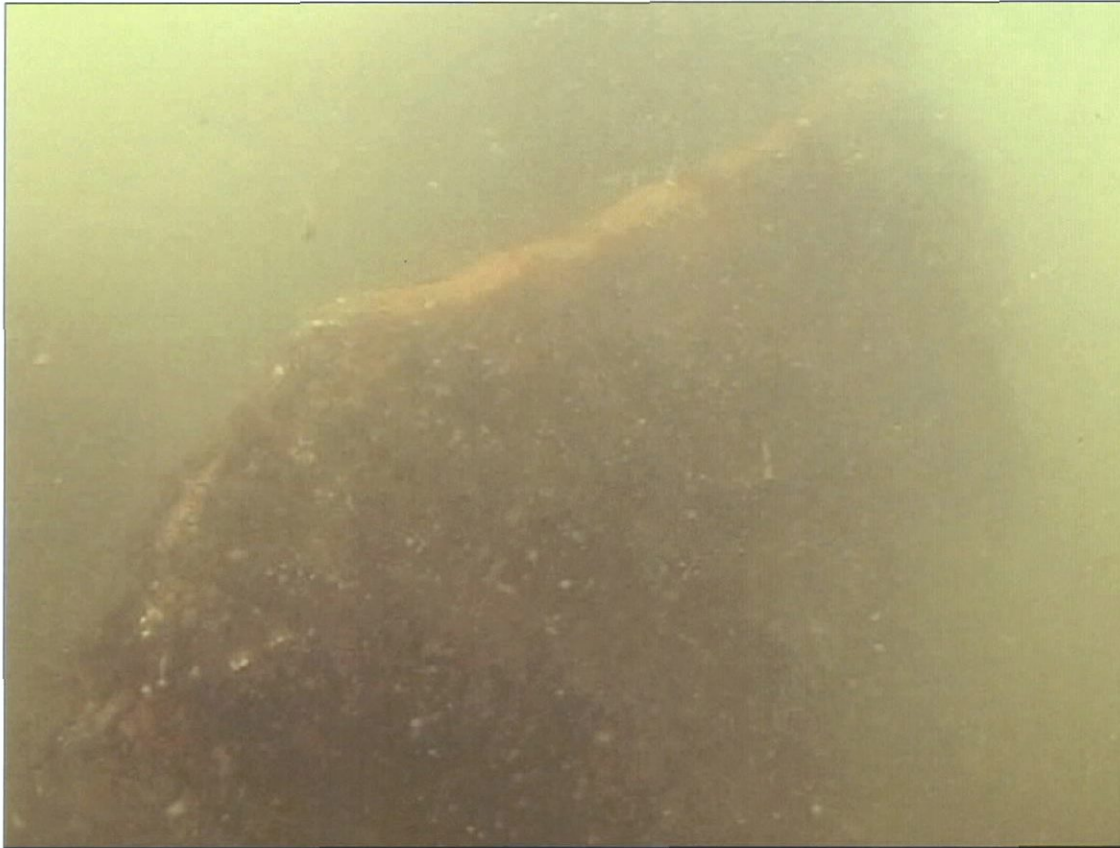
Figure 8-21. Video frame showing broken end of propeller.

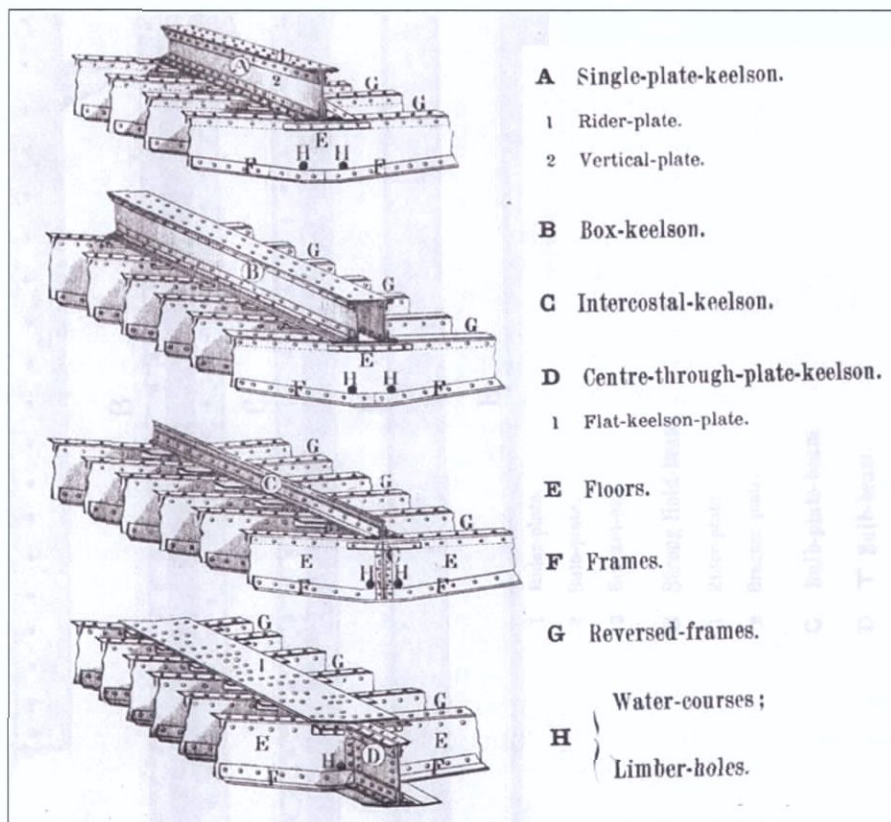
Figure 8-28. Illustration showing frame construction present in SS16b (after Paasch 1890:Plate 38).

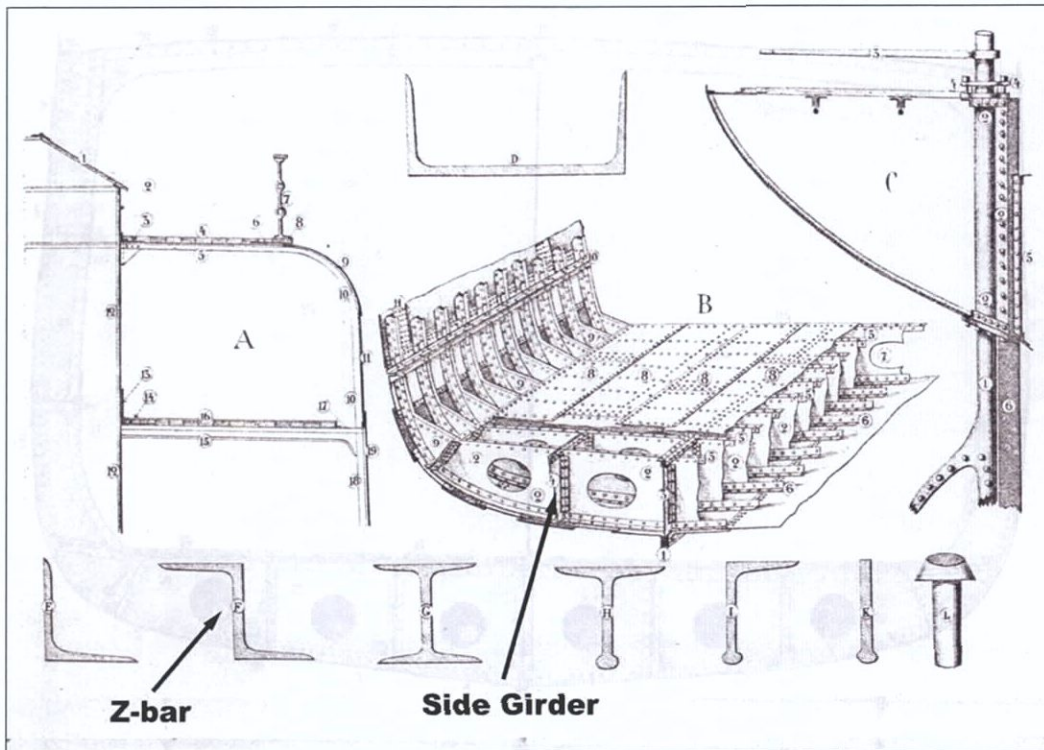
Figure 8-29. Illustration showing side girder framing and Z-bar like that found on SS16b (after Paasch 1890:Plate 29).

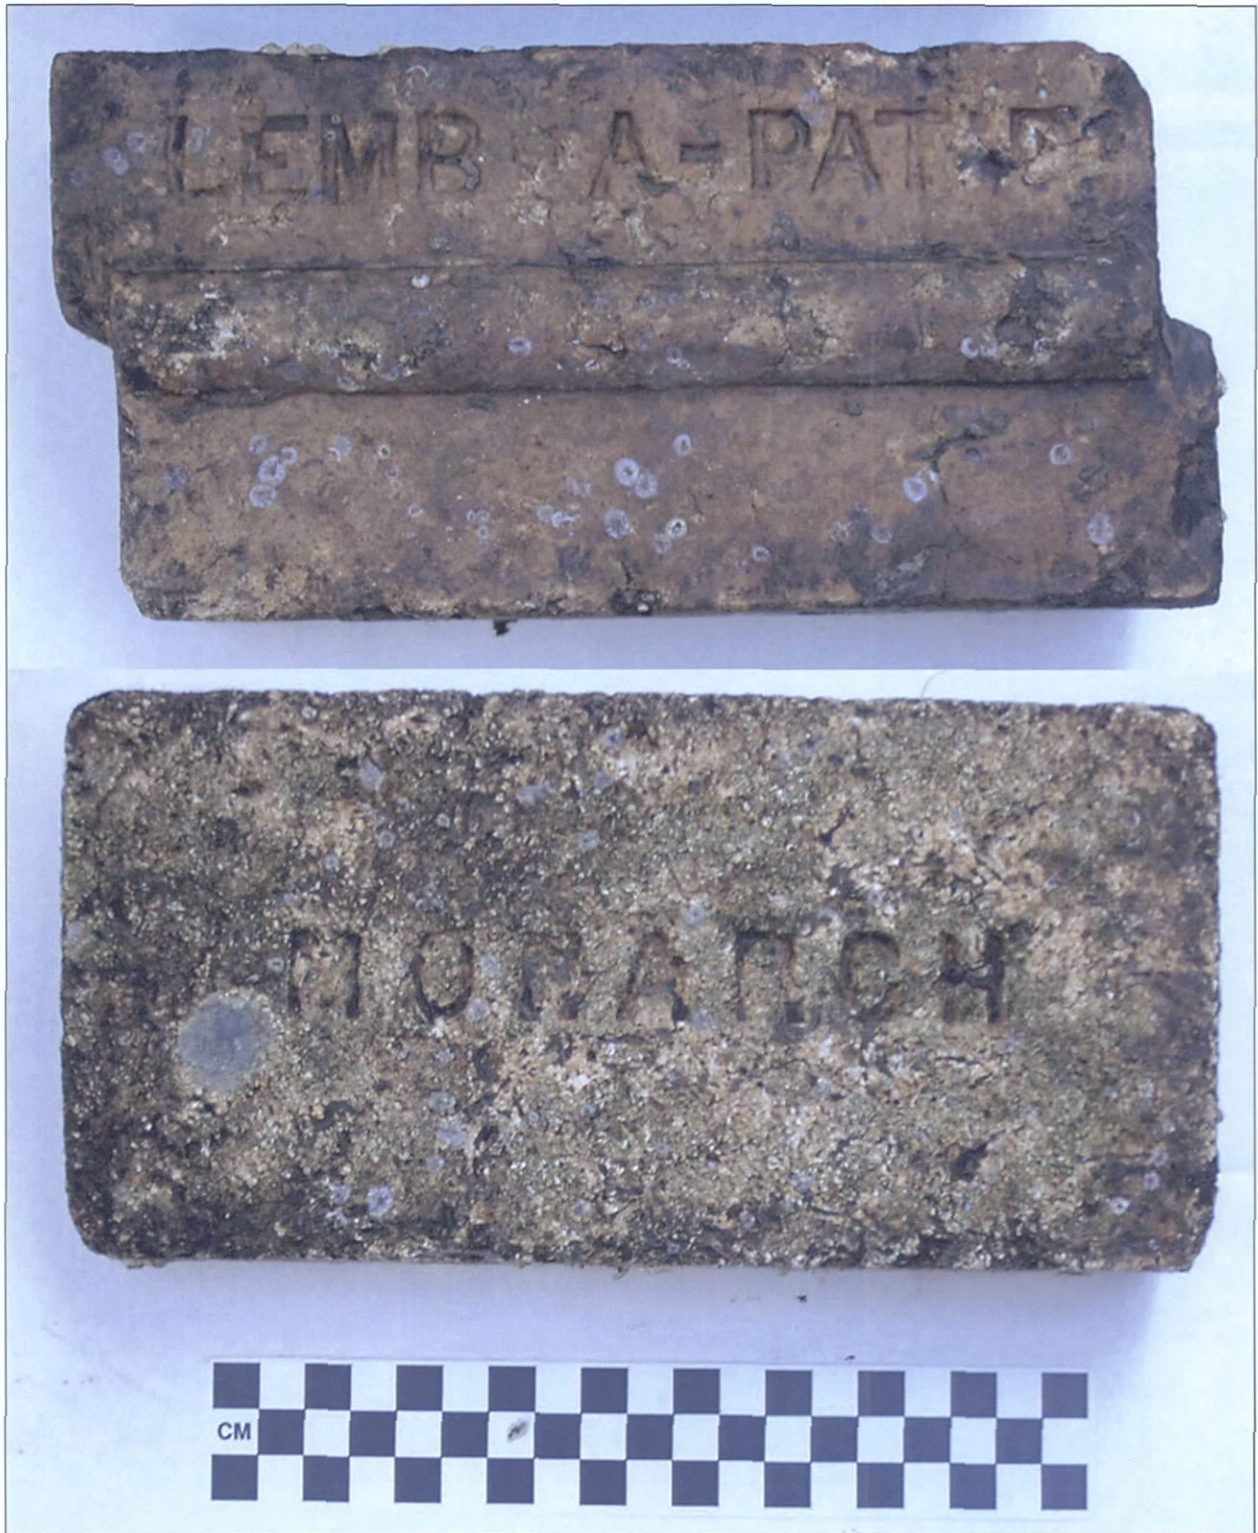
Figure 8-30. Tongue-and-groove brick (top) and Monarch firebrick (bottom) recovered from SS16b.
