**SUBSURFACE TESTING FOR THE PROPOSED QUAKER MEETING HOUSE
PORCH RECONSTRUCTION PROJECT
137-16 NORTHERN BOULEVARD, QUEENS COUNTY, NEW YORK**

**NEW YORK STATE OFFICE OF PARKS, RECREATION AND HISTORIC
PRESERVATION PROJECT REVIEW NUMBER 03PR03481**

Eugene J. Boesch Ph.D., R.P.A.

October 20, 2008

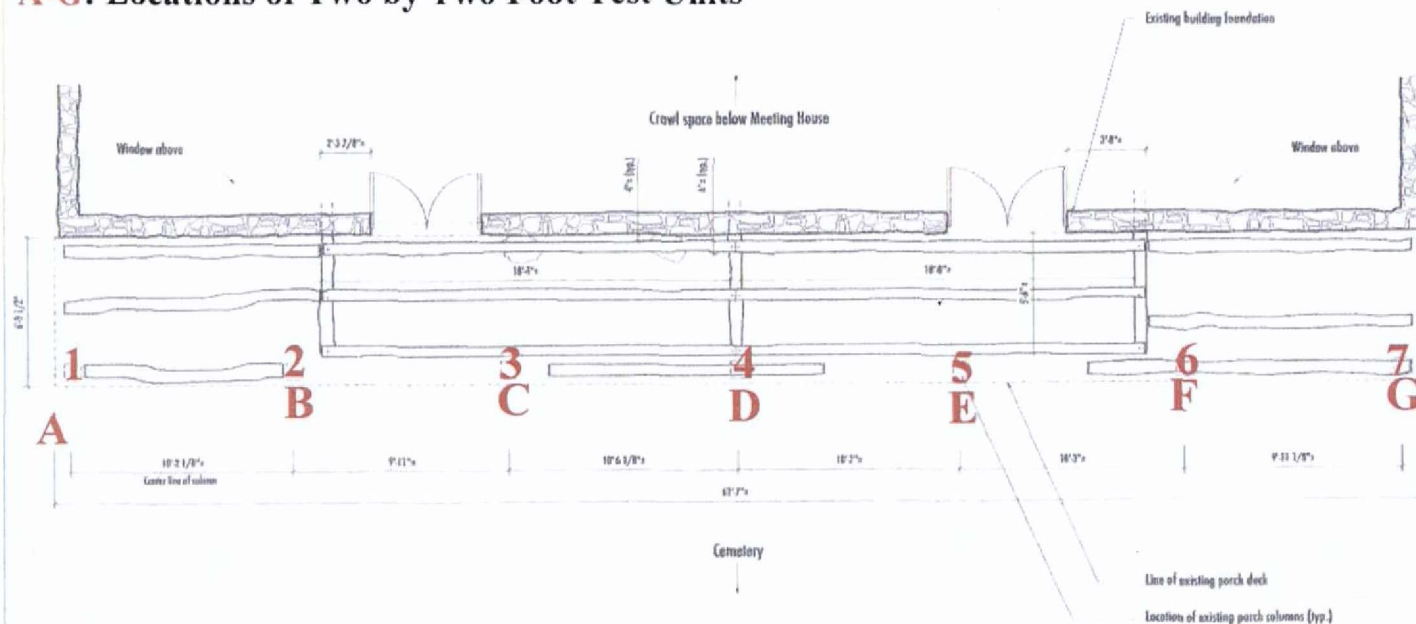
Figure 2

- 1-7: Locations of Shovel Tests**
A-G: Locations of Two by Two Foot Test Units

**Quaker Meeting House Porch Reconstruction Project Showing
Locations of New Posts and the Locations of the Archaeological
Shovel Tests and Test Units**

Two stratigraphic sequences were encountered by the seven shovel tests excavated along the south edge of the existing porch at the planned locations for the new post footings. One sequence was encountered in shovel tests 1, 2, and 6 with the second sequence revealed in shovel tests 3 - 5 and 7 (Figure 2). The two sequences were

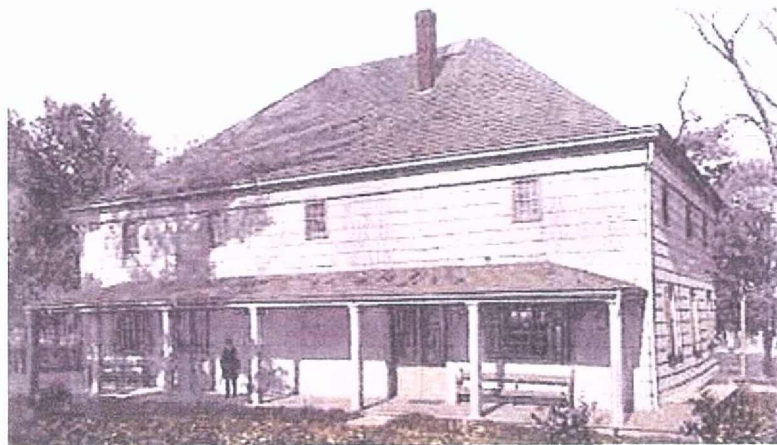
Figure 4

Quaker Meeting House, 1850s. Photo by J. H. Smith. From the collection of the Quaker Historical Society, Philadelphia, Pa.

Undated Historic View of Quaker Meeting House Showing Porch with Pillars

The Society prospered in its new home. Its membership increased rapidly over the next two decades resulting in the need to expand the structure. The new addition, extending westward from the original structure and more than twice its size, was erected in 1717. The Meeting House's exterior dimensions have remained essentially the same ever since (Lowry 1994:5). The existing porch, extending from the south face of the structure for approximately six feet, nine and a half inches, reportedly was constructed during the early nineteenth century (Prudon 1976:3). An earlier porch may have been located in the same area. The appearance of the porch in historic views is similar to that of the existing porch prior to the recent reconstruction work there (Figures 4 - 6).

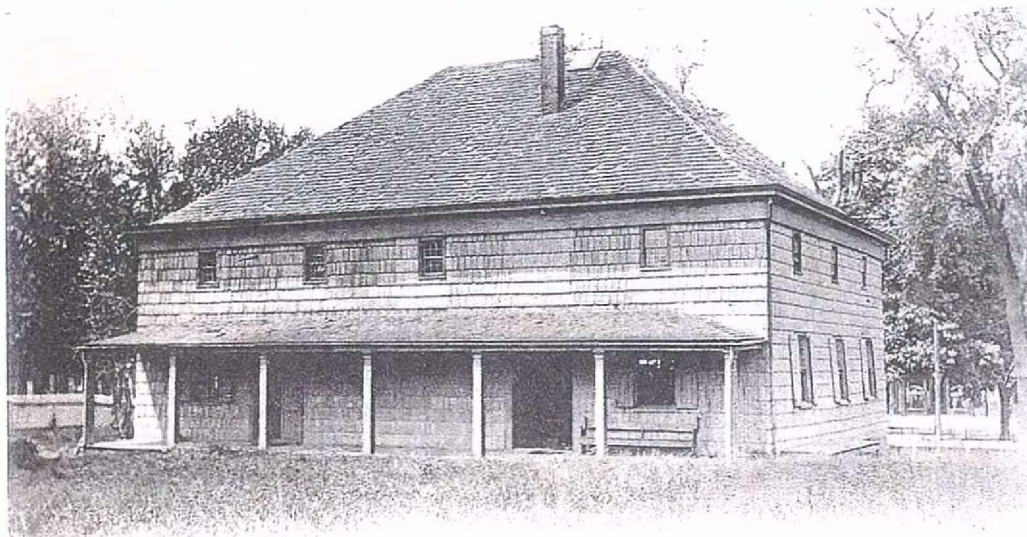
Figure 5

Undated Historic View of Quaker Meeting House Showing Porch with Pillars

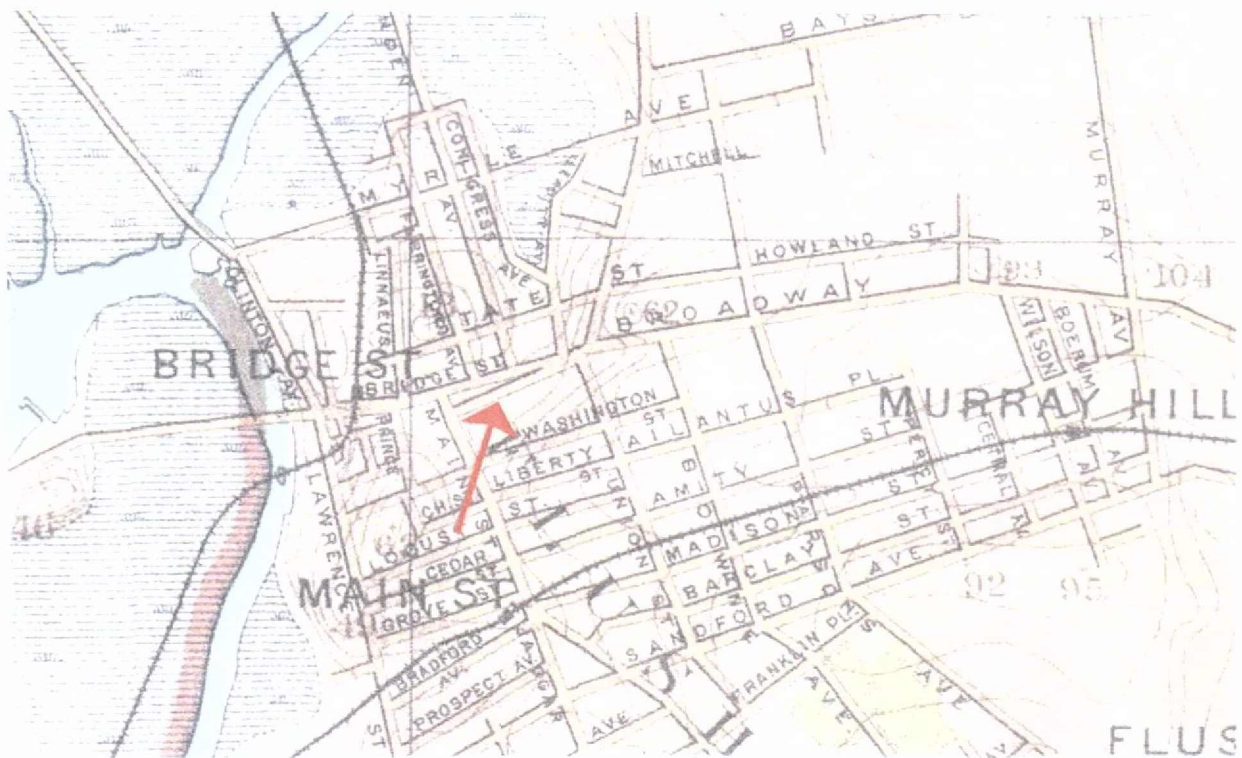
Figure 6

1891 Bien and Vermeule Map Showing the Extensive Wetland and Stream System West of the Quaker Meeting House

Arrows indicates approximate location of the project area.

Any Native American materials present within the project's APE most likely would be related to small, unrecorded campsites oriented towards the exploitation of subsistence resources most likely associated with the large wetland and stream system that still exists, beginning about 1,800 feet west of the project site. Prior to development, the system was more extensive than it is currently with portions having been filled over the course of the twentieth century. The location of the pre-development wetland relative to the Quaker Meeting House property is depicted on the 1891 Bien map reproduced in this report as Figure 6.

Beneath the near surface soil in test units A - D were two to three, thin layers of fill, 15 to 19 centimeters (5.9 to 7.5 inches) thick, containing limited quantities of glass, construction material, coal, slag, and ash. The fill likely was associated with construction or repair of the porch. Underlying the fill was a former ground surface layer containing small amounts of domestic type ceramics (hard paste porcelain, earthenware, slipware, pearlware and creamware), pipe stems, a decorative buckle, nails and other molded metal, bottle glass, red brick, coal, and slag. Underlying the former ground surface layer were encountered the sub-soil transition layer and the naturally occurring sub-soil. No cultural material was recovered from these strata. The Historic period artifacts recovered from the former ground surface date to the late eighteenth and early nineteenth century. However, also recovered from the buried, former ground surface were three Native American artifacts. The artifacts were recovered from test units A and B located adjacent to each other in the western most portion of the APE (see Figure 2). Two of the Native American artifacts are Jack's Reef Pentagonal type points and one is a rose quartz decortication blocky fragment with one edge retouched into a graver and the opposite end showing grinding damage through use as a reamer. The Jack's Reef points functioned as knives. Those artifacts are temporally diagnostic to the Point Peninsula culture of the late Middle Woodland to early Late Woodland period (A.D. 500 - 1,000) in the Northeastern United States. The presence of the Native American artifacts suggest the presence within the vicinity of the tested area of an aboriginal camp site, possibly oriented towards the exploitation of subsistence resources associated with the extensive wetland and stream system which still exists, beginning about 1,800 feet west of the Meeting House (see Figure 6).

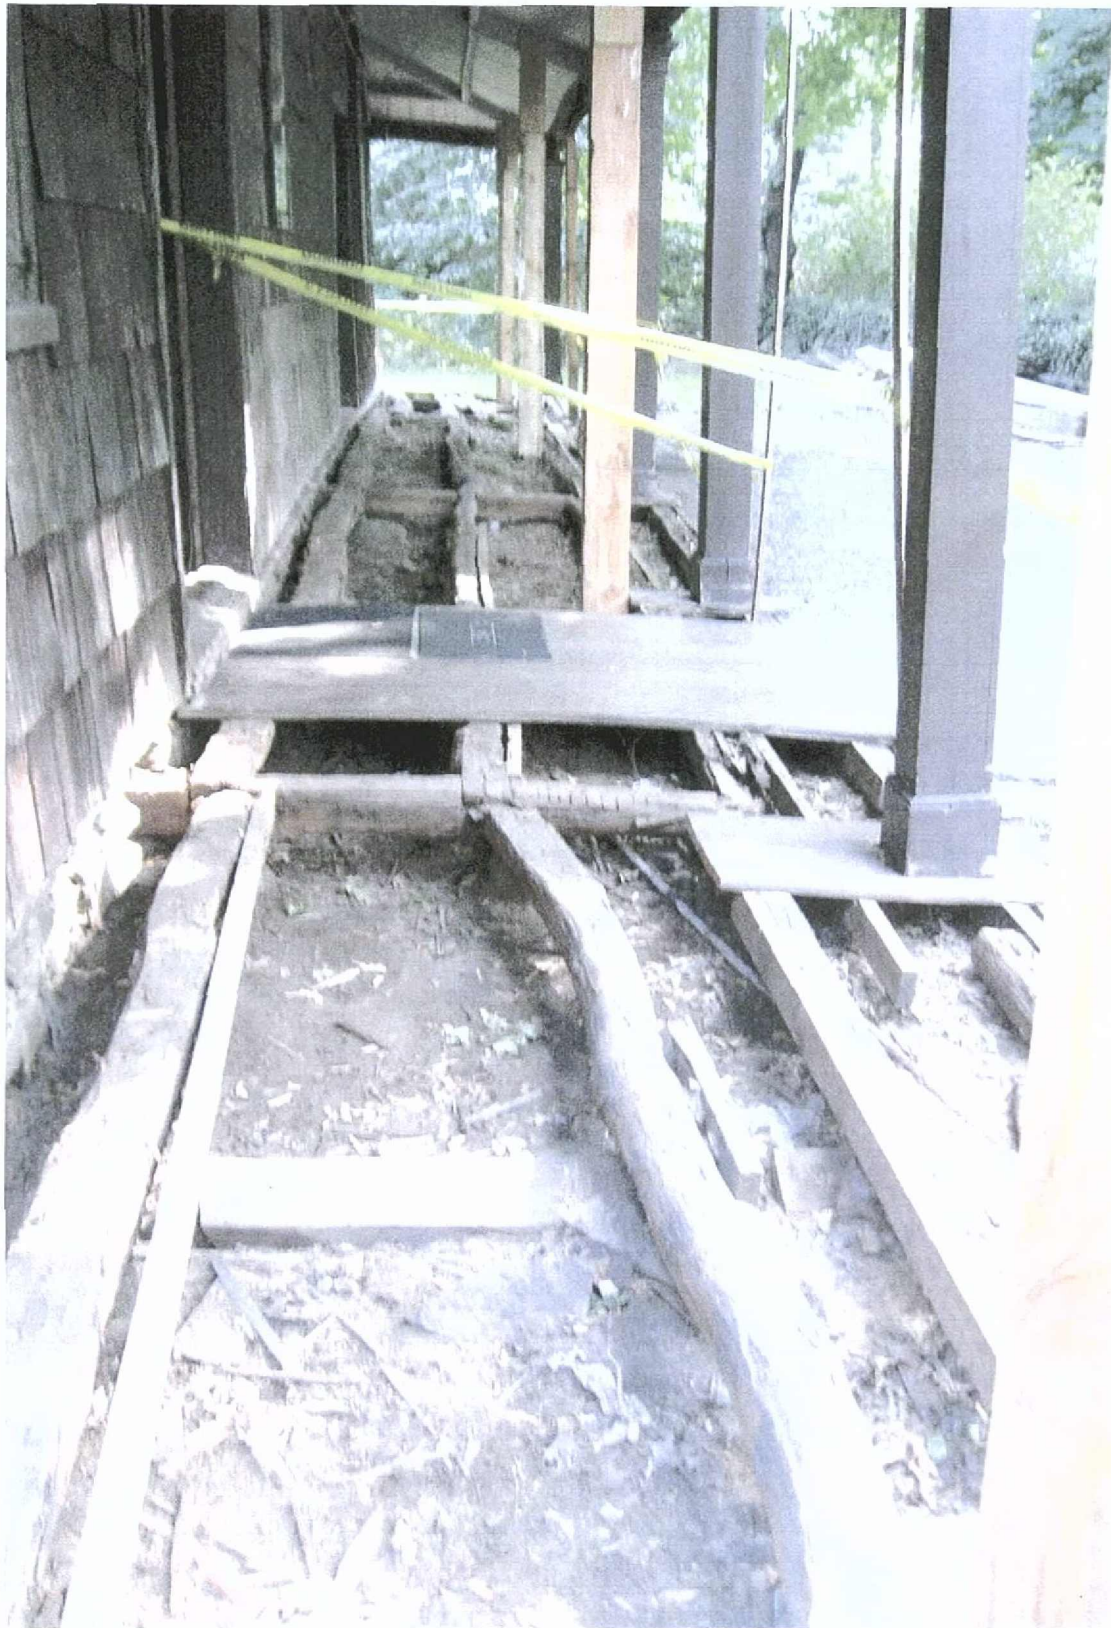
Photograph 5 - Quaker Meeting House Porch with Decking Removed Showing Sleepers

As part of the reconstruction project, the porch's deck also was removed, exposing what are likely the porch's original sleepers and other structural components (Prudon 1976; Photographs 5 and 6). These reportedly will be preserved in place.

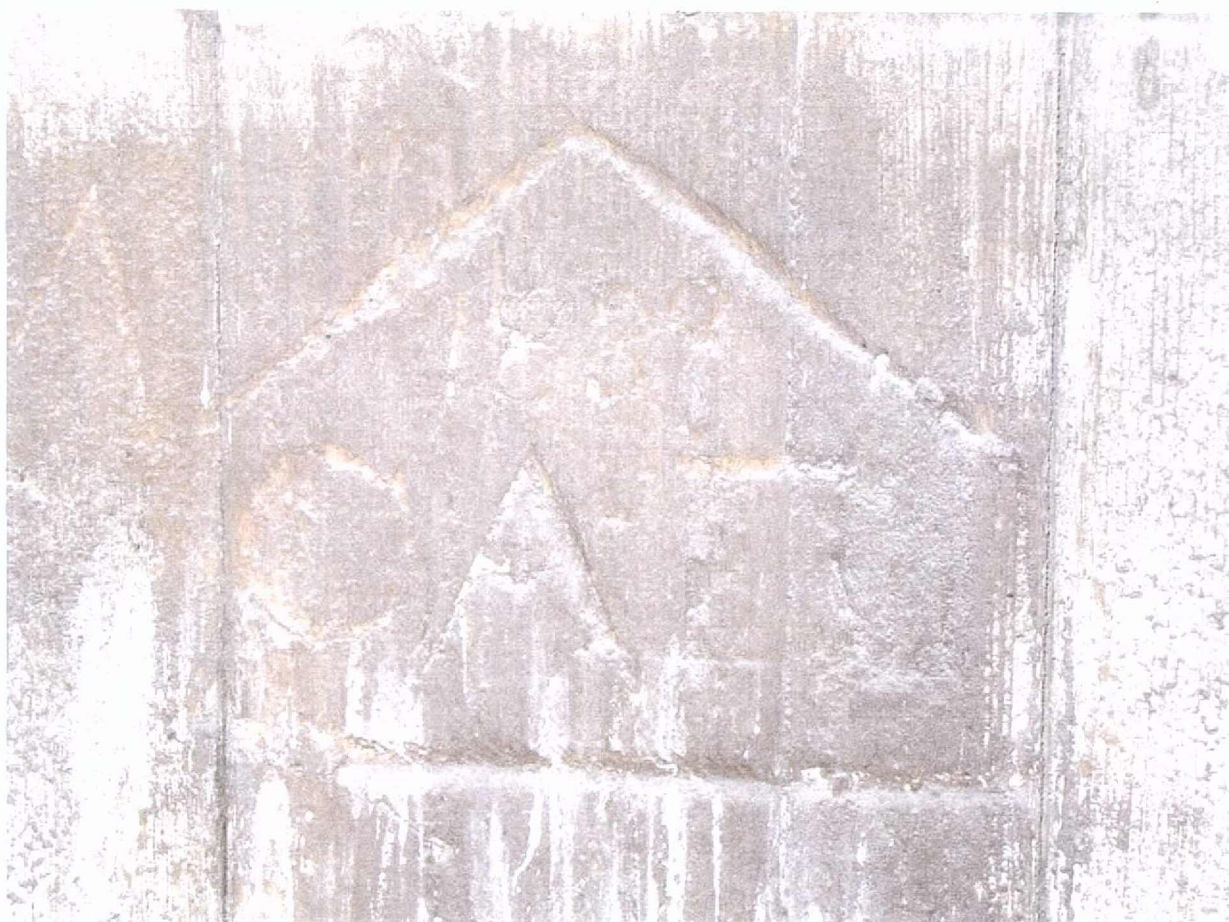
Photograph 6

Apparent 1839 Engraved Graffiti on a Quaker Meeting House Shingle by Porch

During the site work, it was noted that a number of the wooden shingles on the south wall of the Meeting House near the porch contain engraved graffiti marks, some possibly dating to the nineteenth century. One mark of particular interest is an engraving of what apparently is the Meeting House with the date 1839 carved within the image (Photograph 7 and 8). Below it were some faintly perceived letters. Other shingles contain what apparently are initials or names.

During the site work, it was noted that a number of the shingles on the south wall of the Meeting House near the porch contain engraved graffiti marks, some possibly dating to the nineteenth century. One mark of particular interest was an engraving of what apparently is the Meeting House with the date 1839 carved within the image (Photographs 6 and 7). Below it were some faintly perceived letters. Other shingles contain what apparently are initials or names. It is suggested that the graffiti be evaluated, and if warranted, that steps be taken to preserve the images and the shingles that contain them.

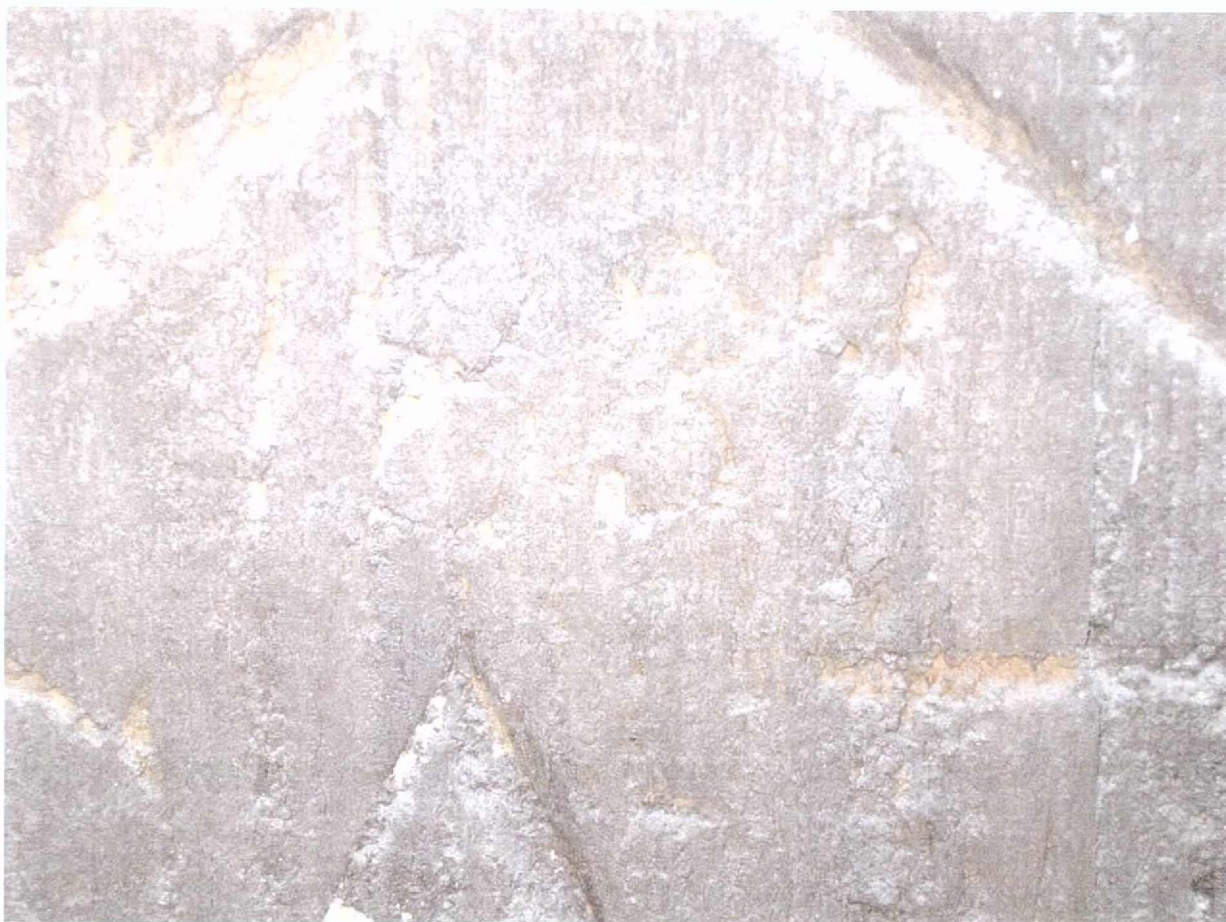
Photograph 7

**Apparent 1839 Engraved Graffiti on a Quaker Meeting House Shingle by Porch –
Close-up View of Date**

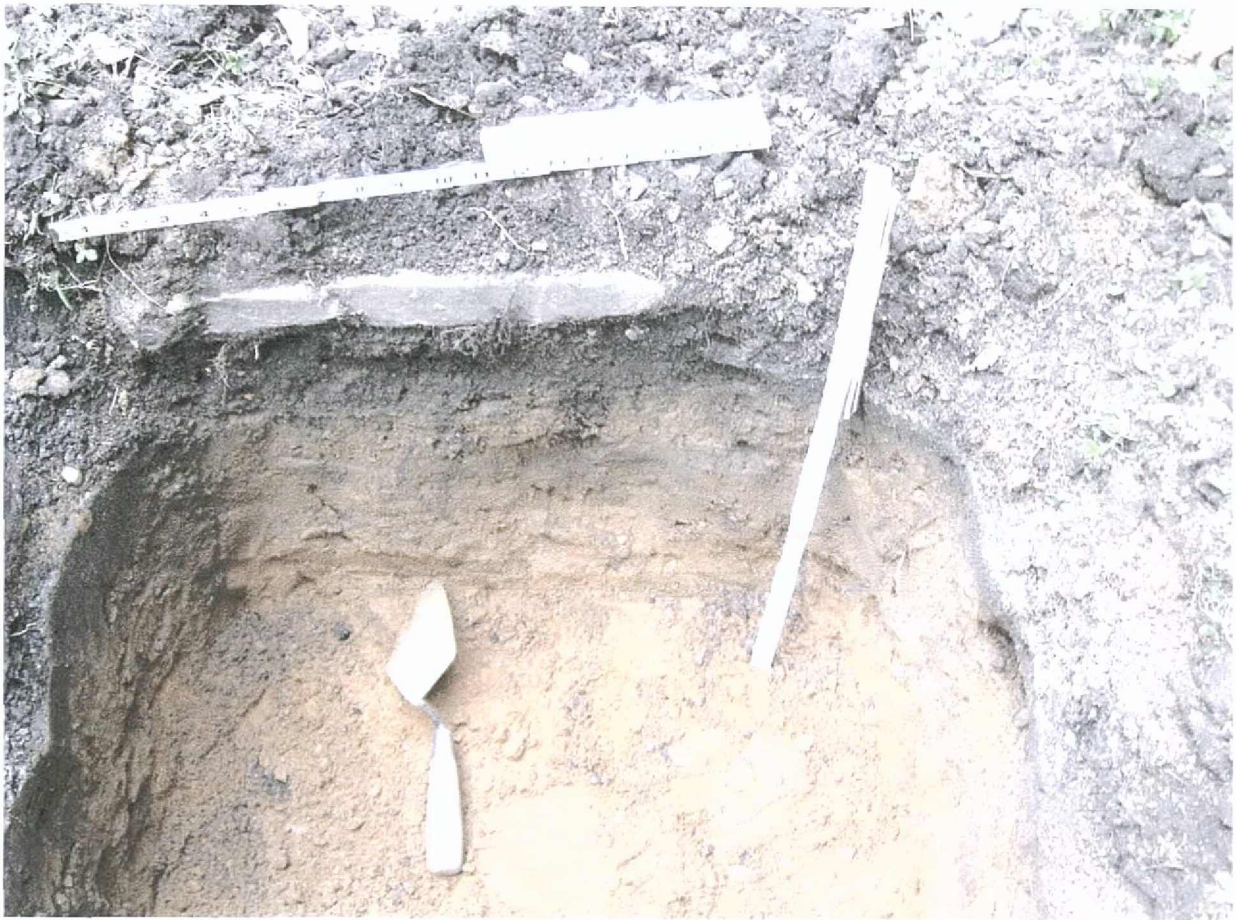
Photograph 8

Test Unit A – North Wall Profile

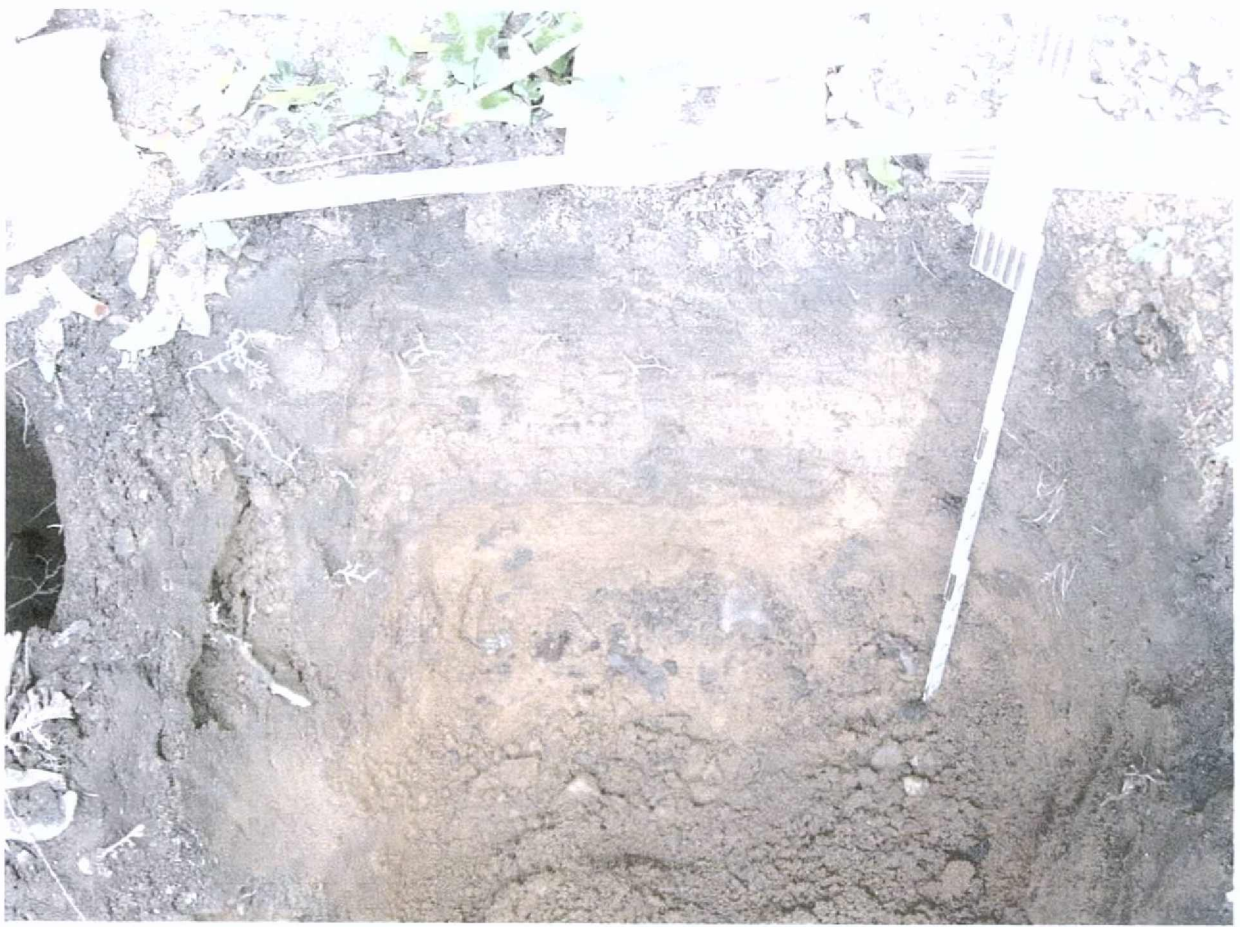
Photograph 9

Test Unit B – East Wall Profile

The 1976 report concluded that the deposits encountered by the two excavation units were associated with the two episodes of construction of the Meeting House. It further concluded that there was little evidence recovered for use of the area prior to the initial construction of the building (i.e. 1694; Mayer 1977:7). The fieldwork for the current project, however, did identify evidence for a prehistoric Native American period occupation on the property (see Chapter 2.2.2; Photograph 9).

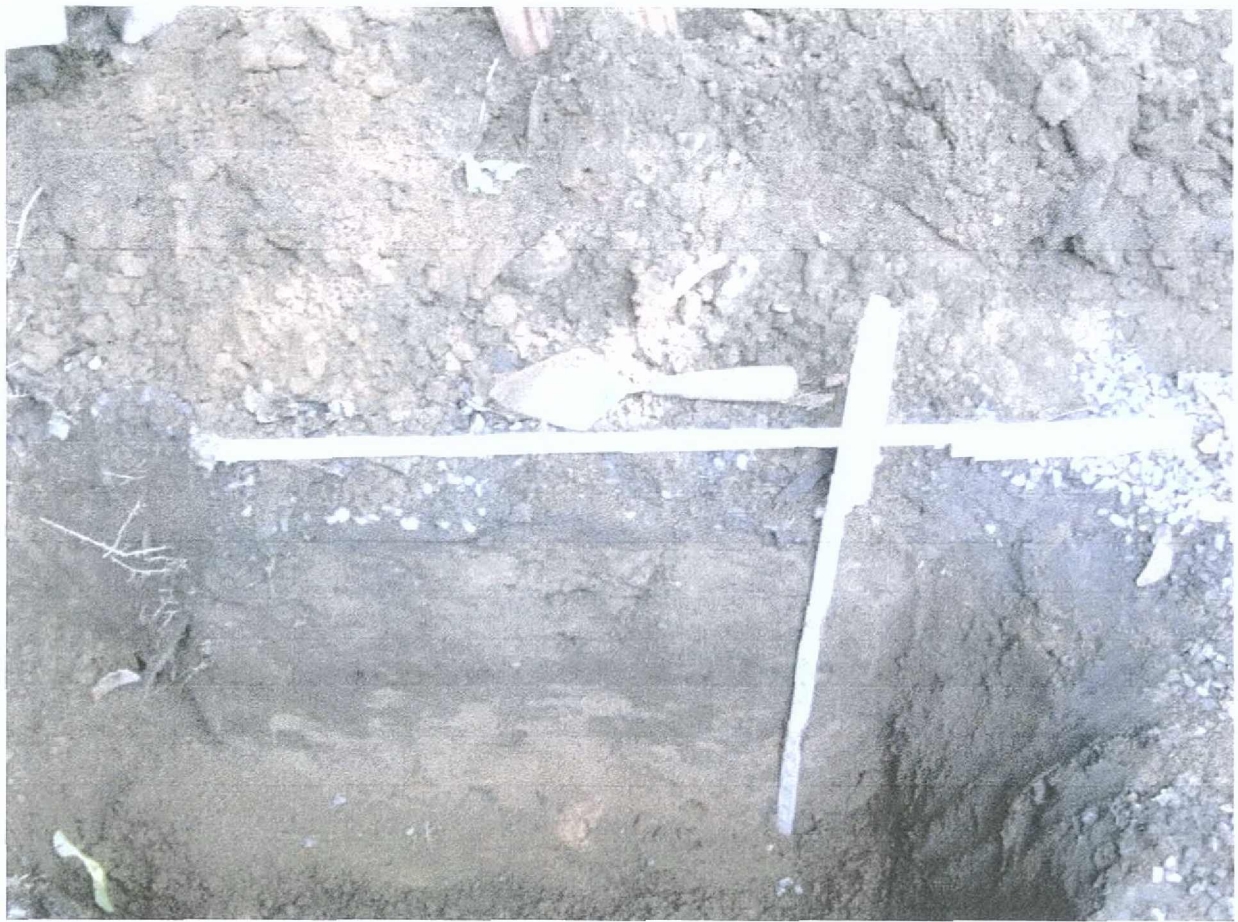
Photograph 10

Test Unit C – East Wall Profile

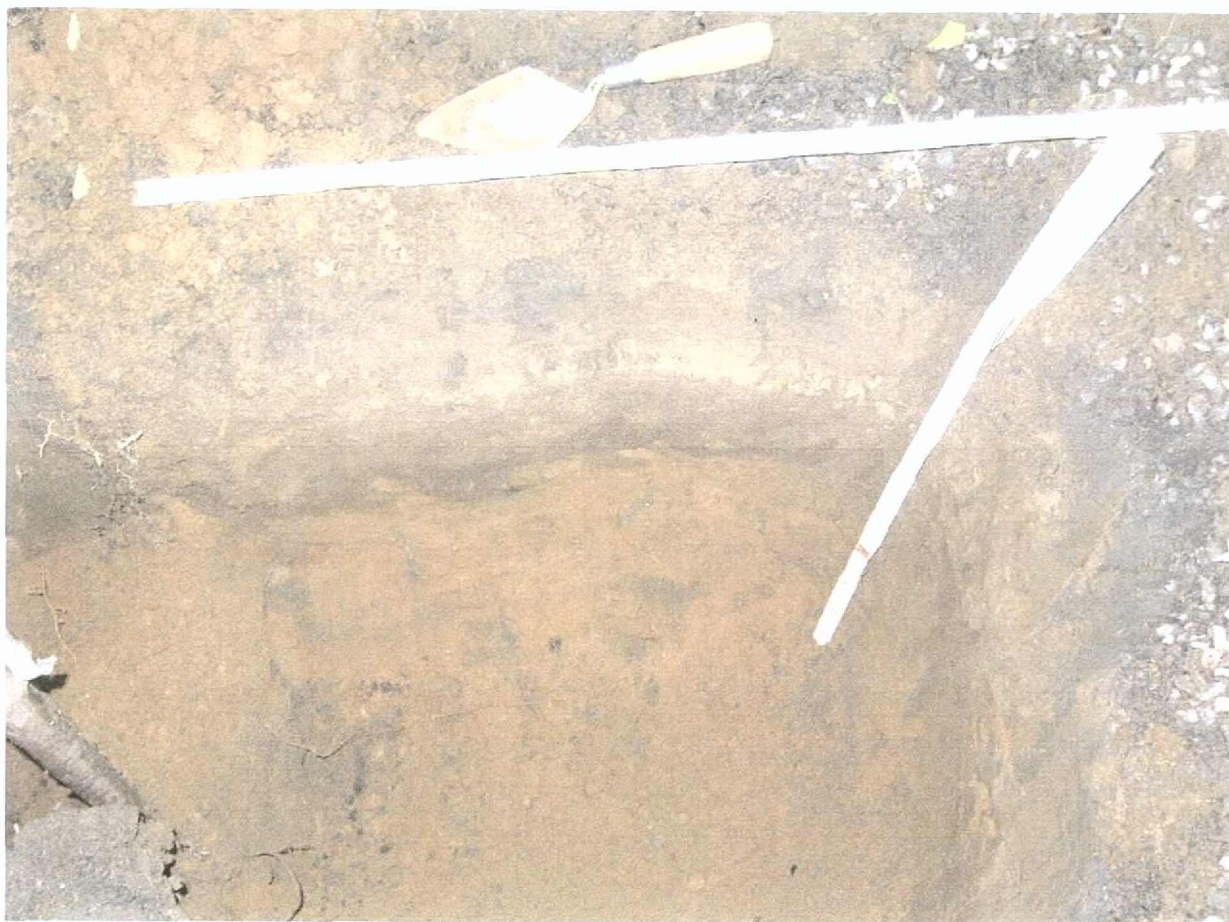
Photograph 11

Test Unit D – East Wall Profile

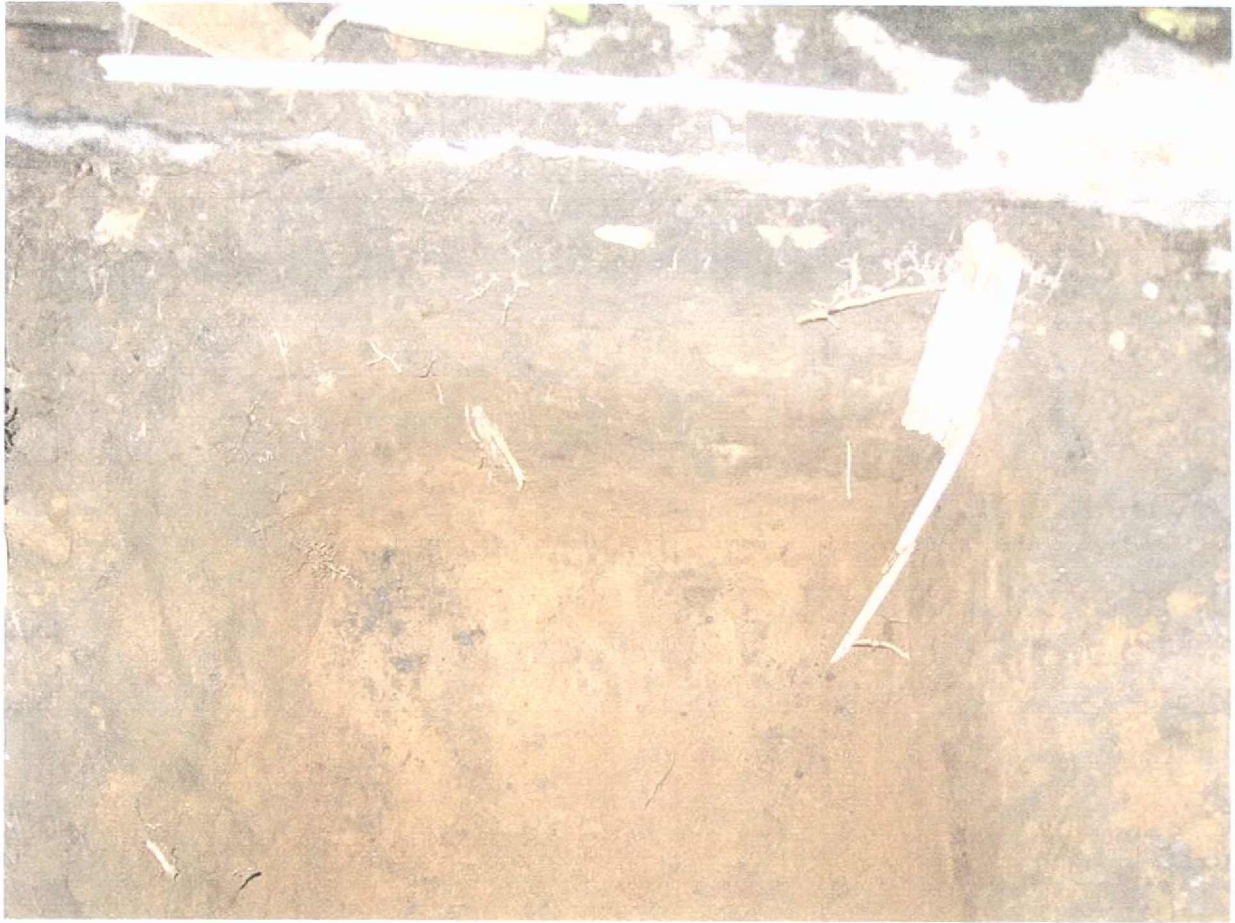
Photograph 12
Test Unit E – East Wall Profile

Beneath the near surface soils in test units E - G was encountered fill layers most likely associated with a trench for a two inch diameter iron pipe (likely a water pipe), that extends through the area. Below the trench fill in test units E - G was encountered the naturally occurring sub-soil.

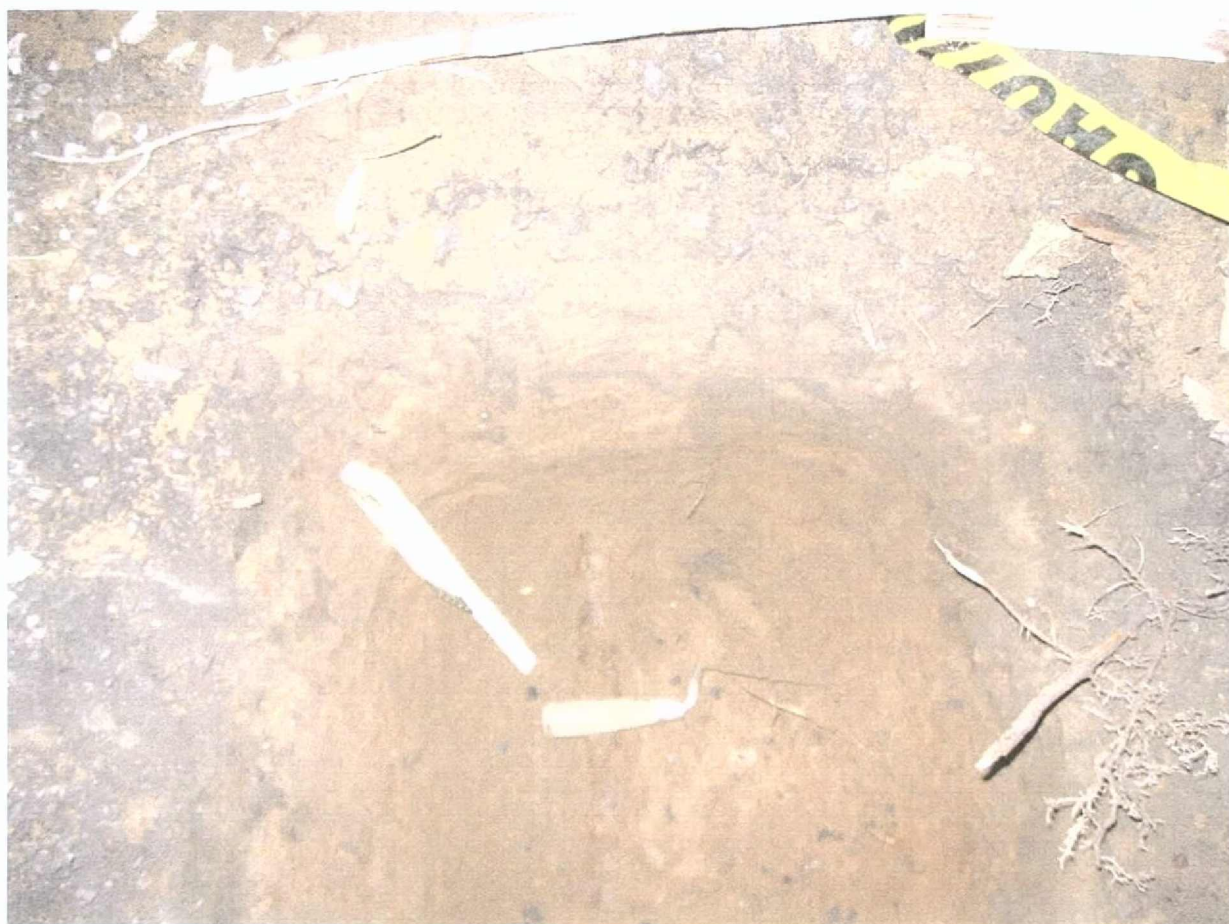
Photograph 13
Test Unit F – West Wall Profile

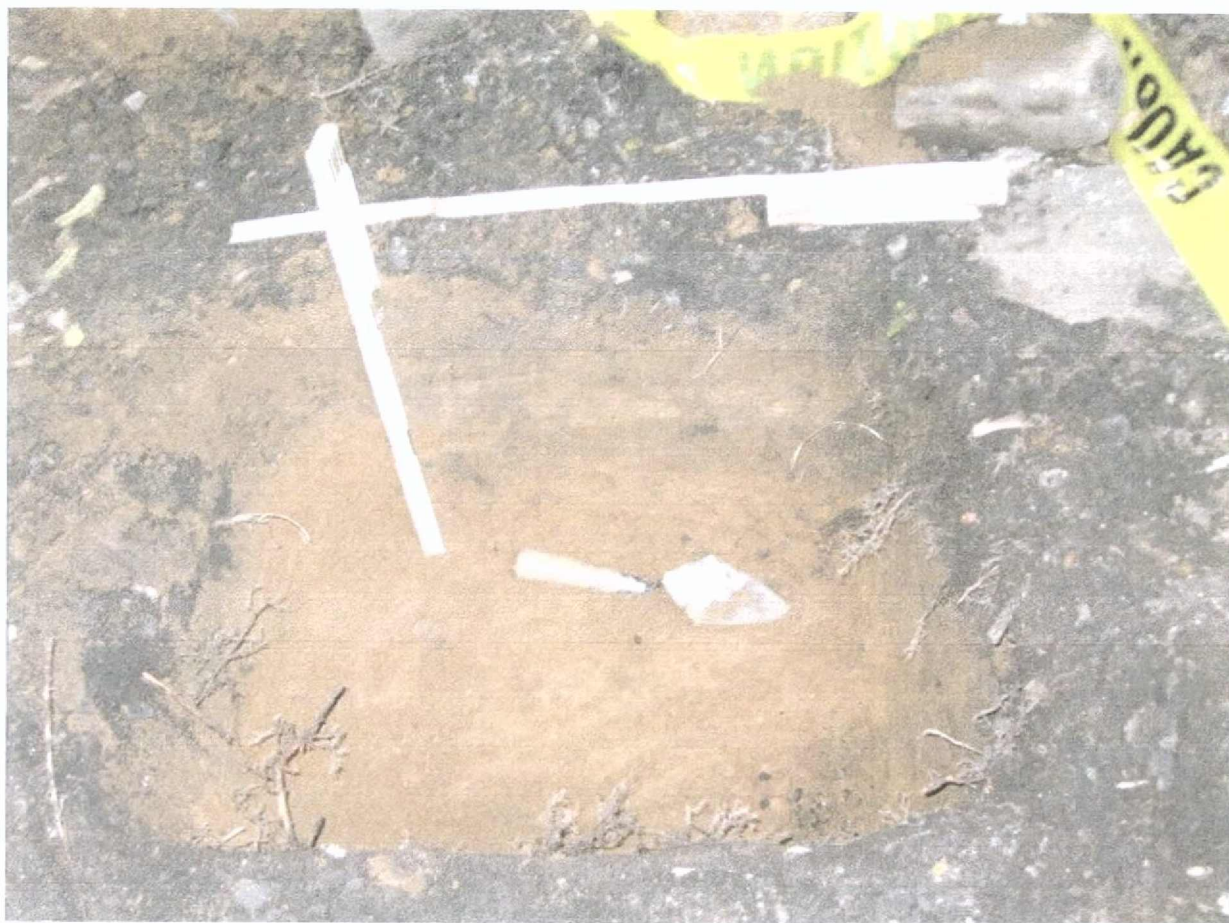
Photograph 14

Test Unit G – West Wall Profile

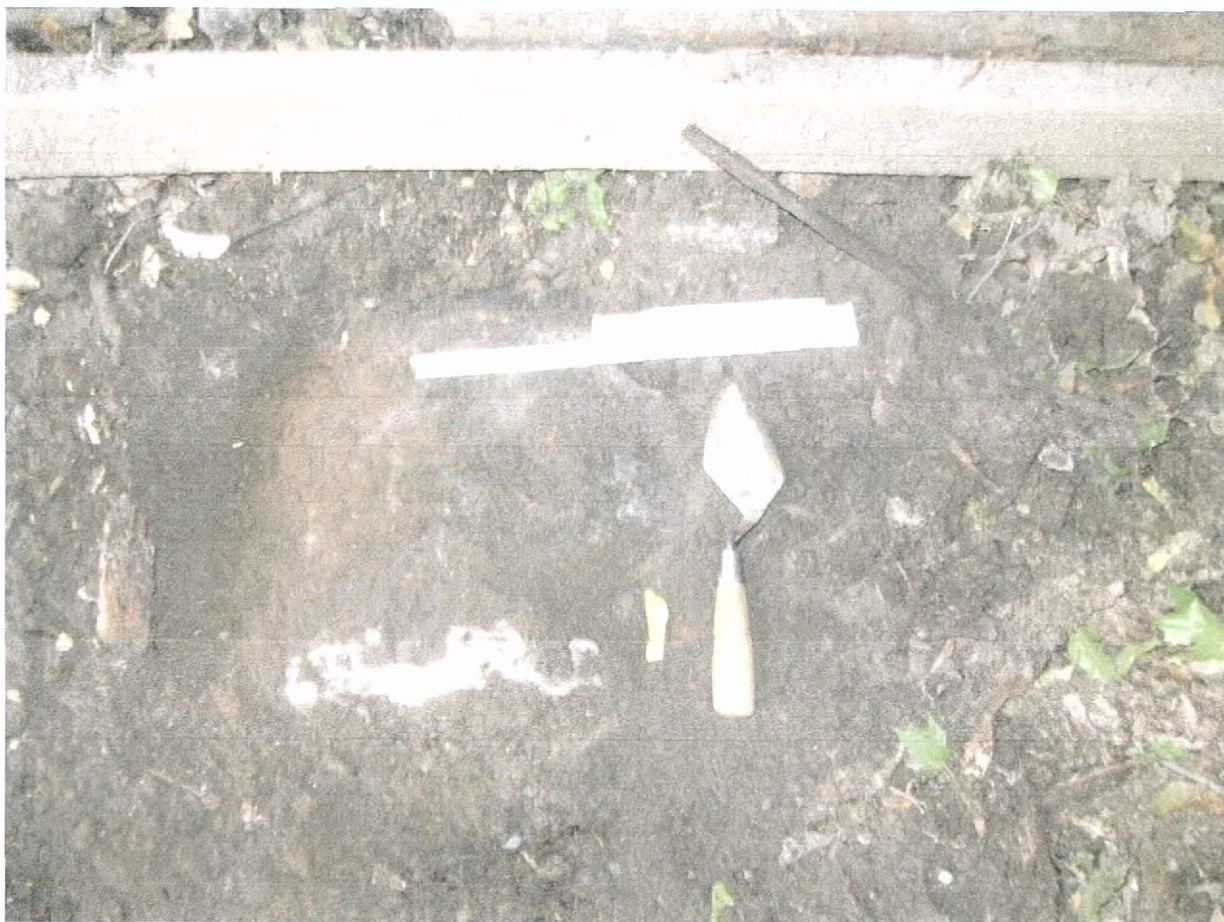
Photograph 15

Stone Support for Pillar or Sill Just Below Modern Surface as Seen in Shovel Test 5

The support stones and the soils they were associated with were located below the recently removed sill for the existing porch, which likely dated to the nineteenth century. Accordingly, the surface soils at the locations of the shovel tests were not relatively recently developed nor were the stones recently laid there. The stones were likely supports for the porch's most recent sill or for an earlier sill, raising them slightly from the ground surface, or with earlier porch pillars or posts associated with the existing porch or a prior porch. Limited quantities of glass, coal, unidentifiable and wire nails, other metal, red brick, and white domestic ceramic were recovered from the near surface layer.

The first stratum seen in shovel test 5 consisted of five centimeters (2 inches) of dark gray black sandy silt (Stratum I). Two overlying stones, one specimen seven inches wide by 11 inches long by two inches thick and the second specimen nine inches wide by 10 inches long, by six inches thick, were located within this near surface soil layer. As discussed above the stones likely were associated with the existing porch or an earlier one. Below Stratum I was a 20 centimeter (7.9 inches) thick layer of fine grained brown silty sandy (Stratum II) that likely represents a buried, former ground surface. A portion of the second, underlying stone seen in Stratum I extended into this layer to a depth of about 20 centimeters (7.9 inches). Below the former ground surface, at 25 centimeters (9.8 inches) below grade, was encountered a 19 centimeter (7.5 inches) thick layer of brown silty sand with yellow brown silty sand mottling (Stratum III) that was transitional to the naturally occurring sub-soil. The yellow brown coarse grained silty sand (Stratum IV) culturally sterile sub-soil was encountered in this shovel test beneath the sub-soil transition layer, at 42 centimeters (16.5 inches) in depth. No artifacts were recovered from any of the strata excavated in shovel test 5.

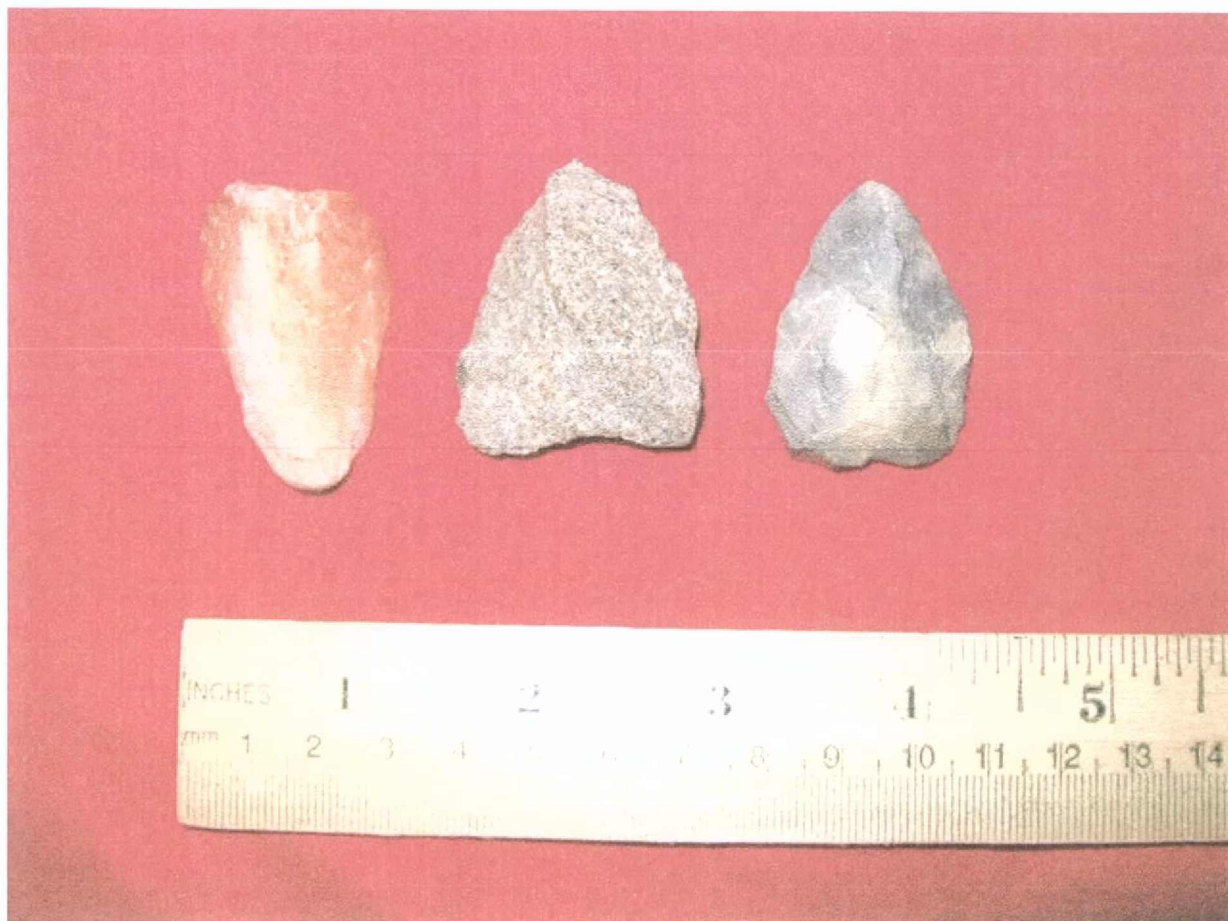
Photograph 16

Native American Artifacts Recovered from Test Units A and B

- Two Native American artifacts, most readily classifiable as examples of Jack's Reef Pentagonal type points, generally a late Middle Woodland to early Late Woodland period form within Late Point Peninsula contexts (c. A.D. 500 – 1,000) in the Northeastern United States, also were recovered from the buried ground surface layer below the southwestern end of the porch (western part of the APE). Based on their morphology and edge use wear damage, it was determined that the artifacts most likely functioned as knives. A rose quartz decortication cobble blocky fragment that was worked into a graving tool also was recovered from the buried surface along with one of the points/knives. The blocky fragment also was used as a reamer resulting in grinding use wear damage on the end opposite the graver. The blocky fragment constitutes a non-standardized or expedient type tool. The presence of the Native American artifacts suggests that an aboriginal camp site is located within the APE or its vicinity. The site may have been oriented towards the exploitation of subsistence resources associated with the large wetland and stream system, which still exists, beginning about 1,800 feet to the west (see Figure 6). The recovered artifacts suggest that cutting activities, possibly relating to hunting and butchering, and woodworking were occurring at the site. When recovered, the Native American artifacts may have been in-situ or they may have been moved a short distance at some point as a result of the Historic period activities that were occurring at the site.
