PHASE 1B ARCHEOLOGICAL SURVEY  
AND GROUND PENETRATING RADAR (GPR) SURVEY  
OF SOUTHPOINT PARK

ROOSEVELT ISLAND  
NEW YORK, NEW YORK

FEBRUARY 2009

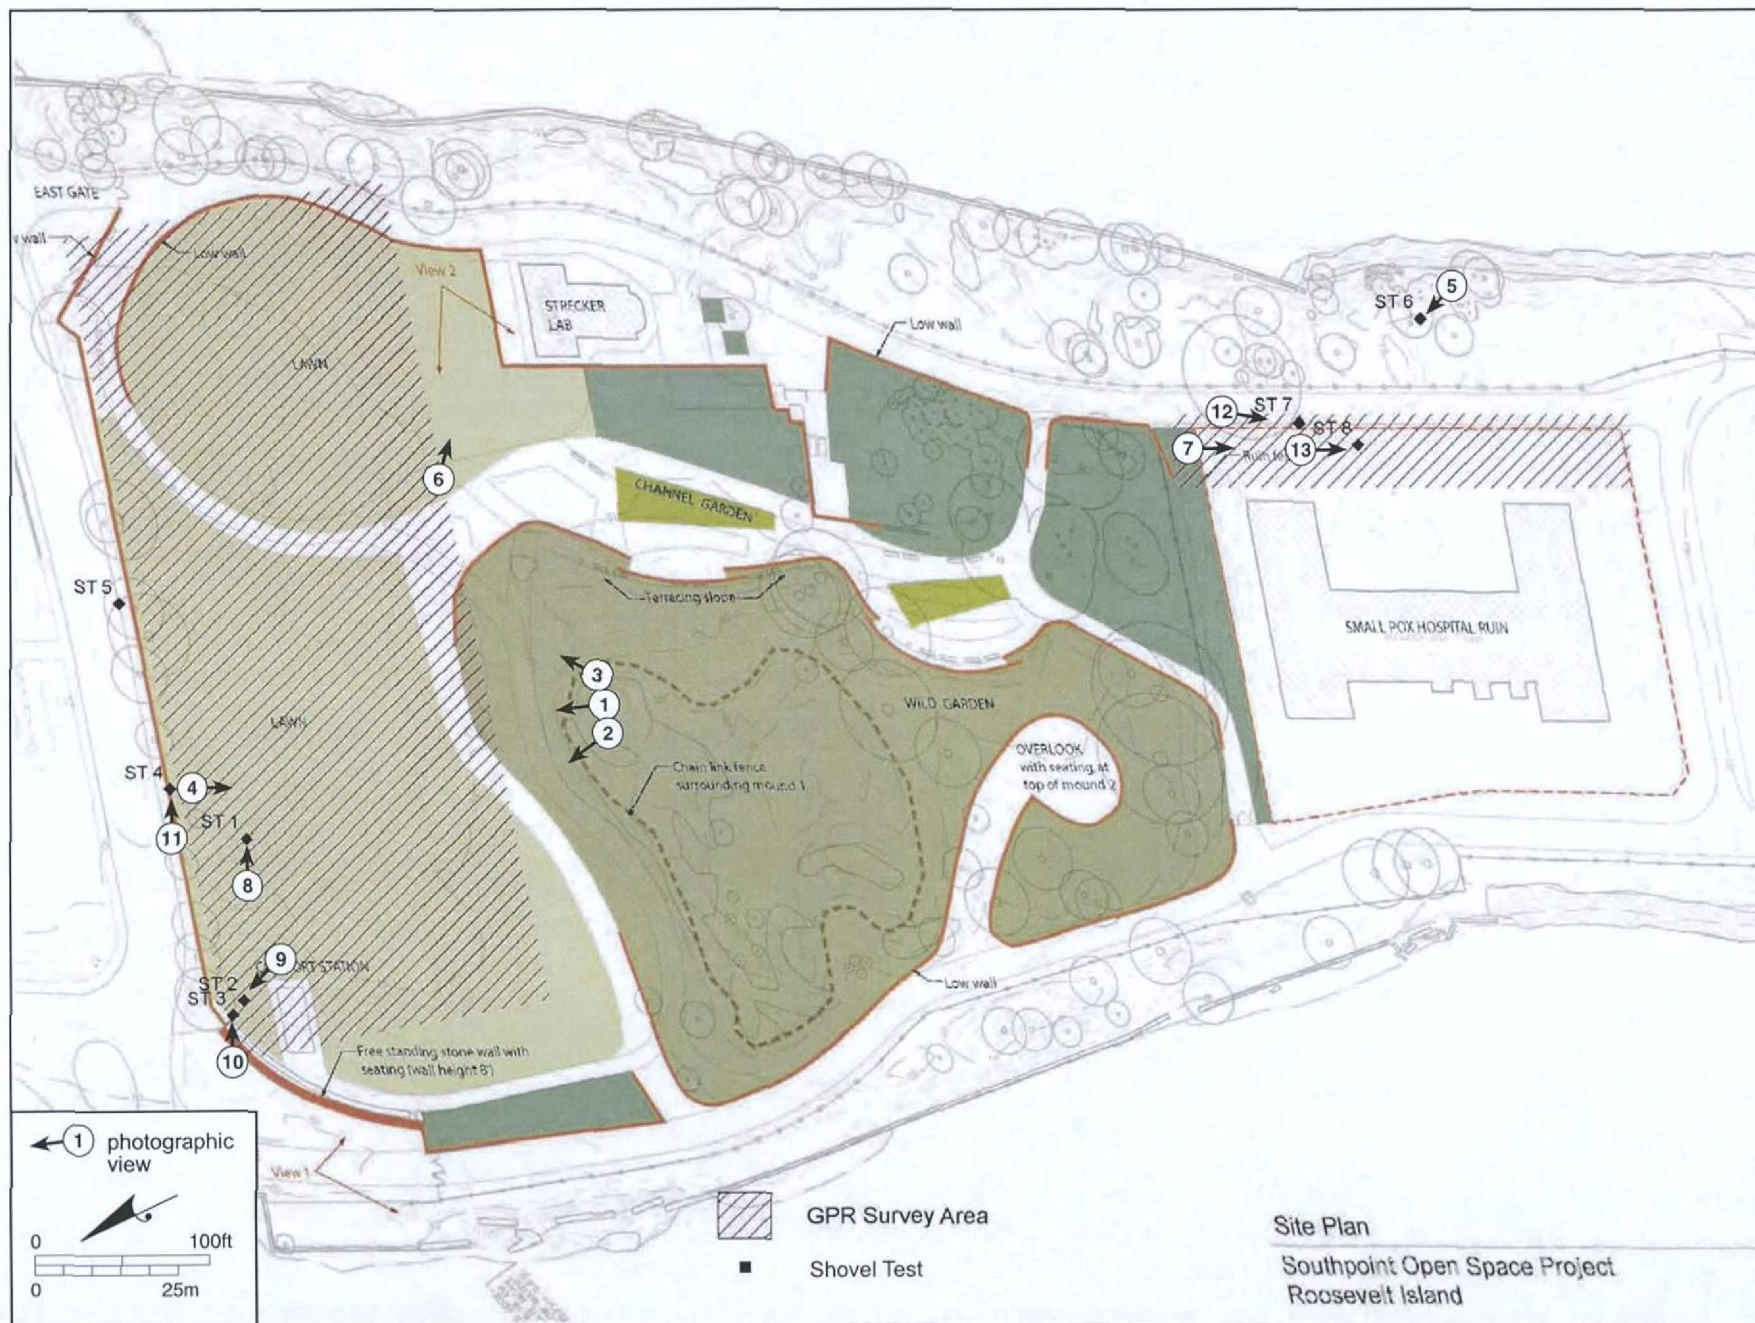
Figure 2. Plan map of the Southpoint Park Project Area showing the locations of excavated shovel tests, GPR survey areas, and photographic views referenced in the report.

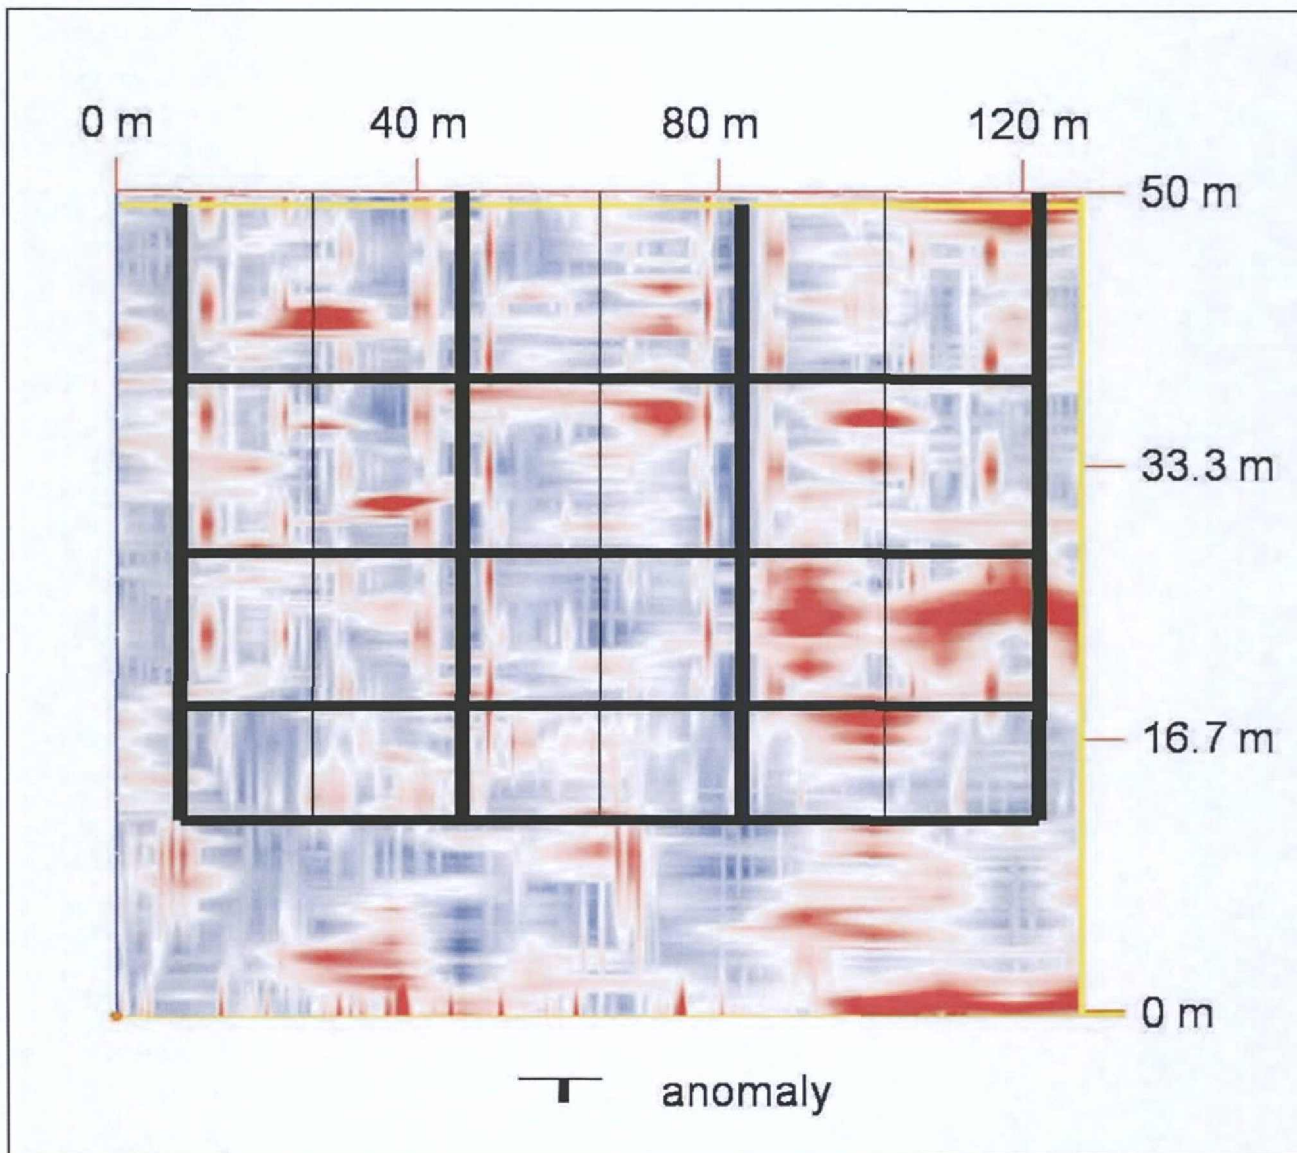
Figure 6. Interpreted geophysical grid in area of City Hospital showing the location of identified anomalies.

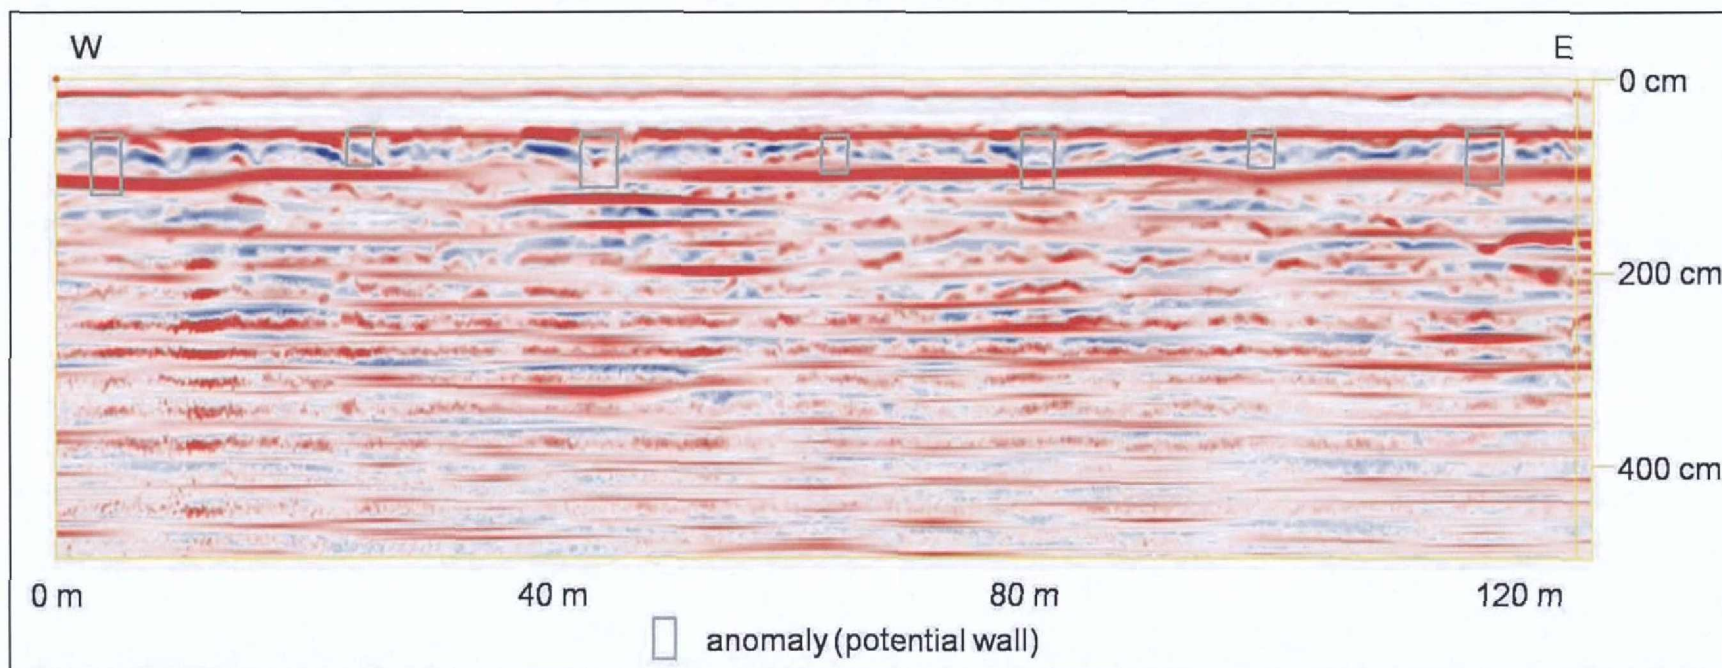
Figure 7. Interpreted vertical west-east cross-section within City Hospital geophysical grid showing location of vertical anomalies.

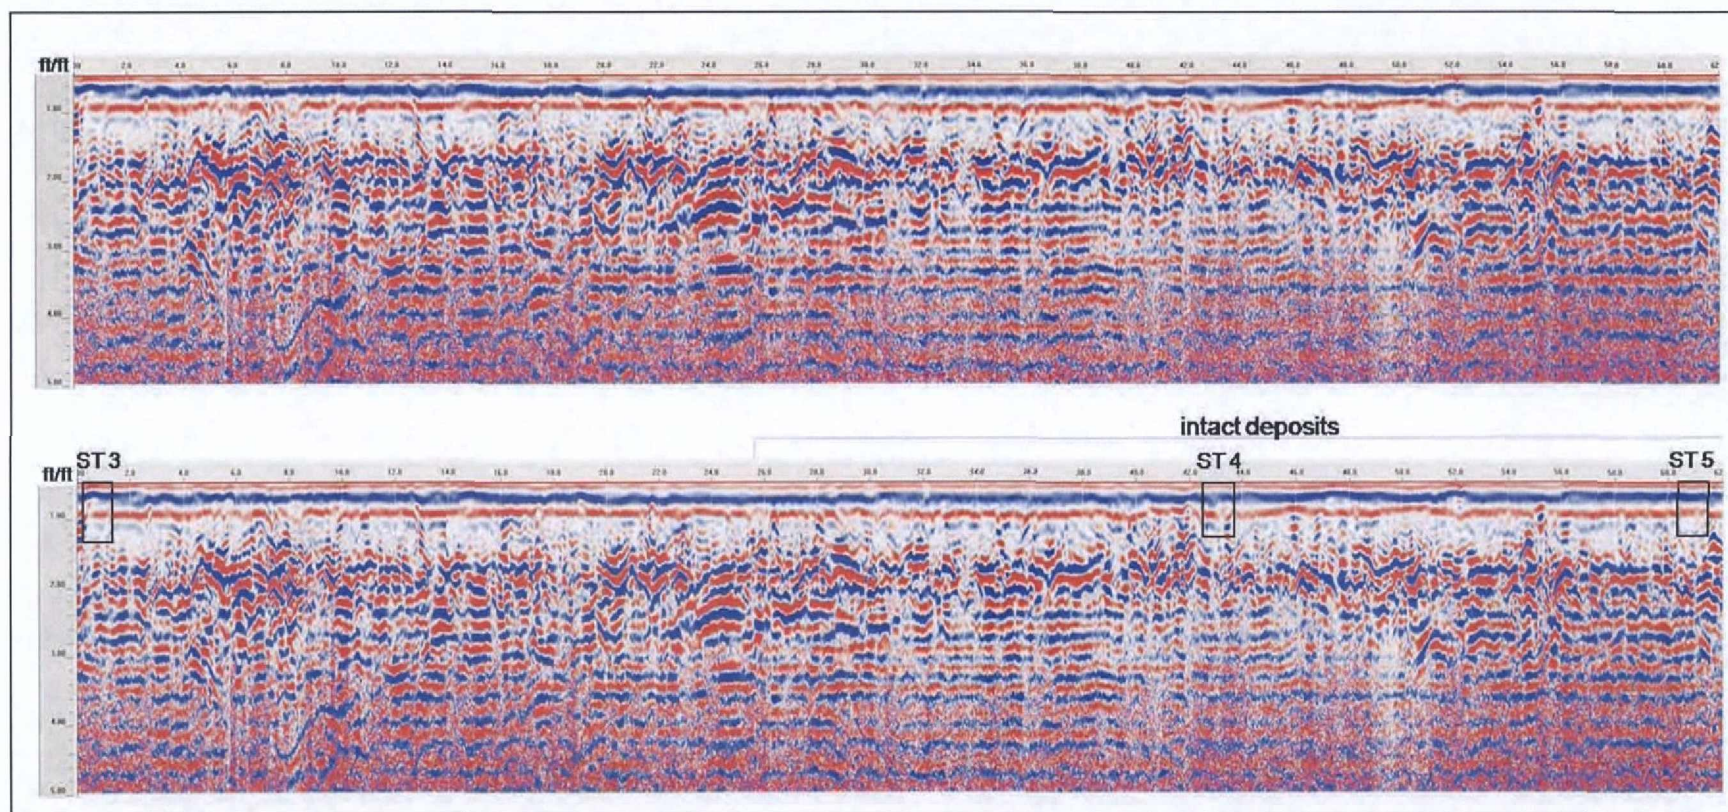
Figure 8. Interpreted vertical west-east cross-section north of City Hospital geophysical grid showing the location of intact deposits in relation to shovel tests.

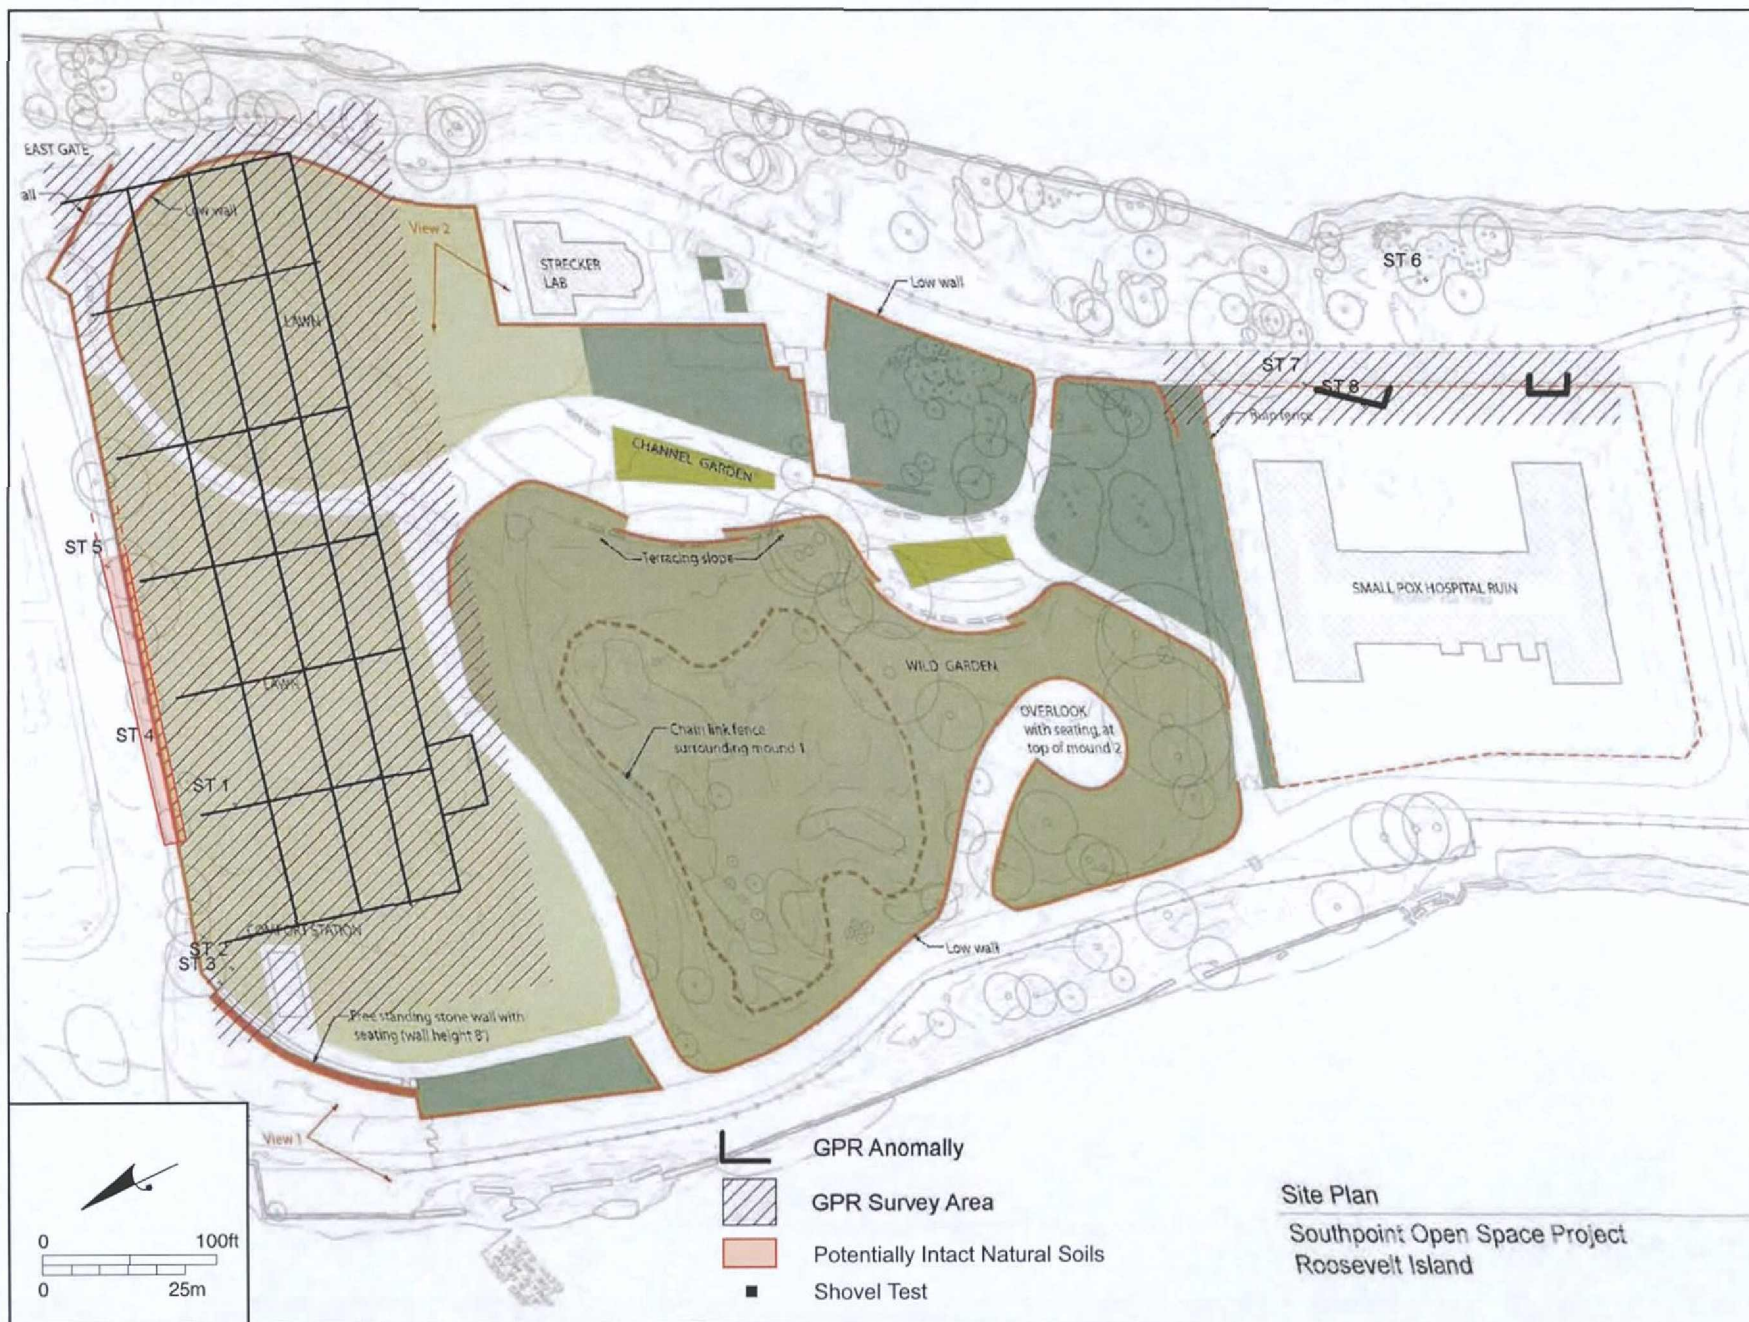
In the area behind the Smallpox Hospital, the GPR survey resulted in the identification of two areas of anomalies (Figure 9). No standard geophysical grid was used in this area due to construction materials and environmental conditions. The anomalies identified in this area are vertical anomalies similar to those identified in the area of City Hospital, and likely represent foundation wall segments.

Figure 9. Map of GPR survey areas with anomalies and shovel test locations identified.

The location of the former City Hospital is represented by an uneven surface of smoothed demolition debris and stacked stones from the former structure. The GPR survey conducted in this area identified several anomalies that may represent foundation footers and walls of the former structure. JMA identified one area on the northern edge of the hospital that contains potentially intact cultural stratigraphy between 55 to 84 cm b.g.s. (in shovel test 4) and a potentially intact land surface below that. The GPR survey conducted in this location suggests that the area that contains the potentially intact land surface is approximately 140 m<sup>2</sup> in size (see Figure 9).

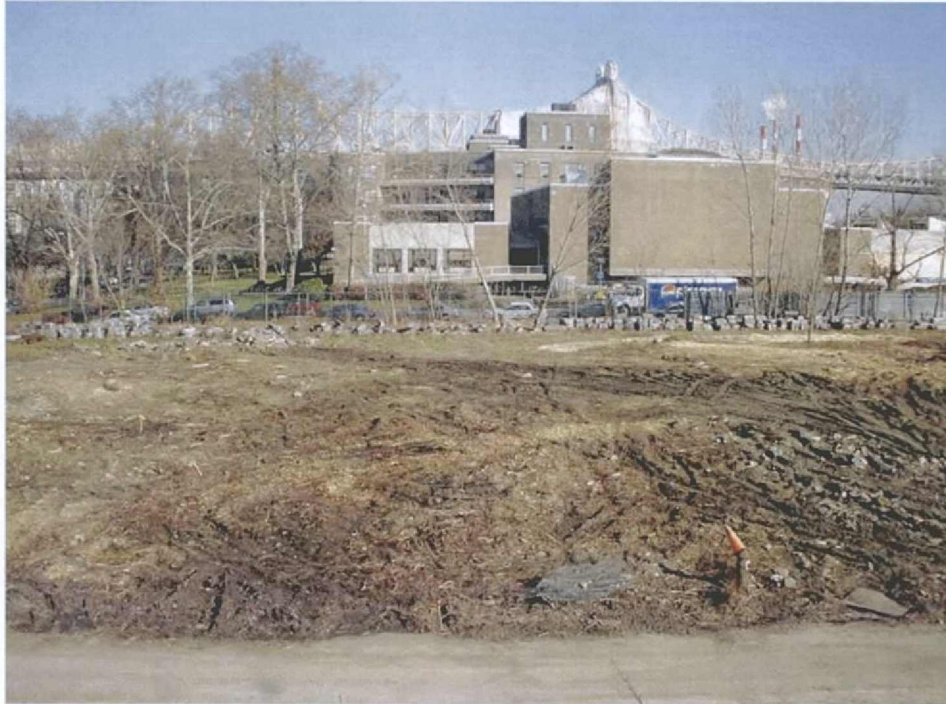
Photograph 1. General overview of the existing conditions in the location of the former City Hospital; view to the north.

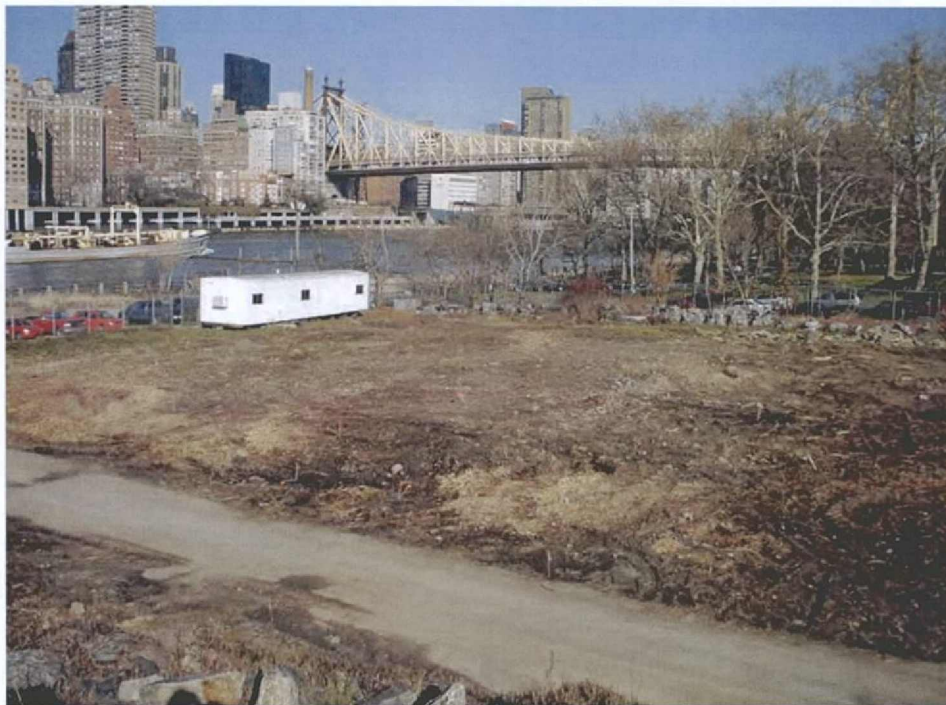
Photograph 2. General overview of the existing conditions in the location of the former City Hospital; view to the northwest.

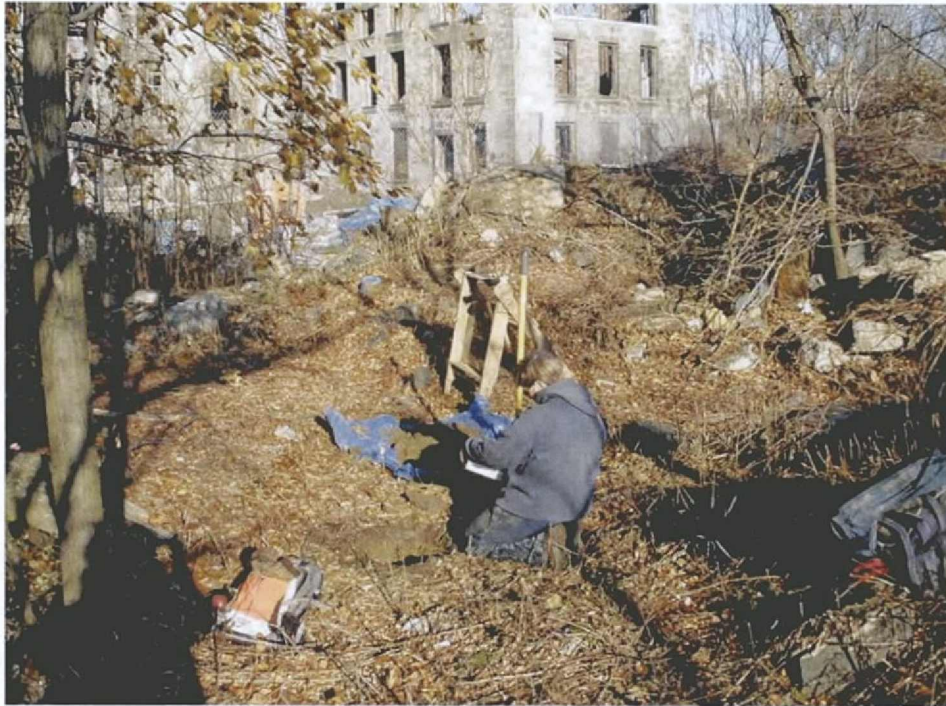
Photograph 5. General overview of the existing conditions in the vicinity of the Smallpox Hospital and kitchen area ; view to the northwest. Note: large rubble mounds and push piles.

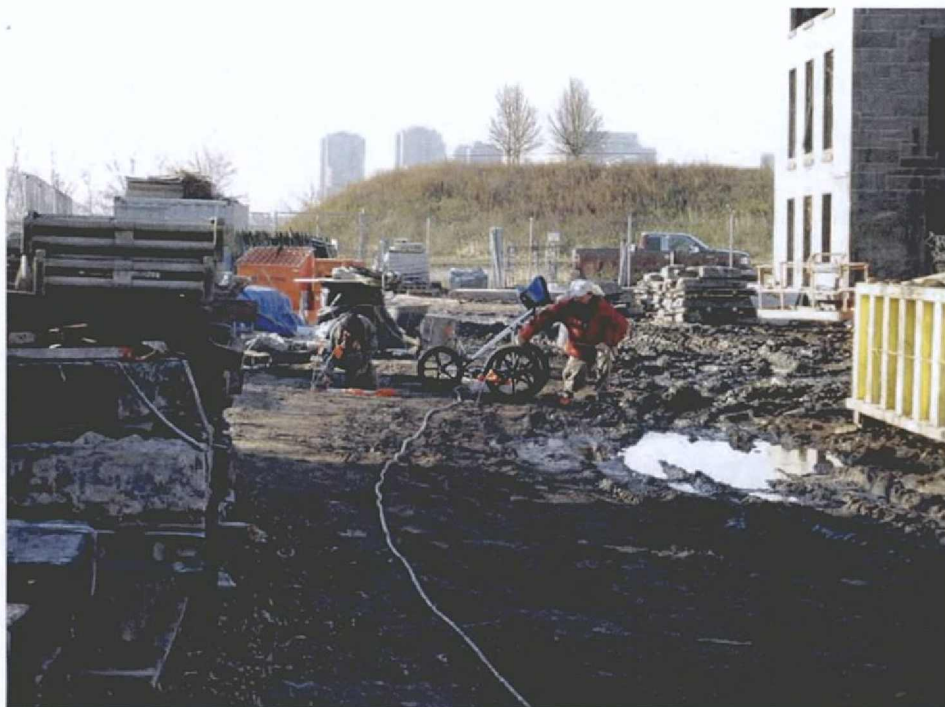
The GPR survey conducted in this portion of the Project Area identified a line of rock rubble in the former kitchen addition area, between 35 and 40 feet east of the Smallpox Hospital (Photograph 7). The survey suggested that the rock features lay approximately 30 cm b.g.s. To check these anomalies, JMA placed shovel tests 7 and 8 (Figure 2, Photographs 12 and 13) in these locations.

Photograph 7. JMA personnel conducting GPR survey in the former location of the kitchen area of the Smallpox Hospital; view to the south.

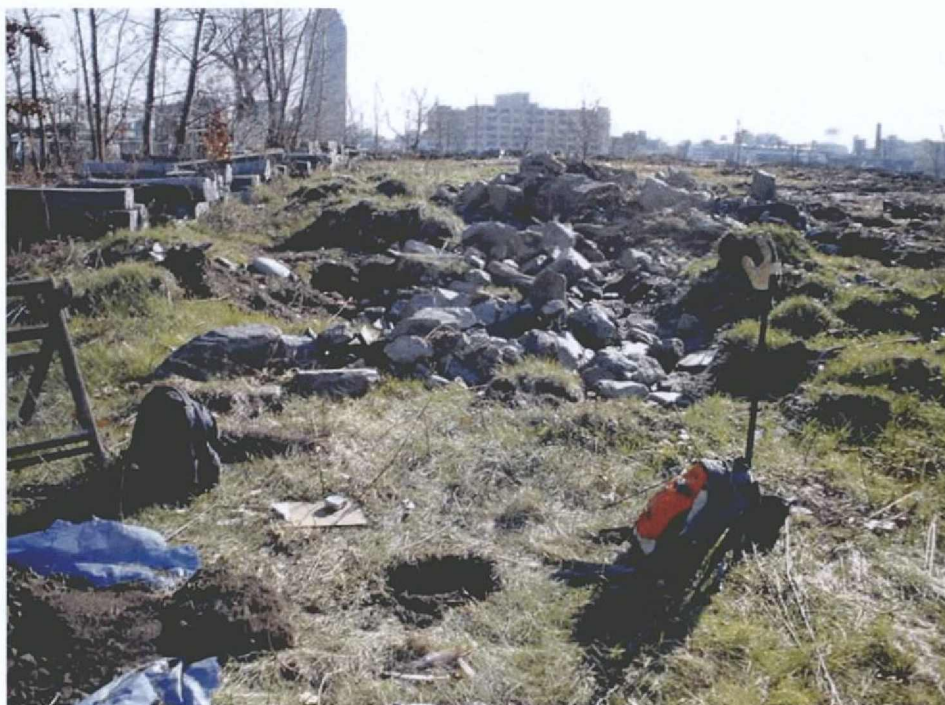
Photograph 8. Location of Shovel test 1 at the northern end of the rubble mound associated with the former City Hospital structure, view to the east.

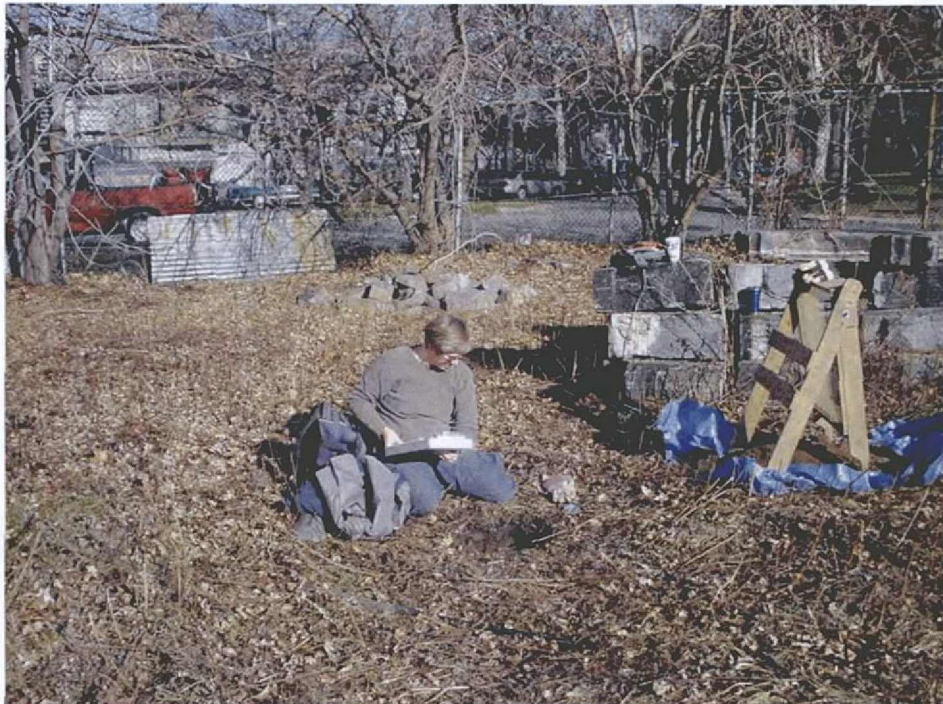
Photograph 9. Location of shovel test 2 at the northwestern corner of the former City Hospital structure, view to the north/northwest.

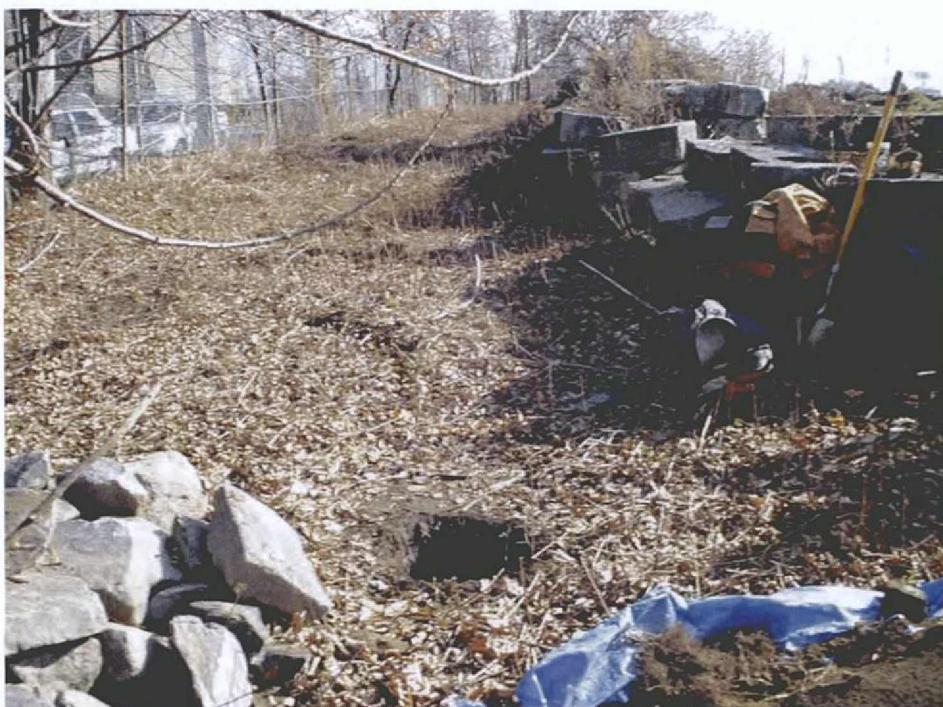
Photograph 10. Location of shovel test 3 at the northern end of the rubble pile; view to the east.

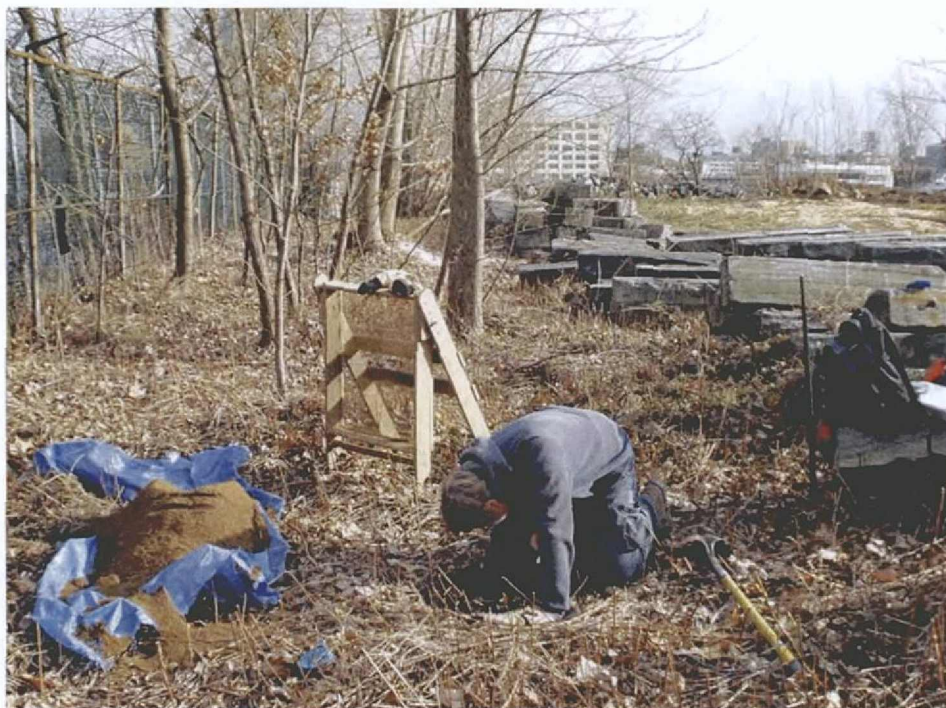
Photograph 11. Location of shovel test 4 at the northern end of the former City Hospital location; view to the east. Note slight uphill slope representing *potentially intact land surface*.

Potentially intact stratigraphy was identified in one shovel test (shovel test 4) located along the northern perimeter of the Project Area, at depths of 55-84 cm below ground surface (b.g.s.). Ceramics, cut nails, bottle glass, clam shells and faunal material that date to the late-eighteenth and/or nineteenth century were recovered. The GPR survey conducted in this area also indicated the presence of apparently intact soils approximately 20 m long by 7 m wide (140 m<sup>2</sup>). Proposed landscaping plans in this area were revised following the Phase 1B survey to avoid the possibility of impacting any undisturbed archeological deposits. If any future ground disturbing activities are planned for this area, then additional archeological work would be appropriate.

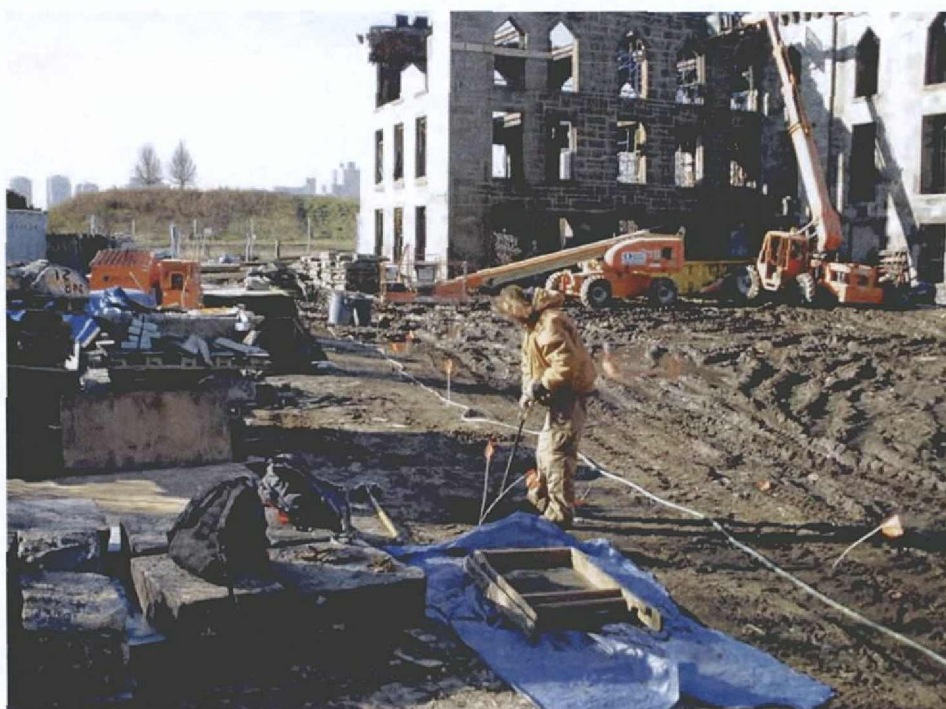
Photograph 12. JMA archeologist excavating shovel test 7 within the former kitchen structure of the Smallpox Hospital, view to the south. Note GPR survey flags and tape.

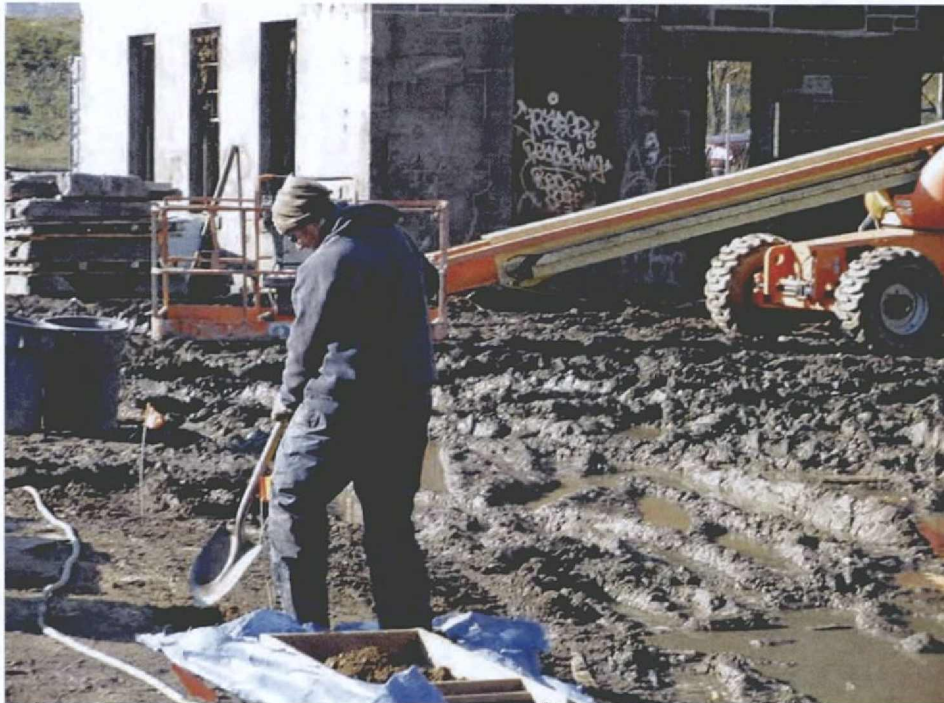
Photograph 13. JMA archeologist excavating shovel test 8 within the former kitchen structure of the Smallpox Hospital, view to the southwest.
