An Archaeological and Environmental Design  
Evaluation of the Richard Cornell Cemetery,  
Far Rockaway, Queens, New York  
(LP-0741)

Prepared Under the Auspices of the  
New York City Landmarks Preservation Commission  
for the Cornell Cemetery Corporation  
April, 1994

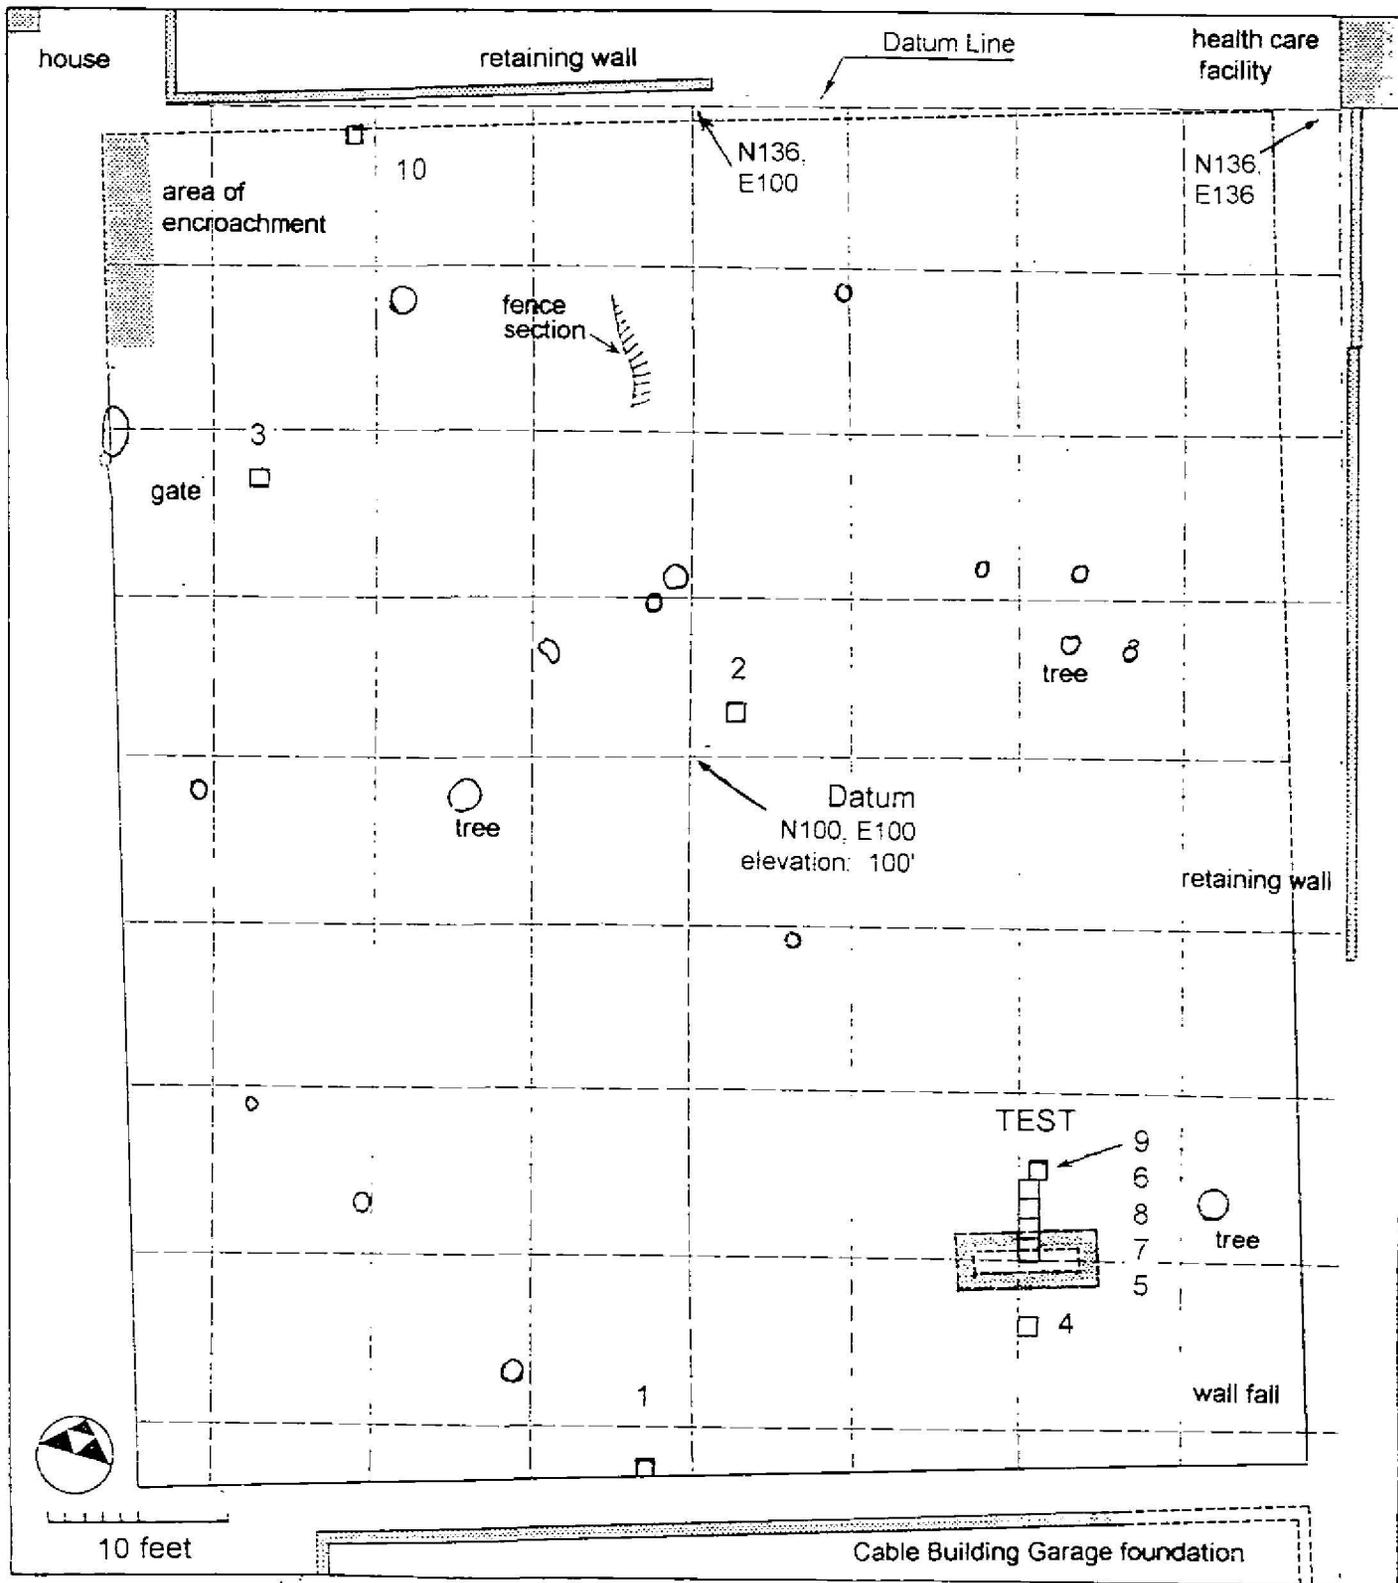
**Figure 11.** Cornell Cemetery Site Plan Showing the Location of Ten Archaeological Tests: Test 1, Feature 1 (N61.2, E97.3); Test 2 (N102, E102); Test 3 (N115, E75); Test 4 (N69, E118); Test 5, Feature 2 (N73, E118); Test 6 (N76, E118); Test 7 (N74, E118); Test 8 (N75, E118); Test 9, Feature 3 (N77, E118.5); and Test 10, Feature 4 (N134, E72).

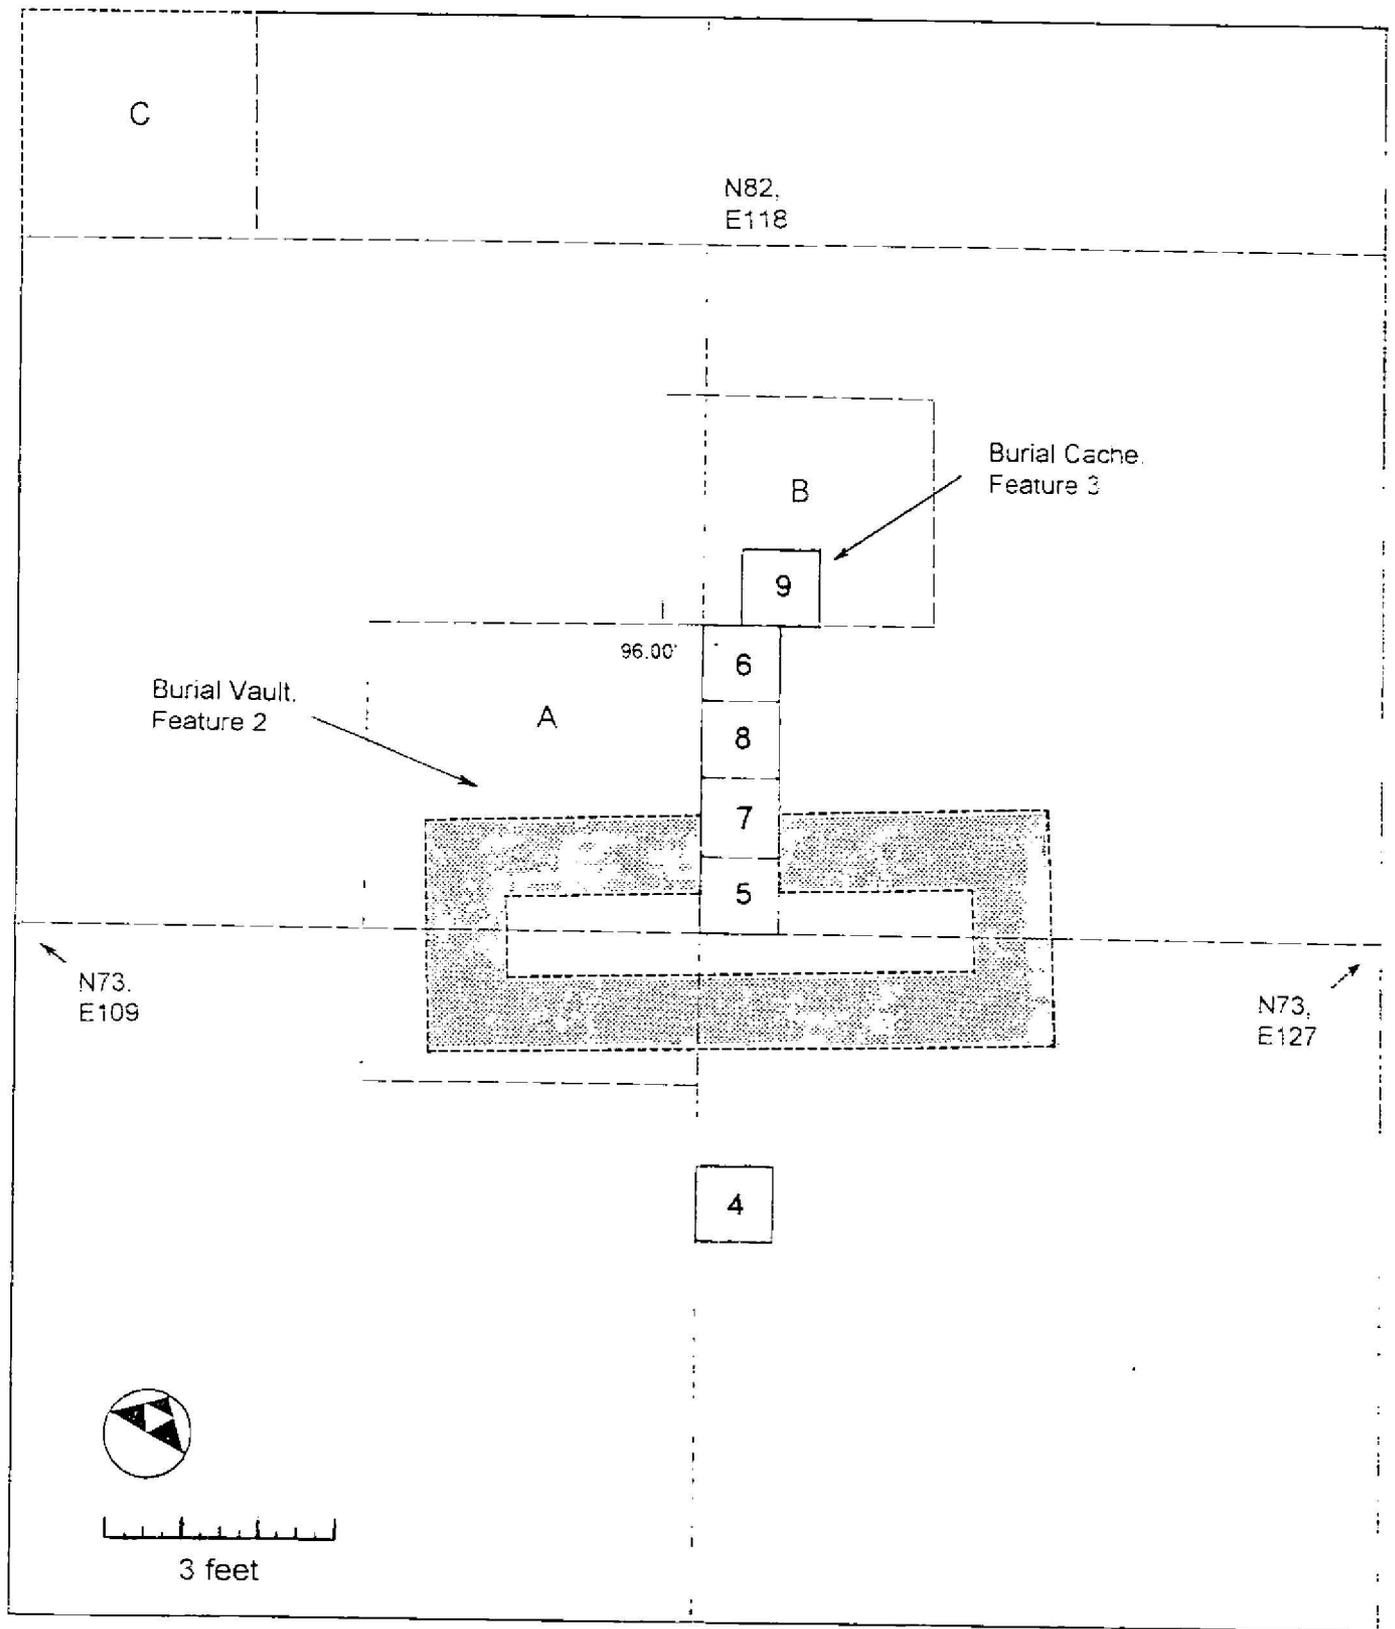
**Figure 12a.** Site Plan Showing Current Archaeological Test Excavations at the Richard Cornell Cemetery including Test 4 (N69, E118), Test 5, Feature 2 (N73, E118), Test 6 (N76, E118), Test 7 (N74, E118), Test 8 (N75, E118), and Test 9, Feature 3 (N77, E118.5) and Proposed Archaeological Excavation Units A, B and C.

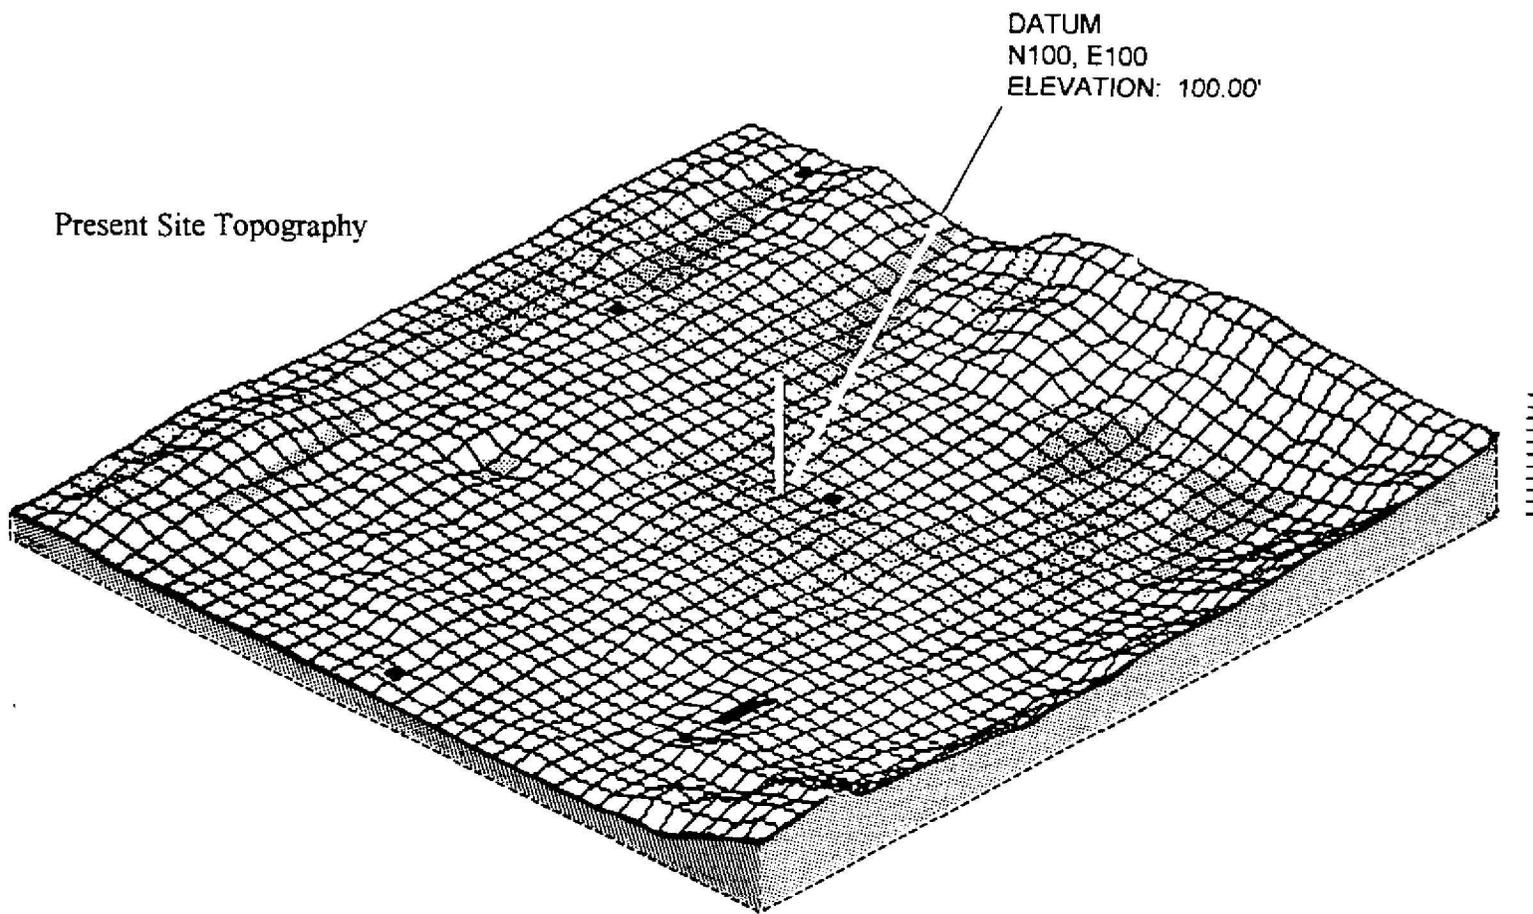
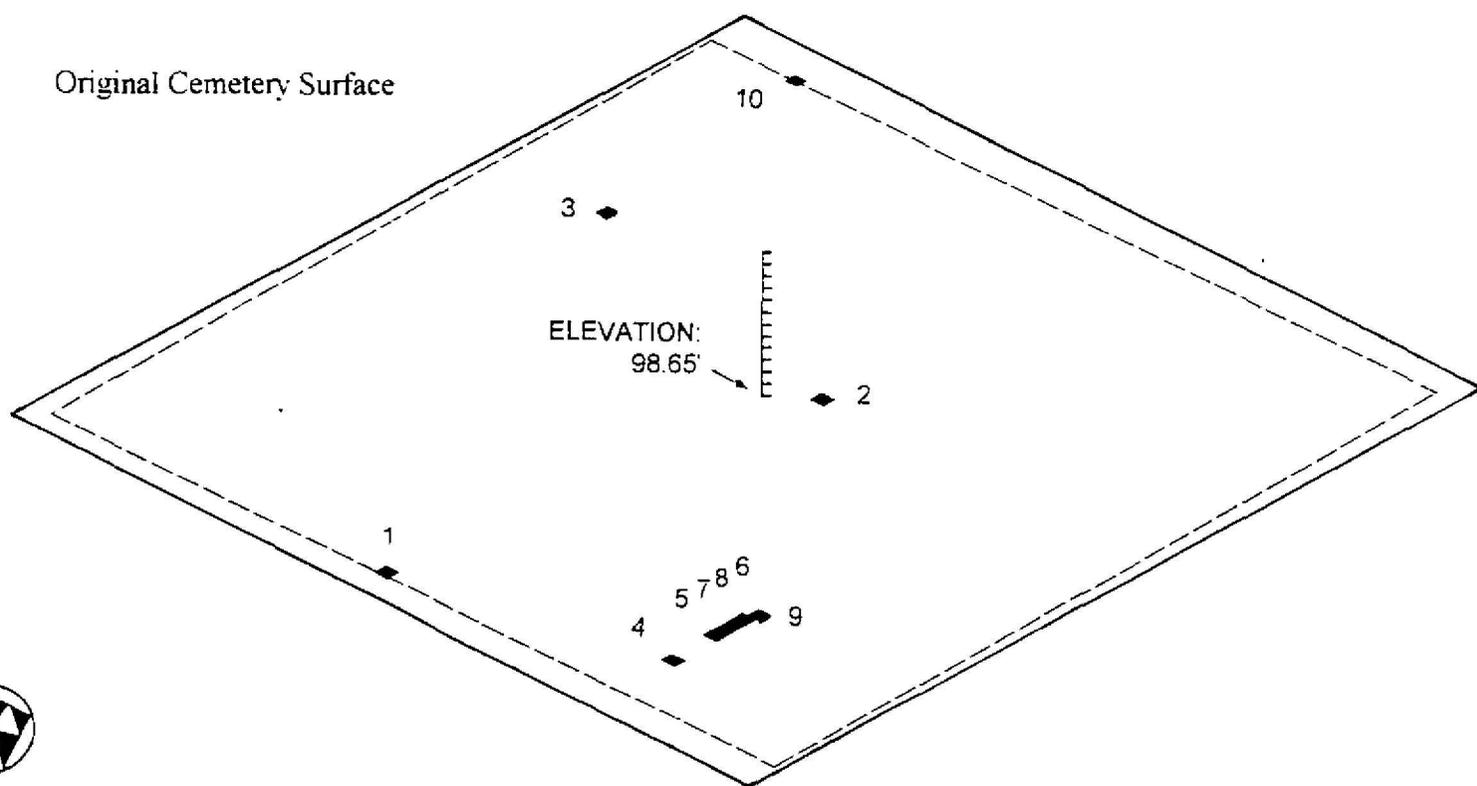
**Figure 13.** *Topographical Map of the Richard Cornell Cemetery Looking West and Showing the Location of Ten Archaeological Tests with Generic Site Deposits Isolated Above the Original Cemetery Surface (Redding and Hafford 1994).*

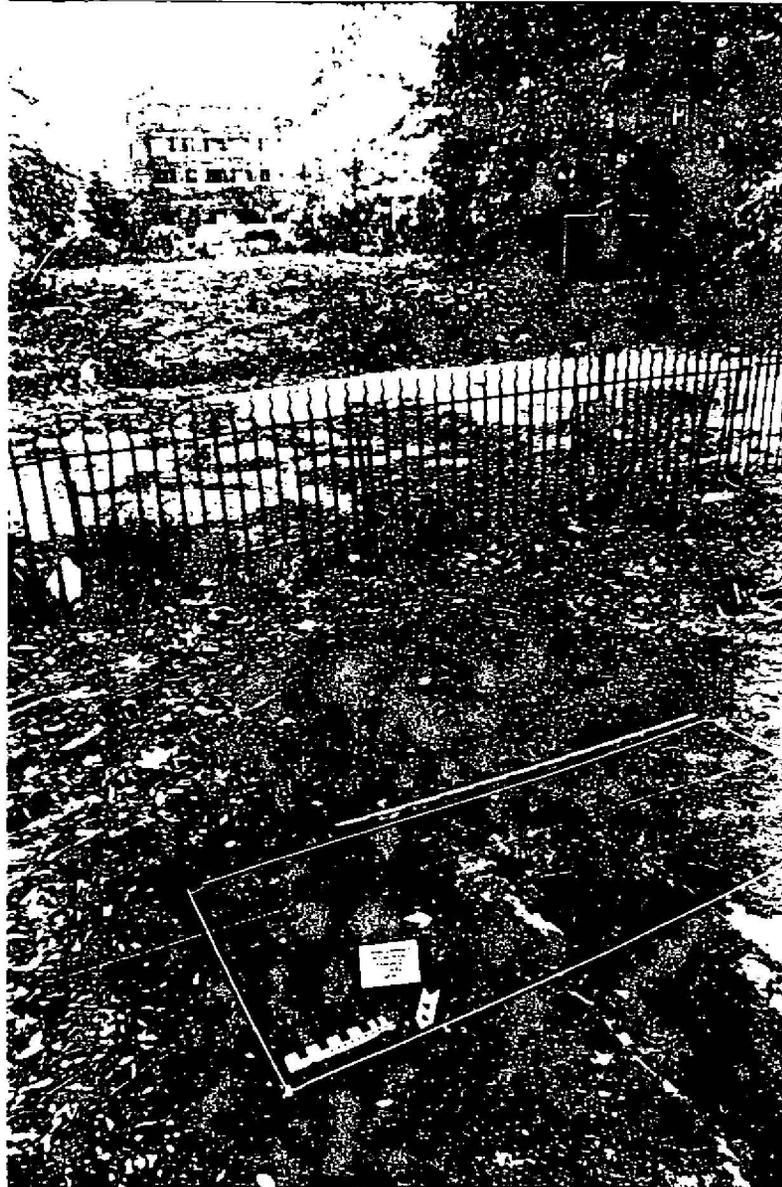
**Figure 24.** Photo showing the location of the burial vault, Feature 2 and its proximity to the wrought-iron perimeter fence and the Historical Park development site.

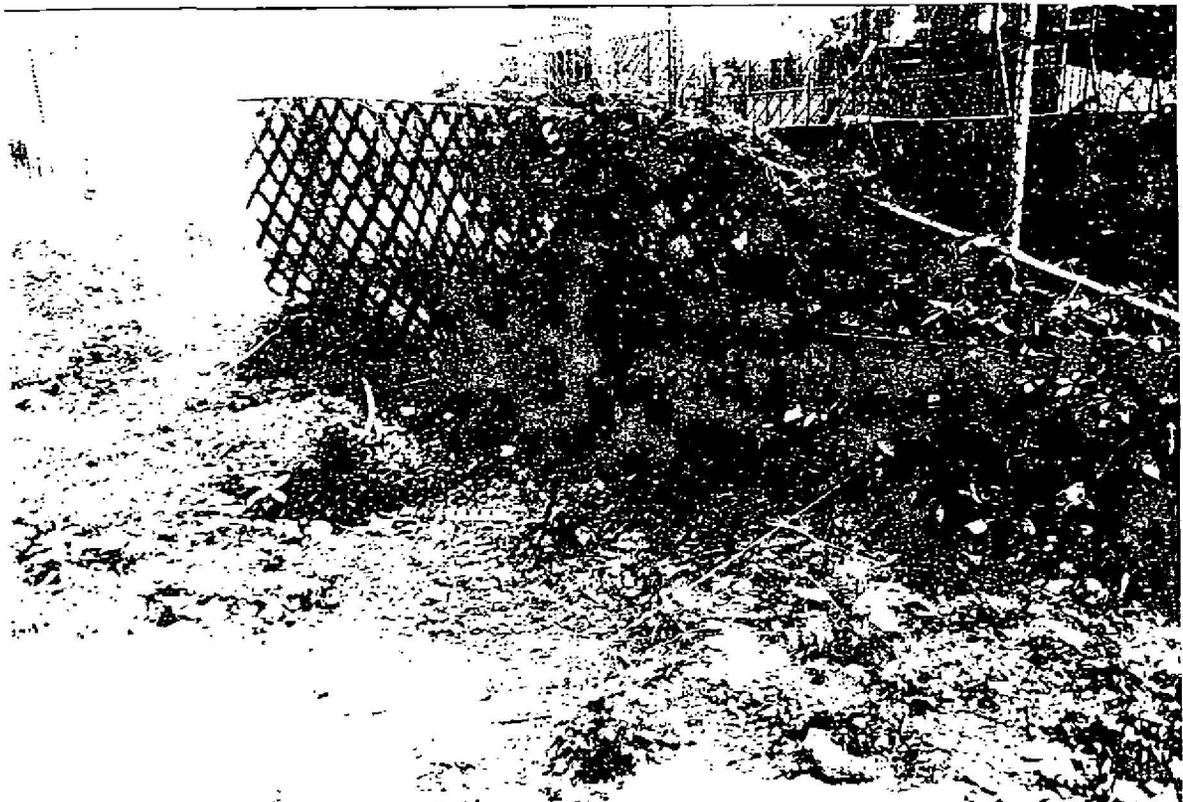
Figure 25. Photo showing a dilapidated section of the chain-link fence along the east side of the cemetery.

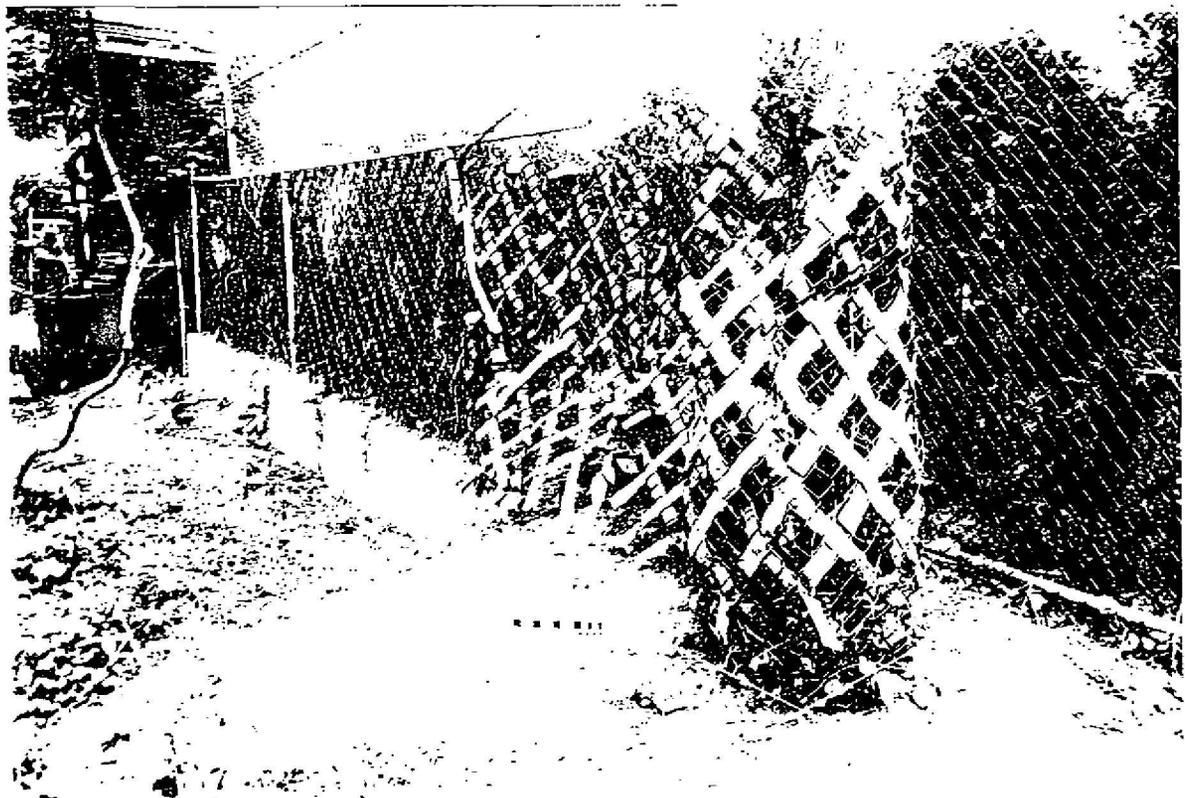
Figure 26. Photo showing an intact section of chain-link fence along the north side of the site. Note that the original wrought-iron picket fence has been completely removed.

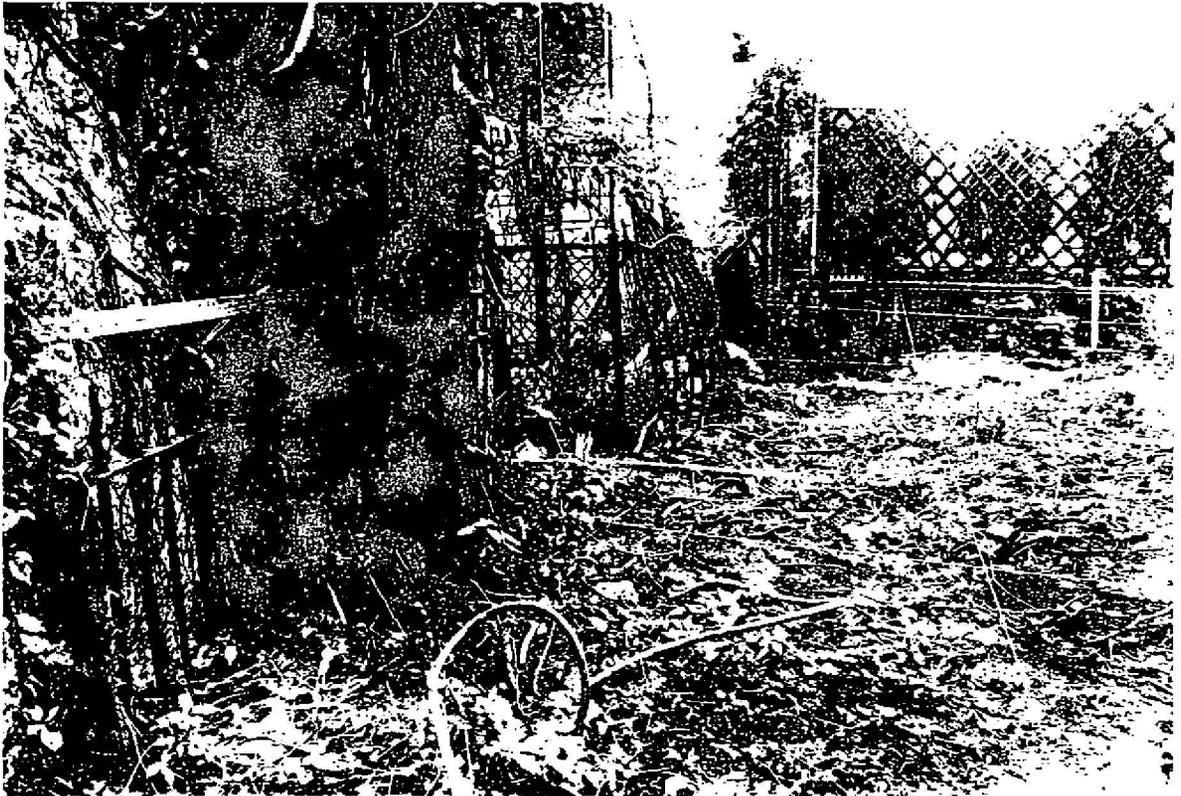
Figure 27. Photo of a relocated 6 foot section of the wrought-iron picket fence and an area of encroachment in the northwest corner of the site.

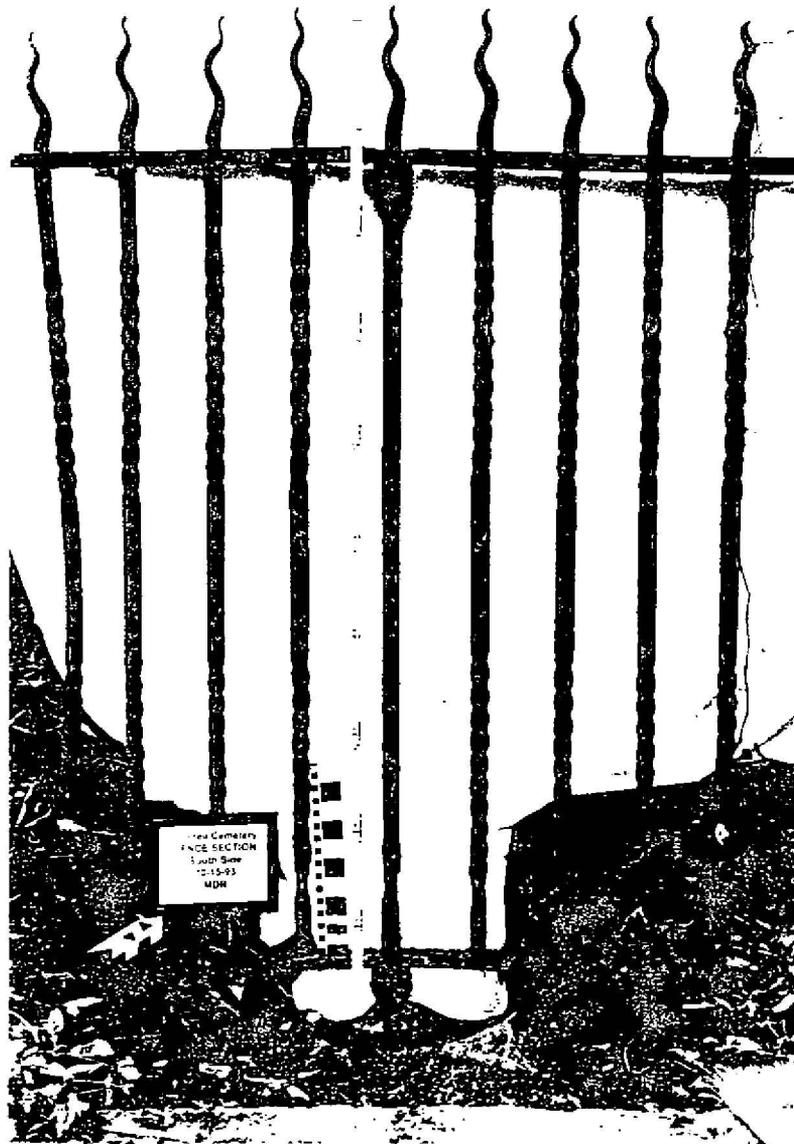
**Figure 28.** Photo of a wrought-iron perimeter fence  
brace section and the location of Test 1. (Photo  
was back-dropped to enhance the clarity  
of the fence structure.)

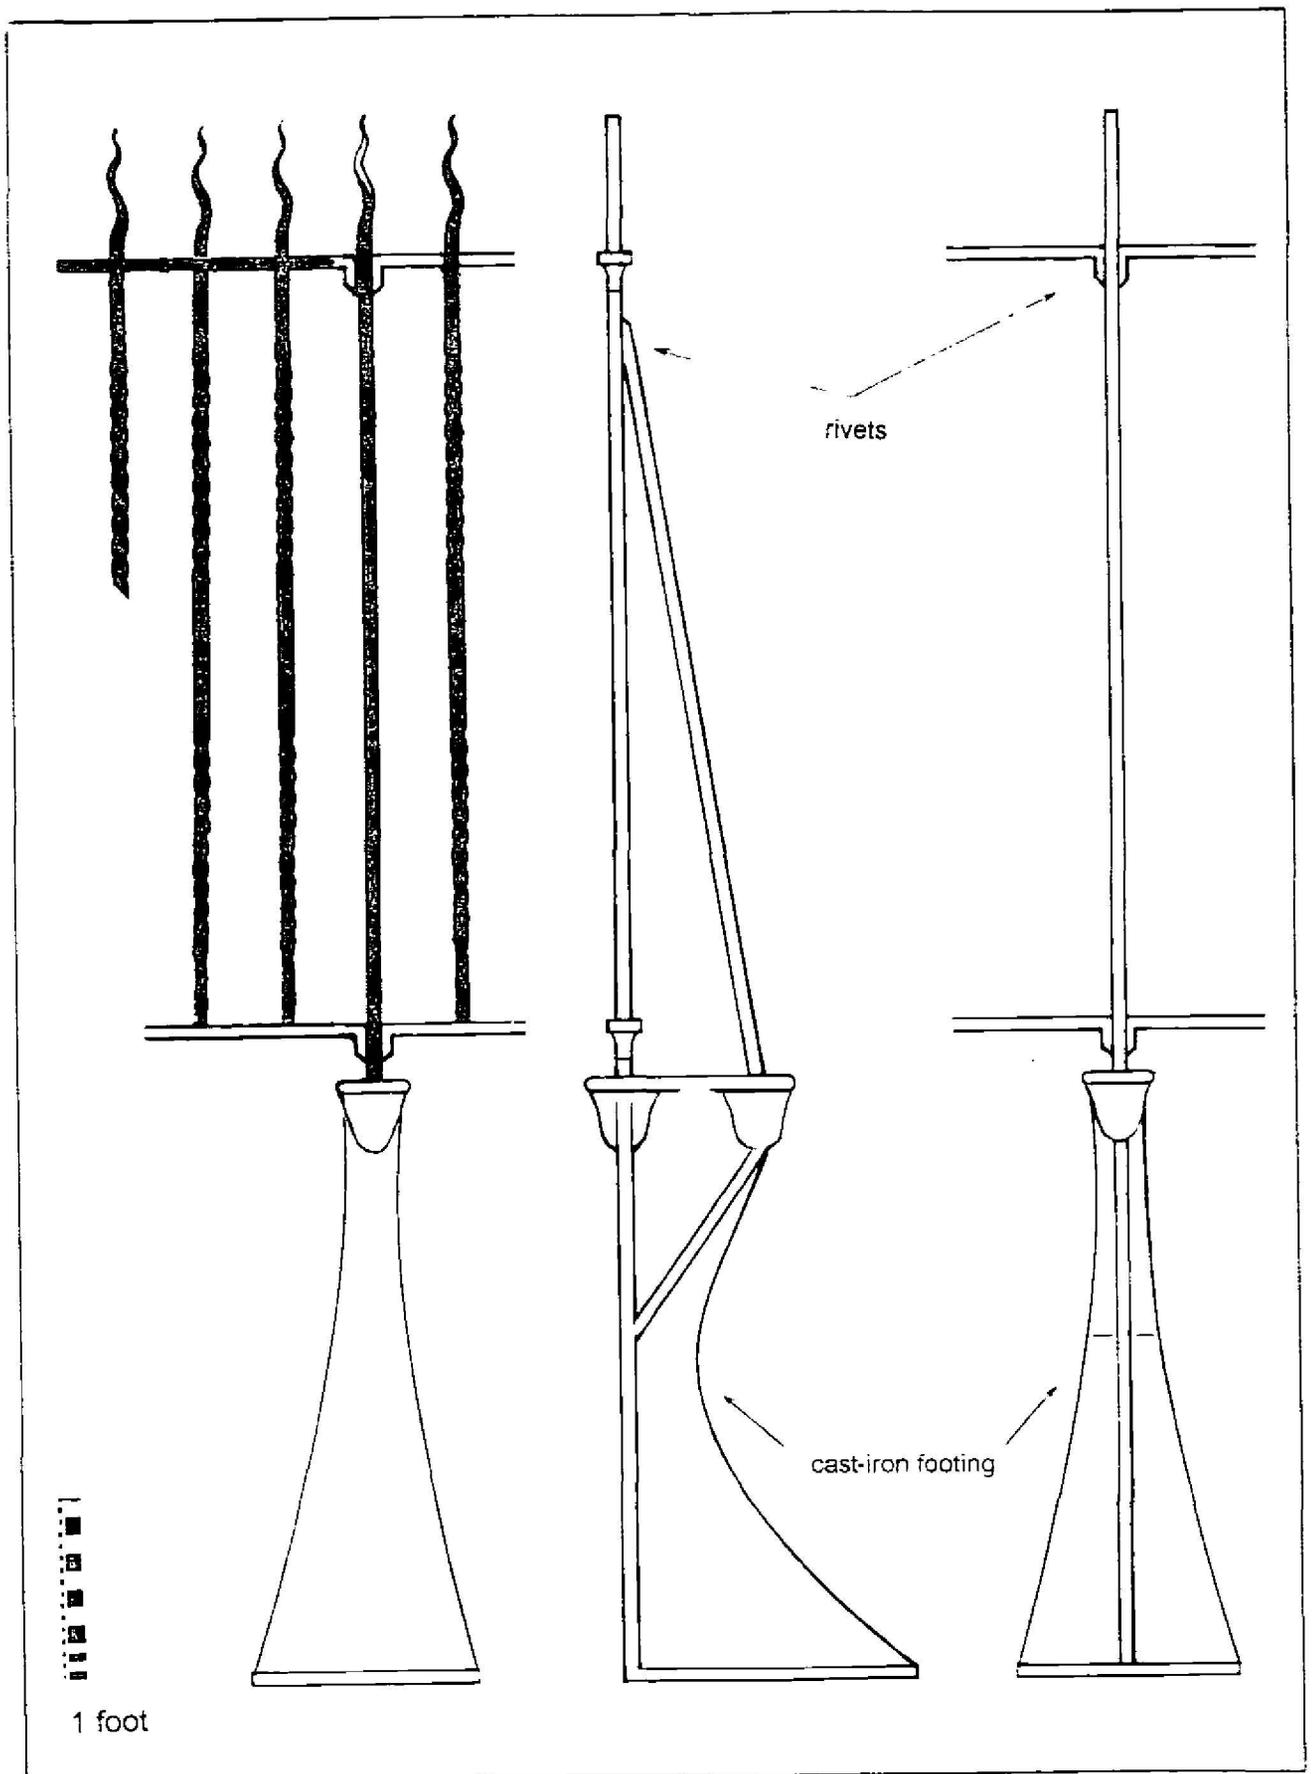
Figure 29. Drawing collage of several views of the wrought-iron picket fence showing the excavated brace and cast-iron footing components.

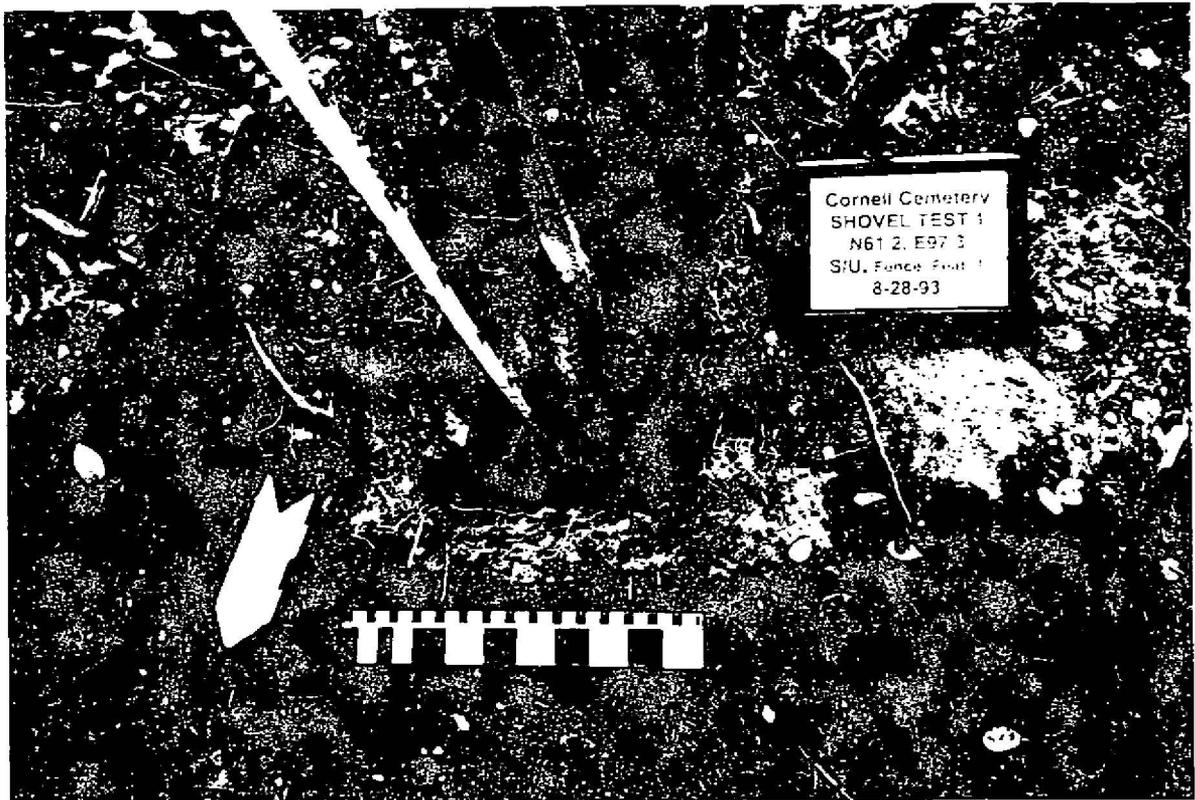
Figure 31. Photo of Test 1, N61.2, E97.3, Feature 1, south-side wrought-iron fence brace and cast-iron footing structure.

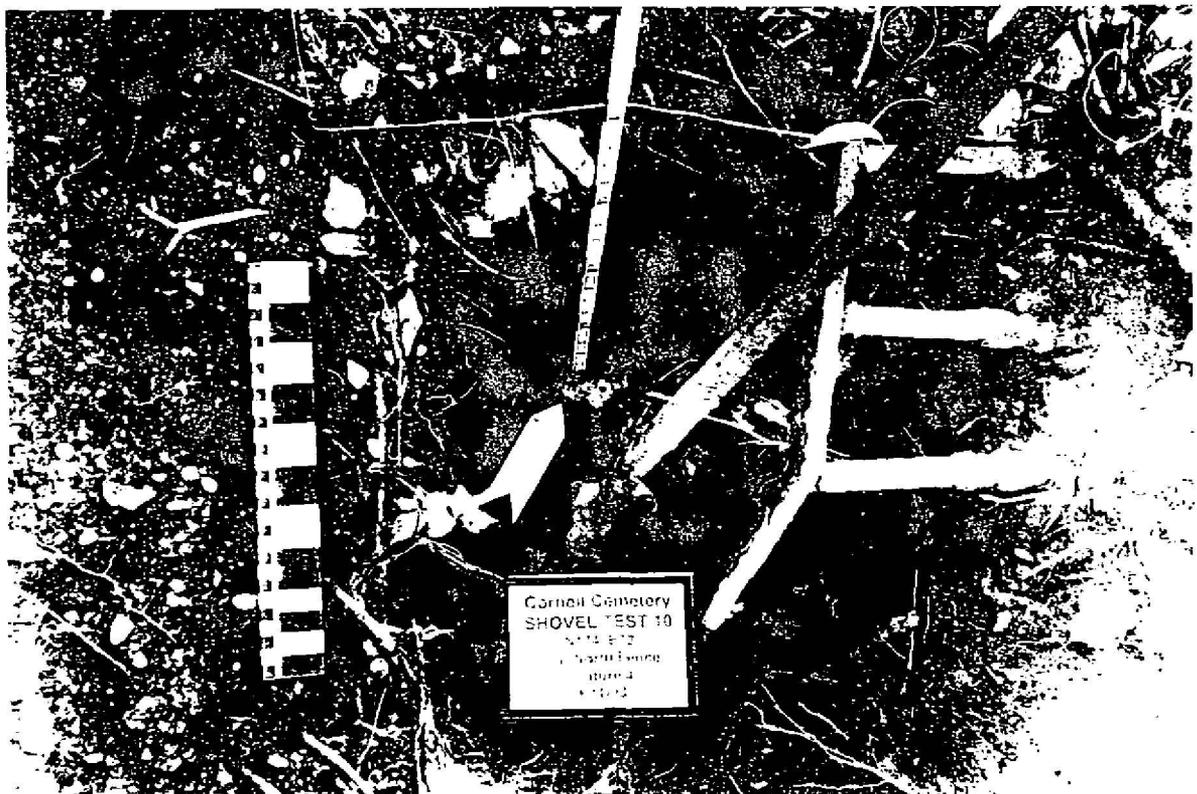
Figure 32. Photo of Test 10, N134, E72, Feature 4, north-side wrought-iron fence brace and cast-iron footing structure.

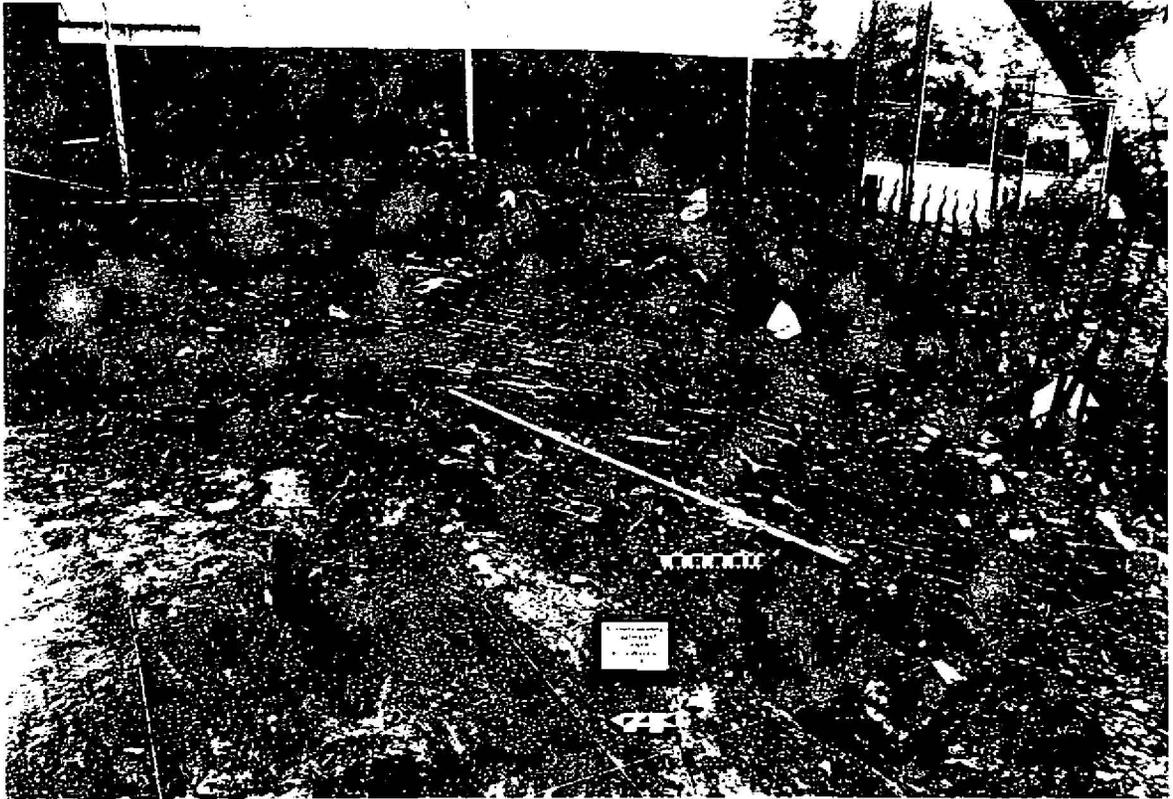
Figure 36. Photo showing brick wall-fall from the Cable Building Garage lying in the southeast corner of the site.

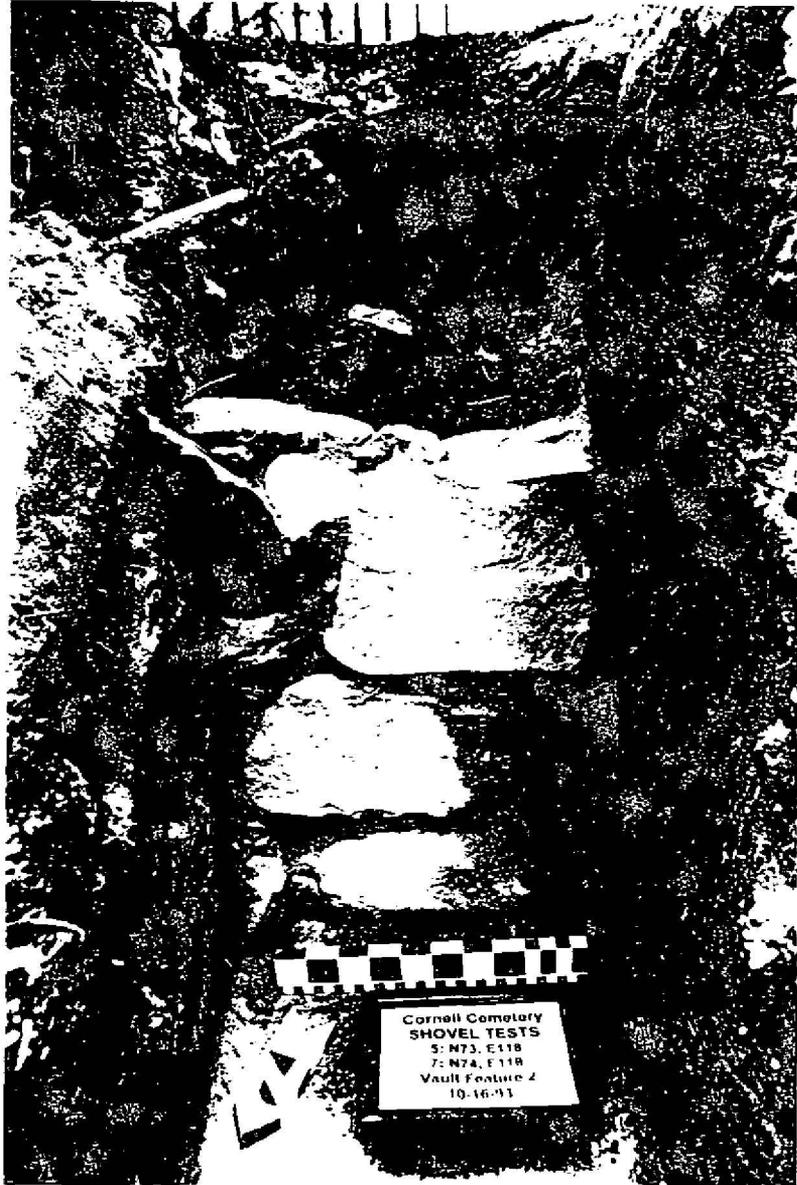
Figure 39. Photo showing the north side of the excavated vault wall section. Feature 2.

The vault, the most elaborate mortuary feature on the cemetery grounds, began as a 3' x 8' walled structure of stacked-stone construction and was completed by setting an impressive 3' x 8' singly hewn inscribed light reddish-brown sandstone lid of great weight upon these walls to seal the interior. Thirty stone and schist fragments (cat. 287) recovered from Test 8, Stratum 4, Level 2 indicate the selection and minimal working of stones during the construction of the stacked-stone walls. An examination of the mortar used during construction reveals a compound of sand and burned shell which would have been mixed with water. Tests for lime content have not been completed. Low-intensity probing along the base of the excavated section of the north vault wall indicate a minimum wall height of 3.5 feet.

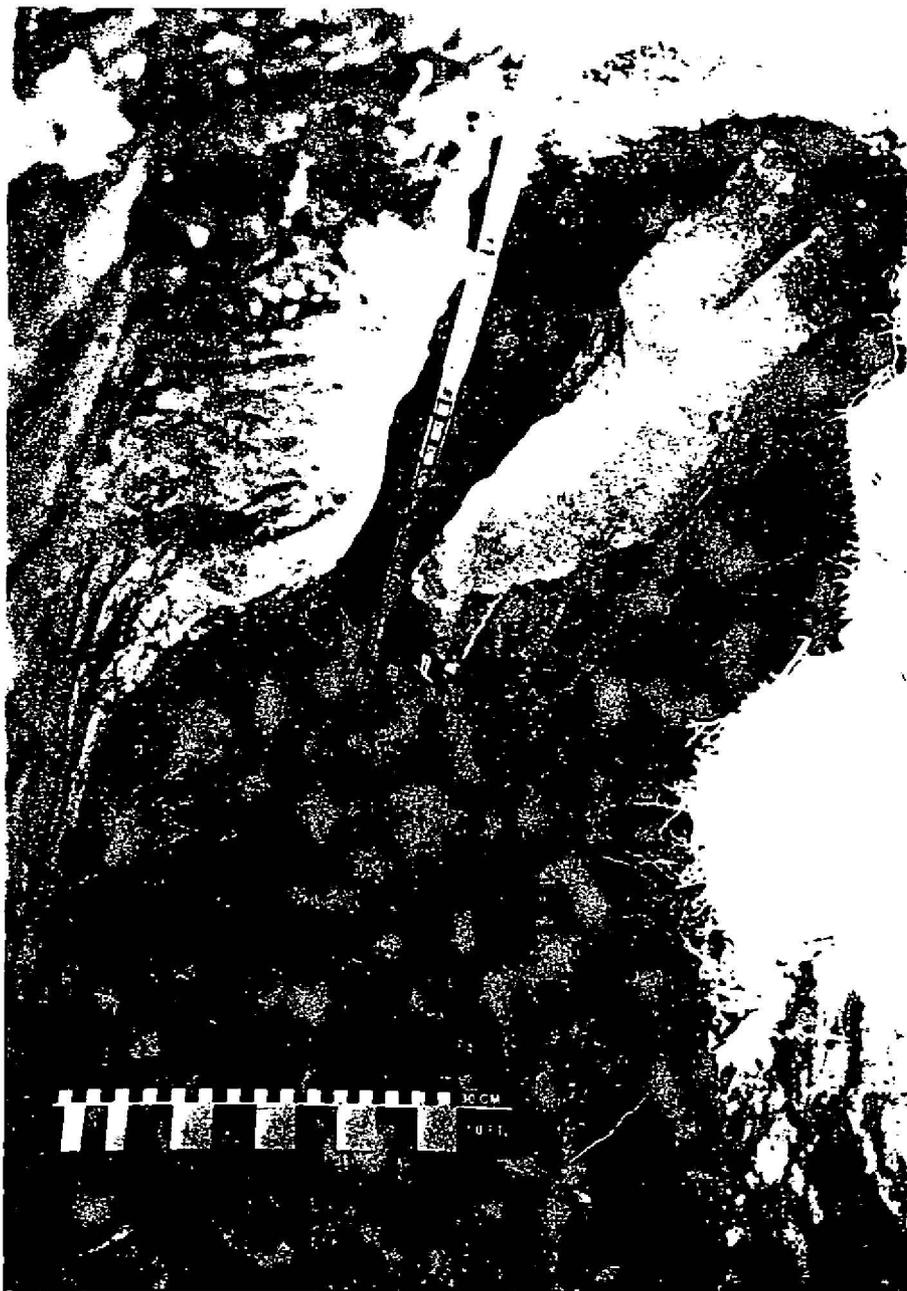
**Figure 41.** Photo of the cache, Feature 3, with brown sandstone lid fragment (cat. 320.1) from the burial vault of Thomas Cornwell (1722-1766) *in situ*.

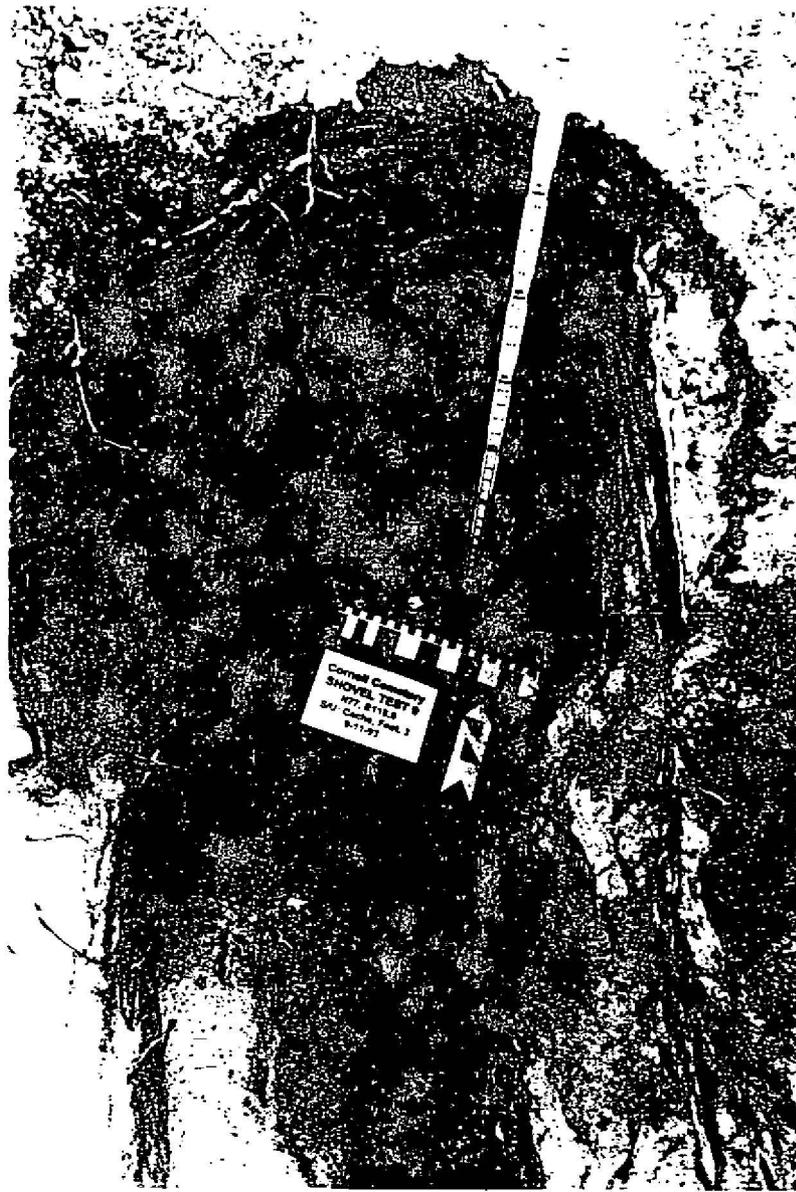
Figure 42. Photo showing the emptied vault lid cache.  
Feature 3.
