An Archaeological and Environmental Design  
Evaluation of the Richard Cornell Cemetery,  
Far Rockaway, Queens, New York  
(LP-0741)

Prepared Under the Auspices of the  
New York City Landmarks Preservation Commission  
for the Cornell Cemetery Corporation  
April, 1994

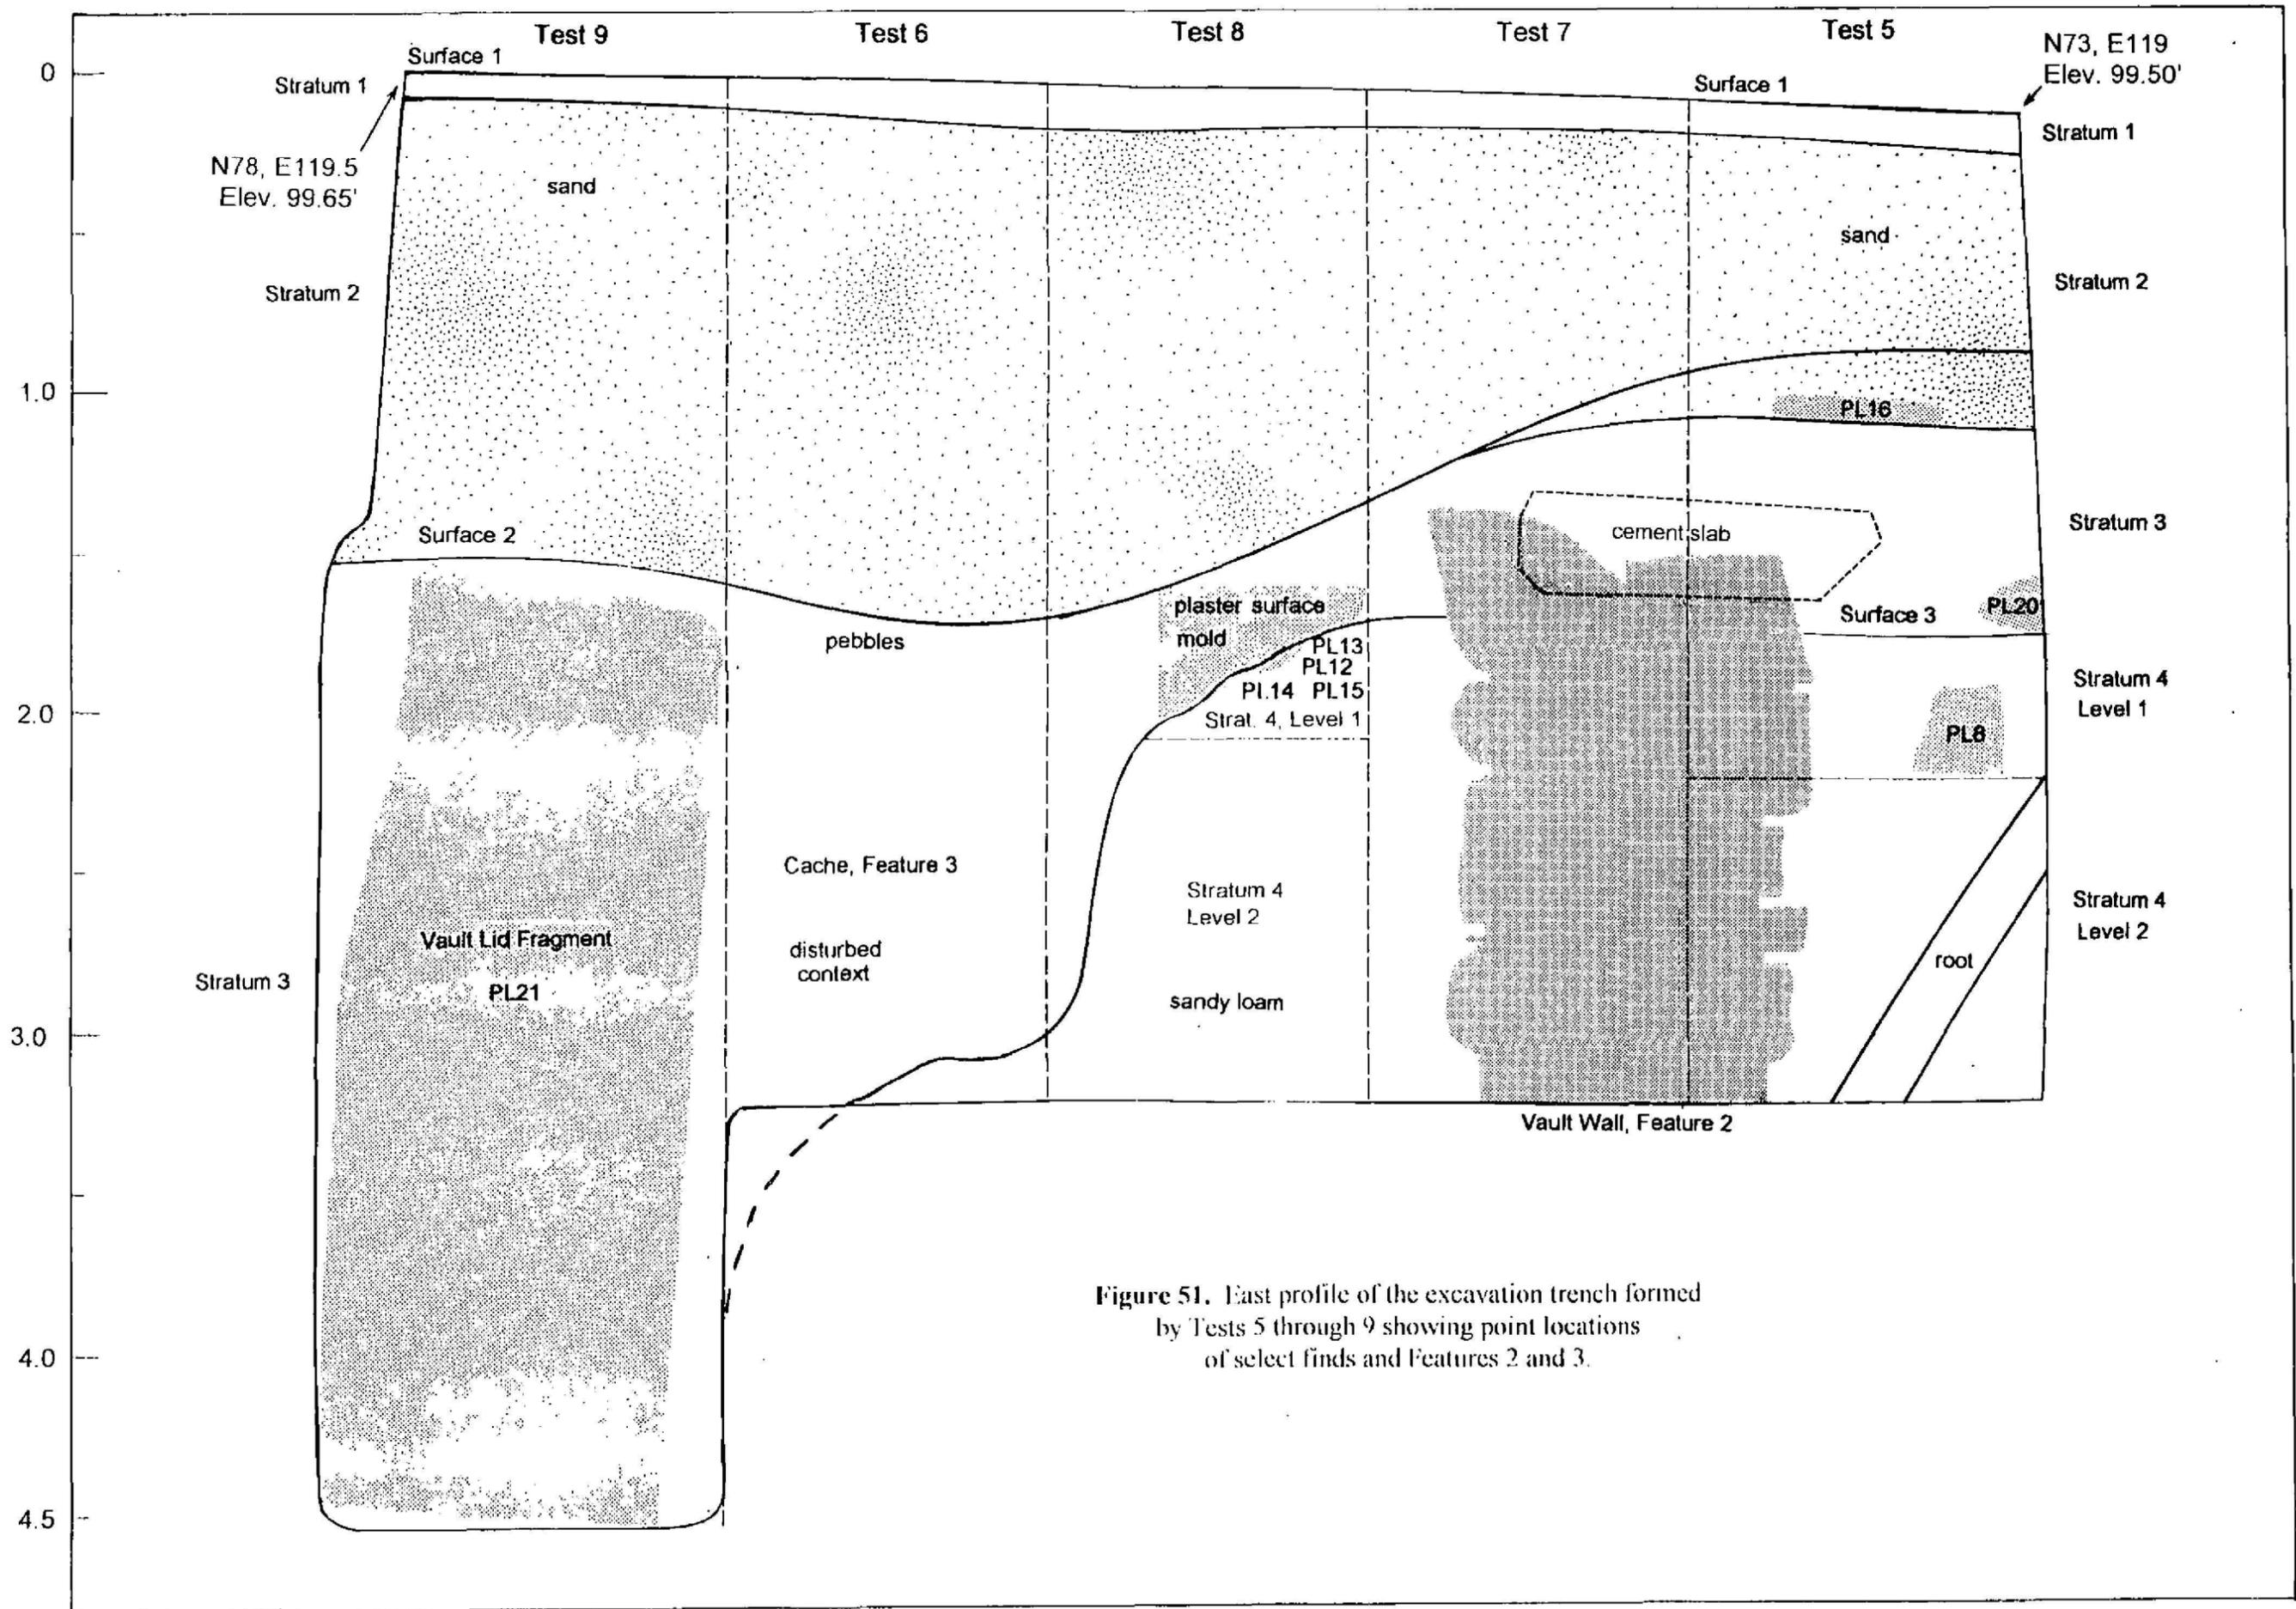
Figure 51. East profile of the excavation trench formed by Tests 5 through 9 showing point locations of select finds and Features 2 and 3.

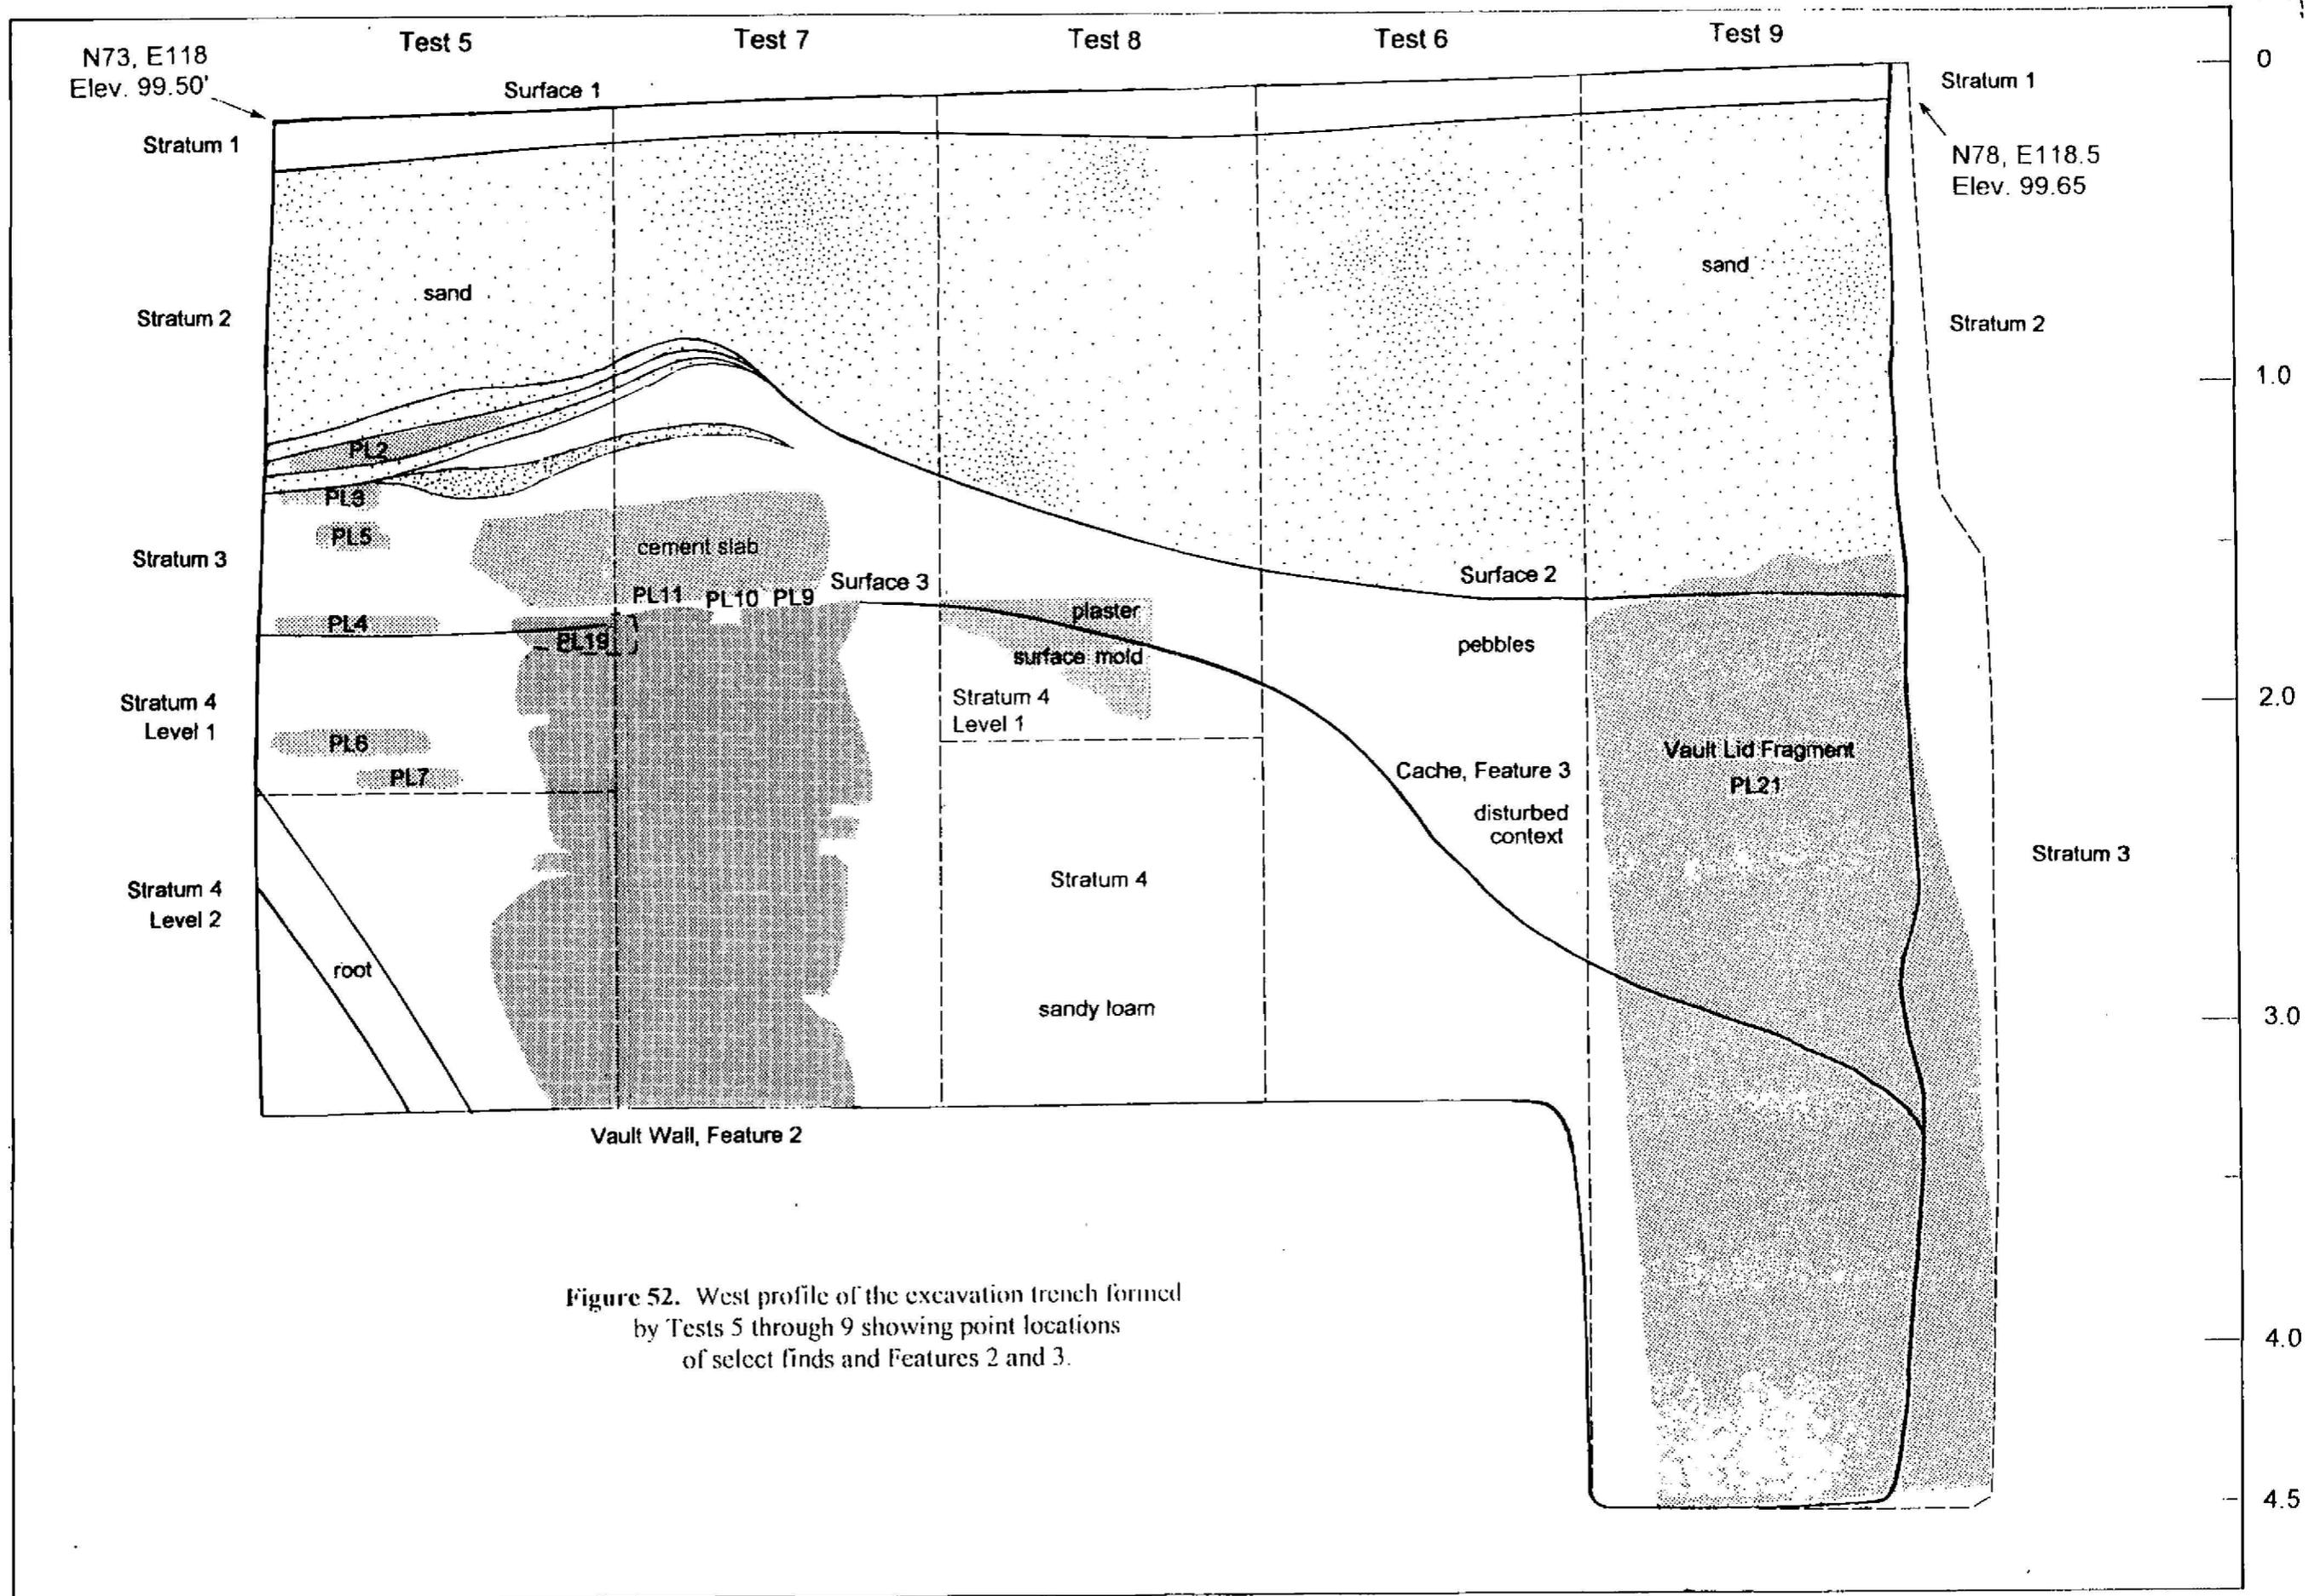
Figure 52. West profile of the excavation trench formed by Tests 5 through 9 showing point locations of select finds and Features 2 and 3.
