FINAL ARCHAEOLOGICAL RESOURCES PROTECTION ACT
SITE DAMAGE ASSESSMENT REPORT
GOVERNORS ISLAND NATIONAL MONUMENT

New York County
Governors Island, New York

September 2008

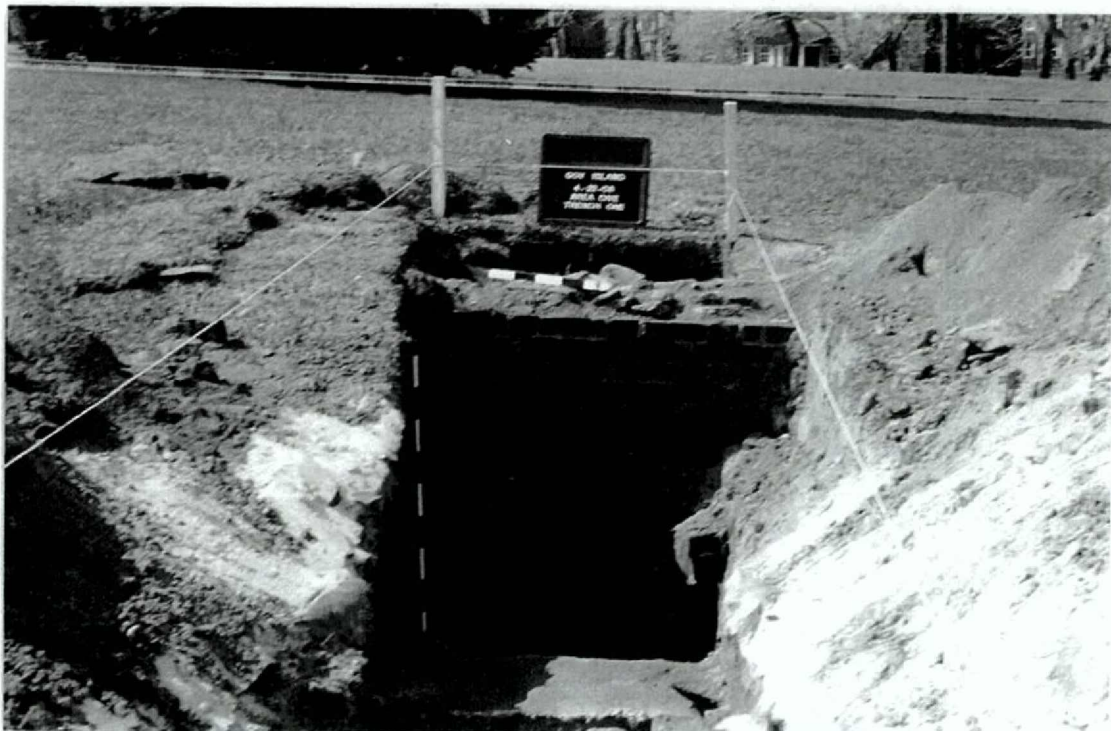
Area 1, Trench 1 close-up of "covered defile" south wall section.

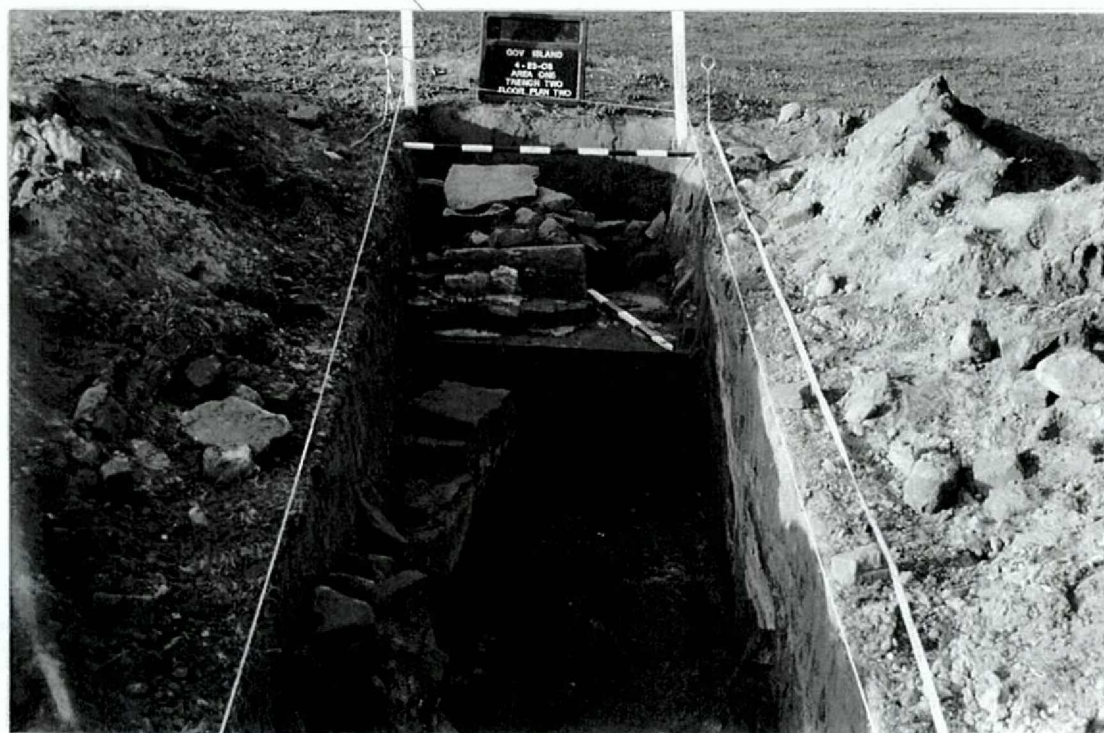
Area 1, Trench 2 "covered defile" south wall section.

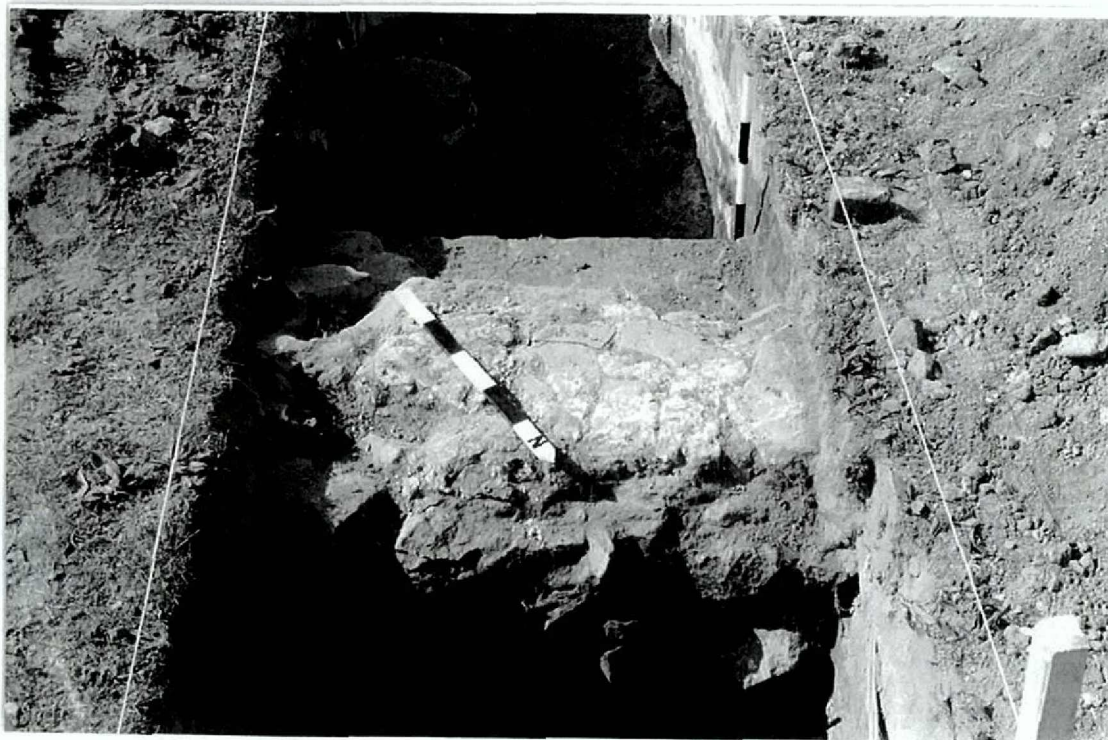
Area 1, Trench 2 outer facing of "covered defile" north wall section.

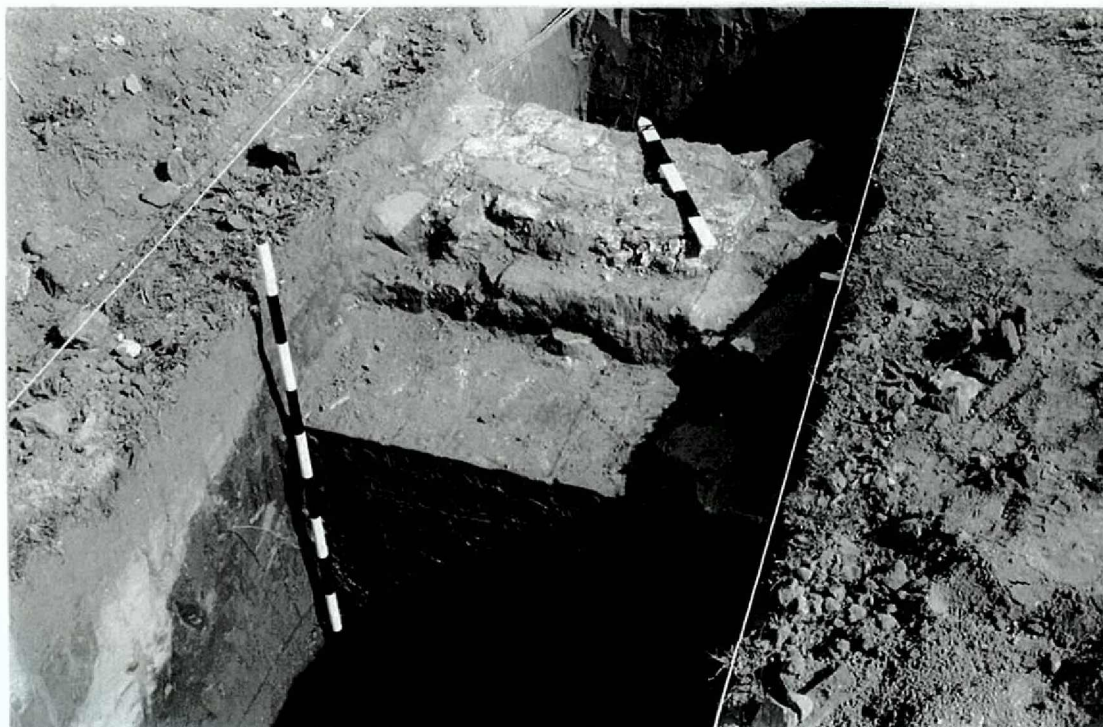
Area 1, Trench 2 inner facing of "covered defile" north wall section.

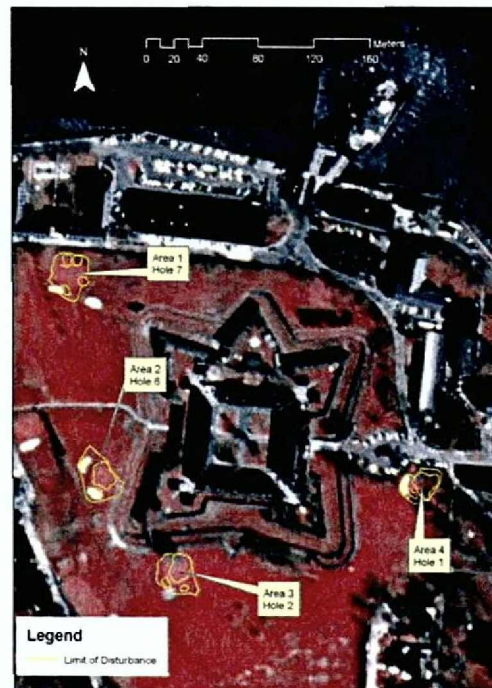
Figure 1 Orthophoto of Fort Jay on GOIS with GPS delineation of damaged areas.
