Supplemental Archaeological Assessment

**Second Avenue Subway:
72nd and 86th Street Stations**

New York, New York

May 2009

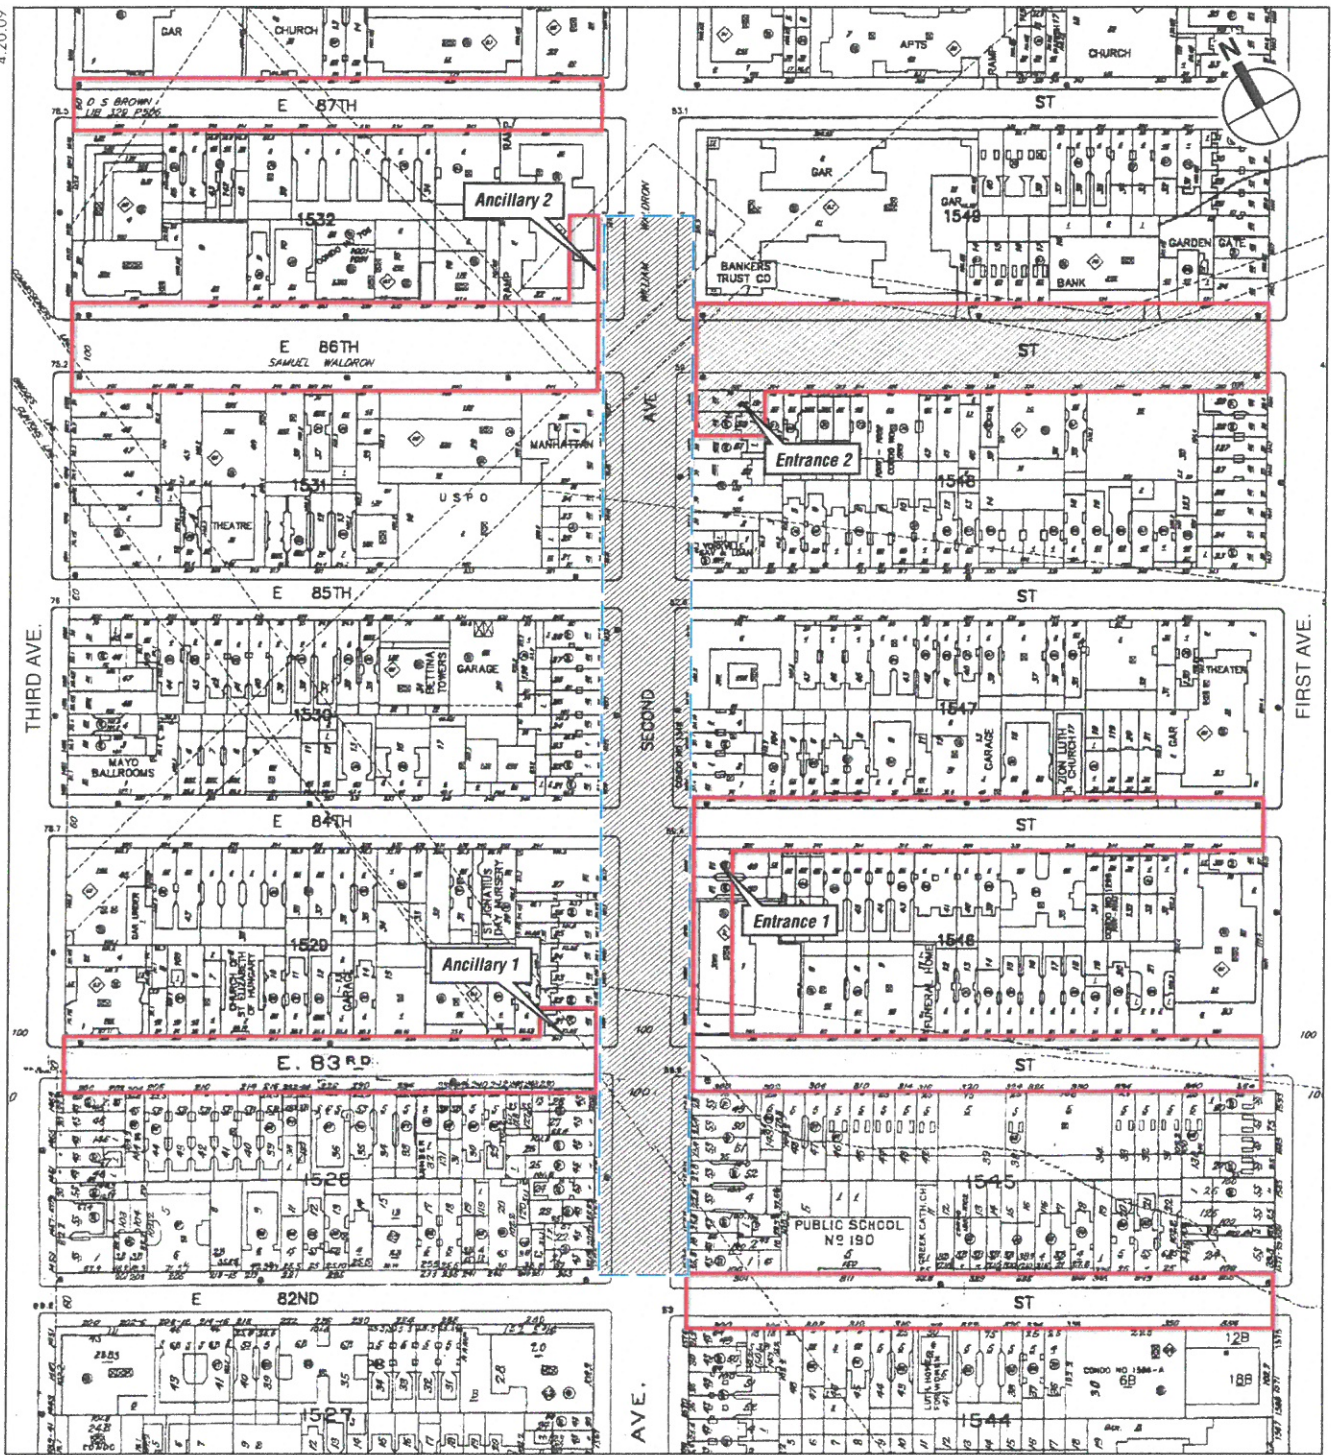
APE Boundaries of the 86th Street Station
Sanborn Map, 2007
Figure 2b

- APE
- Portion of APE Previously Analyzed for Archaeological Sensitivity
- Station Box
