PHASE IA CULTURAL RESOURCES INVESTIGATION

FOR ADMIRAL'S ROW SECTION

FORMER BROOKLYN NAVY YARD, BROOKLYN,

July 2008

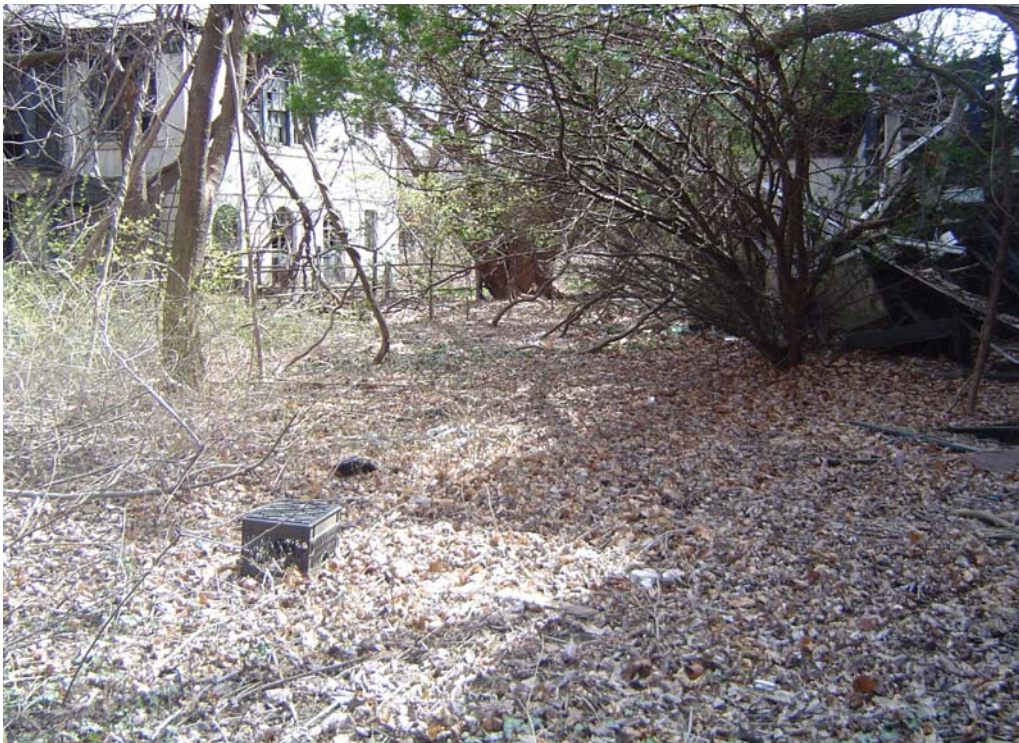
Figure 4.5. View of a yard behind and between Buildings L and H, facing south-southeast. Brooklyn Navy Yard, Kings County, New York (PCI 2008).

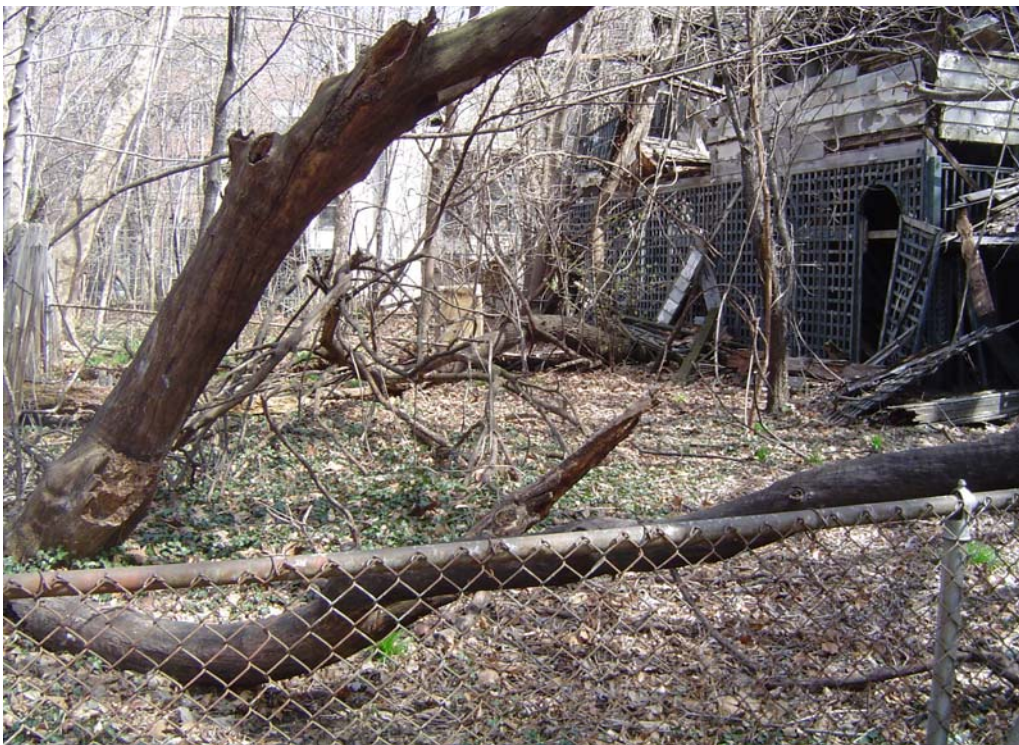
Figure 4.7. View of fallen branches and chain link fences in the yards behind Buildings E, F and G, facing east. Brooklyn Navy Yard, Kings County, New York (PCI 2008).

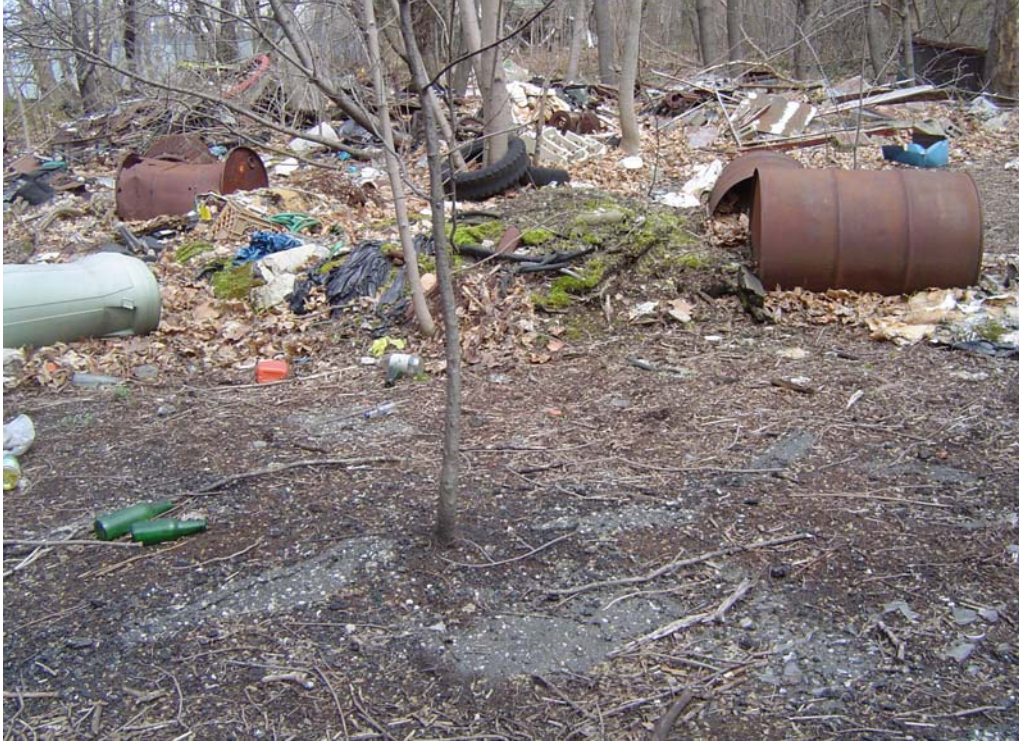
Figure 4.10. Garbage and debris in the open lot north of the Timber Shed, facing northeast. Brooklyn Navy Yard, Kings County, New York (PCI 2008).

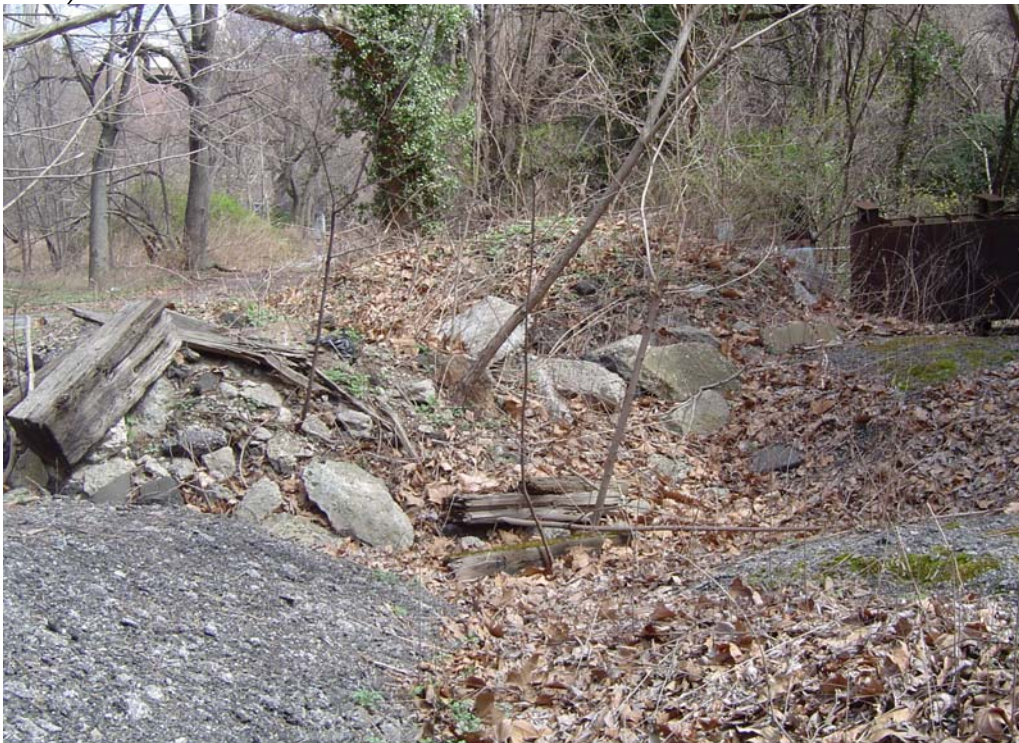
Figure 4.11. Rubble push-piles north of the Timber Shed, facing east. Brooklyn Navy Yard, Kings County, New York (PCI 2008).

Timber Shed (Building 16) Study Area. This study area is bounded on the north by a fence along the Brooklyn Navy Yard Industrial Park (the New York Police Department Brooklyn Tow Pound; on the east by Park Avenue; on the south by a fence along Flushing Avenue; and on the west by the brick wall separating the project area from Navy Street (see Figure 4.1). The area is the historic location of the western shore of the mill pond (see Figures 3.3 through 3.7). This study area presently includes the timber shed and the open rectangular lot to the north. The timber shed previously spanned the length of the open lot but was reduced in size during the 1960s (see Section 6.0). The open lot north of the remaining part of the Timber Shed is approximately 50 cm (1.6 ft) higher ground than Park Avenue along its eastern side (Figure 4.8). Vegetation includes deciduous trees (mostly saplings), ivy, grass, and weeds (Figure 4.9). Modern garbage, debris (e.g., tires, empty 55-gallon drums), and rubble fill are common across the open lot (Figure 4.10). Large push-piles of rubble fill cover a roughly 25 by 75 ft (7.5 by 23 m) area just north of the Timber Shed (Figure 4.11).

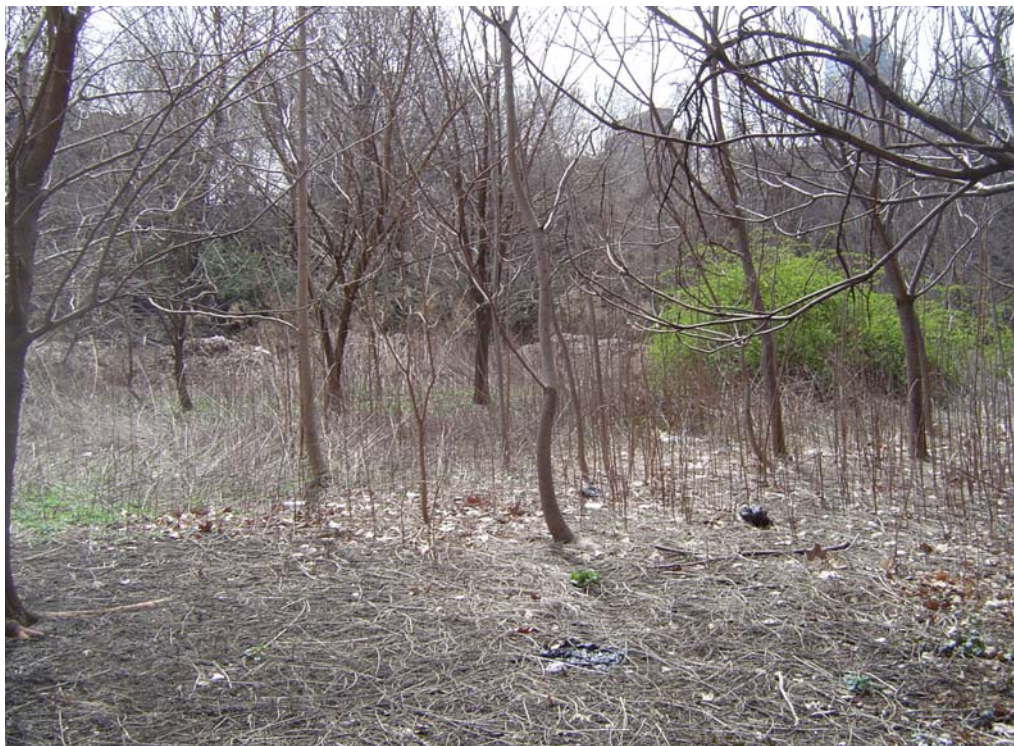
Figure 4.12. Saplings growing across the former Parade Ground, facing south. Brooklyn Navy Yard, Kings County, New York (PCI 2008).

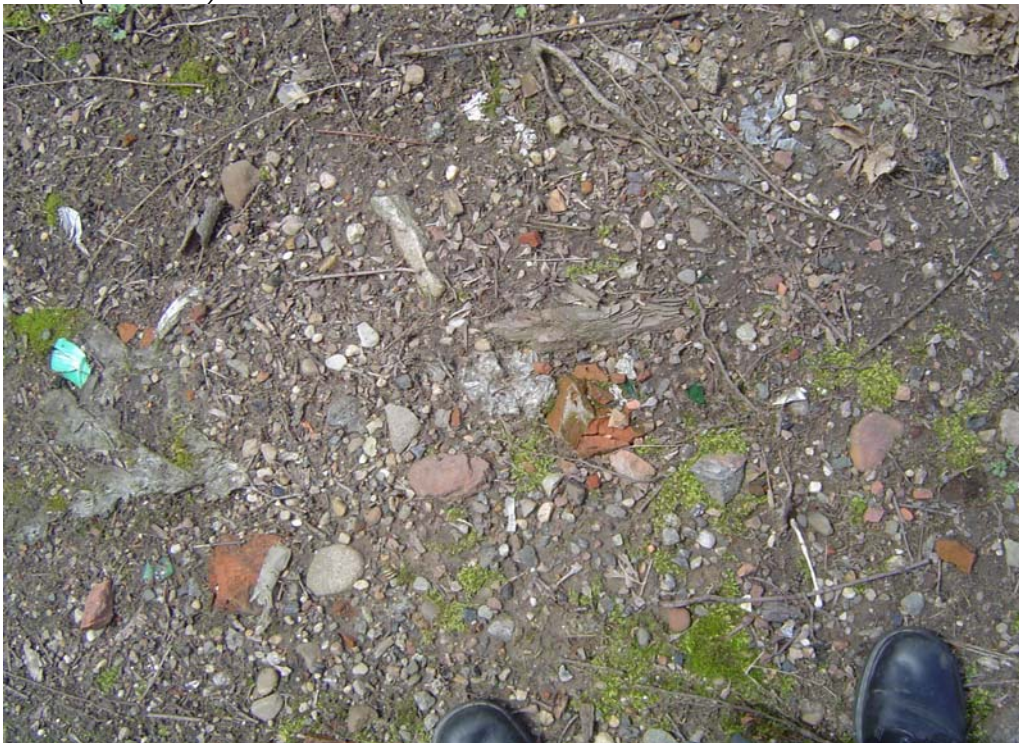
Figure 4.16. Exposed fill in the former Parade Ground, facing down. Brooklyn Navy Yard, Kings County, New York (PCI 2008).

Parade Ground Study Area. This study area includes the former parade ground of the Navy Yard. It is bounded on the north and east by a fence along the Brooklyn Navy Yard Industrial Park; on the south by Park Street; and on the west by Park Avenue (see Figure 4.1). This entire area was originally a tidal marsh that was converted for use as a mill pond through the first half of the nineteenth century (see Figures 3.1 through 3.7). It was filled and converted into a parade ground in the mid-nineteenth century. The area is currently an open lot with scattered trees and some brush (Figure 4.12). Two structural features that appear to be associated with this area's former use as a parade ground include a platform (building number unknown, Figure 4.13) along Park Street and a flagpole (Building 135). Other structures within this area include Building J, a tennis court (Building 710) and an associated wood frame shower room (Building 198) (see Sections 9.0 and 10.0 for photographs and further discussion on these extant structures). A sign on Building 198 stated hazardous PCBs are within or possibly adjacent to the structure (Figure 4.14). A modern monitoring well was observed west of Building 198 (Figure 4.15). Fill with brick and cement fragments was exposed on the ground surface in the southeast part of this study area (Figure 4.16). Modern garbage and mounds of lawn clippings were also seen throughout (Figure 4.17).

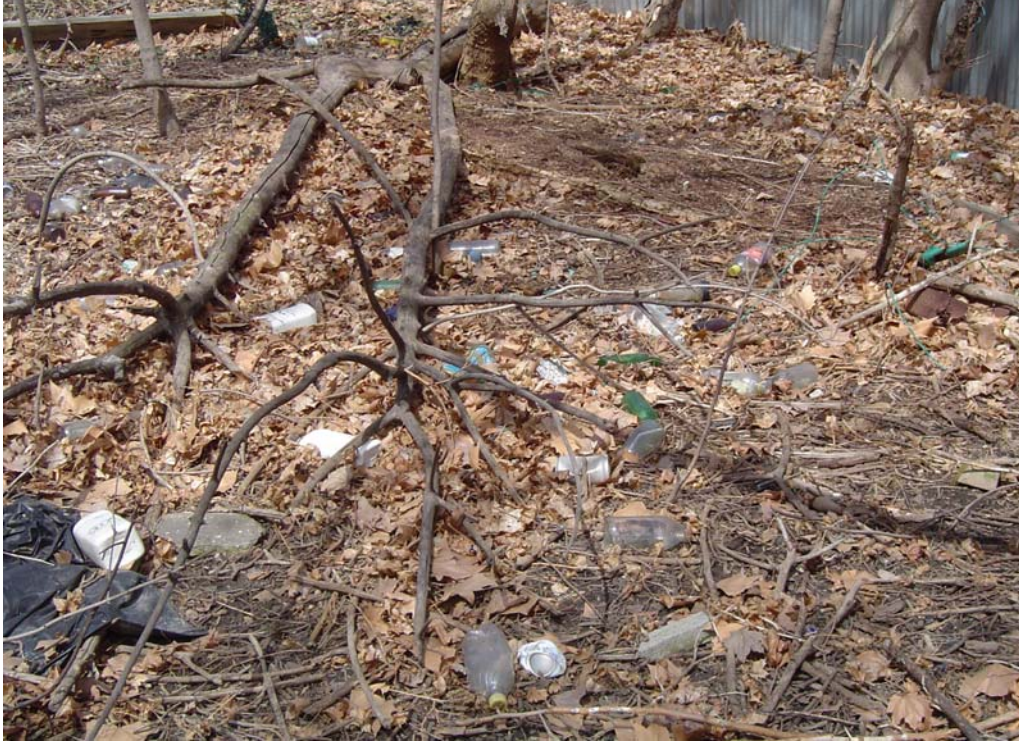
Figure 4.17. Modern garbage scattered across the former Parade Ground, facing north. Brooklyn Navy Yard, Kings County, New York (PCI 2008).

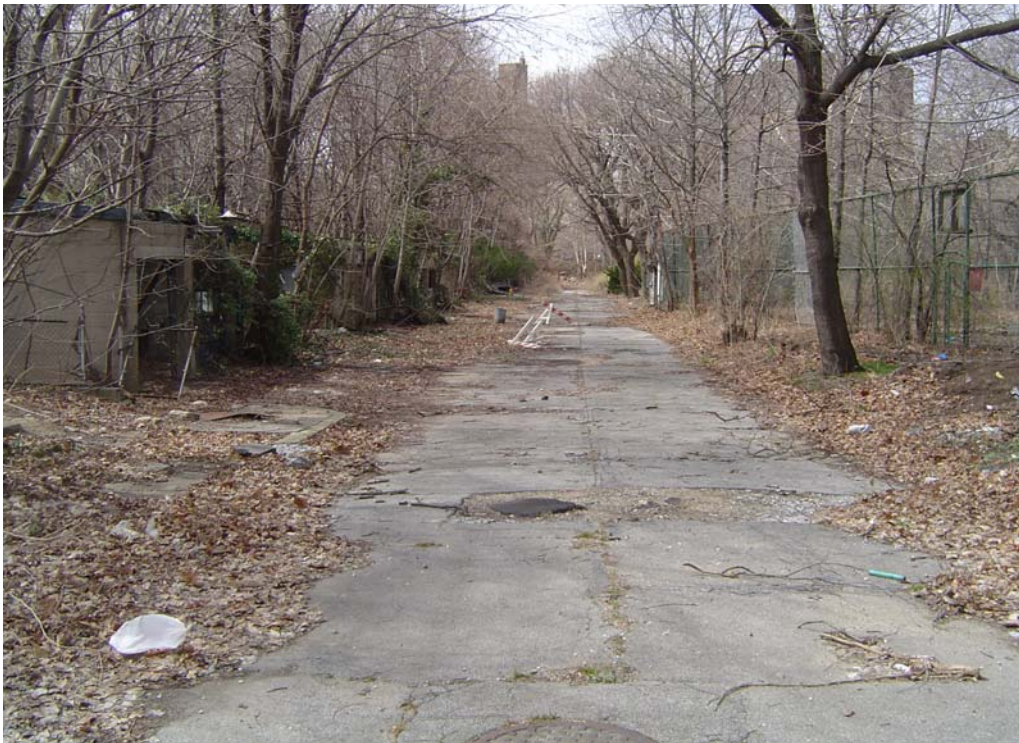
Figure 4.18. A view along Park Street, facing west. Brooklyn Navy Yard, Kings County, New York (PCI 2008).

Park Avenue/Park Street Study Area. This study area includes portions of Park Avenue and Park Street that are located within the APE. This study area is asphalt paved but is in poor condition with numerous open gravel patches and a sinkhole (Figures 4.18 and 4.19). Park Street and most or all of Park Avenue were submerged or tidal marsh until the middle of the nineteenth century when it was filled in and the roads were constructed. The northern portion of Park Avenue is on or adjacent to the western shore of the map-documented mill pond. A sinkhole in the pavement was observed at this location. An original brick pavement is visible beneath the modern asphalt pavement (see Figure 4.20). Rubble-fill push piles are present along portions of Park Avenue (see Figure 4.19).

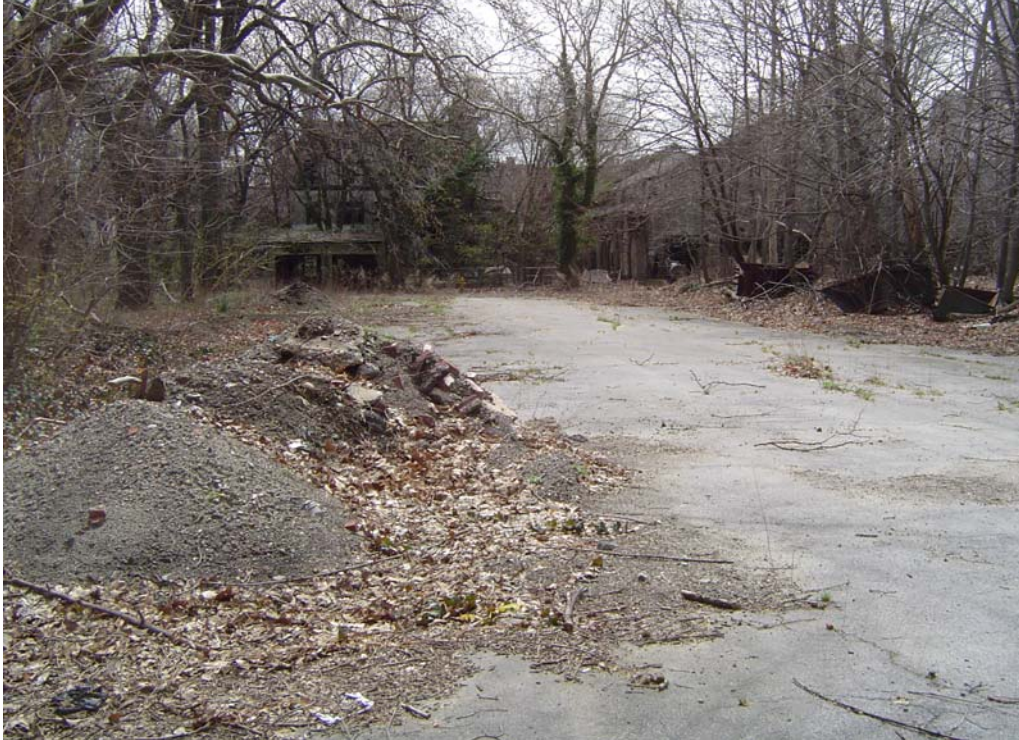
Figure 4.19. A view along Park Avenue showing fill piles along its eastern side, facing south. Brooklyn Navy Yard, Kings County, New York (PCI 2008).

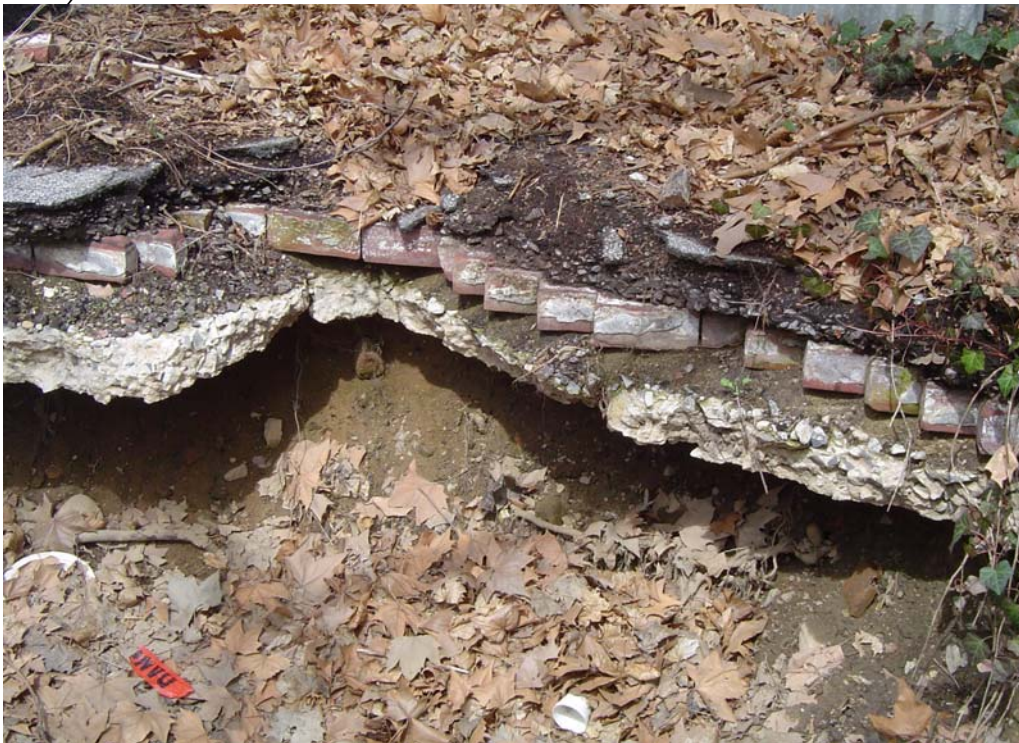
Figure 4.20. A sinkhole at the north end of Park Avenue exposing part of a former brick pavement, facing north. Brooklyn Navy Yard, Kings County, New York (PCI 2008).

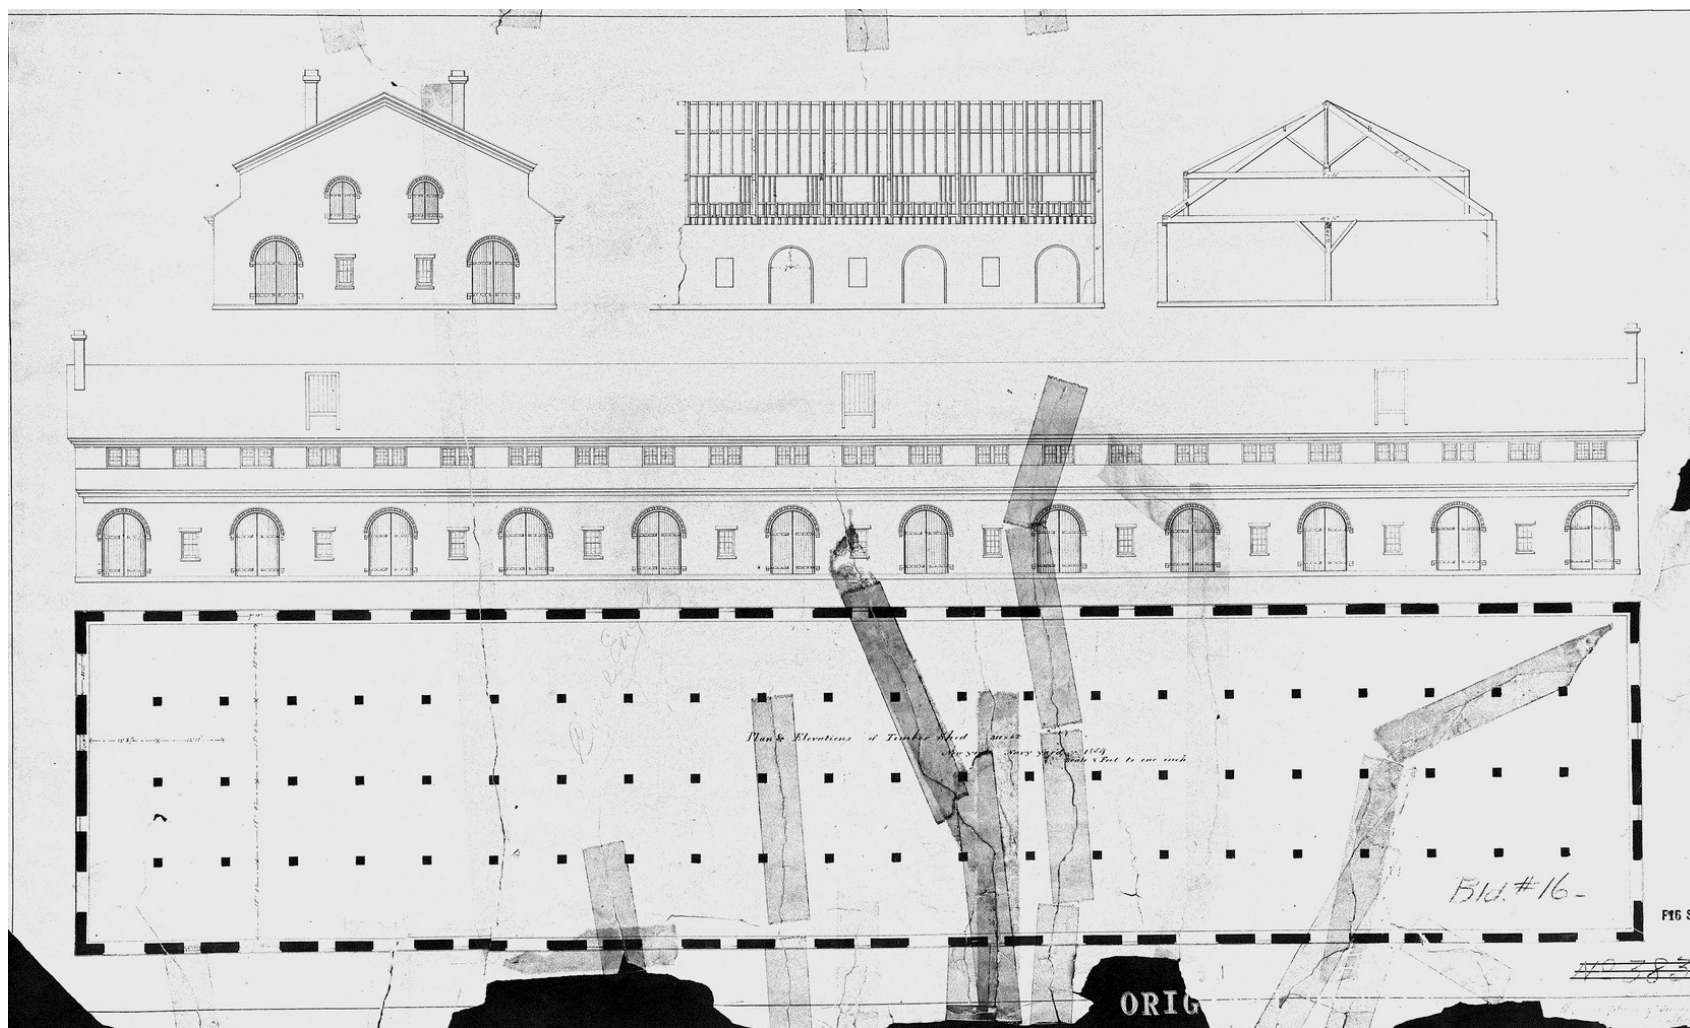
Figure 6.4. “Plan & Elevations of Timber Shed, 1854,” Plan No. F16 S1. Brooklyn Navy Yard, Kings County, New York
(Reproduced courtesy of BNYDC Archives).

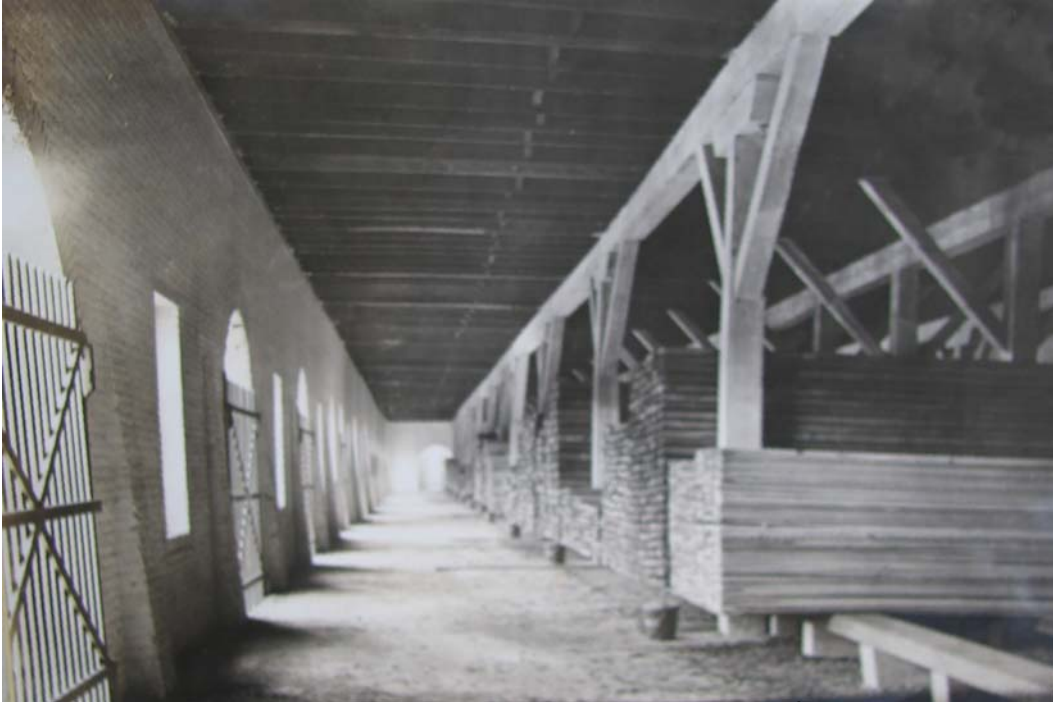
Figure 6.8. “Timber Shed, Bldg 16, Looking S. from 4th door from North End,” November 16, 1914; Brooklyn Navy Yard, Kings County, New York. (New York Navy Yard: 1900-1945; Record Group 181-B; NARA—Northeast Region (NYC). Figure F16 N4.)

The interior is open space with two rows of large timber posts supporting a series of huge timber girts with diagonal bracing. The chamfered timber posts are 12"x12". Narrow brick buttresses line the interior walls (Figures 6.8 to 6.11). Note the interior of the attic level was not accessed during the Phase IA field investigation due to safety concerns regarding the existing condition of the building's roof. Historic photographs from the early twentieth century captured workers or “the timber gang” and the method of lumber storage within the shed as well as outdoor stockpiling (Figures 6.12 to 6.15). A plank runway along the eastern bay provided access to the storage bays of the building.

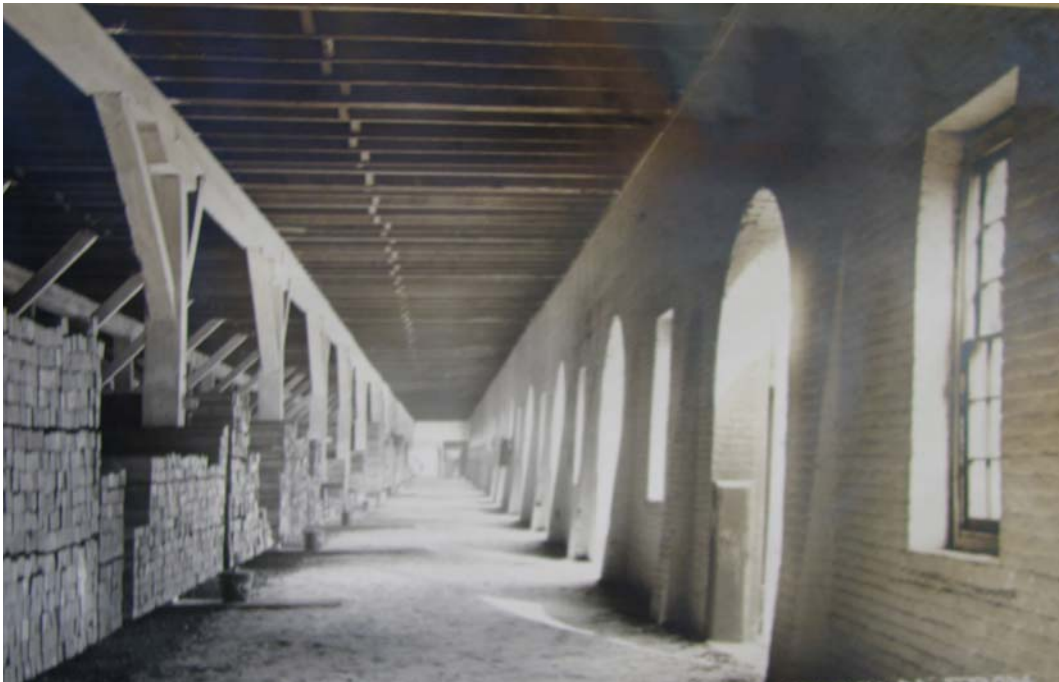
Figure 6.9. “Timber Shed, Bldg 16, Looking N. from South End,” November 16, 1914. Brooklyn Navy Yard, Kings County, New York. (New York Navy Yard: 1900-1945; Record Group 181-B; NARA—Northeast Region (NYC). Figure F16 N3.)

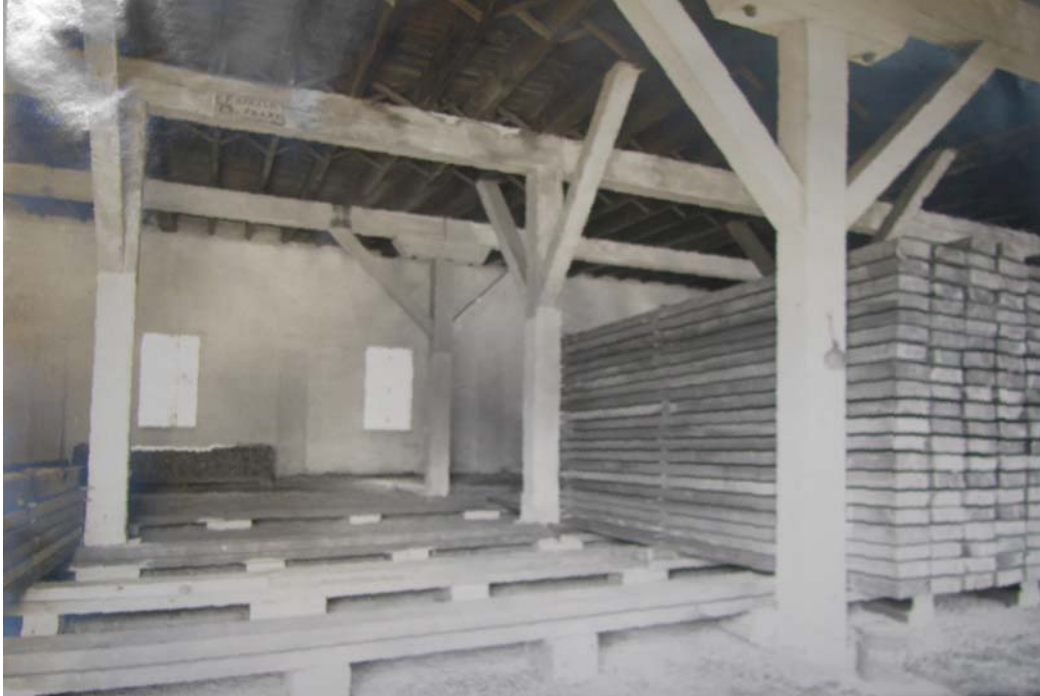
Figure 6.10. “Timber Shed, Bldg 16, Looking W. Across Shed Near Center,” November 16, 1914. Brooklyn Navy Yard, Kings County, New York. (New York Navy Yard: 1900-1945; Record Group 181-B; NARA—Northeast Region (NYC). Figure F16 N5.)

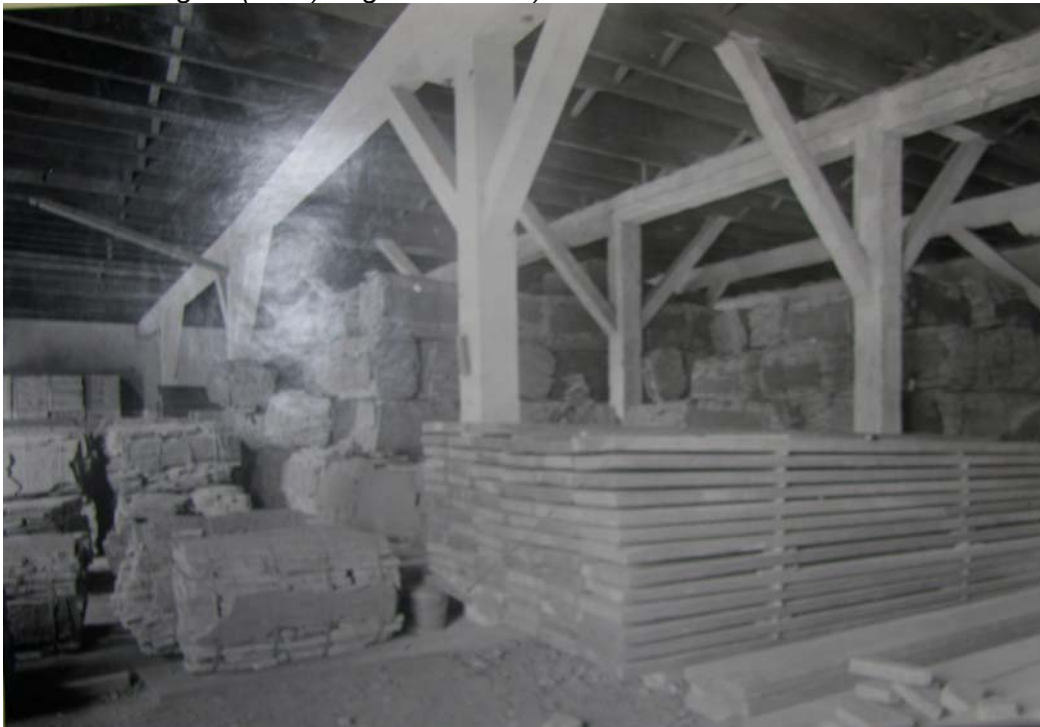
Figure 6.11. “Timber Shed, Bldg 16, Looking S.W. Near S. End,” October 26, 1916. Brooklyn Navy Yard, Kings County, New York. (New York Navy Yard: 1900-1945; Record Group 181-B; NARA—Northeast Region (NYC). Figure F16 N9.)

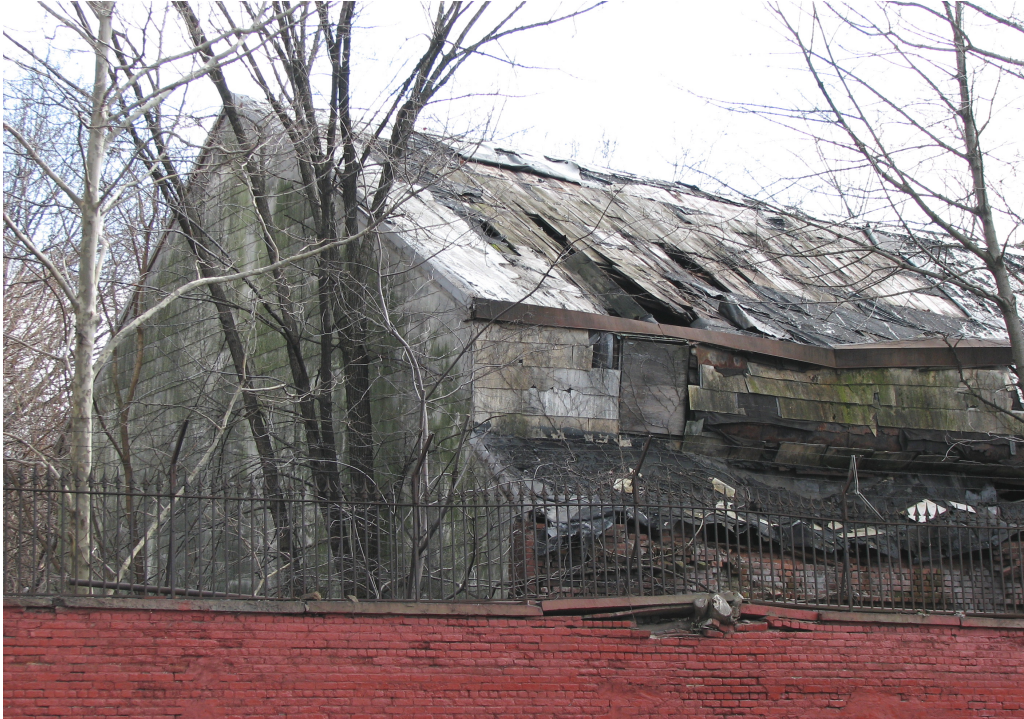
Figure 6.24. Detail of north elevation of Timber Shed at left. Note iron fence and tree growing through the top of the brick wall (at right of center foreground). Brooklyn Navy Yard, Kings County, New York (PCI 2008).

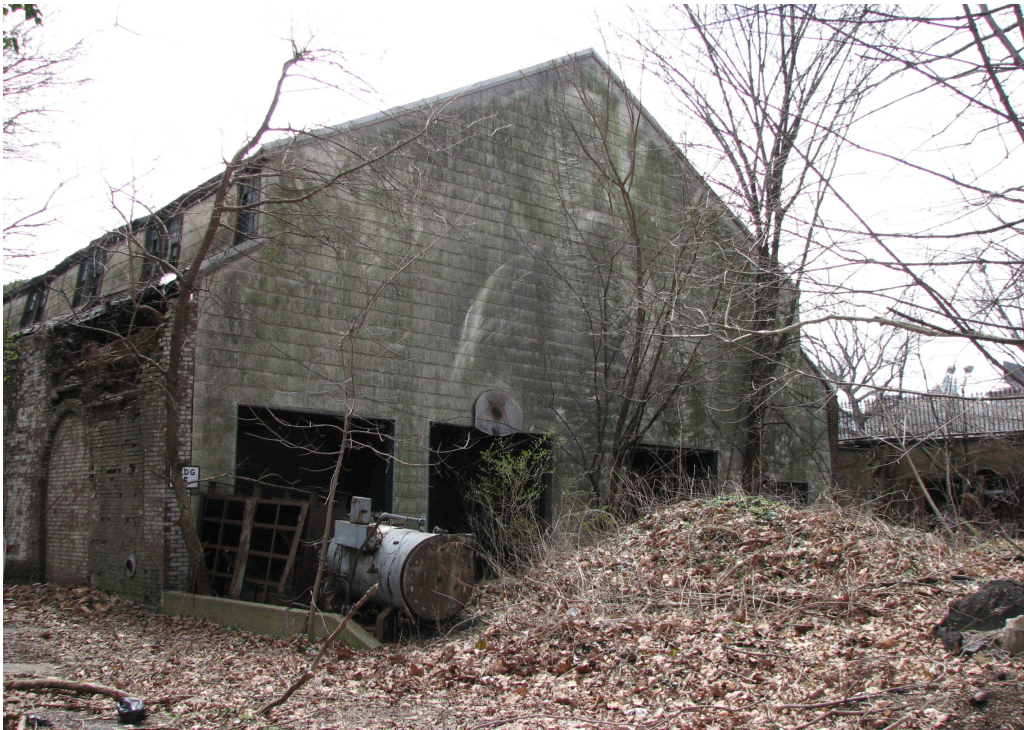
Figure 6.27. North elevation of Timber Shed, facing southwest, from near foot of Park Street. Note mounded dirt fill and debris in front of the building. Brooklyn Navy Yard, Kings County, New York (PCI 2008).

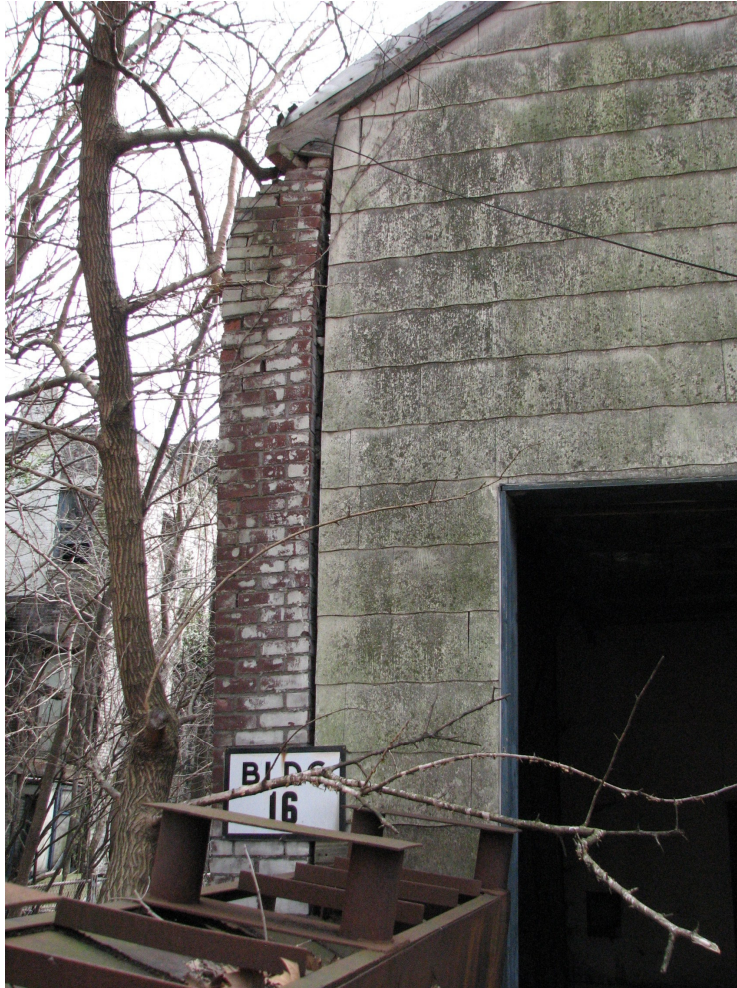
Figure 6.28. Detail of northeast corner of Timber Shed, at left, facing south-southeast. Note juncture of original brick masonry wall and later asbestos-covered frame wall.

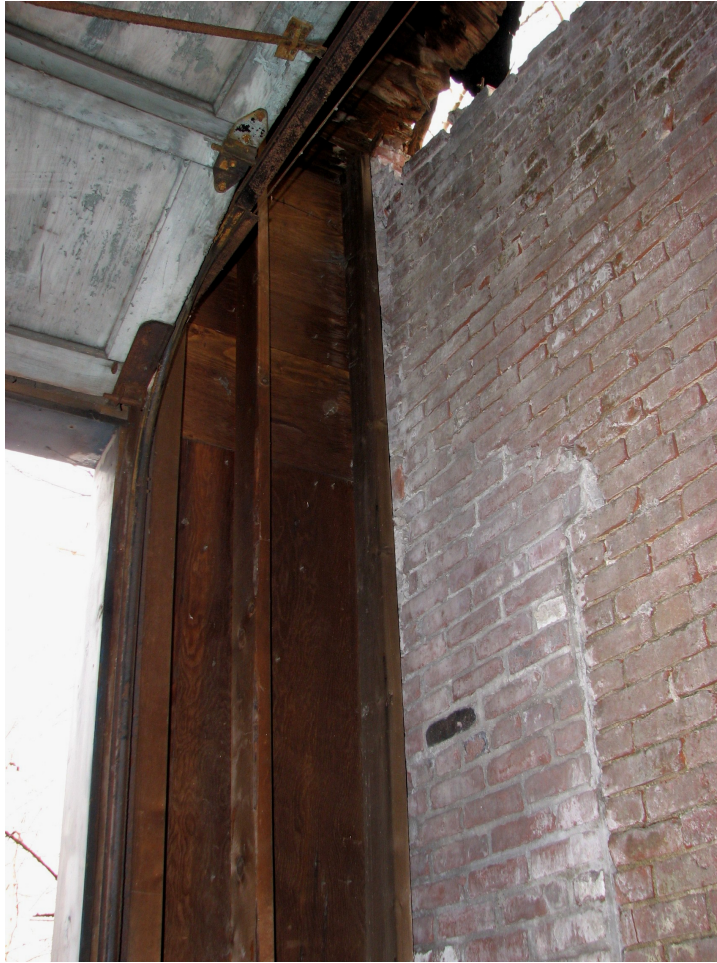
Figure 6.29. Detail of interior of northeast corner of Timber Shed, at right facing north. Note bricked window opening at right. Brooklyn Navy Yard, Kings County, New York (PCI 2008).

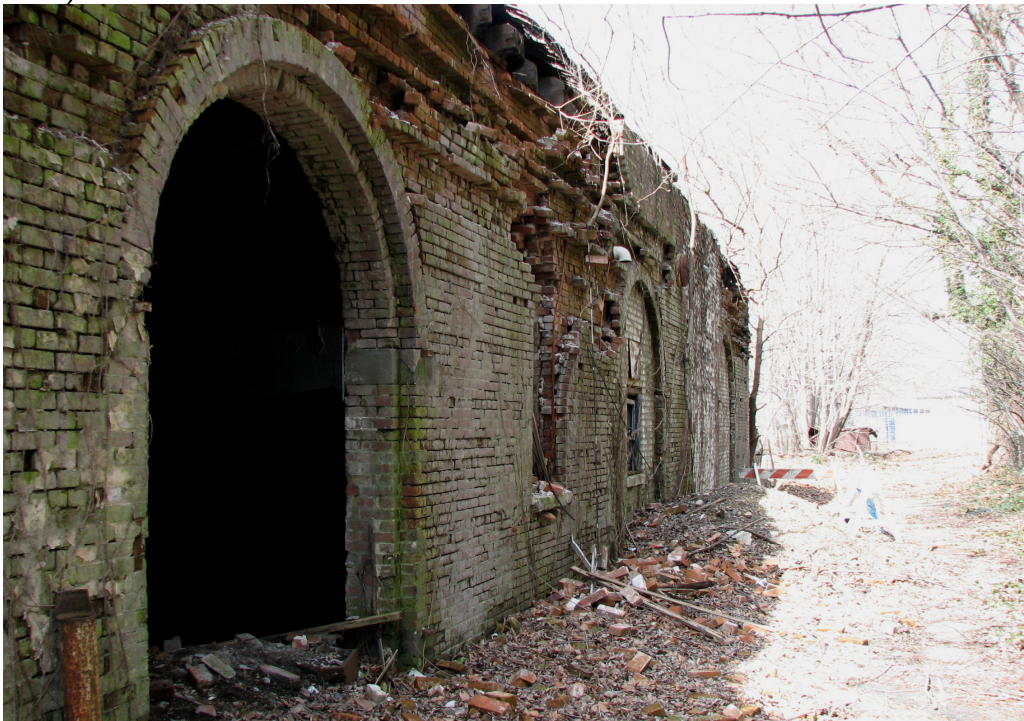
Figure 6.31. East elevation of Timber Shed from south end of building, facing north-northwest. The round arch bay at left is the only open bay remaining on the east side of the building. Brooklyn Navy Yard, Kings County, New York (PCI 2008).

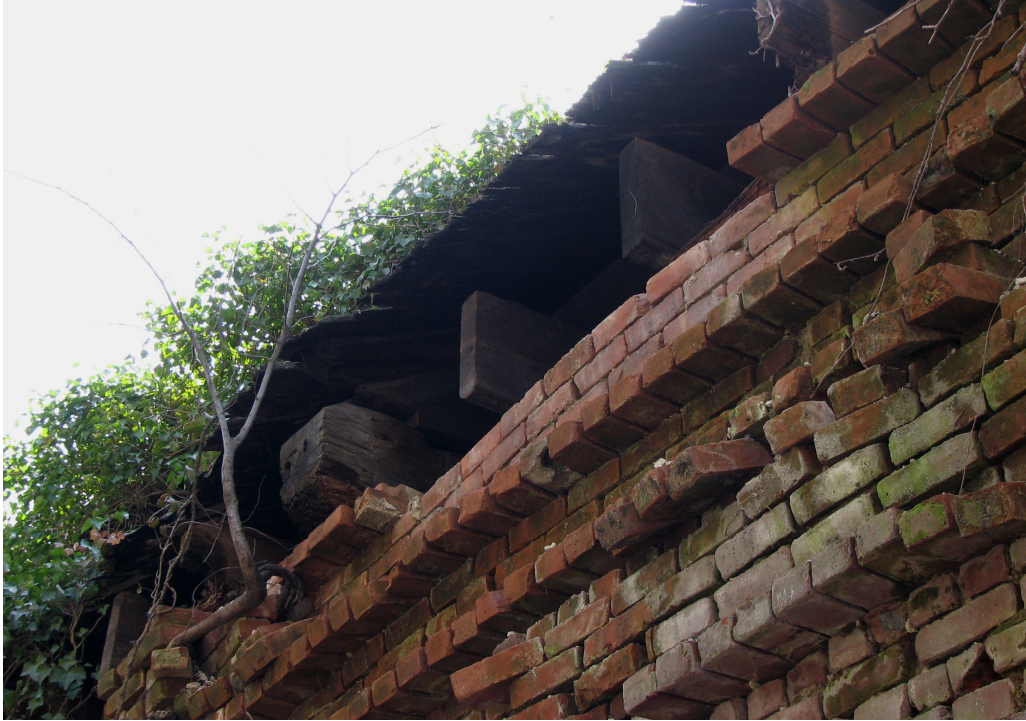
Figure 6.34. Detail of roof—wall juncture on east elevation, facing southeast. Brooklyn Navy Yard, Kings County, New York (PCI 2008).

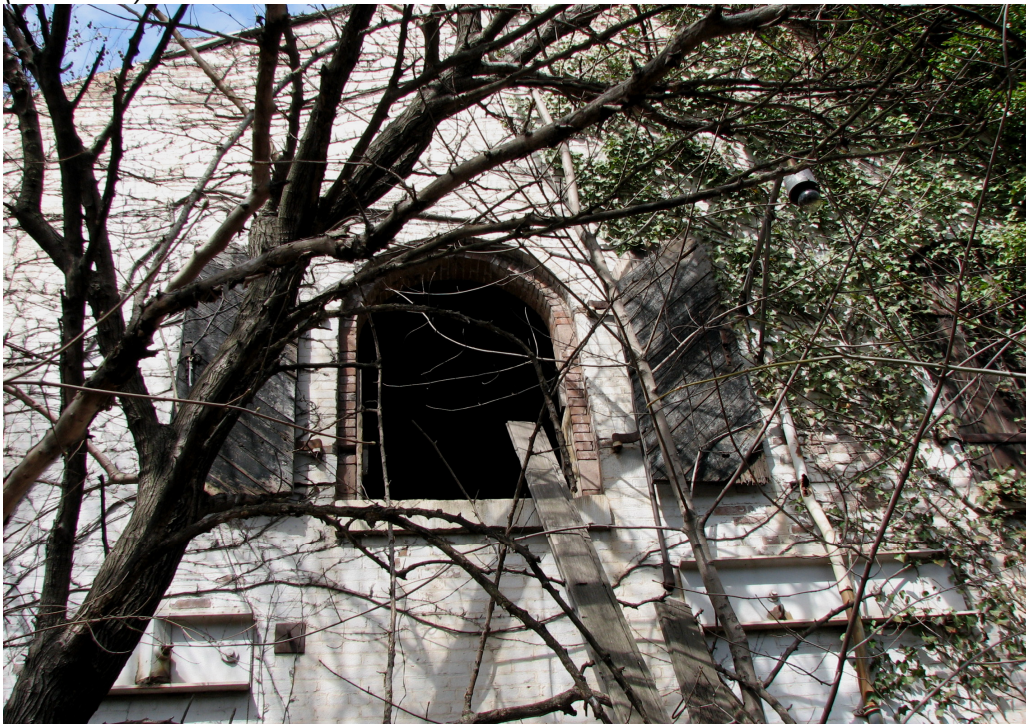
Figure 6.39. Detail of round-arch window opening, with intact wooden shutters and hardware, south elevation of Timber Shed, facing north. Brooklyn Navy Yard, Kings County, New York (PCI 2008).

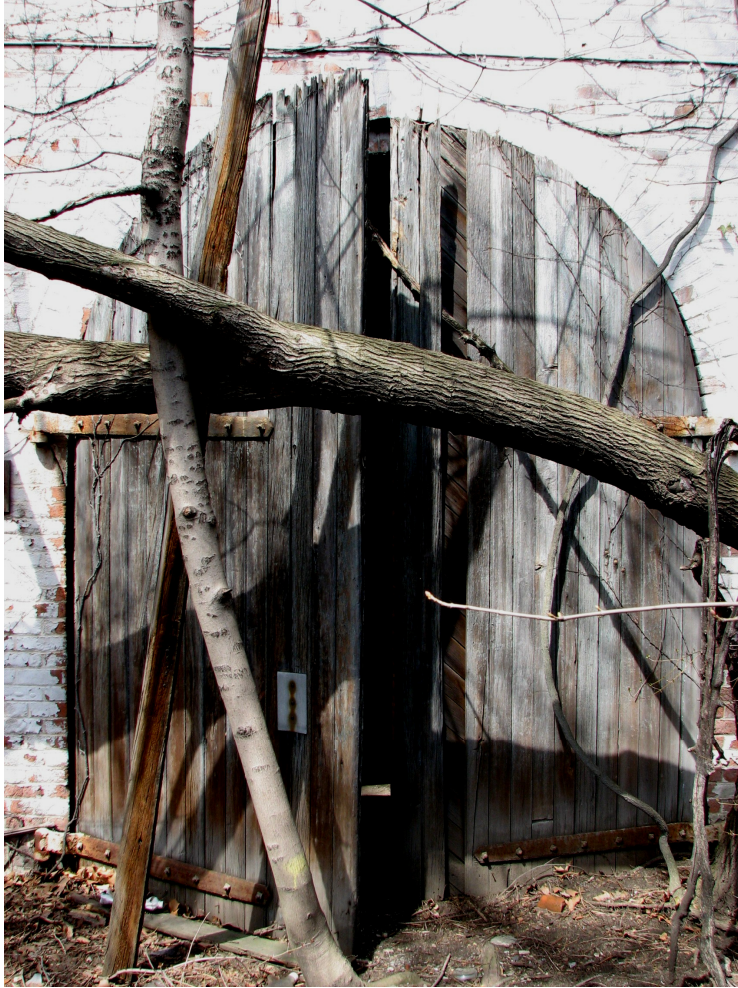
Figure 6.40. West entry bay with double-leaf doors, south elevation of Timber Shed, facing north. Note original hardware. Brooklyn Navy Yard, Kings County, New York (PCI 2008).

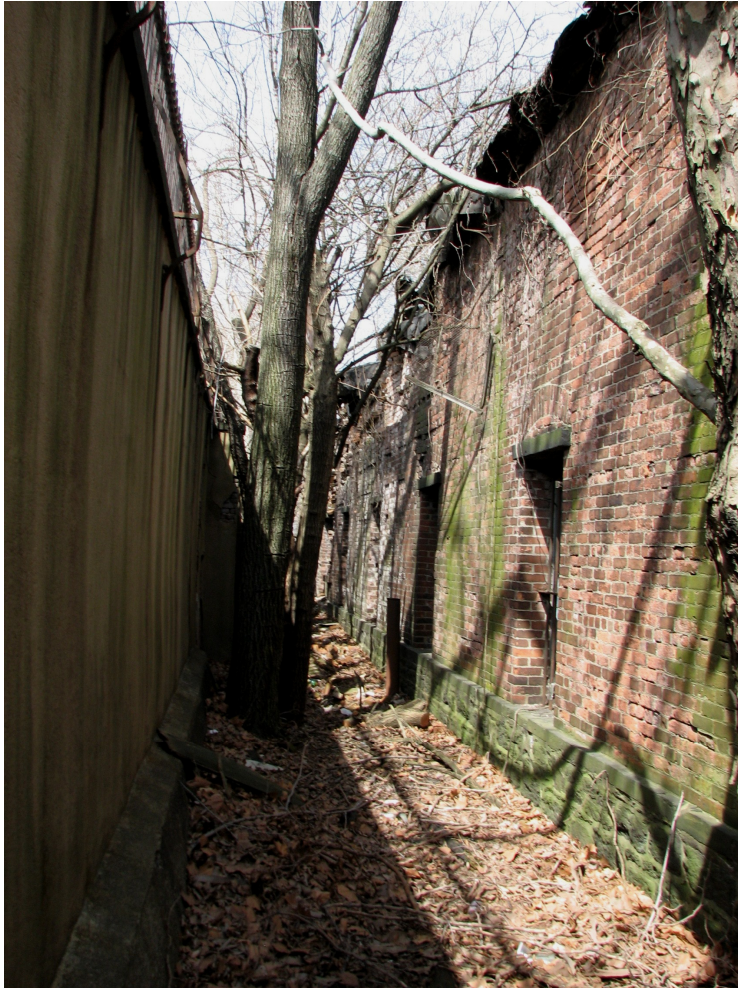
Figure 6.41. West elevation of Timber Shed at right and interior of brick fence at left, facing north. Note raised stone foundation and stone beltcourse. Brooklyn Navy Yard, Kings County, New York (PCI 2008).

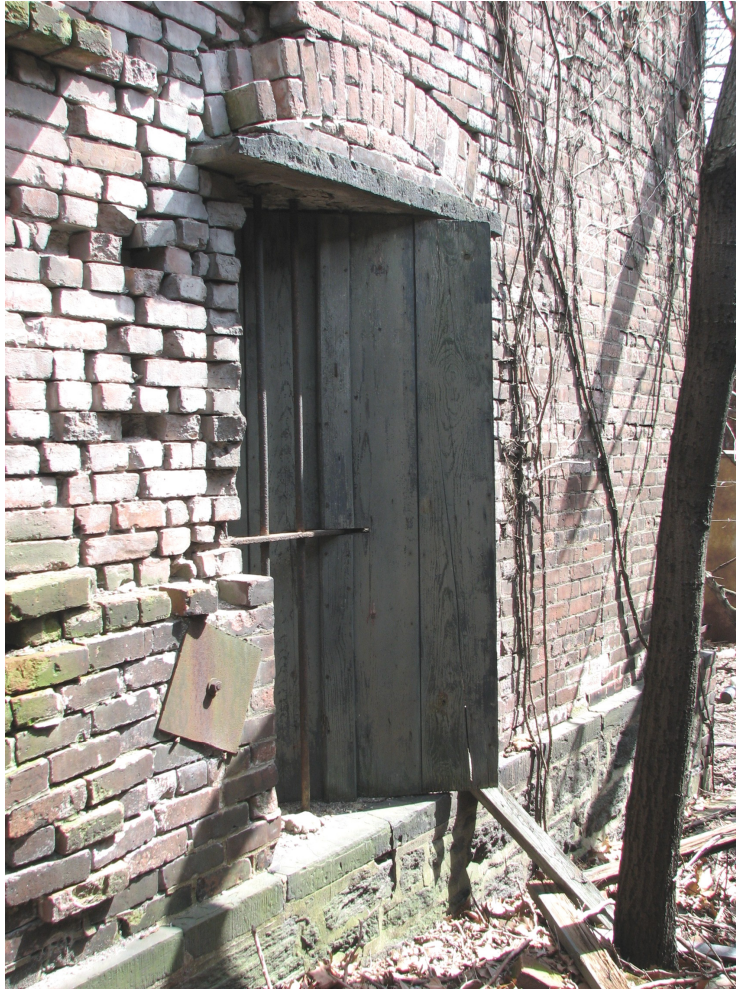
Figure 6.42. Detail of window opening at south end of west elevation of Timber Shed, facing southeast. Brooklyn Navy Yard, Kings County, New York (PCI 2008).

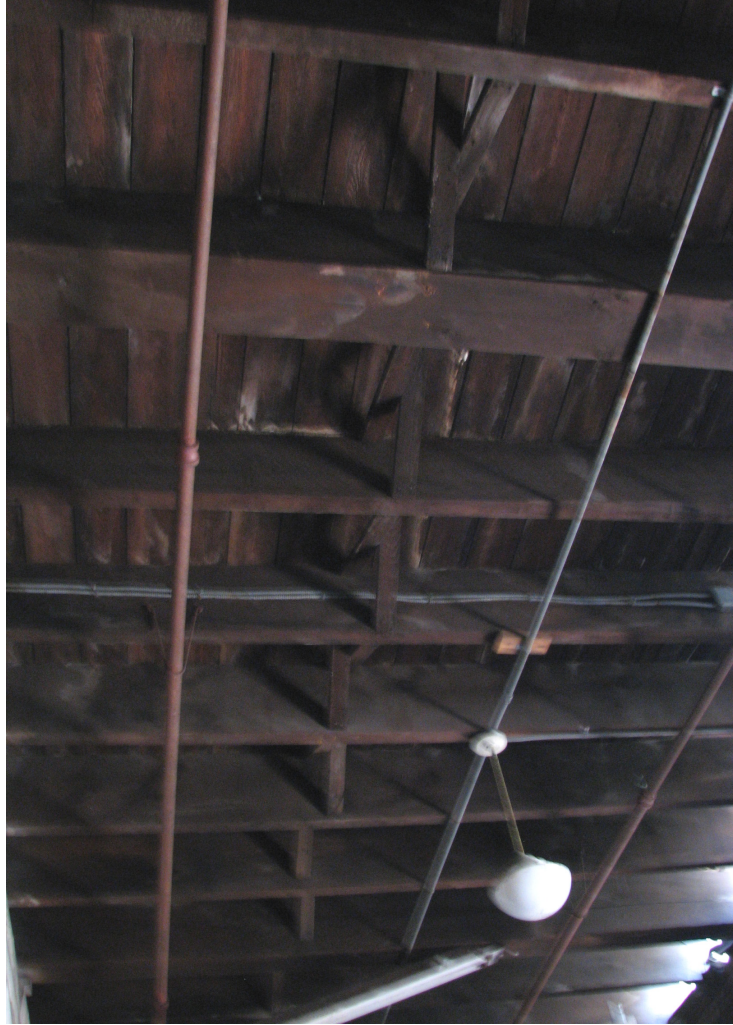
Figure 6.51. Detail of ceiling, interior of south end of the Timber shed. Brooklyn Navy Yard, Kings County, New York (PCI 2008).
