PHASE IA CULTURAL RESOURCES INVESTIGATION

FOR ADMIRAL'S ROW SECTION

FORMER BROOKLYN NAVY YARD, BROOKLYN,

July 2008

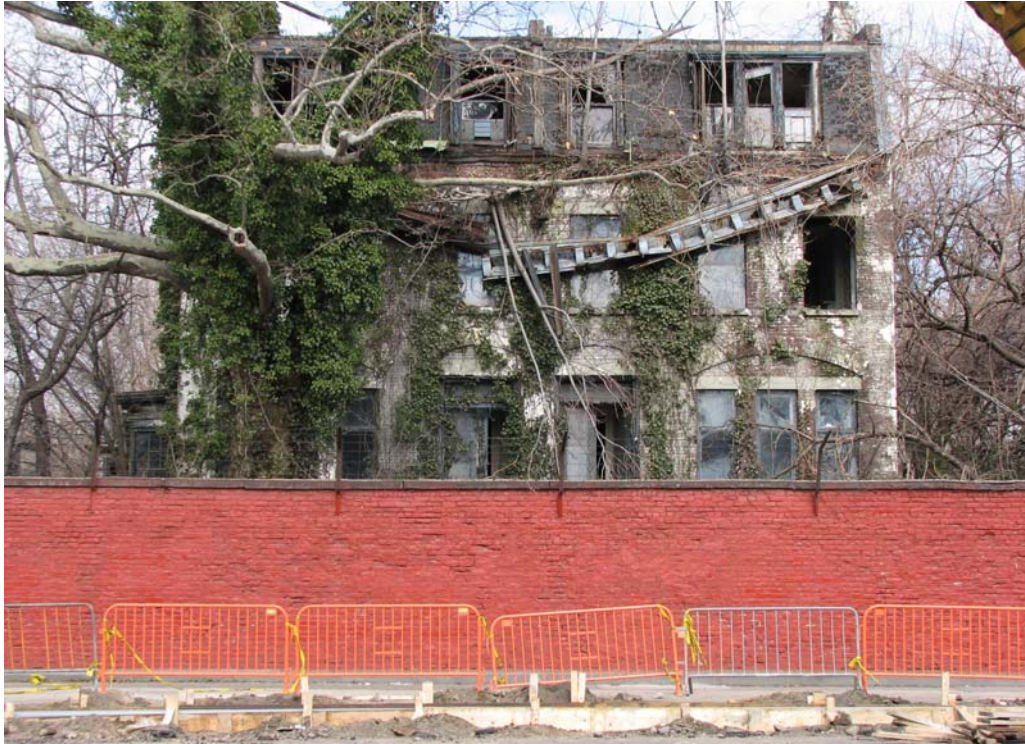
Figure 7.1. Quarters K-L street elevation, facing north. Brooklyn Navy Yard, Kings County, New York (PCI 2008).

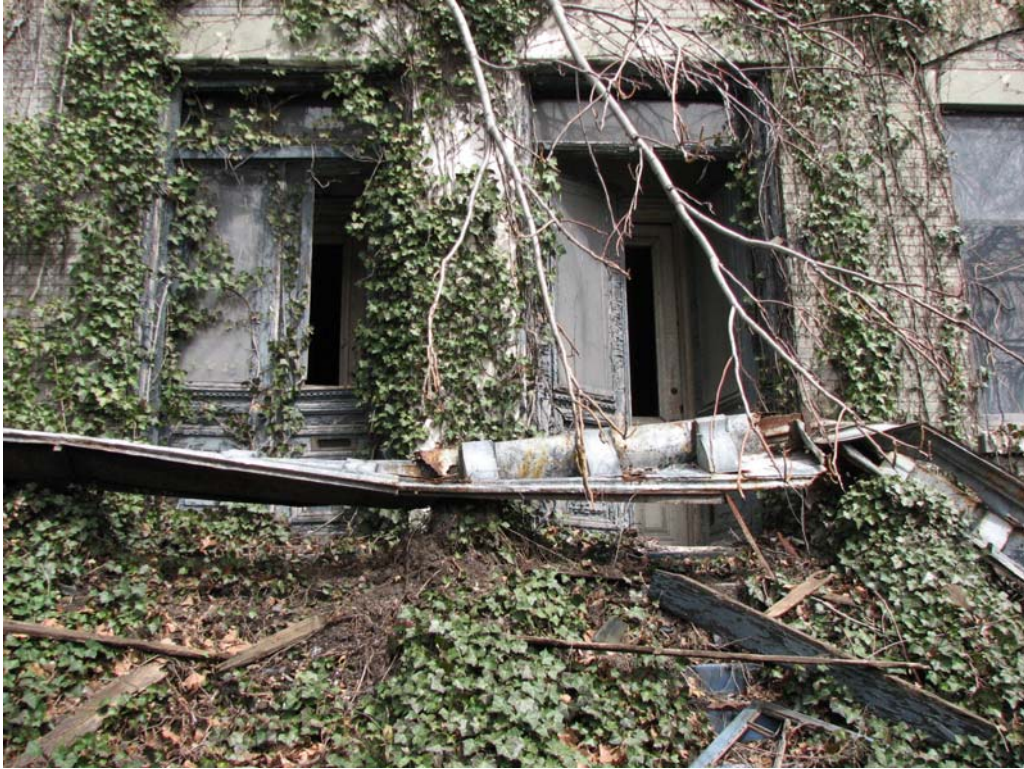
Water damage was determined to have caused significant structural collapse to portions of the rear two-story sections of Quarters K-L and front Mansard Roof areas; "in recent years the roofs on the 1941 sections have failed causing extensive interior framing collapse within those sections" (Beardsley/Crawford & Stearns 2008:155). Overall, the structural integrity for the original nineteenth century portions of Quarters K-L's superstructure appears to be "sound, level and plumb, showing localized areas of framing failures and masonry distress" (Beardsley/Crawford & Stearns:2).

Figure 7.3. Quarters K-L, entrance detail, facing north. Note collapsed cornice. Brooklyn Navy Yard, Kings County, New York (PCI 2008).

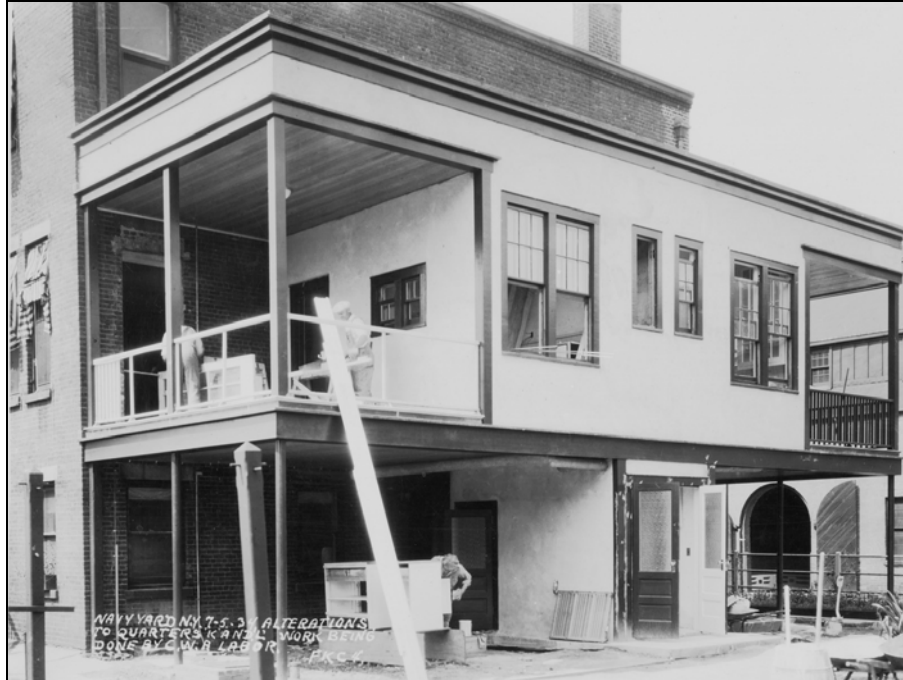
Twentieth century alterations to Quarters K-L included a basement and first-story addition on the rear elevation, a basement and first-story porch on the east elevation, and a basement and first-story living space addition to the west elevation. The interior plan and features of Quarters K-L remained largely as built (Beardsley/Crawford & Stearns 2008:155). The later rear addition contained stairways, access, kitchen circulation and service areas. A historic photograph dated from 1934 illustrates the extension of the rear addition (Figure 7.8).

Figure 7.8. “Alterations and Repairs to Quarters K and L,” July 5, 1934. Note Timber shed at right background. Brooklyn Navy Yard, Kings County, New York (New York Navy Yard: 1900-1945; Record Group 181-B; NARA—Northeast Region (NYC). Photograph FCK4.)

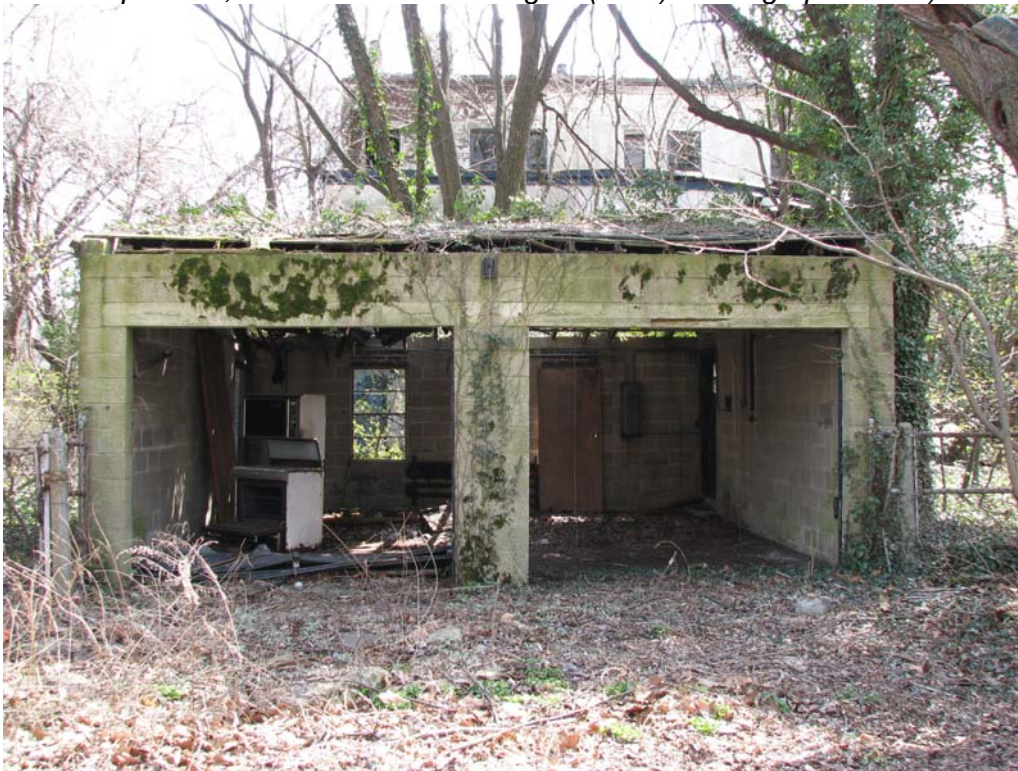
Quarters L has an associated garage, **Building 450**, which was constructed in 1919 as a semi-permanent building (Property Record Card No 2-00437) (Figure 7.9). It is located on the south side of Park Street, north of Quarters L. Building 450 is a one-story, concrete block building consisting of 529 square feet (23'x23'x11'). The structure's real property cost value was listed at \$900 in 1985 when it was transferred from the U.S. Navy to the U.S. Army National Guard Bureau. Upon cursory visual inspection, Building 450 appears to be in fair condition. Its frame roof system has been compromised due to exposure which has caused both collapsed framing and missing sections of roof.

Figure 7.9. Building 450, concrete block garage associated with Quarters L, facing south. Brooklyn Navy Yard, Kings County, New York (PCI 2008).

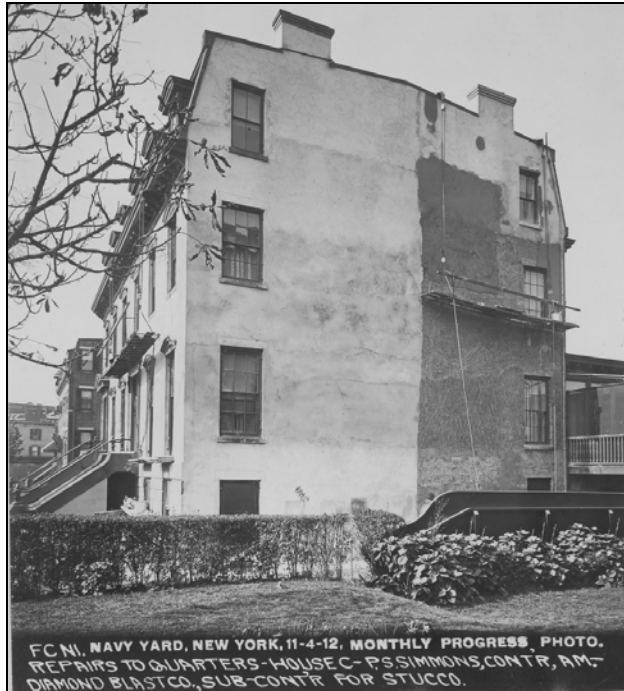
Figure 7.17. “Repairs to Quarters – House C,” November 4, 1912. Note brownstone stylistic accents prior to application of stucco. Brooklyn Navy Yard, Kings County, New York (*New York Navy Yard: 1900-1945; Record Group 181-B; NARA—Northeast Region (NYC). Photograph FC N1.*)

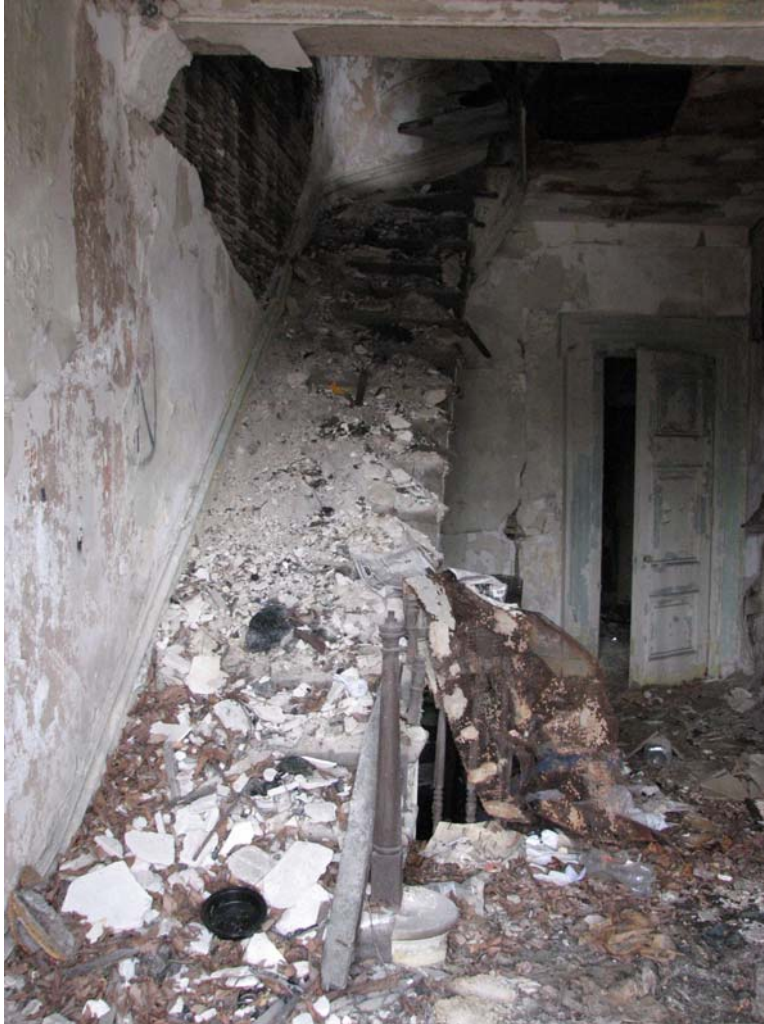
Figure 7.19. Interior of Quarters C from entrance, facing north. Brooklyn Navy Yard, Kings County, New York (PCI 2008).

A fire in the 1990s damaged the third story (Mansard level) of Quarters C leaving the roof and upper story open to the elements. Quarters H was unaffected by the fire. Subsequent water damage caused significant structural collapse to portions of Quarters C and in recent years the roofs on the 1941 sections have failed, causing extensive interior framing collapse within those sections (Figure 7.19).

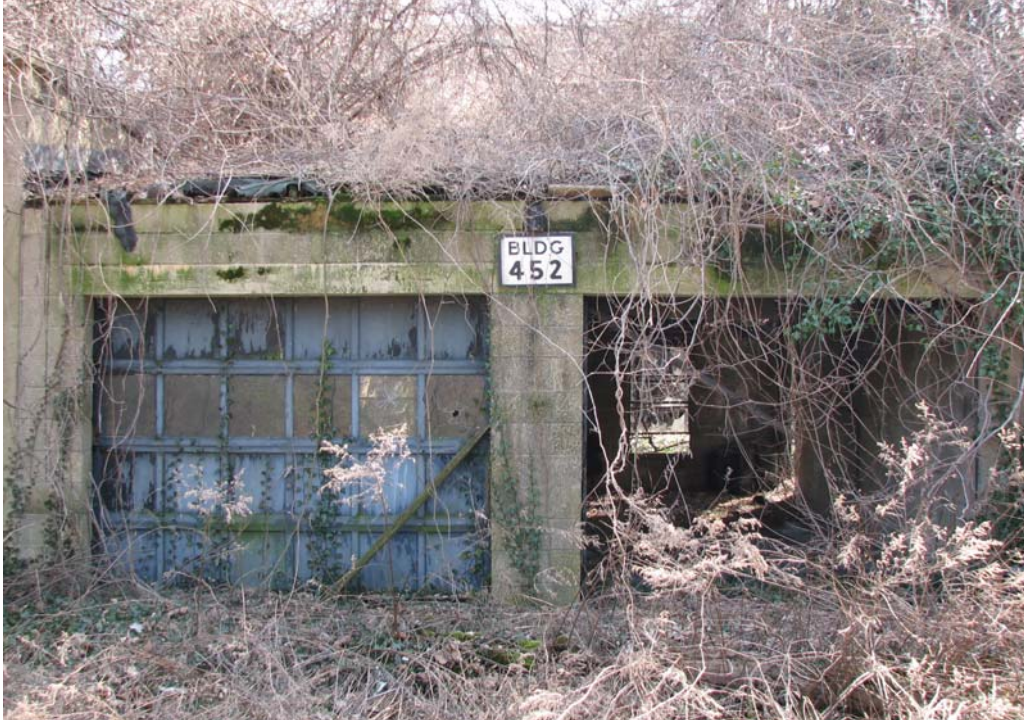
Figure 7.20. Building 452, Garage on Park Street associated with Quarters H, facing south. Brooklyn Navy Yard, Kings County, New York (PCI 2008).

Upon cursory visual inspection, **Buildings 452 and 639** appear to be in fair condition. The buildings have been left open and exposed to natural elements since the 1970s when Admiral's Row was vacated. The frame roof systems of each garage have been compromised due to exposure which has caused both collapsed framing and missing sections of roof and the attached walkway extending from Garage 639 south to Quarters C has collapsed.

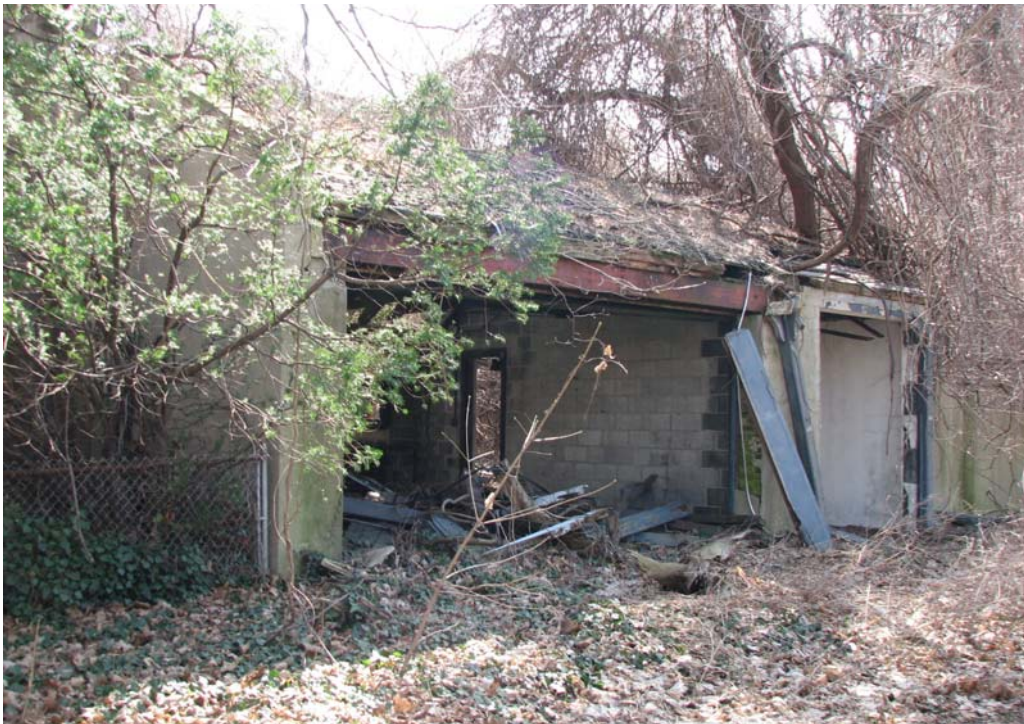
Figure 7.21. Building 639, Garage on Park Street associated with Quarters C, facing south. Brooklyn Navy Yard, Kings County, New York (PCI 2008).

Quarters C has an associated garage, **Building 639**, which was constructed in 1943 as a permanent building (Property Record Card No 2-00441) (Figure 7.21). It is located on the south side of Park Street, north of Quarters C. Building 639 is a one-story, concrete block building consisting of 576 square feet (24'x24'x12'). The structure's real property cost value was listed at \$5,800 in 1985 when it was transferred from the U.S. Navy to the U.S. Army National Guard Bureau.

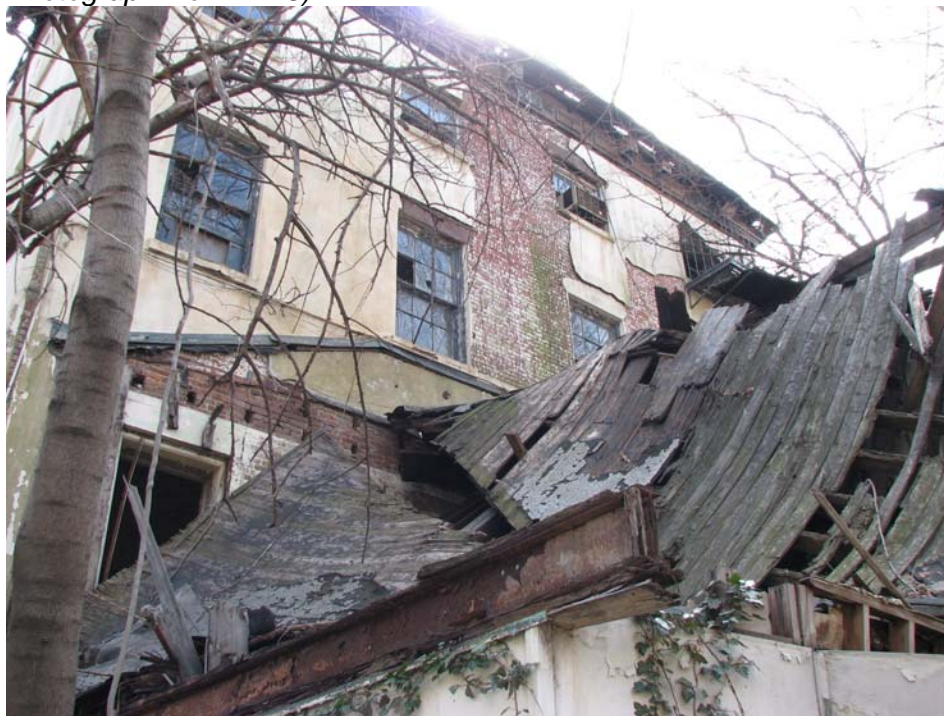
Figure 7.28. Quarters B, detail of rear elevation, facing southwest. Brooklyn Navy Yard, Kings County, New York (PCI 2008).

Portions of Quarters B have deteriorated. Beardsley/Crawford & Stearns identify the source of the damage as

water penetration into the building, mostly all from deteriorated roof conditions, open roof hatches, and basement dampness . . . most of the severe deterioration from roof failure is found in rear sections, porches, and in and below the east roof cornice area. In Quarters 'B' the severe deterioration (collapse) of the rear appendages, side porch, and roofs of the garage is confined to areas that were significantly altered or built well into the twentieth century with modern amenities and features including utilitarian areas such as the kitchens, storage, and service areas. These areas are not part of the historic core sections of the building and while their deterioration is unfortunate, it does not play a major contributing factor to the historic integrity of the historic building sections. Within the rear bay of the pre-1859 quarters roof leaks have caused some framing and detail deterioration to the roof where the gallery was located, and to the north and east walls (Beardsley/Crawford & Stearns 2008:101).

In 1958, a design for an entrance improvement included a circular driveway along Park Street and associated landscaping (Figure 7.34). A covered walkway extended over the driveway. The covered walkway has since collapsed and the area is overgrown with brush and other vegetation (see Figures 7.28 and 7.29).

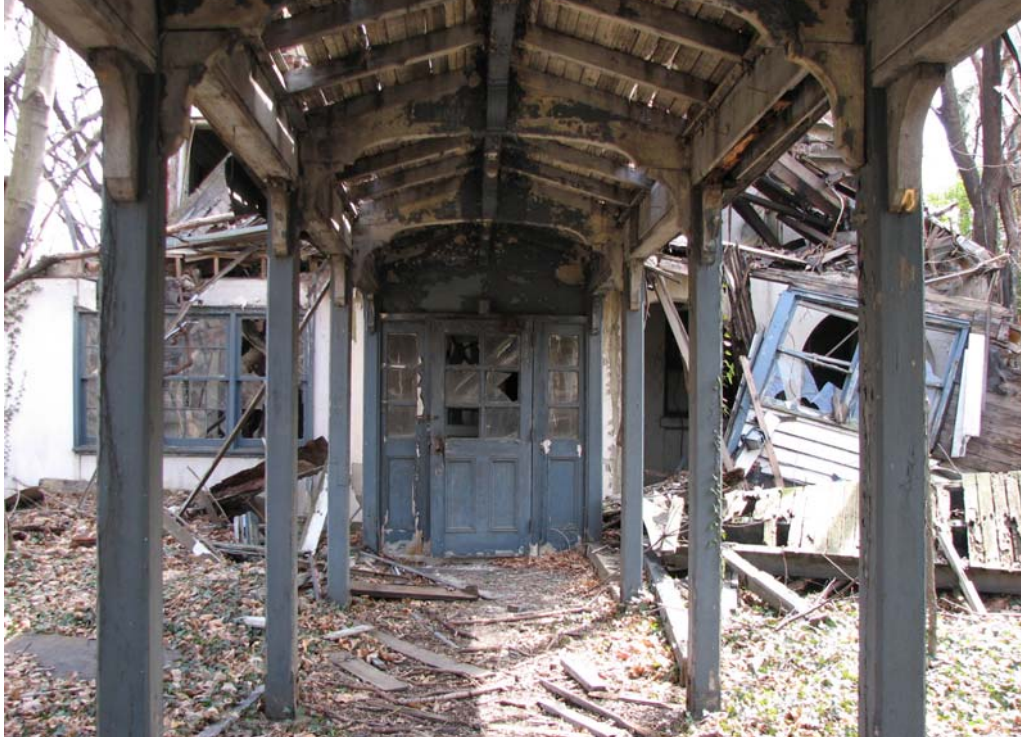
Figure 7.29. Quarters B, covered walkway facing south. Brooklyn Navy Yard, Kings County, New York (PCI 2008).

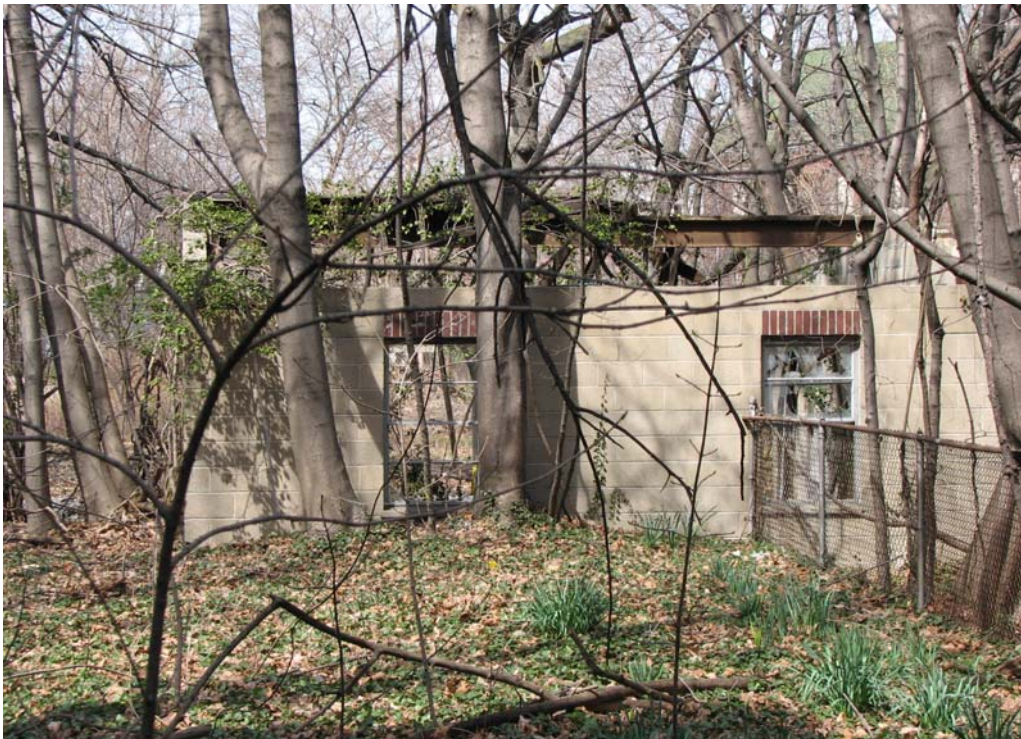
Figure 7.30. Building 463, garage associated with Quarters B, located on northeast corner of lot, facing north. Brooklyn Navy Yard, Kings County, New York (PCI 2008).

Bureau. Upon cursory visual inspection, the present condition of Building 463 is fair. The building has been left open and exposed to natural elements since Admiral's Row was vacated. Its frame roof system has been compromised due to exposure which has caused both framing collapse and missing sections of roof.

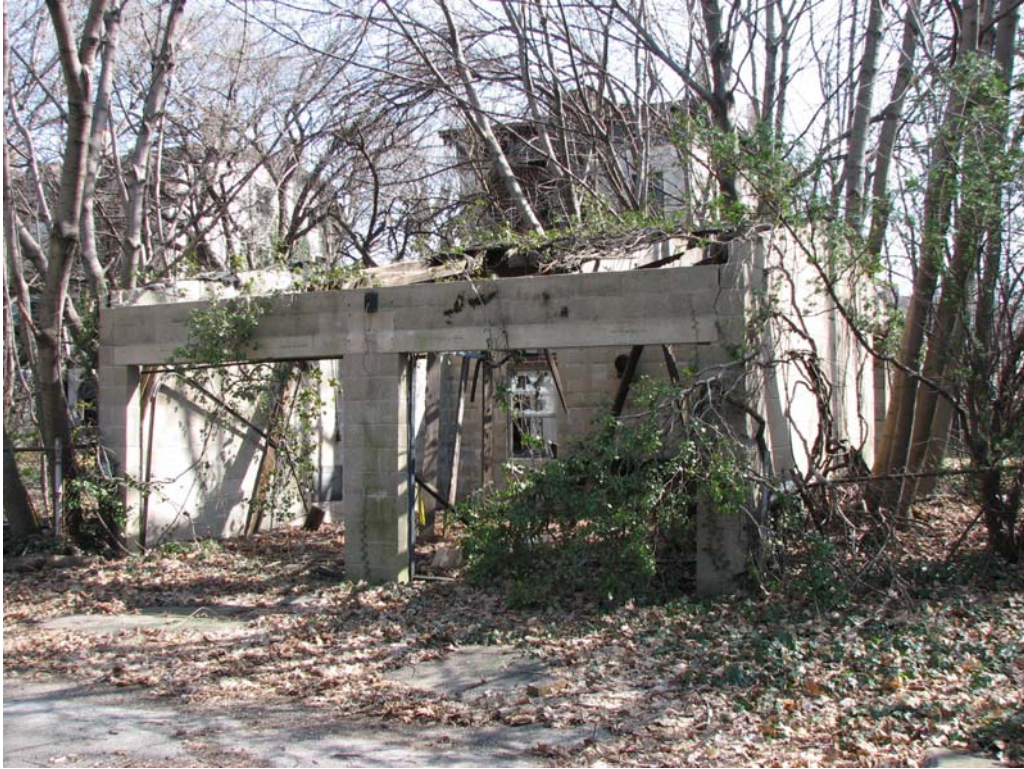
Figure 7.31. Building 463, garage associated with Quarters B, located on northeast corner of lot, facing southeast. Brooklyn Navy Yard, Kings County, New York (PCI 2008).

Quarters B has an associated garage, **Building 463**, which was constructed in 1919 as a semi-permanent building (Property Record Card No 2-00439) (see Figure 7.31). It is located on the south side of Park Street, north of Quarters B. Building 463 is a one-story, concrete block building consisting of 552 square feet (24'x23'x8'). The structure's real property value was listed at \$500 in 1985 when it was transferred from the U.S. Navy to U.S. Army National Guard

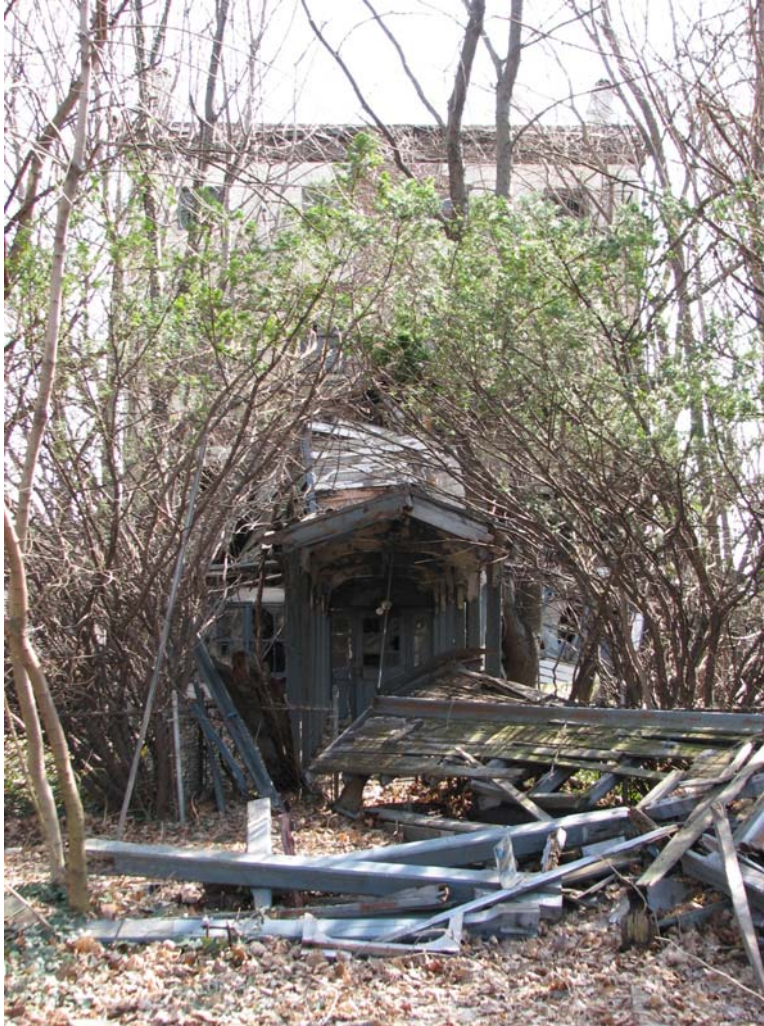
Figure 7.32. Quarters B from Park Street, facing south. Brooklyn Navy Yard, Kings County, New York (PCI 2008).

Historic photographs show that stucco was applied to the brick masonry exterior of Quarters B in 1912 (see Figures 7.25 to 7.27). Twentieth century additions consist of an extensive enclosed frame two-story rear addition with porches and covered walkway to Park Street. The northern section of the covered walkway from Park Street has collapsed (see Figure 7.32).

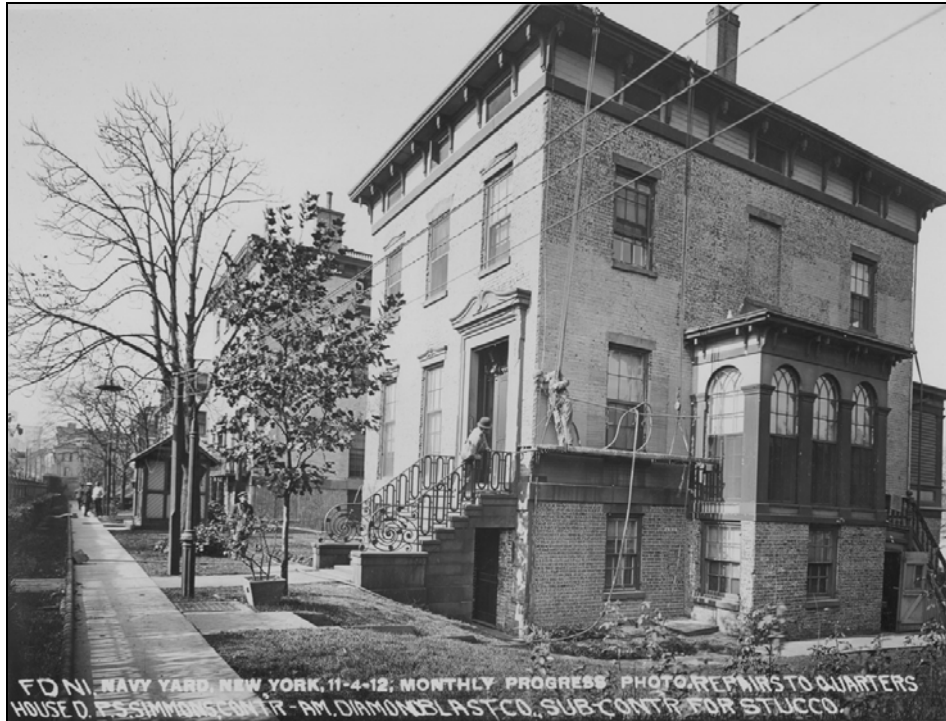
Figure 7.41. “Repairs to Quarters House D,” November 4, 1912. Shows Quarters D prior to application of stucco. (New York Navy Yard: 1900-1945; Record Group 181-B; NARA—Northeast Region (NYC). Photograph No. FD N1. Reproduced courtesy of BNYDC Archives.)

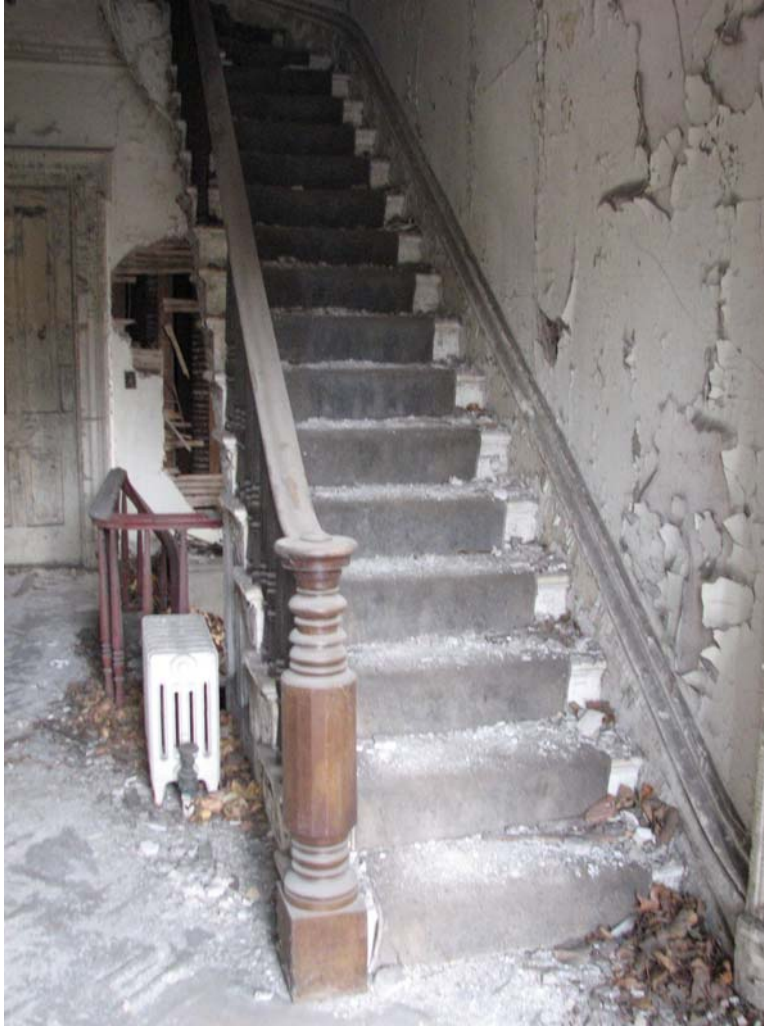
Figure 7.45. Interior stairway of Quarters D. Brooklyn Navy Yard, Kings County, New York (PCI 2008).

Portions of Quarters D are severely deteriorated (Figures 7.45 to 7.47),

with the source of the deterioration attributed to water penetration into the building, mostly all from deteriorated roof conditions, open roof hatches, basement dampness, and open third story burned out roof section. Most of the severe deterioration from roof failure is found in rear sections, porch, and in the burned attic roof areas. In Quarters "D" the severe deterioration (collapse) of the rear appendages, side porch, and roofs of the garage is to areas that were significantly altered well into the twentieth century with modern amenities and features including utilitarian areas such as the kitchens, storage, and service areas. These areas are not part of the historic core sections of the buildings and while their deterioration is unfortunate, it does not play a major contributing factor to the historic integrity of the historic building sections. Damage in the pre-1859 building is limited to the burned interior (not destroyed) of the third story, burned holes in the roof, and water penetration into the rear brick wall causing partial wall failure at the second and first story levels. Ironically the old metal roof is still shedding water in many areas of the main roof even with the fire damage (Beardsley/Crawford & Stearns 2008:81).

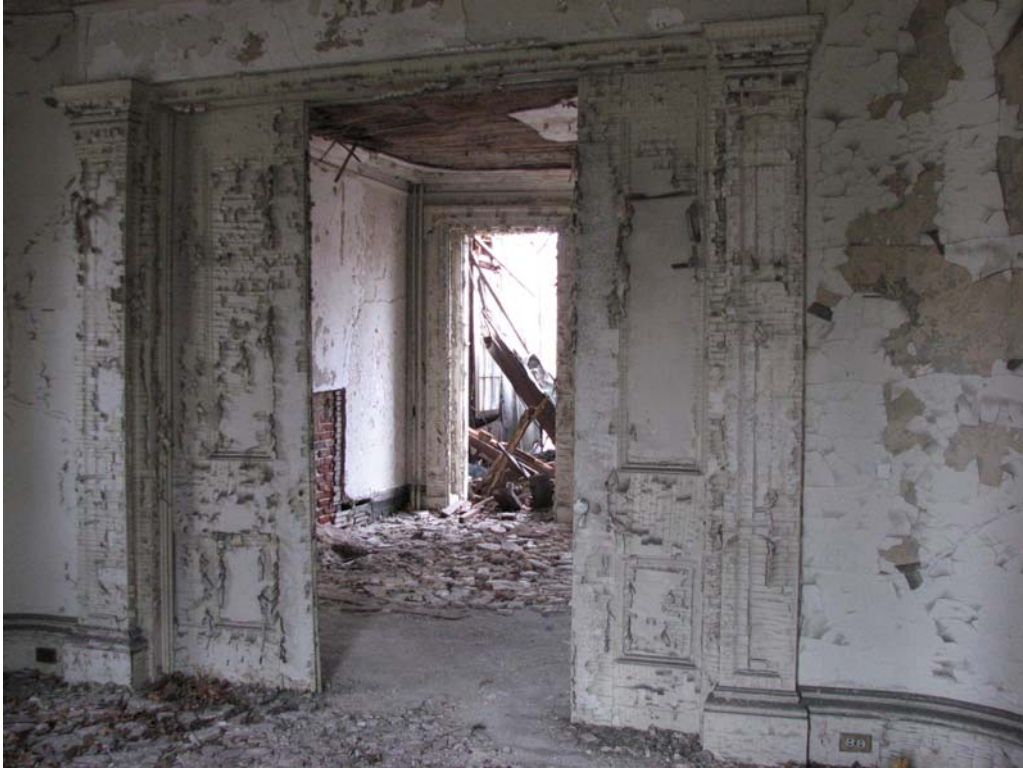
Figure 7.46. Interior of Quarters D. Brooklyn Navy Yard, Kings County, New York (PCI 2008).

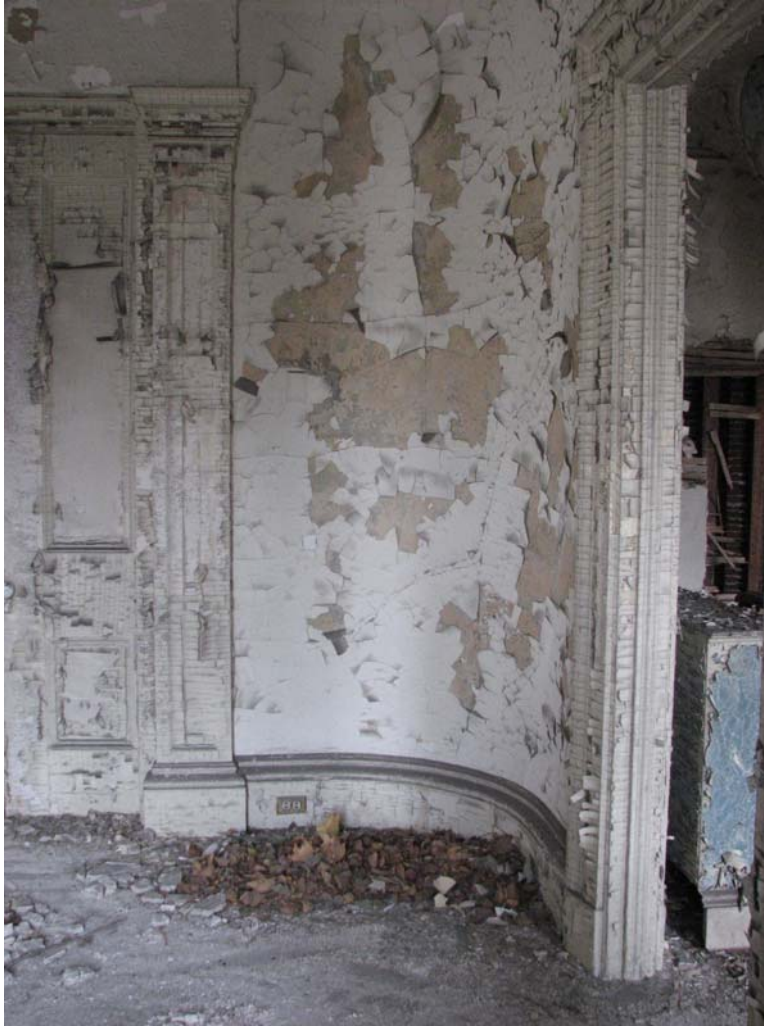
Figure 7.47. Interior of Quarters D. Brooklyn Navy Yard, Kings County, New York (PCI 2008).

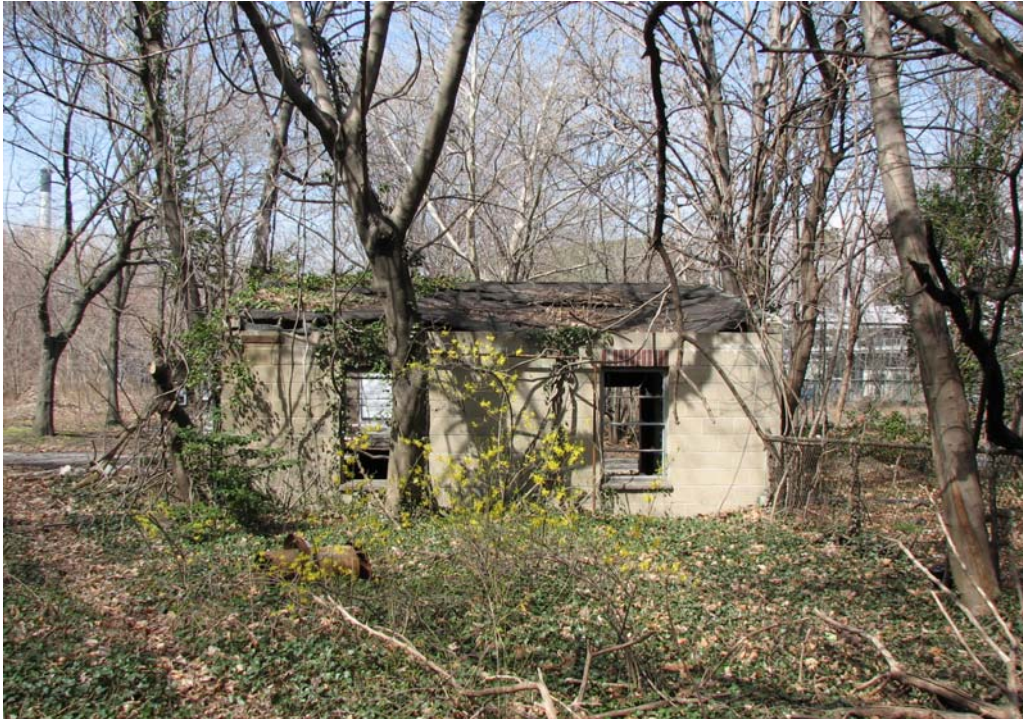
Figure 7.48. Building 464, garage associated with Quarters D, facing north. Located on northeast corner of property. Brooklyn Navy Yard, Kings County, New York (PCI 2008).

Upon cursory visual inspection, Building 464 appears to be in fair condition. The building has been left open and exposed to natural elements since Admiral's Row was vacated. Its frame roof system has been compromised due to exposure which has caused both collapsed framing and missing sections of roof (Figures 7.48 and 7.49).

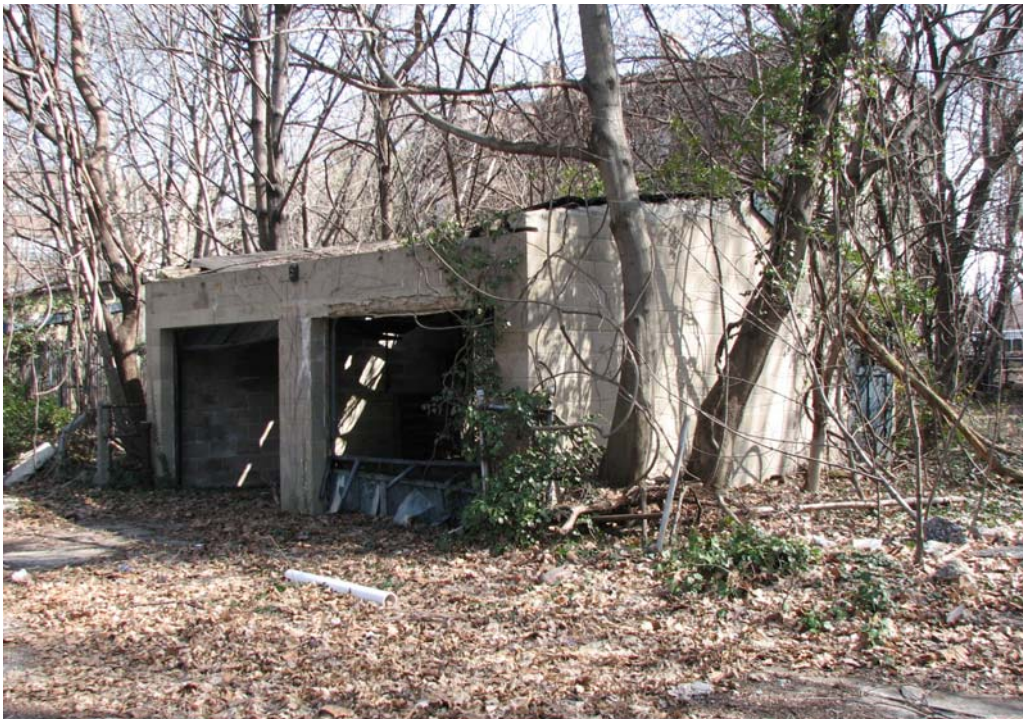
Figure 7.49. Building 464, garage associated with Quarters D, facing southeast. Brooklyn Navy Yard, Kings County, New York (PCI 2008).

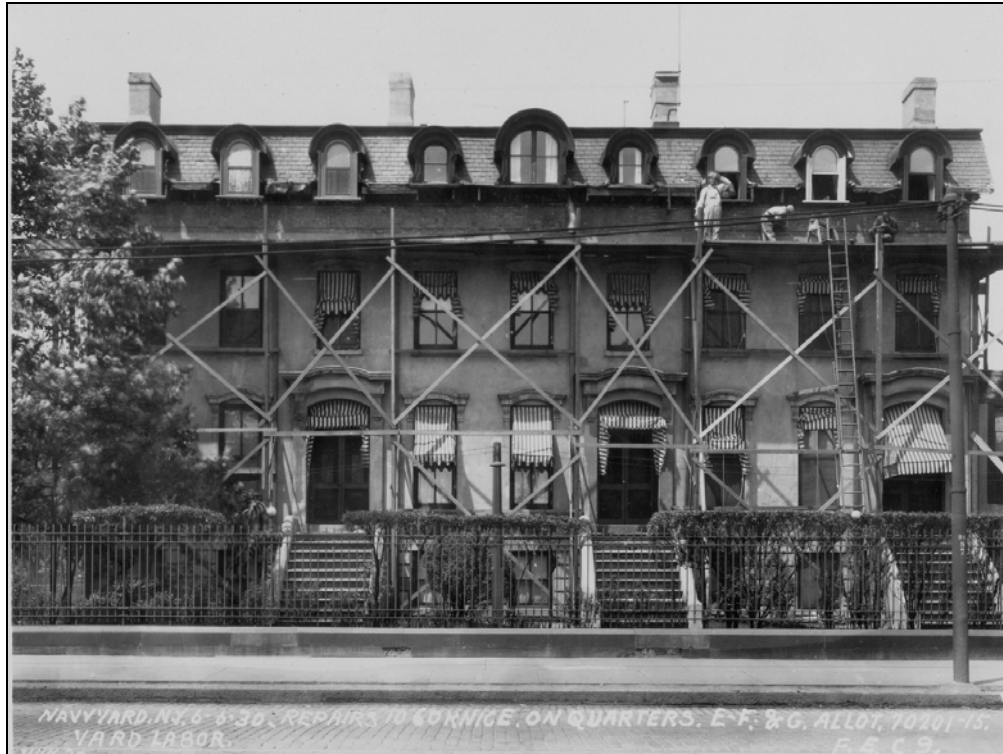
Figure 7.54. “Repairs to Cornice on Quarters E-F & G.” June 6, 1930. (New York Navy Yard: 1900-1945; Record Group 181-B; NARA—Northeast Region (NYC). Photograph No. FE C9. Reproduced courtesy of BNYDC Archives.)

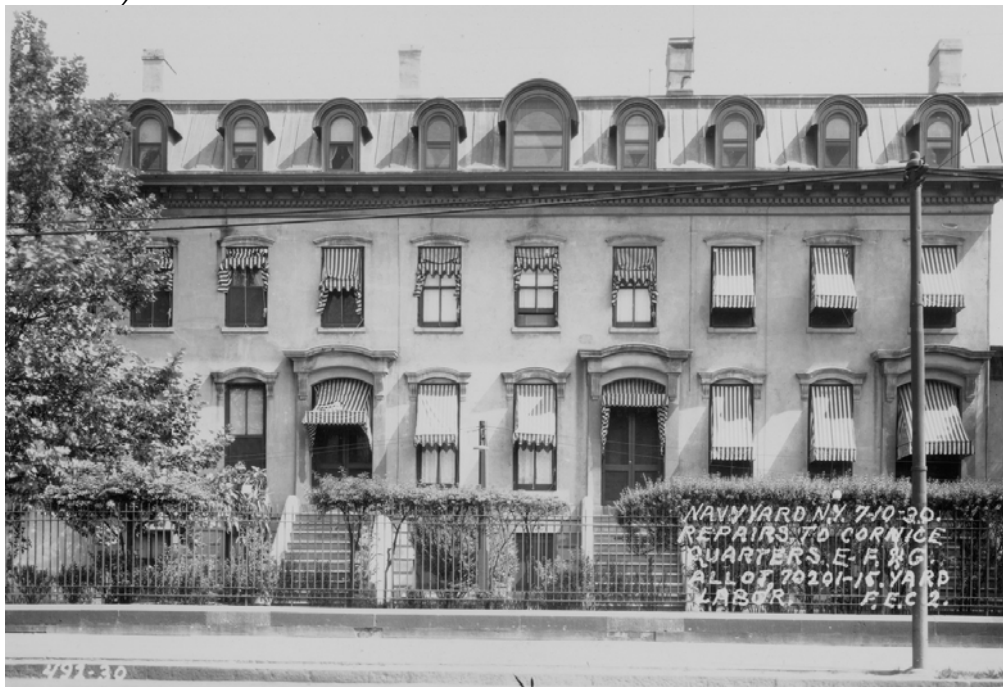
Figure 7.55. “Repairs to Cornice Quarters E-F-G,” July 7, 1930.” (New York Navy Yard: 1900-1945; Record Group 181-B; NARA—Northeast Region (NYC). Photograph No. FE C2. Reproduced courtesy of BNYDC Archives.)

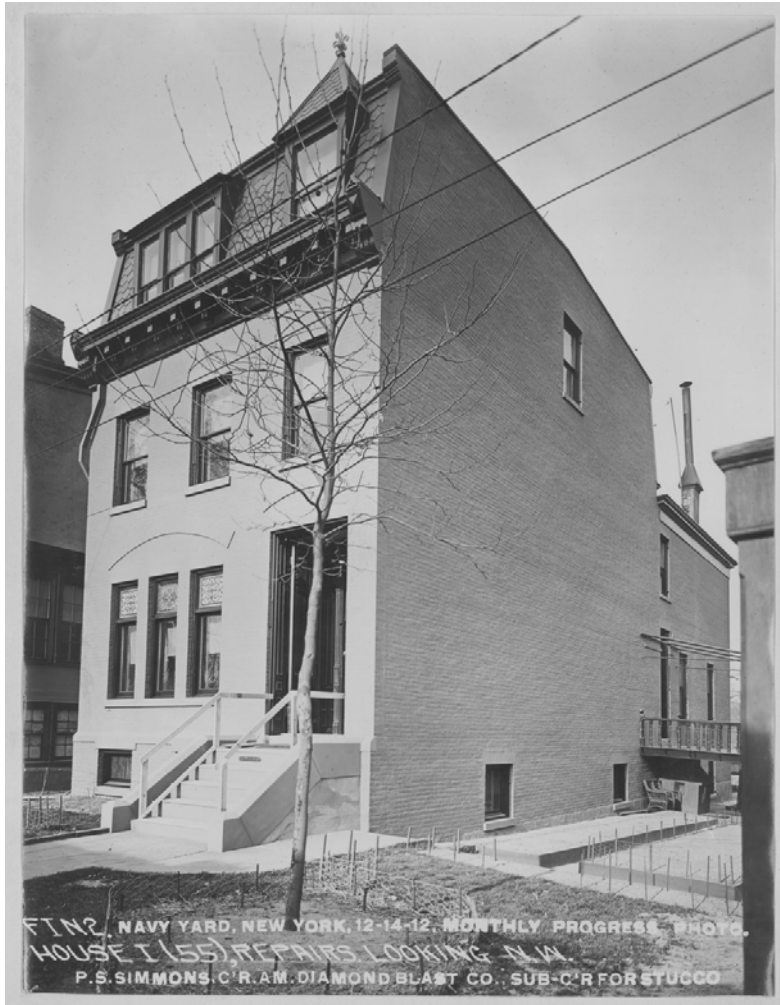
A review of historic photographs from 1912 confirmed when stucco was applied to the brick masonry exterior of Quarters I (Figures 7.67 and 7.68). These photographs also documented Quarters "I" prior to construction of the frame additions on the east and rear elevations.

Figure 7.67. “House I (55) Repairs Looking N.W.,”
December 14, 1912. (*New York Navy Yard: 1900-1945;*
Record Group 181-B; NARA—Northeast Region (NYC).
Photograph No. FIN24. Reproduced courtesy of BNYDC
Archives).

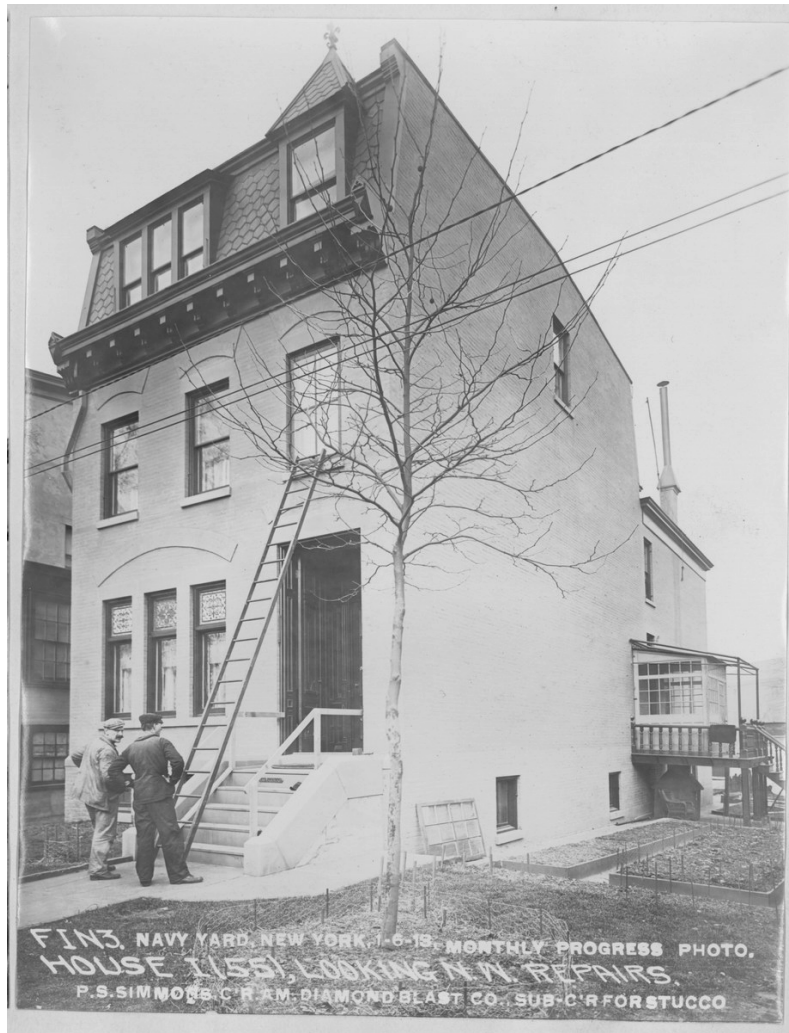
Figure 7.68. "House I (55) Looking N.W. Repairs,"
January 6, 1913. (New York Navy Yard: 1900-1945; Record
Group 181-B; NARA—Northeast Region (NYC). Photograph
No. FIN24. Reproduced courtesy of BNYDC Archives.)

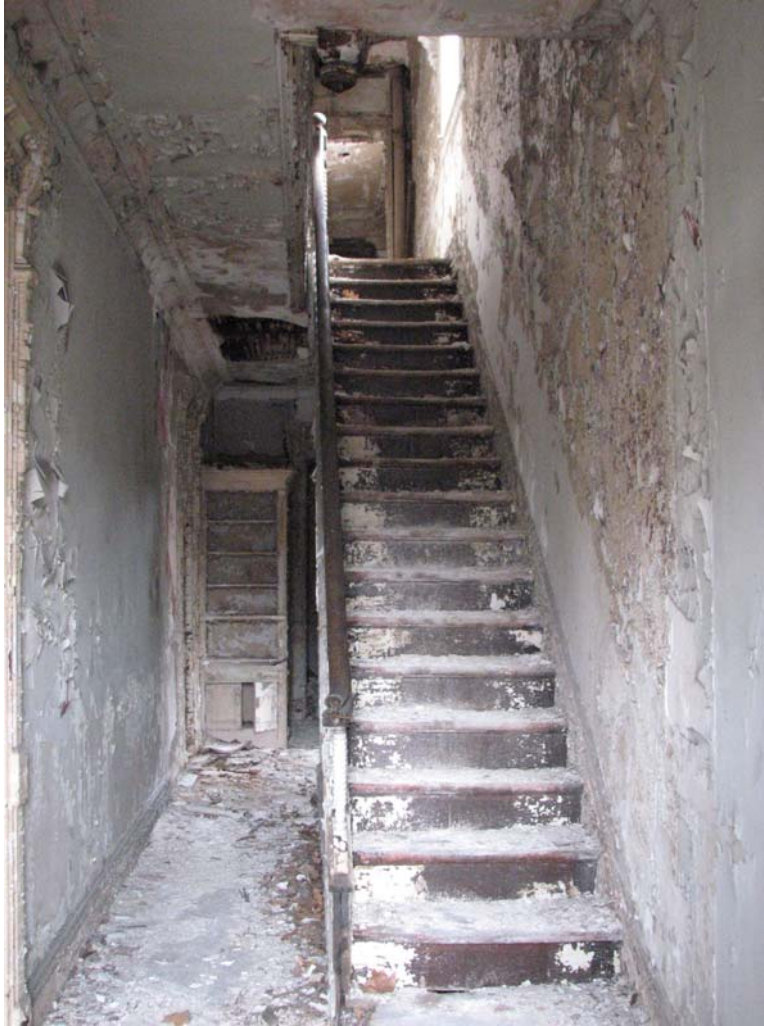
In the case of Quarters "I" the source of the deterioration has been water penetration into the building, mostly all from deteriorated roof conditions, open roof hatches, and basement dampness. While visually alarming, most of the severe deterioration from roof failure is found in rear sections, porch, and in and below Mansard roof areas. In Quarters "I" the severe deterioration (collapse) of the rear appendages, side porch, and roofs of the garage is confined to areas that were altered or built well into the twentieth century with modern amenities and features including utilitarian areas such as the kitchens, storage, and service areas. These areas are not part of the historic core sections of the buildings and while their deterioration is unfortunate, it does not play a major contributing factor to the historic integrity of the historic building sections. Within the rear bay of the circa 1900 building roof leaks have caused severe framing and detail deterioration to the roof, floor framing, and service stairway [Figures 7.69 to 7.71]. Portions of these isolated frame interior features have collapsed within the sound exterior brick masonry walls (Beardsley/Crawford & Stearns 2008:19).

Figure 7.69. Quarters I, interior, facing south. Brooklyn Navy Yard, Kings County, New York (PCI 2008).

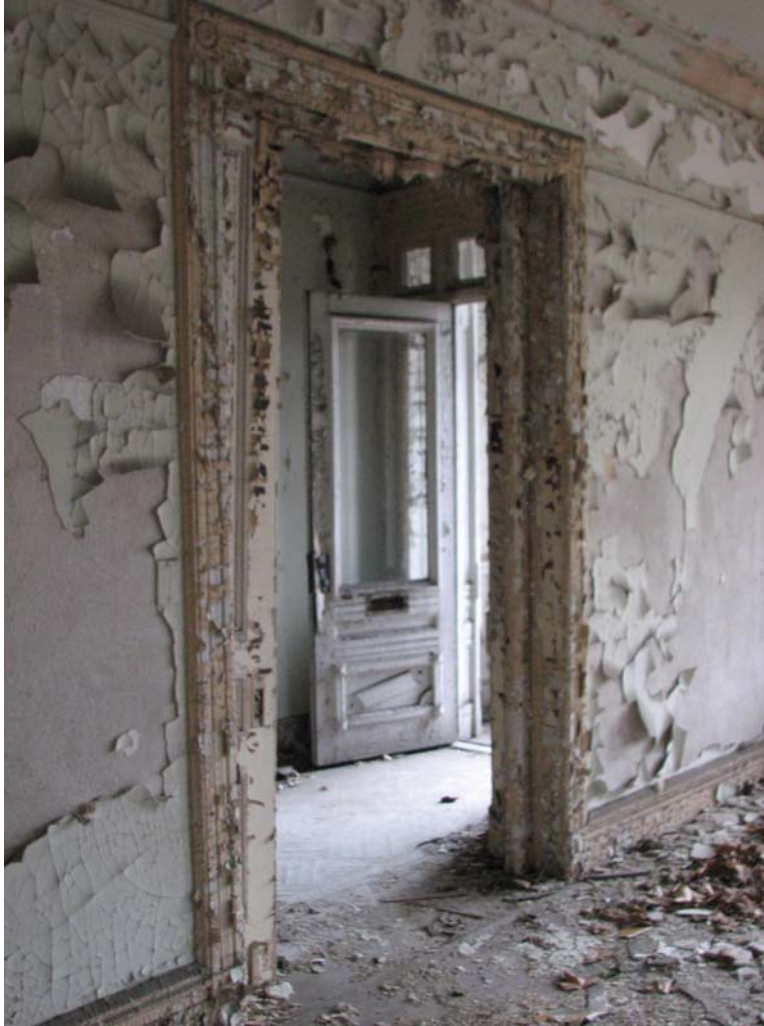
Figure 7.70. Quarters I, interior, facing southeast. Brooklyn Navy Yard, Kings County, New York (PCI 2008).
