PHASE IA CULTURAL RESOURCES INVESTIGATION

FOR ADMIRAL'S ROW SECTION

FORMER BROOKLYN NAVY YARD, BROOKLYN,

July 2008

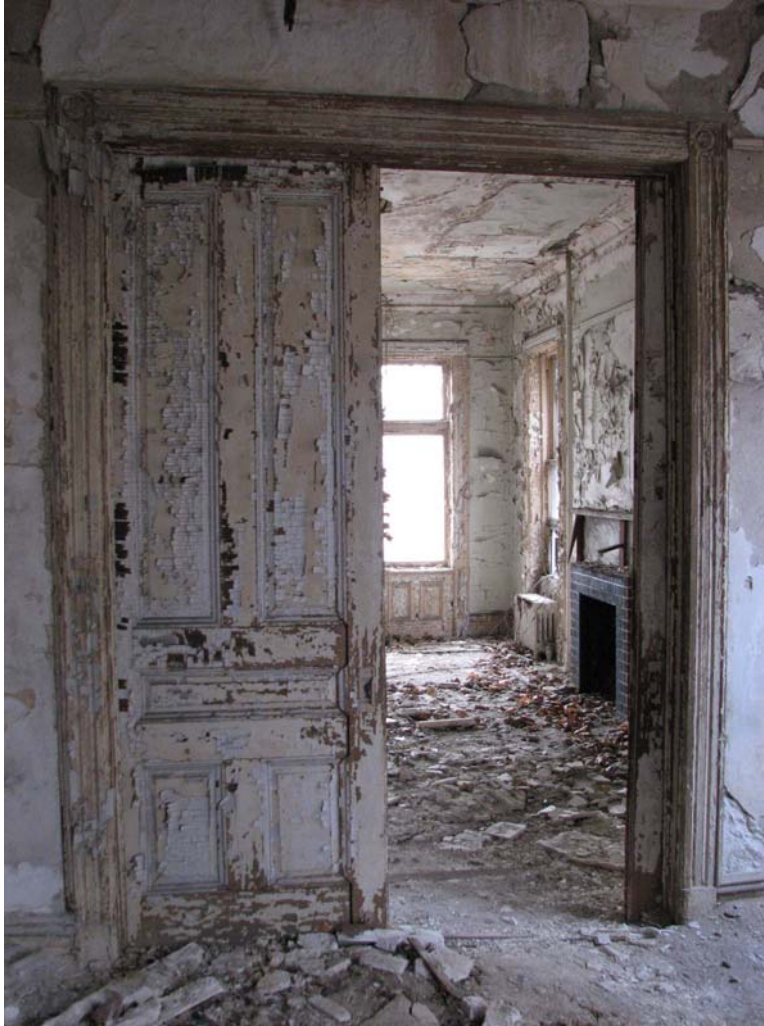
In the case of Quarters "I" the source of the deterioration has been water penetration into the building, mostly all from deteriorated roof conditions, open roof hatches, and basement dampness. While visually alarming, most of the severe deterioration from roof failure is found in rear sections, porch, and in and below Mansard roof areas. In Quarters "I" the severe deterioration (collapse) of the rear appendages, side porch, and roofs of the garage is confined to areas that were altered or built well into the twentieth century with modern amenities and features including utilitarian areas such as the kitchens, storage, and service areas. These areas are not part of the historic core sections of the buildings and while their deterioration is unfortunate, it does not play a major contributing factor to the historic integrity of the historic building sections. Within the rear bay of the circa 1900 building roof leaks have caused severe framing and detail deterioration to the roof, floor framing, and service stairway [Figures 7.69 to 7.71]. Portions of these isolated frame interior features have collapsed within the sound exterior brick masonry walls (Beardsley/Crawford & Stearns 2008:19).

Figure 7.71. Quarters I, interior, facing south. Brooklyn Navy Yard, Kings County, New York (PCI 2008).

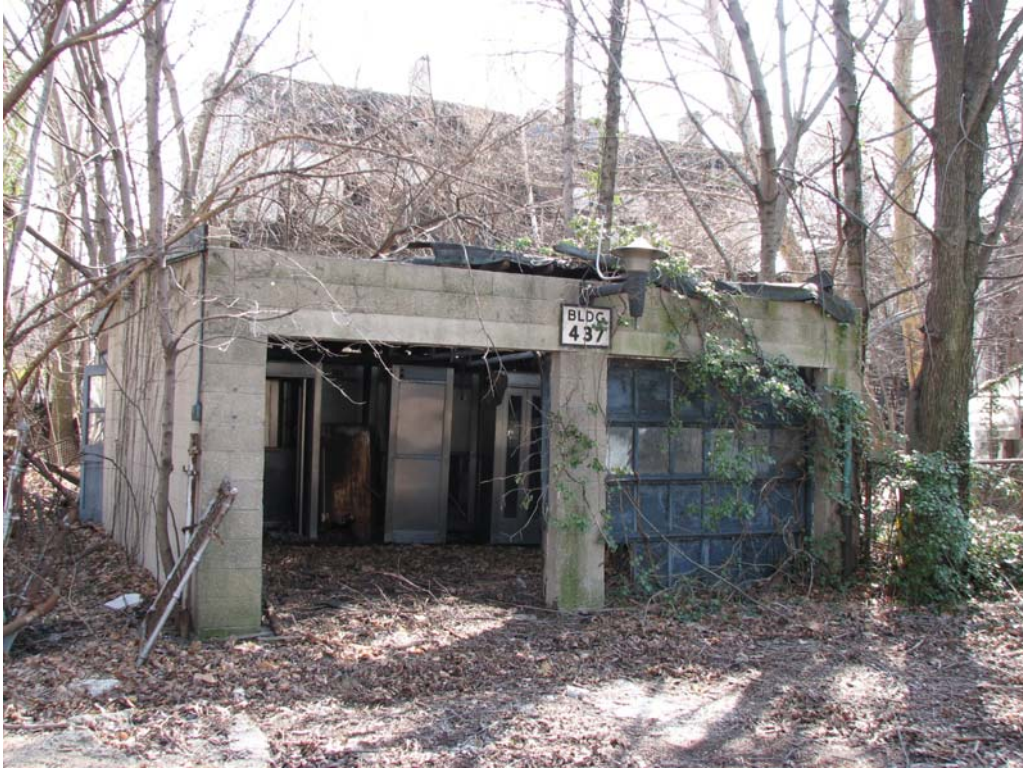
Quarters I has two associated garages. **Building 437** was constructed in 1919 as a semi-permanent structure (Property Record Card No 2-00435). The excess real property supplement identified the building as a Garage (Figure 7.72). It is located on the south side of Park Street, north of Quarters I. Building 437 is a one-story, concrete block building consisting of 483 square feet (23'x21'x10'). The structure's real property cost value was listed at \$860 in 1985 when it was transferred from the U.S. Navy to the U.S. Army National Guard Bureau.

Upon cursory visual inspection, Building 437 and Building 438 appear to be in fair condition. The buildings have been left open and exposed to natural elements since Admiral's Row was vacated. Its frame roof system has been compromised due to exposure which has caused both collapsed framing and missing sections of roof.

Figure 7.72. Building 437, associated with Quarters I, located on northwest corner of the lot, facing southwest. Brooklyn Navy Yard, Kings County, New York (PCI 2008).

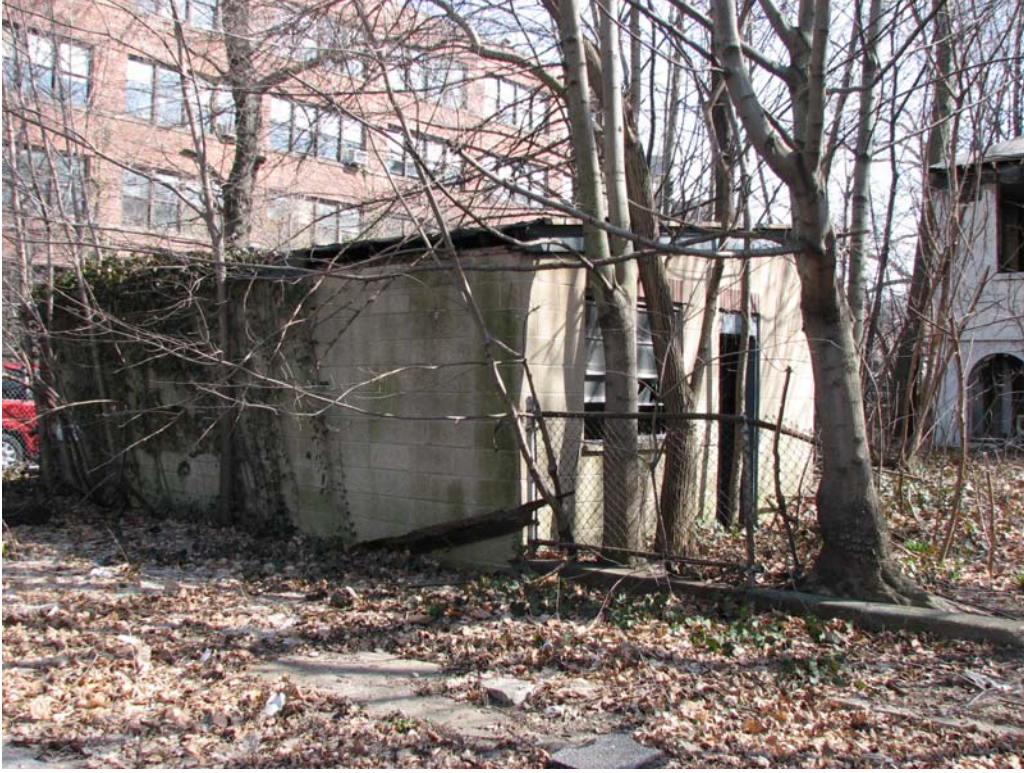
Building 438 was constructed in 1919 as a semi-permanent structure (Property Record Card No 2-00436) (Figure 7.73). It is located on the south side of Park Street, north of Quarters I along the eastern boundary of the parcel. Building 438 is a one-story, concrete block building consisting of 408 square feet (24'x17'x10'). The structure's real property cost value was listed at \$1,200 in 1985 when it was transferred from the U.S. Navy to the U.S. Army National Guard Bureau. Figure 7.74 is a drawing from 1955 [Drawing No F-438-SX] of "Building No. 438 Quarters I Garage Repairs Plans, Elevations & Details," June 6, 1955. It shows the shed roof and other details of the garage.

Figure 7.73 Building 438, associated with Quarters I, located on northeast corner of the lot, facing southeast. Brooklyn Navy Yard, Kings County, New York (PCI 2008).

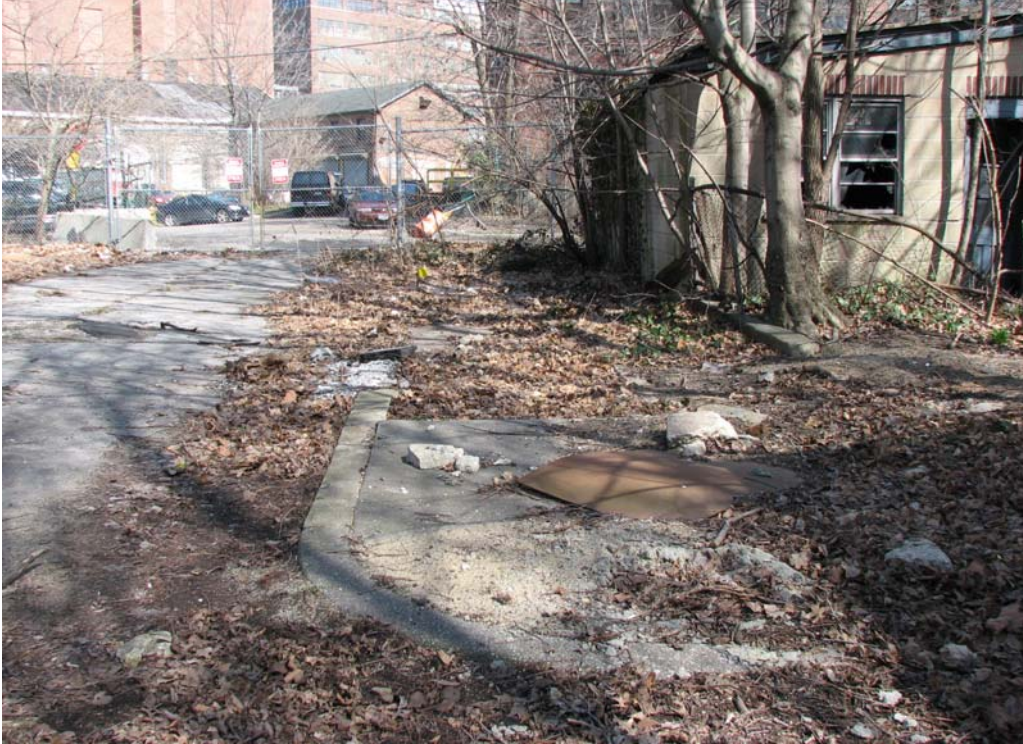
Figure 8.4. Detail of poured concrete sidewalk and curb located between Buildings 438 (at right) and 437, facing east. Brooklyn Navy Yard, Kings County, New York (PCI 2008).

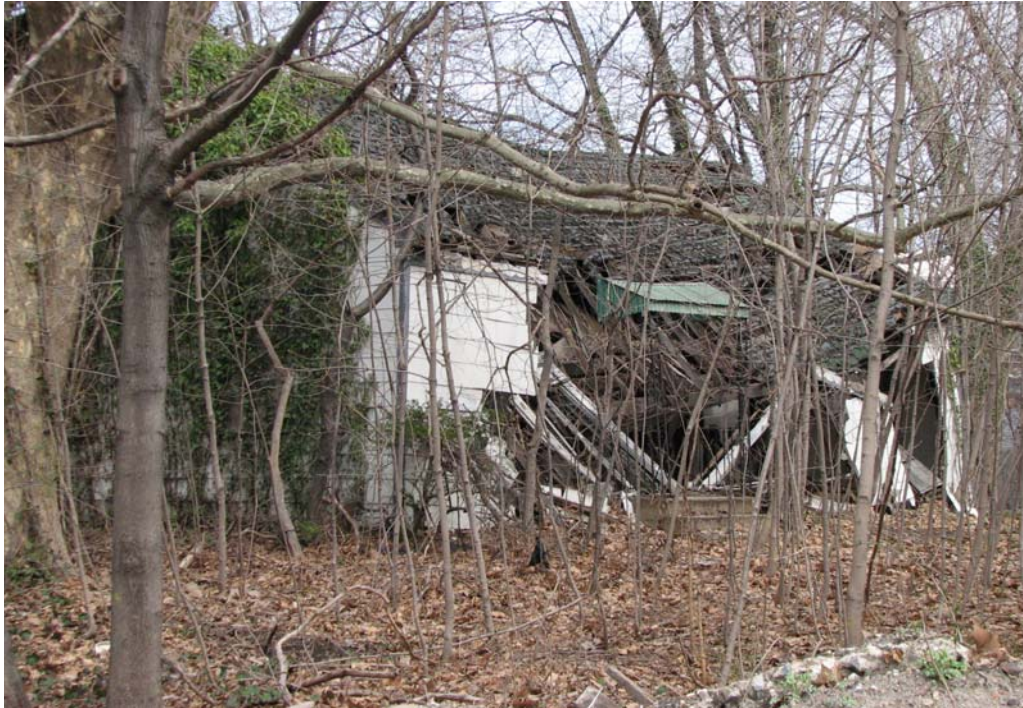
The building is presently in poor condition (e.g., near ruinous) and appears from exterior visual inspection to be structurally unsound. Its southern façade has collapsed and the side elevations appear to be undermined and collapsing.

Figure 9.1. Quarters J, south elevation (façade), facing northeast from Park Avenue. Brooklyn Navy Yard, Kings County, New York (PCI 2008).

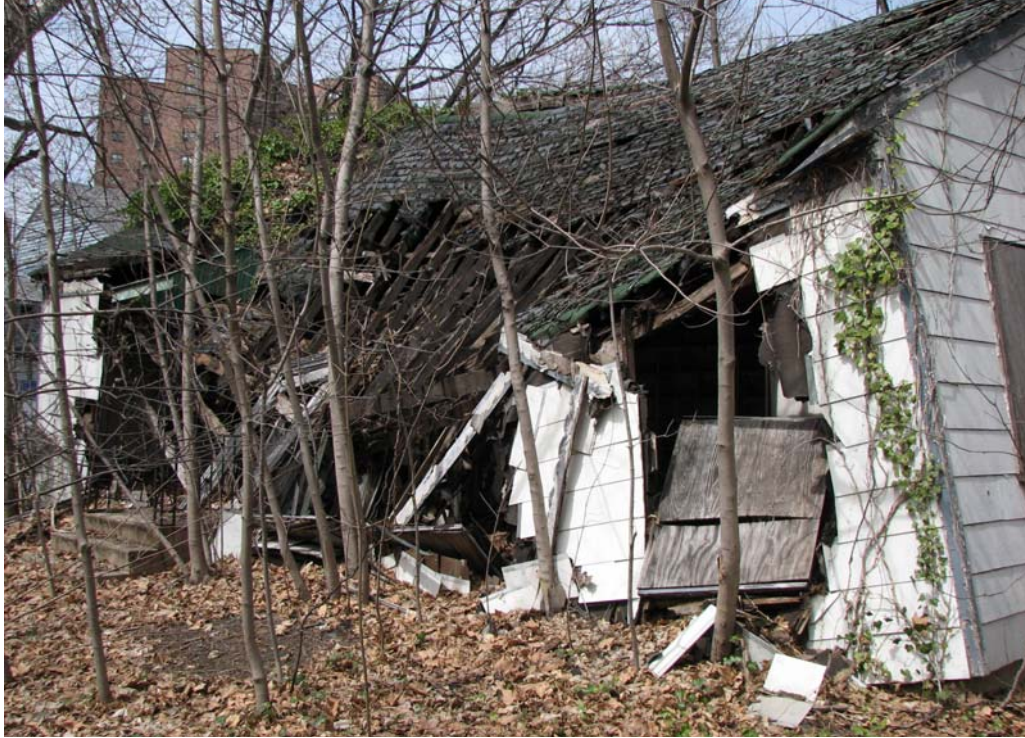
Figure 9.2. Quarters J, south elevation (façade), facing northwest. Brooklyn Navy Yard, Kings County, New York (PCI 2008).

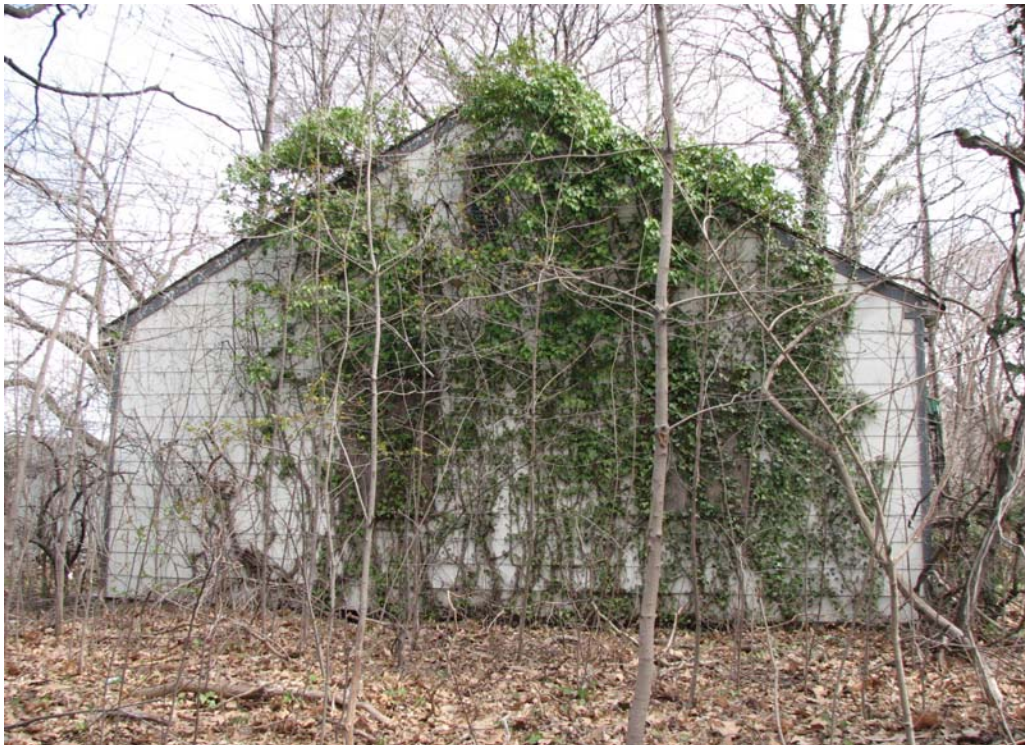
Figure 9.3. Quarters J, west elevation, facing east. Brooklyn Navy Yard, Kings County, New York (PCI 2008).

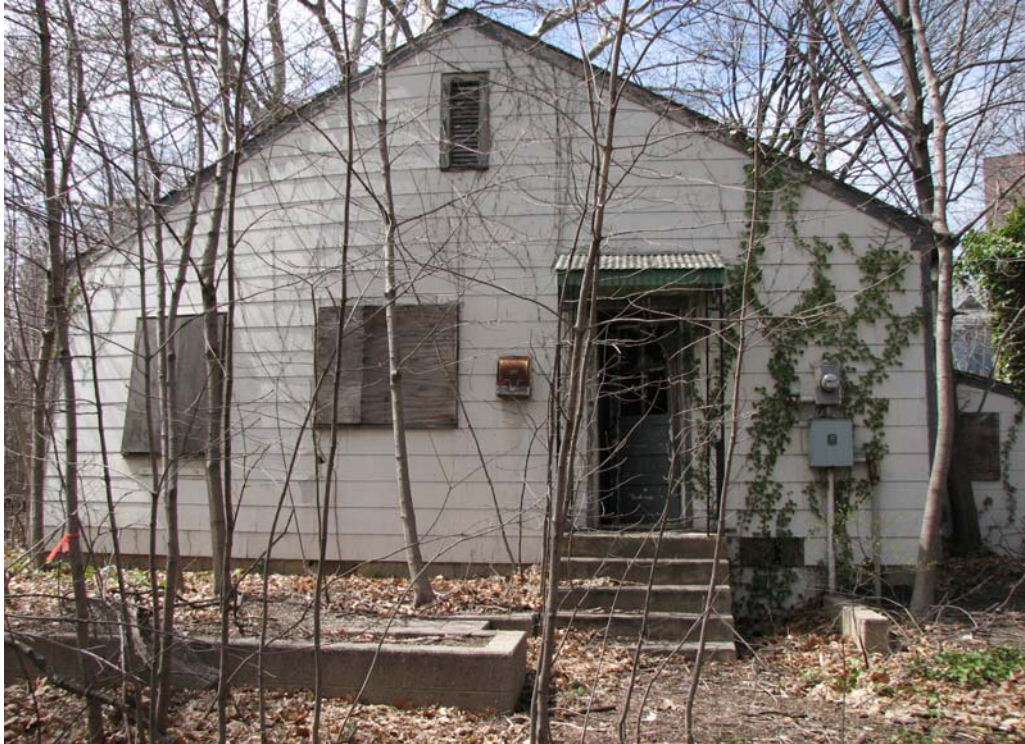
Figure 9.4. Quarters J, east elevation, facing west. Brooklyn Navy Yard, Kings County, New York (PCI 2008).

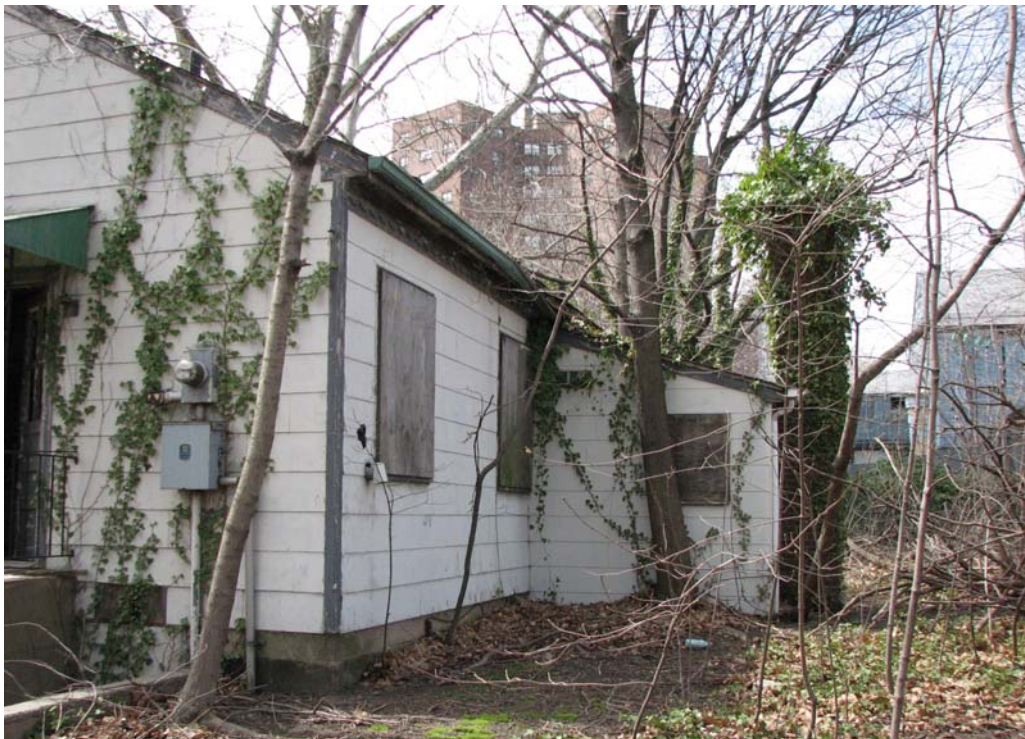
Quarters J was constructed in 1955 as a detached dwelling located on the northeast side of Park Avenue at the northern boundary of the project area (Figures 9.1 to 9.8). The one-story frame building is set on a concrete foundation and is sheathed with asbestos shingles. It has a side-gabled roof and a side entrance porch on the east elevation. A one-story frame addition with exterior brick chimney is attached to the rear elevation. Quarters J is presently dilapidated with a collapsed south façade. Stylistic remnants include a Colonial Revival style door enframement. The building was formerly designated Quarters “M” and once housed the Public Works Officer.

Figure 9.5. Quarters J, rear elevation with shed roof addition and exterior chimney, facing west. Brooklyn Navy Yard, Kings County, New York (PCI 2008).

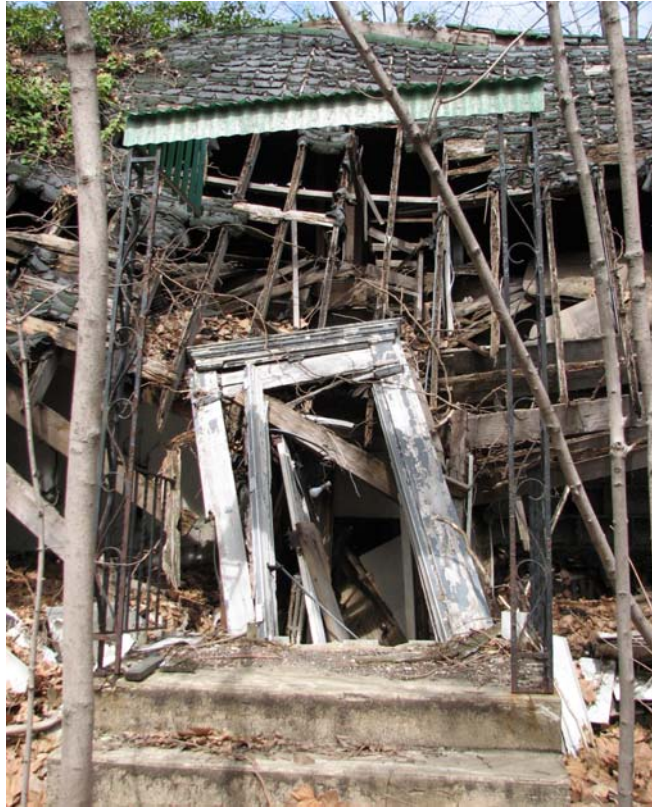
Figure 9.6. Quarters J, detail of entrance on south elevation facing north. Note Colonial Revival style door enframement. Brooklyn Navy Yard, Kings County, New York (PCI 2008).

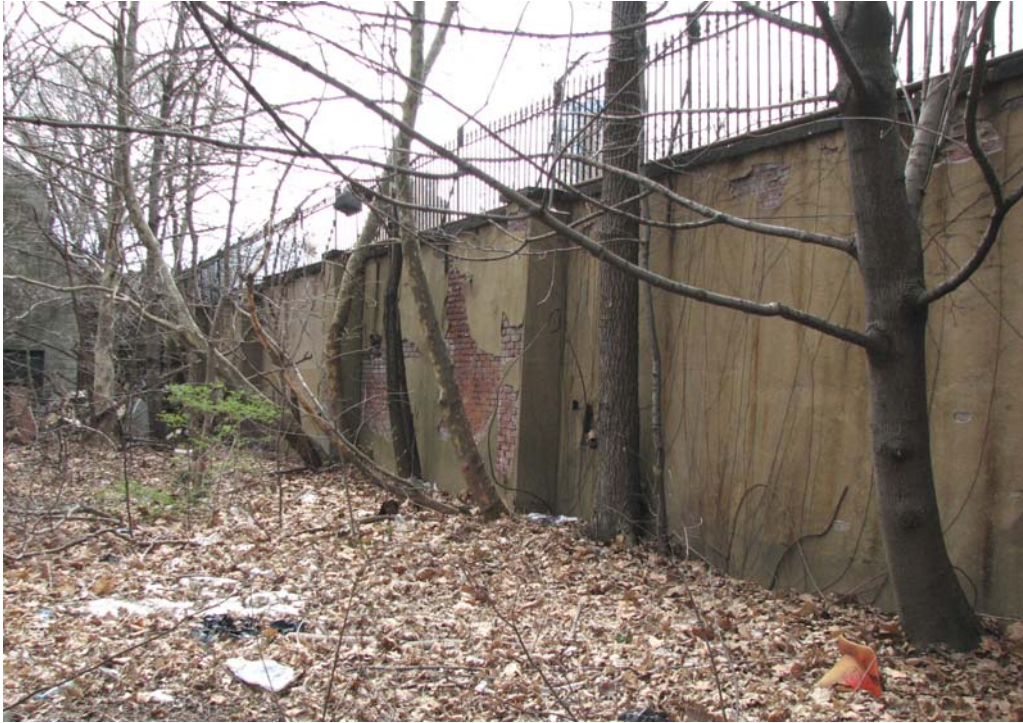
Brick Walls. Three sections of brick walls located along the southern and western perimeters of the parcel were listed separately in the excess real property supplement (Figures 10.1 to 10.4; see also Figures 6.22 to 6.25, Timber Shed, and Figure 7.1, Quarters K-L). The Navy Yard’s brick walls along Navy Street and Flushing Avenue have been a prominent feature of the urban landscape since the nineteenth century. Square brick piers support the walls. Stone coping and decorative iron fencing cap the top of the wall. The interior of the brick wall along Navy Street was covered with stucco, probably circa 1912 at the same time as the Quarters. Large areas of stucco along the interior of the brick wall have detached from the brick surface. Trees have grown along the interior base of the wall, which more than likely have compromised structural soundness in sections of the wall. Each section is listed below:

Figure 10.1. East elevation of the brick wall along Navy Street from near the northwest corner of the project area, facing south. Note trees along base of wall. Brooklyn Navy Yard, Kings County, New York (PCI 2008).

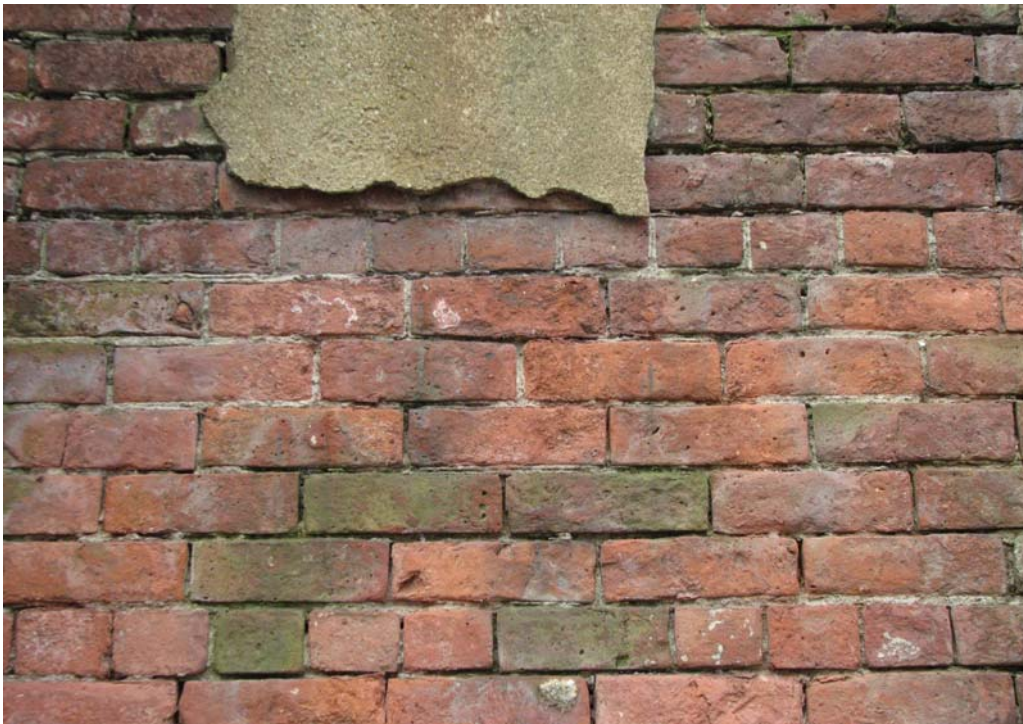
Figure 10.2. Detail of brick masonry of wall showing common bond construction. Note stucco above. Brooklyn Navy Yard, Kings County, New York (PCI 2008).

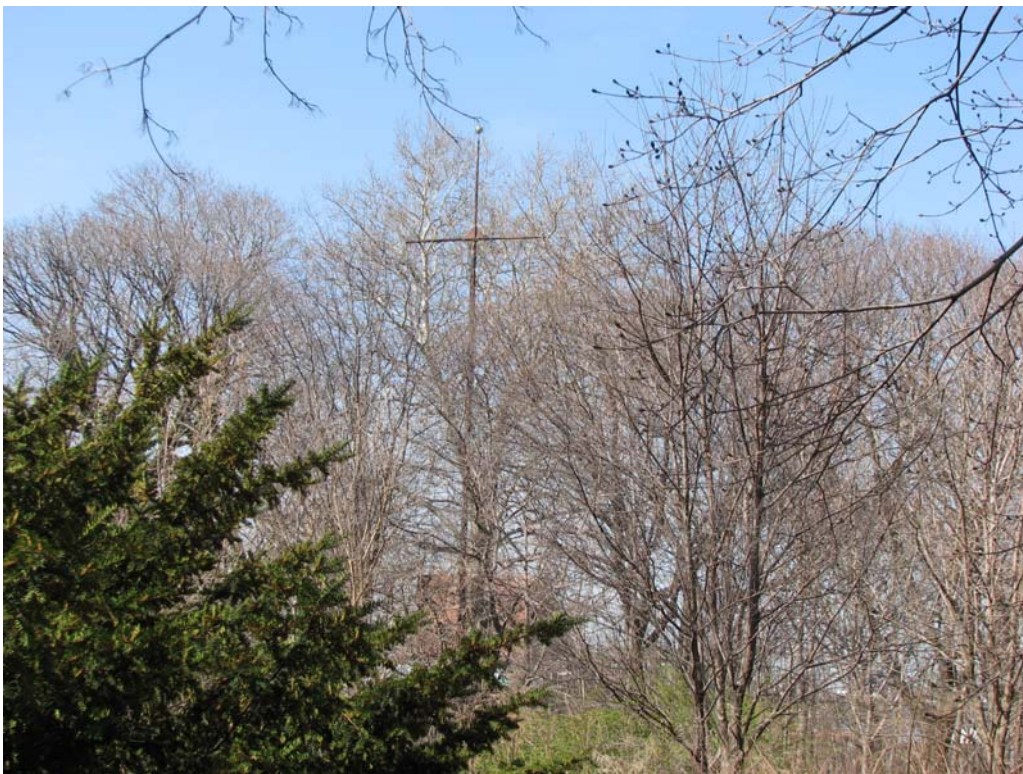
The flag pole still stands, but it is no longer in use. Formerly a prominent feature of the parade ground, the flag pole is not visible from most points in the project area due to surrounding dense vegetation and trees (Figure 10.5).

Figure 10.5. Building 135, a flag pole located in the northern portion of the project area (in center), facing north-northwest. Brooklyn Navy Yard, Kings County, New York (PCI 2008).

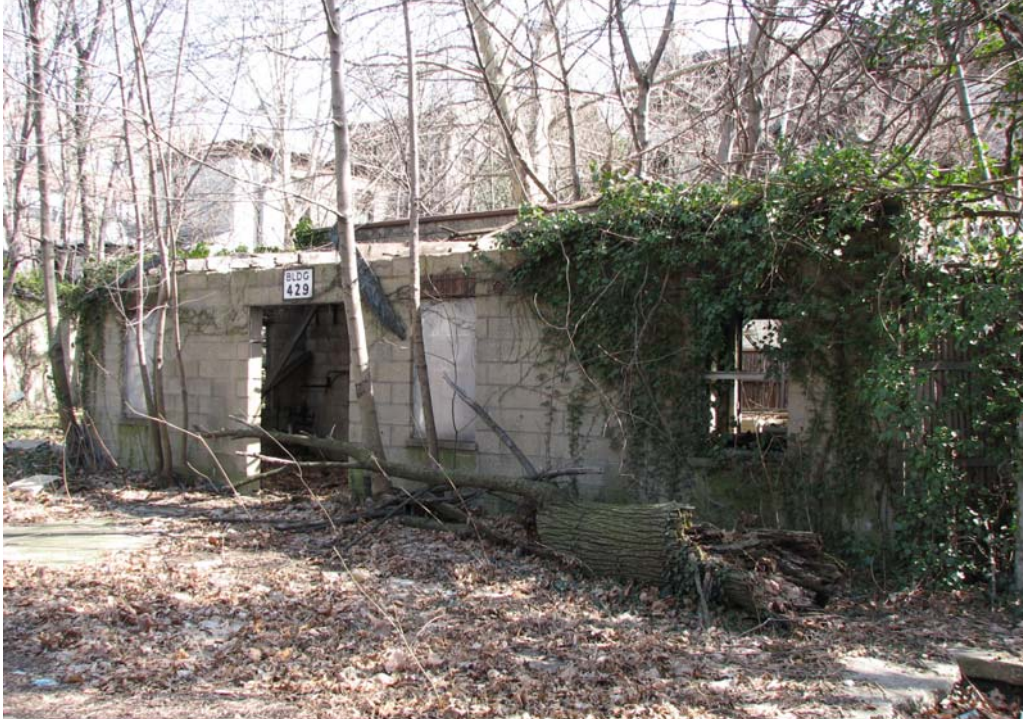
Building 429: Public Works Maintenance Building. Building 429 was constructed in 1919 as a semi-permanent building (Property Record Card No 2-00434). The excess real property supplement identified the building as a Public Works Maintenance Building. It is located on the south side of Park Street, north of Quarters E, F and G. The south elevation has an attached green house. The structure's real property cost value was listed at \$750 in 1985 when it was transferred from the U.S. Navy to the U.S. Army National Guard Bureau. The present condition of the garage is fair. The building has been left open and exposed to natural elements since Admiral's Row was vacated. Its frame roof system has been compromised due to exposure which has caused both collapsed framing and missing sections of roof (Figures 10.12 and 10.13).

Figure 10.12. Building 429, Public Works Maintenance Building, located behind Quarters E, F and G, facing southeast. Brooklyn Navy Yard, Kings County, New York (PCI 2008).

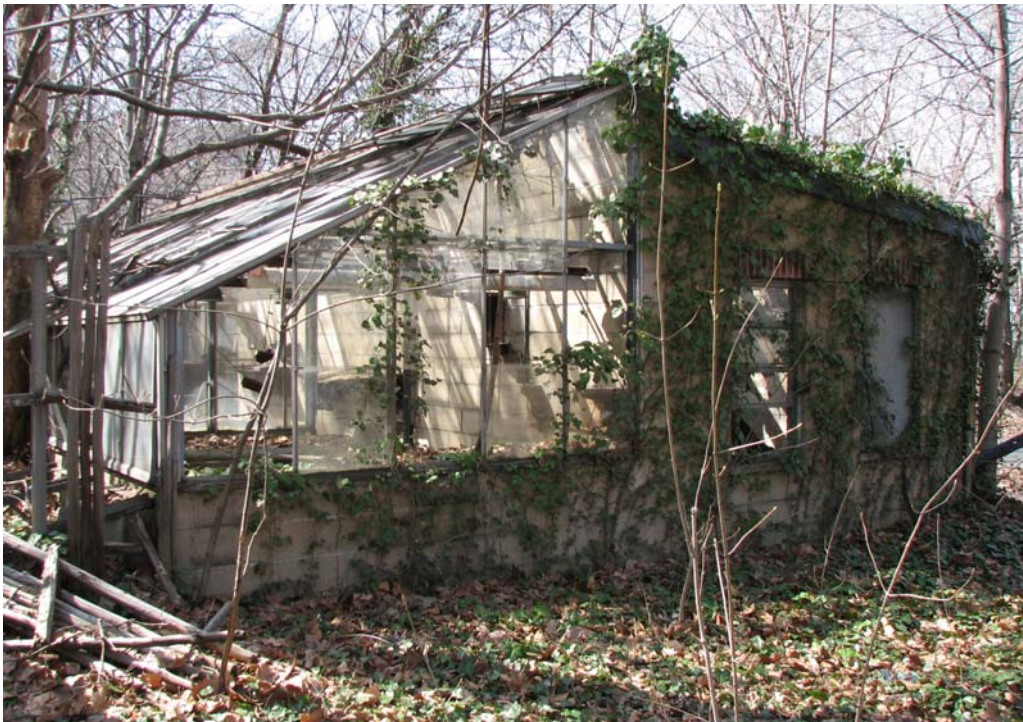
Figure 10.13. Building 429, Public Works Maintenance Building, located behind Quarters E, F and G, facing west. Brooklyn Navy Yard, Kings County, New York (PCI 2008).

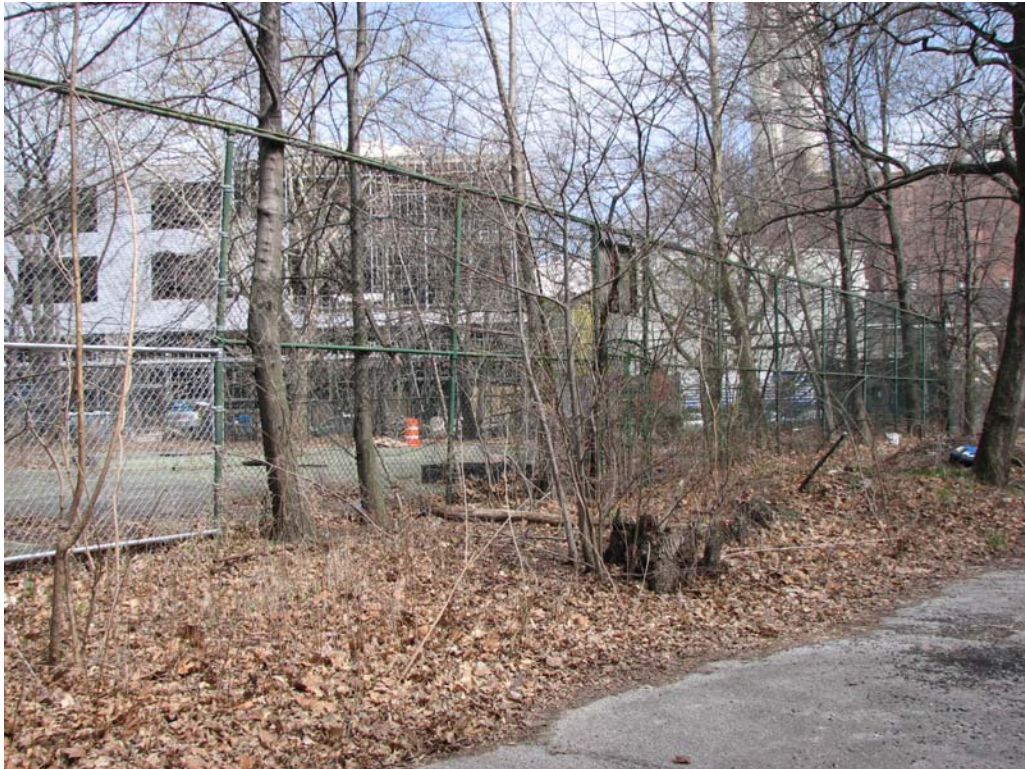
Figure 10.14. Tennis Court (Building 710), from Park Street, facing northeast. Brooklyn Navy Yard, Kings County, New York (PCI 2008).

Building 710: Tennis Court. Building 710 was constructed in 1918 as a permanent facility (Property Record Card No 2-00442). The excess real property supplement identified the facility as “Tennis Court.” It is located on the north side of Park Street, in the northeast corner of the project area. The 165-x-116-ft tennis court is contained within a chain linked fence (Figures 10.14 to 10.16). The structure’s real property cost value was listed at \$20,000 in 1985 when it was transferred from the U.S. Navy to the U.S. Army National Guard Bureau.

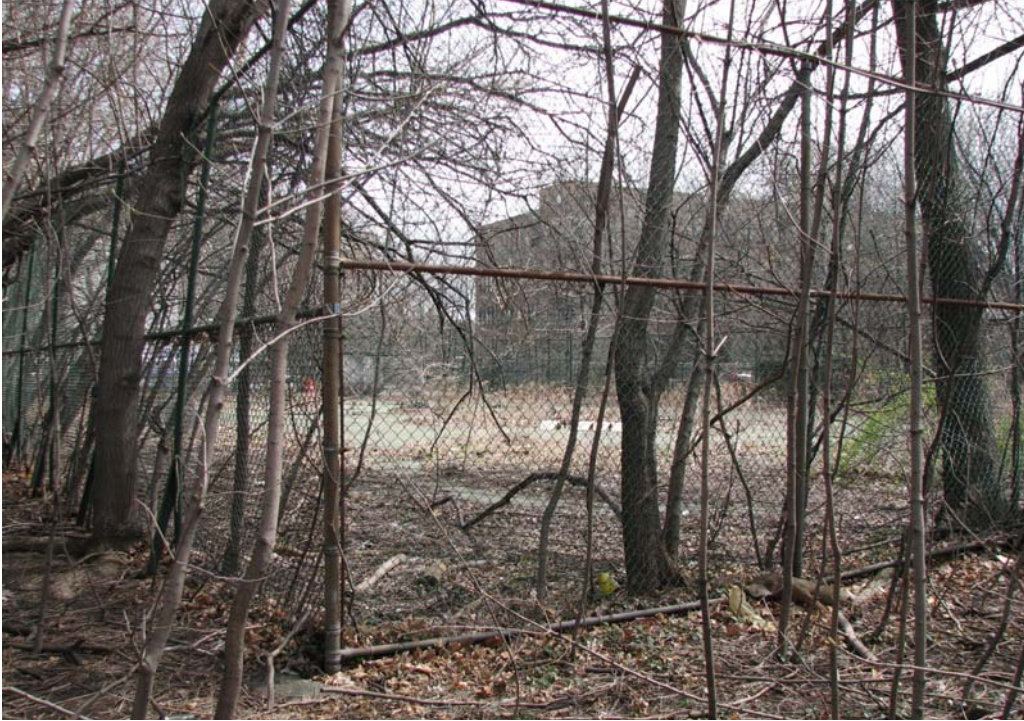
Figure 10.15. Tennis Court (Building 710), from northwest corner of court, facing southeast. Brooklyn Navy Yard, Kings County, New York (PCI 2008).

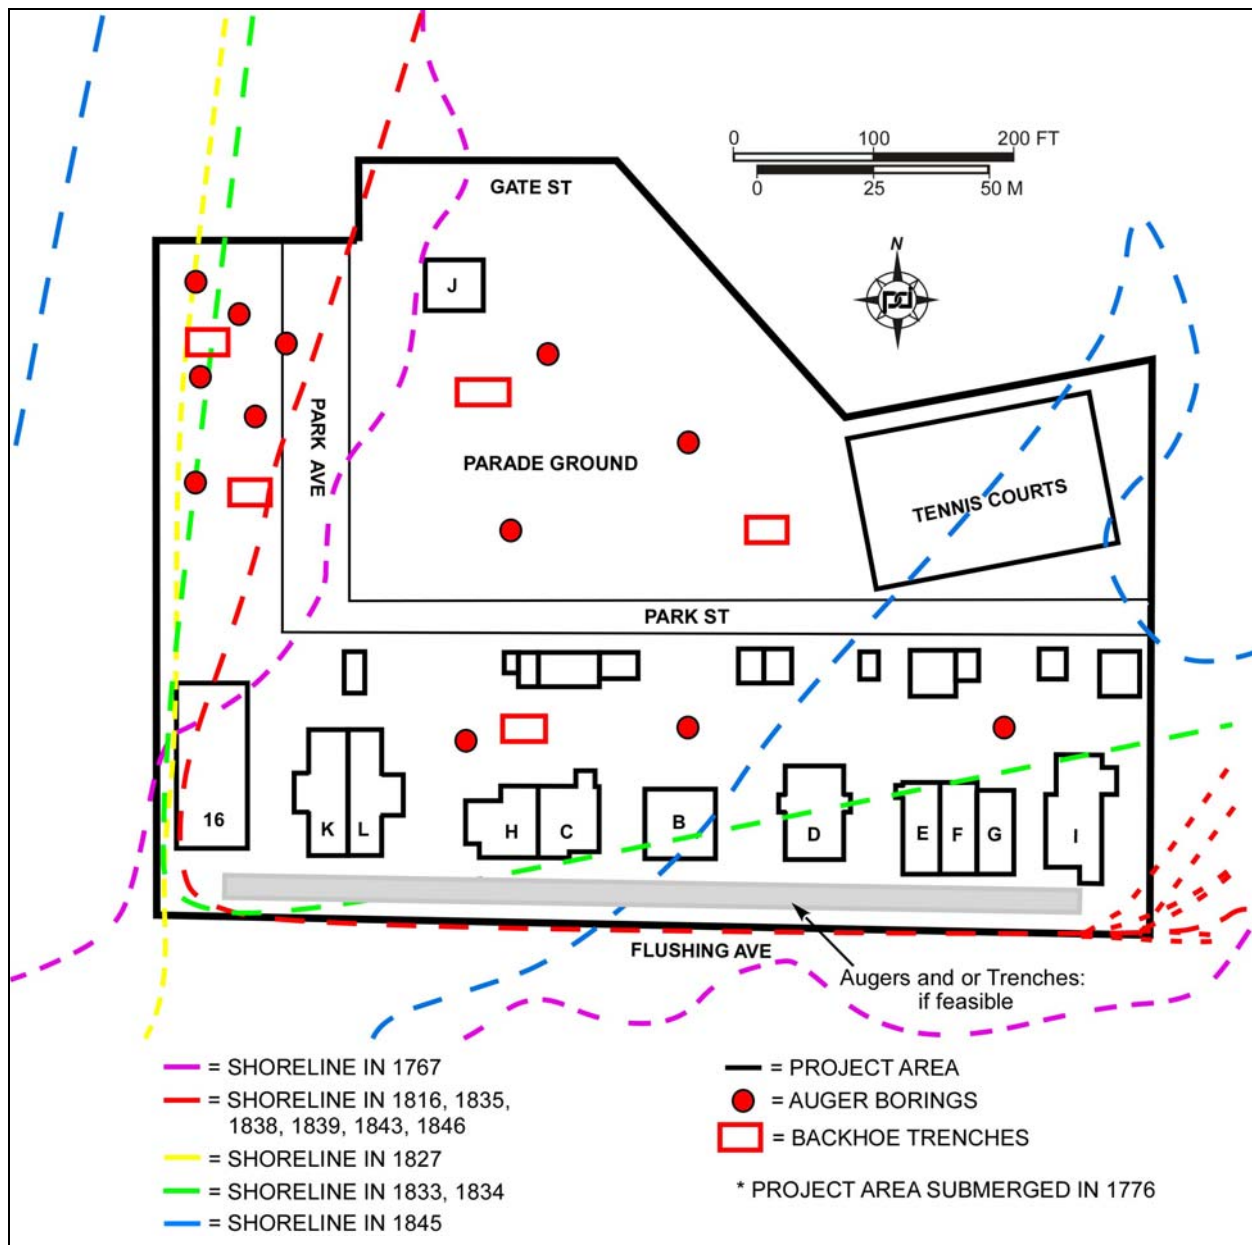
Figure 11.1. Suggested Phase IB geomorphological survey locations relative to historic map-documented shoreline locations (Note: all shorelines are approximate due to the unreliable depiction of scale, location and proportions on some historic maps).

any potentially sensitive soils, however, the thickness (potentially 12+ feet) and nature (10 to 75 percent coarse fragments) of the historic fill will likely require the use of either a hydraulically powered auger (e.g., Giddings Probe) or backhoe. This will be determined by the depths of disturbance required by the proposed project.
