BROOKLYN COLLEGE
SUMMER ARCHAEOLOGICAL FIELD SCHOOL

EXCAVATIONS AT THE
CHRISTIAN DURYEA HOUSE , Brooklyn, N. Y.
1986

H. Arthur Bankoff
Frederick A. Winter
April 14, 1988

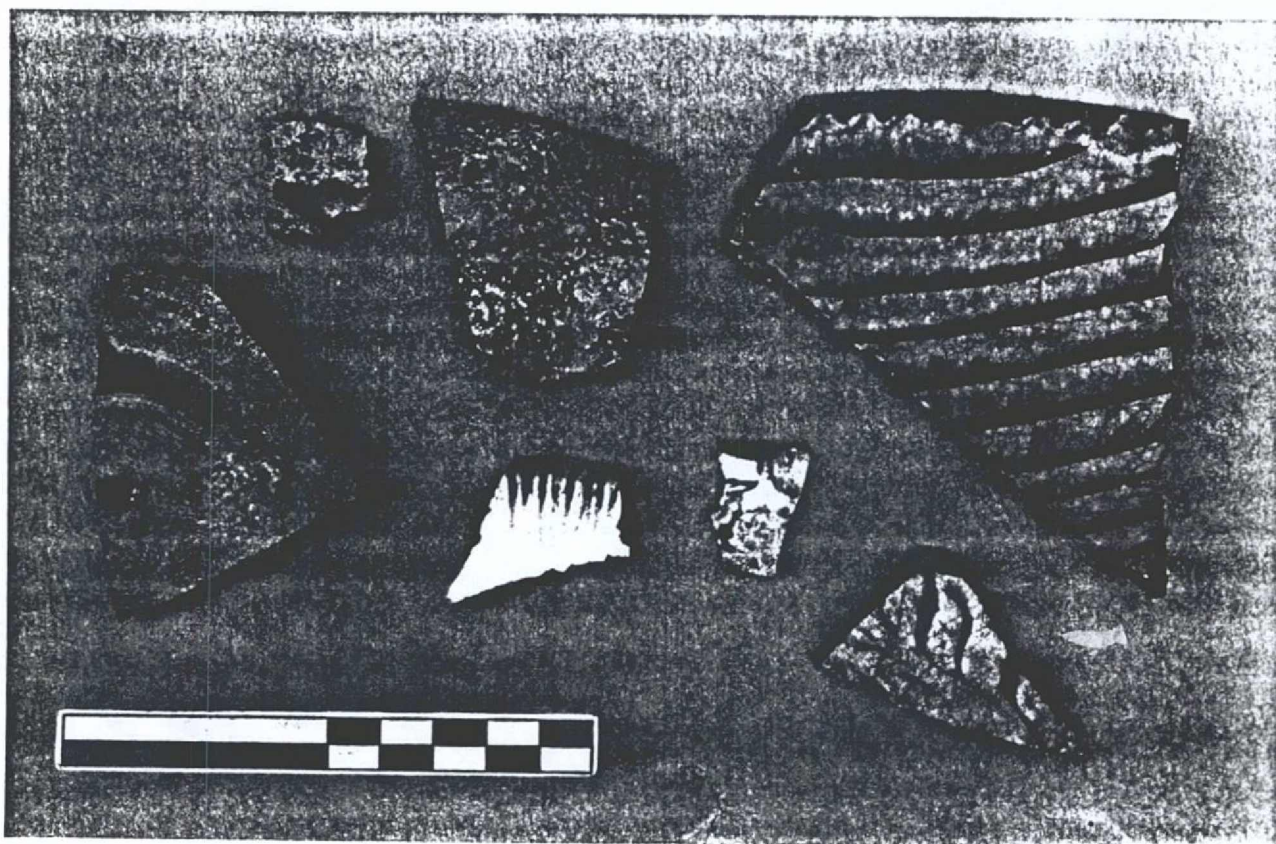
Fig. 5: Sherds from the foundation trench

Trench 2, located on the north side of the older, east wing of the house, produced pottery from the builders' trench adjacent to the deep Duryea House basement, indicating that this segment of the house was constructed sometime around or slightly before the year 1800 (Fig. 5). The gray stoneware sherds from the trench, although fragmentary, undecorated and therefore not precisely datable, would be compatible with a date in the eighteenth or early nineteenth centuries. The two English slipped ware sherds

are of types that were produced in the middle and third quarter of the eighteenth century; the broader stripes on the larger fragment suggest a date close to the time, ca. 1770, when this Staffordshire pottery stopped being imported to the American colonies (Hume 1982:134f and fig. 29). The small fragment of English blue decorated Shell-edged Pearlware is of a type that began to be produced in quantity during the 1780's (Hume 1982:128 and figs. 35 and 46). These pieces thus provide a terminus post quem for the filling of the building's foundation trench.

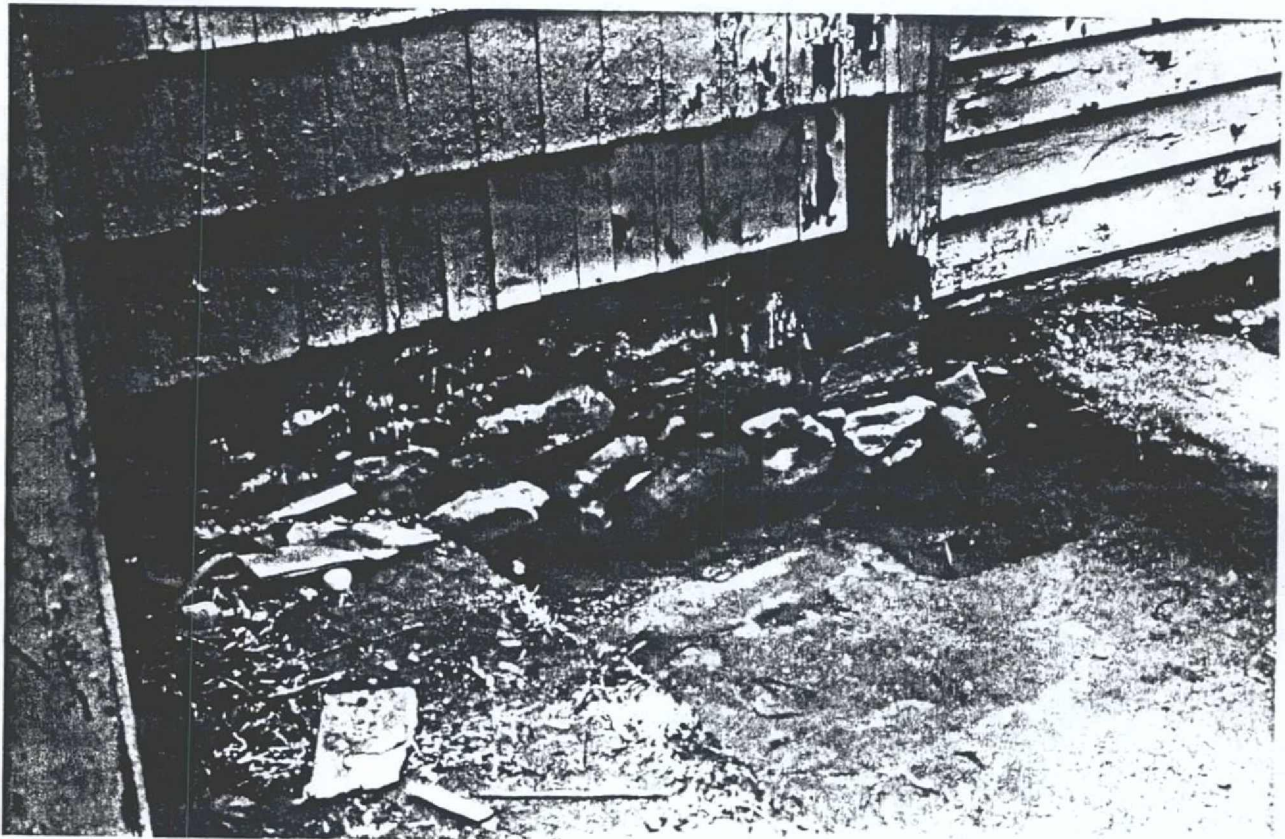
Fig. 9: Trench 6, showing shallower foundations of central portion of the house.

Trenches along the central and western portions of the house (trenches 6, 8, 12, 20, 22) revealed considerably shallower foundations (Fig. 9). In trench 12, later nineteenth- to early twentieth-century white wares were recovered wedged under the foundation stones of the westernmost extension of the house (Fig. 10). Trench 22 showed that the shed-like entrance that extends north of the building had shallower foundations than the central portion of the house, and was presumably a subsequent addition to the building. Trench 8, situated between the basement entrance and the shed-like extension on the house's north, exposed a brick- and cobble-lined access shaft to the house's main sewer drain (early twentieth century?) (Fig. 11). This access shaft was filled with modern glass, predominantly half-pint liquor bottles. The cinderblock steps leading into the house's north entrance overlay and thus post-date this feature.
