**Bulkhead Documentation Report**

**Burling Slip**

**Block 74, Portions of Lots 20 and 1  
Borough of Manhattan, New York, New York**

**June 2, 2011**

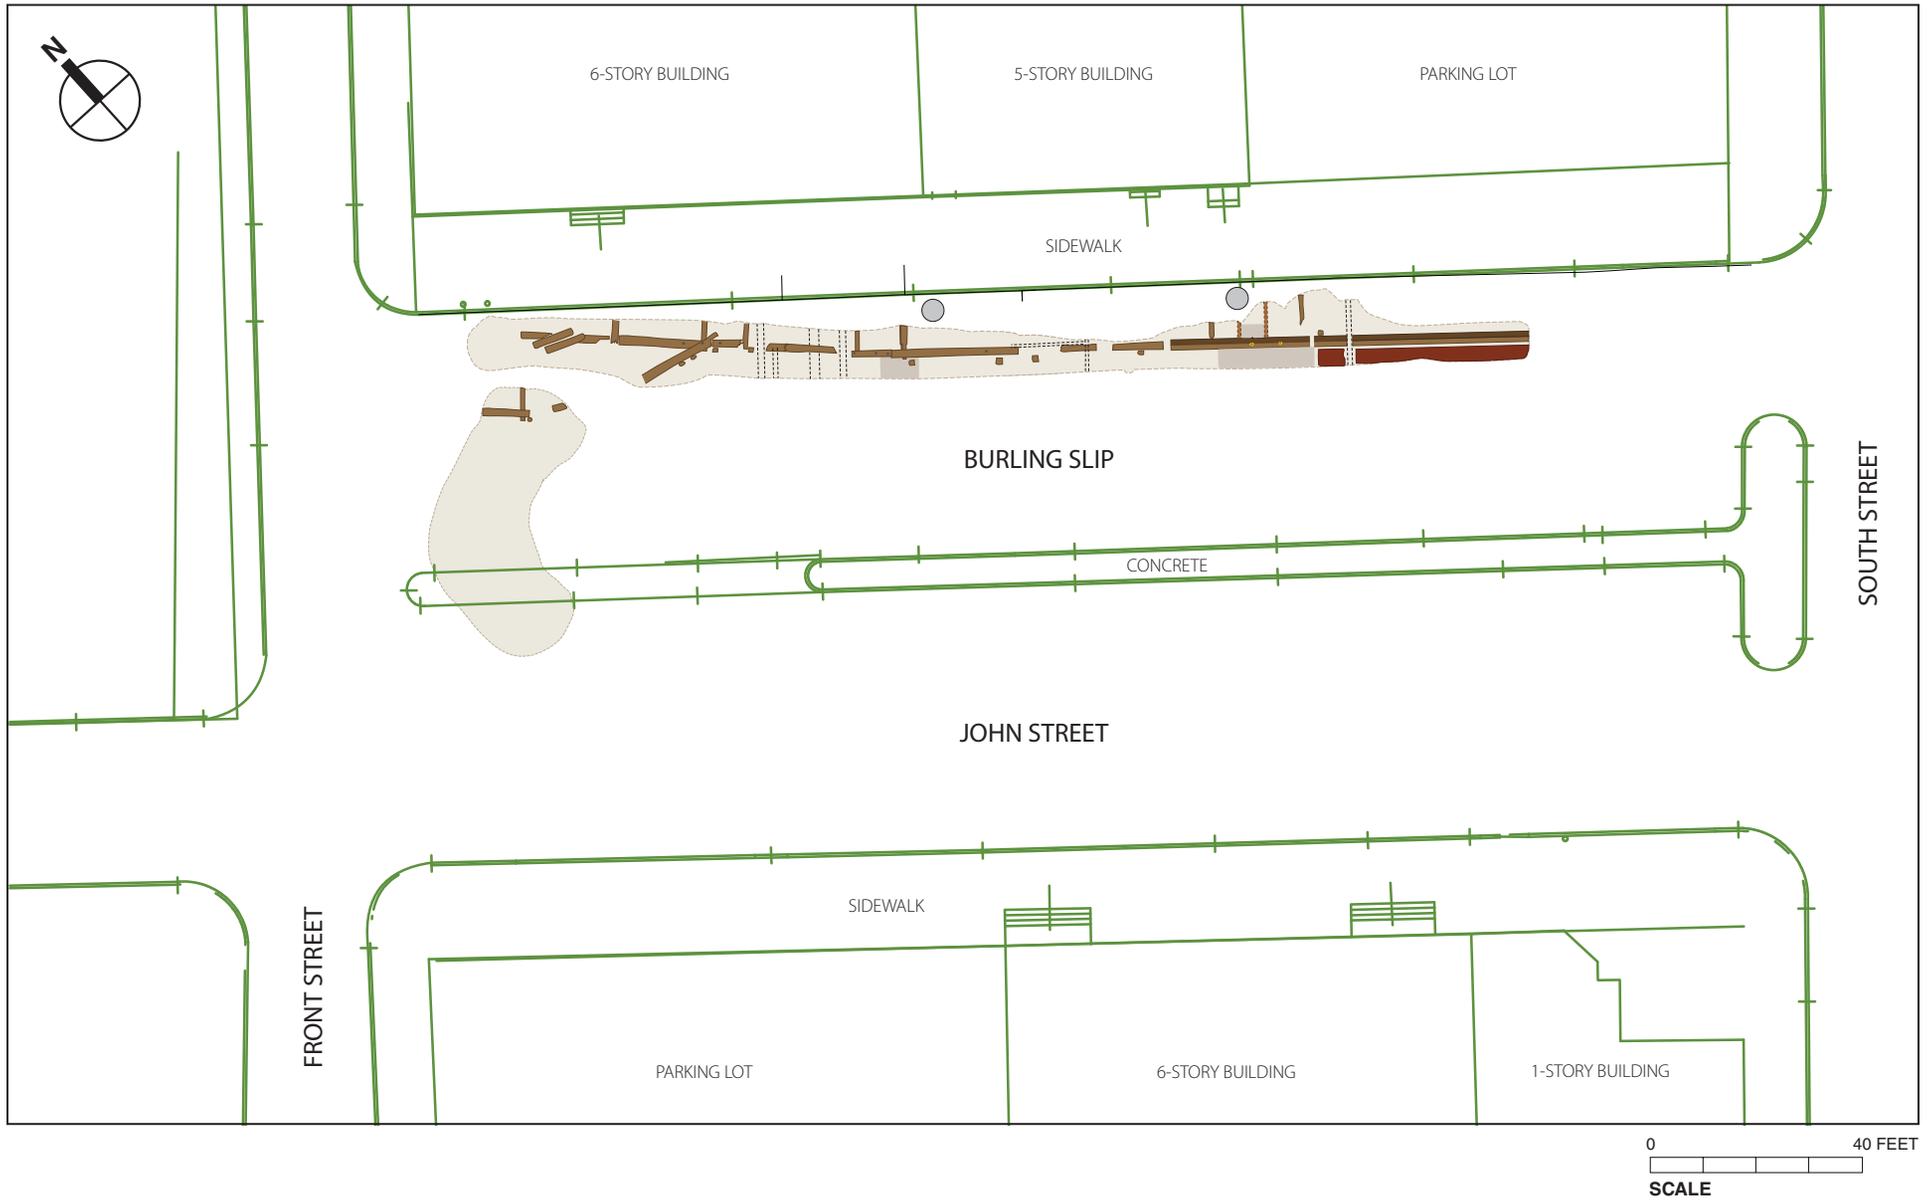
A plan view of the bulkhead in its entirety is provided as **Figure 4**. A more detailed view of this drawing, separated into two sections, is presented as **Figure 5**. Labels denoting the locations of tie-backs, piles, broken or damaged portions of the bulkhead, metal spikes, artifact pockets, and other field observations are included on Figure 5. The depth of the top of the bulkhead at various points and the locations of deep excavation areas are also shown. Photographs of the bulkhead are provided in the Photographs section of this report (see the **Photo Key** and **Photographs 1** through **12**).

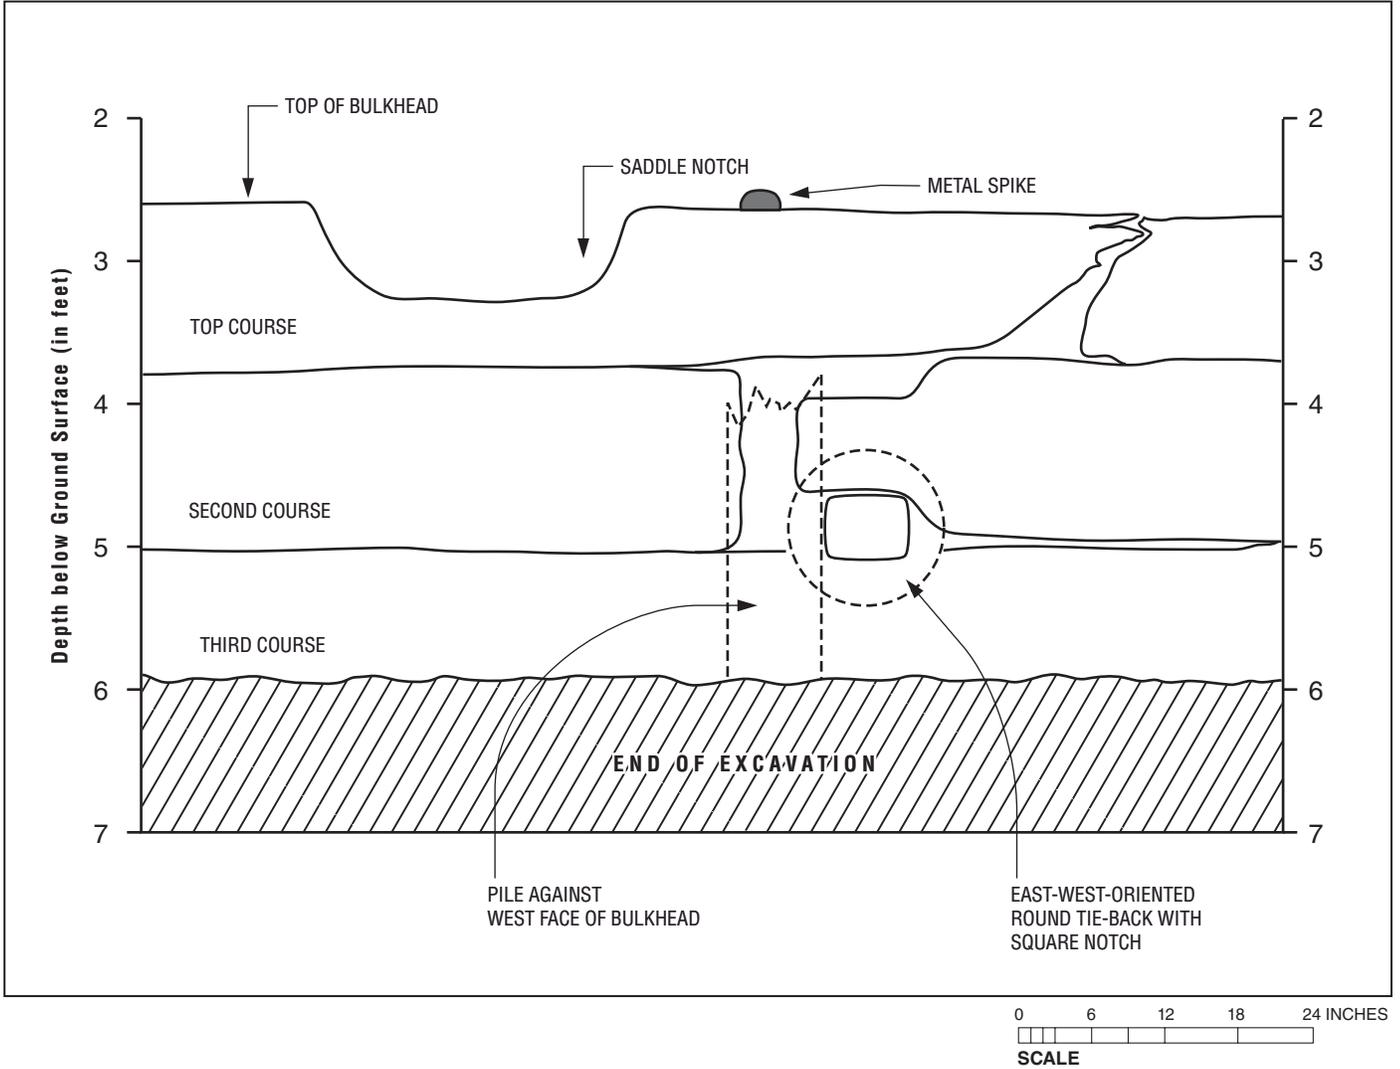
Burling Slip Bulkhead, East Face:  
at Upper Tie-Back 3 (U.3)  
Figure 6

A tie-back located roughly midway along the length of the main section of bulkhead, designated U. 3 (the third tie-back noted in the uppermost tier of tie-backs) was one of several sections of the bulkhead that was sketched in the field. The east face of the wall at this tie-back is shown on Figure 6 and Photograph 7. In this example, the tie-back (U.3) was a round log with the west end hewn into a square notch. The notch was asymmetrical and did not appear to be carefully executed. It was fit into the wall face between the second and third courses of horizontal logs observed, positioned beneath a square-notched squared timber in the second course of timbers. At the point of this assembly, a timber pile was driven behind the bulkhead (on the opposite, ie. western face of the bulkhead). A metal spike was observed in the top course of timber in this location, apparently used to reinforce the assembly. The spike did not appear to penetrate any of the lower timbers, however, it may originally have gone through the second course of timber. A large empty saddle notch was observed on the upper face of the top course of timber immediately south of the tie-back assembly. The original function of this saddle notch was not apparent. When a deep excavation probe was undertaken on the west side of the bulkhead in the location of this tie-back assembly, the end of a lower tie-back was observed immediately beneath tie-back U.3. The western ends of both tie-backs are shown in Photograph 8, as is the timber pile used to reinforce the wall in this location.

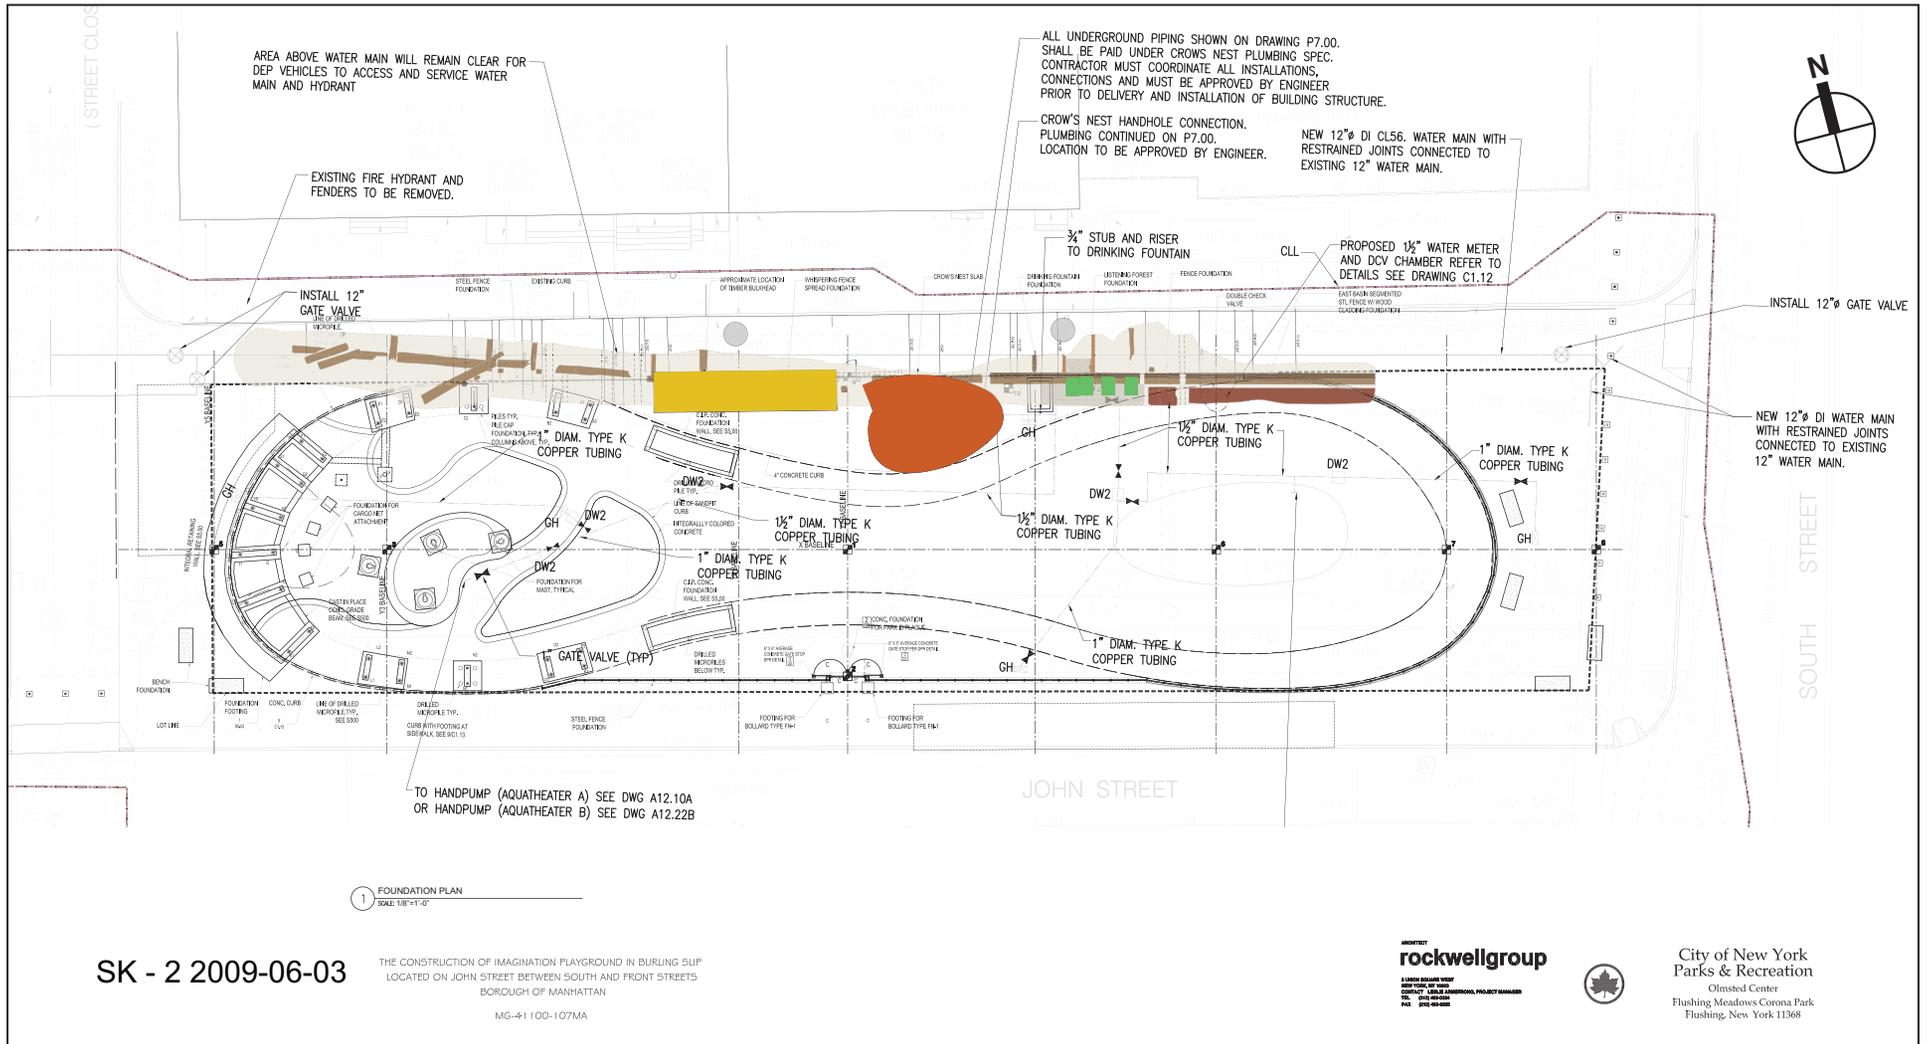
Burling Slip Bulkhead and Proposed Playground Elements  
Figure 8

- Whispering Fence Footings*
- Listening Forest Foundation*
- Crow's Nest Slab*

The Crow’s Nest foundation would extend 15” below ground surface, and would require clearance to a depth of 2 feet below the slab foundation. The total depth of excavation required for the Crow’s Nest feature, therefore, would be 3’ 3.” In the east/central portion of the APE, the top of the bulkhead wall is located at approximately 2’5” below ground surface. Where the Crow’s Nest foundation overlaps with the bulkhead location, direct impacts to the foundation would occur. One course of timber (the uppermost course) would be removed for a total length of 16 feet. DPR determined that this feature could not be feasibly redesigned to avoid impacts.

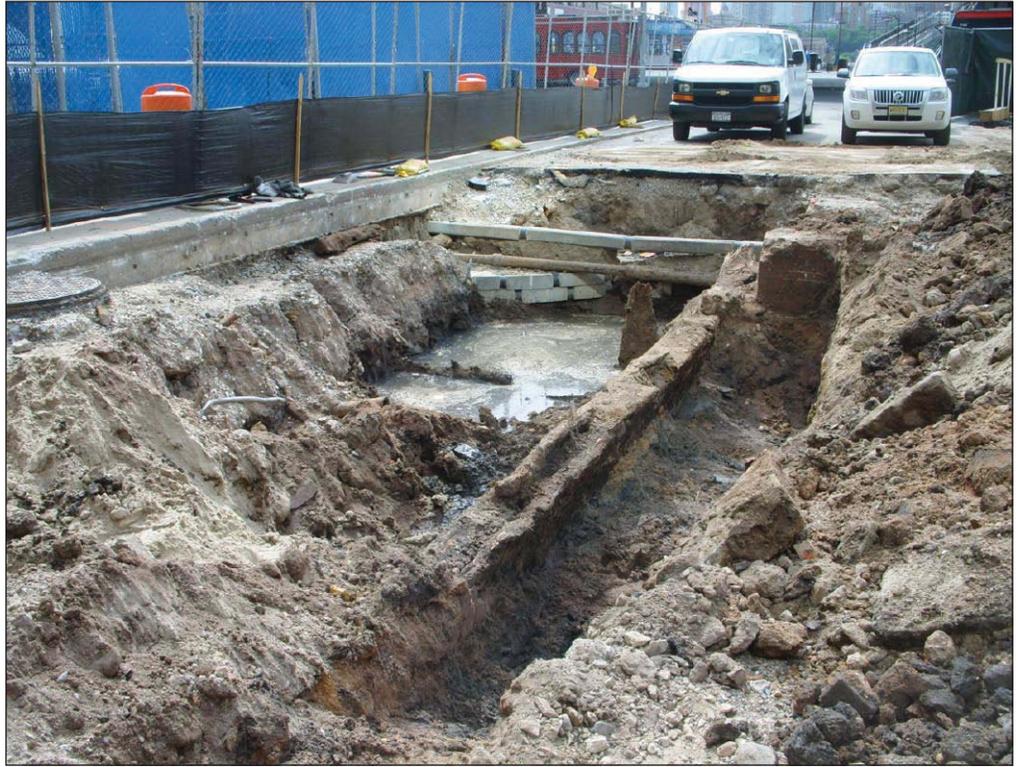
*A view of the first exposed section of bulkhead, looking northwest towards Front Street. Note the brick foundation of the former Comfort Station closely paralleling the bulkhead* **1**

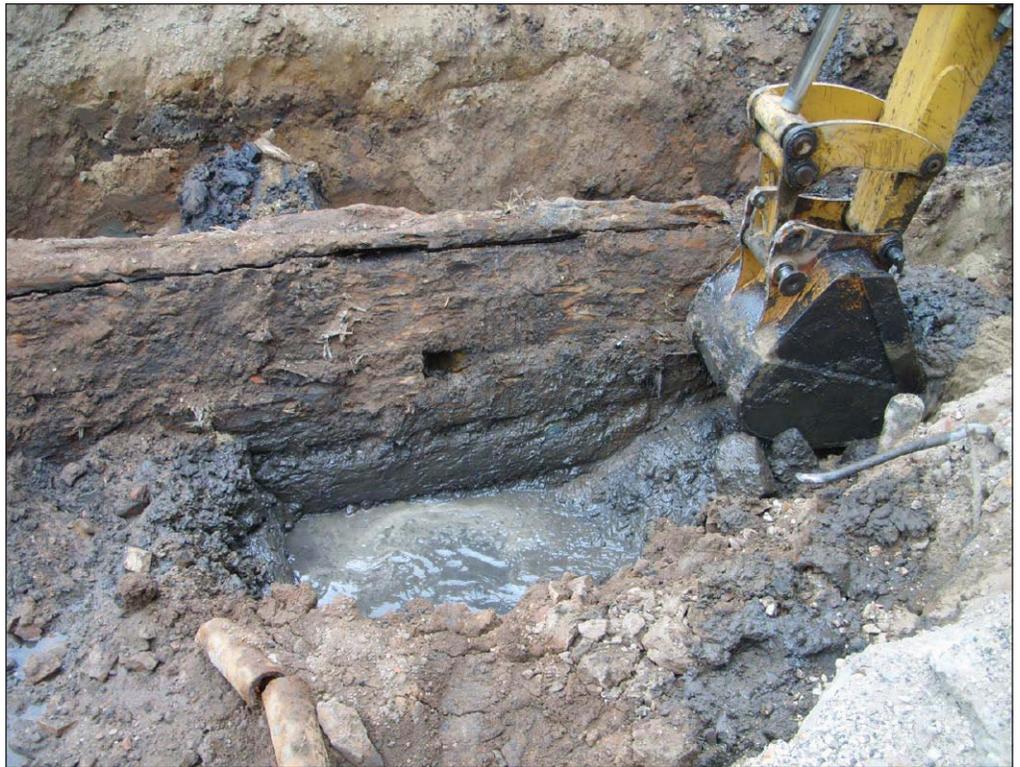
*Excavation of a deep test area along the east face of the bulkhead. Note empty mortises where tie-backs would once have connected to the wall. An extant tie-back is pictured on the left. Silty fills and medium-sized rocks characterize the fill* **2**

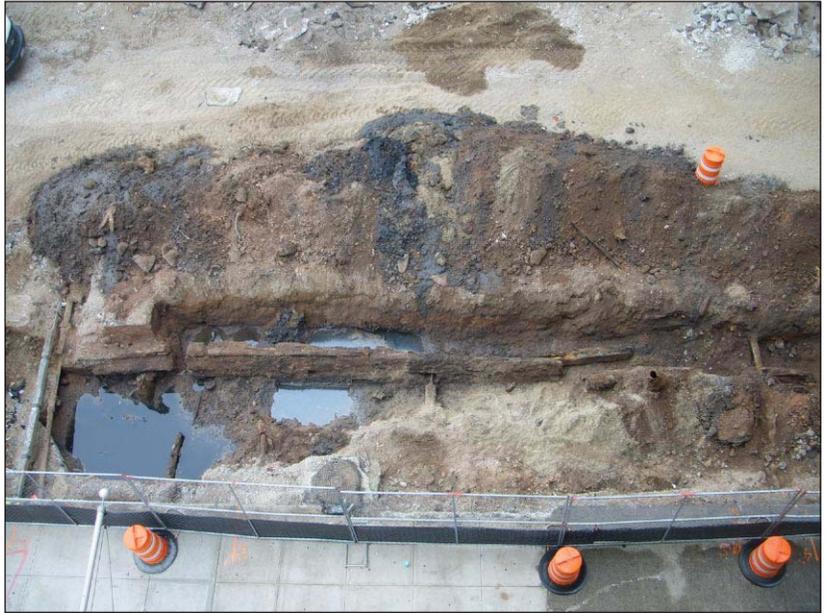
*A view from the upper floor of the South Street Seaport Museum, looking downwards and west on the southern half of the bulkhead* **3**

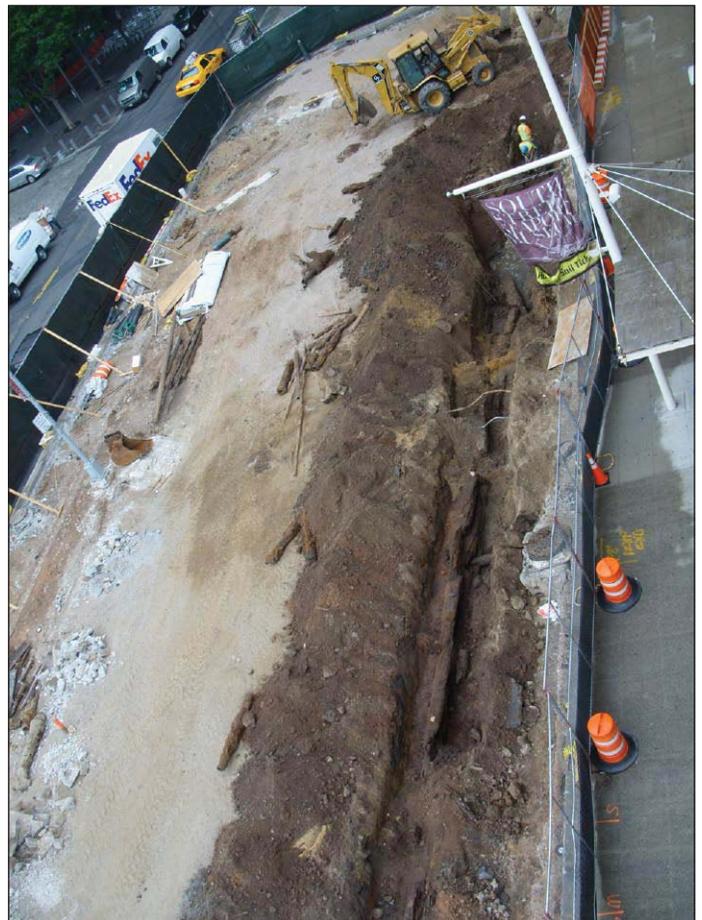
*From the upper floor of the South Street Seaport Museum, looking downwards and northwest on the northern half of the bulkhead* **4**

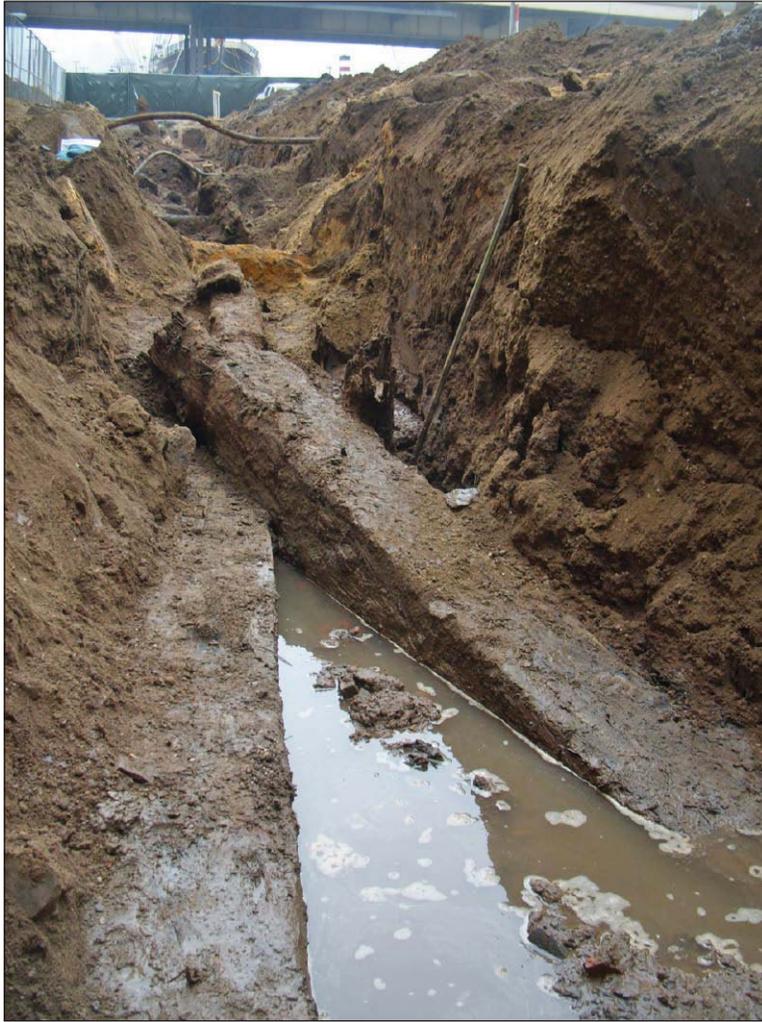
5

Looking south from the northern portion of the trench where one course of timber was oriented at an angle to the rest of the bulkhead wall. This section may represent a dislocated and subsequently shored portion of the bulkhead. Alternatively, the arrangement may have been constructed to tie the northernmost section of the wharf (Remsen's Wharf) to the new section (Codwise's Wharf)

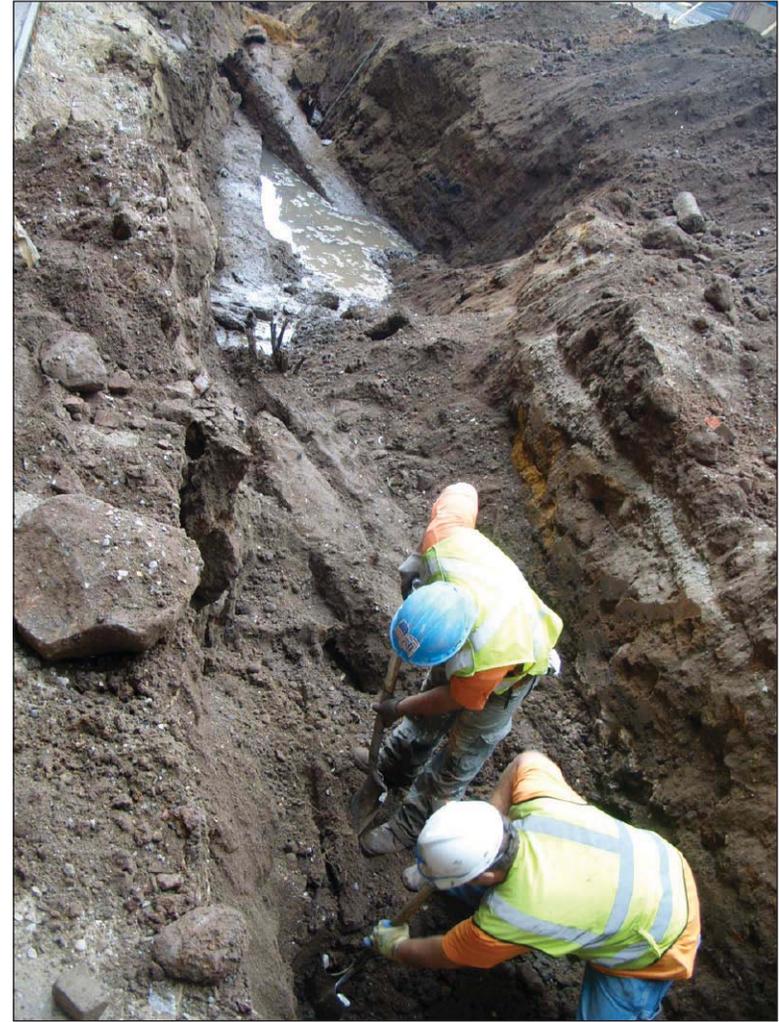
6

A view of the same portion of bulkhead, looking south from the northernmost portion of the trench

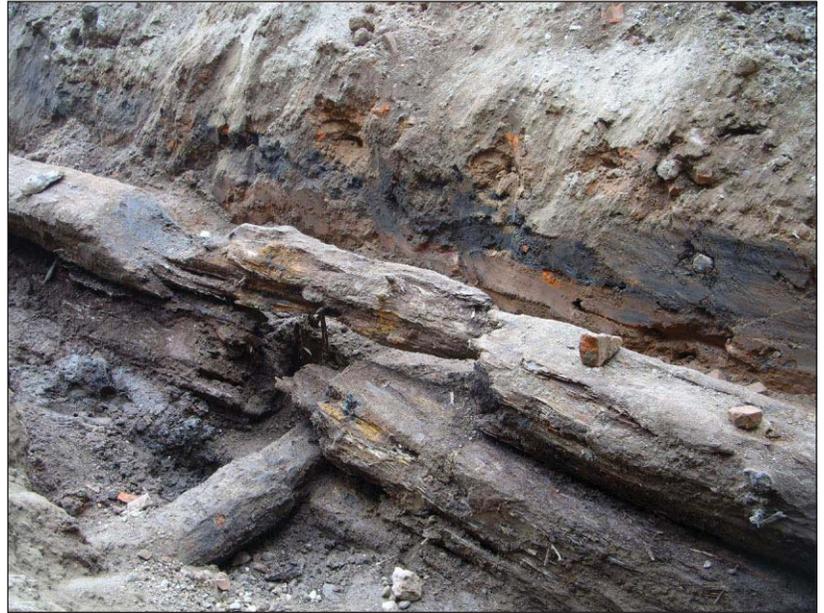
*Looking west, a close-up view of where the tie-back identified as "U.3" is notched into the east face of the bulkhead* **7**

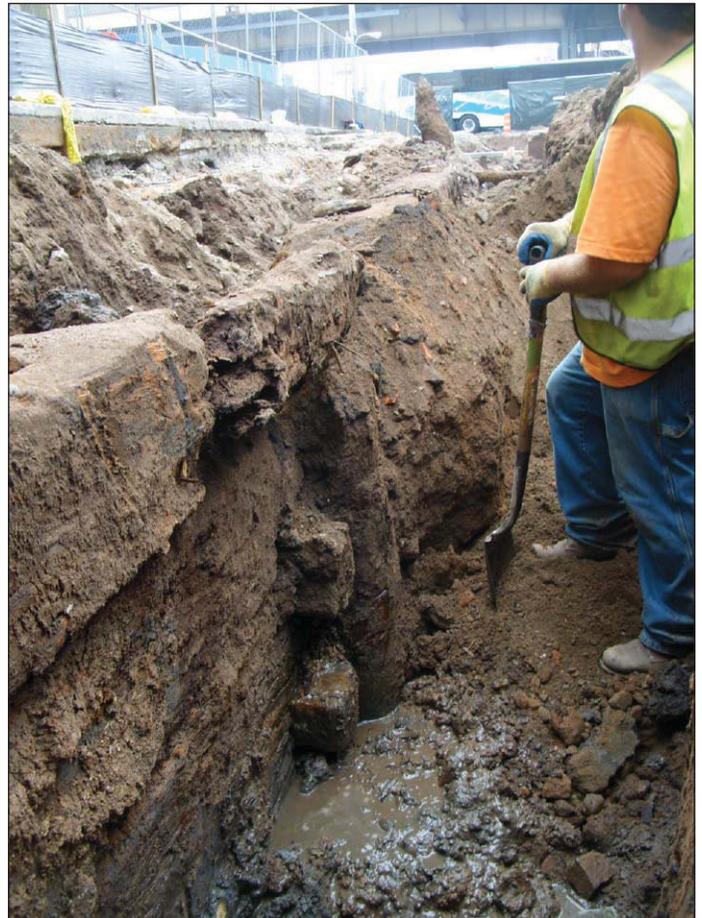
*Looking east at the same assembly from the other (west) side of the bulkhead, this close-up view shows the square lock-notched ends of tie-backs "U.3" and "L.3." A pile (right) was used by the wharf builders to reinforce the bulkhead* **8**

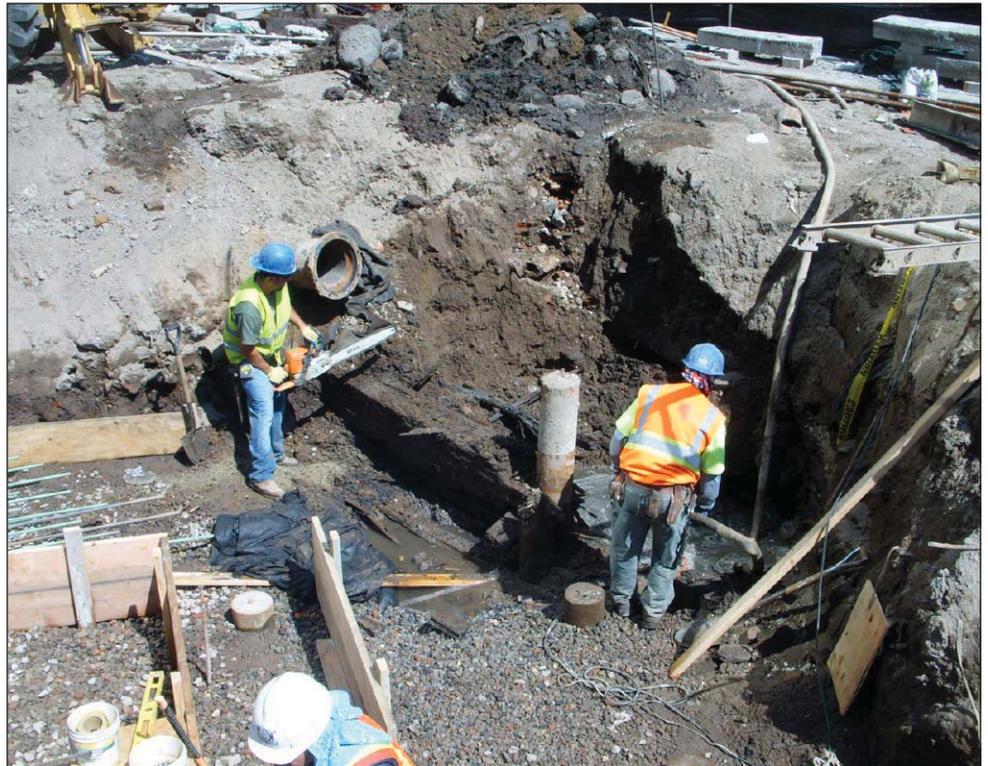
9

*The northernmost section of bulkhead, believed to be the corner of what was Remsen's Wharf. This section of bulkhead was encountered during construction several months after the rest of the bulkhead was documented*

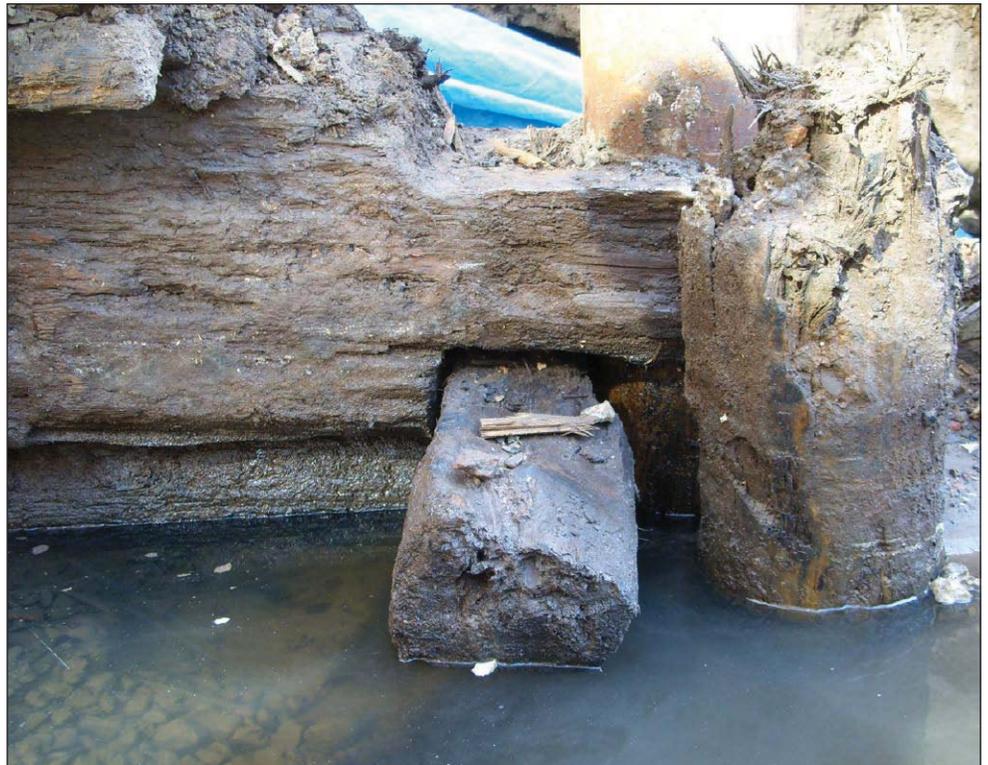
10

*A close-up view of what is believed to be the corner of Remsen's wharf, the northernmost section of bulkhead documented. Note the notched timbers and wood pile. The steel pile pictured was driven for the playground construction prior to excavation in this area*

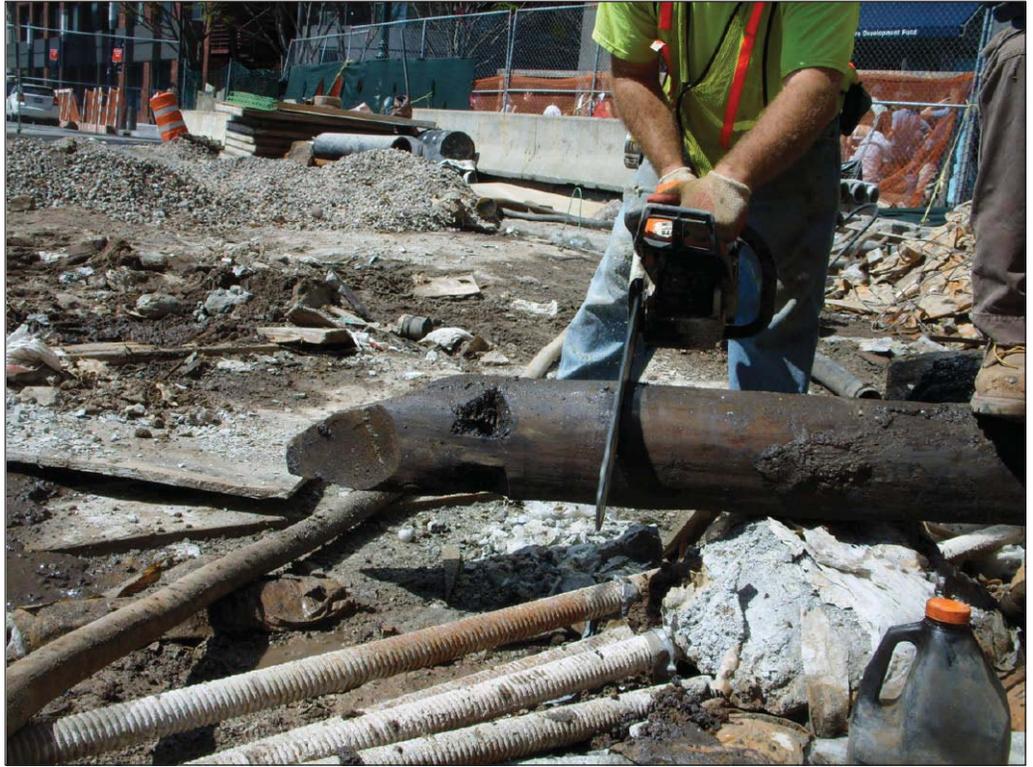
11

*The wood pile used in the construction of the northern section of bulkhead is being sampled for dendrochronology. Note the pointed end of the pile and an apparent dowel hole of unknown function through the end of the timber*

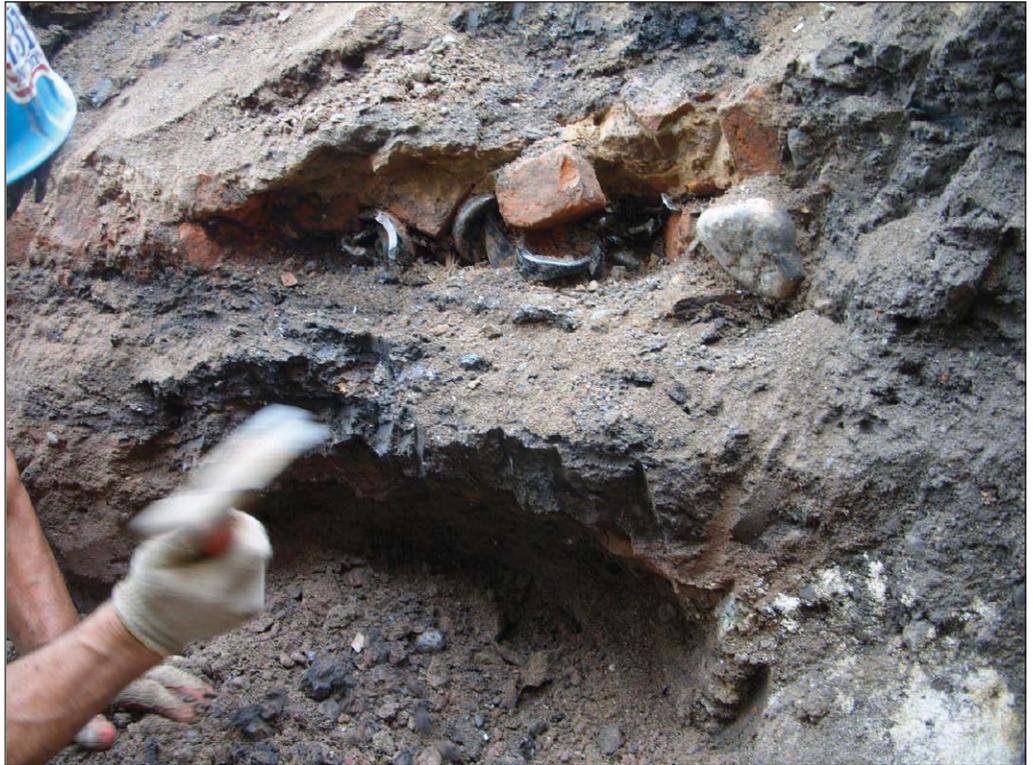
12

*A pocket of bottles, bricks, and a possible paving material was encountered during excavation of the bulkhead, immediately west of the bulkhead*

A concentrated pocket of artifacts consisting primarily of bottles was noted immediately west of the bulkhead and at an elevation just above the extant top of the bulkhead in that location. The location of this cache or pocket is illustrated on **Figure 5** and is shown on **Photograph 12**. It was referred to in the field and in the Artifact catalogue as “the brick artifact pocket north of tie-back U.2.” The pocket contained a large number of bottles, several bricks, and sheet-like chunks of a hard substance that may have been a 19th century paving material. It was clear from its jumbled orientation that the material was not in its original location, however, it is possible that it was at one time used to pave Burling Slip or a nearby street and was dislocated and discarded during a subsequent paving or construction episode. In addition to this material a large numbers of liquor and/or utility bottles were packed into the pocket. None of the bottles were whole, but many were approximately 40 to 60% intact. Approximately 50 bottle fragments from this context were sampled. It is likely that at least 40 individual bottles were represented by the fragments noted in this area in the field. Based on the physical characteristics of the bottles, all appeared to have possible manufacture dates between 1820 and 1860. In addition, a yellow brick and a red brick, a piece of roofing slate, a smoking pipe, and several ceramic fragments were recovered from within or adjacent to this artifact pocket. A puzzling piece of salt-glazed

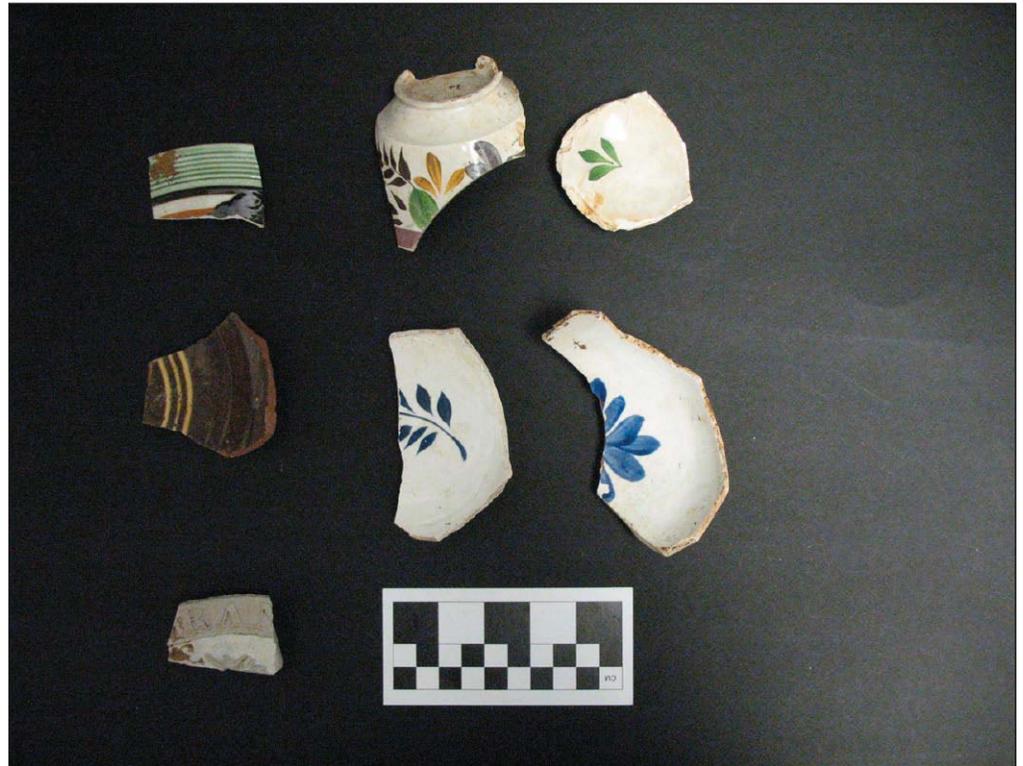
*An example of the ceramics recovered during the Bulkhead Documentation* **13**

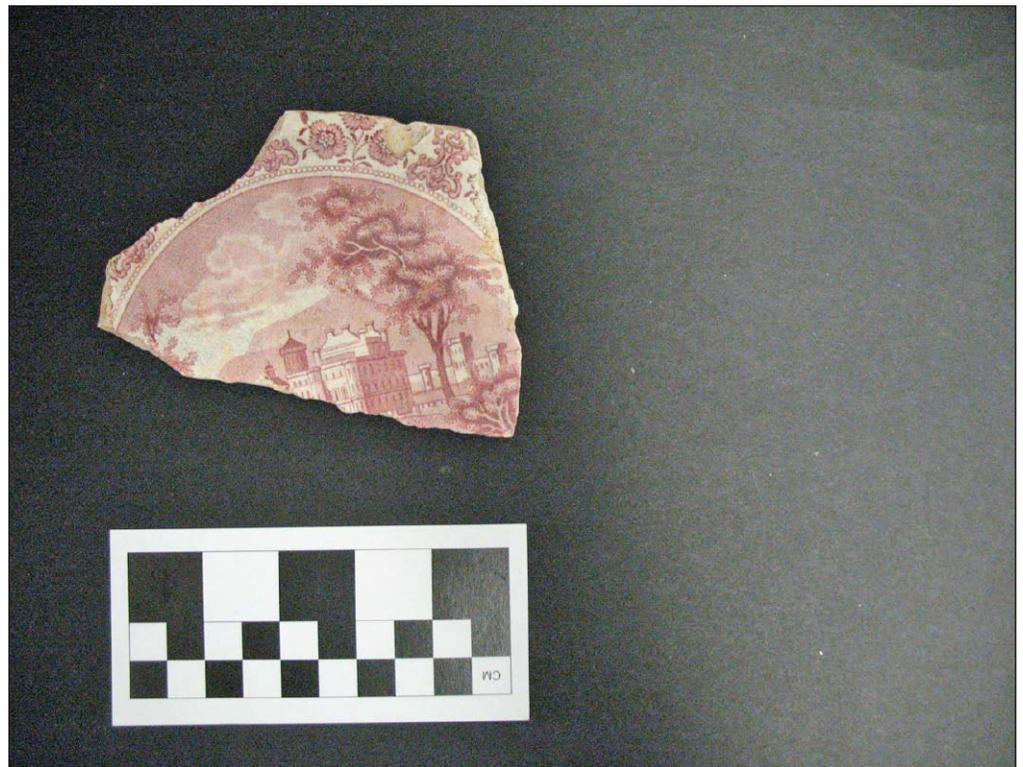
*A red transfer-printed plate fragment which was identified one of the Clyde Scenery series, produced by John and Job Jackson in Staffordshire, England between 1831 and 1835* **14**

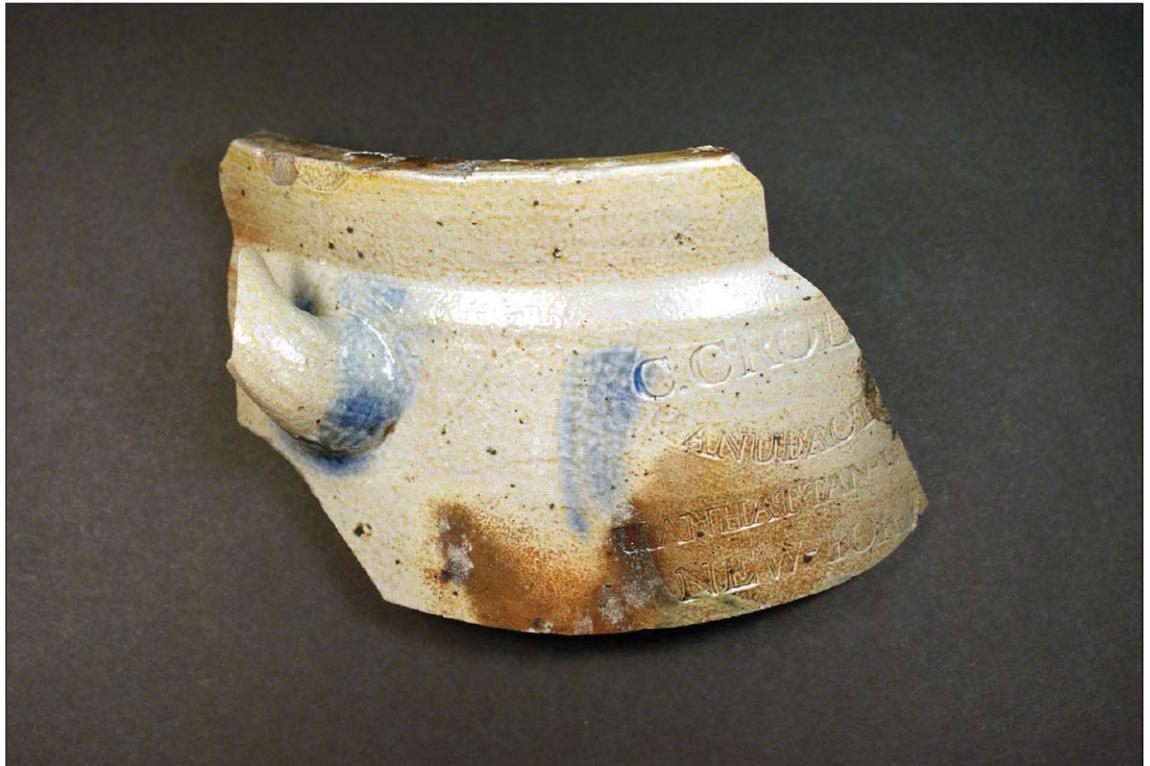
A stoneware jar or crock fragment found during the Phase 1B investigation produced by Crolius of Manhattan between 1800 and 1815 **15**

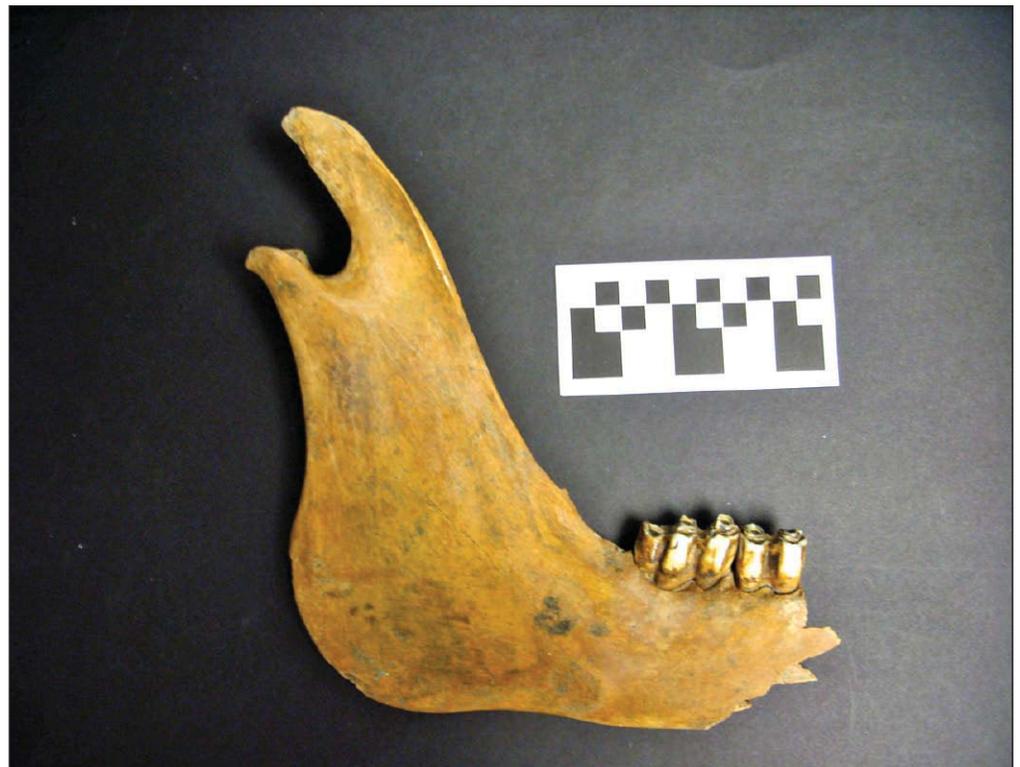
The mandible of a cow, recovered from over 7 feet below ground surface in Trench 6 (on the west side of the bulkhead) during Phase 1B investigation **16**

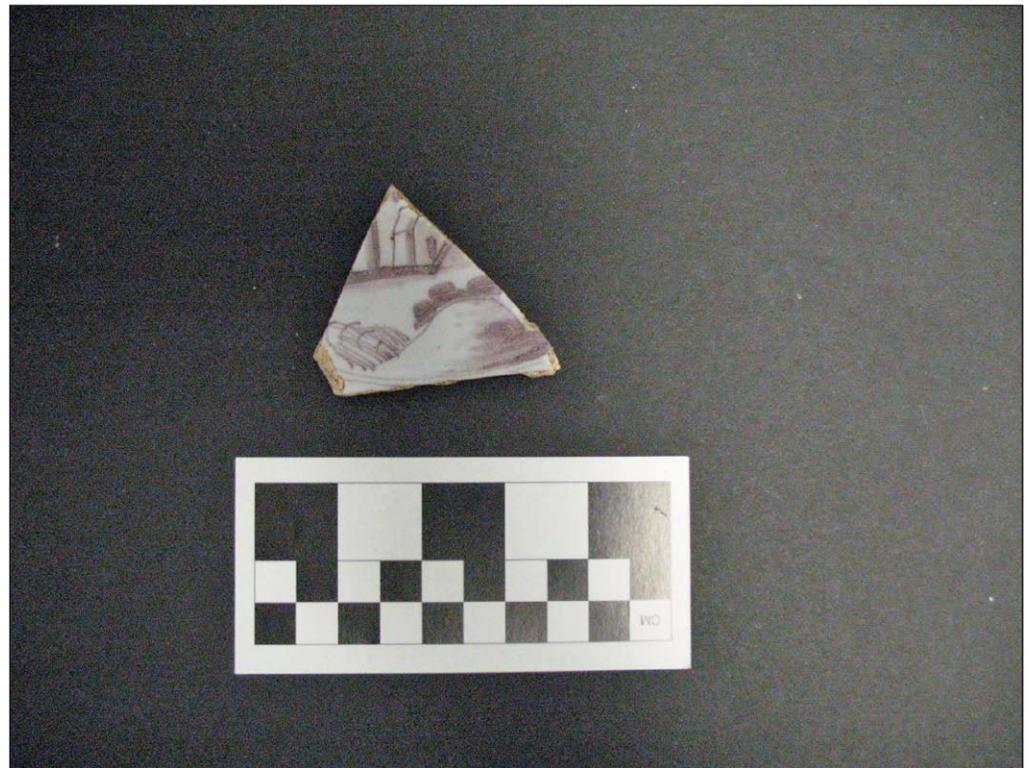
*A fragment of delft tile depicting a scene (likely biblical or a landscape), hand-painted in purple glaze* **17**

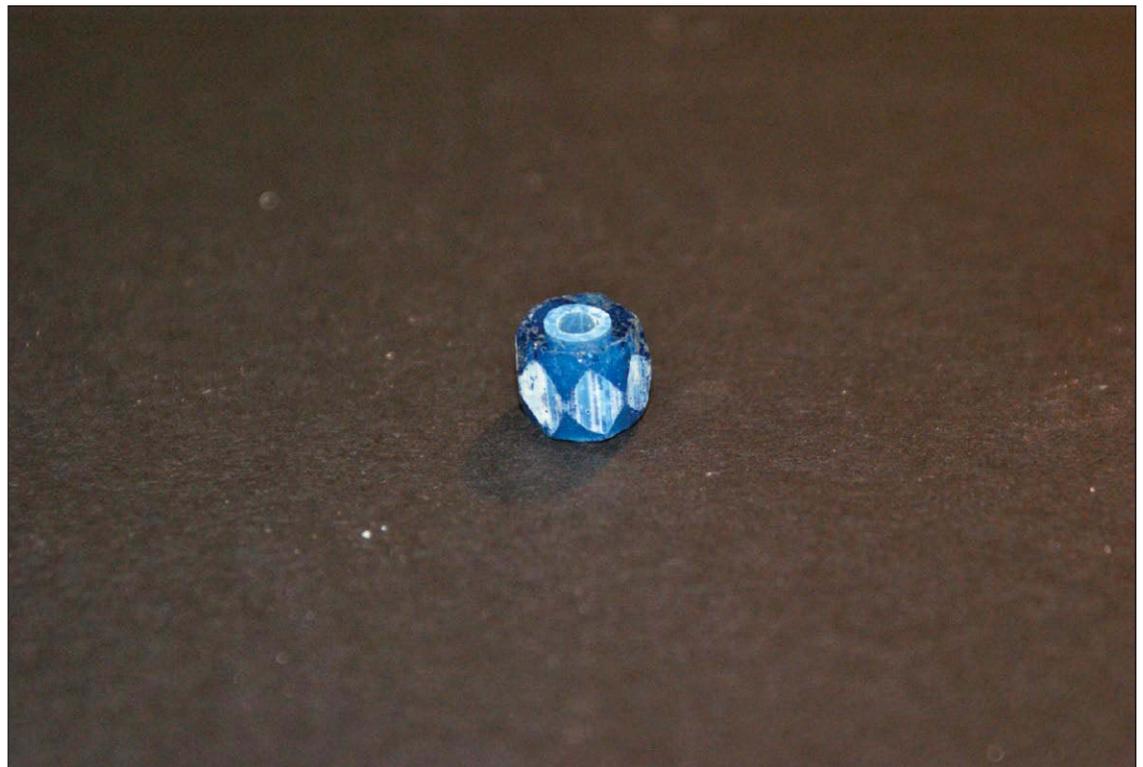
*A glass bead recovered during the Phase 1B investigation, originally thought to be a trade bead, now believed to date to the mid-19th century* **18**

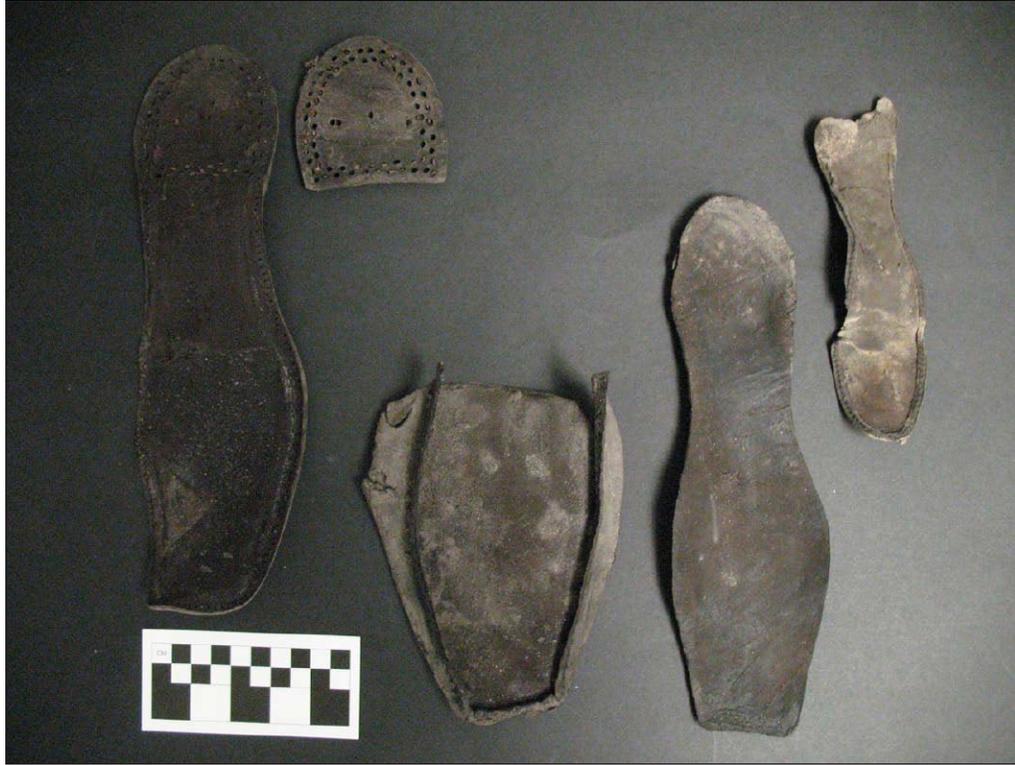
*Examples of the shoe fragments recovered during both phases of excavation* **19**
