**Bulkhead Documentation Report**

**Burling Slip**

**Block 74, Portions of Lots 20 and 1  
Borough of Manhattan, New York, New York**

**June 2, 2011**

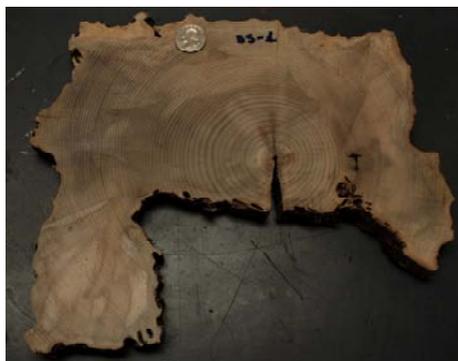
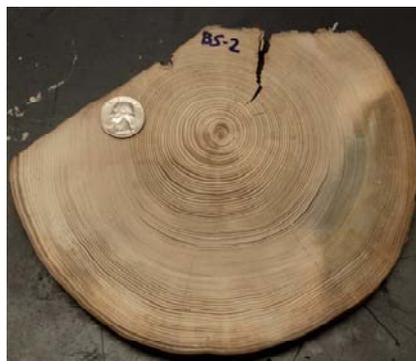
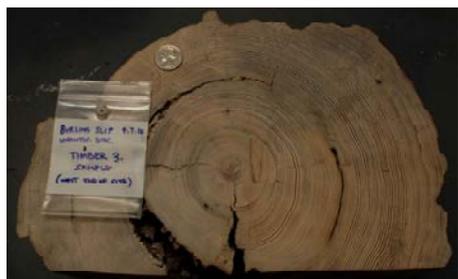
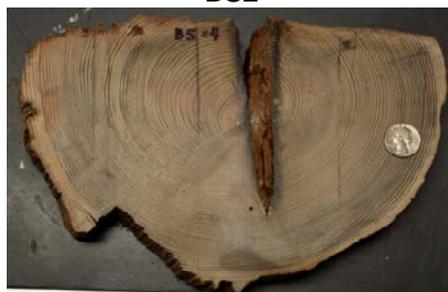
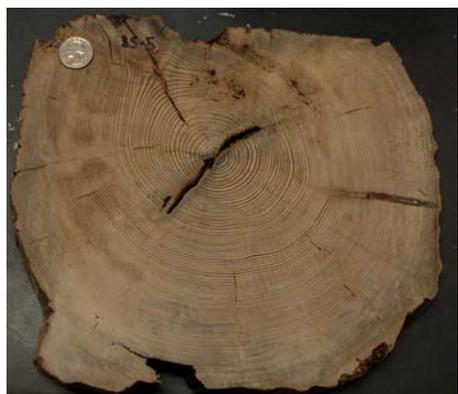
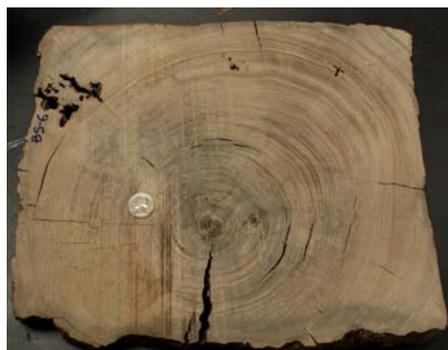
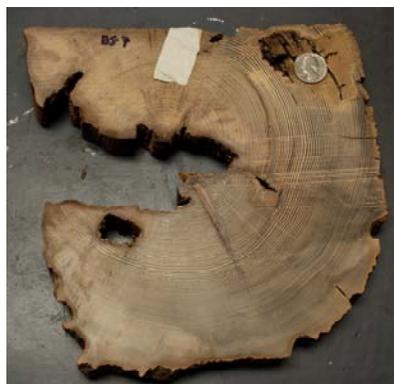
**Figure 1.** Photographs of the seven Burling Slip wood samples dated by tree-ring analysis. Refer to **Table 1** for the wood species and dates of the samples.

Sample	Species	Number of rings	Waney	First ring	Last ring	Correl1	Correl2	Correl
BS1	Pitch pine	73-108	-BE / squared	1686	1793	0.418	0.282	0.350
BS2	Hemlock	112-112	+BE	1714	1825	0.62	0.571	0.595
BS3	Hemlock	205-230	-BE	1495	1724	0.608	0.606	0.607
BS4	White pine	84-89	+BE	1631	1720	0.48	0.416	0.448
BS5	Hemlock	150-154	-BE	1607	1760	0.574	0.521	0.547
BS6	Hemlock	301-305	-BE / squared	1509	1823	0.538	0.554	0.546
BS7	Hemlock	120-127	-BE / squared	1674	1816	0.485	0.394	0.439

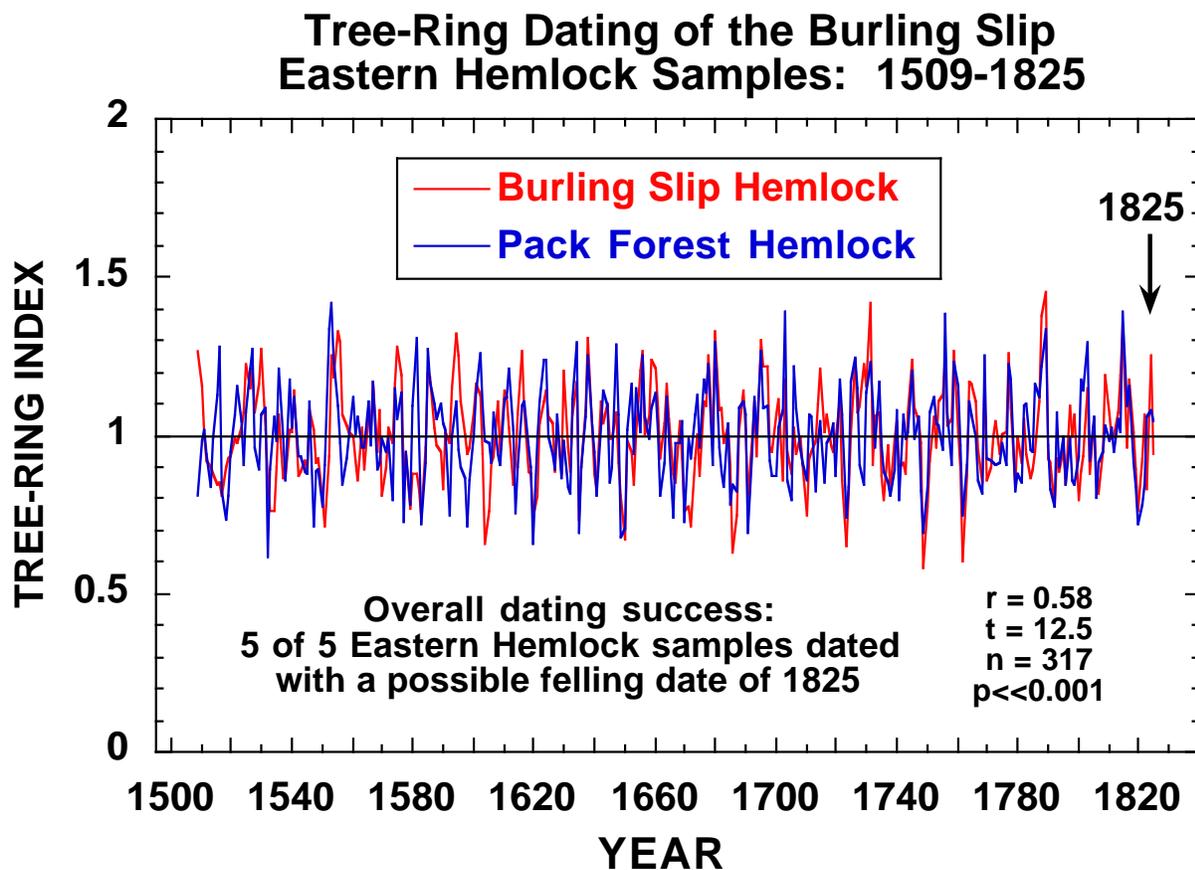
**Figure 2.** Comparison of the cross-dated eastern hemlock master chronology for the Burling Slip against a northern Hudson Valley eastern hemlock chronology based on living trees and independent archaeological samples. The Spearman rank correlation between the series ( $r=0.58$ ) is highly significant ( $p \ll 0.001$ ) with an overlap of 317 years and a t-statistic of 12.5. This extremely strong match suggests that the origin of the hemlock logs used in the Burling Slip was from the northern Hudson Valley and the logs were most likely floated down to New York City. The two other Burling Slip timbers (pitch pine and white pine – not shown) also dated against northern Hudson Valley tree-ring masters of the same species, which essentially verifies this interpretation of the origin of the wood.

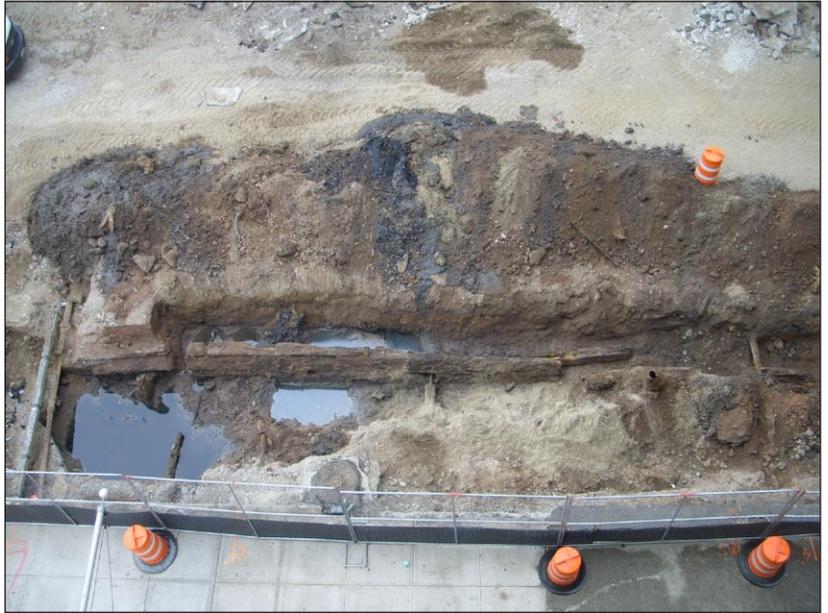
A view from the upper floor of the South Street Seaport Museum, looking downwards and west on the southern half of the bulkhead 1

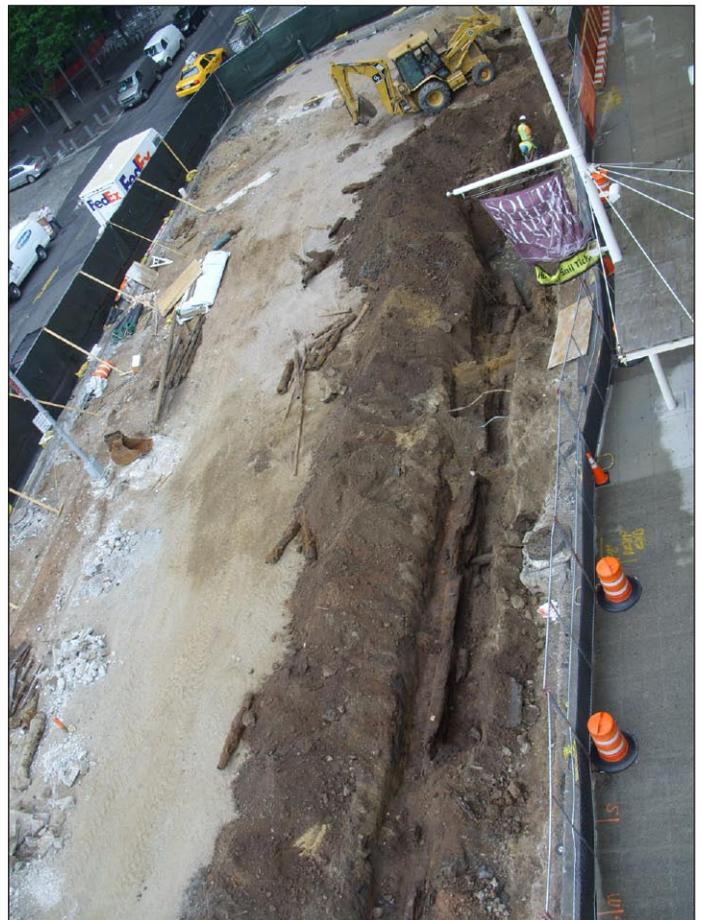
From the upper floor of the South Street Seaport Museum, looking downwards and northwest on the northern half of the bulkhead 2

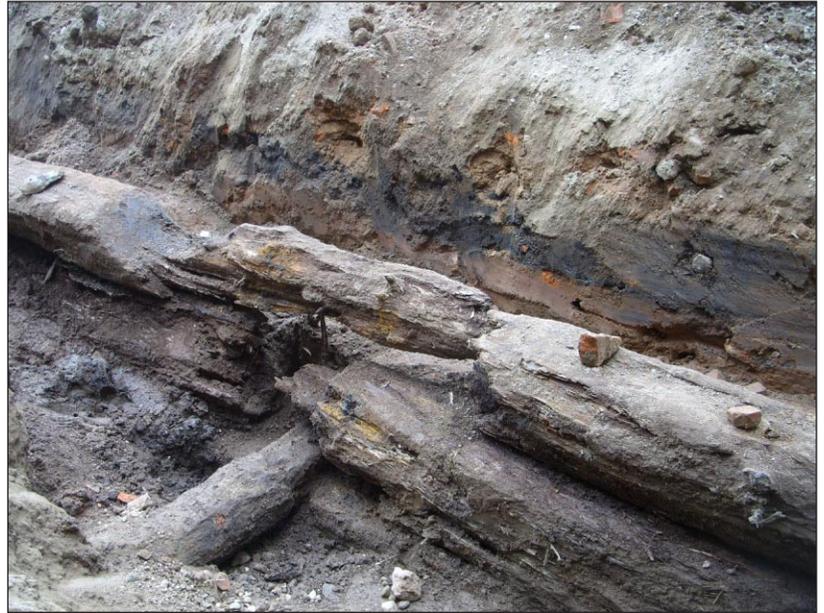
Looking west, a close-up view of where the tie-back identified as "U.3" is notched into the east face of the bulkhead **3**

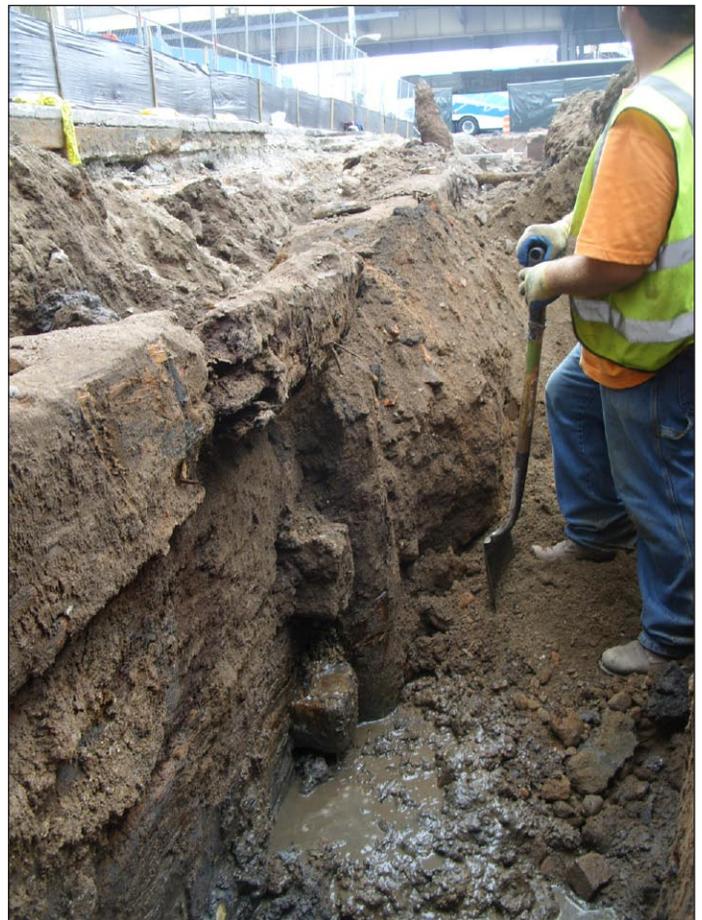
Looking east at the same assembly from the other (west) side of the bulkhead, this close-up view shows the square lock-notched ends of tie-backs "U.3" and "L.3." A pile (right) was used by the wharf builders to reinforce the bulkhead **4**

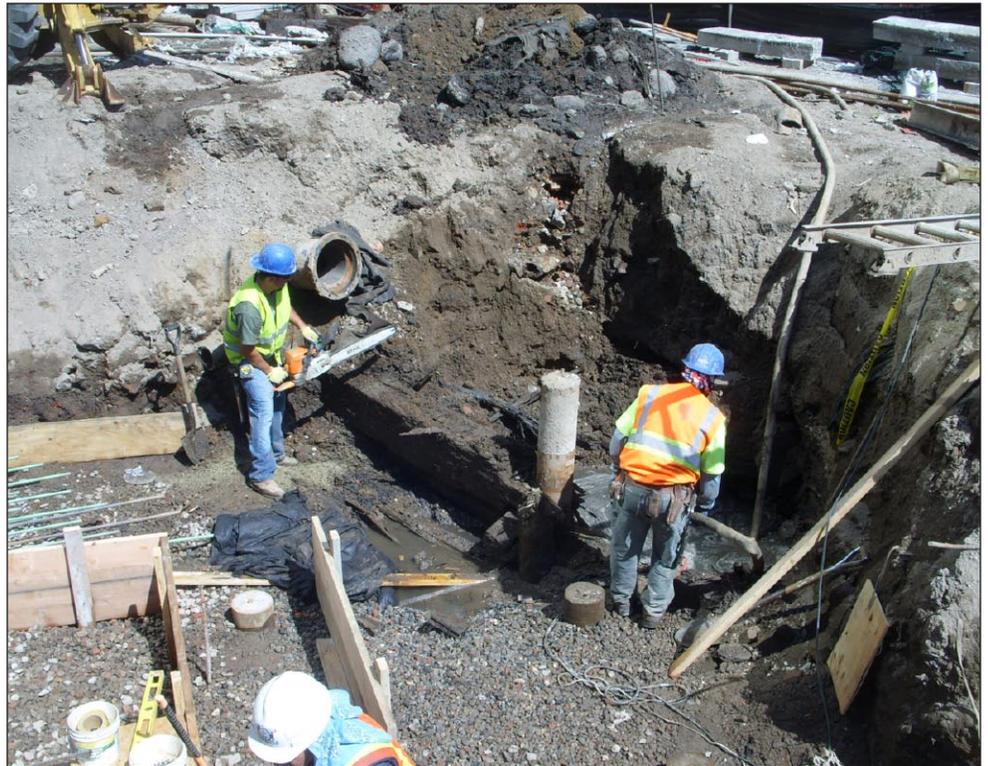
5

*The northernmost section of bulkhead, believed to be the corner of what was Remsen's Wharf. This section of bulkhead was encountered during construction several months after the rest of the bulkhead was documented*

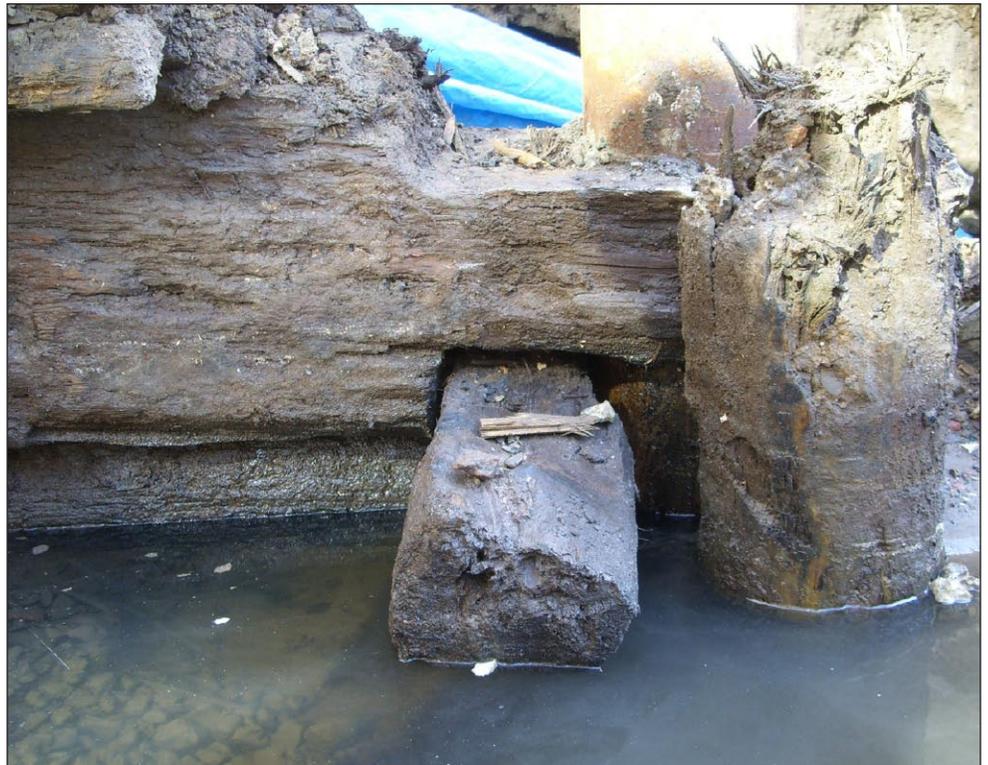
6

*A close-up view of what is believed to be the corner of Remsen's wharf, the northernmost section of bulkhead documented. Note the notched timbers and wood pile. The steel pile pictured was driven for the playground construction prior to excavation in this area*
