The Lower East Side Tenement Museum

Archaeology at 97 Orchard Street

Prepared by Joan H. Geismar, Ph.D.
Prepared for The Lower East Side Tenement Museum
January 1999/August 2003

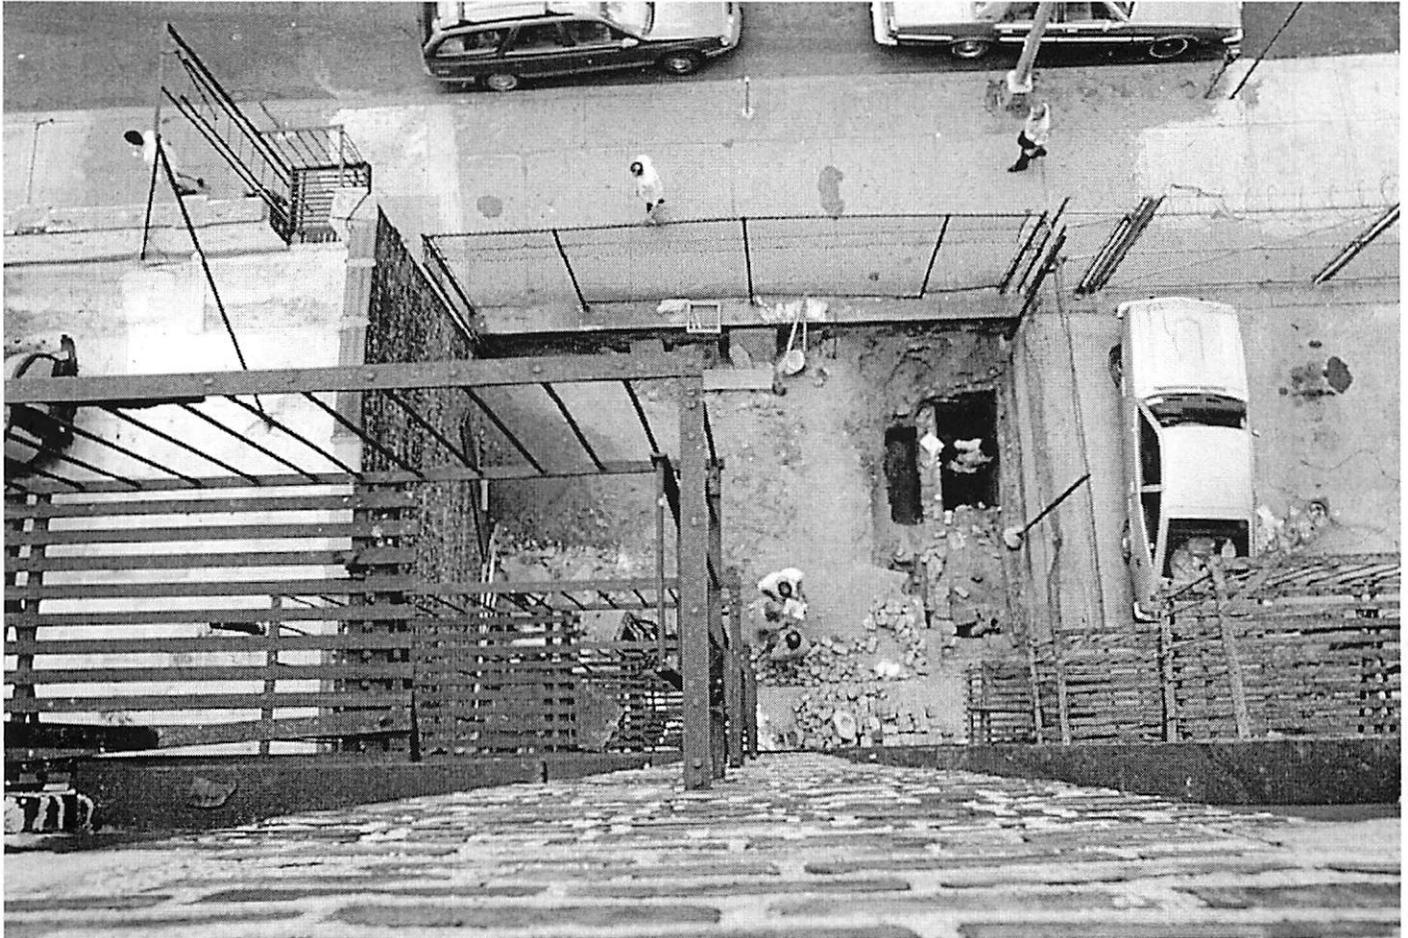
"Aerial" view of the 97 Orchard Street backyard 8/5/93

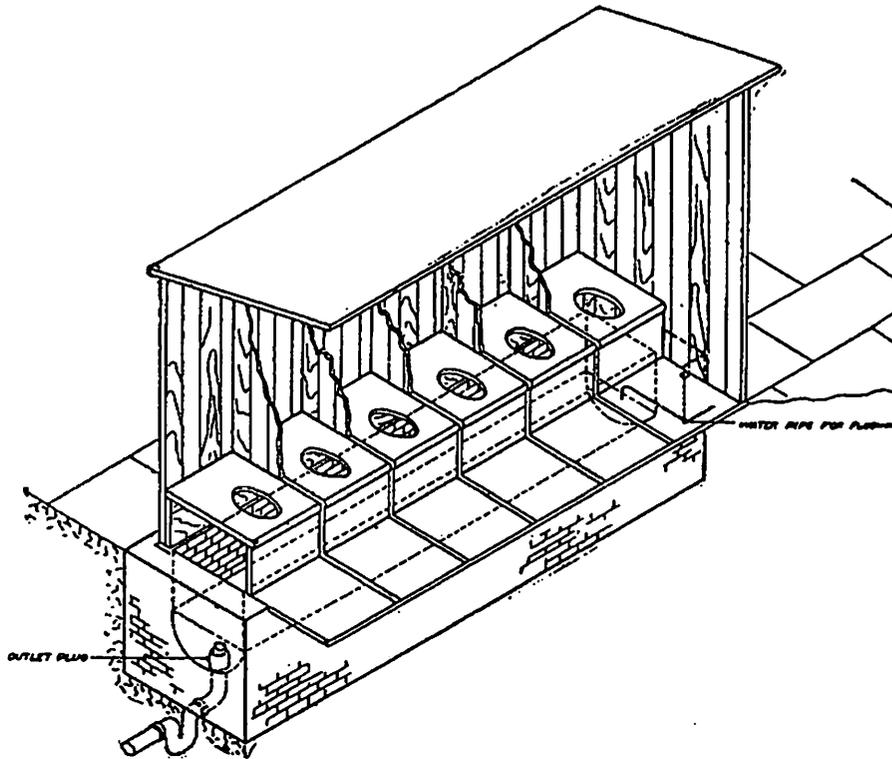
a Diagram of 6-compartmented school-sink

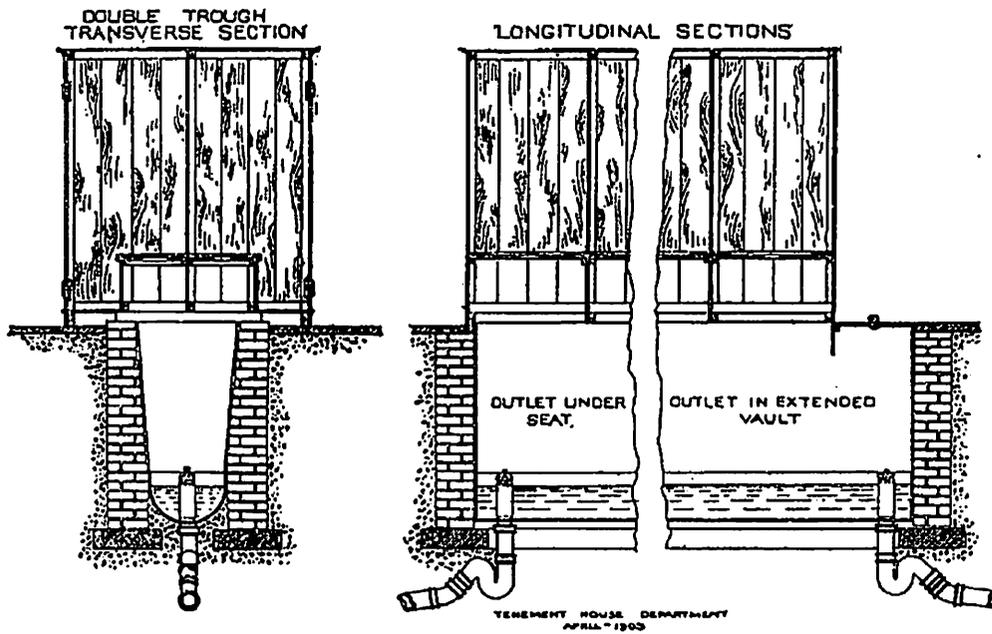
b Structural view of back-to-back school-sinks

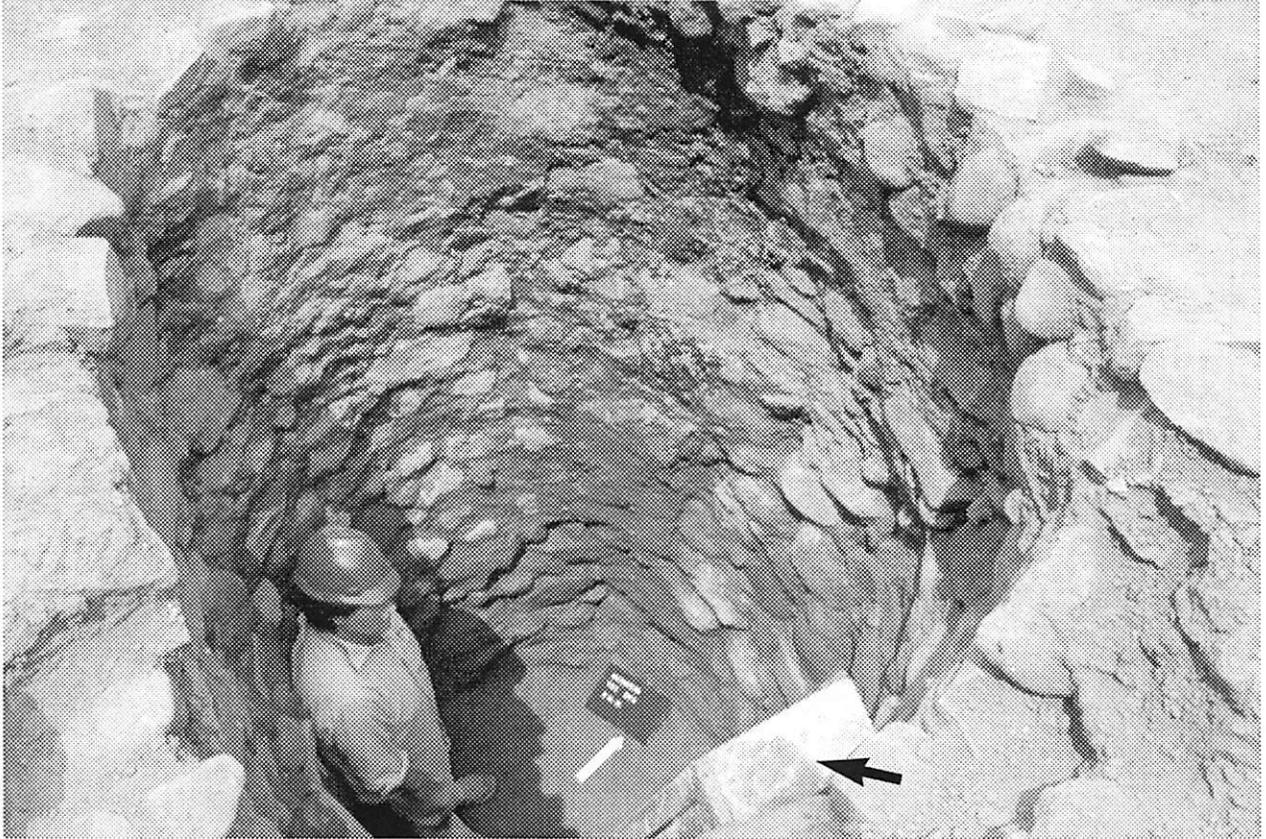
2 A dry-laid stone privy pit built in the 1850s in Brooklyn. The backyard pit, now devoid of fill and artifacts after excavation, is over 9 feet deep. Shelly Spritzer, one of the excavators, is standing on the feature floor, and the ladder (black arrow) used for access can be seen on the right. (5/93)

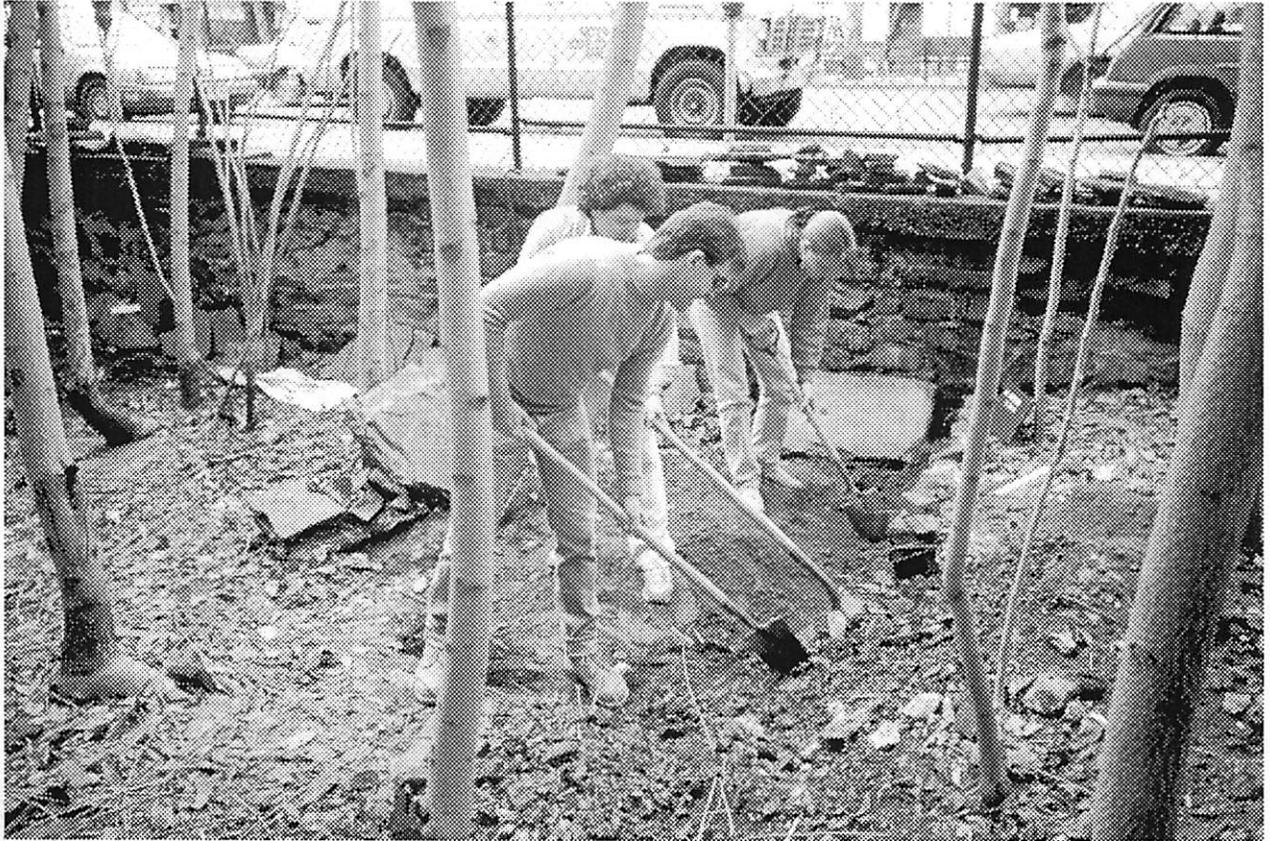
5 Volunteers John Killeen, Shelly Spritzer, and Laura Grauer, clearing in the northwest corner of the tenement's backyard where it was hoped that a privy pit, perhaps like the one shown in Figure 2, might be located. (11/23/91)

Hand excavation by volunteers⁷ (Figure 5) on that beautiful November Saturday uncovered a buried layer of paving stones but no foundation in the yard's southwestern quadrant (Figure 6), the school-sink site according to the I-Card. In the northwestern quadrant, it exposed a row of bricks at and just beneath the surface that appeared to define a former garden (Figure 7), an assessment confirmed by Ruth Abram, the Tenement Museum's president. It also revealed part of a dry-laid brick and paving stone box drain about 2 feet below the surface (Feature 1 [F1] shown in Figures 8 and 9). The buried layer of paving stones ultimately found in both corners of the yard apparently represented a former yard surface, one that was level with the bottom of the drain. Since the northeast corner was the most likely location of any privy pit that might have predated the school-sink, the drain feature was a puzzle. Ailanthus trees--the tree that "grows in Brooklyn"--ever present in urban settings, and scattered throughout the tenement yard, hampered excavation in this corner, and the single day of testing raised more questions than it answered.

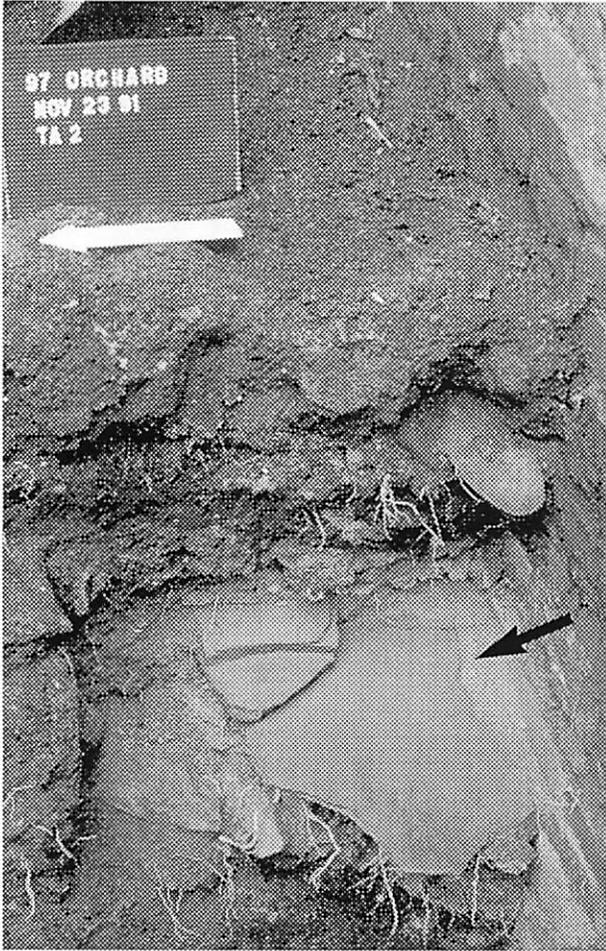
6 Southwestern quadrant in test area 2 (TA2), the location of the building's school-sink according to a 1902 I-Card record. Paving stones (black arrow), uncovered about 2 feet below the yard surface, were found at the same level elsewhere. (11/23/91)

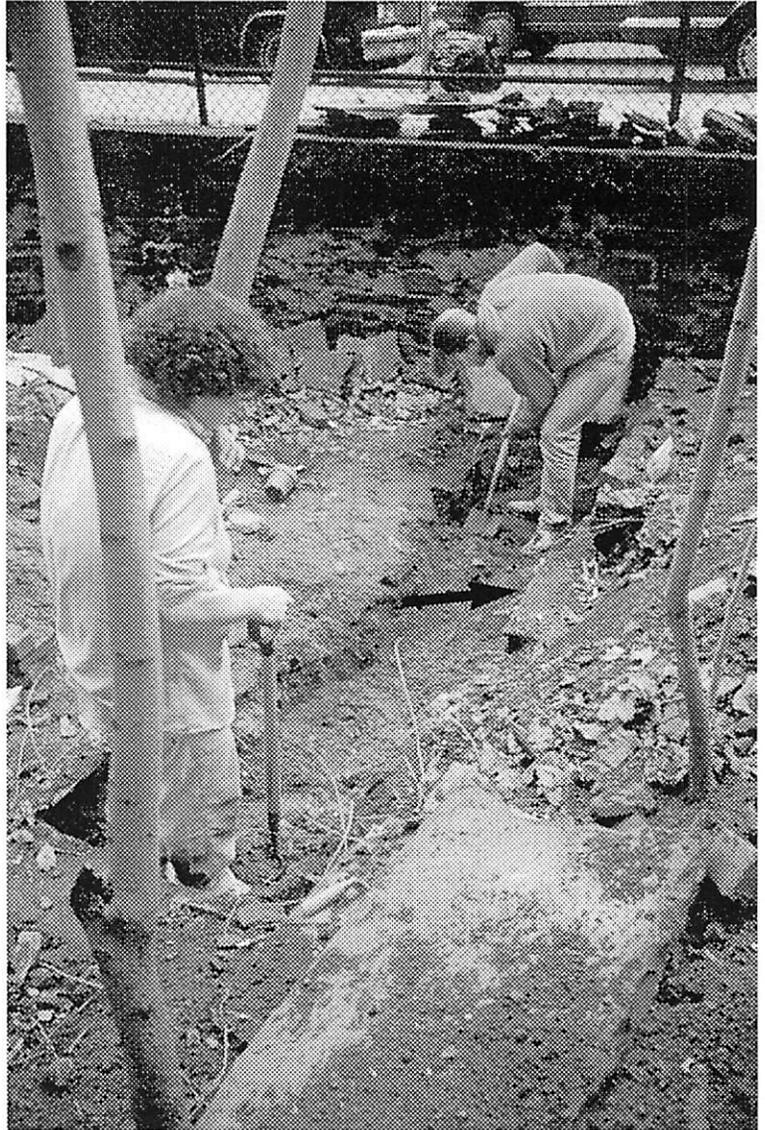
7 Test trench 1 (TT1) in the northwestern part of the yard, adjacent to a brick edging (arrow) that defined a relatively recent but defunct garden. Allen Street is in the background beyond the fence. Note that the yard is well below street level. (11/23/91)

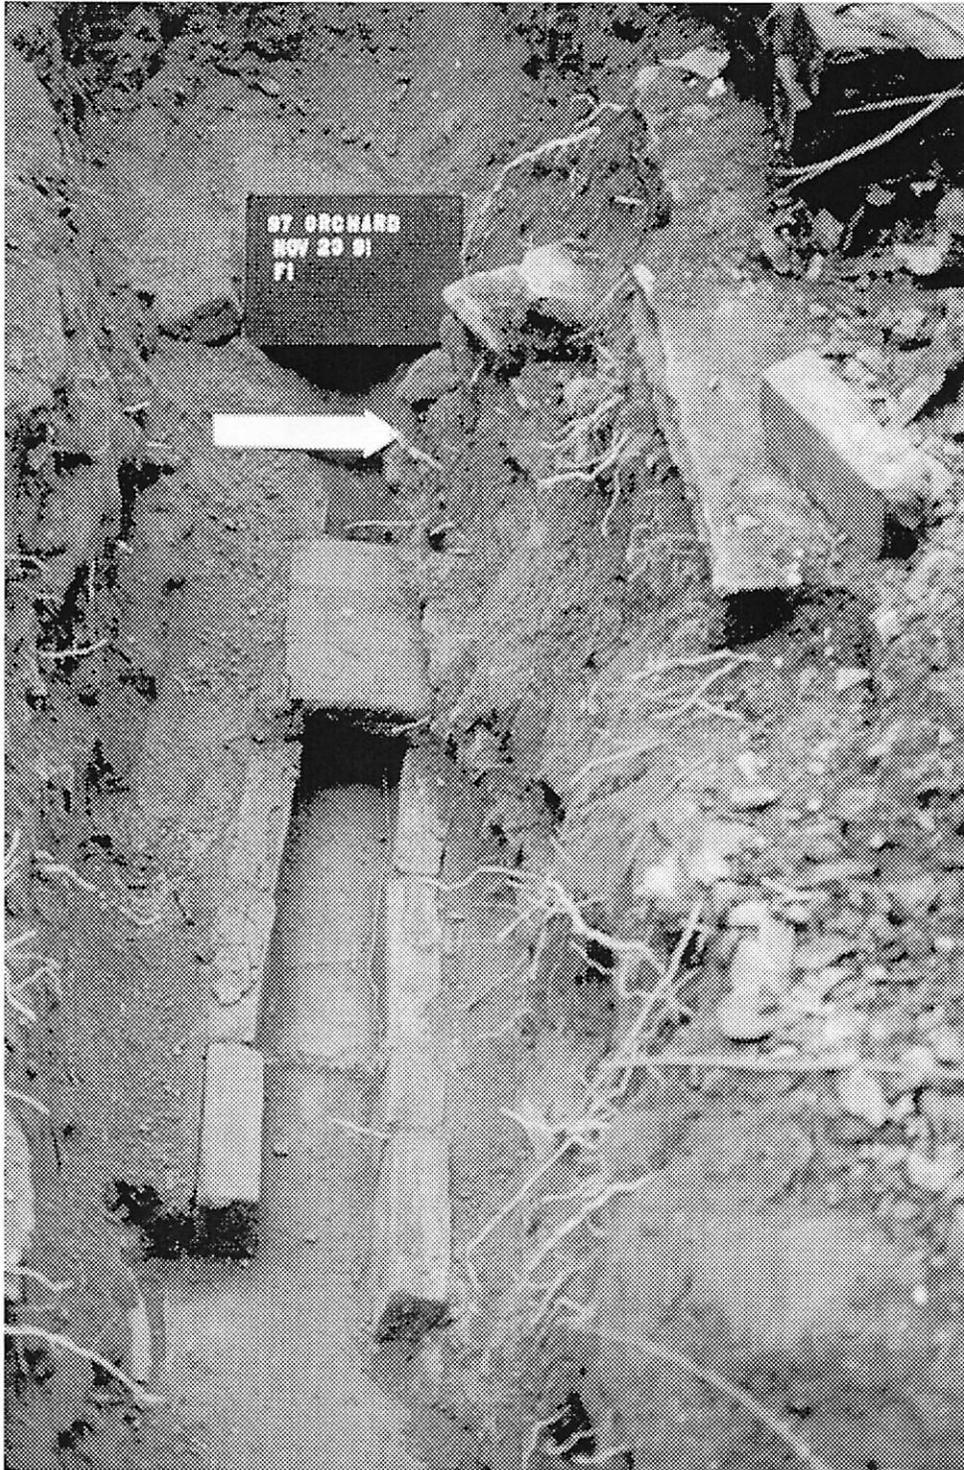
8 A dry-laid brick drain (F1) uncovered in test trench 1 (TT1). The paving stones that form the base are at the same level as those found in test area 2 (TA2; see Figure 6), suggesting a former yard surface. (11/21/91)

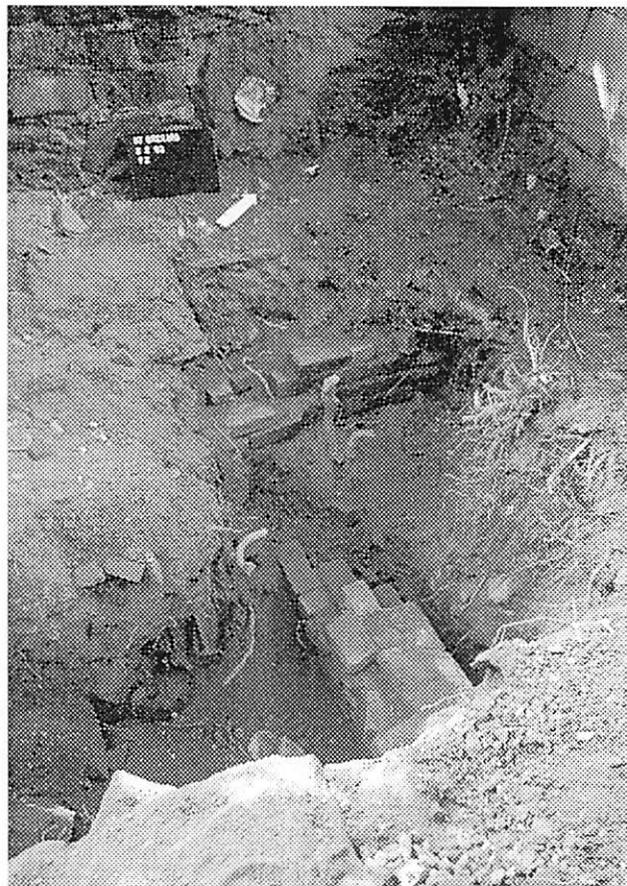
11 Brick walls in northwest corner of the yard exposed during August 1992 testing. Ailanthus trees beyond the photo hampered excavation. (8/6/92)

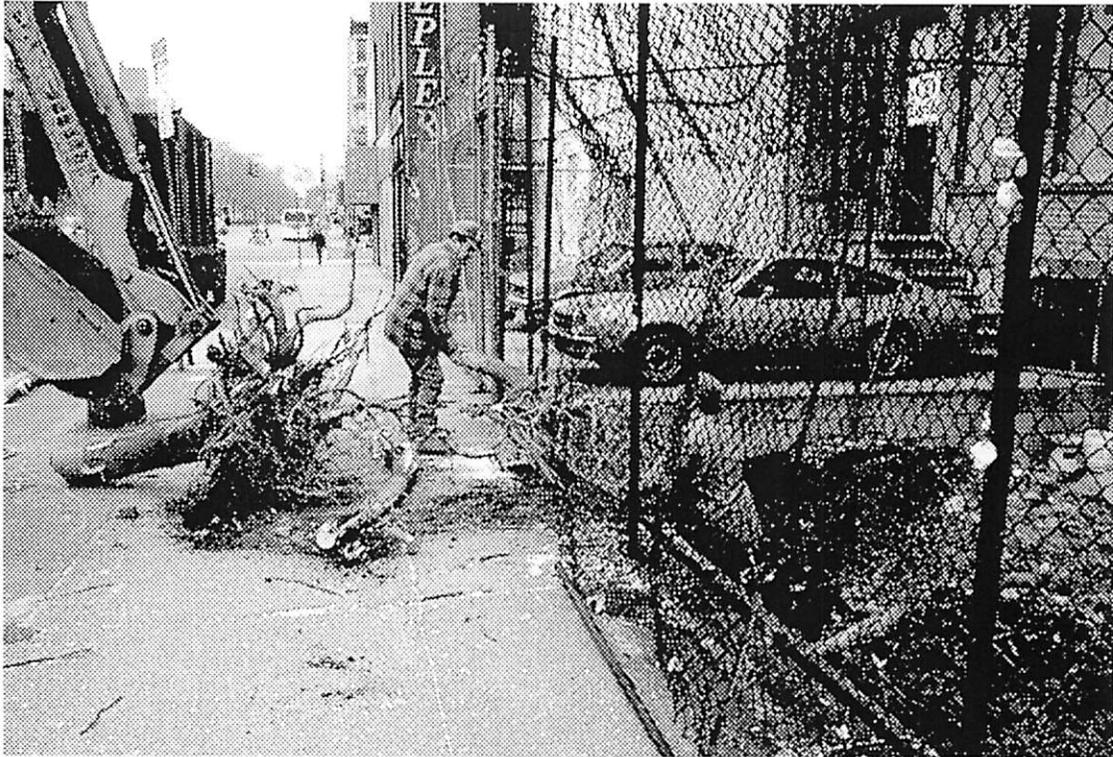
13 Removal of Ailanthus trees on January 23, 1993. The fence on Allen Street was rolled back and the backhoe to the left removed twenty-four trees, including the good-sized root lying on the sidewalk. (1/23/92)

Unfortunately, the trees scattered throughout the yard hampered investigation of the brick wall, and it was decided they should be removed. On January 23, 1993, the chain-link fence on Allen Street was rolled back and the trees were lifted out with a backhoe and chain (Figure 13). This eliminated twenty-four *Ailanthus* trees that ranged from rooted twigs to good size. The backhoe positioned on the Allen Street sidewalk above the yard offered the opportunity to test more intensively for the sought-after school-sink and privy features. Nothing was found where the I-Card documented the school-sink, nor was there any evidence of a privy pit, although what appeared to be privy-like stones were scattered throughout the yard.

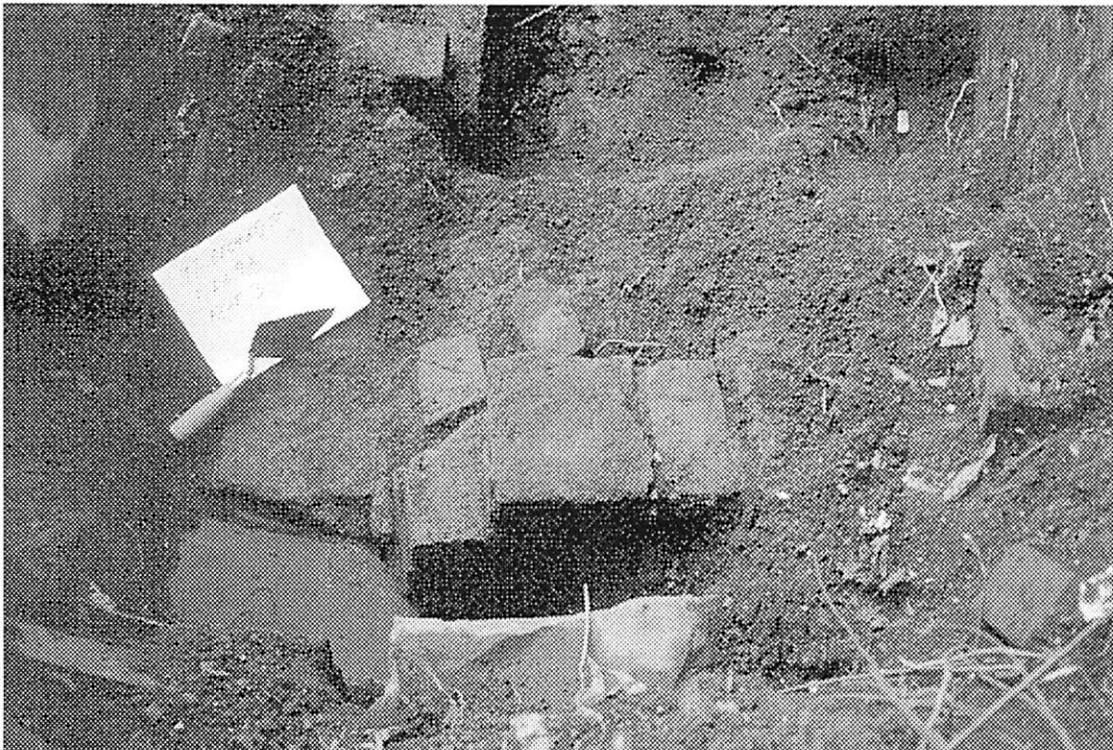
14 Drain-like feature exposed by the backhoe in the northeastern part of the yard. At the time it was thought to be a complete feature (F3), but later proved to be part of the brick vault (F2) partly exposed in the background. (1/23/92)

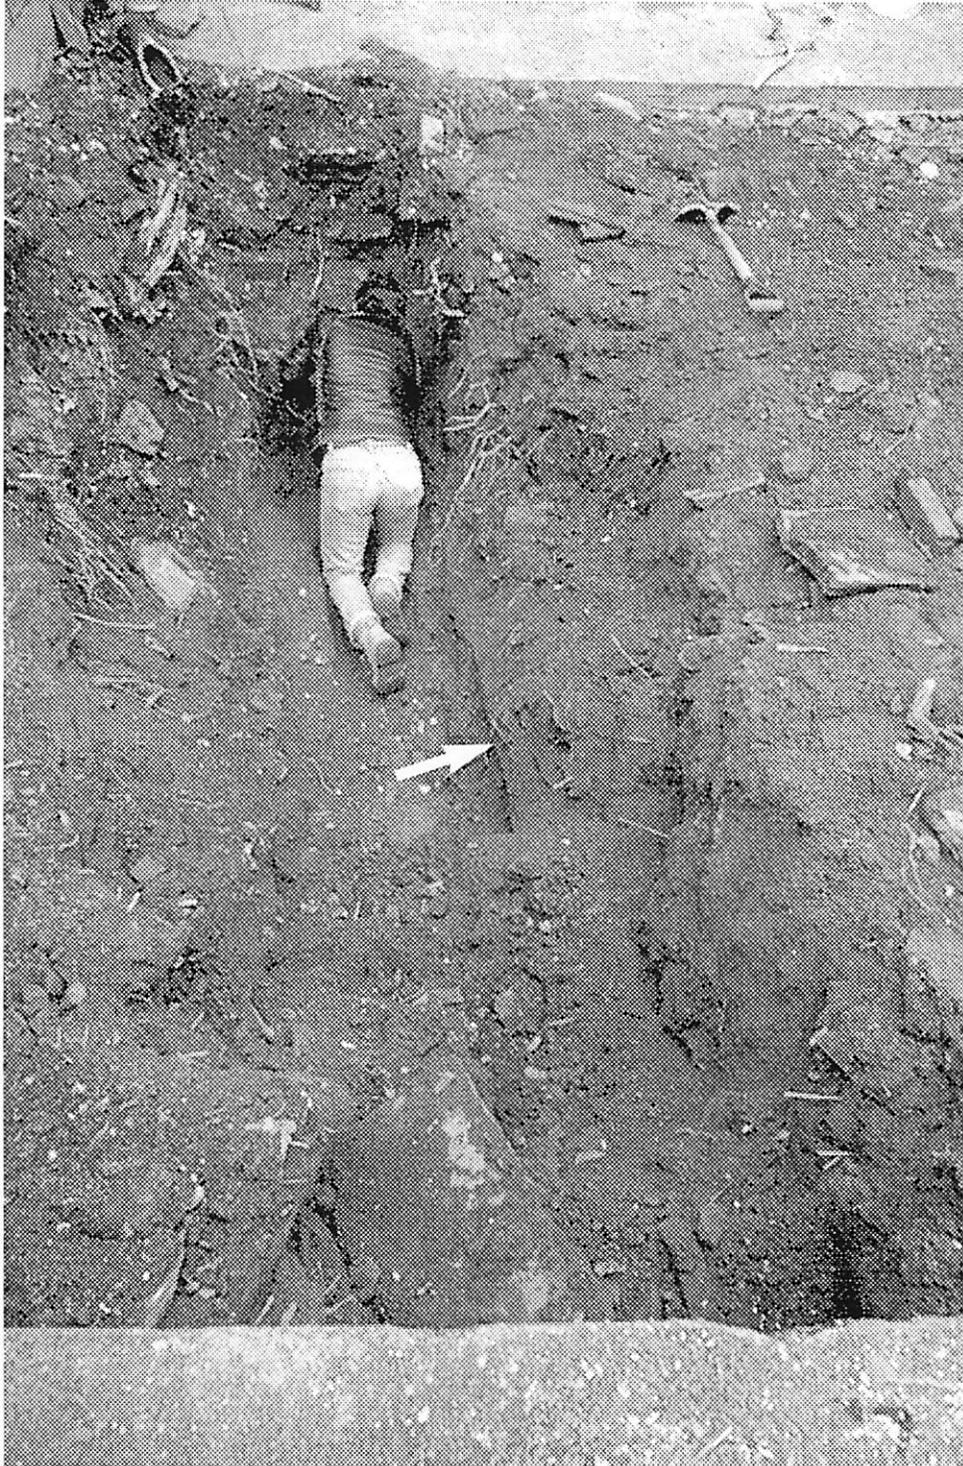
15 The outline of a brick vault (F2) is barely visible (e.g., arrow) after the backhoe removed some of the yard soil in January 1993. John Killeen is troweling to expose the eastern wall just before testing ended for the day (1/23/93)

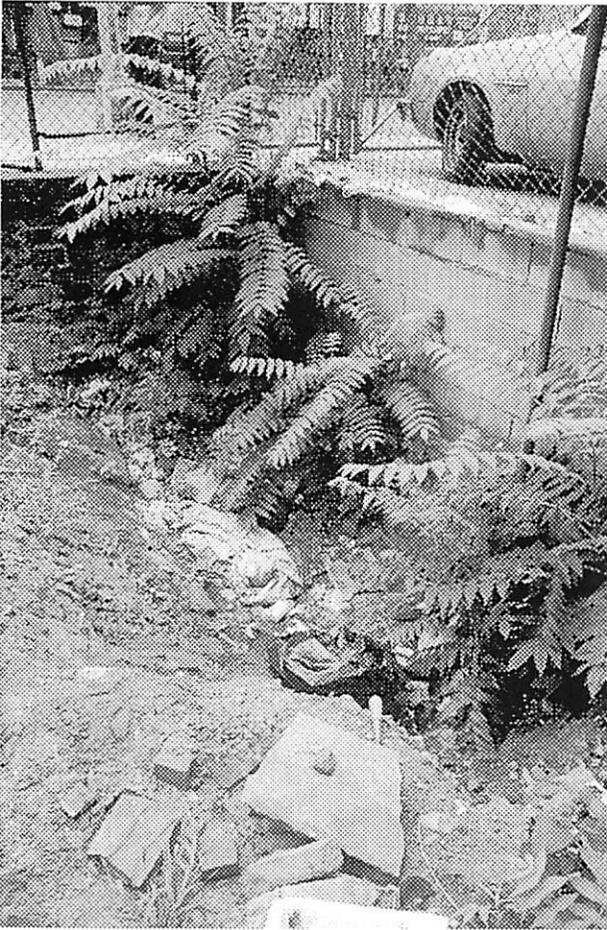
16 Site of brick vault in the northwest corner of the yard on July 28, 1993. Note that debris and new Ailanthus trees have appeared since the January tree removal and backhoe testing. (7/27/93)

Toward the end of July 1993, the Polaroid Corporation, which was documenting the tenement and its renovation, funded a five-day excavation of the suspected school-sink feature, designated Feature 2 (F2).¹⁰ Not surprisingly, a new crop of *Ailanthus* trees had to be cleared before work could begin. This was also true of rubbish that had accrued between the discovery of the brick vault in January and its excavation six months later (Figures 16 and 17).

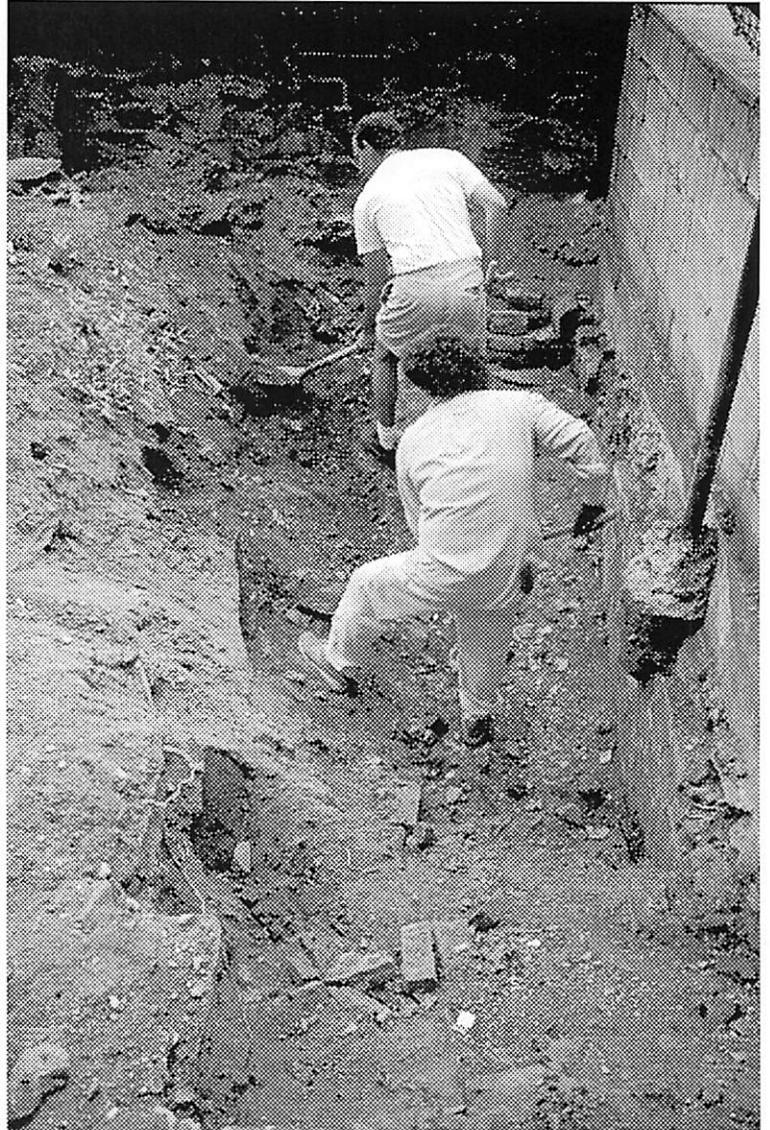
17 Archaeologists clearing the brick vault (F2) on the first day of excavation. Common wall between 97 and 99 Orchard Street is to the right. (7/28/93)

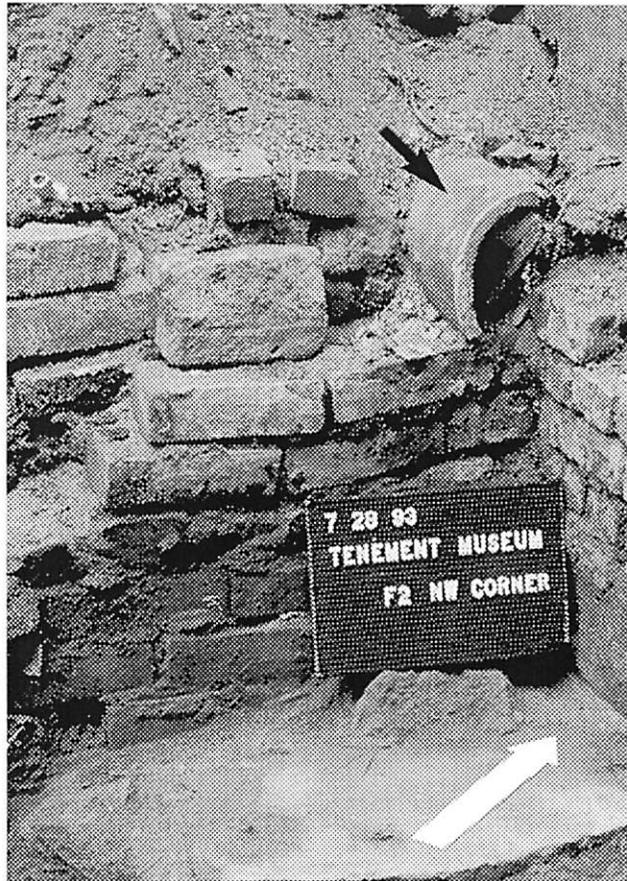
18 Western end of the brick vault, the Allen Street side, with trashed terra-cotta sewer pipe (arrow). Note broken paving stone (under white directional arrow). This stone lies on fill inside the vault. (7/28/93)

been part of the feature floor paved in some unknown fashion. Whatever their original function, only a few stone fragments were left when the yard was graded up to the level found when testing began in 1991. Excavation near the building, in the eastern part of the feature, revealed a large, upright pipe that appeared to be the remnant of a drain, or possibly a toilet vent, although its proximity to the building tended to negate this latter interpretation¹¹ (see Figures 18 and 25).

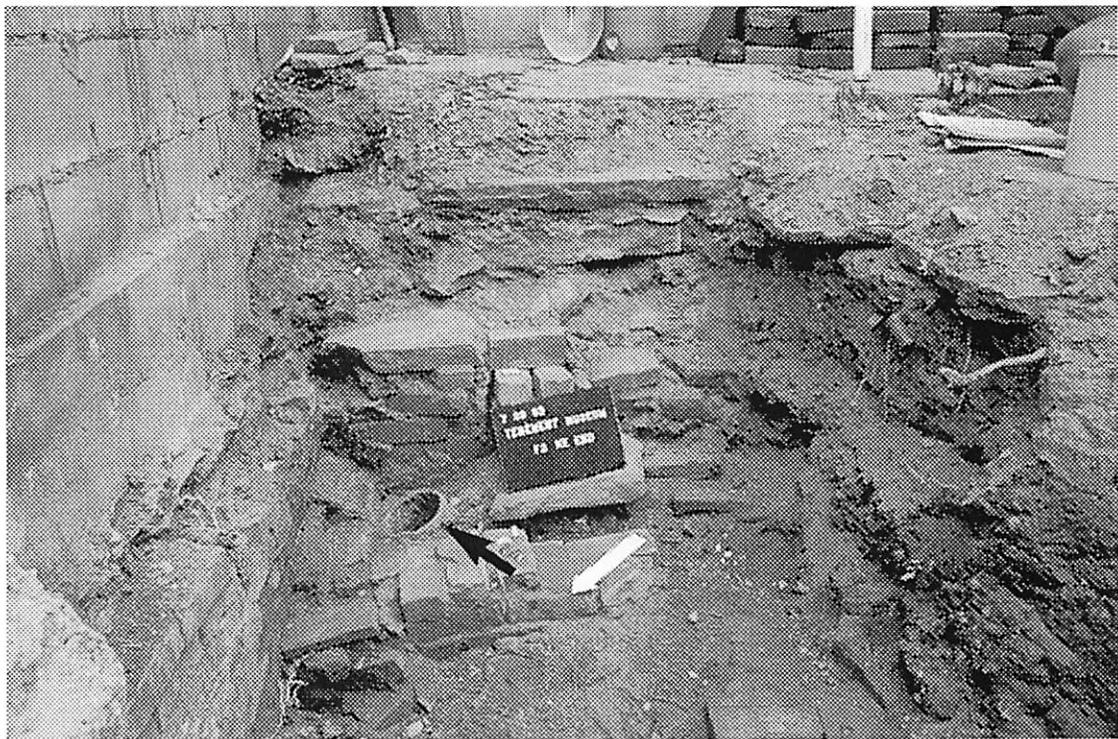
19 Eastern end of the brick vault (F2) with intrusive brick wall (under white directional arrow) and exposed drain or vent pipe (black arrow) between the two brick walls in this part of the feature. (7/28/93)

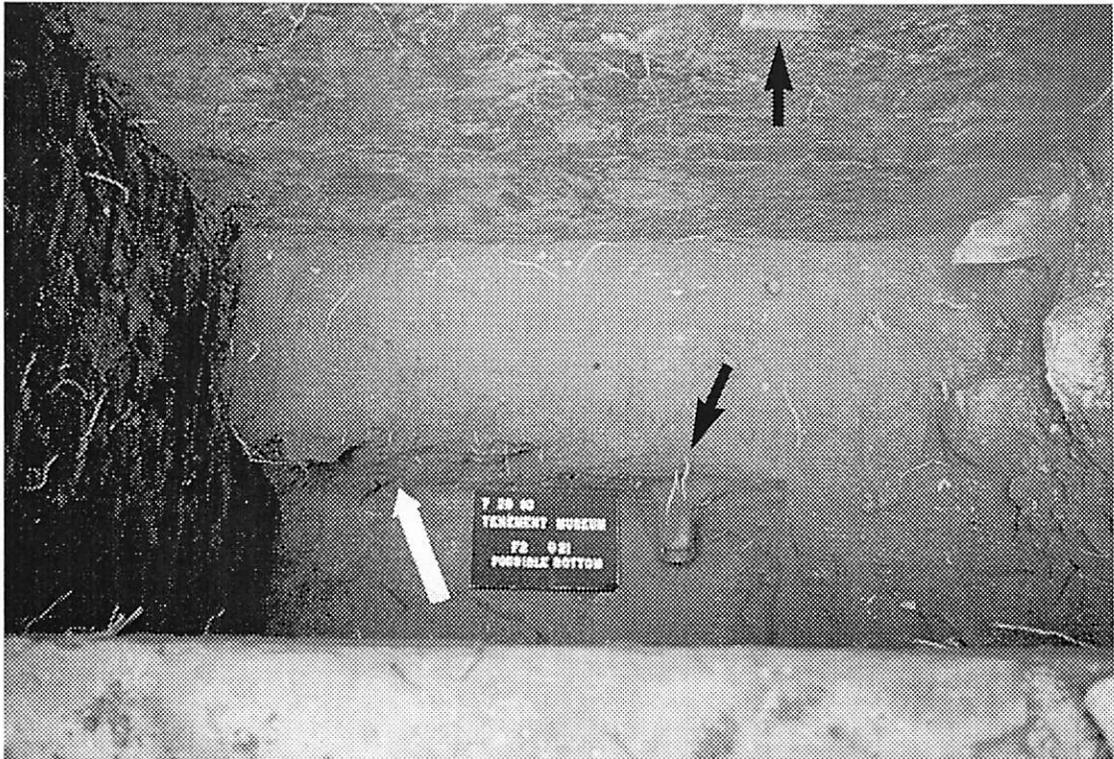
20 Segment of brick vault's floor exposed under story board and white directional arrow. The base of a clear glass mug protrudes from the back wall composed of unexcavated fill (black arrow). Wood-lined drain hole in north wall is indicated by the arrow near the top of the photo. (7/28/93)

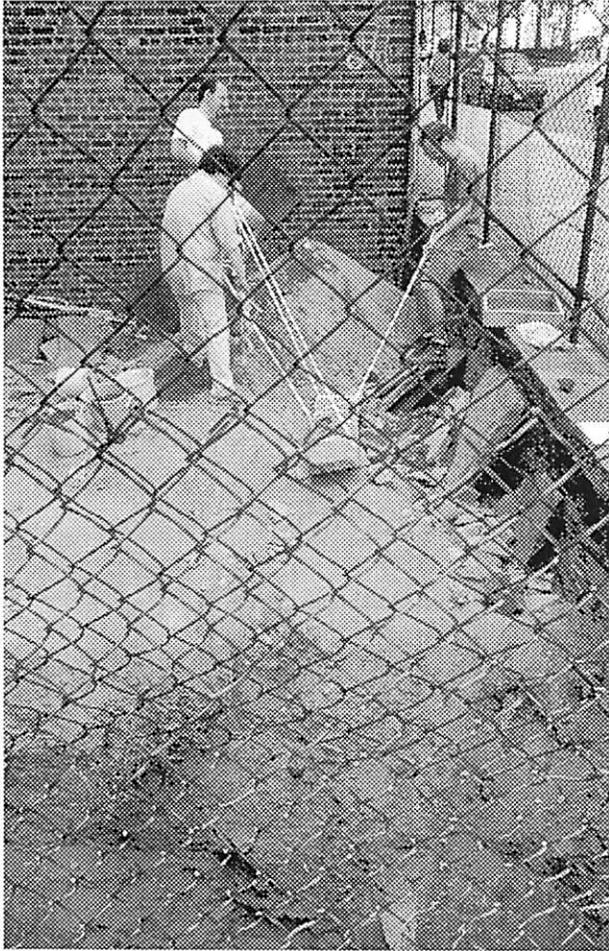
22 Trashed stone slab removed from feature 2 (F2) by excavators. (8/5/93)

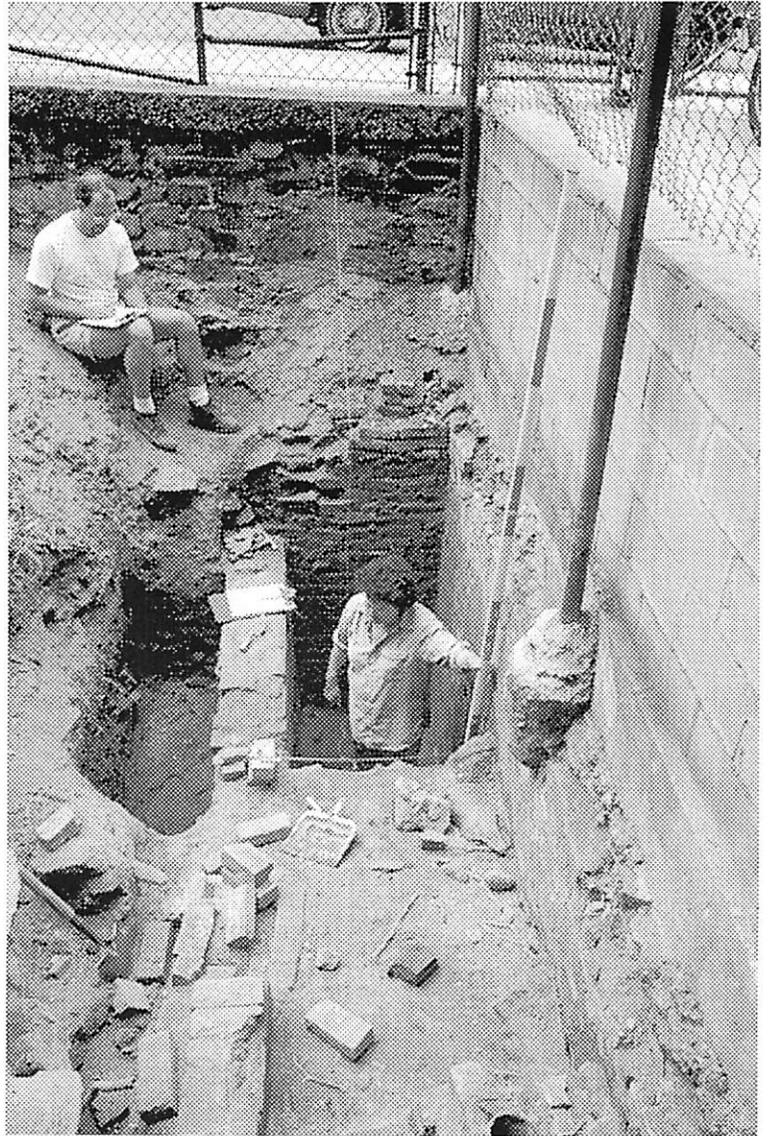
23 Archaeologists measuring depth of western part of the brick vault (F2) after excavation. View is west toward Allen Street. Trench to the left (TT6) is one of two placed outside this part of feature 2. (8/5/93)

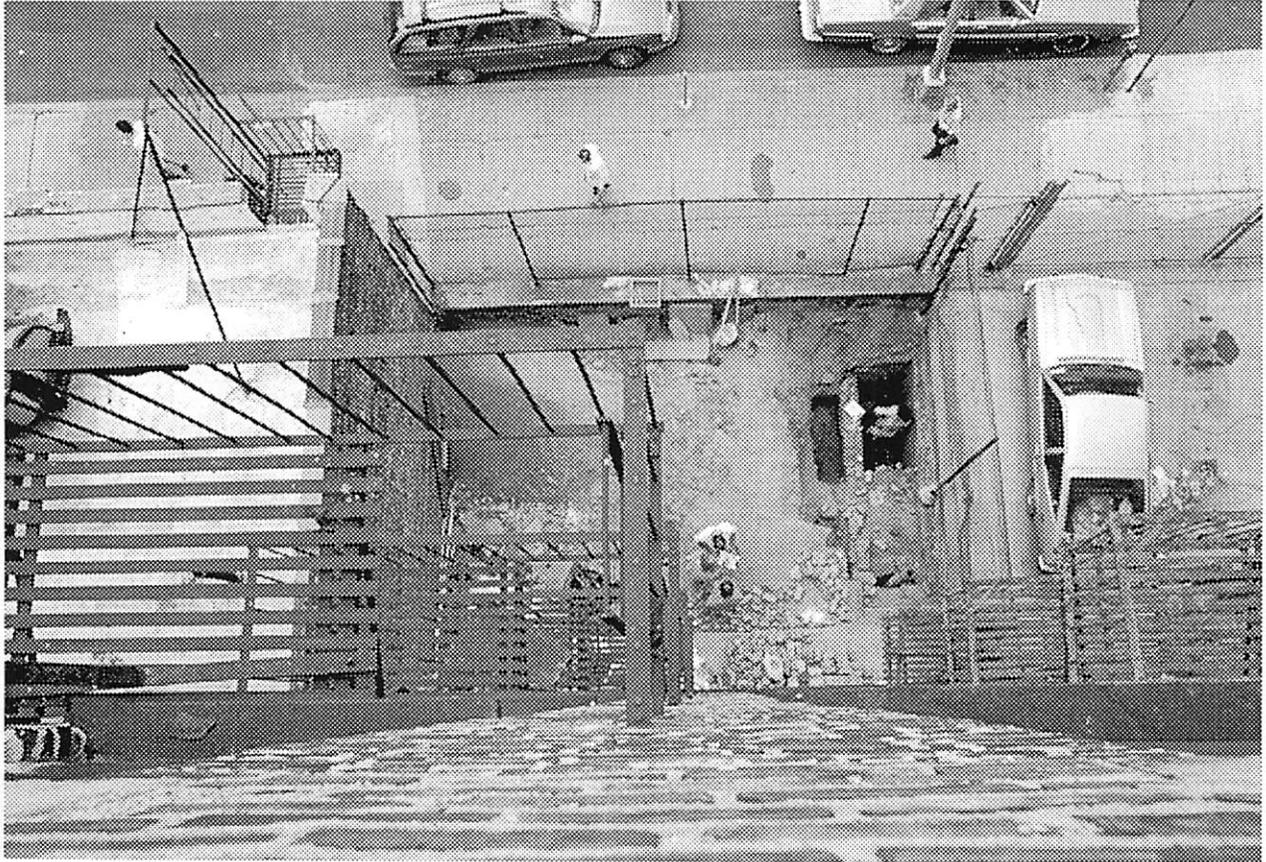
25 View from roof of 97 Orchard Street. The entire yard, Allen Street, and part of the 99 Orchard Street parking area are documented in this "aerial" view taken by Klaus Schnitzler on August 5, 1993. The partially excavated brick vault (F2) is in the upper right corner of the yard; test trench 6 (TT6), a shallow excavation, parallels the vault's southern brick wall. (8/5/93)

After emptying the western half of the feature, a trench was placed outside its long, southern brick wall to see if any evidence of an earlier privy feature might be found in its vicinity. This trench (TT6)¹² is shown in an aerial view taken from the tenement roof by Klaus Schnitzler, a photographer recording the building's interior renovations, as well as some aspects of the dig, for Polaroid (Figure 25; see also Figure 22). If the privy pit were round, it would undoubtedly have been wider than the brick vault (stone privy pits usually range from 6 to 8 feet in diameter and the brick vault was about 4 1/2 feet wide). But hand excavation in TT6 and, later, in a trench that extended well beneath the vault (TT7), failed to reveal a privy pit, or any other feature.¹³

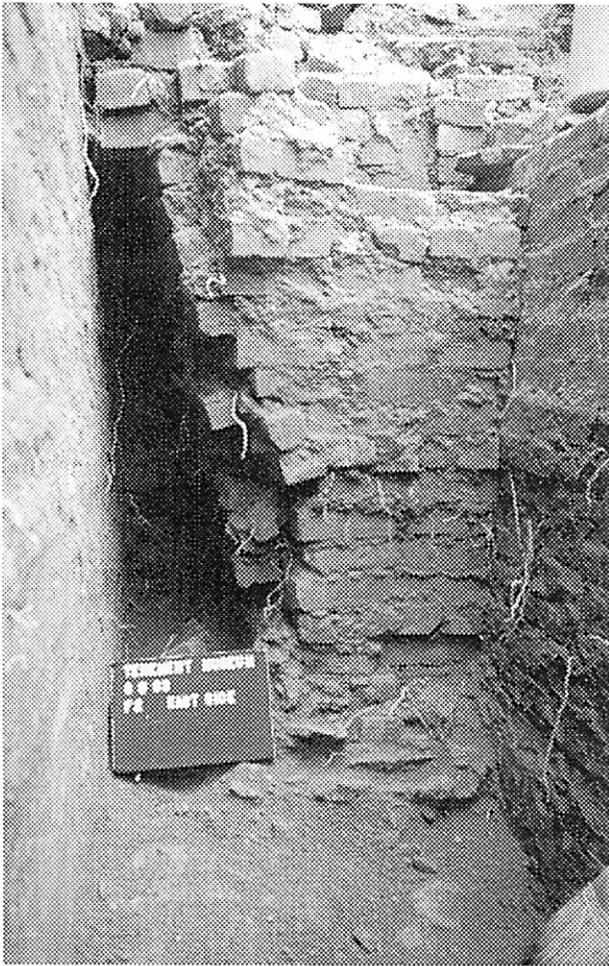
27 Poorly made intrusive brick wall exposed in the eastern part of the brick vault (F2). (8/6/93)

Alterations to the plumbing for the school-sink may have entailed the introduction of the poorly made brick wall that created a narrow chamber at the eastern end of the feature (Figures 26 and 27). Using a jack-hammer, a member of the construction crew working on the building's renovation removed the wall to determine if it hid any identi-

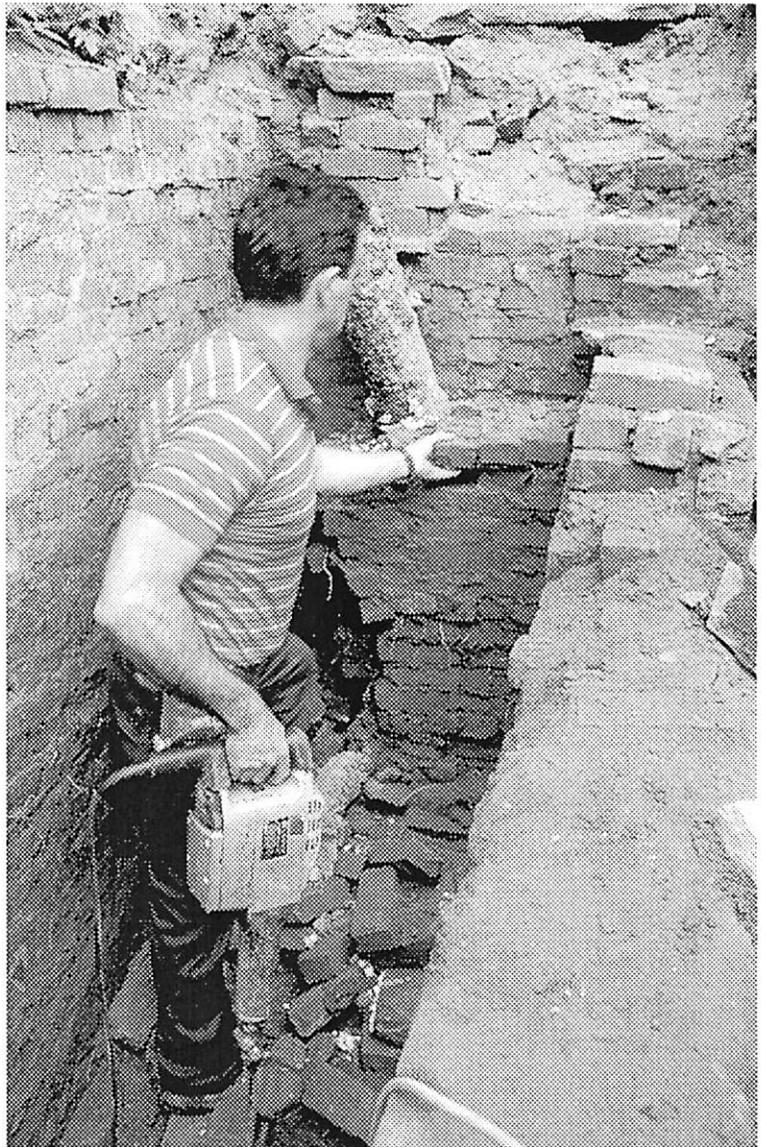
28 Intrusive brick wall being removed by one of the building's renovators. Note partially-exposed metal pipe behind the brick wall, possibly a drain connection or a vent. (8/6/93)

fying plumbing (Figure 28). The slope of the feature's floor suggested the southeast corner, the deepest part, was where an outlet would be found. However, the feature's eastern brick wall had been broken away to accommodate the previously-mentioned drain or vent pipe, and no trace of the original discharge drain remained (Figure 29). The feature was photographed and drawn (see Figures 29 and 31).

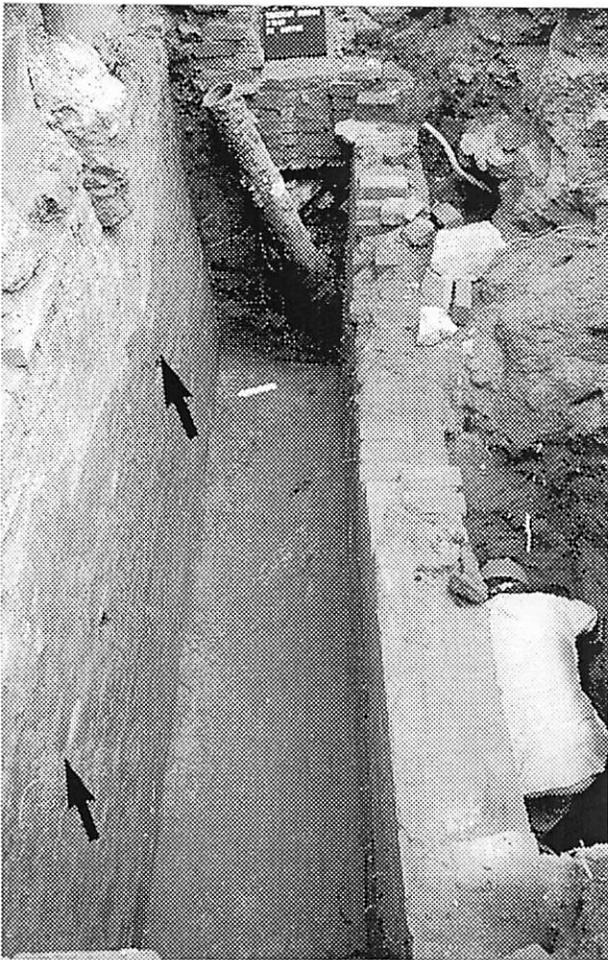
29 Brick vault (F2) fully excavated. View is east with brick wall common to 97 and 99 Orchard Street on the left. Note two wood-lined drains (black arrows), in the common wall. The wall is broken away behind the metal pipe on the eastern end of the feature. Excavation of test trench 7 (TT7) is taking place to the right. (8/6/93)

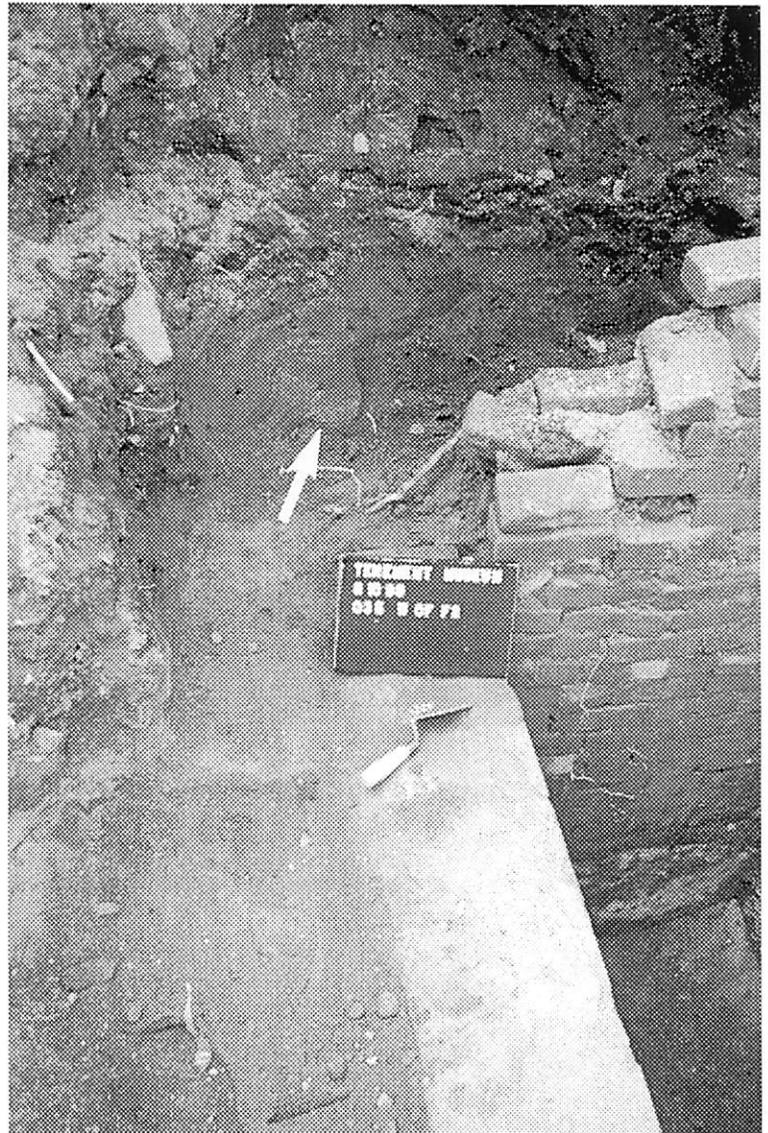
30 Test trench 8 (TT8) (white arrow) outside (west of) western end of brick vault (F2). (8/10/93)

Once the brick vault was completely emptied, a small test trench (TT8) was placed outside the end nearest Allen Street (Figure 30). Here the fill was ashy and laden with fragmented artifacts that clearly contained relatively recent material near the surface. This included a 1962 Jefferson nickel, plastic fragments, and a crack vial. The coin may have been associated with yard alterations, and the crack vial was undoubtedly thrown over the Allen Street fence, as was much of the trash strewn about the yard when excavation began.
