The Lower East Side Tenement Museum

Archaeology at 97 Orchard Street

Prepared by Joan H. Geismar, Ph.D.
Prepared for The Lower East Side Tenement Museum
January 1999/August 2003

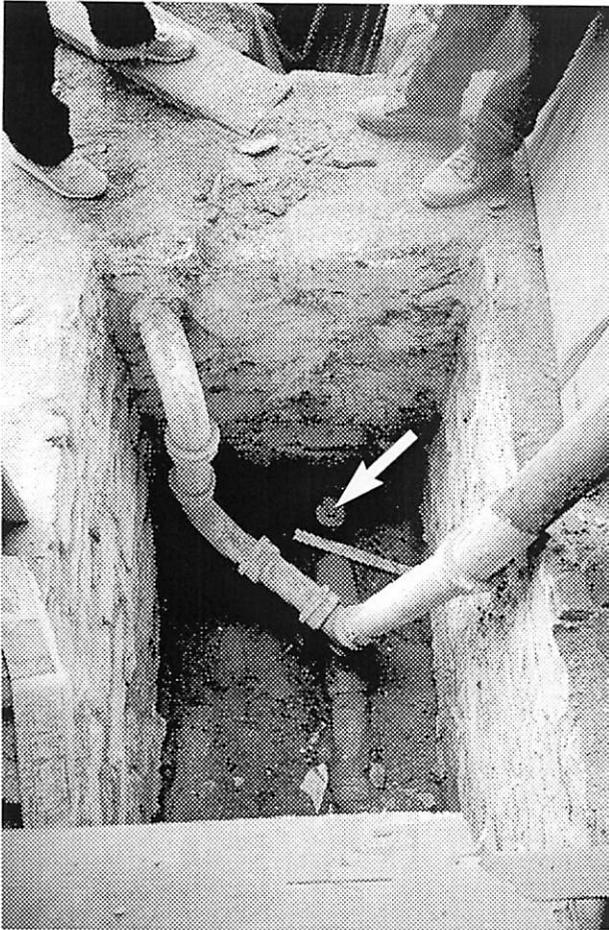
32 Unidentified drain and sewer pipe east of feature 2 (F2) exposed by construction work after archaeological excavation ended. Photo is from the building looking west towards the yard. A sewer connection (arrow) is visible below the drain or vent. (8/16/93)

Once the archaeological investigation ended, the building's renovation called for opening the ground between the eastern end of the brick vault and the tenement, an area covered by a cement slab during excavation. This exposed a network of pipes that may have replaced or supplemented the original connection between the brick vault behind the tenement and a municipal sewer on Orchard Street. It also revealed long-hidden cellar steps and a sealed cellar entrance (Figures 32 and 33).

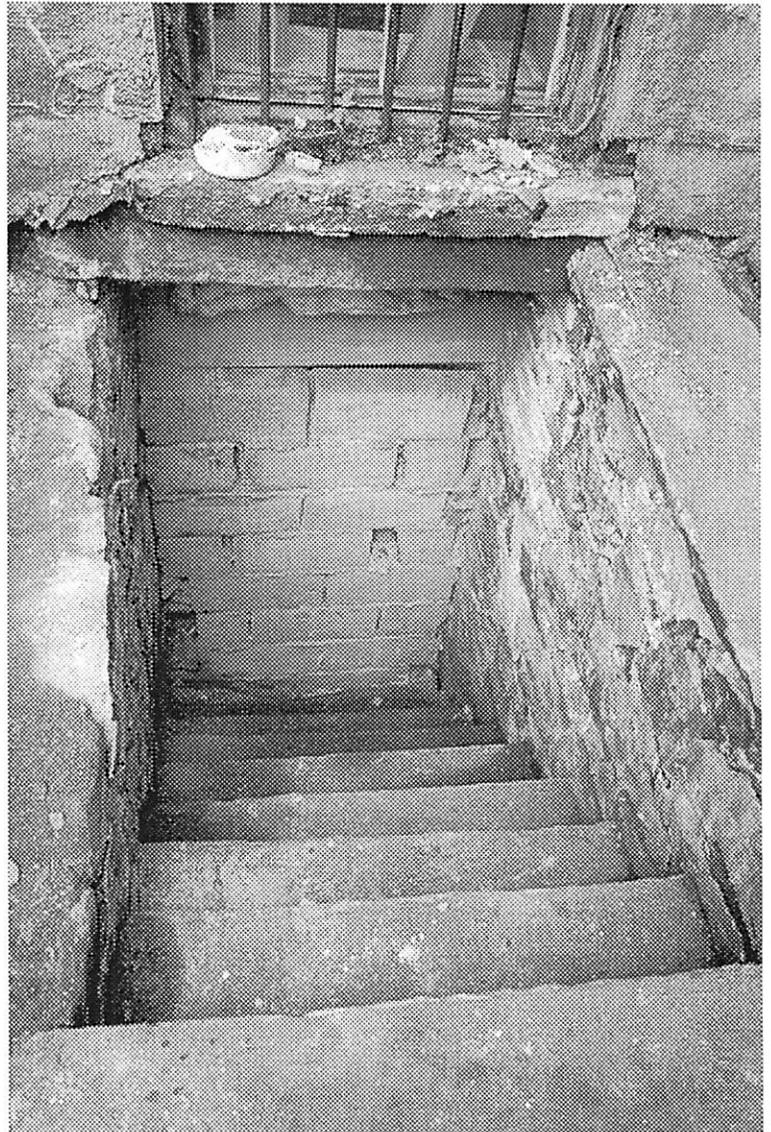
33 Cinder blocks seal cellar entrance exposed after cement slab was removed from behind the building. The stairs, which led to a former cellar entrance on the west side of the building were a surprise. (8/16/93)

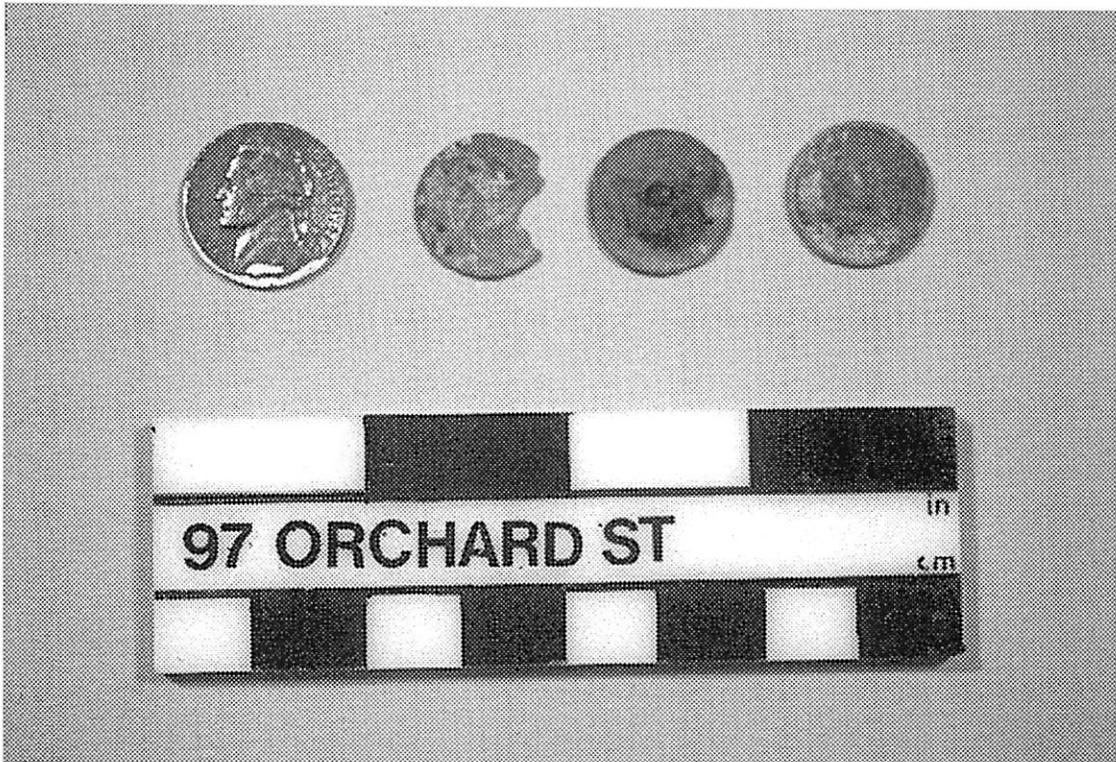
34 Coins found in excavation include the 1962 nickel on left from the upper level of test trench 8 (TT8). The three copper coins on the right, identified as Indian Head pennies, were from fill in the brick vault (F2).

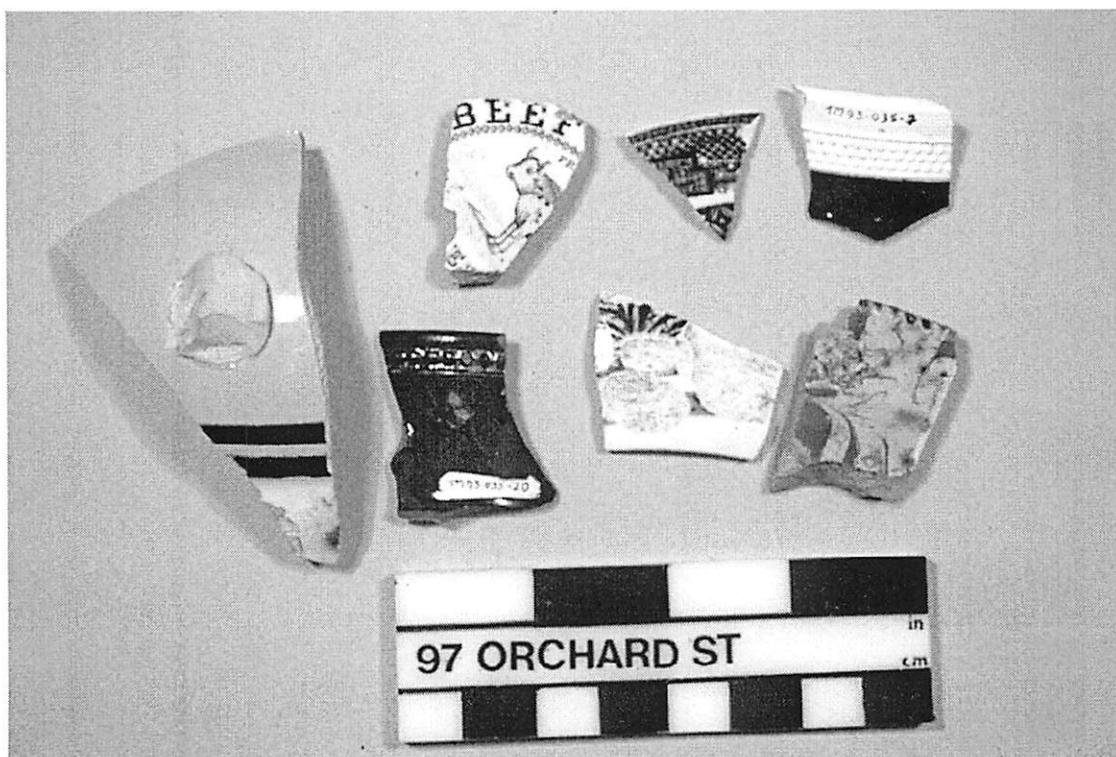
39 Miscellaneous ceramic fragments from feature 2 (F2) fill.

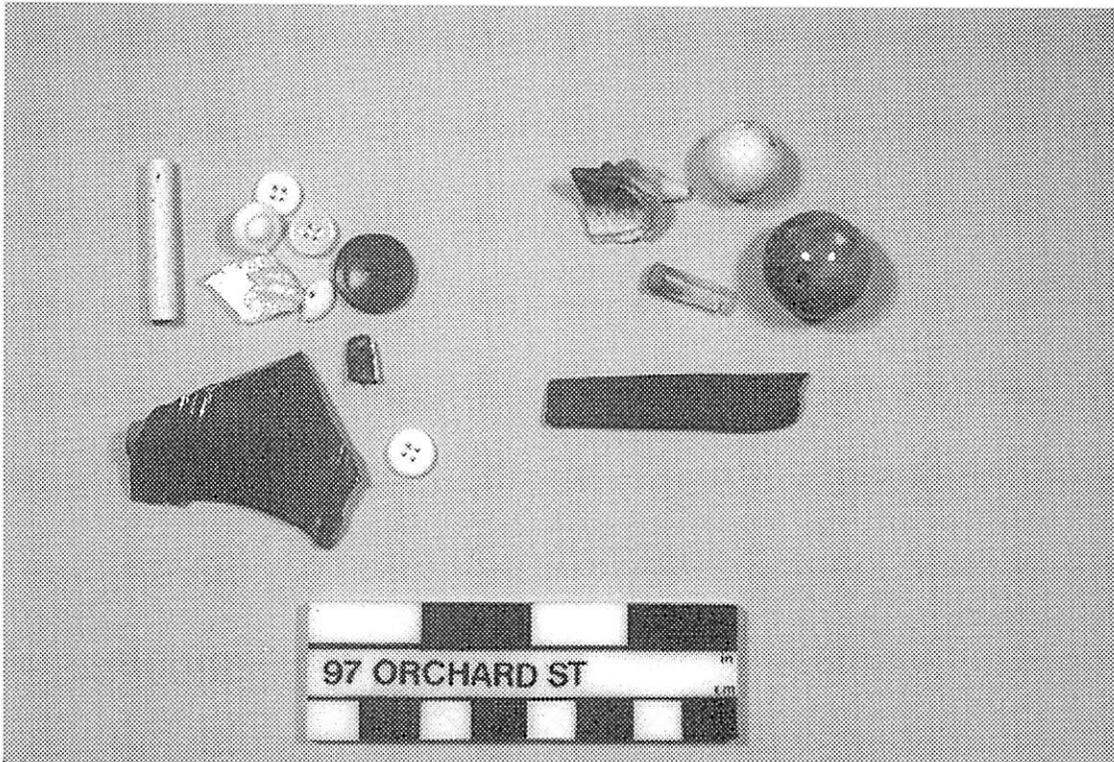
40 Clay pipe stem, buttons, marbles, a crack vial (below and next to marbles), and a leather fragment (below the vial). The crack vial was from the top of test trench 8 (TT8) and was probably trash thrown over the Allen Street fence.

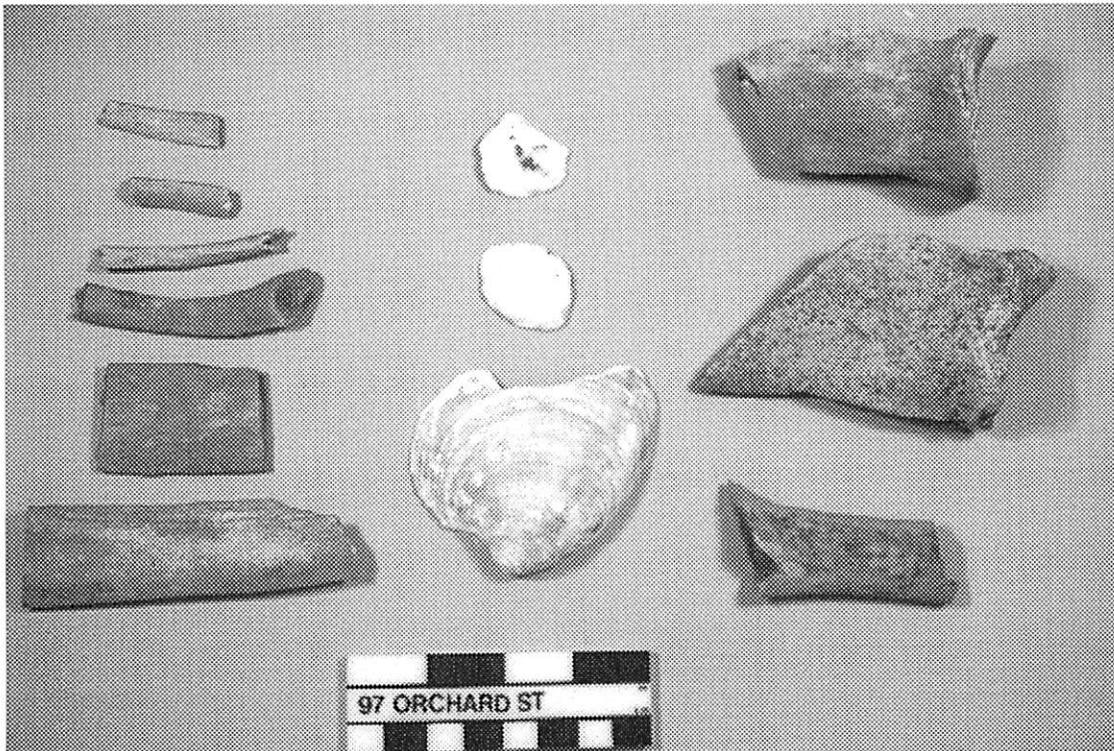
41 Bird bones (upper left corner), butchered meat bones, and shells found in the feature 2 (F2) fill. This kind of material is typical of redeposited fill.

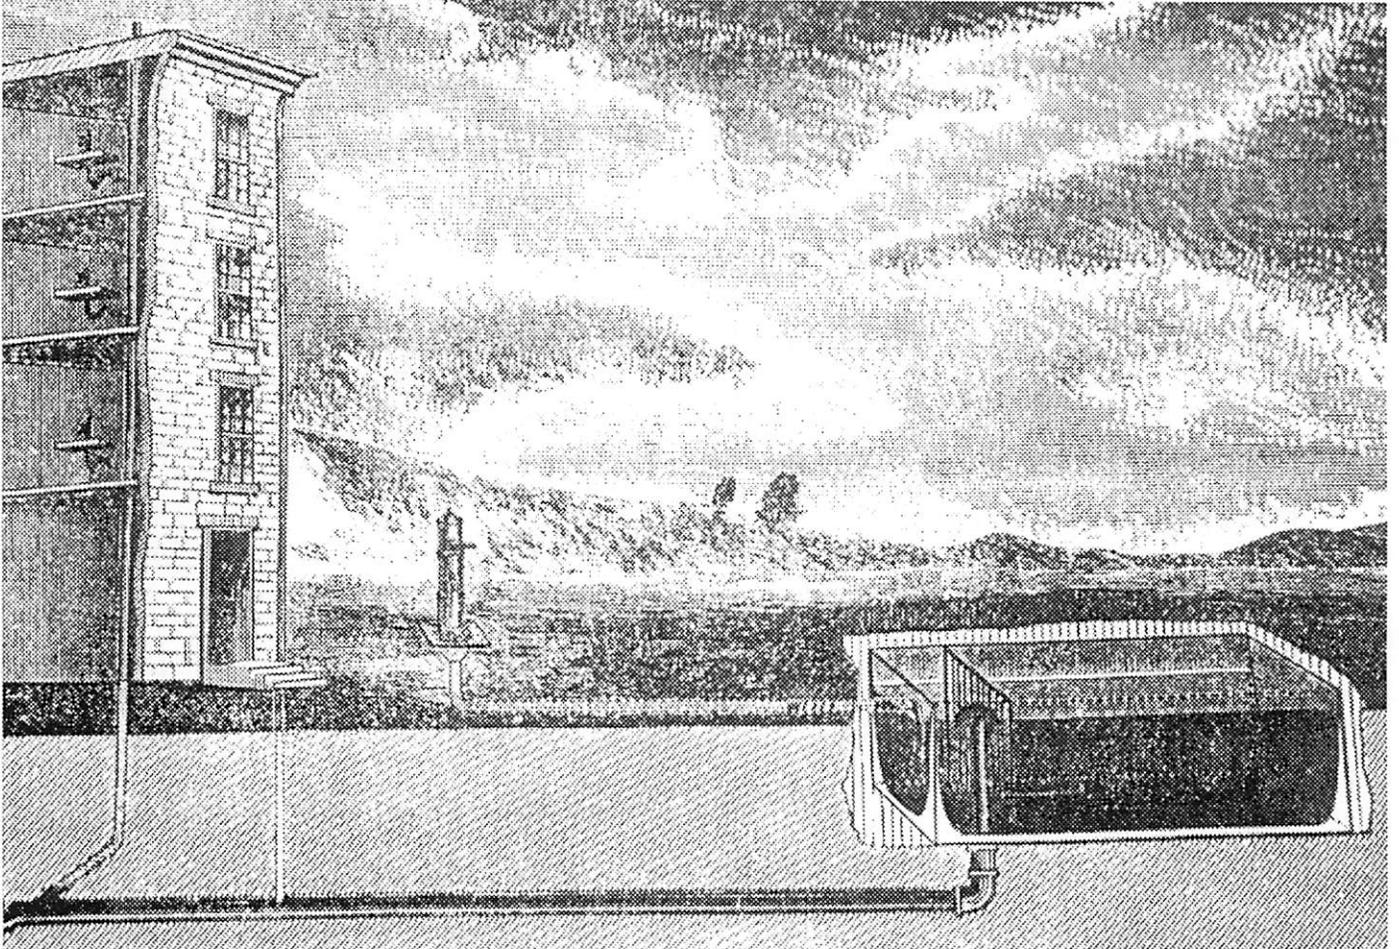
48 Iron privy vault, with hydrant and sewer connections, recommended in an 1877 article on household drainage written by Charles F. Chandler, President of the New York City Board of Health. What was originally perceived as a sanitary improvement was later deemed less than desirable due to corrosion.

Although the interpretation of the brick foundation found in the 97 Orchard Street yard as a privy vault/school-sink appears valid, it is not the round-bottomed vault described in the literature of the time. Its angled, concave, sloping floor would have been less efficient in terms of flushing than a round-bottomed chamber, but it certainly could have functioned overtime as a water-cleansed privy vault that was later termed a school-sink, possibly with the introduction of more complex plumbing. A similar vault, but made of iron rather than brick, was recommended as a solution to defective drainage in dwelling houses in 1877 (Figure 48). This design was extolled in an article by Charles F. Chandler, then the forward-thinking head of the New York City Board of Health.⁵¹ But even the 1877 design was not yet identified as a school-sink.
