**Stage 1A Literature Review and Archaeological and Historic
Sensitivity Potential
for
Block 3995. Lot 1-7 and Lot 33 & 34.**

**Marjorie Richardson Court Senior Housing.
359 Hendrix Street. East New York.
Borough of Brooklyn. Kings County, New York.**

**MARJORIE RICHARDSON COURT SENIOR HOUSING.
359 HENDRIX STREET. EAST NEW YORK.
BOROUGH OF BROOKLYN. KINGS COUNTY, NY.**

**STAGE 1B ARCHAEOLOGICAL FIELD
RECONNAISSANCE SURVEY**

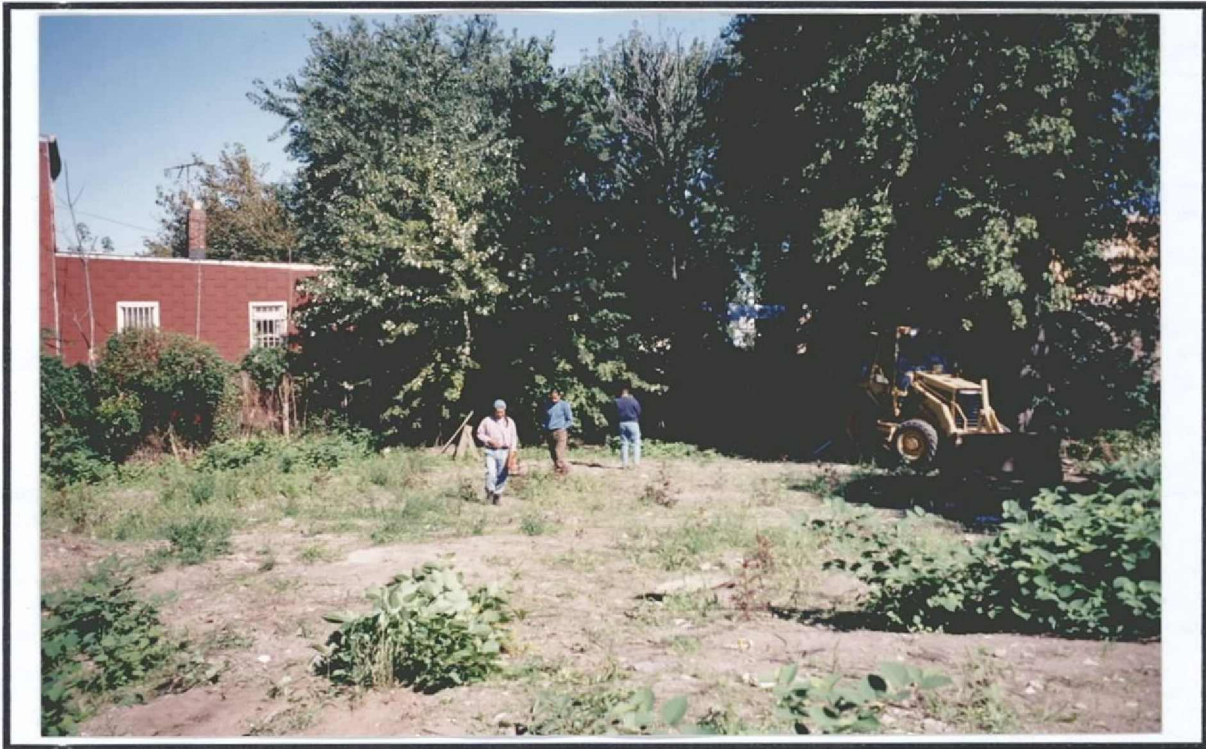
Photo 1: View of the site of proposed Marjorie Richardson Court Senior Housing facility looking northwest. Large trees exist along rear property line, but otherwise site is clear.

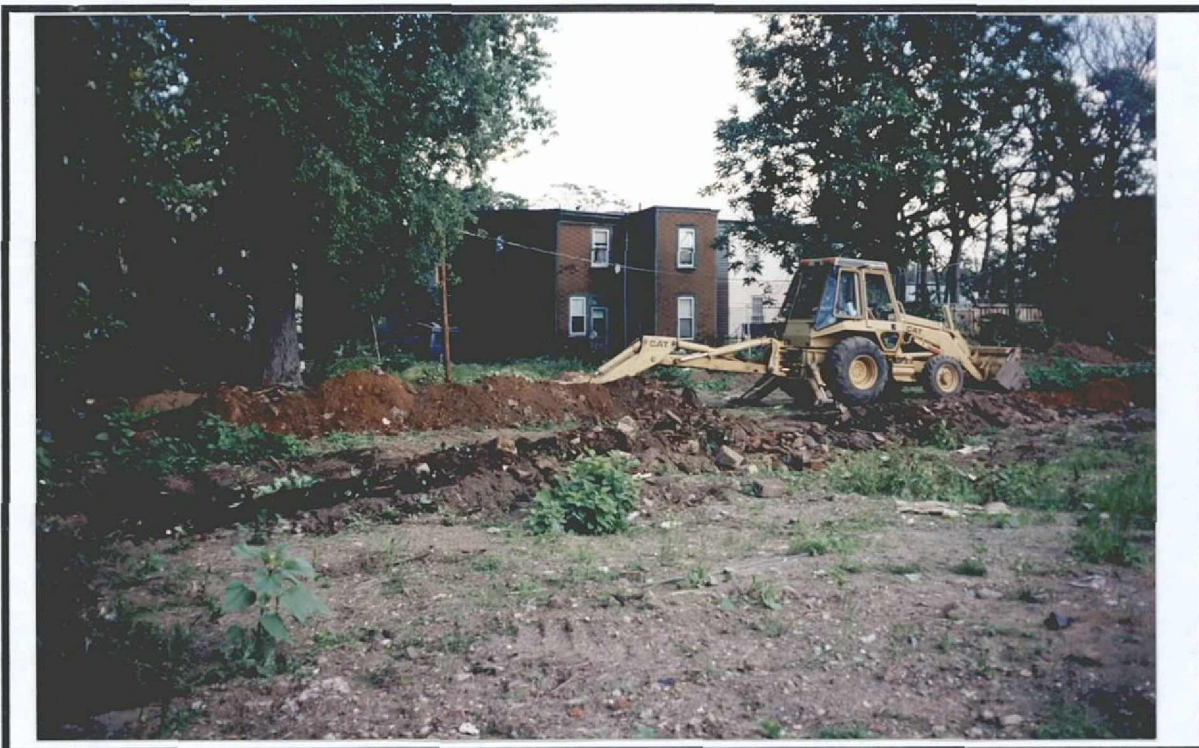
Photo 3: A trench was excavated along rear property lines in attempt to locate privy features. Large trees made excavation difficult. No privy features were revealed.

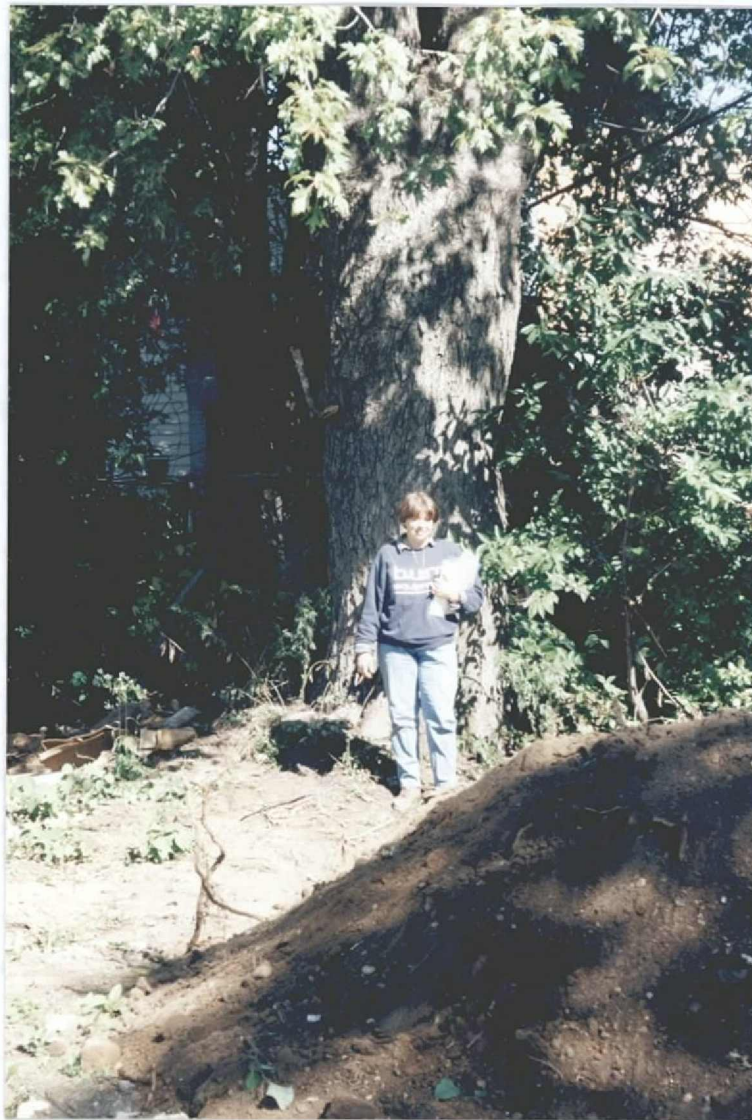
Photo 5: Large trees along the rear lot lines on Lot 1-5 made excavation difficult. No privy features were revealed during trenching.

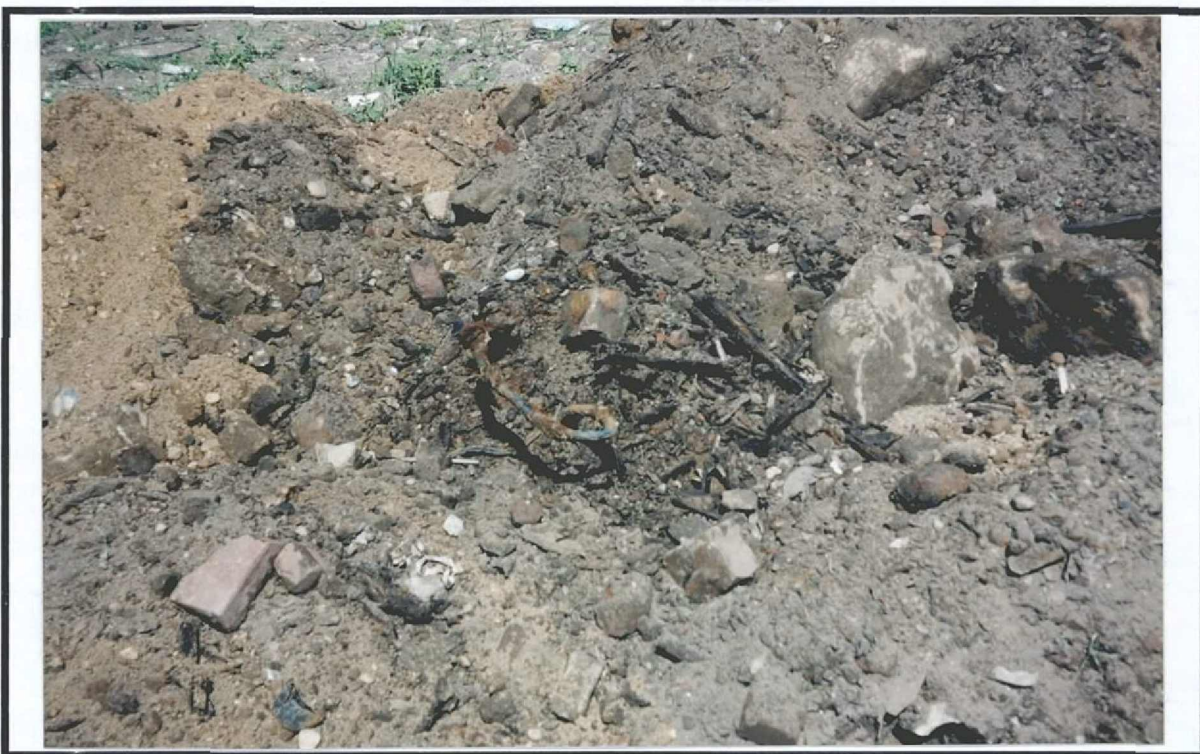
Photo 7: A number of areas suggested burned materials. This material may have come from demolished structures, but were not interpreted as historic dumping episodes.

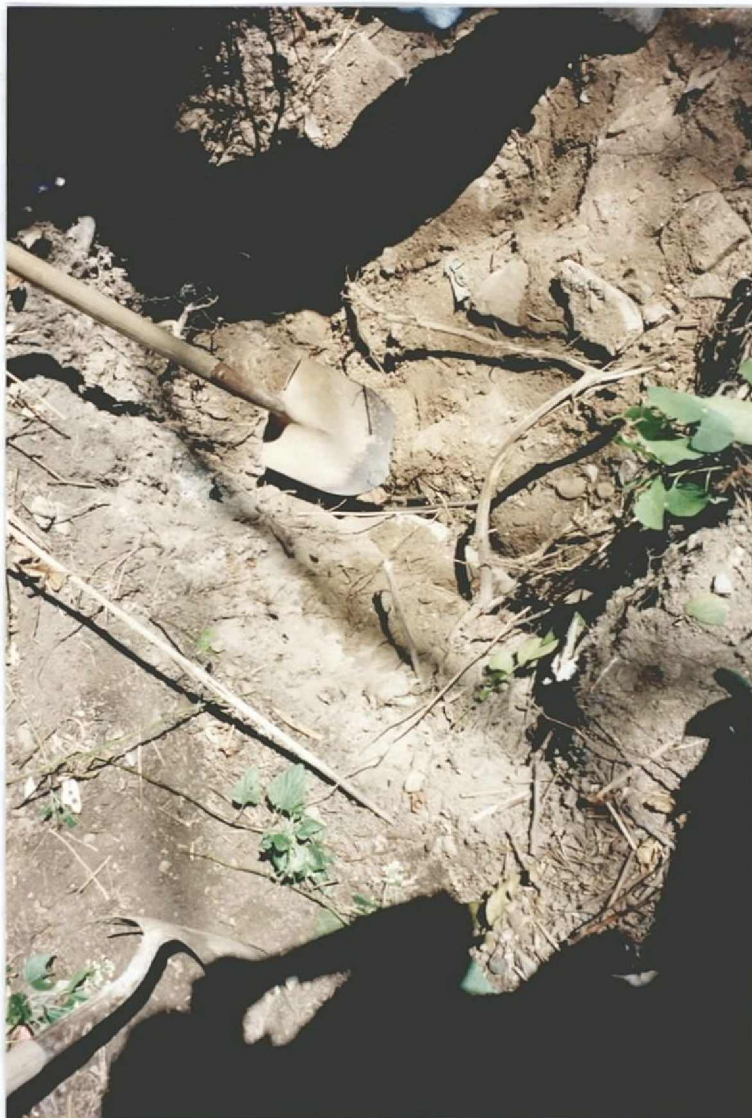
Photo 8: Along the rear lot lines of Lot 1-5 a foundation of dressed stone was uncovered. However, hand excavation revealed that this was the foundation of an outbuilding seen on Sanborn maps rather than a privy feature.

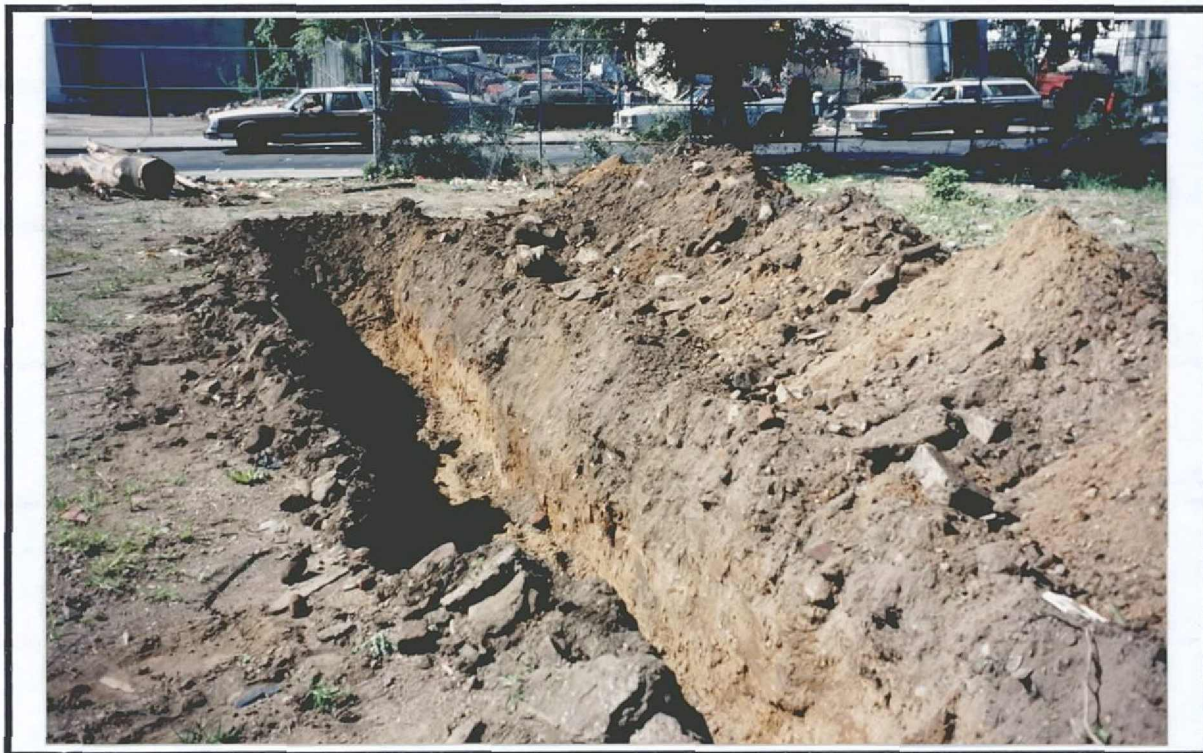
Photo 9: A trench was run along the rear lot lines of Lot 33 & 34 looking for privy or other features.

Trench 2 was placed along the rear boundary of Lots 33 and 34. (Photo 9) Like Trench 1 it was designed to locate privy features that should have been located at the rear of the lots. Trench 2 was identical to Trench 1 in size and execution, with the backhoe operator digging a five foot wide and five foot deep trench in arbitrary one foot strata. At the midpoint of the trench, a substantial amount of brick and burned timber was encountered. This corresponded to an outbuilding noted on maps as early as 1887. In addition, a large concrete foundation wall was encountered at the eastern boundary of Lot 34. (Photo 10) Once again, there were no subsurface traces of 19th century privy features.

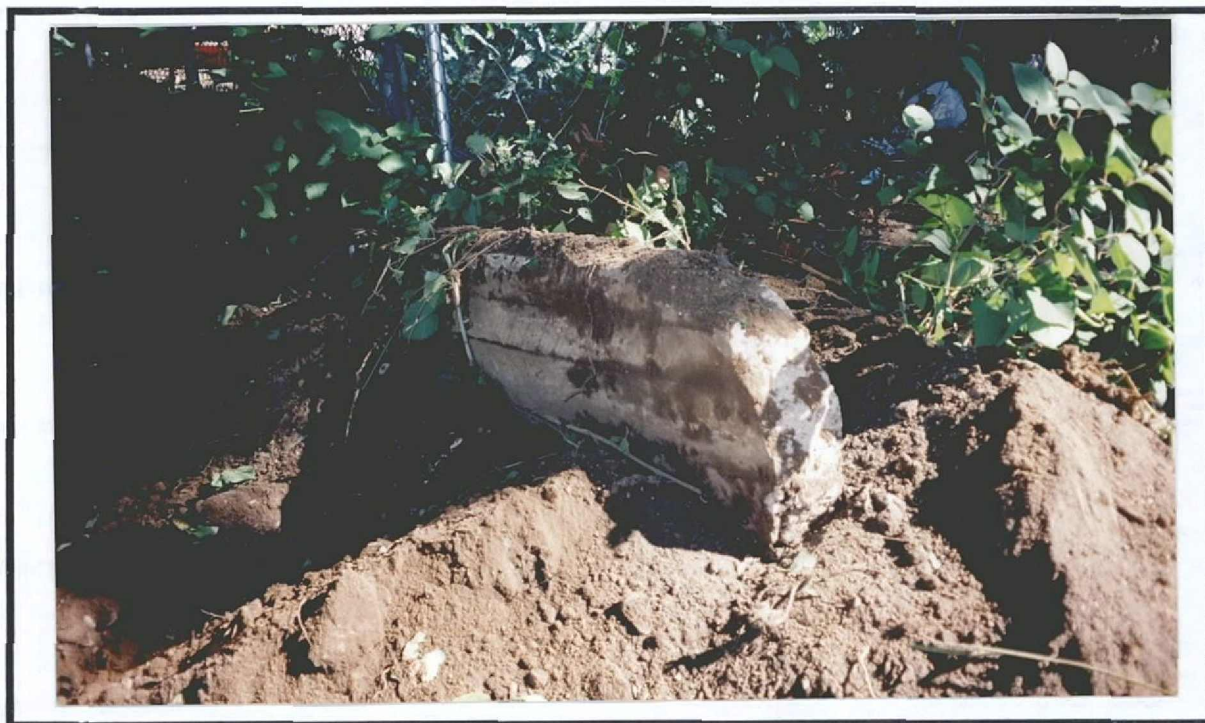
Photo 10: Brick debris and a substantial concrete foundation wall were revealed. These are interpreted as part of an outbuilding appearing on Sanborn maps of the site.

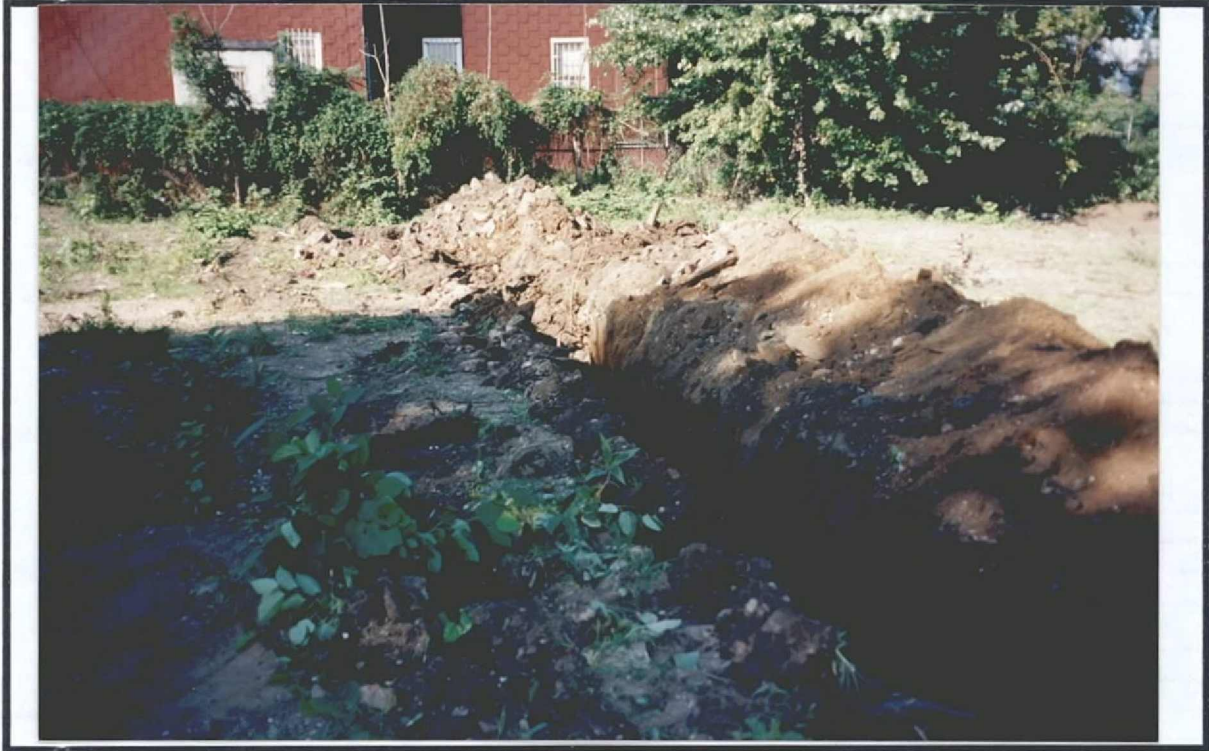
Photo 11: A trench was run along the line of the rear walls of the houses located on the main portion of the site in an effort to locate cisterns. None were found.

On Lot 5 the test trench uncovered sandy soils mixed with jumbled brick debris and wood fragments. (Photo 11) There was no trace of burning on the wood, and all items noted were quite small in size. The presence of galvanized pipe excited a small amount of hope that the cistern feature might be present, however the pipe was present in the soil as a loose artifact. (Photo 12) There was insufficient material in the deposit to represent a feature of any kind, and the objects noted were the result of the destruction of the house. A small east-west brick wall separated Lots 5 and 4. Based on the discovery of this wall, the trench was widened to approximately eight feet to insure that the test cleared the rear foundation. Like Lot 5, the trench in Lot 4 contained substantial wood and brick debris. None of this debris, however indicated the presence of a feature of any kind, and was once again judged to be the remains of the destruction episode. The profile of the trench in Lot 3 was dramatically different from those of Lots 5 and 4. At the junction of the row houses,
