St. Paul's Chapel, West Portico

Archaeological Memo Report

NYCLPC Permit Docket No. 122601

Prepared for Trinity Wall Street
Through Integrated Conservation Resources (ICR)
Prepared by Joan H. Geismar, Ph.D., LLC
May 2012

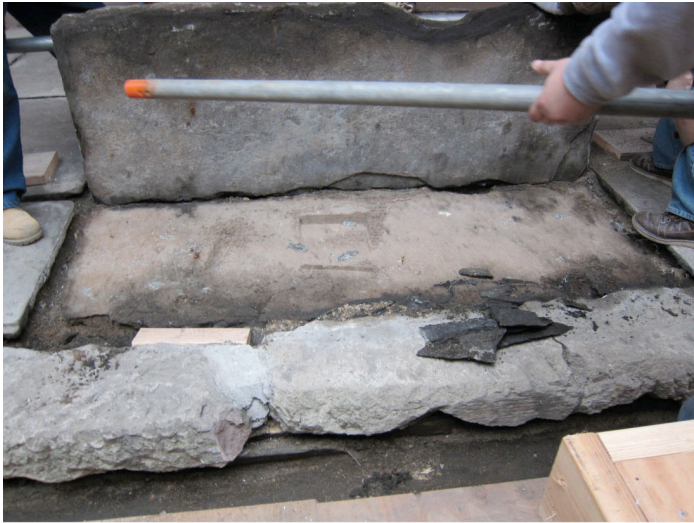
Photo 1. An ICC crew person is lifting a paving stone in the northwest corner of the portico to expose the sand and stone beneath it. The west retaining wall and the construction shelter's flooring are in the foreground. (2/24/12)

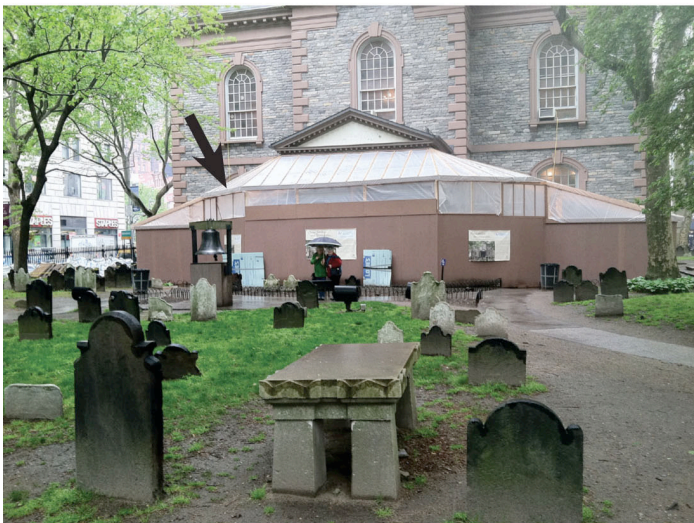
Photo 2. View from the churchyard of the shelter (arrow) erected to facilitate the portico's reconstruction. (5/2/12)

The monitoring, which occurred on March 16 and 19, 2012, entailed observing two trenches during hand excavation by ICC (Integrated Conservation Contracting), the sister company of ICR (Integrated Conservation Resources), the project's architectural conservators.² The portico's paving stones (Figure 2), which had been numbered and expertly removed by ICC (Photo 1), were stored on site within a sturdy and commodious protective structure erected by ICC to facilitate the proposed work (Photo 2).

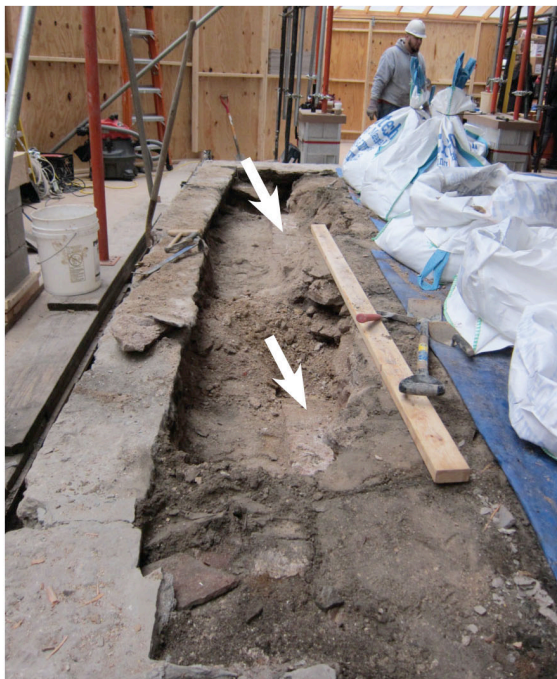
Less than a foot (.6 to .7 feet) into the stone-and-soil fill in TR A, excavation exposed the front of two large, arched, brick burial vaults (Photo 3). Purchased in 1814,³ the vaults are documented on a 1927 plan that shows their location under the portico (Figure 4).⁴ An approximately 1.2-foot gap separated the front edge of the vaults from the portico's west retaining wall. In TR B, the vaults abutted the rear chapel wall. These two family vaults belonged, on the north, to Joshua Waddington and, on the south, to Thomas Ludlow Ogden. "JOSHUA WADDINGTON/VAULT" was engraved on a stone marker exposed under the capstones of the portico's west wall, but only "THOMAS...VAULT" remained on the Ogden marker (Photos 4, 5, and 6).

Photo 3. Excavation in Trench A (TR A) quickly revealed the top of the Waddington (upper arrow) and Ogden (lower arrow) arched brick burial vaults. (3/16/12)

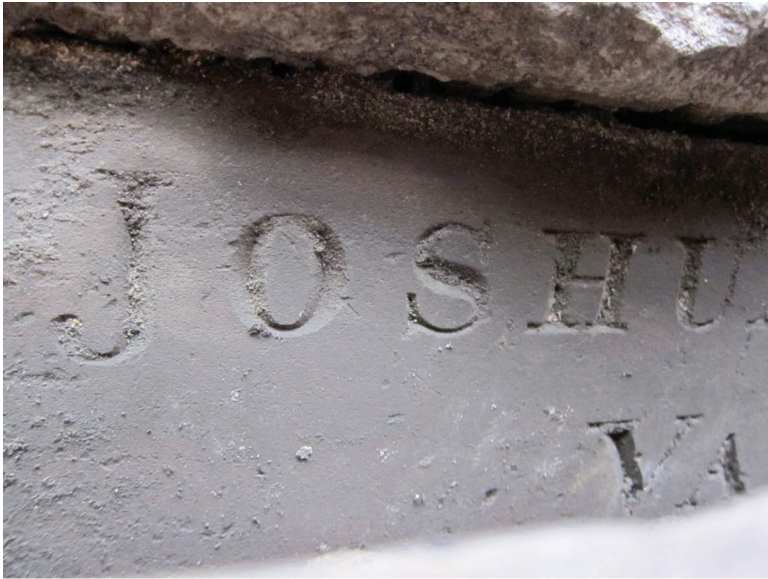
Photo 4. Joshua Waddington's stone vault marker under the capstone of the west retaining wall. (2/24/12)

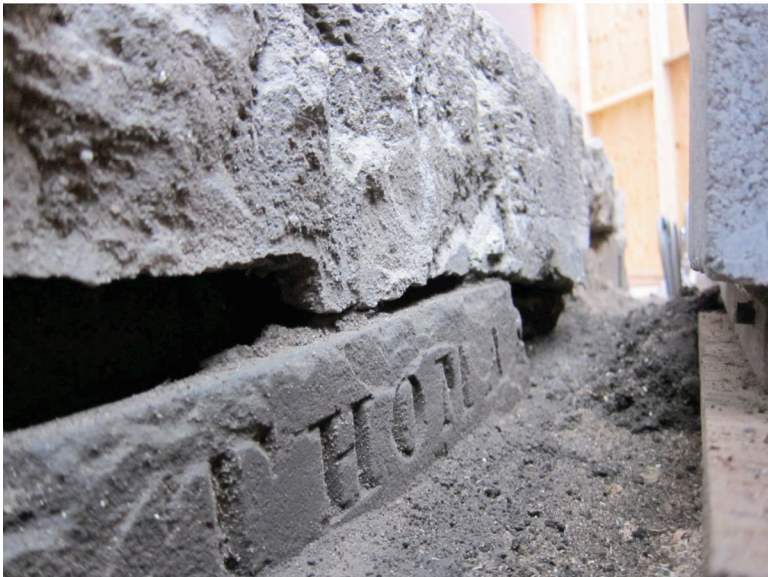
Photo 5. "THOMAS" and "VAULT" remain under the west retaining wall's capstone to mark the Ogden vault. (2/24/12)

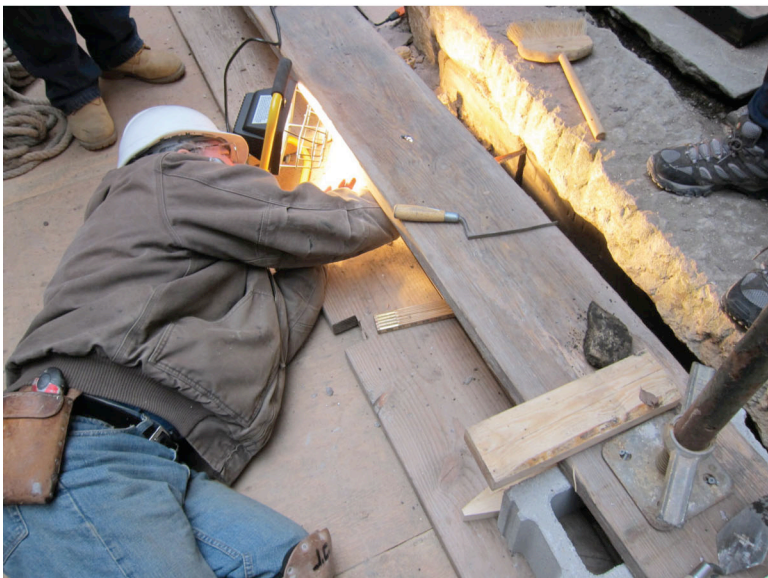
Photo 6. Joe Cordosa of ICC illuminating the Ogden vault marker. (2/24/12)

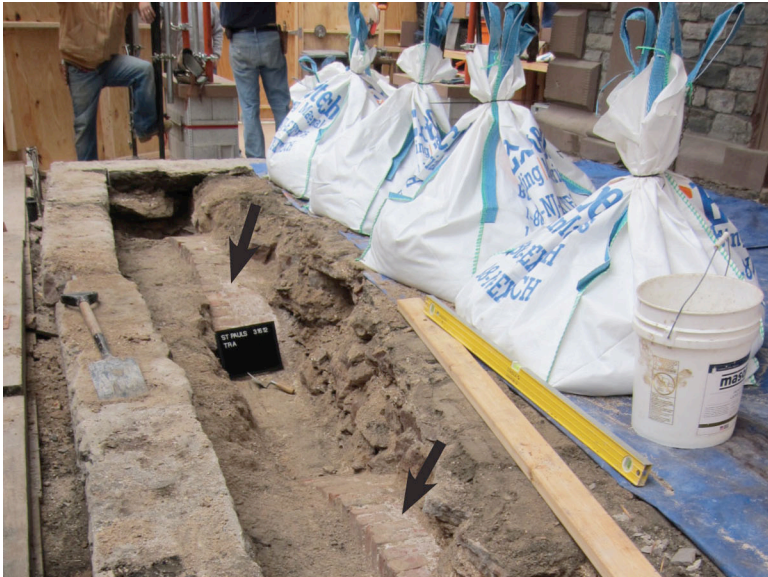
About 1.4 feet below the top of the vaults in TR A, a line of mortared bricks spanned the space created by the arches (Photos 7 and 8).⁵ In TR B, the loosely mortared stones found above the vaults also filled the gap between them. In addition, three iron utility pipes were exposed in the southern part of TR B. All came through the back church wall, and installation of one—a large cast-iron sanitary drain that pitched down toward Fulton Street—had damaged but not breached the back of the Ogden vault (Photo 9).⁶ It should be noted that church records document a water closet in the now-demolished vestry building as early as 1864, but not in the chapel itself.⁷ They also make reference to unspecified repairs to the chapel's sanitary features in the 1920s.⁸

Photo 7. Waddington's vault (upper arrow) and part of Ogden's (lower arrow) in Trench A (TR A) at the end of the first day's excavation. The view is north. Excavated stones and soil, now separated, are stored in the large Tyvek bags to the right. (3/16/12)

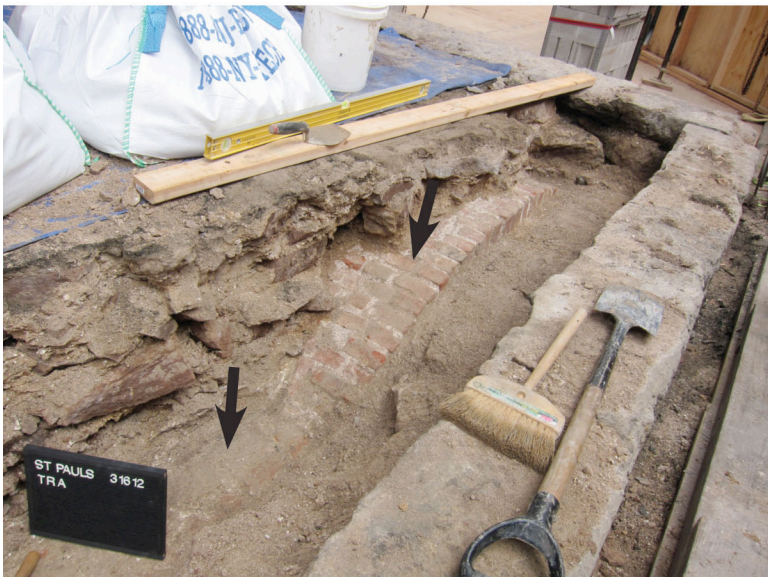
Photo 8. South end of Trench A (TR A) with the upper front edge of the Ogden vault (right arrow) and the brick "floor" between the two vaults (left arrow) exposed. (3/16/12)

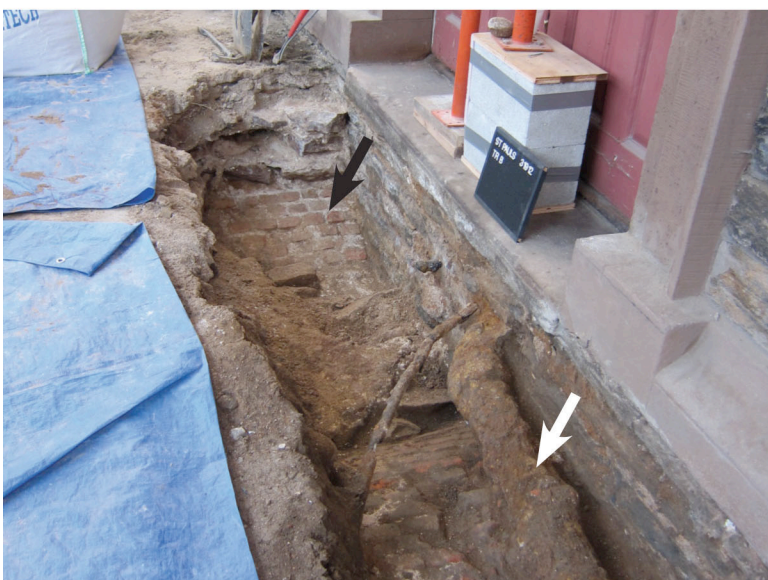
Photo 9. Excavation of Trench B (TR B) revealed that both vaults about the rear chapel wall. Waddington's vault (upper arrow) is intact but Ogden's has been compromised but not breached by a sanitary drain (white arrow) that runs along the back wall. (3/19/12)

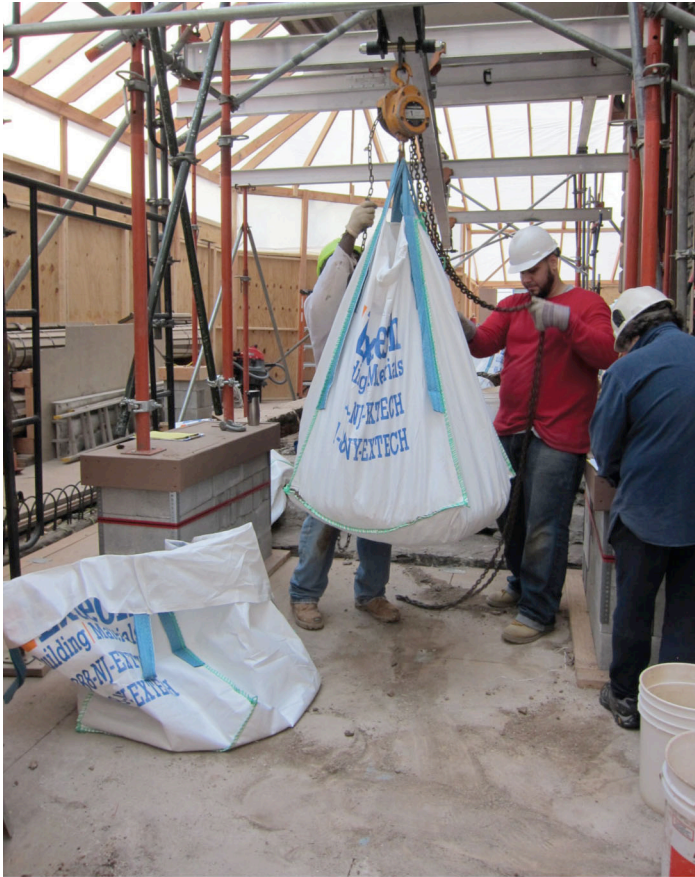
Photo 10. ICC crew moving a soil-filled Tyvek bag to the screening area out of view to the right. (3/19/12)

In a very smoothly coordinated effort carried out by ICC that involved an overhead track and pulleys (Photo 10), the bagged soil was made available for sampling. This was undertaken with the understanding that the proposed 25 percent sampling strategy would be revised if warranted, but this proved unnecessary as the soil was, indeed, virtually devoid of cultural material. Exceptions included a few food bones (identified by Matthew Brown, a faunal specialist who participated in the screening), one whole but small oyster shell, and several oyster shell fragments, a clam shell fragment, snippets of "modern" candy wrappers, a single glass bottle fragment, several badly corroded but possibly wrought nails, and a plastic-tipped bobbi pin. Most of this material came from a cache of debris located in the southeast corner of TR B (Photo 11), apparently associated with the introduction or repair of the aforementioned sanitary drain.

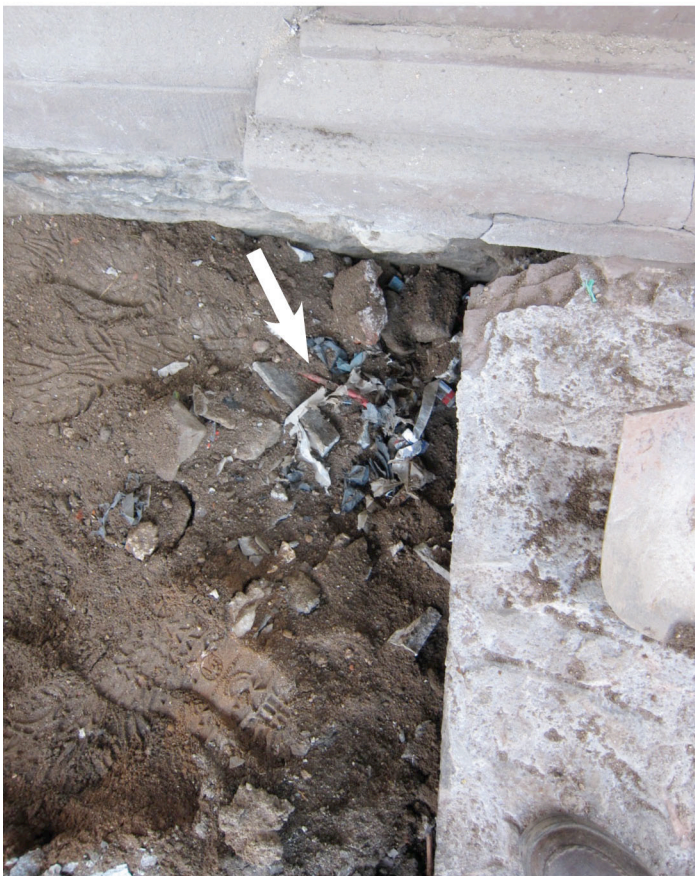
Photo 11. Concentration of debris (arrow) in the southeast corner of Trench B (TR B). The “modern” material is probably associated with plumbing repairs. (3/19/12)

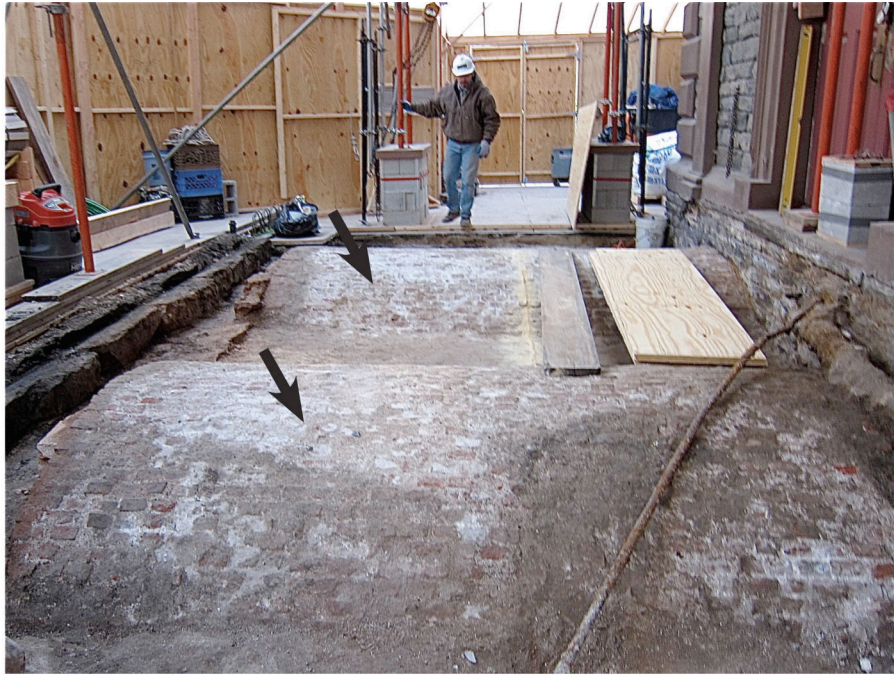
Archaeological monitoring and screening officially ended on March 19. However, the fully exposed top of both vaults was documented on a subsequent site visit (Photo 12). At that time, it was also confirmed the vaults filled the entire portico footprint, which would make them more than 8 feet wide. Excavation had also exposed the top of brick access "tunnels" (Photo 13) that enclose steps leading into the vaults. As described in an article about the 1942 interment of Fanny Ogden, Thomas Ogden's granddaughter, in 1942,¹⁶ access to these steps is buried just beyond the portico's west retaining wall:¹⁷

Photo 12. The top of the arched brick Waddington (upper arrow) and Ogden (lower arrow) vaults fully exposed. The view is north. (3/27/12)

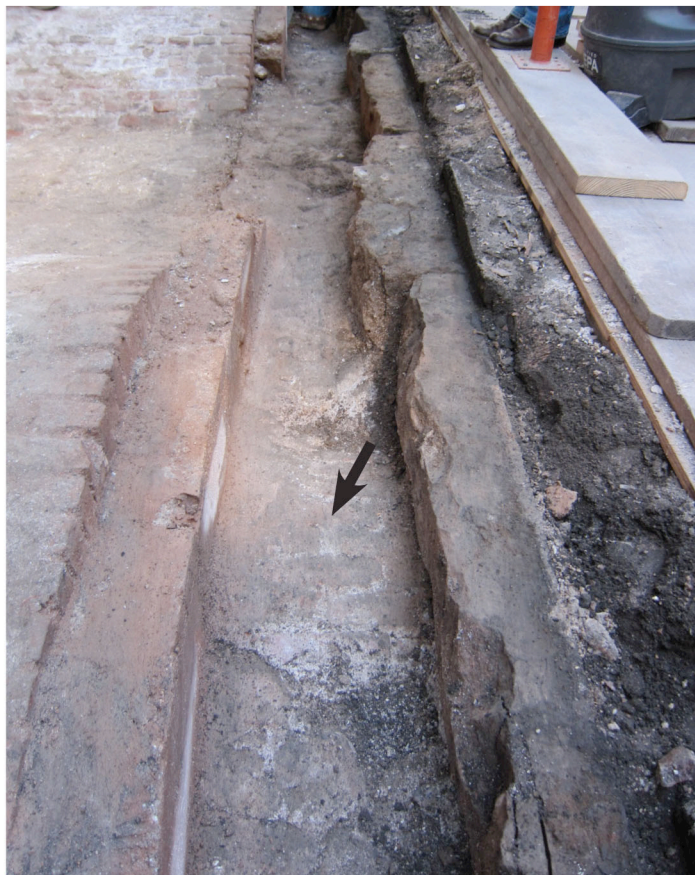
Photo 13. Further excavation along the western edge of the vaults partially exposed the brick "tunnel" (arrow) enclosing underground steps to the Waddington vault. The west retaining wall (right) is to be replaced. (3/27/12)
