**Phase II Archaeological Testing  
Test Areas 6 and 7  
Brooklyn Bridge Park Project**

**Brooklyn, New York**

## **Abstract**

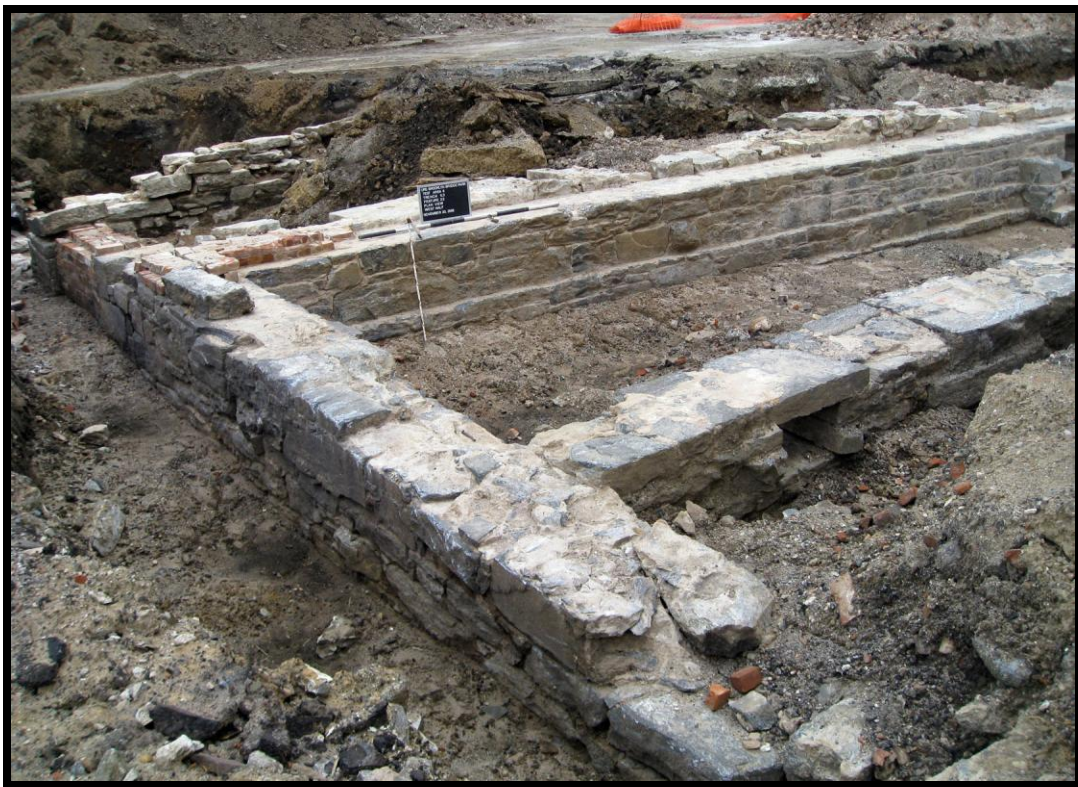
The exposure of a larger area revealed that although the foundations uncovered in the Phase IB investigation represented two distinct buildings, they were on the same and not different orientations (Photograph 4.1). Two distinct north-south oriented walls (Features 22 and 24) and four east-west oriented walls (Features 11, 12, 13, and 23) were uncovered (Figure 4.3) (see Appendix A). These walls were connected in sequence, constructed of cut schist stone with a plain sand mortar. Some areas contained brick built atop the stone (Photograph 4.2).

Photograph 4.1 Test Area 6, Feature 22 foundation walls, looking northeast.

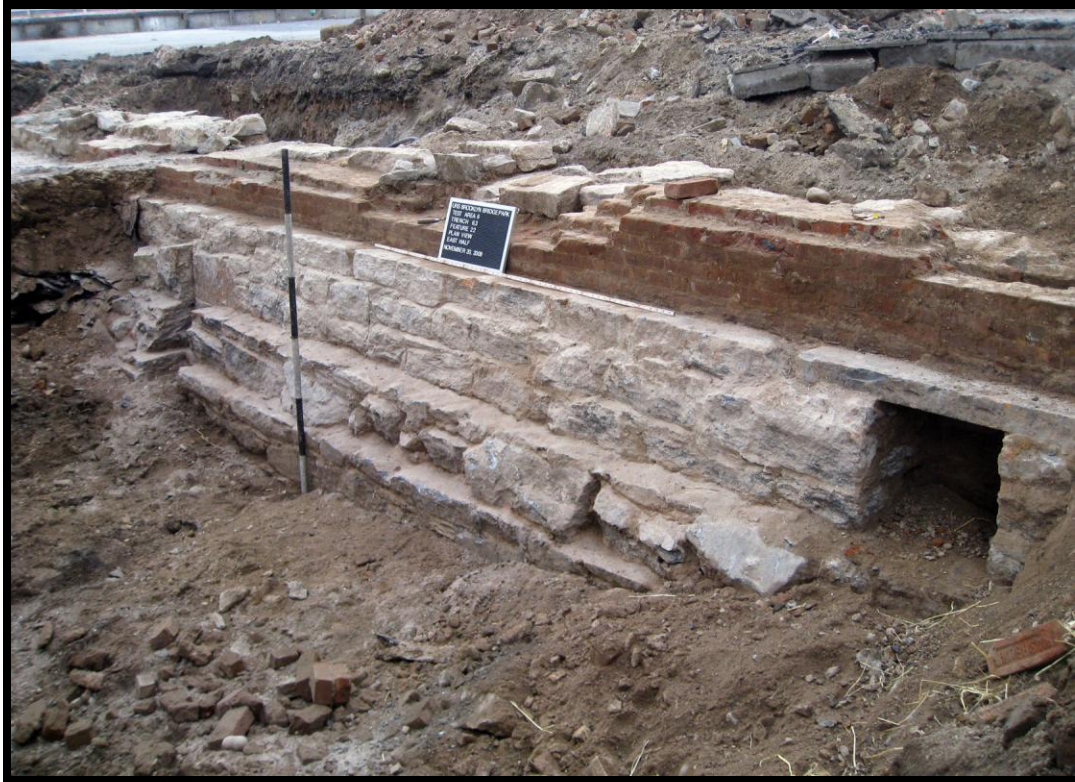
Photograph 4.2 Test Area 6, Feature 22, schist foundation wall with stepped footers and brick wall built atop the foundation, looking northwest.

Along the southern half of the center/party wall are stepped footers (Photographs 4.2 and 4.10). These extend 18 inches and run the length of the wall. At 9-foot intervals at the mid-section of the wall were three larger footers comprised of 30-inch-wide stone blocks and extending 24 inches. These footers further suggest this was a load-bearing exterior wall. Unmarked red bricks are built atop the wall, possibly remnant of the above surface walls of the structure. The red brick exterior would be fitting to the building style in the area during the nineteenth century (Figures 4.4 and 4.5; Photograph 4.11).

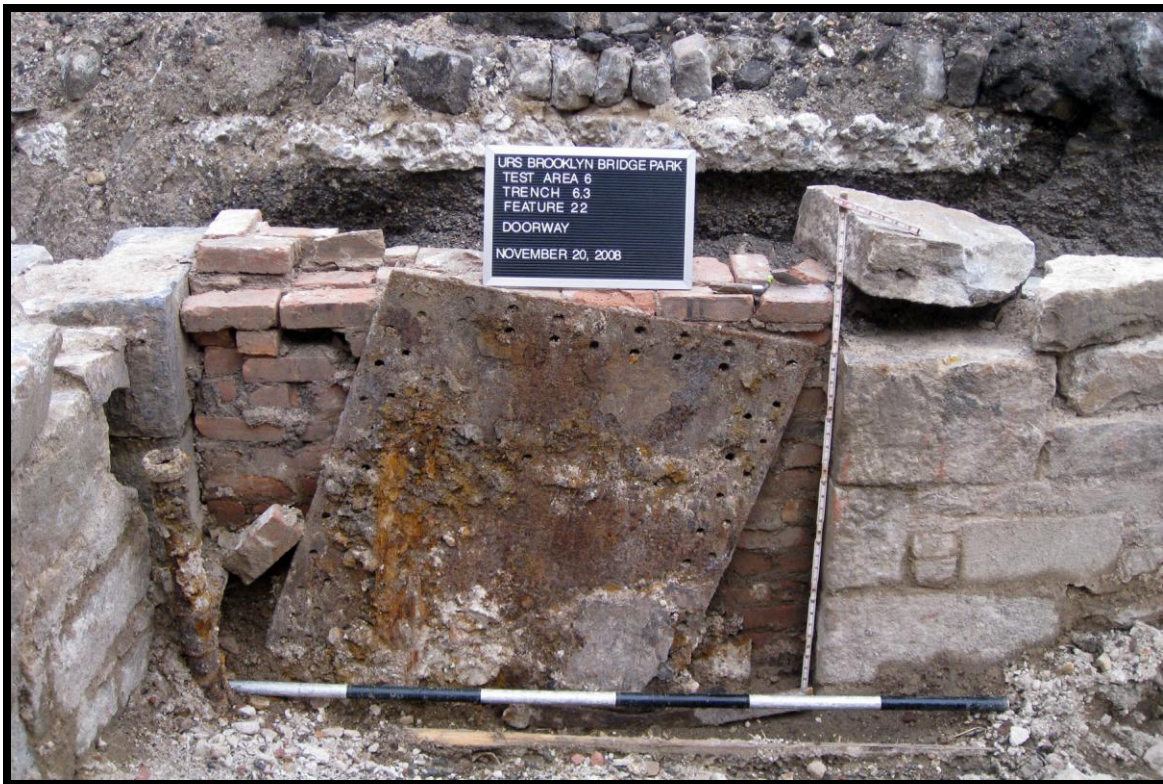
Photograph 4.3 Test Area 6, Feature 22, bricked-up doorway, looking west.

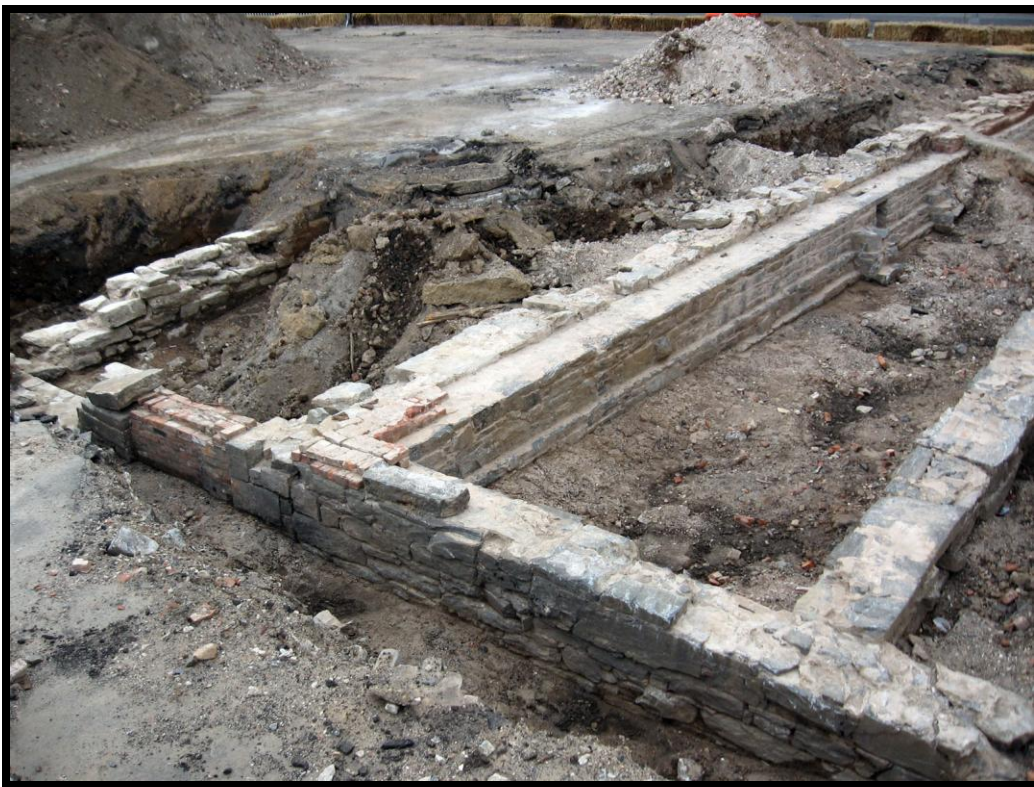
Photograph 4.4 Feature 22 schist foundation walls, looking northeast.

The exposure of a larger area revealed that Features 11, 12, and 22 formed one continuous structure. This continuous structure was designated as Structure 2 (see Figure 4.3; Photograph 4.4). It appears that the east-west oriented wall (Feature 11) formed basement divisions, or bays, for the structure. However, there was no means of egress between the bays. This suggests that access would have been via the first floor of the structure. A bricked-up doorway was uncovered along the southern end of a north-south oriented wall (Feature 22), what would have been the western wall of the structure (see Photograph 4.3). The doorway measures 5 feet wide and would have been associated with Bay 3 on the plan view schematic (see Figure 4.3). The base of the doorway was located at 6.2 feet below ground surface, identifying the nineteenth-century basement level of the structure as being approximately 6 feet below modern grade. It also indicates that there was access to the outside and the waterfront from this level.

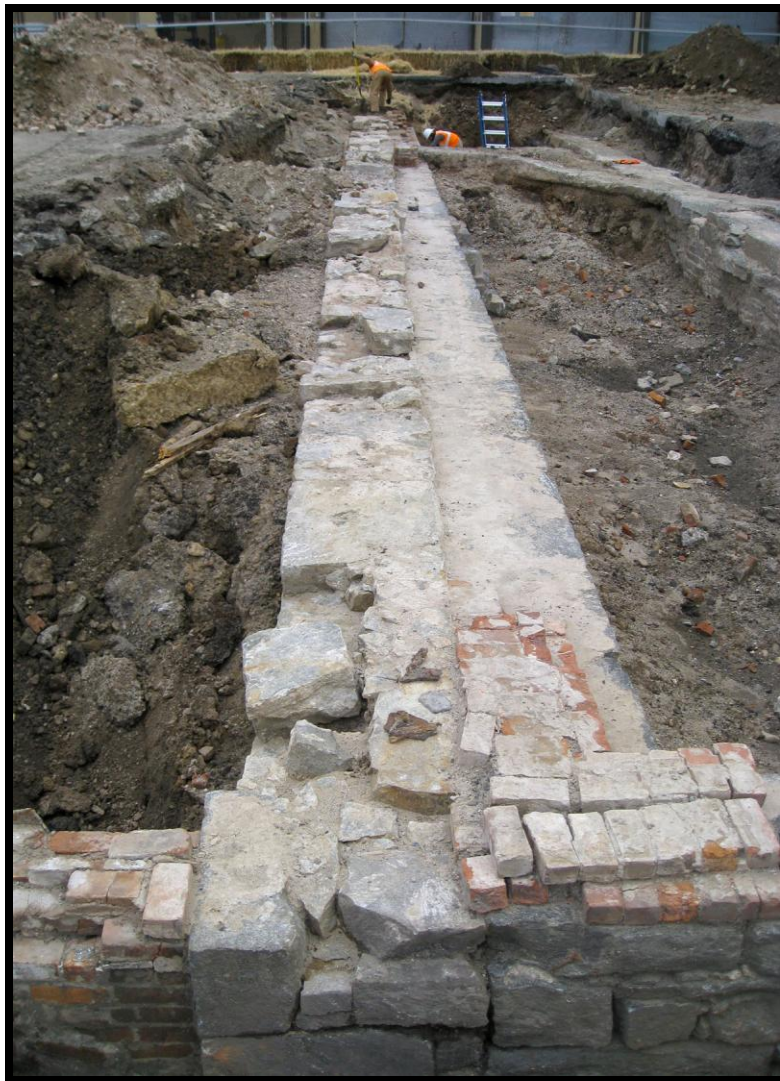
Photograph 4.5      Test Area 6, Features 12 and 13, wall referred to as the center/party wall between two buildings, looking east.

The wall between Structures 1 and 2 appears to be two separately constructed walls, each comprising the outside or exterior wall of a structure and later a party wall (i.e., separate buildings/addresses) (Photograph 4.5). It is double the width of the other walls exposed and there are slight differences in the construction of either half of the wall supporting this conclusion. Both halves of the wall are constructed of cut schist stone. However, the southern half of the wall (Feature 23) is constructed of stones that are fairly uniform, while the northern half (Feature 12) is composed of stones of varying size and shape. The mortar along the northern half does not appear to have the same compaction or density as the mortar along the southern half of the wall.

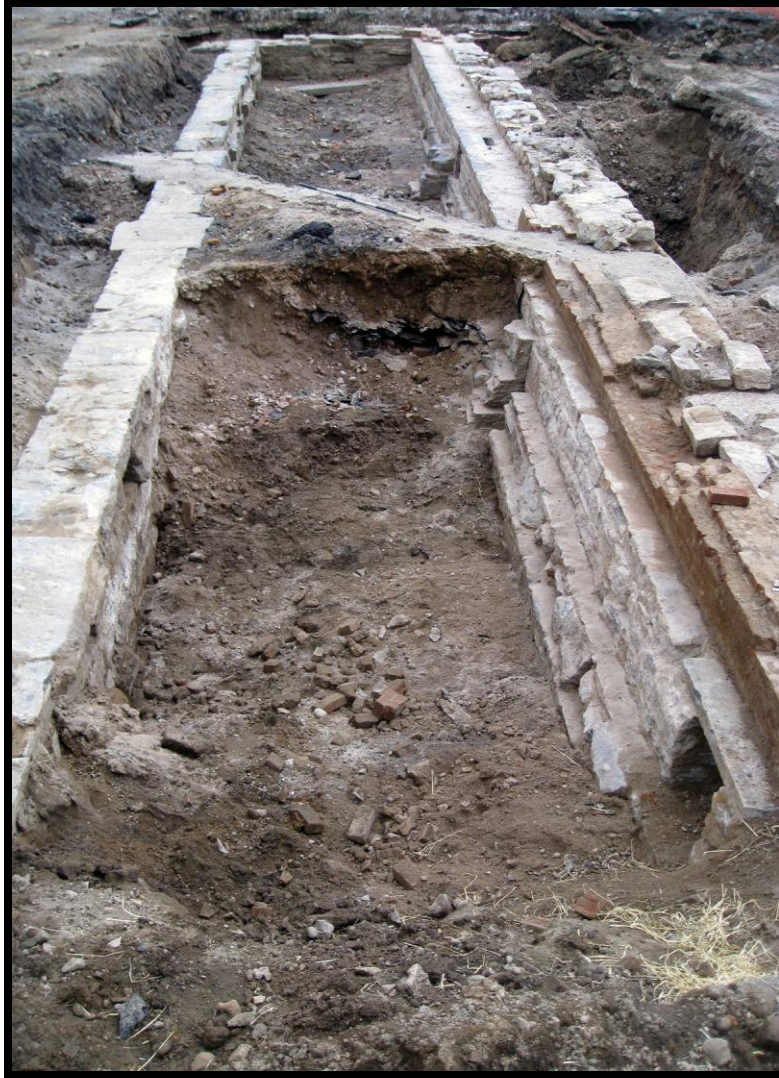
The entire length from the western wall to approximately 5 feet from the property line at Furman Street was excavated between Features 11, 23, and 24 (Photograph 4.6), or would have formed Bay 2 of Structure 1 immediately adjacent to the National Cold Storage building (see Figure 4.3; see Photograph 4.6). Along the southernmost wall (Feature 11), two rectangular openings—measuring 1.3 x 1.1 feet and extending through to the other side of the wall—were observed (Photograph 4.7). There also appears to have been two additional similar openings along the wall that had been closed some time after their construction.

Photograph 4.6 Test Area 6, Feature 25 (Structure 1), length of the structure excavated as seen from Furman Street, looking west.

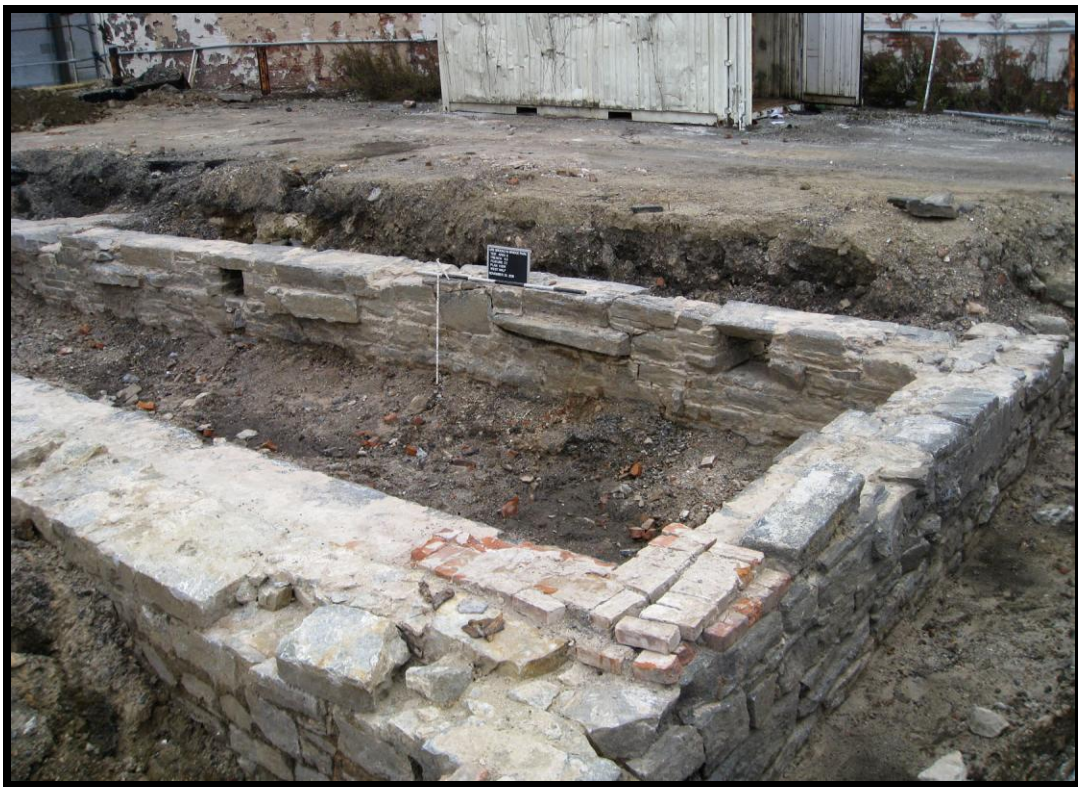
Photograph 4.7 Test Area 6, Feature 25 (Structure 1), rectangular openings built into the foundation wall, looking southeast.

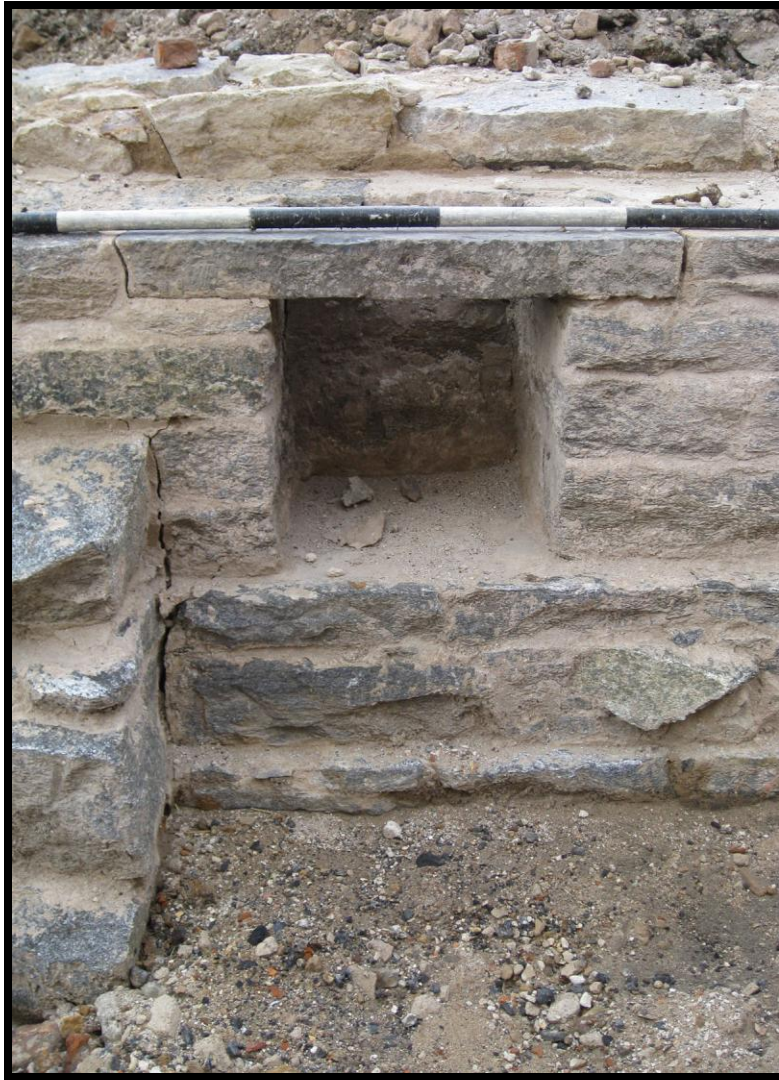
Photograph 4.8      Test Area 6, Feature 25 (Structure 1), close-up of rectangular opening along the southern half of the center/party foundation wall, looking north.

Along the northern wall (Feature 23) of Structure 1, two similarly constructed rectangular openings were also observed. Unlike those on the southern wall, these were not open to the other side or to what would be the basement of the adjoining structure (Photograph 4.8). These openings were abutted against and blocked, or closed, by the neighboring foundation wall. The top of the opening is comprised of a stone slab with an opening. There is no evidence of brick having been built atop this area of the foundation, and it could have aligned to lie between the joists of the interior wall (Photograph 4.9). It is hypothesized that these openings facilitated some form of airflow within the structure. They were probably retrofitted after the southern wall of Structure 2 was against the northern wall of Structure 1, indicating that it post-dates Structure 1.

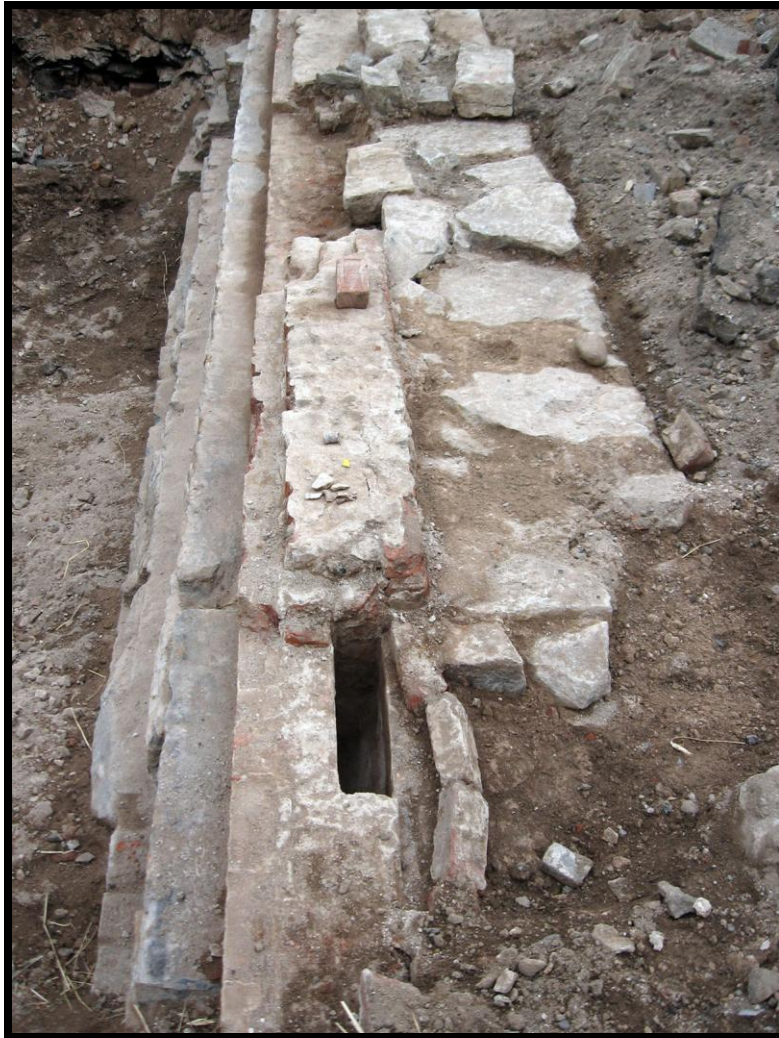
Photograph 4.9 Test Area 6, Feature 25 (Structure 1), top of rectangular opening along the southern half of the center/party foundation wall, looking west.

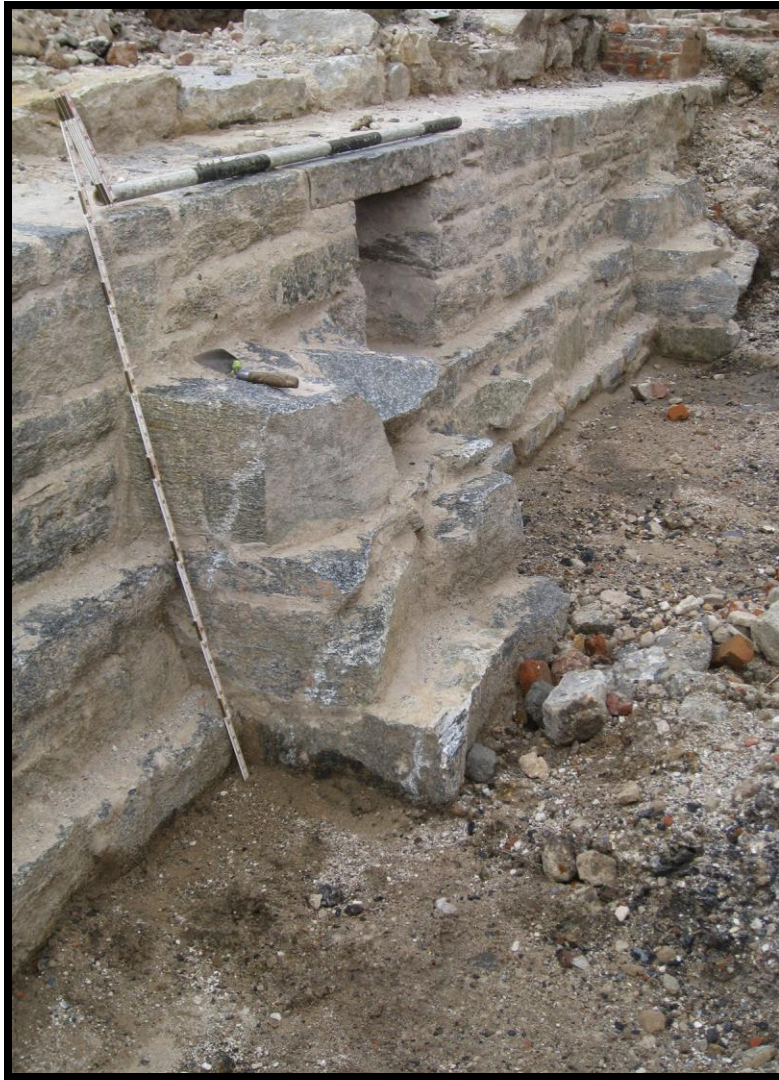
Photograph 4.10 Test Area 6, Feature 17, one of three stepped footers along the southern half of the center/party foundation wall, looking northeast.

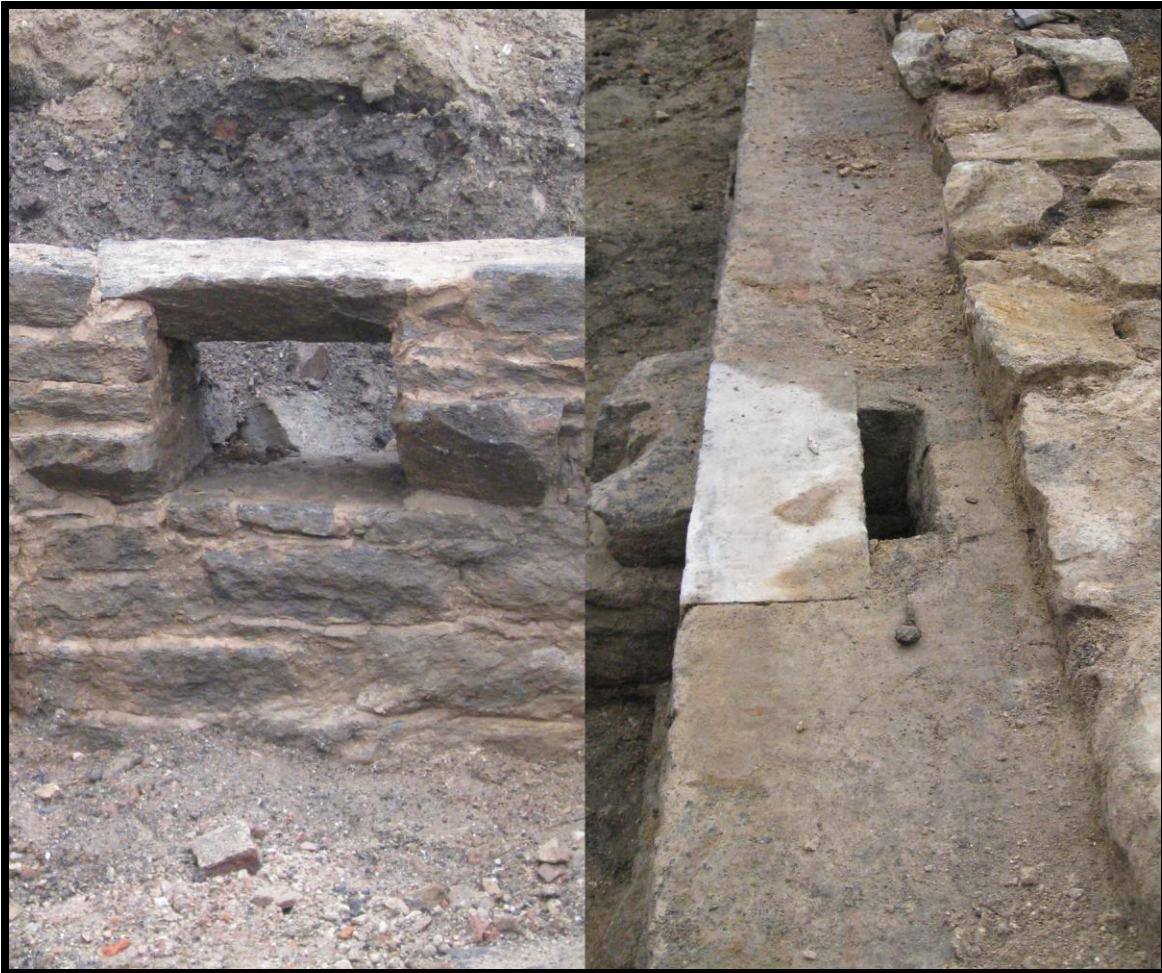
Ventilation of cold storage rooms was effected in various ways. Ventilating shafts located in the ceiling of storage rooms were often used as a means to effect a change of air (Siebel 1899:186). If properly constructed, ventilating shafts will meet all ventilation requirements. It is noted that the best location for these air ducts is within each room through the sidewall near the ceiling (Siebel 1899; Cooper 1905). The following diagrams show recommended construction and placement for airflow (Figures 4.6 and 4.7). These diagrams show construction consistent with that exposed in the foundation walls of Test Area 6 (Photograph 4.12).

Photograph 4.12      Composite image displaying the side and top of ventilation openings within the foundation wall. This is consistent with the design in diagrams featured in Figures 4.6 and 4.7.

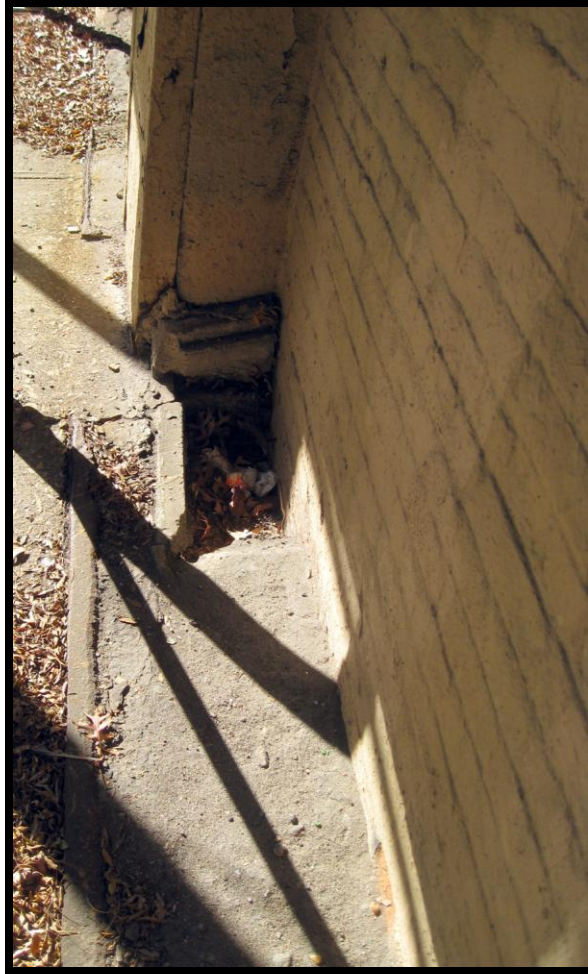
A walking survey of the area surrounding the then extant National Cold Storage building allowed observation of a rectangular opening in the sidewalk along the foundation of the building (Photograph 4.13), corresponding to open spaces within the foundation of the building. The similarity between this feature and those observed in the excavated foundations further suggests that they facilitate some form of airflow.

Photograph 4.13 Sidewalk vent alongside the National Cold Storage Building.

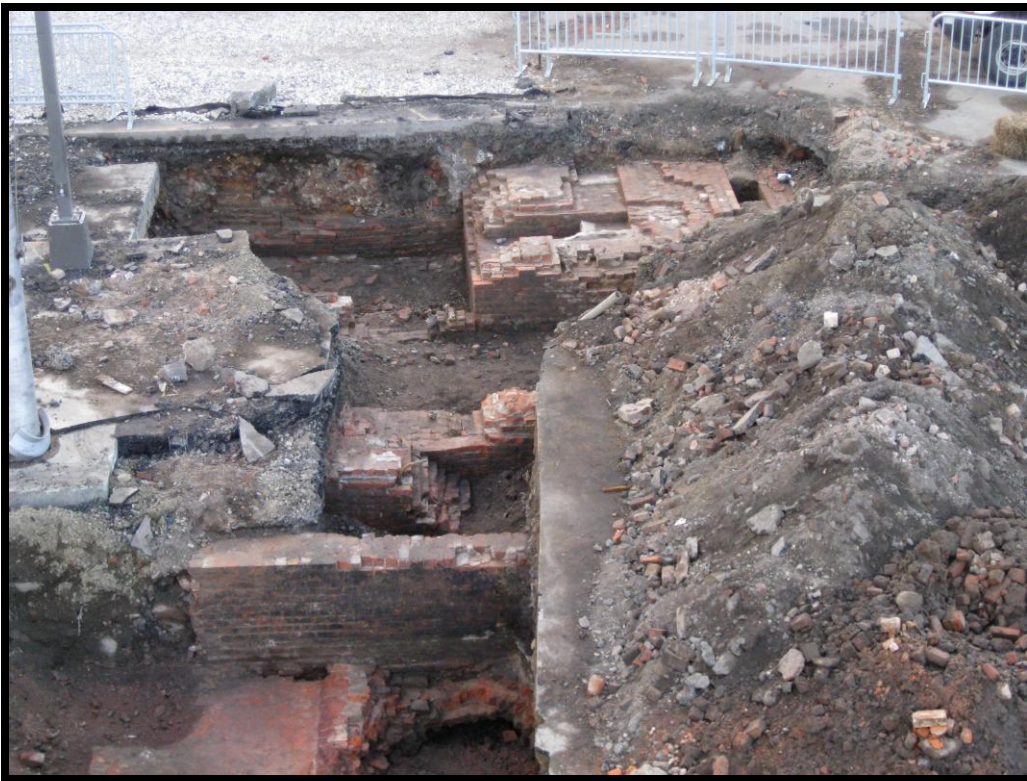
Photograph 4.16 Test Area 7, section of mill complex (Feature 14), looking east.

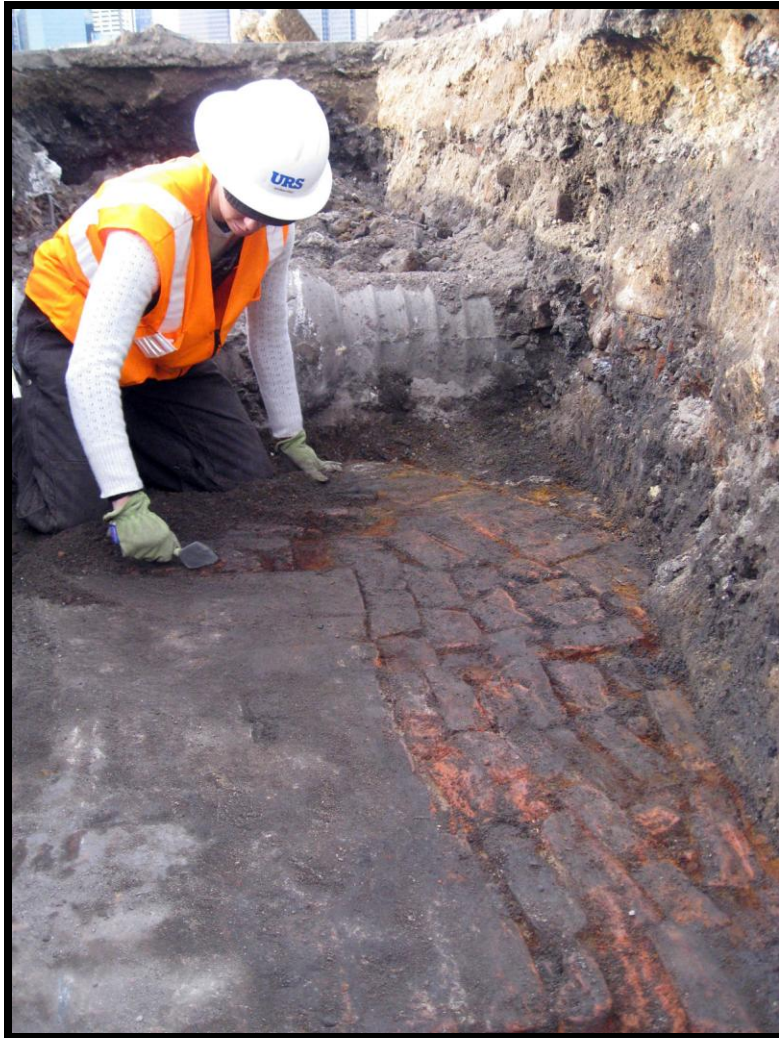
Photograph 4.17 Test Area 7, hand clearing basement floor of mill complex (Feature 14), looking west.

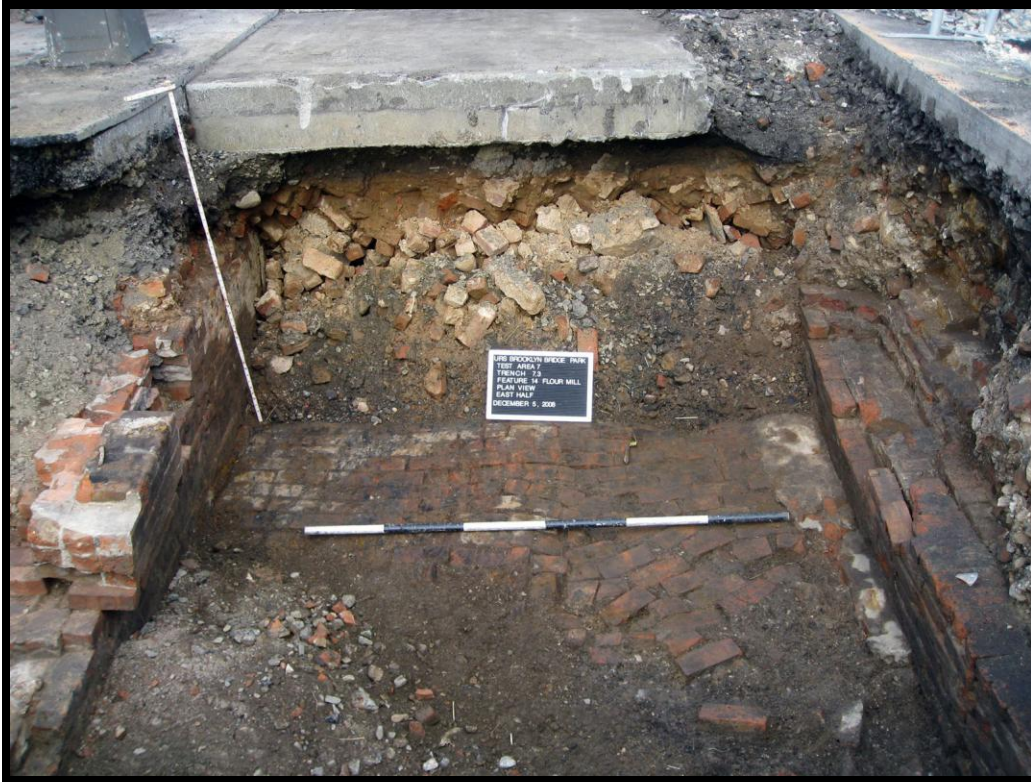
Photograph 4.18 Test Area 7, brick floor, looking north.

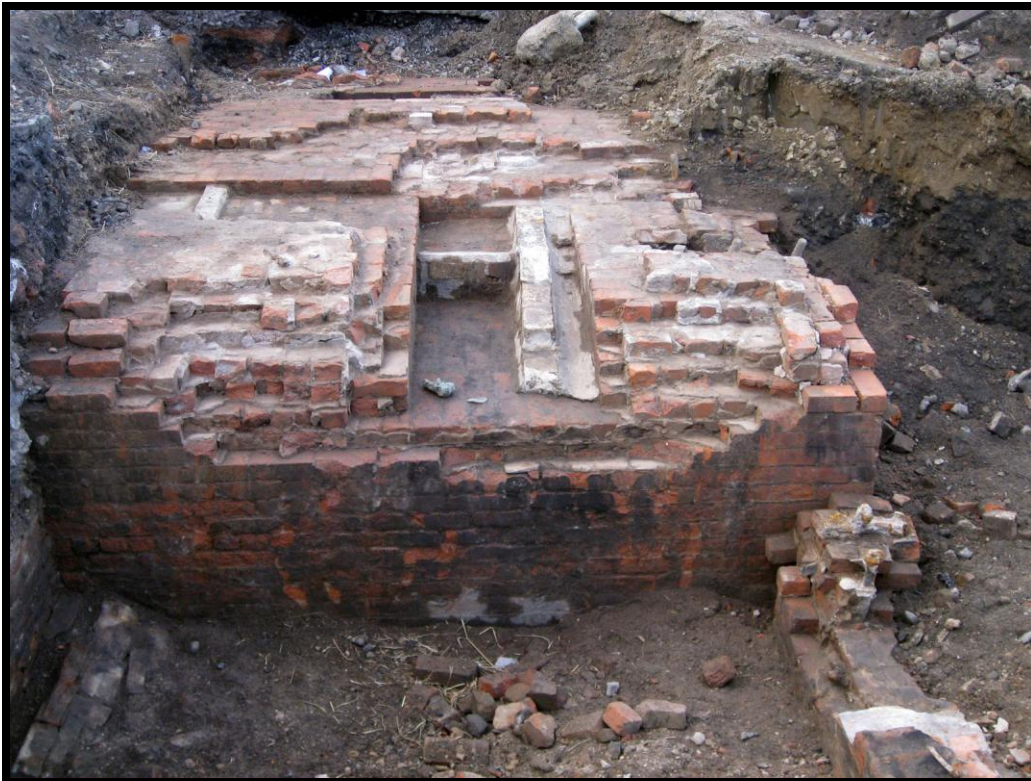
Photograph 4.19 Test Area 7, possible support base for boiler, looking south.

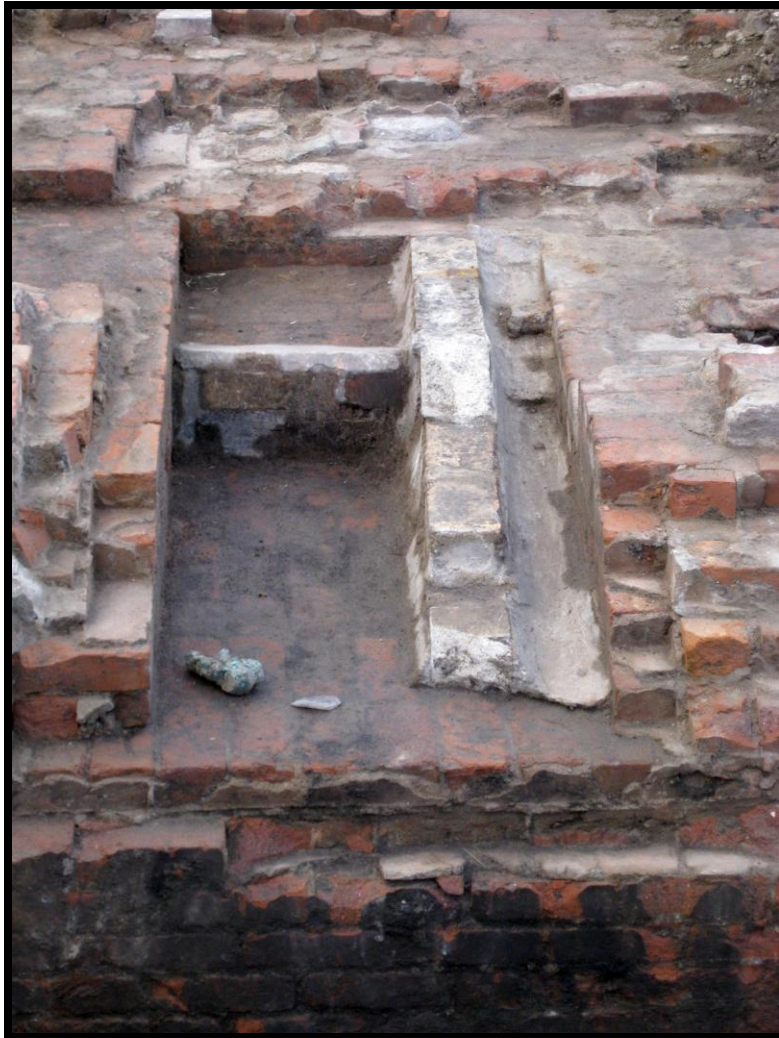
Trench 7.3 was placed to further investigate the brick conduit and to examine and record any mill remains in the area of the proposed guardhouse. The trench re-exposed and uncovered additional sections of the mill complex, revealing a series of foundation walls that appear to represent extensions to the rear of the mill building (Figure 4.10; Photographs 4.17 and 4.18). In several areas, brick floor surfaces were uncovered at approximately 5 feet below surface. These floor surfaces likely represent the basement level of the structure (Photograph 4.19). Excavations did not occur beneath the brick floor surface due to tide issues. At high tide, water rose in several areas and covered the exposed floor within the trench up to 2–3 feet deep. A large rectangular base constructed of brick occupies the western end of Trench 7.3. The surface of the base is multi-leveled with a tiered pad and two channels. Both channels are cement slipped. One of the channels is recessed 1.5 feet and slopes from the center of the base toward its edge. The edge of the base is situated 2.5 feet above the brick floor (Photographs 4.20 and 4.21).

Photograph 4.20 Test Area 7, brick base with channels inset, looking south. The channeled area is constructed of fire-brick and faced with cement.

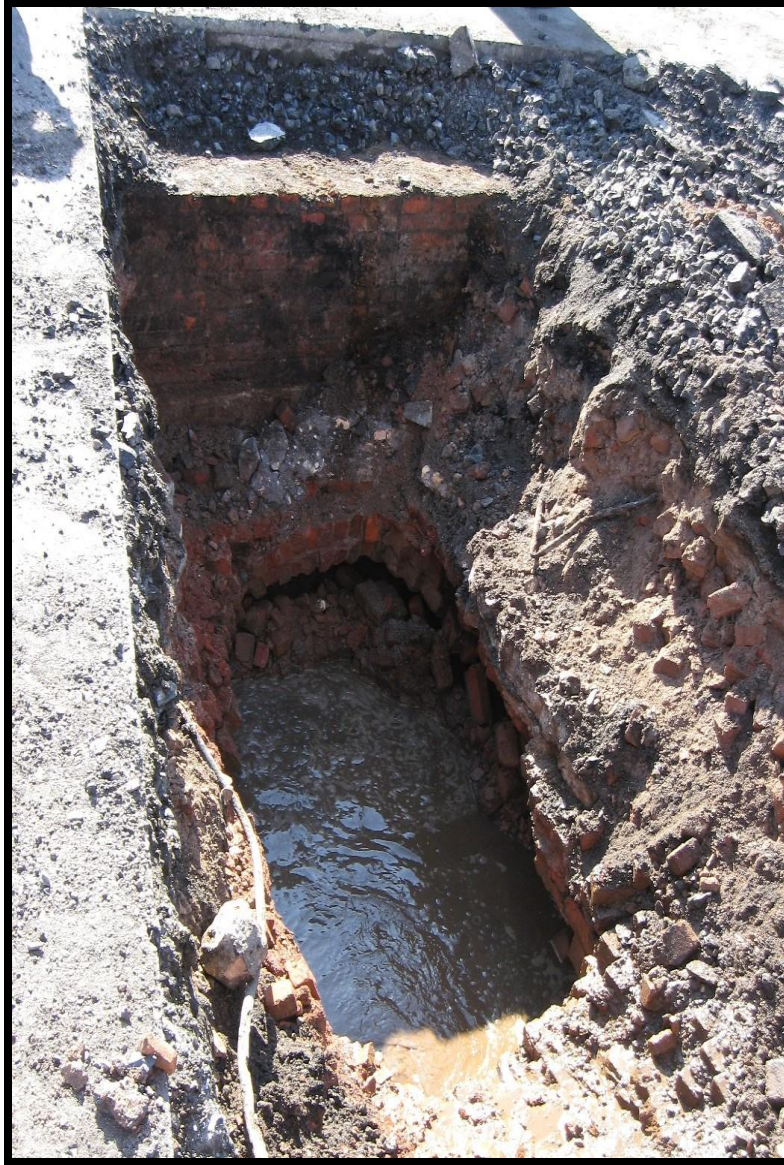
Photograph 4.21      Test Area 7, original conduit exposed during Phase IB testing, looking east.

brick (see Photograph 4.21). What was thought to have been a brick floor turned out to be the top of a brick-lined conduit. Therefore, a portion of Trench 7.3 was positioned to expose more of the outside or northern edge of the conduit. An additional area of the previously identified concrete “floor” was removed and a second conduit (Conduit 2) was uncovered to the north, abutting the original one (Photograph 4.22). Both were located at 4.8 feet below surface. The discovery of this second conduit raised the question of whether or not these were the only two conduits or additional ones may be present in sequence. Testing constraints (limited to areas of proposed disturbance) did not allow for further investigation.

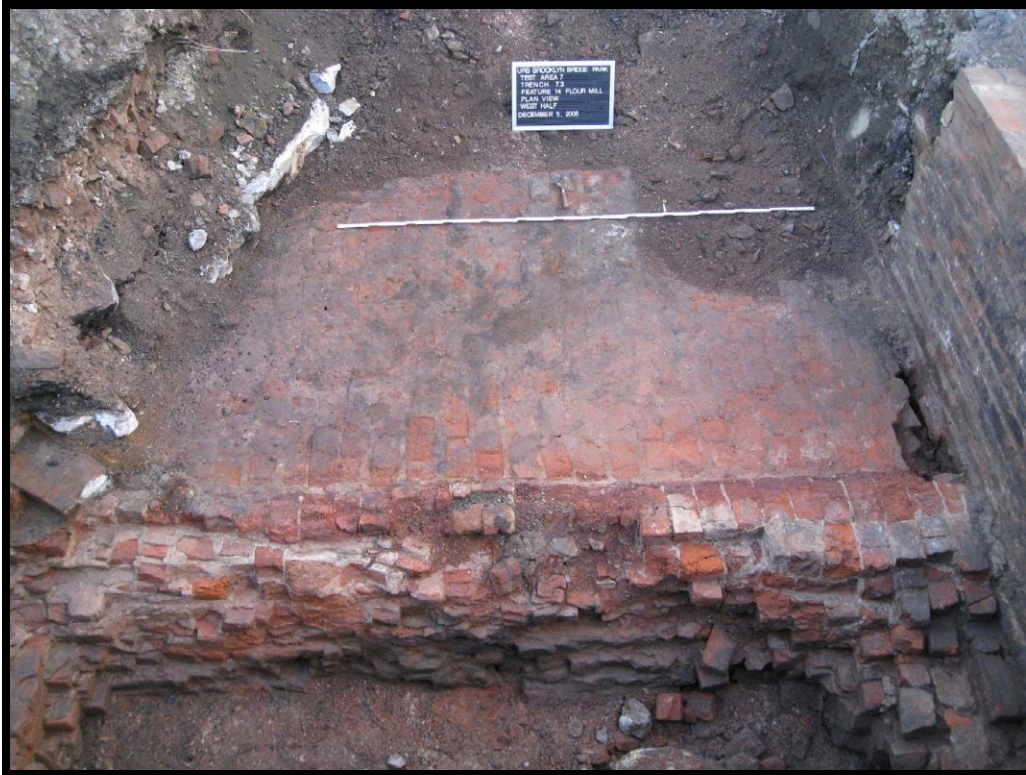
Photograph 4.22 Test Area 7, brick floor and sidewall of newly discovered conduit, looking north.

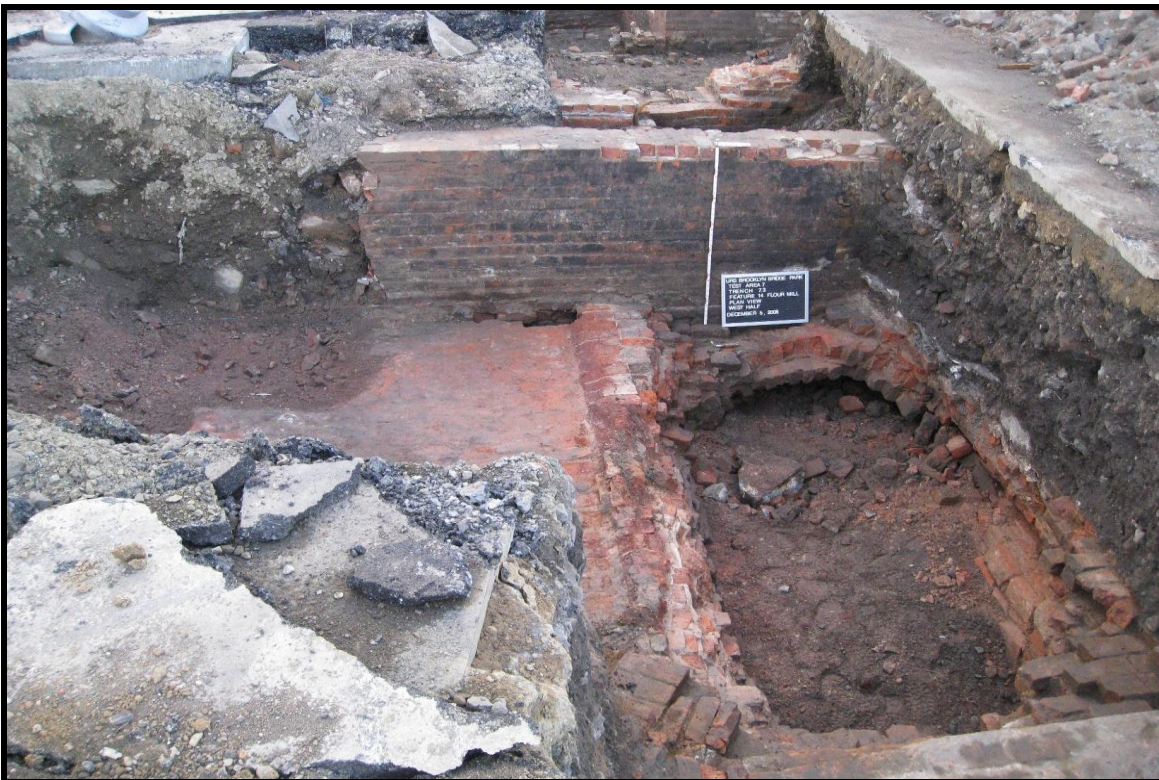
Photograph 4.23 Test Area 7, interior of original conduit discovered during Phase IB testing. Second conduit lies beneath brick surface, looking south.

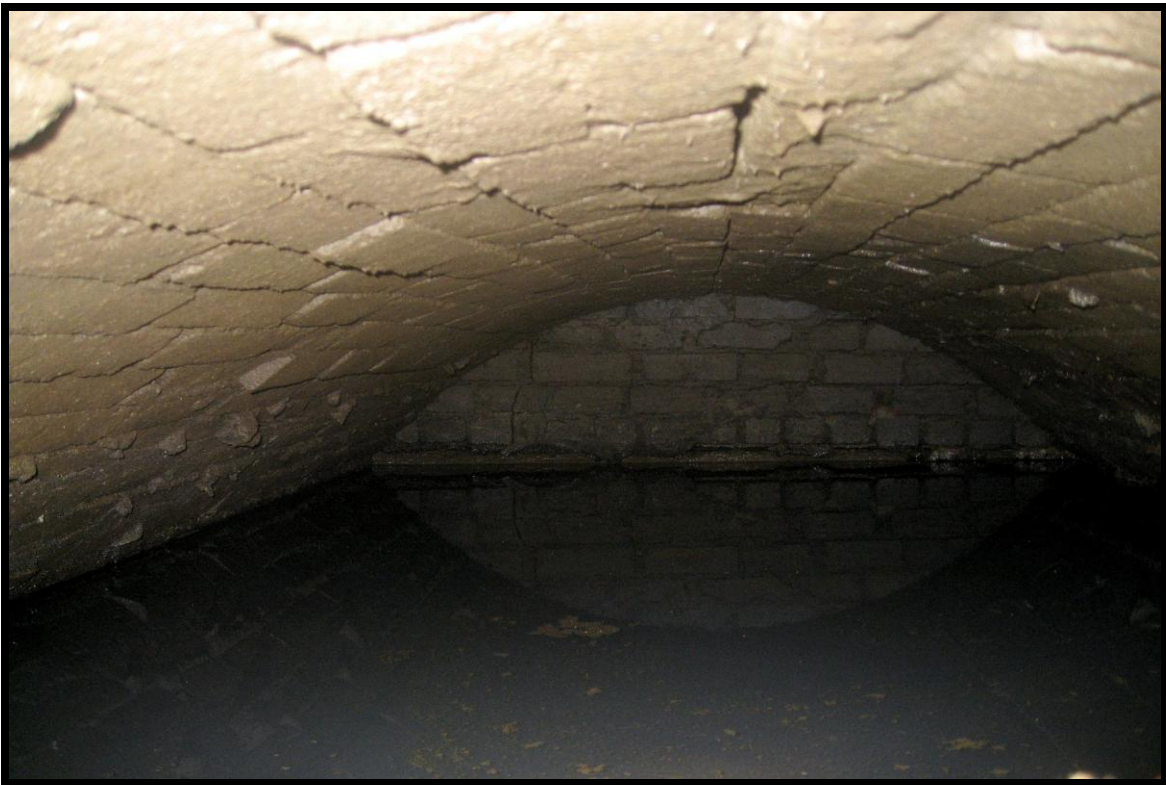
Photograph 4.24 Test Area 7, interior of original conduit with brick wall sealing it off, looking west.

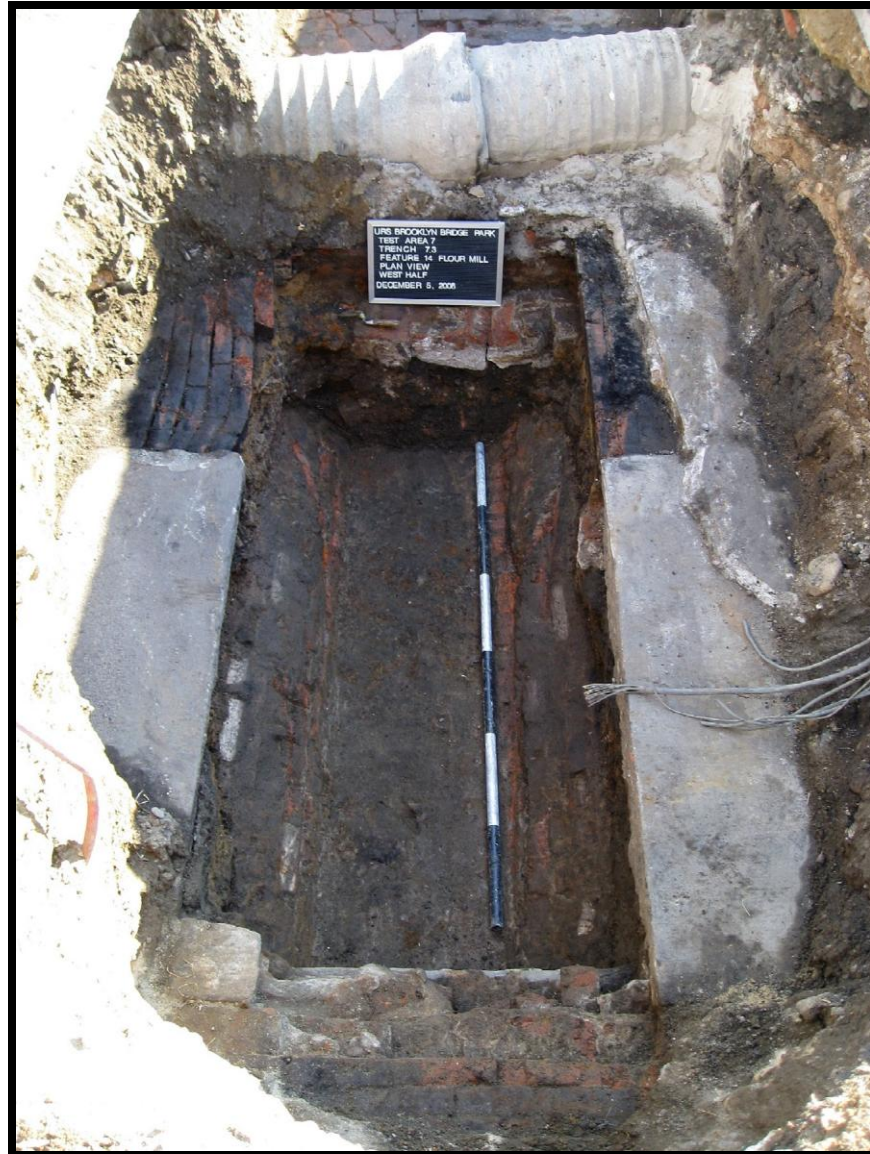
Photograph 4.25 Test Area 7, area between the two conduits showing diversion, looking east.

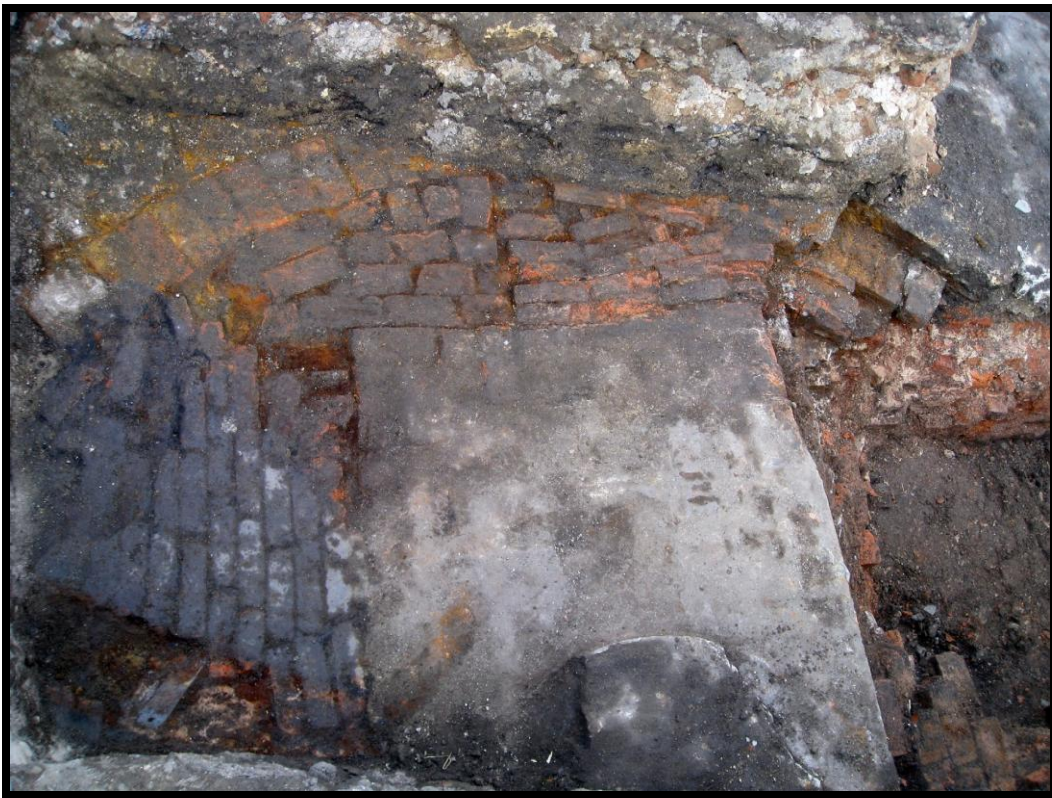
Photograph 4.26 Test Area 7, circular brick pattern with rectangular interior brick pattern covered in cement slip above the two conduits, looking north.
