**Phase II Archaeological Testing  
Test Areas 6 and 7  
Brooklyn Bridge Park Project**

**Brooklyn, New York**

## **Abstract**

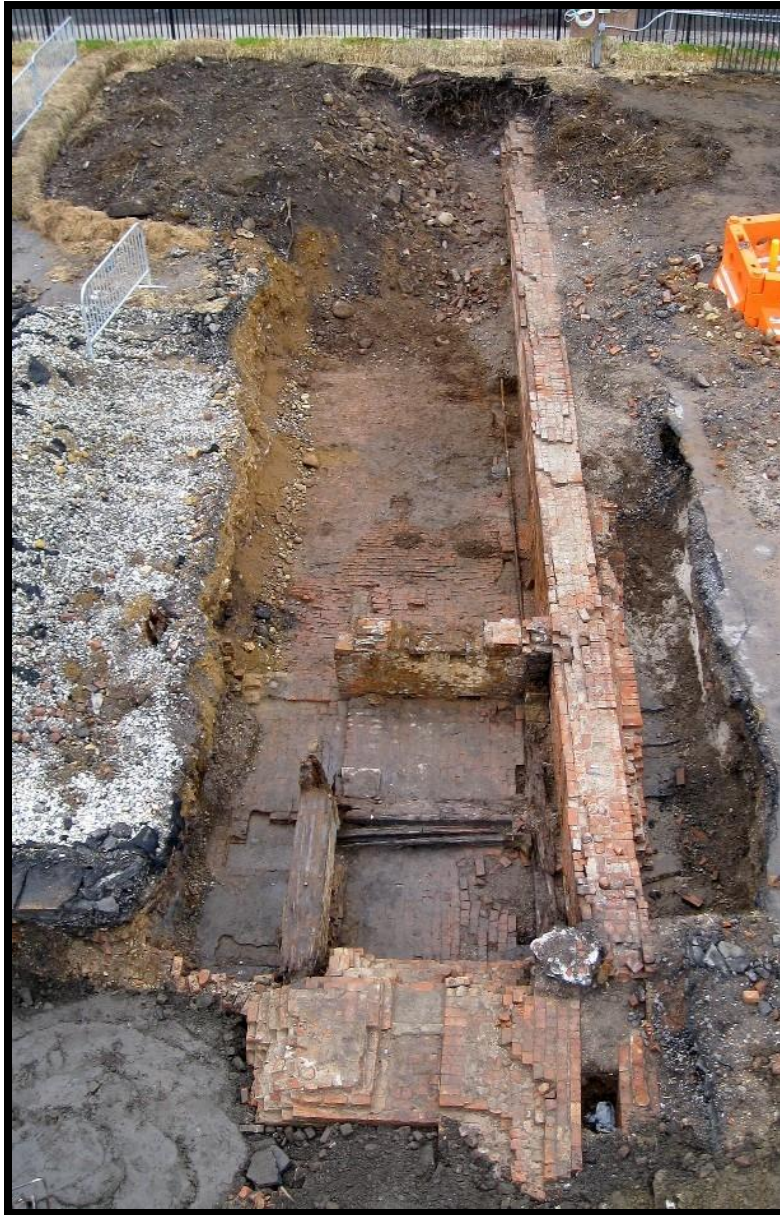
Photograph 4.27 Test Area 7, Trench 7.4, aerial view of eastern mill foundations (Feature 14), looking east.

Trench 7.4 measured 62.5 x 19 feet and began from the eastern edge of Trench 7.3 (see Figure 4.5). It exposed the eastern edge of the brick base and almost the full length of the primary mill structure’s southern foundation wall (Figure 4.11; Photograph 4.27). A brick floor was uncovered at 5 feet below surface, representing the basement of the building (Photographs 4.27 and 4. 28). While almost the complete east to west length of the building was exposed, only 16 feet of its width along Furman Street was excavated to allow for continued access to the Old Fulton Street entrance to the property.

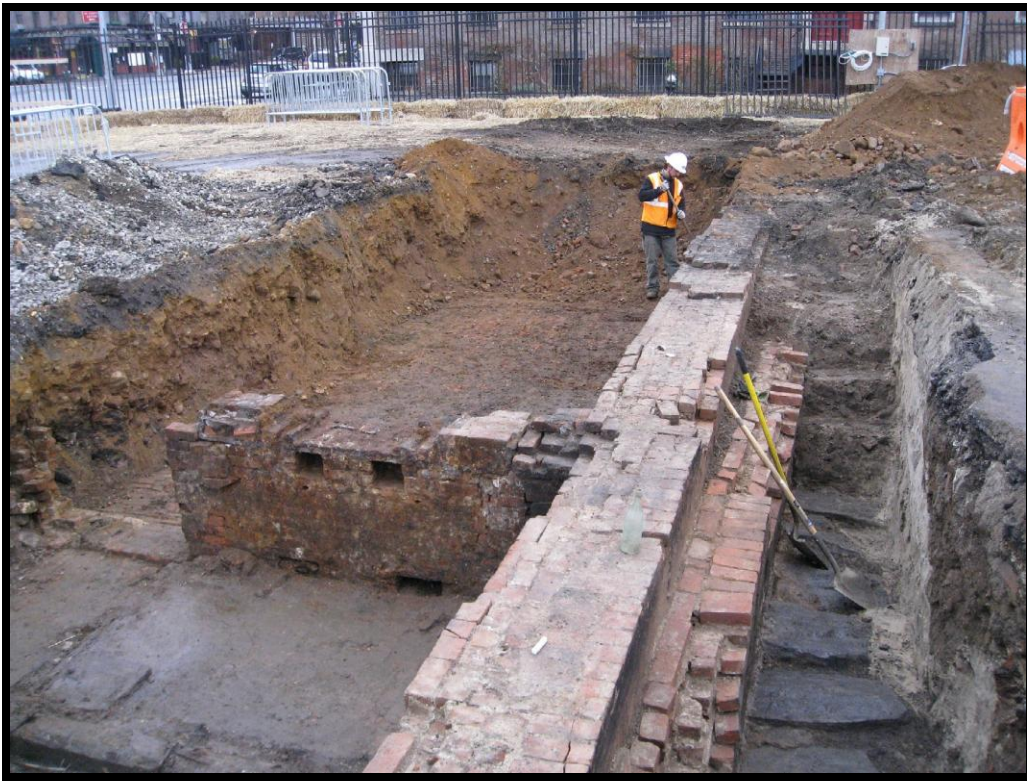
Photograph 4.28      Test Area 7, Trench 7.4, eastern end of mill foundations, looking northeast.

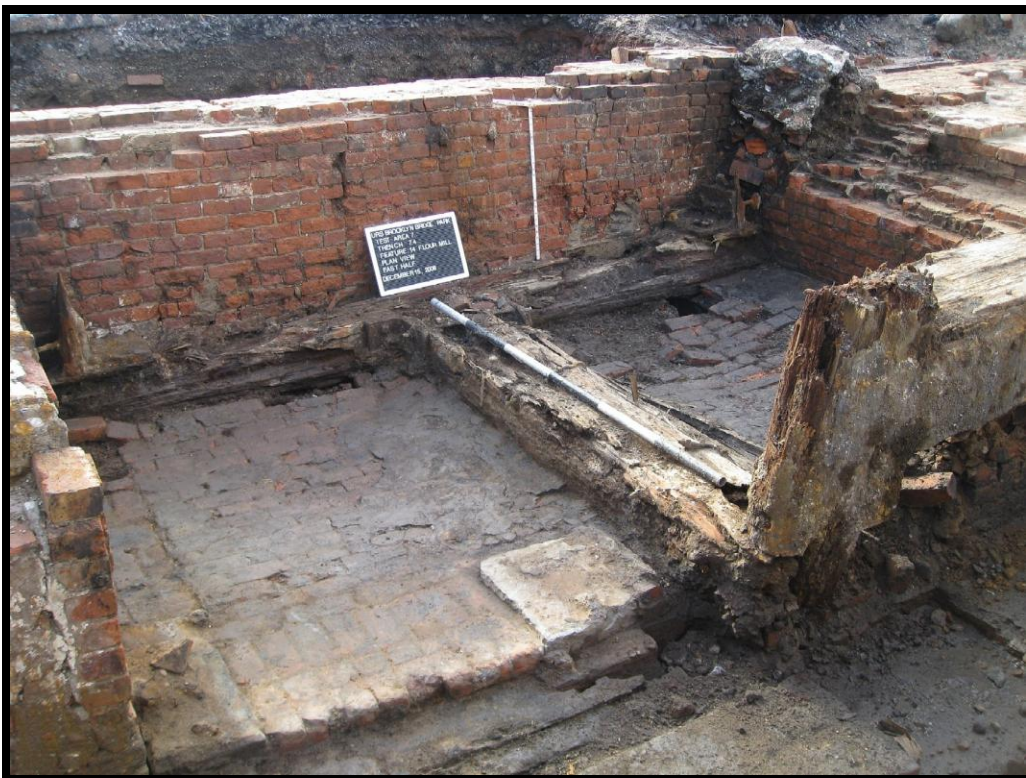
Photograph 4.29 Test Area 7, Trench 7.4, basement level at the southwestern end trench, looking southwest.

structure with a corridor along the northern side of the small room (Photographs 4.29 and 4.30). There could have been additional subdivisions in the northern half of the basement, but this area was not excavated because it was not in the area of potential effects. The larger portion of the basement area was devoid of any specific features other than a brick floor and a tension rod with turnbuckle that extended over 30 feet in length. The rod ran along the southern foundation wall and likely ran the entire length of the southern wall (Photographs 4.31 and 4.32). It was observed inset into the floor beneath the wooden beams within the small room. The foundation wall itself exhibited several areas with structural cracks (Photograph 4.33). The exterior of the southern wall was abutted by what appears to be a later foundation wall. Adjacent to this were several stepped bluestone slabs (Photograph 4.34). This immediate area had been filled with clean sand from earlier nearby utility work, which collapsed following inclement weather and could not be investigated further due to safety concerns.

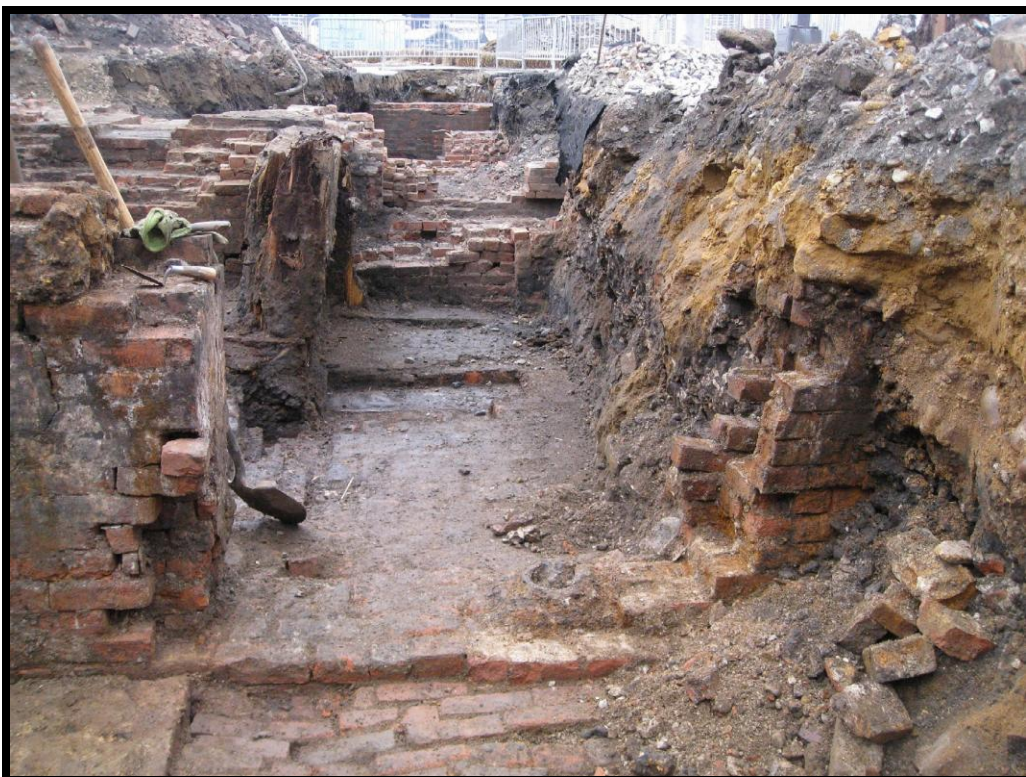
Photograph 4.30 Test Area 7, Trench 7.4, basement level corridor north of the small room at the southwestern corner of the mill building, looking west.

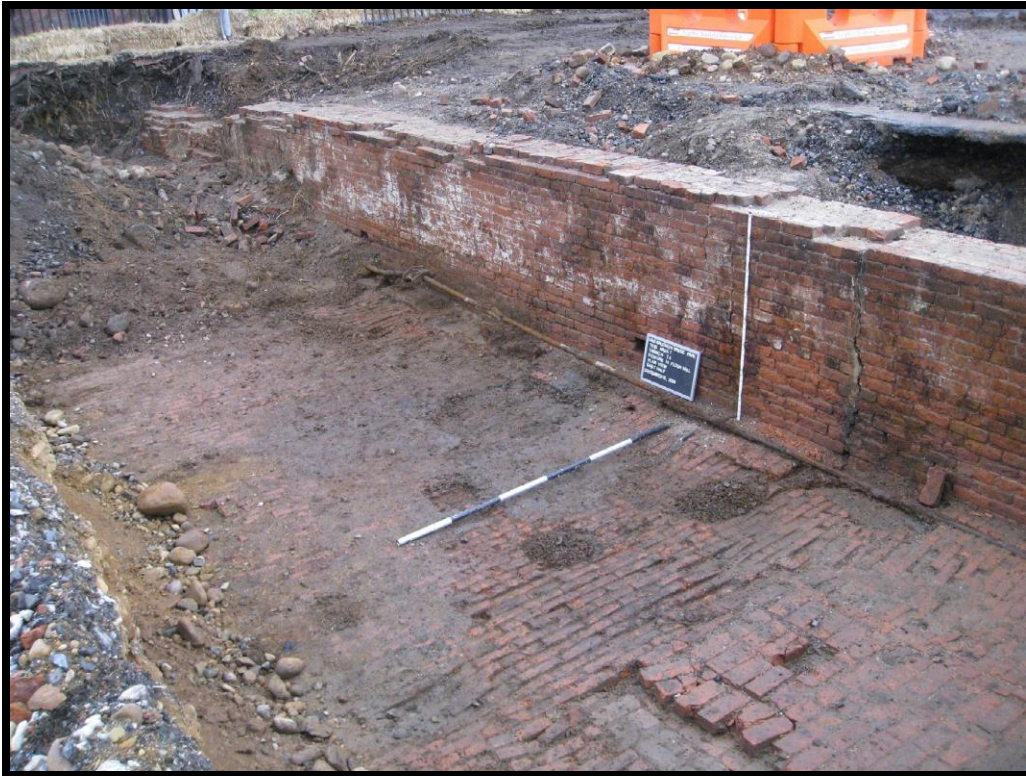
Photograph 4.31      Test Area 7, Trench 7.4, basement surface of main mill structure, looking southeast. Note structural crack in the foundation wall can be seen to the right.

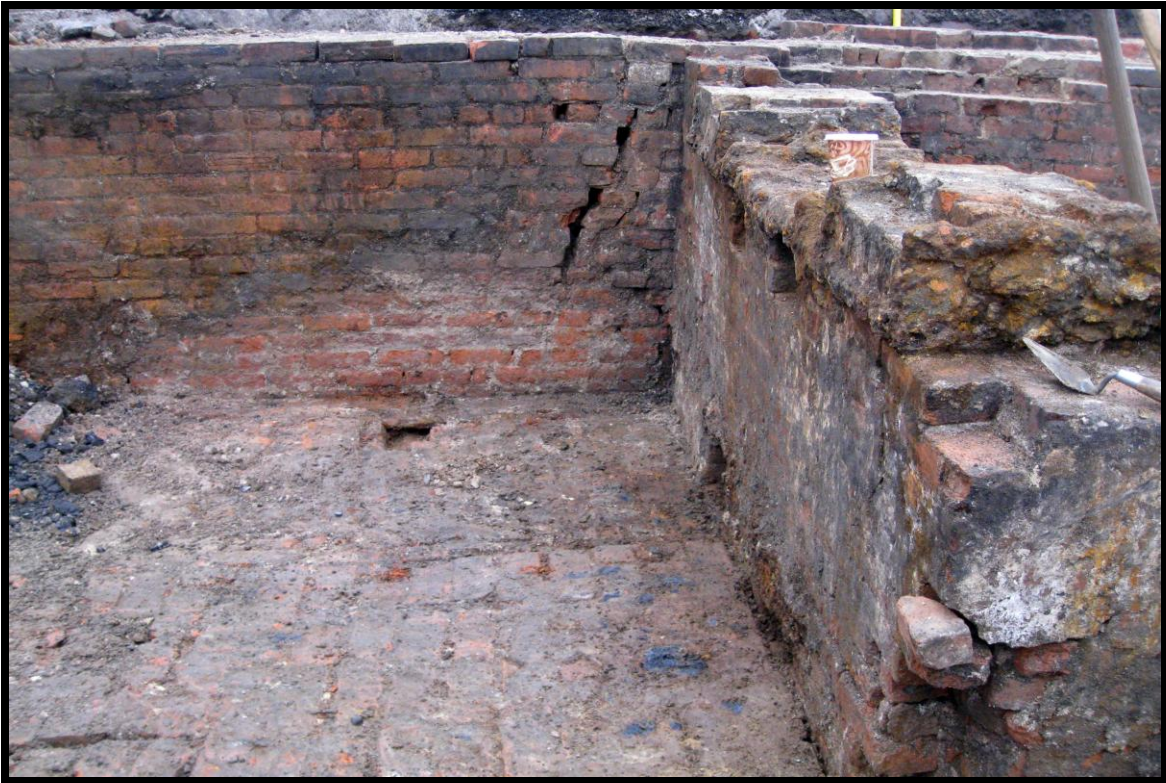
Photograph 4.33 Test Area 7, Trench 7.4, one of several structural cracks observed in the foundation wall, looking south. Boiler explosions, known to have occurred in this area of the mill, likely caused this damage.

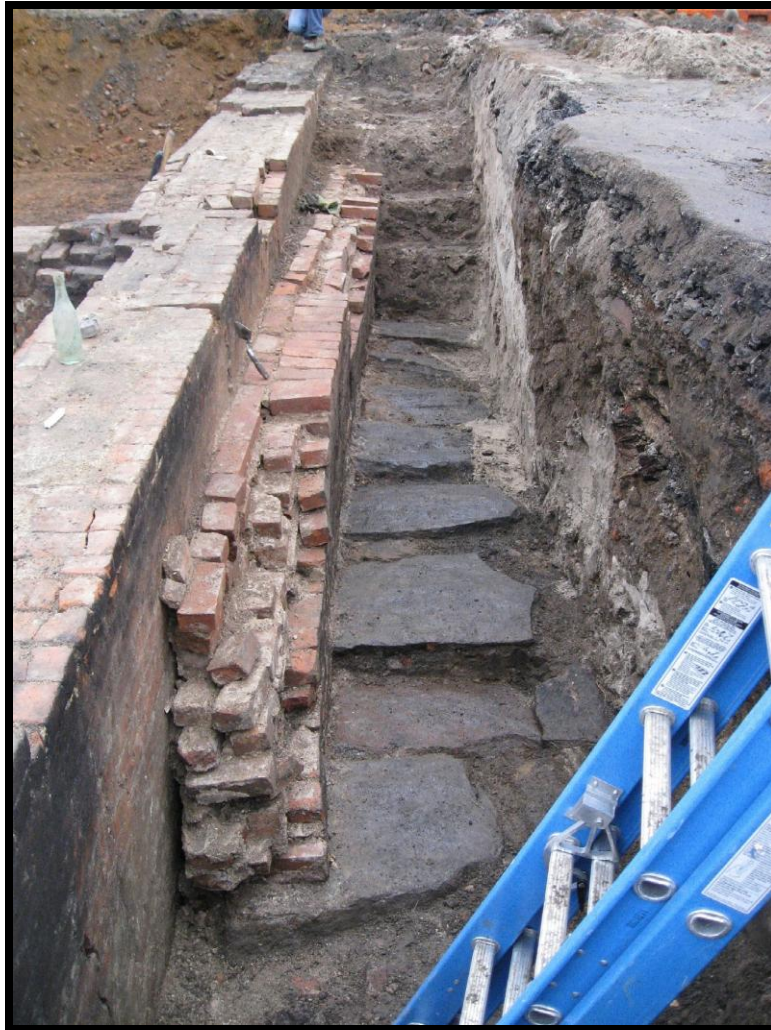
Photograph 4.34 Test Area 7, Trench 7.4, exterior southern foundation wall of the mill structure, looking east. shorter brick wall and stepped blue stone are a separate construction.

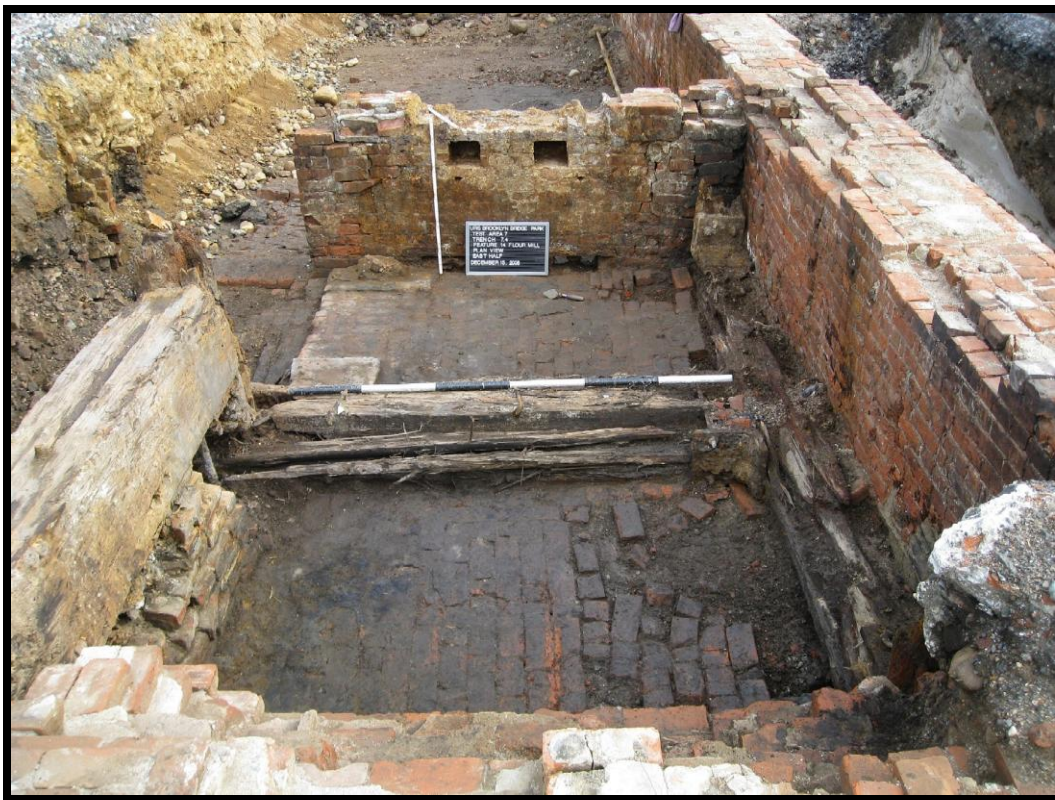
Photograph 4.35 Test Area 7, Trench 7.4, room at southwestern end of basement of main mill structure, aerial view of eastern mill foundations, looking east.

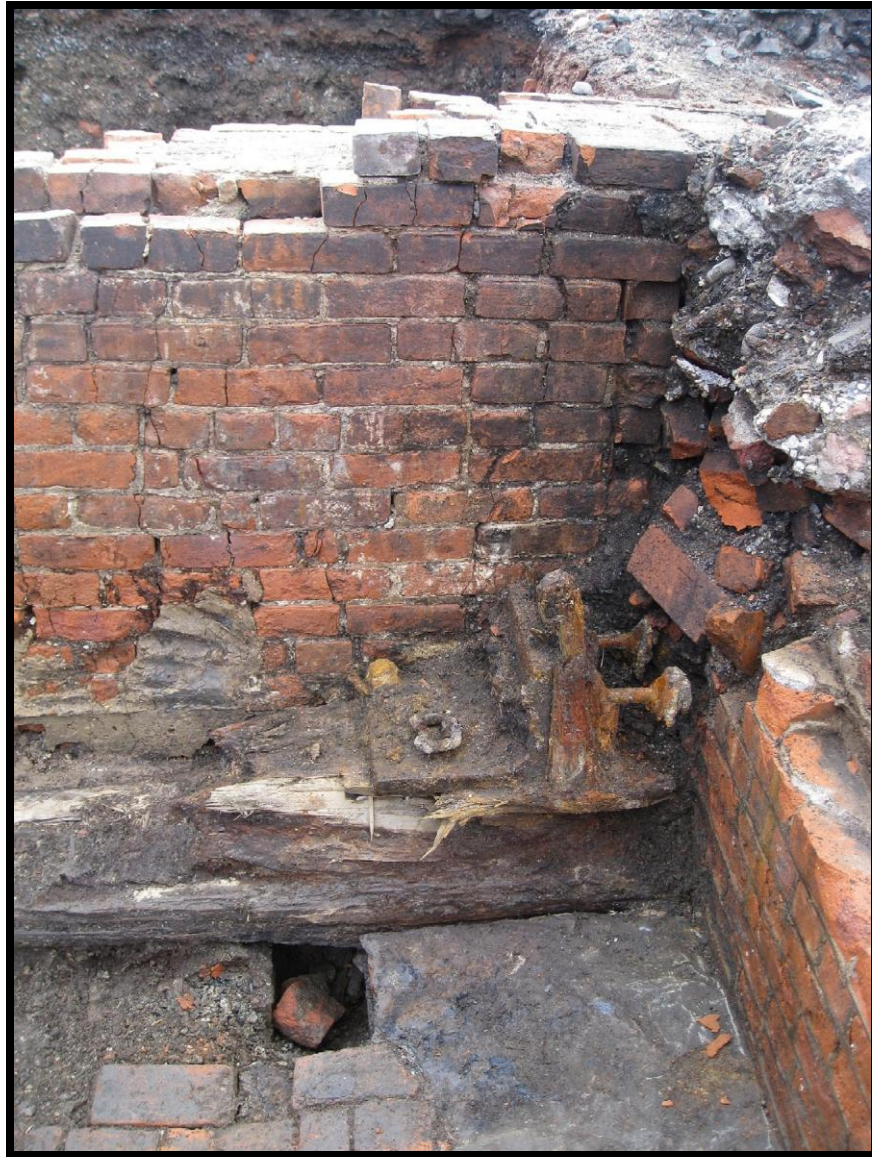
Photograph 4.36 Test Area 7, Trench 7.4, iron brackets securing wooden beams in the basement of main mill structure, looking south.

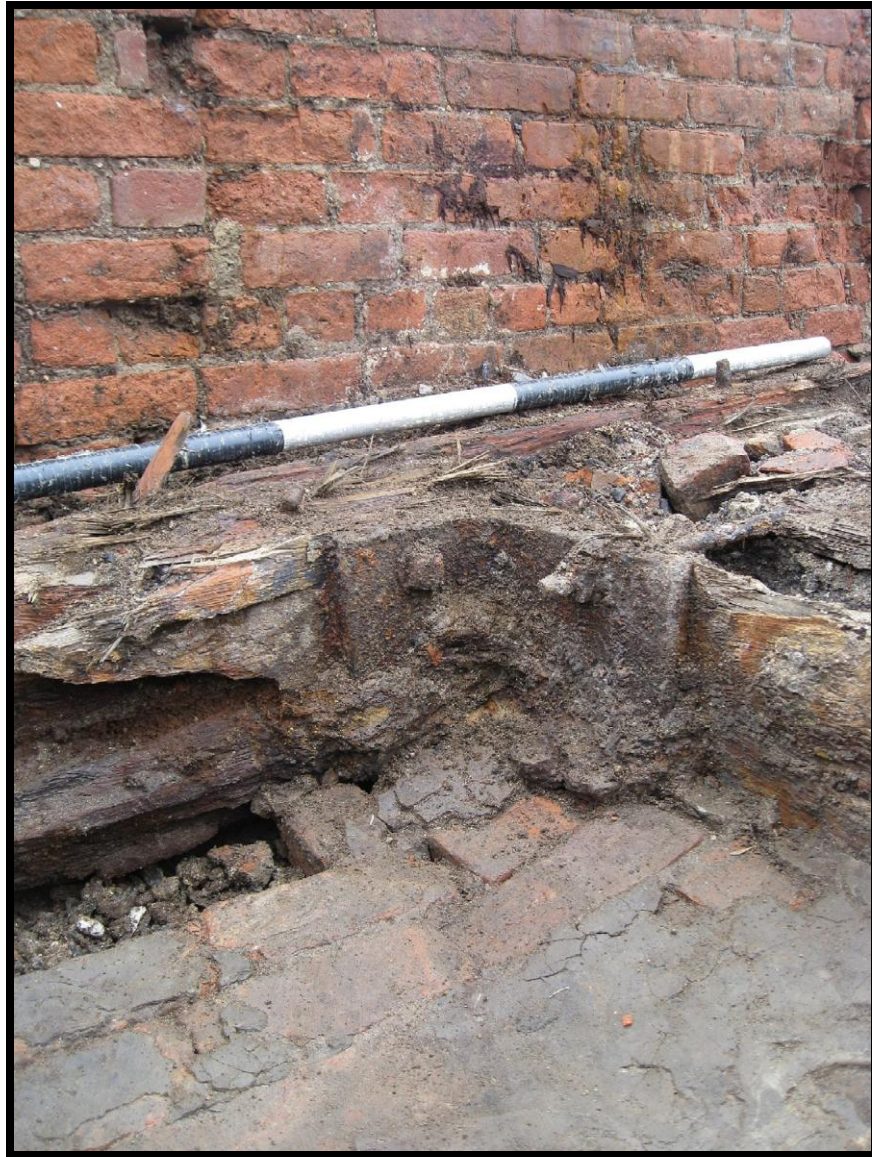
Photograph 4.37      Test Area 7, Trench 7.4, iron brackets securing wooden beams in the basement of the main mill structure, looking southwest.

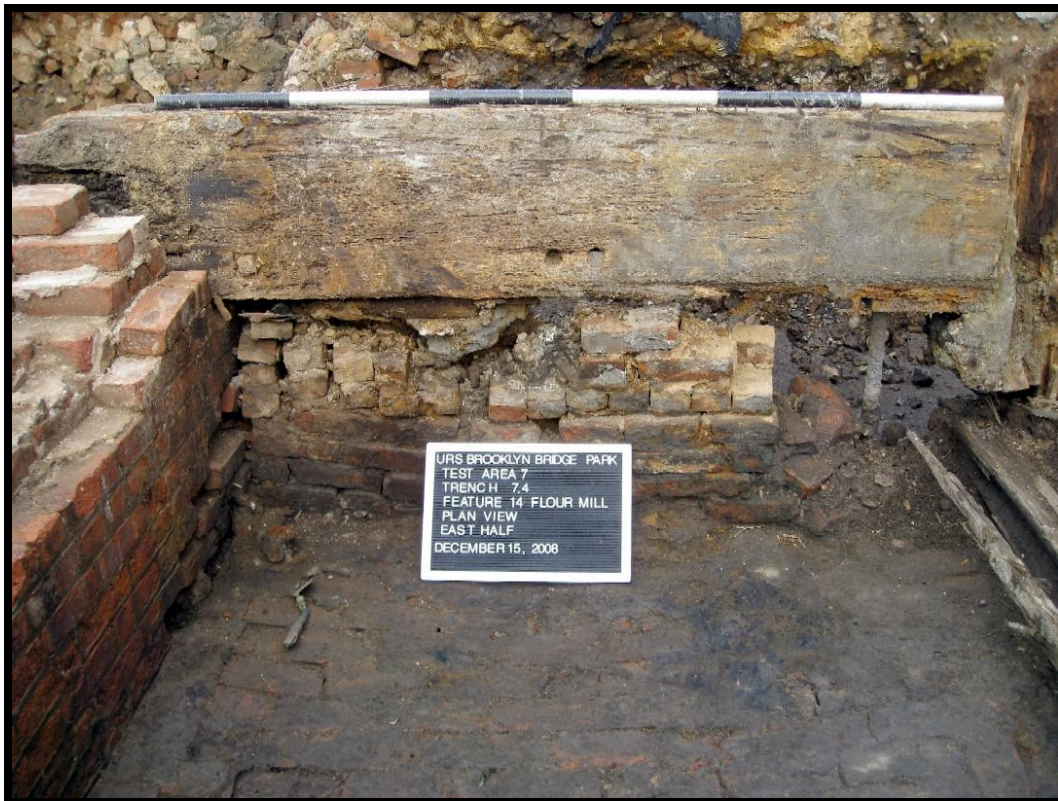
Photograph 4.38 Test Area 7, Trench 7.4, one of three large wooden beams framing a small room in the basement of the main mill structure, looking north.

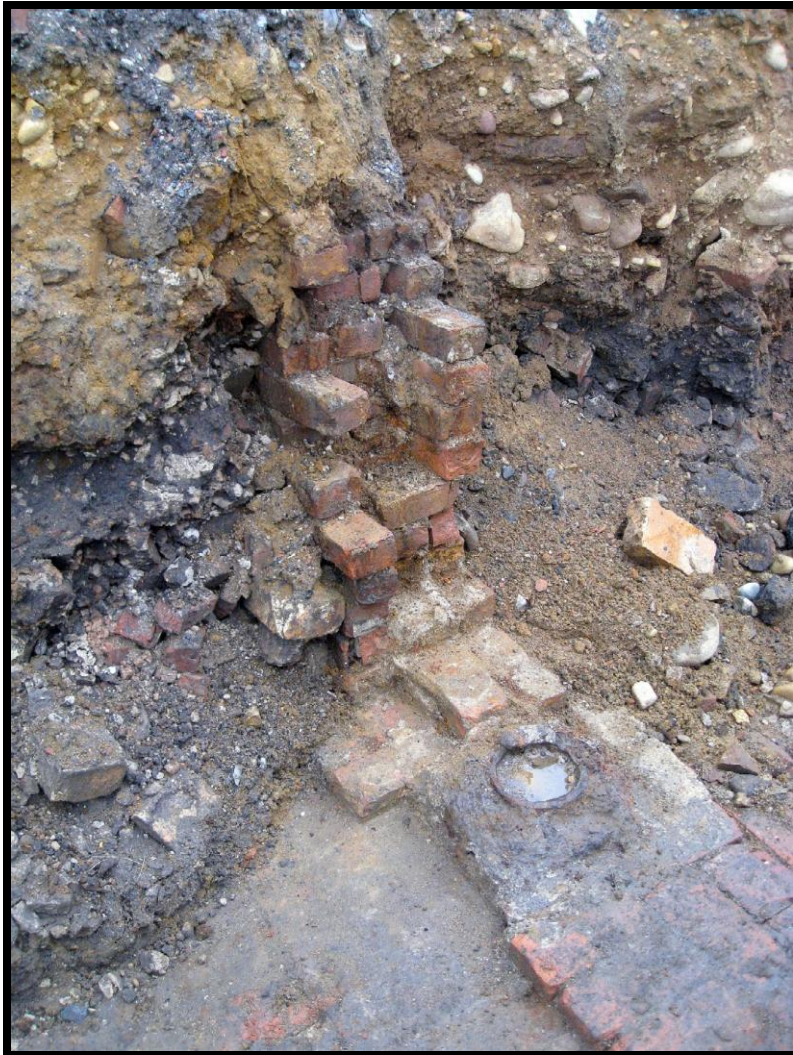
Photograph 4.39 Test Area 7, Trench 7.4, part of a doorframe leading to what appears to be a corridor in the main mill structure, looking northeast.

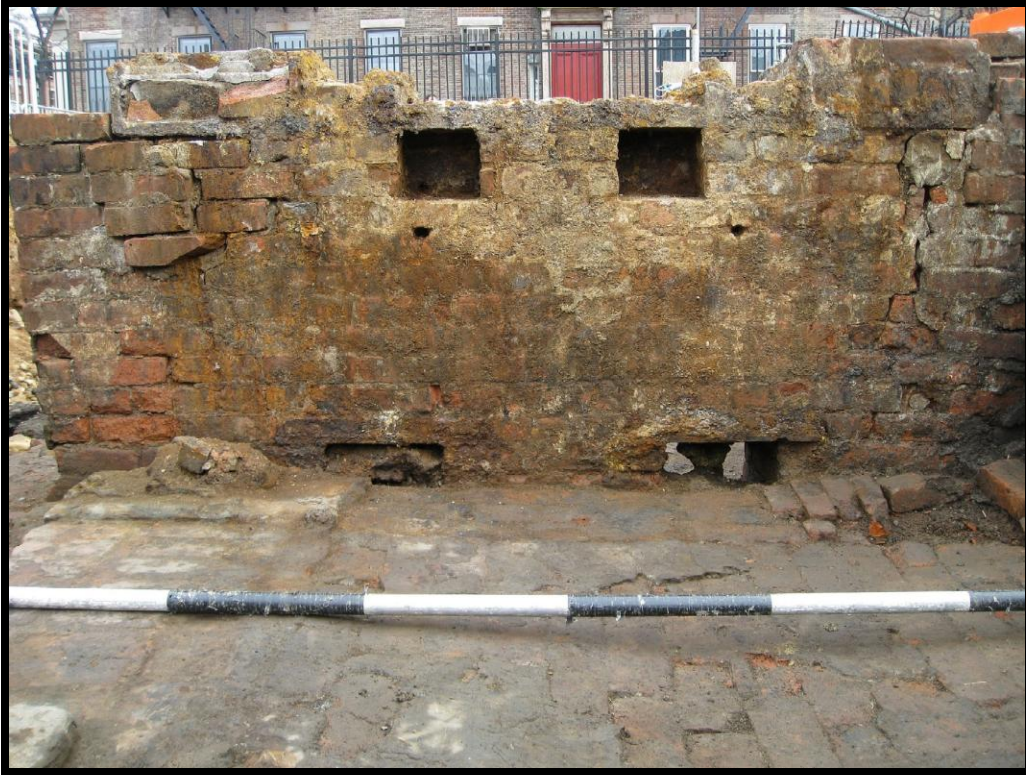
Photograph 4.40 Test Area 7, Trench 7.4, interior wall composed of iron and brick, looking east.

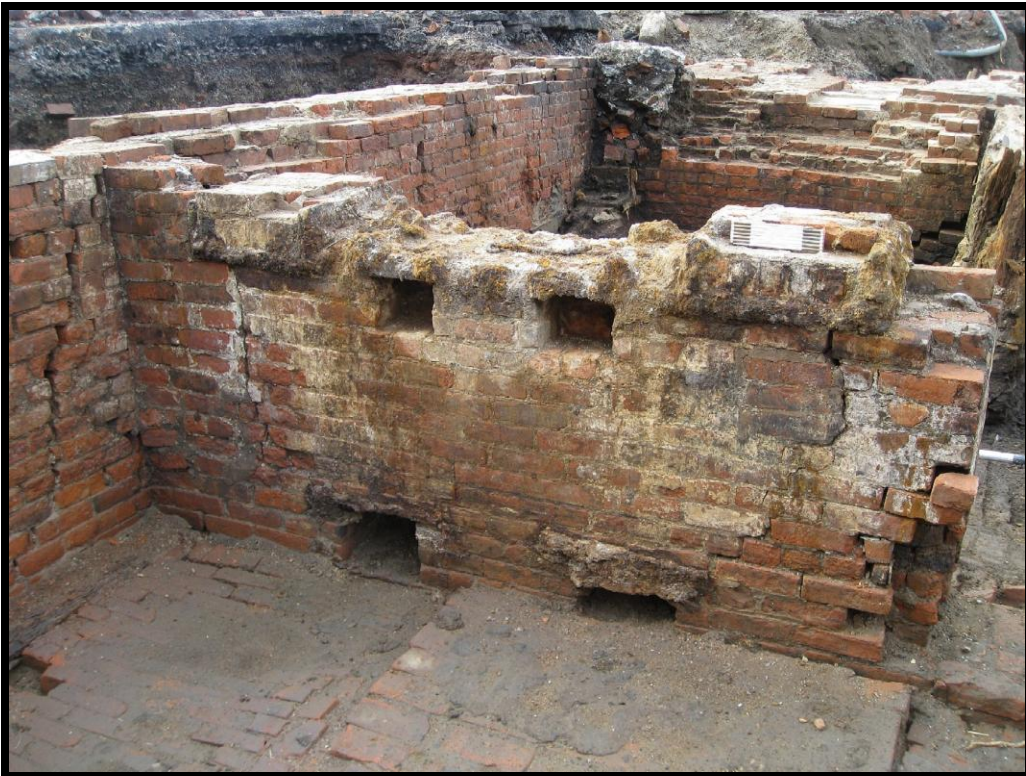
Photograph 4.41 Test Area 7, Trench 7.4, interior wall composed of iron and brick, looking southwest.

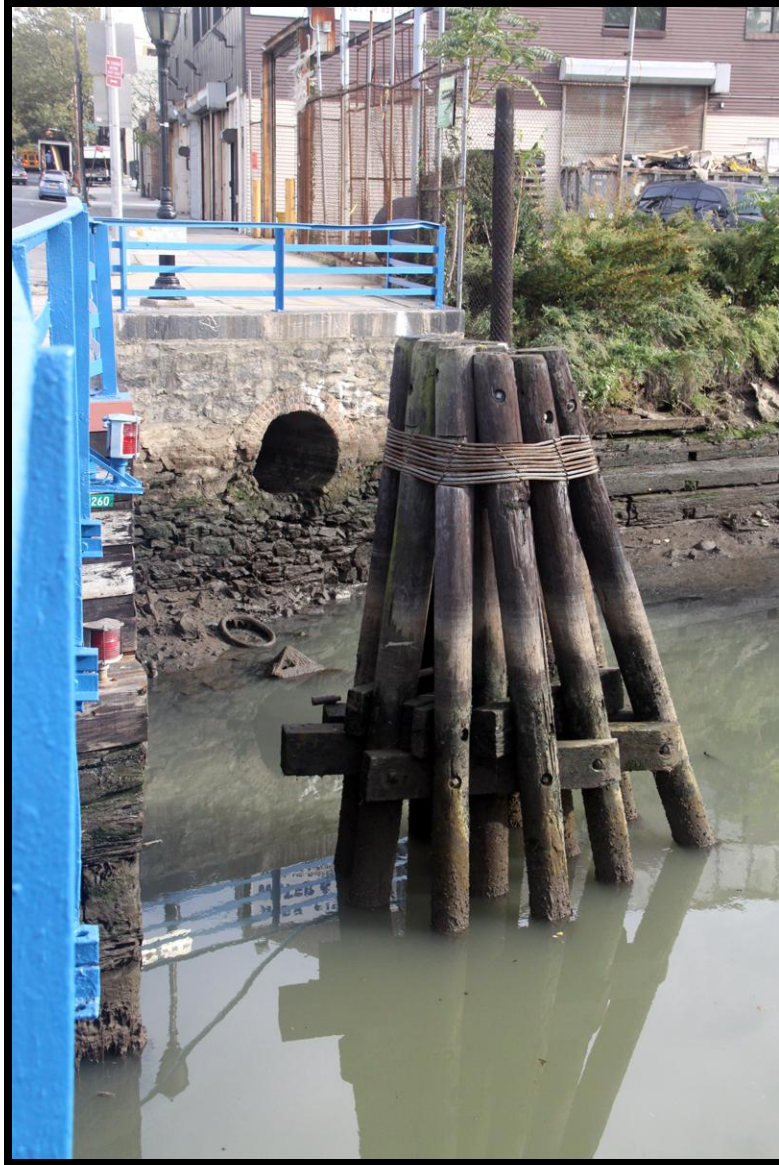
Photograph 4.42      Example of nineteenth-century sewer outlet along the Gowanus Canal, Brooklyn.

Divers on site to assess the stability of the seawall noted circular openings in the seawall that appeared to be in line with the conduits exposed (Phoenix Marine, personal communication 2008). They also observed additional similar circular openings along the seawall throughout the area. Therefore, it is likely that similar conduits exist throughout the property. Recent surveys throughout the Gowanus Canal have observed similar openings along the shoreline. According to information DEP archaeologist John Vetter provided, these were illegal sewer outlets (personal communication 2011) (Photograph 4.42). Businesses may have established illegal sewer connections to avoid paying associated fees. Additionally, restrictions against dumping wastewater within the East River, or other bodies of water, may have been less stringent in the nineteenth century. The East River was a common receptacle for trash deposition by Manhattan residents during the first half of the nineteenth century (Minutes of the Common Council 1784–1831; Burrows and Wallace 2000; Cantwell and Wall 2003).

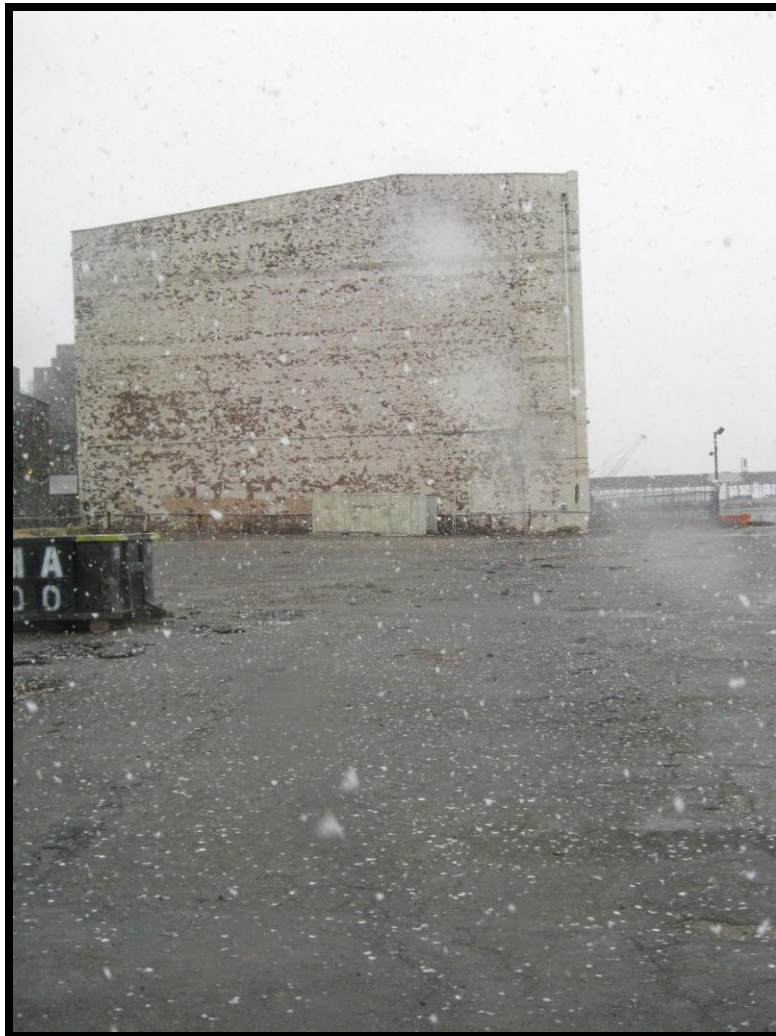
Photograph 5.1      Test Area 6, Cold Storage Building with brick foundations, looking south
