**ARCHAEOLOGICAL DOCUMENTARY STUDY  
AND FIELD TESTING REPORT  
BOWNE HOUSE  
37-01 BOWNE STREET  
FLUSHING, QUEENS, NEW YORK 10014  
Block 5013 Lot 6**

The New York City Department of Parks and Recreation  
Olmsted Center  
Flushing Meadows Corona Park  
Flushing, NY 11368

Historical Perspectives, Inc.  
P.O. Box 529  
Westport, CT 06881

**October 2012**

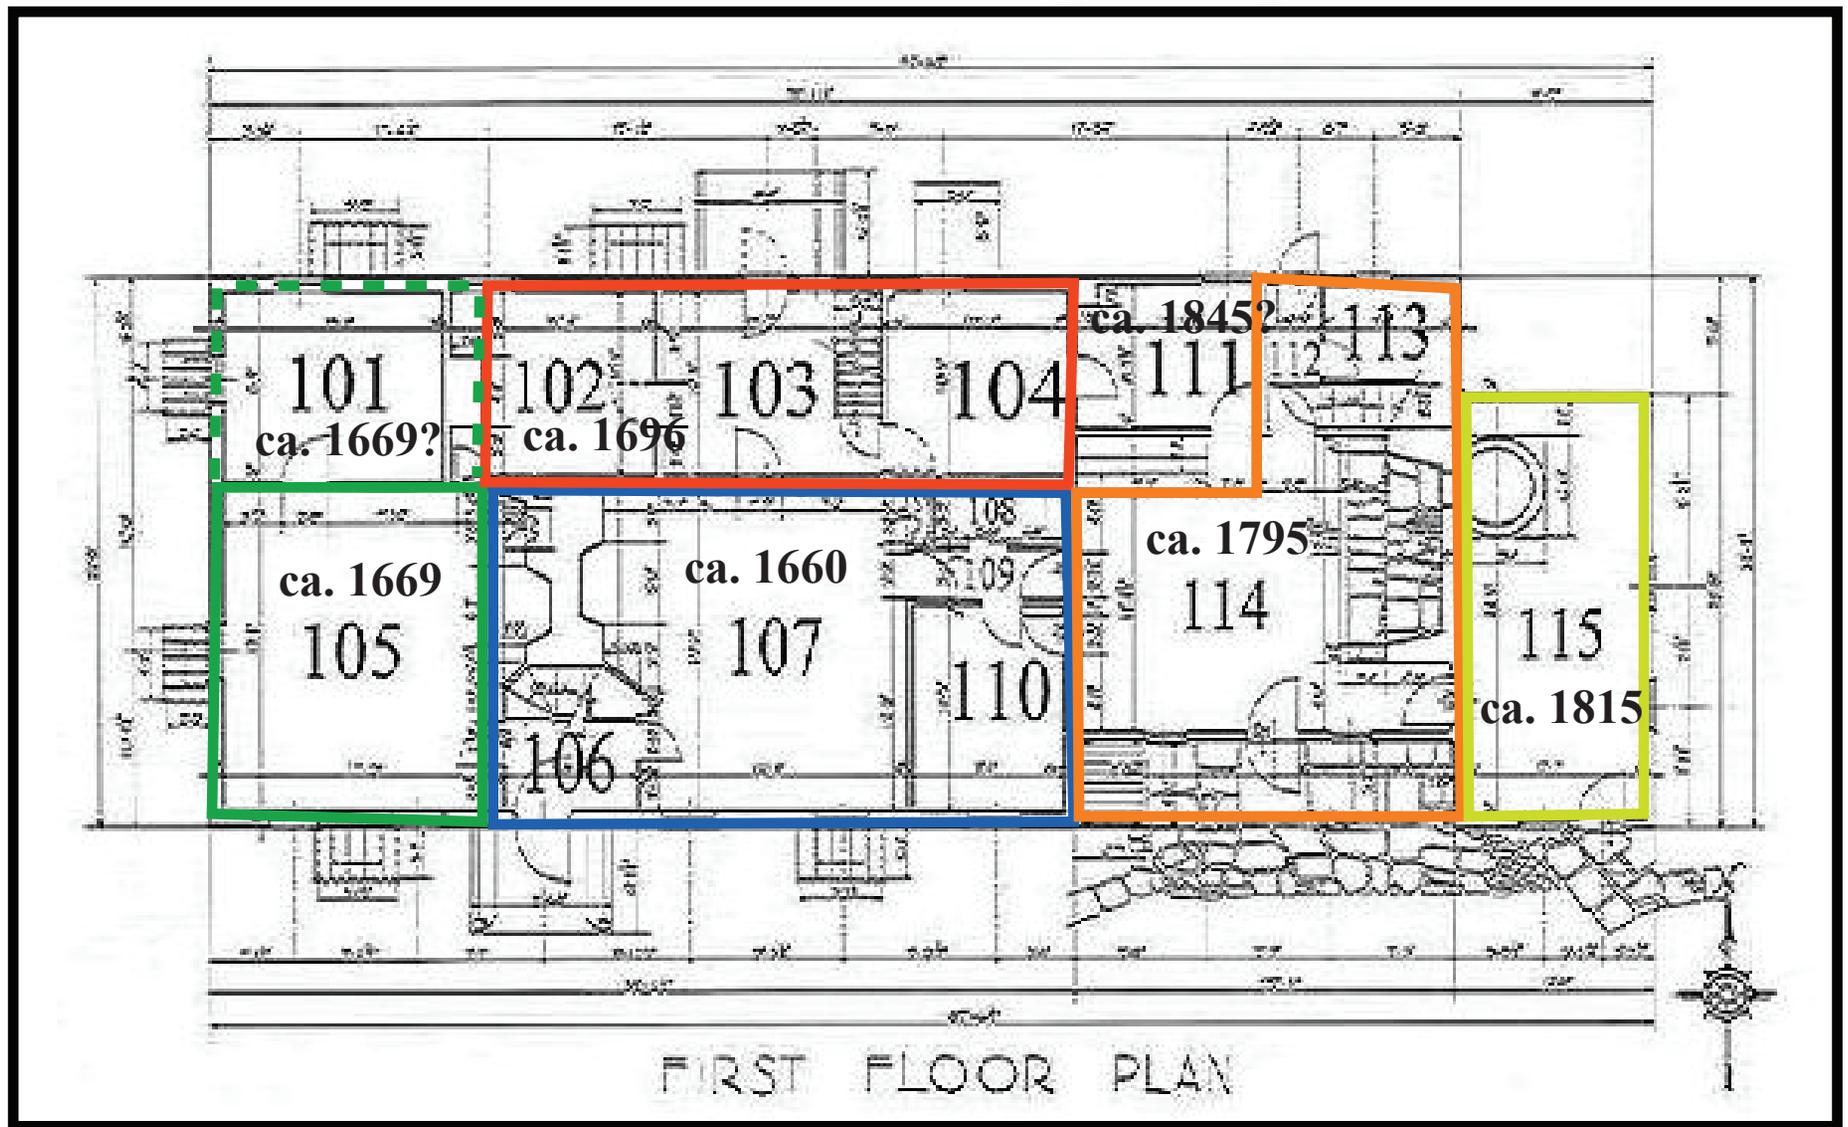
**FIGURE 5.** HABS (Historic American Buildings Survey), Bowne House, First-floor Plan, 1936  
(Revised by Wheeler [2007], approx. dates of construction added, 2012)

Boulevard and Union Street, about 750 ft. northwest of the APE. The journal of later Bowne House owner, Samuel Parsons, places the building somewhat farther north, at 35th Avenue near the east side of Union, with foundations visible as late as 1800 (Wheeler 2007:2.1). In 1656, John Bowne married Hannah Feke (or Feake), daughter of Lt. Robert Feke of Flushing, and the couple eventually moved into the newly built Bowne House, at what was then the eastern edge of Flushing village (Figure 4). Following tradition, the house was built in 1661 (Brodhead 1853:705n), based on references by Bowne to “our house at Flushing” in 1661 and 1662. Hannah Bowne’s brother, John Feke, may have been the builder of the original house, the south-central part of the current building, which was a 1½-story, one-room structure, measuring about 31 × 21 ft. (Figure 5, current Rooms 106–110) (Wheeler 2007:2.7–2.8).

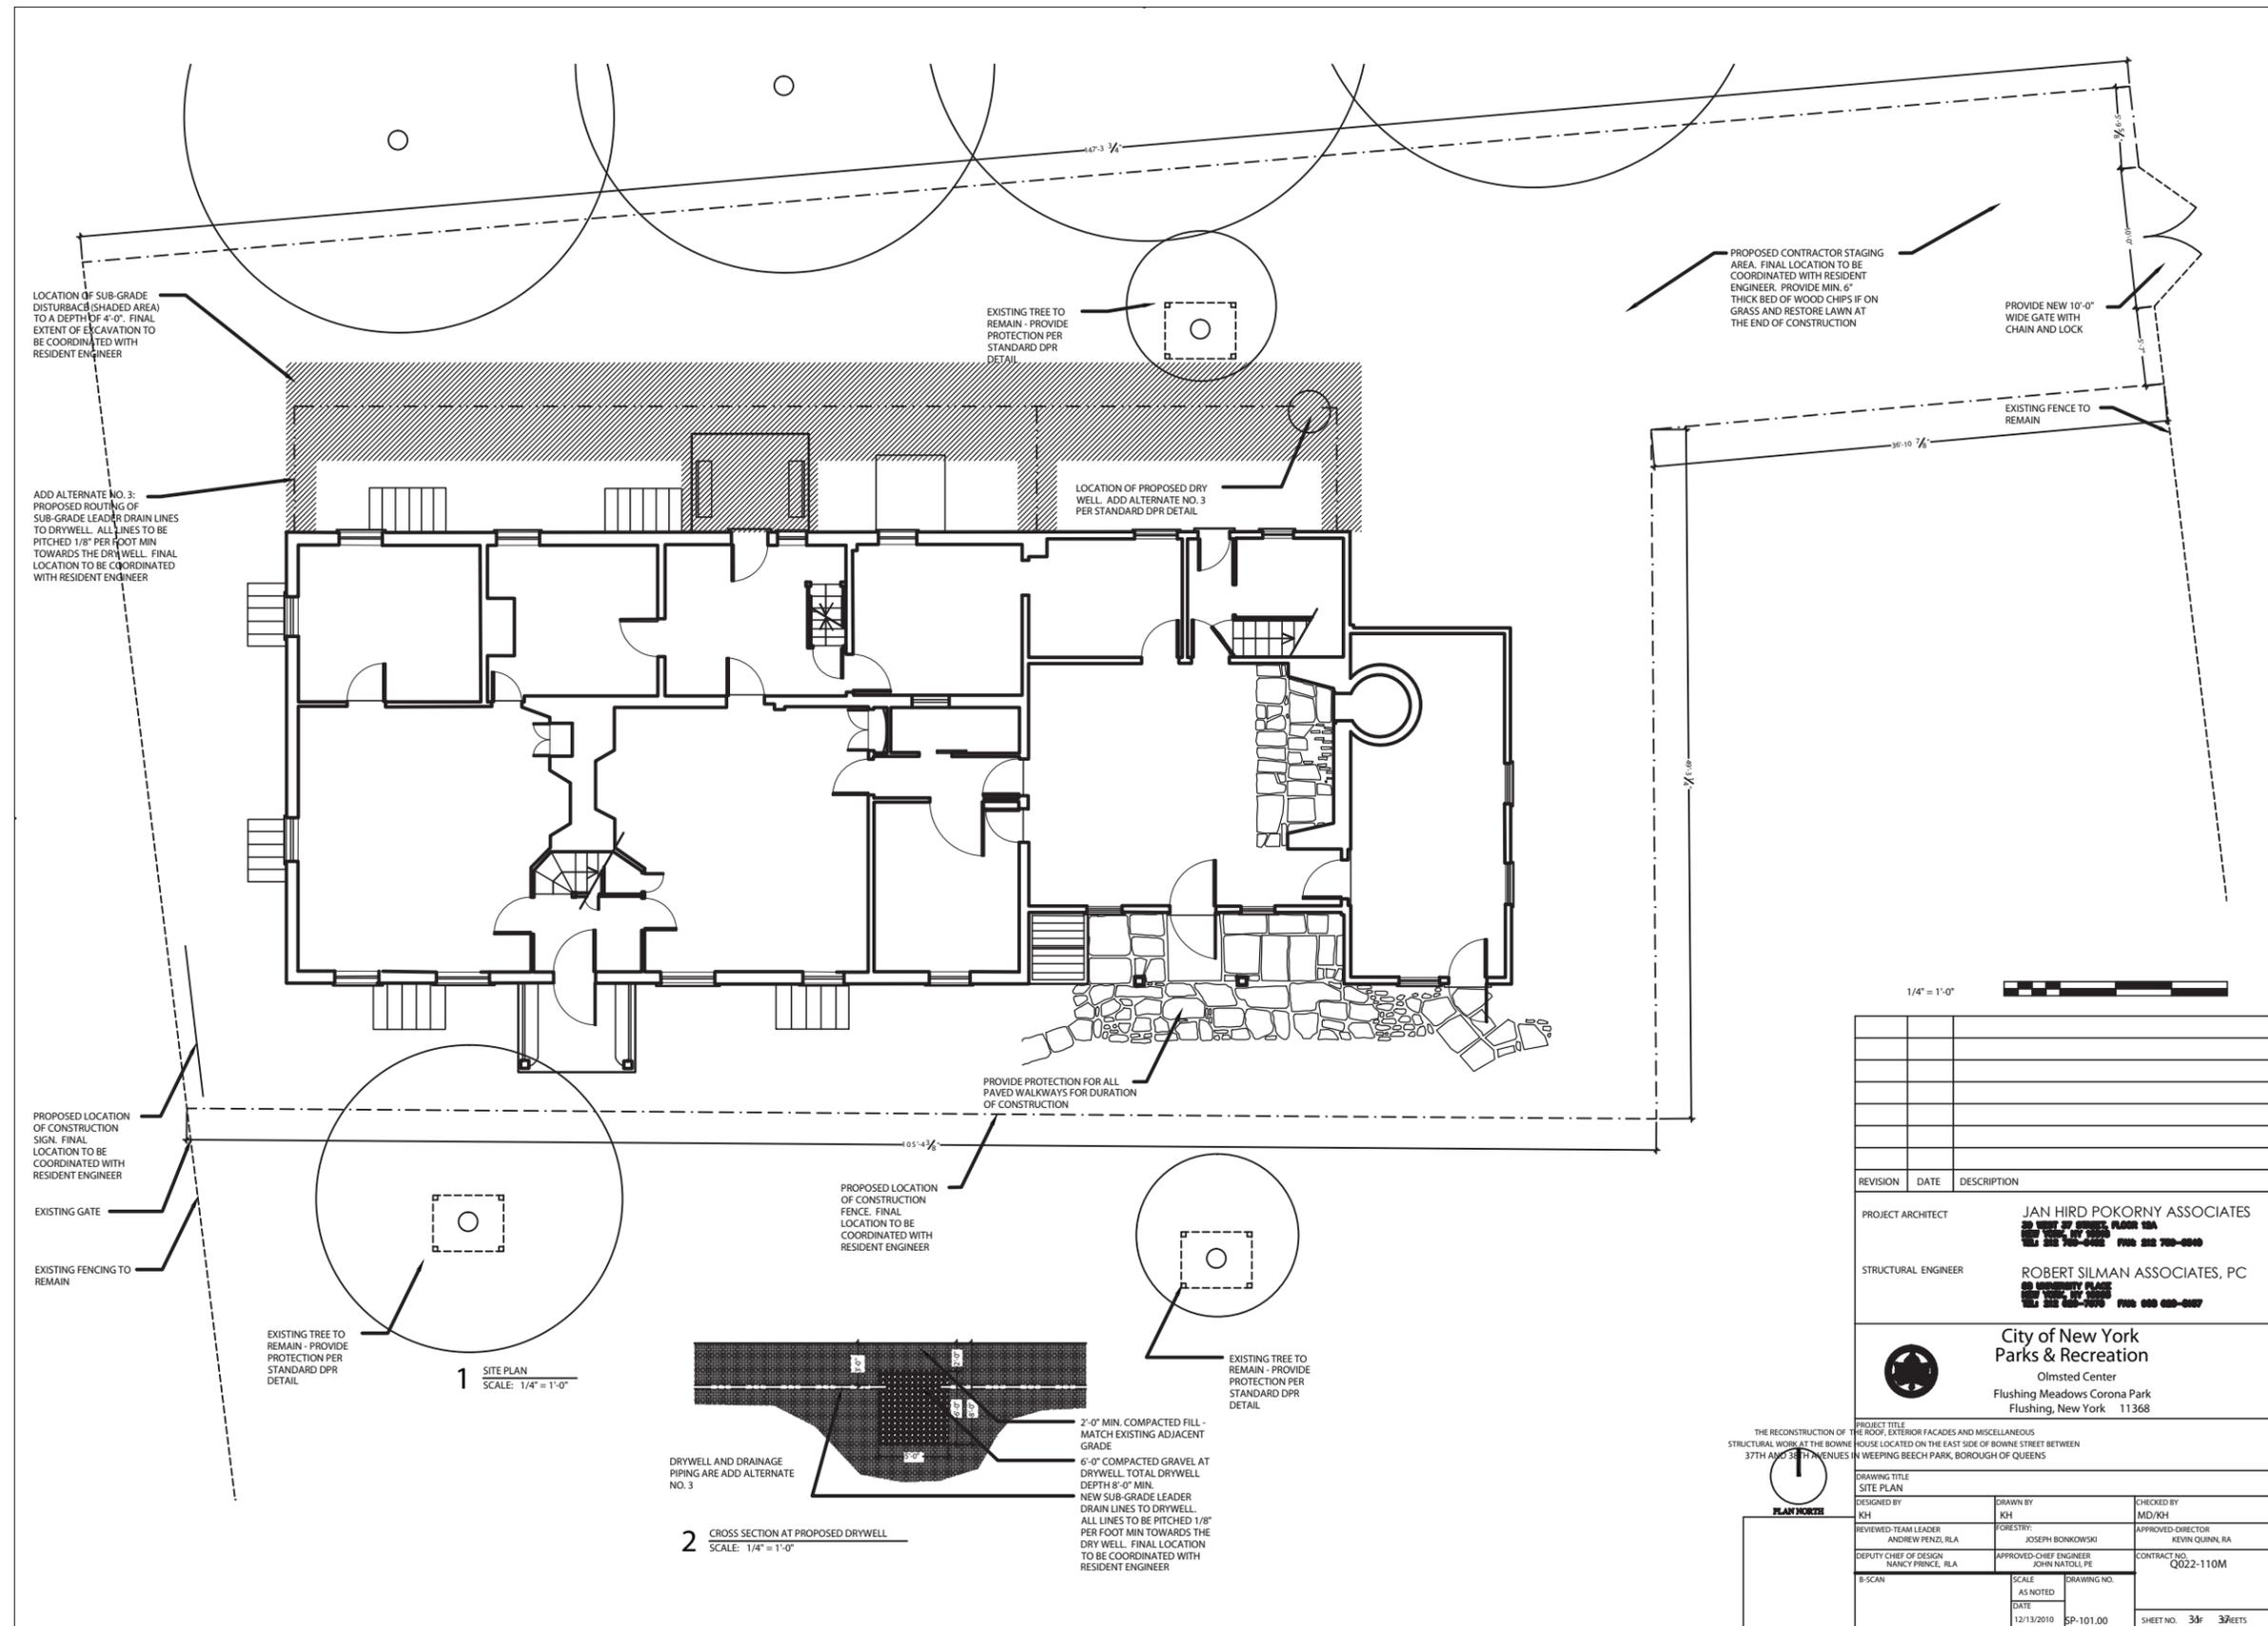
**FIGURE 15.** Map of Detailed Resoration Plans, Bowne House, Flushing, New York.

Figure 15 identifies the location of the proposed below ground work conducted in conjunction with restoration efforts. The proposed impact area is a narrow strip running east-west approximately 5-10 feet north of the dwelling, connecting to the building in four locations along the north wall. The review of previous archaeological testing found that numerous test units

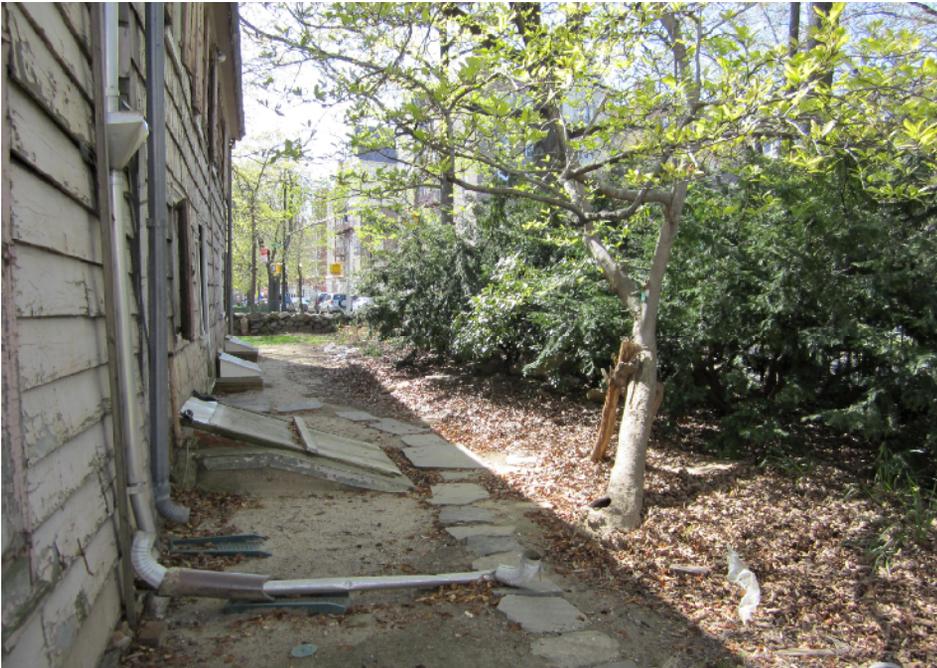
Photograph 6. View W from the NE corner of the kitchen wing. Oil spill area.

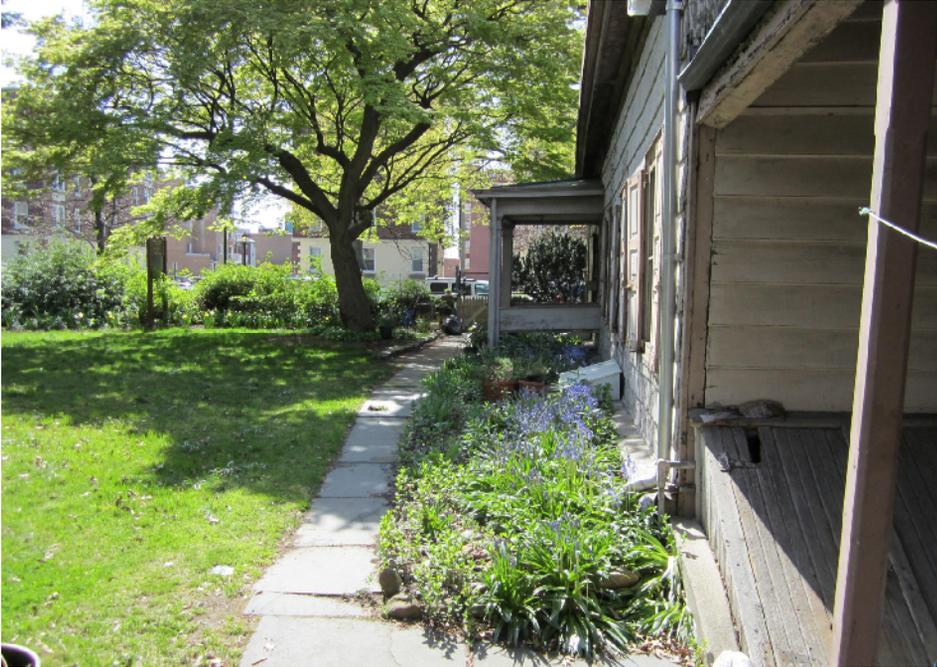
Photograph 11. View W from the walk along the S side of the kitchen wing. Note the concrete sill at foundation level between porch/cellar entrance and main entrance.

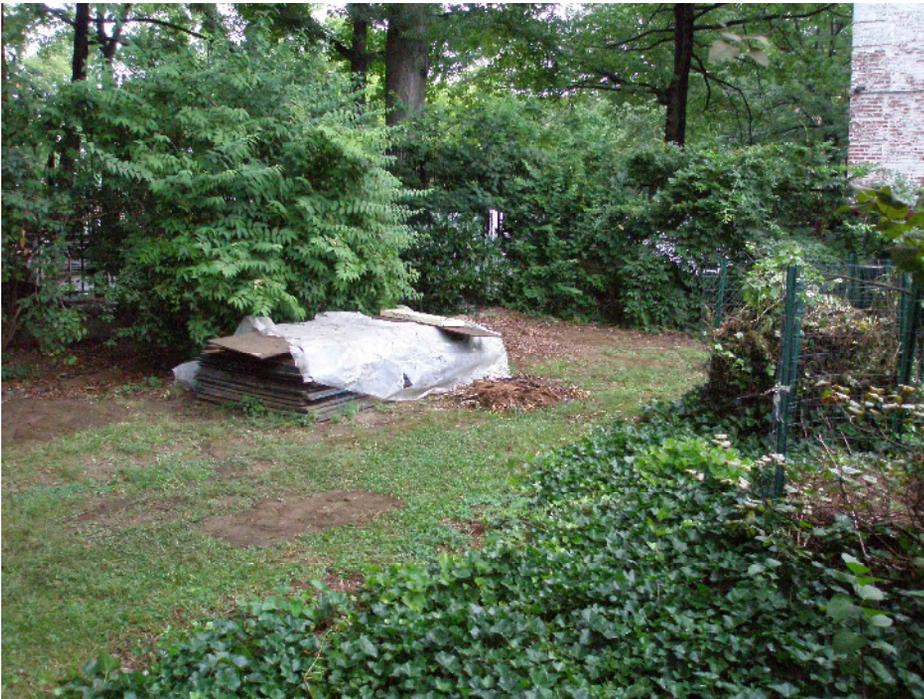
Area 2 was identified as the location of the potential staging area for the restoration/construction project (see Photograph 12). Currently, this location is a relatively flat area that is partially covered with spotty patches of grass. The northeast yard also contains planting beds with small trees and flowering bushes. The center of the area was covered with a pile of large plywood and composite boards. Soil tests conducted in this location found little evidence of contaminants.

Photograph 12. View of the northeast yard area. Note: the large plywood and composite board pile surrounded by the garden plantings.

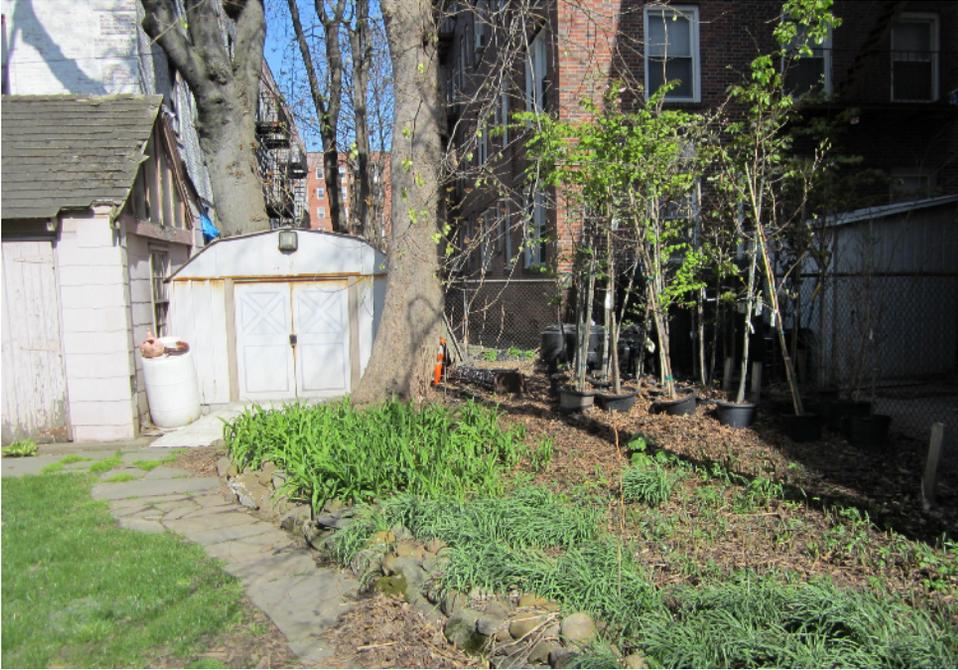
Photograph 15. Looking E to SE corner of property. Area is raised due to dumping leaves and composting, otherwise should be level with rest of property. Location of the outbuilding from 1841 map.

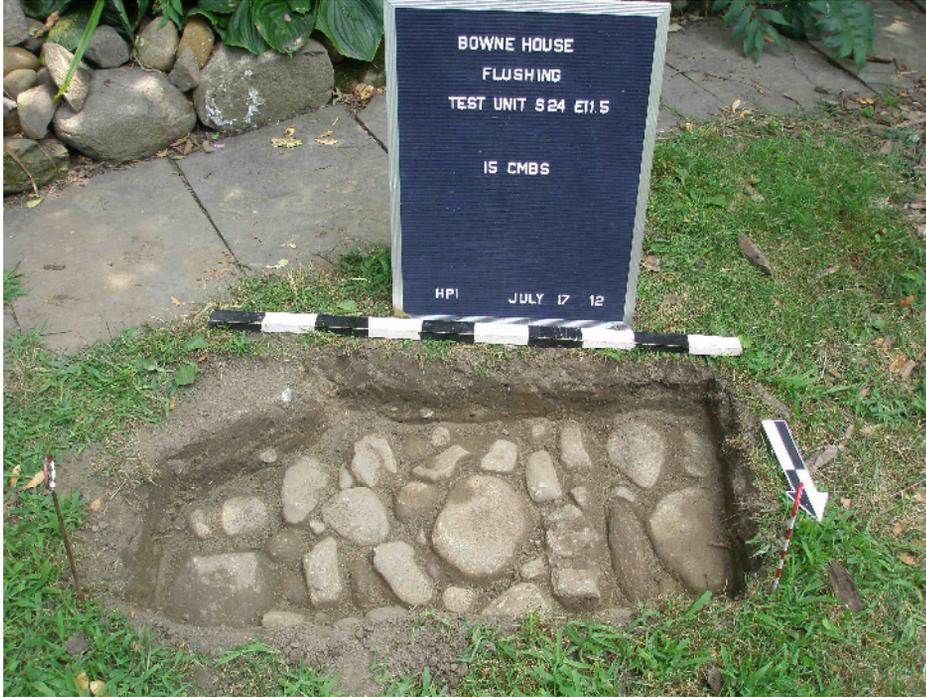
As mentioned above, 38 Test units were examined in Area 1, the southeast yard. Twenty-eight of these test units encountered the historic cobble surface (Feature A; see Figure 17; Photographs 19-22). The HPI team found that, although the surface had been impacted during 20<sup>th</sup> century landscaping activities, a large portion of the cobble surface was still *in situ* beneath shallow layers, of sod and sandy loam 10-20 centimeters (cm) (Appendix II).

Photograph 19. Cobble surface (Feature A) in southeast yard: Test Unit S24 E11.5.

As mentioned above, the cobble surface was likely laid out to provide access to the outbuilding depicted on the 1841 map of the property (see Figures 8 and 17). It is likely that the building was a stable or carriage house that required year-round access by horses and/or wagons. The artifacts collected above the cobble surface date from the 18<sup>th</sup> through the 21<sup>st</sup> centuries and are typically very small fragments of general yard scatter, similar to those noted by Moore in 1998 (see Photograph 26; Appendix III). The test units excavated along the current edges of Feature A indicate that the stratum below the cobbles is brown silty sand that contains late 18<sup>th</sup> and early

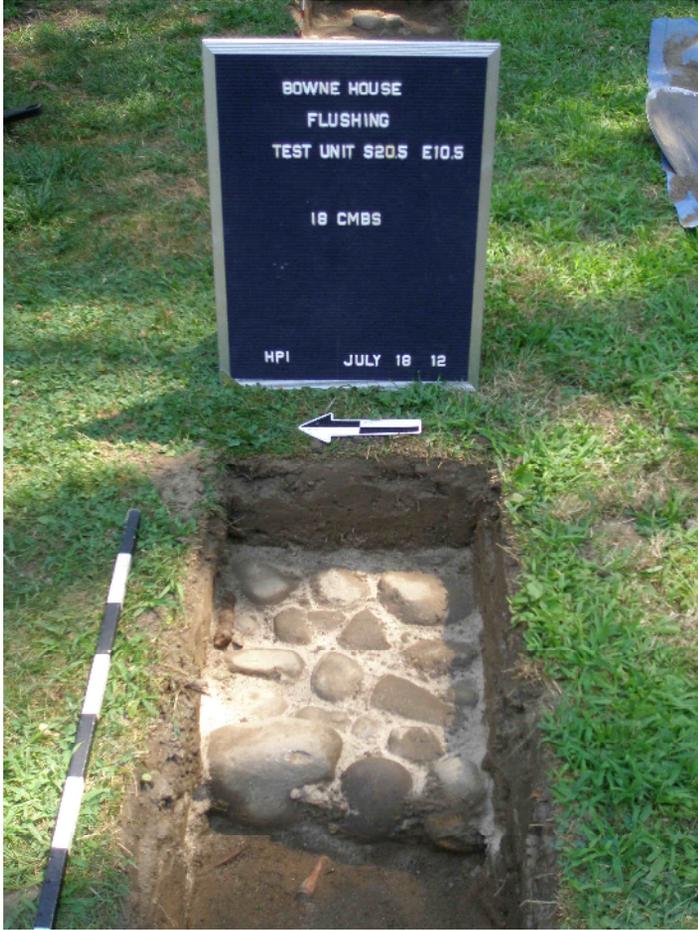
Photograph 20. Cobble surface (Feature A) in southeast yard: Test Unit S20.5 E10.5.

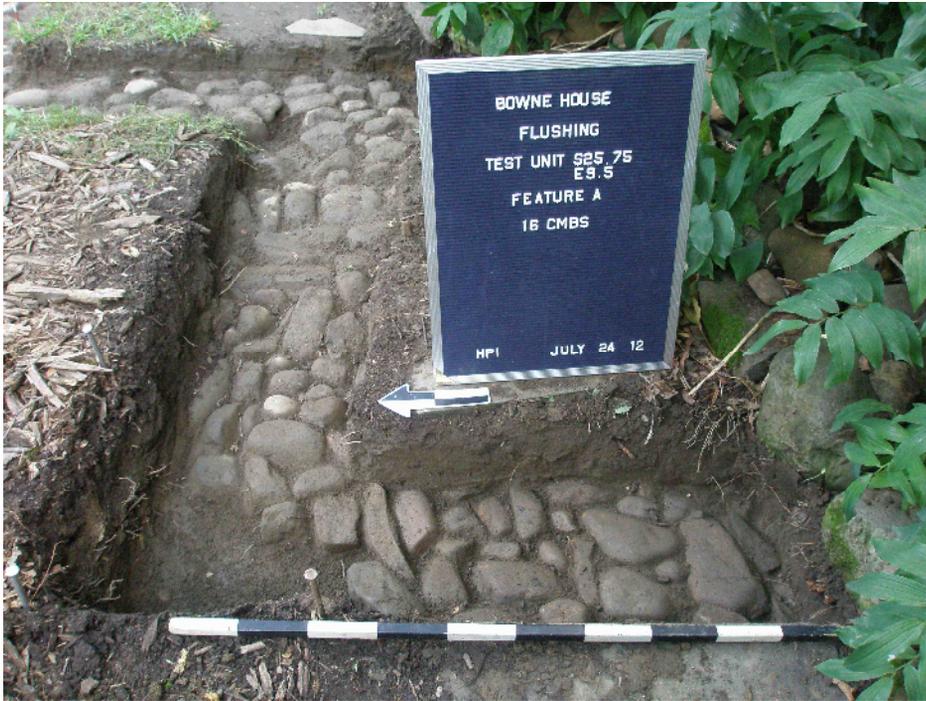
Photograph 21. Cobble surface (Feature A) in southeast yard: Test Unit S25.75 E9.5.

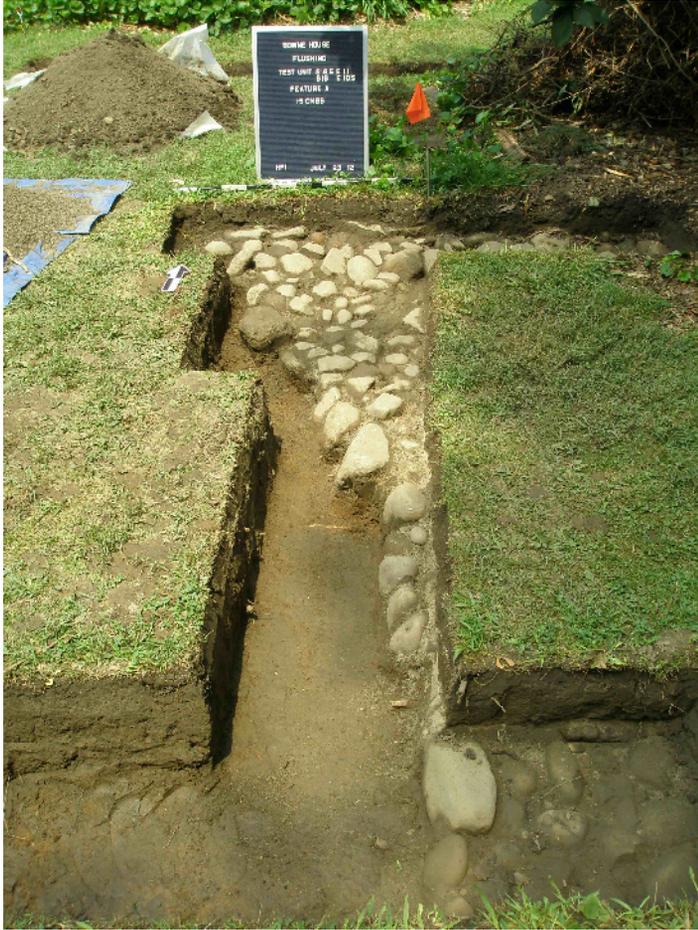
Photograph 22. Cobble surface (Feature A) in southeast yard: Test Units S18.5 E11 and S18 E10.5.

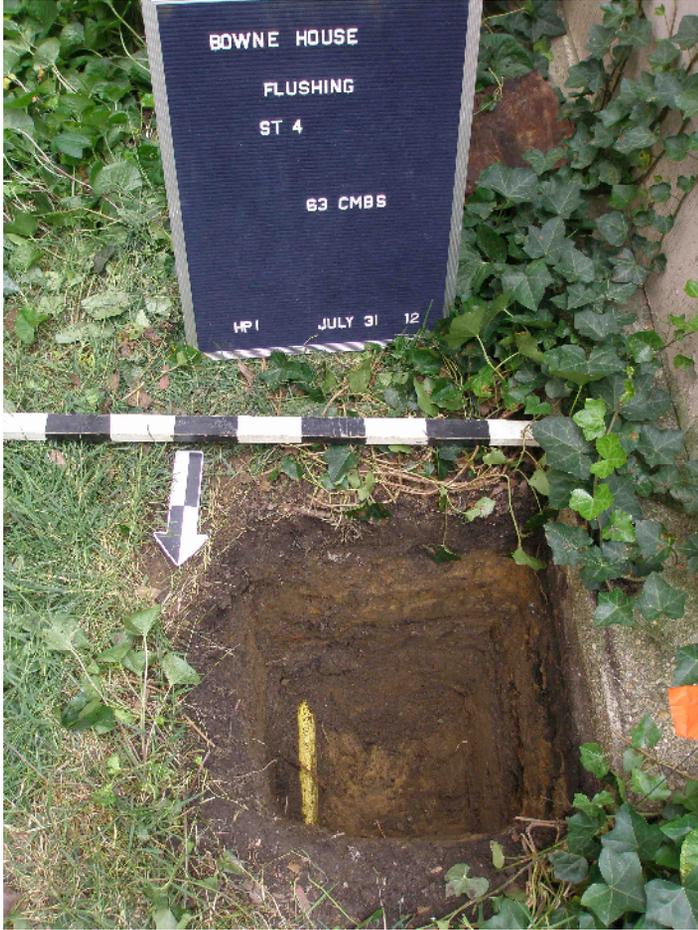
Photograph 23. Complete Shovel Test 4. Note the presence of the pipe trench and yellow PVC pipe.

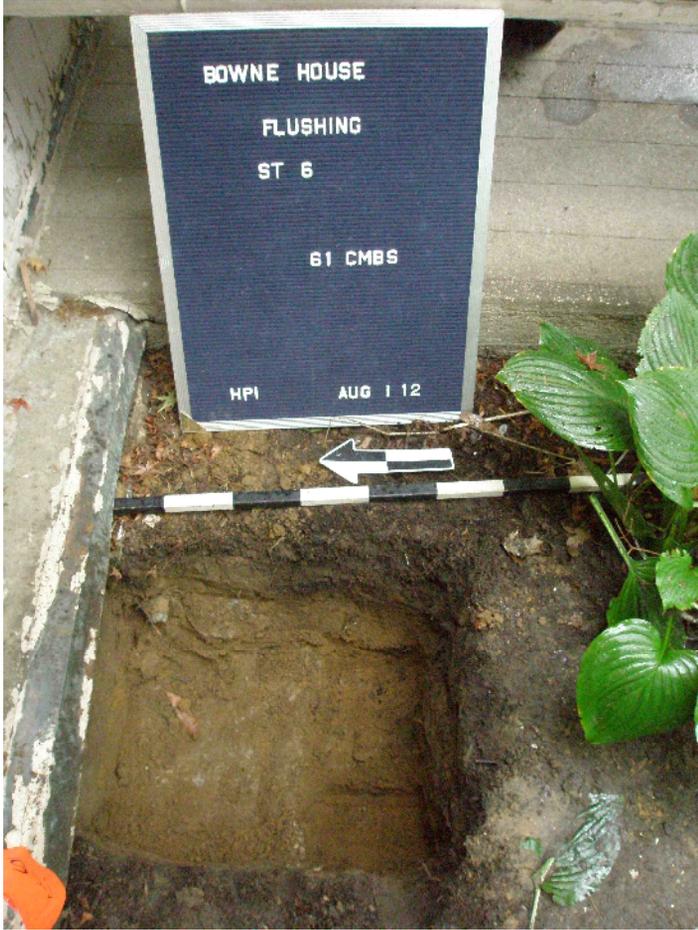
The examination of these two test units found that the strata immediately adjacent to the main house foundation has been extensively disturbed during the repair of the below-ground foundation, which is now encased in concrete on the exterior wall. In fact, the concrete actually extends out from the foundation in order to provide additional support (Photograph 25). No features or artifact concentrations were identified in these two test units.

Photograph 25. Shovel Test 6 against the foundation of the Bowne House. Note the presence of the extended concrete footing at the base of the unit.

The 2012 field investigation adjacent to the foundation of the eastern portion of the house confirmed the disturbance and encasement of the foundation. Continuous drainage problems around the house have necessitated a series of stabilization trenches, drainage trenches, French drains, and dry wells, mainly to the north of the house. Much of Moore's (2000) testing and excavation along the north side of the house has been mitigation work related to proposed construction disturbance, where he also encountered earlier dry wells as well as ceramic piping leading westward along the north facade to the sewer system in Bowne Street. Moore's excavation units completed on the north side of the house and adjacent to the additions, appear to have been placed in the only locations where access to the foundation and adjacent features surrounding the house were possible.

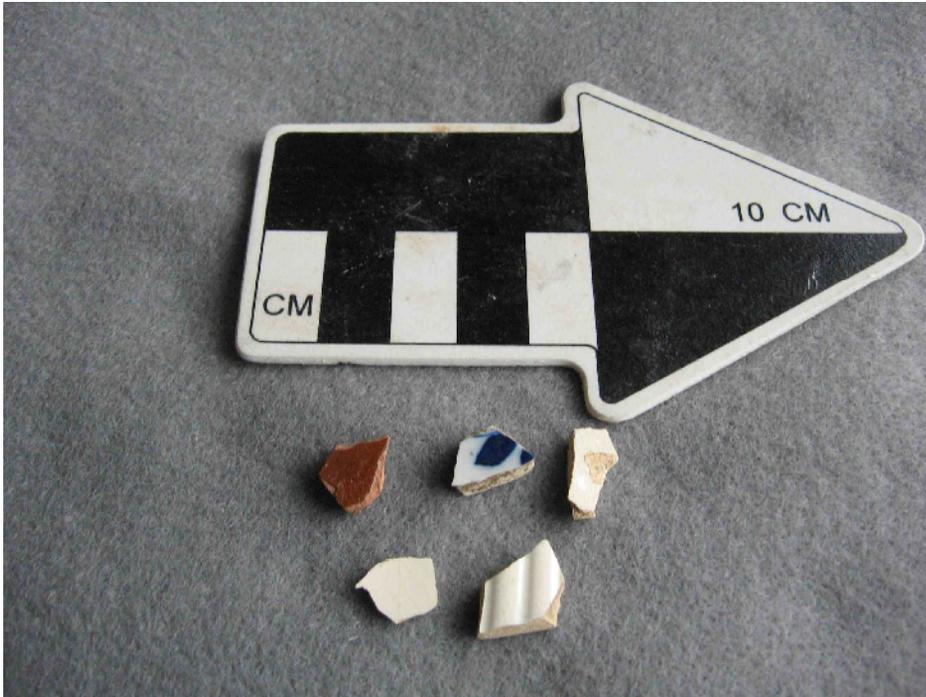
As anticipated from a domestic site, the majority of the artifacts were food related materials followed by architectural (Table 1). Most of the pieces recovered were extremely small fragments or spalls of artifacts that are typically associated with yard scatter (Photograph 26). Since the majority of the test units were located above the cobble surface, it is likely that the

Photograph 26. Sample of artifacts recovered from the Bowne House site, 2012. Note the small size of the fragments.

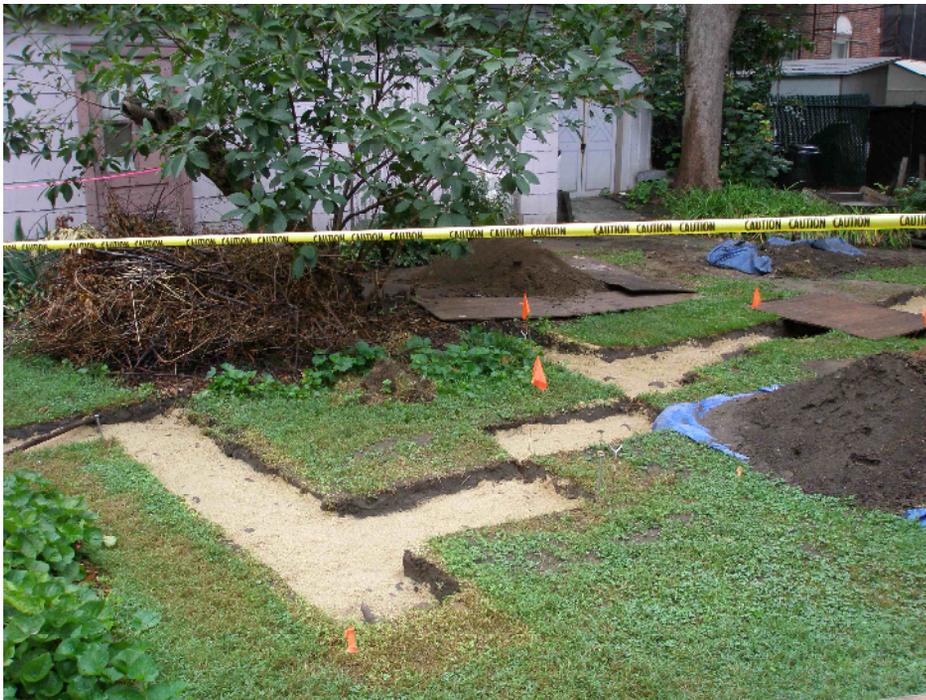
Photograph 27: Cobbled Surface (Feature A) covered with sand prior to backfilling In southeast yard.
