Phase IB Archaeological Monitoring – Construction of Combined Sewer
In: Water Street Between Old Fulton Street and Adams Street, Old
Fulton Street Between Front Street and Furman Street and Washington
Street Between York Street and Plymouth Street
(aka Downtown Brooklyn Water Main Replacement Project), Brooklyn
(Kings County), New York – Project PIN Number: SEK002355

The City of New York – Department of Design
and Construction
Long Island City, Queens, New York

Alyssa Loorya, M.A., R.P.A., Principal Investigator
Christopher Ricciardi, Ph.D., R.P.A. and
Diane George, M.A., R.P.A.
for: Chrysalis Archaeological Consultants, Incorporated

Final Report – November 2012

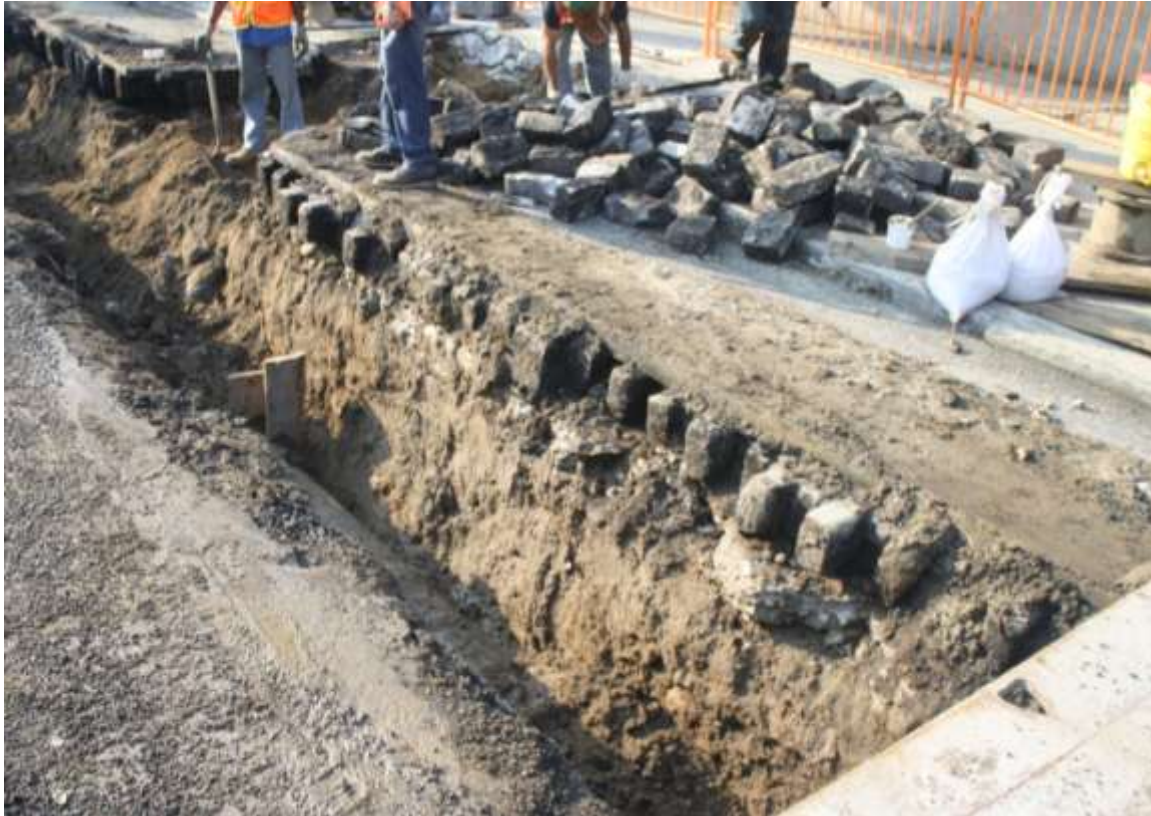
Image 07: Typical stratigraphy for the project area.

The project area was generally paved with asphalt over Belgian block set in sand above a concrete underlayment (Image 07). The thickness of the pavement, including the underlayment, varied within the project area, ranging between 14” - 24”. Overall, the project area had a fairly consistent stratigraphic profile (Table 01). The stratum directly beneath the road bed consisted of a sandy loam fill. This was followed by a medium- rusty-brown sandy loam with gravel and small rock and pebble inclusions extending to an approximate depth of 7’ below surface (Image 08 and Schematic 01). On Water Street and Dock Street the soil was contaminated with a dark organic, noxious substance, most likely some type of petroleum or petroleum by-product at 6’ –

7' below grade. In other areas at this depth along the east-west portion of Water Street, a stratum of fine black sand was present, averaging approximately one foot thick. At 8' below surface dark-gray silty sand, with occasional clay inclusions was present throughout the entire project area. This stratum likely represents the original river bed.

Strat	Depth	Description
I	0 – 14”/24”	Pavement
II	14”/24” – 3’	Sandy loam fill – 10 YR 5/4
III	3’ – 7’	Medium rusty-brown sandy loam; gravel and small rock/pebble inclusions – 10 YR 4/3
IV	6’ – 7’	Dark, organic, noxious ² - 10 YR 2/1
V	7’ – 8’	Fine, dark sand fill – 2.5 Y 3/1-4/1
VI	8’ +	Dark gray silty sand; clay pockets, possibly original river bed – 10 YR 4/1

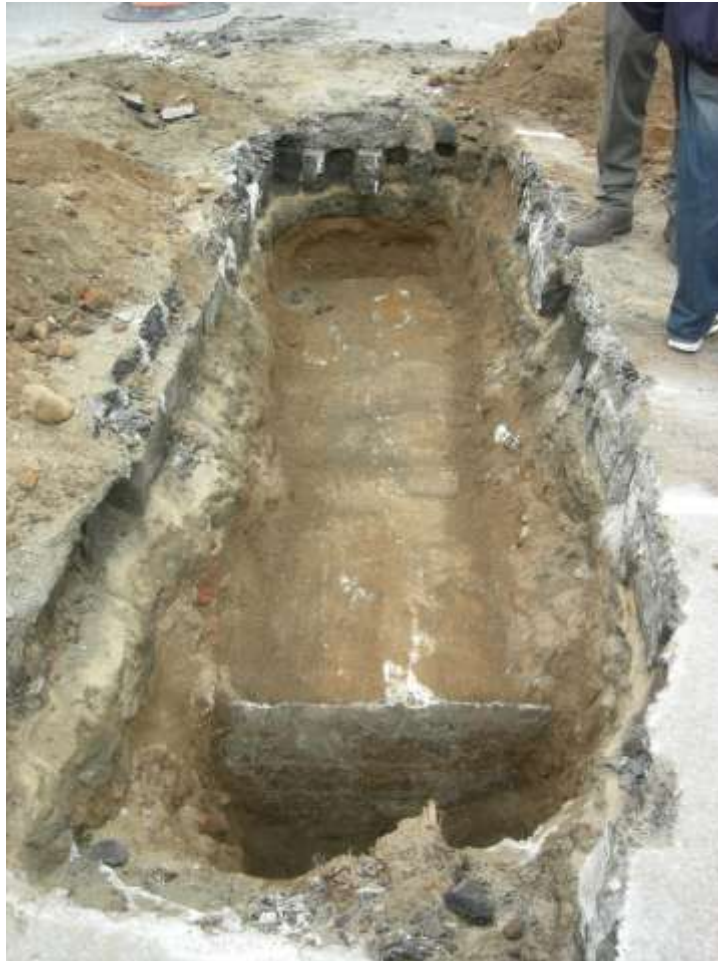
Image 10: Concrete sewer housing in Test Pit 2.

Test Pit 2 measured 14' x 5' and was located near the center of Old Fulton Street at the intersection of Water Street (Image 10). The road surface was typical of the project area and the stratum beneath the road base consisted of rusty medium-brown sandy loam fill with gravel, pebble and small rock inclusions. The top of a concrete sewer casing was exposed at 3½' below surface. The sewer ran east-west and was exposed across the 5' width of the test pit. A 10' length was exposed north to south. The overall depth of the concrete casing was not determined but it extended beyond the final excavation depth of 5½'. A substantial amount of loose, modern brick was found in the area of the casing and it appeared that there had been a brick facing to the concrete. No archaeological resources were uncovered and no intact stratigraphic layers were exposed.

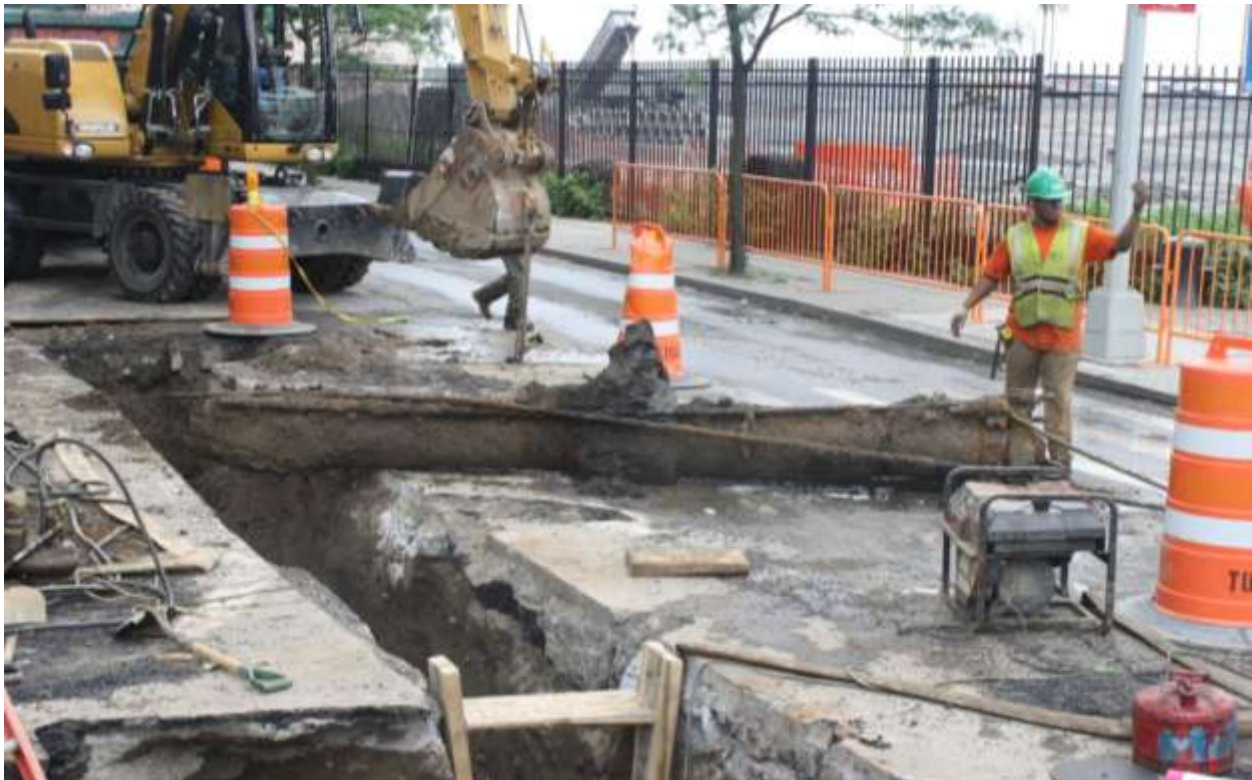
Image 12: Cast iron water main laid in the 1890s being removed from Furman Street.

Extant utilities included a number of late nineteenth and early twentieth century lines and one mid nineteenth century main. The latter was a 6" cast iron pipe laid in 1858, according to the contractor's plan drawings. This main was present on Old Fulton Street throughout almost the entire length of the trench at a depth of approximately 3'-4' below surface. The existing water main on Furman Street ran north/south at 5' below street grade and was laid in the 1890s (according to construction plan drawings) (Image 12). Square wooden ducts observed in the test pits and in trenches throughout the project area ran at approximately 3' below street grade north/south on Furman Street and east/west below or slightly north of the south curb line of Old Fulton Street. At Everit Street, another wooden conduit branched off of the conduit running along Old Fulton Street. This connection contained a lead cable (Image 13).

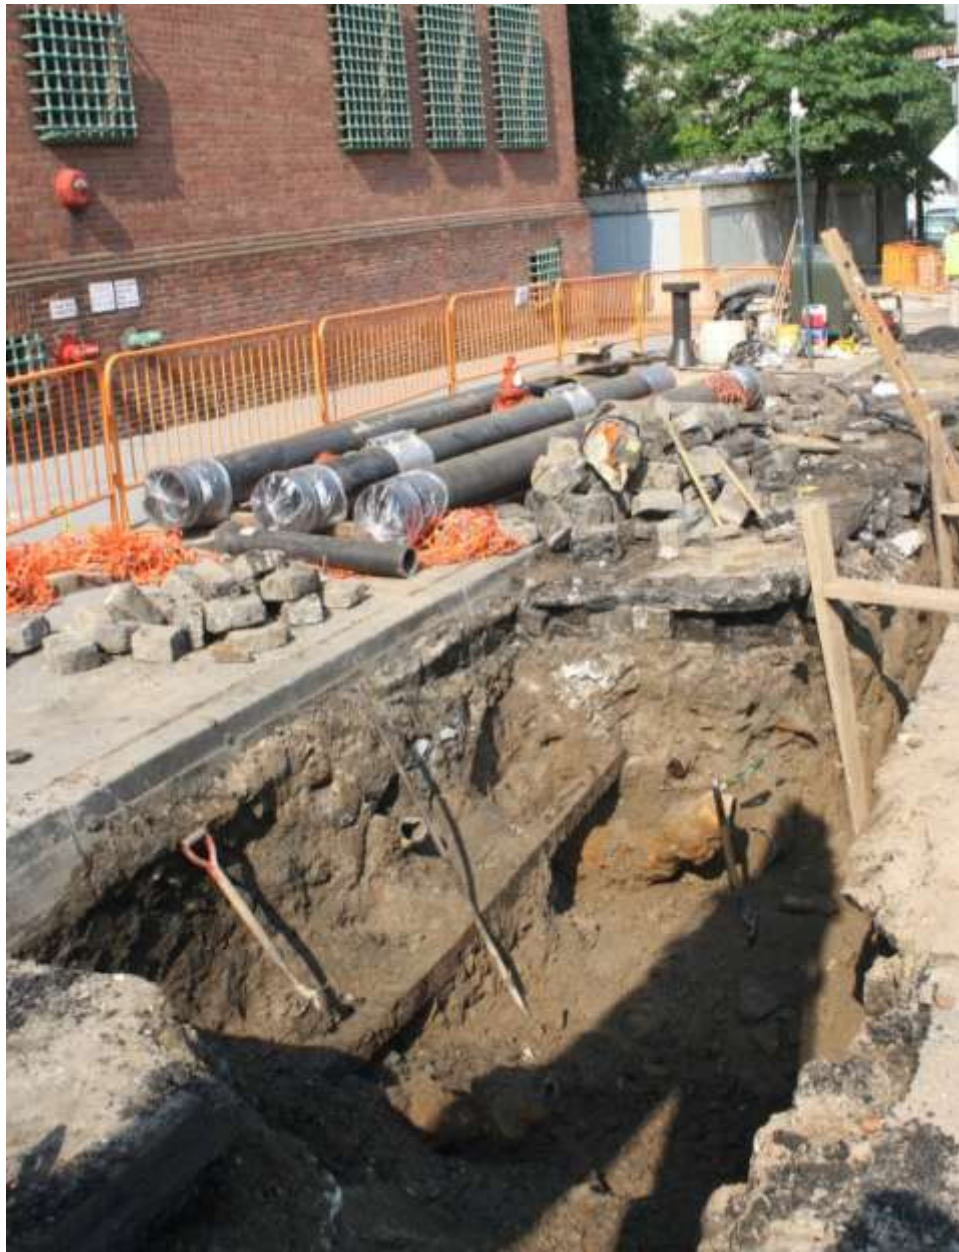
Image 13: Wood duct on Old Fulton Street by the Eagle Warehouse.

Other early modern utilities observed in this portion of the project area were a salt-glazed ceramic conduit in the south wall of the Old Fulton Street trench west of Everit Street at 3½' below the street grade; at least two disused brick manholes at the intersection of the Furman Street and Old Fulton Street trenches; and a small brick sewer pipe visible in the north trench wall on Old Fulton Street east of Everit Street.

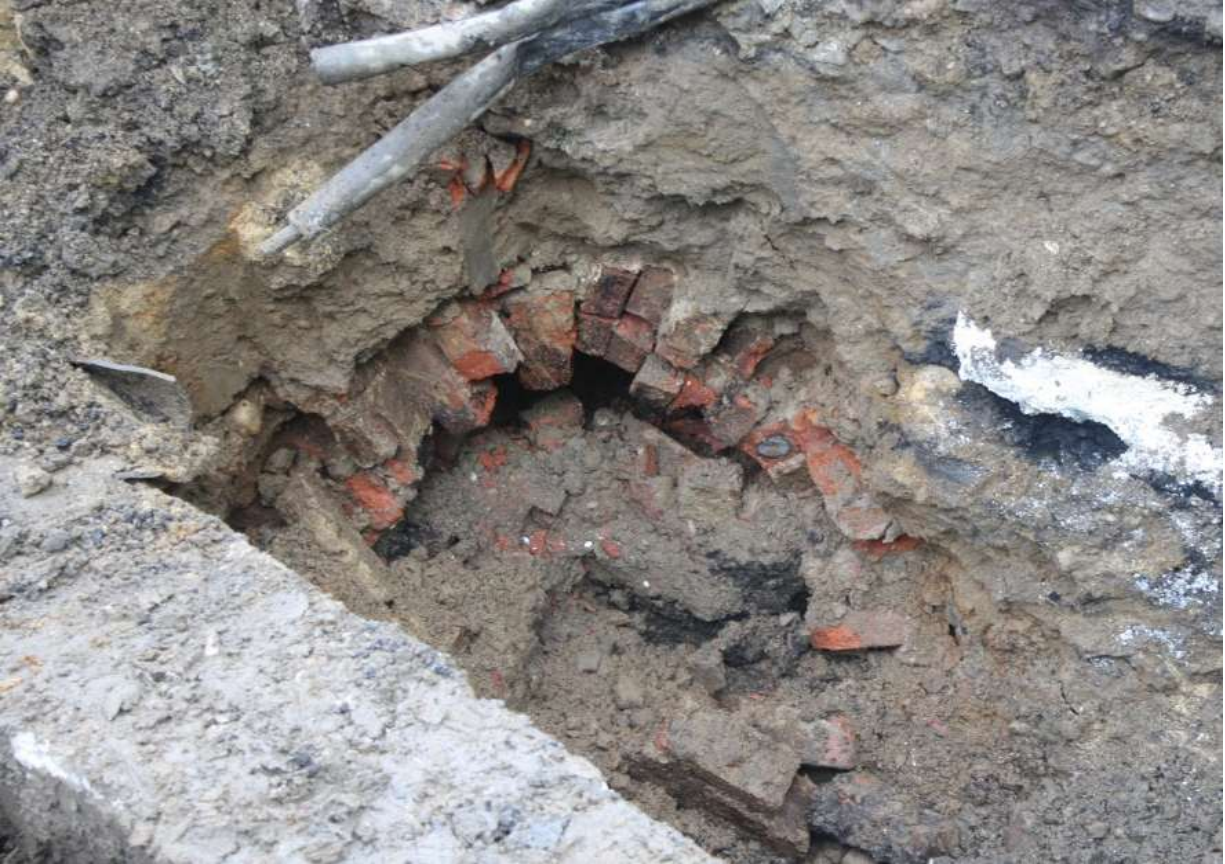
Image 16: Brick sewer on Old Fulton Street west of Everit Street.

To the west of Everit Street, visible in the north trench wall, was a rectangular brick feature. The exposed wall measured 8' from the south curb line of Old Fulton Street proceeding north (Image 16). The feature measured 2' wide and was exposed at 2' below street grade, extending to the trench floor at slightly more than 4' below surface. It was the working field assumption that this feature was likely part of the manhole for the sewer based on the similarity of materials. However, this was inconclusive as no manhole cover was directly associated with the feature. One sherd of American salt-glazed stoneware with a tan slip interior was recovered from the matrix surrounding the wall face.

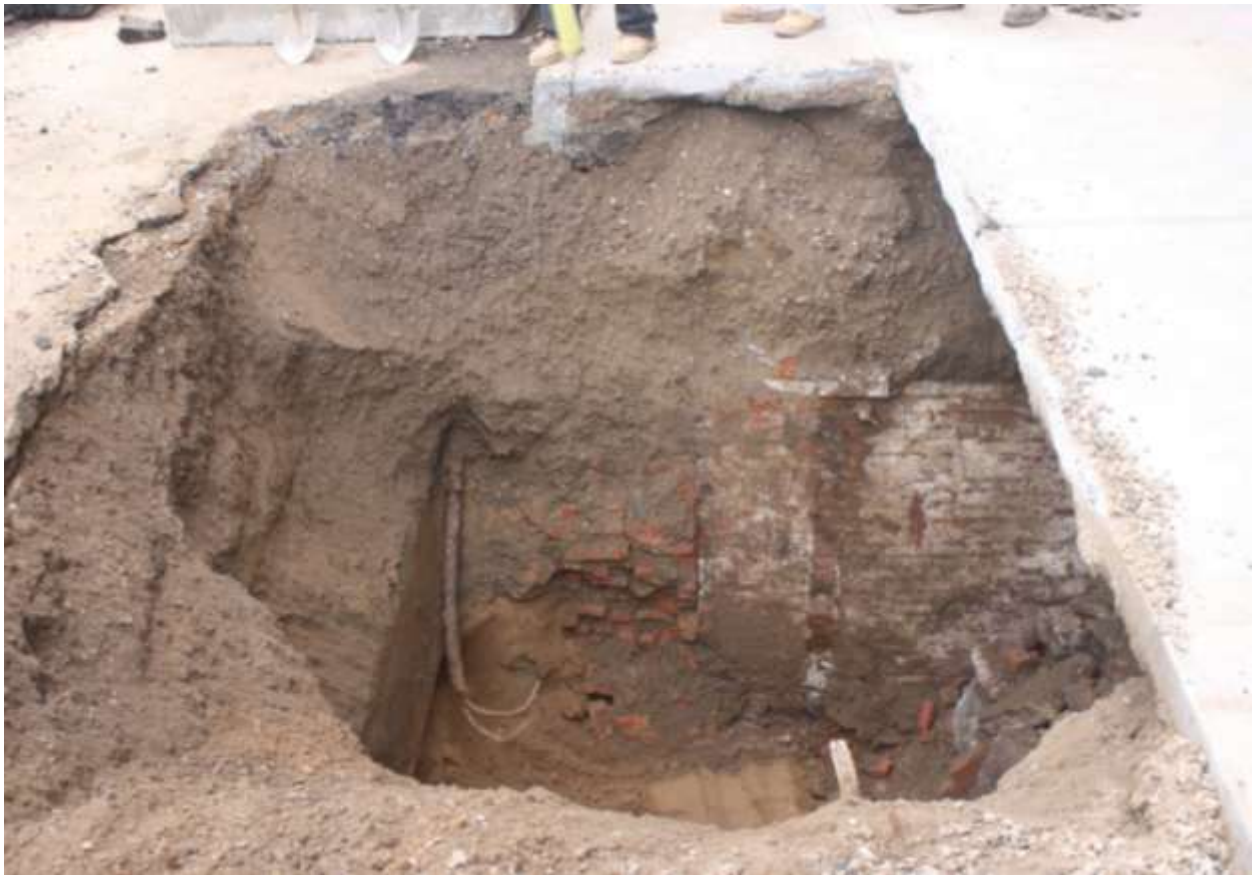
Image 17: Sidewalk vault in front of the Eagle Warehouse, looking east.

In the western profile of the trench segment, a substantial amount of disarticulated bluestone was observed at approximately 3' below sidewalk grade. Another brick wall, running north to south, was present to the north of the bluestone at 6' below sidewalk grade (IMAGE 16). This wall was a minimum of 5' long. Another fragmentary brick wall, also measuring 2' wide, was exposed running parallel to the curb line. The matrix surrounding all of these features consisted of disturbed fill, a medium-brown sandy loam and rust colored sand. No artifacts were observed in association with any of the exposed features within this area. (PHOTO/PLAN VIEW/PROFILE)

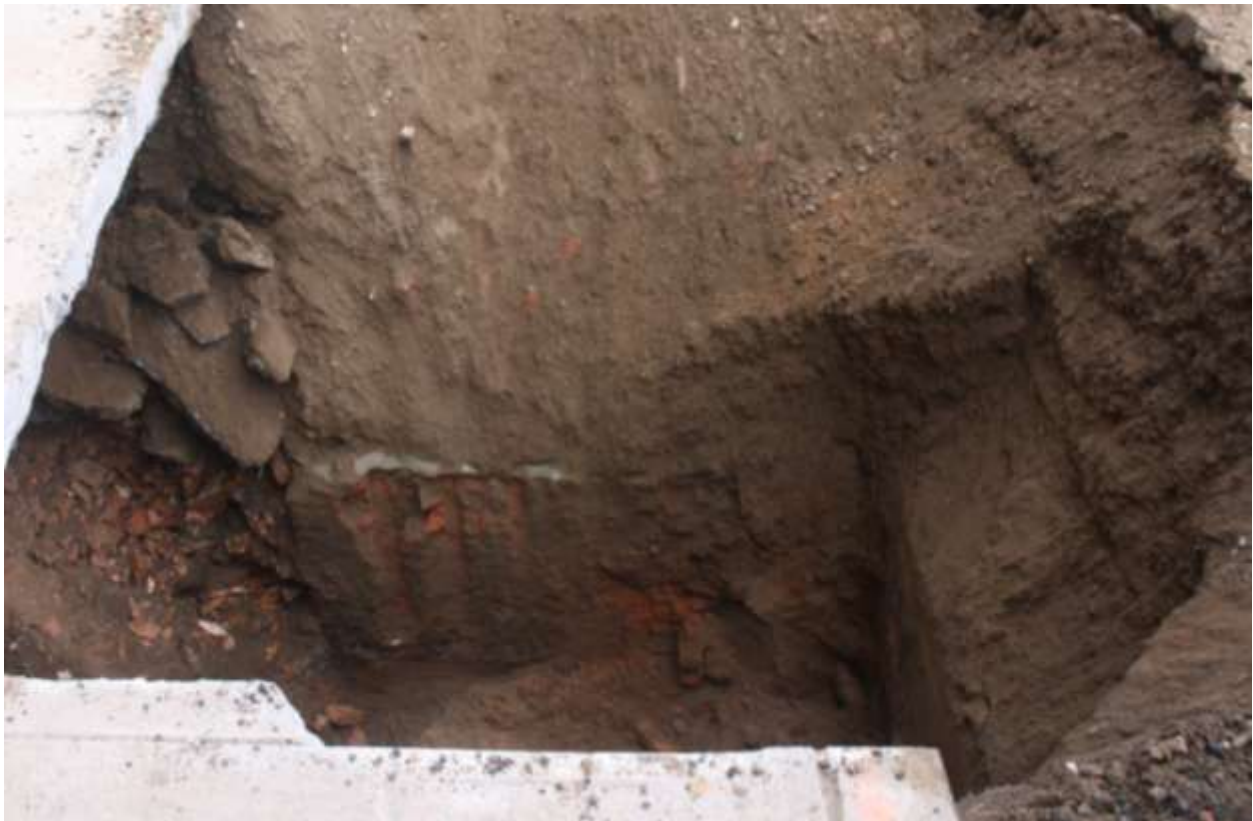
Image 18: Brick and bluestone features in front of the Eagle Warehouse, looking west.

Another trench to impact the sidewalk in this block was located at approximately 80' east of the building line on the east side of Elizabeth Street. This trench segment connected to the primary trench on its northern side to the curb line on its southern side. It measured approximately 6' north to south and 14' east to west. A wooden duct was exposed at 3 ½' below grade. Part of a brick wall and several irregularly-shaped bluestone slabs were visible in the south profile beneath the curb line (Image 18).

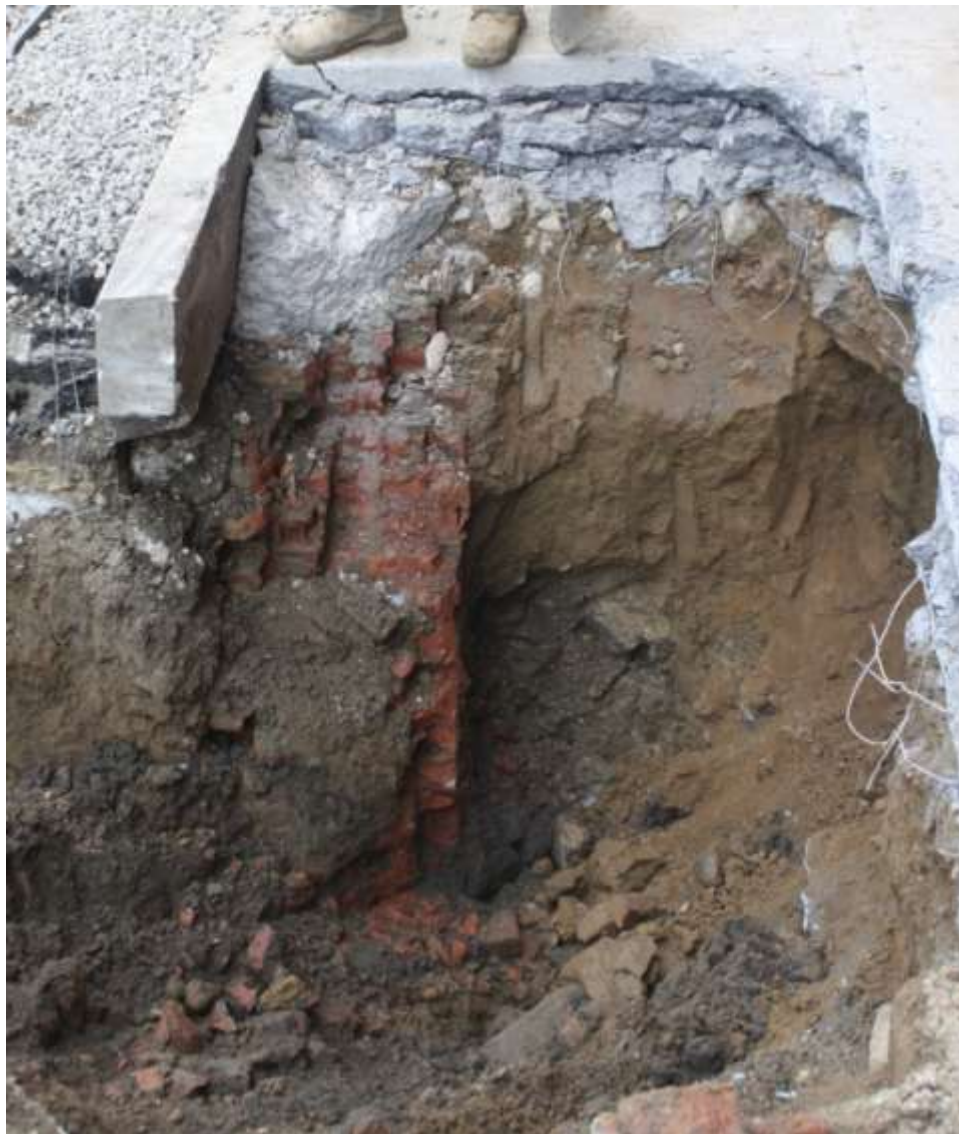
Image 19: Brick wall on Old Fulton Street west of Front Street, looking east.

A brick wall was observed in the east profile of the trench beneath the sidewalk (Image 19). The wall extended to the final excavation depth of 5½' below surface continuing below the trench floor. The wall had a north/south width of 2' and an east/west length of 2½'. Bricks measured 8" x 3½" x 2¼" and had no visible stamps or marks. There were five courses oriented lengthwise east to west so that their ends were visible in the east profile. No structure, intact or otherwise, was visible in the west trench wall, although there was a substantial amount of loose brick. A square wooden duct and a flat 4" wide wood plate over an iron pipe were present in the trench in front of the curb line at 5' and 3½' below grade, respectively. Fill beneath the sidewalk consisted of clean orangish-brown sand. As with the other trenches containing brick features in

this area, the soils were disturbed and the features impacted by earlier utility installations. No associated artifacts were observed.

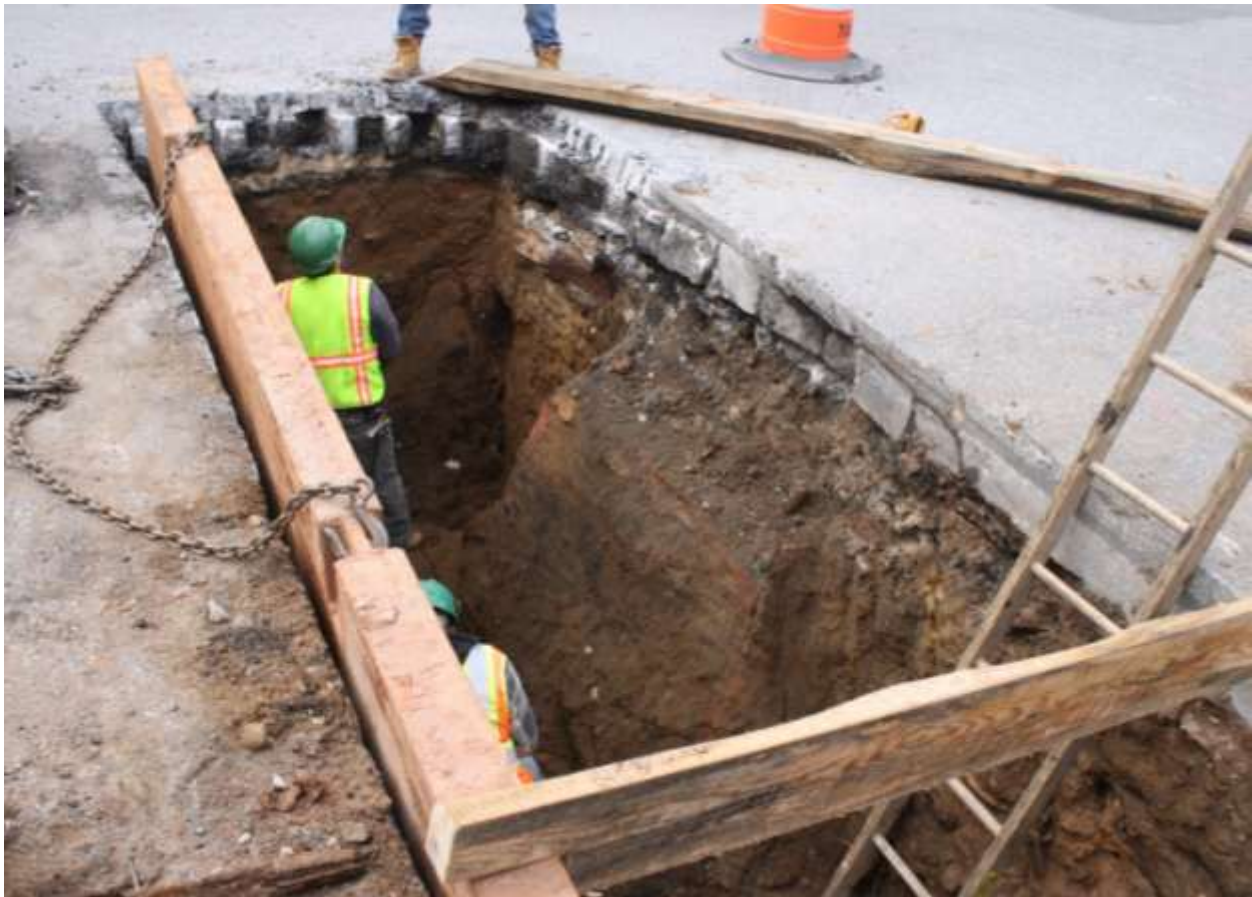
Image 20: Brick footing in sewer trench on Old Fulton Street, looking southwest.

The only area of archaeological concern in this phase of the excavation lie in the first portion of the trench on Old Fulton Street. In the south central portion of the intersection with Water Street, two trapezoidal brick and stone features were exposed. The features, believed to be footings, were oriented lengthwise north to south and were partly embedded in the west trench wall (Image 20). Some utility disturbance was present between the two footings from 2½'-4' below grade. Plans in the possession of the contractor showed two "abandoned railway" supports in the same approximate location. The southeast corner of the southernmost footing was located approximately 120' north of the south building line of Old Fulton Street and 112' east of No. 1 Water Street. The top of this feature, at 2½' feet below grade, measured 4' long north to south and extended from the west trench wall 12" at the north end and 16" at the south end. The base of the feature was visible at approximately 6½' below grade, making it 4' total in height. The base was approximately 2' wider than the top but excavation conditions prevented entry into the trench for precise measurements. At the base of the feature was an approximate 4" thick slab of bluestone was exposed. Part of a disused ceramic sewer pipe was uncovered below the base of the brick feature at its center, 8' below grade.

The northern footing was located 17' north of the first, or approximately 141' north of the south building line of Old Fulton. Its east face was slightly west of the southern footing. It protruded only a few inches from the west trench wall and was not fully excavated before the trench was sheeted. The dimensions and composition of this footing were similar to the first. No sewer pipe was noted below this feature.

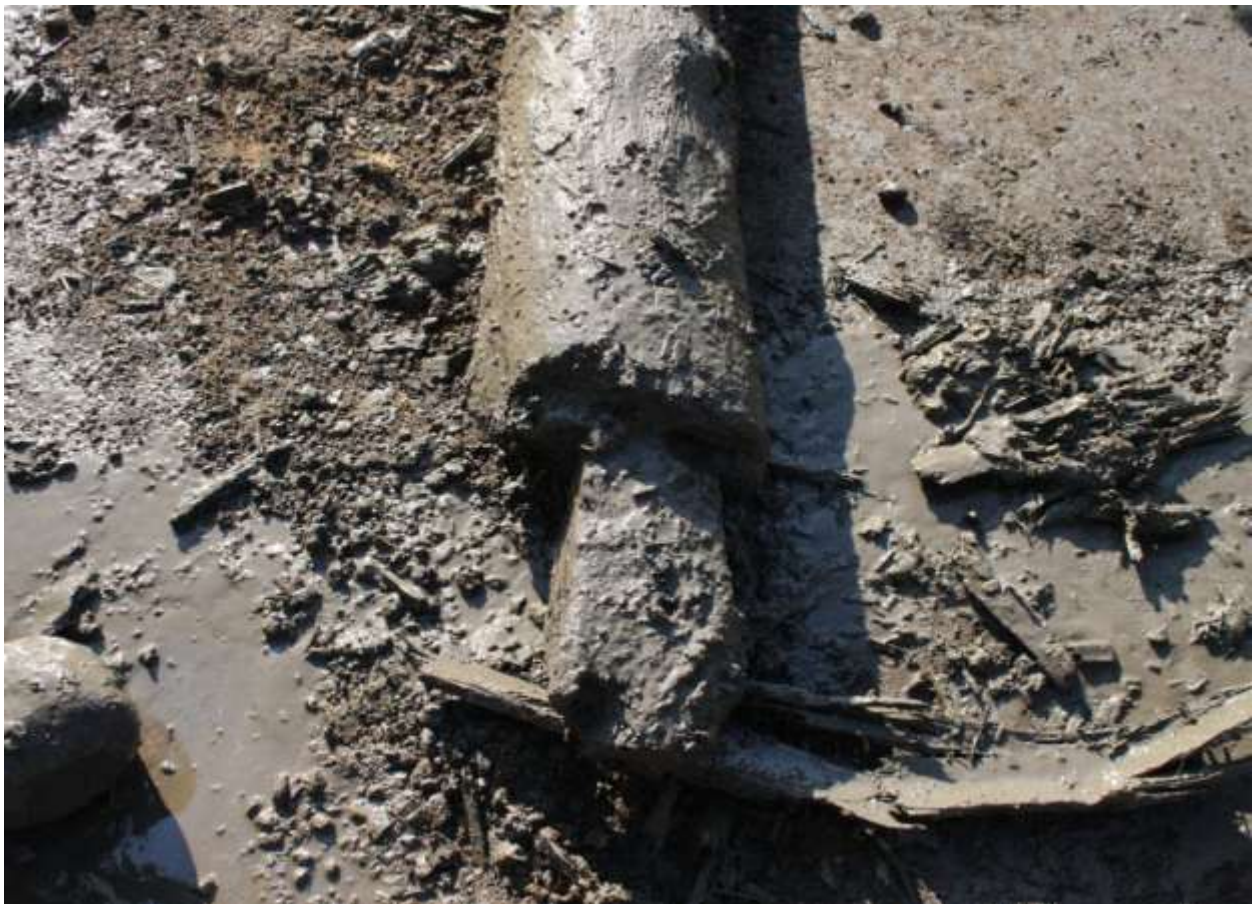
Image 21: Key-like end of log found in trench on Old Fulton Street near brick footings.

Adjacent to the north footing, several disarticulated logs between 4'-7' in length and 8"-10" in diameter were removed from the trench at 9' below grade. Most of the logs had splintered ends, but one had a key-like end (Image 21), with a flat 3" thick piece protruding 1' from the end of the log. These were disarticulated in the trench but were likely once part of a landfill device utilized in the area. The structure may have been destroyed when the railway footings were installed.

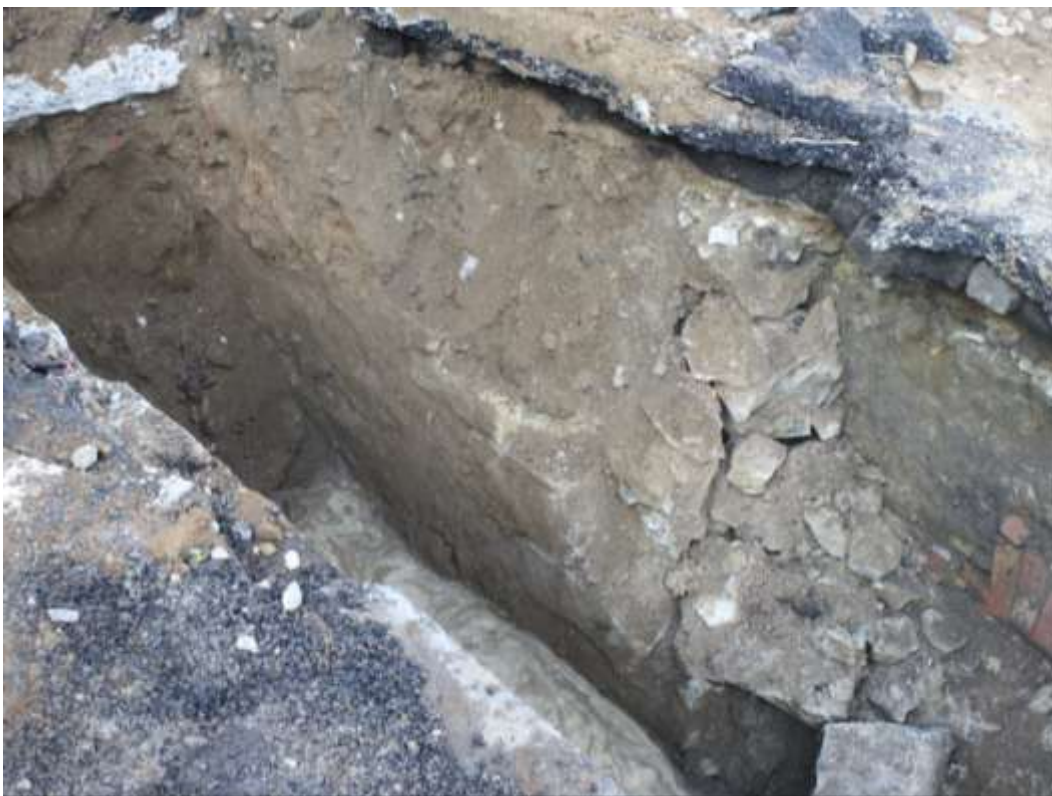
Image 22: Rough-cut, mortared stone wall adjacent to dry fieldstone wall and brick structure.

The stone wall observed in the west profile consisted of two segments, a dry-laid fieldstone portion and to the south, a rough-cut stone block wall with limestone mortar (Image 22). The total north/south length of the wall measured 12'3": the fieldstone portion measured 6' and the cut block portion measured 6'3". The latter continued into the unexcavated area of the street to the south so the total length is undetermined. Both portions of the wall protruded between 12"-18" from the plane of the west wall and continued beneath the trench floor at 5½' below street grade. The total visible height of the wall could not be determined precisely due to collapse but was approximately 4½' for the fieldstone portion and 3½' for the cut stone portion. Fieldstones measured between 14"-21" long and between 12"-18" wide. The stone blocks were granite and measured approximately 14" long and 10" wide and deep.

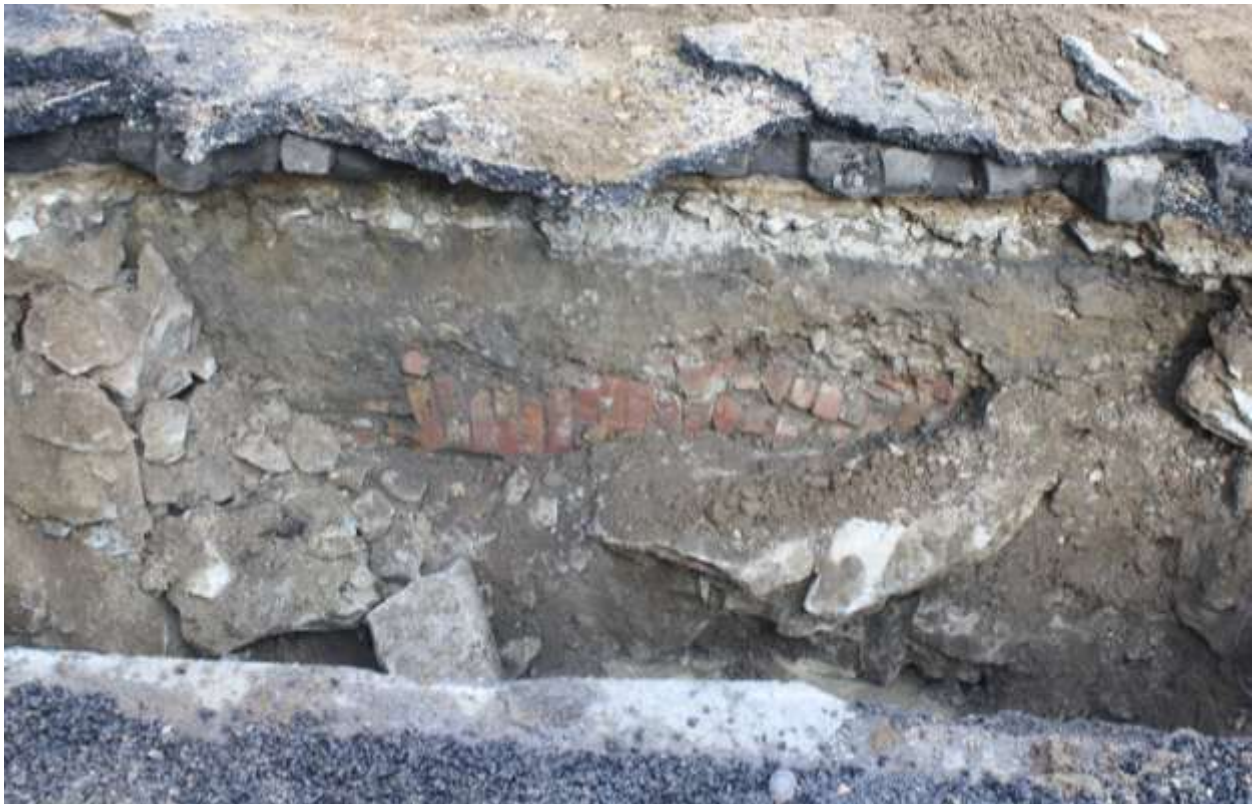
Image 23: Brick portion of Everit Street feature with collapsed fieldstone wall, looking west.

The brick feature behind the stone wall (discussed above) consisted of a row of at least fourteen vertical bricks in a semi-arched configuration, that appeared to be collapsed, with a length of 4½' (Image 23). At the north end for approximately 2', the ends of a row of at least seven bricks placed horizontally were visible above the first brick row. At the south end were two layers of horizontally-placed bricks, with at least twelve bricks in each row, with the top of these rows two or three inches below the top of the arched row. Measurement of individual bricks was difficult as all were *in situ*, but they were approximately 7" x 3" x 2" (Schematic 02).

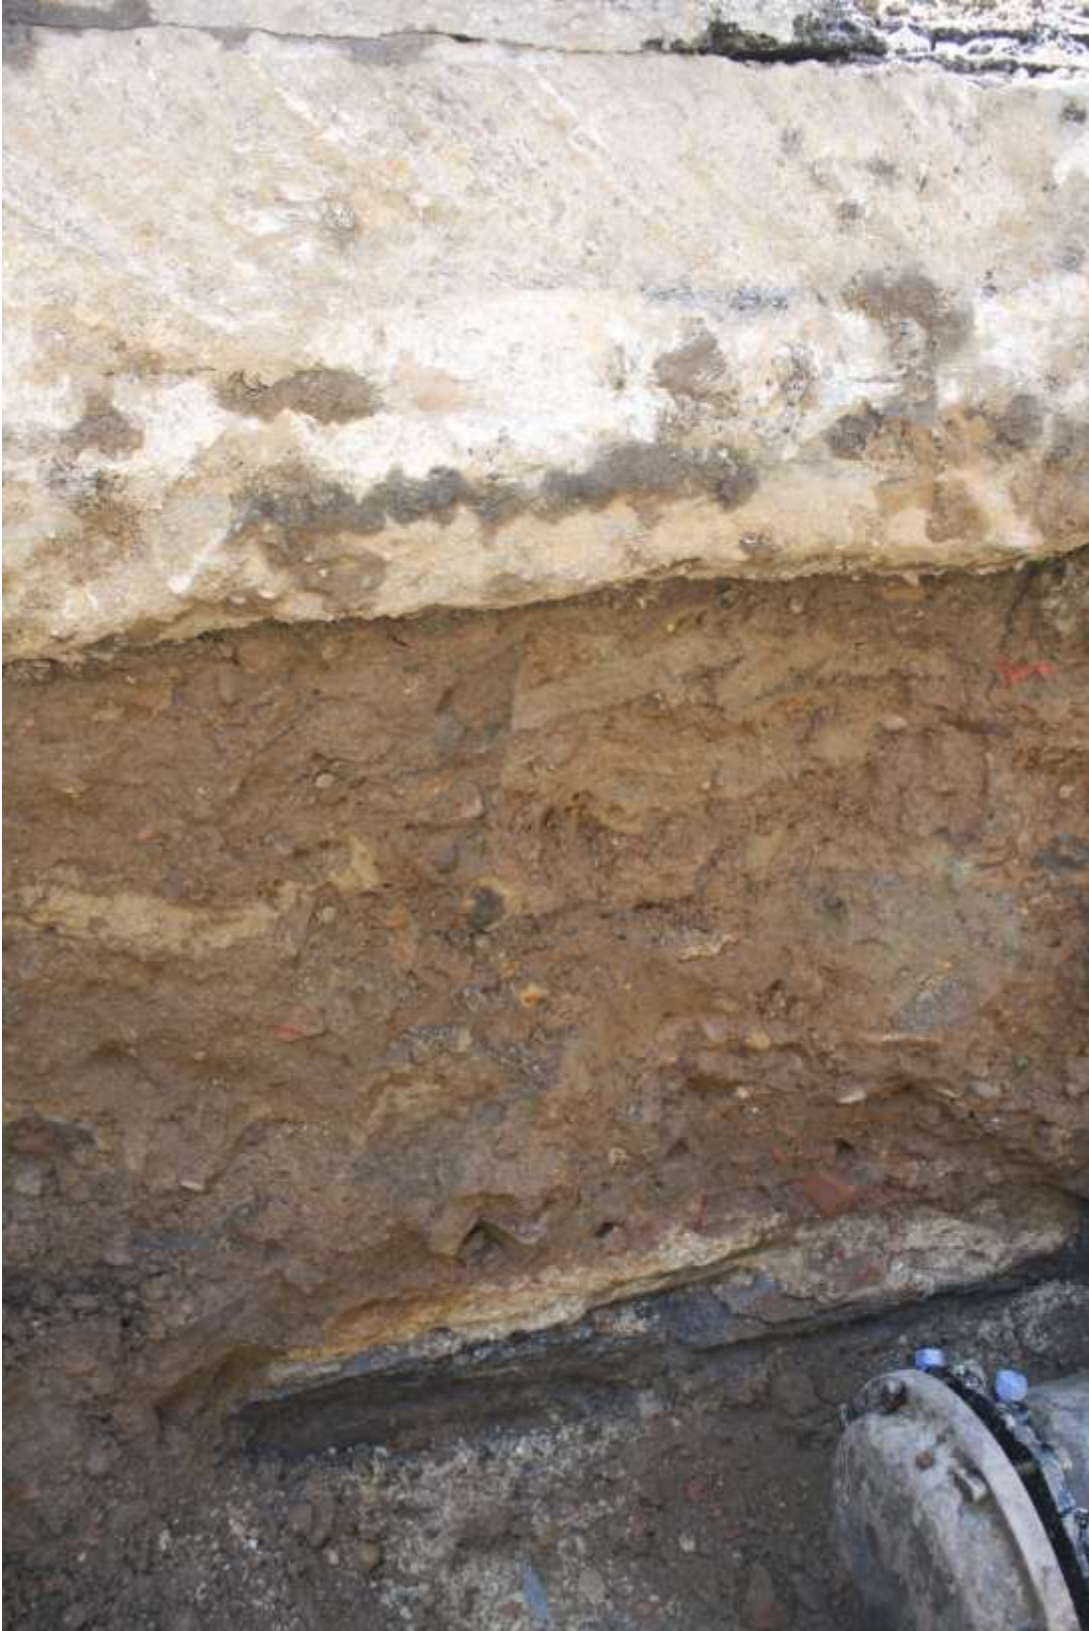
Image 24: Bluestone surface visible in east trench wall on Everit Street.

The bluestone noted in the east wall of the trench consisted of a horizontal surface 1"-2" thick running north/south at 5'4" below grade; 2½' of length was exposed (Image 24). The edges of the stone were fragmented and fractured in layers, and it appeared that installation of the water pipe, only a few inches to the east, had destroyed a portion of this feature. A 3"-4" stratum of solidified yellow fill sand overlay the bluestone and several pieces of loose brick were visible in the profile just above the sand. The stratum above the sand and below the road bed was rusty medium-brown sandy clay loam typical of the area.

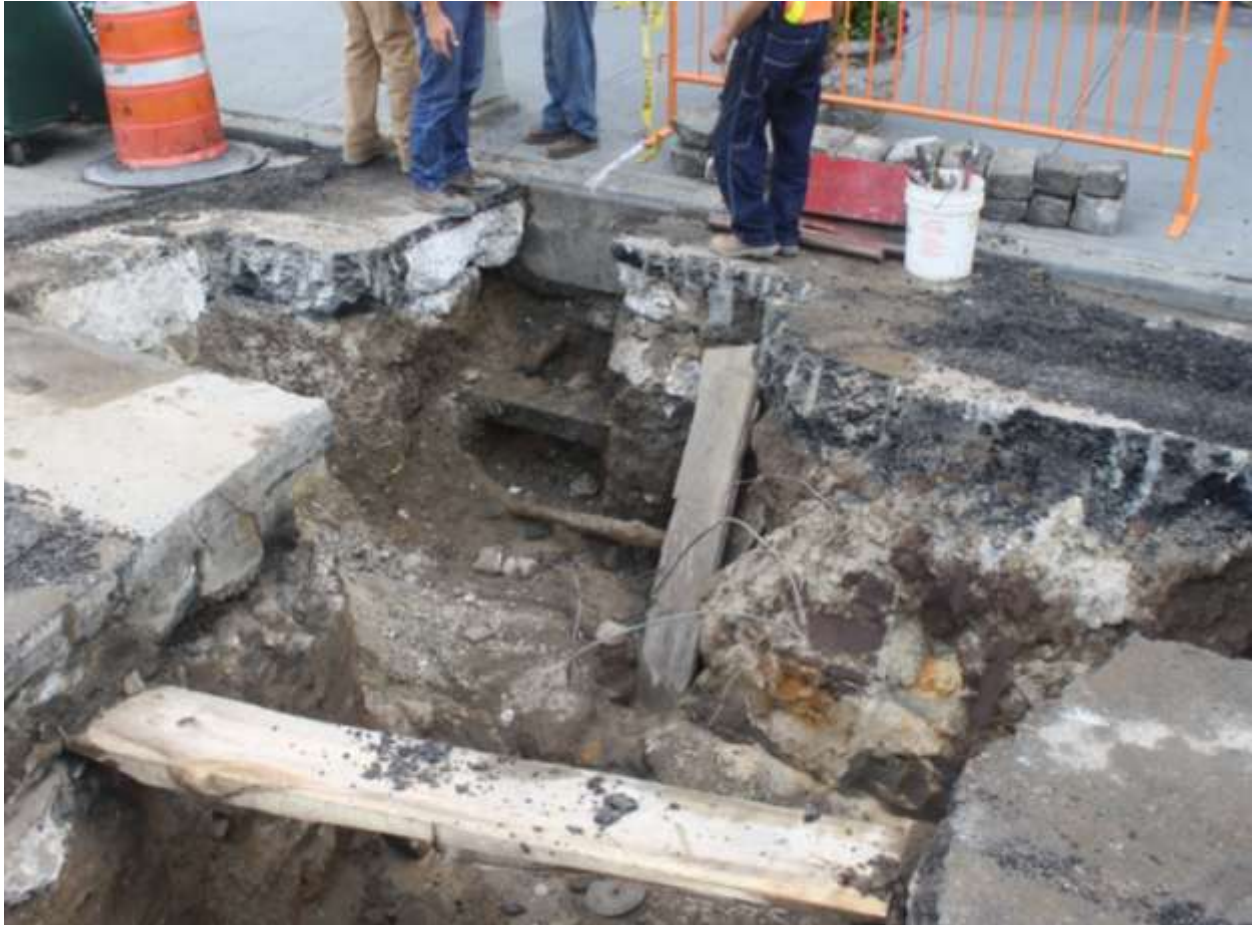
Image 25: Wood duct on north side of Old Fulton at Water Street, looking north.

Utility disturbance was substantial in the eastern half of the trench with evidence of a number of episodes of disturbance throughout the twentieth century. Utilities were located between 1'-5' below street grade and included an early twentieth century ceramic conduit with lead telephone cables running east/west in the trench center at 3'-4' below grade. Several small metal pipes transected the trench and several PVC pipes were present. A large plastic duct and an early twentieth century copper service pipe with a hand-driven lead tap, a type that was generally not used after the mid portion of the twentieth century, were also present. A square wood duct, identical to those found on Furman Street and on the south side of Old Fulton Street, was present in the trench located near the west building line of No. 2 Water Street (Image 25).

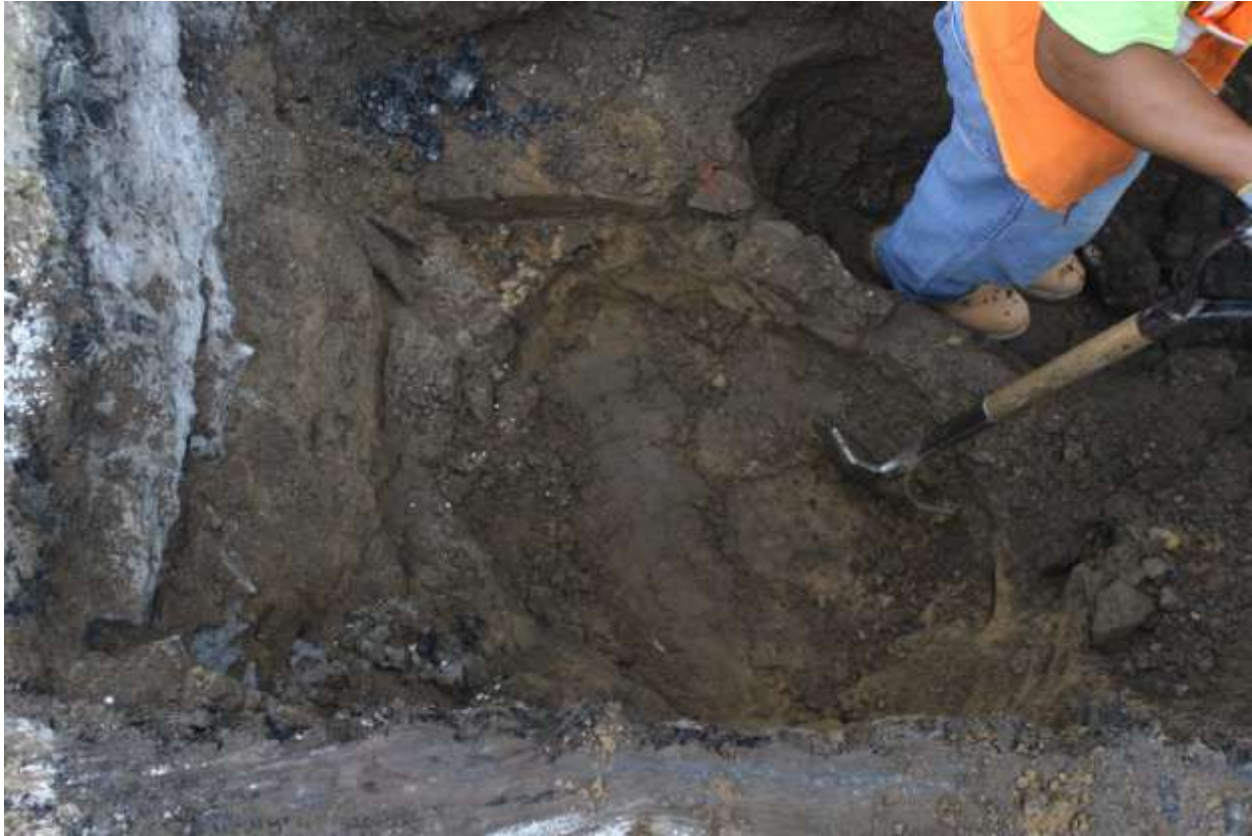
Image 26: Bottom of circular brick feature in southwest corner of test pit one on Old Fulton Street east of Water Street.

Three brick features were documented near the northwest corner of Old Fulton and Water Streets – a sidewalk vault and two partial circular structures that appear to have been utility-related (Image 26). Additionally, an early-modern twentieth century brick catch basin was present in this area.

The northeast arc of one of the circular brick features was visible along the west wall of the trench at 15' south of the building line on the north side of Old Fulton Street. It curved to the southeast and eventually headed into the south trench wall 4' east of the west wall. The interior of the structure contained yellowish sand, while the surrounding matrix consisted of rusty medium-brown sandy loam. The component bricks measured 8" x 3½" x 2¼", and some contained a frogged stamp reading "DPBW." This is likely Denny's Point Brick Works, one of the many Hudson River valley brick manufacturers. The height of the feature could not be accurately determined due to excavation circumstances and prior utility disturbance.

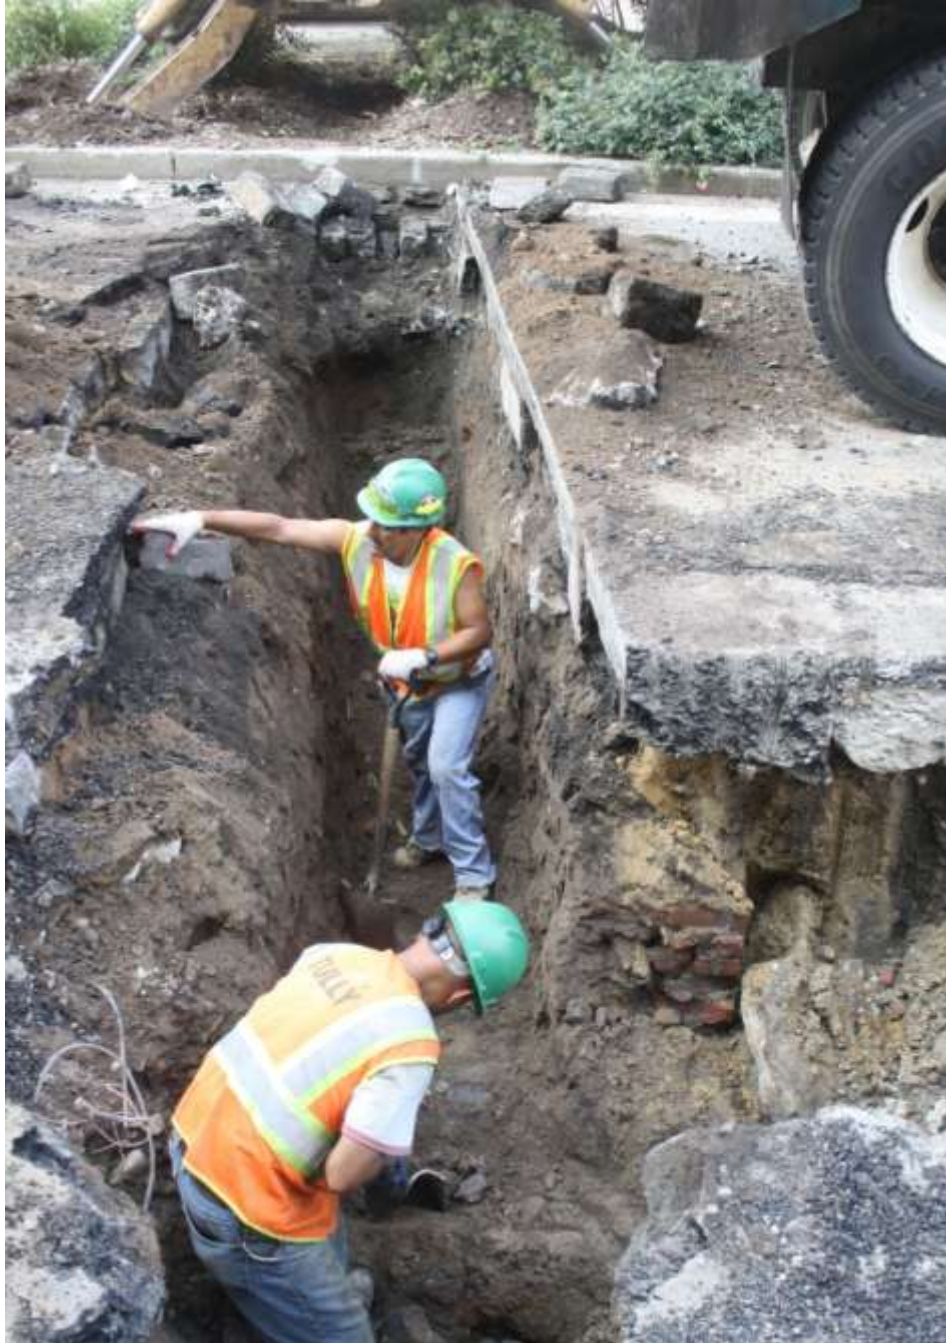
Image 27: Cross-section of second circular brick feature in test pit one, looking south.

The second circular feature was first visible as what appeared to be the cross-section of a brick wall at 18½' south of the building line and 2½' below the street surface (Image 27). After further excavation, it became clear that the structure had a slight curvature, with its convex side toward the southeast. Construction consisted of two or three layers of odd-sized bricks, cut to fit the curvature. The cross section was approximately 10" wide and a minimum of 2½' high. The structure continued below the final excavation depth. The wall may have been an access point for an old water main. A twentieth century cast iron main ran beneath the wall at 5' below grade, although no valve was visible. Tan sand fill was present on the interior/southwest of the wall.
