Phase IB Archaeological Monitoring – Construction of Combined Sewer
In: Water Street Between Old Fulton Street and Adams Street, Old
Fulton Street Between Front Street and Furman Street and Washington
Street Between York Street and Plymouth Street
(aka Downtown Brooklyn Water Main Replacement Project), Brooklyn
(Kings County), New York – Project PIN Number: SEK002355

The City of New York – Department of Design
and Construction
Long Island City, Queens, New York

Alyssa Loorya, M.A., R.P.A., Principal Investigator
Christopher Ricciardi, Ph.D., R.P.A. and
Diane George, M.A., R.P.A.
for: Chrysalis Archaeological Consultants, Incorporated

Final Report – November 2012

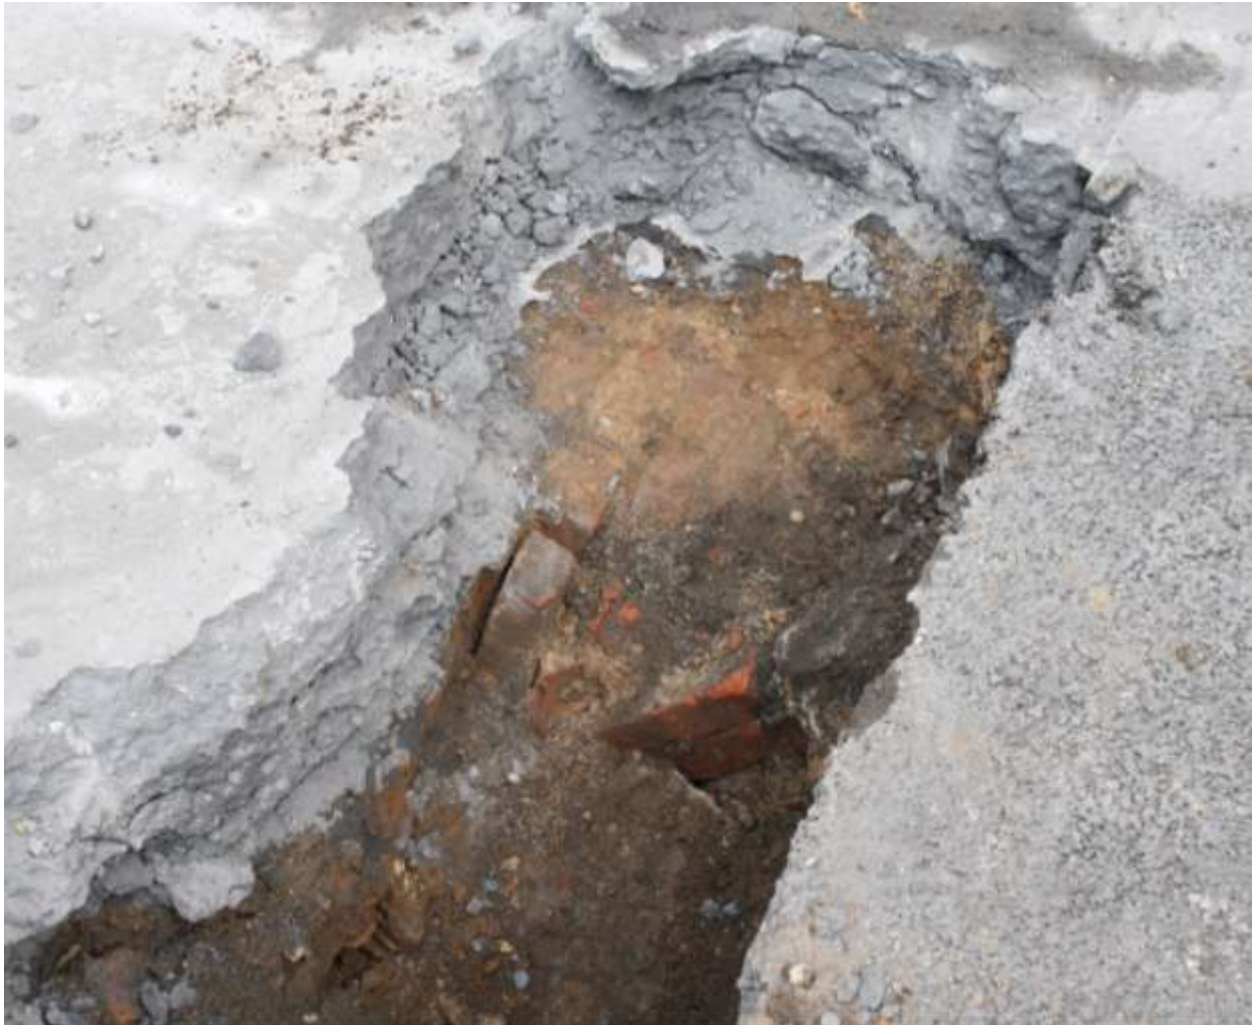
Image 28: Top of sidewalk vault in front of No. 2 Water Street, on the south side of the building.

The third brick feature in this area was the top of a functioning sidewalk vault (Image 28) on the south side of Pete's Restaurant, located at No. 2 Water Street on the northeast corner of Old Fulton Street and Water Street. The top of the vaulted brick structure was exposed immediately beneath the paving. An old brick catch basin was also noted in the southwest corner of the trench wall east of the brick vault, visible directly beneath the asphalt extending to at least 6' below street grade. An arched metal cap covered a clay sewer pipe approximately 3½' below grade, running south from the catch basin. Bricks were frogged and stamped "Brigham" and measured 8" x 3½" x 2¼". Located in Ulster, New York, the Brigham Brick Company was part of an

extensive brick making industry that was prominent along the Hudson River Valley from the mid-eighteenth to mid-twentieth centuries. Brigham was founded as the Rosendale and Kingston Cement Company by Henry R. Brigham, who in the late 1880's expanded to include brick making. By 1891, the Brigham Bros. brickworks was established, as evidenced by historic maps from that period. The Brigham Brick Company operated until at least 1957 (<http://brickcollecting.com/shultz.htm>).

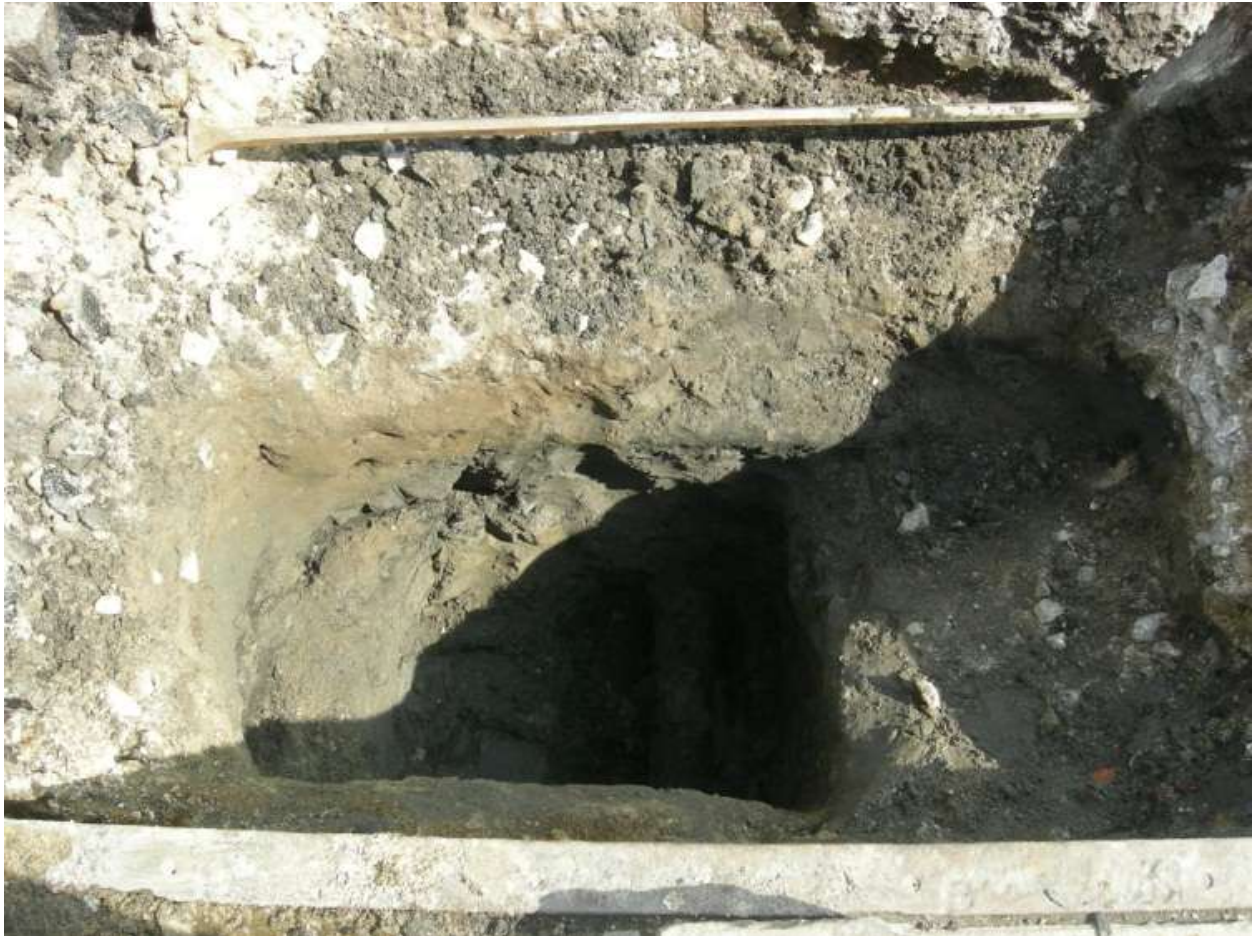
Image 29: Looking north into Test Pit 4. The dark stratum is visible in the deepest area of the test pit, and the concrete slab (not fully excavated) is in the lower right corner.

Test Pit 4 was located on the south side of Water Street at a point approximately 100' east of Test Pit 3 and directly south of the west side of New Dock Street. The unit measured 4' x 7' with the south wall abutting the south curb of Water Street. Stratigraphy remained consistent with that of Test Pit 3 with the rusty medium brown sandy loam extending 3 ½' feet below grade, followed by a stratum of dark gray-brown sandy. A small amount of coal, charcoal and brick inclusions were present in this layer, which measured approximately 1' thick. No other artifacts were found in this stratum. Two feet below surface, in the southeast corner of the trench, a one-foot thick concrete slab was exposed (Image 29). This slab ran diagonally from the south to the east trench wall and was not removed. Utility disturbance was minimal in Test Pit 4, but extended to 5½' below surface. No artifacts were found in this test pit. No intact surfaces or deposits were exposed.

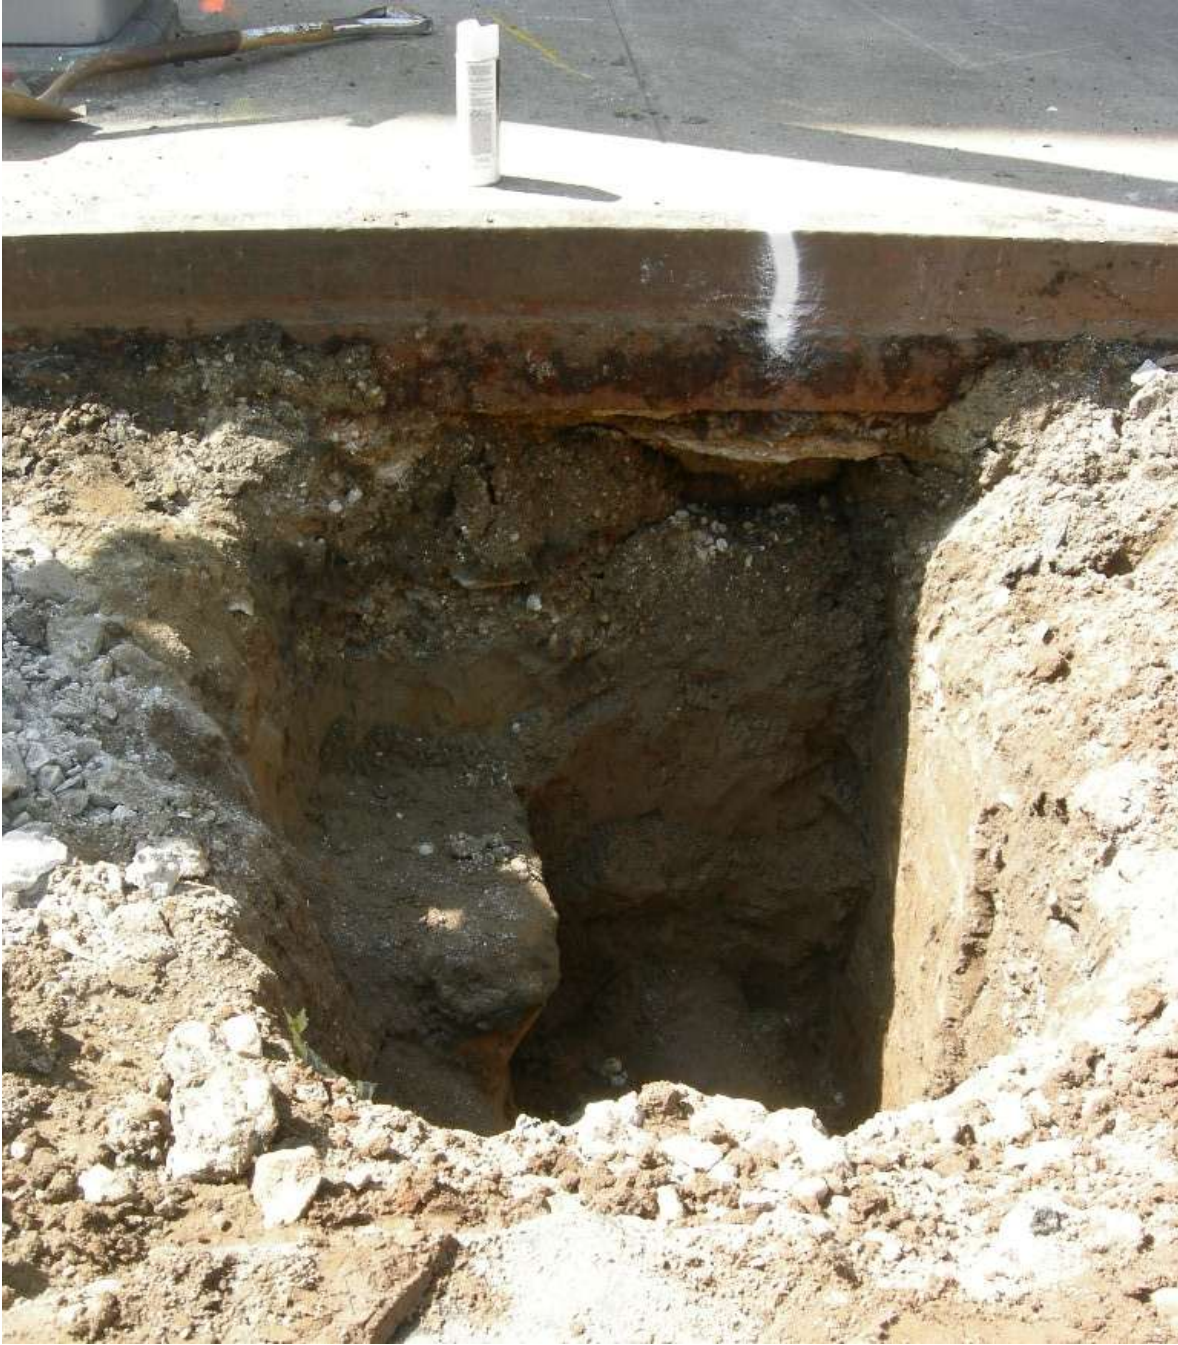
Image 30: Test Pit 5 looking south. The bluestone slab (pedestaled) is in left of trench (east) and the concrete wall is visible in the trench wall on the right (west).

Test Pit 5 was located further east on the south side of Water Street between New Dock and Dock Streets. The pit measured approximately 5' x 4' abutting the south curb line of Water Street. Most of the test pit contained the rusty medium-brown sandy loam fill observed elsewhere. Two large pipes, one running parallel to the curb at 3½' below grade and one (an older ceramic pipe) running perpendicular at 4½' below grade, comprised the only utility disturbance. A 6" thick bluestone slab was uncovered at 3' below grade in the southeast corner of the trench, opposite the concrete wall (Image 30). Only a 1½' x 1' segment of the stone was exposed
