# **GOWANUS CANAL BULKHEAD AND CRIBBING DOCUMENTATION at CARROLL GARDENS, 365 BOND STREET and 400 CARROLL STREET BROOKLYN, KINGS COUNTY, NEW YORK**

**17 April 2013  
100287501**

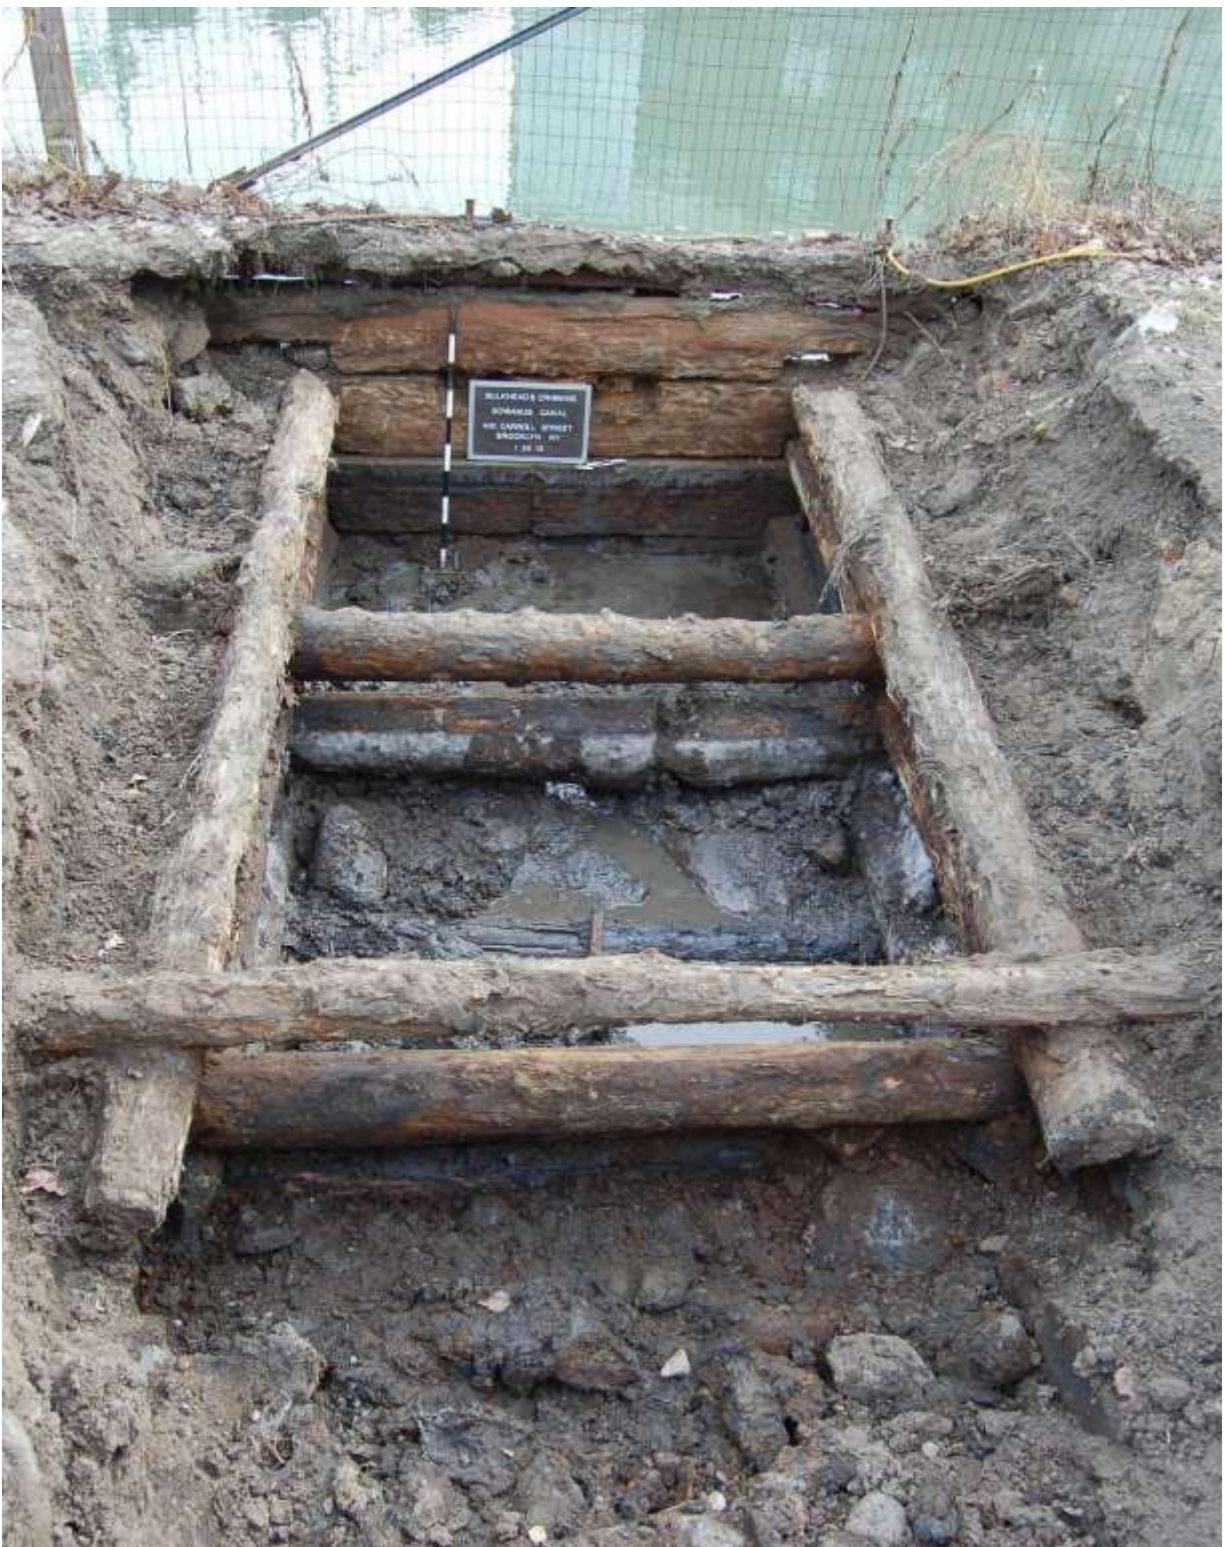
The Carroll Street property has the more intact bulkhead wall and cribbing of the two properties. The Carroll Street bulkhead retains a better state of preservation, although, the top of the bulkhead has begun to deteriorate (Photo 1). The ends of the tie back timbers that used to go through the bulkhead wall and could be seen on the water ward side of the bulkhead wall were not evident in the top row of timbers and only partially present in the second row of timbers (Photos 2 and 3).

Photo 1 – Plan view of the 400 Carroll Street cribbing and interior of bulkhead wall, facing east.  
Photograph taken by Michael Audin, 1/25/2013.

As excavation progressed the top timbers of the cribbing system were also deteriorating and were a much smaller diameter than originally (Photo 1, 4 through 7). Regardless, the cribbing maintained its placement under the surface and it seems that little has disturbed it over the past 100+ years. Close ups of the timber joints (Photo 8) and the hand hewed tie back timbers illustrate how the cribbing was constructed and integrated with the bulkhead wall. The measured drawings illustrate how the bulkhead and cribbing was constructed.

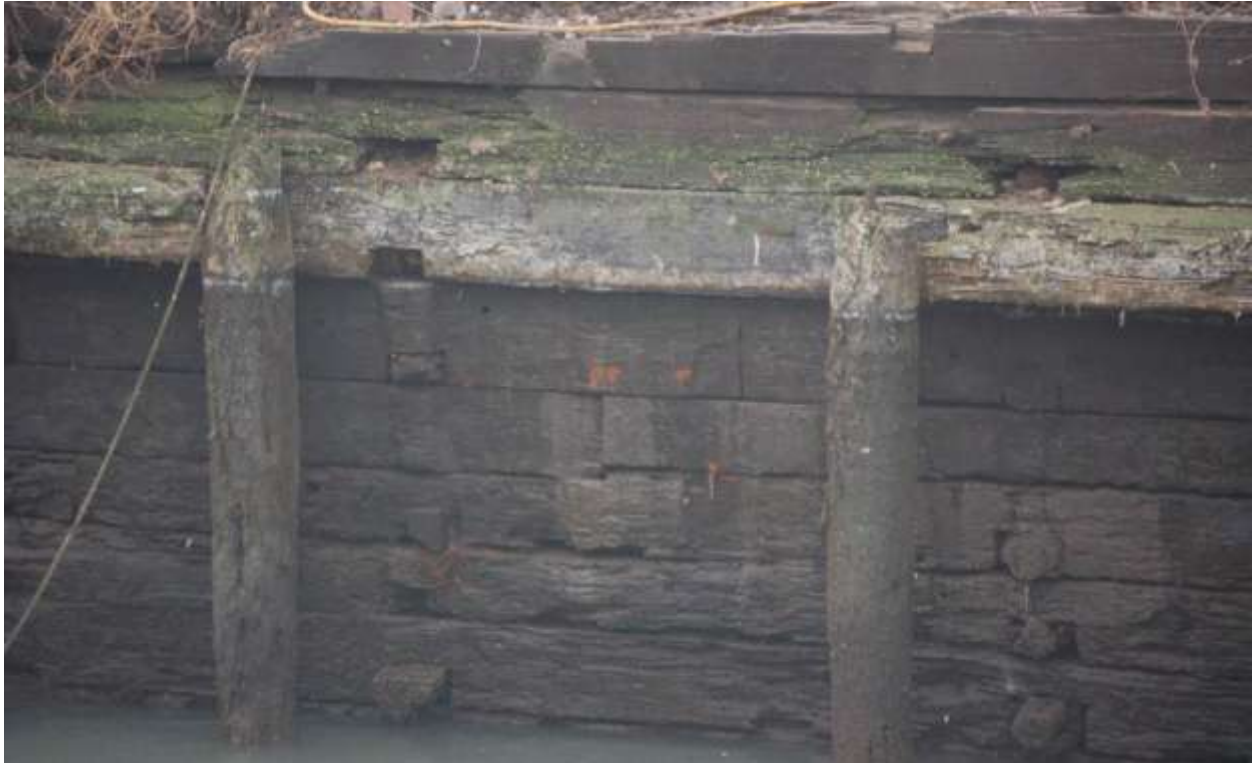
**Photo 2 – View of the Canal face of the bulkhead wall at 400 Carroll Street, facing southwest.  
Photograph taken by Michael Audin 1/25/2013.**

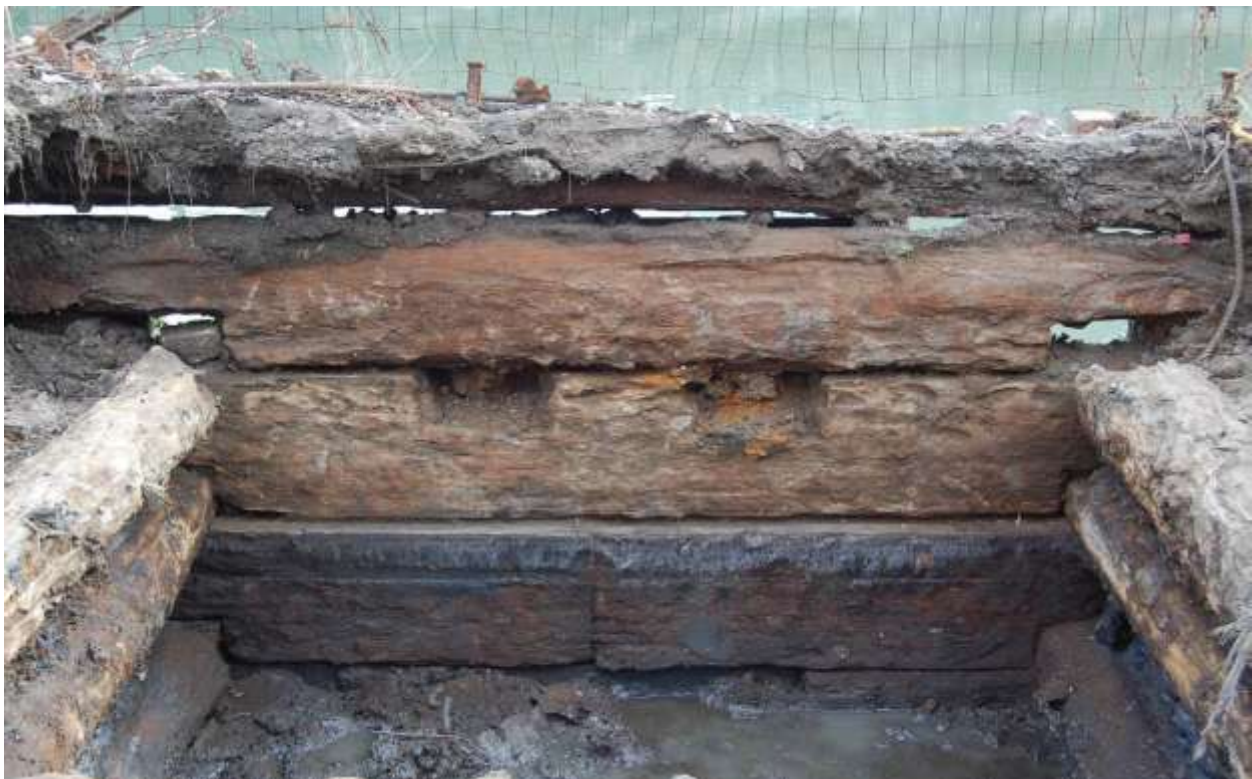
**Photo 3 – Close up of landward side of bulkhead wall, facing east.  
Photograph taken by Michael Audin 1/25/2013.**

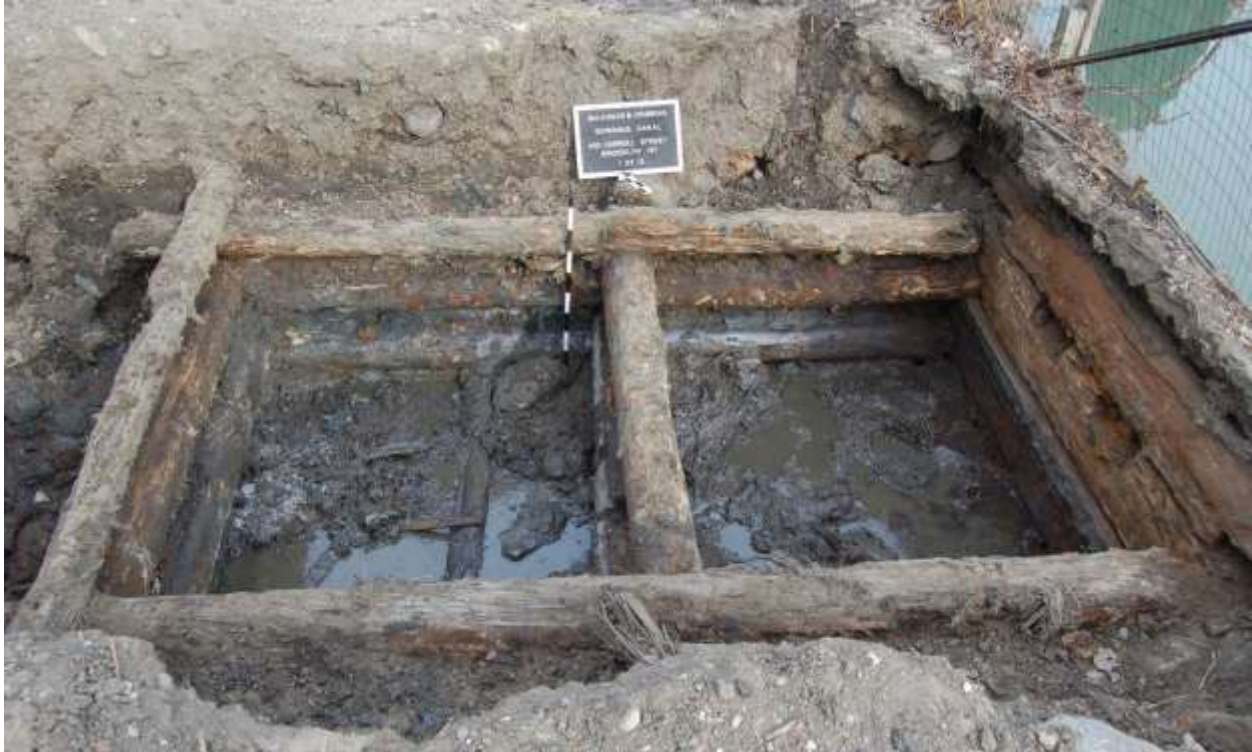
**Photo 4 – Plan view of the 400 Carroll Street cribbing and interior of bulkhead wall, facing north.  
Photograph taken by Michael Audin, 1/25/2013.**

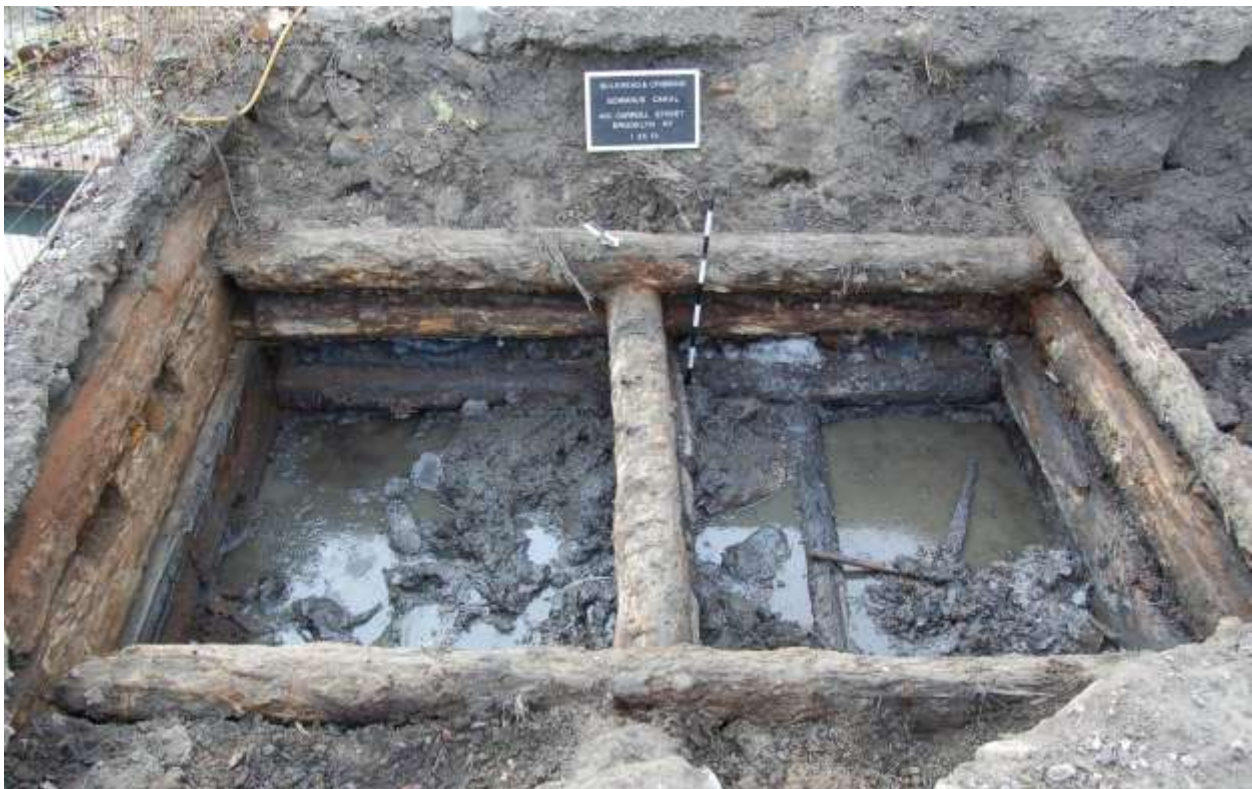
The cribbing system at 400 Carroll Street property resembles most closely the style originally suggested in the geotechnical due diligence memo, Structure Type 5 (Fender Piles along Bulkhead Face) (Figure 4) described in the *Gowanus Canal Preliminary Bulkhead Study, Brooklyn, Kings County, New York* by Douglas McVarish. Noticeable differences include a center timber, parallel to the bulkhead wall, in the cribbing structure much higher in the structure than indicated in this style. In addition the center timber seems to shift landward as seen in photographs 5 and 6.

**Photo 5 – Plan view of the 400 Carroll Street cribbing and interior of bulkhead wall, facing south.  
Photograph taken by Michael Audin, 1/25/2013.**

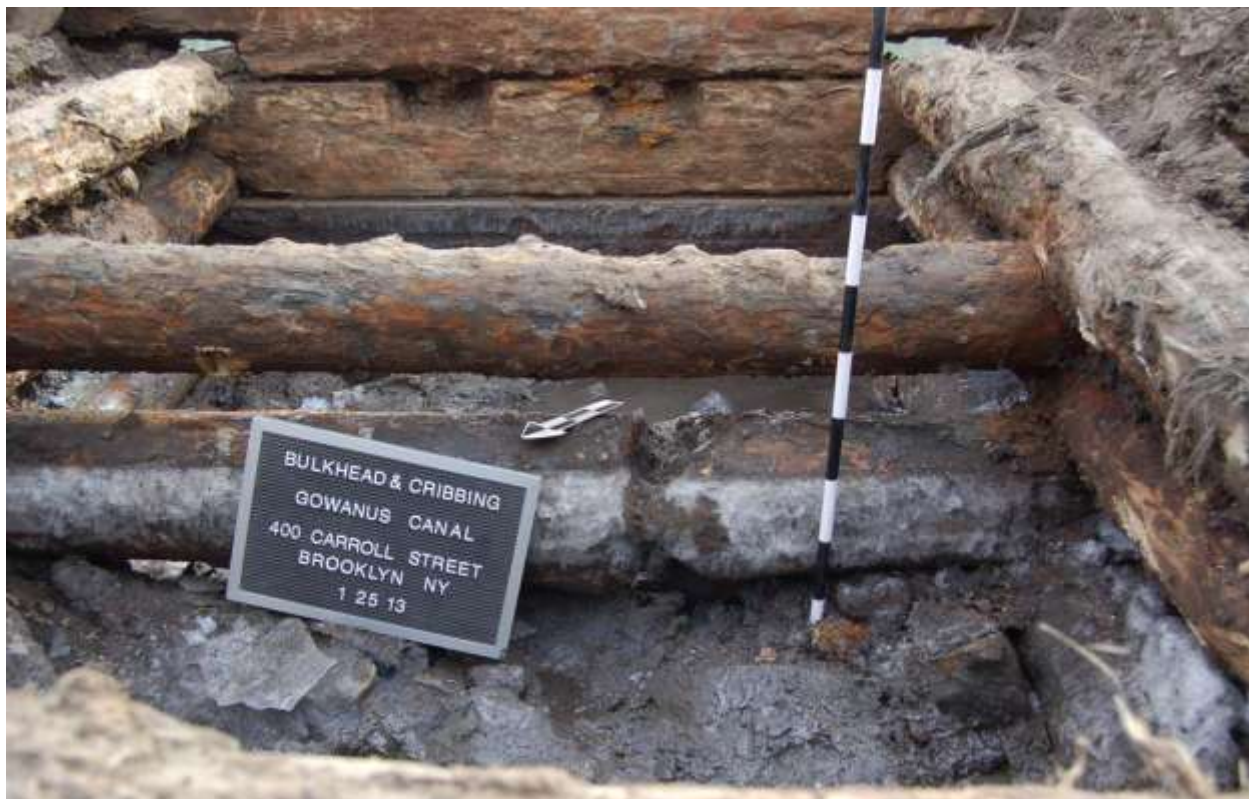
**Photo 6 – View of central timbers of cribbing, facing east, notice joint in second row of one timber ending and another beginning. Photograph taken by Michael Audin, 1/25/2013.**

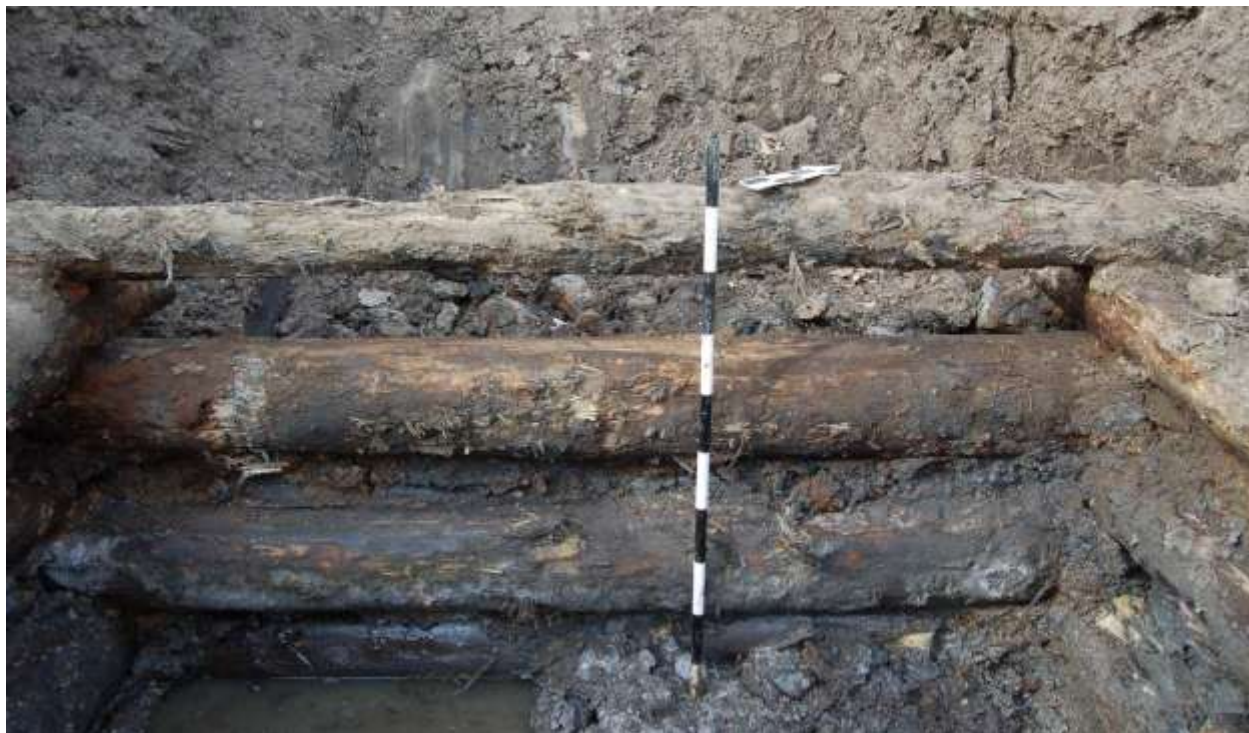
**Photo 7 – View of west end of cribbing structure near end of tie back timbers, facing west. Photograph taken by Michael Audin 1/25/2013.**

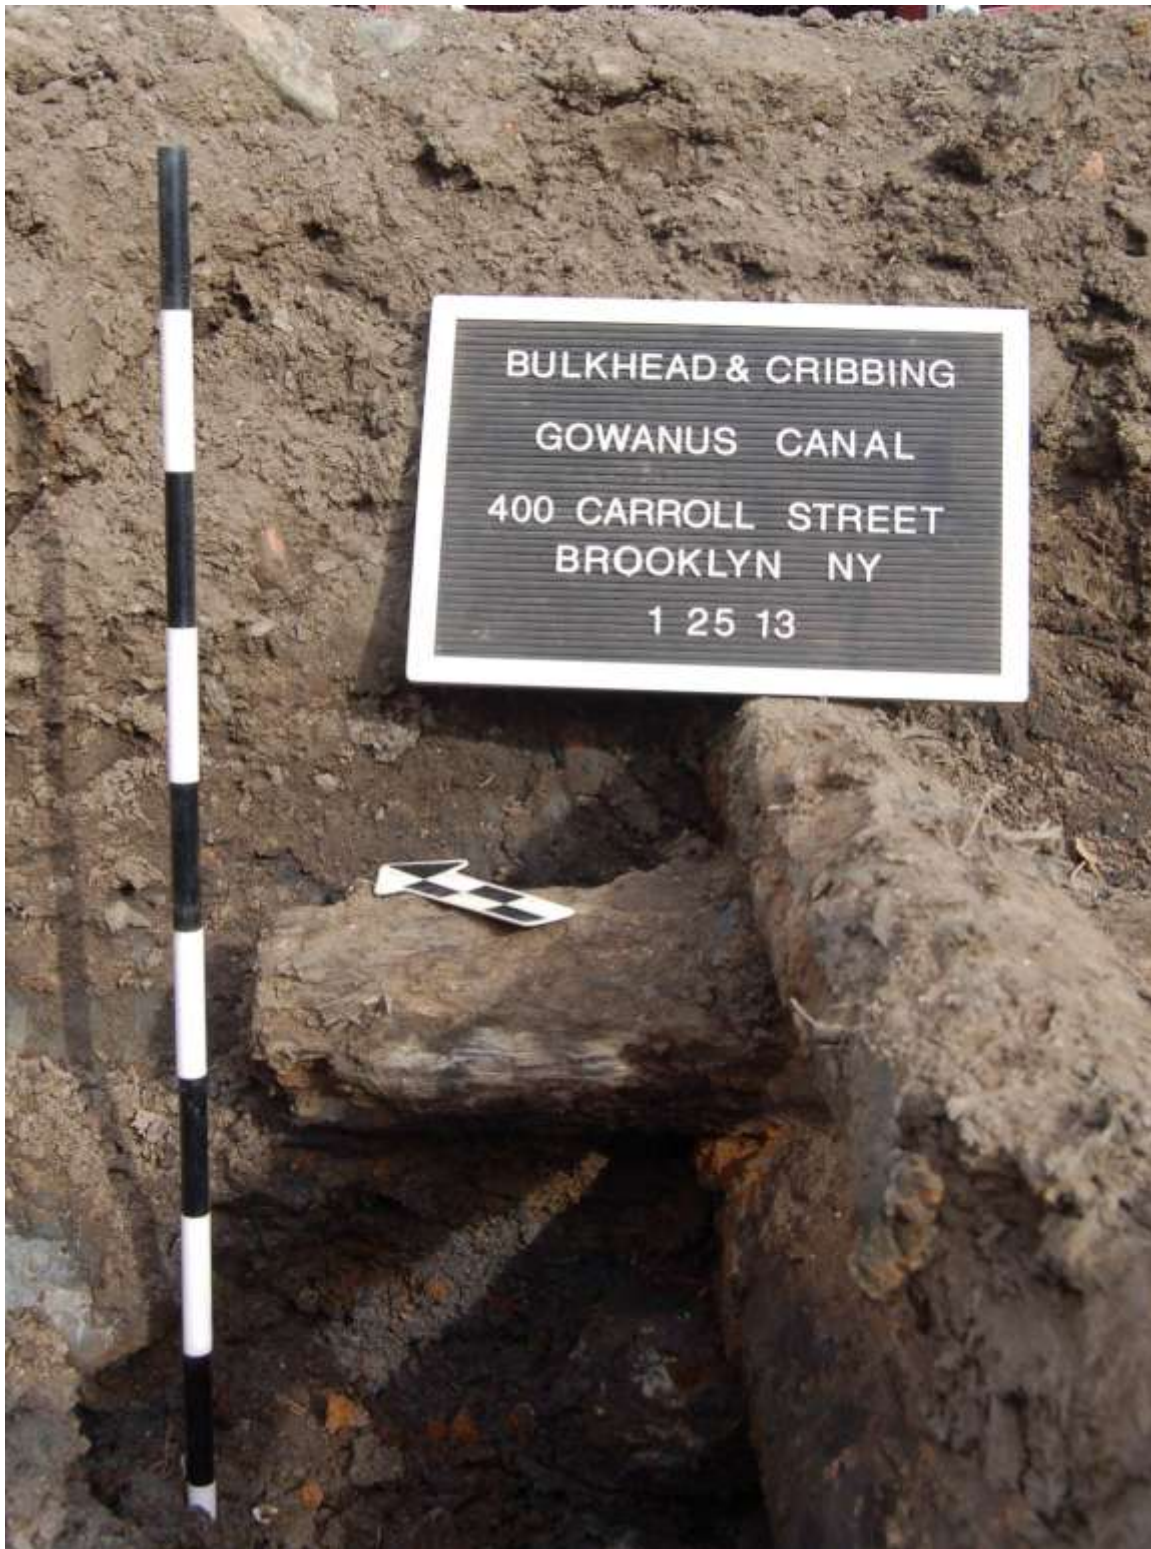
Photo 8 – Close up of end of tie back timbers at west end of cribbing, facing north.  
Photograph taken Michael Audin 1/25/2013.

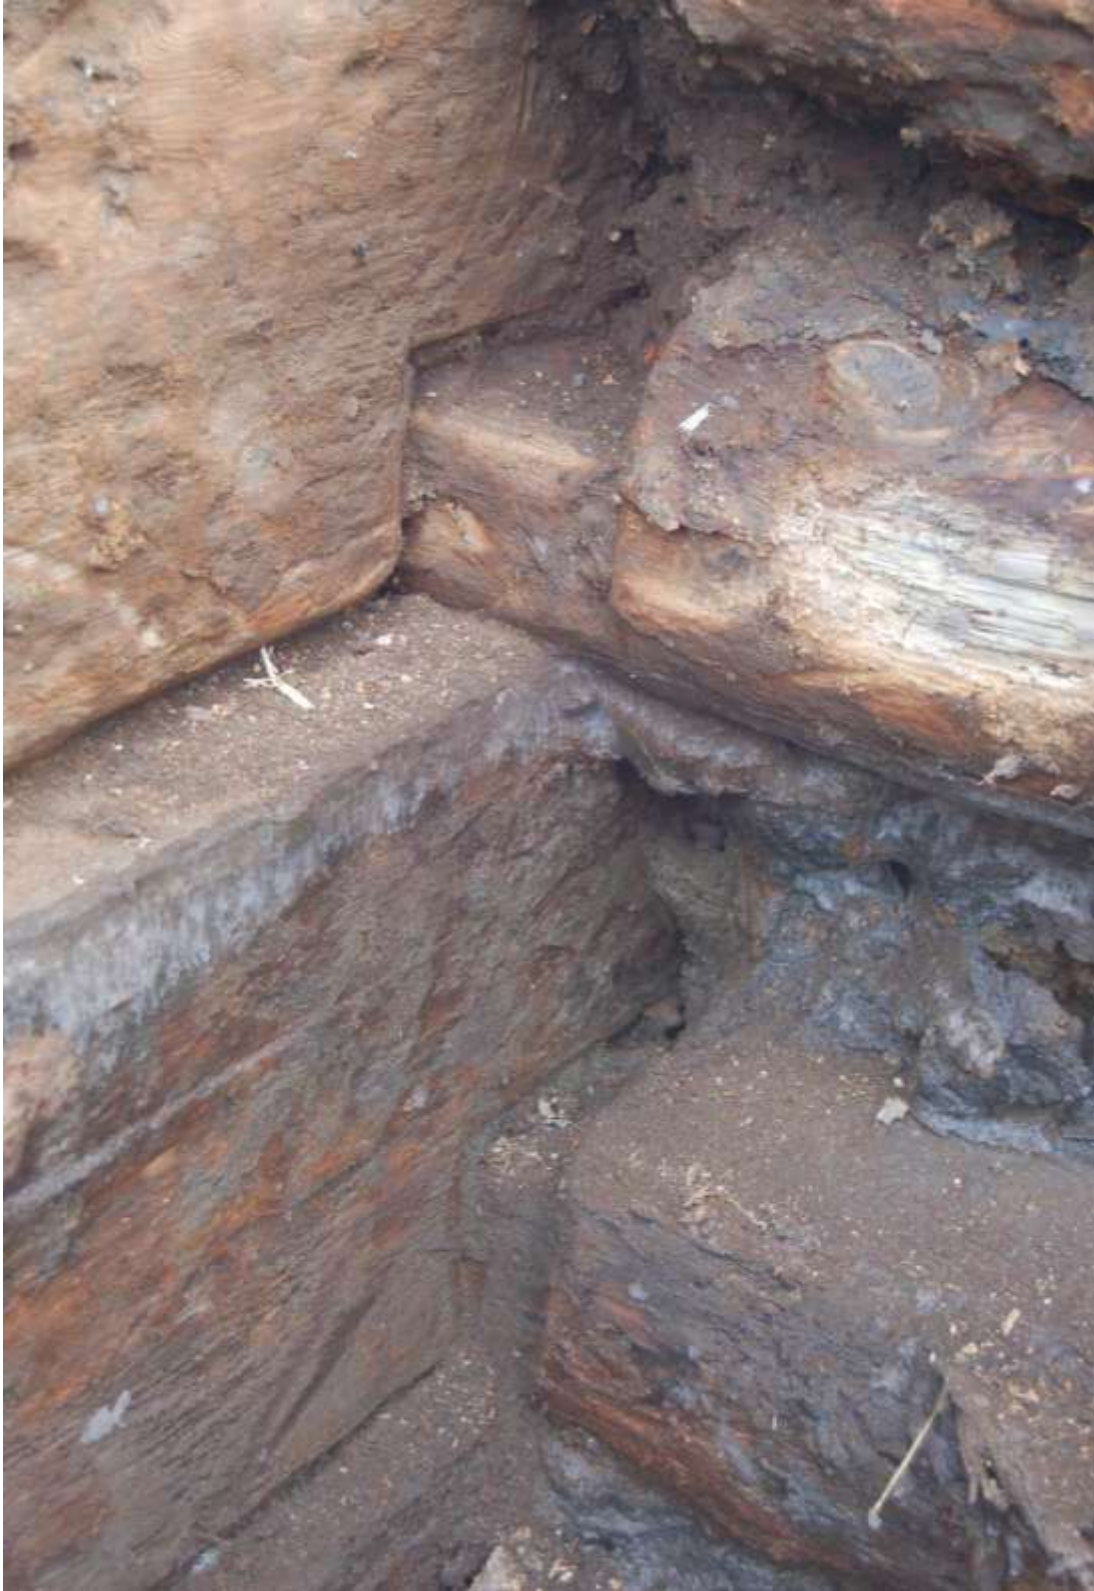
**Photo 9 – Close up of tie back timbers tapered to fit into the bulkhead wall, facing southeast.  
Photograph taken Michael Audin 1/25/2013.**

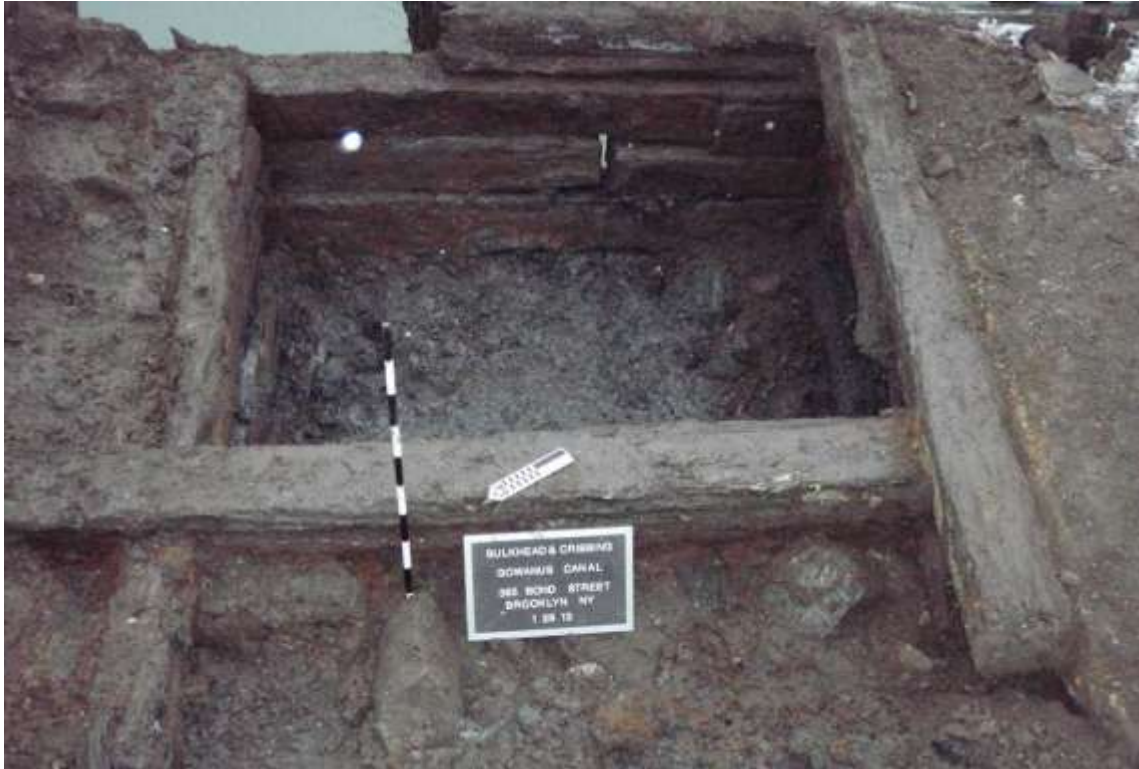
The bulkhead wall and timber cribbing has more advanced decay throughout the bulkhead wall and cribbing (Photos 10 & 11). A gap in the bulkhead wall can be seen in one of the lower rows of timbers (Photo12). The upper layer(s) of timber bulkhead wall and cribbing seem to have been replaced at some point, as indicated by the square timbers that are more crudely constructed on top as compared to the lower round timbers (Photos 13 through 16). In addition, concrete up to three feet thick was observed to the west of the bulkhead wall suggesting that this cribbing was repaired and concrete place on top of it as was possibly suggested in the due diligence memo.

**Photo 10 – Plan view of the bulkhead wall and cribbing at 365 Bond Street, facing southeast.  
Photograph taken by Michael Audin 1/29/2013.**

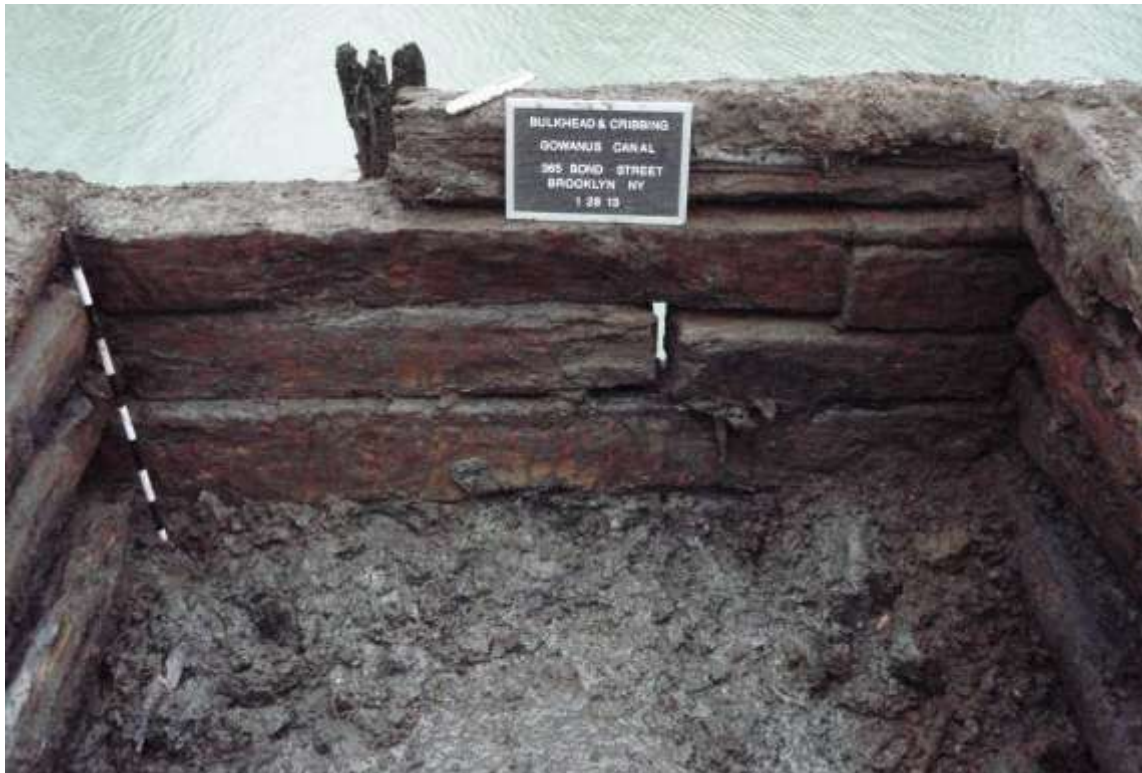
**Photo 11 – View of landward side of bulkhead wall at 365 Bond Street, facing southeast.  
Photograph taken by Michael Audin 1/29/2013.**

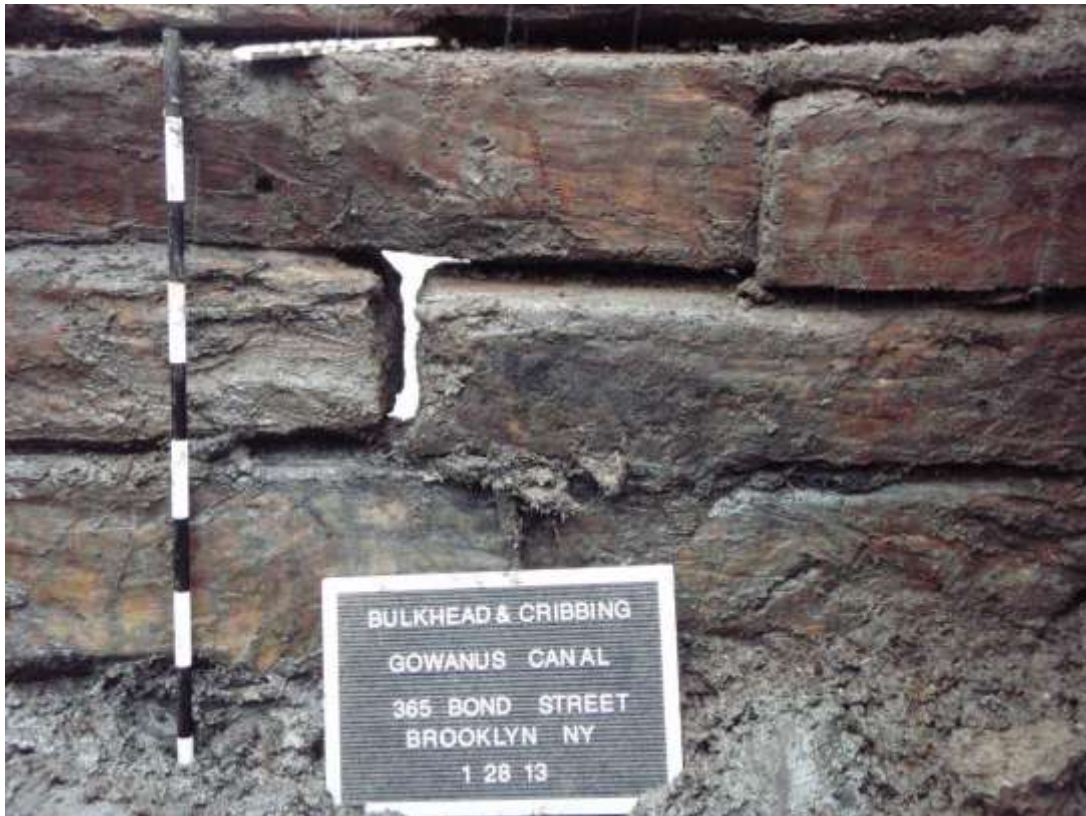
**Photo 12 – Close up of landward side of bulkhead wall, facing southeast. Notice gaps from deterioration. Photograph taken by Michael Audin 1/29/2013.**

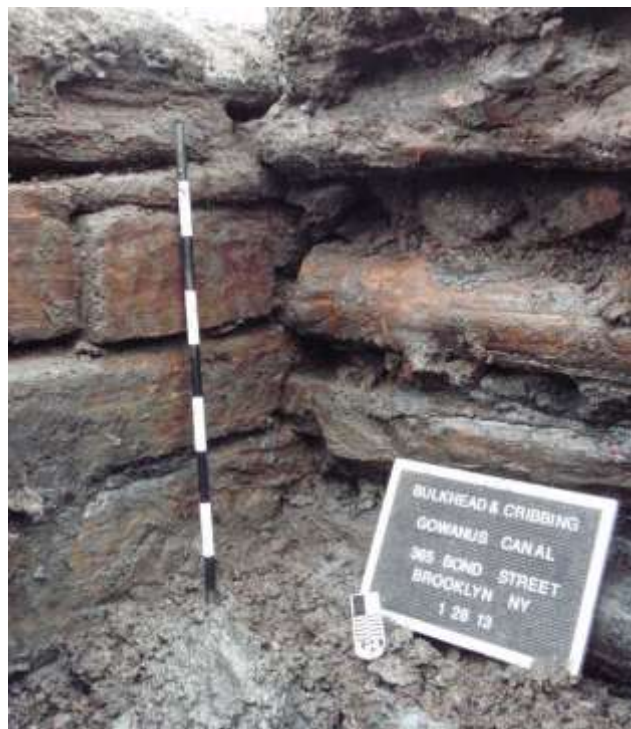
**Photo 13 – Close up of tie back timbers taper cut to fit into bulkhead wall slots, facing south. Photograph taken by Michael Audin 1/29/2013.**

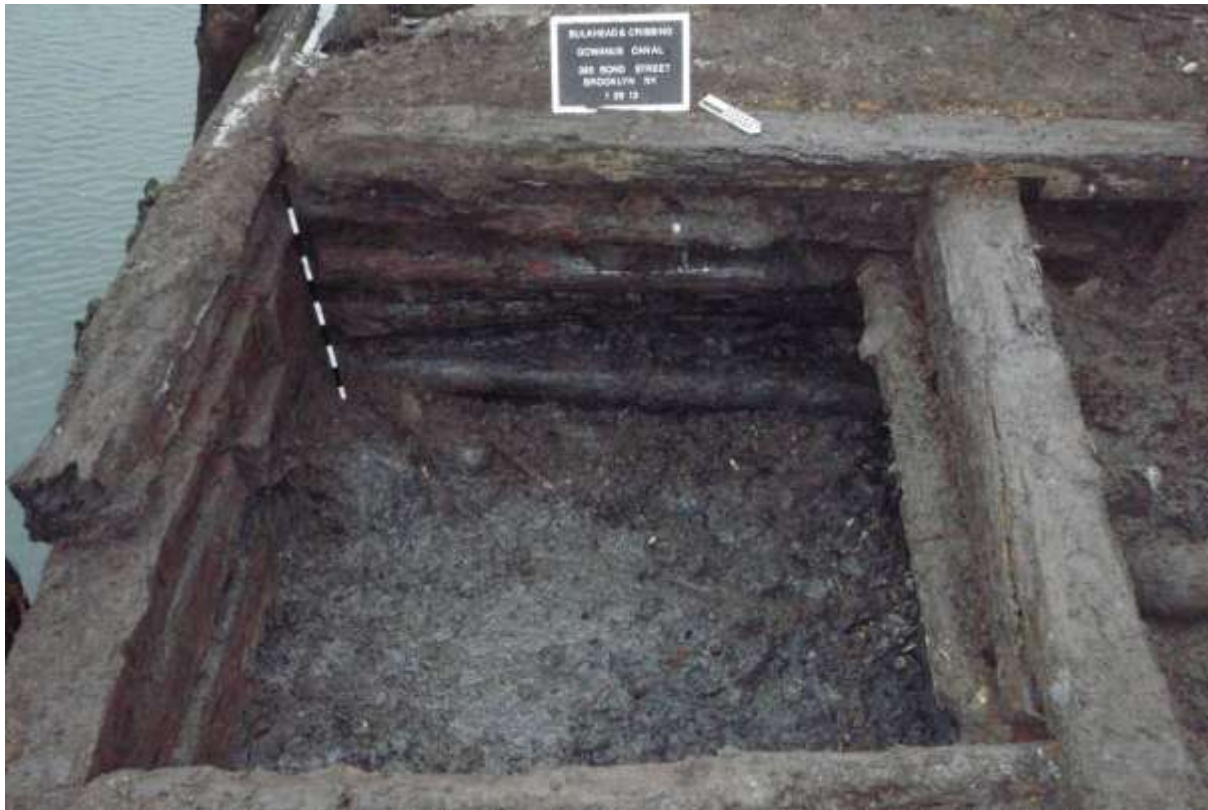
**Photo 14 – View of the south wall of cribbing, facing southwest. Notice the top timbers are square and lower timbers are round with 3rd row of round timbers pushed out. Photograph taken by Michael Audin 1/29/2013.**

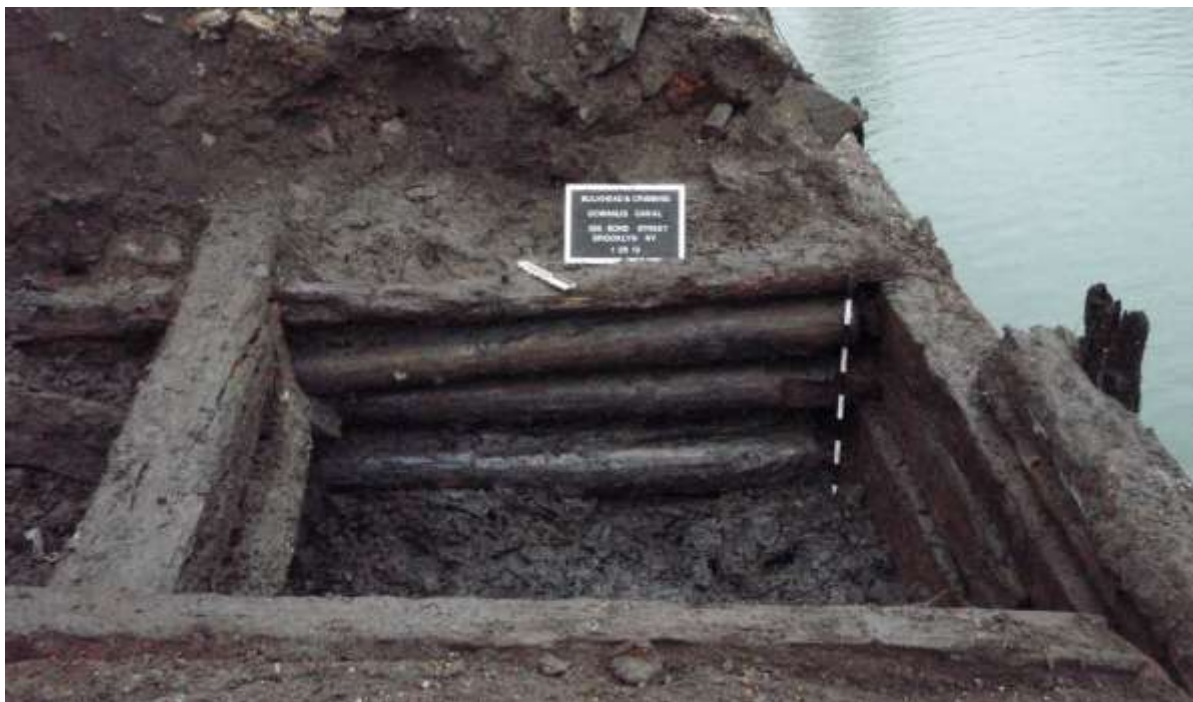
**Photo 15 – View of North wall of cribbing, facing northeast. Photograph taken by Michael Audin 1/29/2013.**

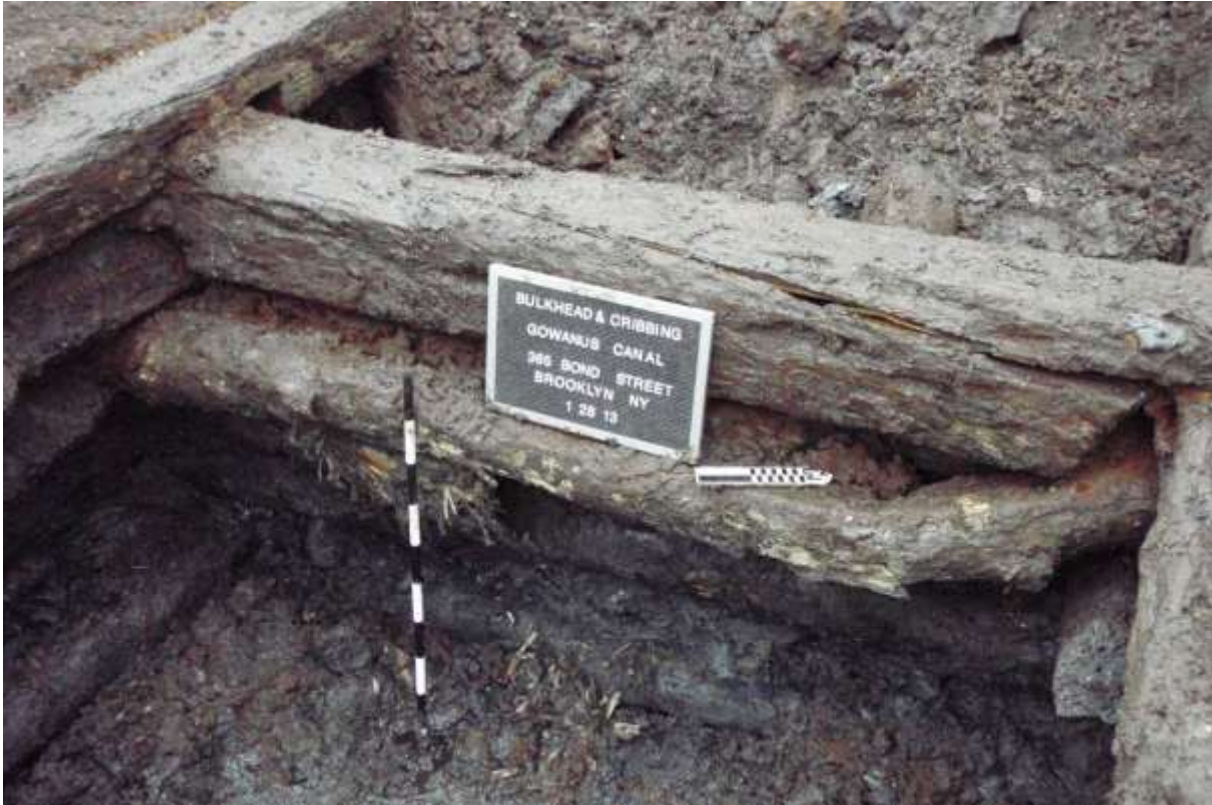
**Photo 16 – View of west side of cribbing near landward end of tie back timbers, facing northwest.  
Photograph taken by Michael Audin 1/29/2013.**

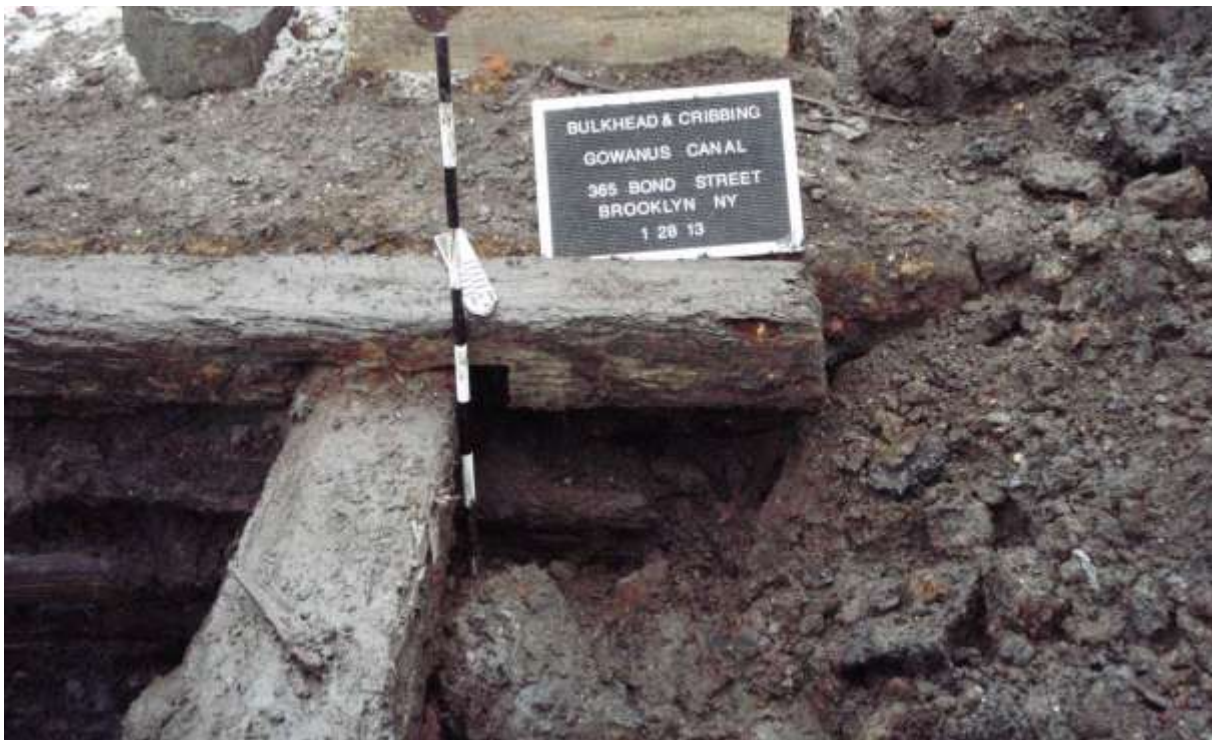
**Photo 17 – View of notch cut for top square timbers of cribbing most likely more recent than the round timbers below, facing south. Photograph taken by Michael Audin 1/29/2013.**

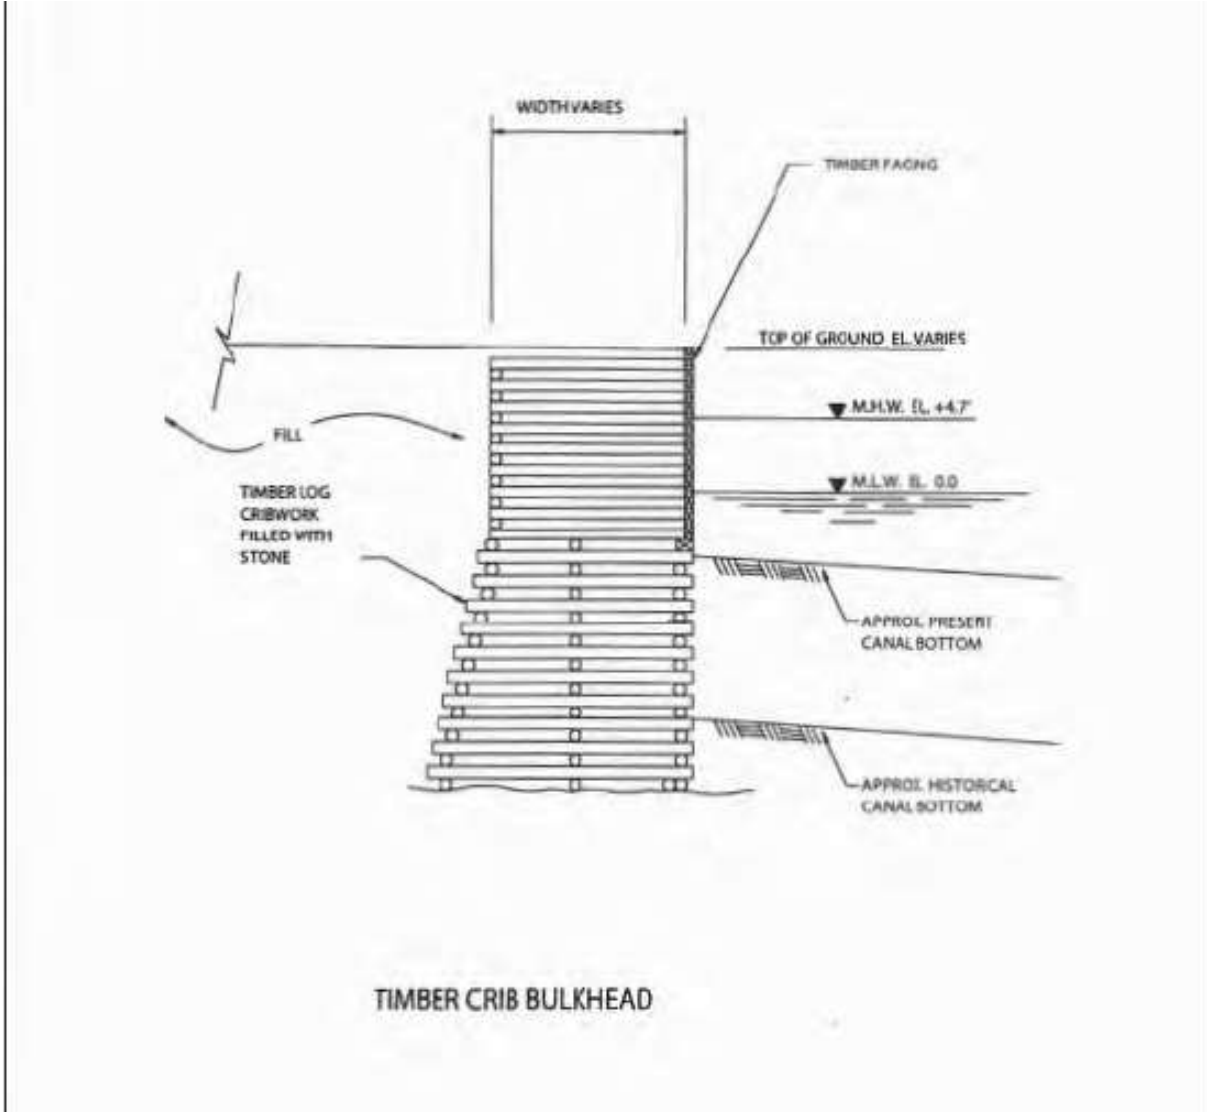
The timber cribbing and bulkhead wall most likely began as Structure Type 1 (Timber Crib Bulkhead, Figure 5) and was later converted to Structure Type 2 (Timber Crib Bulkhead With Mass Concrete For Upper 3 To 5 Feet, Figure 6) when it was repaired. This would account for the higher level of rot in the round timbers below the square timbers. The irregular spaced fender piles might have been added later to shore up the bulkhead wall and prevent it from collapsing into the canal.

Figure 5 – Structure Type 1 as described in *Gowanus Canal Preliminary Bulkhead Study* (McVarish 2010).

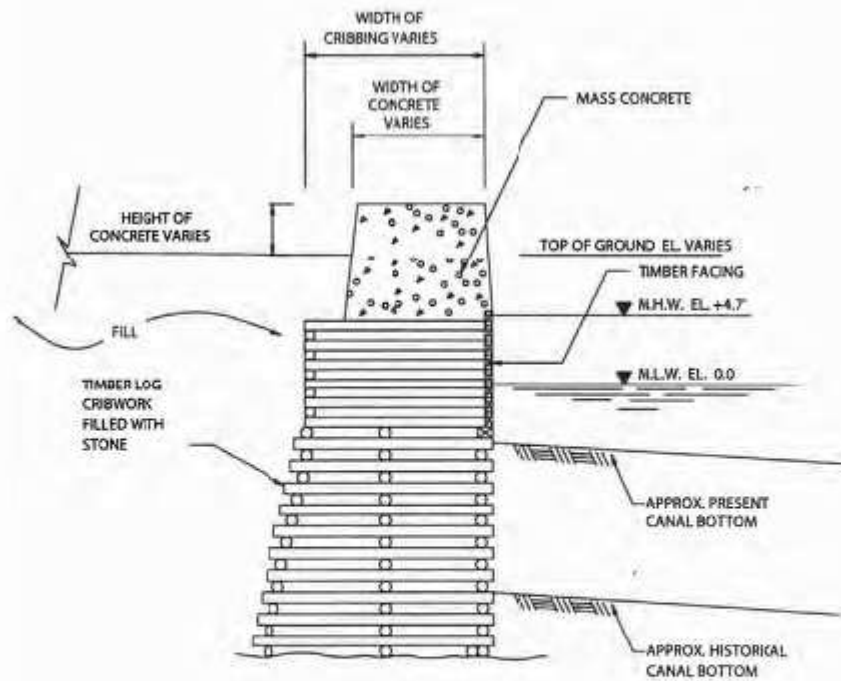
TIMBER CRIB BULKHEAD WITH MASS CONCRETE  
FOR UPPER 3 TO 5 FEET

Figure 6 – Structure Type 2 as described in *Gowanus Canal Preliminary Bulkhead Study* (McVarish 2010).
