# **GOWANUS CANAL BULKHEAD AND CRIBBING DOCUMENTATION at CARROLL GARDENS, 365 BOND STREET and 400 CARROLL STREET BROOKLYN, KINGS COUNTY, NEW YORK**

**17 April 2013  
100287501**

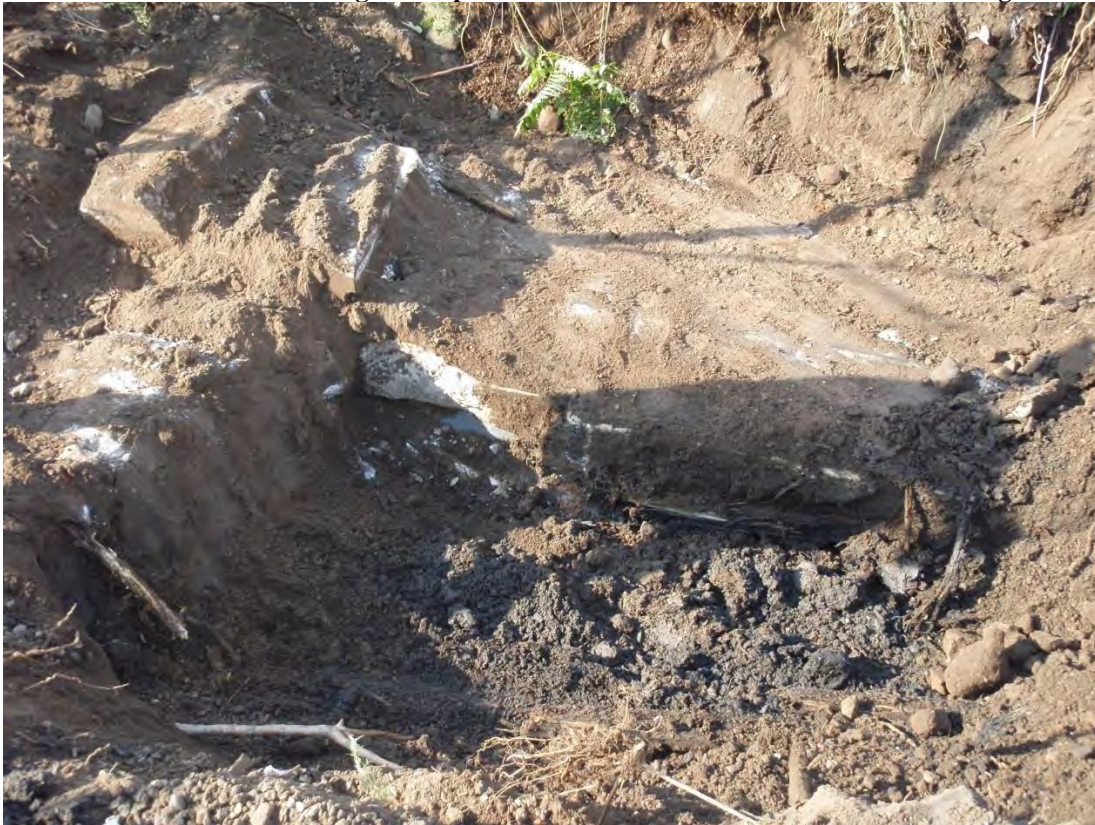
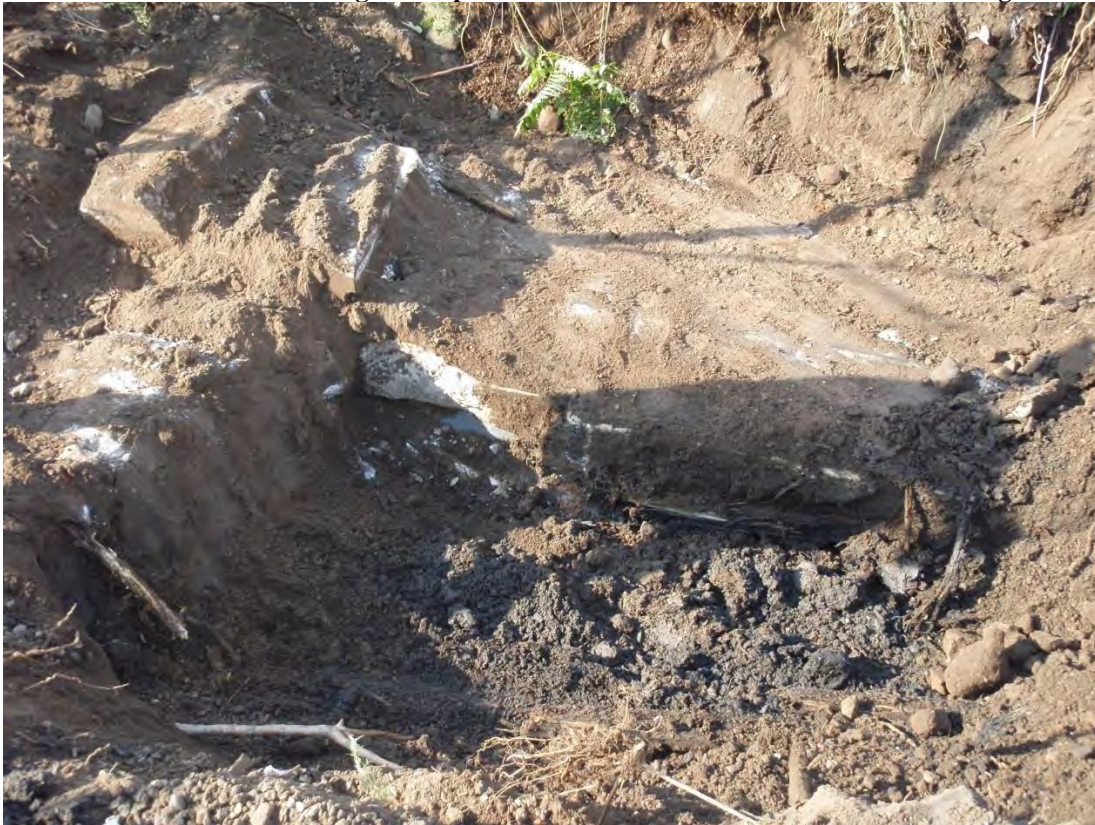
**Photo 4 – View of concrete slab found approximately 2 feet below surface at 365 Bond Street.**

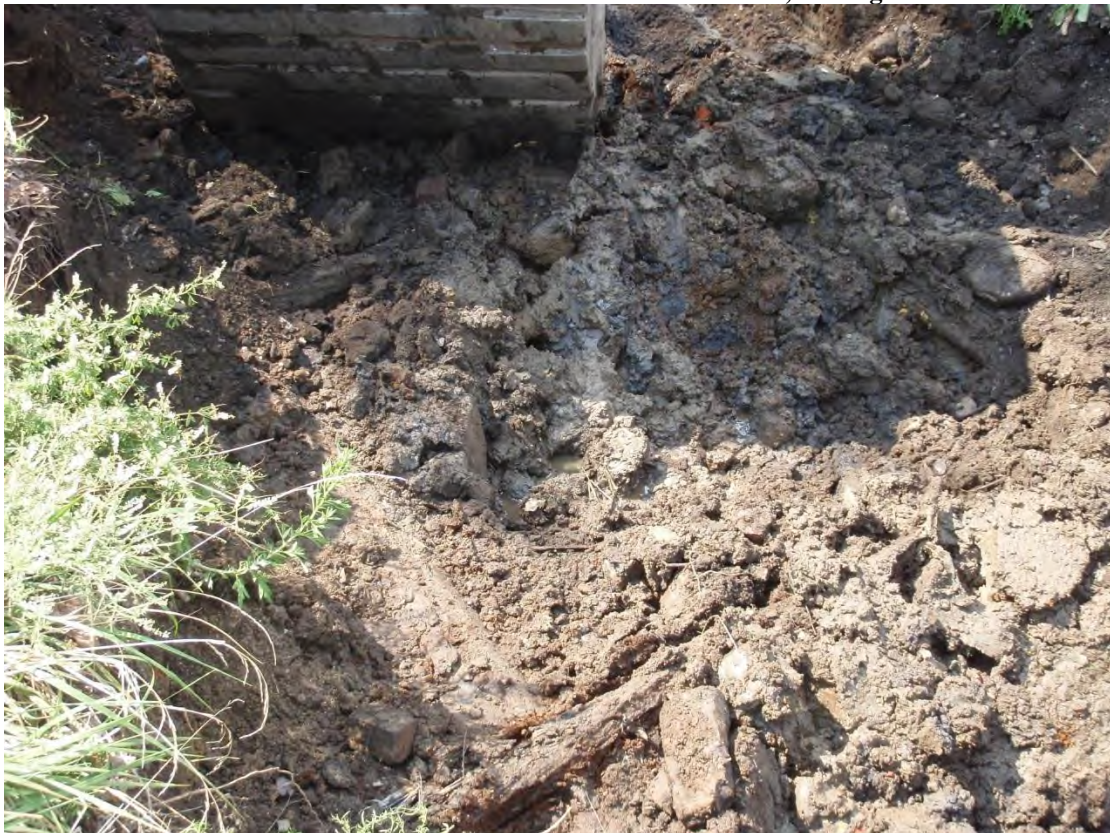
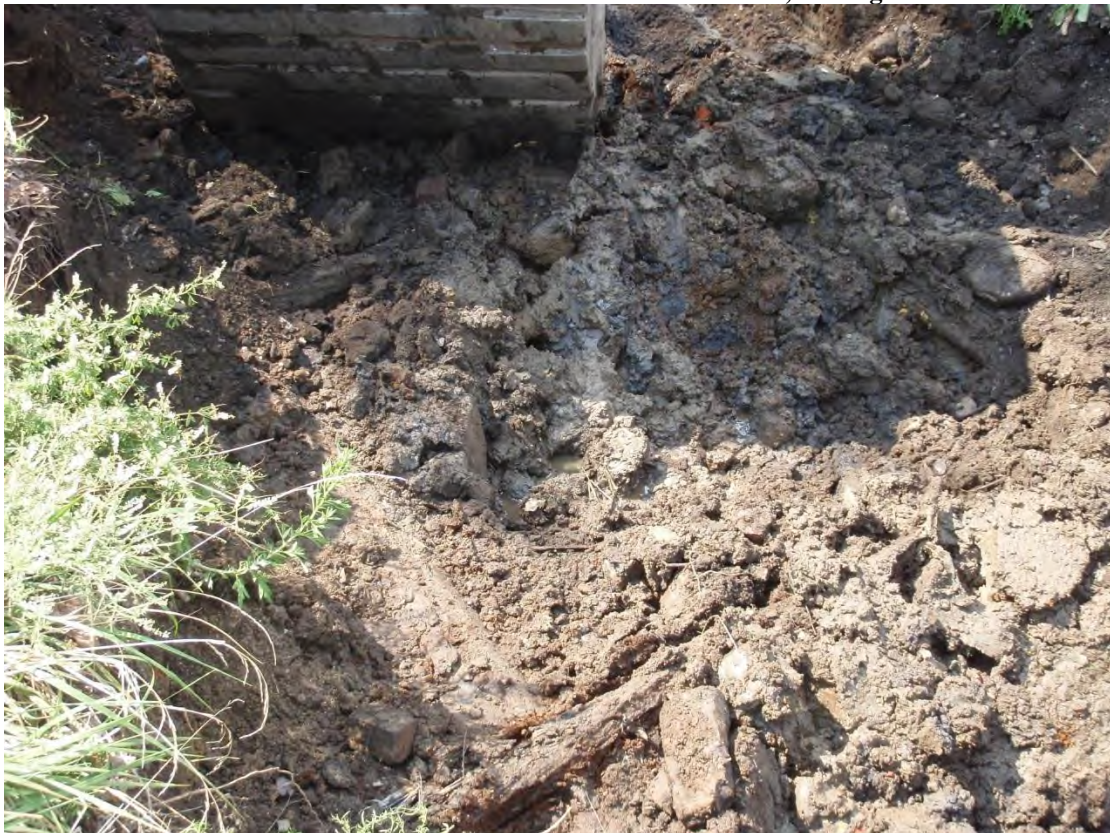
**Photo 6 – View of excavation at 400 Carroll St with first portion of cribbing exposed.**

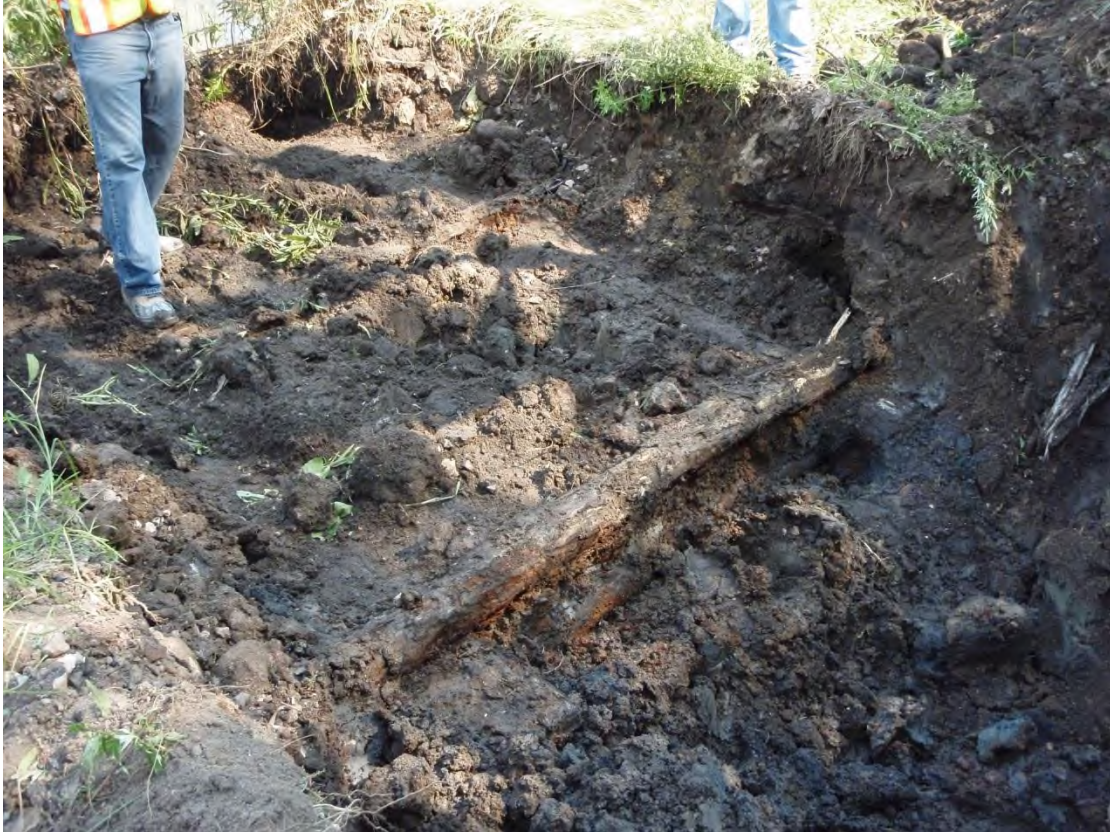
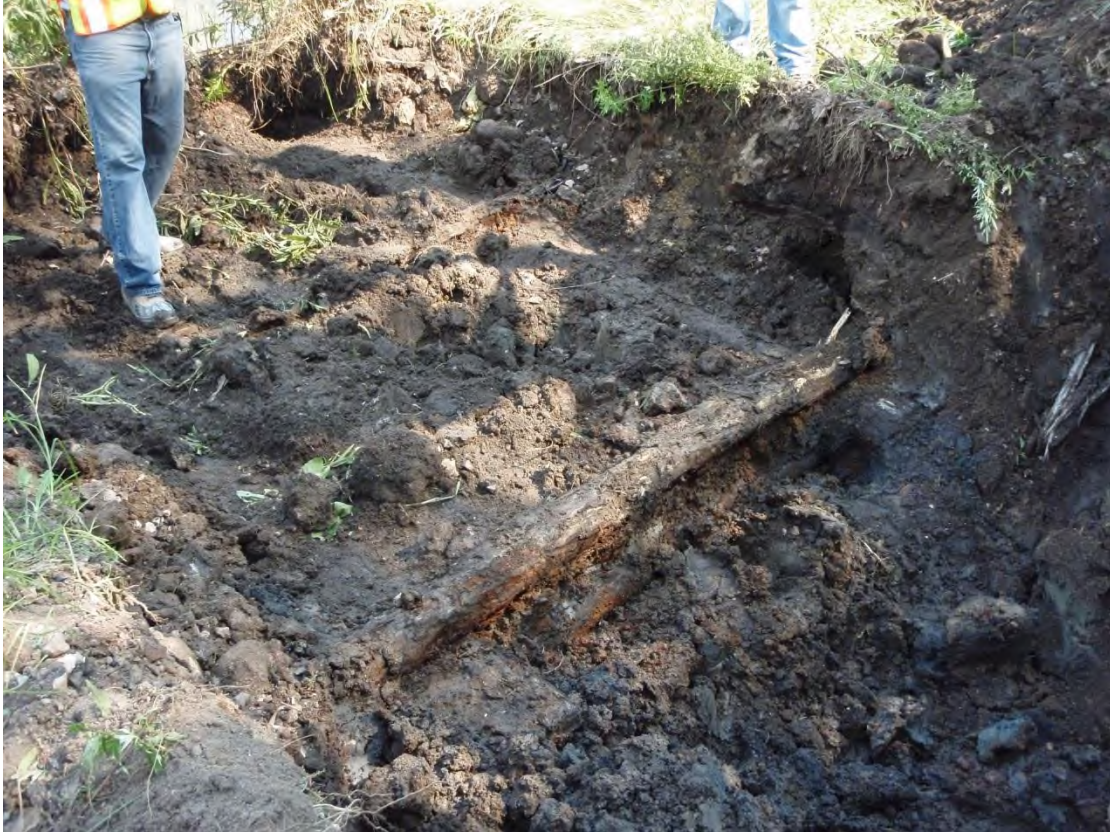
**Photo 7 – View of cribbing system at 400 Carroll St. looking southeast.**

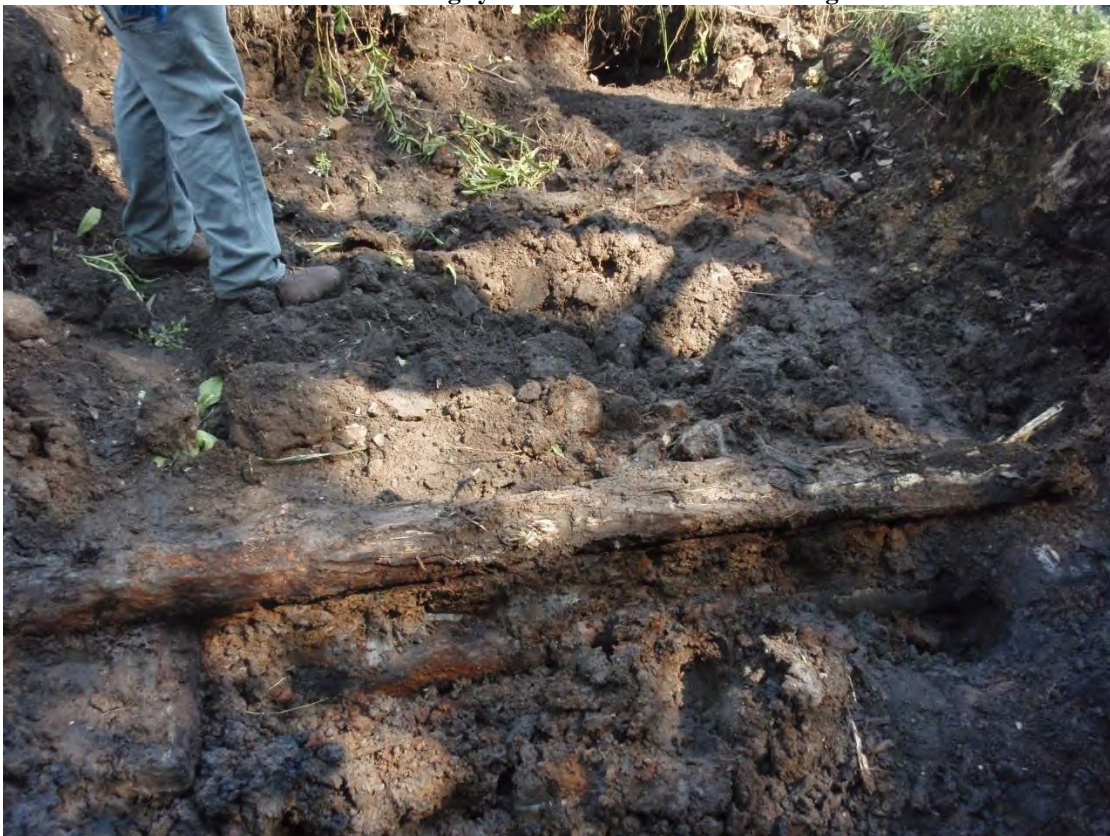
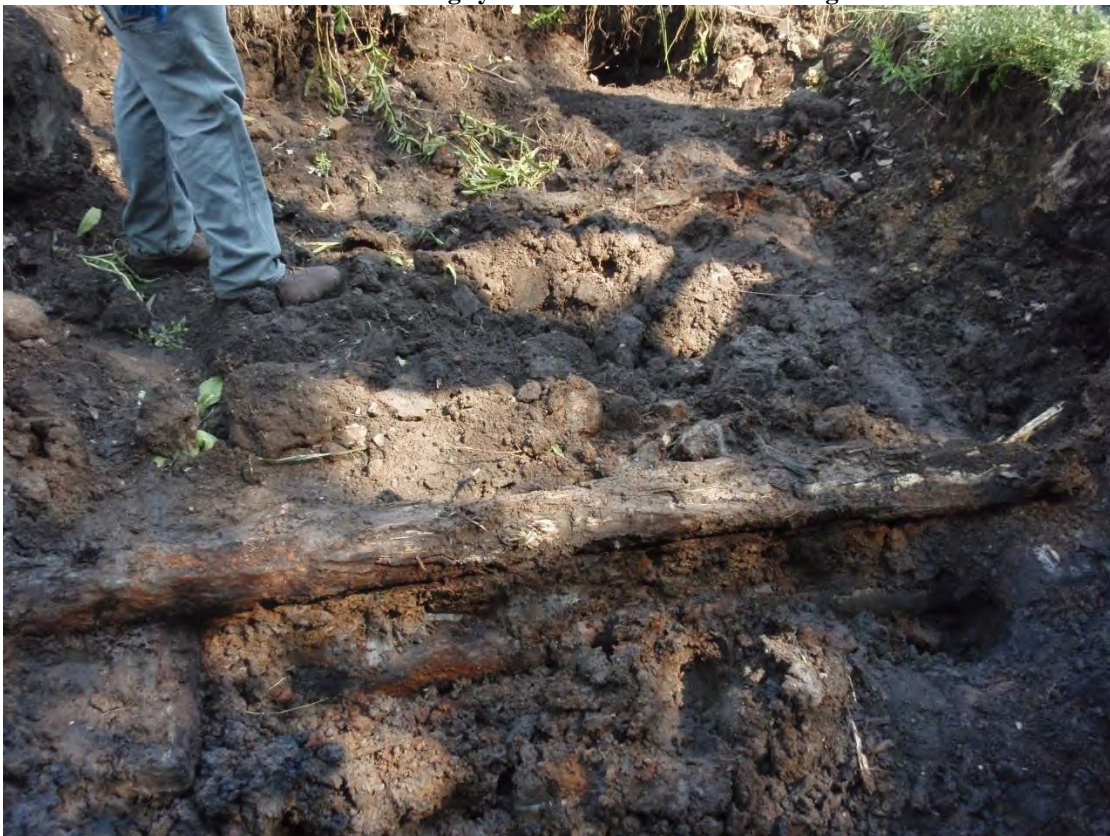
**Photo 8 – View of additional layers of cribbing at 400 Carroll Street.**
