Phase 1B Archaeological Survey

**Bronx Zoo Parking Lot and Roadway Improvements:
Jungle World Road**

Bronx, New York

SHPO Project Review Number: 08PR01059

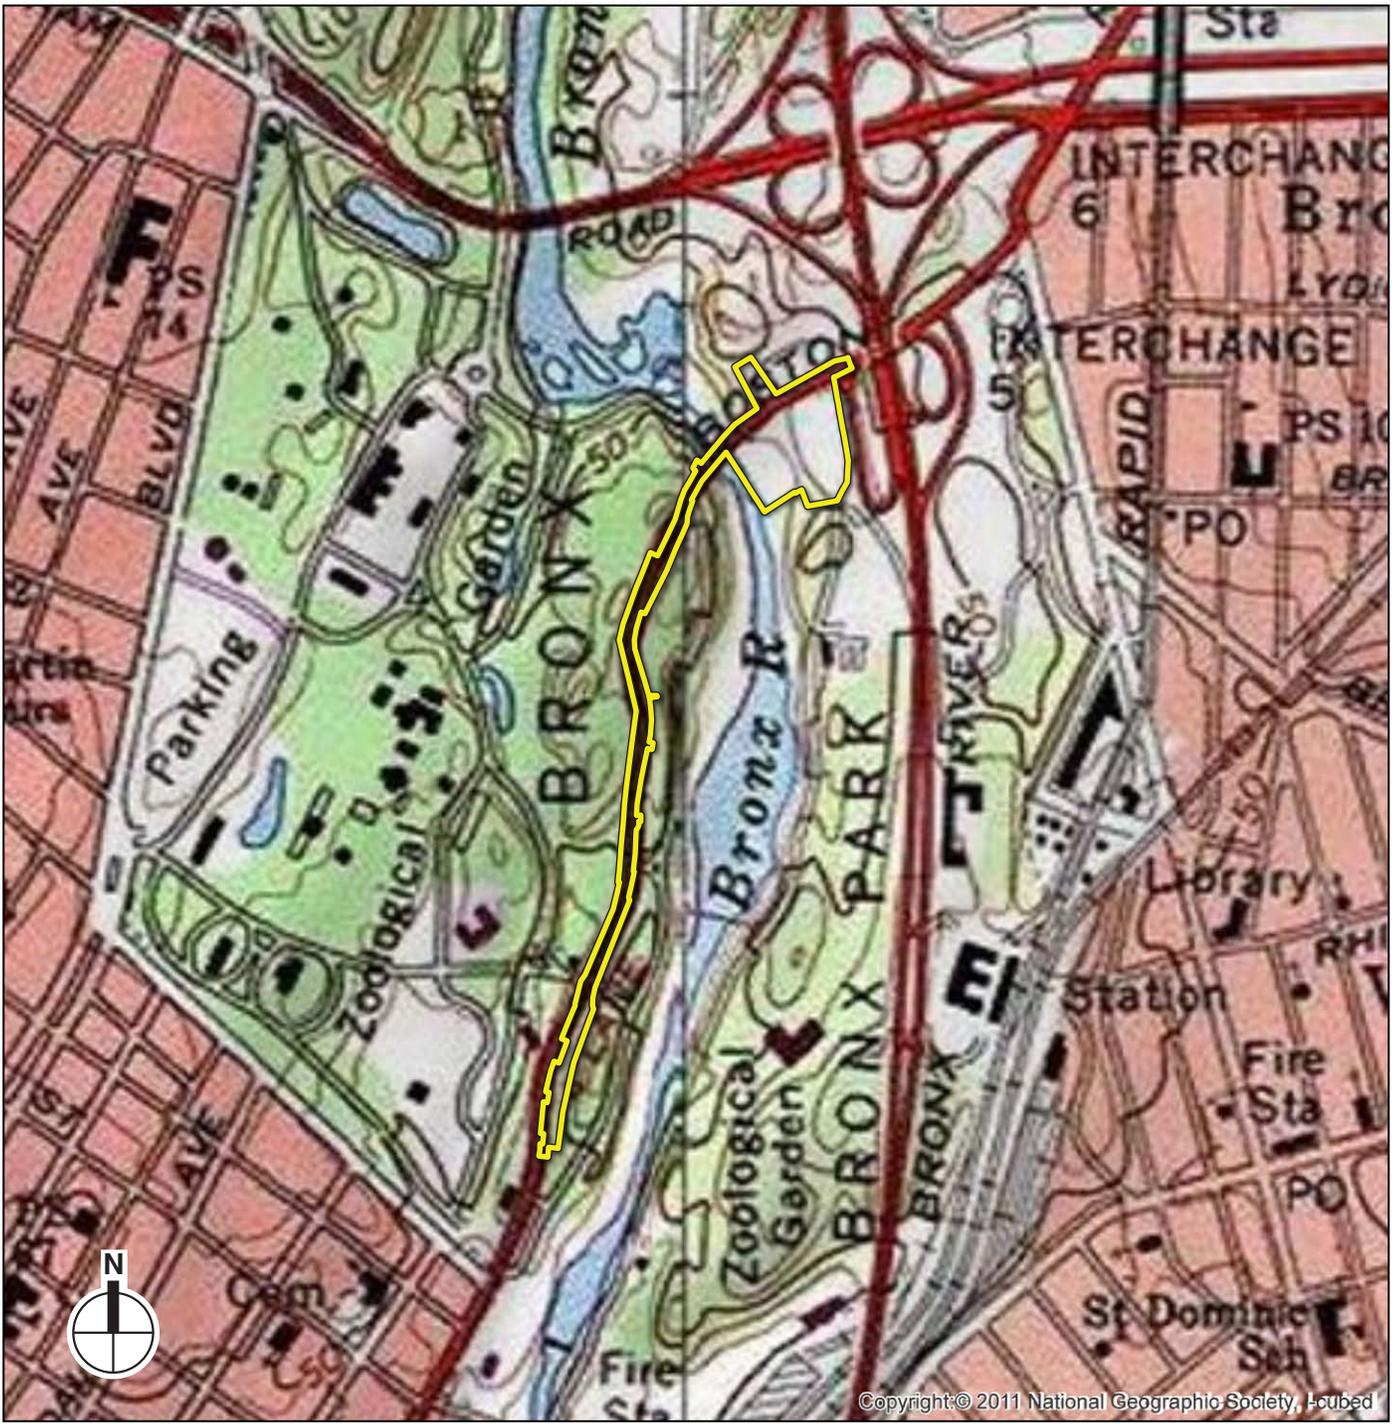
USGS 7.5 Minute Topographic Map -
Flushing and Central Park Quads
Figure 1

*Project Site Boundary
(Revised Since the Completion
of the Phase 1A Study)*

The Wildlife Conservation Society (WCS), owner and operator of the Bronx Zoo, Bronx, New York, proposes to construct transportation improvements within the Bronx Zoo in the Bronx (see **Figure 1**). The project site is located in the vicinity of Boston Road (also known as “Jungle World Road”), which runs along the western side of the Bronx River within the park boundaries (Block 3120, Lot 20). The proposed project would involve the widening of and improvements to Jungle World Road along its entire length—a distance of approximately 3,000 feet—between the Zoo’s southeast corner and the existing bridge over the Bronx River that connects Jungle World Road with the Bronx River Parking Lot in the Zoo’s northeast corner.

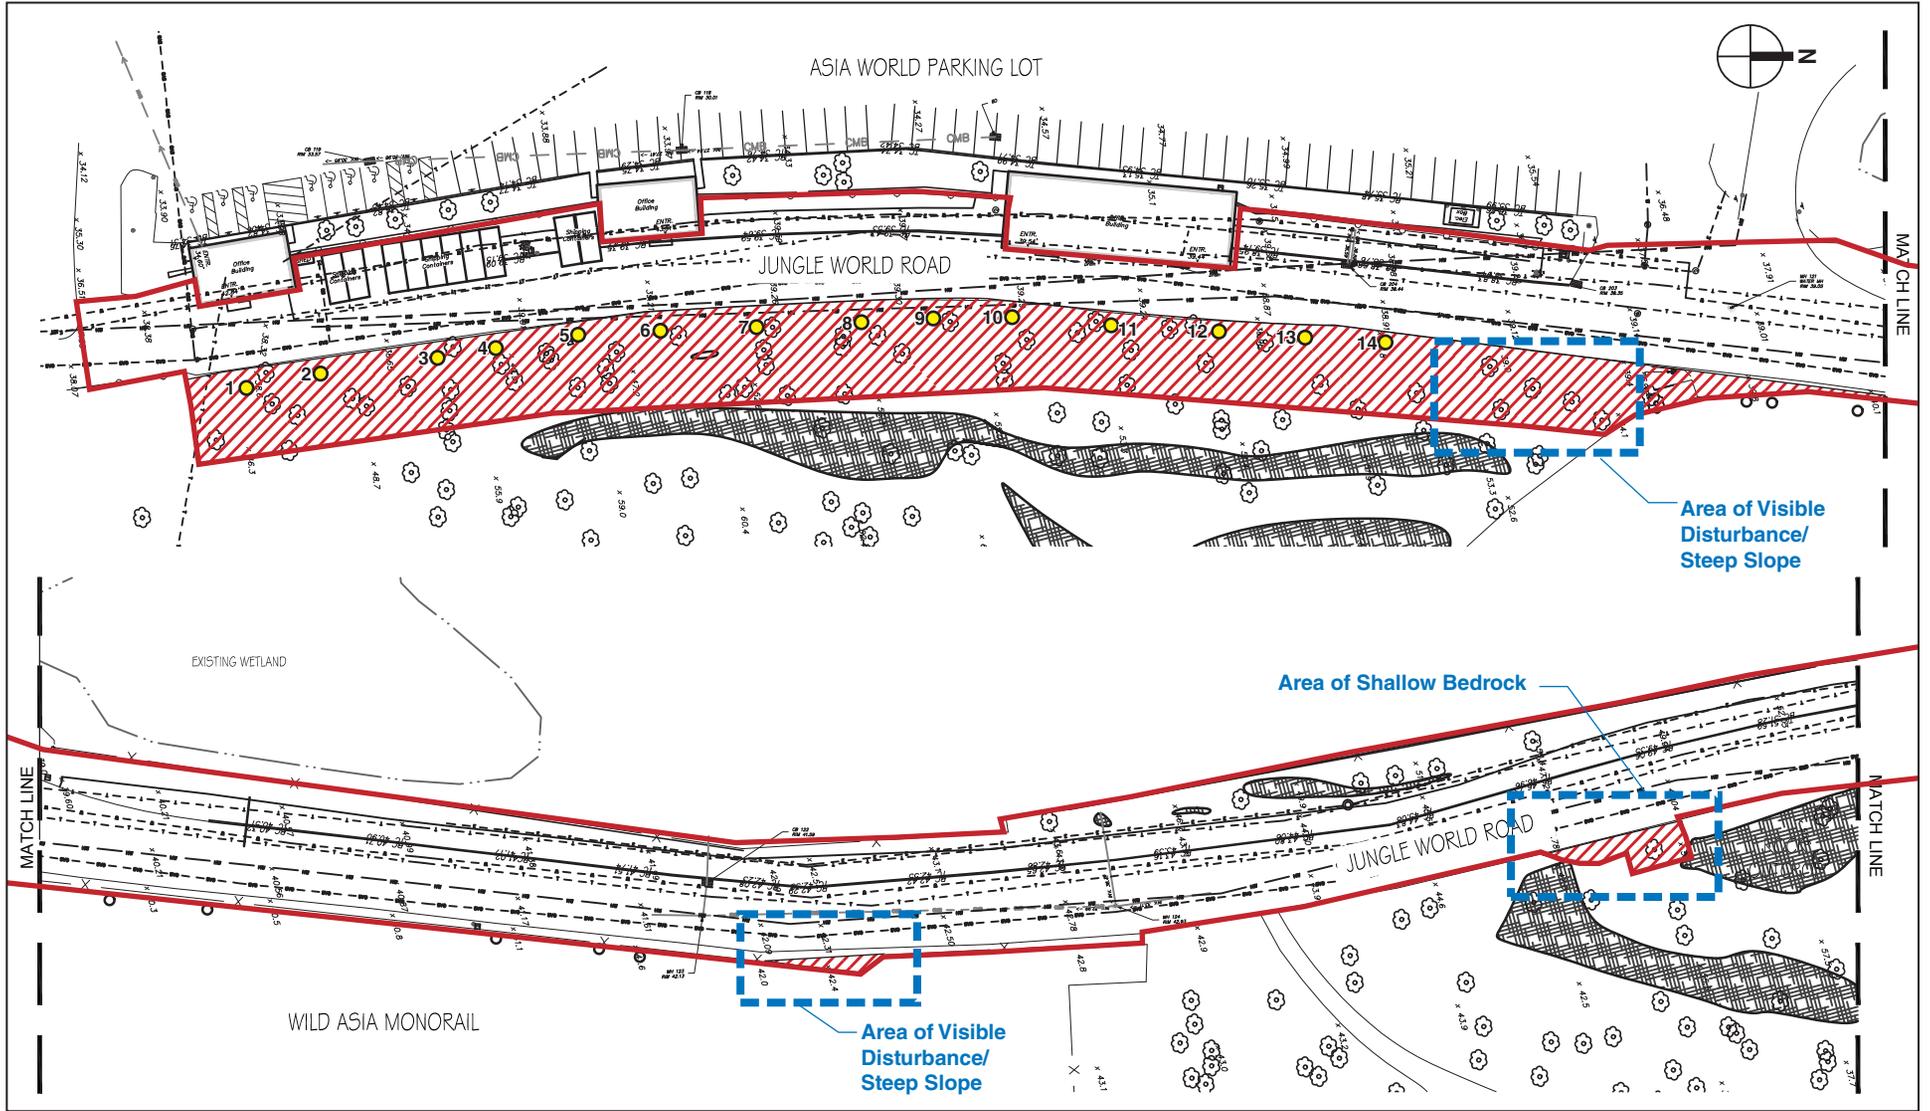
Phase 1B Testing Locations:
Jungle World Road, South Half
Figure 2

- Project Site Boundary
- Shovel Test Pit and Number
- Areas of Archaeological Sensitivity, Excluding Areas with Slopes Greater than 10 Percent and Areas with Exposed Bedrock

The Phase 1B testing procedure consisted of the excavation of 25 shovel test pits (STPs). The test pits were placed at approximately 30 foot intervals along the side of the road within areas identified as archaeologically sensitive in those areas with level slopes and where visible disturbance or shallow bedrock was not present. Several STPs were judgmentally placed in areas that were not identified as archeologically sensitive on both the east and west sides of Boston/Jungle World Road to confirm the disturbance of those areas.

In total, 25 STPs were excavated along the line of Jungle World Road between its southern terminus and the bridge that carries it over the Bronx River. The STPs were placed at distances varying from 2 to 9 feet east of the edge of the existing pavement, depending on locations of utilities, visibly disturbed areas, exposed bedrock, and steep slopes. The STPs were placed at an approximately 30 foot interval except in locations that were not considered to be archaeologically sensitive. Of the STPs, all but one were placed along the eastern side of Boston/Jungle World Road. One STP was placed along the western side of the road to confirm disturbance in that area. Other STPs were attempted on the western side of the road but were obstructed by shallow pavement or utilities.

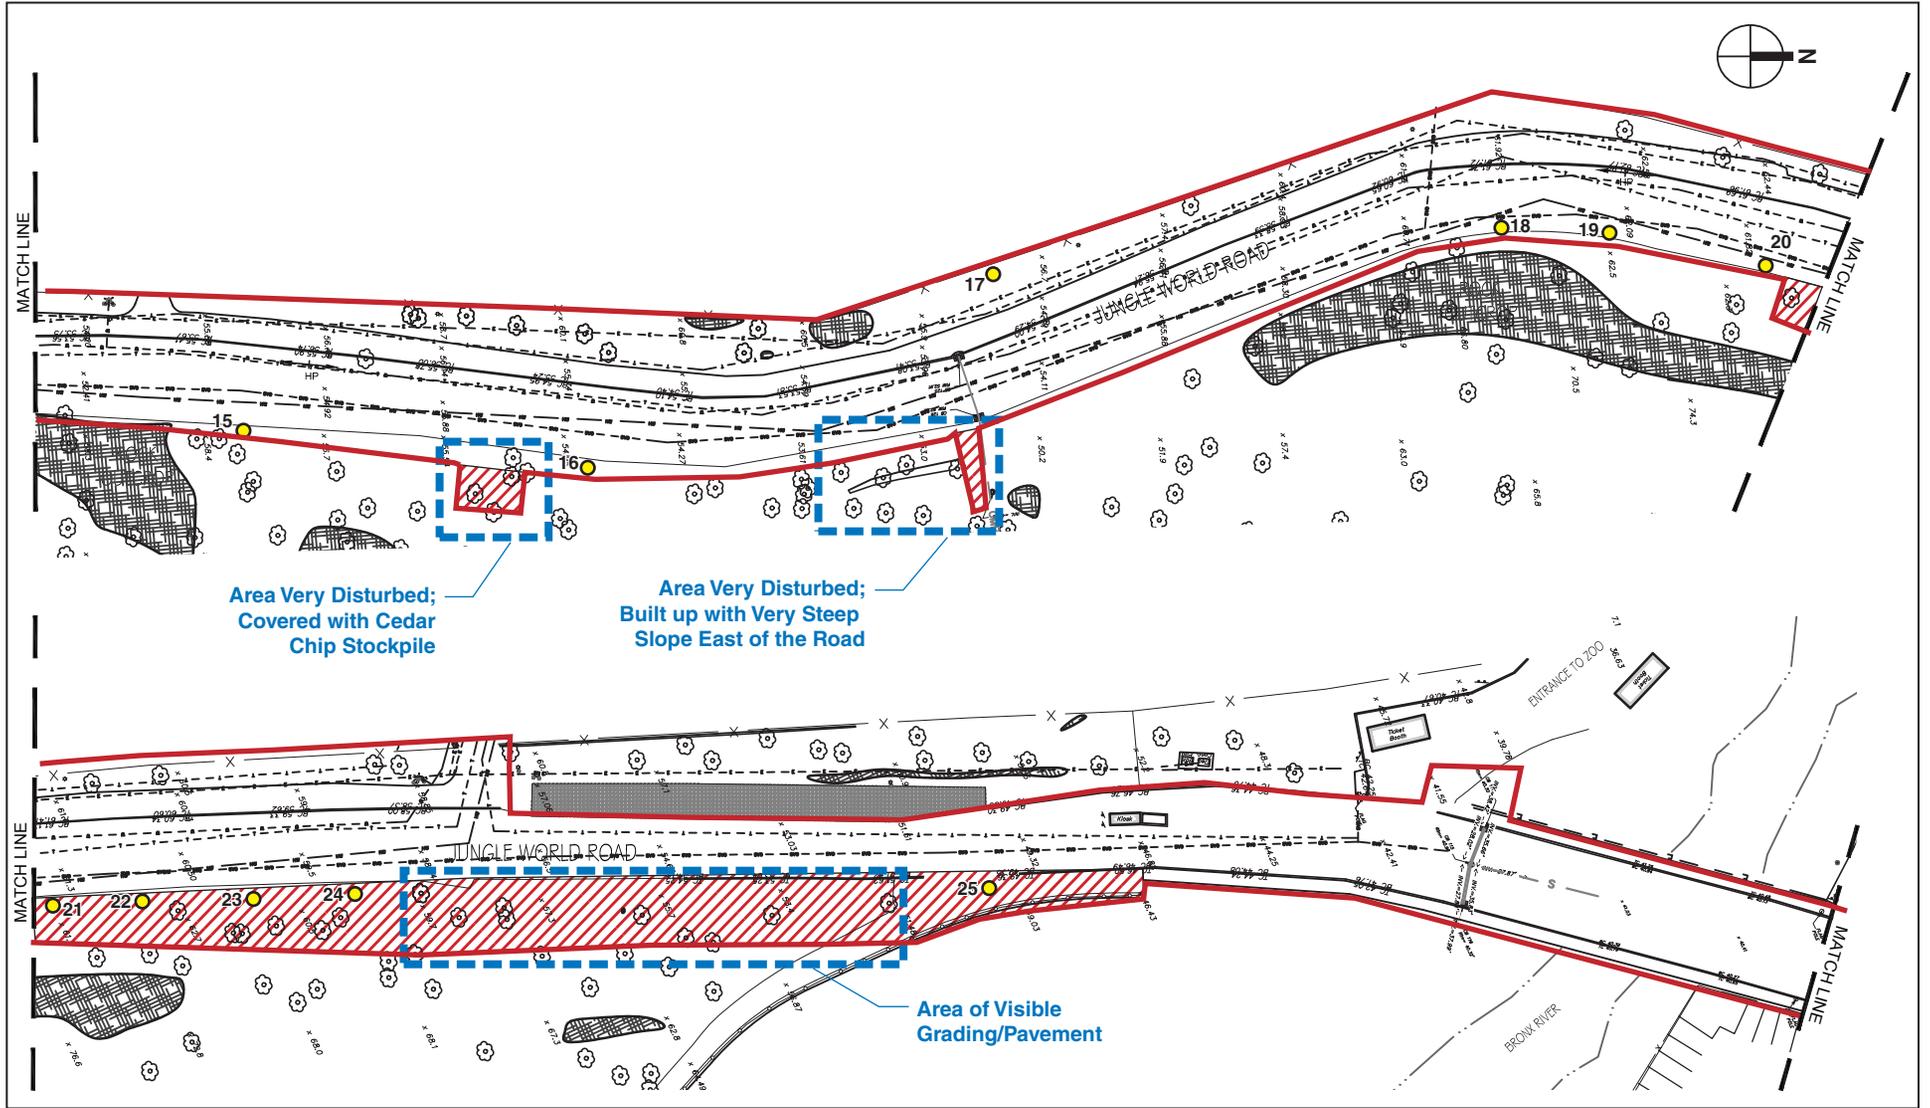
Phase 1B Testing Locations:
Jungle World Road, North Half
Figure 3

17 ● Shovel Test Pit and Number

▨ Areas of Archaeological Sensitivity, excluding areas with slopes greater than 10 percent and areas with exposed bedrock

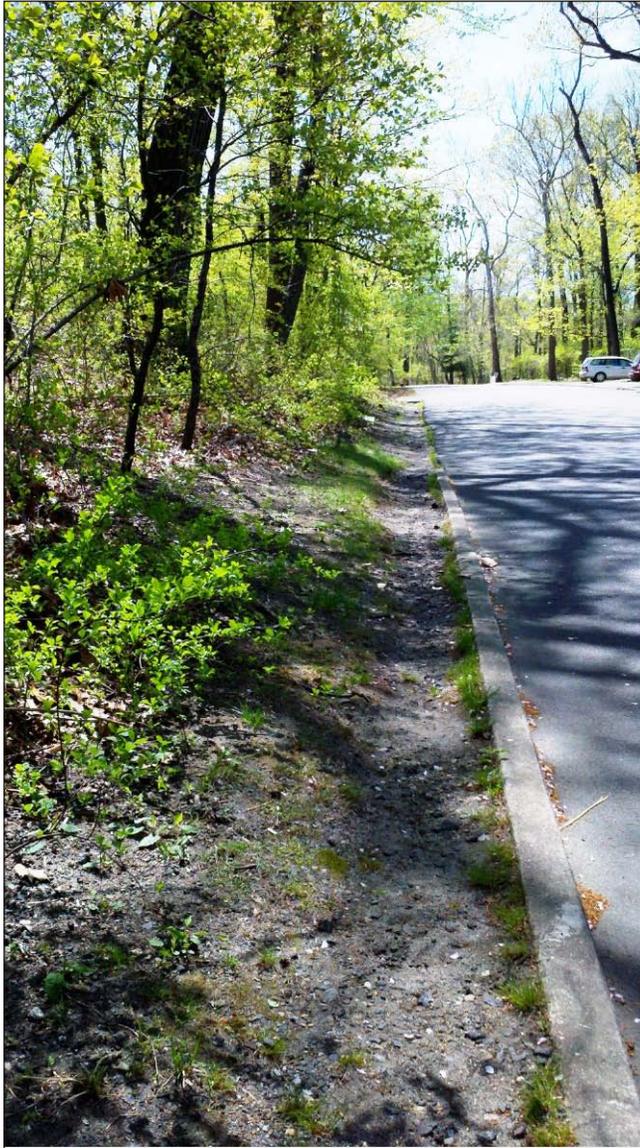
Looking south along the eastern side of Jungle World 1
at an area of visible disturbance

The 25 STPs that were excavated along the western and eastern sides of Boston/Jungle World Road showed that the roadbed and its immediate vicinity have been disturbed. This disturbance was likely caused as a result of the construction, grading, paving, and maintenance of the road as it was transformed from a colonial road to a modern thoroughfare and again for use within the zoological park. A consistent, intact buried original ground surface was not observed in the area identified as archaeologically sensitive in the Phase 1A study. In addition, the artifacts recovered during the Phase 1B testing are largely consistent with late-20th century refuse. A significant quantity of bottle glass fragments which appears to represent many different vessels with few mends suggests the disturbance and redeposition of the soils near the road surface. The remaining areas within the portions of the project site that were identified as archaeologically sensitive in the Phase 1A but were not subjected to Phase 1B testing featured steep slopes or visible disturbance.

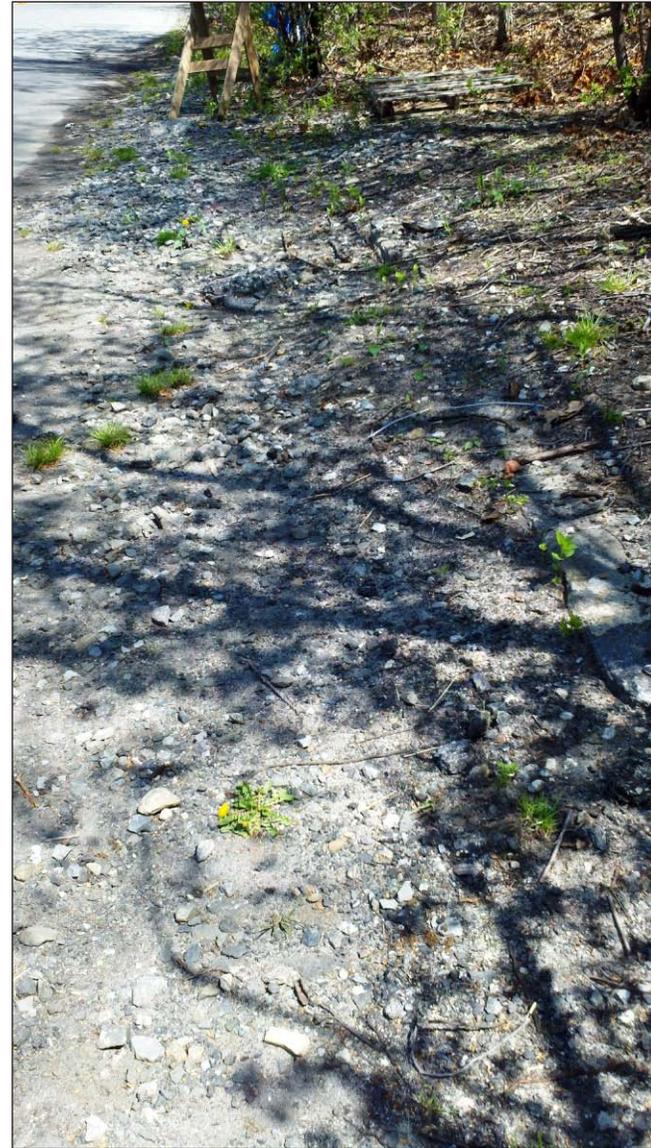
Disturbance along the southern side of Jungle World Road 2
