**Phase 1B Archaeological Survey**

**Bronx Zoo Parking Lot and Roadway Improvements:  
Lot B and Overflow Parking Areas**

**Bronx, New York**

**May 2014**

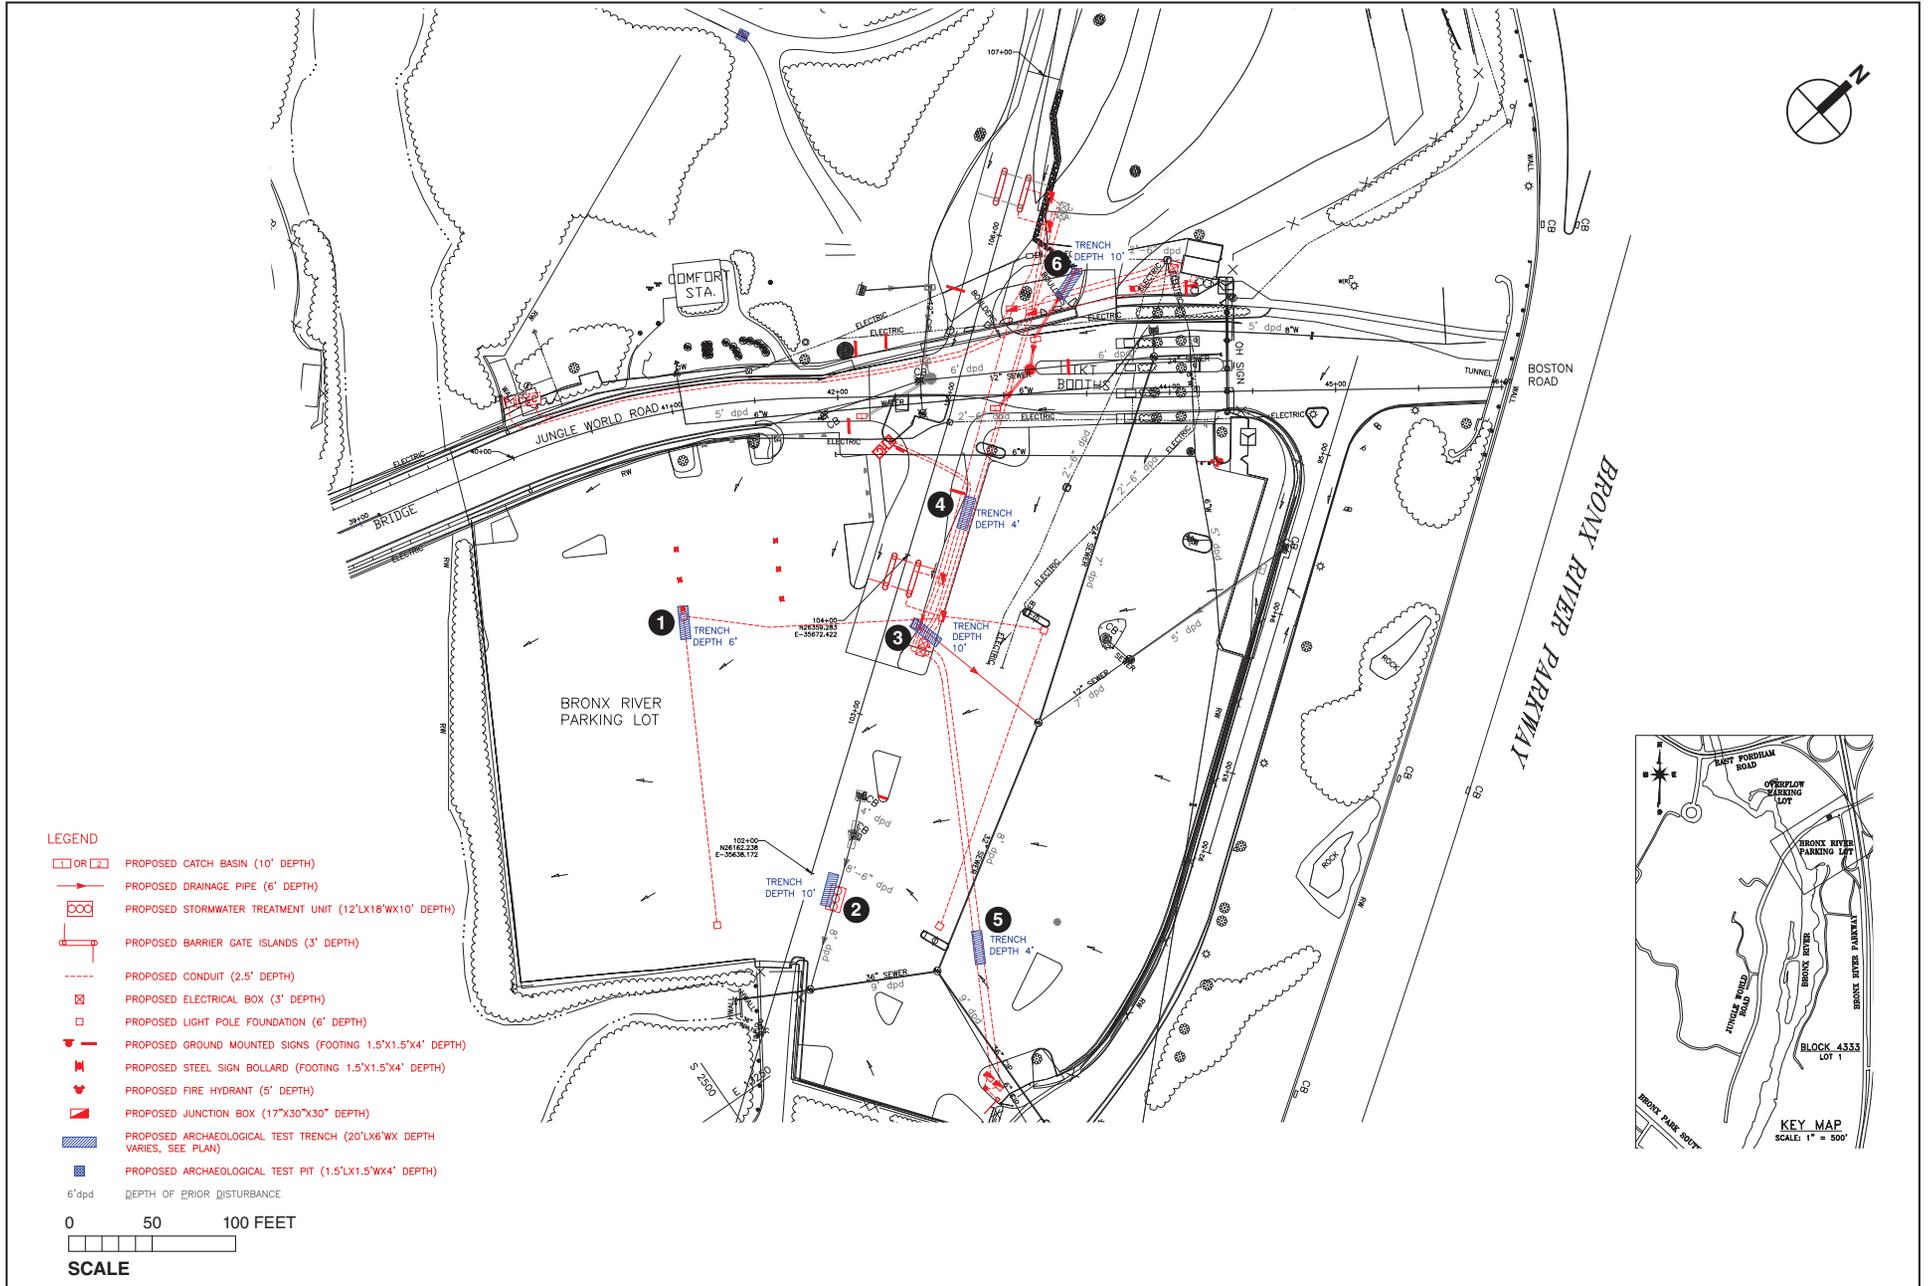
In total, 6 backhoe trenches were excavated in Lot B. The following table provides a summary of the results of the trench excavations and their locations are depicted on Figure 2.

Trench Number	Location (Figure 2)	Dimensions	Depth	Results
1	West side of parking lot	5 by 20 feet	4.5 to 6 feet	Multiple fill layers to 4.5 feet; 2 utility lines at 4 feet; sands to 6 feet between utilities; ground water at 4 feet 10 inches
2	Southern portion of parking lot	5 by 20 feet	10 feet	Multiple fill layers to 6 feet; buried ground surface with misc. 20th c. artifacts and root remains at 3.5 feet; possible earlier ground surface and peat at 6 feet; ground water at 9 feet; coarse sand and bedrock at 9-10 feet
3	Center of lot	5 by 20 feet	10 feet	Multiple fill layers to 3.3 feet; remnant of disturbed buried ground surface; sterile silty clay from 6 to 8 feet; fine sands to 10 feet
4	North-central portion of lot	5 by 20 feet	4 feet	Multiple fill layers to 4.3 feet
5	Southeastern portion, near exit gate	5 by 20 feet	4 feet	Multiple fill layers to 4 feet; modern refuse such as chain-link fencing observed extending into floor of finished trench

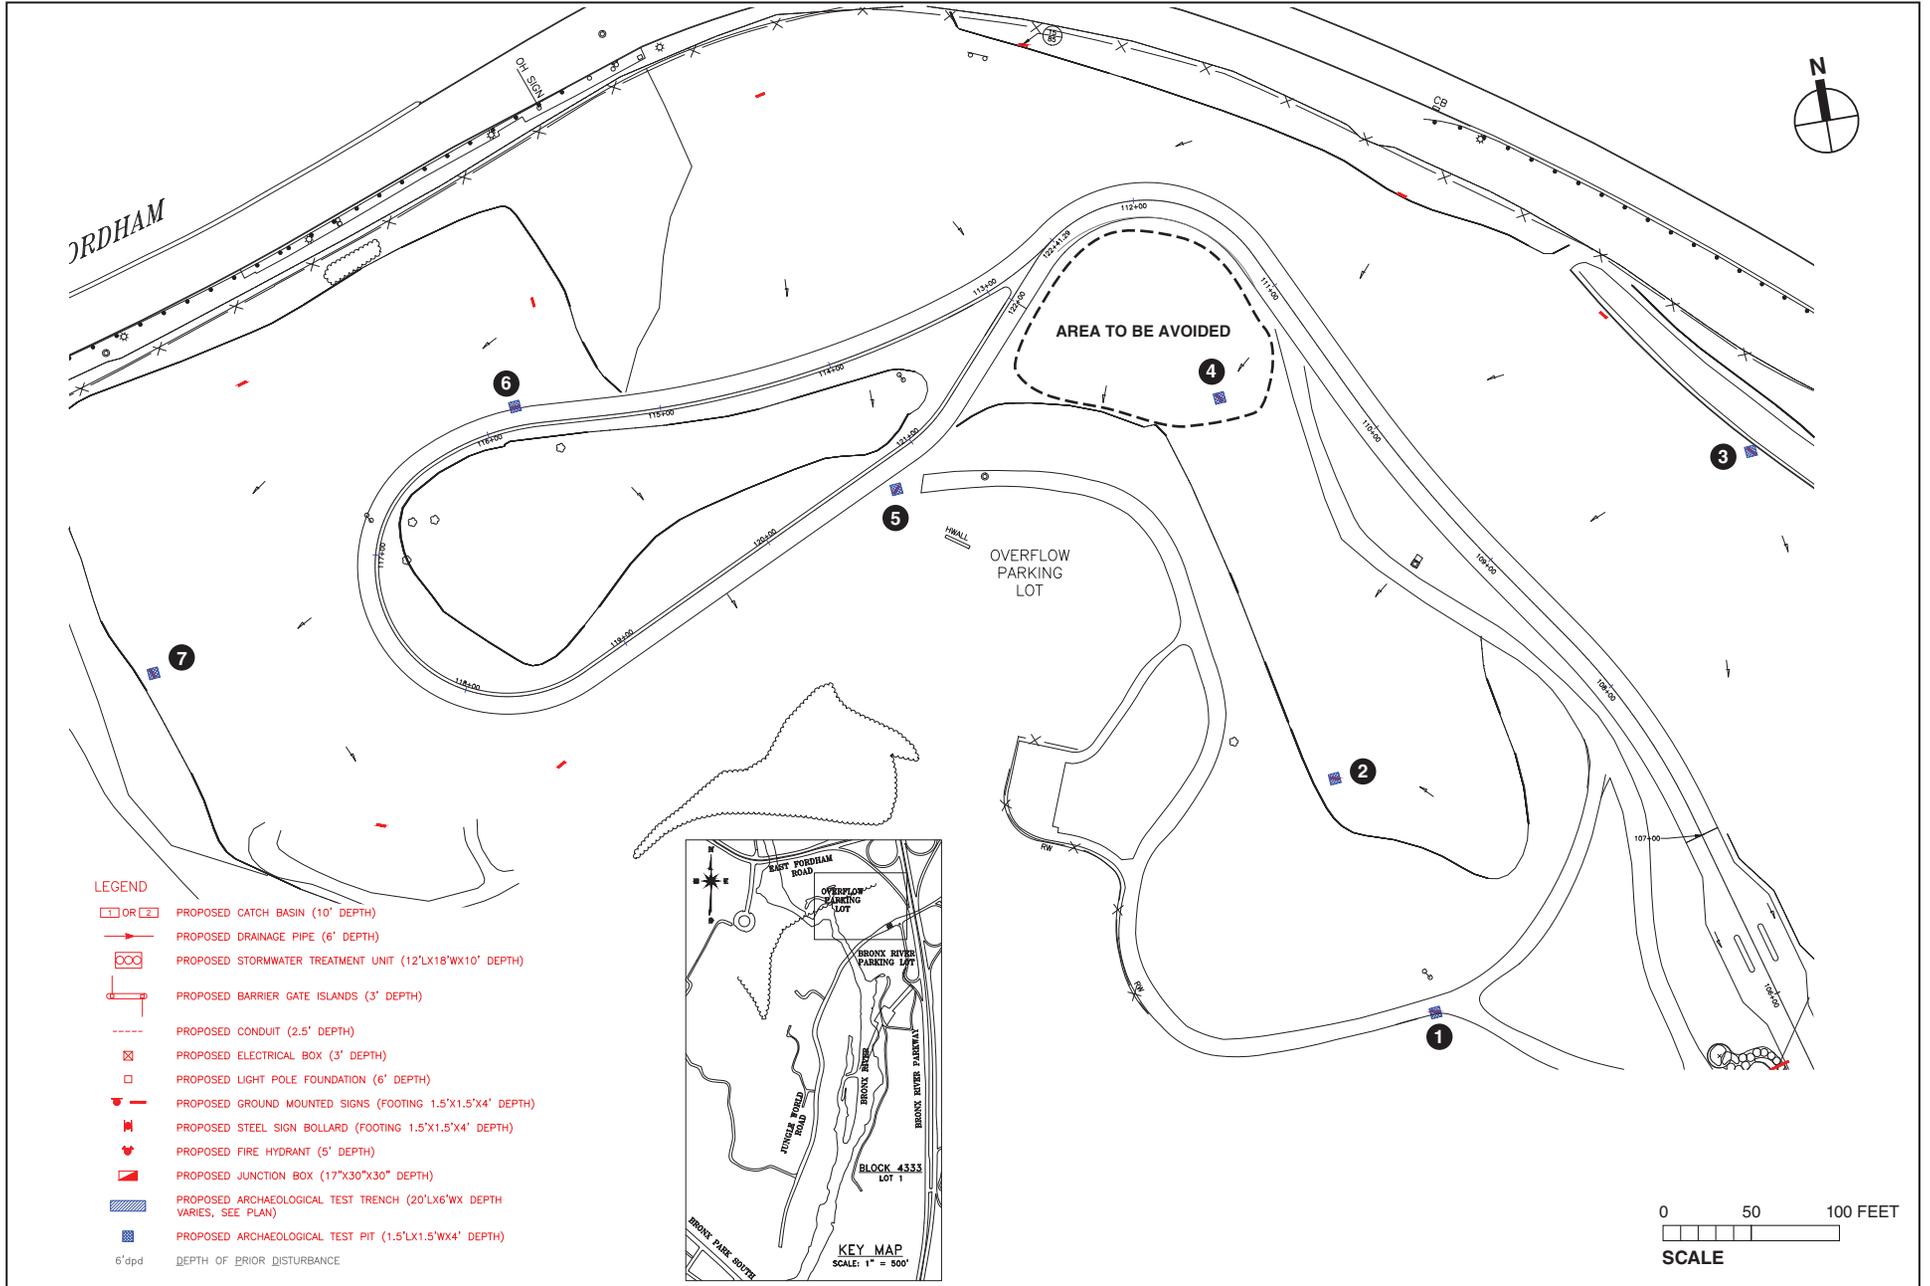
In total, 6 STPs were excavated in the Overflow Parking Lot. The following table provides a summary of the results of the test pit excavations and their locations are depicted on Figure 3.

<b>Test Pit Number</b>	<b>Location (Figure 3)</b>	<b>Results</b>
1	Southern portion of lot next to trail	10 inches of topsoil followed by subsoil to almost 4 feet; a small quantity of historic and modern artifacts was recovered
2	Southern portion of parking lot	Disturbed area; shallow remnant of original ground surface to 6 inches; sterile subsoil to 3 feet
3	Eastern edge of lot on highland next to roadway	Disturbed area; very compact gravel roadbed to 3 inches; disturbed soil to 7 inches; sterile subsoil to 2.5 feet
4	North-central portion of lot	Encountered portion of southern side of buried wooden barrel; remains included deteriorating wooden staves and rusted metal hoops; apparently filled with soil and large cobbles; no associated artifacts
5	South-central portion of lot near trails	Test location on substantial quantity of modern fill; not excavated
6	Northwest portion of lot adjacent to roadway	10 inches of compact fill/redeposited soil; several inches of remnant of disturbed original ground surface; sterile subsoil to 3 feet; large rock obstacle at bottom of pit

No additional archaeological analysis is recommended for the Lot B Parking Lot or the Overflow Parking Lot. It is recommended that the area immediately surrounding the location of the buried barrel (as depicted on Figure 3) identified in Test Pit 4 be avoided to preserve potential archaeological resources in place. During e-mail correspondence conducted on April 4, 2014, WCS and the DDC Design Team have agreed to eliminate the proposed sign location that could have impacted the buried barrel from the proposed actions. Therefore, the possible historic resource will not be impacted by the project and will remain intact in its current location. In the absence of archaeological resources that could be impacted by the proposed project, no additional fieldwork is recommended.

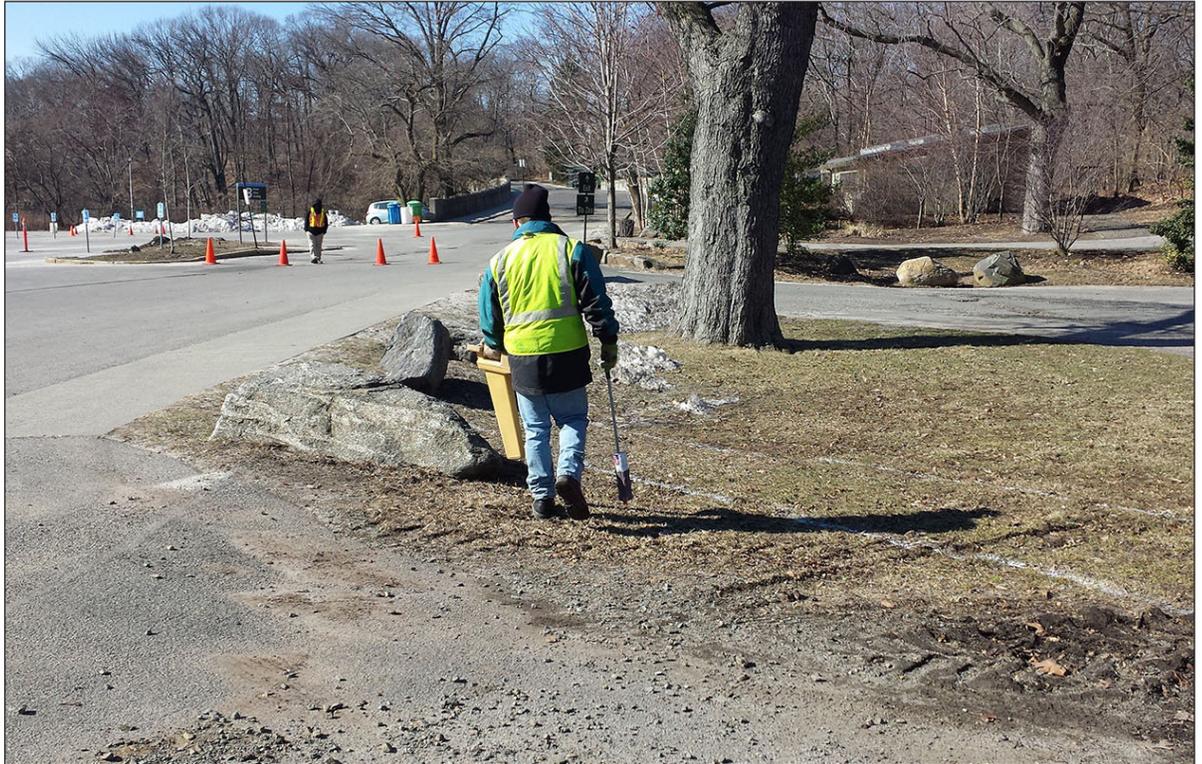
Facing south from north edge of Lot B showing utility mark out for Trench 6. Lot B parking lot is to the left 1

Trench 6 was excavated approximately 20 feet from a large mature tree (see Photo 1). A buried ground surface was encountered in this trench beneath multiple layers of mixed fill and shallow pockets of coal ash. This trench contained the greatest number of artifacts of all of the trenches, over 80. Most of these artifacts came from the mixed fill layers and included a variety of domestic refuse, possibly associated with the homes that once stood further to the north and east in the Overflow Parking Lot. The buried ground surface contained only 5 artifacts: a mint green tile fragment, a fragment of a whiteware dish, and a few pieces of bottle glass. The bottle glass fragments included a base embossed with the maker’s mark of Owens-Illinois Glass Company. Based upon the makers’ mark, as well as the embossed Duraglass name and date of production on the bottom, this bottle fragment dates to 1941. An additional 19 artifacts were recovered from the 24 inches of soil excavated from beneath the buried ground surface, suggesting soil disturbance and redeposition.

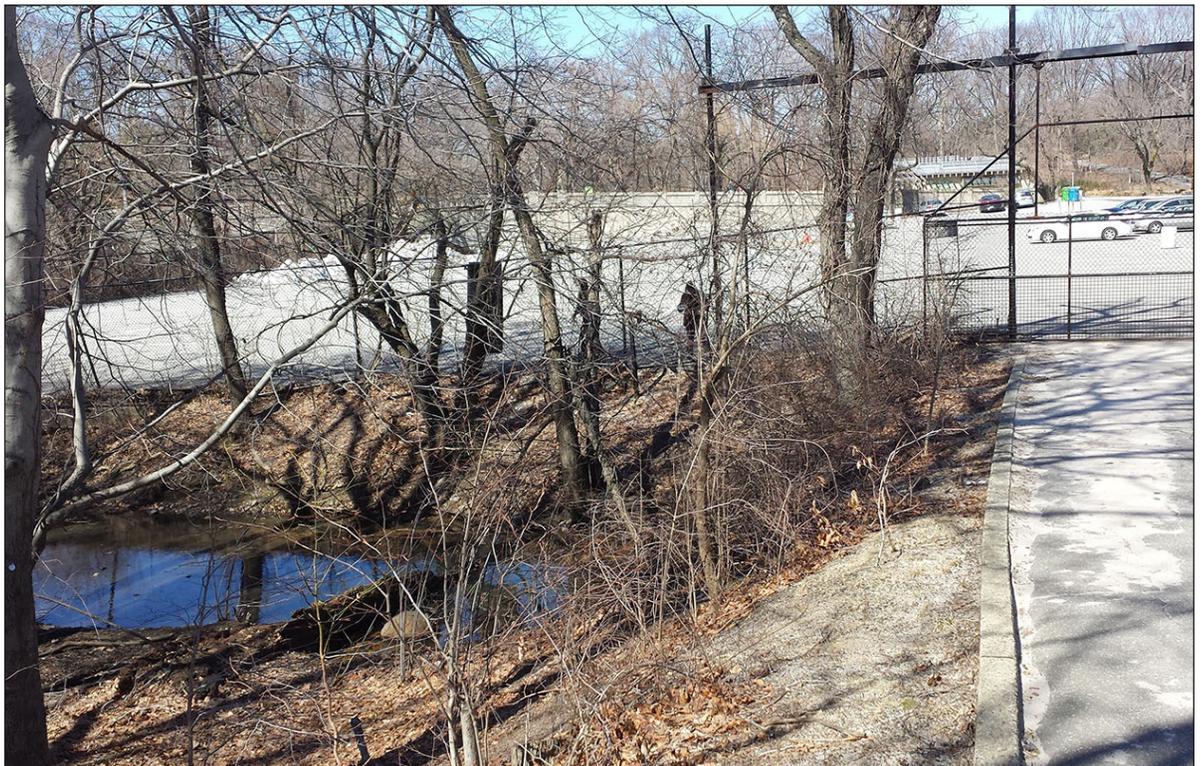
Facing northwest from south of Lot B showing change in elevation from northeast (right side of photo) to southwest (left side of photo). The Bronx River is beyond the left side of this photo. The standing water in the left foreground drains into the Bronx River and is a few feet lower than the elevation of the parking lot adjacent to it 2

After removal of asphalt and bedding, excavation encountered various layers of mixed sandy fill in each of the trenches and the remains of buried ground surfaces below the fill in three of the trenches. The fill was deepest in Trench 2 (6 feet), the trench excavated furthest to the south and having the lowest elevation. Only 3.3 feet of fill was encountered in Trench 6, the trench excavated furthest to the north and in the area with the highest elevation. This observation seems to indicate that the difference in elevation from the north to south sides of the Lot B parking lot was more pronounced in the past and that various filling episodes occurred that attempted to make the area more level and raise the grade in the vicinity of the Bronx River (see Photo 2).

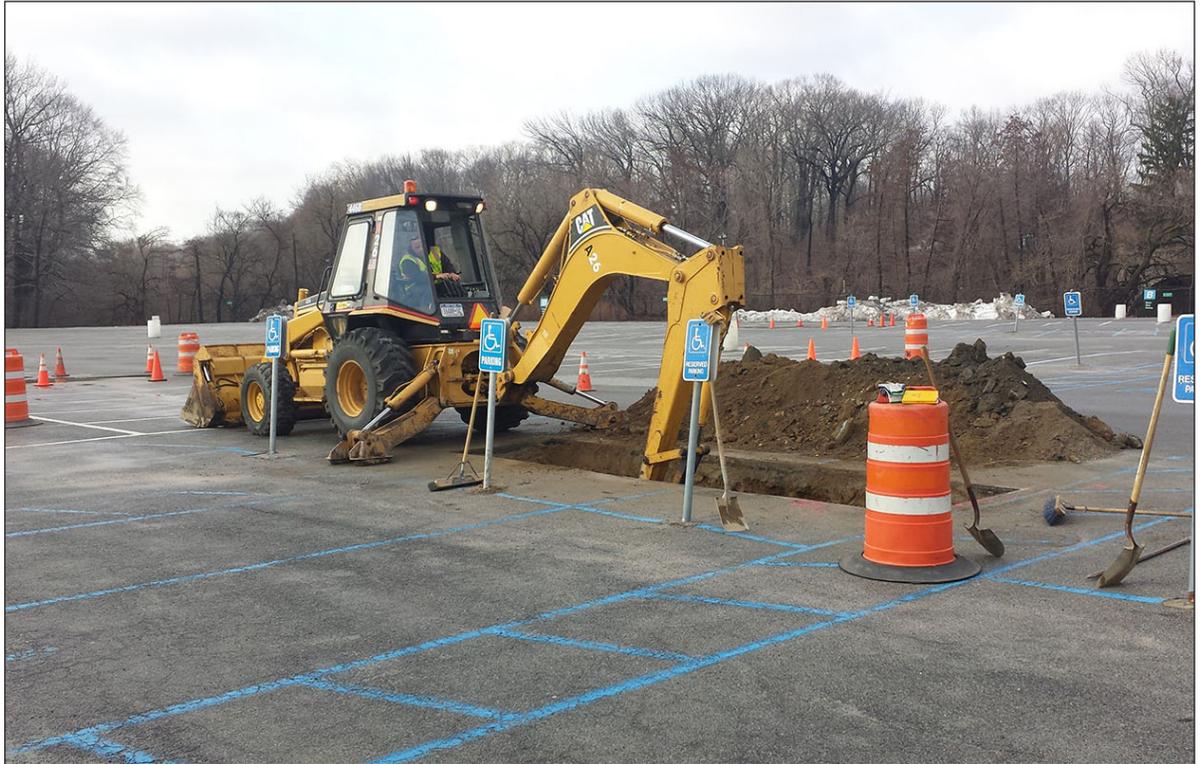
Facing south from just north of Trench 4. The Bronx River extends along the tree line in the background of this photo **3**

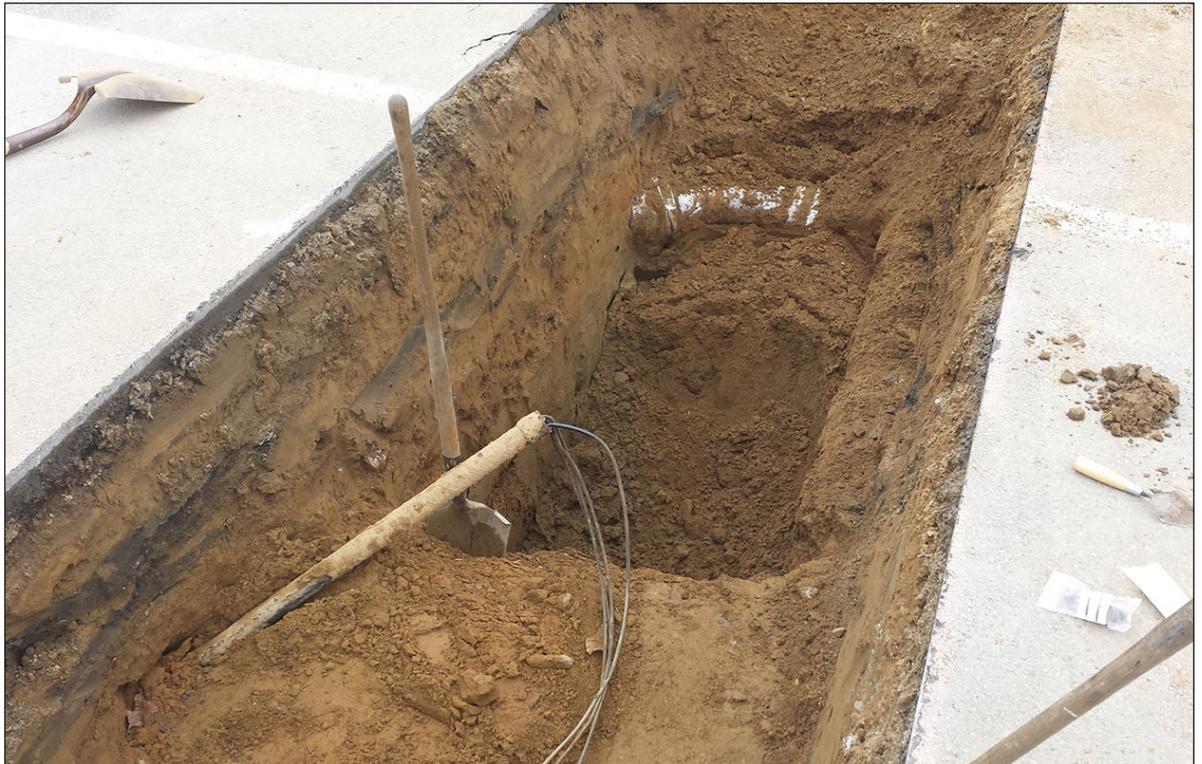
Facing southeast showing completed Trench 1. Note electrical conduit extending from wall towards bottom of photo and water line in background **4**

Based on the presence of mid- to late-20th century refuse, the fill deposits appear to have been deposited over the past several decades. Two utility lines, an electrical conduit and a water pipe, were encountered in Trench 1 at a depth of approximately 4 feet, indicating more recent excavation and refilling. Neither line was broken by the backhoe bucket. Though they no longer appear to be in use, they were avoided and excavation was only able to reach the target depth of 6 feet in an approximately 6-foot-wide gap between the two utilities.

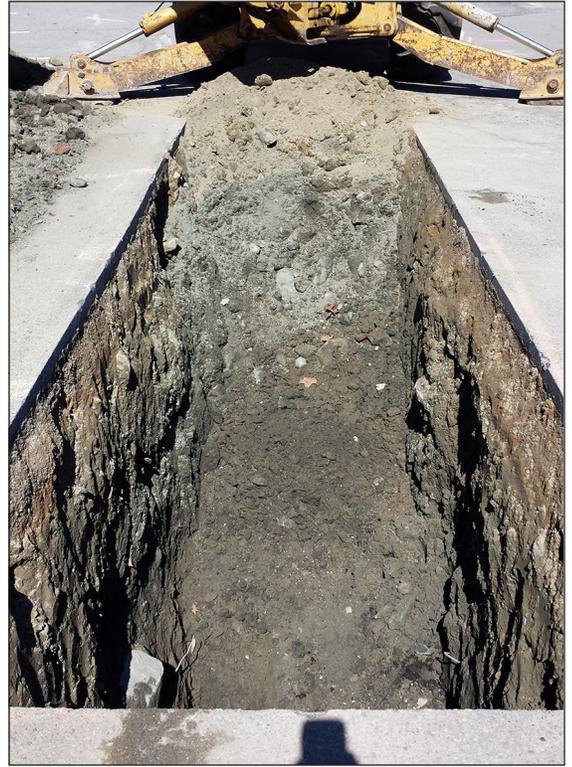
Facing northwest showing in progress excavation of Trench 2 5

In Trench 2, two buried ground surfaces were encountered: the first at a depth of about 40 inches and the second at a depth of 6 feet below ground surface. The field archaeologists observed a well-preserved, modern looking wooden stake extending vertically from the darker soil of the shallower, and therefore more recent, ground surface. The upper end of the stake was broken and the bottom end terminated in a 45 degree point. The 2-inch by 4-inch stake may have supported a sign. The preservation and modern appearance of the stake is further indication of the relatively recent deposition of fill across the Lot B project site.

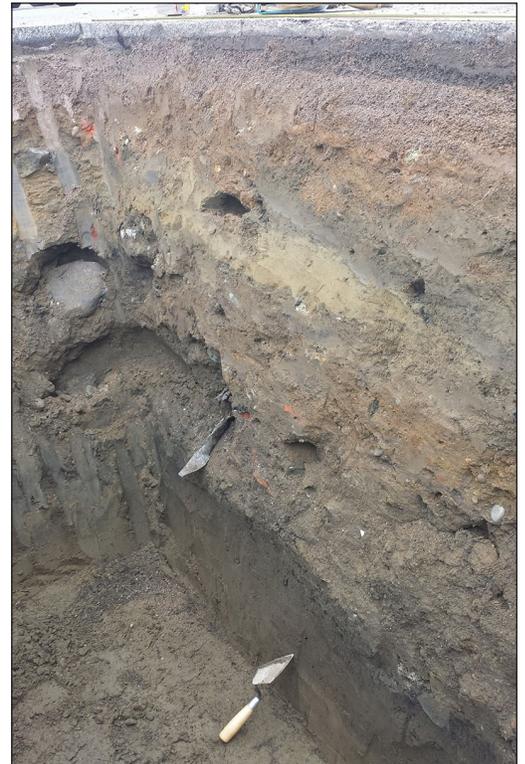
Facing northwest showing north wall of Trench 3. Note multiple layers of fill and remnants of original dark gray brown sandy silt ground surface at trench bottom 6

Several inches of the remnants of a disturbed buried topsoil layer were encountered beneath the fill deposits in Trenches 2, 3, and 6 (see Photos 6 and 9). These layers would have been at or near the ground surface for some period of time before the overlying fill layers were deposited. It is possible that this layer could have also been encountered in Trenches 1, 4, and 5 if excavation had proceeded deeper in those trenches (excavation only proceeded to the maximum depth of potential impacts from the proposed action in each area). In Trenches 2 and 6, it seems that temporary new ground surfaces were established after deposition of fill onto the natural original ground surface, before later being buried by additional fill deposits.

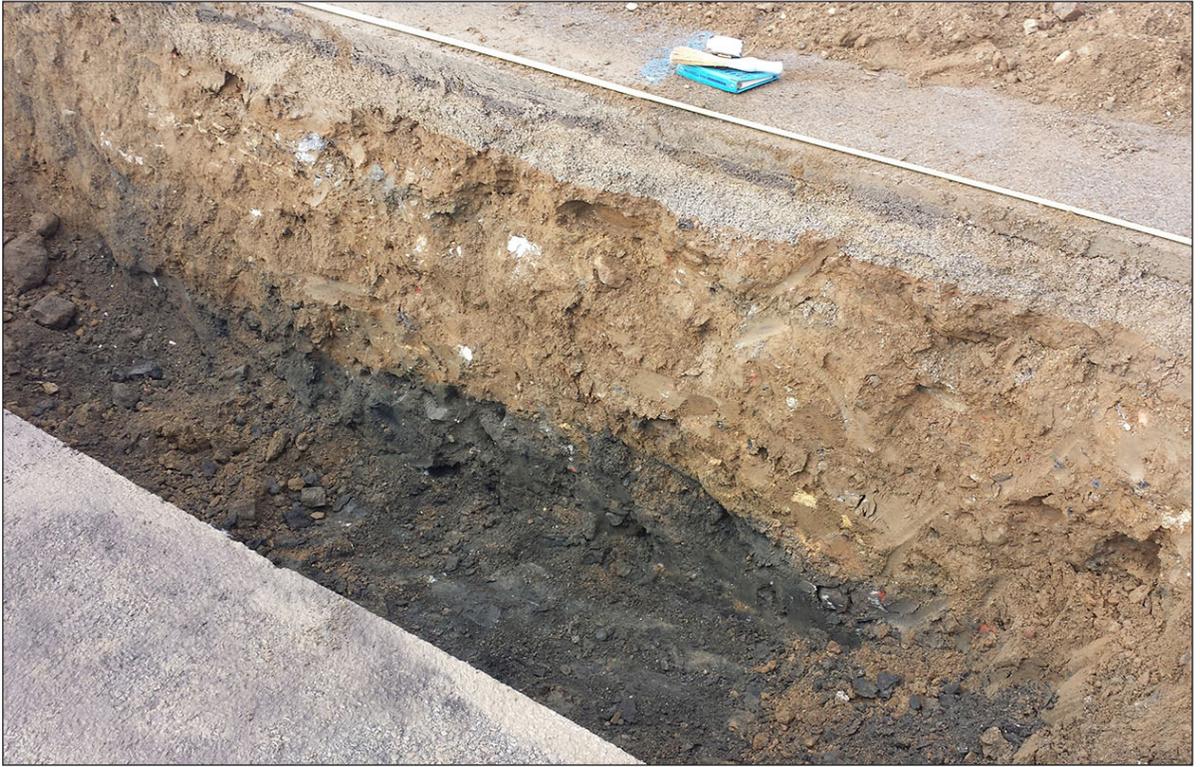
Facing west showing west wall profile of Trench 4 and mixed modern gravelly fill 7

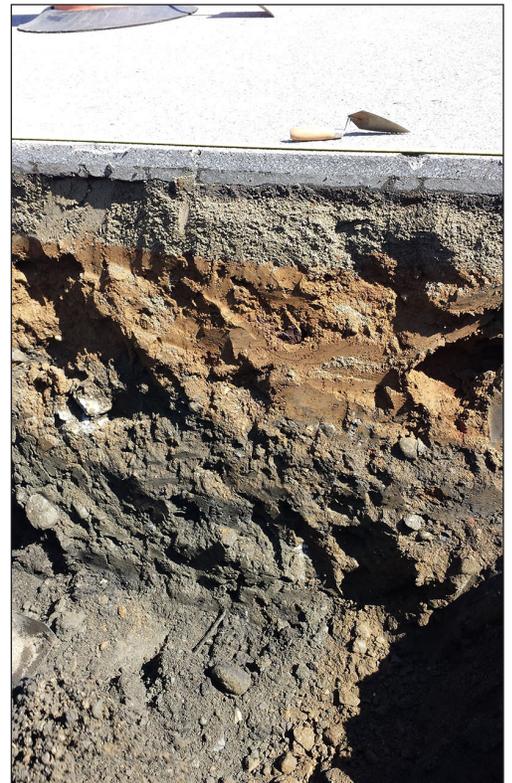
Facing north showing north wall profile of Trench 5 and mixed modern gravelly fill 8

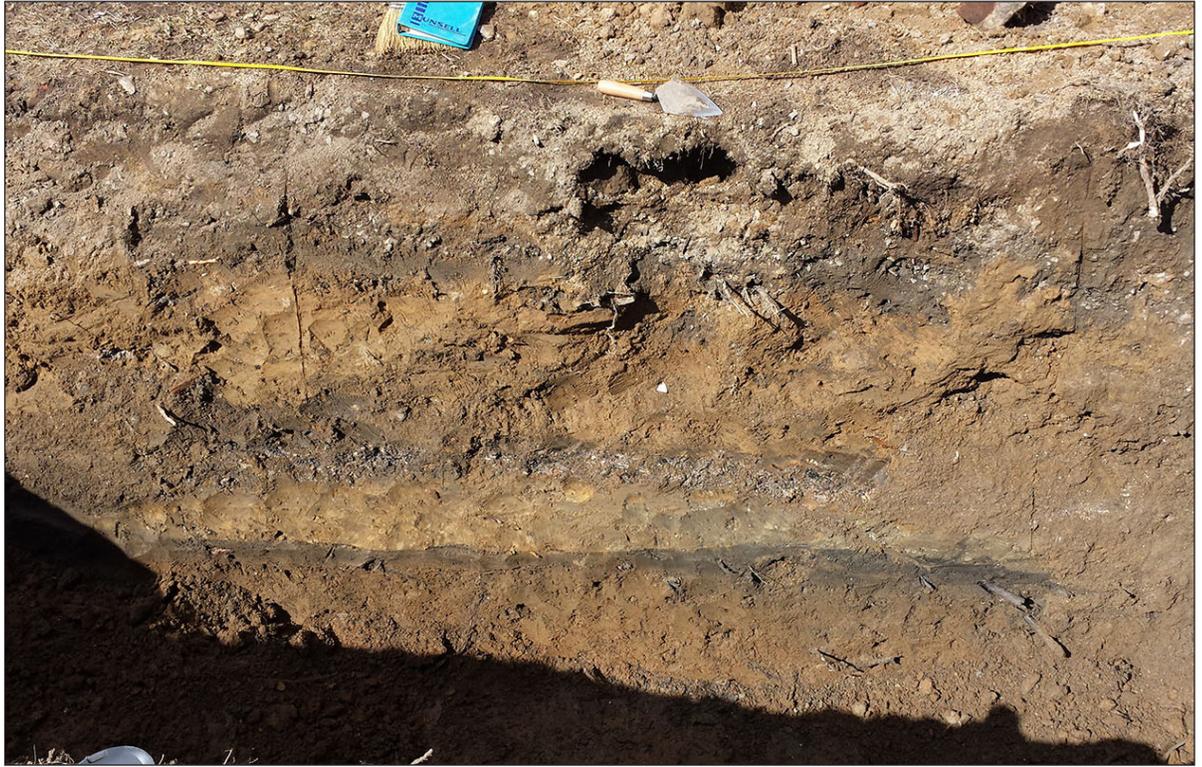
Facing west showing the west wall profile of Trench 6. Note multiple layers of modern fill followed by remnant of the original ground surface and subsoil at bottom of photo at a depth of about 3 feet below ground surface 9

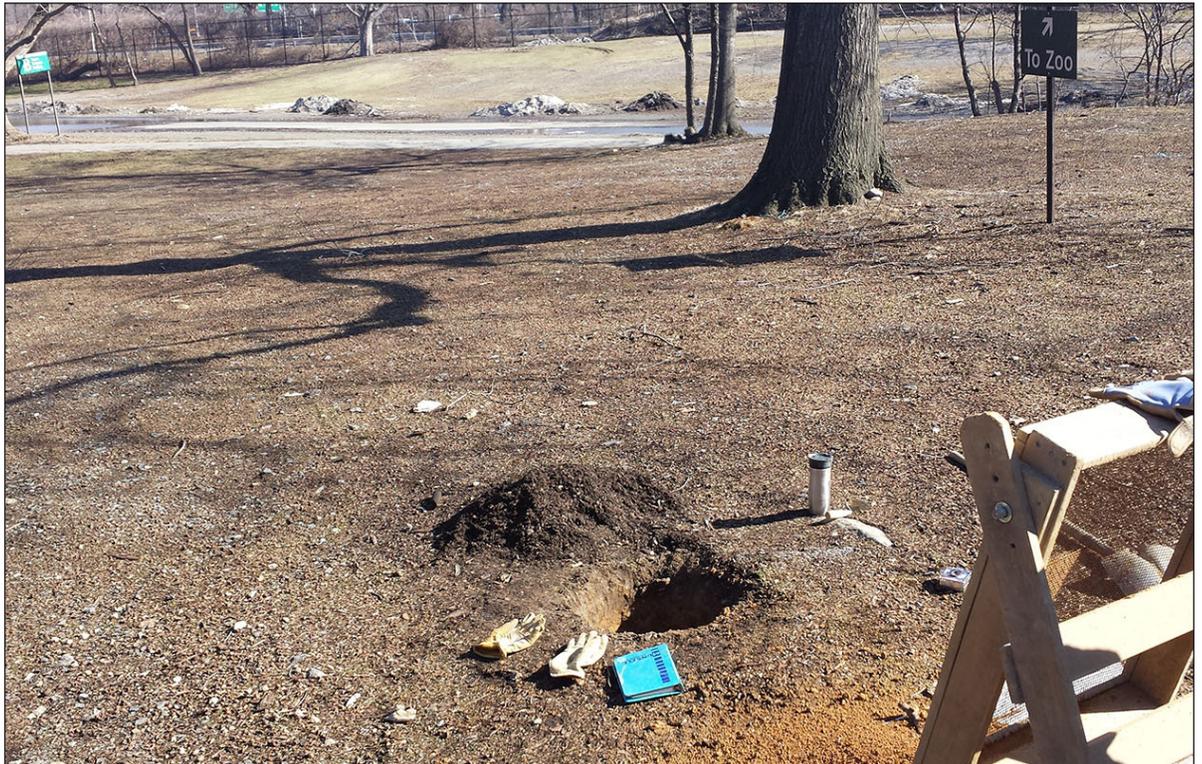
Facing north from south of STP 2 showing area recently stripped of ground cover and mature tree in the background 10

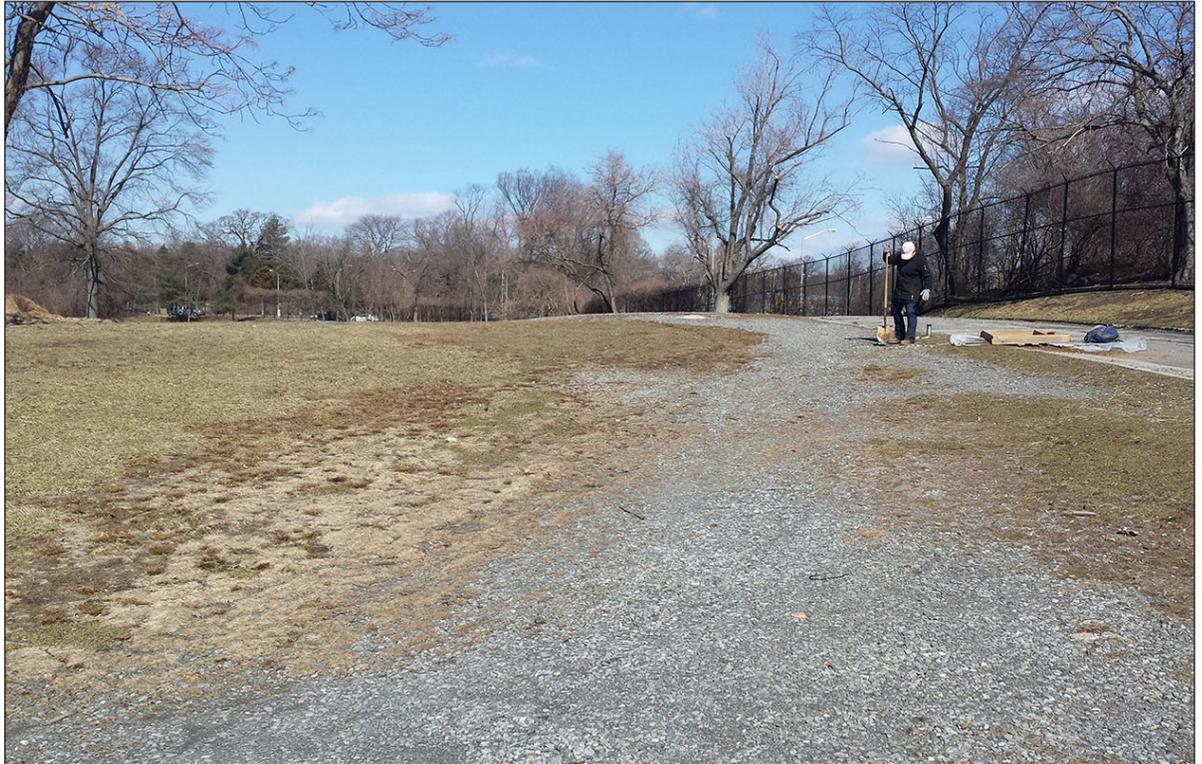
Facing north showing excavation of STP 3. Note topography and compacted gravel roadway 11

varying amounts of fill followed by subsoil or a disturbed topsoil layer. Small quantities of fragmentary non-diagnostic artifacts and modern refuse were recovered from all of the STPs. The soils in STPs 2, 3, and 4 were excessively compact, most likely due to their use as roadways (see Photos 11 and 14).

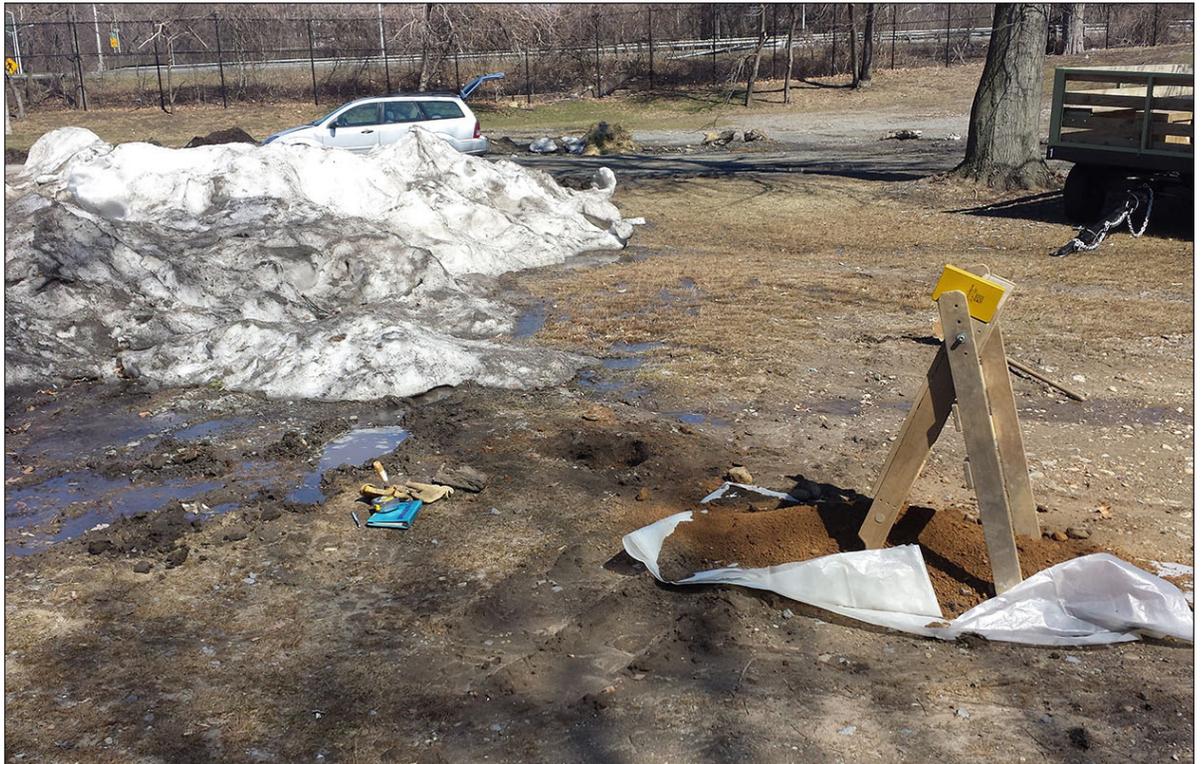
Only one of the test pits, STP 4 (Photo 12), encountered a possible historic resource. During wall cleaning after completion of the STP, decaying wood was observed emerging from the pit’s north wall. Additional hand clearing revealed a possible wooden feature (Photo 13). The test pit was subsequently expanded to the north an additional 12 by 18 inches in order to expose more of the possible feature. This additional testing exposed what was identified as the curved southern side of a buried wooden barrel. The barrel’s vertically oriented wooden staves were identifiable but badly deteriorated. The horizontal metal barrel hoops were in better condition than the staves but were heavily rusted. A portion of the wooden staves fell away from the barrel during cleaning revealing a mixture of dark soil and large cobbles in the barrel’s interior. The small number of artifacts observed during excavation of STP 4 did not appear to be associated with the feature and no artifacts were observed in the small exposed portion of the feature’s interior. The exposed portion of the barrel was photographed and sketched before being reburied.

Facing northwest showing excavated STP 4 and general vicinity 12

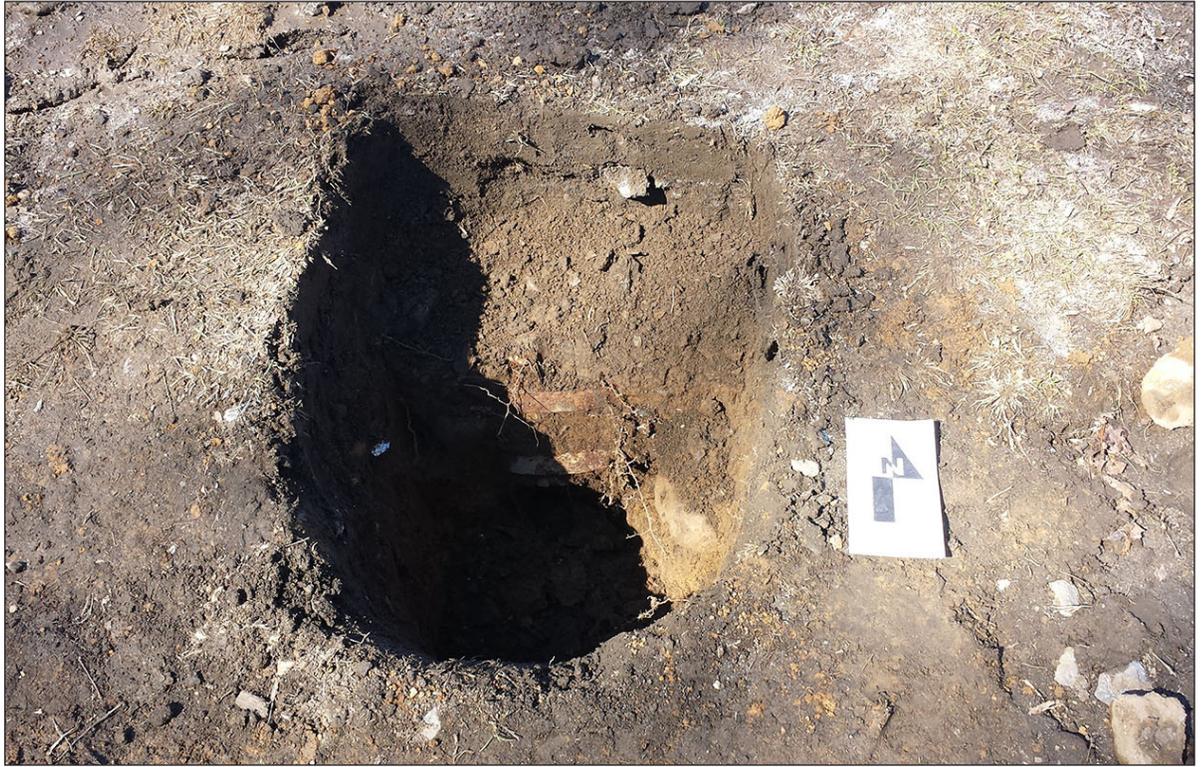
Facing north showing expanded STP 4 and buried wooden barrel. Note horizontal barrel straps 13

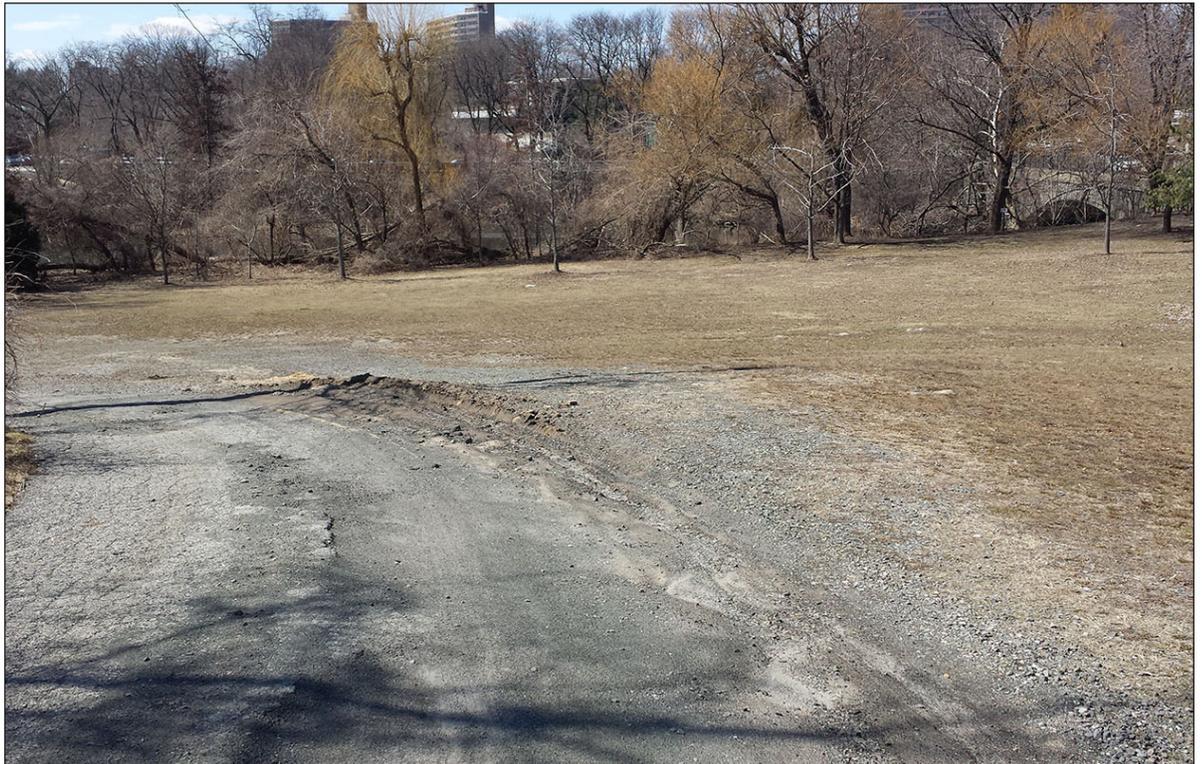
Facing west from the location of STP 6, which was excavated on the shoulder of the gravel roadway on the right side of the photo 14

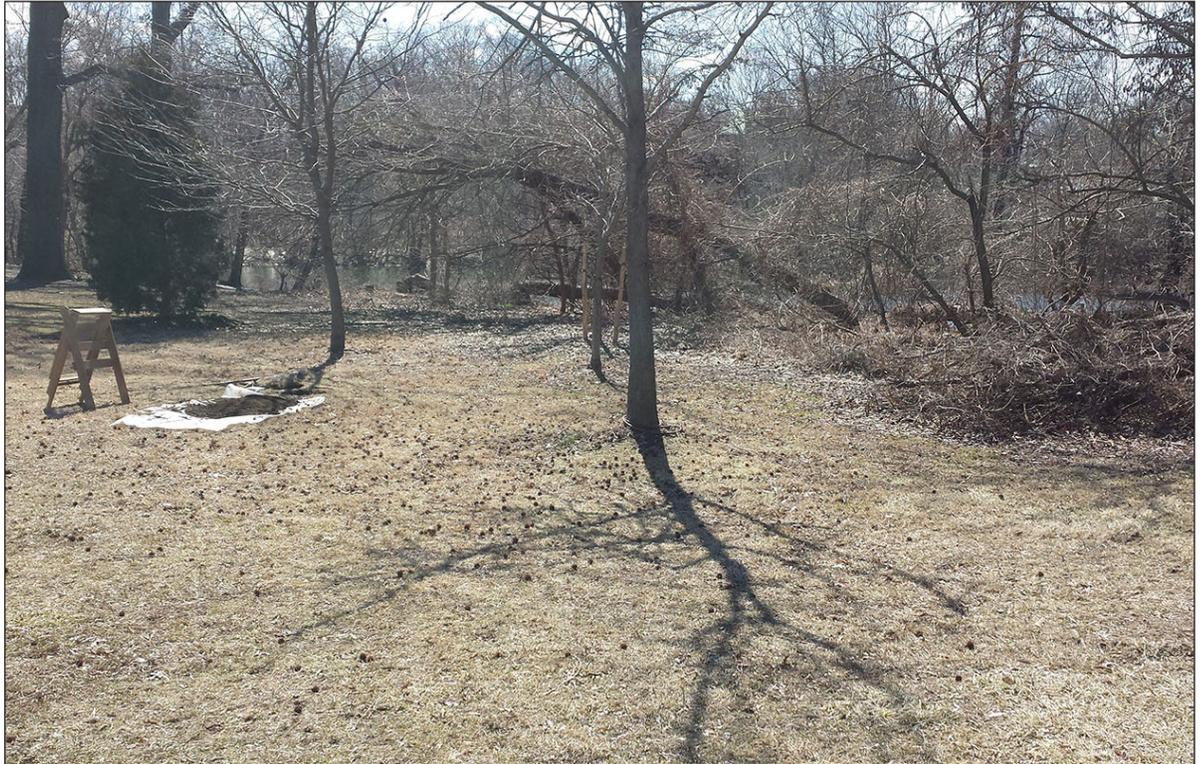
Facing southwest showing excavated STP 7 (on left) and general vicinity. The Bronx River is 15  
beyond the trees and brush in the photo background

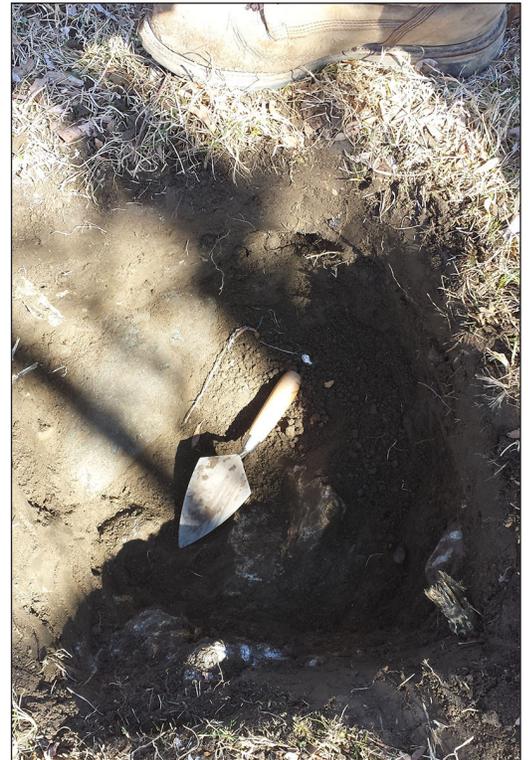
Possible bedrock in floor of the completed STP 7 at a depth of less than one foot. 16  
Trowel indicates north
