## **PHASE IB ARCHEOLOGICAL INVESTIGATION**

### **Bloomingdale Road Reconstruction Project Utility Improvements**

Bloomingdale Road  
Borough of Staten Island  
Richmond County, New York

HAA # 4437-31

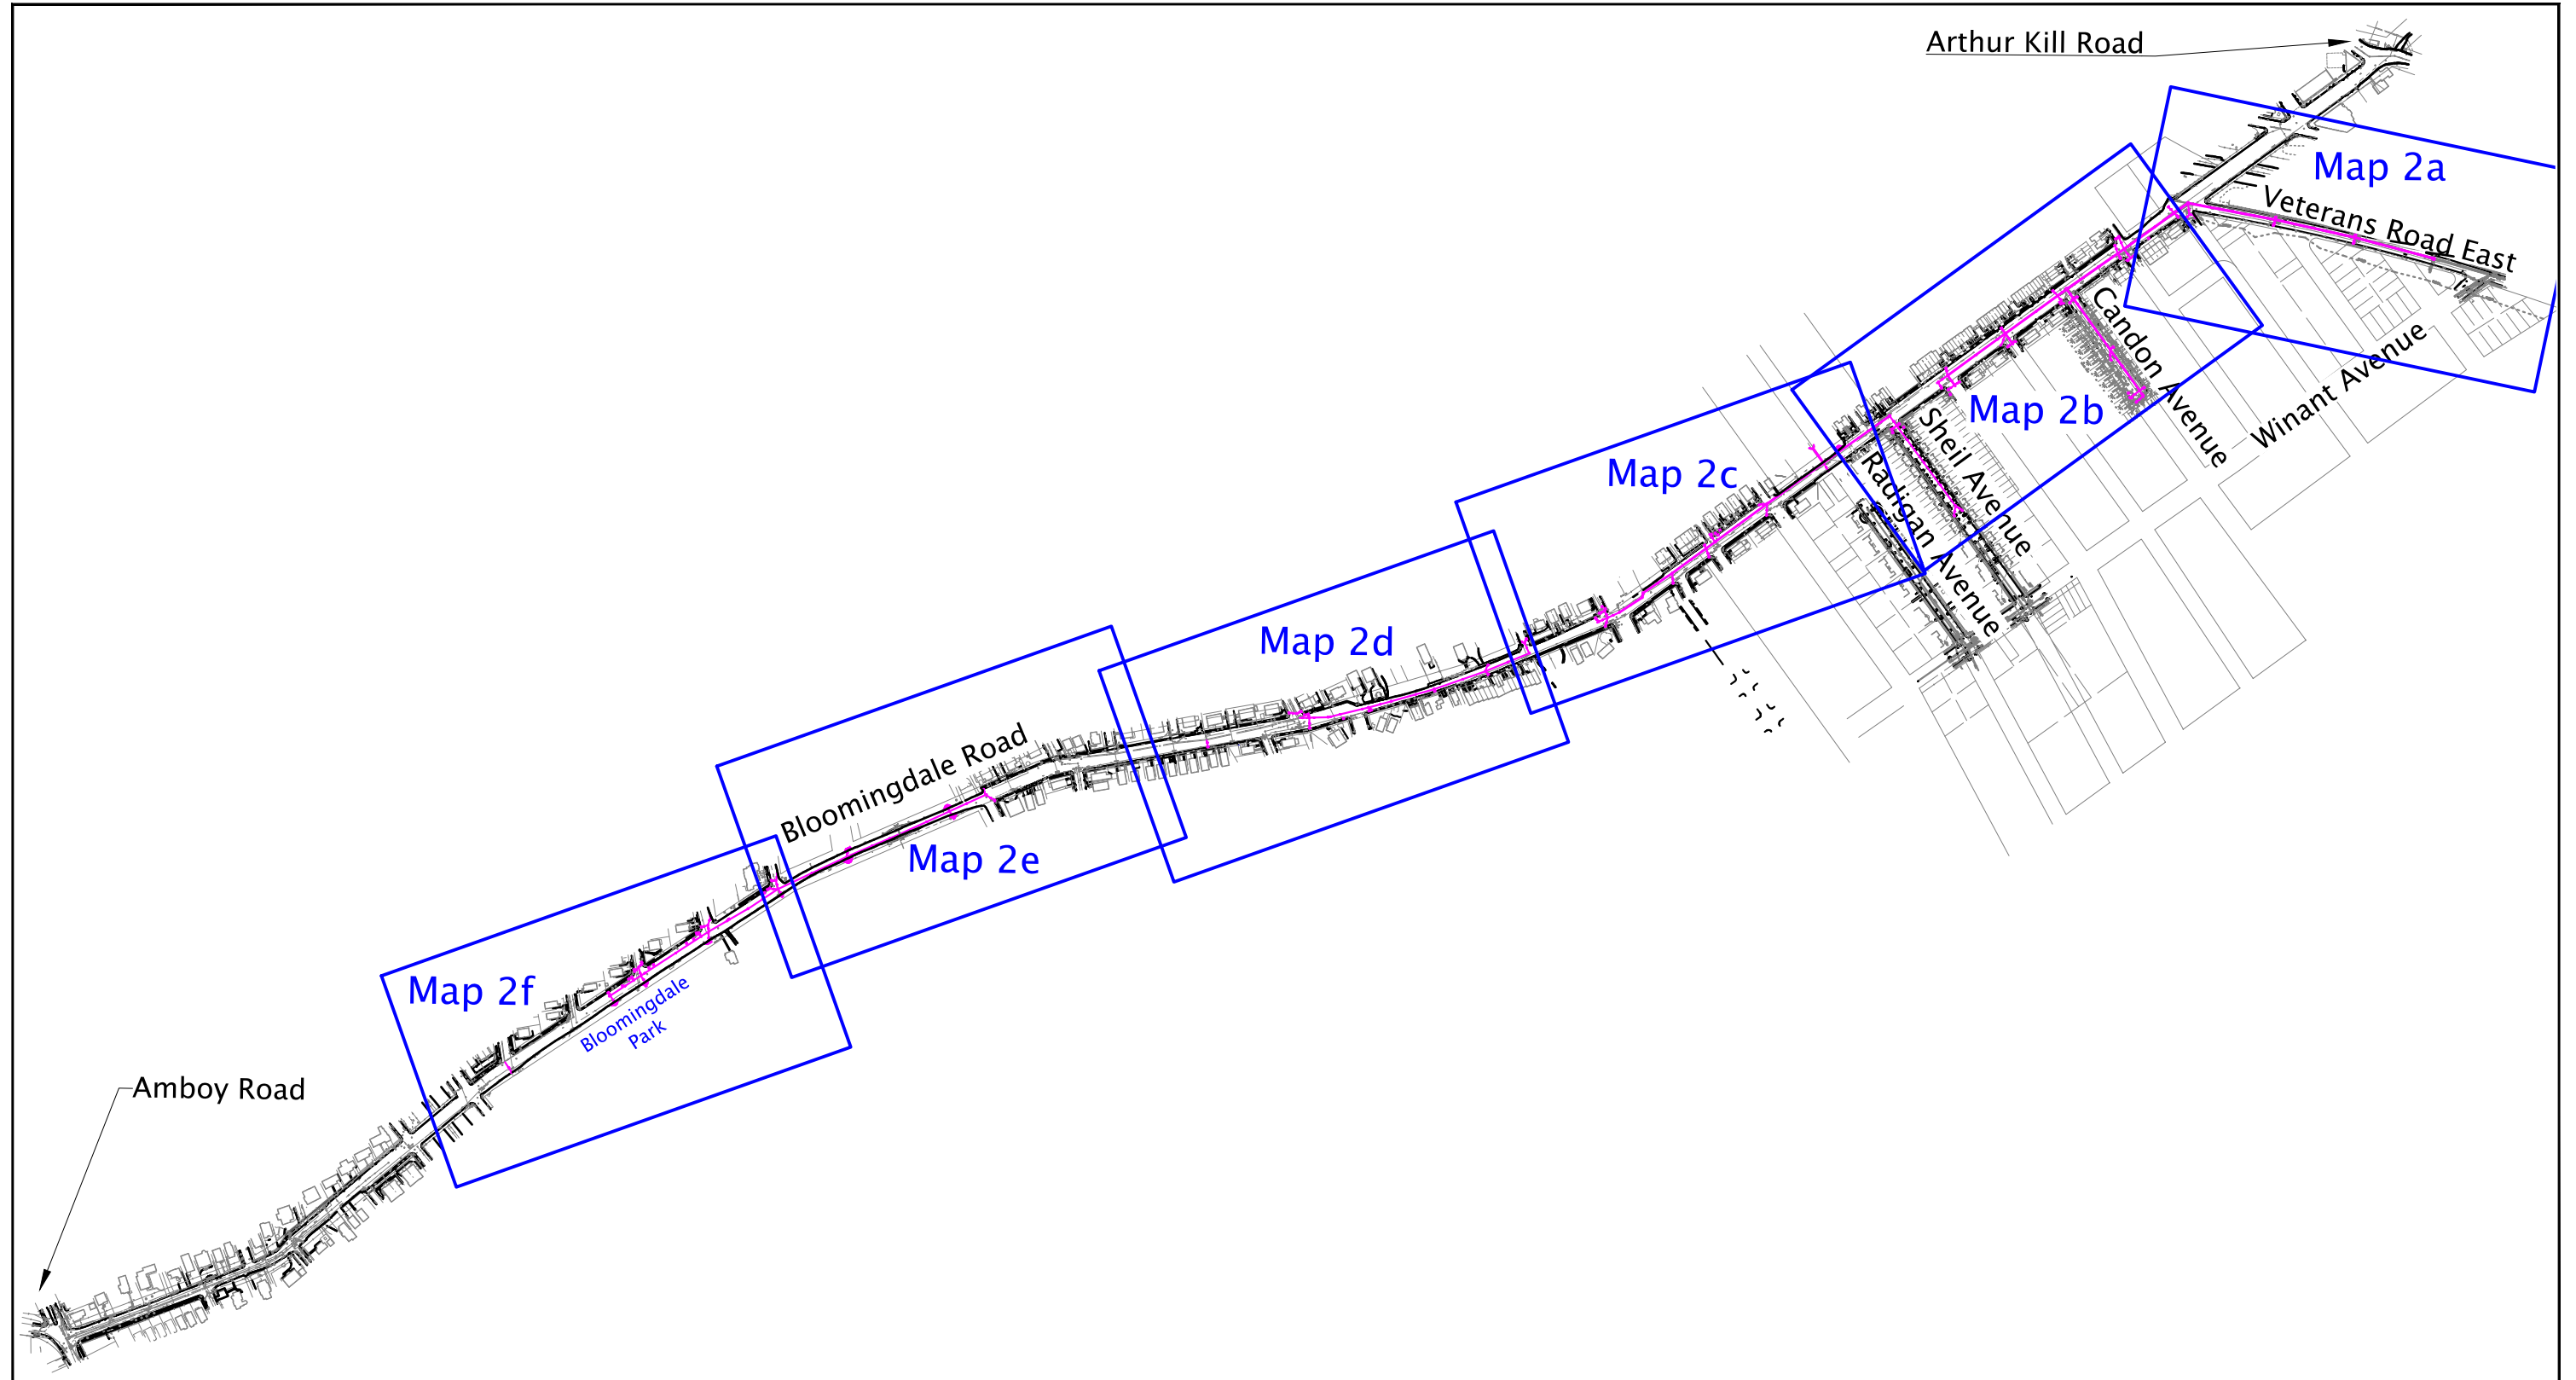
**Map 2**

Project Overview Map  
(HAKS Engineering 2013,  
Hartgen 2013)

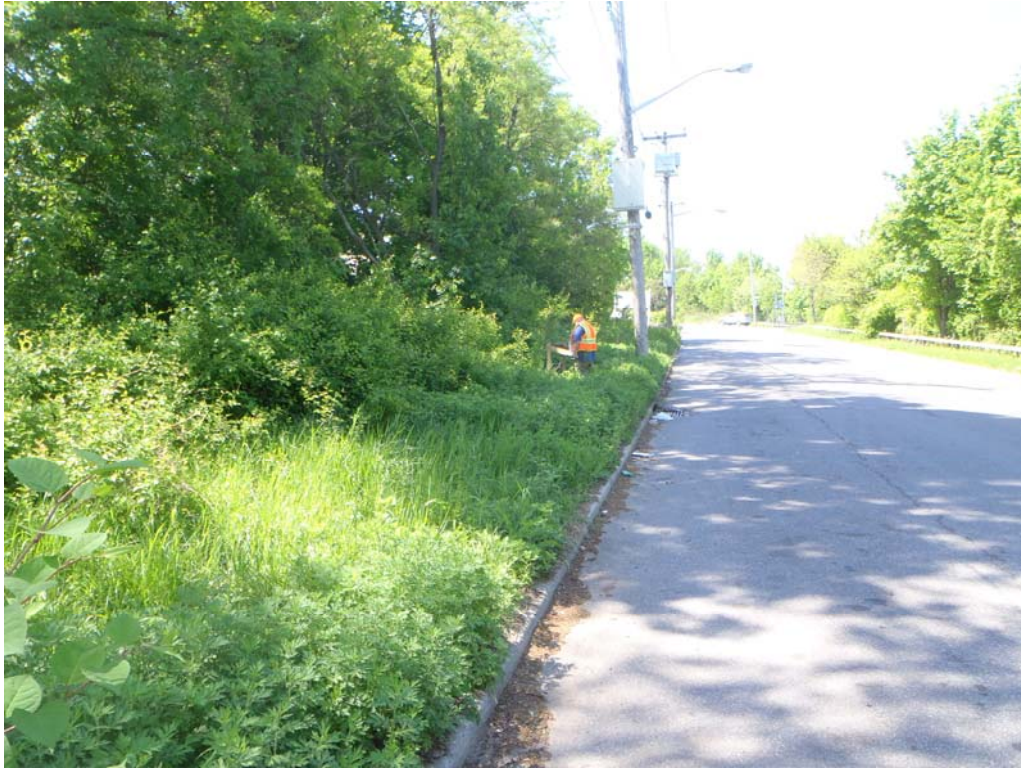
Photo 1. View southwest of the excavation of Test 1 located along the east side of Veterans Road. The area has experienced extensive surface soil disturbance resulting from road construction.

Test 1 was excavated along Veterans Road in an area where the utility will cross the street and the Phase IA study noted the potential of limited testing along the road shoulder. The excavation revealed extensive surface soil disturbance resulting from construction of the road and an on-ramp connecting with the West Shore Expressway (Map 2a; Photo 1). The soil stratigraphy consisted of a sandy loam 16 centimeters (6 in) thick underlain by a very compact clay fill (Appendix 1). All of the soils in this area appear to have been deposited during road construction and no precontact or significant historic cultural resources were evident.

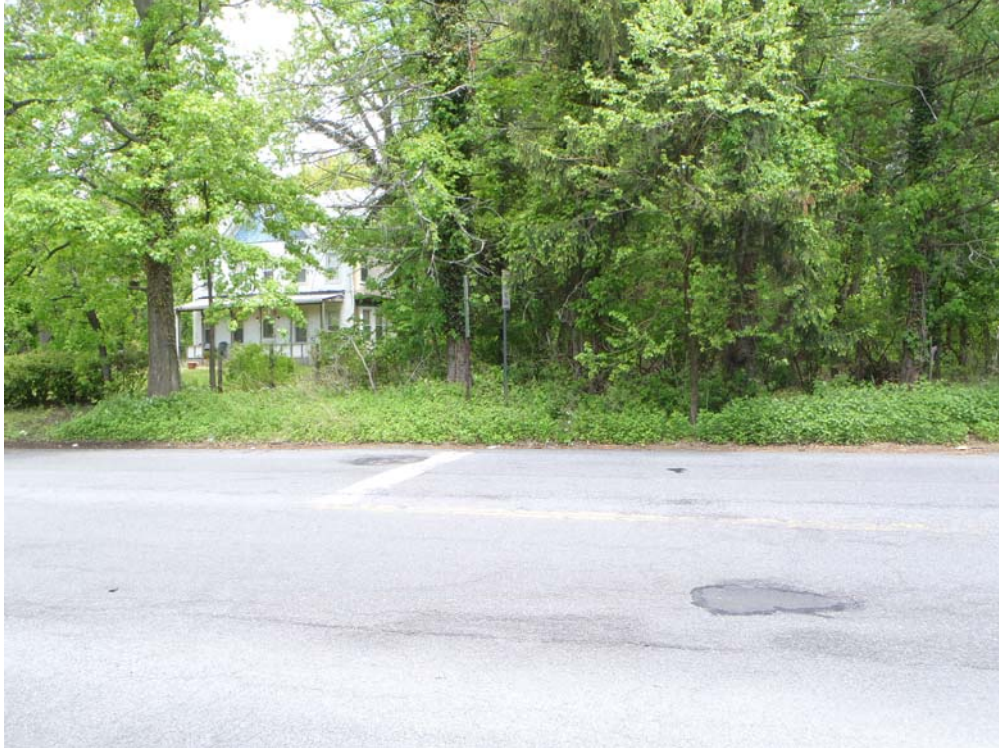
Photo 3. View east of the general location of Test 7 excavated along the east side of Bloomingdale Road across from Englewood Avenue.

Tests 7–10 were excavated along the east and west sides of Bloomingdale Road between Englewood Avenue and Bromley Avenue (Map 2e and 2f; Photos 3 and 4). These tests were located at points where the utility will cross the road and where the Phase IA study identified testable areas. Two of the shovel tests (Tests 7 and 8) exhibited a black to brown and reddish brown surface soil ranging from 29 to 38 centimeters (11 to 15 in) in

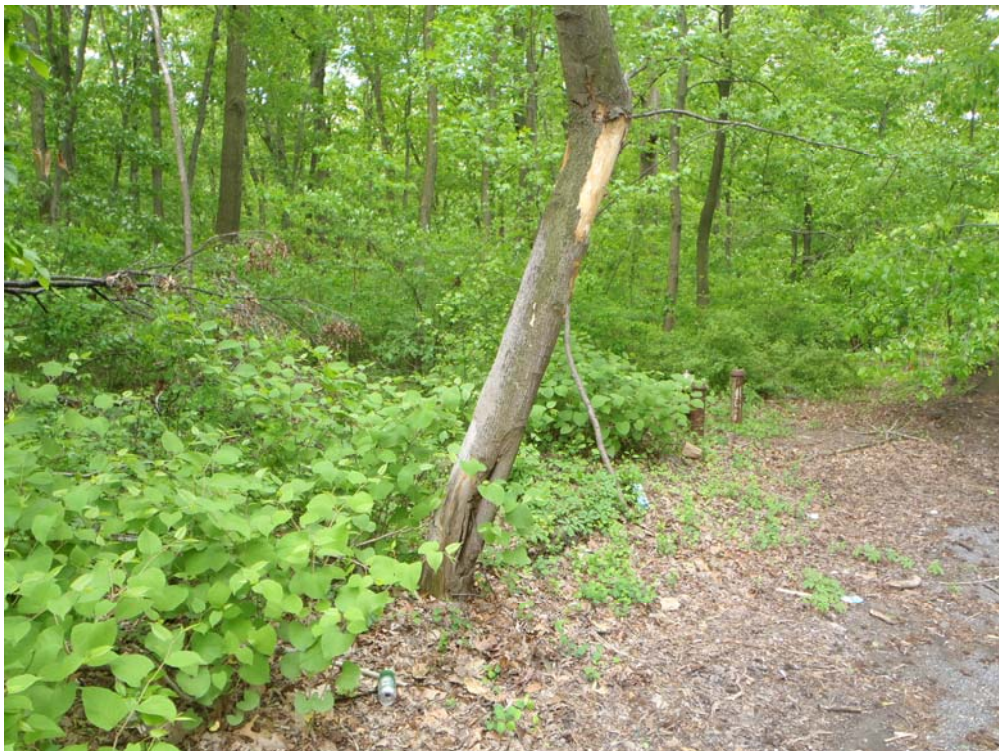
Photo 4. View west of the general location of Test 9 excavated in a wooded area along the west side of Bloomingdale Road north of Hargold Avenue

depth underlain by a yellowish brown subsoil that continued to depths greater than 60 centimeters (24 in) below the surface. Tests 9 and 10, located within Bloomingdale Park, exhibited multiple levels of dark brown, reddish brown and yellowish red silty clayey loam with gravel (Appendix 1). All appear to be the result of multiple filling episodes resulting from road construction. No precontact or significant historic cultural materials were recovered from the four shovel tests.

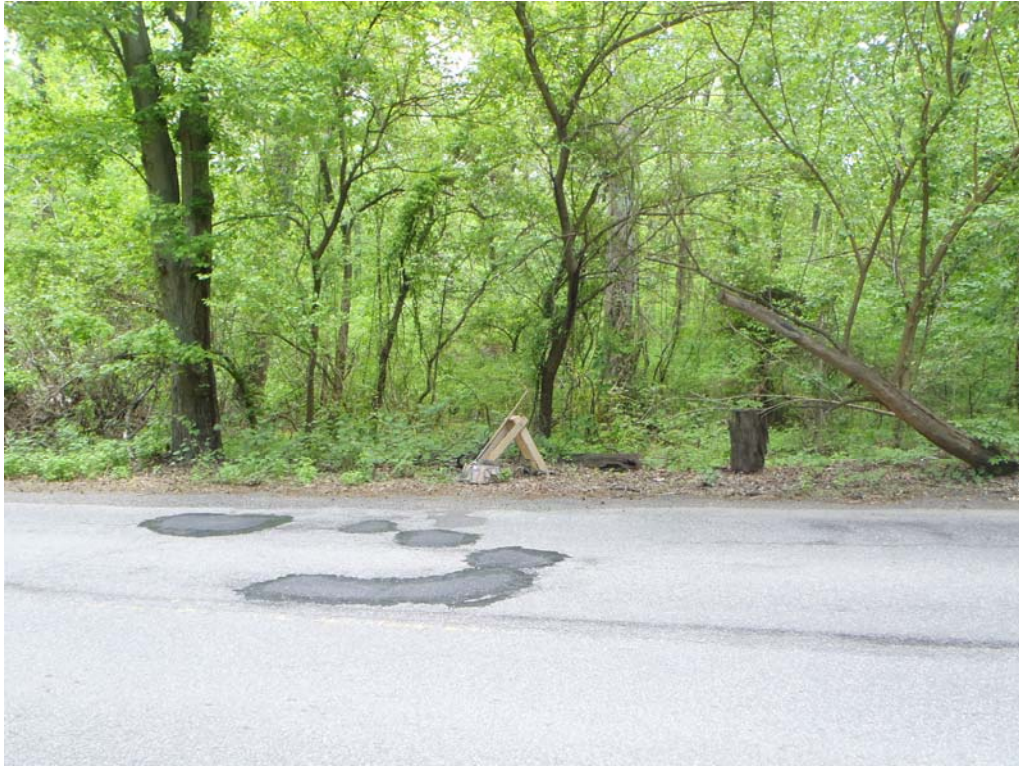
Photo 5. View east of the general location of Test 12 excavated in a wooded area located along the east side of Bloomington Road south of Ramona Avenue.

Tests 11 and 12 were excavated in Bloomingdale Park on either side of Bloomingdale Road south of Ramona Avenue (Map 2e; Photo 5). These tests were at a point where the utility will cross the road and where testing was recommended in the Phase IA study. The soil stratigraphy consisted of a black to dark reddish brown silt and sand 18 to 20 centimeters (7 to 8 in) in depth underlain by a brown to yellowish red subsoil that continued to depths greater than 47 centimeters (19 in) below the surface (Appendix 1). No precontact or significant historic cultural materials were recovered from the two shovel tests.

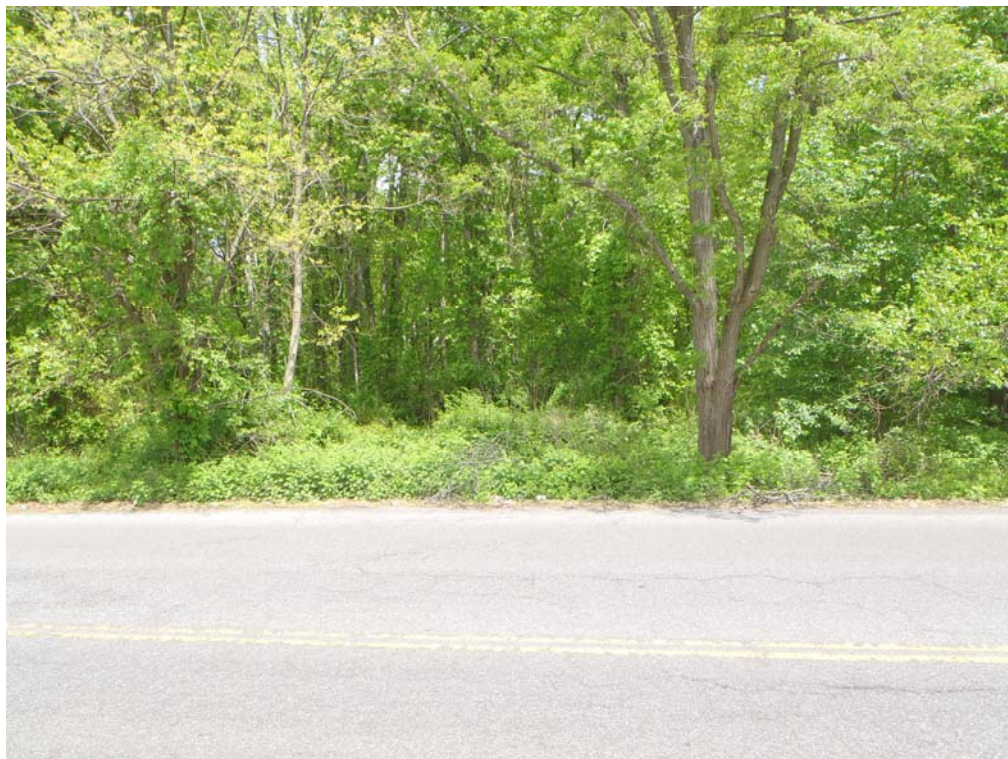
Photo 6. View east of the general location of Test 13 excavated along the edge of a wooded area located along the east side of Bloomington Road south of Herrick Avenue.

Test 13 and 14 were excavated along the west side of Bloomingdale Road along the edge of a wooded area located between Pitney Avenue and Herrick Avenue (Map 2f; Photo 6). These tests were located in Bloomingdale Park at crossing points in an area recommended for testing. The soils encountered in the two tests consisted of a black to dark reddish brown topsoil 12 and 15 centimeters (5 to 6 in) thick underlain by a brown to yellowish red subsoil that continued to depths greater than 45 centimeters (18 in) below the surface (Appendix 1). No precontact or significant historic cultural materials were recovered from the two shovel tests.
