Phase IB Archaeological Investigation
Bluebelt Improvements Sweet Brook Watershed, BMP-SB-1
Annadale Wedge Pond
Staten Island, New York

New York City Department of Environmental Protection
07DEP063R

July, 2014

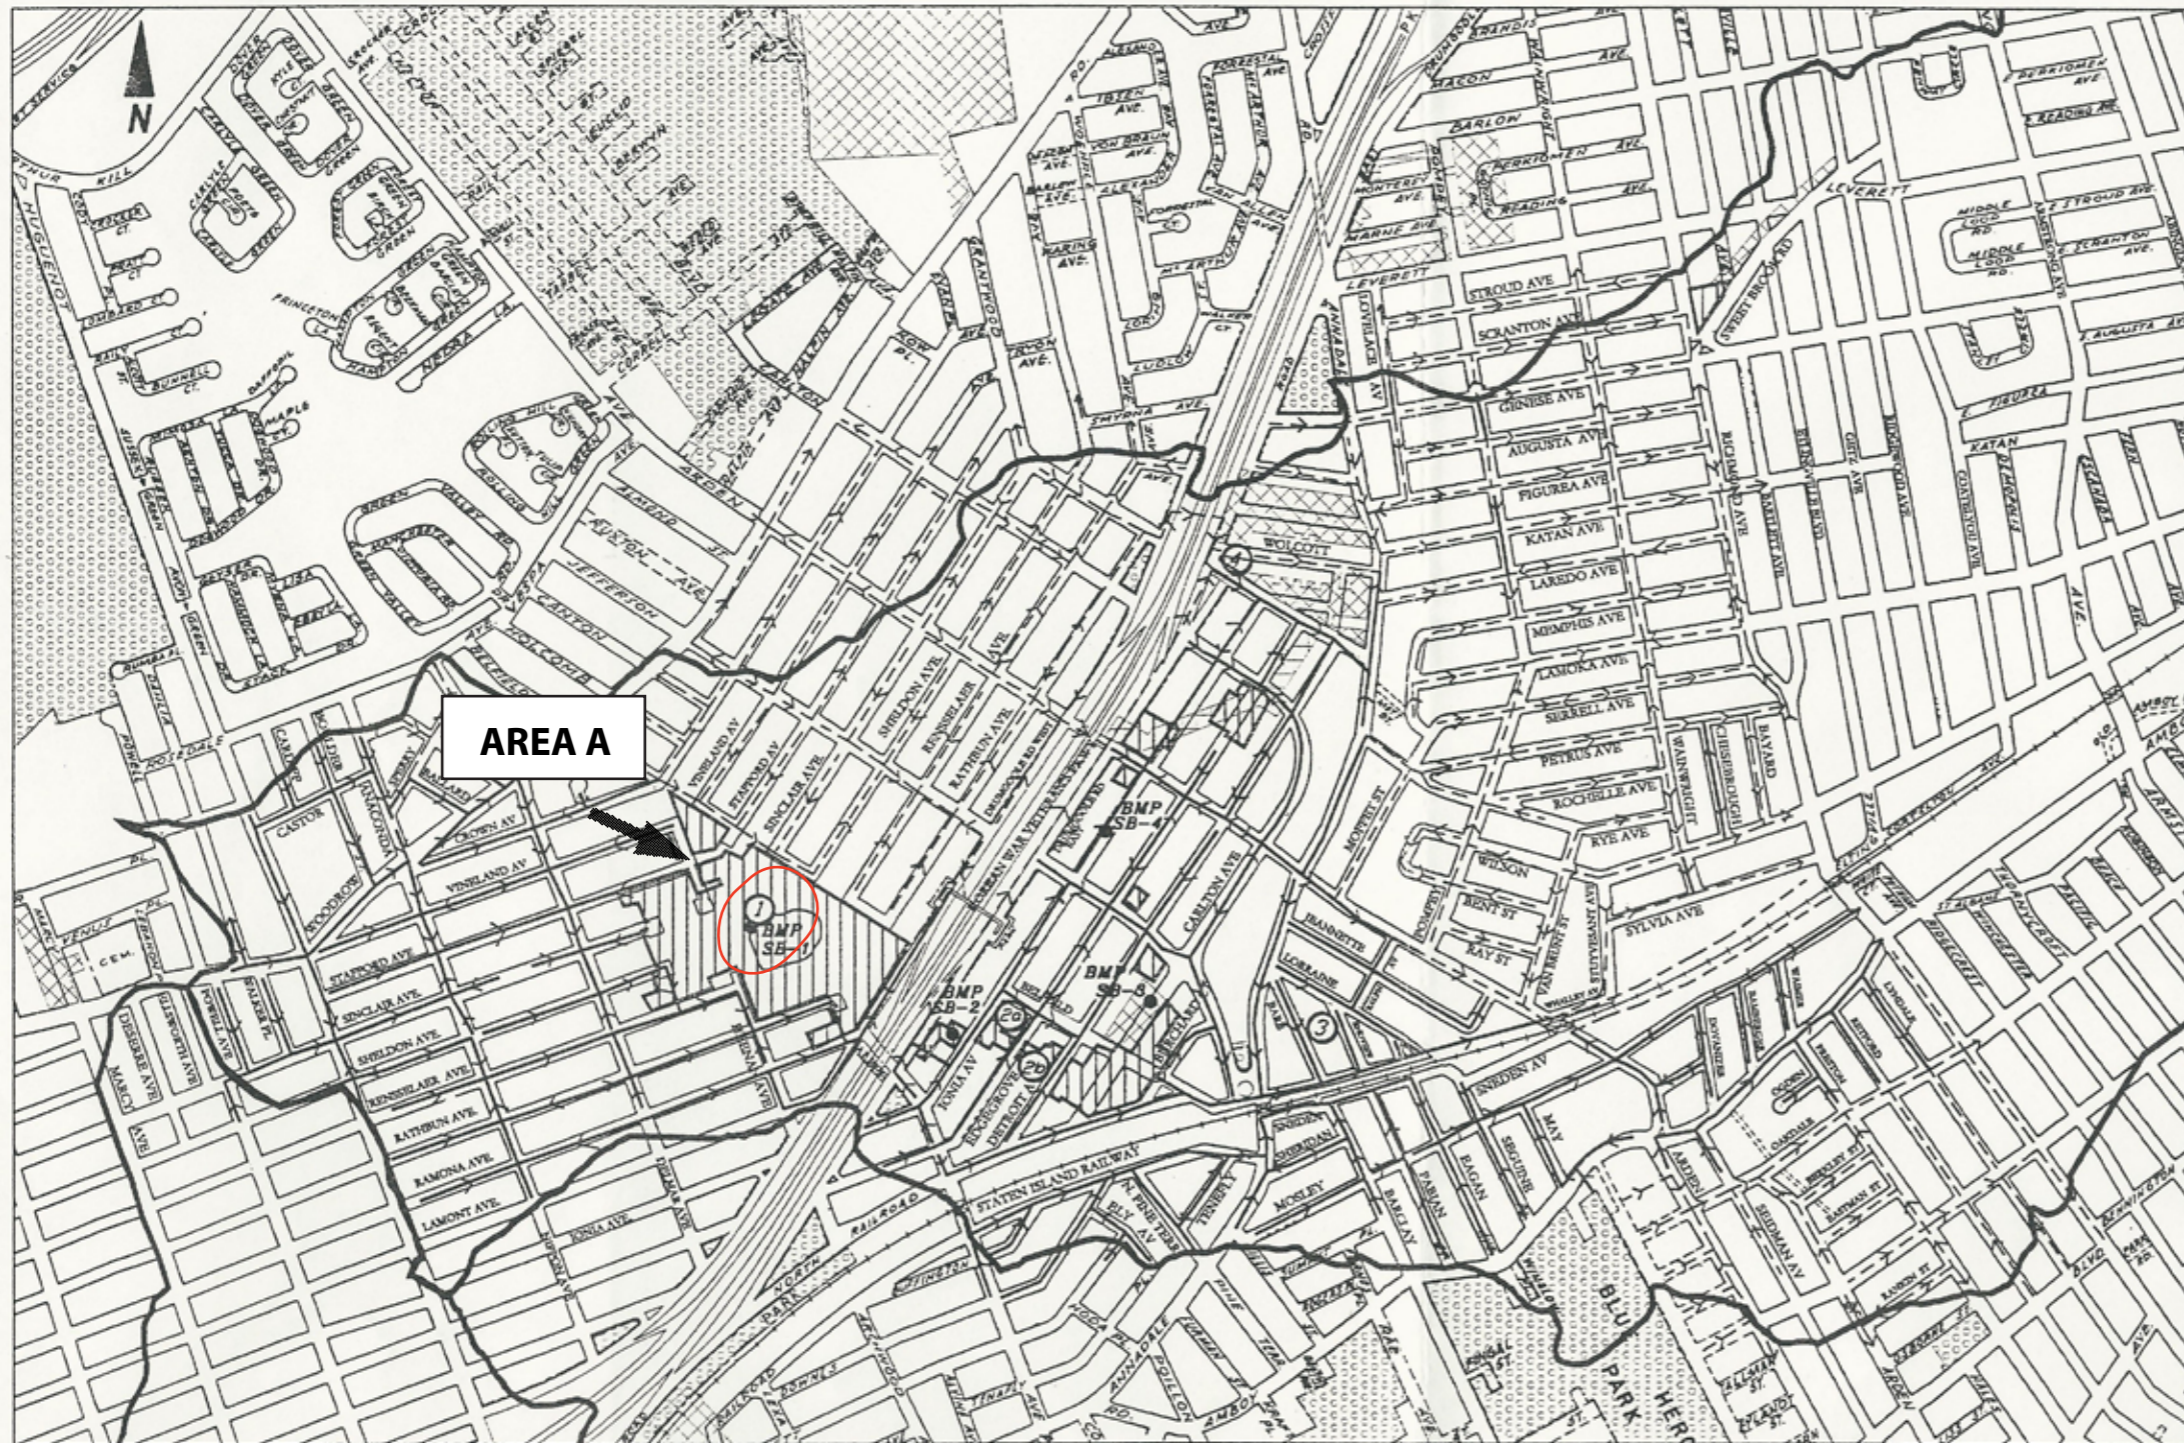
Figure 2: Archaeological Sensitive Areas, Sweet Brook Watershed (HPI 1999: Figure 5A).

HPI's prior documentary study (1999) found that there were no known precontact sites in or near the BMP-SB-1 APE, but that the characteristics of the landform – proximity to a fresh water source, elevation, and drainage – may indicate it is potentially sensitive for Native American resources (Figure 2). This location is designated as Area A for management purposes, as identified on the attached clearing and construction sequence plan (Figure 4). In compliance with environmental review requirements, a Phase IB archaeological investigation of Area A within the BMP-SB-1 installation site was conducted by HPI in July 2014 under the direction of HPI President Cece Saunders, RPA and William Sandy, RPA. Archaeologist Michael Thomas assisted with the field investigation.

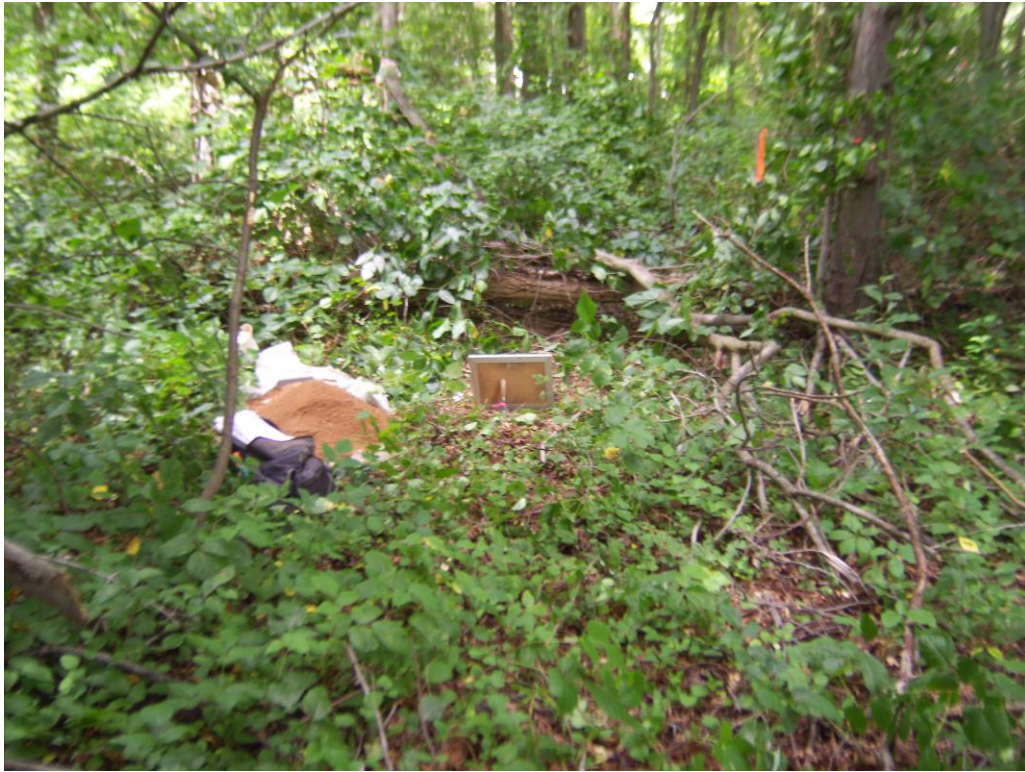
Photograph 1. View looking north at Shovel Test 4 in the center of Area A at BMP-SB-1.

observed in some locations. Ornamental groundcover was present near the end of pavement at Sheldon Avenue (Photos 1, 3, and 4).

Eight STs had intact, natural profiles (ST3, 4, 5, 8, 9, 12, and 13). ST4 had a natural stratigraphic soil profile (Photos 1 and 2). ST4 represents a typical test unit with an undisturbed profile.

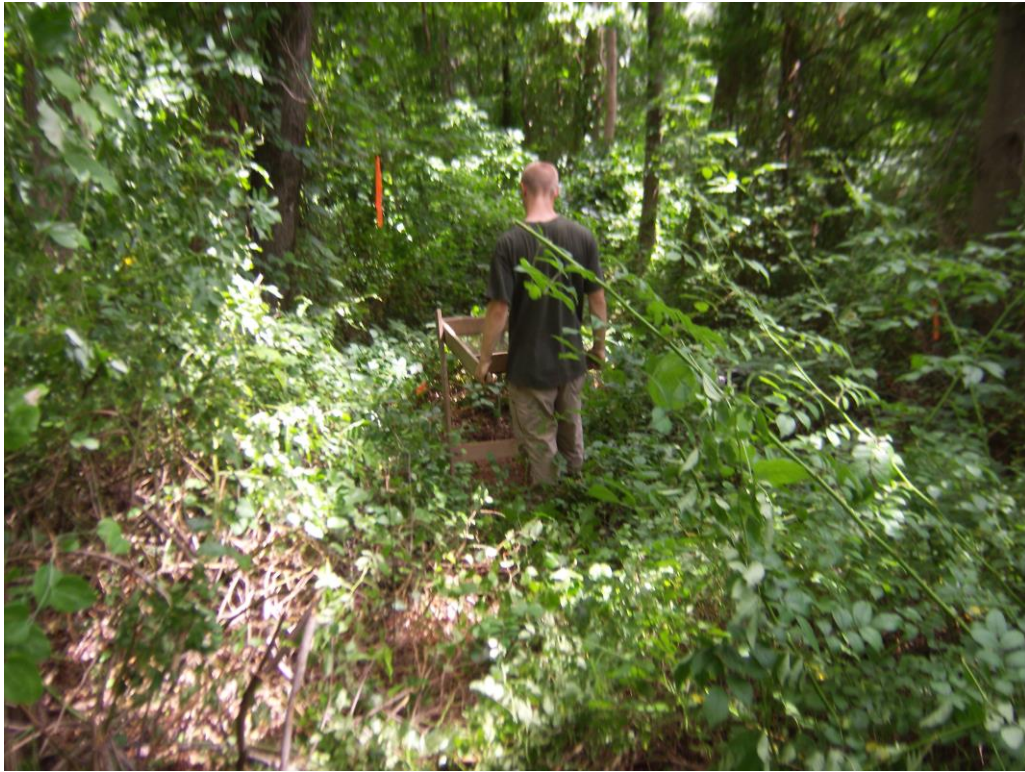
Photograph 3. View looking east toward Shovel Test 9 in the east end of Area A in BMP-SB-1.

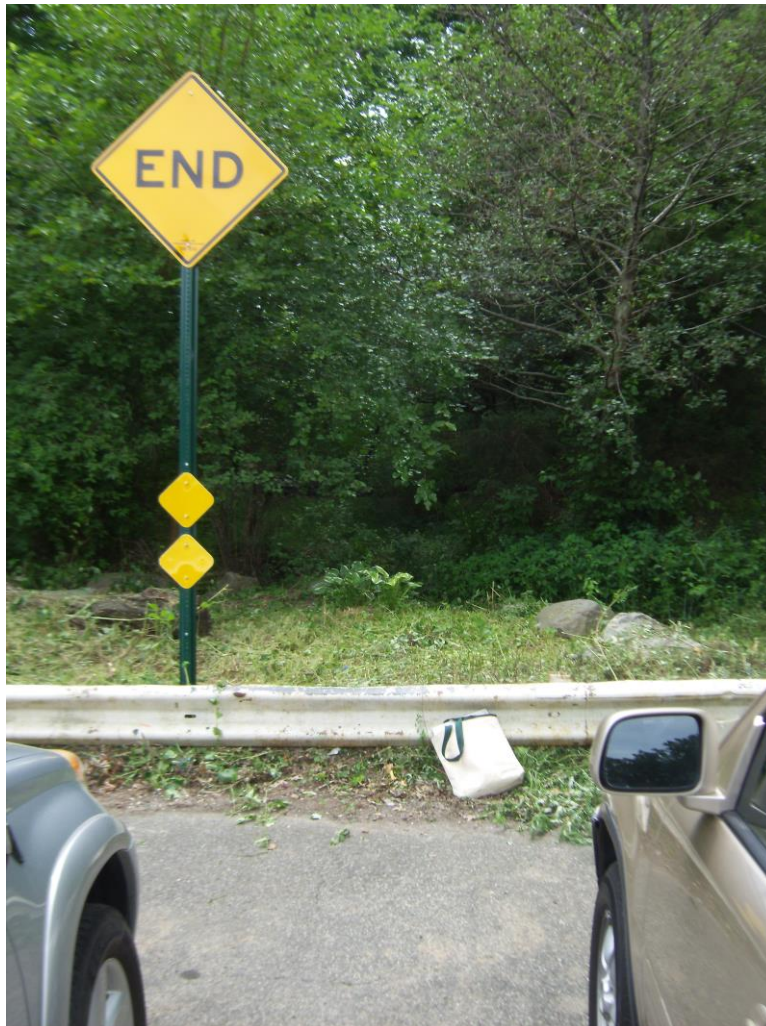
Photograph 4. View looking south from Sheldon Avenue at the north end of Area A in BMP-SB-1.
