**Joan H. Geismar, Ph.D.  
Archaeologist**

To: Zachary Edinger, Sexton/Ritual Director, Shearith Israel  
From: Joan H. Geismar, Ph.D.  
Re: 11<sup>th</sup> Street Cemetery, Test Pit 1 (TP1) End-of-Field Memo  
Date: October 20, 2014

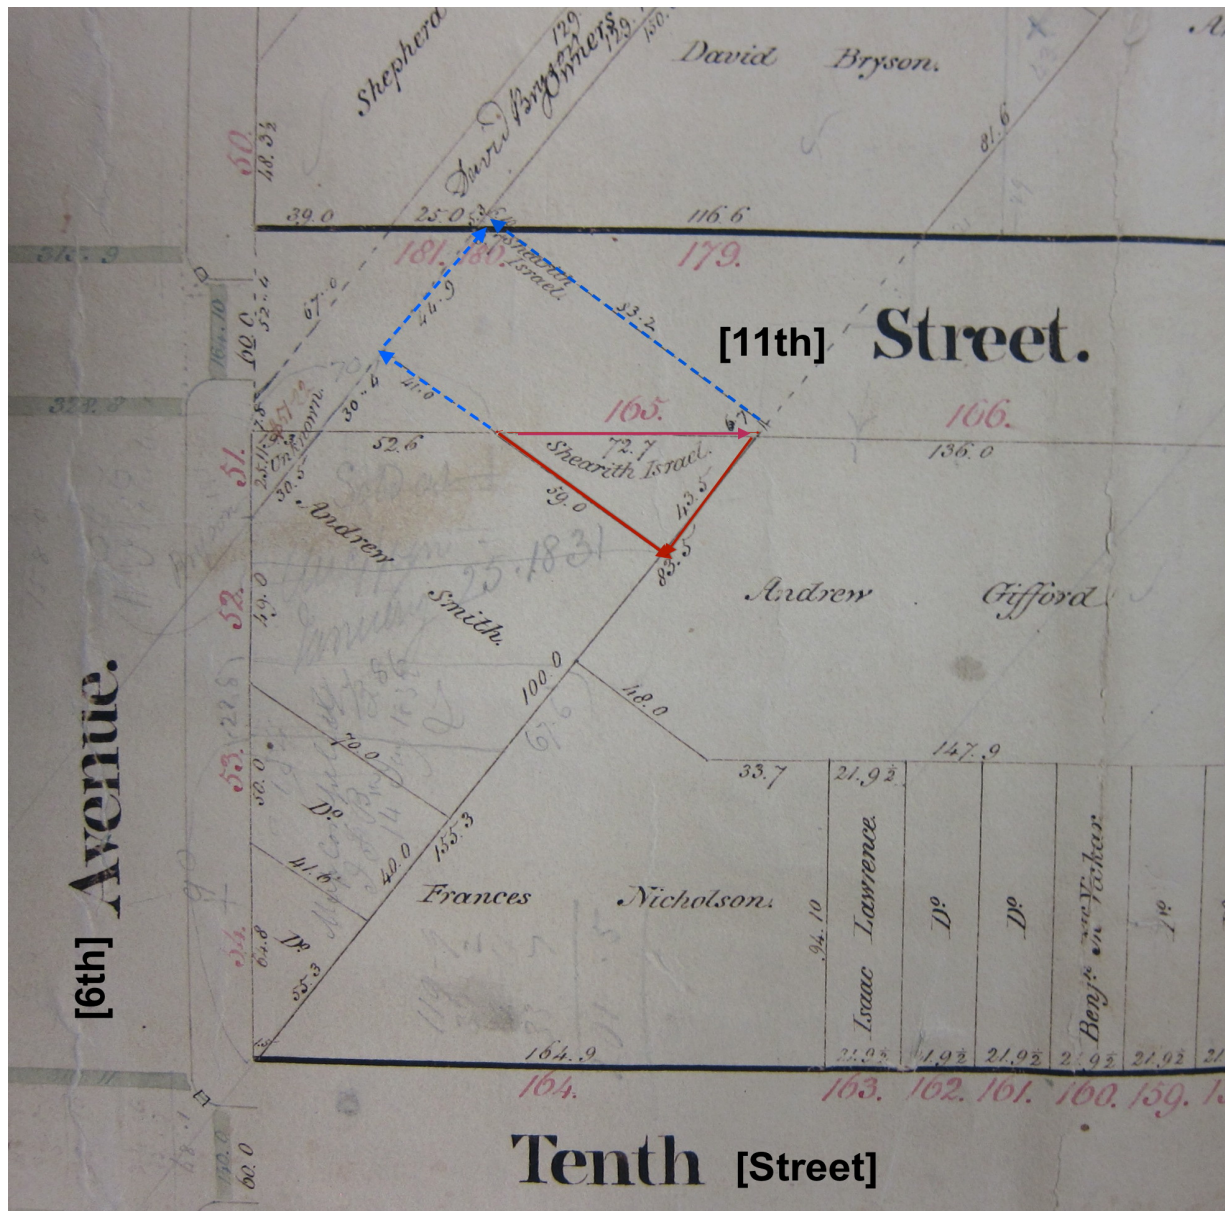
**Figure 2.** Proposed truncation of the 11<sup>th</sup> Street Cemetery indicated on an 1829 map prepared for the grading of 6<sup>th</sup> Avenue. The full extent of the original cemetery is indicated with a blue dashed line; the truncated cemetery is outlined in red. (Detail of Map Accompanying the Assessment for Pitching and Paving Sixth Avenue from Sixth to West 13<sup>th</sup> Streets. Ms. Edward Doughty, City Surveyor, 1829. File Map 343 Topographic Bureau of the Manhattan Borough President's Office)

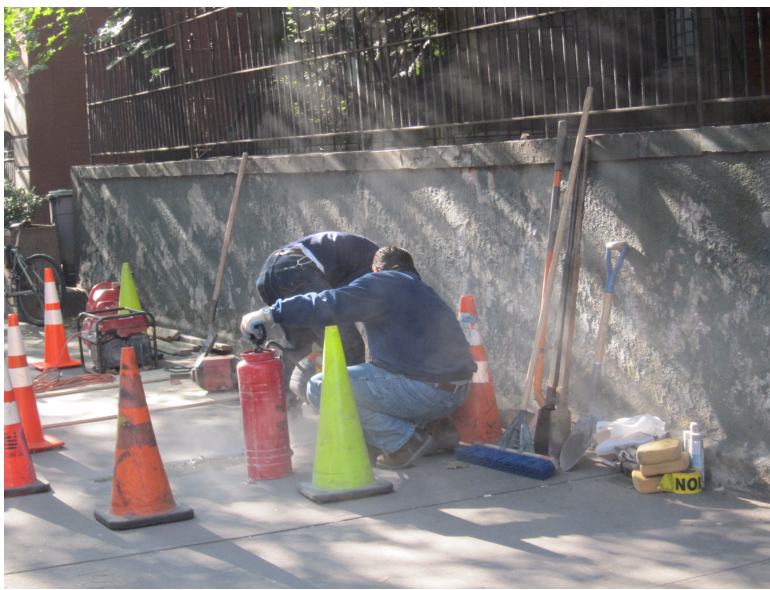
**Photo 1.** Cutting sidewalk cement, the first step in accessing the excavation area. The view is southeast from the north side of the cemetery wall. (9-19-14)

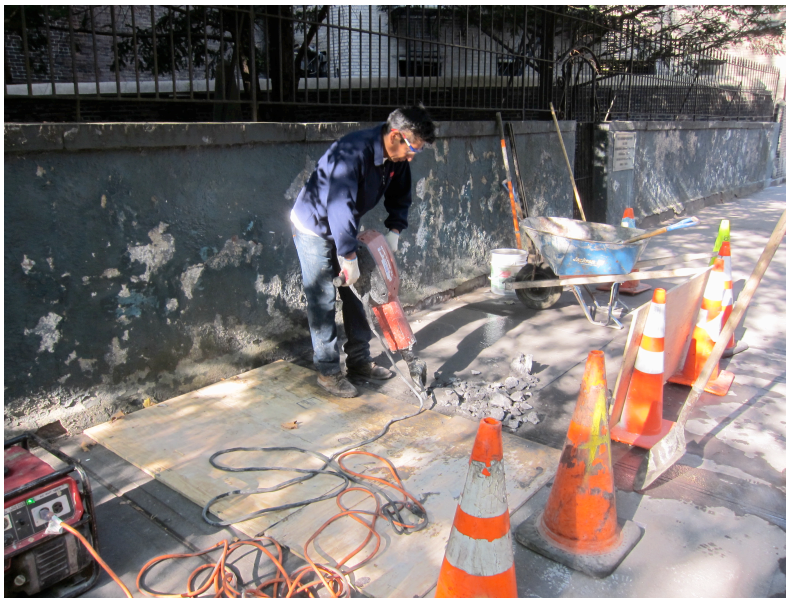
**Photo 2.** After the cement was cut, a jackhammer was used to break up the sidewalk square. The cement debris was then removed to an awaiting truck. The view is northwest from the north side of the cemetery wall. (9-19-14)

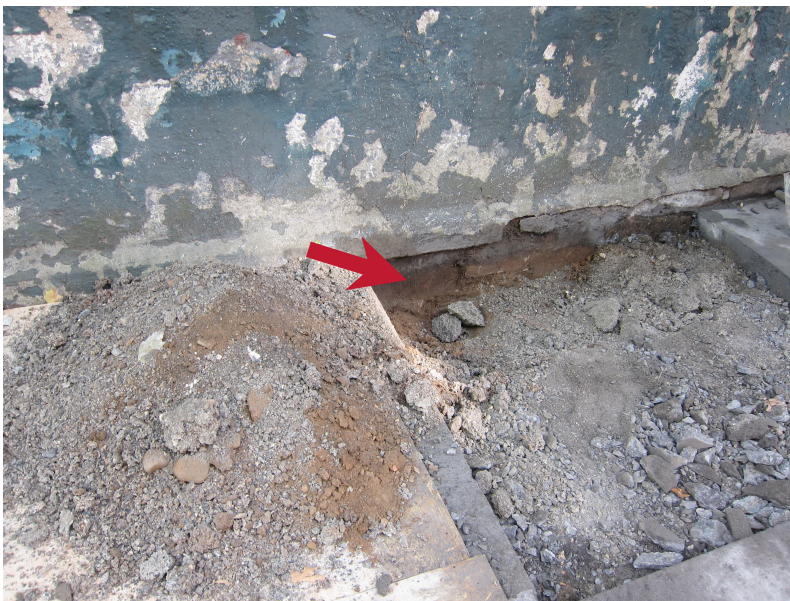
**Photo 3.** A ca. 0.5 feet (0.31 m) ash layer was exposed under the concrete. Note soil change visible in the upper left corner of the square (arrow). This soil level, which was about 1.5 to 2.0 feet (0.45 to 0.61 m) thick, contained brick fragments as well as stones. and some ash. (9-19-14)

At 9:00 A. M., the concrete from a 5.0 x 4.6 foot (1.52 x 1.40 m) sidewalk square was removed, first by cutting and then by jack hammering. This exposed approximately 0.8 feet (0.15m) of ash fill followed by a fill with stones, water-worn cobbles, pebbles, and some small slag fragments in a brown soil. The upper layer of this fill also included some brick fragments. Further down, but from an undetermined depth, a decayed oyster shell and two small aqua glass bottle fragments were noted in the backdirt of what proved to be a basically clean fill. One evidenced a small part of the base corner and part of an embossed panel ("[O?] T I O N S" at the end of the upper line / ...[H?]

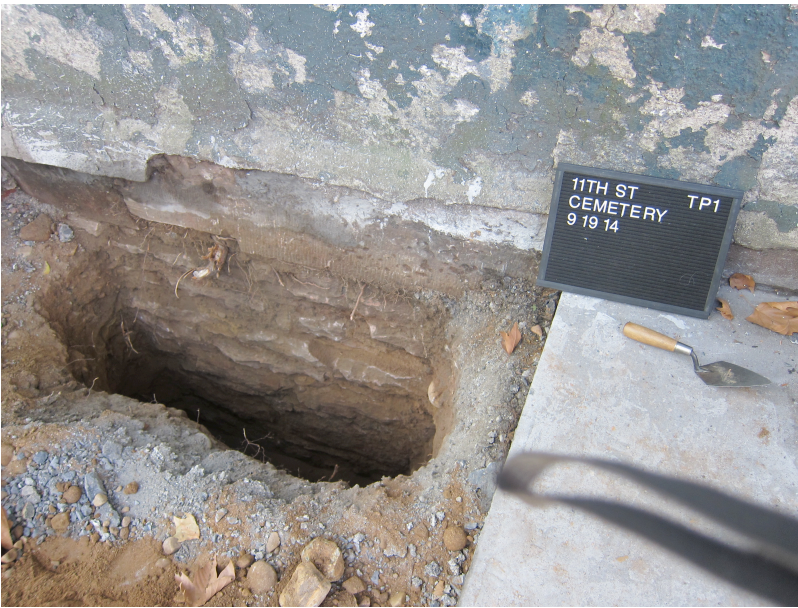
**Photo 4.** Test excavation along the north side of cemetery wall. Note the rough surface of the foundation stones that have been brushed clean. (9-19-14)

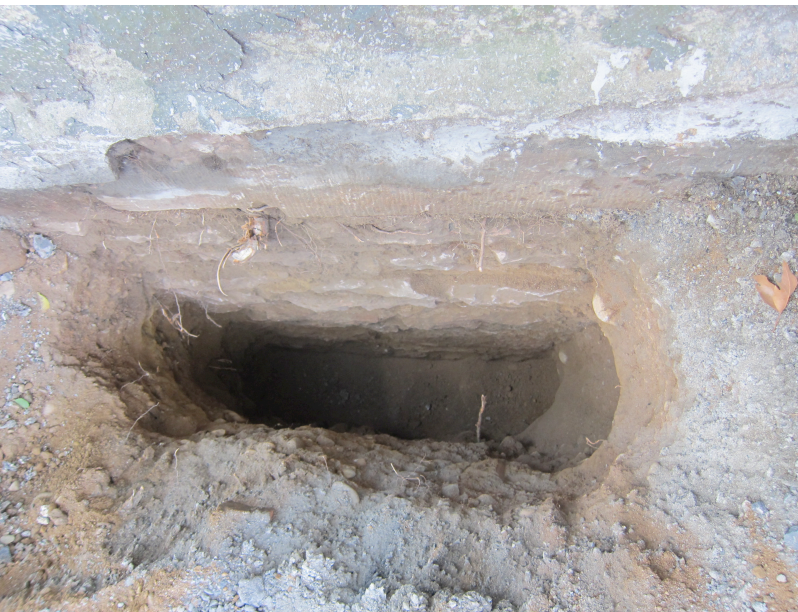
**Photo 5.** Looking into the test pit at the end of the excavation. Founding stones, which undoubtedly would be found below the wall, were not encountered in the 5-foot (1.5-m) deep excavation. (9-19-14)

If the foundation dates from 1829, it is possible the founding stones were placed on the original, deeper ground surface prior to removal of the burials from what was to become the new street bed. It is also possible the test pit excavation was in a backfilled builder’s trench that extended further north to facilitate construction of a later wall of this depth, but all this is conjectural. No bone material of any kind was noted, and, other than the above-mentioned bottle fragments, the fill material was devoid of the domestic artifacts typical of 19<sup>th</sup>-century fill.

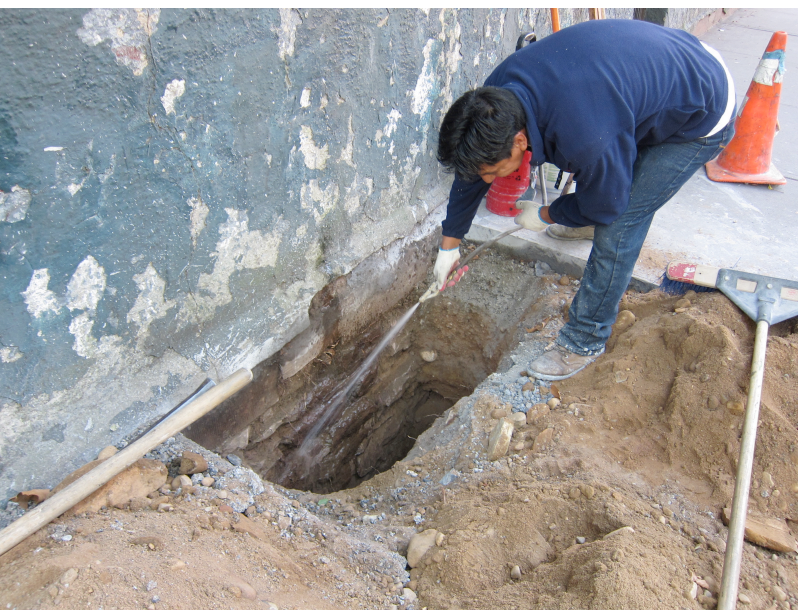
**Photo 6.** The exposed stones were then washed with water from a spring pump. (9-19-14)

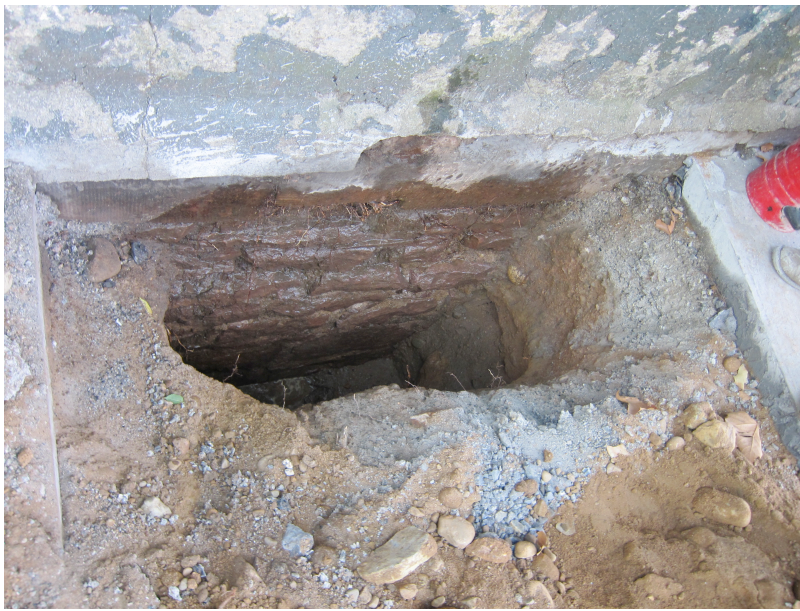
**Photo 7.** Foundation stones after washing. (9-14-14)

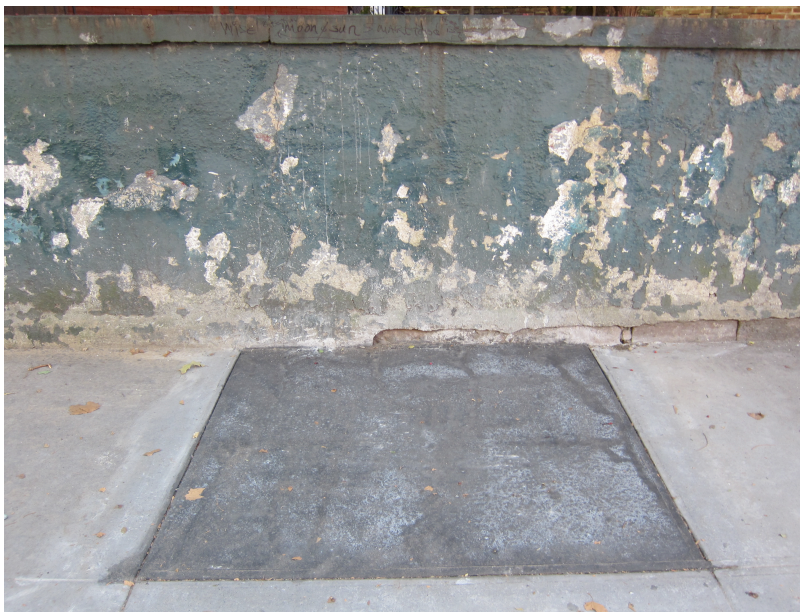
**Photo 8.** View of the restored sidewalk looking south toward the cemetery wall. (9-19-14)

In accord with the permit, the pit was backfilled and the sidewalk restored. To document the undertaking, I photographed the excavation (for example, see Photos 1-7) as well as the restored sidewalk (Photo 8) and the bottle glass fragments. (Photo 9).

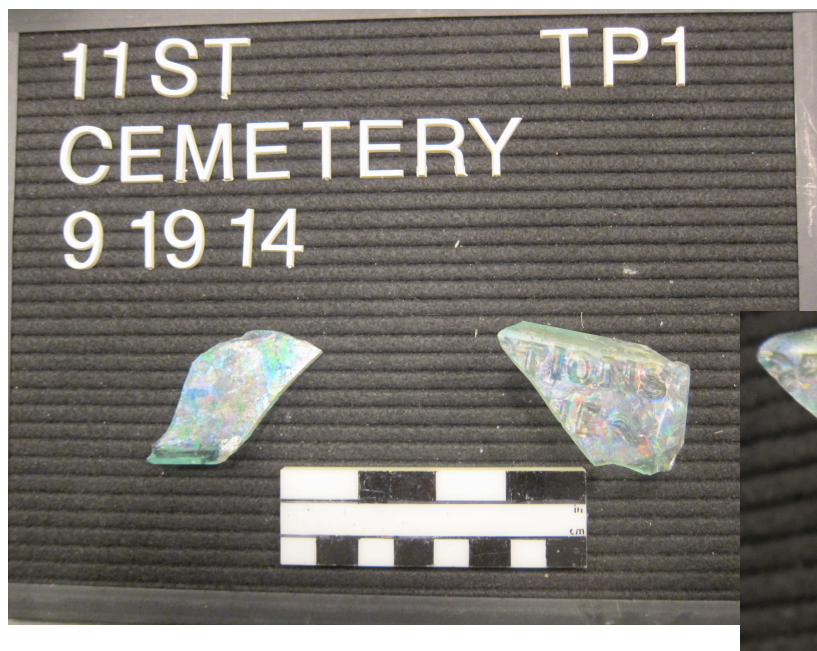
E ~” at the end of the lower line) on what I presume was the front of the bottle. What I presume is the side panel, the embossing appears to be “...Y O R [K?],” so what I again assume is that it says "New York." (see Photo 9 inset). While my initial assessment was that this was the fragment of a post 1850 bottle, subsequent research suggests it could be considerably earlier<sup>4</sup> and might have been a component of the fill used to grade west 11<sup>th</sup> Street. It should be noted, however, that these artifacts were from fill excavated when the pit was extended east and could conceivably have fallen in from a higher, more recent fill episode, but this is unclear.

**Photo 9.** Bottle glass fragments, possibly from the same bottle but no mend. The one on the right reads "...[O?]TIONS," "... [I?] E ~" on the line below (see inset). An embossed side panel suggests a New York City origin. The iridescence is the hallmark of "sick" glass.

<sup>4</sup> e.g., Munsey, Cecil, 1970, *The Illustrated Guide to Collecting Bottles*, New York: Hawthorne Books: 40). Joseph Diamond, a bottle glass expert, reviewed photos of the bottle fragments but was unable to provide information beyond his assessment that serif embossments, which one fragment displays, are assigned a ca. 1840 to 1865 date lacking any additional information, such as an identifiable and researchable product or manufacturer (J. Diamond email 9-28-14).
