**PHASE IB ARCHAEOLOGICAL
TESTING
ADDENDUM**

**CROTON WATER
TREATMENT PLANT
MOSHOLU GOLF COURSE,
VAN CORTLANDT PARK
BRONX, NEW YORK
DEP/98DEP027X**

October, 2014

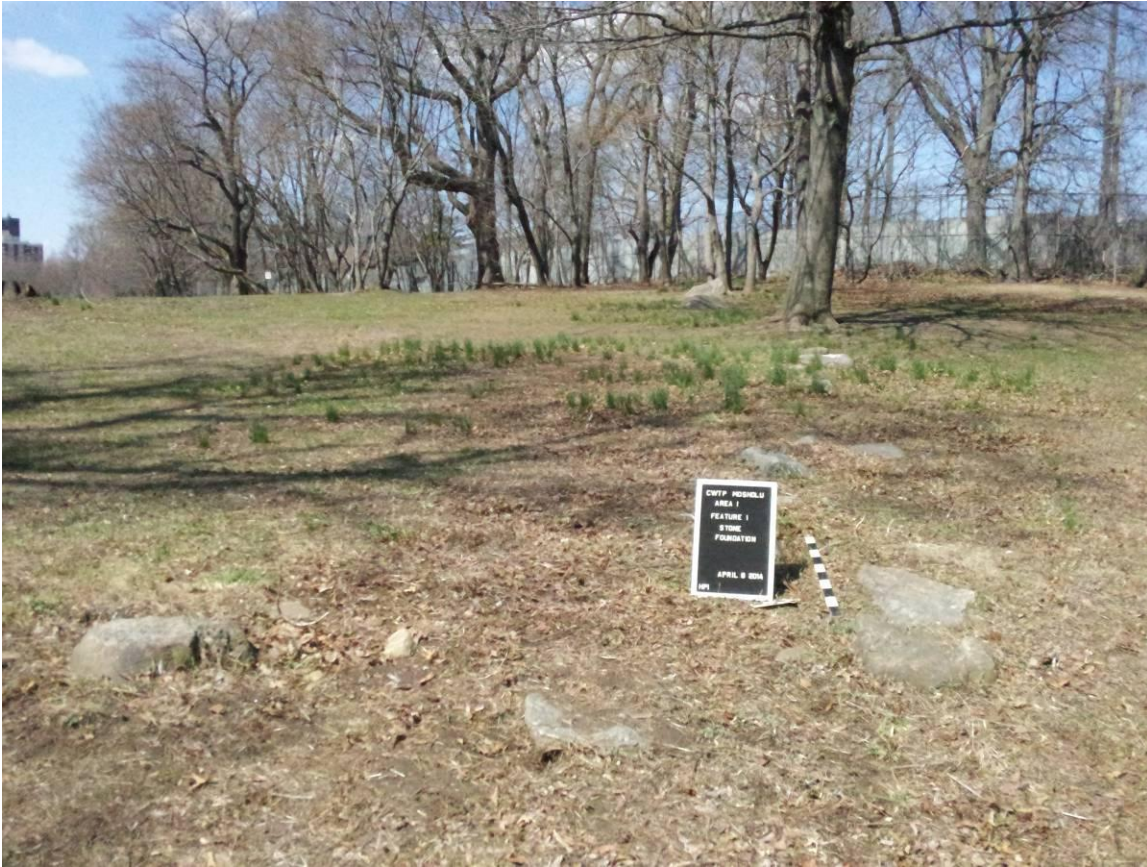
Photograph A: Area 1 in Van Cortland Park facing northwest to the WTP construction site. Feature 1, an “L” shaped line of stones, is in the foreground and continues northwest to the right of the meter stick.

No definitively historical artifacts were recovered in undisturbed strata in Area 1, and no evidence of a definitive historical feature, other than an “L” shaped line of stones designated as Feature 1, was encountered. ST J1 was excavated immediately north and east of Feature 1, however it only yielded late-20th century bottle glass, a piece of sewer pipe, a small fragment of shell, and a 2002 penny in the upper stratum (Appendix A and Photograph A). Excavation of the ST also revealed that there were no associated stacked stones present below ground, as would be expected with a historic foundation or shaft feature. Likely, Feature 1 was associated with the 20th century use of this area as part of the golf course, perhaps as part of a tee box. Ultimately, no intact historical or precontact deposits were encountered in any of the STs in Area 1.

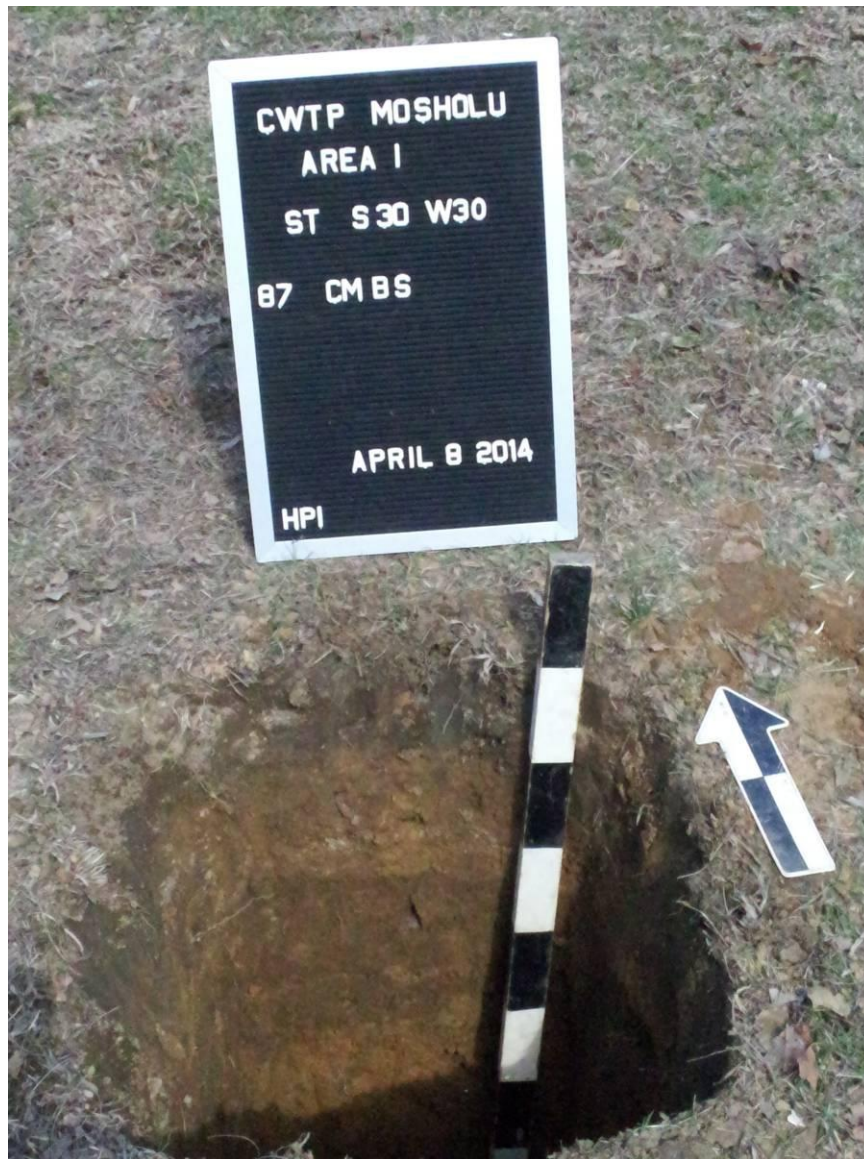
Photograph B: North wall profile of ST S30W30 in Area 1 with two fill levels over a Buried A and B horizon.

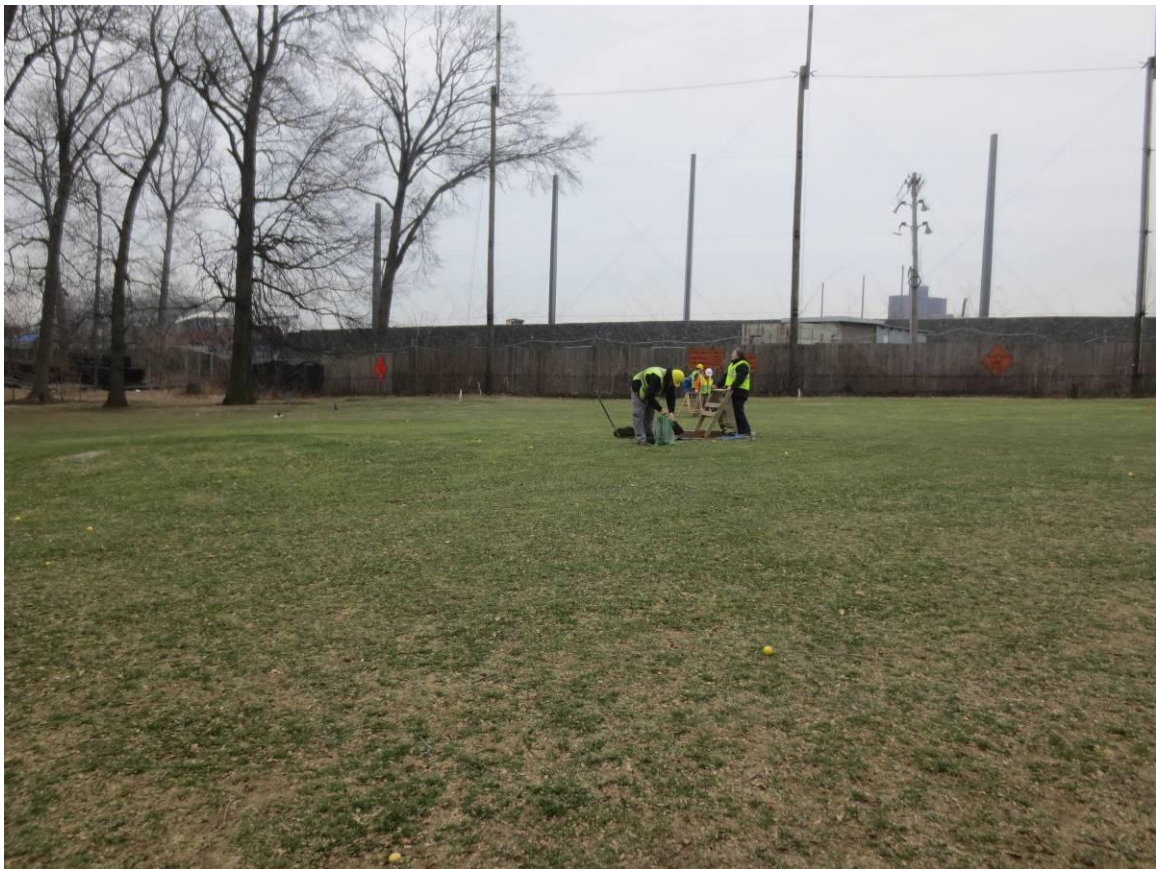
Photograph C: Driving range at north end of Area 2, facing southeast toward Line of Alienation surrounding WTP construction site.

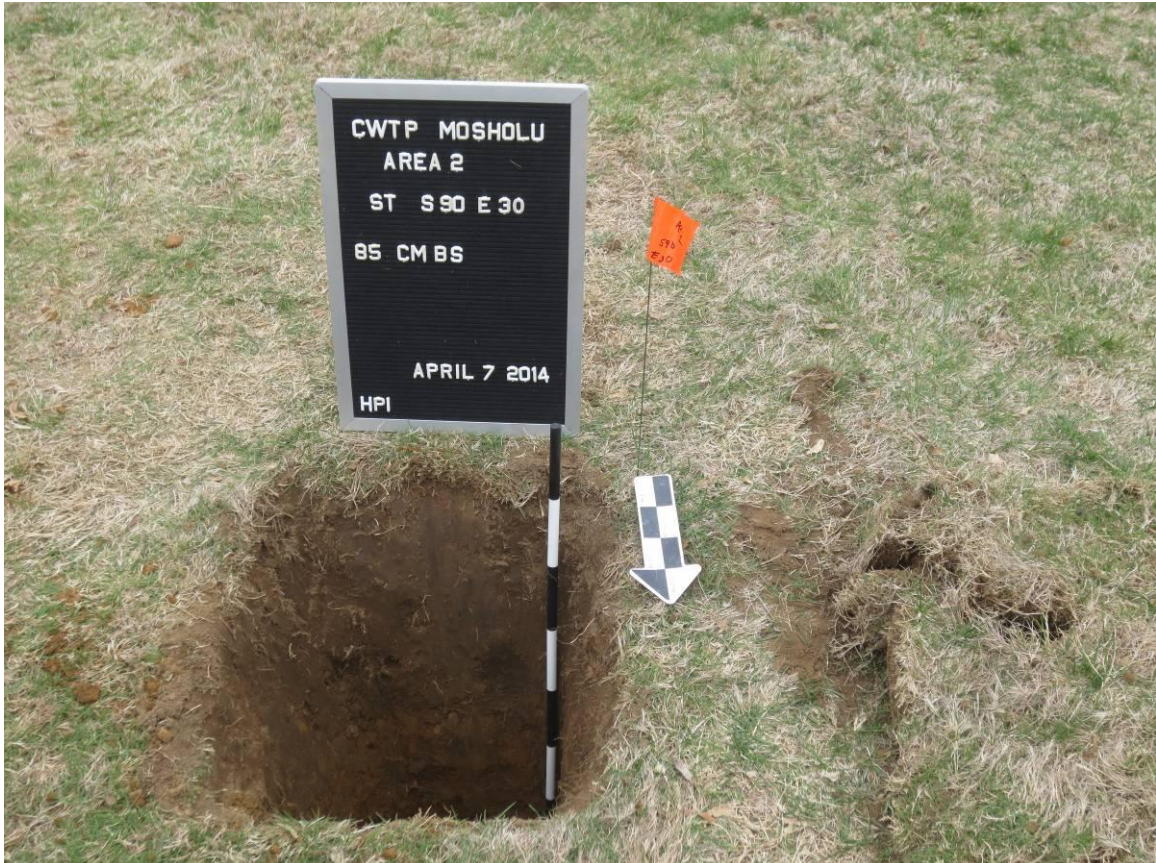
Photograph D: South wall profile of Area 2 Shovel Test S90E30 that yielded two chert flakes in the uppermost 30cm (12ins) fill level, above a buried A horizon.

In one ST, S90E30, three precontact artifacts were encountered in the uppermost fill level: two chert tertiary reduction flakes and one cordmarked pottery sherd (Appendices A and B). The precontact material was recovered from a fill stratum above an A/B horizon that yielded one cut nail (Appendix B and Photograph D). Thirty meters (98ft) to the west, ST S90E0 yielded a smoky quartz piece of shatter (from stone tool making) at the base of the fill level, and ST S75E15 yielded a brown chert tertiary reduction flake from within the fill (Appendices A and B). Although these three STs were located within a 30m (98ft) radius, no precontact material was found beneath the upper fill or A horizon in any of them. Lower levels were either sterile or contained a single historical artifact. Likely, the precontact material was introduced to the site with the fill that was used to cover this area. The similarity between the pottery sherd found in ST S90E30 and the pottery sherd found in 2004 roughly 100 meters to the east suggest that they may be from the same site, the location of which has since been eradicated. No intact undisturbed precontact or historical deposits were encountered in any of the STs in Area 2.

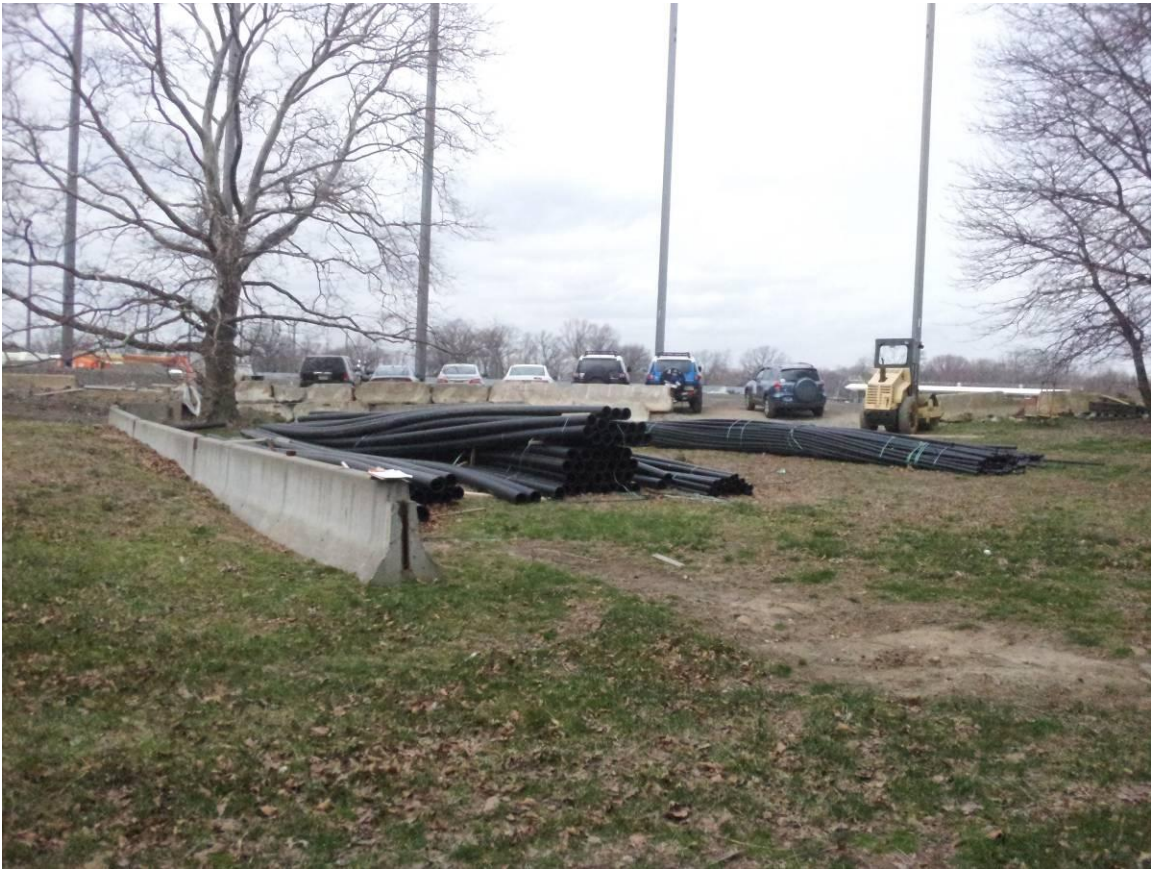
Photograph E: Area 4 in the WTP construction site facing northwest. Note the stacks of pipes that caused testing to be offset.

Testing was limited in this Area due to the presence of stockpiled utility pipes (Photograph E). The three STs that were excavated found either fill or modern material in the upper A horizon (Appendix A and Figure 4a). Artifacts included slag, whiteware, and coal (Appendix B). Testing also revealed an undisturbed B and C horizon in two of the STs, but no precontact or intact historical deposits were present.

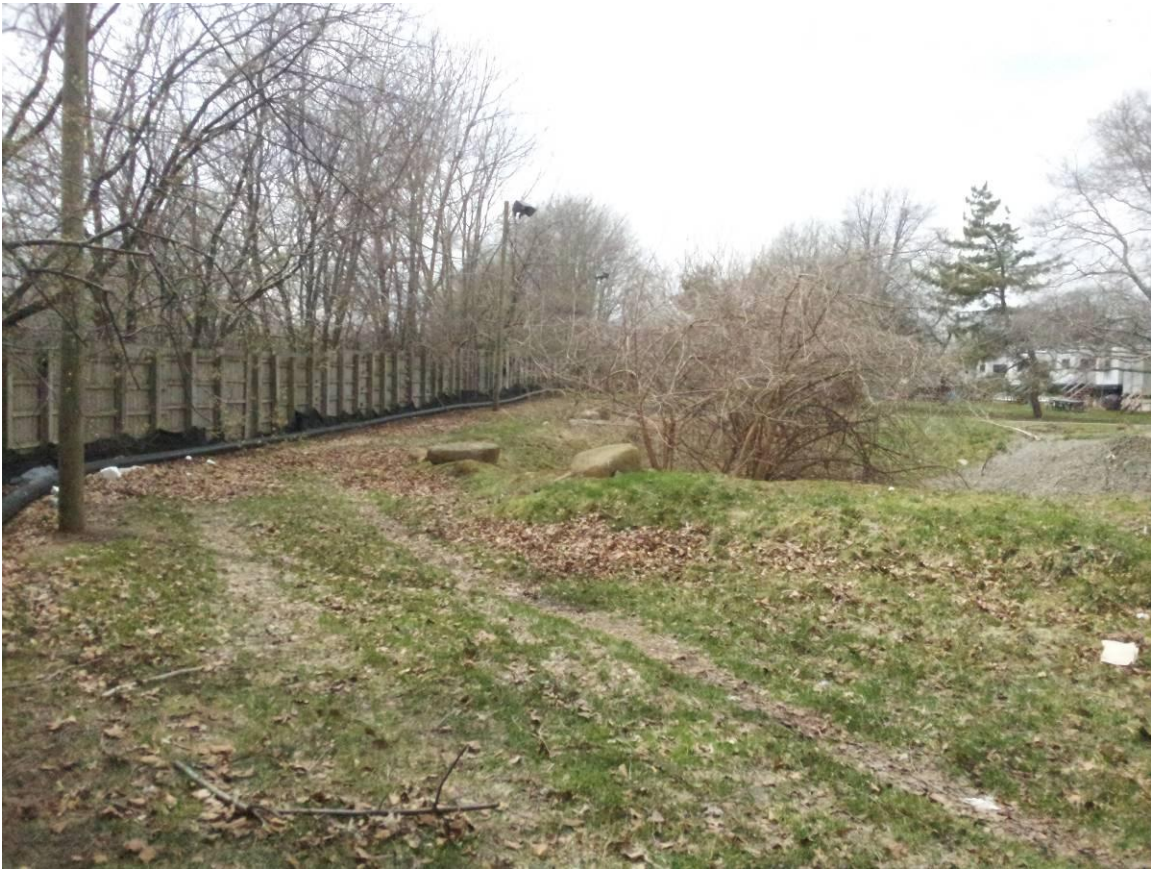
Photograph F: Area 5 facing northwest. Note the extent of landscaping and man-made depression at the right.

A total of seven STs were excavated on a 15m (49ft) grid in Area 5 (Figure 4a). No testing was completed at the extreme western end of the Area due to prior disturbance in the form of a landscaped depression (Photograph F). Of the seven STs completed, several contained historical cultural material in the uppermost levels. Whiteware fragments, one small possible pearlware fragment, and a hand-blown wine glass fragment were recovered in the A horizon of ST N0W45, but not within an undisturbed context (see Appendices A and B). Historical manipulation of the landscape in this area, during the construction of the Mosholu Golf course, appears to have compromised the subsurface conditions (Appendix A).
