***Phase IA/IB Archaeological Assessment, NYC Farm
Colony (LPC #LP-01408)***

**Staten Island, Richmond County, New
York**

December 2014

Phase of Survey: Phase IA/IB archaeological assessment

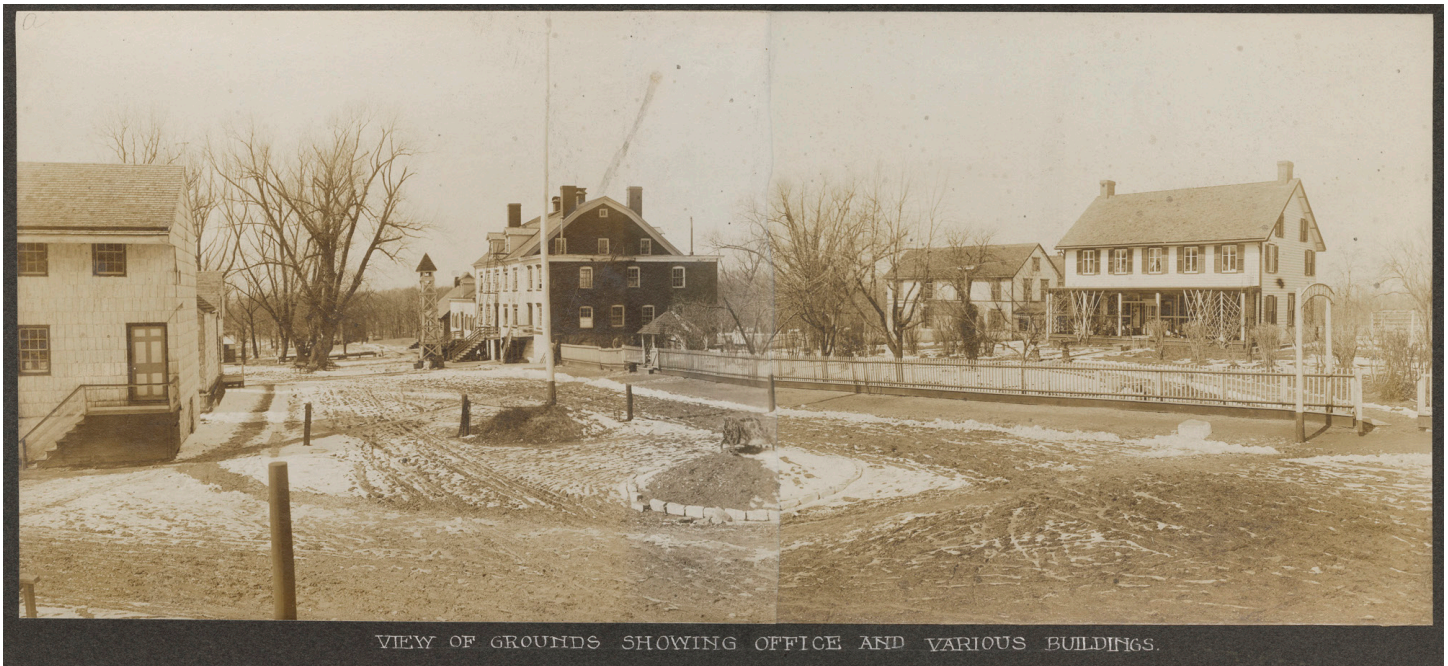
VIEW OF GROUNDS SHOWING OFFICE AND VARIOUS BUILDINGS.

An object is “primarily artistic in nature” and may be modest in size and not elaborate (Ibid). These objects have significance however because of their setting, use, role, or character. Examples of objects that have been listed on the National Register are a boundary marker, a fountain, a milepost, and a sculpture. In the Farm Colony study, the only objects recognized in the New York City Municipal Archives photographs were a flagpole and a bell tower (Municipal Archives dpc_2751_1; Photograph 1.1 herein) which were located in the Farm Colony core complex yard. The core complex is defined as the central focal area which contained the Martins farmstead originally and then the Superintendent’s House and nearby Alms House (Photograph 1.1; also Figures 1.3 and 2.1 thru 2.4).

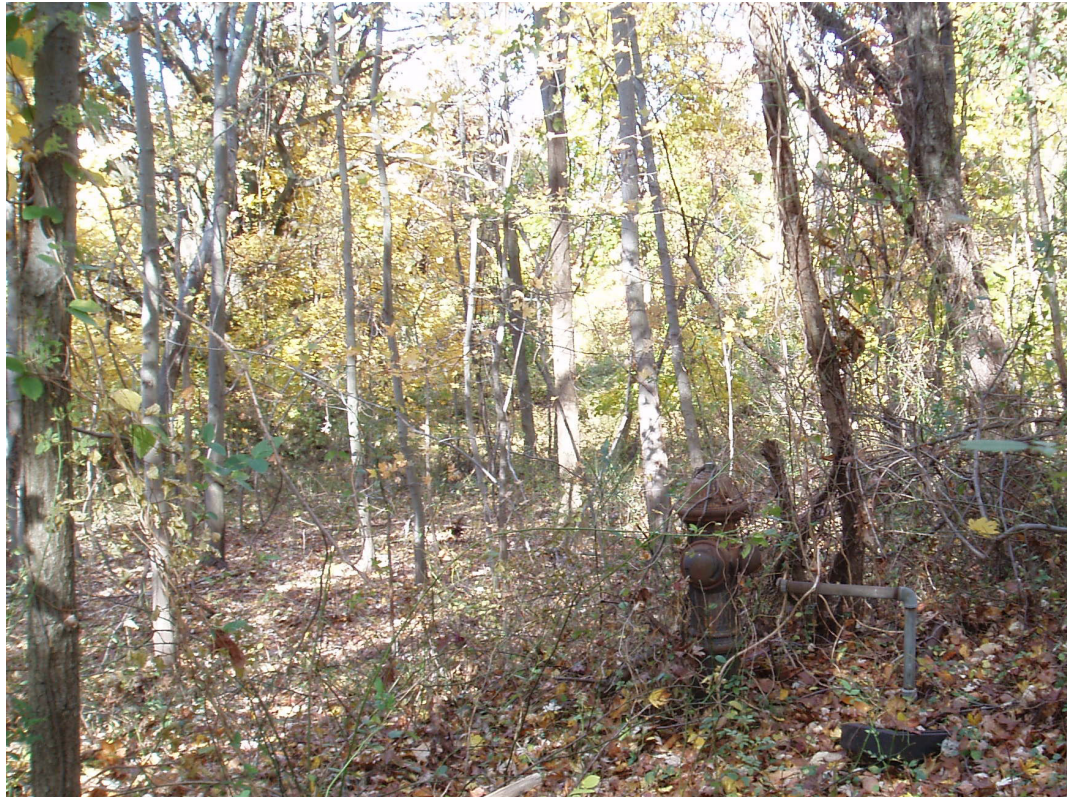
Photograph 2.1

Example of existing fire hydrant and attached water lines. The picture also illustrates current ground cover conditions in the southwest area of the core area.

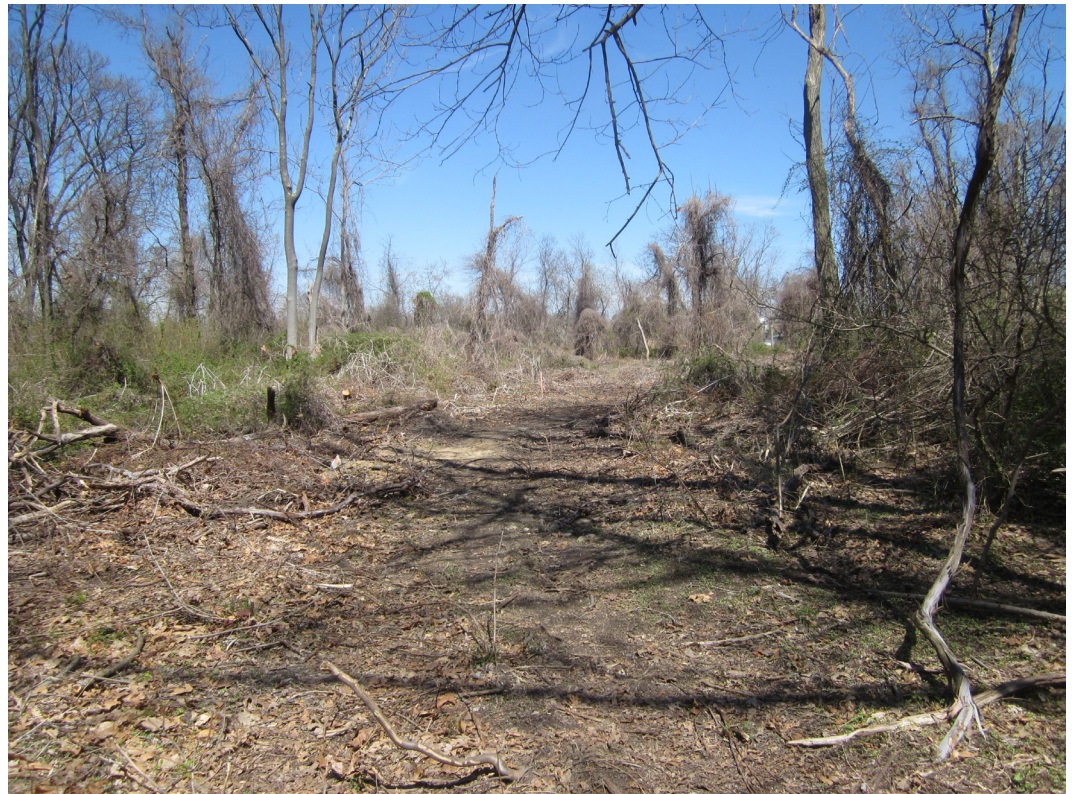
**Photograph 2.2**

Looking north at the larger cleared area showing the extent of that area and the surrounding conditions.

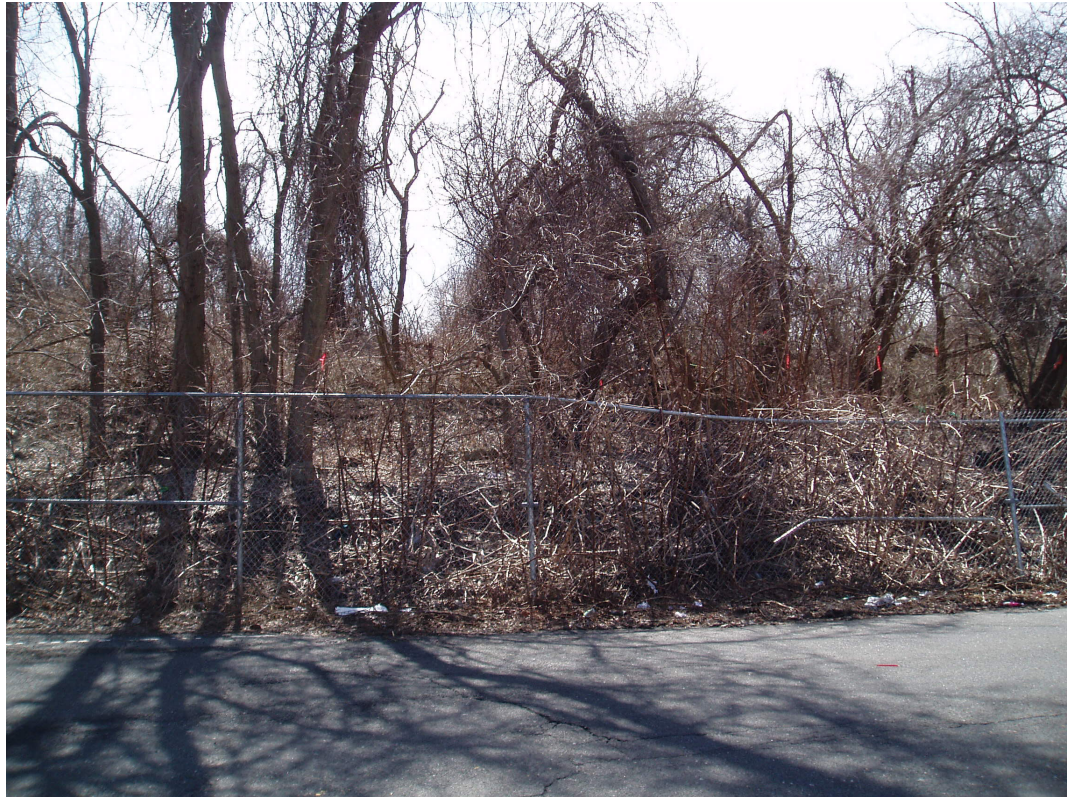
Photograph 2.3

Looking south from Walcott Avenue toward the Potter's Field landform.

Regarding Zavin's various points, additional information is available from the Phase IA research. The size is based on the 1911 map. Two maps (Figures 1.3 and 2.4 herein) illustrate the location and orientation of the allee and its location can be confirmed archaeologically and through identification of the remaining silver maples. The possible remnants of the morgue were observed in 2014 during area walkover and subsequently revealed during the Phase IB close interval survey of the cemetery and design buffer areas. Photographs 2.3 and 2.4 show the northern boundary of the Farm Colony adjacent to Walcott Avenue (Photograph 2.3) and the presumed northern boundary of the cemetery (Photograph 2.4).

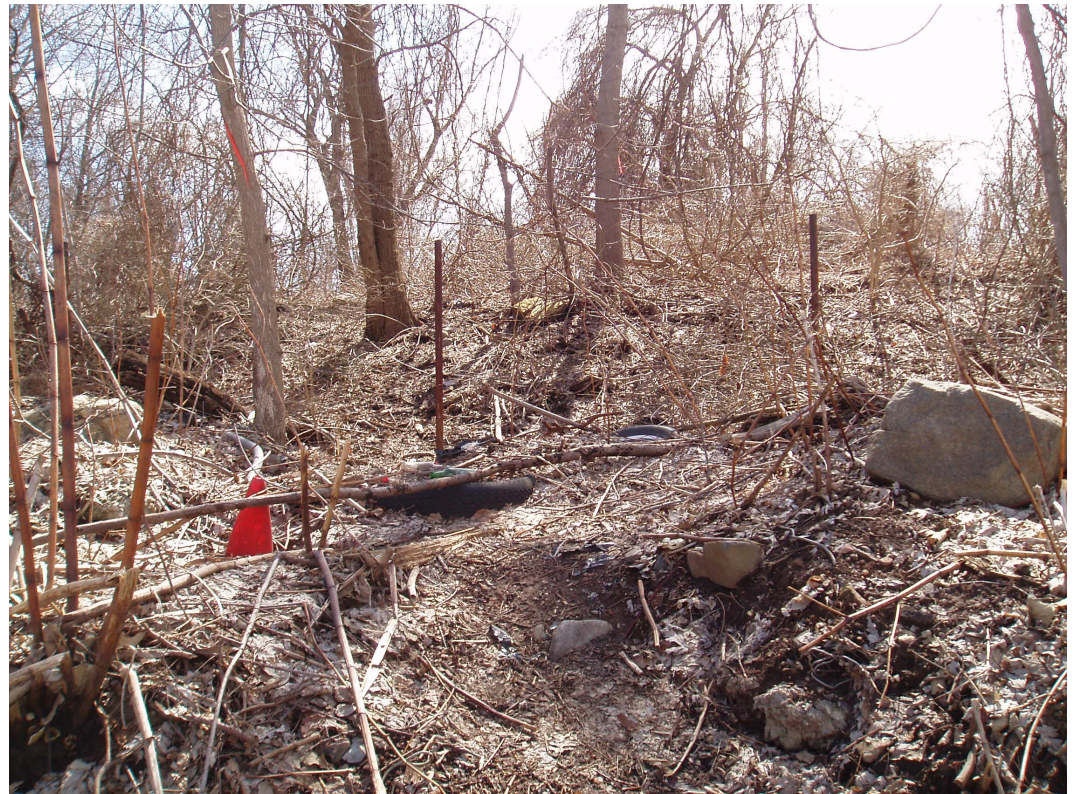
Photograph 2.4

Looking south at the detail of the landform edge showing the step with the fence posts in place. This appears to be facility fencing rather than fencing that encircled the Potters Field.

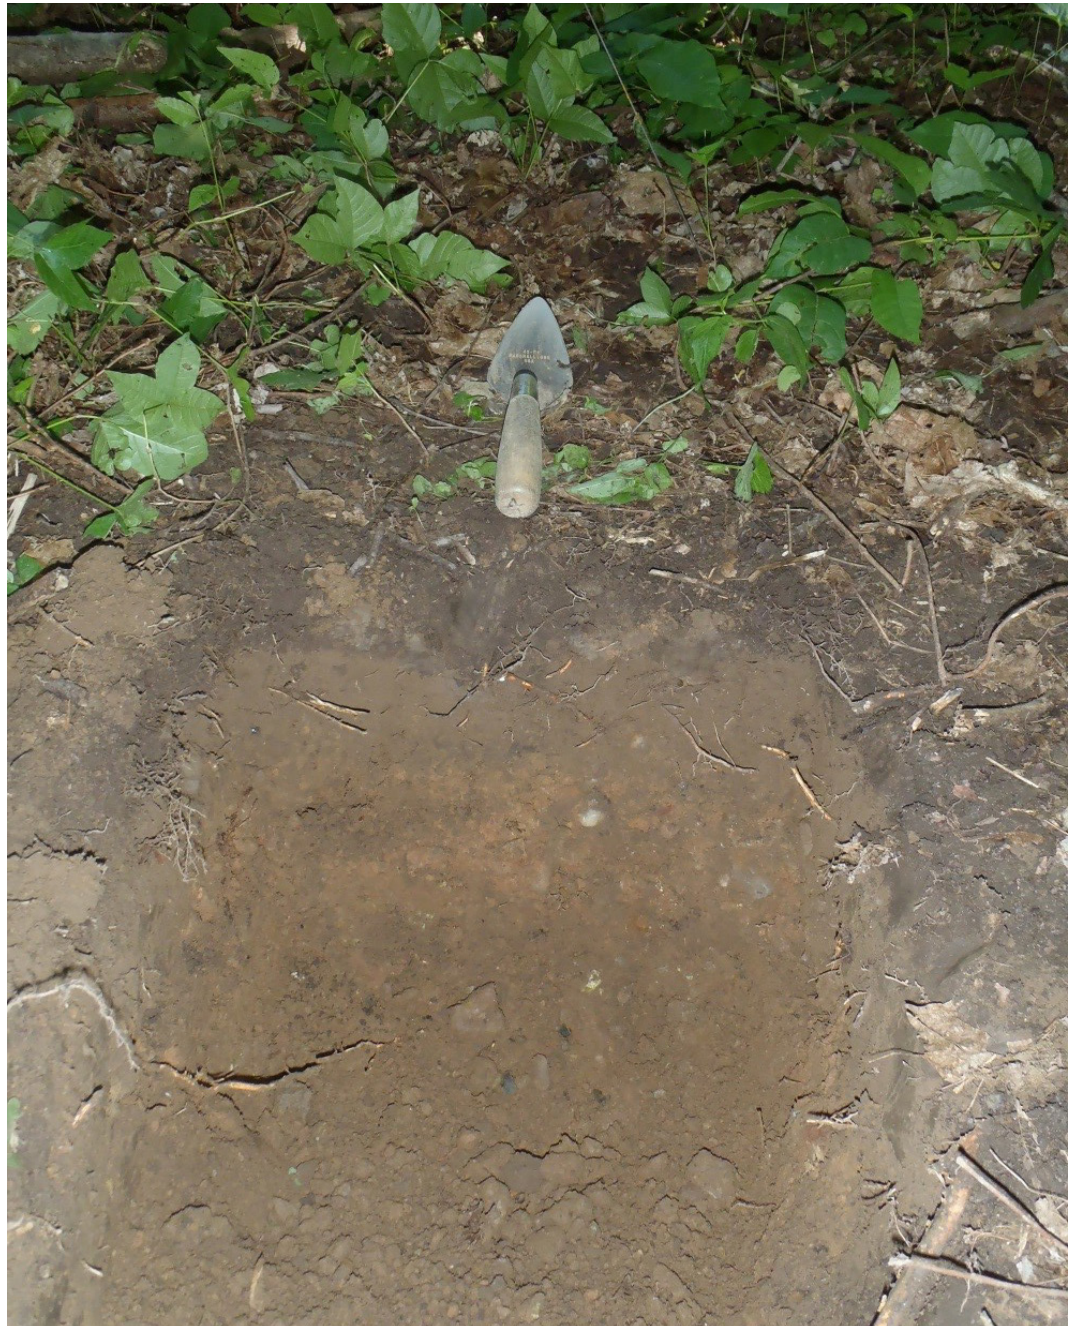
Photograph 3.1

The majority of the 49 excavated STPs showed consistent intact stratigraphy including an A1 forest mat, an A2 horizon with low-frequency small artifact inclusions, and a compact B horizon with increasingly sandy and pebbled soil (Table 3.1; Photograph 3.1; also Appendix C, Table C-1). The 10YR 3/1 sandy loam A1 varied in depth +/- 10 cm (4 in). The 10YR 4/3 loamy silt A2 varied in depth from 11 cm (4.3 in) below surface to 54 cm (21 in) below surface, with slightly thicker A2 horizons found in the northwest portion of the Administrative Core in STPs B1 and C4 and A2 generally terminating by 20 cm (7.8 in) in the northeast portion of the testing area. No major disturbances or plow scars were evident in the A horizons.

Administrative Core Area,
STP 16 north profile,
representative of stratigraphy
revealed across majority of
excavated STPs.

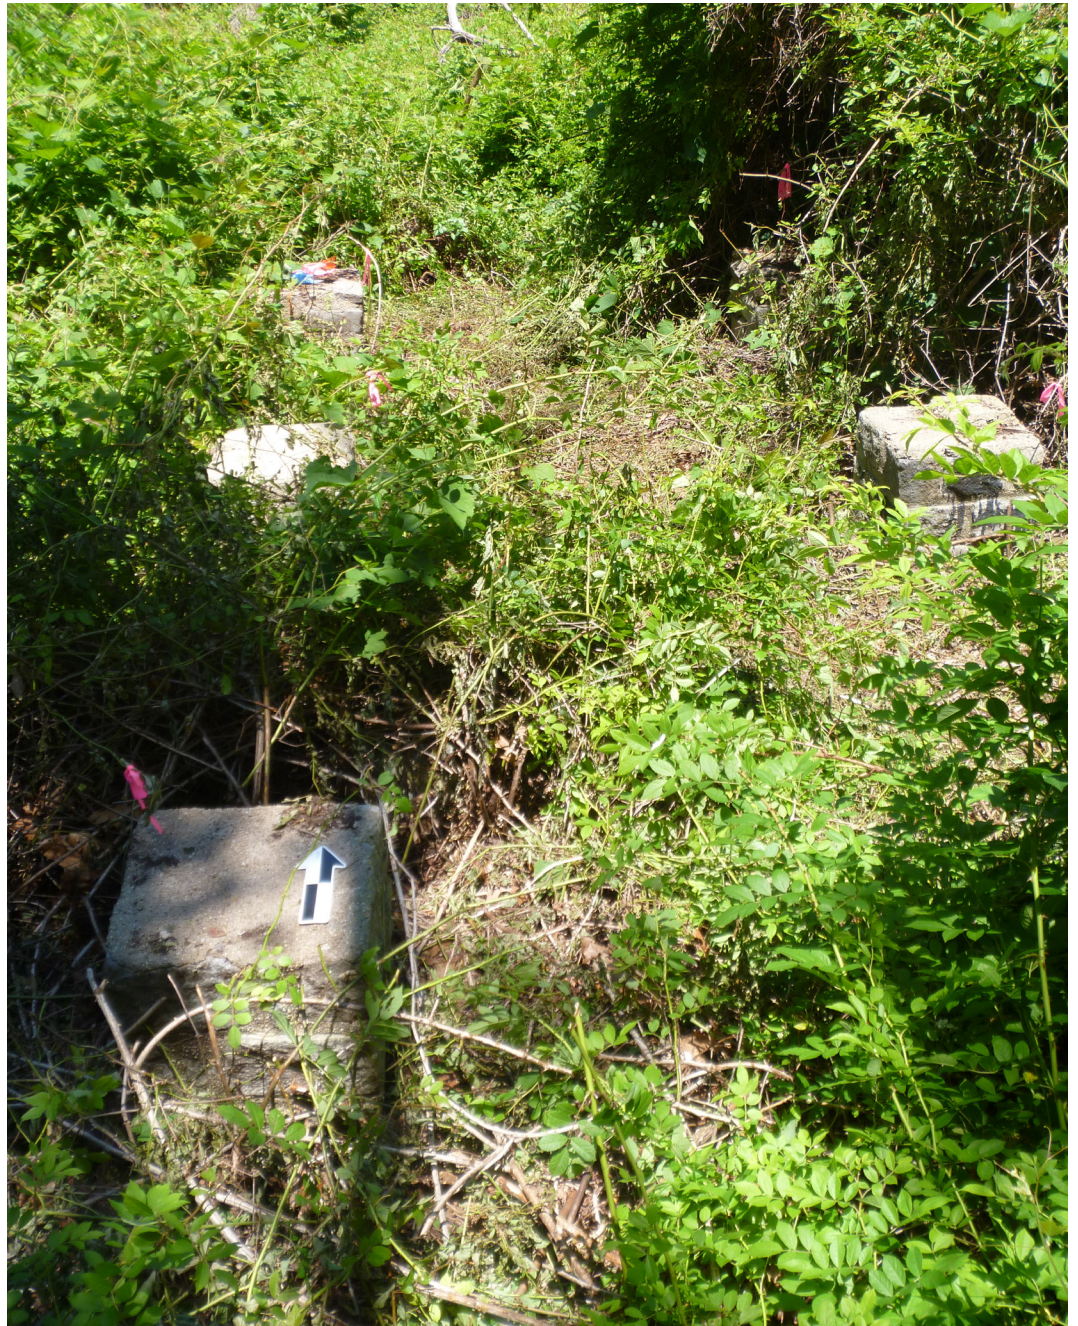
Photograph 3.2

View facing north. Cemetery
Area, feature 1 central
pillars after clearing.

Based on the September 2014 landscape plan and its proposed approaches to vegetation clearance, surface preparation, and new plantings, VHB and Chrysalis recommend no further work in the cemetery area and design buffer. The landscape plan will be implemented under the UDP and if ground excavation or disturbance is required it will be done with an archaeological monitor in place.

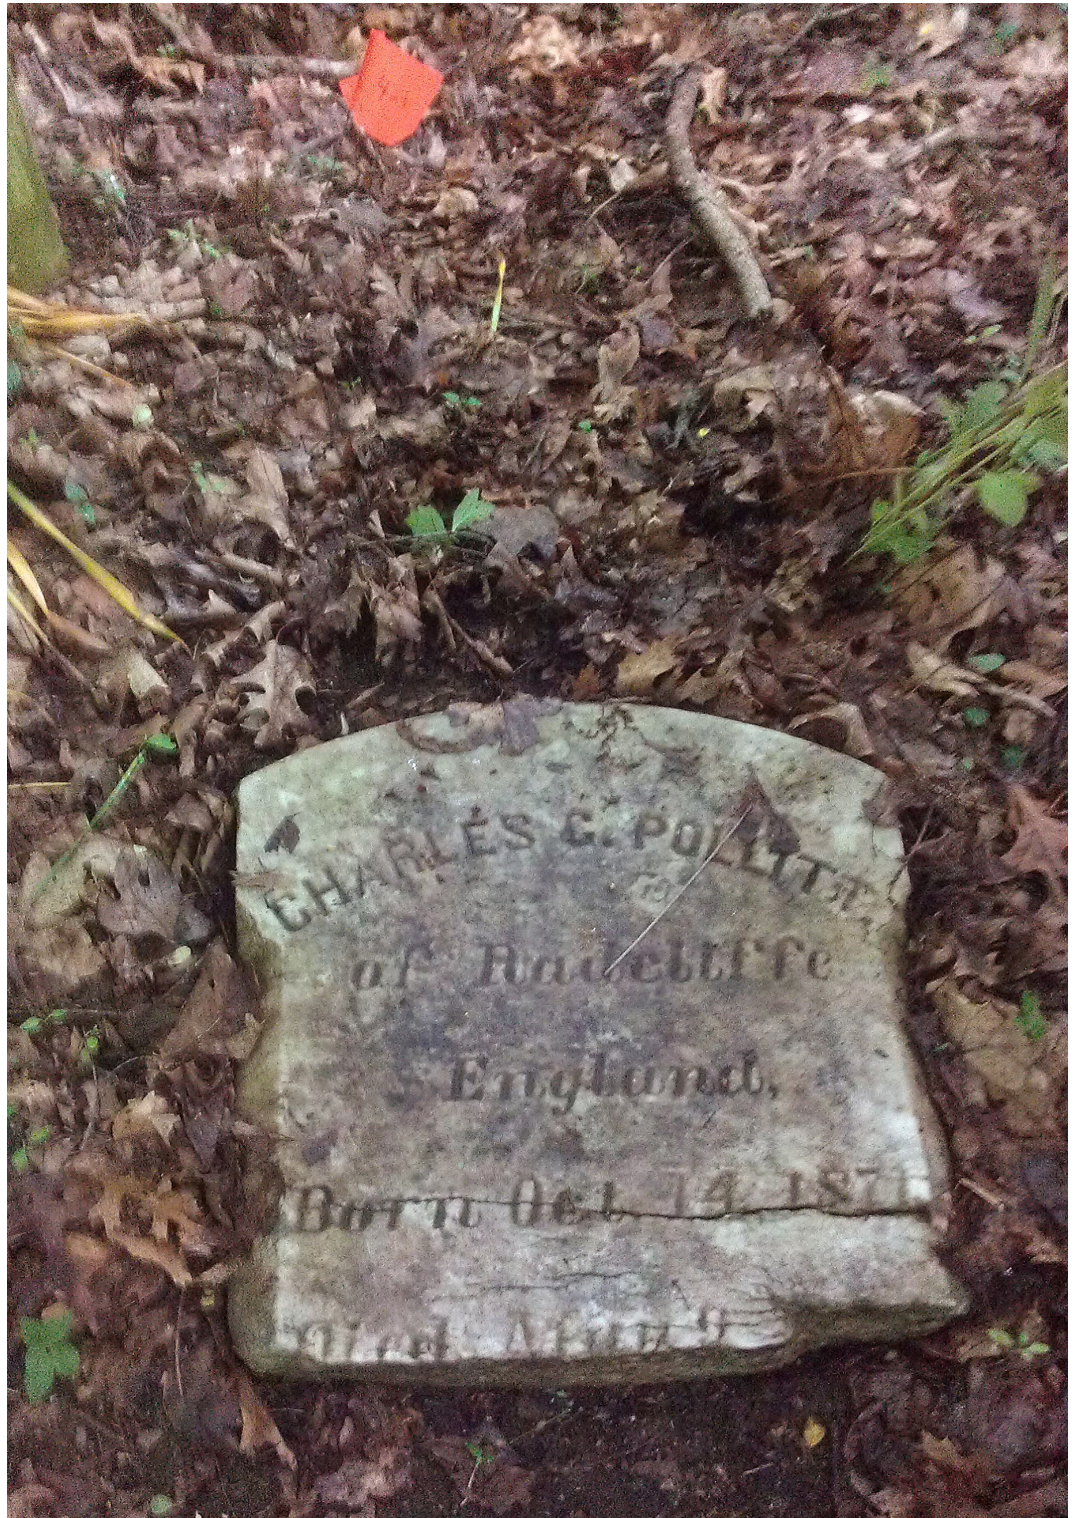
Photograph 3.3

The lone grave marker identified during survey, designated Feature 12, was a .5 by .48 m (1.8 by 1.6 ft) standing, intact portion of marble with a detached upper engraved portion (see Figure 3.5). The broken, top portion of marble slab was marked: “Charles G. Pollitt of Radcliffe England, Born Oct. 14, 1871, Died May 9...” The date of death was obscured by the break in the grave marker (Photograph 3.3). According to an 1881 English census, a Charles G. Pollitt resided in Radcliffe, Lancashire, England born around 1872 (National Archives of the UK 1881:RG11, Piece: 3870; Folio: 6; Page: 3; Roll: 1341925). Pollitt’s father, Charles Grimes Pollitt, appeared to have immigrated to the United States, as a Charles Pollitt of his age and English origin is listed as entering the pension care system of the National Home for Disabled Volunteer Soldiers while residing in Connecticut after serving 36 months with a unit in New York (National Home for Disabled Volunteer Soldiers 1899: 291). It is unknown when the junior Charles Pollitt indicated on the grave marker may have journeyed to the United States or when he died. His father’s pension of \$12 per month for a hernia injury suggests the family was not extremely wealthy, perhaps leading Charles G. Pollitt or his family to find residence at the Colony.

Matching chamfered corners on the standing portion of Pollitt’s gravestone with the broken section confirmed the marker’s engraved side faced north. A shallow depression lay immediately south of the standing tombstone measuring 2 m (6.5 ft) north-south by 1.2 m (4 ft) wide and lowering from .13 m (.4 ft) to .3 m (1 ft) below the surrounding ground surface in its center. Decomposition or removal of Pollitt’s body may be responsible for this depression if the deceased rested south of the grave marker. Notably, this would indicate marker placement in front of the buried remains rather

View facing south. Cemetery Area, broken-off, engraved portion of the Pollitt grave stone.

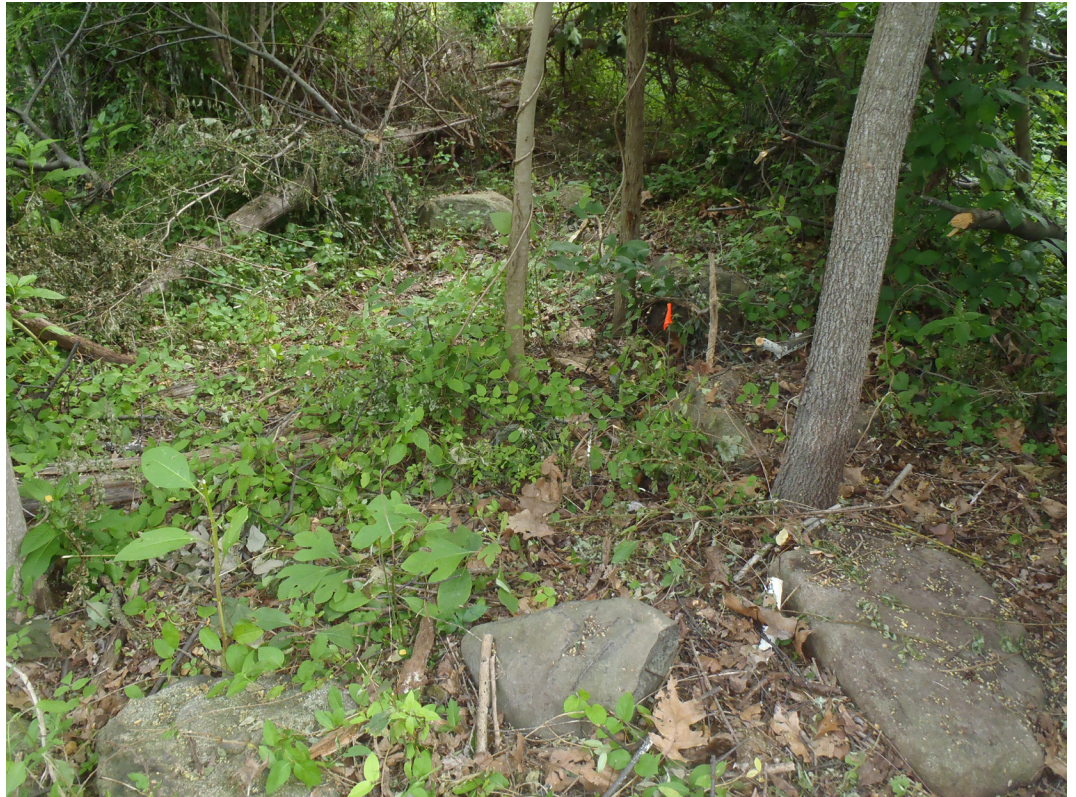
Photograph 3.4

Cemetery Area ground survey also found three stone wall segments (Features 2, 3, and 4). Two of these wall segments were comprised of dry-laid, irregular large fieldstones forming walls varying in thickness between .45 m (1.5 ft) and .6 m (2 ft) wide. The first stone wall remnant, Feature 2, was oriented northwest to southeast 7.6 m (25 ft) west of and roughly parallel to Transect 1/Line C (Figure 3.5). This dry-laid wall section began 3 m (10 ft) east of the survey baseline before turning at a nearly 90 degree corner to run north-northwest and tapering off near Transect 7 (Photograph 3.4). Although outside of the ground survey area, daily entrance and exit to the Cemetery Area through a foot-worn path southwest of the APE initially revealed the Feature 2 stone wall. Chrysalis surveyors performed basic land clearing along the length of Feature 2 to better identify its extent outside Transect 1. Feature 2's west terminus lay 6.1 m (20 ft) southwest of Transect 1, tapering off without a formalized end point. Probing with 1.6 ft long chaining pins did not indicate additional wall stones lay nearby below the forest mat. Feature 2's north terminus similarly tapered off, with stones becoming less numerous and ending between Transects 7 and 8.

View facing north.
Cemetery Area, feature 2
fieldstone wall.

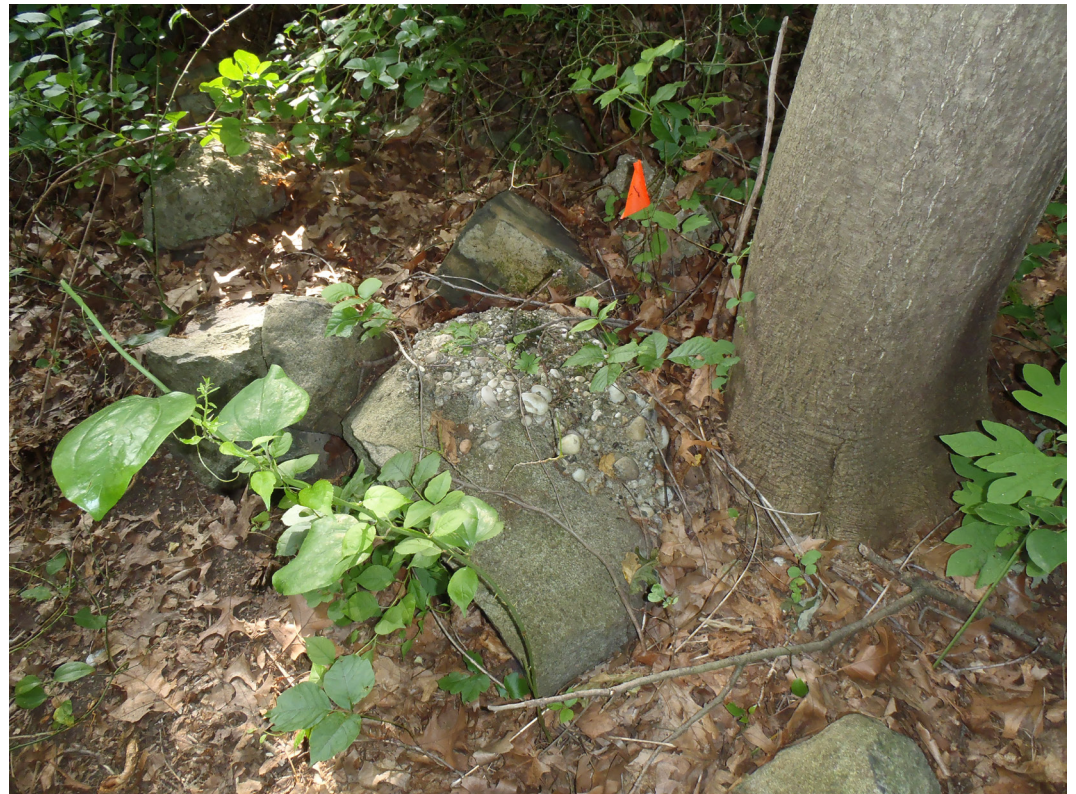
Photograph 3.5

View facing east.
Cemetery Area, feature 3
fieldstone wall.

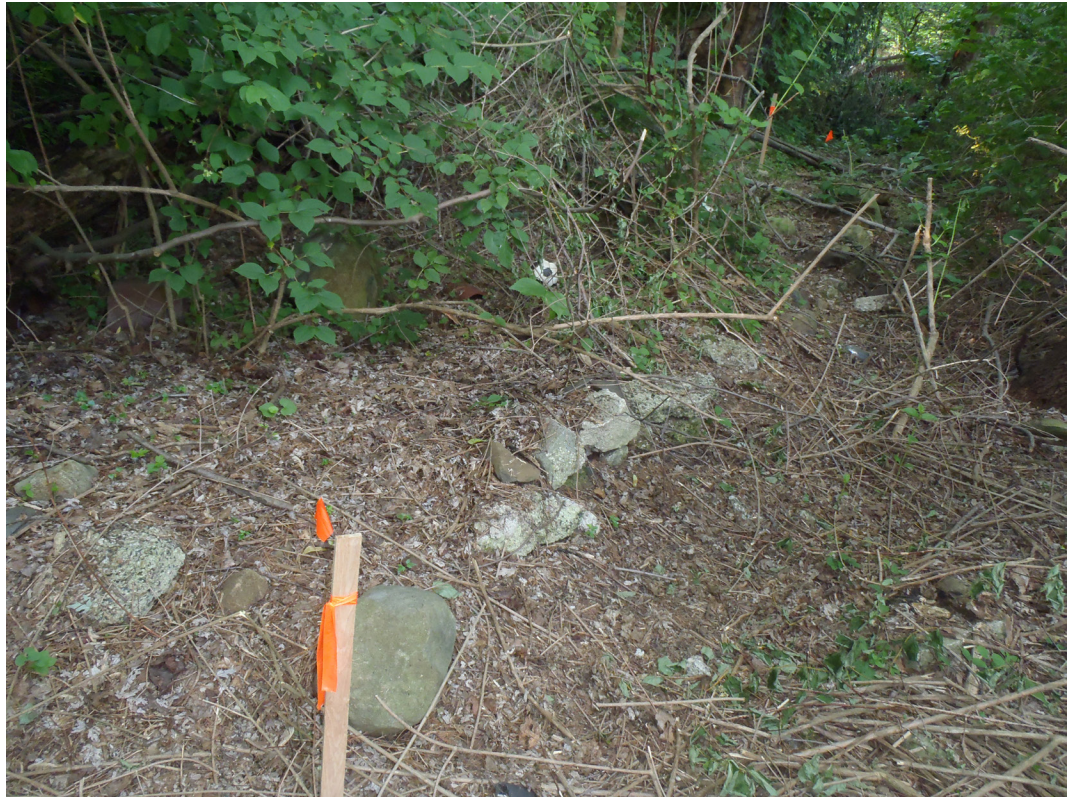
Photograph 3.6

View facing southwest.
Cemetery Area,
feature 4 mortared
fieldstone wall complex.

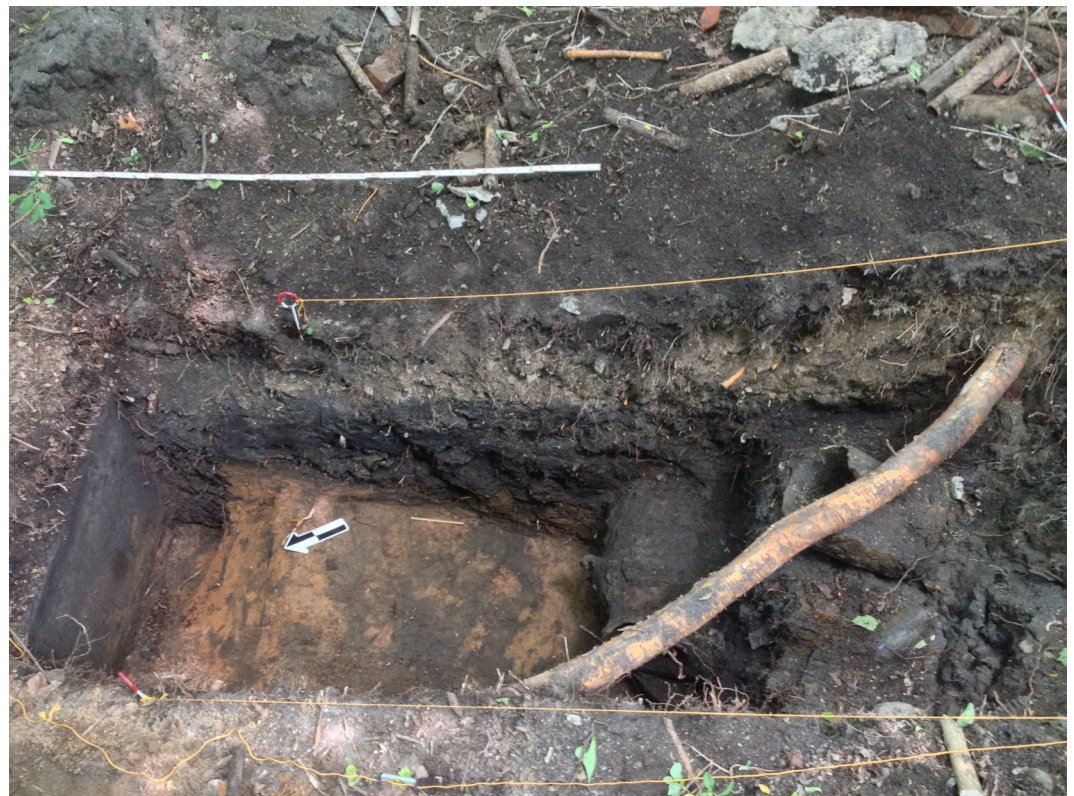
Photograph 3.7

Table 3.2 - Cemetery Area, Feature Location and Description			
Feature	Transect(s)	Distance From Baseline (ft)	Type and Description
			modified glass.
16	12 - 33	0 – 155 ft	Fill deposit including heat-damaged early 20th century glass, ceramics, and metals.

View facing southeast.
Cemetery Area, feature 16
(TU1) southeast profile.

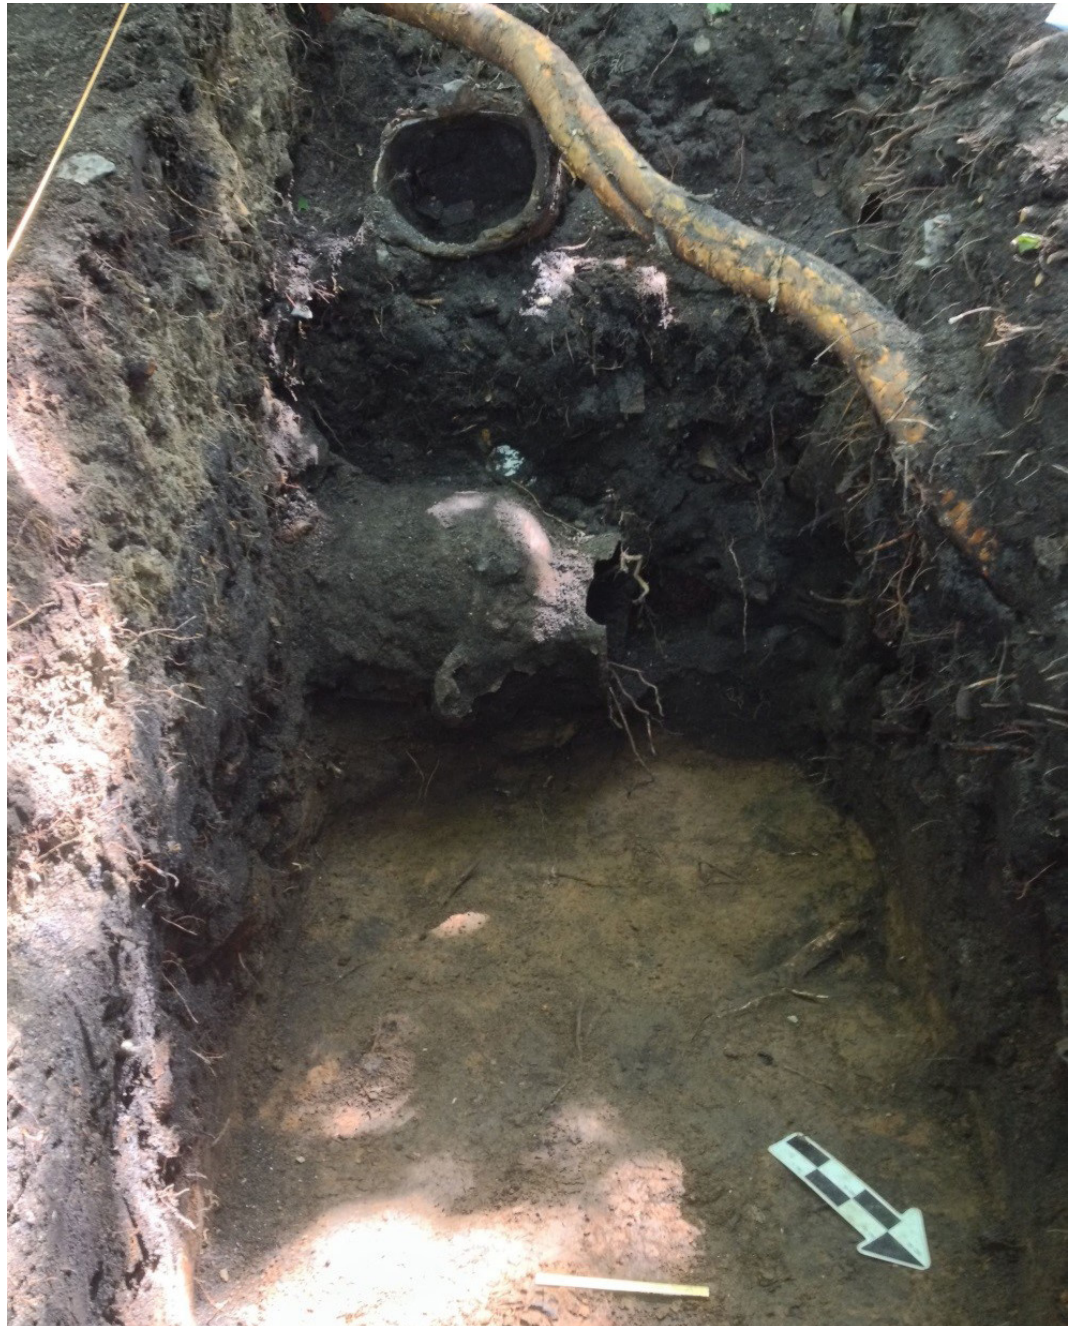
Photograph 3.8

Cemetery Area, feature 16
(TU1) southwest profile,
with iron vessels embedded
within 50cm step and unit
wall.

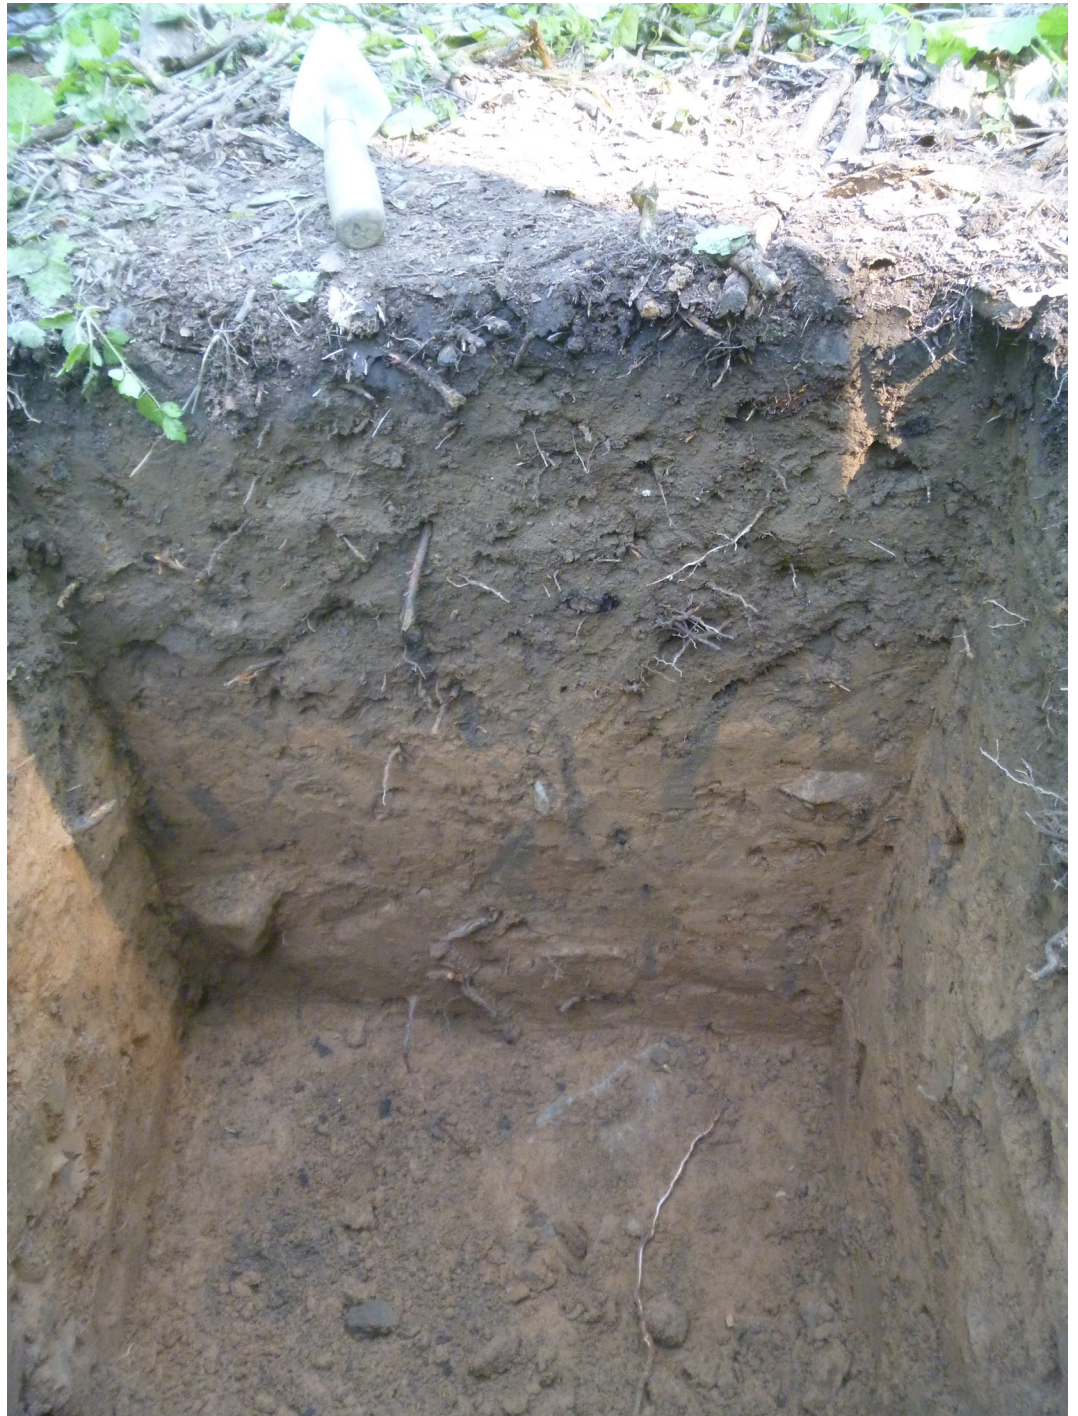
Photograph 3.9

Excavation of three STPs in the southwestern portion of the Cemetery Area yielded only three artifacts. These artifacts, one aqua and two colorless window glass shards, appeared within C-STP 2's A2 horizon. The window glass fragments recovered were non-diagnostic, providing little temporal insight to A2 formation or activity. Unlike the Administrative Core STPs, no discarded 20th century materials appeared in the Cemetery Area STPs.

Cemetery Area, C-STP 2
north profile.
