Saratoga Square Urban Renewal Area, Brooklyn, New York

Field Testing October 1993

Prepared for the City of New York
Department of Housing Preservation and Development

Prepared by Joan H. Geismar, Ph.D.
December 1993/March 1994

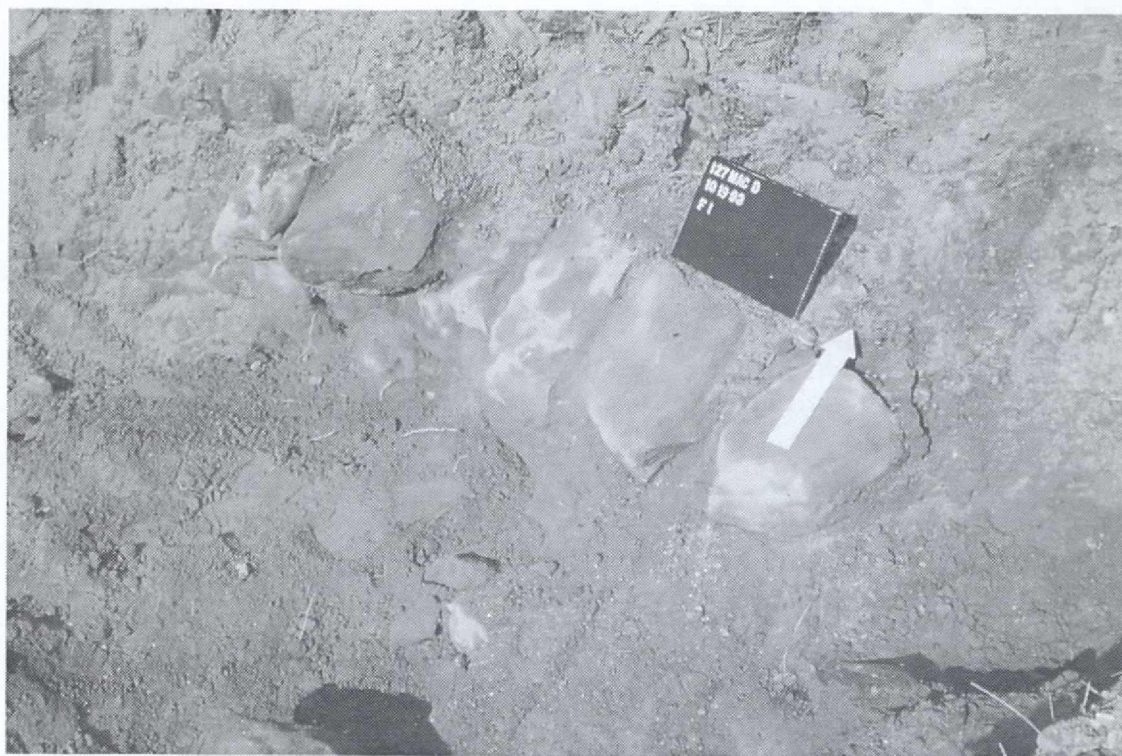
TT3 was opened just south of a large Ailanthus tree situated near the western property line in the rear part of the lot, and extended eastward. Excavation included the northern property line where the top of Feature 1 (F1), a dry-laid stone privy, was exposed just beneath the surface in the northeast corner of the lot, directly on the property line. Only the very top of the northernmost stones (a line about 7 ft. long) and the northeastern corner of the feature were uncovered. It did not appear that this feature had been disturbed. It should be noted that its location directly on the rear and eastern property lines does not conform with nineteenth-century Brooklyn ordinances requiring that privy pits be at least 2 ft. from these lines. This may in part reflect the fact that the adjoining lot to the east was also owned by Haege. The explanation for placement on the rear lot line has not been explored. F1 was photographed (Exhibit 4), plotted, and backfilled.

4 Top of north wall of Feature 1 (F1), the stones of a privy pit at 127 MacDougal St.

It is recommended that the privy pit at 127 MacDougal Street (F1) be excavated as soon as possible. This feature, associated with one of the more affluent residents of the village of New Brooklyn, did not appear to have been looted (unfortunately, privy pit features, a source of saleable antique medicine and beverage bottles, are often looted, destroying the invaluable social and economic information these features can provide). It is also recommended that F6, the privy pit at 78 MacDougal Street, be tested to determine if in fact it has been looted.

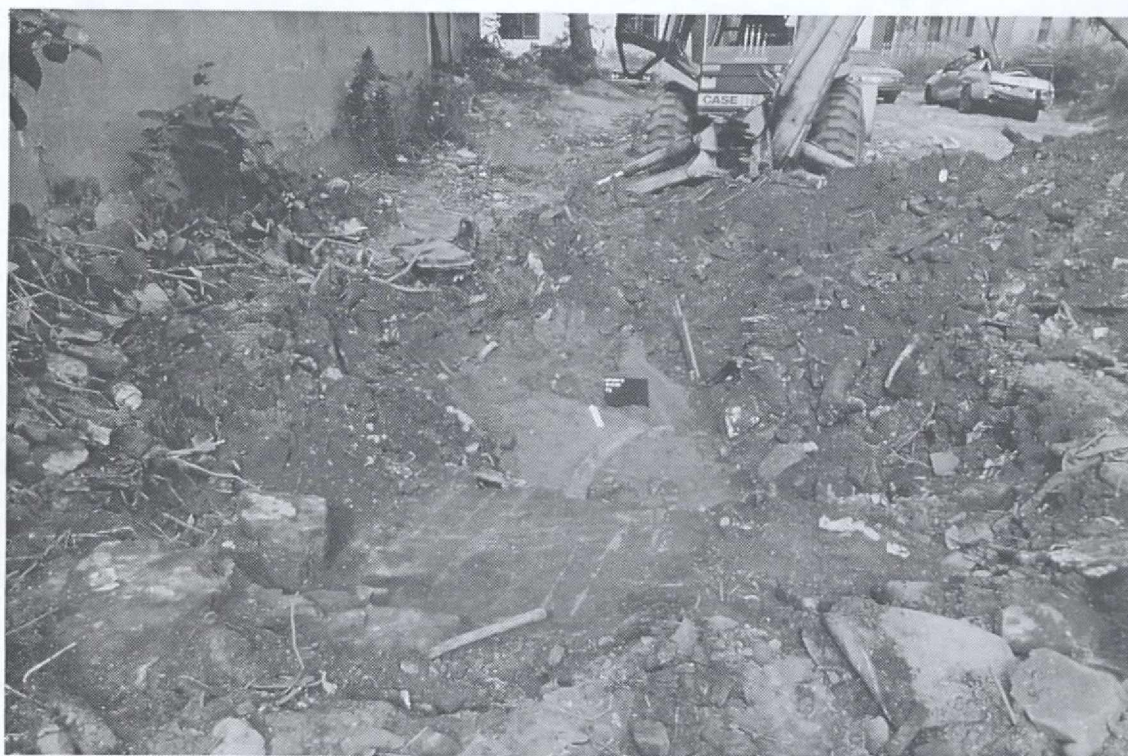
Test Trench 4 (TT4) traced the western part of the rear building foundation, beginning about 28 ft. north of MacDougal Street with an extended area of excavation. It exposed a circular brick cistern (F2) about 3 ft. north of the building foundation (Exhibit 5). This feature may originally have been beehive shaped, but the cap is now missing. F2 was plotted, photographed, and backfilled.

5 View of Feature 2 (F2), upper bricks of cistern exposed (arrow), looking north. Backhoe and car to north.

It is recommended that the contents of identified cisterns (F2, F4, F8, and F12) be tested and, if warranted, excavated. At another Brooklyn site, cisterns constructed in the mid-nineteenth century were found to be filled in one episode, mainly with ashes and

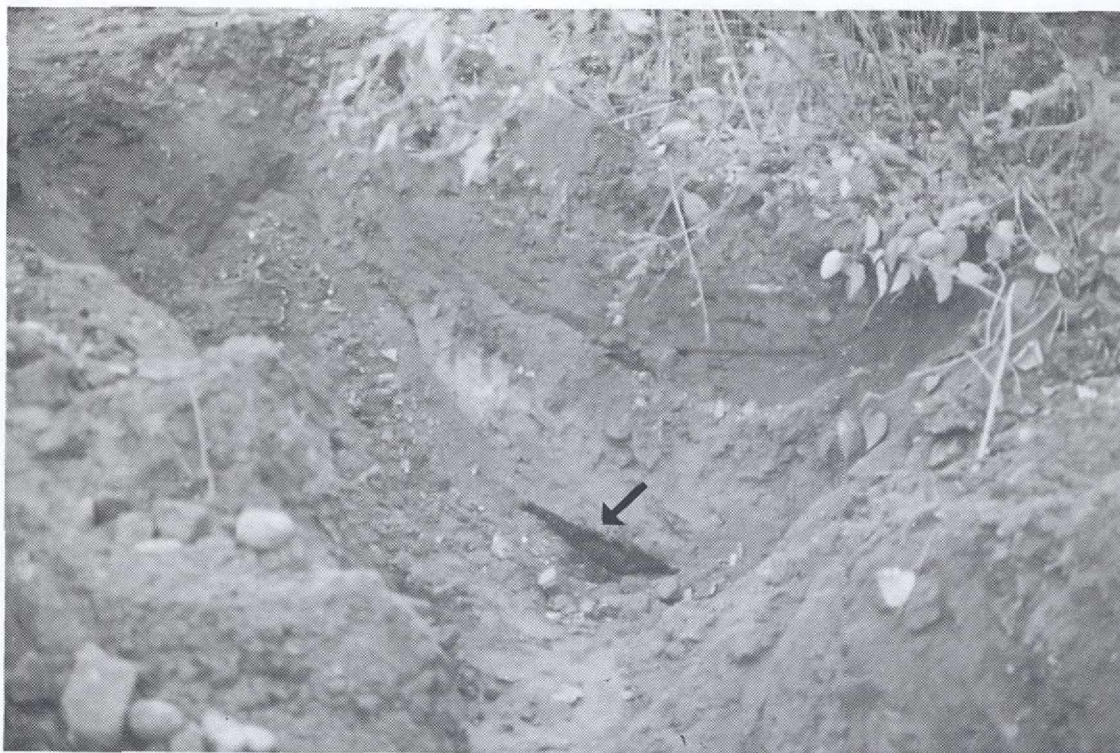
109 MacDougal Street (Block 1525, Lot 49). As noted above, test Pit 1 (P1) crossed both the 111 and 109 MacDougal Street yards. During testing of 109, another test pit (P2) was extended southward from the rear part of the yard about 13 ft. along the eastern property line to include and go beyond the area where a break in excavation had originally occurred, but no privy pit was found (this test pit was excavated to a depth of 8 ft.). Although no features were located in the northern part of the yard, a lens of dark brown or black sterile sand was noted in the sterile yellow sand in the western part of Pit 2 at a depth of about 5 ft. (see Exhibit 7). A similar deposit at a depth of about 4 ft. had been noted a little further east in this yard. Bob Wogish, the backhoe operator, suggested it was a meadow mat deposit, but this is a question and the stratum remains unexplained.

7 Lens of dark (brown/black) sterile sand (arrow) in test Pit 1 (P1) at 109 MacDougal St.

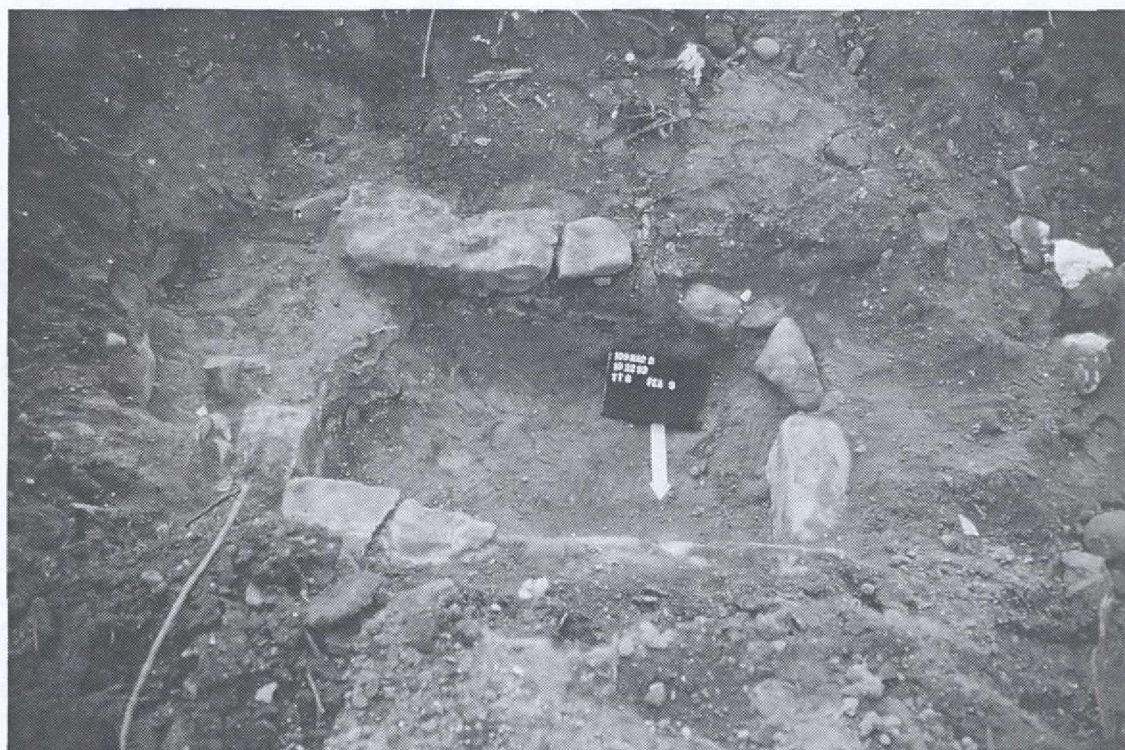
Based on map data, excavation was started about 40 ft. north of MacDougal Street, but wood and rubble encountered almost immediately below the surface indicated we were still within the confines of a former building. Excavation was moved 2.5 ft. north (TT6) where a rectangular stone feature (F3) was uncovered about 1.5 ft. west of the eastern property wall. This shallow 3.5 by 5 ft. feature (exterior measurements) was basically dry-laid stone, but traces of mortar were noted on some of the upper stones. It was two stone courses high and 3 ft. from the ground surface to the bottom stone. This small shallow feature was virtually excavated during clearing. Only a few artifacts were noted --a small blue Bromo Seltzer bottle, an Armour milk glass meat jar, and a clear bottle with an applied neck rim embossed "C.H. SLICK/NEW YORK"--and none were collected. Sterile sand was found at the bottom, and no difference was noted between the soil inside and outside the feature. Its function and original height remain unknown, but from all indications it may have been a shallow foundation for a small, unidentified structure. The feature was photographed (see Exhibit 8) and plotted.

8 Unidentified shallow dry-laid stone feature (F3) center of yard at 109 MacDougal St.

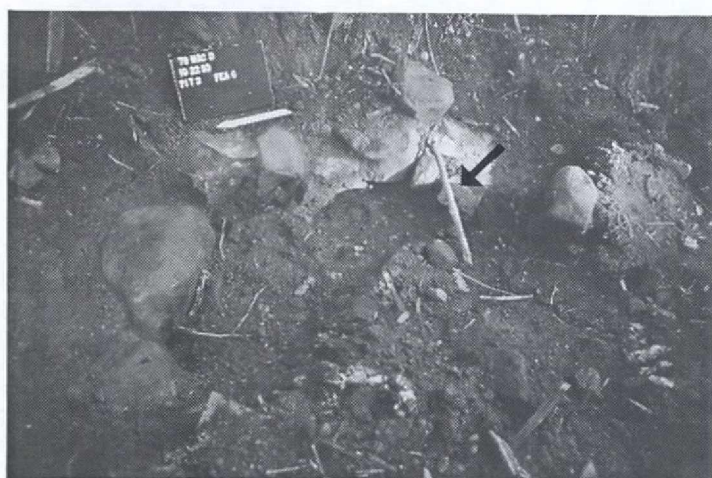
been located. The backhoe cleared about 1.6 to 2.6 ft. of building rubble and dark soil, but no feature was found, and the irregular test pit was extended across the rear of the lot. A dry-laid stone feature (F6), identified as a privy pit, was exposed just below the ground surface in the southeastern part of the test pit, approximately 5.5 ft. west of the eastern property line and 2 ft. from the rear fence. This feature was small--its outside diameter 5.5 ft., its inside only 4 ft.--and the soil within it appeared very loose. An upright piece of plastic hose extending out of the soil (see Exhibit 9) suggested the feature may have been looted and backfilled. F6 was photographed (Exhibit 10), plotted, and backfilled (it should be noted that this feature was basically round although it is shown as rectangular in Exhibit 2, the convention used in the graphic to depict a stone privy).

9 Top of stone privy pit (F4) at rear of 78 MacDougal (inadvertently labeled Pit 3). Note plastic hose (arrow) and loose soil that seem to indicate backfilling after looting.

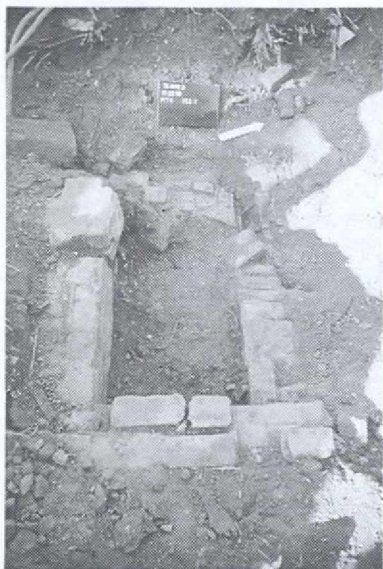
At first, it seemed possible that the brick feature was the remnant of a small cistern, but, although the bricks were mortared, there was no mortar seal inside the feature to make it water tight as is usually the case. Mortar on the top course of brick indicated the feature had once been higher. It was filled with building debris and one animal longbone was noted, but no "old" artifacts were found. The depth of the feature was undetermined, as was the nature of its bottom. It was photographed (Exhibit 10), and excavation continued to the east where a 9-ft. diameter, intact brick beehive cistern (F8), with a .9-ft. diameter central drain, was located east of F7. This large feature, which was only partially exposed during testing, extended almost to the eastern property wall. It was photographed (Exhibit 11), and it and F7 were plotted and the test pit backfilled.

10 Unid. rectangular brick feature (F7) behind demolished building at 78 MacDougal St.

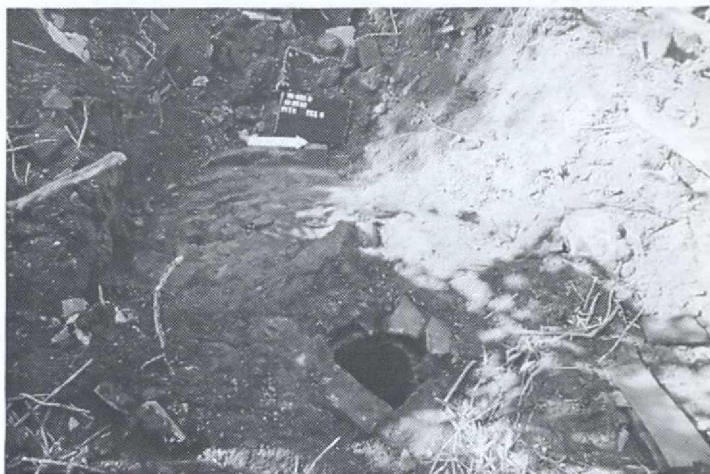
11 Large (c.9.5 ft. diameter) brick beehive cistern (F8) at 78 MacDougal St.

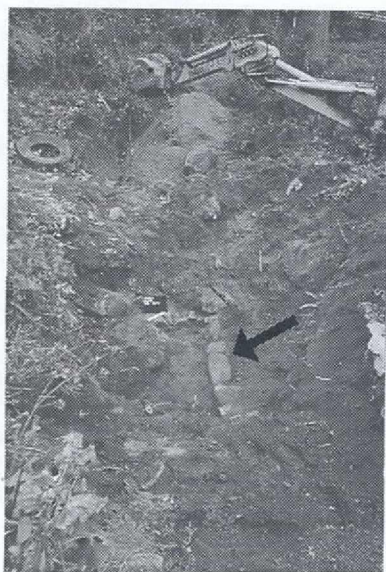
Excavation of TT9 exposed a rectangular dry-laid stone feature (F10), or what remains of this feature, in its eastern part, about 2.5 to 3.3 ft. below the ground surface. It extended another 2.5 ft. into sand. The 5-ft. long feature was located approximately 1 ft. west of the eastern property line. The feature, which is similar to F3 at 109 MacDougal Street, incorporates a large rock into its eastern side, and, although privy-like in construction, it is shallow and contained few artifacts. Since this part of the yard is well below the 43 MacDougal Street lot and is filled with modern debris, this feature could be a remnant of a former privy pit mainly destroyed during yard alterations. If so, it has been cleaned out, but this is conjecture. Like F3, clearing virtually excavated the feature which was found to contain very few artifacts. Those that were present--including a large metal wrench--appeared to be modern. The vertical position of the wrench in the fill suggested backfilling and the possibility of looting prior to destruction of the feature. F10 bottomed out on the same sterile sand found throughout the lower part of the trench. It was photographed (Exhibit 12), and the trench and feature were plotted and backfilled. No further excavation is recommended in this area.

12 Remnant of privy-like feature (F10)
(arrow) in what appears to have been
part of the 43 MacDougal St. yard.

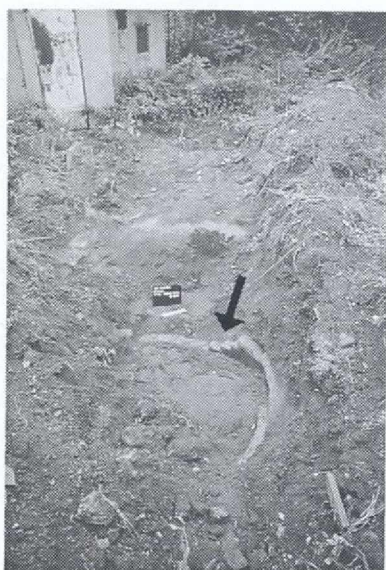
day in the field, an attempt had been made to test the rear part of this vacant lot where a privy pit might be located, but a thick cement slab made this impossible (the slab was later identified by a neighbor as the floor of a demolished shed [Carlton 1993:personal communication]). Several days later, testing resumed in the vicinity of the former house structure with the running of TT10 approximately 28 ft. south of the Sumpter Street property line. At that time, stone foundation walls (F11) and a basically circular, 6.5-ft. diameter, brick water cistern (F12) were revealed not far beneath the ground surface (F11 was 1.5 ft. below the ground surface, the top course of brick in F12 was 2.3 ft. beneath the surface). It appeared from a curvature in the bricks that the cistern may have originally been the classic beehive shape, but its top brick courses are now missing. The wall and cistern feature were partially exposed, plotted, and photographed (Exhibit 13); the excavation was then backfilled.

13 Outline of brick cistern (F12; arrow) at 126 Sumpter St. Part of stone foundation (F11) visible above story board.

In addition, it is recommended that testing proceed on the five selected lots that have not yet been tested. It is also recommended that the cement slab in the rear yard of 126 Sumpter Street be removed so that this part of the yard can be tested. Its removal should be followed by testing as soon as feasible so that any privy pit features located under it can be identified and, if necessary, excavated.
