**Phase I Archeological Survey for
Installation of Scaffolding at Fort Jay,
Governors Island National Monument,
New York County, New York**

GOIS 2013C PEPC 15779 PMIS 195023

Richard D. Holmes, Ph.D., R.P.A.
Archeologist, Hurricane Sandy Recovery Team
National Park Service

February 2015

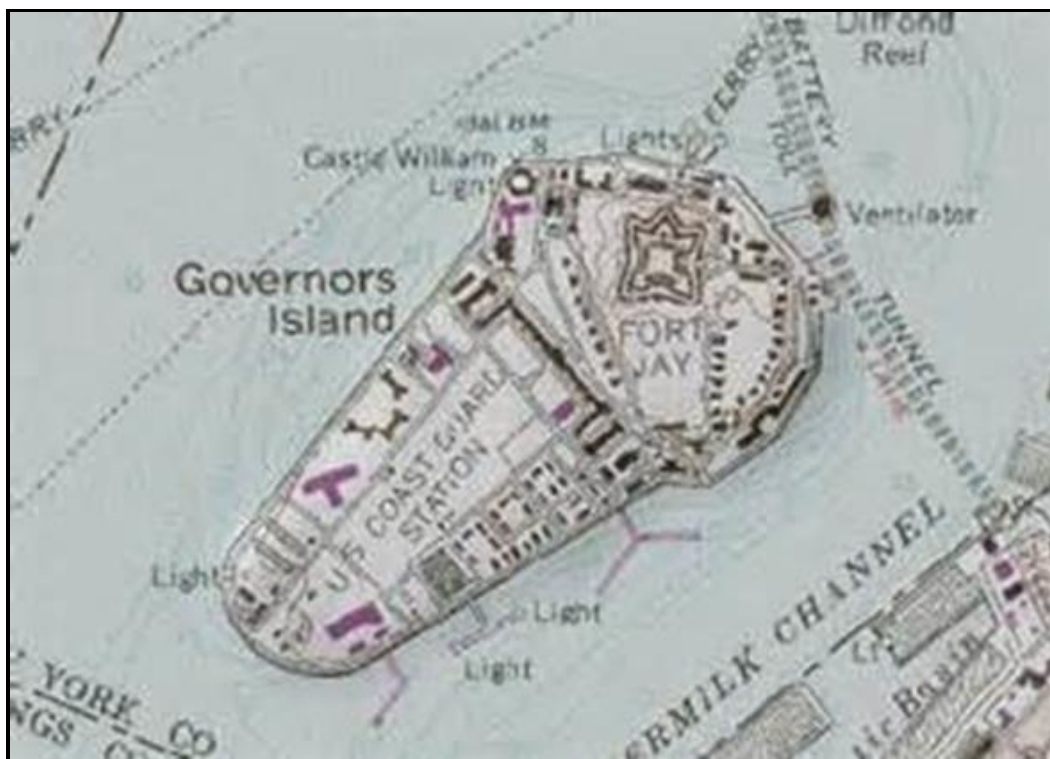
Figure 2. Governors Island on USGS Jersey City, NJ/NY Quadrangle. Most buildings in the southern part of the island have been demolished.

Location. Governors Island is in the Upper Bay of New York Harbor (Figure 1). It consists of approximately 172 acres, of which 22 acres are under NPS administration as Governors Island National Monument. The mouth of the East River, a tidal strait, separates Governors Island from Manhattan, and Buttermilk Channel flows between it and Brooklyn (Figure 2).

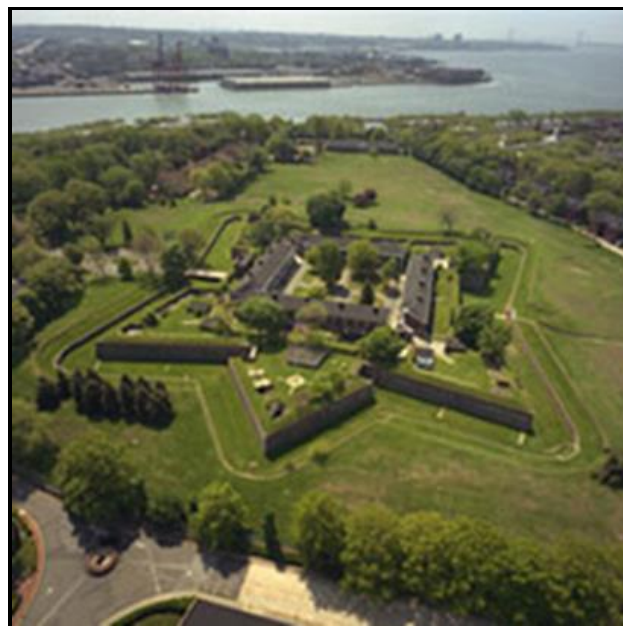
Figure 4. View of Fort Jay, looking south, with project area in the left middle ground.

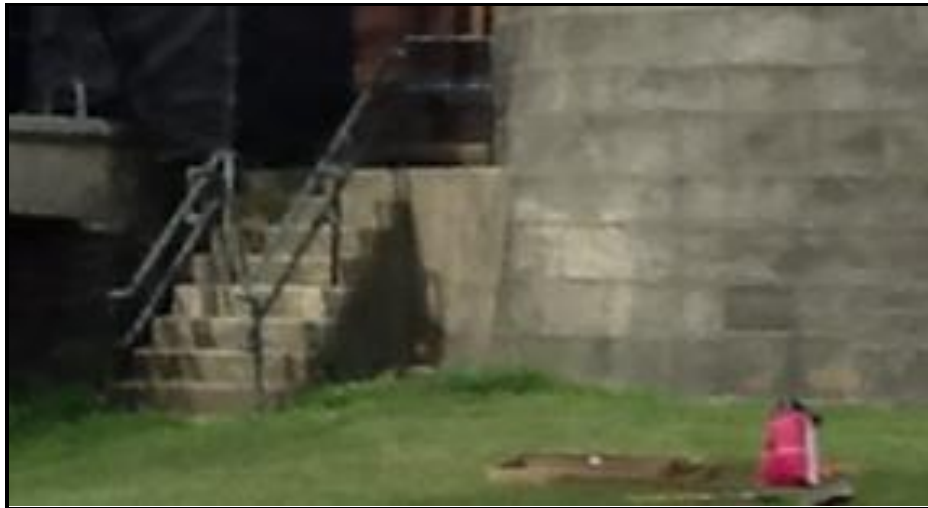
Figure 7. Dry Moat – North of Bridge Area, looking southwest.

Dry Moat – North of Bridge Area. This area is the floor of the dry moat, from where the granite scarp (i.e., wall of the fort on the inner side of the dry moat) curves west towards the gate, extending up to the bridge (Figure 7). It has an area of approximately 4 x 4 m (13 x 13 ft). A concrete stairway leads down to the moat floor. A drawing from 1881 depicts the area without the concrete stairs (Figure 8), which apparently date to the World War II era.

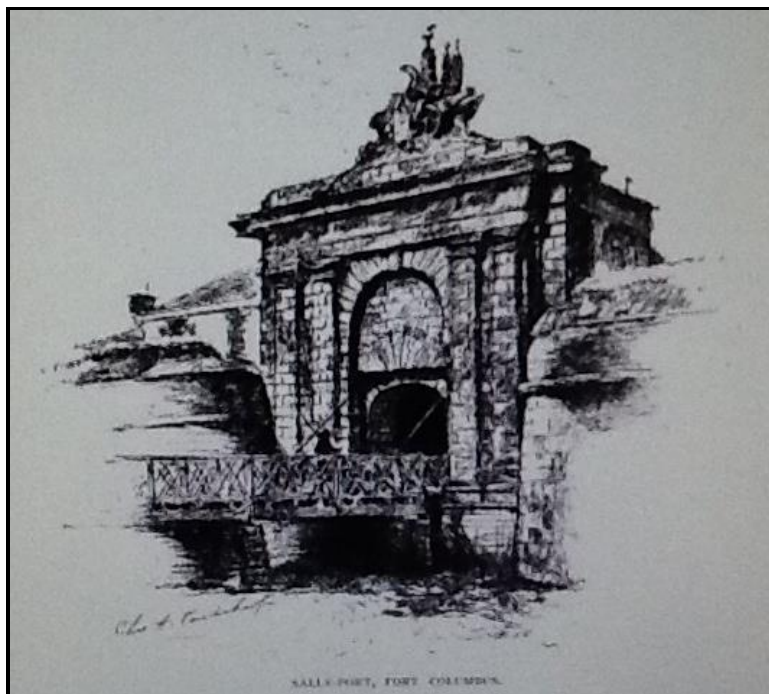
Figure 8. Drawing of Gate, showing location of North of Bridge Area, 1881. Note absence of stairs. From Yocum 2005: Figure 41.

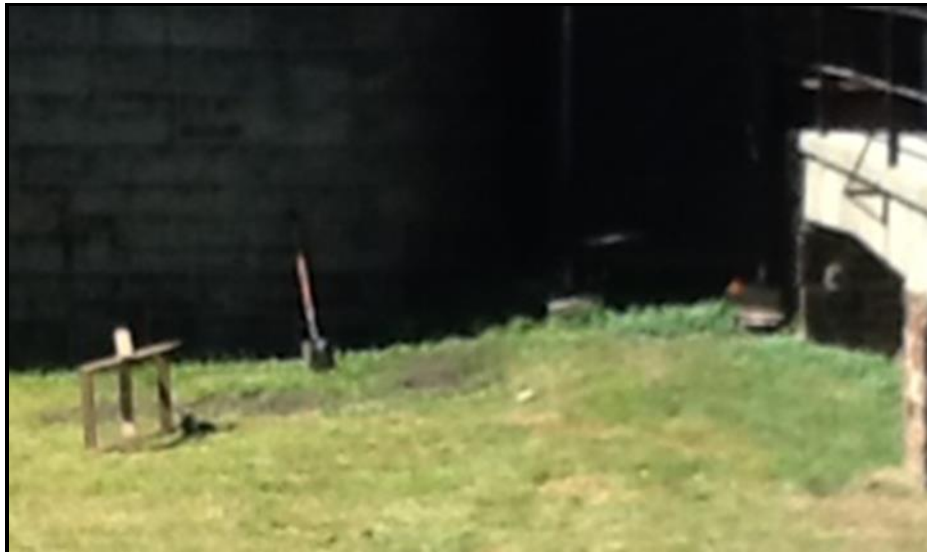
Figure 9. Dry Moat – South of Bridge Area, looking northwest.

Dry Moat – South of Bridge Area. This area is on the floor of the dry moat, from where the granite scarp of the fort curves towards west the gate, extending to the bridge (Figure 9). It has the same dimensions as the previous area. A mound of earth is in the corner formed by the scarp and the gate. The area is level in a photograph from 1913 (Figure 10).

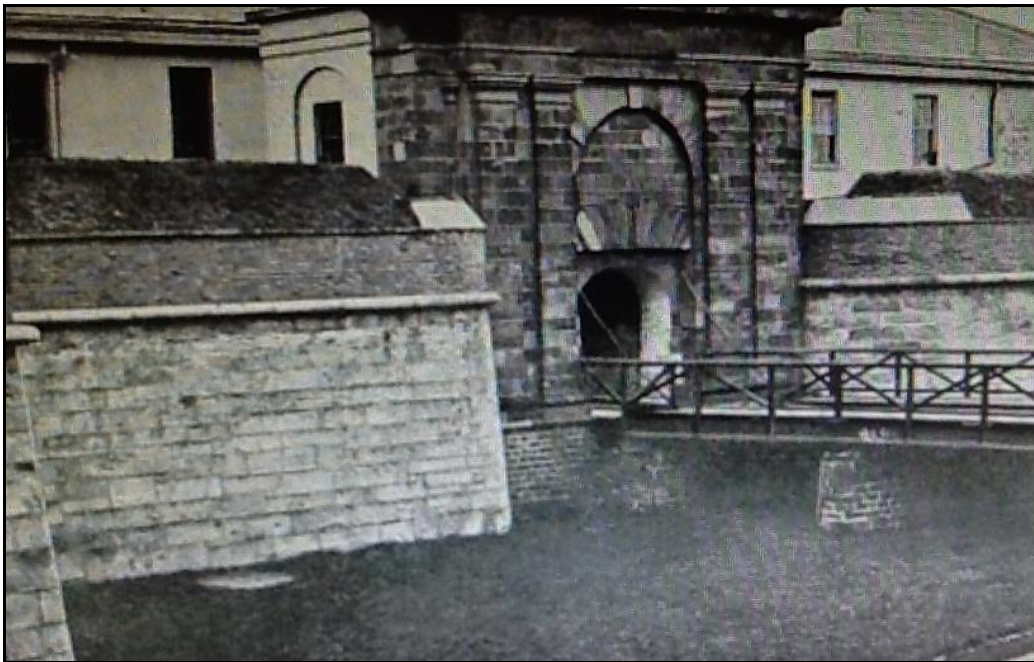
Figure 10. Photograph of Dry Moat – South of Bridge Area, 1913. Ground is level. The bridge has since been replaced. From Yocum 2005: Figure 55.

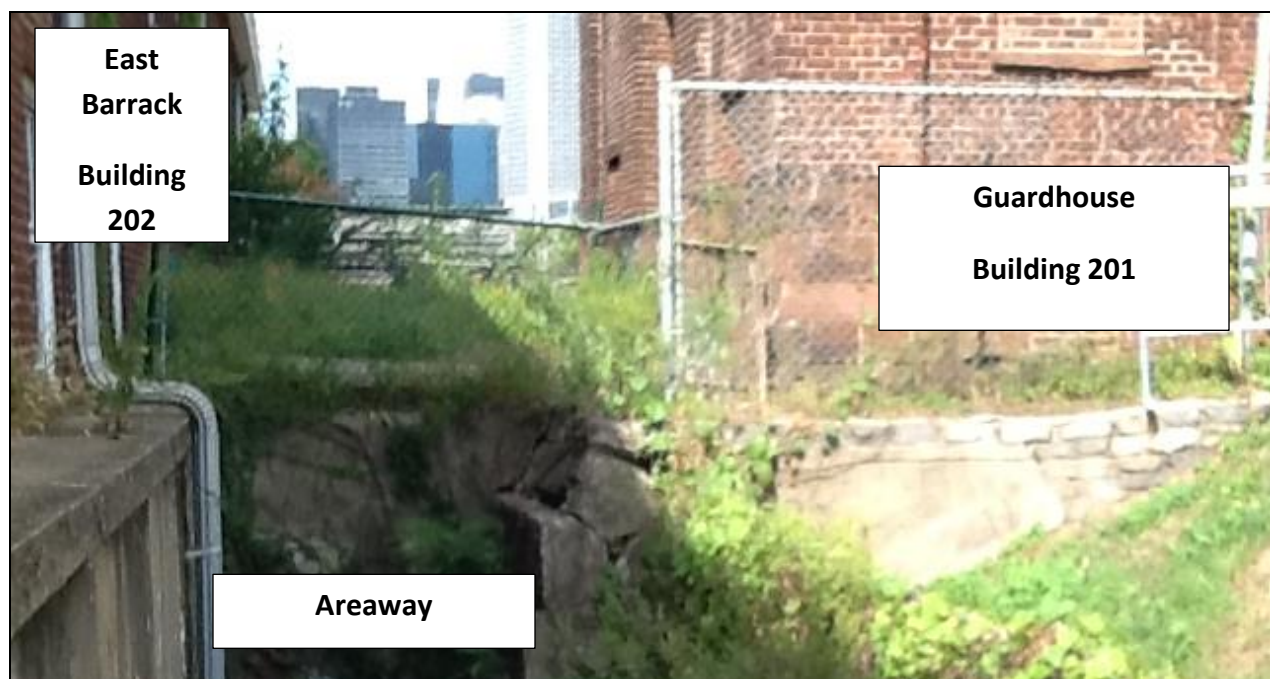
Figure 11. Guardhouse Area, looking north. Note condition of retaining wall.

Guardhouse Area. “A brick Guardhouse abuts the upper gate of Fort Jay on the interior (west) side, where it sits above the sally- port tunnel” (Yocum 2005: 196). The brick wall of the Guardhouse forms the eastern boundary of this area. The eastern wall of the East Barracks (Building 202) is the western boundary of this area. Retaining walls adjacent to the areaway (i.e., a sunken space affording access, air, and light to the basement of the East Barrack [Building 202]) form the northern and southern boundaries of this area. It is approximately 9.75 x 4 m (32 x 13 ft). An overview of this area is shown in Figure 11.

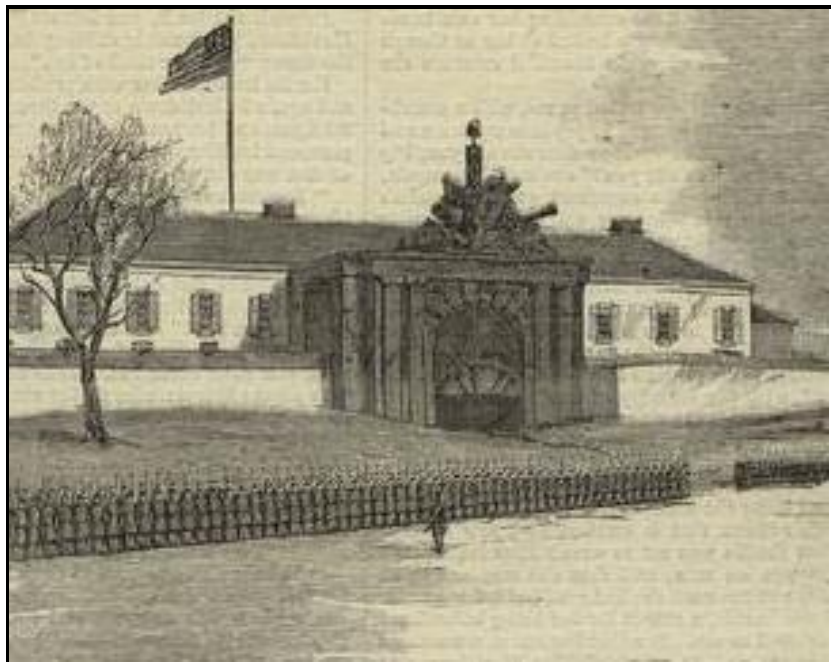
Figure 12. Gate, Guardhouse, and East Barrack, 1861.
From Yocum 2005: Figure 28.

The original Guardhouse had a wing, remnants of which may remain below grade. The APE underwent significant changes in the 1830s, including rebuilding and relocation of the East Barrack and rebuilding of the original 1795 Guardhouse. By the mid-19th century, the configuration of the Gate and Guardhouse seems similar to that of today (Figure 12).

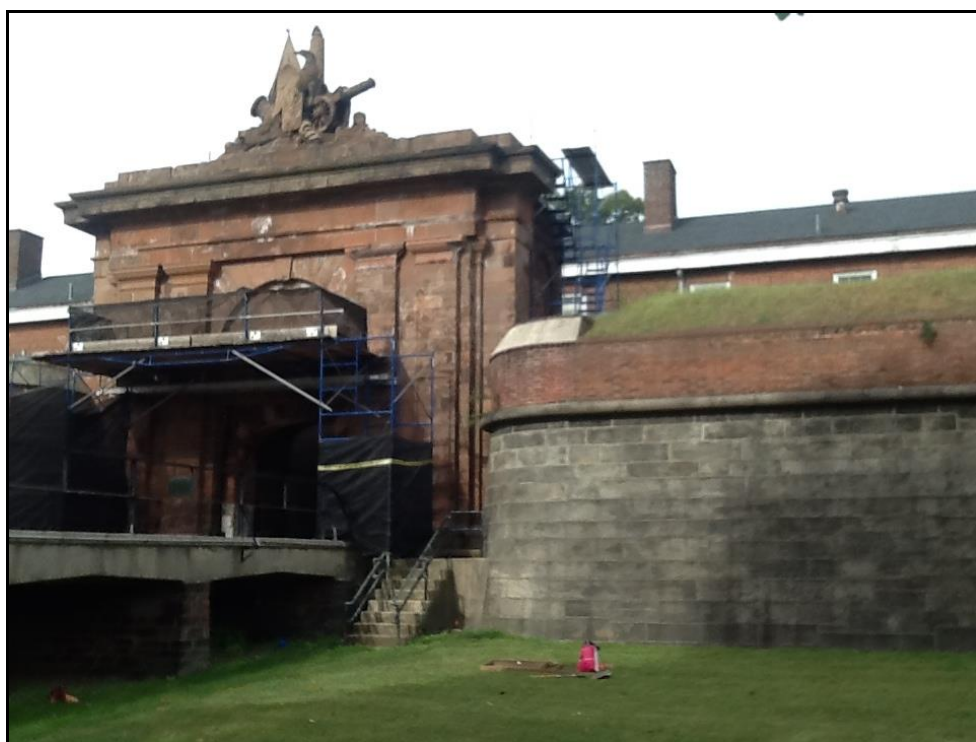
Figure 14. Looking southwest at Dry Moat -- North of Bridge Area. STP 1 (coordinates N 0/E+1; the northwestern corner is in line with the North datum and 1 m [3.2 ft] to the east of it) is being excavated.

Dry Moat – North of Bridge Area. Seven STPs (STPs 1-7) were excavated 1 m apart in the dry moat north of the bridge to Fort Jay (Figures 14 and 15). A datum point was selected on the scarp where it begins to curve towards the gate. Horizontal coordinates in this part of the APE are measured from this datum. Vertical measurements are taken from the northwest corner of each STP. The ground surface is fairly level throughout this part of the APE, except for a slight depression in front of the concrete stairs and a slope at the edge of the bridge.

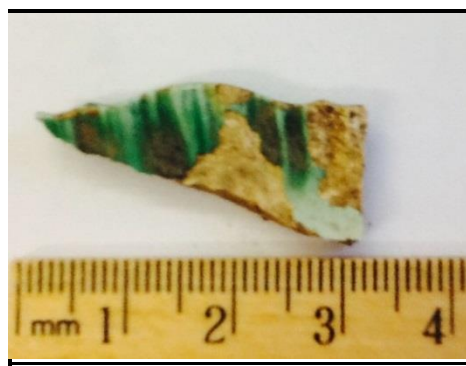
Figure 16. Green shell-edged pearlware (1800-1830), found in STP 6, 50 cm (1.6 ft) bgs.

The typical STP stratigraphy was very dark brown (7.5YR 2.5/2) silty fine sandy loam (0 to 30 cm [0 to 1 ft] bgs) over yellowish-brown (10YR 5/4) silty fine sand to 50 cm (1.6 ft) bgs. All walls had similar profiles and no features. Artifacts in the upper stratum included modern trash. In the second stratum were late 18th and early 19-century artifacts (e.g., clay pipe stem and bowl fragments, olive green bottle glass, a sherd of hand-painted blue-on-white porcelain, and a sherd of green incised shell-edged pearlware [1800-1830, Figure 16], and a brick [1870-1929]).

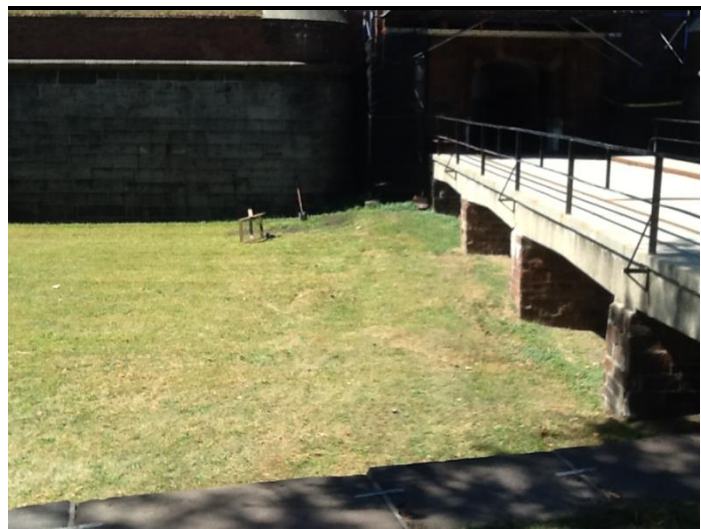
Figure 17. Dry Moat – South of Bridge Area. STP 8 (coordinates S 0/E+1; the northwestern corner is in line with the South datum and 1 m [3.2 ft] to the east of it) is being excavated.

Dry Moat – South of Bridge Area. Seven STPs (STPs 8-14) were excavated 1 m apart in the dry moat north of the bridge to Fort Jay (Figures 17 and 18).

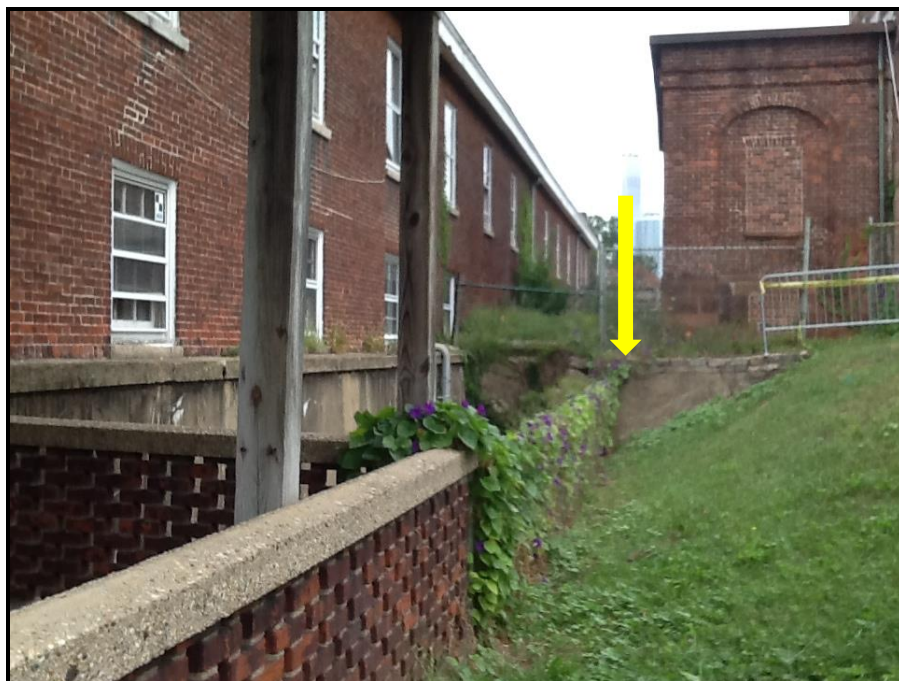
Figure 20. Looking south towards Guardhouse Area. Building 201, right; eastern wall of Building 202, left. Unit A excavated at arrow.

Guardhouse Area. Two 1 x 1-m units were excavated here. Understanding the location and complex characteristics of this area is aided by the drawings and photographs below. (Figures 19, 20, 21, 22, and 23).

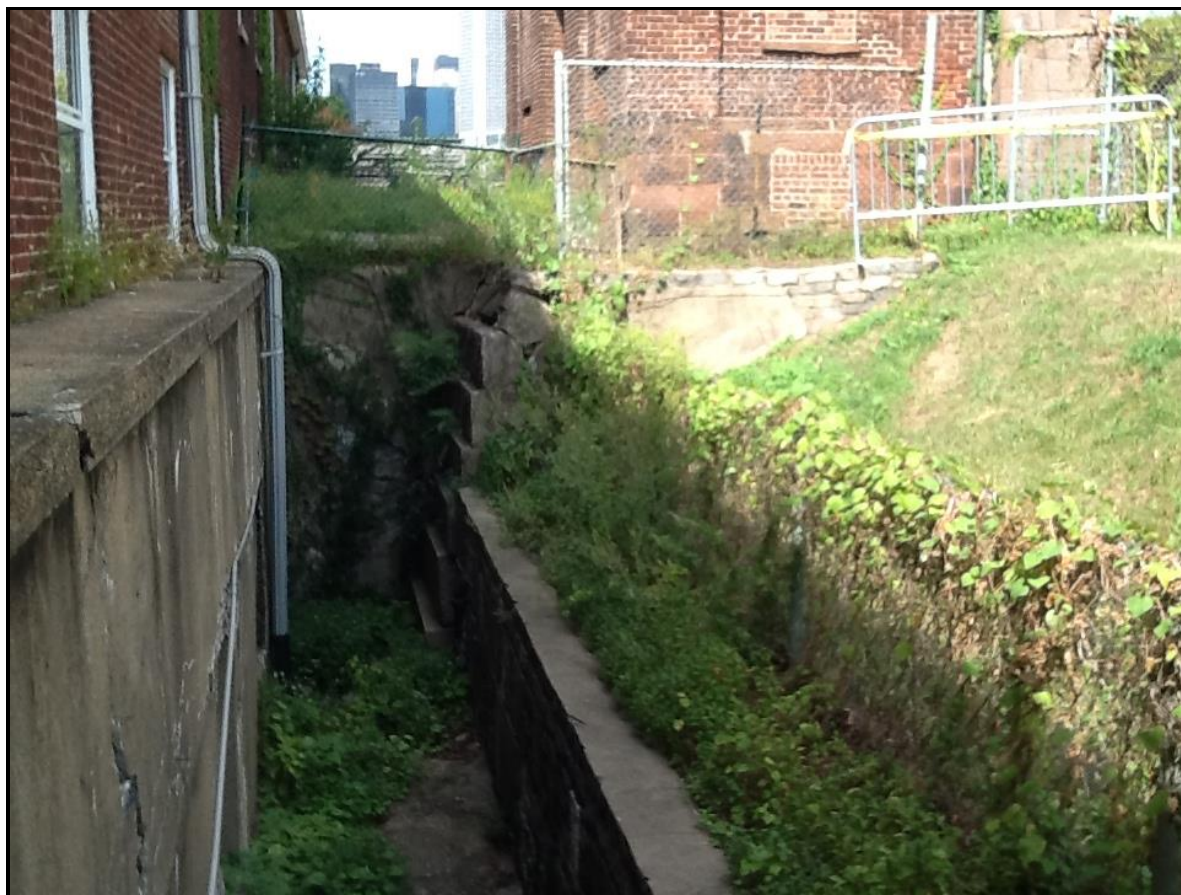
Figure 22. Guardhouse Area, looking north, with areaway in foreground. Note condition of retaining wall below hurricane fence. Photograph taken in September 2014.

Unit A was next to a hurricane fence bordering the retaining wall that borders the areaway (Figures 22 and 23). This retaining wall shows signs of stress, and engineers for the project were interested in learning more about the condition of the wall. Thus, in addition to addressing archeological questions about (a) the possible presence of cultural materials at this location and (b) the construction sequence of the Guardhouse and potential remains associated with former wings of the building, excavation of Unit A could provide information on the structural condition of the wall.

Unit A was increased (to 1.4 m [4.6 ft] in length) to compensate for two areas of concrete blocking excavation. Next to a deteriorated retaining wall, Unit A exposed an opening in its western edge. The condition of the wall was reported to the project managers, and work concluded on this unit as a matter of safety.

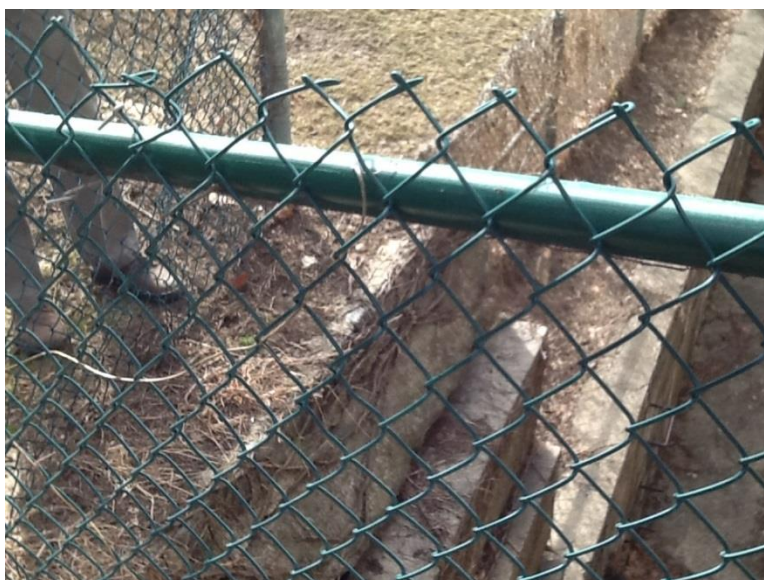
Figure 23. Retaining wall in Guardhouse Area, next to areaway, looking south. Photograph taken in March 2014.

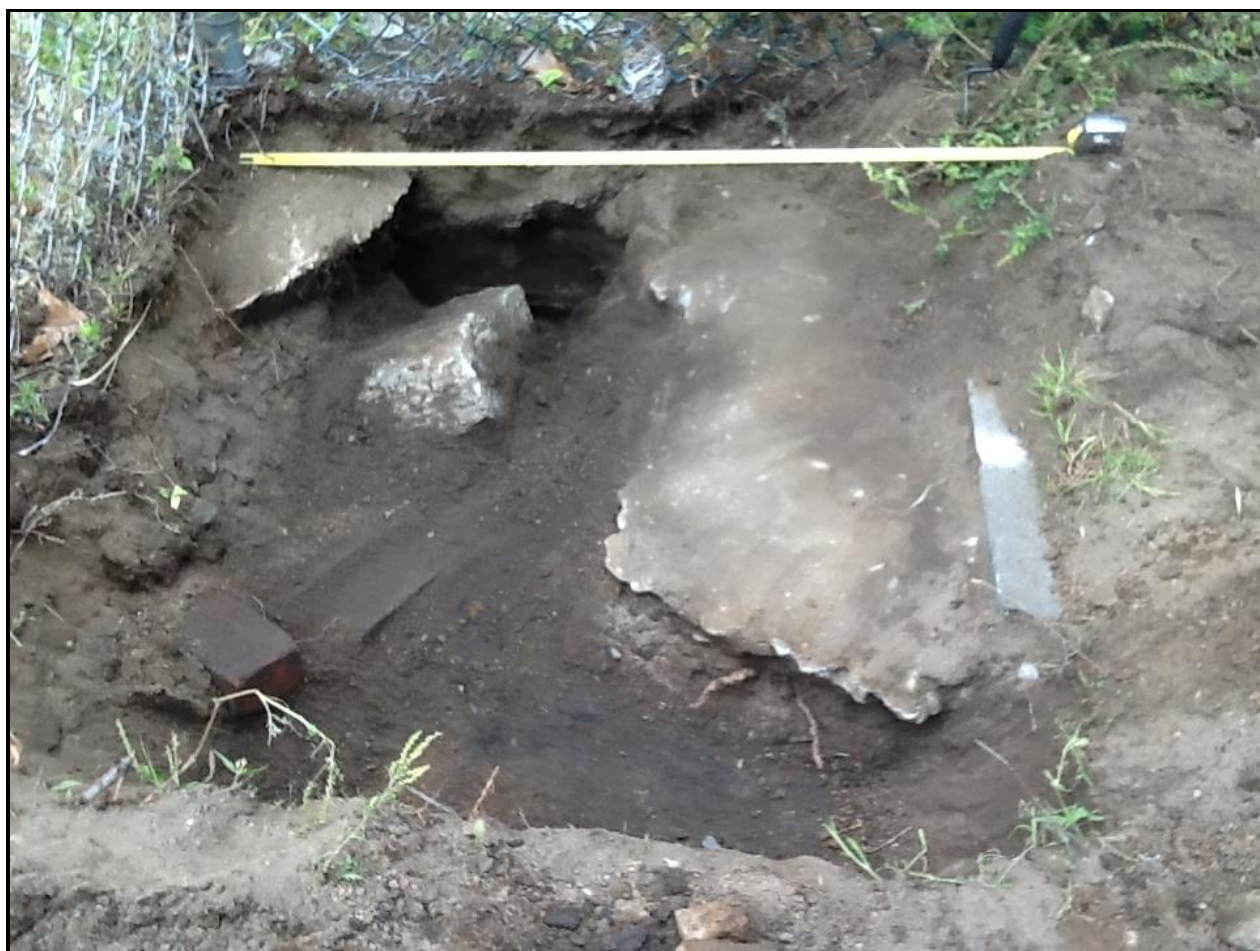
It was necessary to lengthen Unit A to compensate for two areas of concrete. At the western edge of Unit A was a trimmed rectangular granite stone not aligned with any other architectural element and dipping into a hole (Figures 24, 25, and 26). This hole was where the large stone blocks that were used to make the wall are turning in (Figure 22). The information on this unit was recorded, the unit was not backfilled, and the Project Manager was notified of the condition of the wall and potential dangers of further excavation here. Because of the perceived hazards, excavation was halted on this unit except for some careful probing.

Figure 24. Unit A, looking west, tape extended 1 m (3.2 ft). Note dark soil, stone, and bricks.

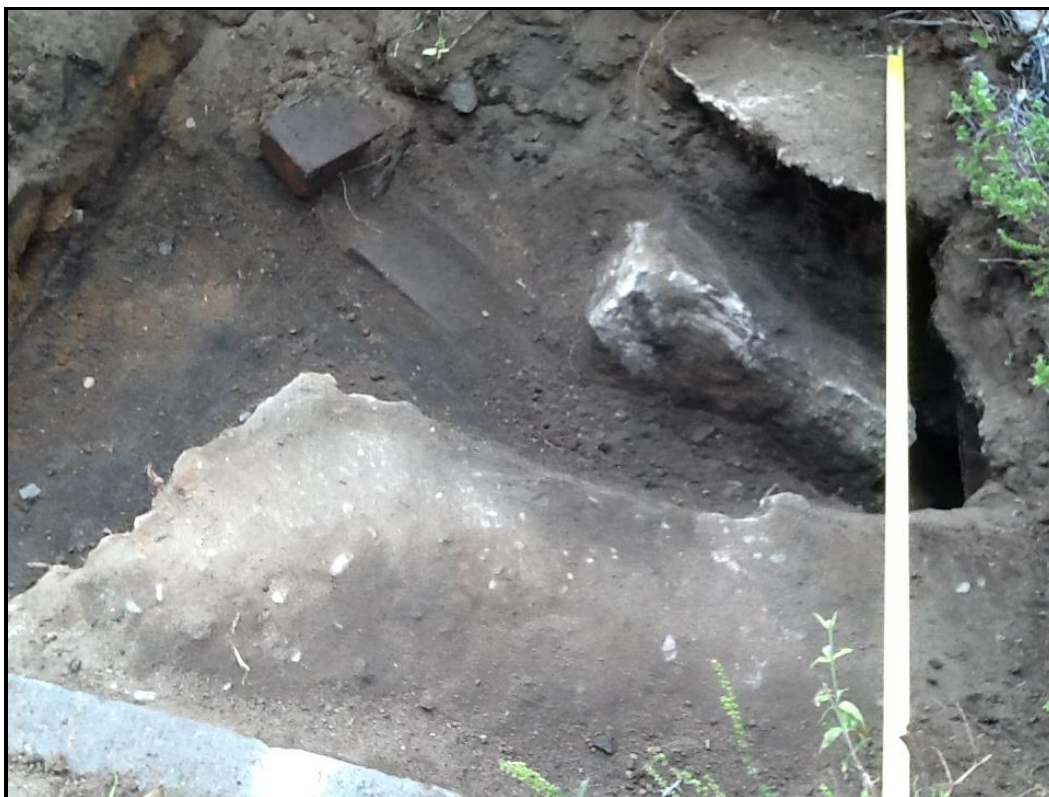
Figure 25. Unit A, looking south, tape extended 1 m (3.2 ft).

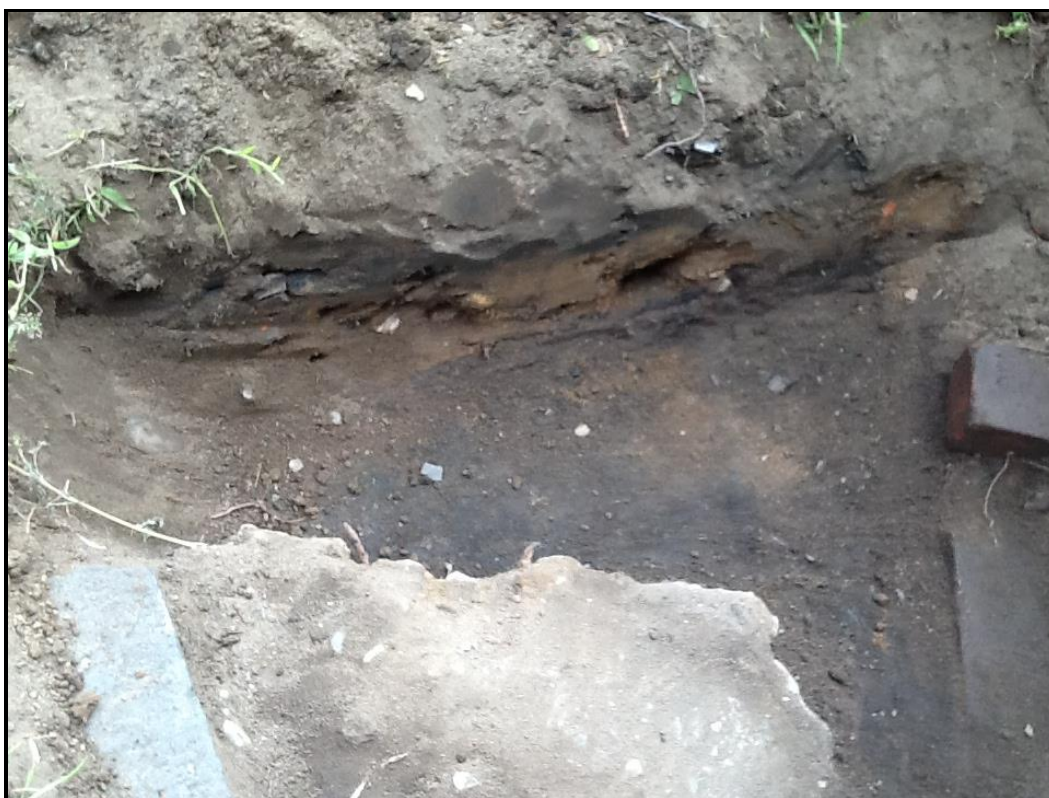
Figure 26. Unit A, looking southeast, showing eastern wall.

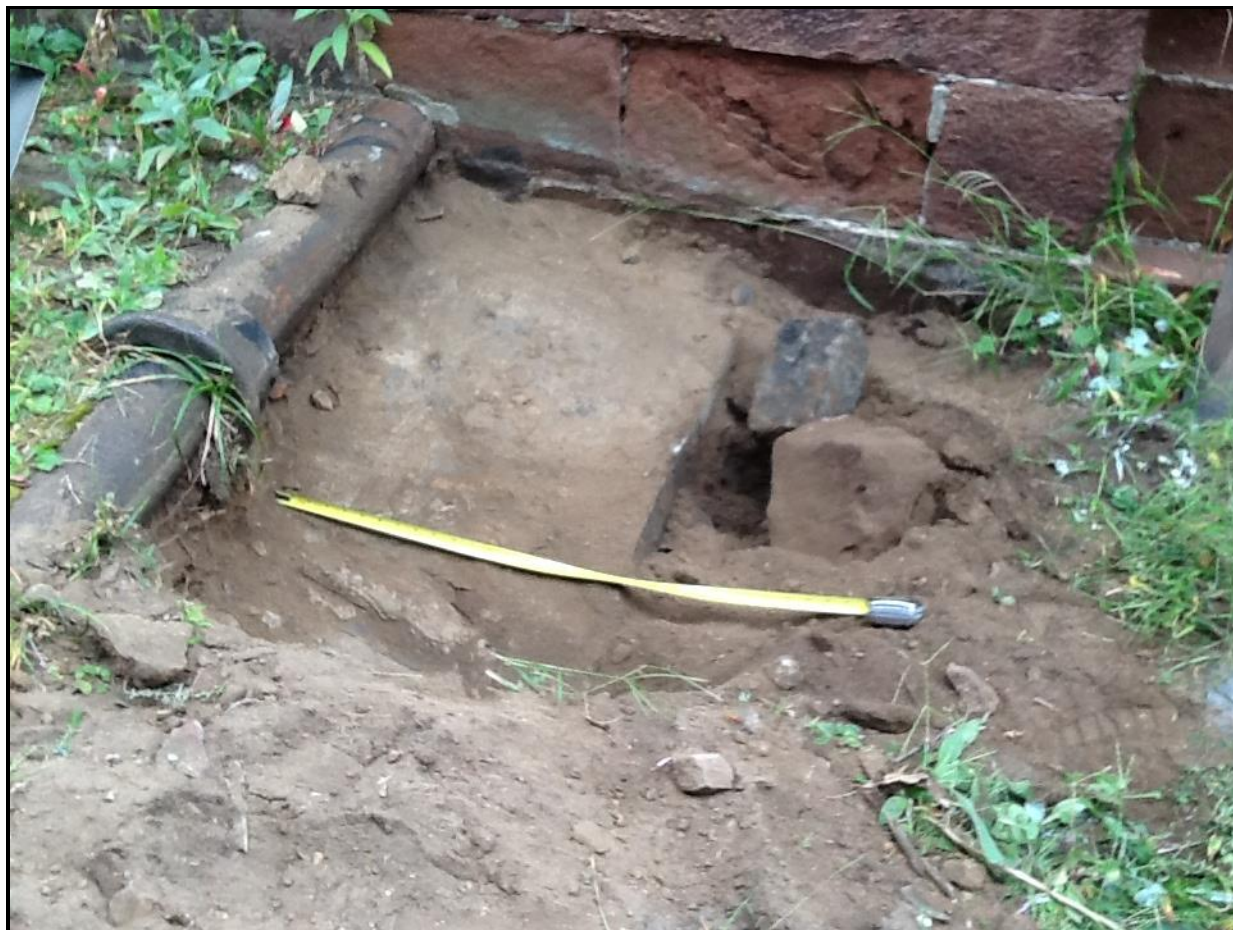
Unit B was located next to the western wall of the Guardhouse, 6' (1.8 m) from the east-west centerline of the Guardhouse (Figure 21). The northern edge of the unit is a cast iron pipe (Figures 27 and 28). Next to the Guardhouse wall is an electrical cable that is not continuous and is out of service; this was detected by a utility survey prior to archeological fieldwork. Fragments of the cable sheathing were present in the unit and on the nearby surface. Two flagstones were removed from the location chose for the unit, and a thin layer of sparse vegetation and loose mixed fill soil was cleared from the surface of this unit (Figure 27). Within 0.05 m (2") bgs was the top of Feature 1.

Figure 27. Unit B, looking northeast, tape extended 1 m. Western wall of Guardhouse (Building 201) abutting the unit on the east, cast iron pipe on the northern edge of the unit. Feature 1 is the concrete structure at the northern end of the unit.

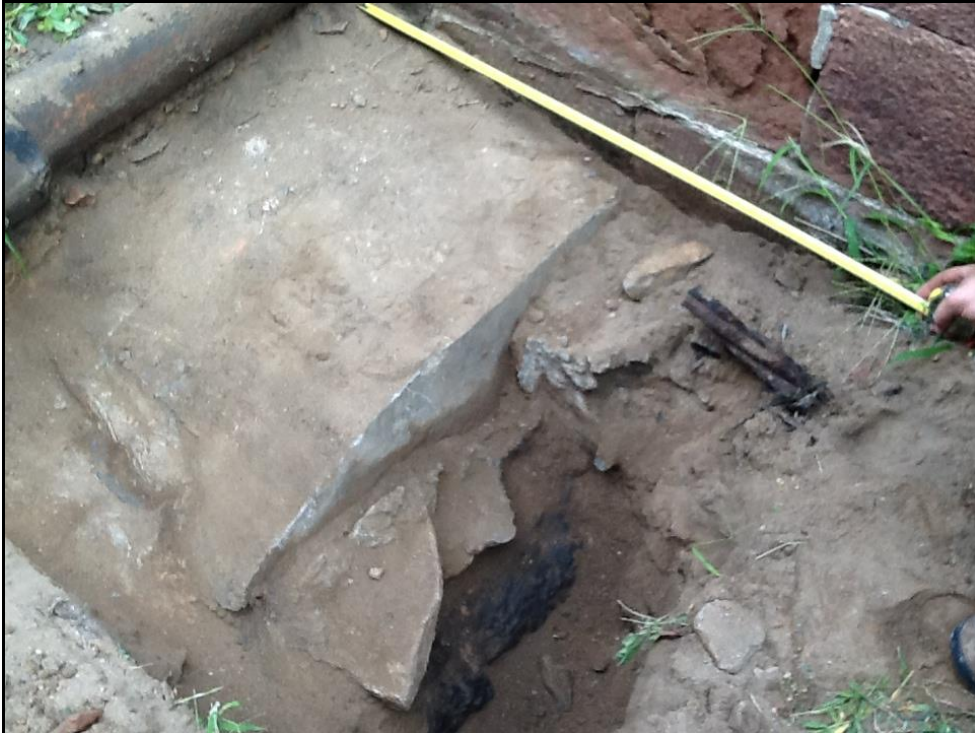
Beneath the concrete in Feature 1 is an area covered with a tar-like substance (Figures 28 and 29). This material extends for the width of the unit in an east-west direction over the Sally Port tunnel, but it is not exposed in the southern wall of Unit B (Figure 30). A drawing from construction plans (1938) indicates that there was to be 2 inches of concrete with a 5-ply waterproofing (Figure 31). The same plans call for the removal of the brick arch and replacing it. Thus, the present Sally Port roof and Feature 1 date from this period or later.

Figure 28. Unit B, looking northeast, tape extended 1 m (3.2 ft).
Feature 1: Concrete over coated lower level. Note disconnected electric cable
and cast iron pipe.

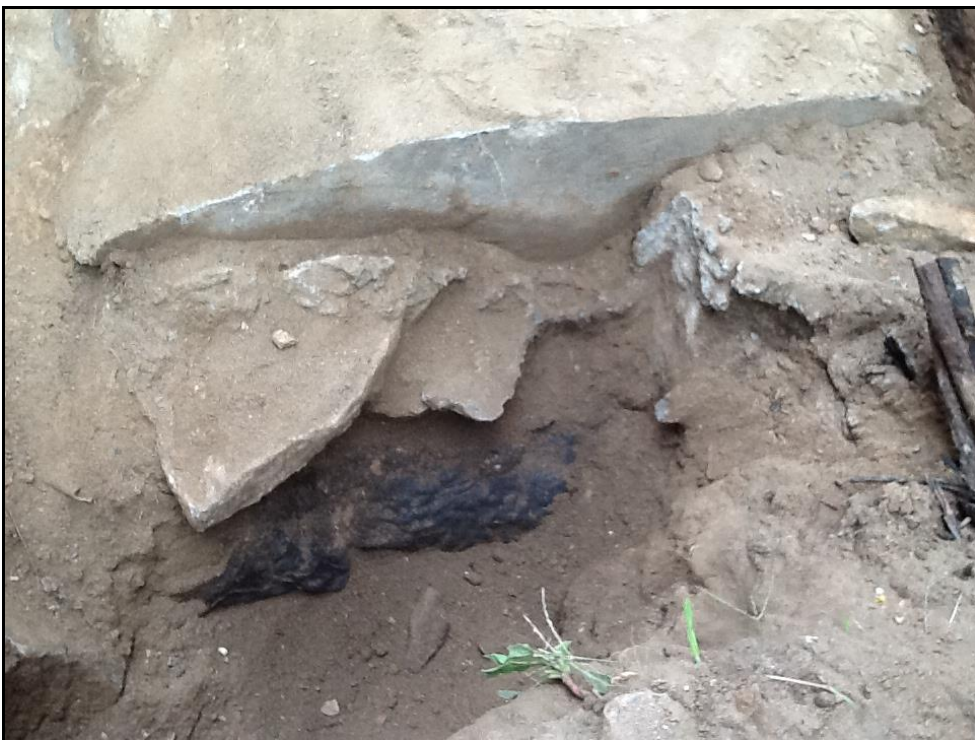
Figure 29. Unit B, looking north. Two components of Feature 1 exposed.

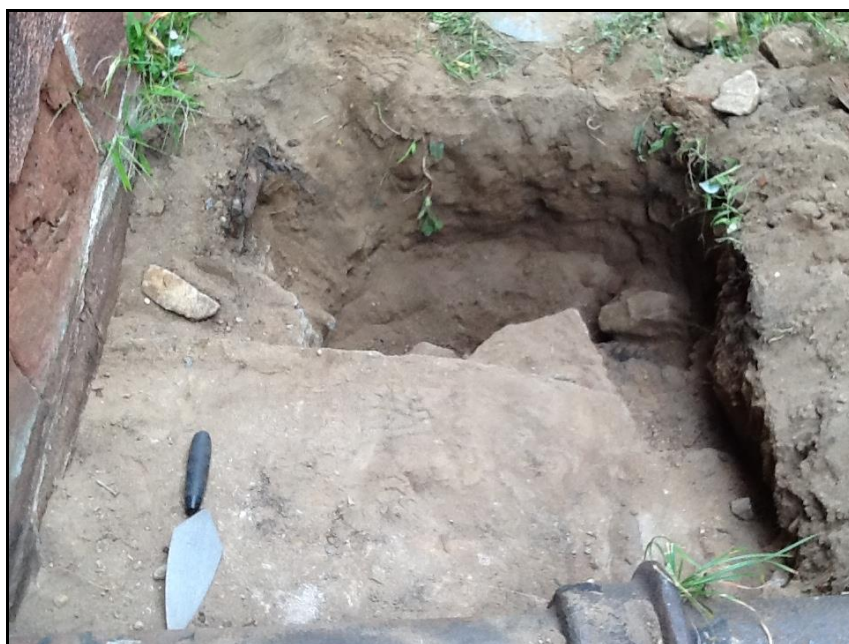
Figure 30. Unit B, looking south.

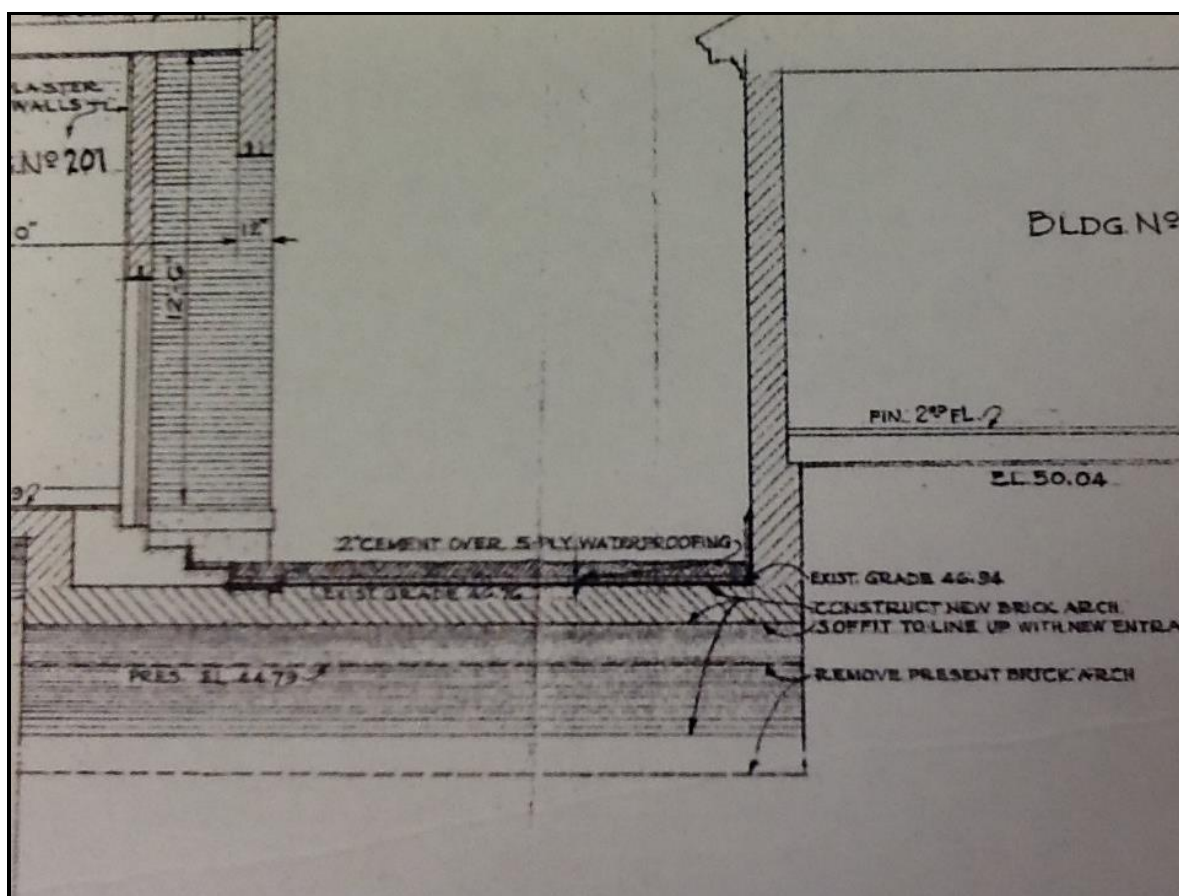
Figure 31. Construction plan (1938): Specification for cement over 5-ply waterproofing.
