## **PHASE IB ARCHEOLOGICAL FIELD RECONNAISSANCE**

**James J. Peters, Veterans Affairs Medical Center  
Spinal Cord Injury/Disorder Center and Parking Structure**

130 West Kingsbridge Road  
New York City, Borough of the Bronx  
Bronx County, New York

March 2012

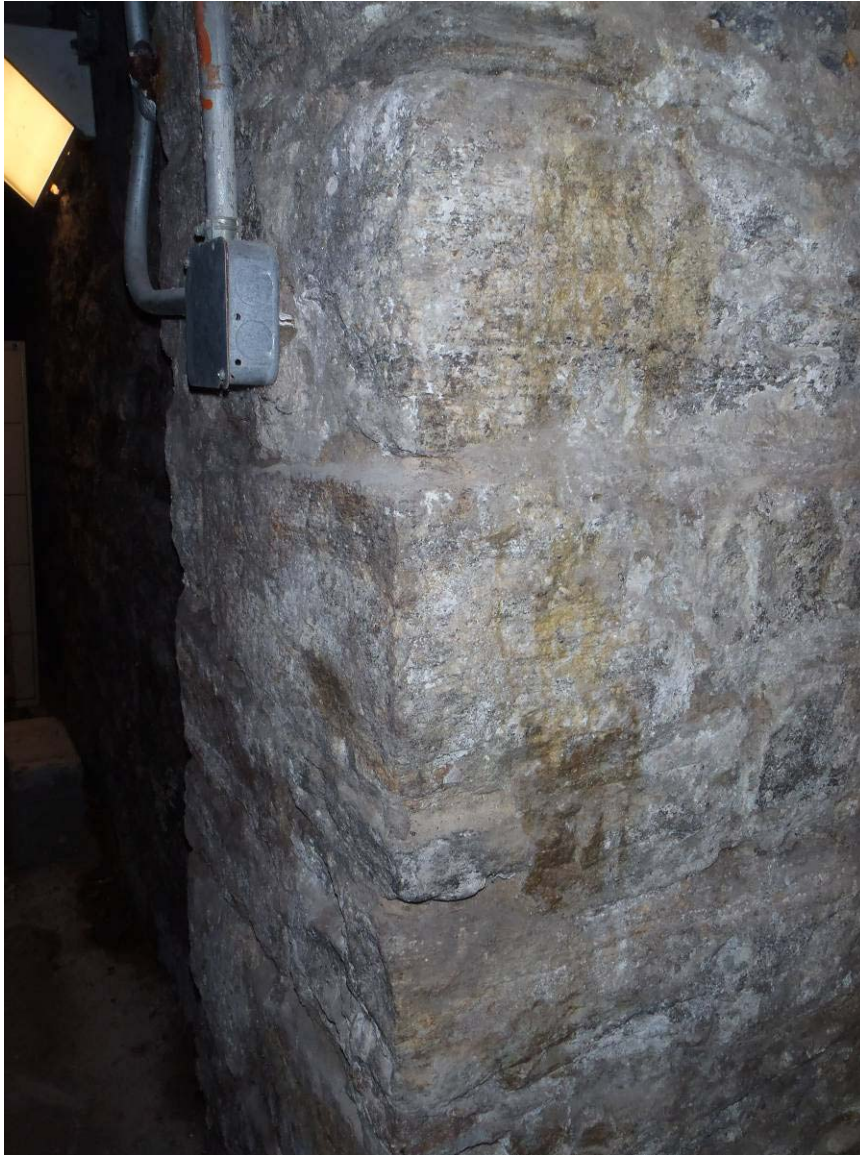
Photo 1. The foundation under the extant chapel that was part of the early 20<sup>th</sup>-century Roman Catholic Orphan Asylum at the VAMC property. This stone appears to be Fordham gneiss, a black-and-white banded, metamorphic rock that underlies this area of the Bronx. Stone similar to the type shown here were found in the 1970s demolition layer from the razing of the Roman Catholic Orphan Asylum in Trenches 1-3.

The Phase IA report described the bedrock geology in the project area as Inwood Marble. However, upon closer field inspection of bedrock outcrops, as well as bedrock encountered in the trenches and reexamination of the bedrock geology map (Fisher et al. 1970) it was determined that Fordham Gneiss is the bedrock type underlying the project area. This is notable as this is the type of stone used to construct the c. 1899 orphanage building foundations (Photo 1).

this variety of gneiss was used in the construction of the old orphanage/hospital buildings (Photo 1). A layer of dark yellowish brown loamy sand subsoil was uncovered below the demolition layer at about 8.2 ft (2.5 m) below current ground surface. The trench terminated when large fragments of gneiss bedrock were encountered at about 9.5 ft (2.9 m) below ground surface.

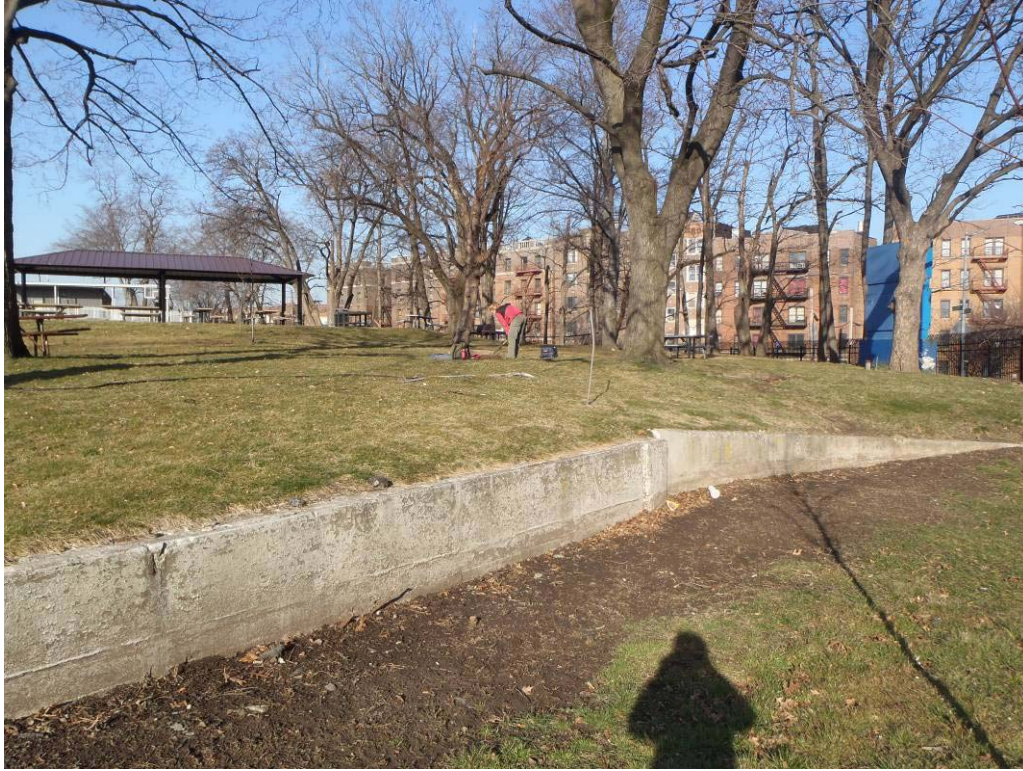
Photo 2. View west of an archeologist excavating STP 7 in the grassy area near the north end of the SCI/D APE.

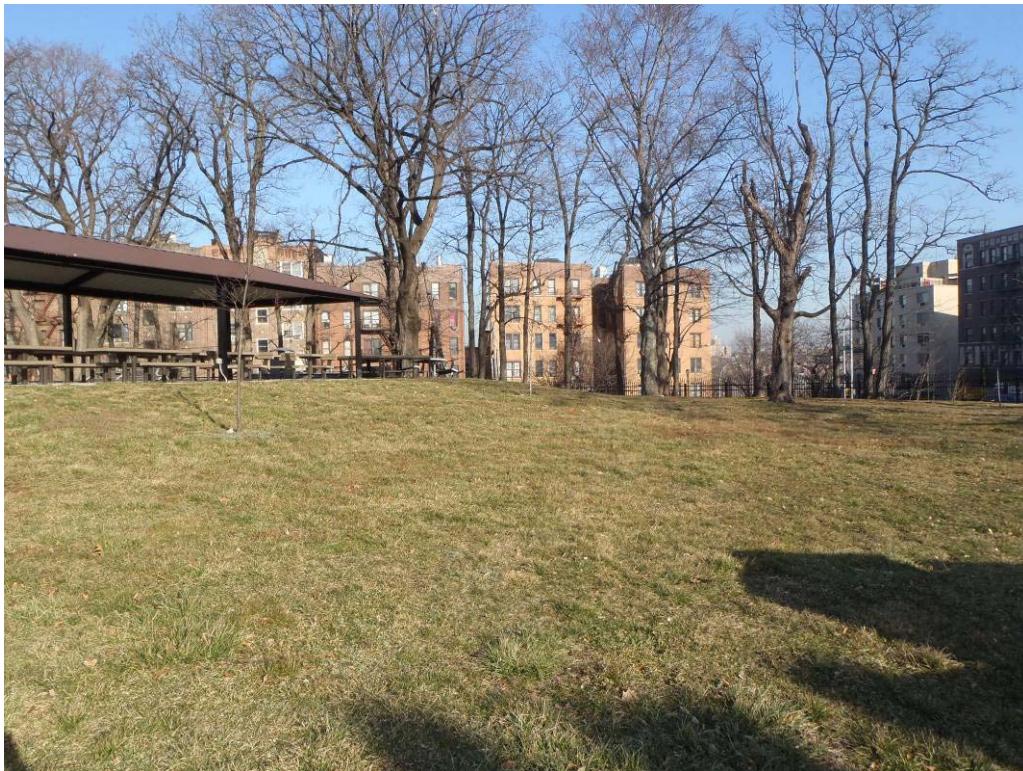
Photo 3. View north of the existing picnic pavilion and the filled elevated area it is located upon. This area was not tested.

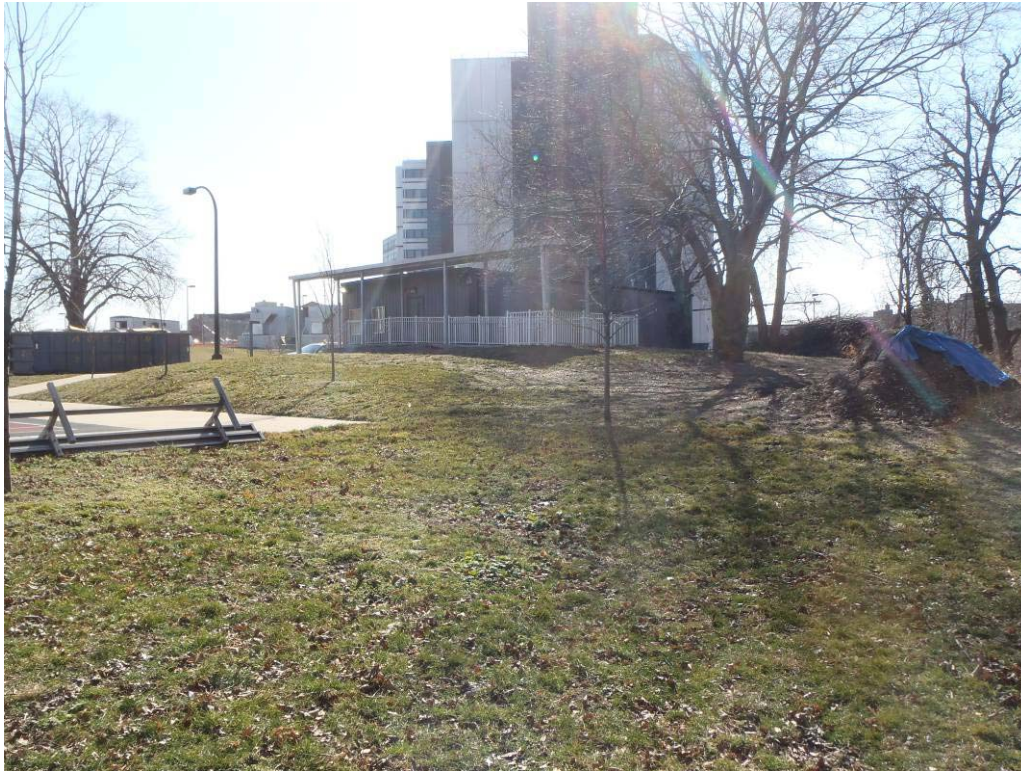
Photo 4. View southwest of the south portion of the grassy area at the north end of the SCI/D Center APE. A filled elevated area was constructed for the small one-story building in the mid-ground between the photographer and the main hospital building. This area was not tested.

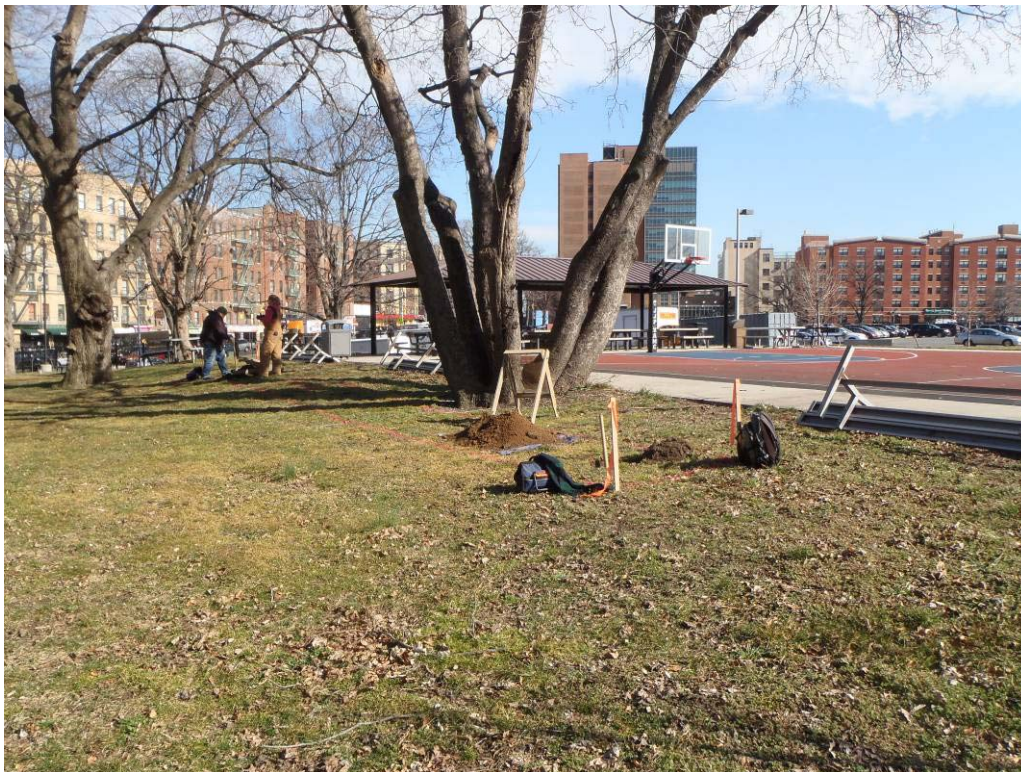
Photo 5. View east of STP 1 (screen and pile of soil in the foreground) and STP 2 being excavated by two archeologists in the distance.

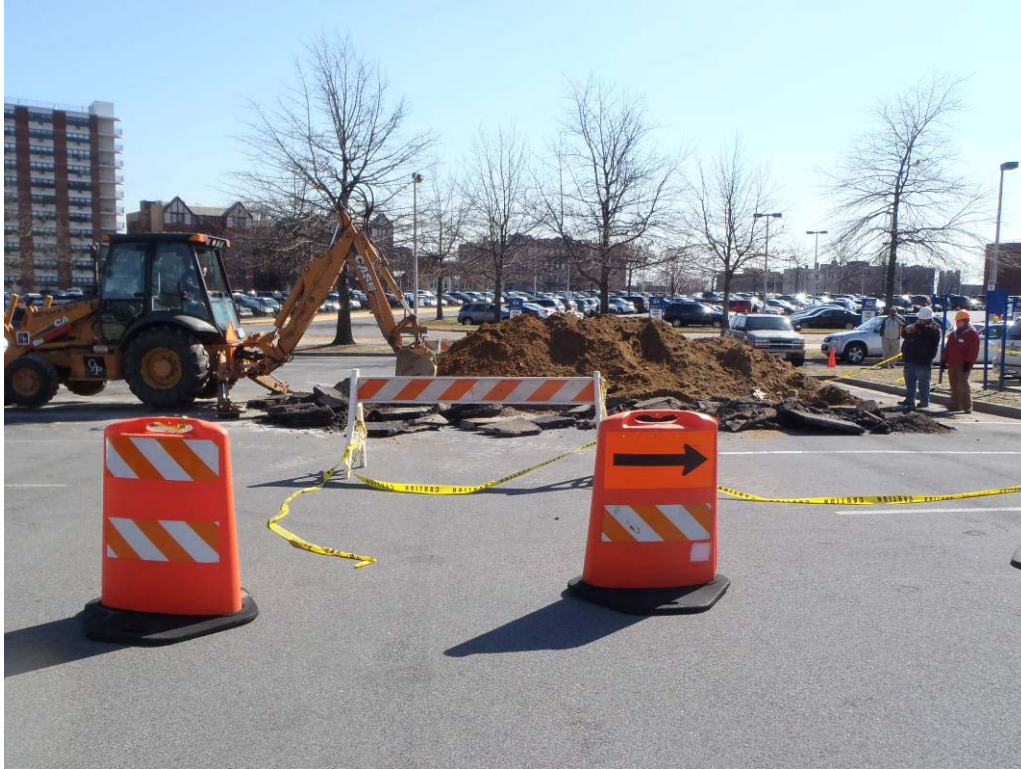
Photo 6. View south of Trench 1 being excavated.

Trench 1, located in the parking lot near the southwest portion of the SCI/D APE was placed between two of the orphanage wings to look for deposits associated with the occupation of the orphanage or earlier deposits associated with the Revolutionary War-era fort adjacent to the APE (Maps 2 and 2a, Photo 6, Figure 1). Beneath about 17.7 inches (45 cm) of parking lot asphalt and modern crushed stone fill, the trench uncovered a brown sandy loam fill layer about 6.3 to 19.7 inches (16 to 50 cm) thick with large gneiss cobbles interspersed (Figure 1, Level 2). Beneath this fill layer there was a thick deposit of yellowish brown loamy sand with large gneiss cobbles. This layer represents the razing of the old orphanage/hospital buildings in the 1970s. Examination of the foundation in the basement of the extant c. 1899 chapel at the site revealed that

No historical or precontact artifacts were identified in Trench 1. The stratigraphy in this trench indicates that the 1970s demolition and grading of the site removed or disturbed any pre-1970s deposits or soils, as the natural subsoil was immediately below the demolition layer.

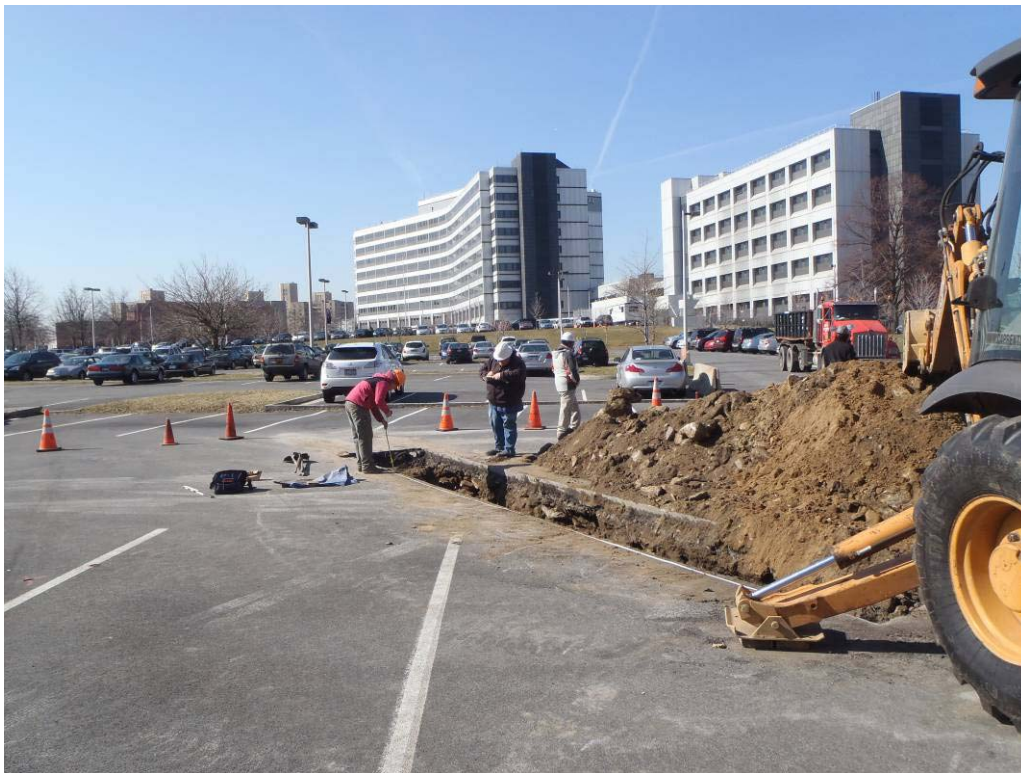
Photo 7. View southwest of two archeologists measuring and documenting Trench 2.

Trench 2 was excavated in the northeastern portion of the SCI/D Center APE in order to identify remains associated with MDS 1, a structure attributed to L. Valentine on the 1872 Beers map (map not shown in this report, see Phase IA Map 6) (Maps 2 and 2a, Photo 7, Figure 2). The first layer below the asphalt was the 1970s demolition layer represented by 29.5-inch (75 cm) thick dark yellowish brown loamy sand with large gneiss cobbles (Figure 2, Level 1). Mottled light olive brown and dark brown loamy sand about 24 inches (60 cm) thick was encountered below the demolition layer (Level 2). This layer was likely associated with the early 20<sup>th</sup>-century construction of the orphanage. A 9-inch diameter c. 1920-30s terracotta drain was uncovered in this layer. The construction type and location of the drain buried beneath the 1970s demolition layer indicated that it was associated with early 20<sup>th</sup>-century orphanage/hospital buildings. Below the early 20<sup>th</sup>-century construction layer was a mottled yellowish brown and dark yellowish brown sand about 15.8 inches (40 cm) thick. This deposit represents a disturbed layer of natural subsoil. Subsoil consisting of dark yellowish brown loamy sand with large fragments of gneiss bedrock was encountered about 6.2 ft (1.9 m) below the current ground surface. The east end of Trench 2 terminated at about 6.9 ft (2.1 m) below current ground surface when the backhoe encountered large fragments of gneiss bedrock. The west end of the trench was not excavated any deeper than the terracotta drain at about 3.3 ft (1 m) below ground surface.

The intact c. 1920-30s drain tile below the 1970s demolition layer evidenced that pre-1970s deposits were intact in Trench 2. However, examination did not uncover artifacts or other indications of historical or precontact activity in the trench. Levels 2 and 3 were also mottled indicating some disturbance perhaps associated with historical construction on the site.

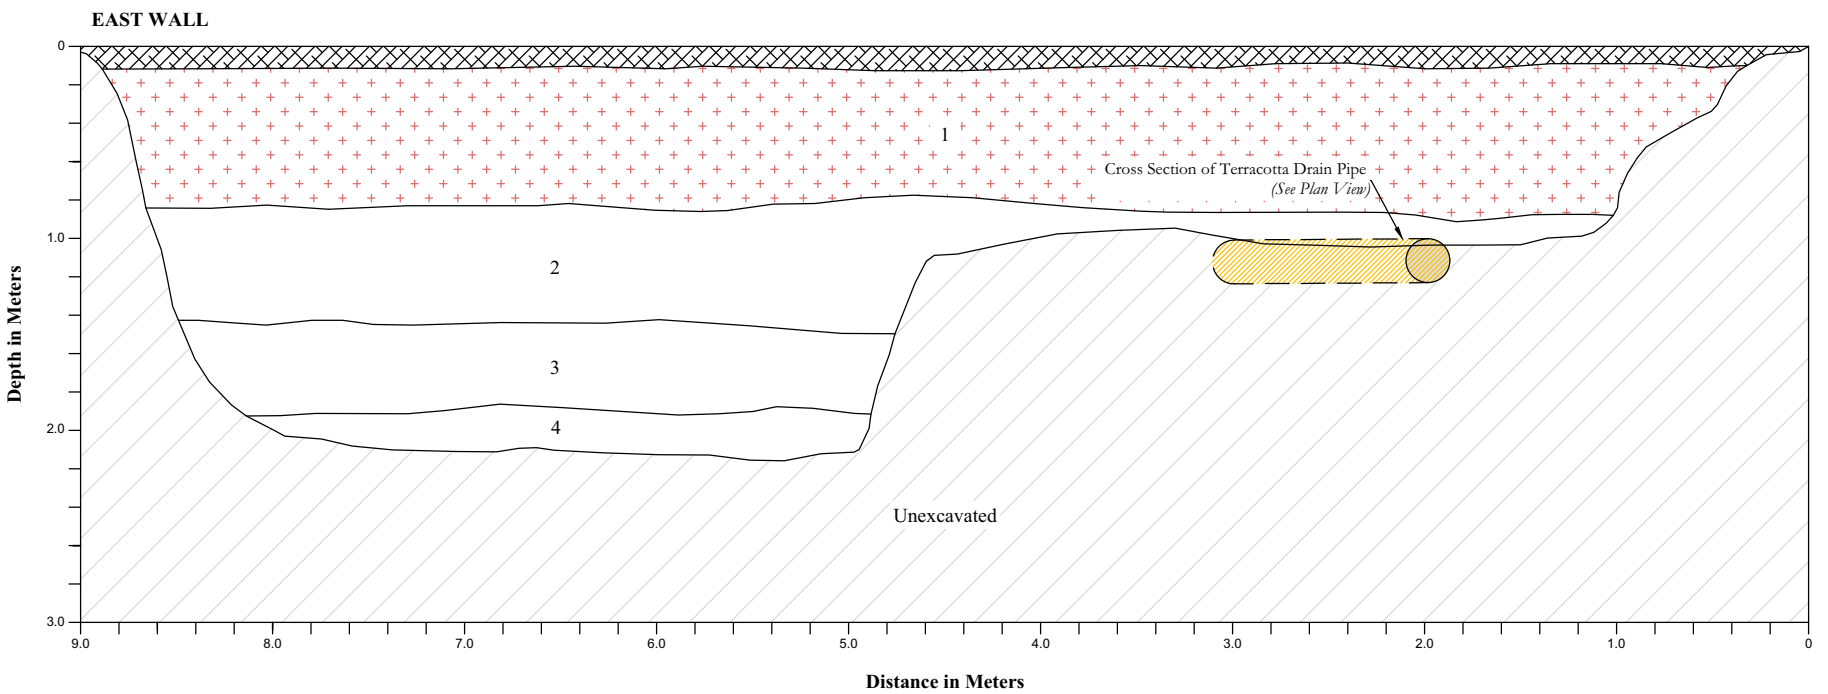
- Asphalt parking lot surface
- 1970s demolition rubble/fill
- Level 1: Dark yellowish brown (10YR 4/4) loamy sand with large gneiss cobbles (1970s demolition layer)
- Level 2: Light olive brown (2.5Y 5/3) and dark brown (10YR 3/3) loamy sand (early 20<sup>th</sup>-century construction layer/fill)
- Level 3: Yellowish brown (10YR 5/6) and dark yellowish brown (10YR 4/6) sand with small cobbles (early 20<sup>th</sup>-century disturbance/construction layer mixed with buried subsoil)
- Level 4: Dark yellowish brown (10YR 4/6) loamy sand with large fragments of gneiss bedrock (subsoil)

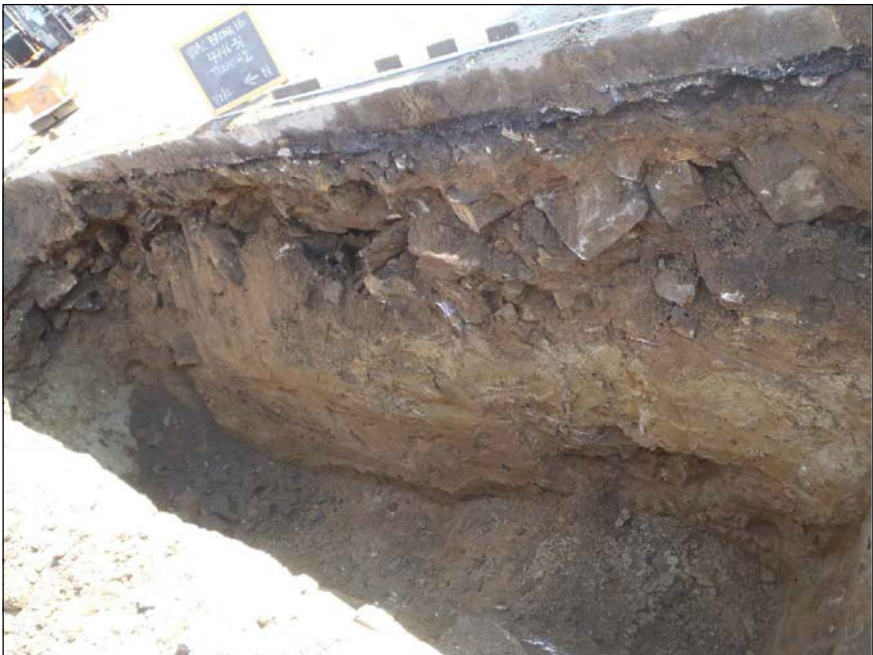
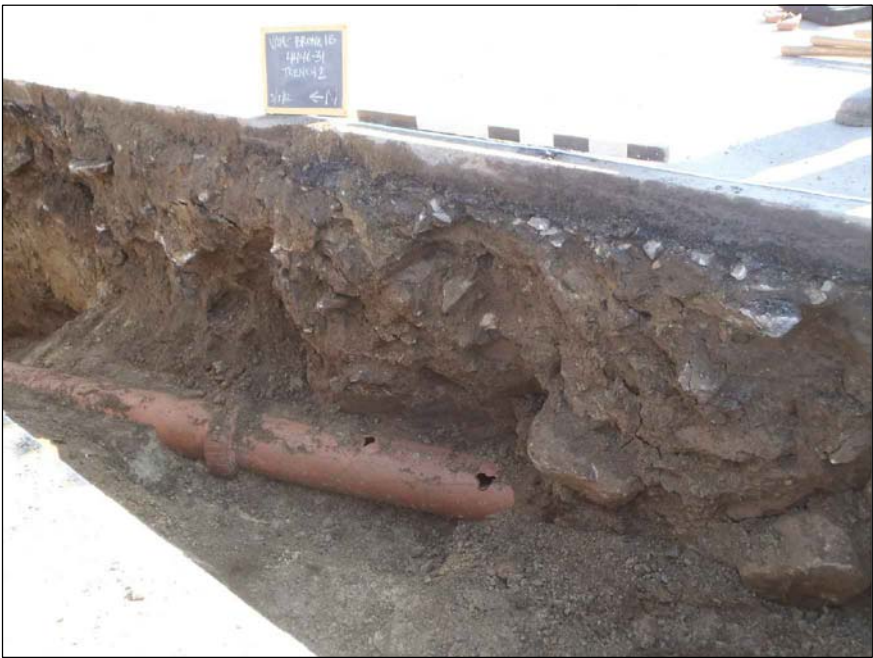
- Asphalt parking lot surface
- 1970s demolition fill/rubble
- Level 1: Dark yellowish brown (10YR 4/4) cobbles and sand (modern parking lot fill)
- Level 2: Yellowish brown (10YR 5/6) sand and dark brown (10YR 3/3) sandy loam (1970s demolition layer)
- Level 3: Large gneiss cobbles (hole rubble associated with c. 1914 outbuilding)
- Level 4: Dark yellowish brown (10YR 4/6) loamy sand with lenses of light olive brown (2.5Y 5/4) sand (early 20<sup>th</sup>-century construction layer)
- Level 5: Dark brown (10YR 3/3) loamy sand (pre- 20<sup>th</sup>-century buried A horizon)
- Level 6: Dark yellowish brown (10YR 4/6) loamy sand (subsoil)

No artifacts were identified in Trench 3. The stone rubble (Level 3) in the center of the trench was a feature associated with a c. 1900 toilet building attached to the orphanage. This building was likely in use until the 1970s and was demolished with the adjacent portions of the orphanage/old hospital. No structural remains or artifacts were apparent in the rubble. Although portions of the pre-20<sup>th</sup> century buried A horizon were intact (Level 5) no artifacts or features were noted in the layer.

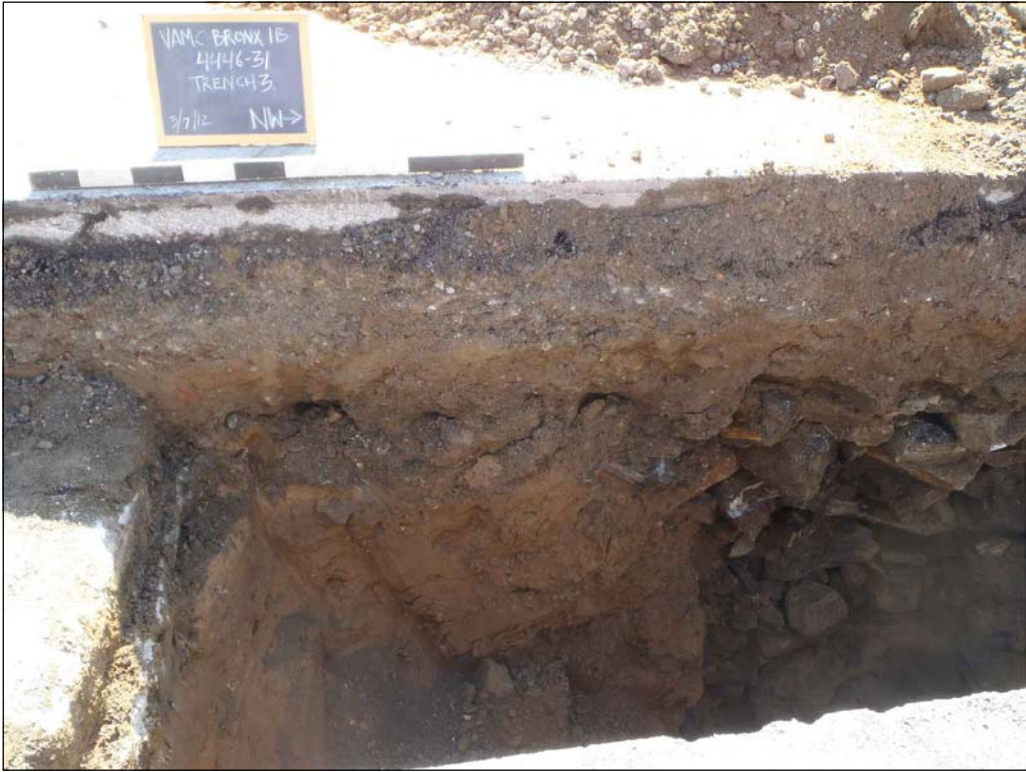
View southwest of the south wall of Trench 3 near the east end of the trench.

Trench 3 was excavated in the northeastern portion of the Park Structure APE (Map 2b, Figure 3). The purpose of this trench was to uncover intact historic deposits associated with the early 20<sup>th</sup>-century orphanage. Level 1 below the parking lot asphalt was 11.8 to 21.7 inches (30 to 55 cm) of dark yellowish brown cobbles and sand modern fill (Figure 3, Level 1). A concrete slab foundation associated with a c. 1950 storage building shown on the 1950 Sanborn map (not shown in report) was uncovered about 19.7 inches (50 cm) below ground surface at the east end of the trench. The 1970s demolition layer was uncovered at about 22 to 31.5 inches (56 to 80 cm) below ground surface (Level 2). The cellar hole and stone rubble associated with an outbuilding shown on the 1914 and 1950 Sanborn maps was identified in the center of the trench (Level 3). The outbuilding was a toilet room probably constructed between 1900 and 1914 for the girls' side of the orphanage. The label of "toilet," rather than privy or outhouse, as well as the close proximity to the main building, suggests that the facilities had running water and flushing toilets rather than a waste vault. The archeology also confirms that there was no waste vault under the building. When the orphanage was built around the turn of the century, indoor flush toilets were just beginning to become standard in urban areas. Providing accommodations for 1,600 children without such facilities could have been dangerously unsanitary. In addition, toilet facilities at an institution such as an orphanage would have been deemed even more imperative as an opportunity to educate children from indigent circumstances on the relatively new ideas of sanitation and health.
