**EUGENE J. BOESCH PH.D., R.P.A.**  
**ARCHAEOLOGY AND HISTORIC PRESERVATION CONSULTANT**

**Re:** Sub-surface Testing for the Expanded APE for the Pelham Bay Park South Waterfront  
Naturalization project, located in Pelham Bay Park, the Bronx, New York. New York  
State Office of Parks, Recreation and Historic Preservation Project Review Number  
13PR01852

**April 25, 2016**

### **1.0 Introduction**

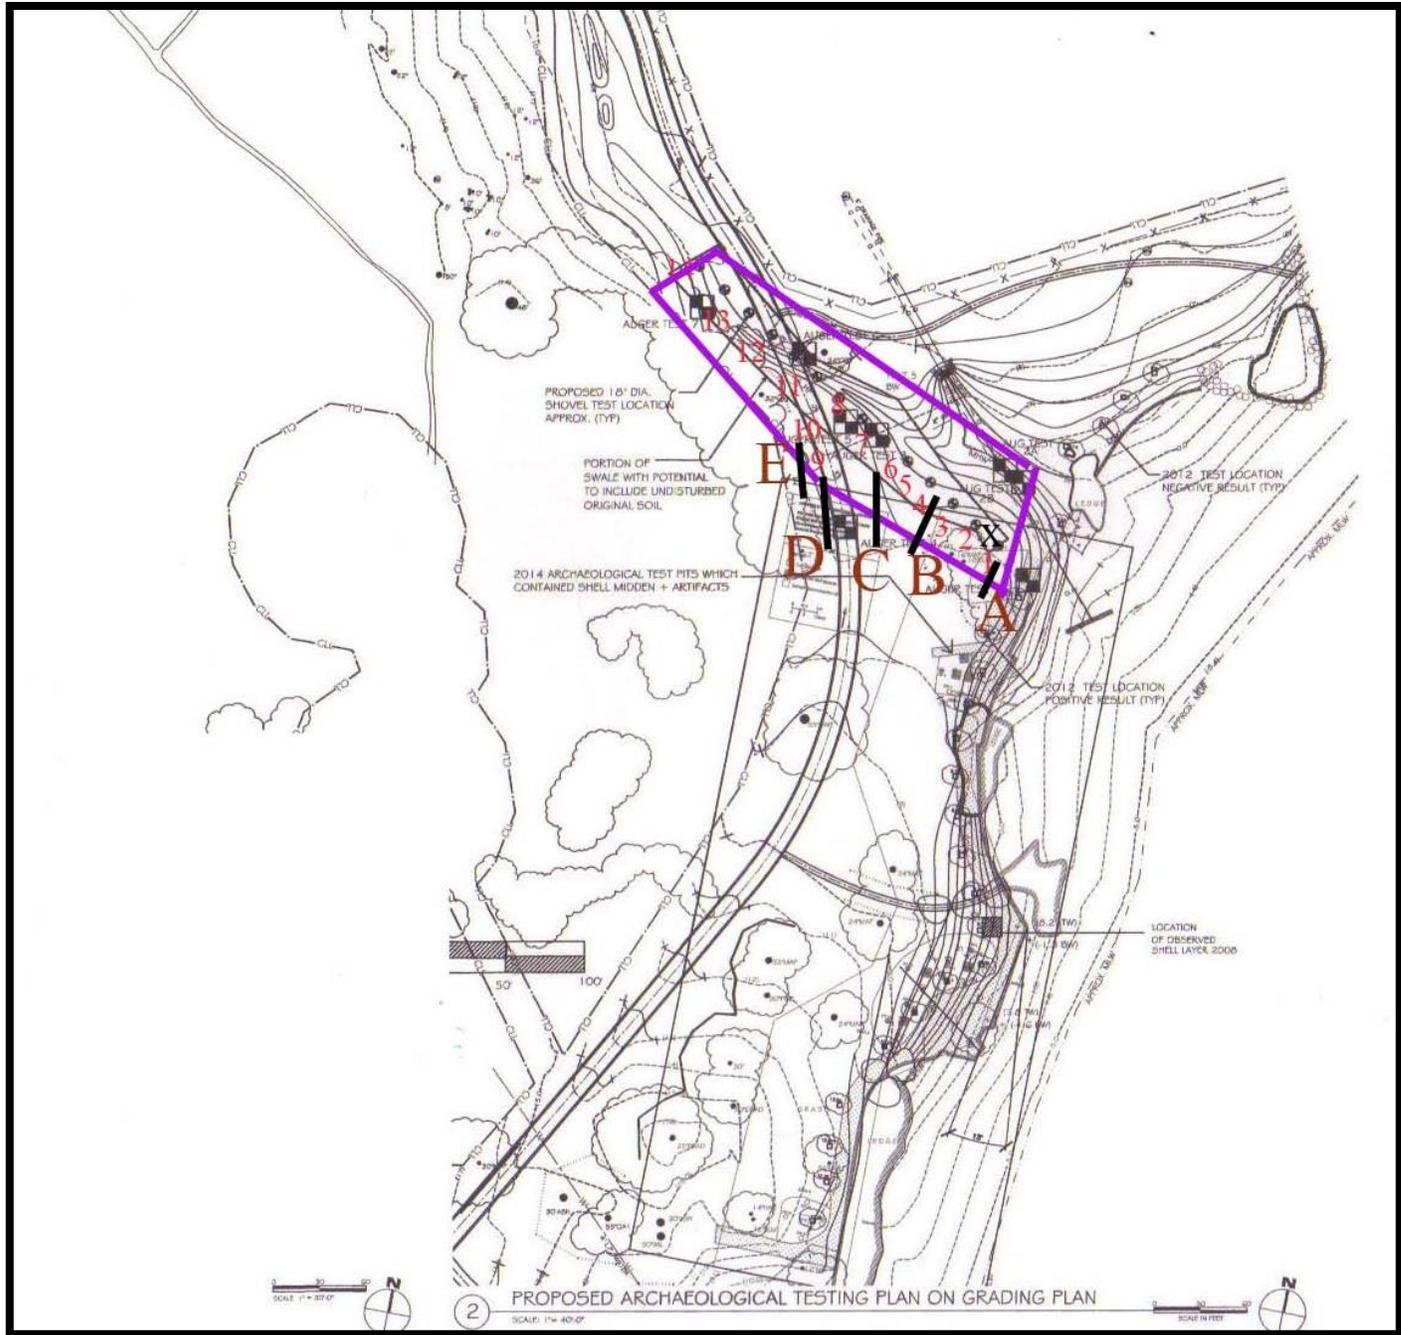
**Figure 2**

The shovel testing investigated the stratigraphy present in the expanded APE and recovered a sample of the cultural material that may be associated with those strata in order to determine whether evidence of Pre-Contact period and/or Historic period activity were present. The shovel tests were located on the slightly raised ground overlooking the south edge of the swale (Figure 2). Each shovel test was approximately 18 inches (46 cm.) in diameter and extend either to depths below which naturally occurring, culturally sterile sub-soil was encountered or the extent achievable using the shovel testing techniques employed. At a minimum, however, tests were extended to at least 30 inches (76 cm.) below modern grade or to bedrock. Shovel tests were placed along a single transect at intervals of 20 to 25 feet. If potentially significant soil layers or artifacts were identified within a shovel test, additional tests were to be placed in the immediate vicinity of the initial test find to further evaluate the location. This proved not to be necessary. The location of each shovel test conducted is shown on Figure 2.

**Approximate Locations of Shovel Tests, Test Trenches, and Brick and Concrete Feature**

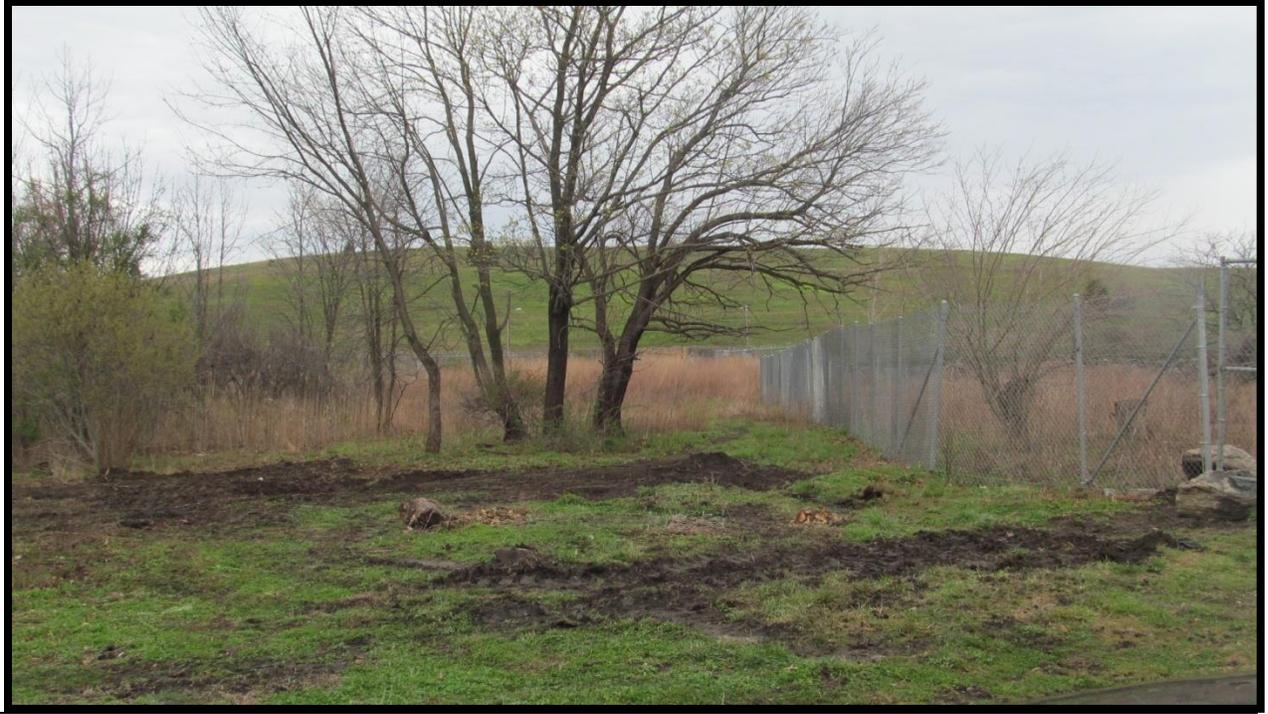
**Figure 3**

**Southeastern Part of the Tested Portion of the Expanded Area of Potential Effect for the Pelham Bay Park South Waterfront Naturalization Project**

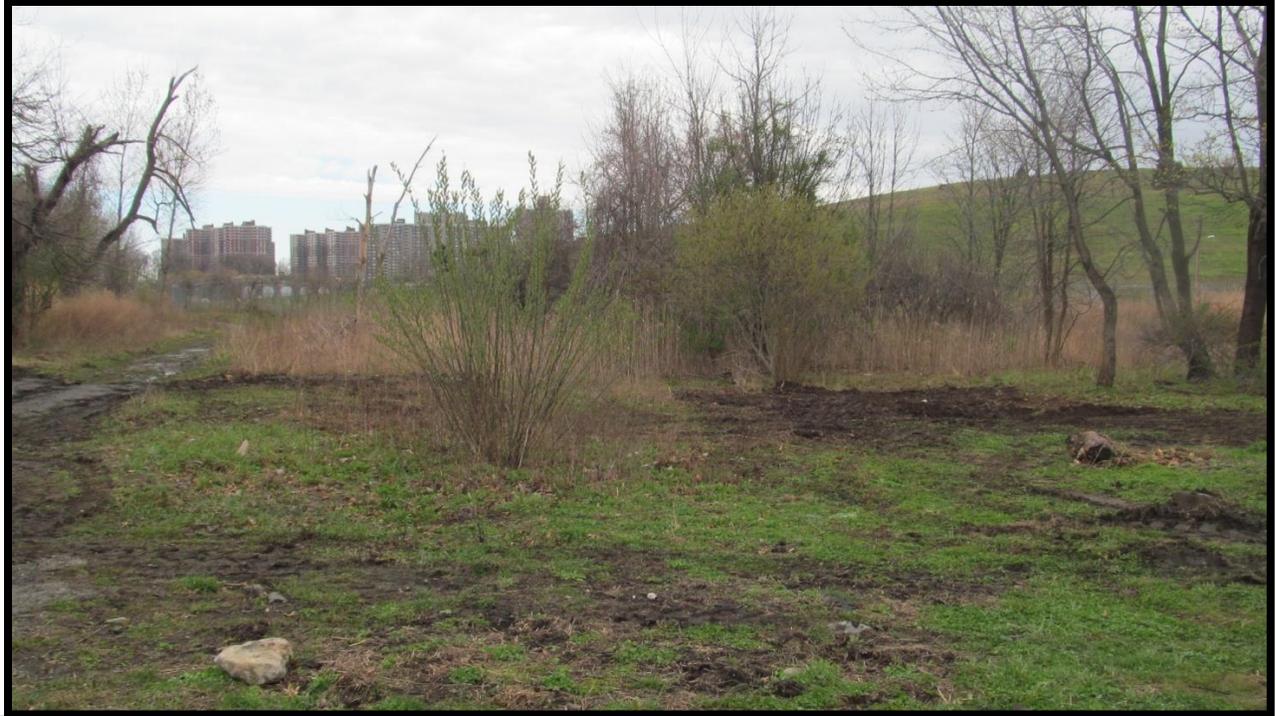
**Figure 4**

**South Central Part of the Tested Portion of the Expanded Area of Potential Effect for the Pelham Bay Park South Waterfront Naturalization Project**

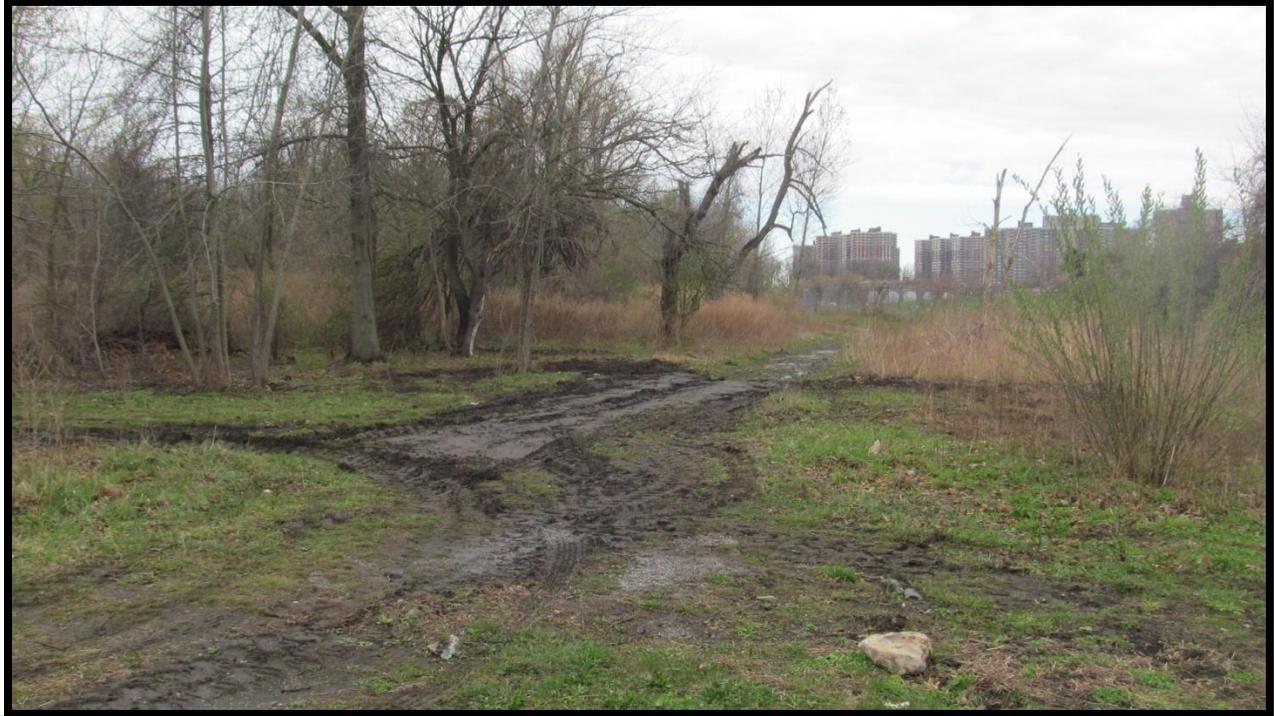
**Figure 5**

**Southwestern Part of the Tested Portion of the Expanded Area of Potential Effect for the Pelham Bay Park South Waterfront Naturalization Project**

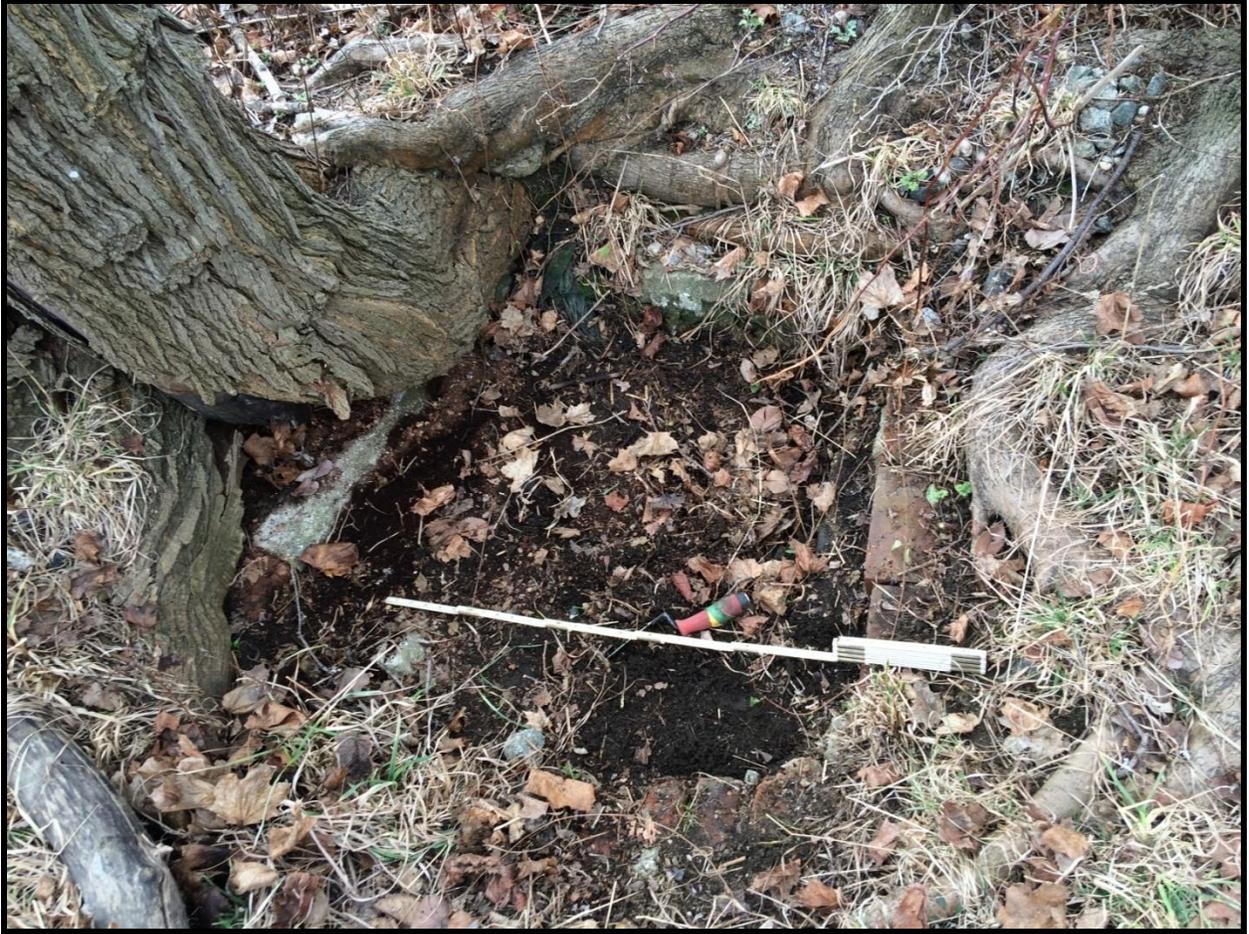
**Figure 6**

**Brick and Concrete Recreational Feature – Early Twentieth Century**

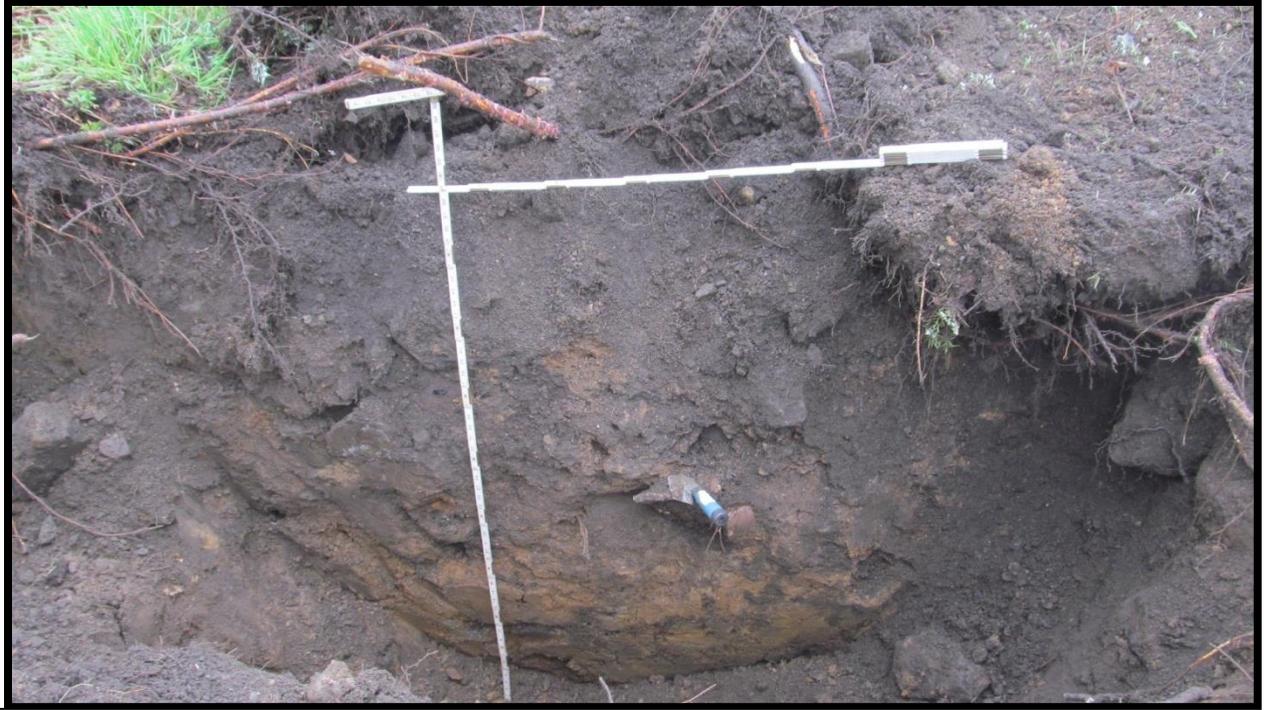
**Figure 7**

Test trench A was 12 feet north to south by three feet east to west in size. It was located in the southeast portion of the expanded APE, nearest the Eastchester Bay shoreline (Figures 2 and 7). The initial 32 inches encountered in test trench A (Figures 2 and 7) consisted of various fill layers (Stratum I) including pipe trench deposits for what likely were a potable water pipe and stoneware drainage pipe. The water pipe was oriented towards the red brick and concrete feature (Figure 6), located about 15 feet to the north mentioned earlier which likely was the base for a water fountain or other recreational feature. Plastic, coal, oxidized metal, 20 twentieth century ceramics including drainage pipe fragments, and soda cans were noted and recovered from Stratum I. At 32 inches in depth was a layer of dark brown sandy silt with yellow brown sandy silt mottling (Stratum II) which represents a continuation of the fill or a disturbed buried former ground surface. No artifacts were recovered from the layer. Beneath Stratum II, at 35 inches below grade was encountered the naturally occurring, culturally sterile yellow brown sandy silt sub-soil (Stratum III) which was excavated to 56 inches below grade. Ground water was encountered in test trench A at 56 inches in depth.

**Test Trench A – East Profile**

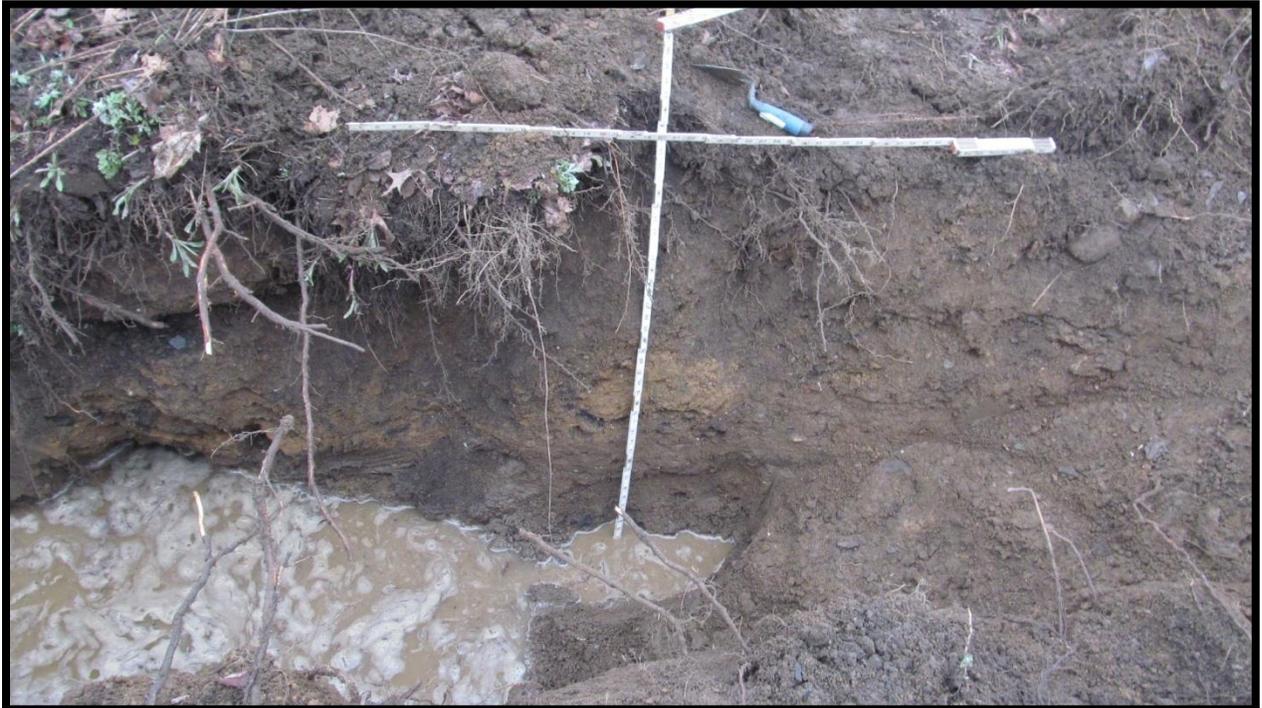
**Figure 8**

Test trench B was 15 feet north to south by three feet east to west in size. It was located in the south central portion of the expanded APE (Figures 2 and 8). The initial 44 inches encountered in the test trench consisted of various fill layers (Stratum I). Beneath the fill was encountered a wetland related soil deposit consisting of black gray silty clay (Stratum II) associated with the pre-development marsh that was present in the original swale area prior to local filling. No peat or other vegetation layer was seen to overlie the black gray silty clay which would usually be present in natural settings. According to Ms. Johnson (2016), such layers were sometimes stripped for some commercial or private use. Such an event may have occurred prior to the filling of the former swale vicinity. Stratum II was excavated to 50 inches below grade at which depth excavation of test trench B was terminated. Ground water was encountered in the test trench at 42 inches below grade. Plastic, coal, glass, and oxidized metal from Stratum I were the only artifacts recovered or noted from test trench B.

**Test Trench B – East Profile**

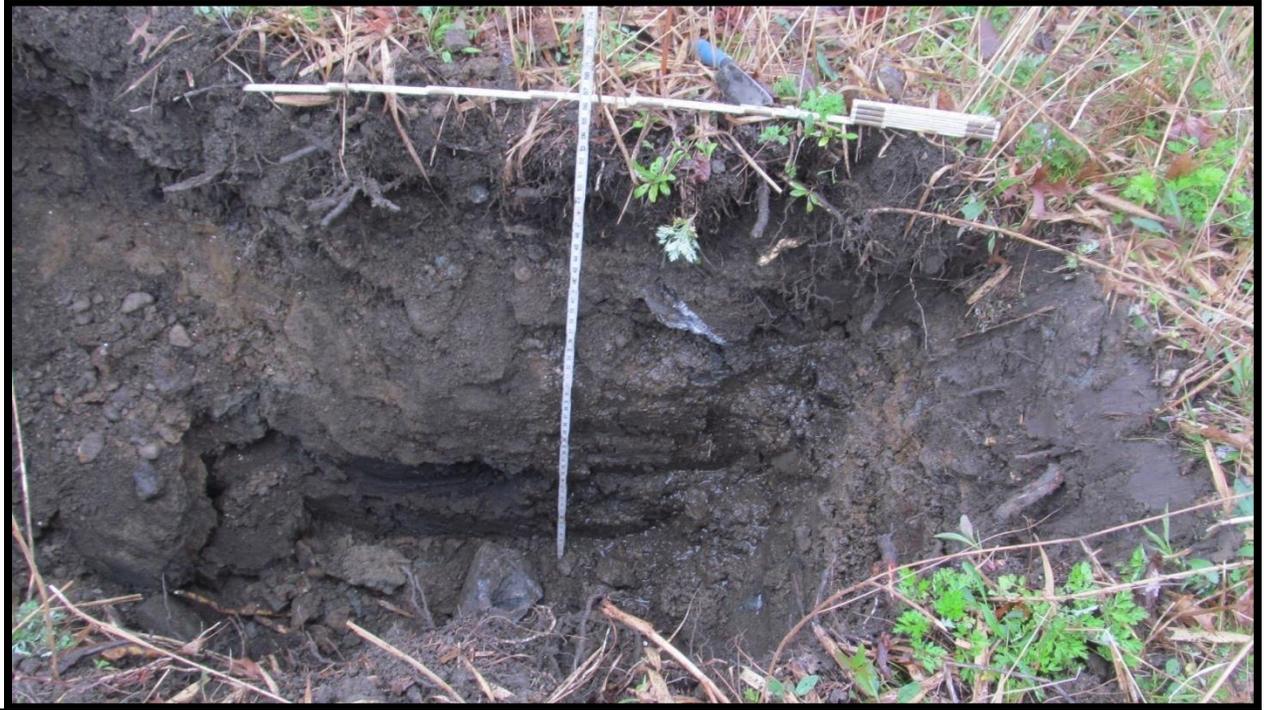
**Figure 9**

Test trench C was 12 feet north to south by three feet east to west in size. It was located in the south central portion of the expanded APE (Figures 2 and 9). The initial 40 inches encountered in the test trench consisted of various fill layers (Stratum I). Beneath the fill was encountered a wetland related soil deposit of black gray silty clay (Stratum II) similar to that seen in test trench B. Stratum II is associated with the pre-development marsh that was present in the original swale area prior to local filling. According to Ms. Johnson (2016) such layers were sometimes

stripped for some commercial or private use. Such an event may have occurred prior to the filling of the former swale vicinity. Stratum II was excavated to 51 inches below grade at which depth excavation of test trench C was terminated. Ground water was encountered in the test trench at 25 inches below grade. Plastic, coal, glass, and oxidized metal from Stratum I were the only artifacts recovered or noted from test trench C.

**Test Trench C – East Profile**

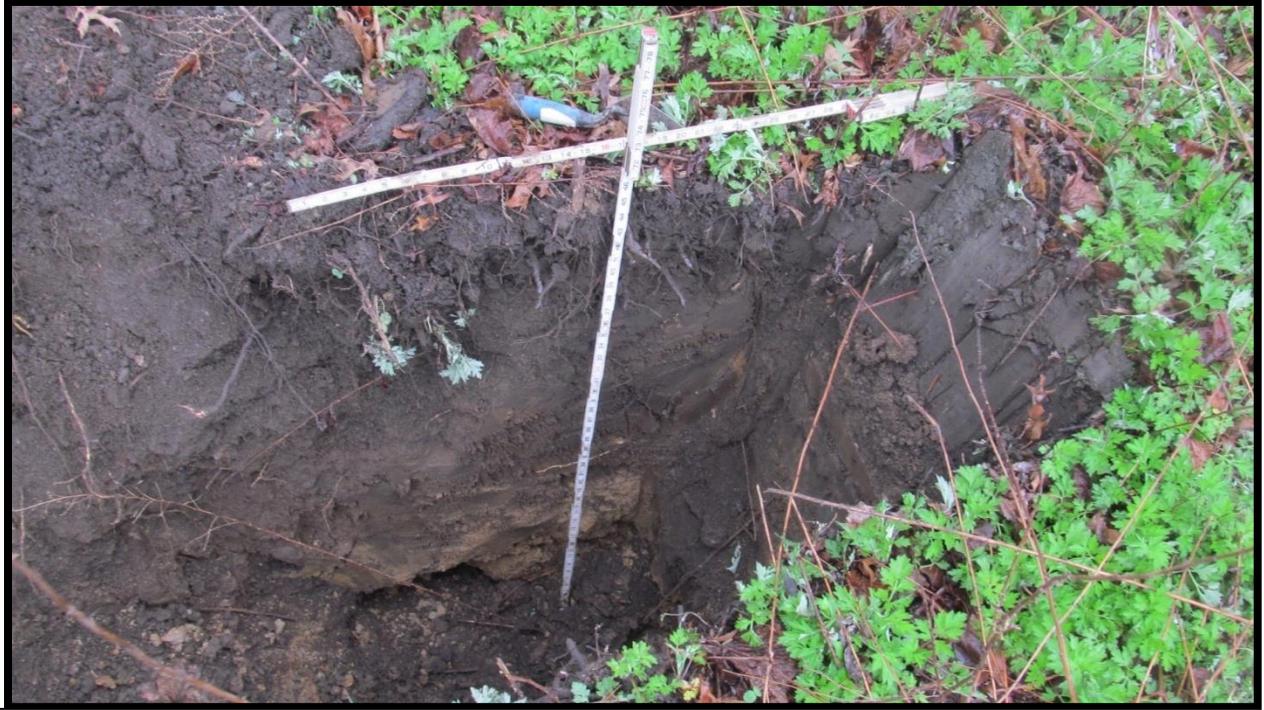
**Figure 10**

Test Trench D was 10 feet north to south by three feet east to west in size. It was located in the southwestern portion of the expanded APE (Figures 2 and 10). The initial 16 inches consisted of sod (Stratum I) overlying intact asphalt pavement (Stratum II), indicating the former presence of a paved road, followed by an underlying gray silt with rock (Stratum III) that served as road bedding. Beneath Stratum III was a 12 inch thick deposit of dark brown black sandy silt with light brown sandy silt mottling (Stratum IV) that represents a natural soil accumulation layer possibly with some redeposited former surface soils also contribution to the layer as fill. Underlying Stratum IV, at 38 inches in depth, was a water deposited layer of light gray clay with light brown sandy silt mottling (Stratum V) that was six inches thick. Following Stratum V, at 44 inches in depth, was the naturally occurring yellow brown sandy silt sub-soil (Stratum V), which was excavated to 66 inches below grade at which point excavation in test trench D was terminated. Plastic items from Stratum I and asphalt pavement from Stratum II were the only artifacts recovered or noted from test trench D.

**Test Trench D – East Profile**

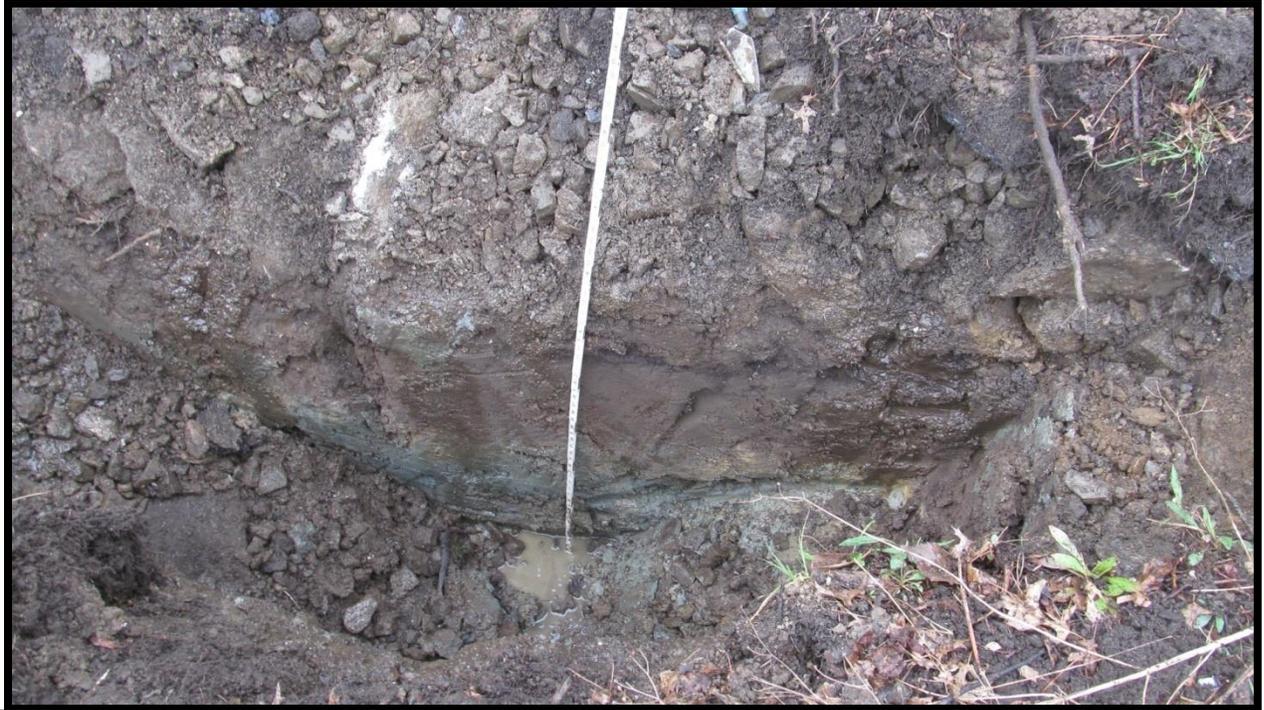
**Figure 11**

Test Trench E was 10 feet north to south by three feet east to west in size. It was located in the western portion of the expanded APE (Figures 2 and 11). The initial 13 inches consisted of recently developed dark brown black sandy silt (Stratum I) humus overlying a dark gray brown sandy silt (Stratum II) leaching zone. Beneath Stratum II was a 19 inch thick deposit of dark brown black sandy silt (Stratum III) that represents a natural soil accumulation layer possibly with some redeposited former surface soils contributing to the layer as fill. Underlying Stratum III, at 27 inches in depth, was a water deposited layer of yellow brown silty clay with rust and brown clay lenses and mottling (Stratum IV) which was excavated to 53 inches below grade at which point excavation in test trench E was terminated. No artifacts were recovered or noted from test trench E.

**Test Trench E – West Profile**

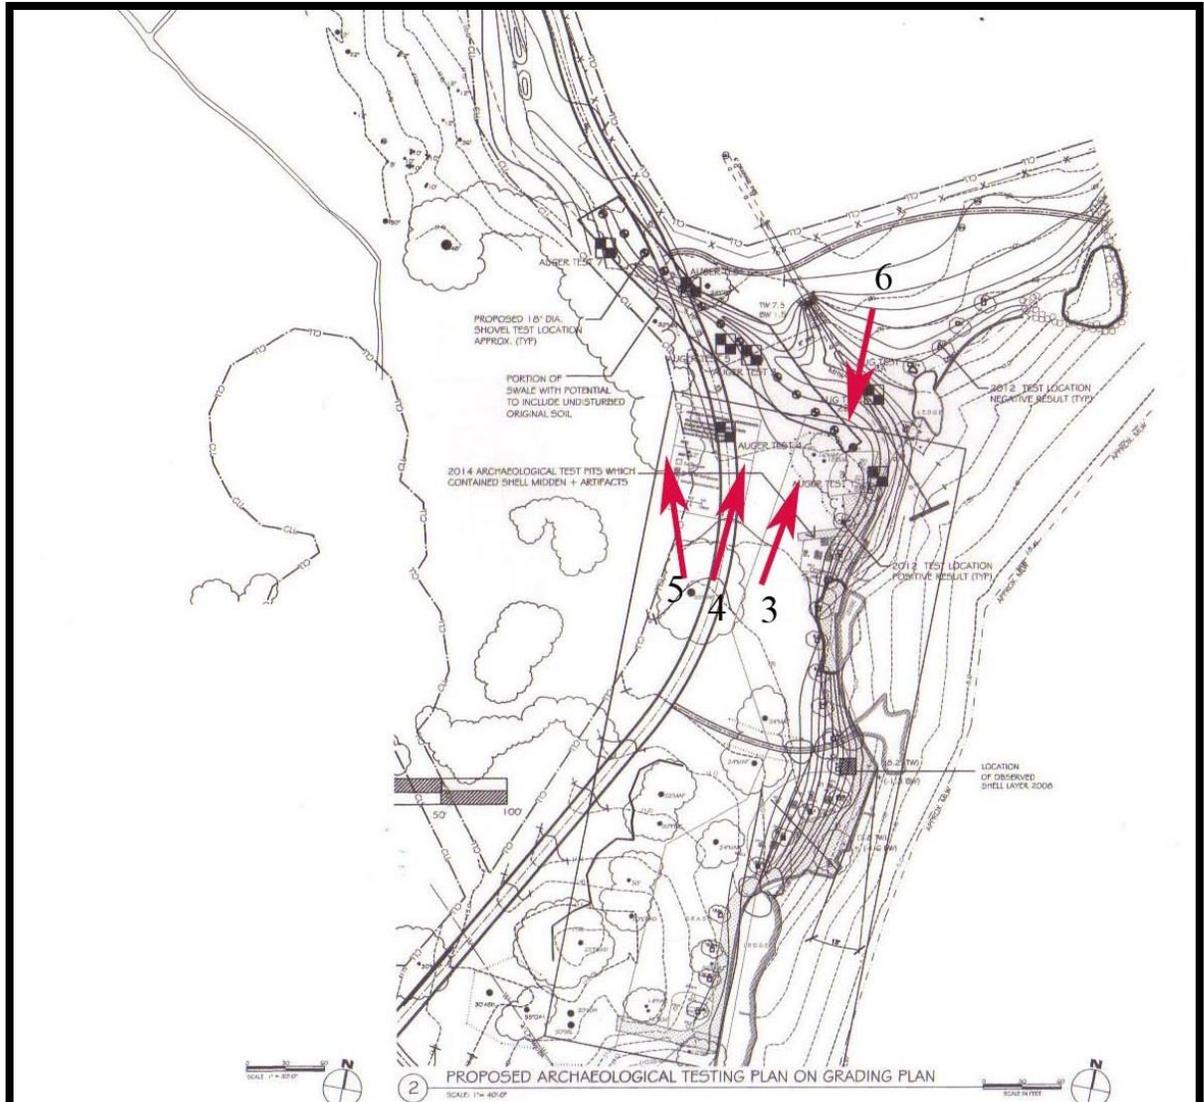
**LOCATIONS OF PHOTOGRAPHIC VIEWS INCLUDED IN THIS REPORT  
AS FIGURES 3-6**

**LOCATIONS OF PHOTOGRAPHIC VIEWS INCLUDED IN THIS REPORT AS FIGURES 3-6**

**LOCATIONS OF PHOTOGRAPHIC VIEWS FOR FIGURES 7-11 ARE TOWARDS THE INDICATED PROFILE WALLS FOR TEST TRENCHES A-E**

Locations of photographic views included in this report as Figure 3- 6 are shown in Appendix C. Locations of photographic views for Figures 7-11 are towards the indicated profile walls for test trenches A-E.
