**Phase IB Archaeological Investigation**

**New York City Department of Environmental Protection  
Wards Point Infrastructure Improvements  
Amboy Road from Wards Point Avenue to  
U.S. Pierhead and Bulkhead Line  
Staten Island, Richmond County, New York**

**LPC Project #10DEP024R  
Department of Design & Construction / ER.R**

June 2016

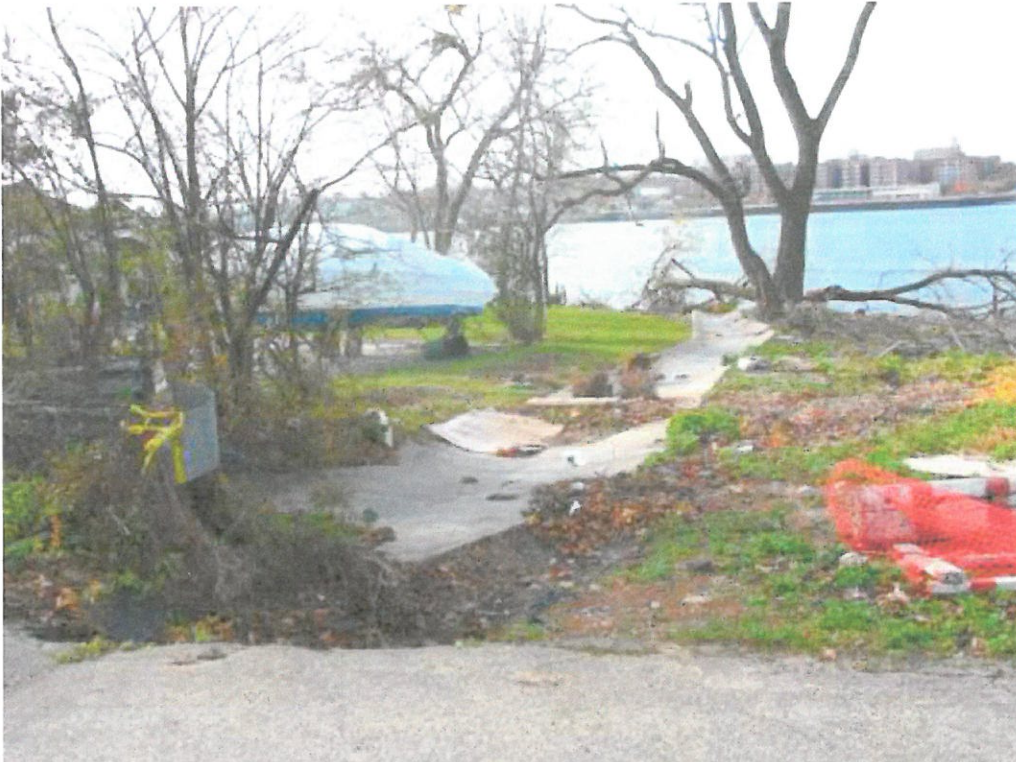
Photograph 1: Project site section from the intersection of Amboy Road and Wards Point Boulevard to the beach, showing concrete drainage culvert or swale. View looking west from Amboy Road terminus.

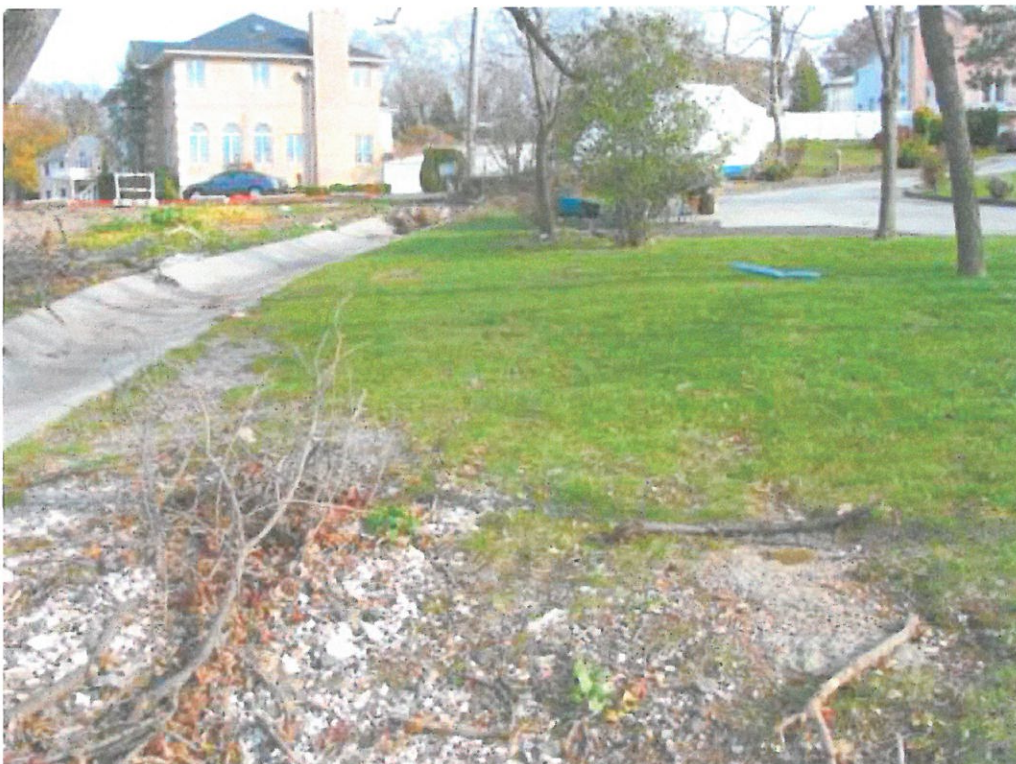
Photograph 2: Project site section from the intersection of Amboy Road and Wards Point Boulevard to the beach, showing disturbed soils and landscaped yard area surrounding concrete drainage culvert or swale. Portion of asphalt driveway and large boat in background are included in APE. View looking northeast from interior of site.

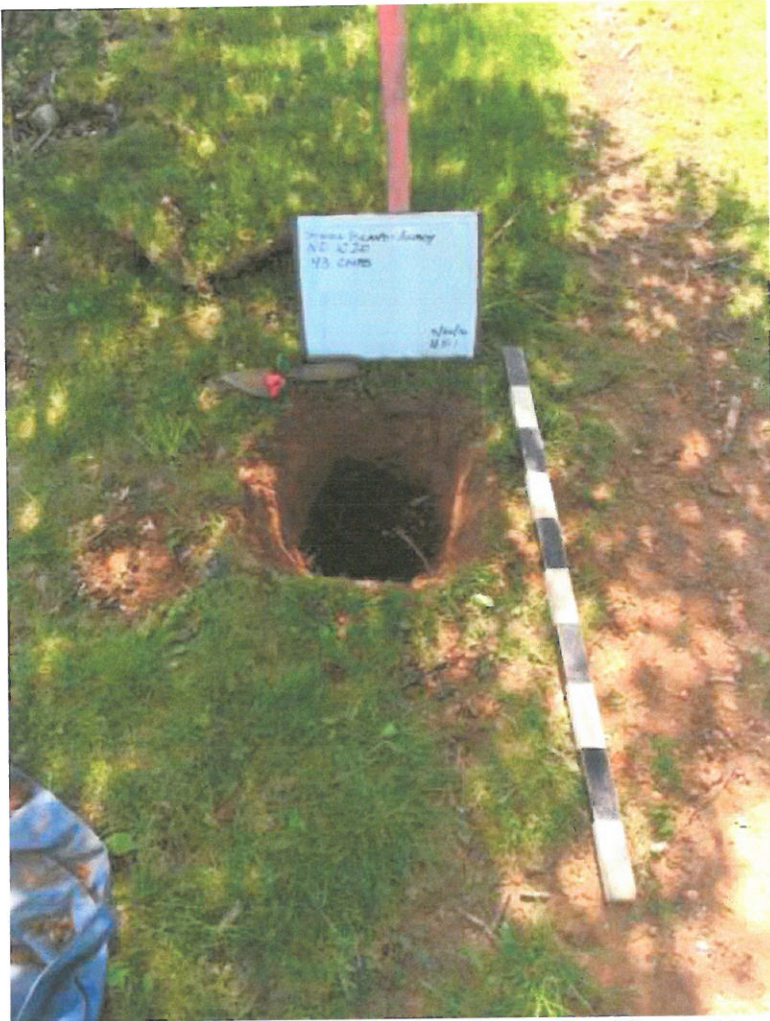
The three STs excavated on the portion of the APE between Amboy Road and the beach (N0/W0, N0/W20, and N0/W30) all exhibited significant disturbance (Photograph 5). The very compact soils consisted of redeposited materials or imported fill, mixed with modern debris and construction materials such as concrete and gravel. This area was part of a former roadway that extended Amboy Road to the waterfront, and more recently may have been used as an informal boat launching spot. All of the STs ended in obstructions (large rocks, heavy gravel concentrations) that prevented excavations from extending through this very compacted fill stratum and reaching natural subsoil. Excavations of these STs ended at ca. 40 cm below grade.

Photograph 5: ST N0/W20 at conclusion of excavation. View looking east.

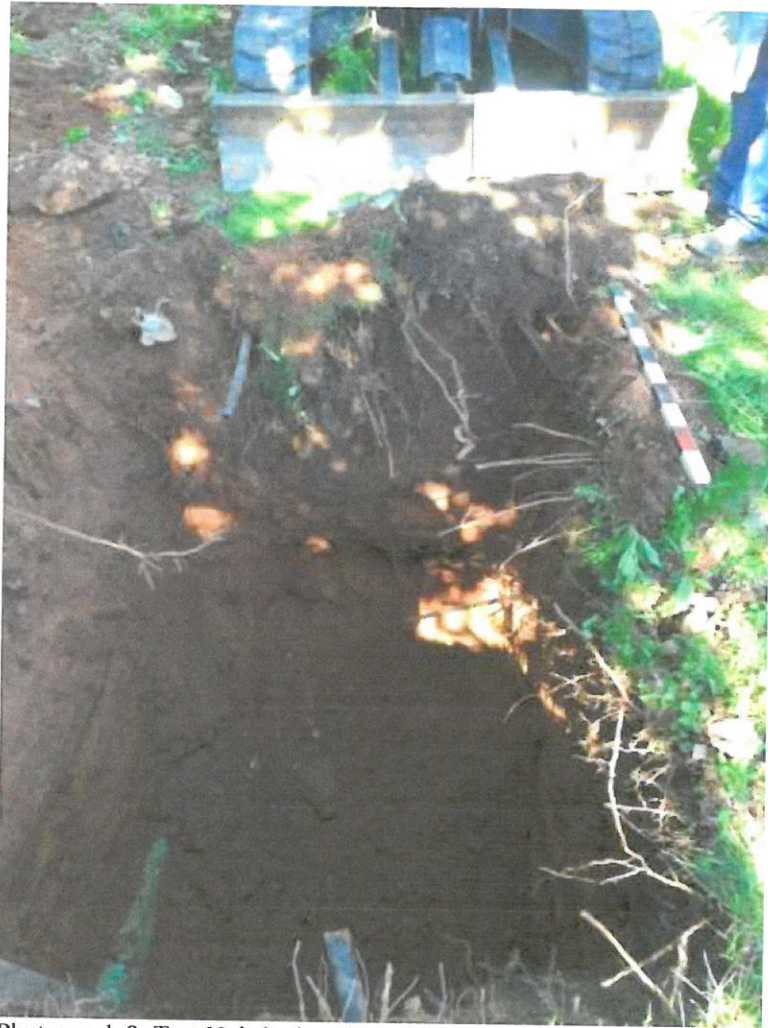
Test Unit 3 was excavated ca. 5m north of ST N0W20. This pit was approximately four feet square (1.2m<sup>2</sup>), and was excavated to a depth of approximately 7.5 feet (2.3m; Photograph 7). The Verizon conduit was located at seven feet (2.1m) below the ground surface (Photograph 8). The upper soil stratum consisted of fill, and at about 2.5 feet (0.8m) below the surface, the soil changed to a 10R 3/4 (dark red) wet sand, corresponding to a C-horizon. This color and texture extended to the base of the test unit. This sterile soil only contained some natural shell fragments. Surrounding the utility conduit were pockets of 10YR 2/1 (black) wet, clay loam, which may be suggestive of horizontal directional drilling methods. This soil was devoid of any other material, shell or otherwise. There was no evidence of a buried cultural layer between the fill and the subsoil, and no precontact or historic archaeological resources were found in Test Unit 3.

Photograph 8: Test Unit 3, showing Verizon conduit (green casing) at base of pit adjacent to sterile subsoil. View looking east.

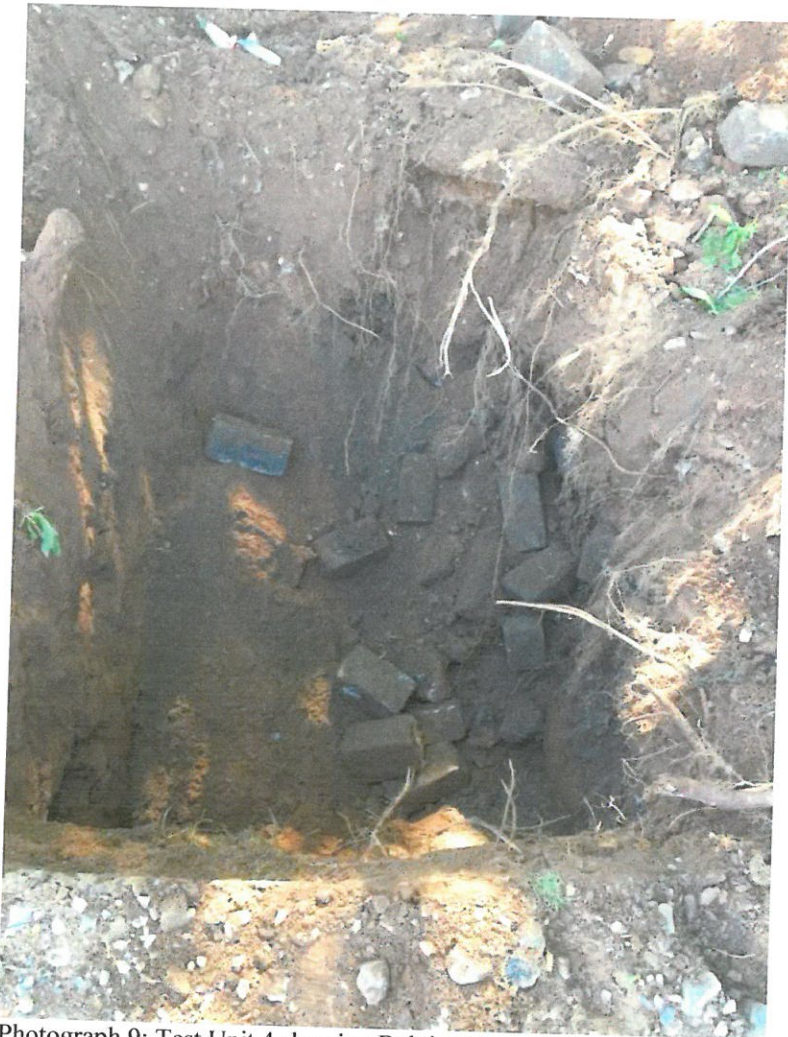
Test Unit 4 was excavated ca.5m north of ST N0W30. This pit was approximately a four-foot square (1.2m<sup>2</sup>), and was excavated to a depth of approximately five feet (1.5m). The upper stratum consisted of fill, with gravel rock bedding and large concrete fragments found through 60cm of excavation. At 1.9 feet or 60cm below the ground surface asphalt was encountered and, just below the asphalt (2.3 feet/70cmbs), several Belgian blocks were visible within of the south wall of the test unit (Photograph 9). No Belgian blocks were encountered in the north wall of the test unit. Beneath the Belgian blocks, the soil transitioned to a 10R 3/4 (dark red) wet sand, corresponding to a C-horizon. This soil color and texture extended to the base of the test unit. The sterile soil only contained some shell fragments; no precontact archaeological resources were found.

Due to the presence of the Belgian blocks, the decision was made to extend Test Unit 4 pit to the south to investigate if the Belgian blocks and asphalt were simply part of a fill level or if they represented a historic surface. Test Unit 4A was excavated directly to the south of Test Unit 4. This pit measured approximately three feet (1m, E-W) by four feet (1.2m, N-S), and was excavated to a depth of approximately five feet (1.5m). The asphalt and several Belgian blocks were encountered at the same depths as in Test Unit 4, along with large fragments of concrete and yellow painted asphalt. This color is similar to that one would see on walkways or platforms to designate "warning" areas. Though there were several more blocks encountered in this pit, they did not represent an *in situ* surface of any kind. If the blocks were a portion of a historic "road" or "landing" which extended to the water and was later paved over with portions of painted asphalt, the surface was demolished prior to the current excavation. Beneath the fill stratum, the soil again transitioned to a 10R 3/4 (dark red) wet sand, corresponding to a C-horizon.

Photograph 9: Test Unit 4 showing Belgian blocks in south wall. View looking east.
