Phase 1 and Phase 2 Archaeological Investigation

420 Albee Square

**Block 146, Lots 12, 41 (part), 42, 43, 46, and 47
Downtown Brooklyn, Kings County, New York**

July 2016

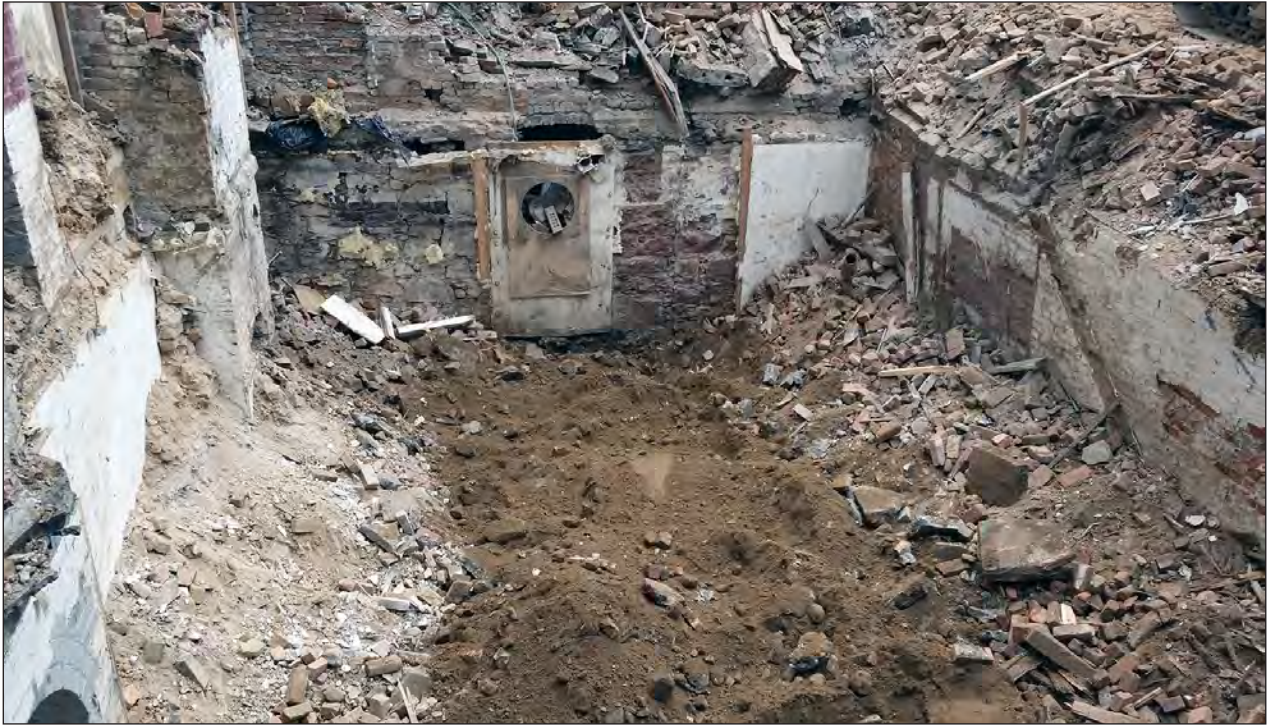
A

View east of the sub-cellar cavity showing the north (left), east (center), and south (right) walls of the foundation of the former building at 233 Duffield Street. The arched doorway to the stone ventilation shaft is covered with plywood in this photograph

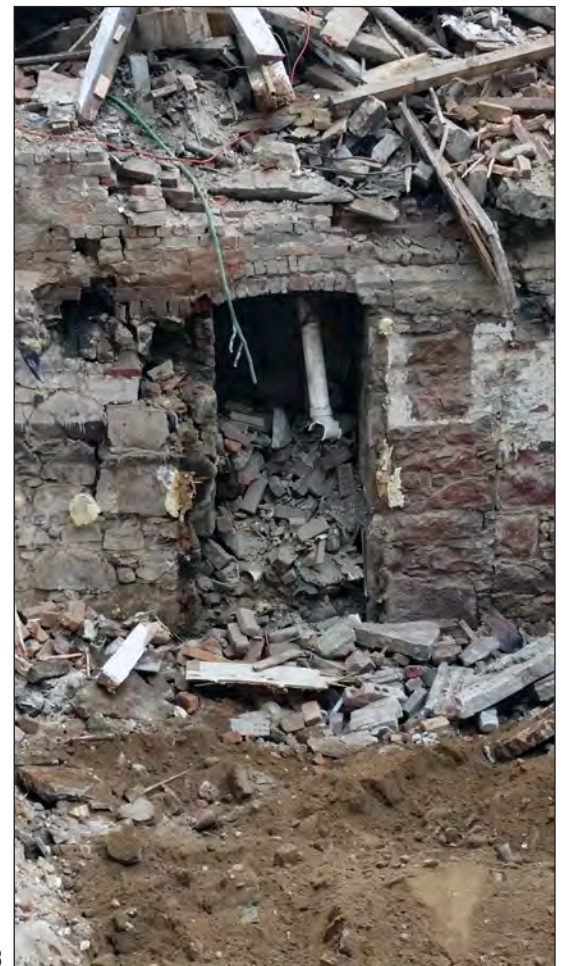
B

The arched doorway to the stone ventilation shaft after the removal of the plywood covering. The PVC pipes represent modern ventilation modifications and the remainder of the opening is filled with demolition rubble

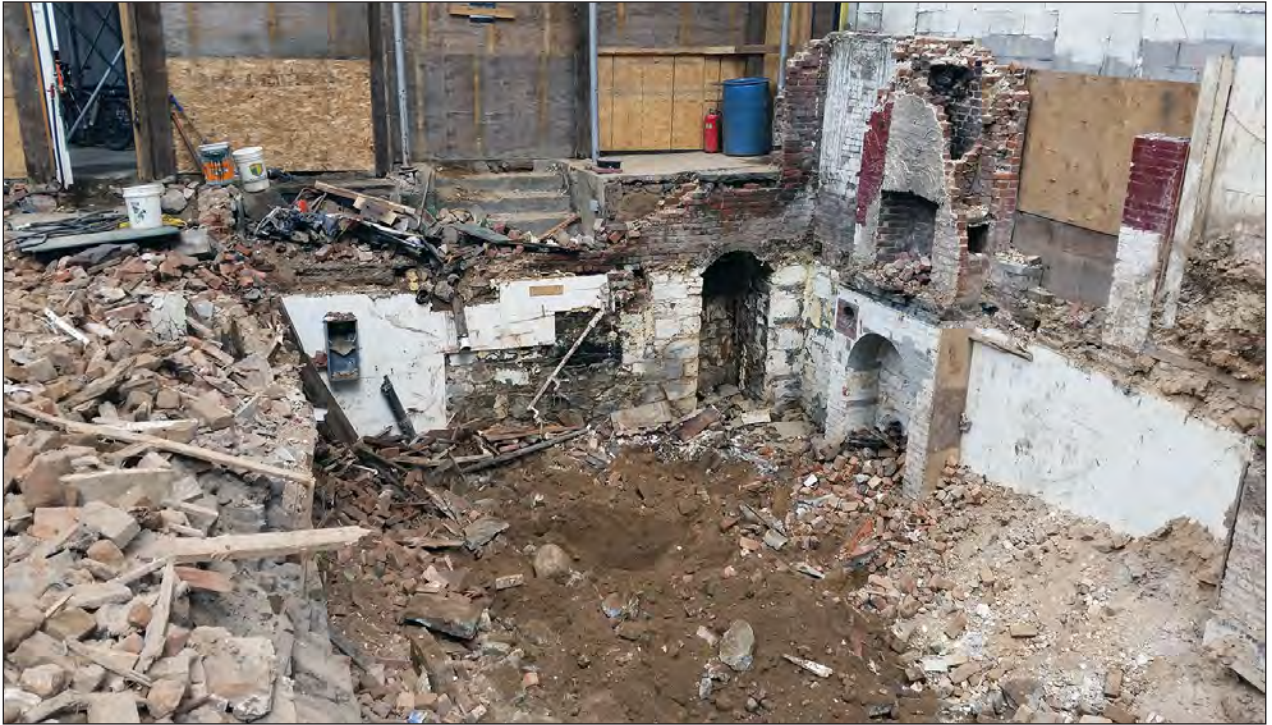
A

View west at the western (center) and northern (right) foundation walls of the 233 Duffield Street sub-cellar. The arched doorwar to the former coal vault is near the center of the photograph, adjacent to the stacked fireplaces from the sub-cellar (lower) and basement (upper) levels

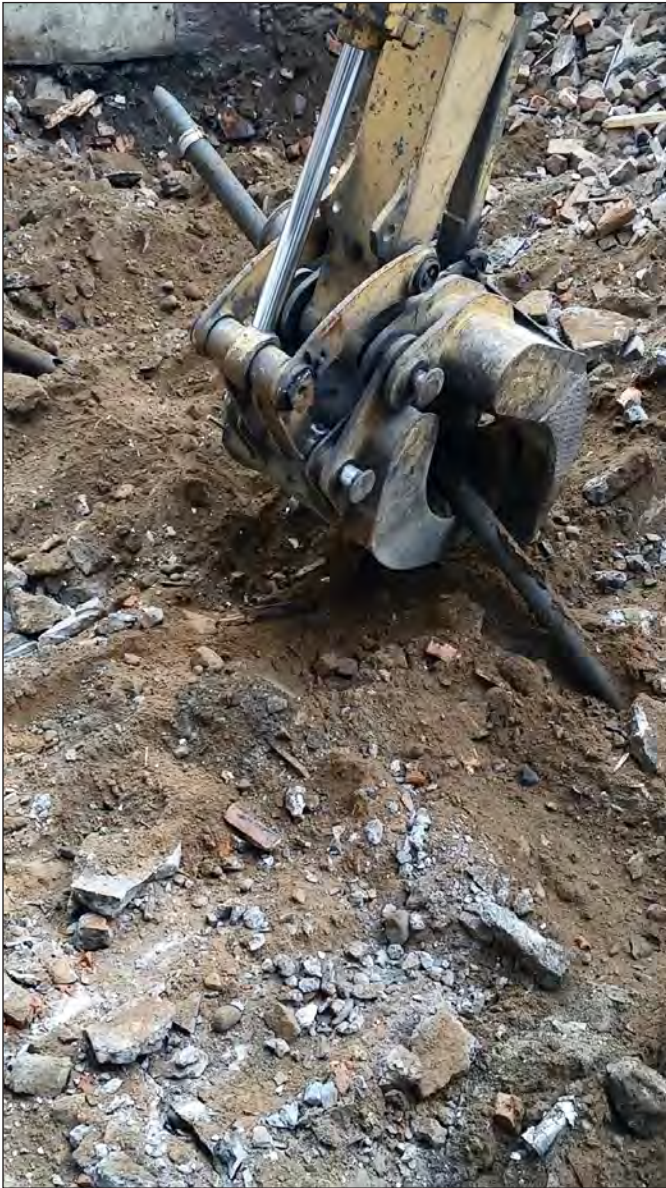
Large pipe being removed from beneath the slab during the demolition of the sub-cellar floor **A**

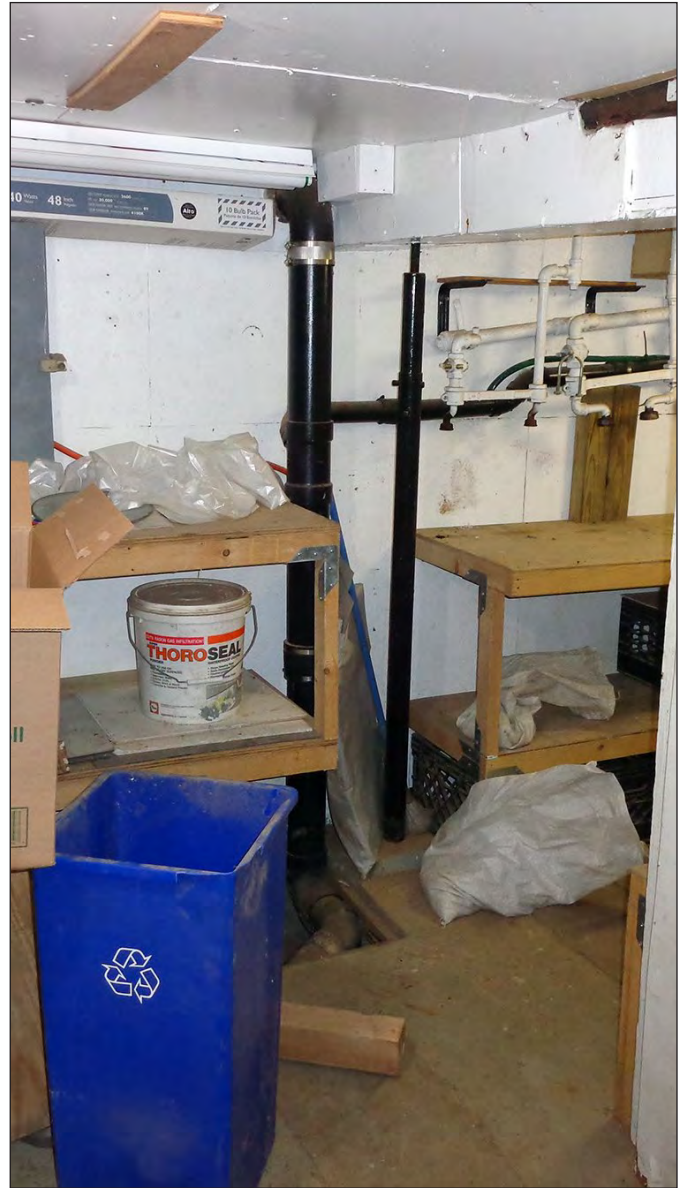
The sub-cellar before demolition; showing an extension of the same pipe extending vertically down the west wall of the building from the basement and then extending beneath the slab via an unpaved section of the floor **B**

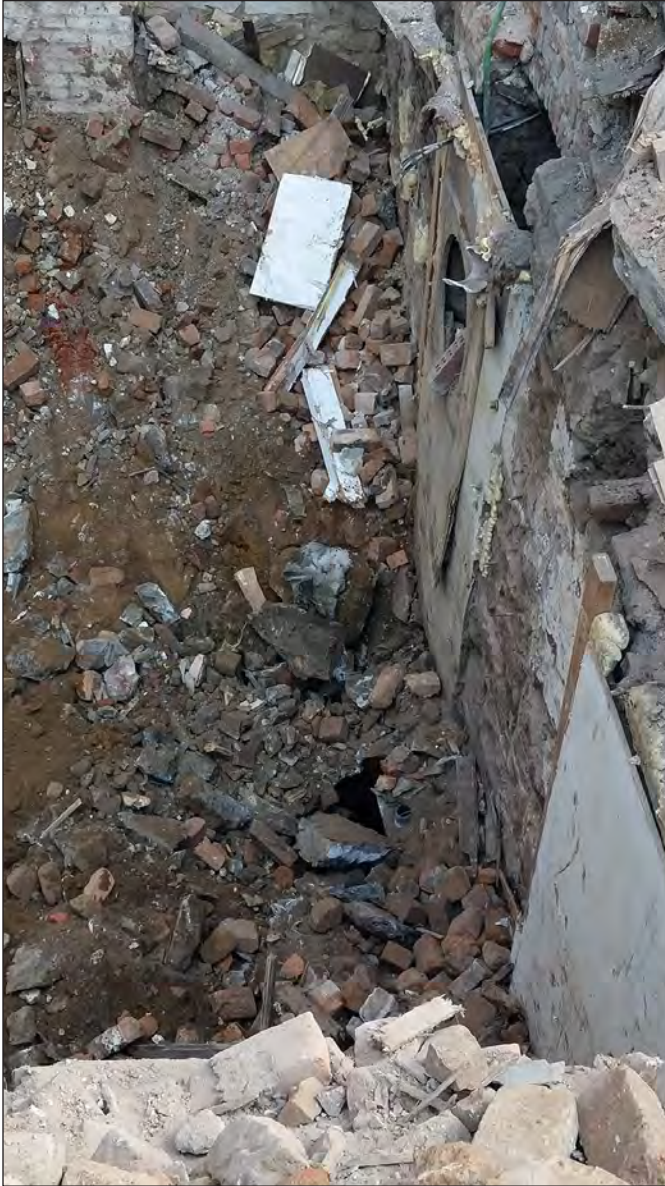
A

Looking north at the stone rubble and iron pipe or tank (the circular void) at the base of the arched doorway in the east wall of the building formerly at 233 Duffield Street

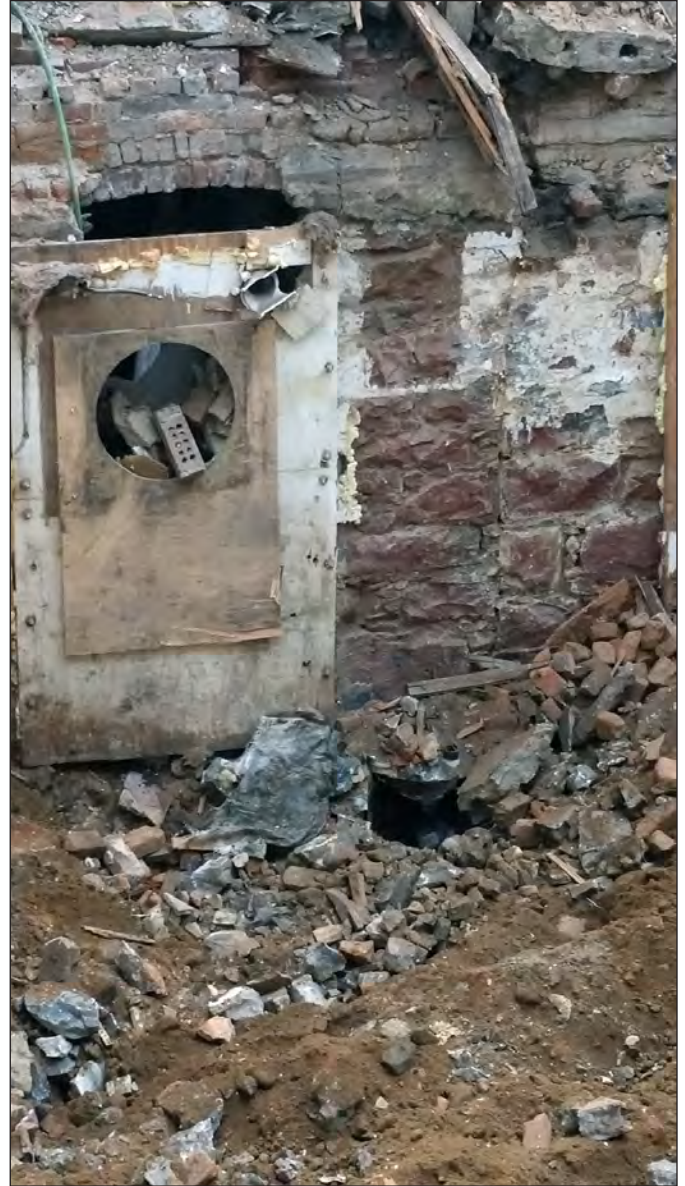
B

Same, showing the view from the west. The circular iron void is noticeable to the right of the plywood covering the arched doorway

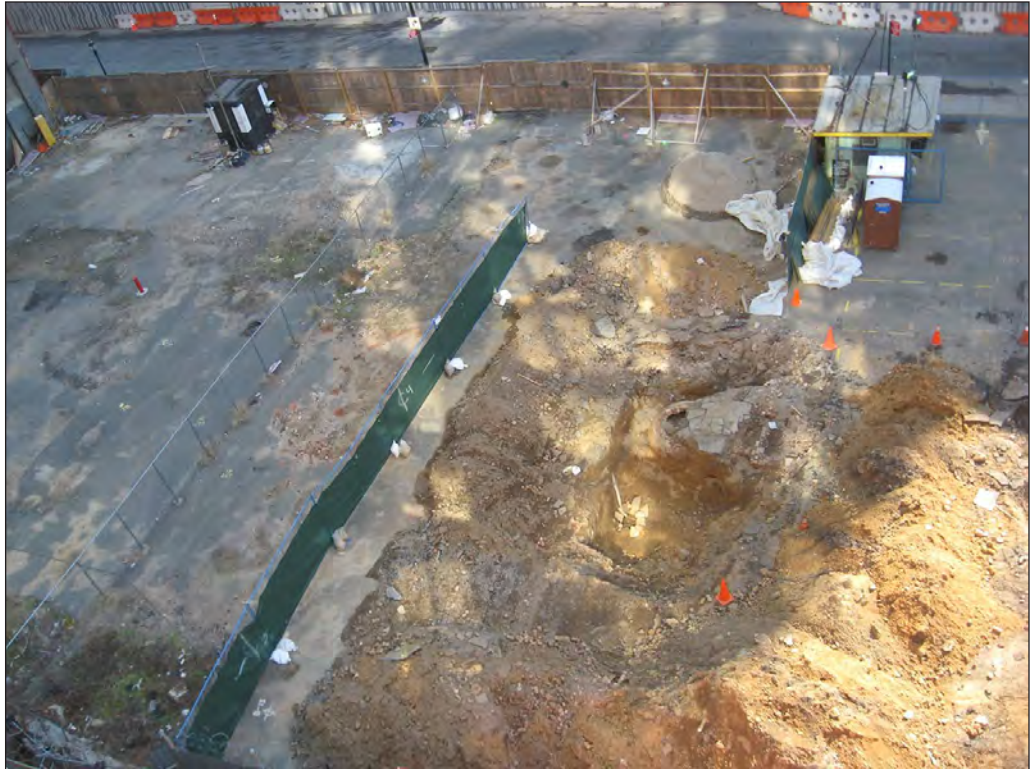
View of well and cistern on Lot 42 before Phase 2 evaluation. **1**
Photo credit: Dave DeBord (Hotel Indigo Guest, used with permission)

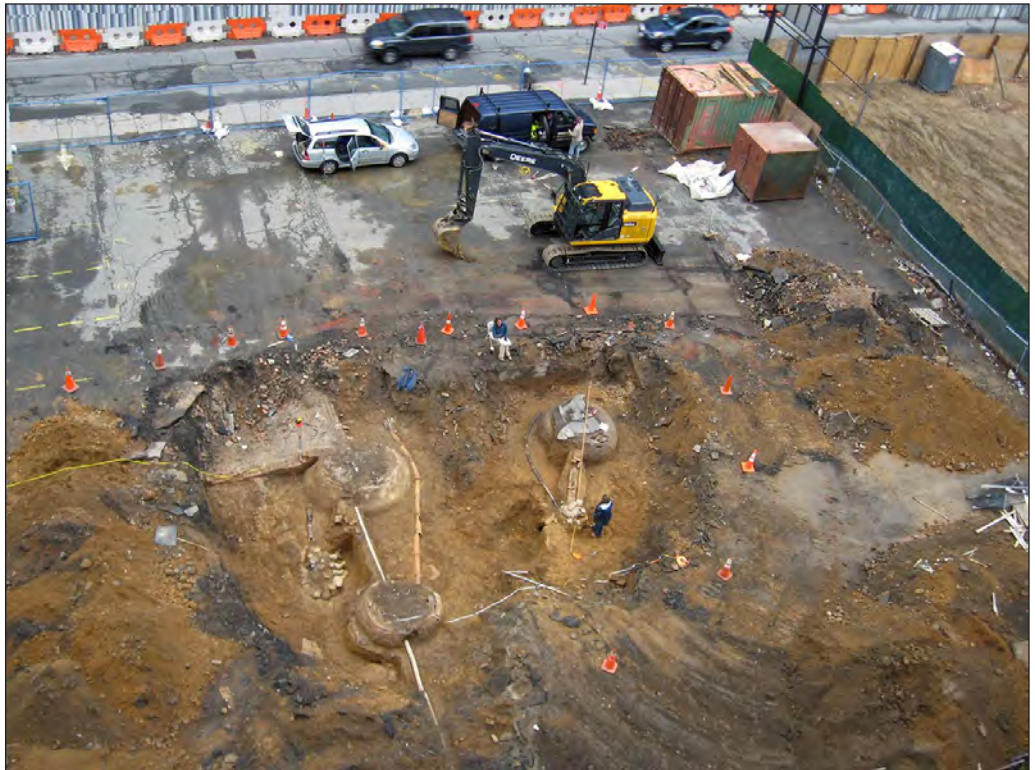
View of features on Historic Lots 44 (left) and 45 (right) before Phase 2 evaluation. **2**
Photo credit: Dave DeBord (Hotel Indigo Guest, used with permission)

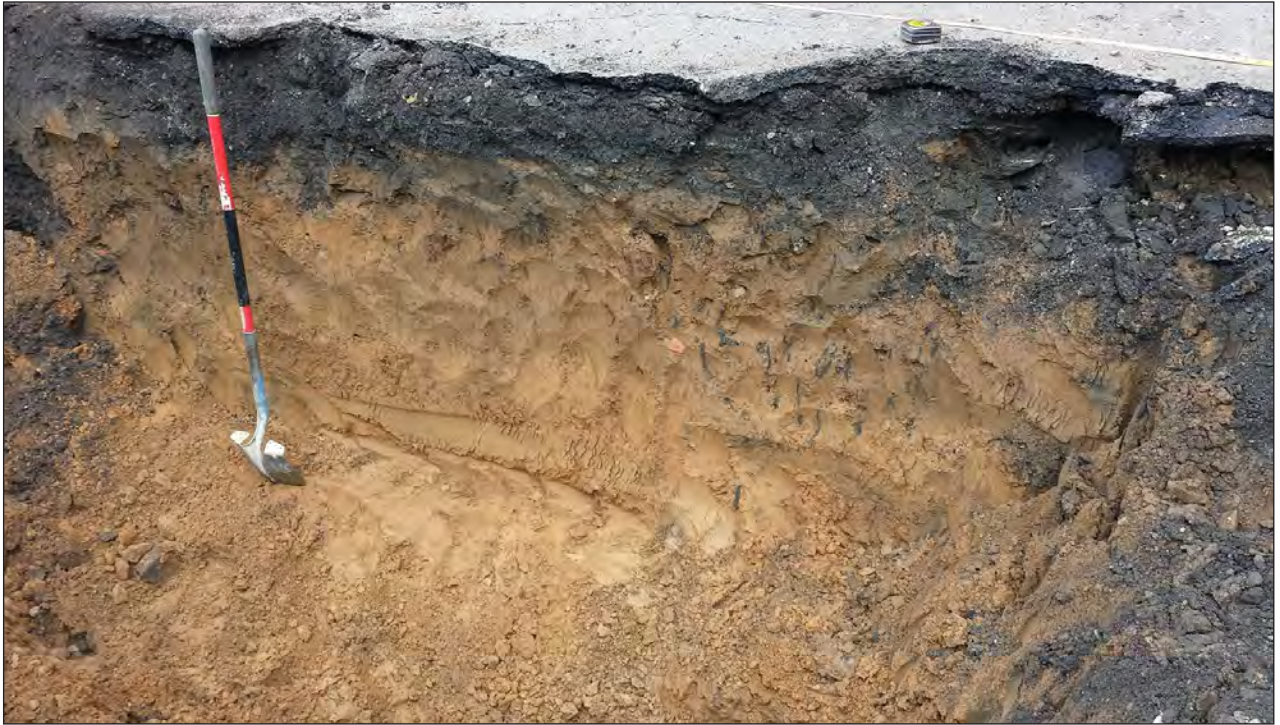
View of the western wall of Trench 1, showing the shallow subsoil near the rear lot line **3**

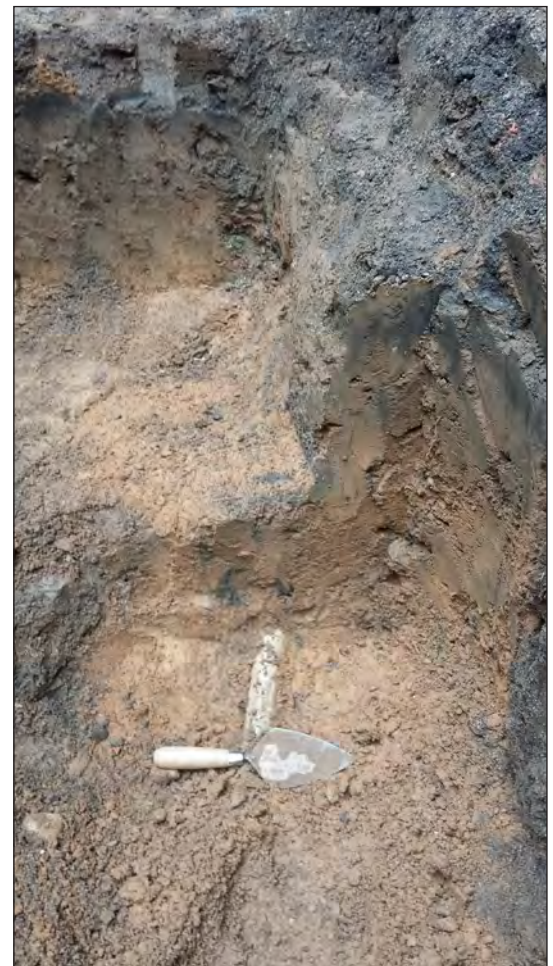
Lead pipe within apparent subsoil within Trench 6 in the rear yard of Lot 12 **4**

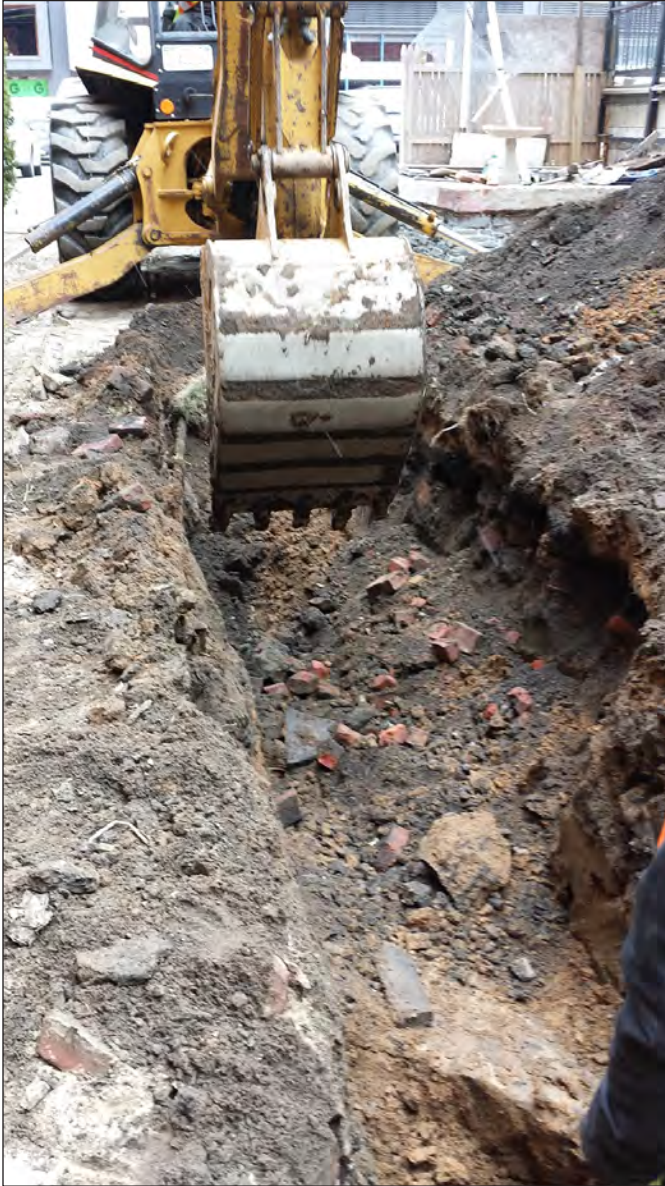
Looking east as brick rubble is excavated from the center of the rear yard of Lot 12 within Trench 7 **5**

- Photograph 5:** Looking east as brick rubble is excavated from the center of the rear yard of Lot 12 within Trench 7. (See **Figure 11**)
- Photograph 6:** View southeast at the possible midden feature observed in Trench 8 within the rear yard of Lot 12 (the fence in the background lines the southern side of Lot 12). (See **Figure 11**)

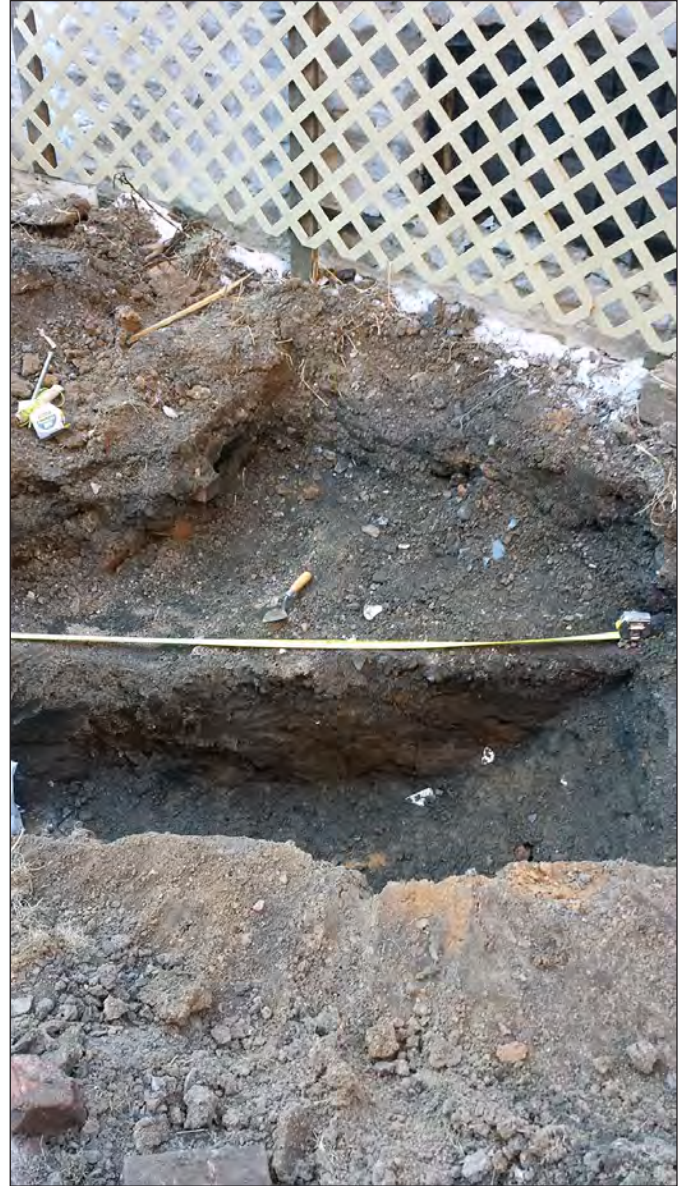
View southeast at the midden feature observed in Trench 8 within the rear yard of Lot 12 (the fence in the background lines the southern side of Lot 12) **6**

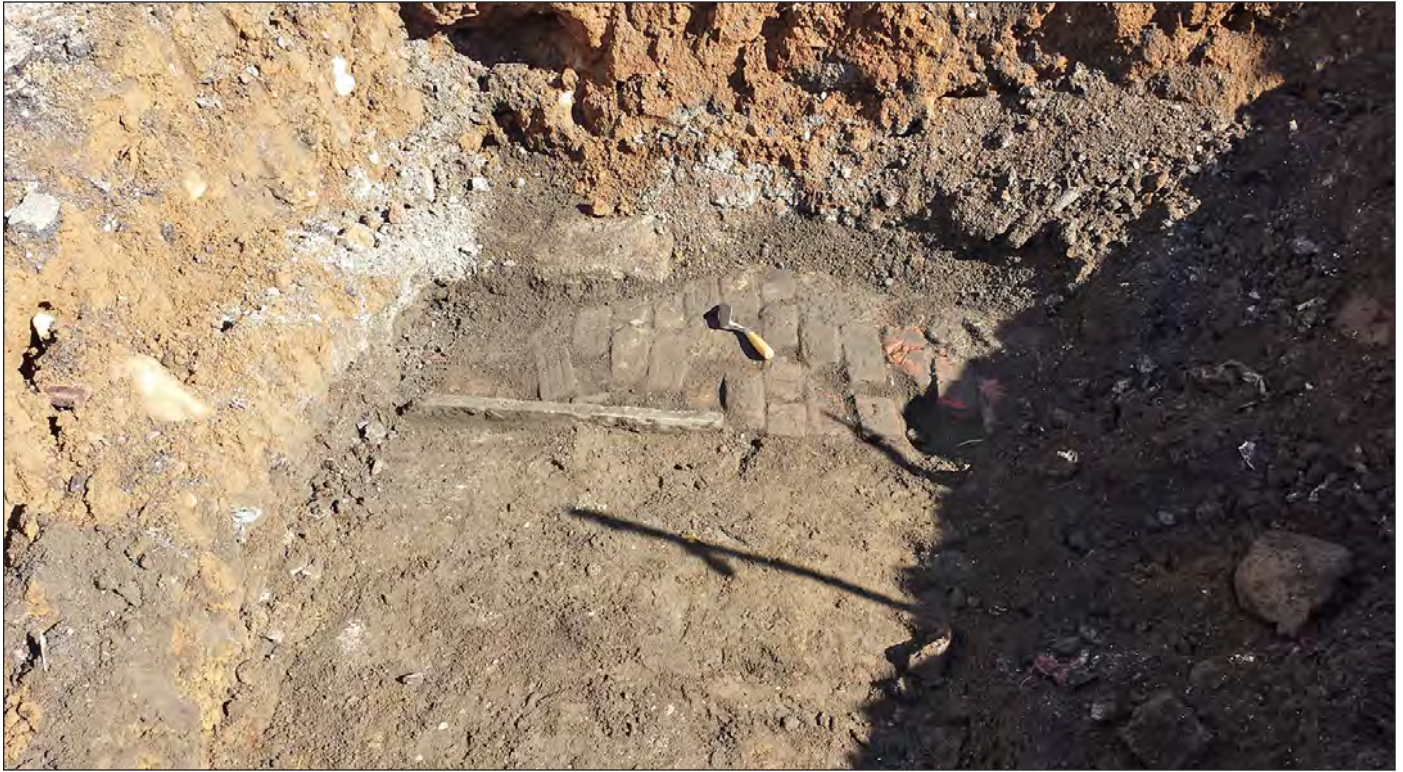
Looking north at the brick patio feature observed within Trench 11 7

- Photograph 7:** Looking north at the brick patio feature observed within Trench 11. (See **Figure 12**)
- Photograph 8:** View west of the brick and terra cotta pipe drainage feature observed in Trench 16. (See **Figure 12**)

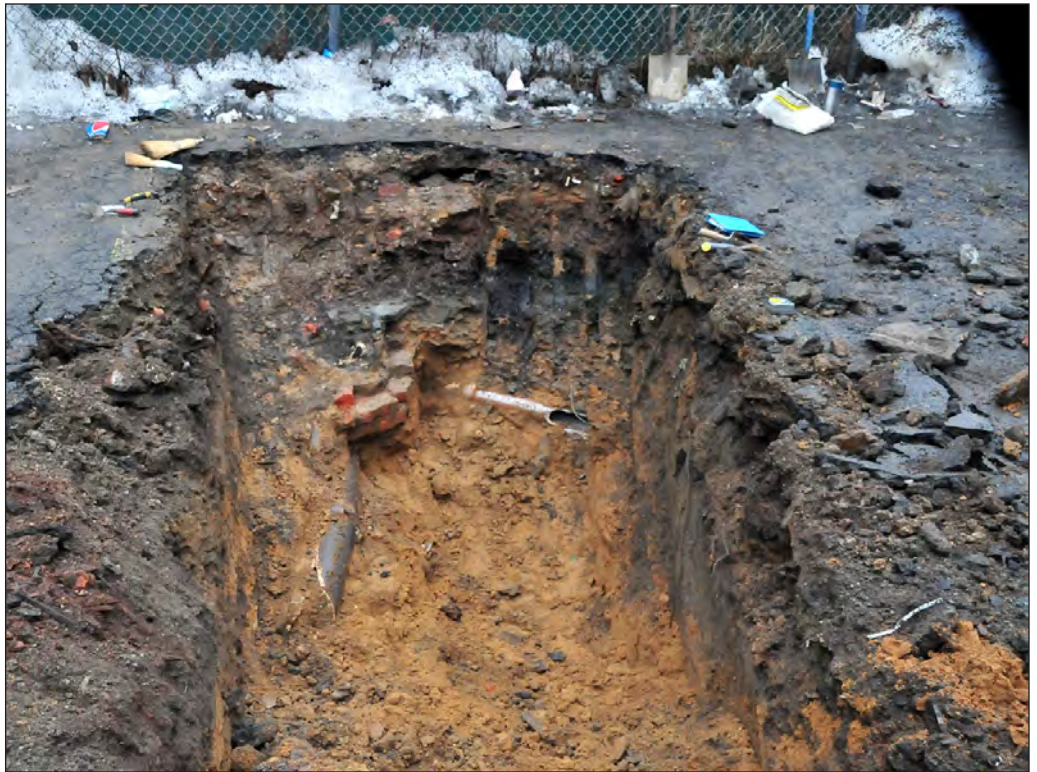
View south of the brick and terra cotta pipe drainage feature observed in Trench 16 8

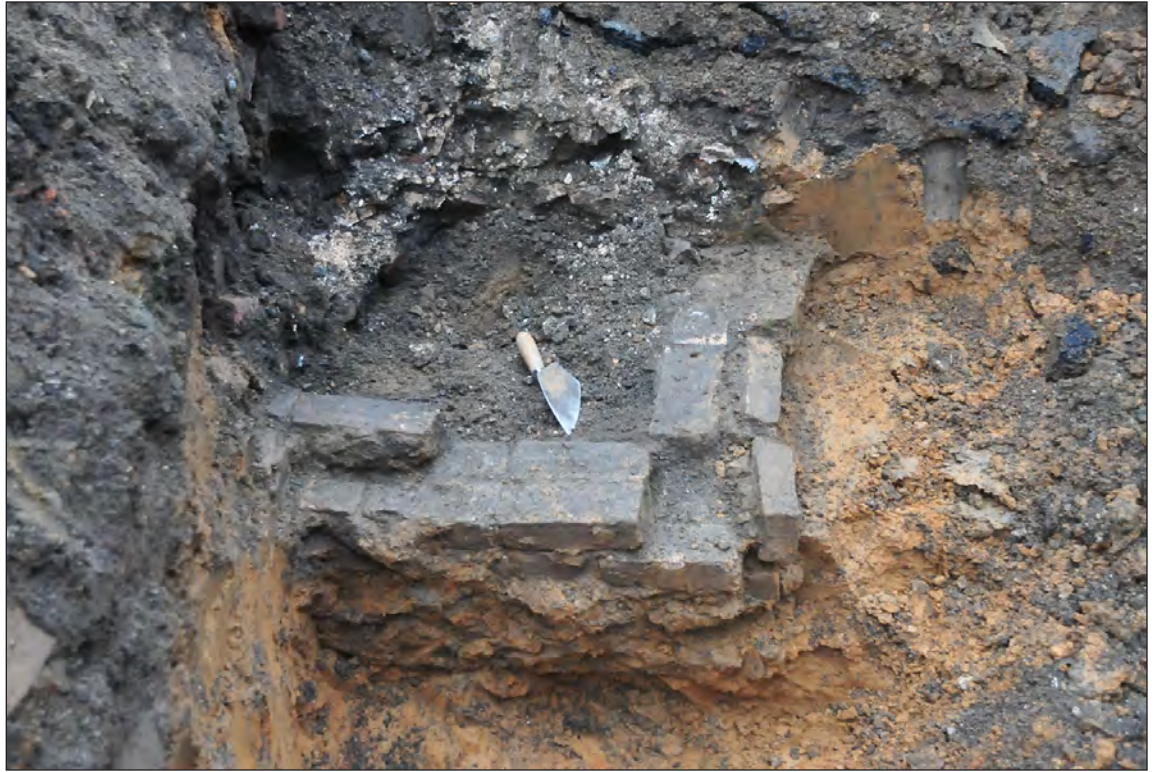
Looking south at the foundation corner remnant observed in Trench 17 9

- Photograph 9:** Looking east at the foundation corner remnant observed in Trench 17. (See **Figure 13**)
- Photograph 10:** View northeast at the foundation corner remnant observed in Trench 20A. (See **Figure 13**)

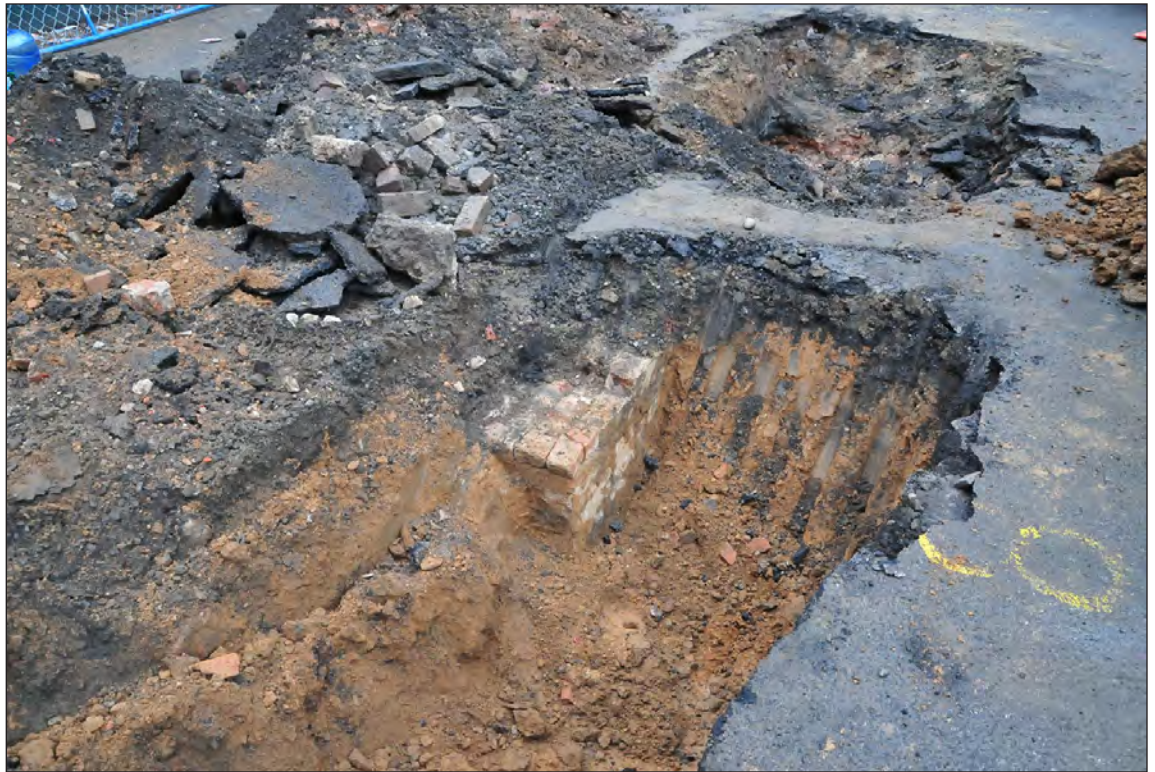
View northeast at the foundation corner remnant observed in Trench 20A 10

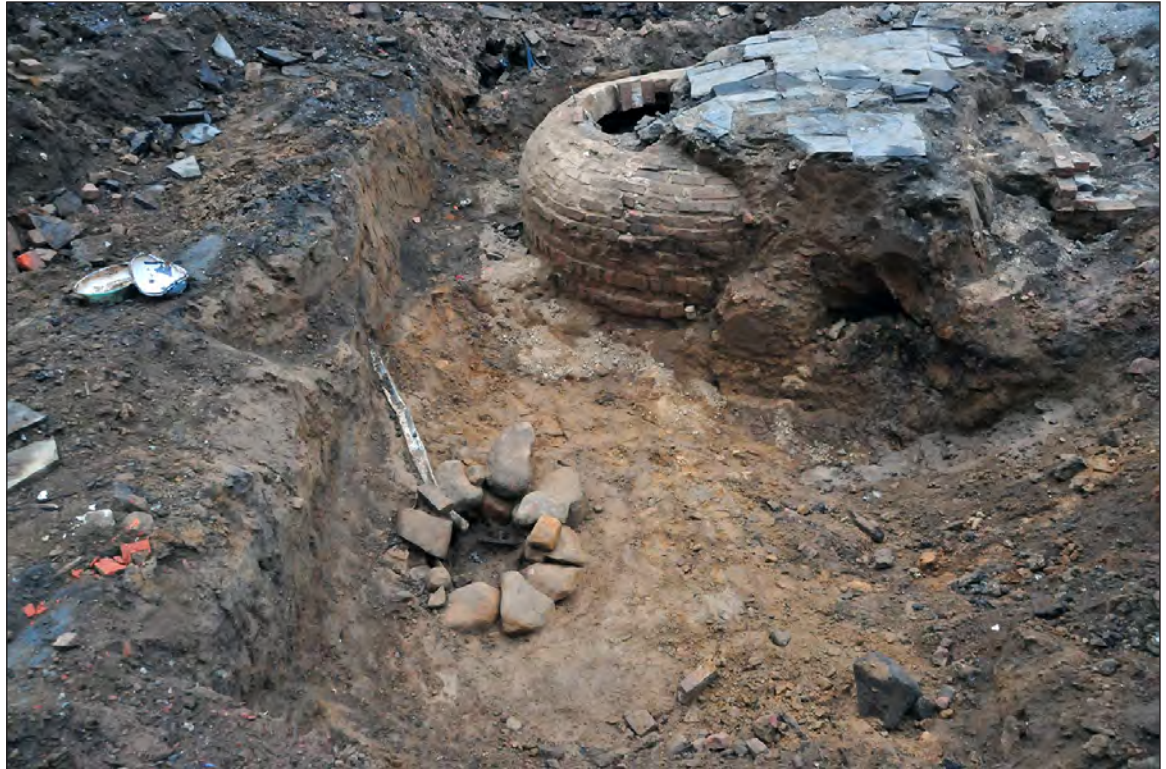
View east of the features on Lot 42 prior to the Phase 2 evaluation. The stone well is at the center of the photograph and the cistern is in the background 11

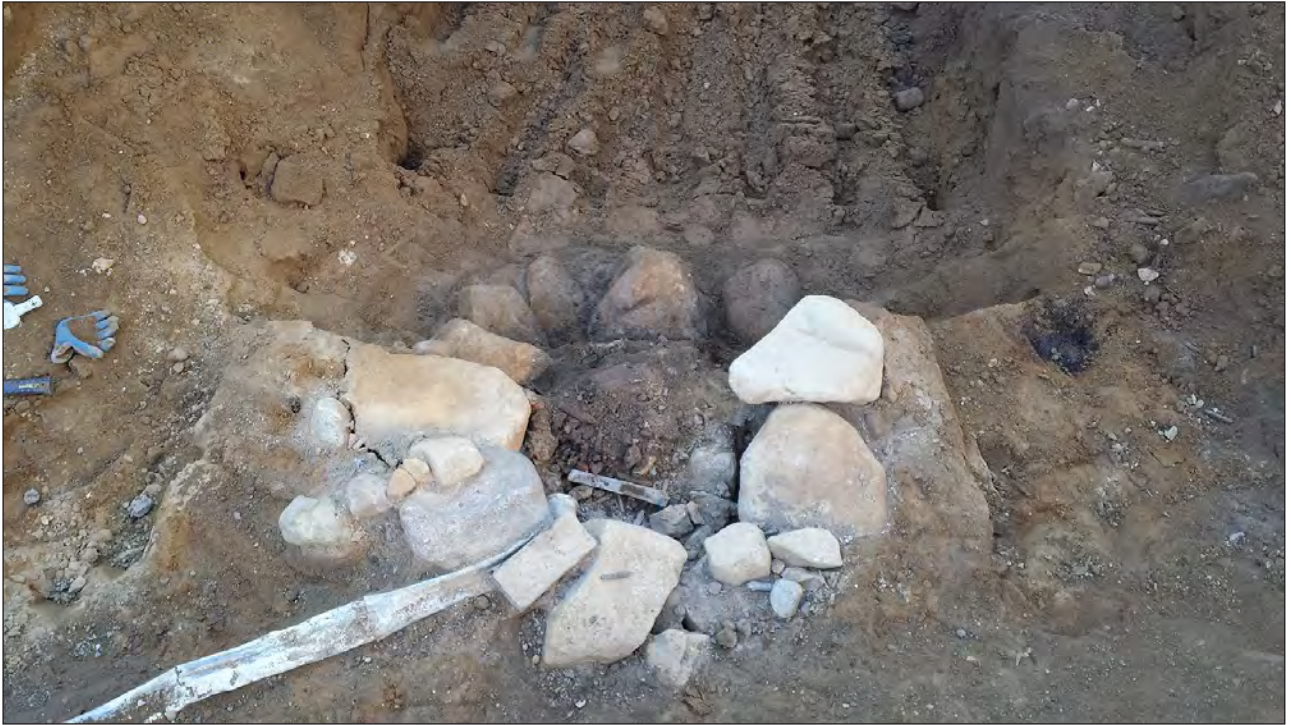
The top of the well on Lot 42 before excavation; the lead pipe is at the left **13**

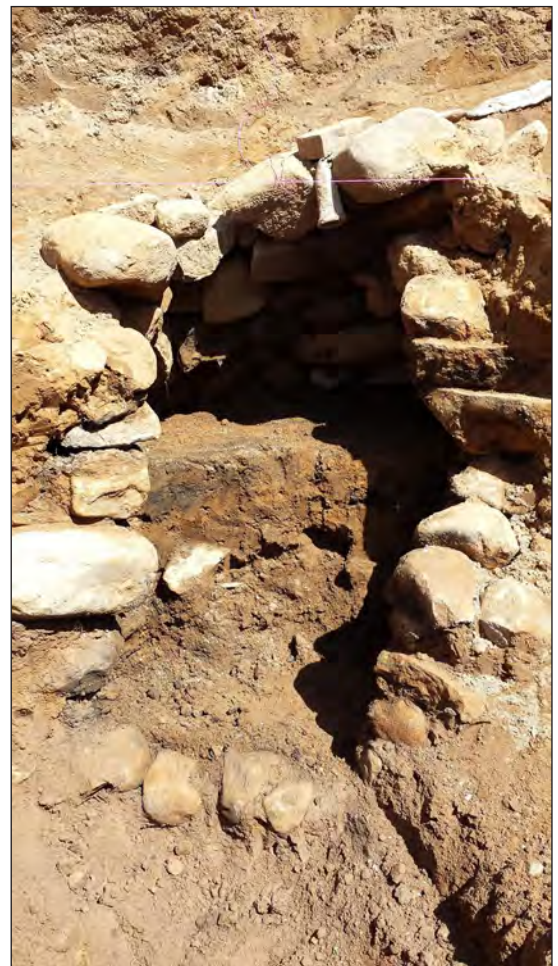
The northern half of the well on Lot 42 after excavation and removal of south wall and fill **14**

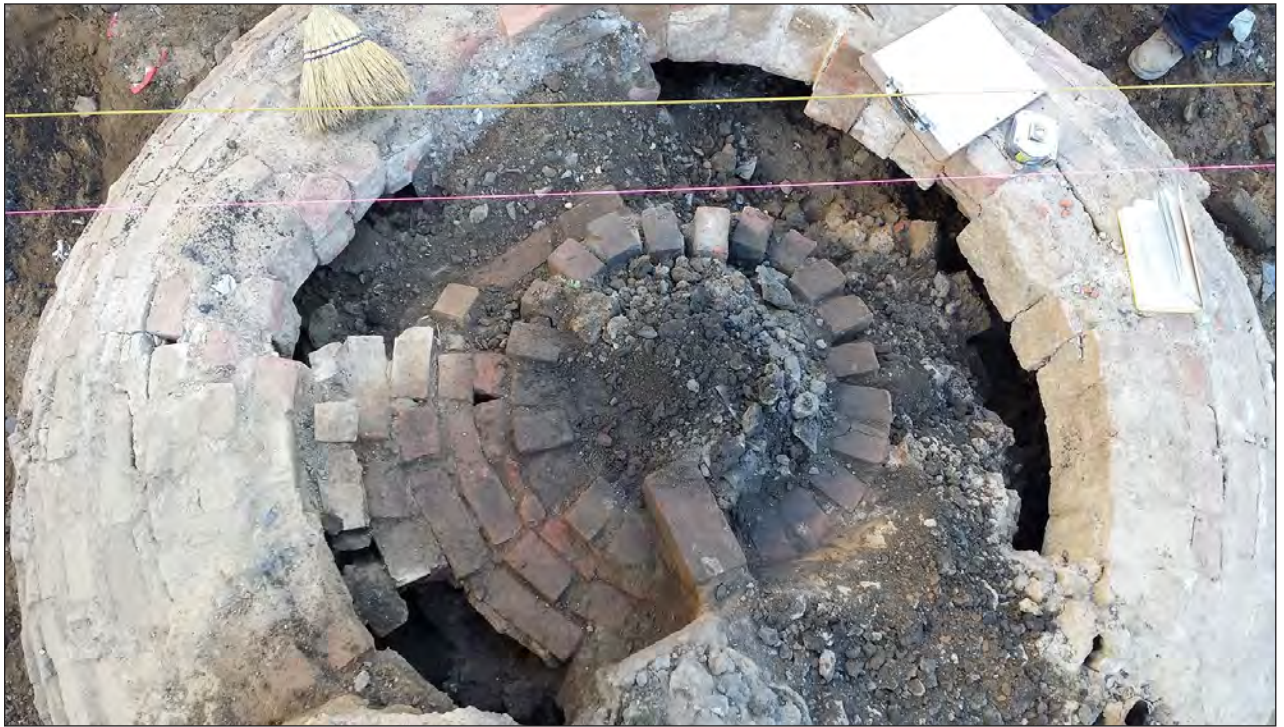
The top of the intricate dome of the cistern on Lot 42 with an intact brick ring in the center 15

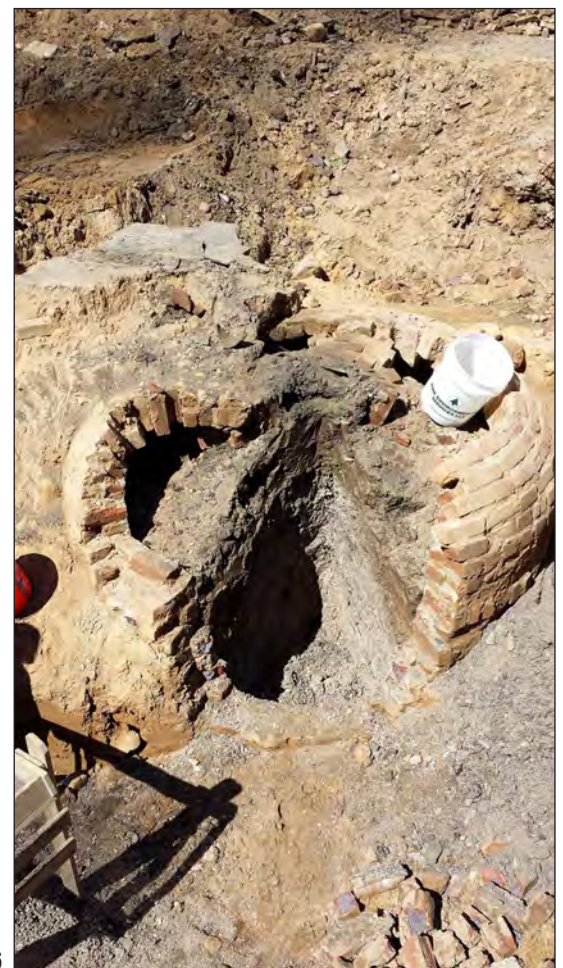
16

Looking northwest at the cistern on Lot 42 during excavation after removal of a portion of the wall in the southeast quadrant. Note the tall mound of gray ash making up most of the fill

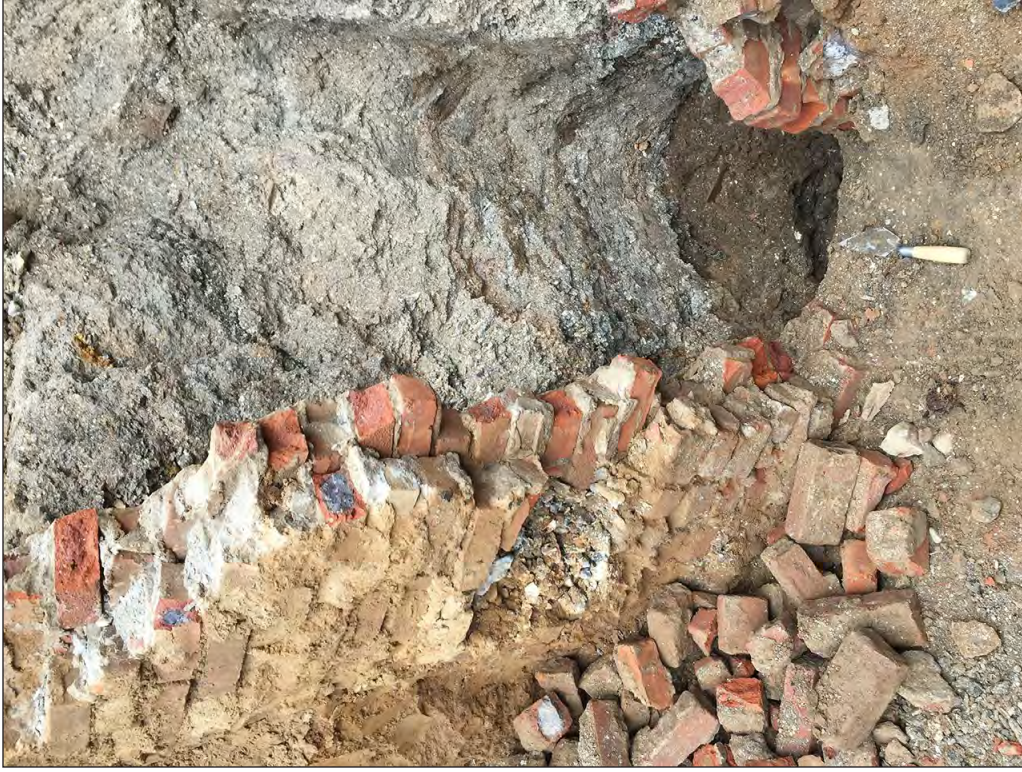
The East Feature on historic Lot 44 after excavation and removal of a portion of the wall in the southwest quadrant **17**

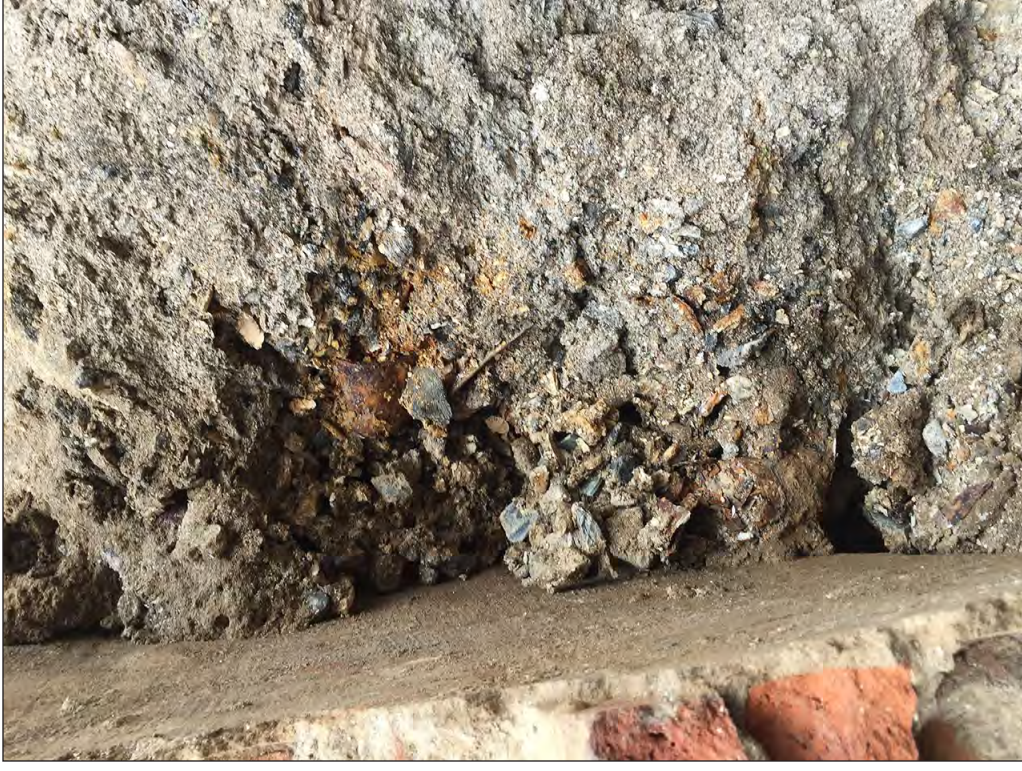
Close-up of the loose gray and brown ash with rusted metal making up the fill within the East Feature on historic Lot 44 **18**

- Photograph 18:** Close-up of the loose gray and brown ash with rusted metal making up the fill within the East Feature on historic Lot 44. (See **Figure 19**)

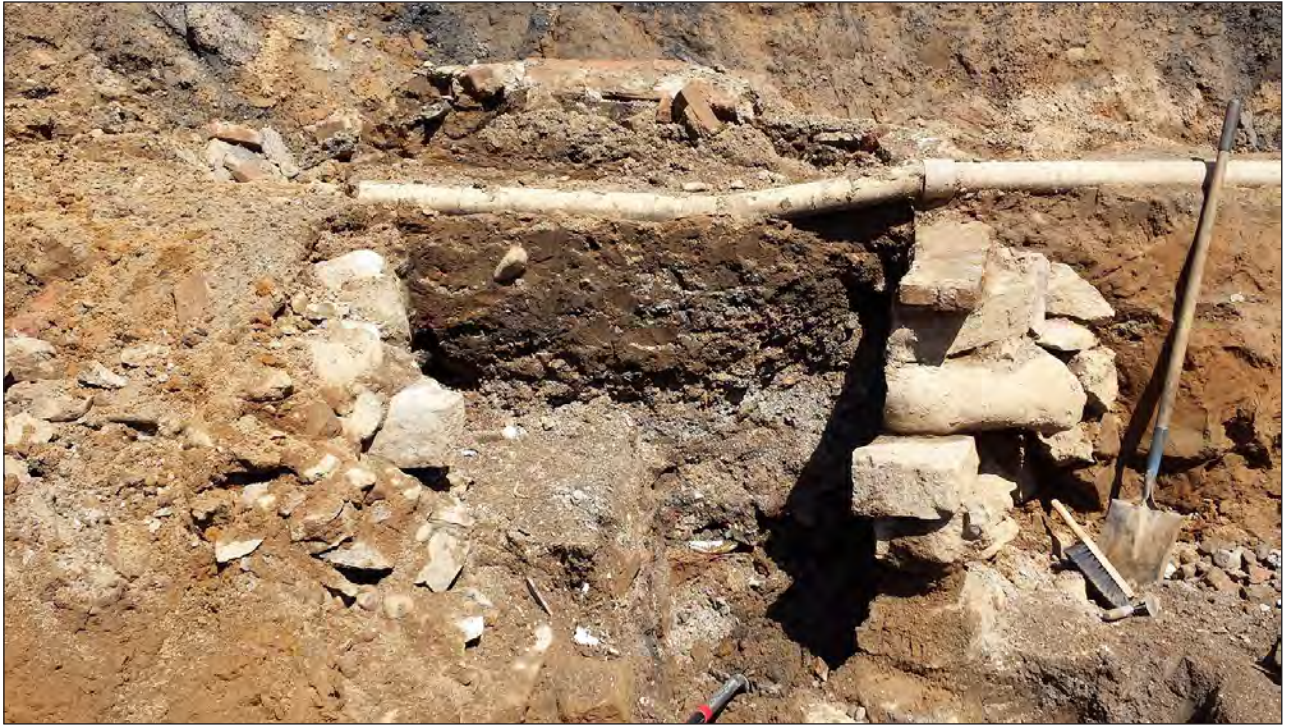
Upper portion of the south side of the West Feature on historic Lot 44 during excavation. Note the brick cap built over the angular stone shaft and the asbestos pipe that bisected the entire rear yard **19**

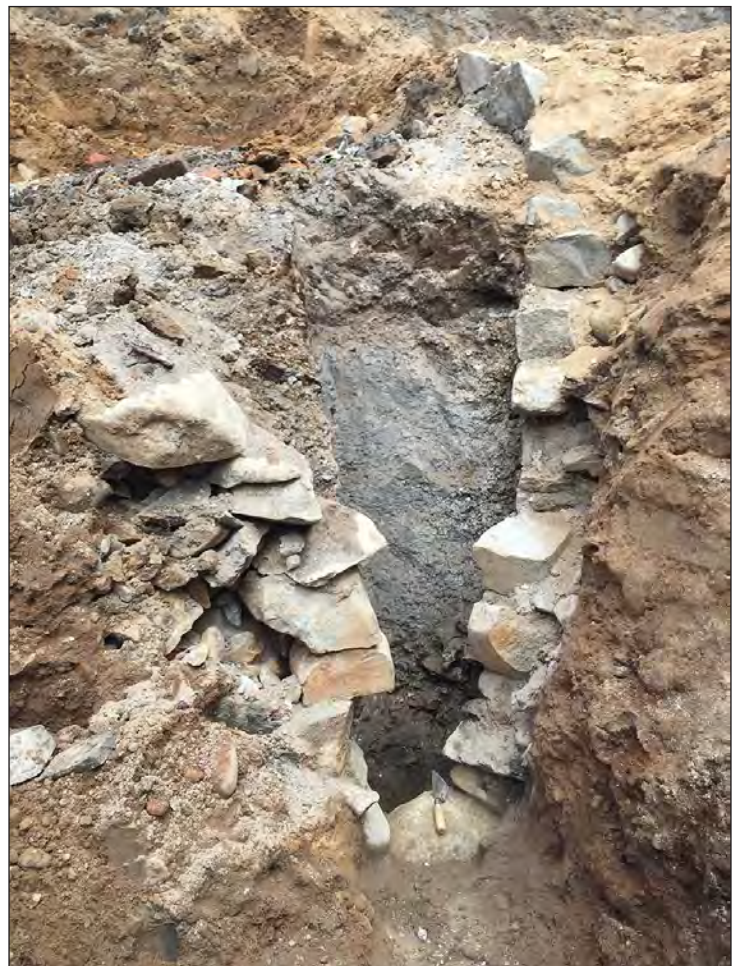
The southern side of the lower portion of the West Feature on historic Lot 44 following the removal of the upper section. Note the light, loose gray ash making up the fill **20**

- Photograph 20:** The southern side of the lower portion of the West Feature on historic Lot 44 following the removal of the upper section. Note the light, loose gray ash making up the fill. (See **Figure 20**)

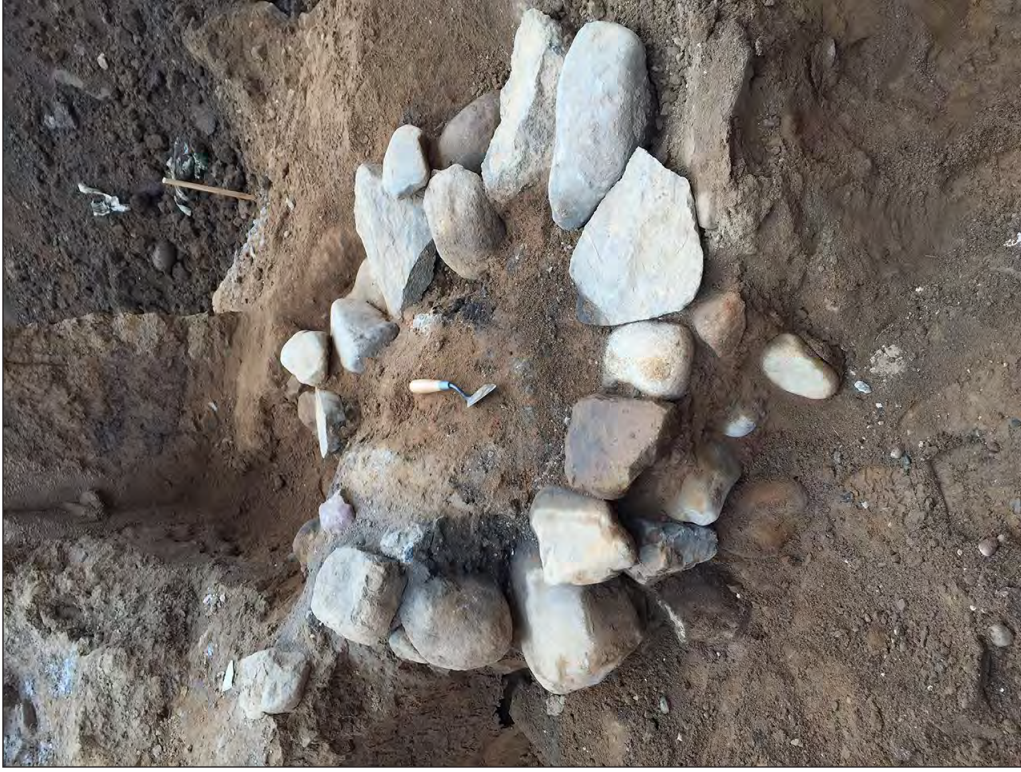
The northern face of the well on historic Lot 44 before excavation **21**
