Phase 1 and Phase 2 Archaeological Investigation

420 Albee Square

**Block 146, Lots 12, 41 (part), 42, 43, 46, and 47
Downtown Brooklyn, Kings County, New York**

July 2016

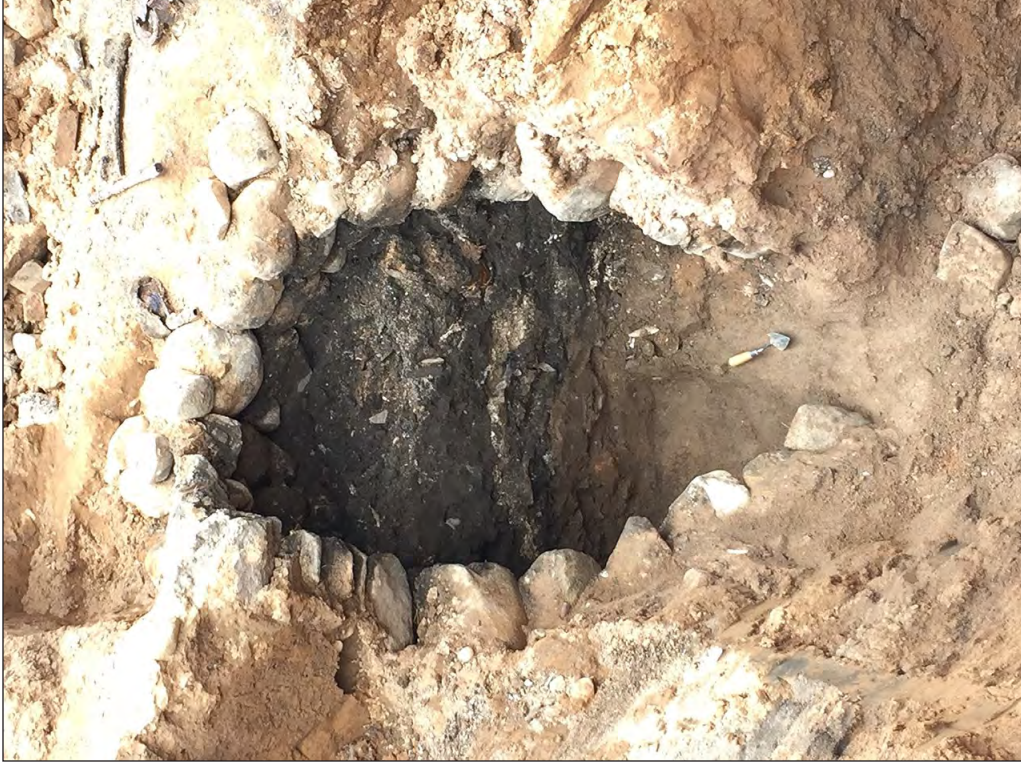
The northern side of the well on historic Lot 44 after excavation, showing the dark fill and clean, silty base **22**

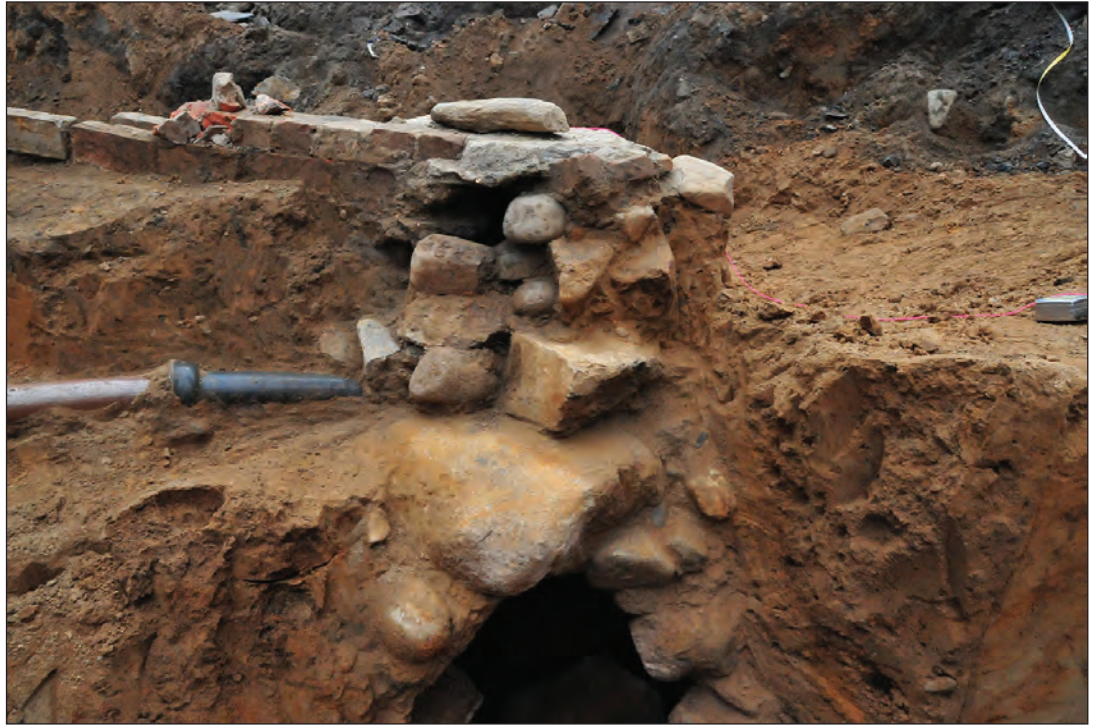
The northern façade of the intact stone cap of the well on historic Lot 45 before excavation. **23**
The missing stones at the bottom of the wall collapsed inward prior to the start of the Phase 2 work

- Photograph 23:** The northern façade of the intact stone cap of the well on historic Lot 45 before excavation. The missing stones at the bottom of the wall collapsed inward prior to the start of the Phase 2 work. (See **Figure 23**)

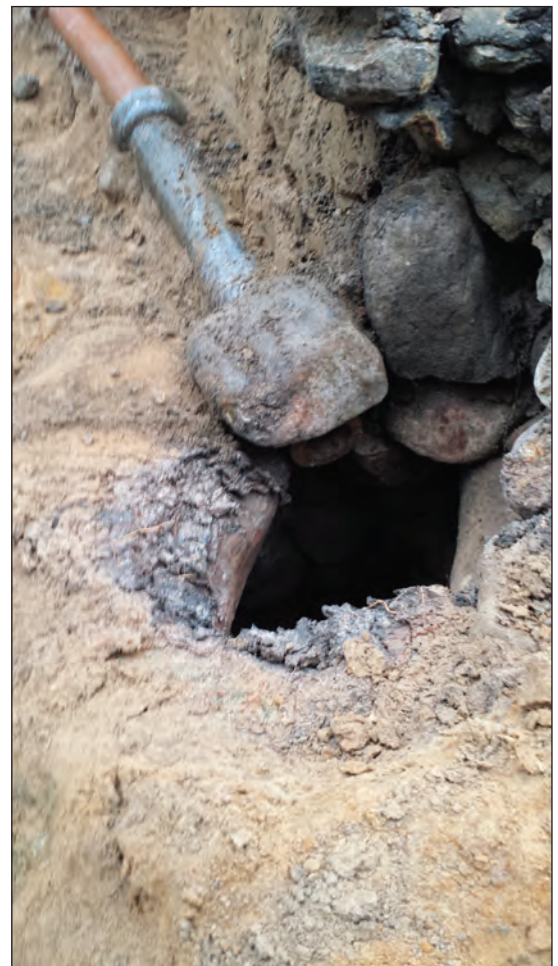
Drainage improvements made to connect terra cotta pipes to the stone well **24**

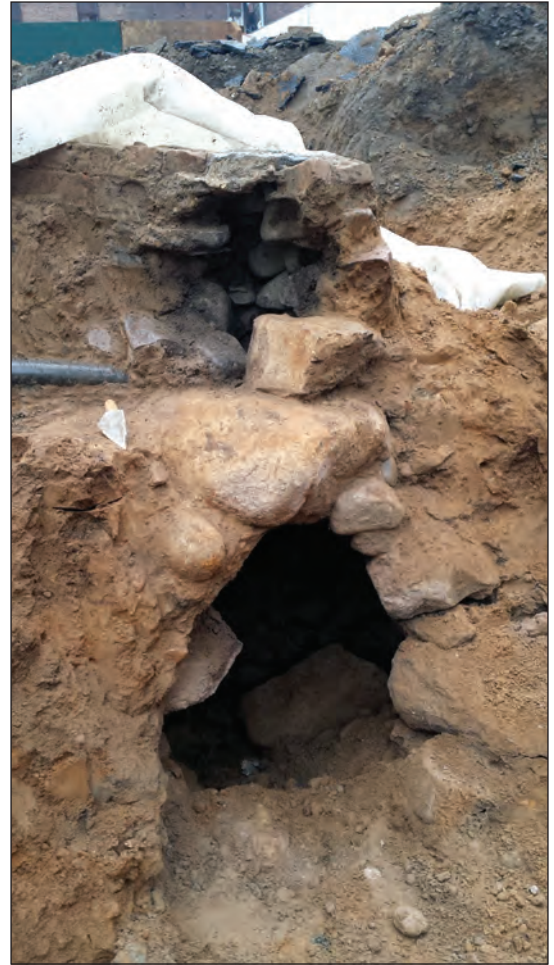
The northern side of the well on historic Lot 45
after the removal of rocks 25

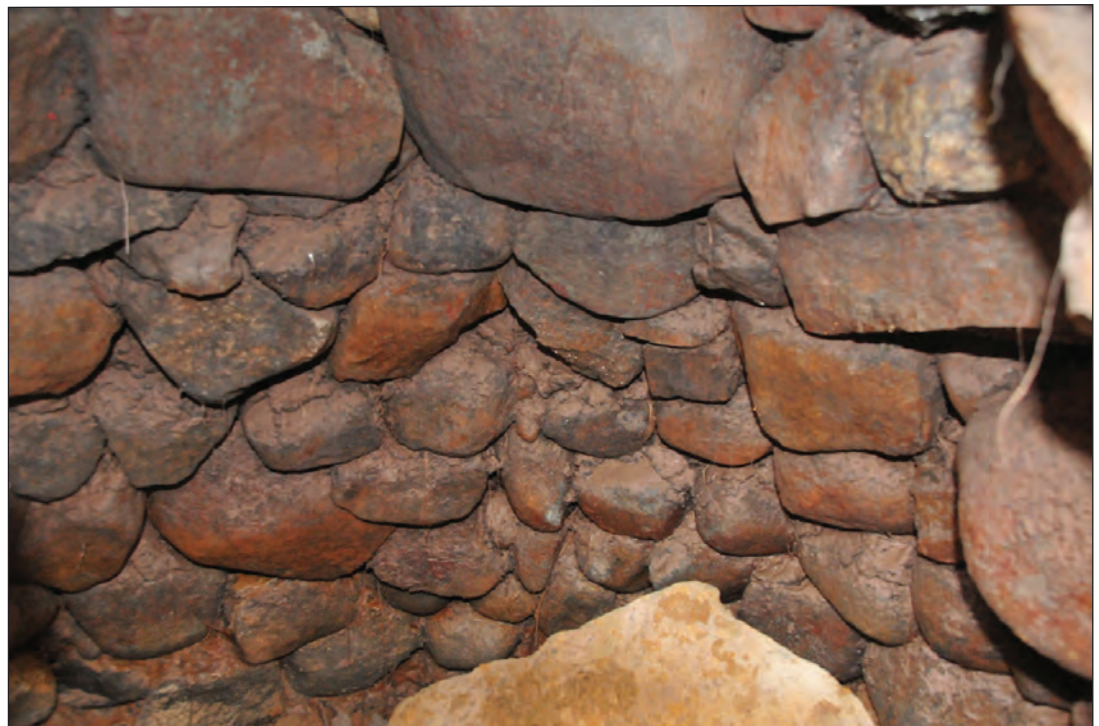
The interior of the stone well on historic Lot 45 26

- Photograph 26:** The interior of the stone well on historic Lot 45. (See **Figure 24**)
- Photograph 27:** The northern face of the cistern on historic Lot 45 after removal of the wall and excavation of the loose ash in the upper portion. (See **Figure 25**)

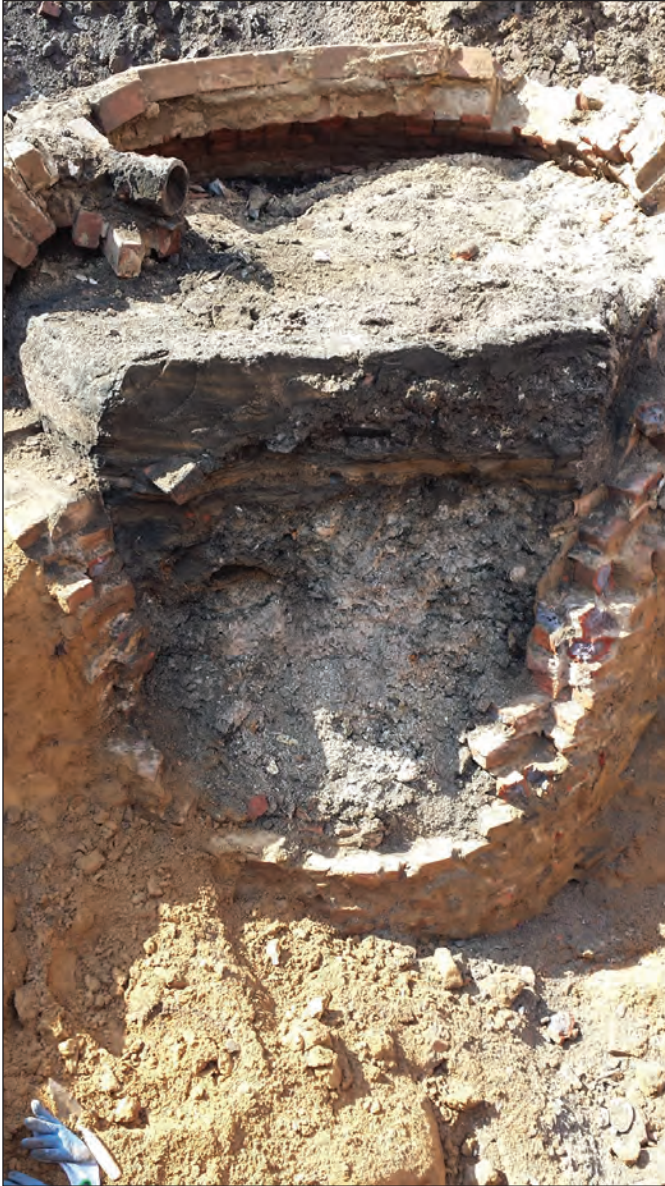
The northern face of the cistern on historic Lot 45 after removal of the wall and excavation of the loose ash in the upper portion **27**

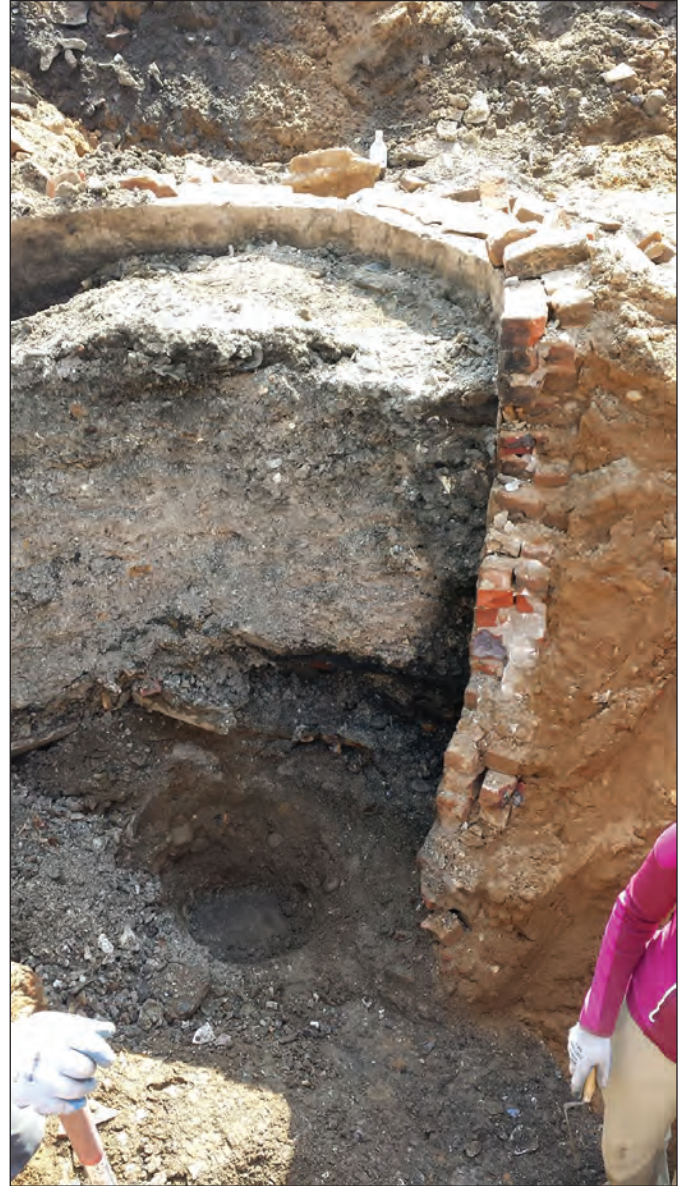
The lower portion of the cistern on historic Lot 45 after the completion of excavation. The shovel test pit at the very bottom of the ash was excavated to the depth of the mortared cistern bottom **28**

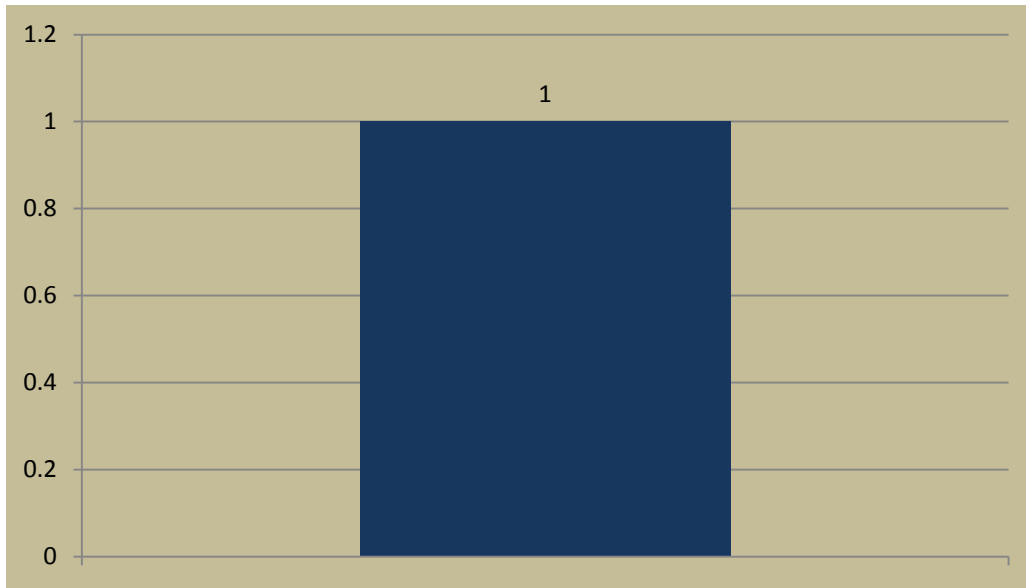
Figure 01: Average density of plant macro-remains recovered from 420 Albee Square.
