Coastal and Social Resiliency Initiatives for the Tottenville Shoreline: Living Breakwaters and Tottenville Shoreline Protection Projects

STATEN ISLAND, RICHMOND COUNTY, NEW YORK

Revised Phase 1A Archaeological Documentary Study

MAY 2017

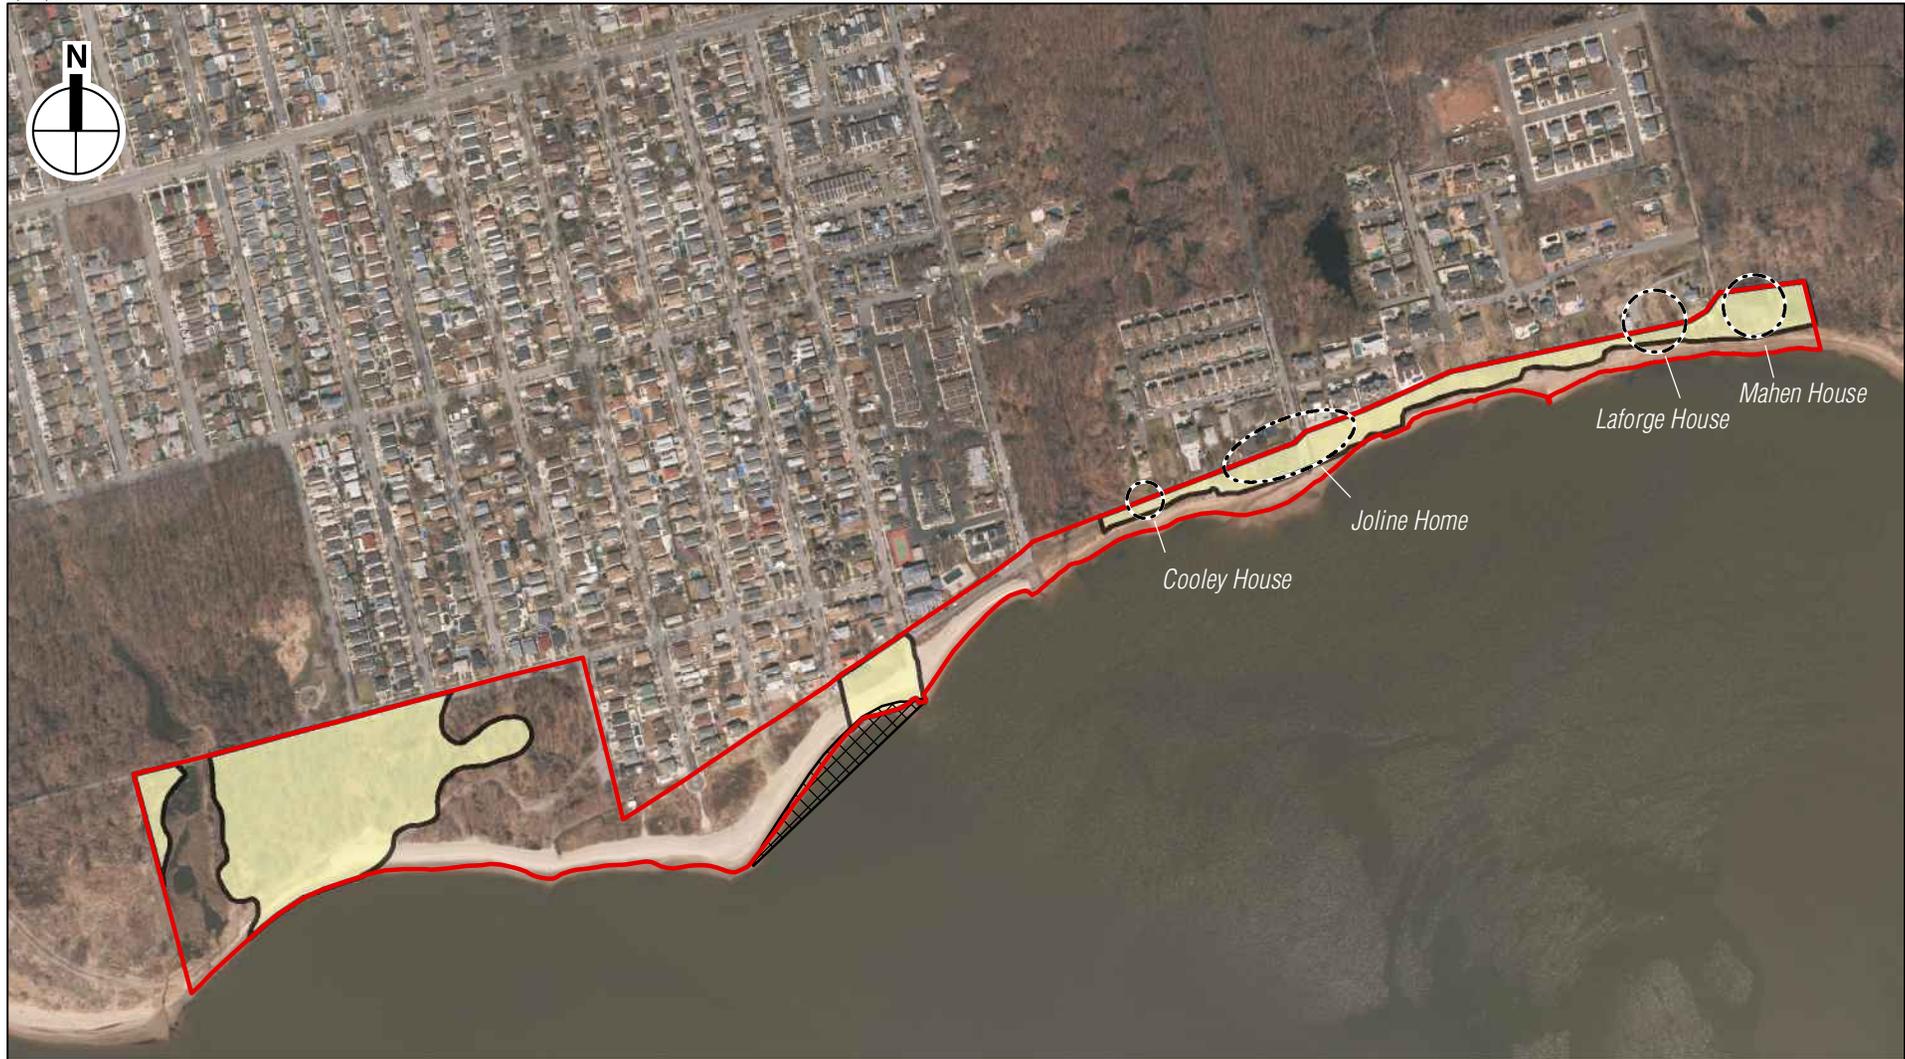
Archaeological Sensitivity Map:
Shoreline APE (Including Water Hub Potential Location 1)
Figure 9a

- Upland Areas with Potential Precontact Sensitivity
- Shoreline Area of Potential Effect (APE)
- Proposed Shoreline Restoration Area

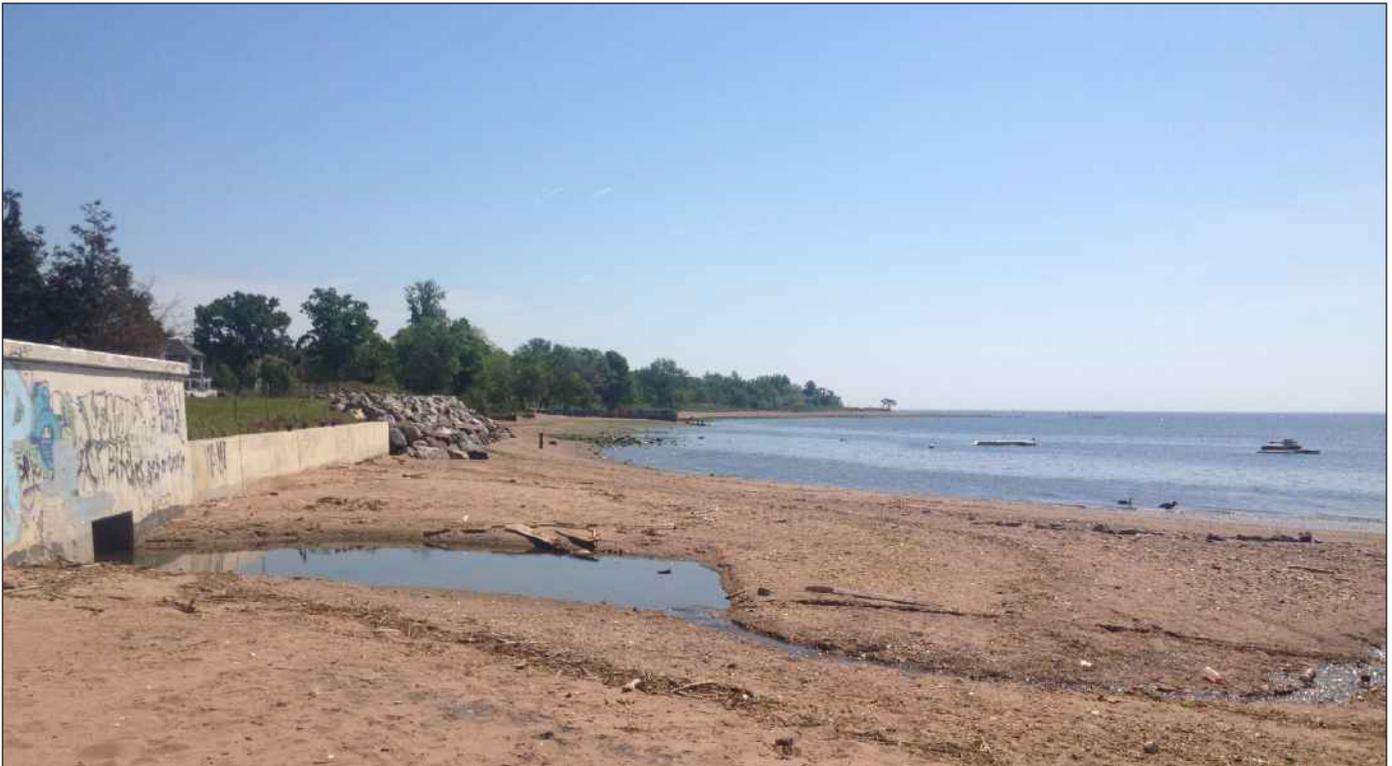
View east of drainage structures and rip-rap walls lining the beach near the food of Bedell Avenue. 4

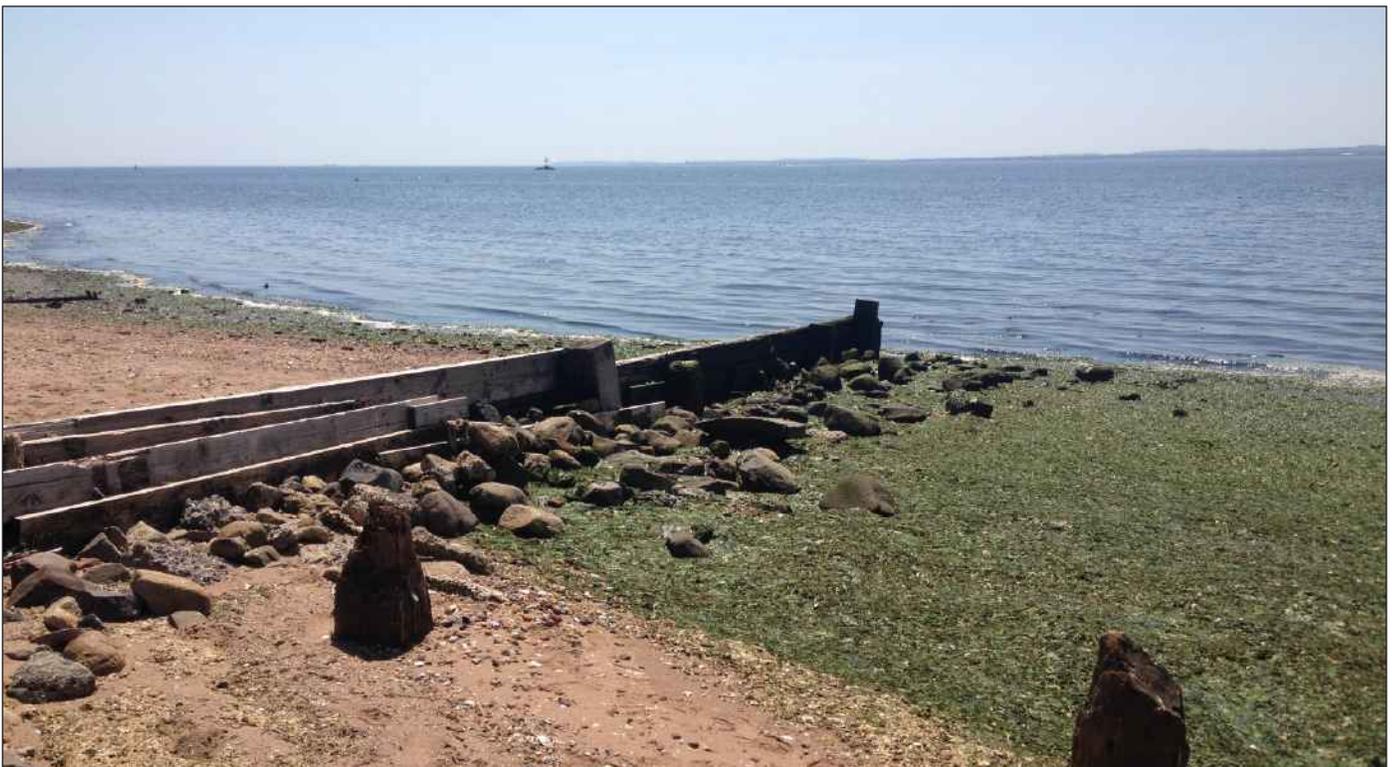
Remnants of a waterfront structure near the southern end of what was once the Cooley and Robinson property. 6

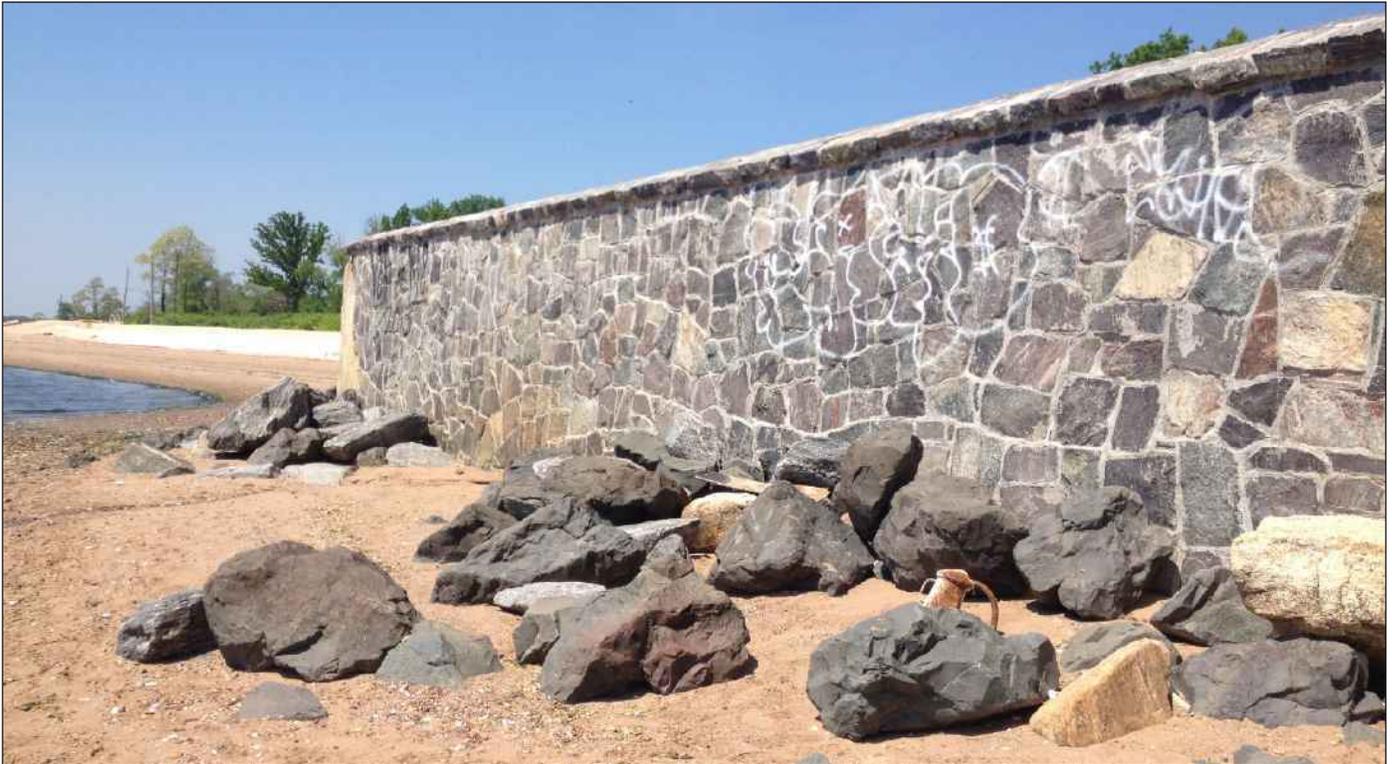
Stone seawall located near the foot of Sprague Avenue. 7

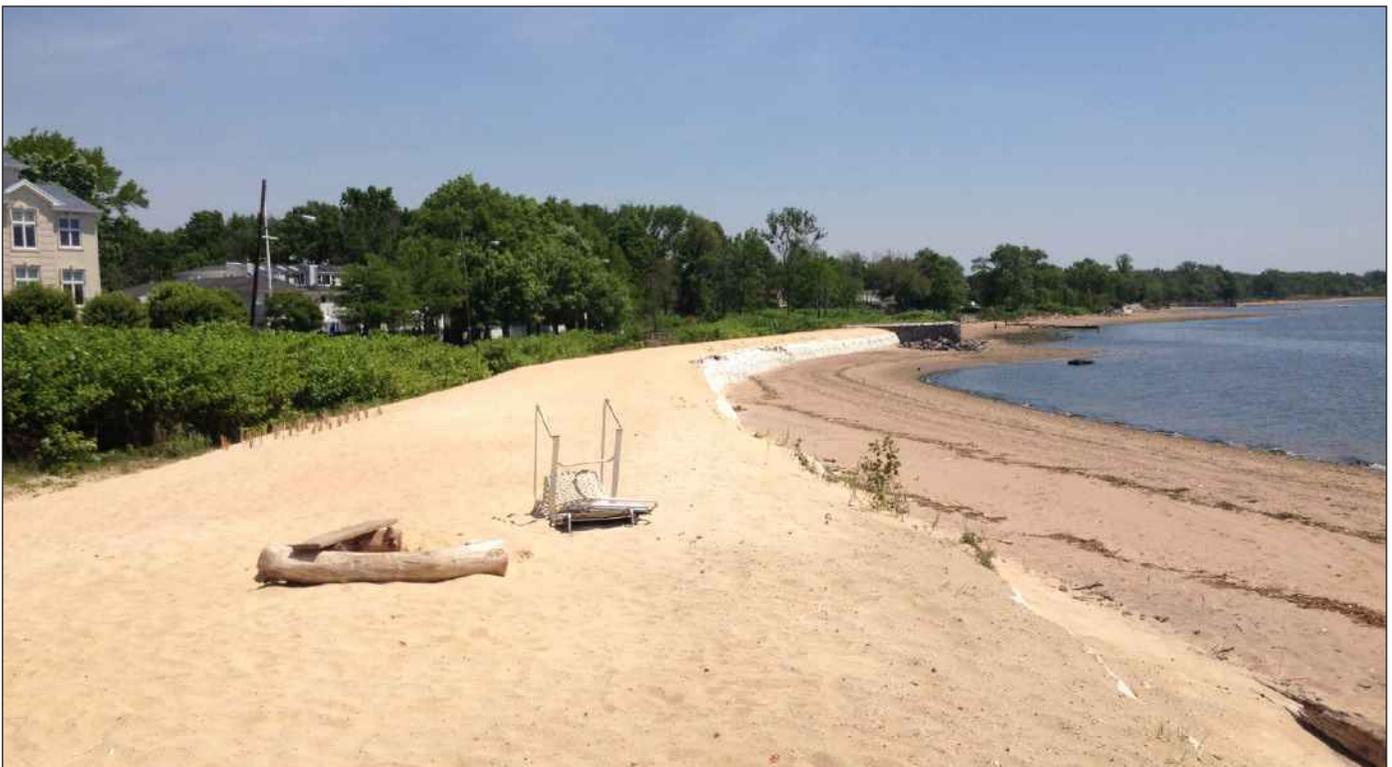
View east along the beach near the terminus of Loretto Street, showing sandbags and stone and concrete sea walls constructed along the waterfront. 8

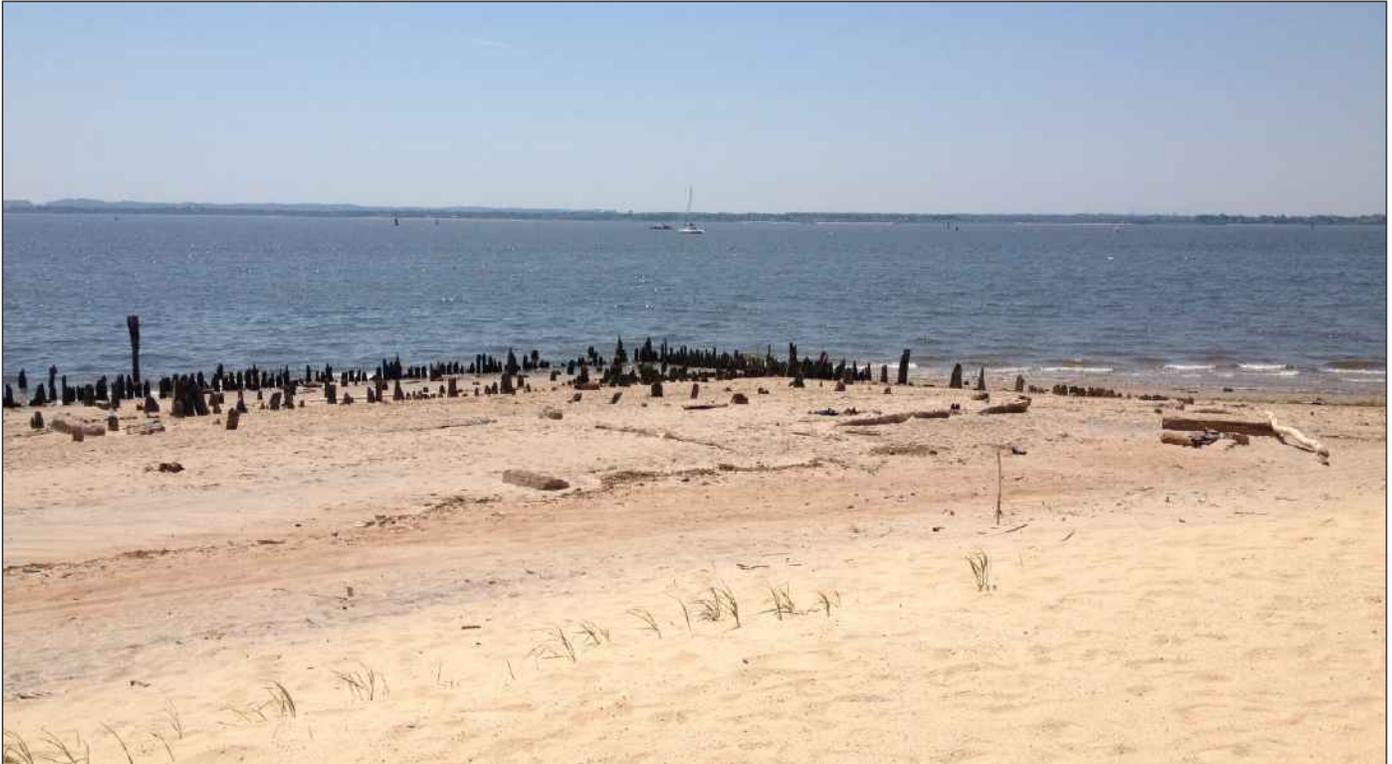
Remnants of a wooden platform extant along the beach near the foot of Yetman Avenue. **10**

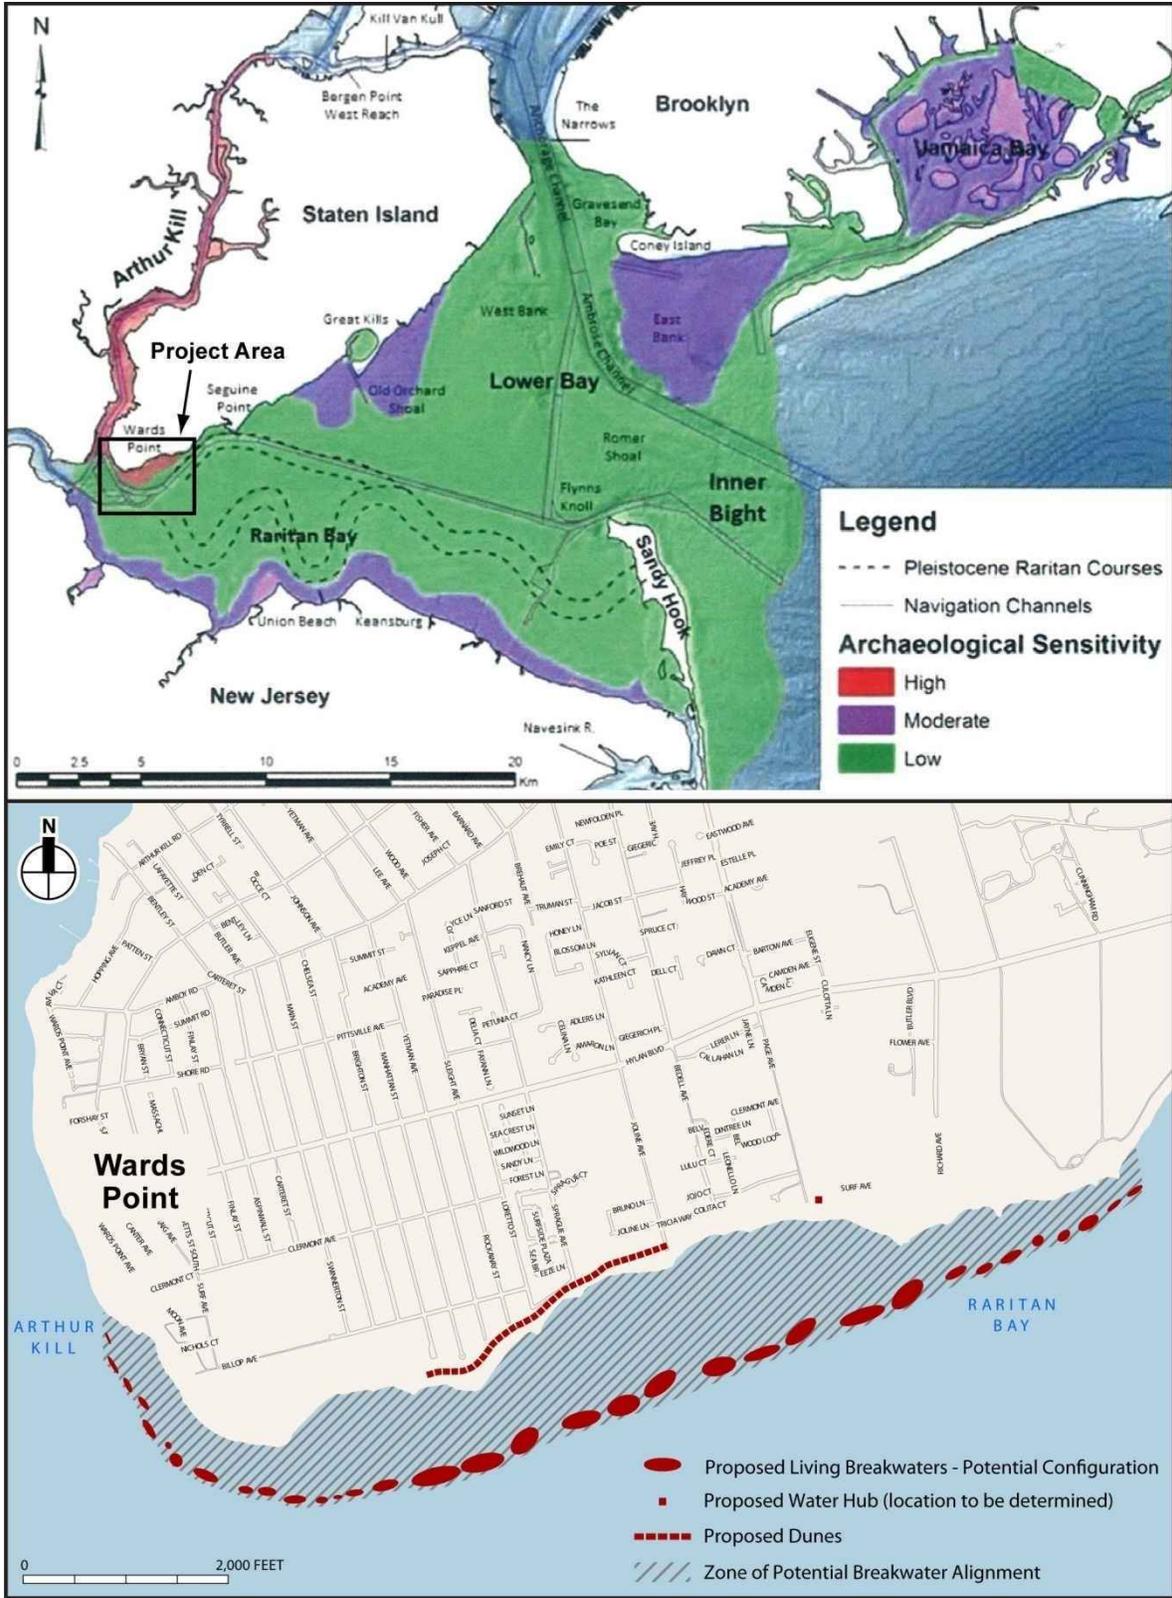
Figure 2. Archaeological sensitivity assessment of Raritan Bay from Schuldenrein et al. 2014 showing the project area (top), and the project APE (bottom).

As part of the NYNJHNP, GRA collected primary data in the study area through the advancement of 20 split-spoon soil cores (GRA 2014). The cores were examined for a detailed description of their sediment lithology, Carbon-14 dating of several shell samples, and various types of biological evidence to identify changes in temperature and salinity, flora and fauna, and other indicators of past environmental conditions (ibid). This information was synthesized to identify those areas within the Harbor that could have been occupied prior to the rise of sea levels and to determine the probability that those sites would have been preserved beneath a protective layer of peat deposits.

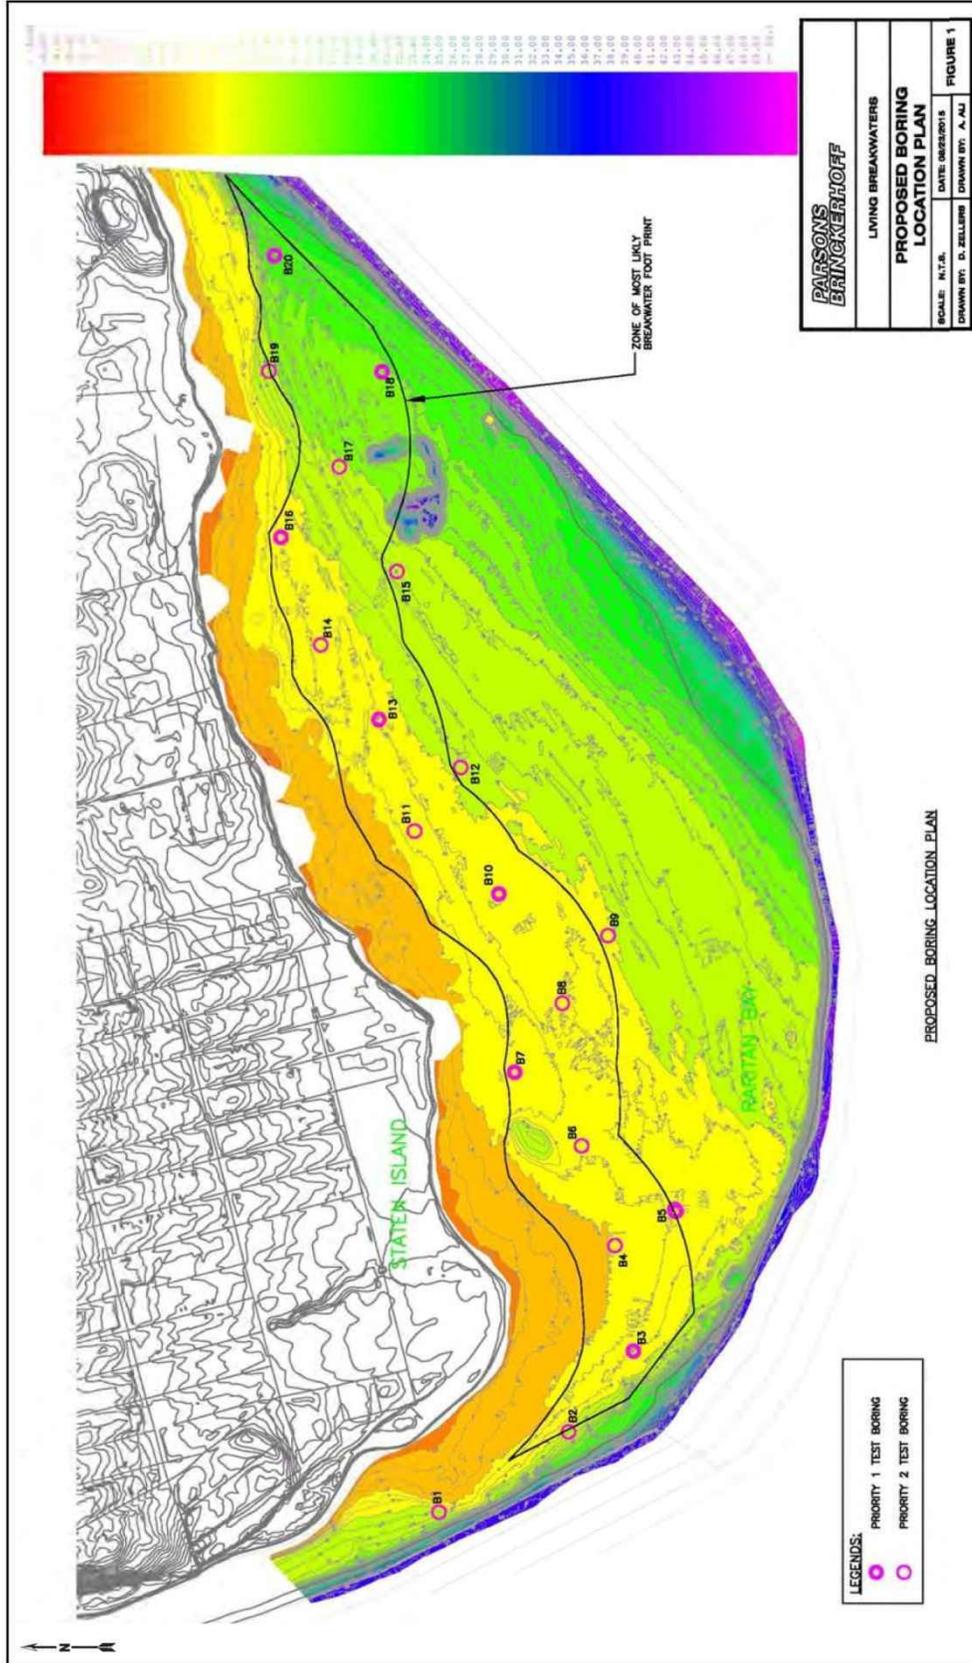
Figure 3. Living Breakwaters proposed boring location plan for B-1 through B-20, Raritan Bay, Staten Island, NY.

The geomorphological investigation conducted by UMass in 2015 (see **Appendix A**) involved the observation of 20 geotechnical borings ranging in depth between approximately 60 and 150 feet below the bay floor in and around the Breakwaters APE.¹ No intact buried ground surfaces (known as "A-horizons") were observed in any of the borings, though it was noted that they may have been "drilled through and unobservable" as a result of the drilling methodology (Lynch 2016: 6). Soil levels that were identified as "hypothesized B-horizons," or the subsoil layers immediately below presumed ground surfaces, were observed in some borings. In addition, no C-horizons—the soil layers beneath the subsoil that serve as the parent material from which the subsoil is formed—or developed peat layers suggesting inundation were observed. Overall, the soils were identified as similar to those observed by GRA during their prior boring program, which were determined to have been formed during the Cretaceous period between 66 and 144 million years ago (ibid; Isachsen, et al. 2000).

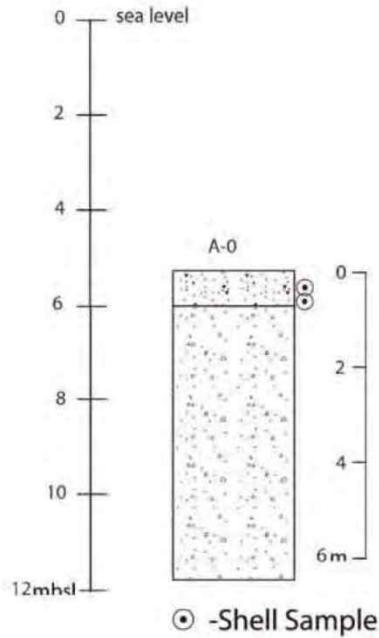
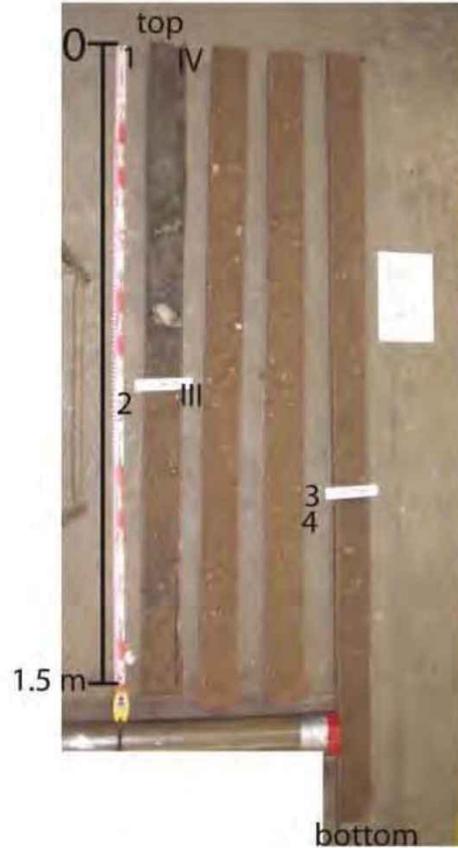
Core: A-0
 Location: 40° 30.26N 74°11.59W
 Water Depth: 17.8' (5.43m)
 Pene 39' (11.89m), Recov. 21' (6.40m)
 Description (depths in meters below core top)

Figure 4. Core A-0 reproduced from Shuldenrein et al. 2014, page 171.

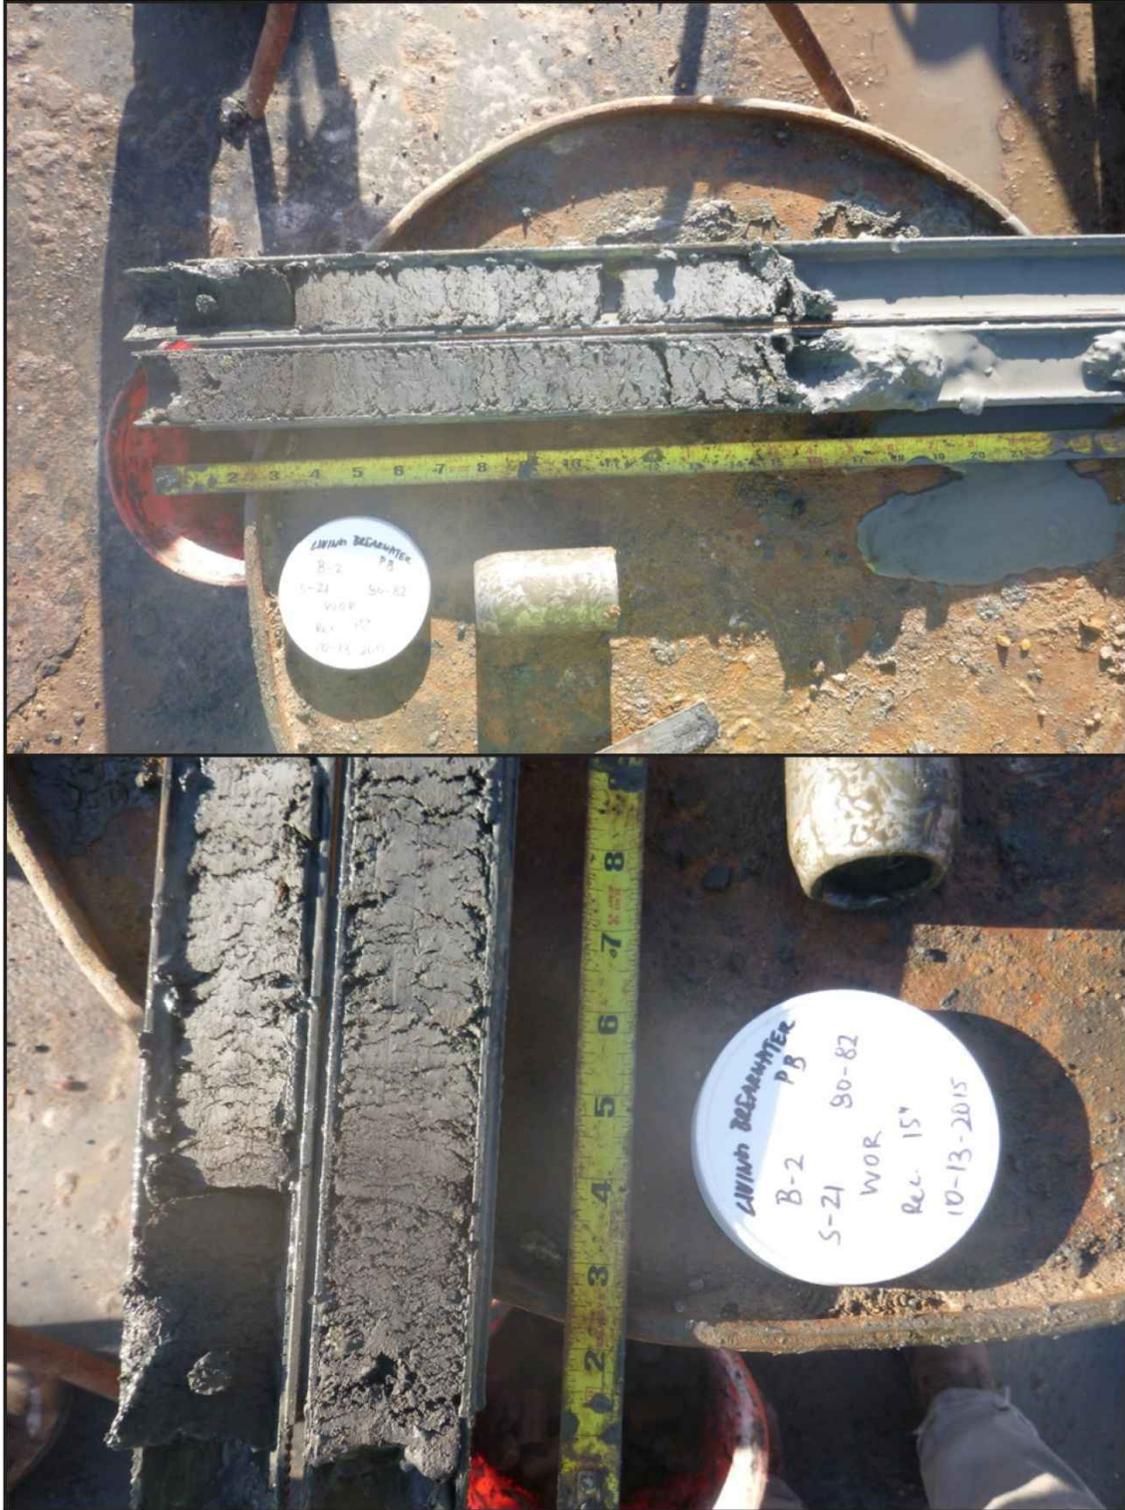
Figure 5. Photograph of bore segment 72-74 ft (79.2-81.2 ft bmsl) at bore location B-2 (top), and a close up photograph of grayish brown clay silt with botanical inclusions 80.8-81.2 ft bmsl (bottom).

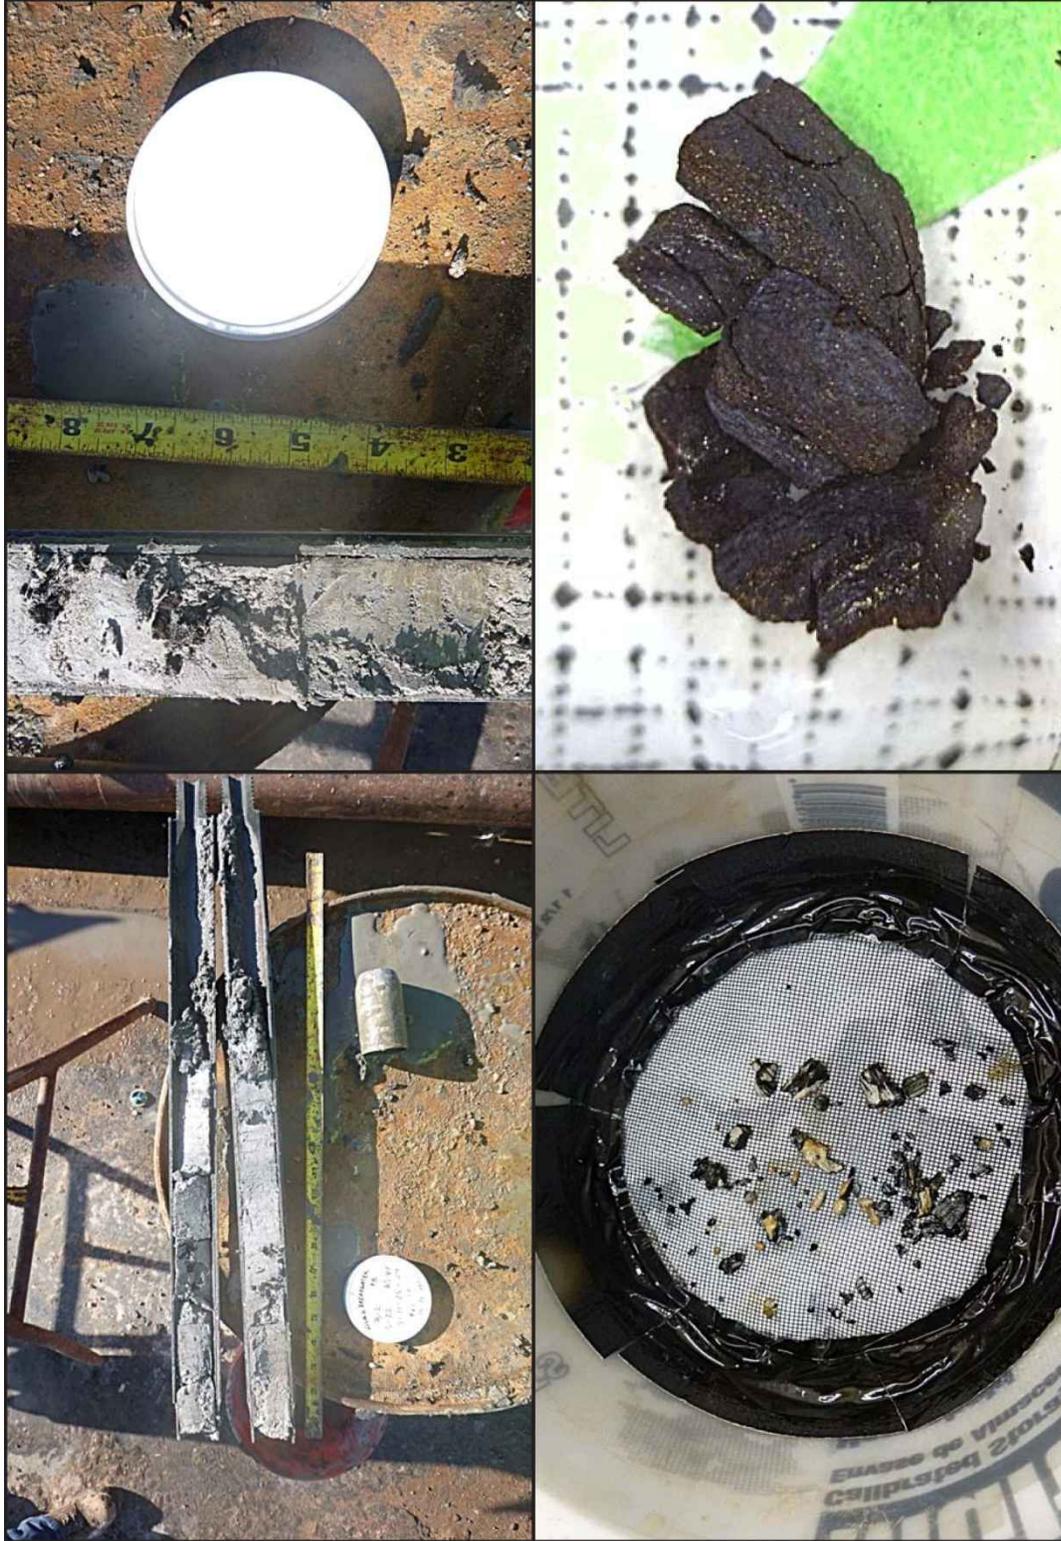
Figure 6. Photographs of bore segment 74-76 ft (81.2-83.2 ft bmsl) at bore location B-2 (top left), a close up of the charred inclusions in-situ (top right), the fragment remaining following flotation at the bottom of a two gallon bucket (bottom left), and an example of the charred material after being pretreated for radiocarbon dating at the Beta Analytic lab showing mineralized flecking (bottom right).

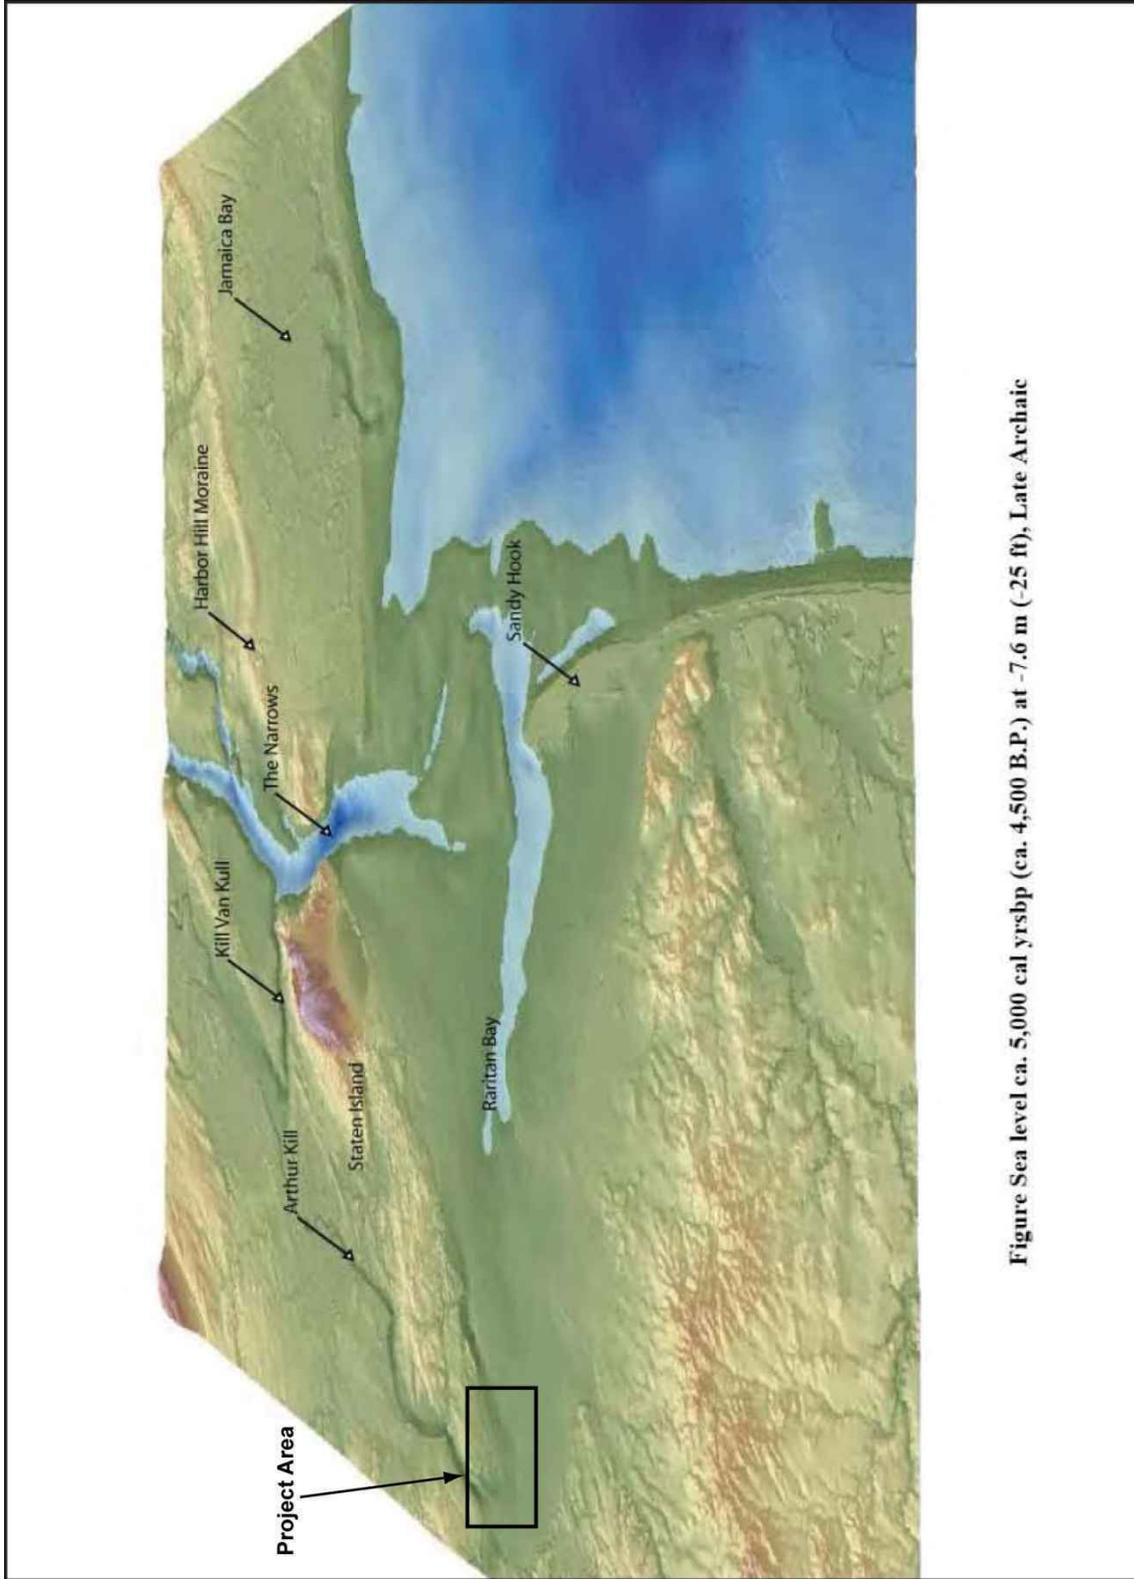
Figure Sea level ca. 5,000 cal yrsbp (ca. 4,500 B.P.) at -7.6 m (-25 ft), Late Archaic

However, Lynch (2016) also report that many of the sediments seen by GRA in borings elsewhere in Raritan Bay were absent in the borings located within the Breakwaters APE. On the western side of the Breakwaters APE, Lynch identified a layer of mud "indicative of post-inundation deposition" in five boring locations near the western end of the Breakwaters APE, which was inconsistent with the borings observed by GRA in 2014 (Lynch 2016: 7). Remnants of charred and uncharred terrestrial botanicals were also observed in twelve boring locations near the western end of the APE and in two locations in the vicinity of the now-eroded Ward's Point. The borings suggest that during the Late Archaic period (circa 5,500 years before present), the soils currently situated approximately 35 feet below sea level were situated below what was then the exposed ground surface.

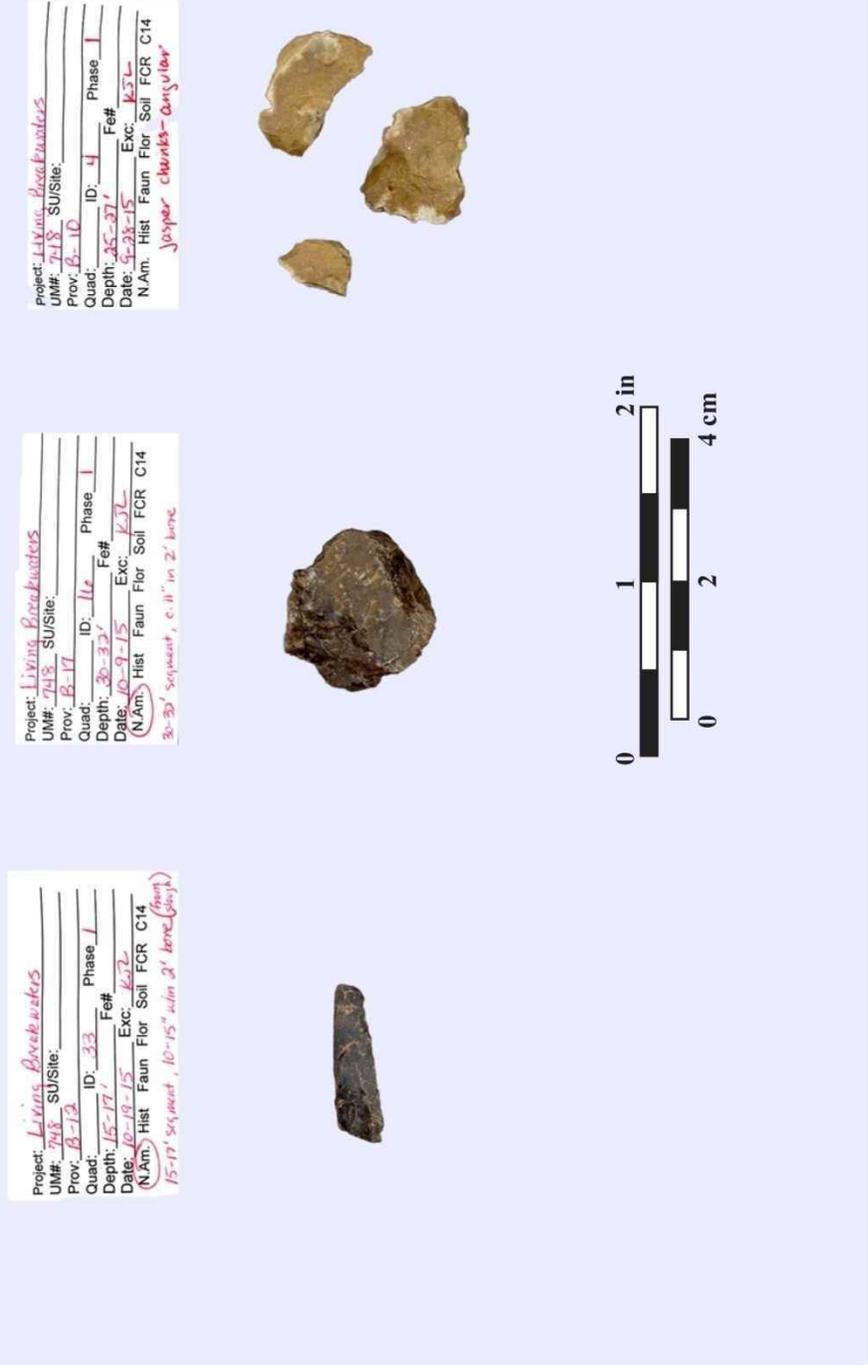
Figure 8. Lithic material recovered from Living Breakwaters bore segments; bore location B-12, chert fragment from approximately 26 ft bmsl (left); bore location B-17, chert fragment from approximately 42 ft bmsl (center); and bore location B-10, jasper nodule fragments from 34.6 ft bmsl (right).
