Second Avenue Subway: Phase Two

**SECOND AVENUE BETWEEN EAST 104TH AND EAST 125TH STREETS AND
EAST 125TH STREET BETWEEN SECOND AVENUE AND ADAM CLAYTON
POWELL, JR. BOULEVARD
NEW YORK, NEW YORK**

Supplemental Phase 1A Archaeological Documentary Study

NOVEMBER 2017

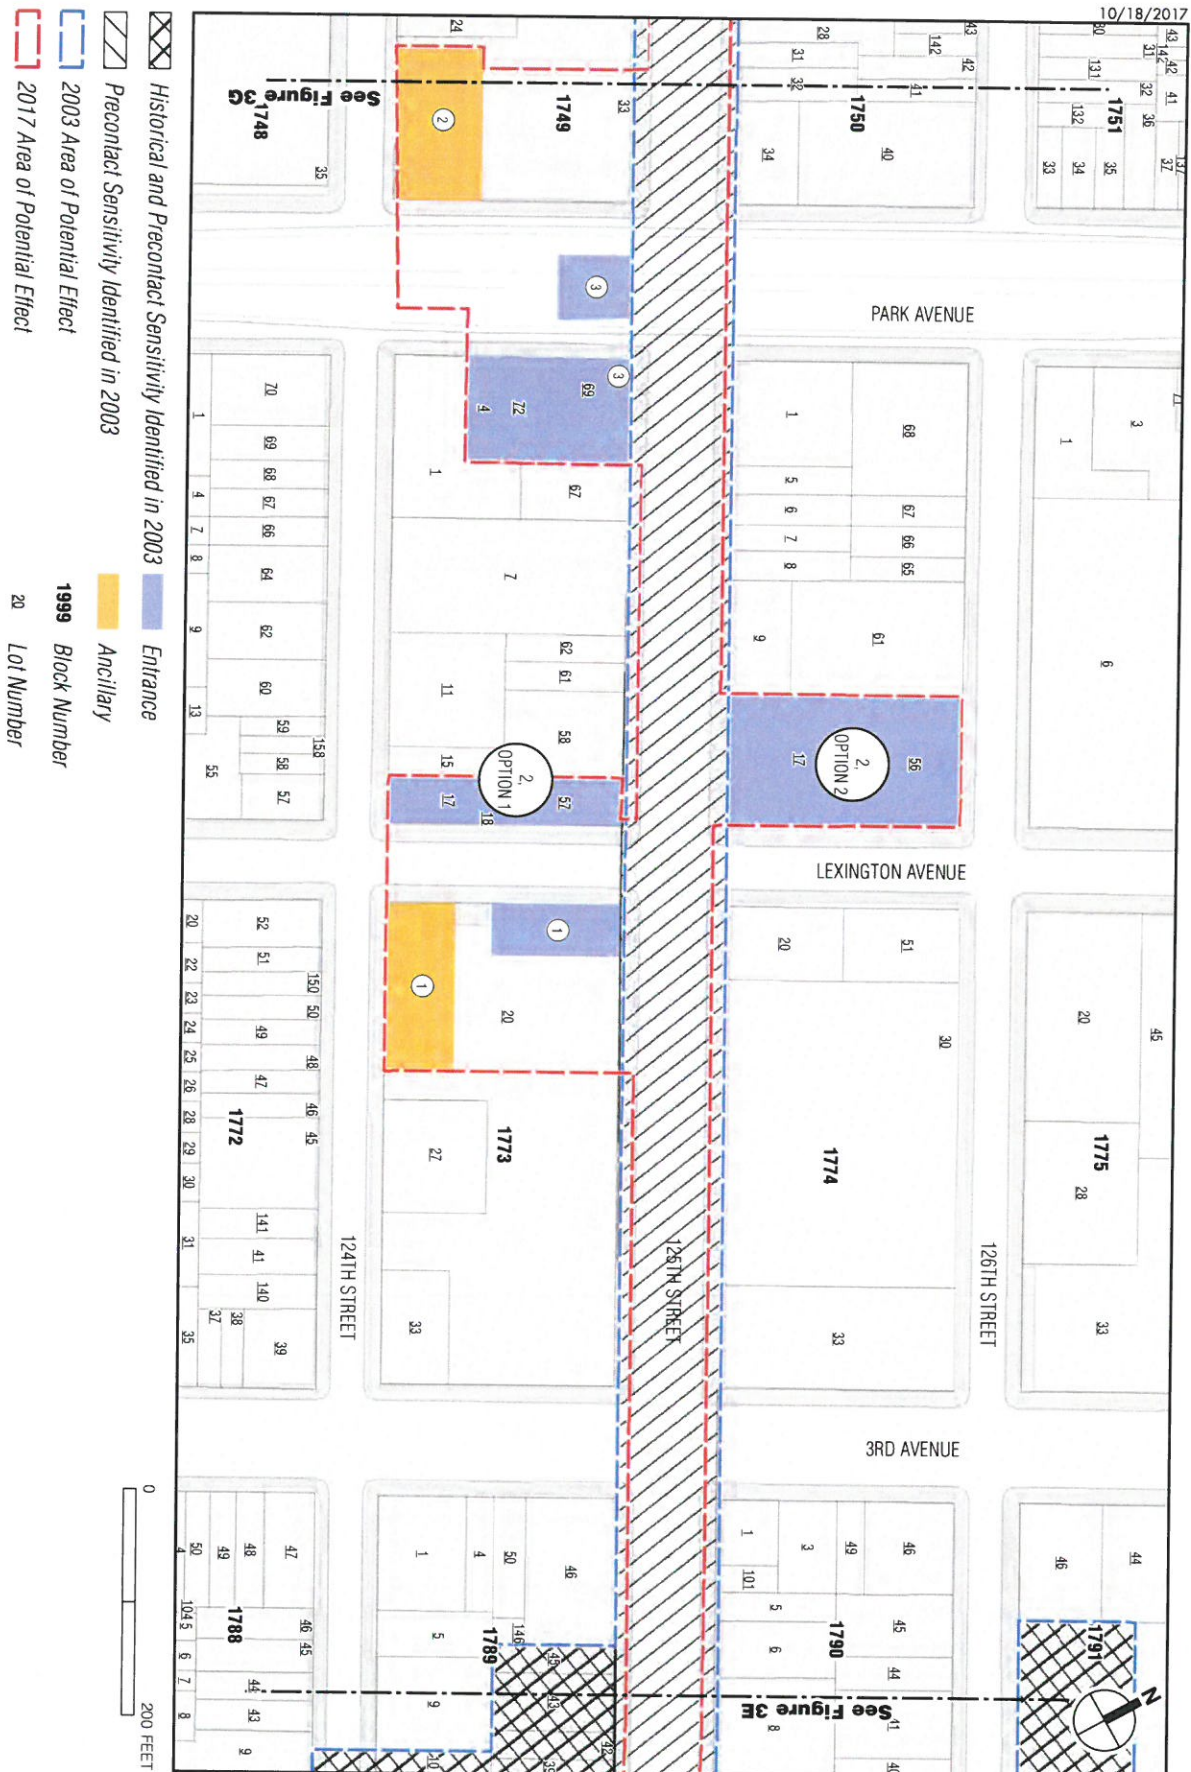
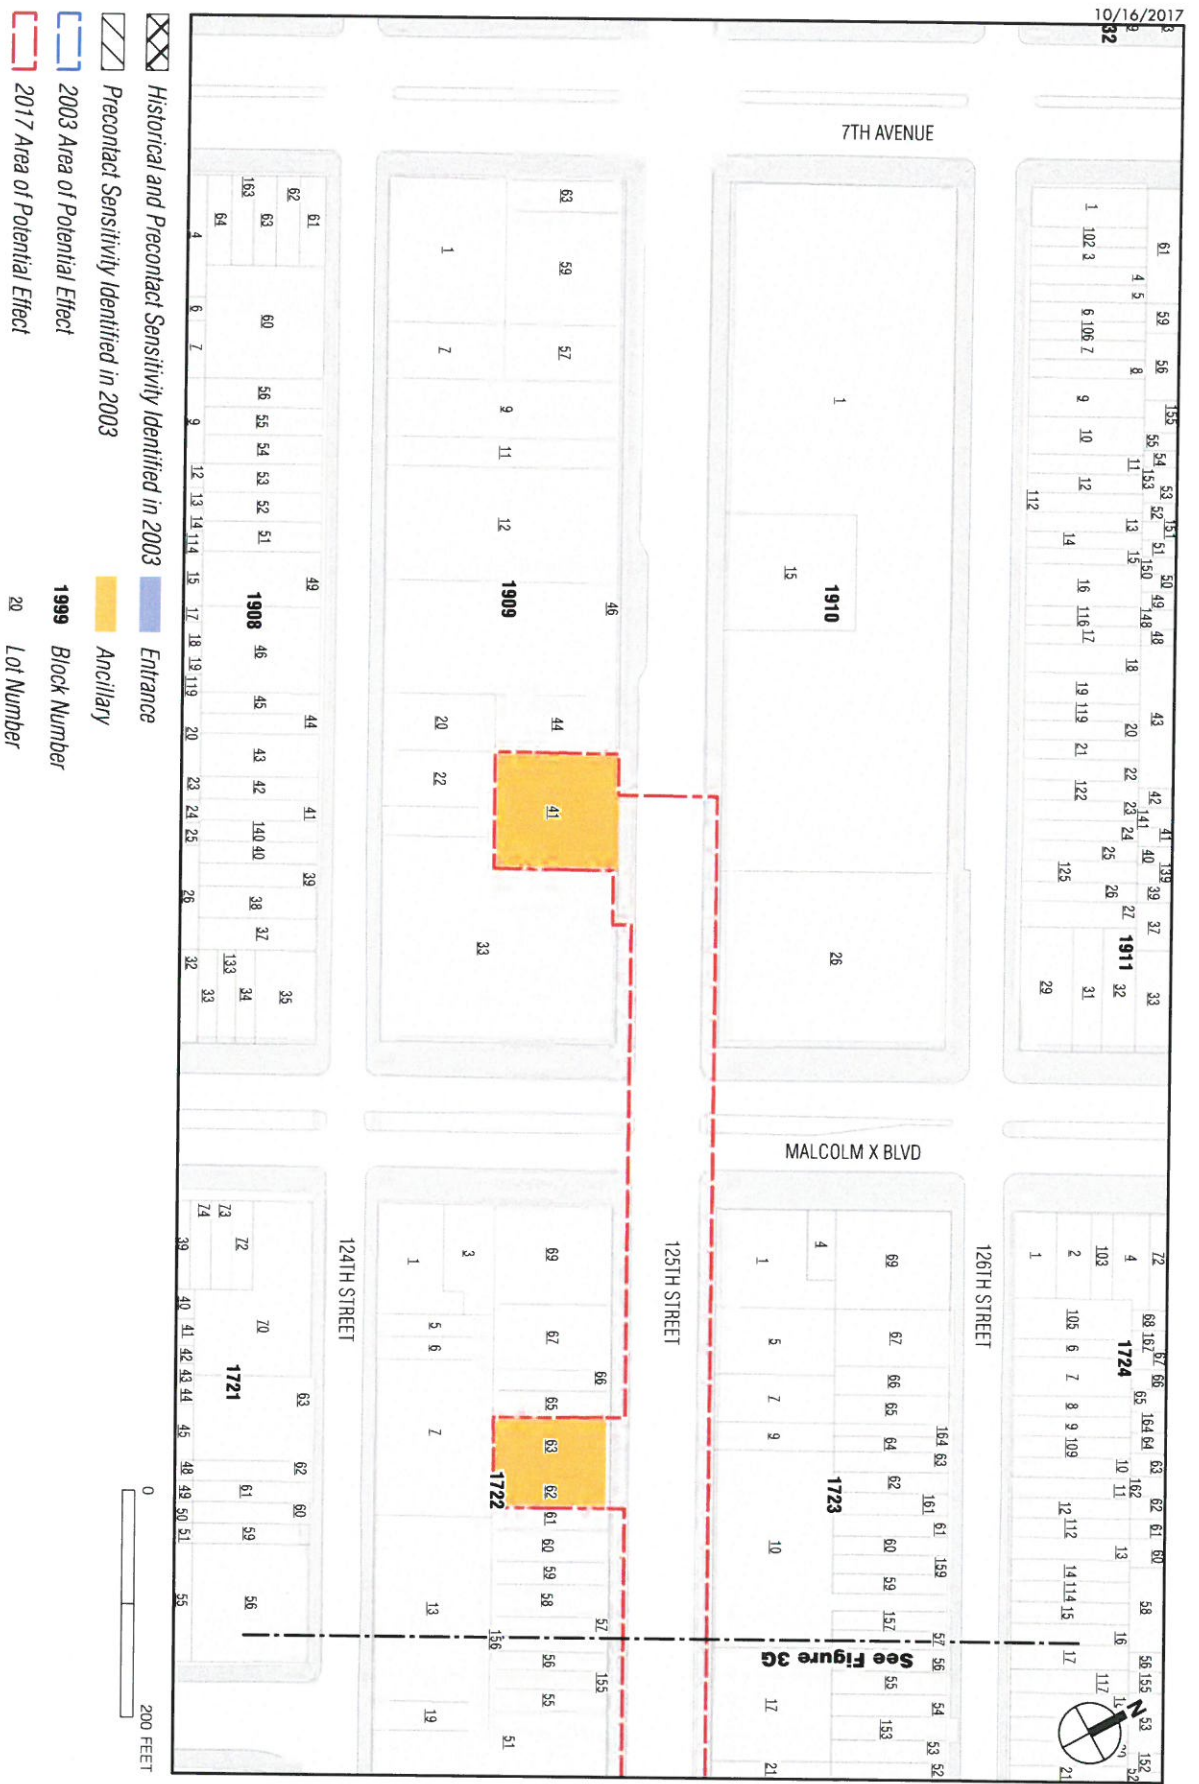
Archaeological Area of Potential Effect
Figure 3A

Archaeological Area of Potential Effect
Figure 3B

Archaeological Area of Potential Effect
Figure 3C

Archaeological Area of Potential Effect
Figure 3D

SECOND AVENUE SUBWAY PHASE 2
 Archaeological Area of Potential Effect
Figure 3E

Archaeological Area of Potential Effect
Figure 3F

Archaeological Area of Potential Effect
Figure 3G

Archaeological Area of Potential Effect
Figure 3H

An extensive analysis of cultural resources, including archaeological resources, was completed as part of the 2004 FEIS. The Federal Transit Administration (FTA) issued a Record of Decision (ROD) for the Second Avenue Subway project on July 8, 2004. The ROD was issued based on the findings presented in the FEIS, which examined the potential impacts of the 8.5-mile-long Second Avenue Subway from East 125th Street in Harlem to Hanover Square in Lower Manhattan. The FEIS identified the environmental impacts of the Second Avenue Subway during its construction and the permanent impacts once the subway is operational. It also identified mitigation measures to alleviate the identified impacts. As part of the FEIS, a Phase 1A Archaeological Documentary Study (“Phase 1A study”) of the proposed subway route was prepared by Historical Perspectives, Inc. (HPI) in 2003 (HPI 2003a). HPI’s 2003 study and numerous supplemental studies that were prepared thereafter—including an assessment of previous soil borings (HPI 2003b)—identified areas of prehistoric and historic archaeological sensitivity along much of the subway alignment (see **Figures 3A to 3H**).

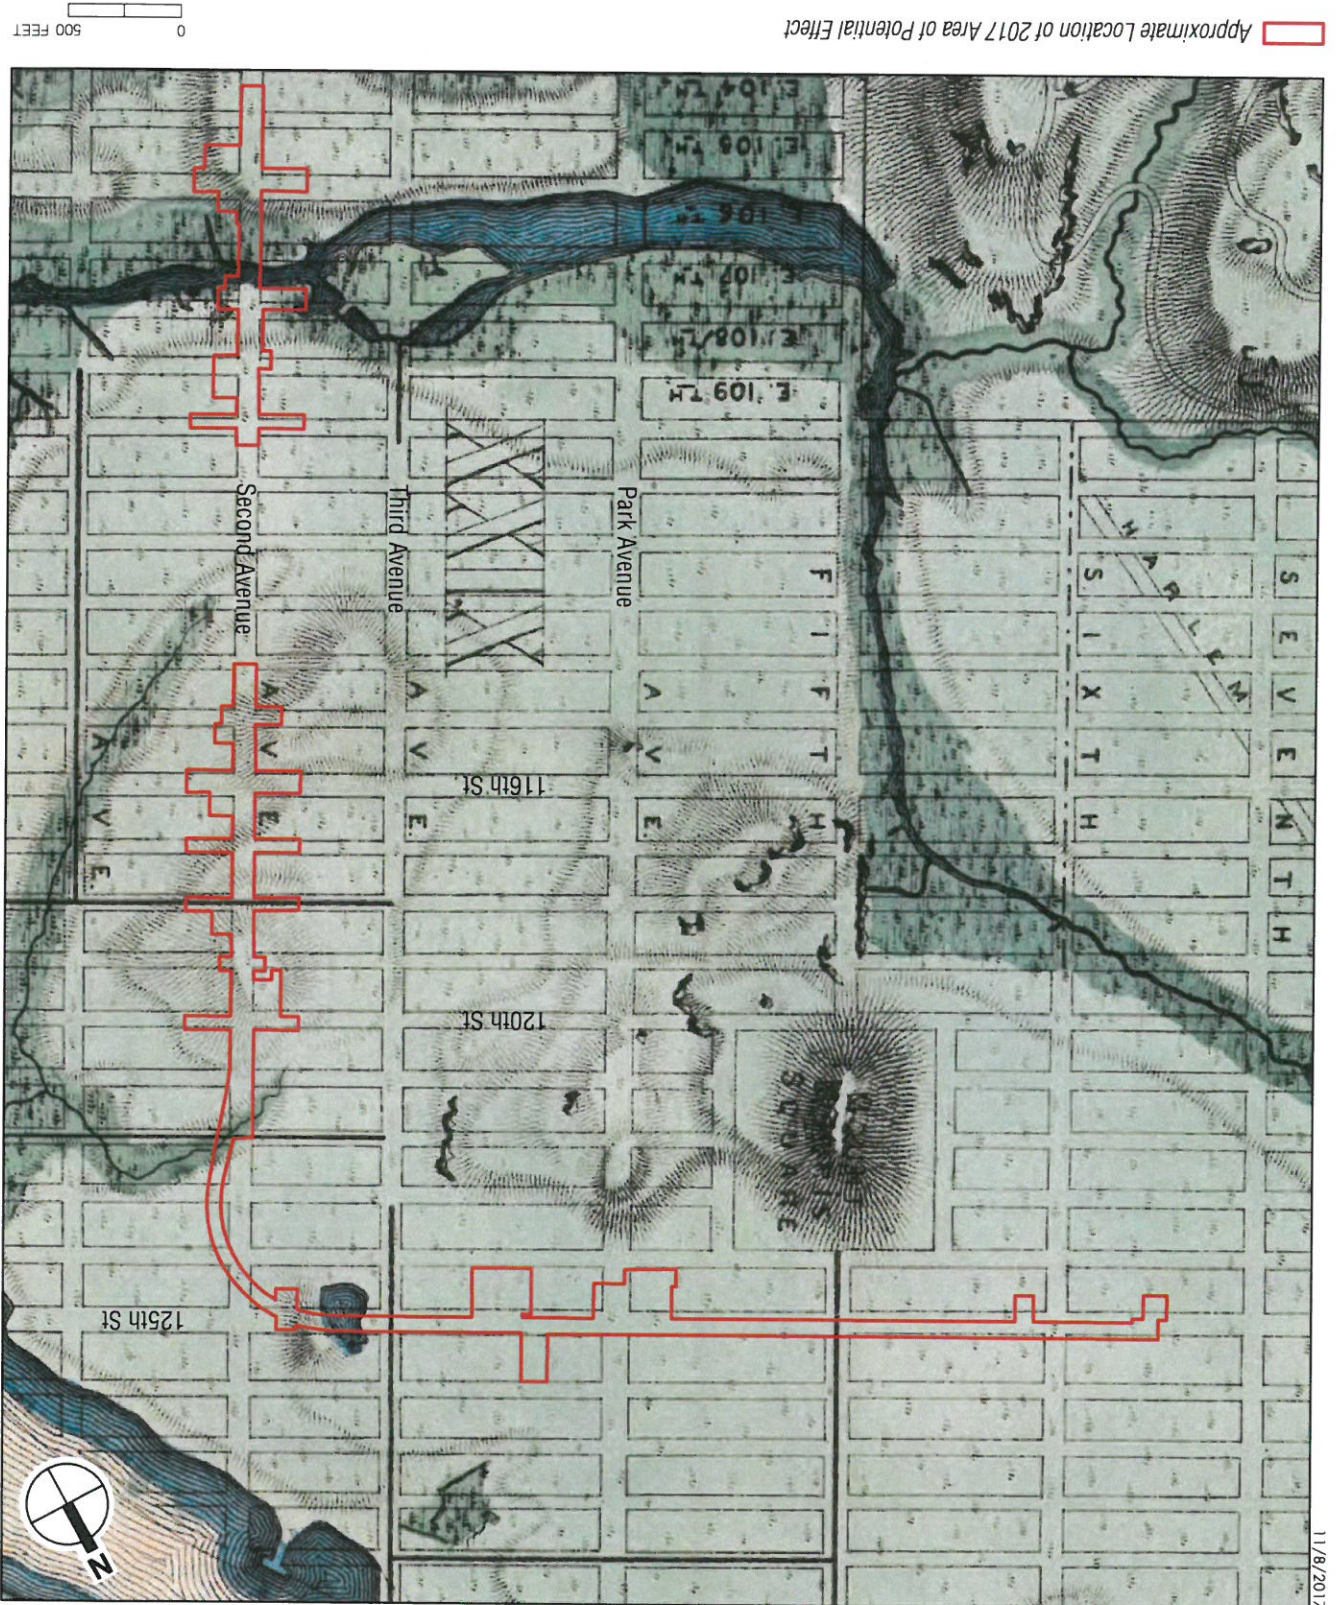
1865 Vieie Map
Figure 4

As seen on the 1865 Viele map (see **Figure 4**), the large creek originally bisected the eastern side of Manhattan and ran to a point west of Fifth Avenue before turning north and continuing along the west side of Fifth Avenue and further to the northwest. The creek was allegedly “so imposing it split the Manhattan holdings of its original occupying tribes” (Koeppel 2000:10). The 1820 Randel map depicts the creek running east-west surrounded by thick tracks of marsh between approximately East 106th Street and East 109th Street. A large pond was situated across what is now East 125th Street just east of Third Avenue. A small stream crossed Second Avenue between East 121st and East 122nd Streets. A second stream with a large associated marshland was situated just south of the southern end of the project corridor, in the vicinity of what is now Second Avenue and East 103rd Street. A long, narrow valley containing a marsh-bordered stream extended to the northeast of the project site starting from a point near Second Avenue and East 113th Street. Additional hills crossed Second Avenue between what is now East 113th and East 121st Streets.

Both the 1865 Viele map (see **Figure 4**) and the ca. 1820 Randel map depict a number of hills in the vicinity of the project site which appear to have been graded as part of the transformation of the

Maps dating to the first half of the nineteenth century, such as the 1811 Bridges map (see **Figure 5**) and 1820 Randel map, depict the location of Ancillary 1 as undeveloped portion of the Waldron farm. The 1865 Viele map (see **Figure 4**) indicates that the site of Ancillary 1 was located at the base of a hill that extended to the west and southwest. A second hill was located to the east of the project site that bordered a valley through with a marshy stream ran from a point near the intersection of East 113th and Second Avenue to the northeast, draining into the Harlem River at a point near East 123th Street just west of First Avenue. The 1836 Colton and 1851 Dripps maps continues to depict the site

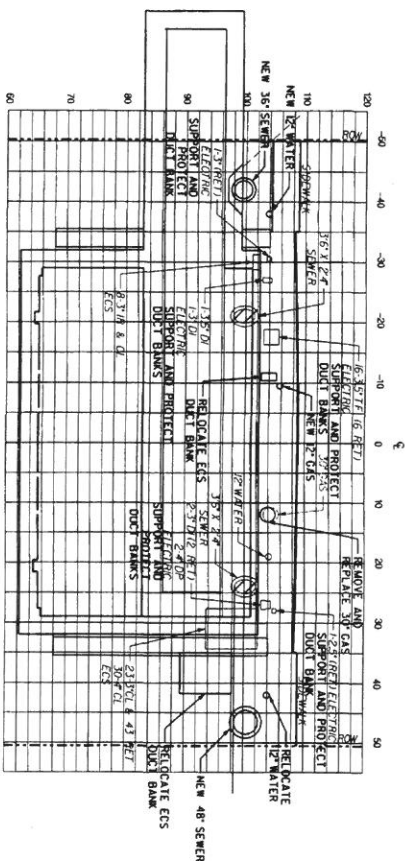
CROSS SECTION
 SCALE 1" = 10'
 A

2ND AVENUE
 106TH STREET &
 LOOKING SOUTH

The construction of the Phase 2 of the Second Avenue Subway would require the replacement or relocation of utilities within the streetbed of East 106th Street for a distance 200 feet west and 200 feet east of the streetbed of Second Avenue. The 2003 Phase 1A study determined that the streetbed of Second Avenue at East 106th Street is sensitive for archaeological resources dating to the precontact period between depths of 0 and 22 feet below the ground surface.
