STAGE 1B-1 DEEP TESTING CULTURAL RESOURCE REPORT
RED HOOK WATER POLLUTION CONTROL PROJECT
(CONTRACT 1B-1)

Joel W. Grossman, Ph.D.
William I. Roberts IV
GREENHOUSE CONSULTANTS INC.
50 Trinity Place
New York, N.Y. 10006

October 1984

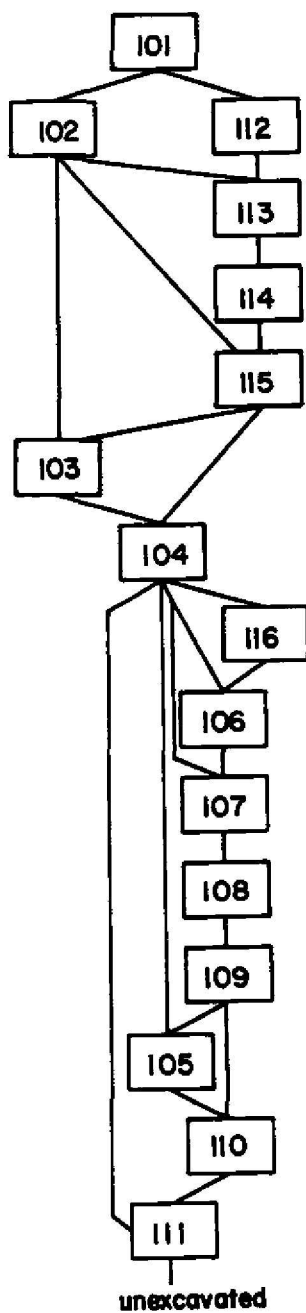
Figure 6

RED HOOK · CONTRACT 18-1
TEST TRENCH I · HARRIS MATRIX

Following the context description charts are Harris Matrices for each of the test trenches. These are schematic representations detailing all the interrelationships of the contexts from a given test trench. Each context is represented by its context number within a rectangular box. The lines between the boxes indicate interfaces between those contexts. The three matrices are included here as Figures 6, 7 and 8.

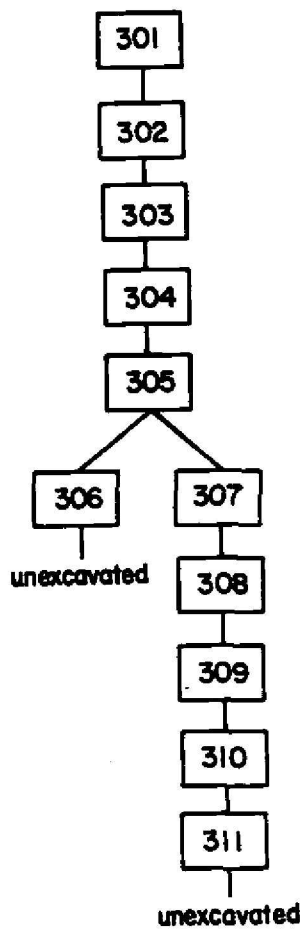
Figure 8

RED HOOK · CONTRACT IB-1
TEST TRENCH III · HARRIS MATRIX

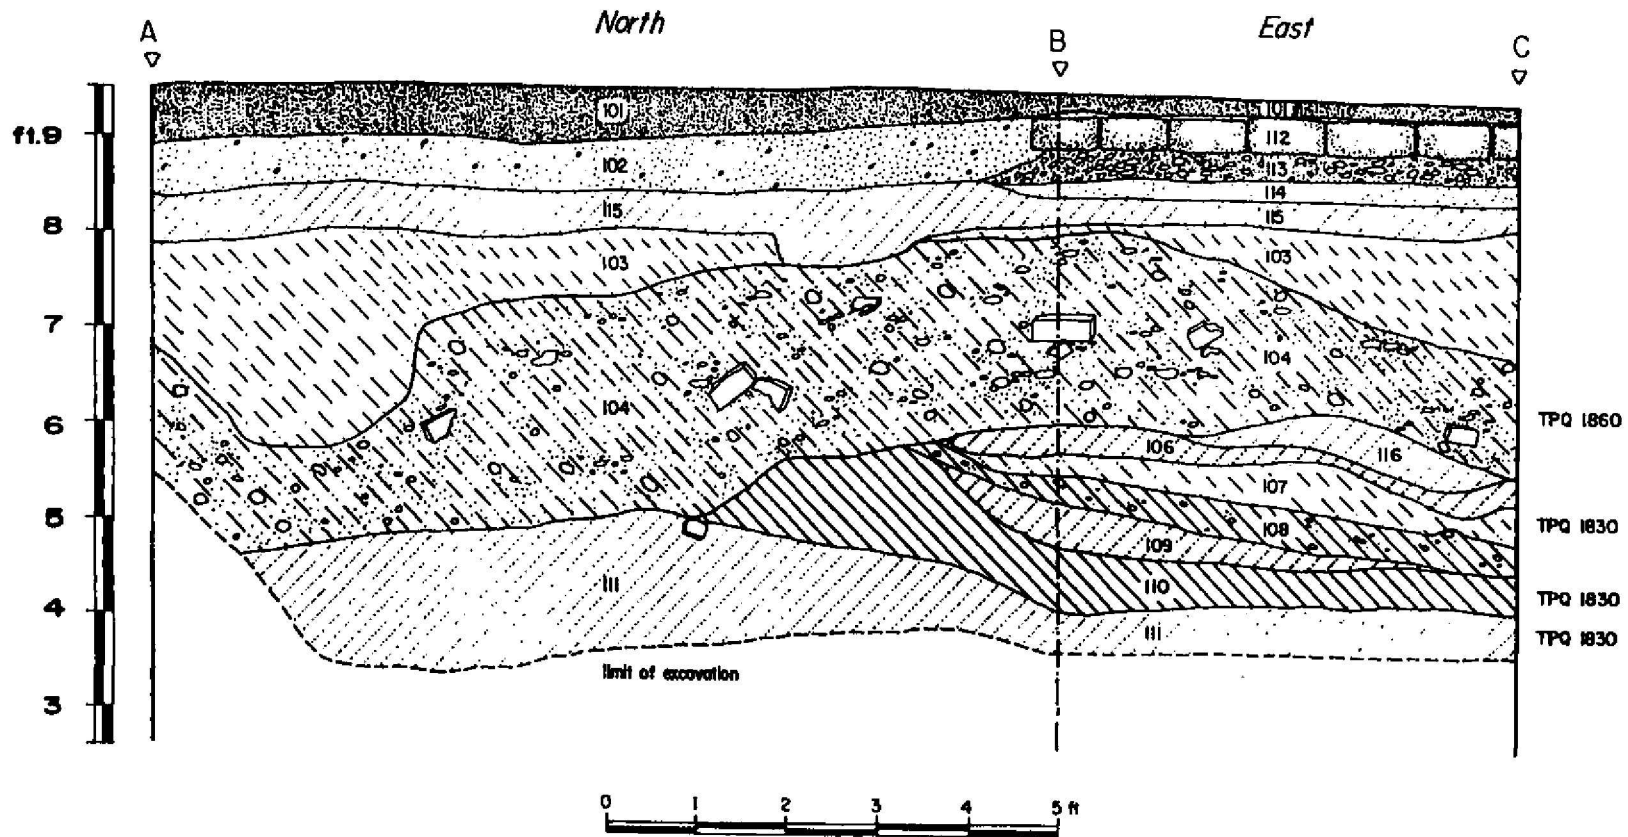
Figure 9: SECTION DRAWING

TEST TRENCH I
NORTH & EAST
Drawn: W.R., B.B.

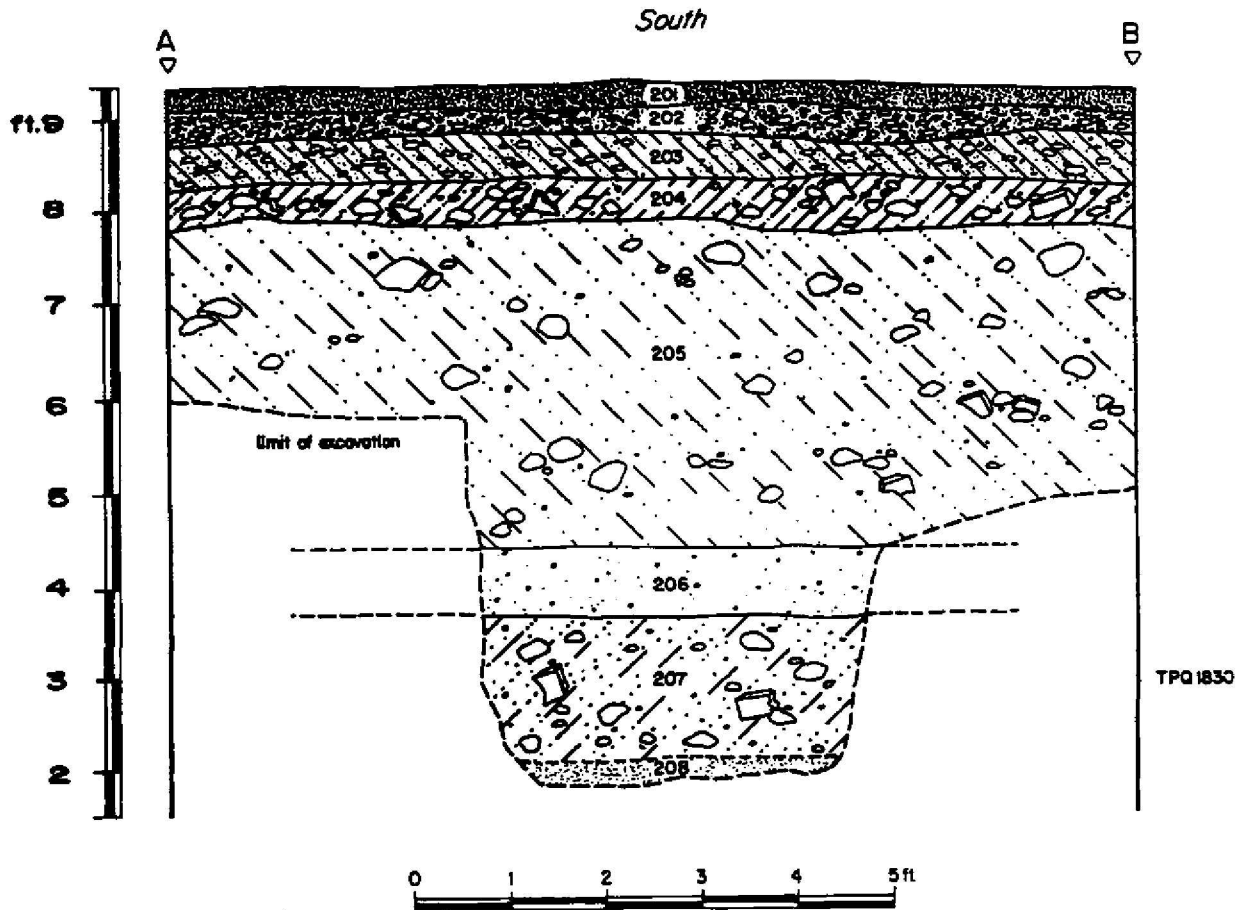
Figure 10: SECTION DRAWING

RED HOOK
TEST TRENCH 2
SOUTH
Drawn: J.B., B.B.

Remains of two buildings were encountered during the excavation of the three test trenches. They were assigned to Component 6. A basement floor was uncovered in Test Trench II (Cx. 206). Since this floor was constructed of concrete reinforced with iron or steel rods, it must post-date the introduction of this building technique in North America. The first use of reinforced concrete was an experiment carried out by Sir Marc Isambard Brunel in 1832 for an arch to be used as part of a tunnel under the Thames. This experiment appears to have been an isolated incident and did not introduce any widespread appearance of the technique. A much more reasonable Terminus Post Quem is the year that François Coignet obtained a French patent for the process (Encyclopedia Britannica 1973:Vol. 6:263-5). Therefore, the building found during the excavation of Test Trench II was constructed sometime after 1855. The fill of its basement was deposited sometime in the 20th century, judging by the presence of BX type electrical cables in the fill. More extensive remains of a second building were found in Test Trench III, including a stone and hard mortar wall (Cx. 307), the foundation slab it rested on (Cx. 308) and the concrete basement floor (Cx. 306). The only dating evidence for this building is the use of non-reinforced concrete in the floor and foundation which requires a hydraulic cement. Cements of this type were being produced in the U.S.A. during the 1820's (Encyclopedia Britannica Vol 5:153-4). Their earliest use in this country would appear to be construction of the Erie Canal circa 1815 (Roberts pers. comm. 1984). Even if one accepts the later date of 1820 as a TPQ for this building, it is still earlier than the 1830 TPQ of the landfill (see below) on which it was constructed. This second building also went out of use in the 20th century as evidenced by the TPQ of 1915 taken from a glass bottle in the basement fill (Cx. 305).

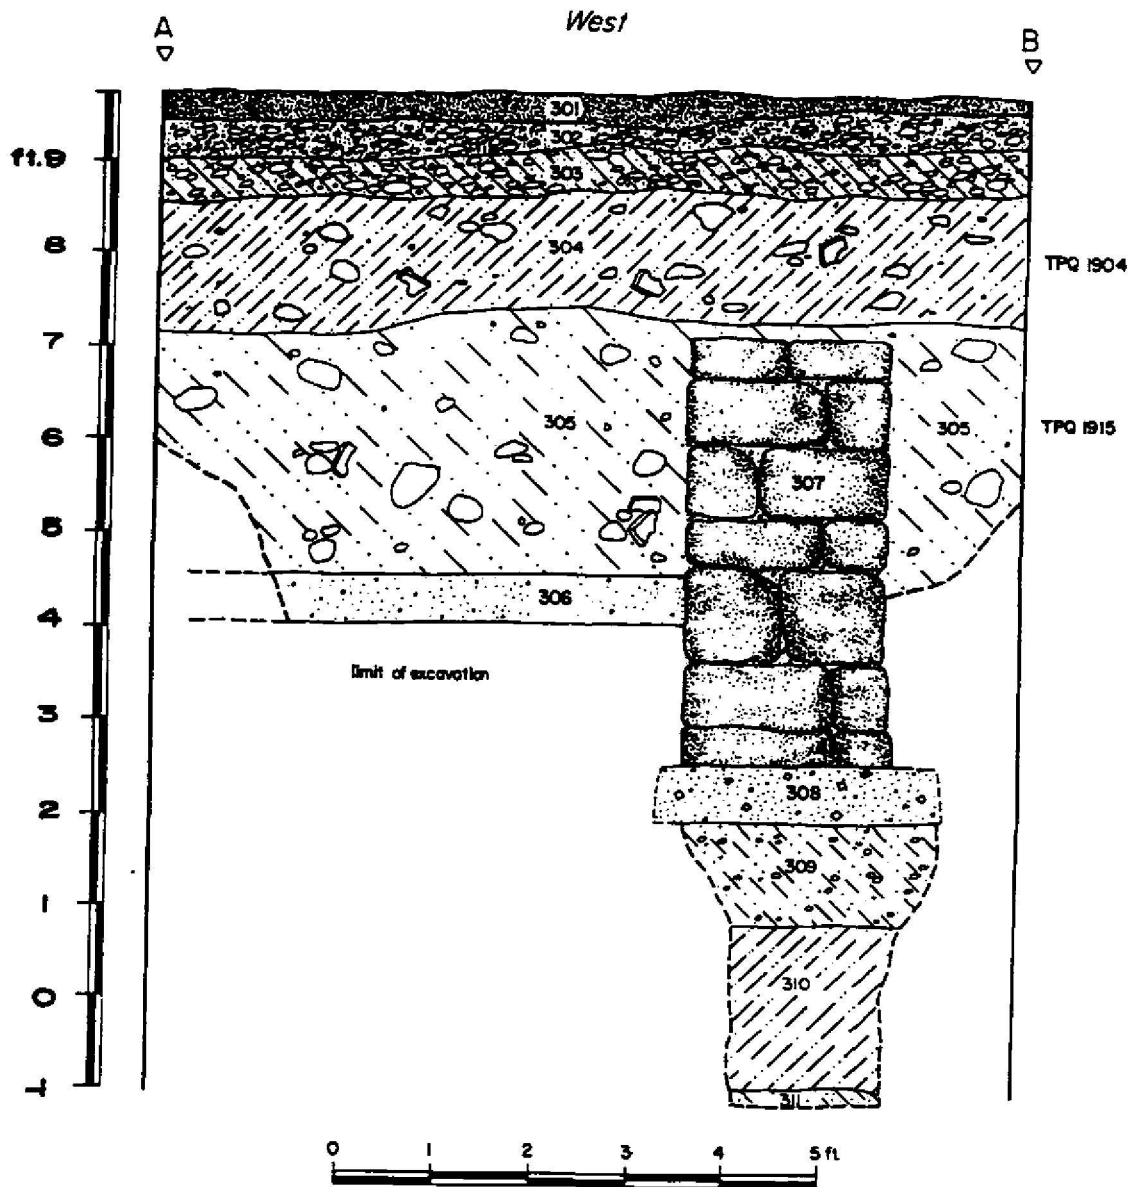
Figure 11: SECTION DRAWING

RED HOOK
TEST TRENCH 3
WEST
Drawn: J.B., B.B.

Test Trench III was positioned as close to the foot of Amity Street as possible to search for any surviving remains of the 18th century Patchen's Dock. At least two possible locations for this structure have been suggested: at the foot of Amity Street, and at the foot of Atlantic Ave. (Solecki 1983:15). No remains that could be associated with Patchen's Dock were found in Test Trench III, so it would seem that a location closer to Atlantic Ave. would be more likely.

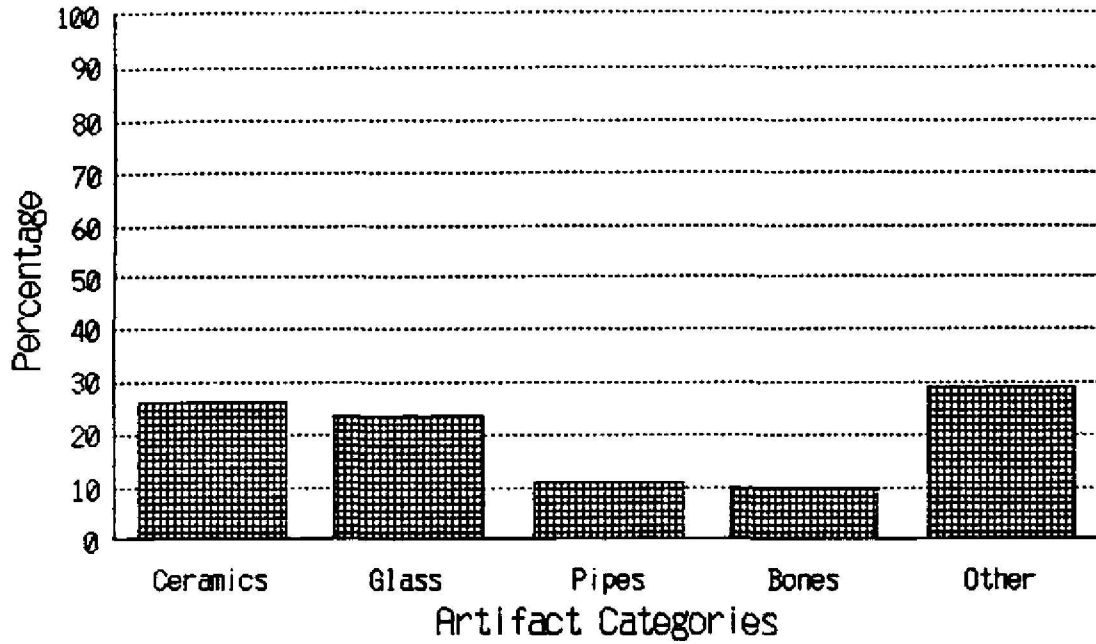
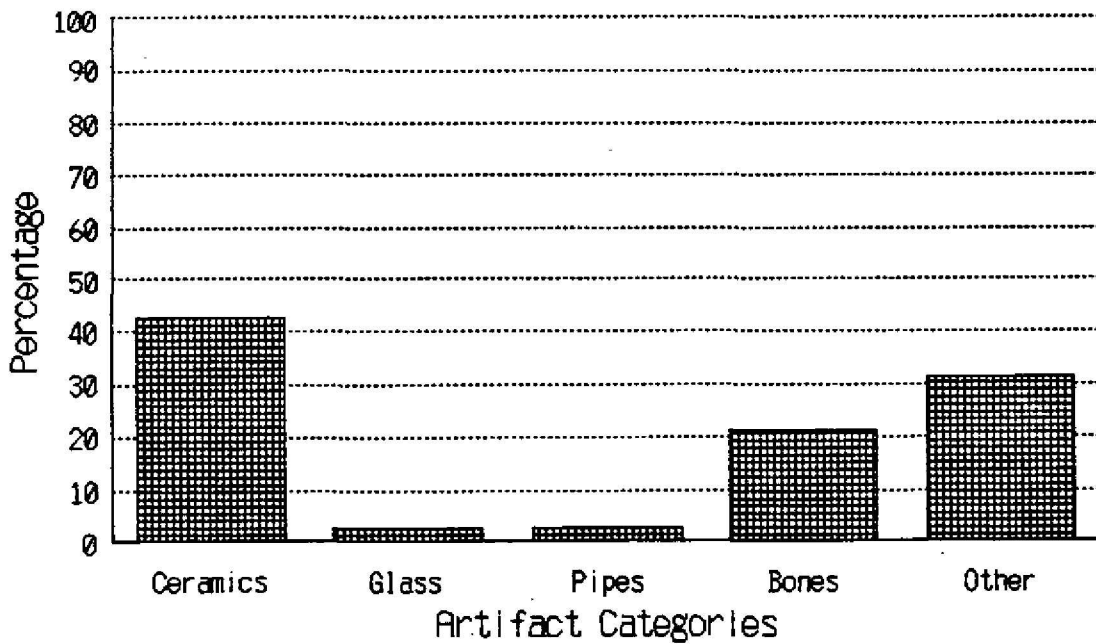
Figure 12: ARTIFACT PERCENTAGE GRAPHS

REDHOOK: Test Trench I CMP 2

REDHOOK: Test Trench I CMP 3

Component 2: (Test Trench I): 2 contexts (Cx. 103 and 104); Upper portion of landfill - lenses of sandy silt with varying amounts of inclusions such as gravel, cobbles and cinders. Color ranges from dark yellow-brown to dark grey-brown. TPQ is 1860 (from Cx. 104). Samples of both contexts were screened through 1/4" mesh and a total of 341 artifacts were recovered. See Figure 12 for a bar graph of the relative percentages of ceramics, glass, pipes and bones. Component 2 yielded a total of 89 fragments of ceramics of which 84, or 94% were diagnostic. Component 2 also yielded 83 fragments of glass of which none were diagnostic.

Component 3: (Test Trench I): 8 contexts (Cx. 105, 106, 107, 108, 109, 110, 111, 116); Lower portion of landfill - lenses of sands and silts with varying amounts of inclusions such as gravel, cobbles, ash, cinders, coal, red brick, wood and mortar. Color ranges from very dark yellow-brown to brown and dark brown to very dark grey-brown. TPQ is 1830 (from Cx. 105, 107, 110, 111). Samples of these contexts were screened through 1/4" mesh and a total of 42 artifacts were recovered. See Figure 12 for a bar graph of the relative percentages of ceramics, glass, pipes and bones. Component 3 yielded a total of 18 fragments of ceramics of which 14, or 78% were diagnostic. Component 3 also yielded 1 fragment of glass which was not diagnostic.

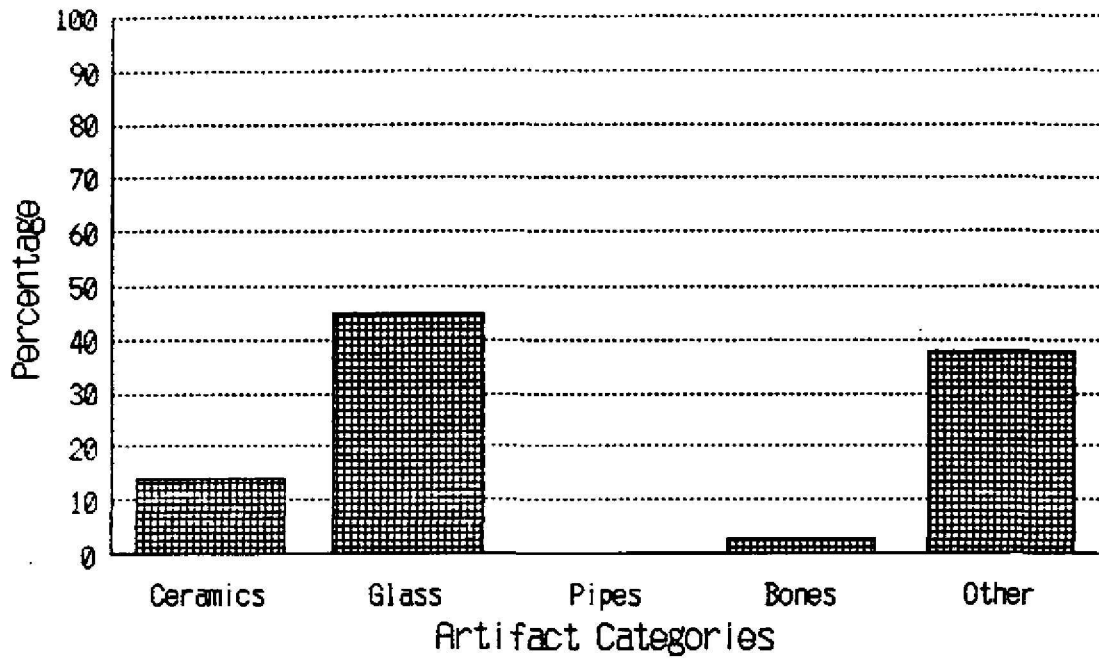
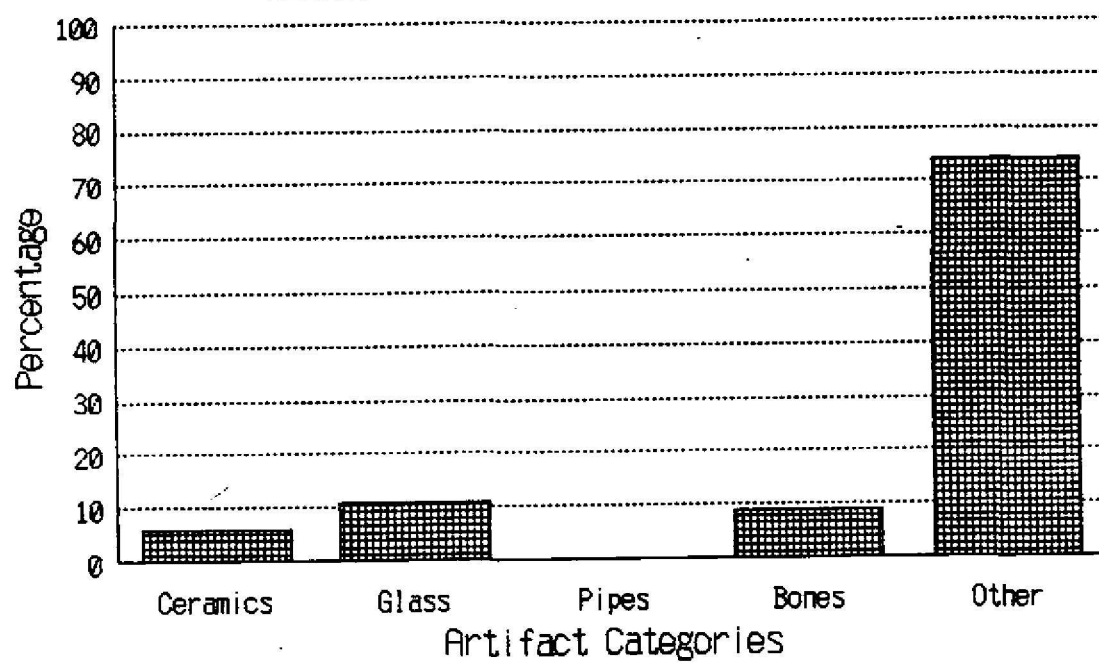
Figure 13: ARTIFACT PERCENTAGE GRAPHS

REDHOOK: Test Trench II and III CMP 5

REDHOOK: Test Trench II and III CMP 7

Component 5: (Test Trenches II and III): 4 contexts (Cx. 204, 205, 304, 305); Basement fill - lenses of sand and silt with inclusions such as gravel, cobbles and red brick fragments, tile fragments, concrete slab fragments and modern BX type electrical cables. TPQ is 1915 (Cx. 305), possibly later depending on the BX cable date. Samples from Contexts 205, 304, and 305 were screened through 1/4" mesh and a total of 154 artifacts were recovered. See Figure 13 for a bar graph of the relative percentages of ceramics, glass, pipes and bones. Component 5 yielded a total of 21 fragments of ceramics, of which 12, or 57% were diagnostic. Component 5 also yielded 69 fragments of glass, of which 3 or 4% were diagnostic.

Component 7: (Test Trenches II and III): 5 contexts (Cx. 207, 208, 309, 310, 311). Landfill - lenses of sands and silts with inclusions such as gravel, wood fragments, and red brick fragments. TPQ is 1830 (Cx. 207). Samples of these contexts were screened through a 1/4" mesh and a total of 35 artifacts were recovered. See Figure 13 for a bar graph of the relative percentages of ceramics, glass, pipes and bones. Component 7 yielded only 1 ceramic, but this fragment was diagnostic. Component 7 also yielded 4 fragments of glass of which none were diagnostic.

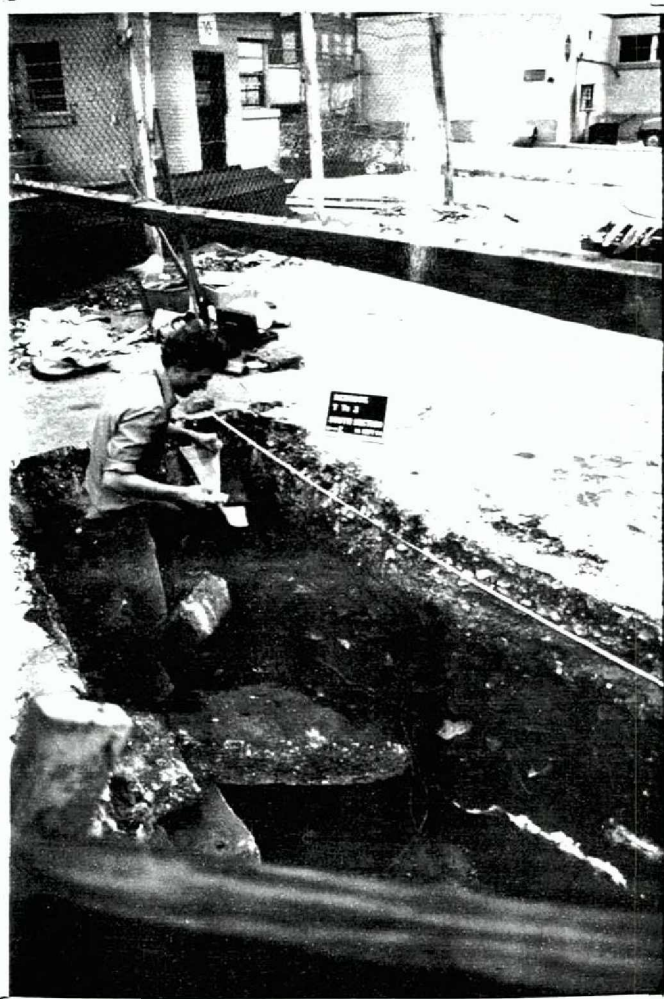
Plate II: Section Drawing in progress, Test Trench II

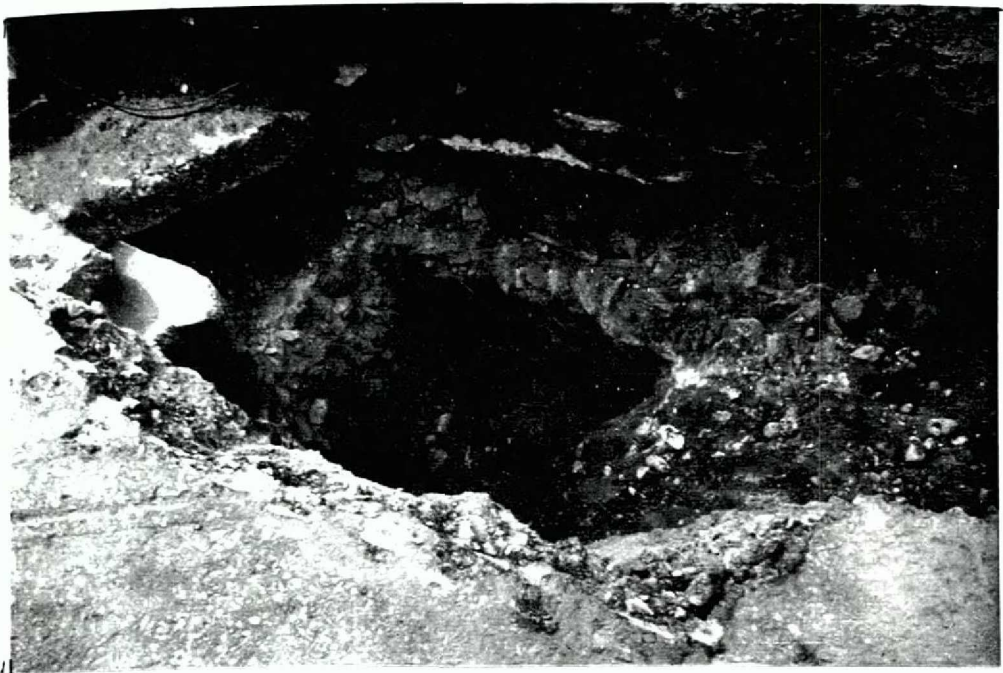
Plate IV: Detail of concrete floor, Cx. 206, & landfill below, Test Trench II.

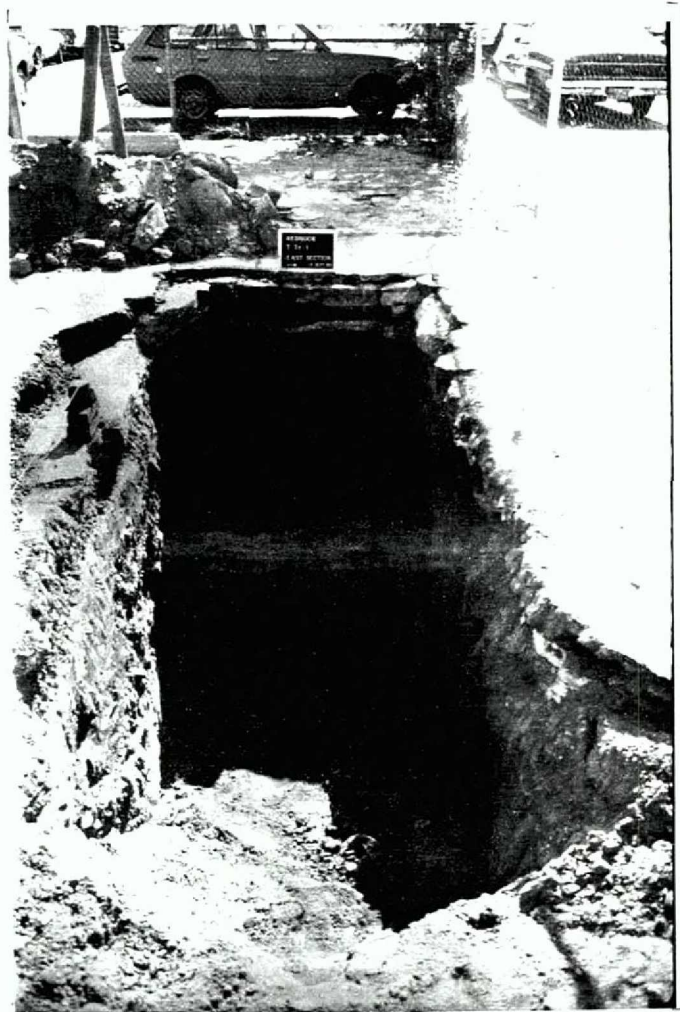
Plate III: East Section, Test Trench I.

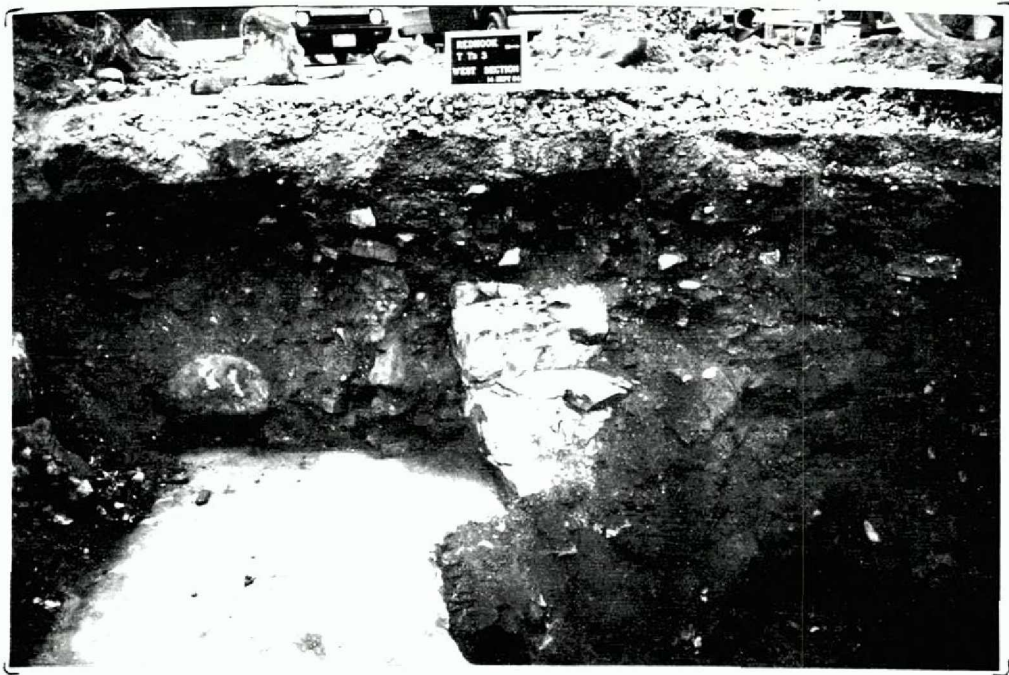
Plate V: West Section, Test Trench III. Scale = 1 ft.

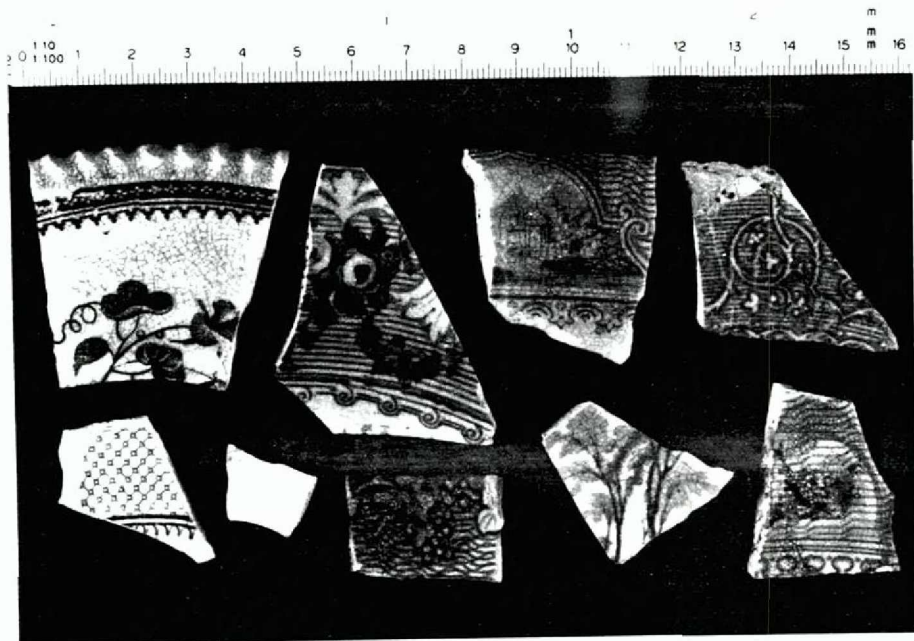
Plate VI: Cx. 104: Transfer printed thick whitewares with washed out colors. Post 1855 (Price 1979:31). Scale in cm.

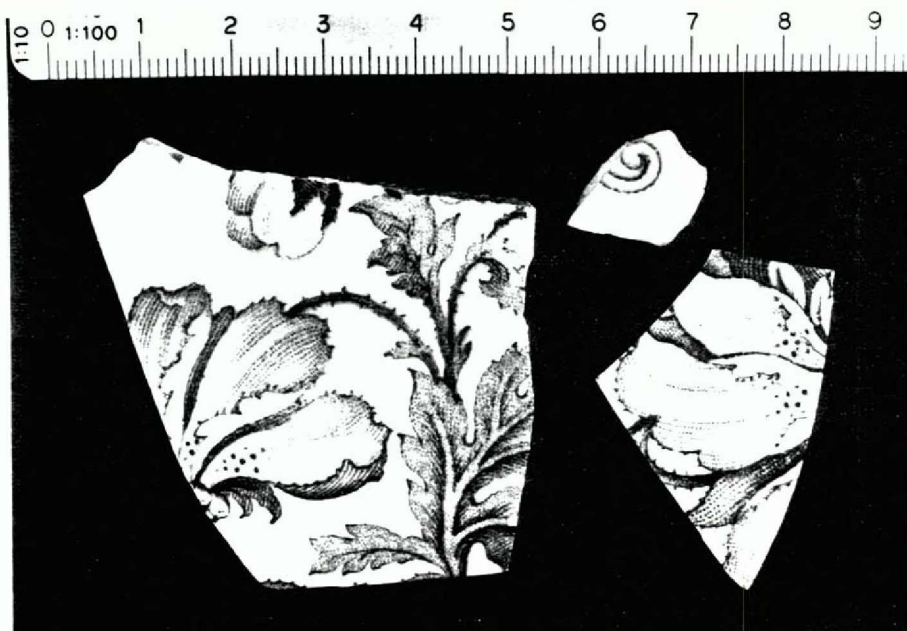
Plate VII: Cx. 104: Bright green transfer printed thick whiteware. 1855-1900 (Price 1979:31). Scale in cm.

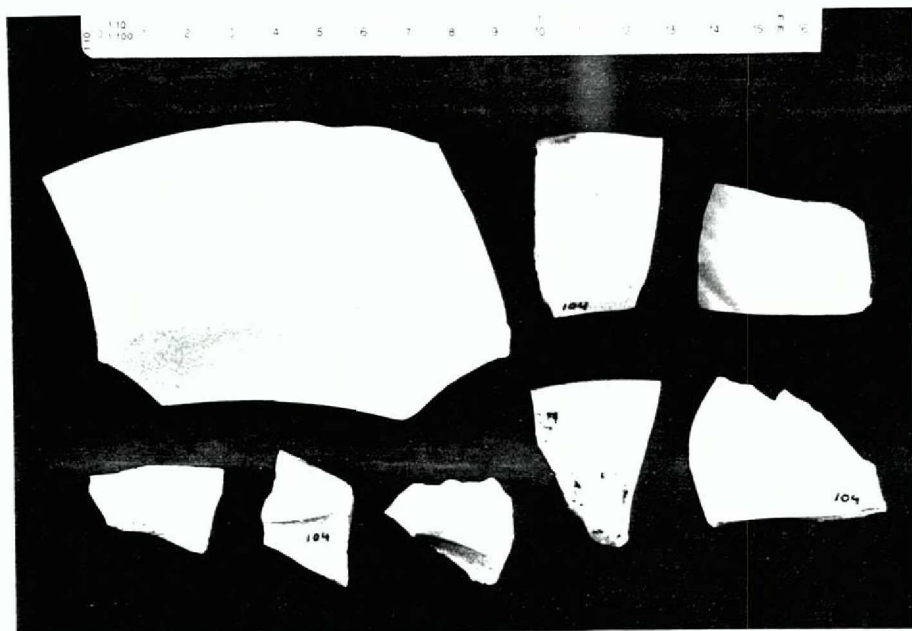
Plate VIII: Cx. 104: Plain thick whitewares with blue-grey cast. Post 1860 (contemporary with hotelware)(Price 1979:31). Scale in cm.

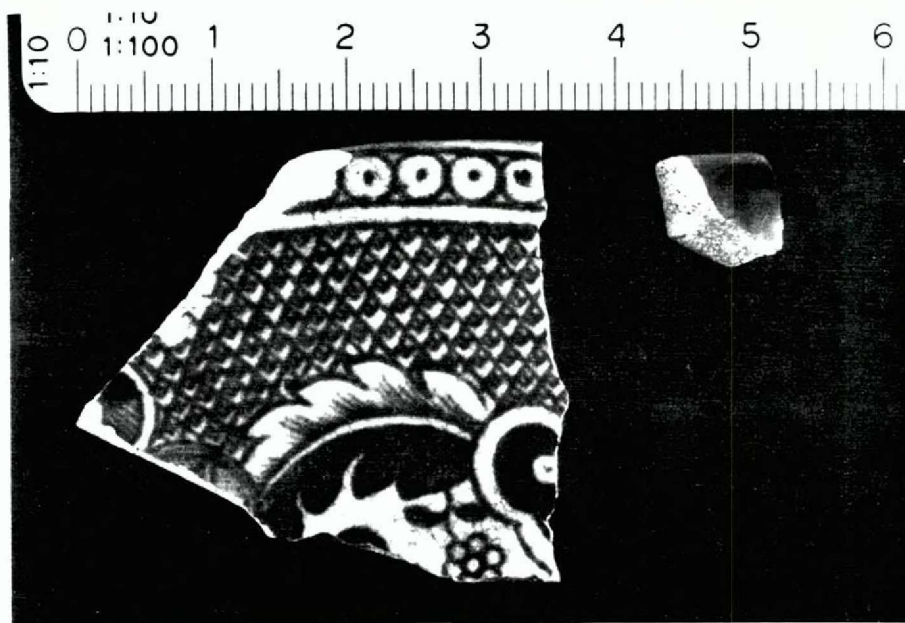
Plate IX: Cx. 104: Blue transfer printed thick whiteware.
1855-1900(Price 1979:31). Scale in cm.

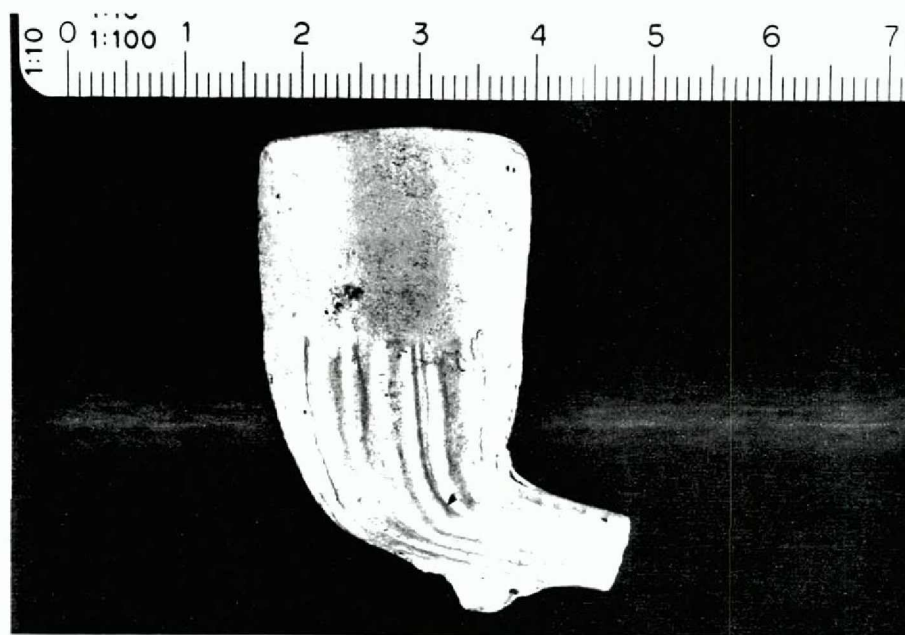
Plate X: Cx. 104: Fluted pipe bowl, type 1. 1825-1875.
(Alexander 1983:214, fig. 5). Scale in cm.

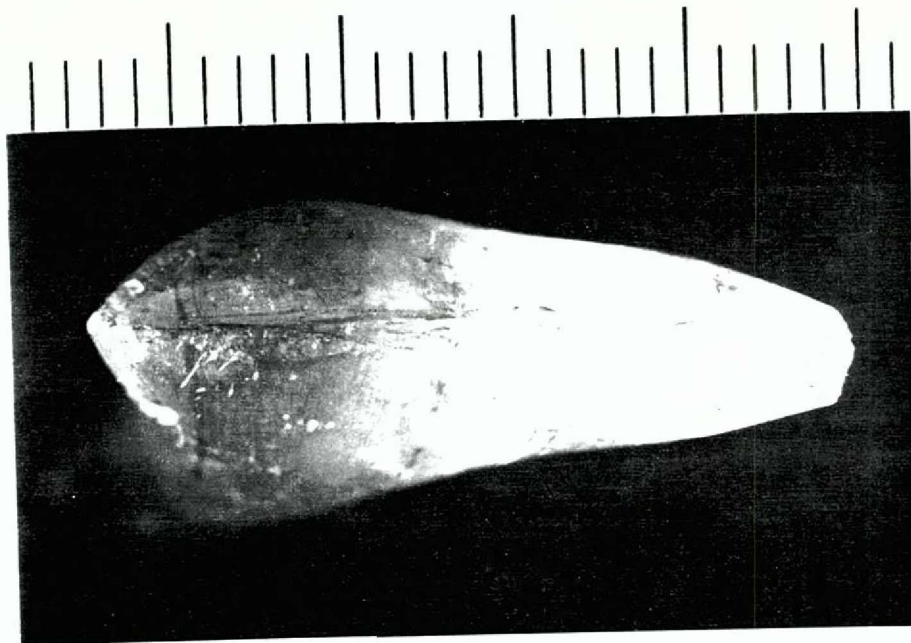
Plate XI: Cx. 104: Glass off-cut, industrial waste. Scale in cm.

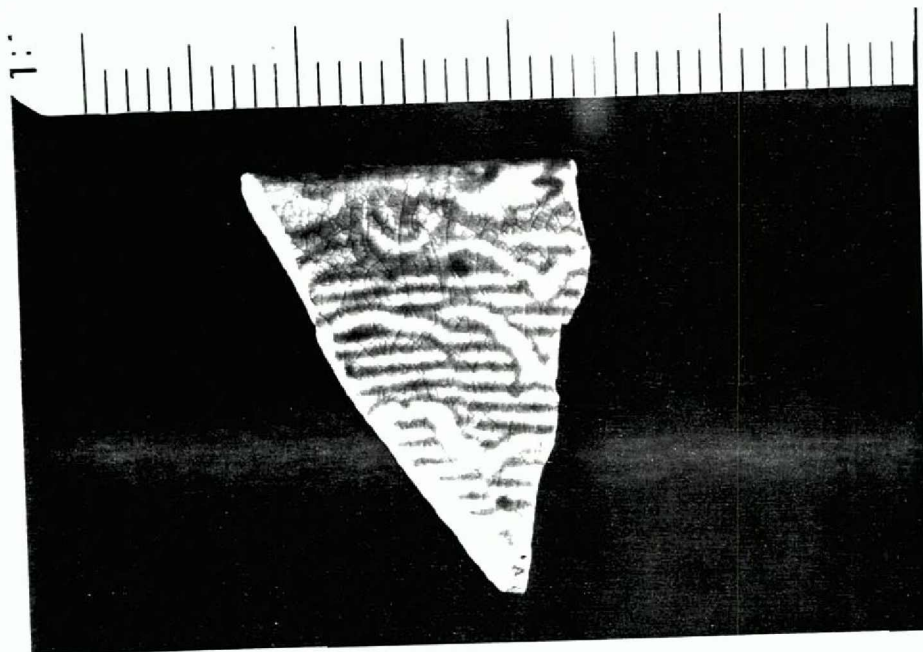
Plate XII: Cx. 105: Light blue transfer printed whiteware rim. 1830-1860 (Price 1979:31). Scale in cm.

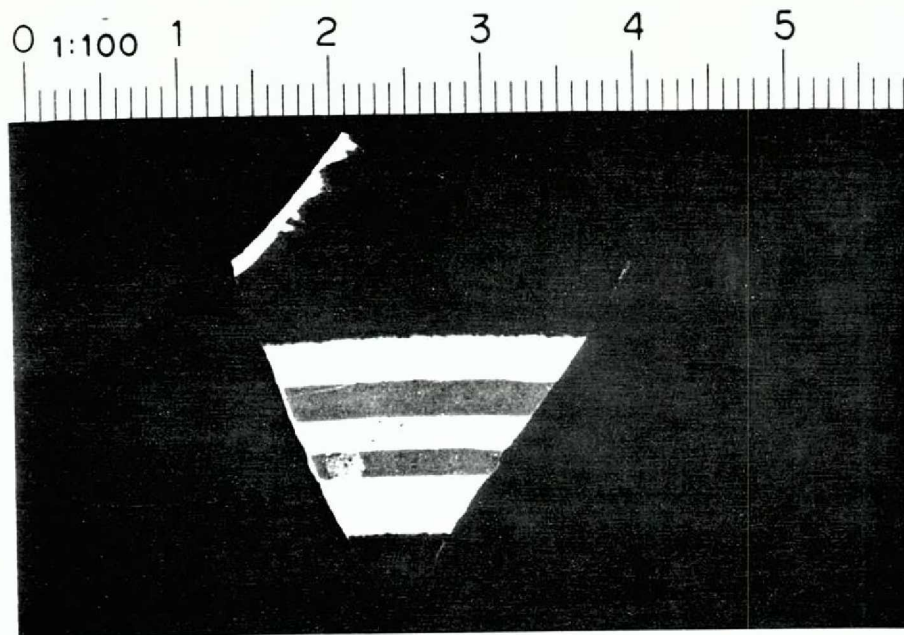
Plate XIII: Cx. 107: Annular whiteware with earthen band. Post 1830 (Price 1979:31). Scale in cm.

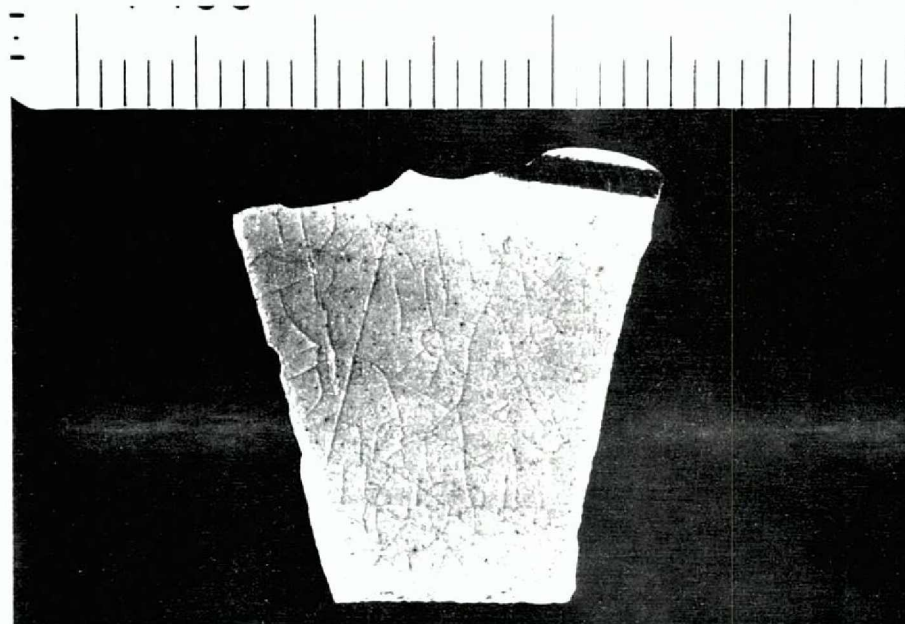
Plate XIV: Cx. 110: Annular whiteware 1830-1855 (Price 1979:31). Scale in cm.

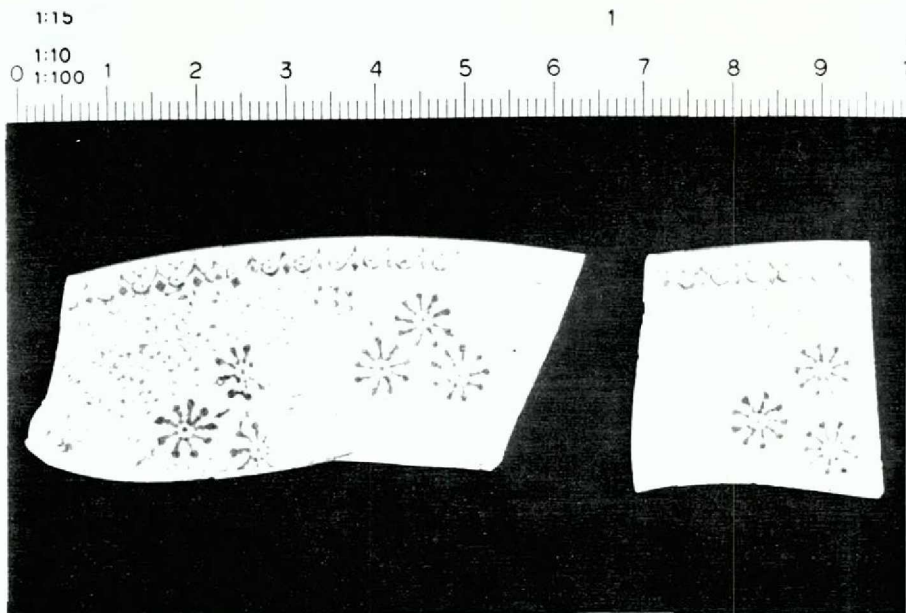
Plate XV: Cx. 110: Light blue transfer printed whiteware rim.
1830-1860 (Price 1979:31). Scale in cm.

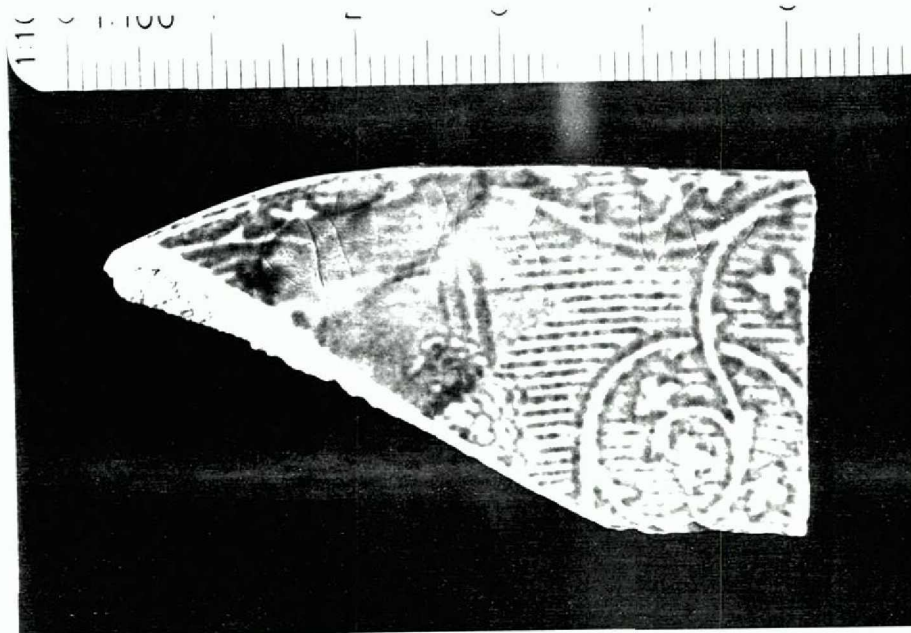
Plate XVI: Cx. 111: Light blue transfer printed whiteware rim.
1830-1860 (Price 1979:31). Scale in cm.

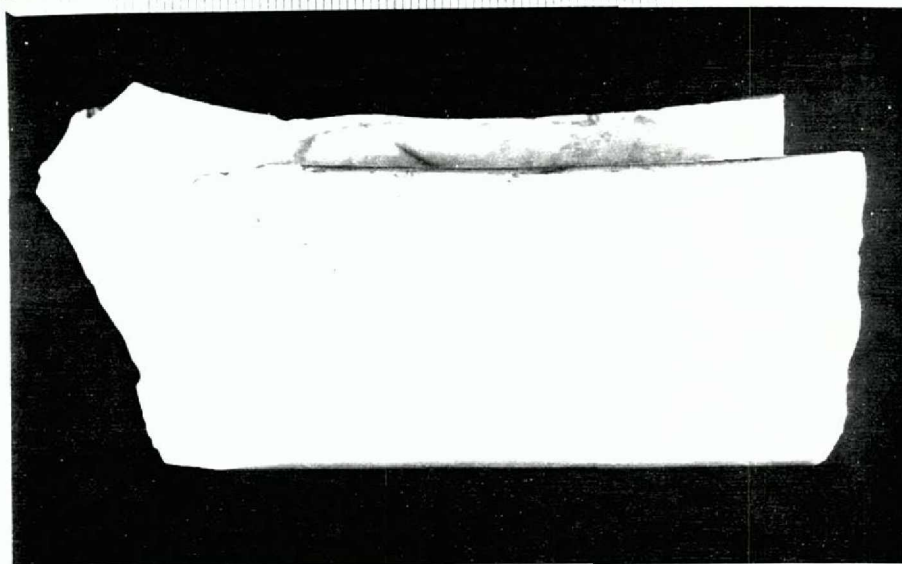
Plate XVII: Cx. 205: Porcelain toilet bowl fragment.
Scale in cm.

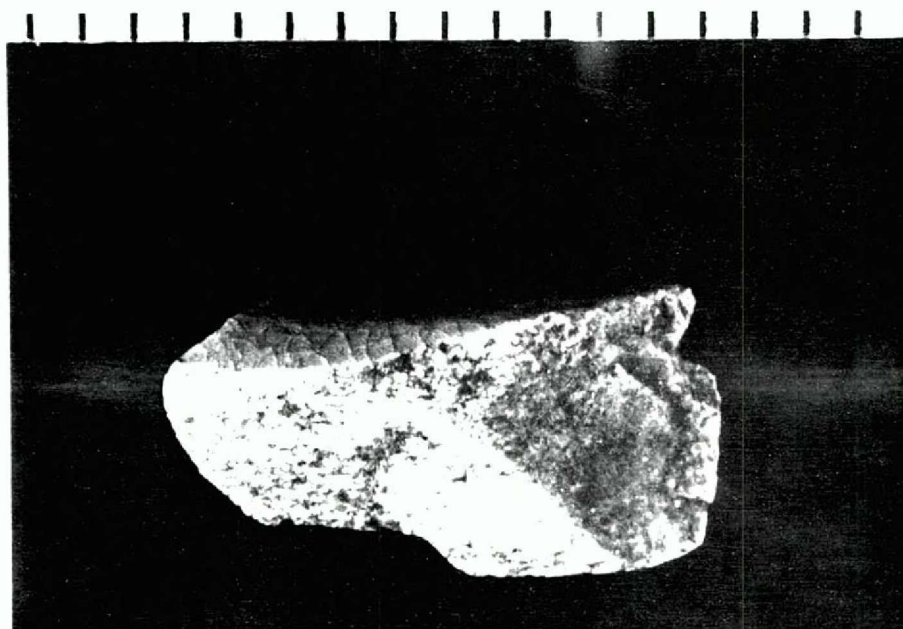
Plate XVIII: Cx. 207: Plain whiteware fragment. Scale in cm.

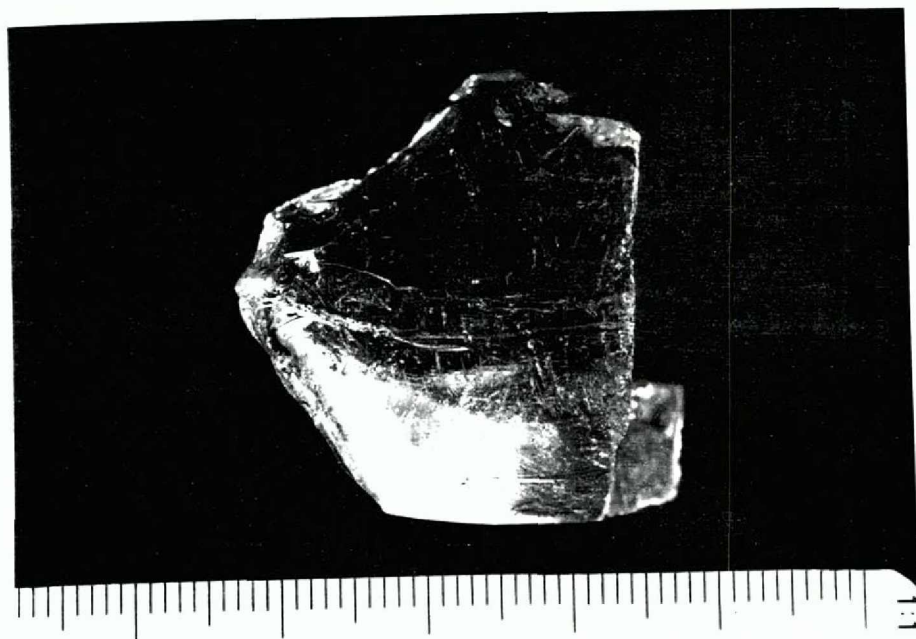
Plate XIX: Cx. 304: Light blue glass bottle base fragment with machine cut-off scar. Post 1904 (Miller & Sullivan 1981:15-16). Scale in cm.

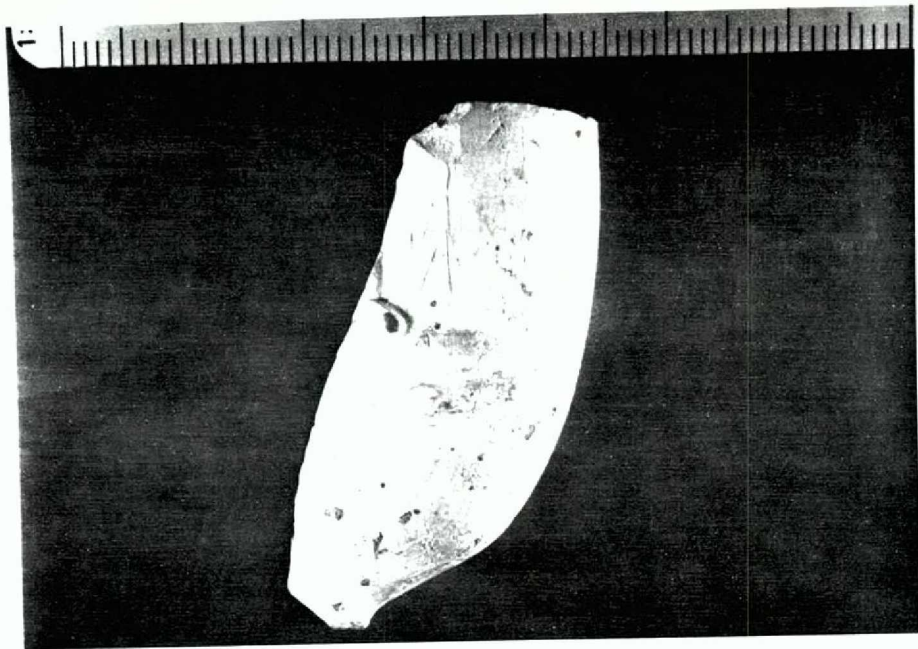
Plate XXI: Unstratified. Right side of pipe bowl decorated with a side wheel steamship. 19th century. Scale in cm.

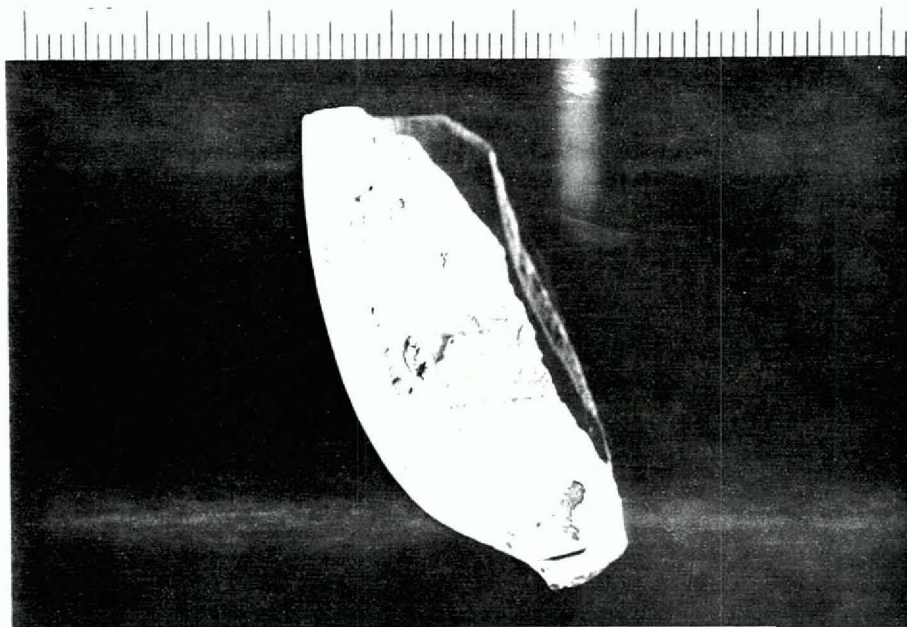
Plate XXII: Unstratified. Left side of pipe bowl with an early steam locomotive. 19th century. Scale in cm.
