# **Proposed Affordable Housing Development at 1074-1080 Washington Avenue**

**MORRISANIA, BRONX COUNTY, NEW YORK**

## **Phase 1B Archaeological Survey Report**

**MAY 2018**

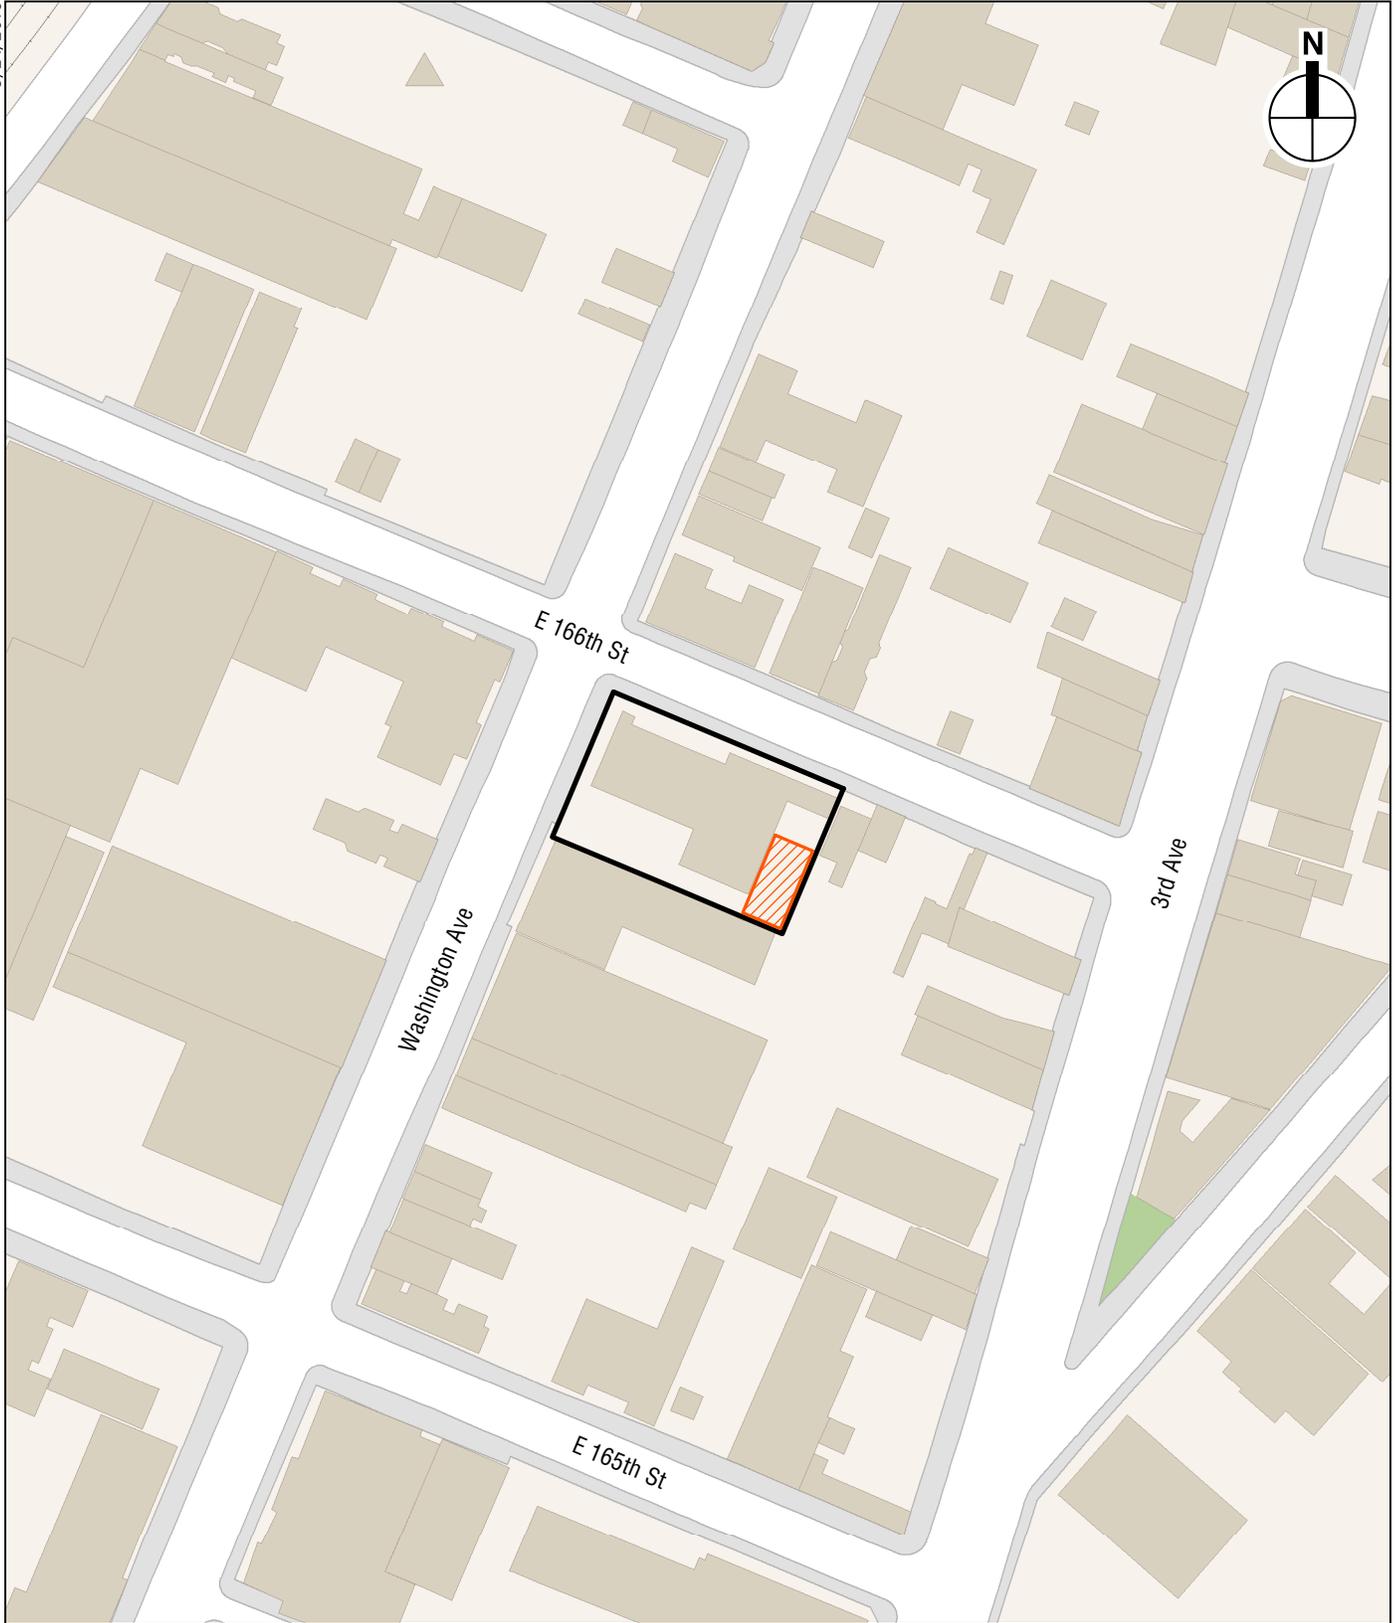
Area of Archaeological Sensitivity  
**Figure 2**

17) has moderate sensitivity for shaft features including cisterns, privies, and wells. The area of archaeological sensitivity is depicted on **Figure 2**.

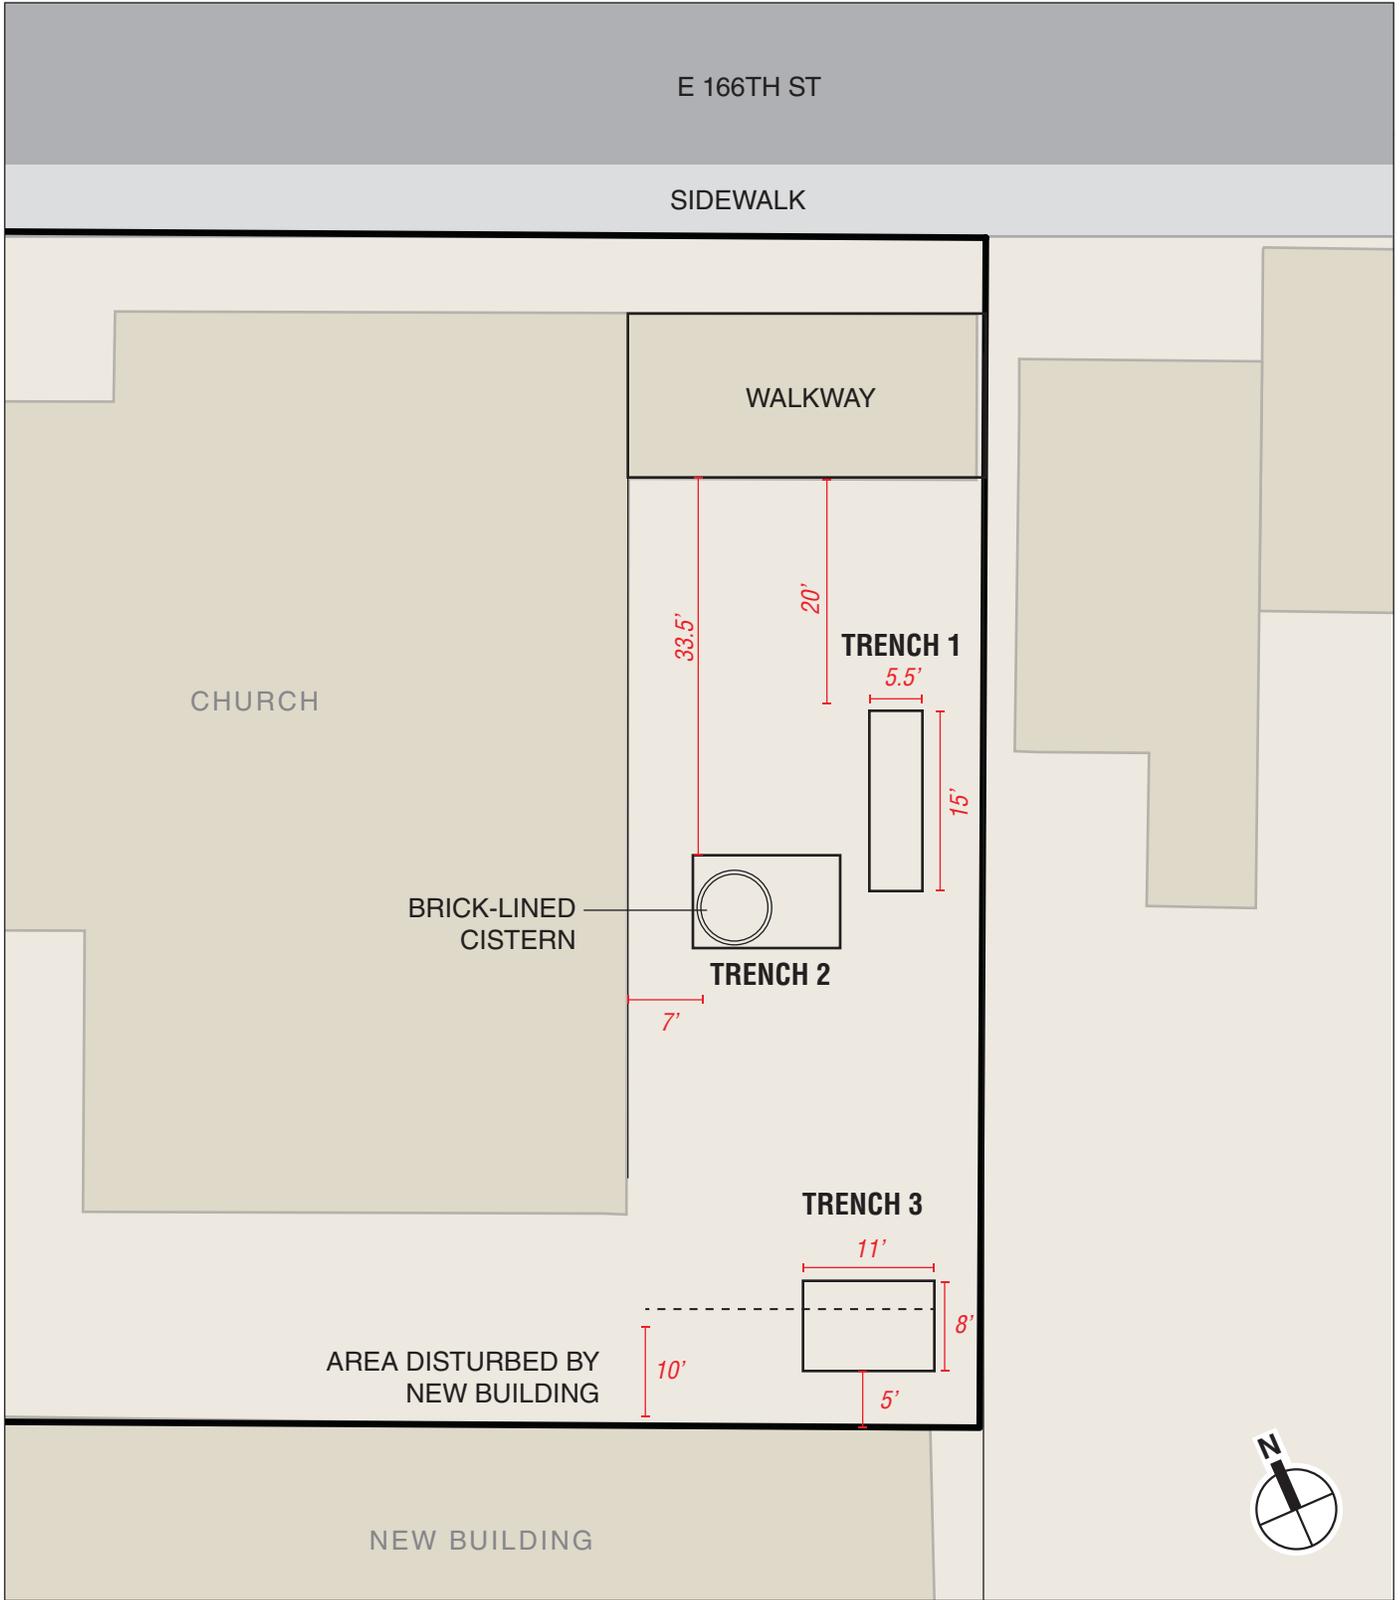
Trench 1 was oriented north-south in order to identify the rear foundation wall of the former residence. It was excavated 5 feet west of the chain link fence marking the test area's eastern border and 20 feet east of the back of the church (see **Figure 3** and **Photo 1**). The trench had a length of 15 feet and a width of 5.5 feet and was excavated to a depth of 6 feet below grade. As indicated in **Photo 2**, below several inches of modern overburden, the archaeologist encountered disturbed soils and demolition debris along the northern half of this trench to a depth of 6 feet below grade and clean, undisturbed subsoil at a depth of about 1 foot below grade in the southern portion. It appears that this trench extended across the location of the former rear foundation wall of the former structure located in this area revealing a filled-in basement cavity. The disturbed soils consisted of a mixture of dark brown sands and gravels and demolition debris such as brick, concrete, and cinder block intermixed with a small quantity of modern artifacts such as plastic packaging material. The clean, undisturbed subsoil outside of (south of) the filled-in cavity consisted of strong brown (7.5YR 4/6) sand. Having established construction disturbance in the northern half and undisturbed sterile subsoil across the rest of the trench, excavation stopped at a depth of about 6 feet below grade. No historic resources were observed in this trench.

Trench 2 extended to the west from the southern end of Trench 1 in order to investigate for the presence of backyard shaft features. The trench was excavated to a point approximately 8 feet east of the back of the church and was 12 long and 8 feet wide (see **Figure 3**). At a depth of 1.5 feet below grade the archaeologist encountered a circular, brick-lined cistern that once served as a storage structure for water (see **Photo 3**). At its surface, the cistern appeared to be filled with ash. A small circular shovel test was excavated into the center of the cistern to determine if it contained historic artifacts. As the two-foot deep test encountered only ash and no evidence of household refuse the field archaeologist decided to mechanically expose the eastern face of the cistern's exterior in order to facilitate a more extensive investigation of its contents.

The final trench was oriented east-west and excavated along the southern edge of the test area in order to investigate for privy features in the rear edge of the former residence's back yard (**Figure 3** and **Photo 7**). The trench was placed 5 feet north of the new residential building lining the southern edge of the test area and 4 feet west of the chainlink fence lining the property's eastern edge. Trench 3 had a length of 11 feet, a width of 8 feet, and was excavated to a depth of 8 feet below grade. Trench 3 was excavated in halves. The southern half encountered uniform dark gray fill to a depth of 8 feet (**Photo 8**). The northern half encountered sterile strong brown (7.5YR 4/4 to 7.5YR 5/6) sandy subsoil below several inches of modern overburden. Examination of the profile of the trench's eastern wall (see **Photos 9** and **10**) revealed that the project site had been previously excavated and backfilled with the uniform grey fill, presumably as part of the construction of the new residential building to the south. No historic resources were observed in this trench.

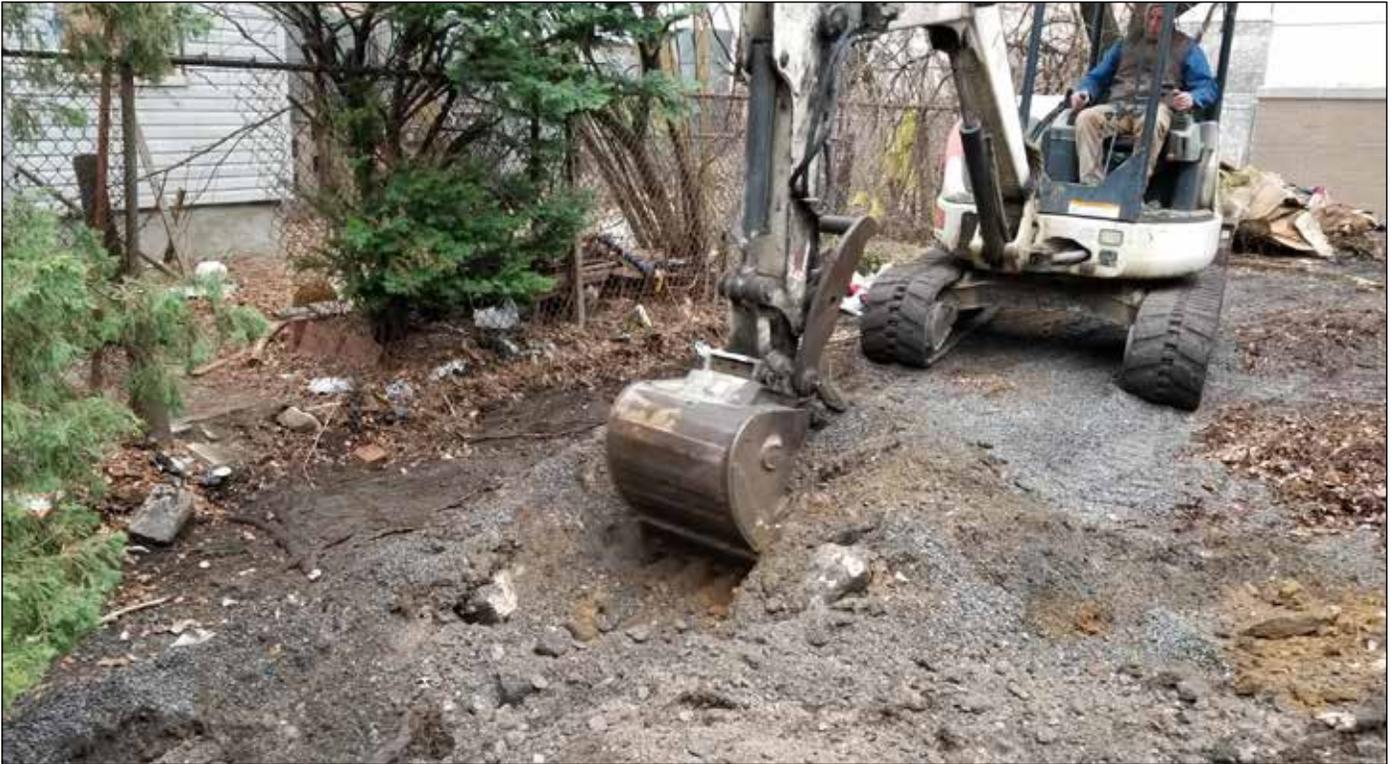
Facing southeast from center of site showing rear yard of church and excavation of Trench 1 1

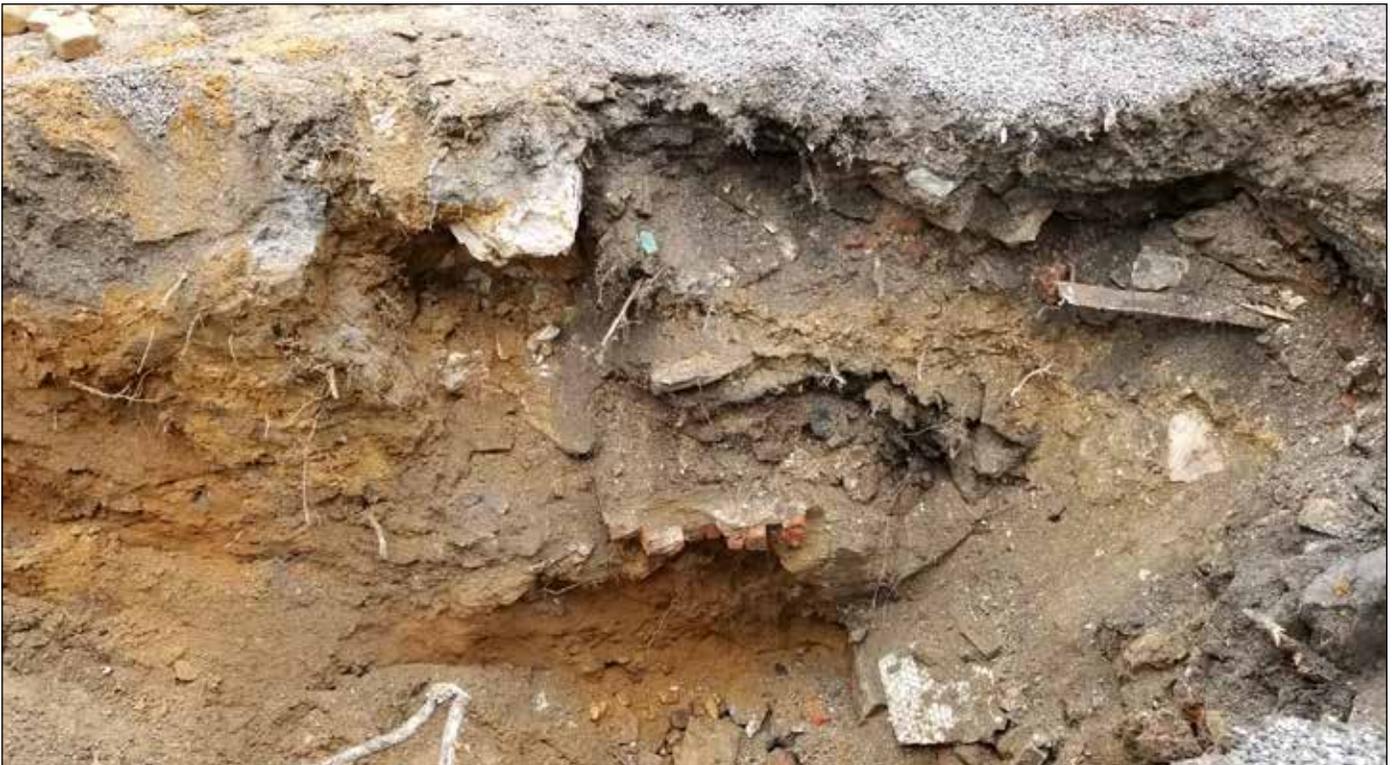
Facing west showing the western wall of Trench 1. Note natural brown sandy soil to the left and demolition debris and fill to the right 2

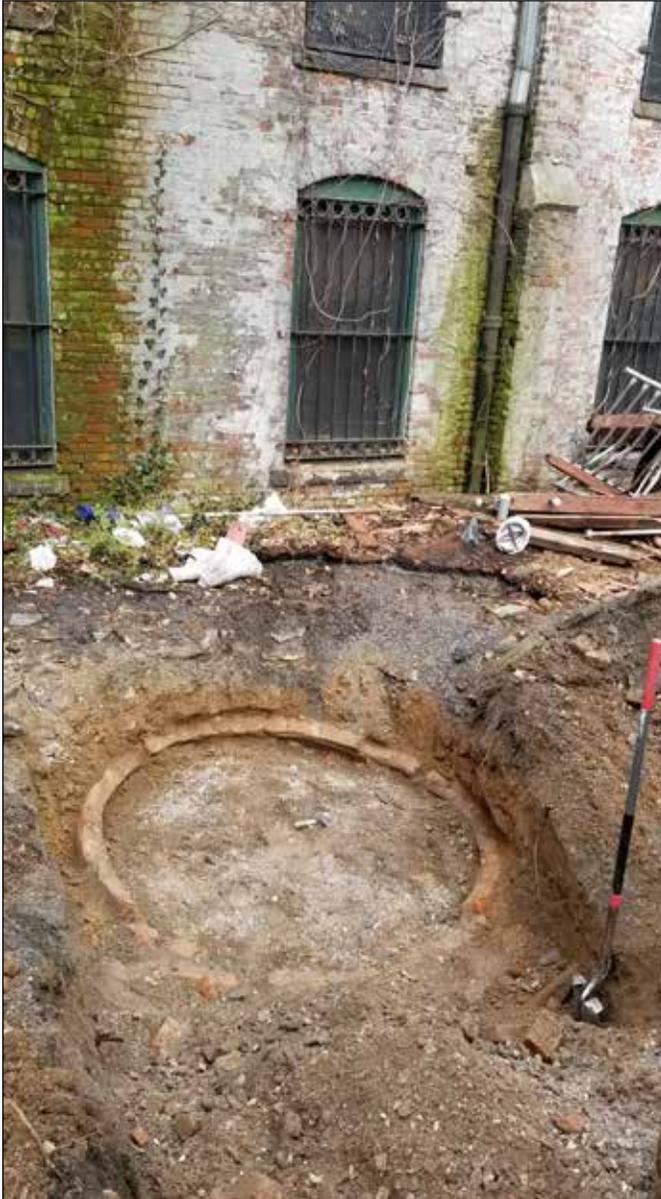
Facing west showing Trench 2 close to the rear wall of the church. Note circular brick-lined cistern **3**

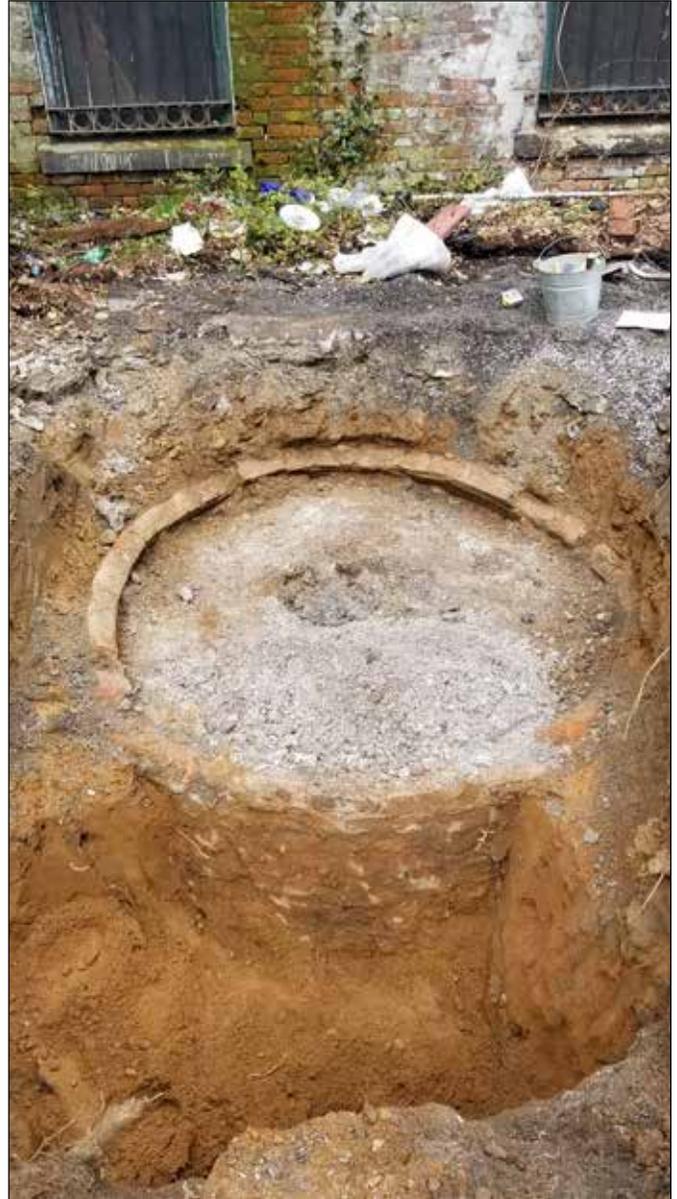
Facing west showing Trench 2 after excavation of a shovel test pit into center of brick-lined cistern and excavation of several feet of natural sandy brown soil from east side of cistern **4**

**Photos 4** and **5** depict the excavation of the exterior of the cistern into the reddish brown subsoil, which involved excavation of an approximately 4 foot by 6 foot trench adjacent to the cistern. At a depth of about 5 feet below grade the brick was partially dismantled with the backhoe revealing that the ash continued deeper and that no artifacts were present (**Photo 5**). Excavation proceeded to a depth of 7.5 feet below ground surface at which point the cistern's bottom was encountered. The cistern had a width of 6 feet and a height from its top (at 1.5 feet below grade) of 6 feet. The bottom of the cistern is mortar-sealed brick and its walls consisted of a single course of mortared brick. Periodically the archaeologist used a trowel and/or shovel to excavate the ashy fill from the cistern's eastern third (**Photos 5** and **6**). Close examination of the ashy fill suggested multiple dumping episodes, perhaps as part of the regular cleaning

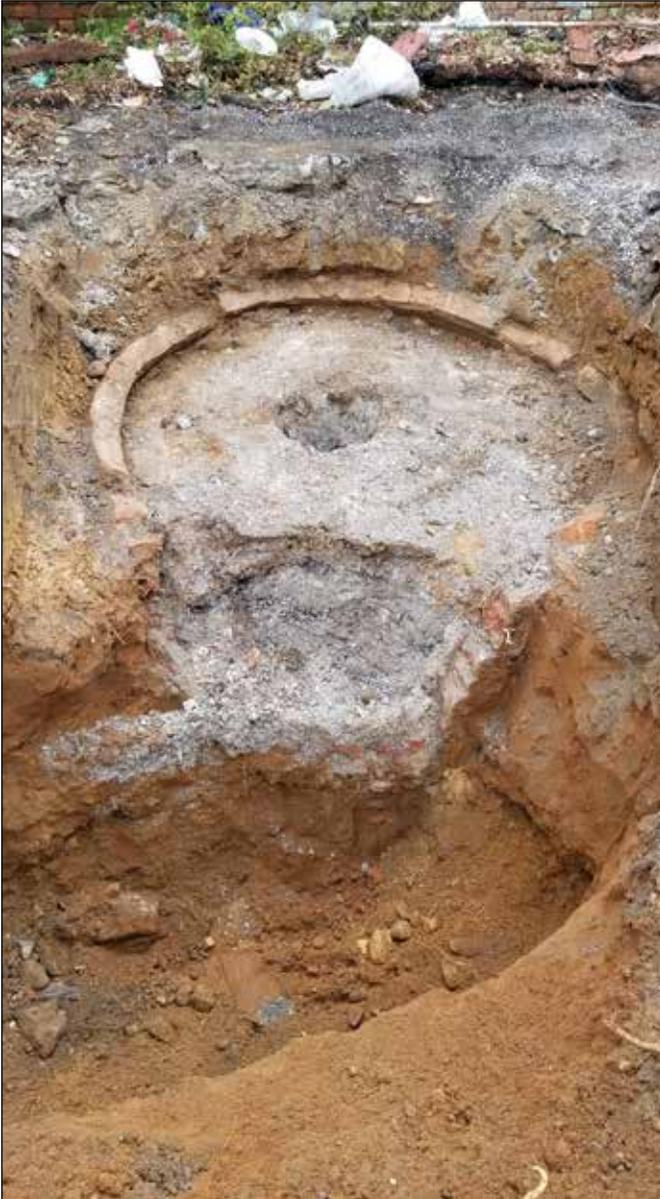
Facing west showing Trench 2 after removal of a portion of the cistern's eastern side, revealing dense deposits of coal ash **5**

of a coal-fueled heating system. Given the total absence of artifactual material the cistern has no archaeological research value.

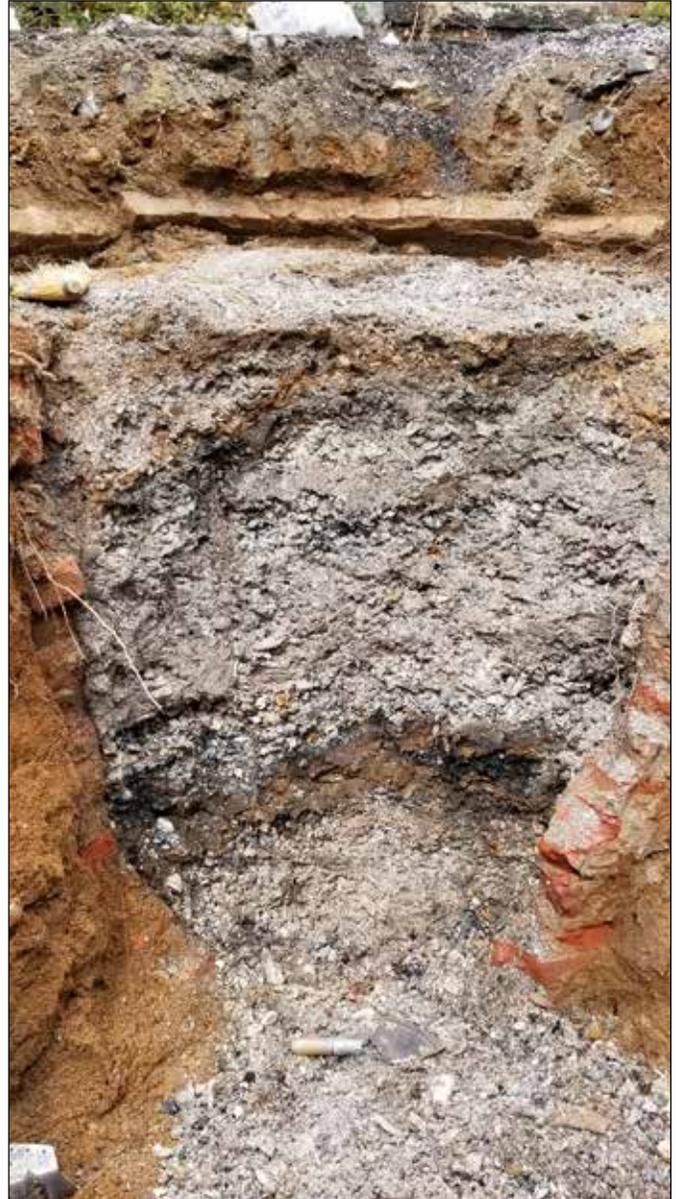
Facing west from within Trench 2 showing that the ash deposits extended to a depth of 5 feet below the top of the feature **6**

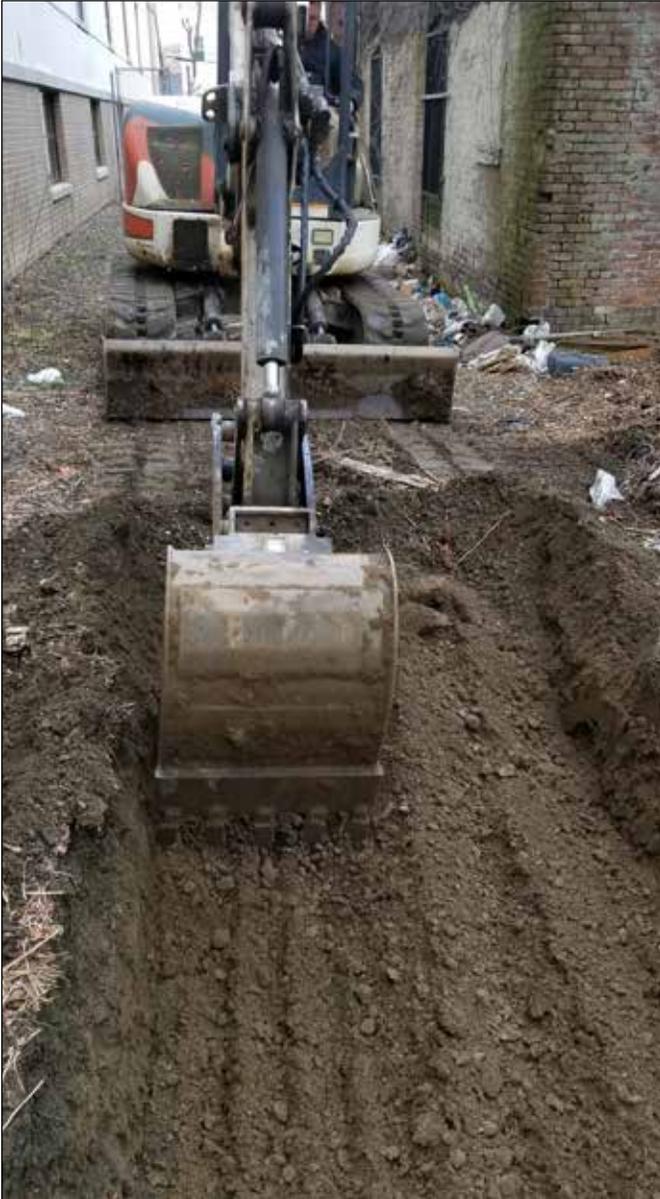
Facing northwest from the southeast corner of the backyard area showing excavation of Trench 3 **7**

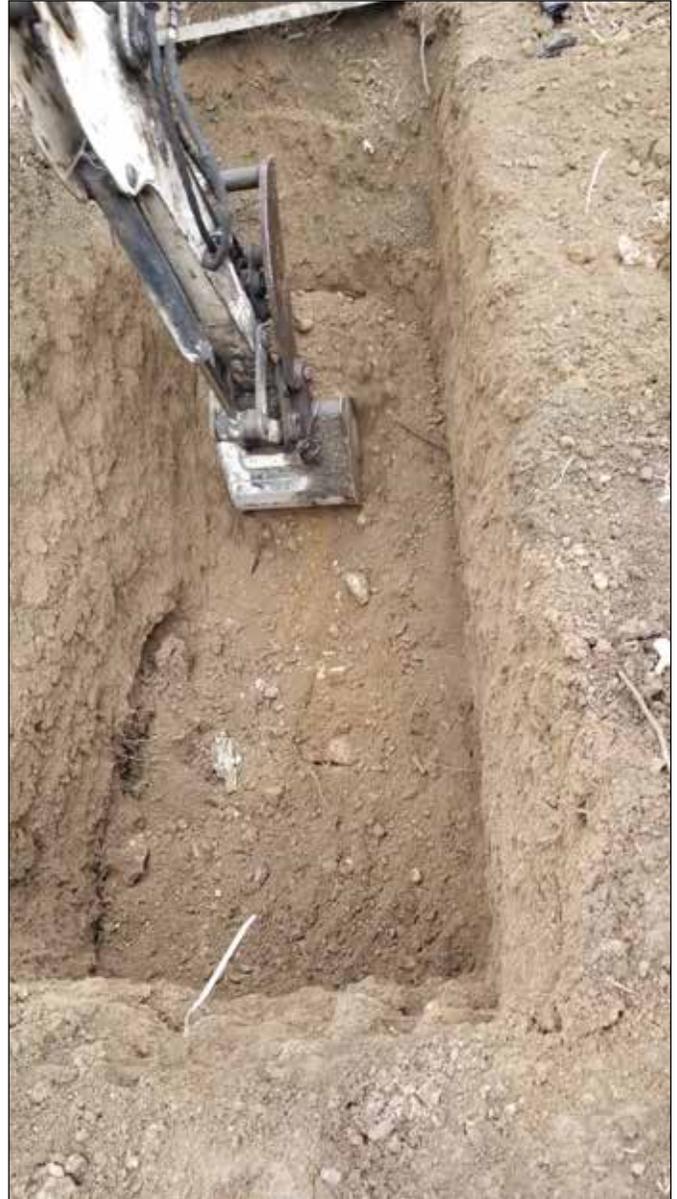
Completed excavation of the south half of Trench 3 to a depth of 8 feet below ground surface. Note that excavated soil consisted of clean dark grey fill **8**

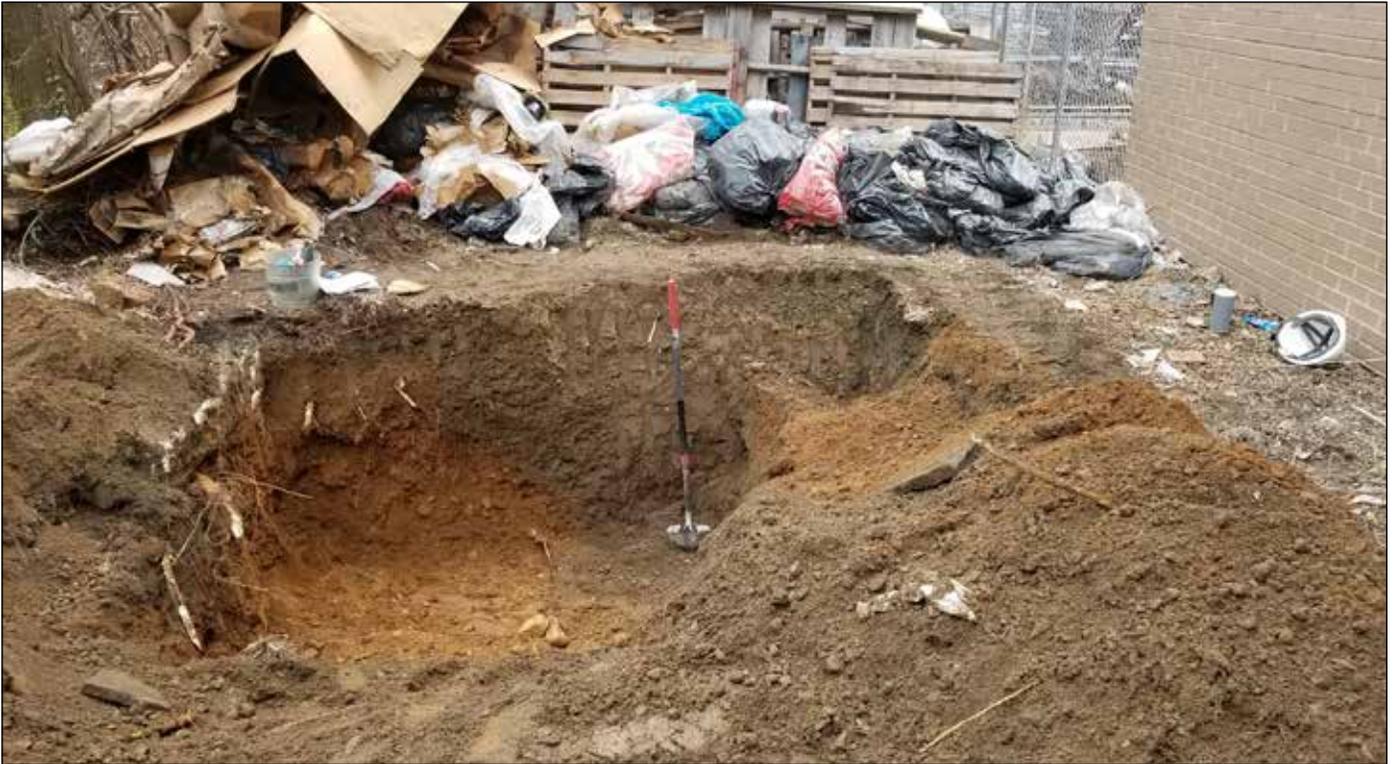
9

Facing southeast showing excavation of north half of Trench 3. The dark grey sandy soil to the right is clean fill associated with construction of the building at the right edge of photo. The brown sandy soil to the left is natural

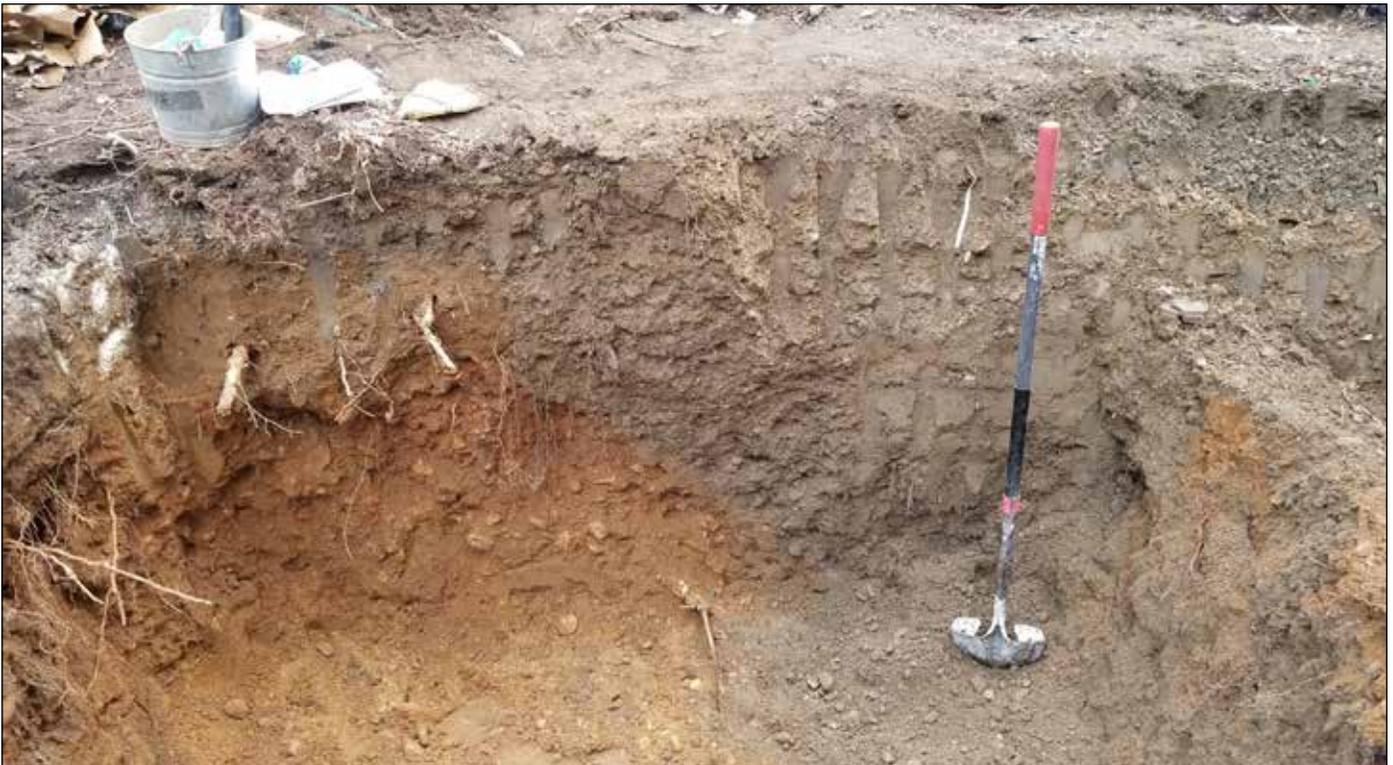
10

Detail of east wall of Trench 3 showing natural brown sands to the left and dark grey fill to the right
