Brooklyn Bridge Park Project: Pier 2 Uplands

Phase 1B Archaeological Investigation Final Report

SHPO Project Review Number 03PR02488

JULY 2018

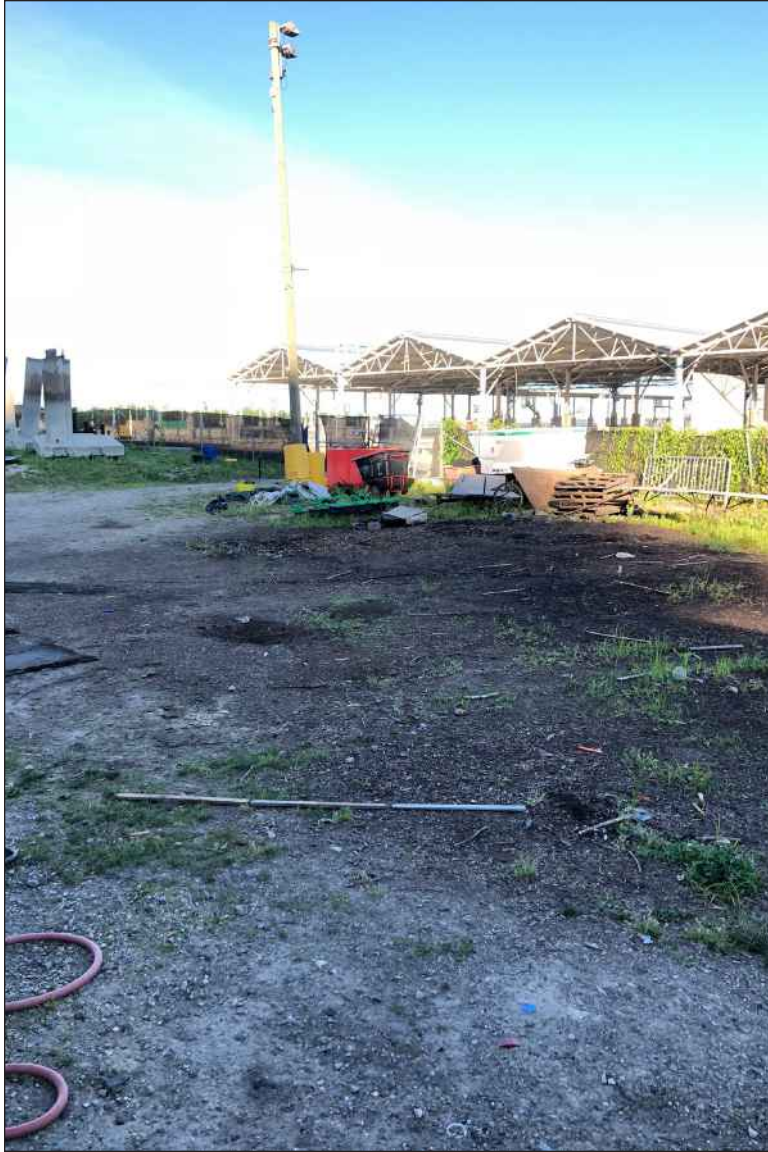
View southwest of the location of Trench 1 prior to excavation 1

As described in **Chapter 2, “Research Design and Survey Methods,”** fieldwork consisted of the excavation of one large backhoe trench monitored by an archaeologist. The trench extended partially through Monitoring Area 4 and Testing Area 5 as identified in the Testing Protocol. The trench’s location was selected to examine the area of deepest proposed disturbance associated with the proposed Irrigation Reuse Tank and was also selected to confirm the presence or absence of mapped utility lines in the area (see **Photograph 1 on Figure 5**).

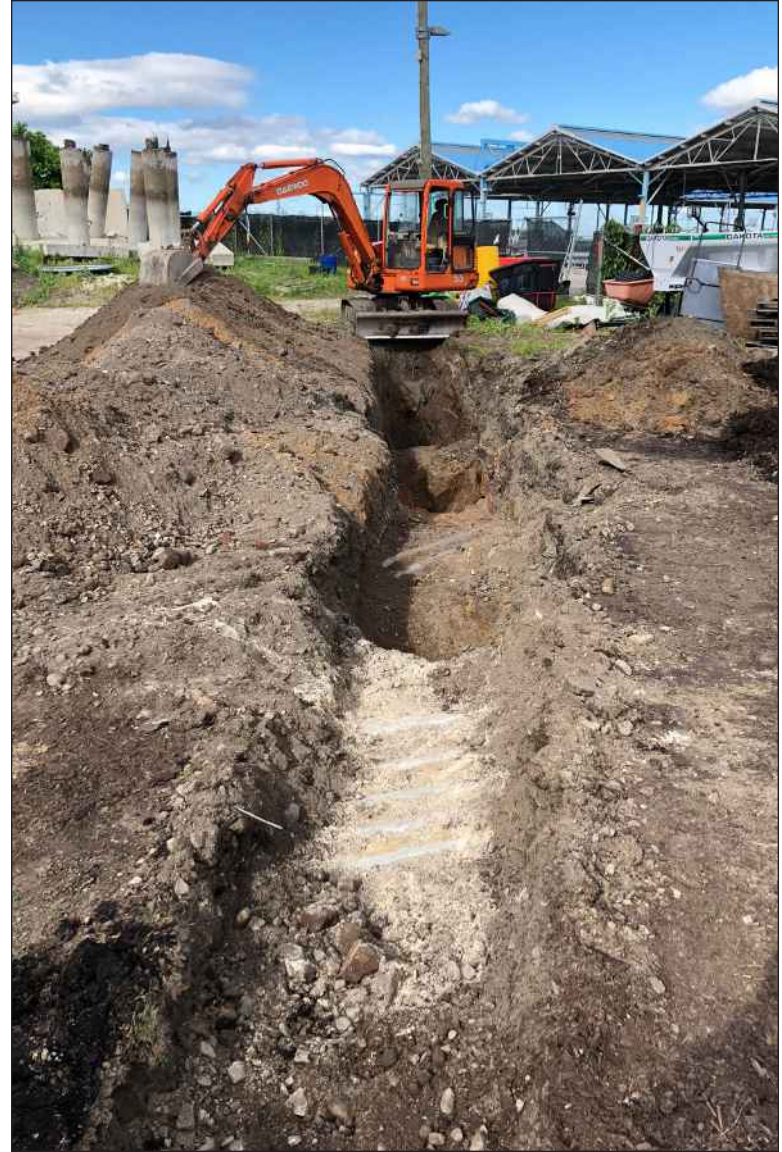
View of Trench 1 after excavation, showing two sets of utilities in foreground and brick footer in background 2

The eastern 20-foot section of the trench contained two sets of live utility conduits spaced approximately 10 feet apart (see **Photograph 2 on Figure 5**). The presence of these utilities prevented the excavation of the trench in this area. The first set of conduits included five parallel utility lines running northwest-southeast across the trench situated at a depth of less than 1 foot below the ground surface. The second set of utilities comprised a pair of larger lines running east-west across the trench at a depth of 2.5 feet below the ground surface. Minimal excavation was completed between the two sets of utilities.

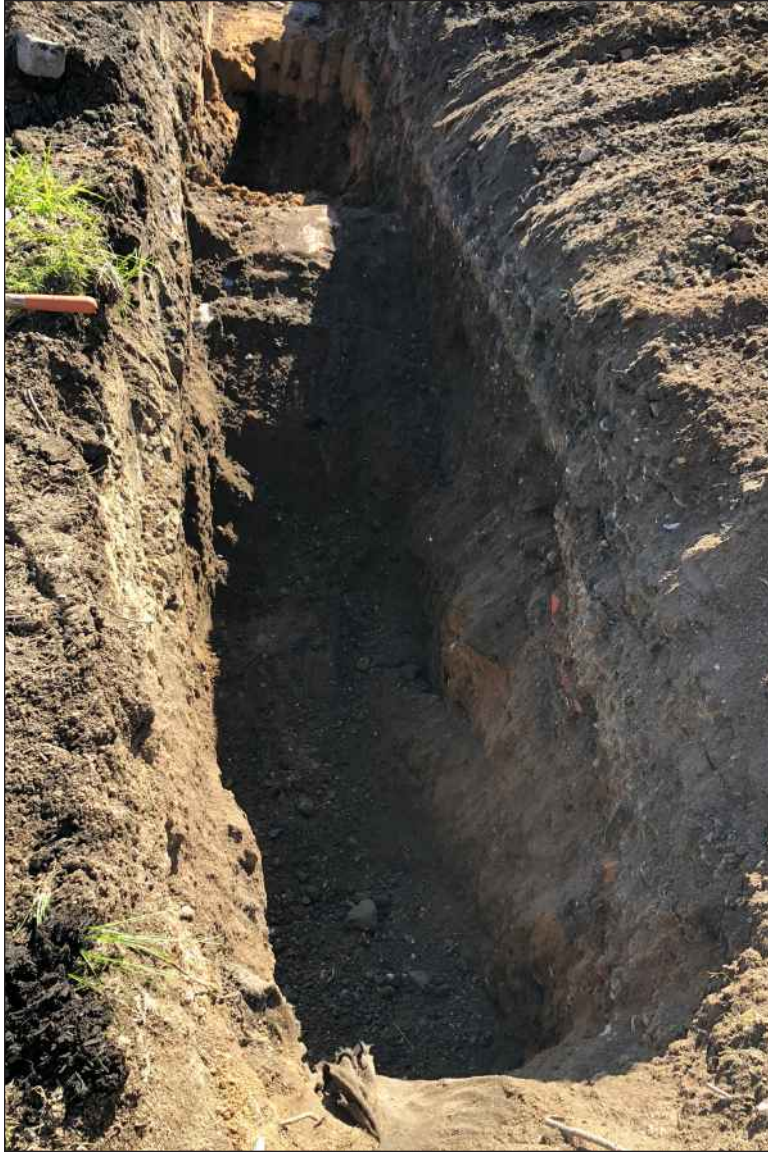
Looking northeast at Trench 1, showing sandy fill in foreground and utility lines in background **3**

The trench was continued to the west of the utility lines for a length of more than 25 feet. Where possible, the trench was excavated to a depth of 6 to 7 feet below ground surface. Along the entire western half of the trench, only fairly uniform, loose light-colored sandy fill deposits were observed (see **Photograph 3 on Figure 6**). One feature was observed approximately 17 feet east of the western end of the trench. The feature was an approximately 5-foot square brick footer the top of which was situated at a depth of 2 feet below ground surface (see **Photograph 4 on Figure 6**). The footer was cleared off by hand and a discernable corner was identified, though the width of the feature appeared to taper toward its sides. The feature did not seem to be archaeologically significant and no other features, including landfill deposits or landfill-retaining structures, were observed. Similar features are described in URS’ 2009 Phase 1B survey report.

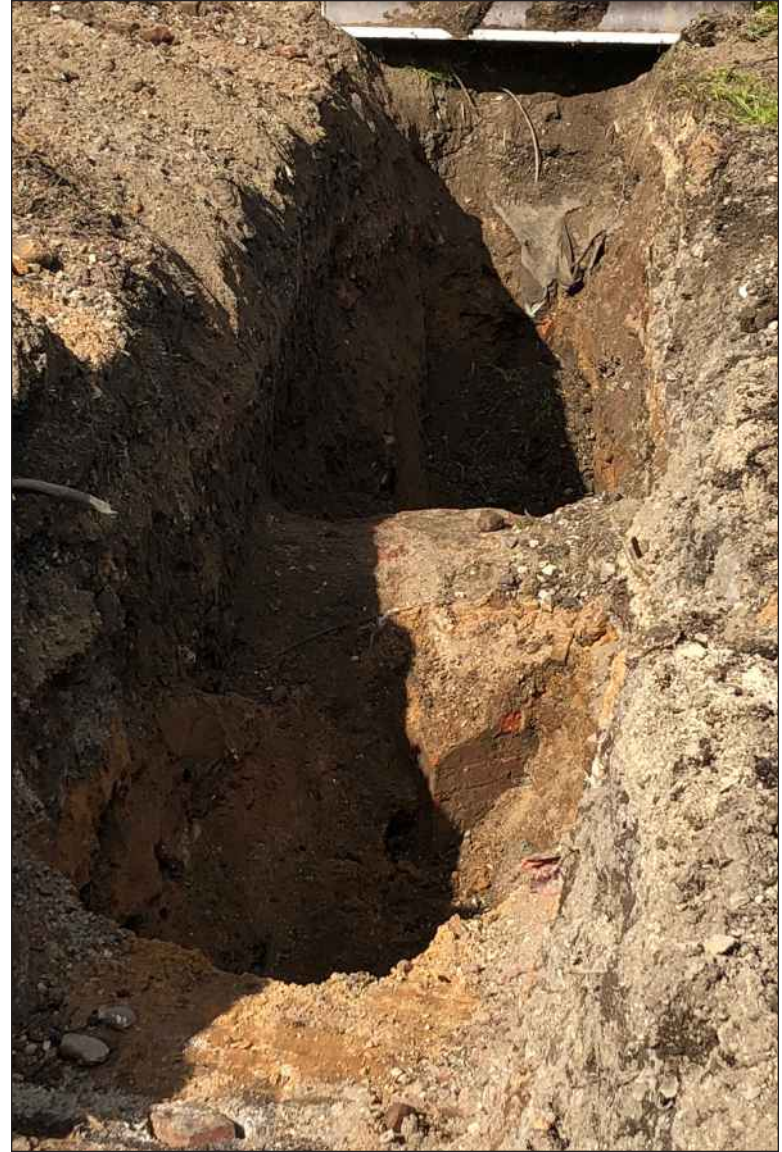
The northeastern face of the brick footer in the southwestern end of the trench, showing visible corner **4**
