# **Phase IB Archaeological Monitoring Report for the Reconstruction of a Portion of the Western Shoreline on Randall's Island Project, Borough of Manhattan (New York County), New York**

Project Number:	M104-116M
Involved State/Federal Agencies:	City of New York – Landmarks Preservation Commission City of New York – Department of Parks & Recreation
Phase of Survey:	Phase IB Archaeological Monitoring
Location Information:	Randall’s Island, Manhattan, NY
Survey Area:	less than one-acre
USGS 7.5 Quad Map:	Central Park, NY-NJ (USGS 2016)
Archaeological Survey Overview:	Monitoring of terracing in APE
Sensitivity Assessment:	Low potential for historic resources and human remains.
Results of Archaeological Survey:	Monitoring recommended for any future work in APE. Field testing recommended for work exceeding 4” in depth.
Report Authors:	Leah Mollin-Kling, M.A.A., R.P.A.
Date:	January 2019

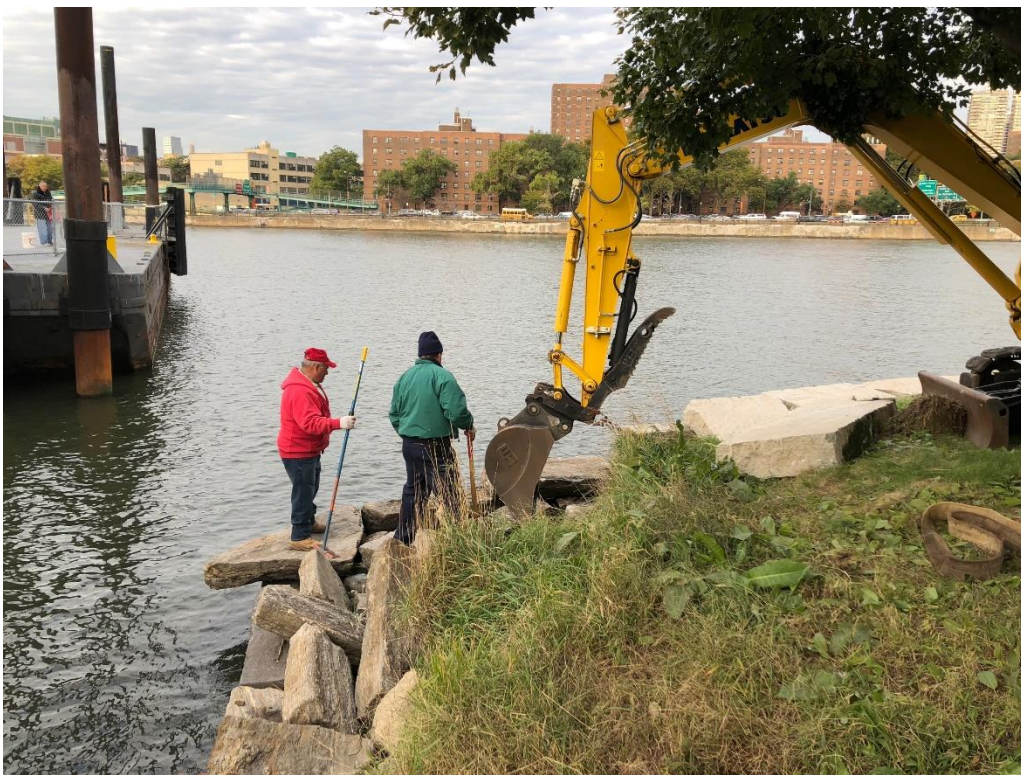
Archaeological monitoring of project excavation on Randall's Island began on Monday, October 22, 2018 for seawall reconstruction in a promontory adjacent to the floating dock, beginning at station 23+49, just north of the “point of beginning” (POB) at station 23+00 (Image 01) (Map 03). While subsurface excavation of area soils did occur, seawall reconstruction largely involved disturbances within its existing footprint.

Image 01: Excavation in progress of seawall reconstruction area (looking west).

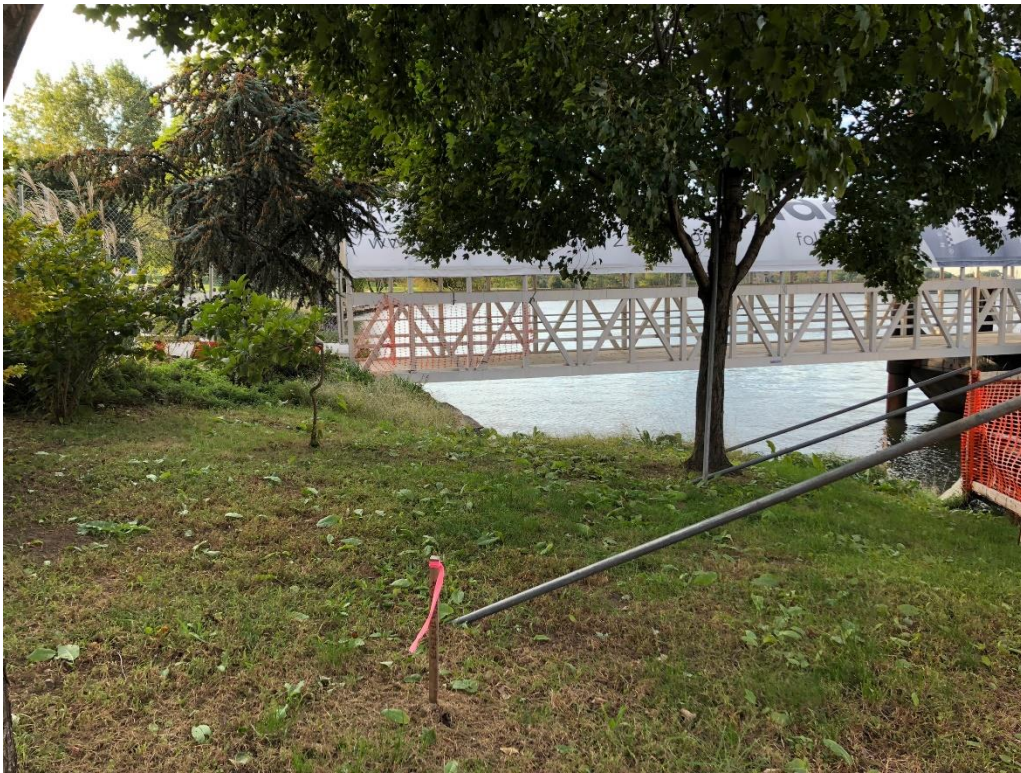
The terrain in the seawall reconstruction area is open and grassy with a maple tree near the promontory's edge (Image 02). A stone seawall surrounds the promontory on its western and southern edges. The stones are a mixture of large 7'x2.5'x1' cut metamorphic stones and semi-rounded and smaller more natural looking stones. Project excavation work in this area featured minimal subsurface disturbances as the bulk of the work involved the removal and replacement of disarticulated seawall stones. Some of the project work involved the removal of disarticulated seawall stones directly from the river. No damming was needed in this area as the existing seawall provided enough of a boundary against the river.

Image 02: Terrain of seawall reconstruction area (looking southwest).

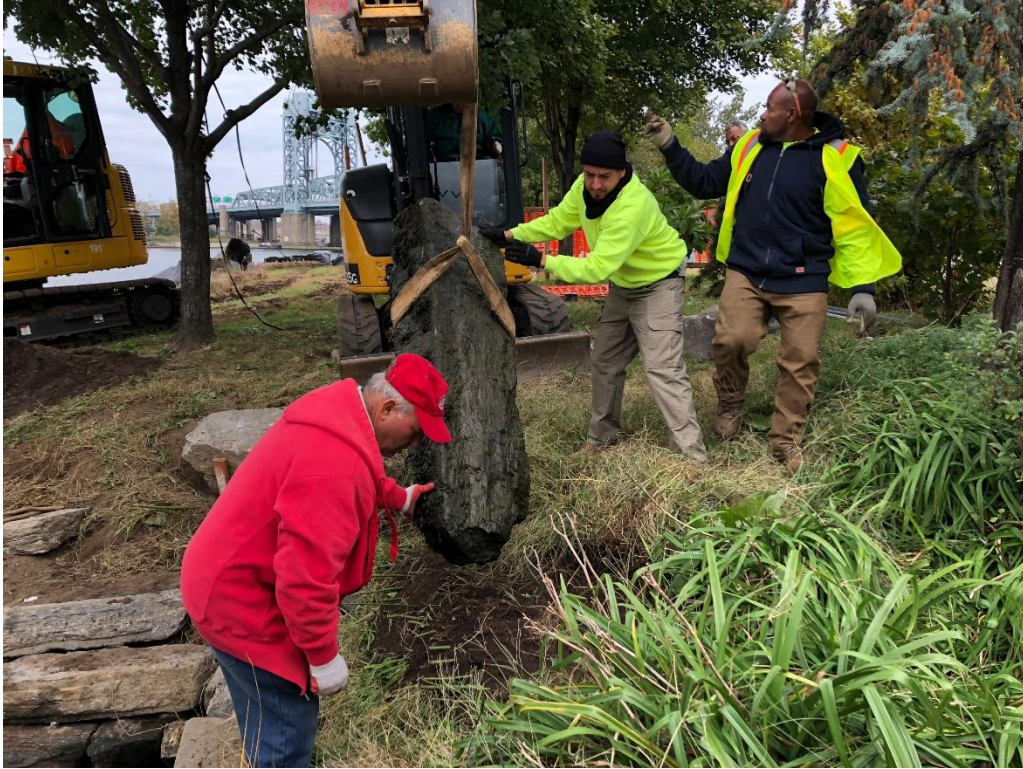
Using a small hydraulic excavator, construction crew repositioned existing stones that had fallen out of place by water action to recreate the seawall. Some of the stones were placed along a series of terraces created by the excavator (Image 03). The terracing utilized the existing slope along the embankment, minimizing the level of subsurface disturbance (Image 04). For the most part, the soil horizon impacted by project plans was redeposited A/topsoil (Table 01). Modern trash, including plastic wrap, was observed in this area.

Image 03: Seawall terracing construction and stone relocation (looking north).

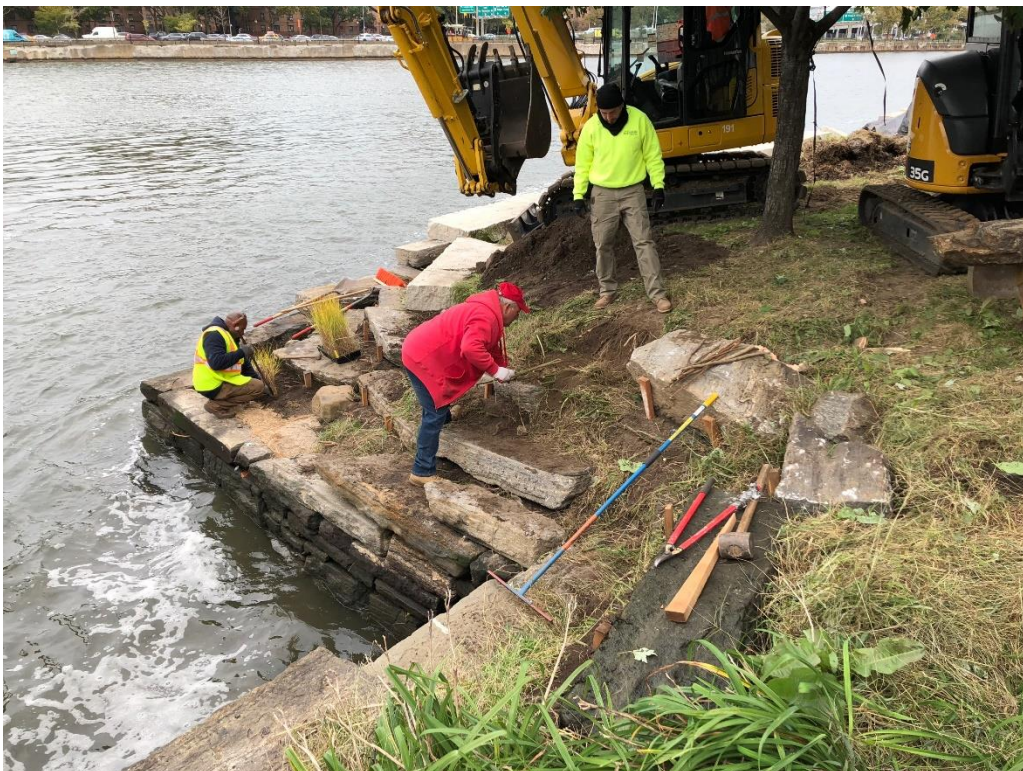
Image 04: Seawall reconstruction and terracing (looking northwest).

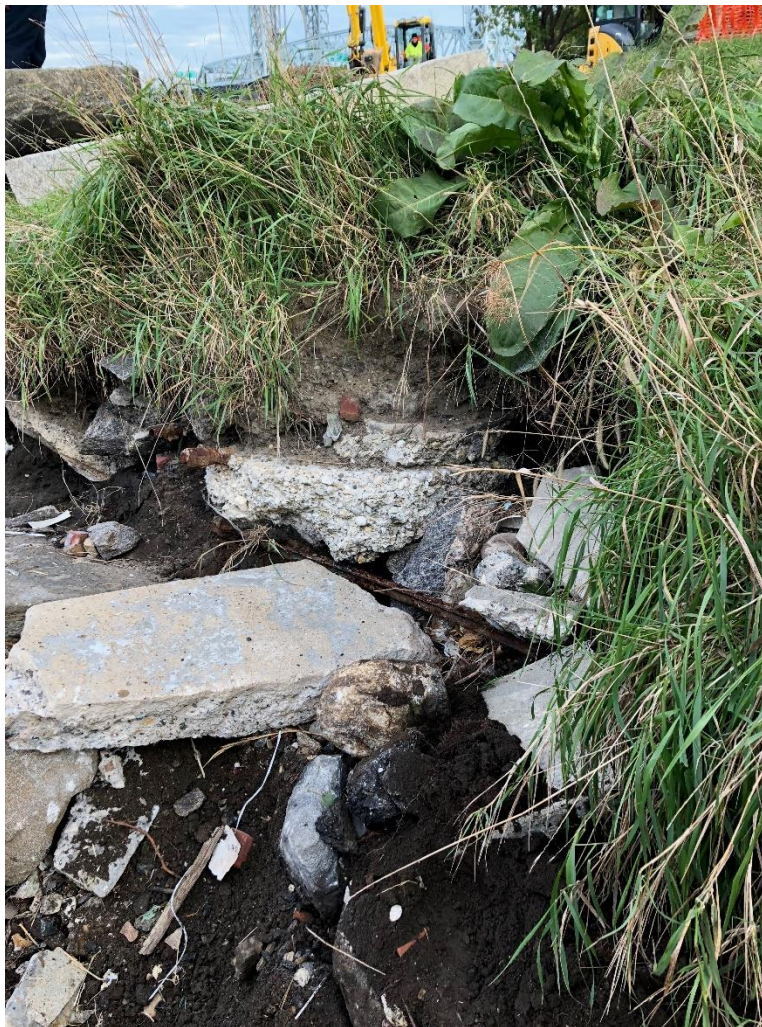
Along the southern edge of the seawall reconstruction area and approximately 8' southwest of an adjacent maple tree, a collection of broken and disarticulated concrete slabs were discovered during terracing (Image 05). The concrete slabs are relatively crude and featured large inclusions. Given the position of the slabs, they were probably placed here at some point to help protect the shore from destructive water action. The slabs were recorded and photographed, but no further action was taken. The slabs remain in situ.

Image 05: Disarticulated concrete slabs underneath slope, seawall reconstruction area (looking north)

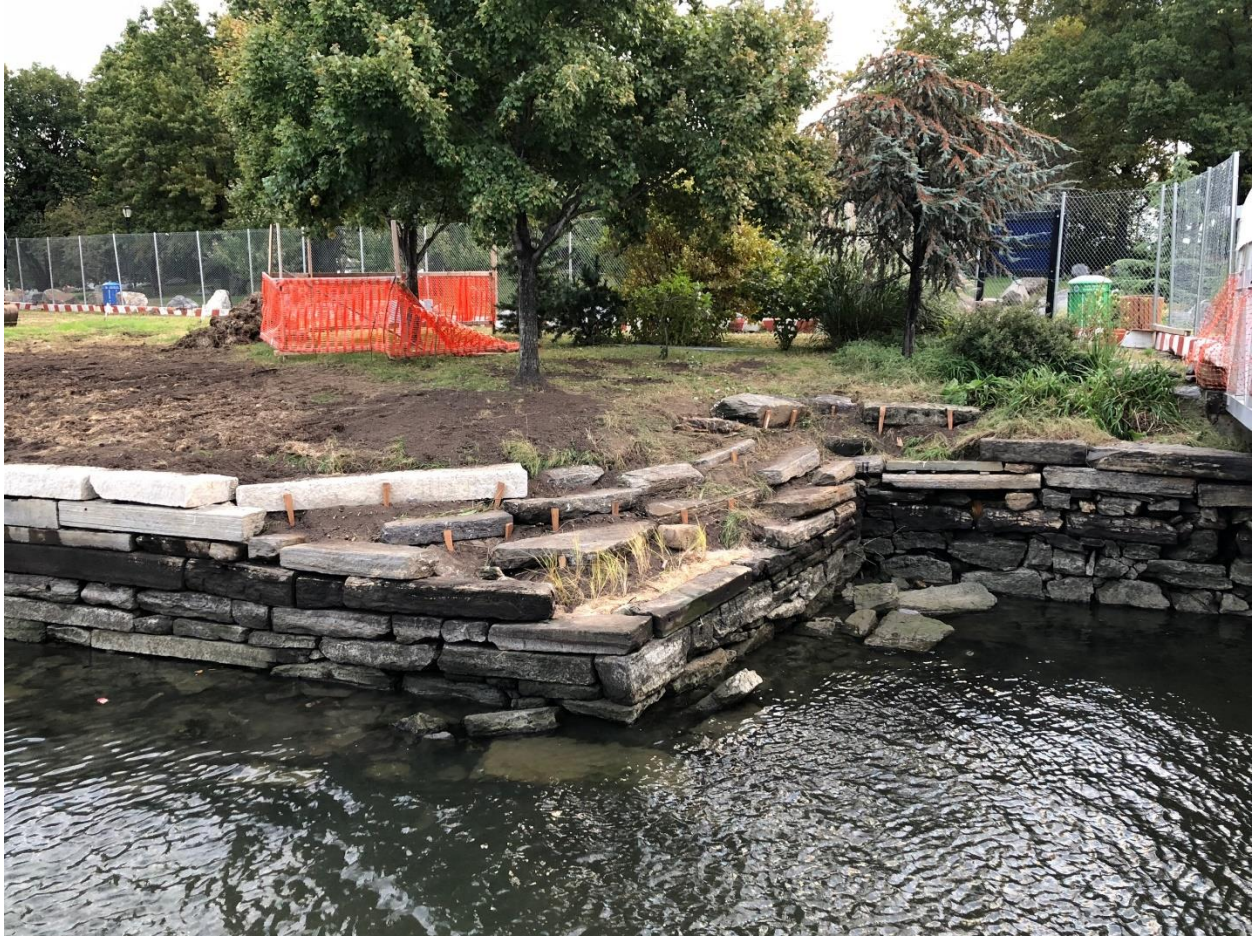
Image 06: Seawall reconstruction area, post construction (looking east).

After terracing, eco-friendly materials were used in the construction of the new seawall. No further subsurface activities are planned for this area (Image 06). No significant cultural resources or intact stratigraphy were encountered during seawall reconstruction.

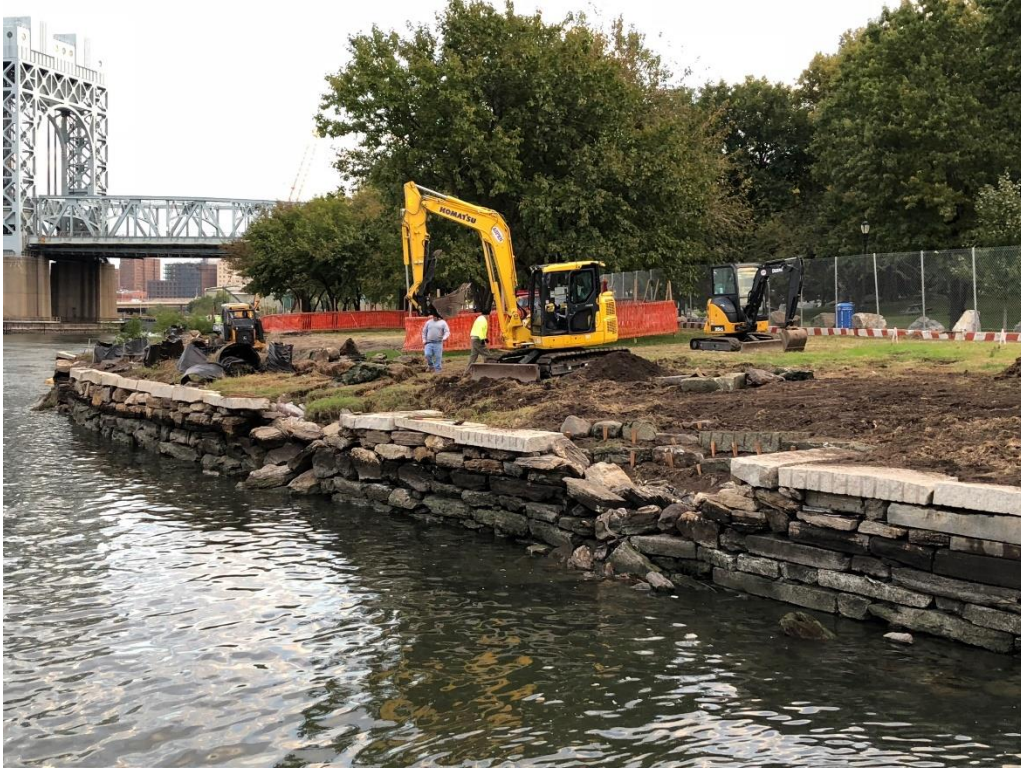
Two tidal pools were constructed at locations of seawall erosion along the western shoreline of Randall's Island in the APE and heading north from the POB. The Tidal Pool areas were placed in locations previously disturbed by water action prior to the commencement of project plans (Image 07). The seawalls were partially destroyed in the two locations, allowing the erosion of adjacent banks. In order to decrease the level of erosion and to create the tidal pools, construction methodology followed that of the seawall reconstruction and featured the repositioning of fallen seawall stones, terracing via excavator, and the use of "green" materials.

Image 07: Tidal Pool 1 (right) and 2 (left), preconstruction (looking northeast).

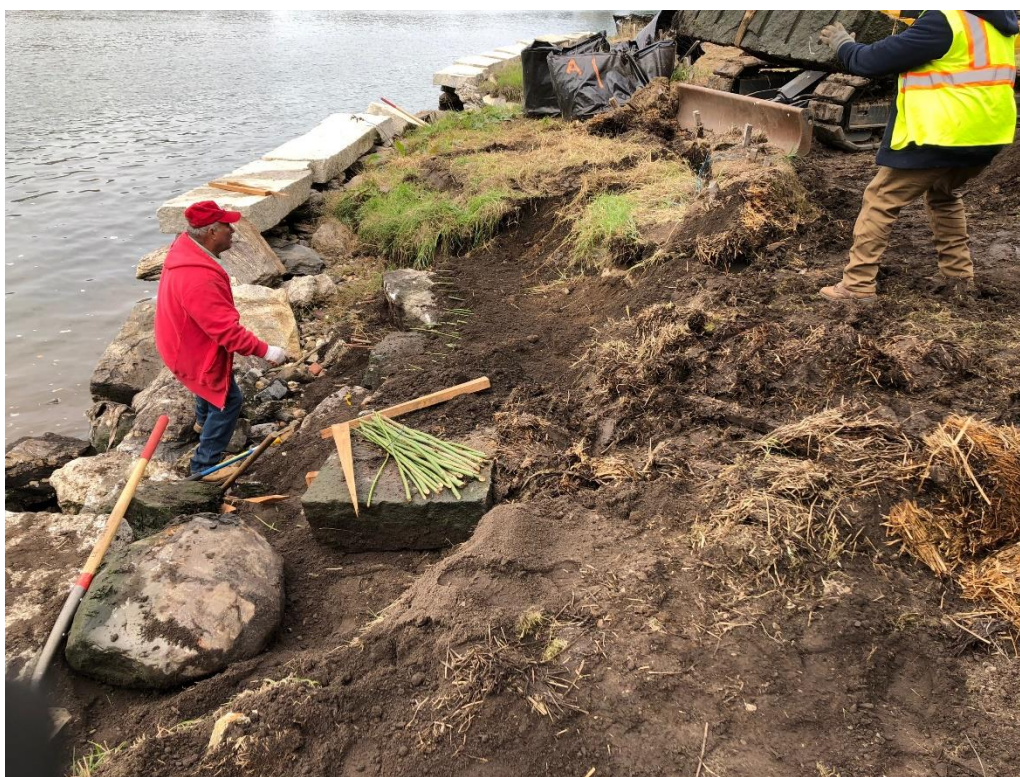
The terrain is similar to that of the seawall reconstruction area and is an open grass field at a higher elevation than the Harlem River. Some work involved the removal of disarticulated seawall stones from the river, although the bulk of the work was the creation of a series of terraces in the eroded bank (Image 08). No damming was necessary as the existing seawall provided enough of a boundary against the river.

Tidal Pool 1's typical stratigraphic profile, visible in the eroding bank, featured redeposited A/topsoil over a layer of very compact redeposited A and B soils to a depth of 6.5' NAVD88 or 1.5' below ground surface (Table 02). The redeposited A and B layer is indicative of disturbance in the area. As none of the nineteenth or twentieth century buildings shown on historic maps are visibly present in the APE, the compact redeposited layer could be the result of their destruction and/or other historic and/or modern construction efforts.

Image 08: Excavation of Tidal Pool 1 (looking north).

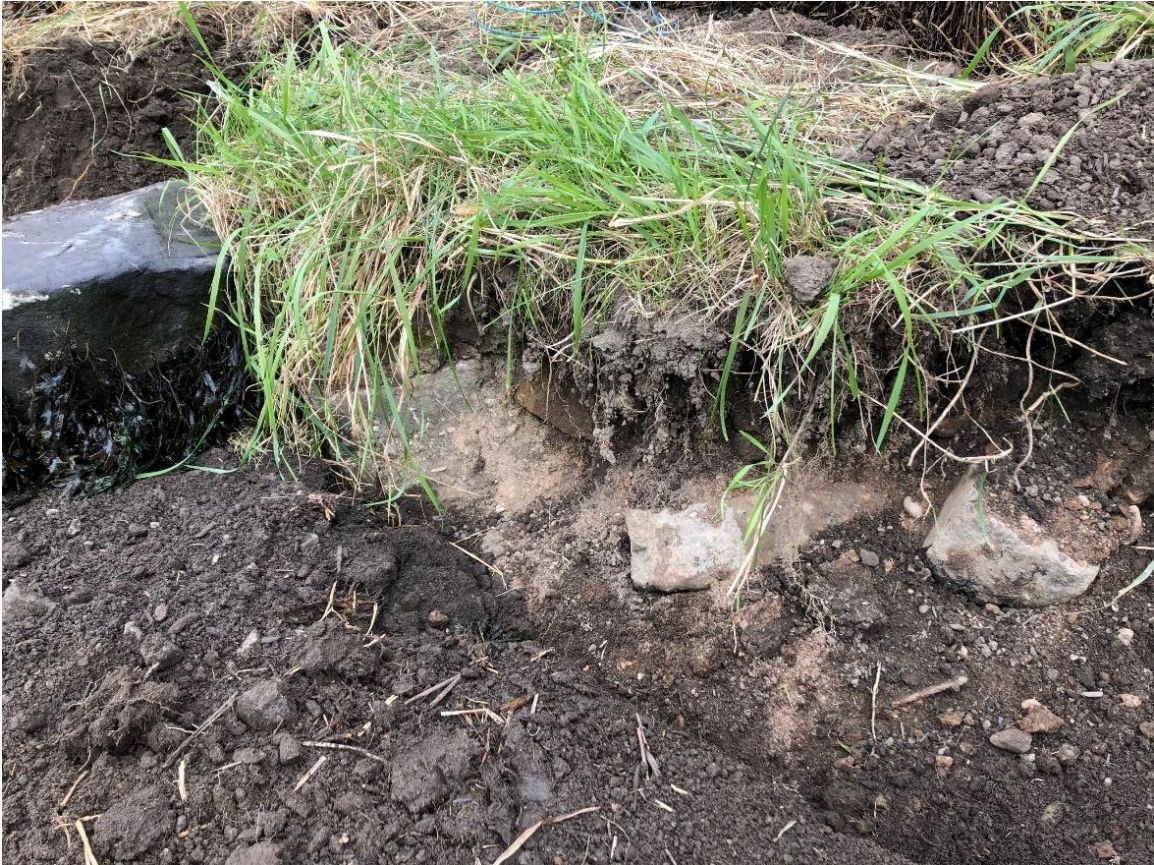
A series of disarticulated building stones and bricks were uncovered approximately 14' north of the southeastern edge of the tidal pool footprint and within the redeposited A and B layer (Image 09). The stones and bricks were recorded and photographed. No further impact to this particular area was required by project plans and the stones and bricks were left in situ. The stones and bricks are not considered significant cultural resources as they were not articulated and were within obvious fill or redeposited subsoil. None of the bricks included maker's marks and thus could not be dated. However, they may indicate that buildings once stood in the area, possibly the nineteenth or twentieth century buildings found on historic maps. It is also possible that the materials were redeposited on Randall's Island from a different location. However, at present there is no known record of materials having been brought in from an off-island source.

Image 09: Disarticulated building stones and bricks, Tidal Pool 1 (looking north).

However, disarticulated building materials in Tidal Pool 1 and intact subsoil in Tidal Pool 2 increase the possibility that potentially significant cultural resources could still exist in the APE at greater depths. Thus, any future work involving subsurface disturbances greater than 4" bgs in the APE should require archaeological monitoring, at a minimum.

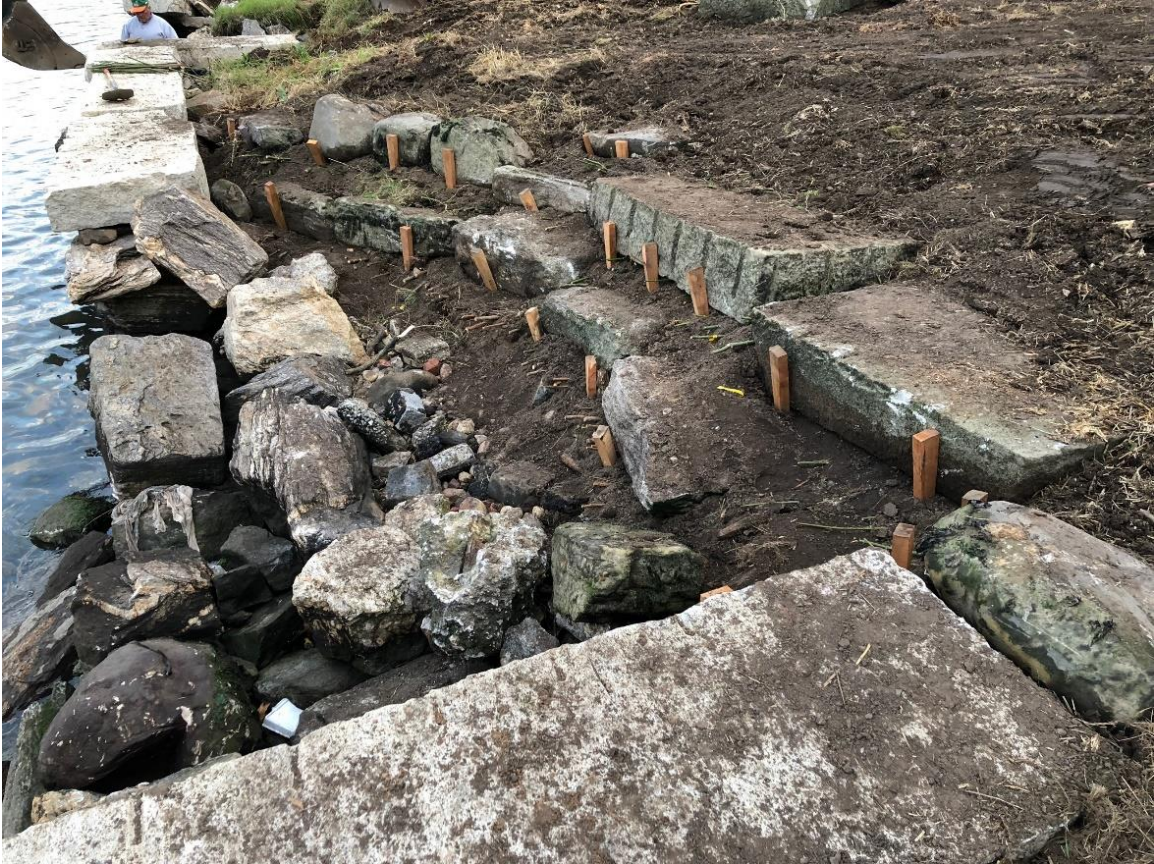
Upon completion of terracing, no additional subsurface work in the Tidal Pool 1 area is planned (Image 10). No significant archaeological resources or intact stratigraphy was encountered in Tidal Pool 1.

Image 10: Tidal Pool 1, postconstruction (looking north).

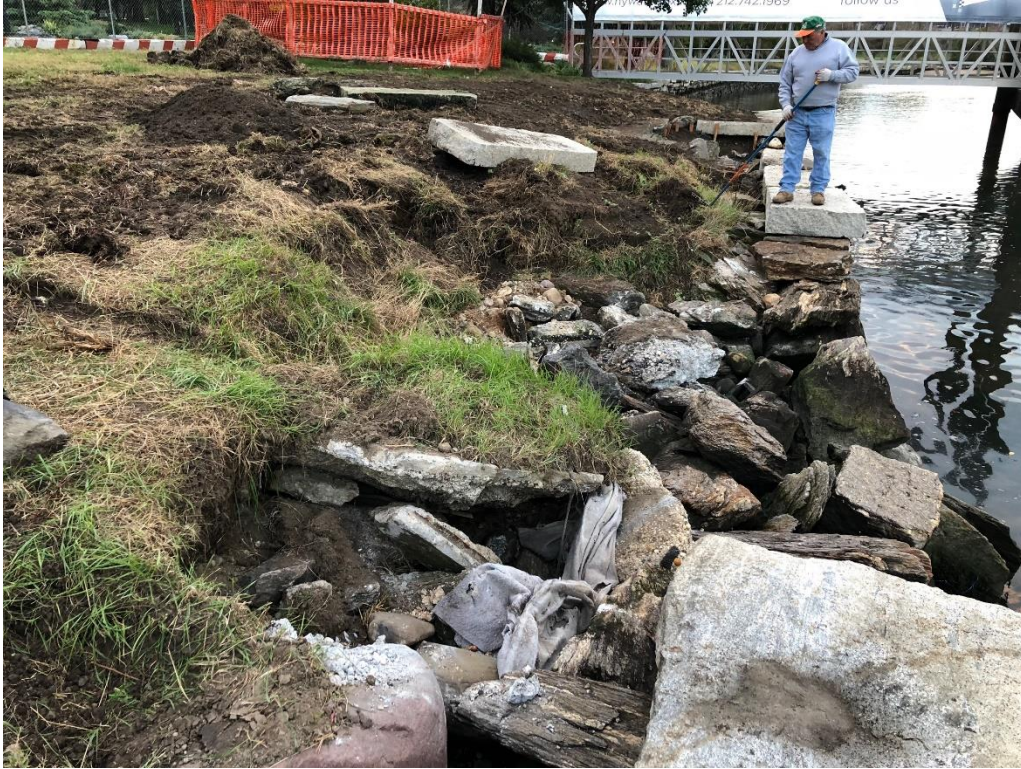
Tidal Pool 2 is located at station 24+22, 32' from Tidal Pool 1 and 122' north of the POB. The measurements, shape, and construction methodology are similar to that of Tidal Pool 1 (Image 11). No significant cultural resources were encountered. However, intact subsoil was observed in the eroding bank (Table 03) (Image 12). It is not known at this time what the exact subsoil strata is exhibited in the stratigraphic profile, although a B horizon is likely. It is probable this horizon is truncated and was impacted by the deposition of the redeposited/fill layers above. The presence of the B horizon indicates that pockets of intact stratigraphy are present in the APE.

Image 11: Tidal Pool 2, preconstruction (looking south).

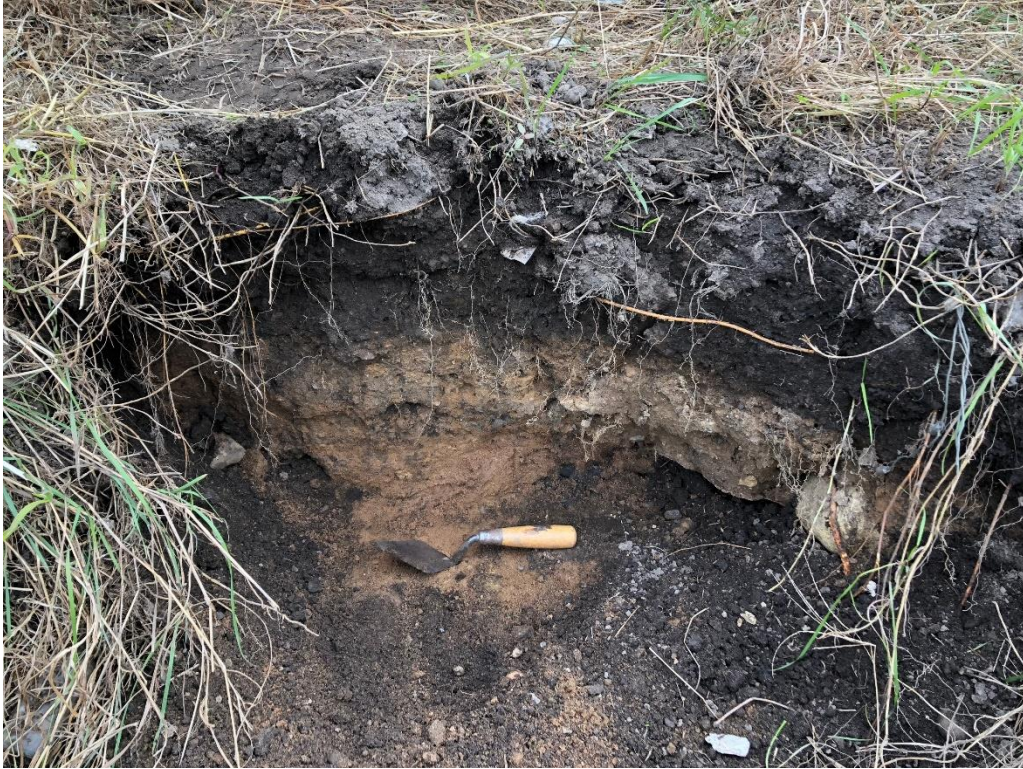
STRATUM	DEPTH	MUNSELL	DESCRIPTION
Redeposited A soils	8.0-7.2' NAVD88 (0-0.8' bgs)	10YR 3/2	Fine sandy silt with modern trash (not saved)
Redeposited A and B soils	7.2-6.75' NAVD88 (0.8-1.25' bgs)	10YR 4/6 mottled with 7.5YR 4/4	Medium sand trace silt with cobbles
Indeterminate B	6.75-6.3' NAVD88 (1.25'-1.7' bgs)	7.5YR 4/4	Medium sand

Image 12: West wall profile of Tidal Pool 2.

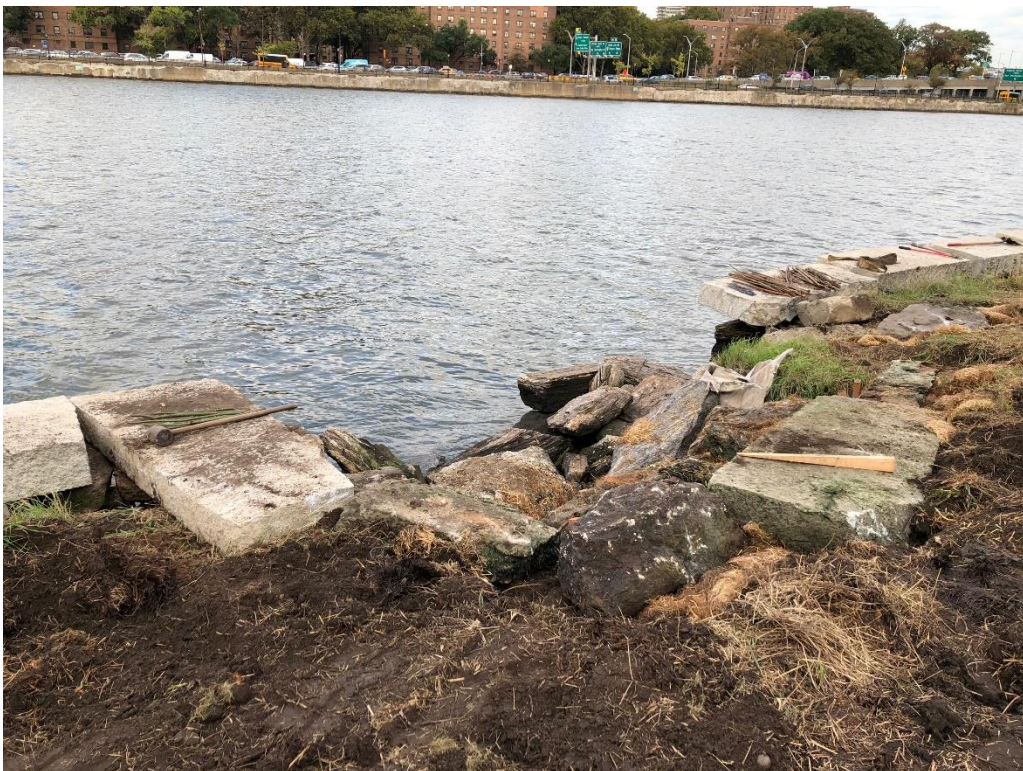
No further subsurface construction activities are planned for the Tidal Pool 2 area upon completion of terracing (Image 13). No significant cultural resources were encountered in Tidal Pool 2.

Image 13: Tidal Pool 2, postconstruction (looking west).
