**Reconstruction of the Pavilion at the end of Hylan Boulevard
Adjacent to Satterlee Street in Conference House Park, Staten
Island, Richmond County, New York Project (Contract Number
R006-213M; E-PIN: 8461780040001)**

EXECUTIVE SUMMARY TABLE

EXECUTIVE SUMMARY TEXT

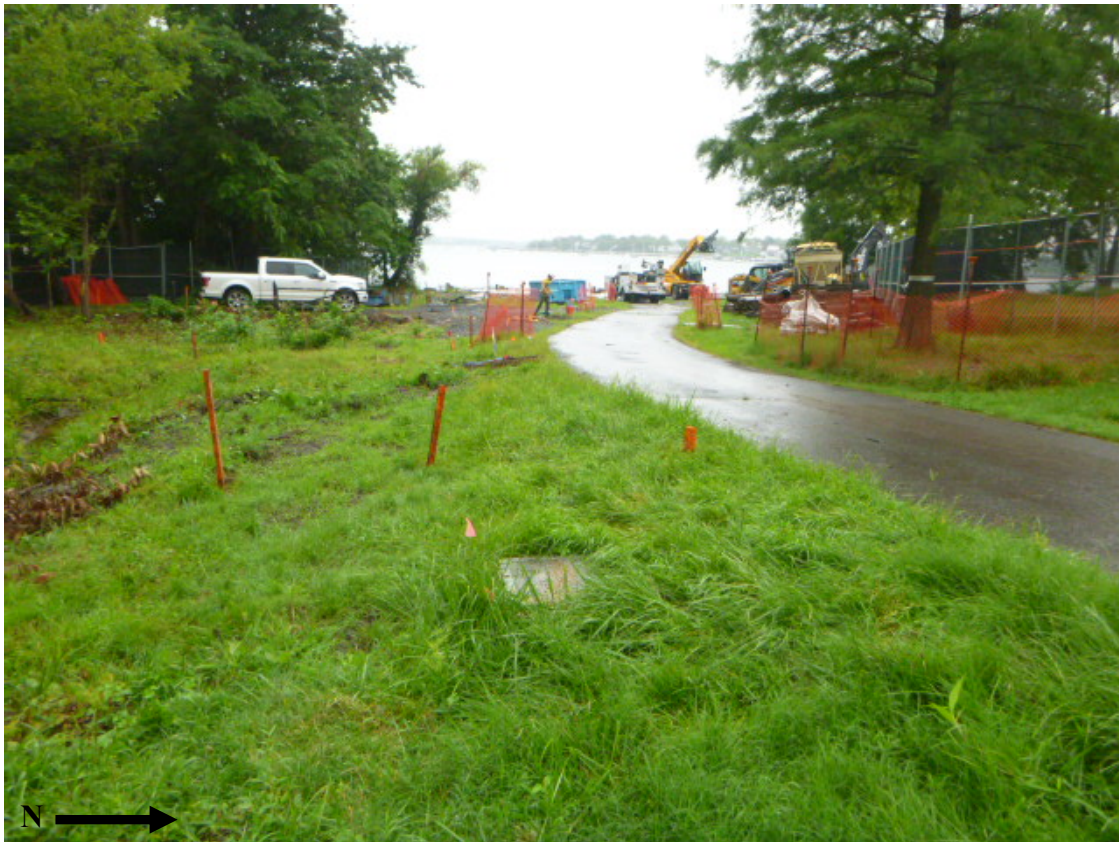
Image 01: Overview of Transect A.

The stratigraphy for most of Transect A was heavily disturbed by modern construction efforts. In some cases, excavation was discontinued due to a shallow water table, especially at the western end of the transect. Limited intact stratigraphical profiles and no significant cultural resources were encountered during Transect A archaeological excavation.

Transect A began at the western edge of the untested, and thus potentially sensitive, area of the APE (Map 05). A-01 was placed next to an extant lamp post on the southern edge of the Hylan Boulevard extension. Transect A STPs were then placed off of A-01 on a 50' (15m) interval heading west. However, as Transect A abutted the existing roadway, modern disturbances in the form of electrical boxes and other utility features influenced the placement of some STPs (Image 01) (Map 05).

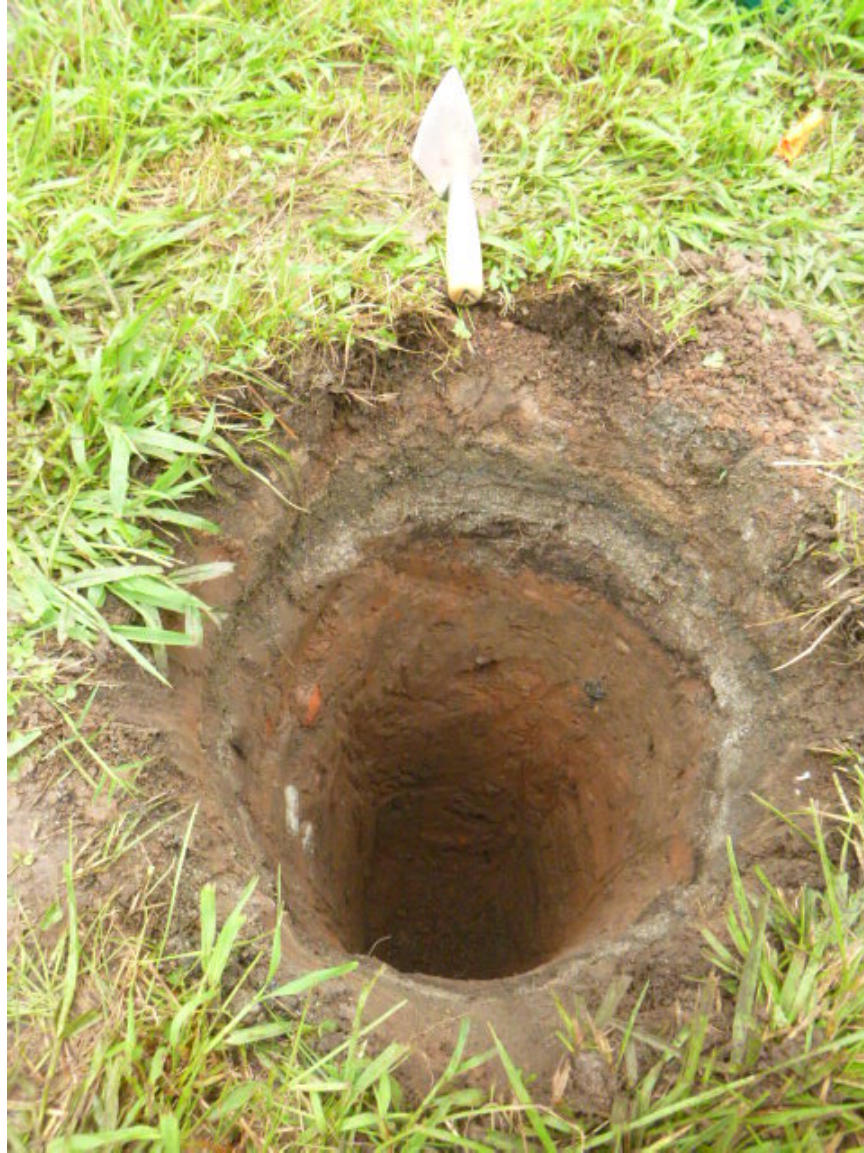
Due to the ground conditions, only two Transect A STPs (A-02 and A-03) were able to be excavated to the maximum depth of 3.3' (1m) below ground surface. The stratigraphy for both of these STPs was similar, featuring a developing Ao overlaying fill in the topmost layers and buried A horizons overlaying intact subsoils further down (Image 02) (Table 01). Variation in the compactness and proportion of clay in subsoils was noted across Transect A and the APE.

Image 02: Stratigraphic profile, east wall, A-02.

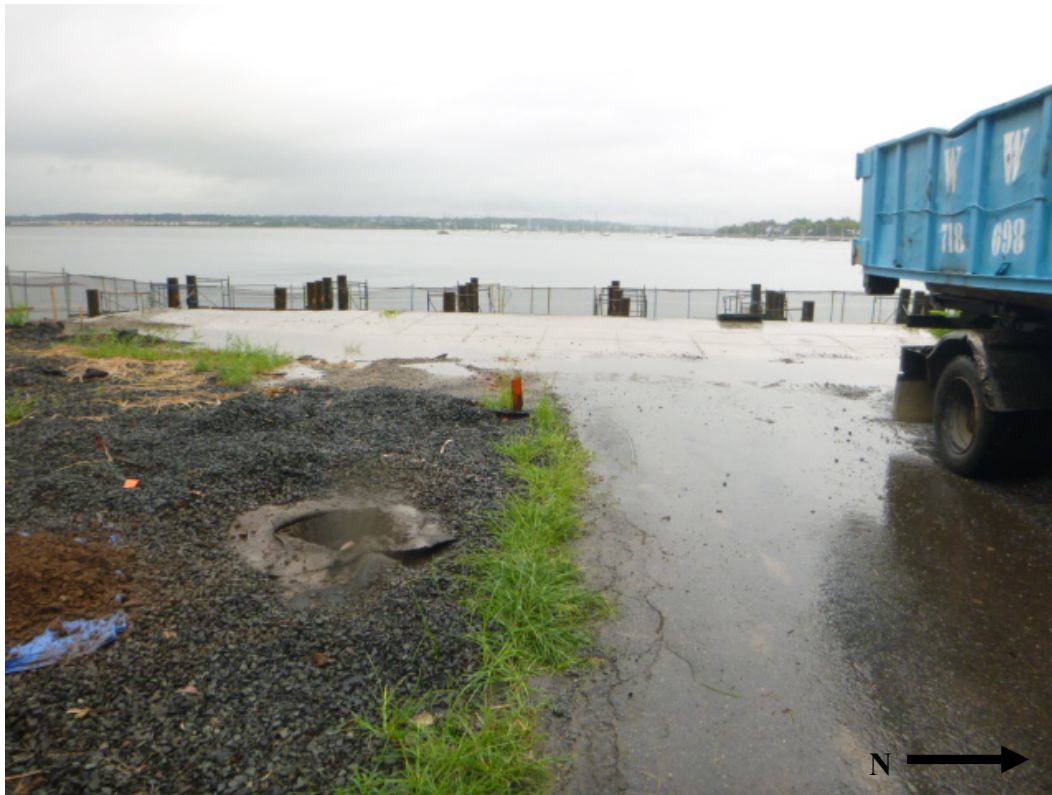
Stratigraphy became even more disturbed as Transect A headed further west towards the beach, and the elevation slowly decreased. No intact stratigraphic profiles were encountered in the last three Transect A STPs. Instead, a thick gravel layer was observed atop subsequent layers of fill and truncated subsoils (Images 03 and 04).

Image 03: End of Transect A (A-08), with modern surface disturbances.

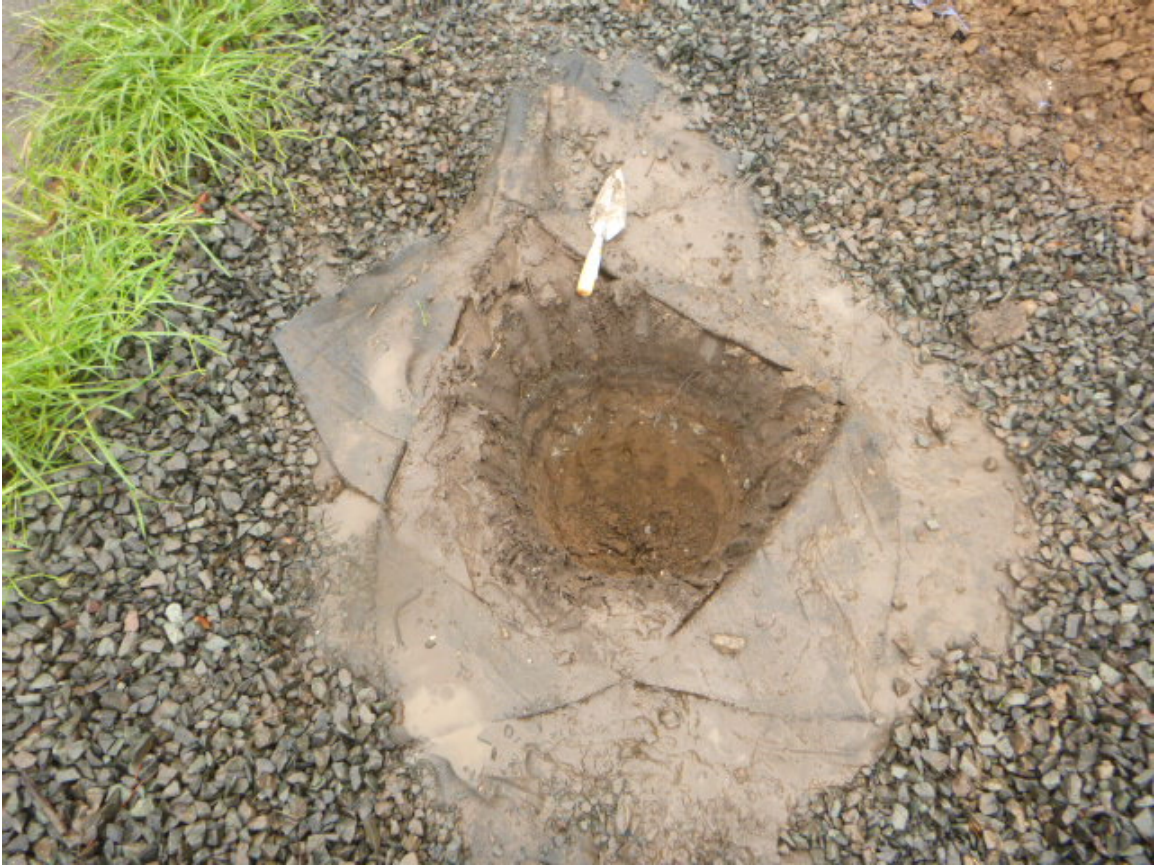
Image 04: Excavation of A-08, with modern disturbances.

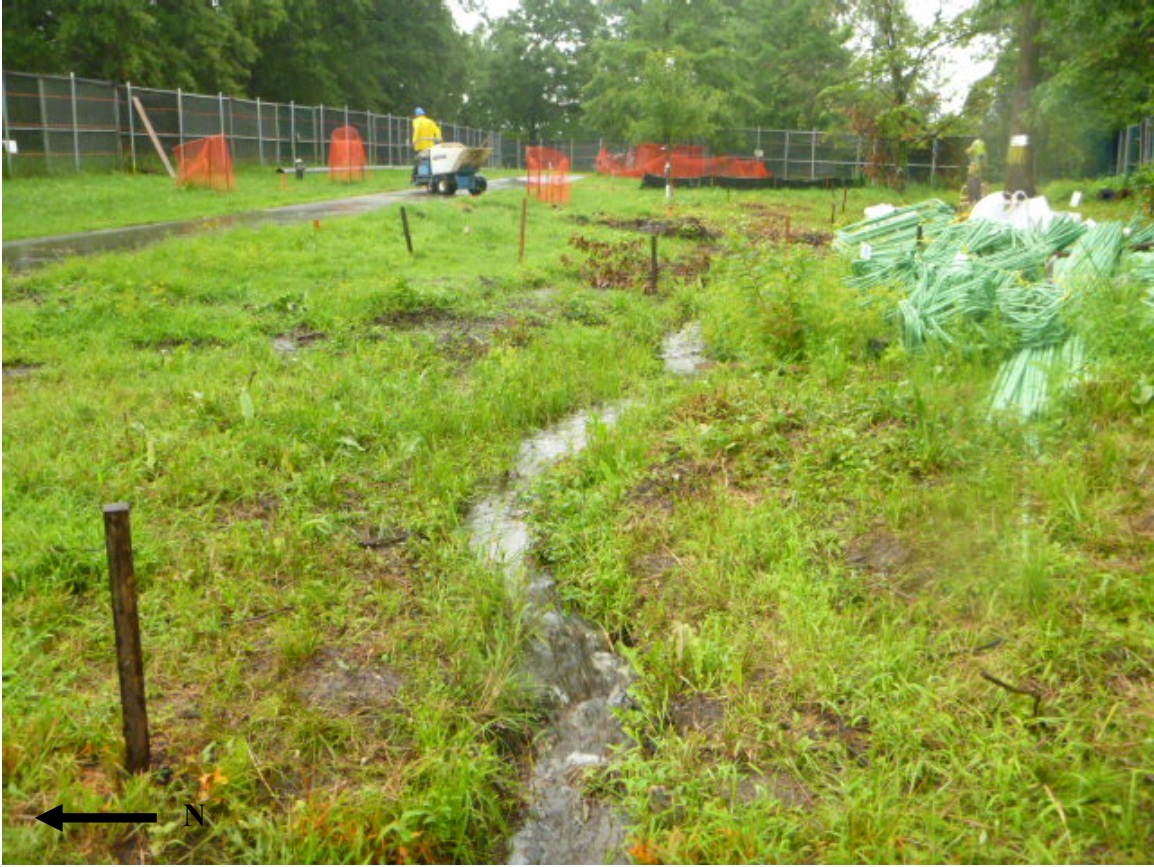
Transect B was placed in the location of an existing water management system and in the future location of the Project's new weirs, which accounted for the shallow water tables across the transect (Image 05). Transect B STPs did not follow a strict 50' interval due to impediments from the existing drainage system and the area's use as the construction project's staging area. B-01 was the easternmost STP on the line, located in an open field directly south of the existing weir system. B-02 was placed 83' (25m) off of B-01 at 261°. B-03 was located 48' (13m) east, at 245° off of B-02.

Image 05: Overview of Transect B, with existing drainage system and modern disturbances.

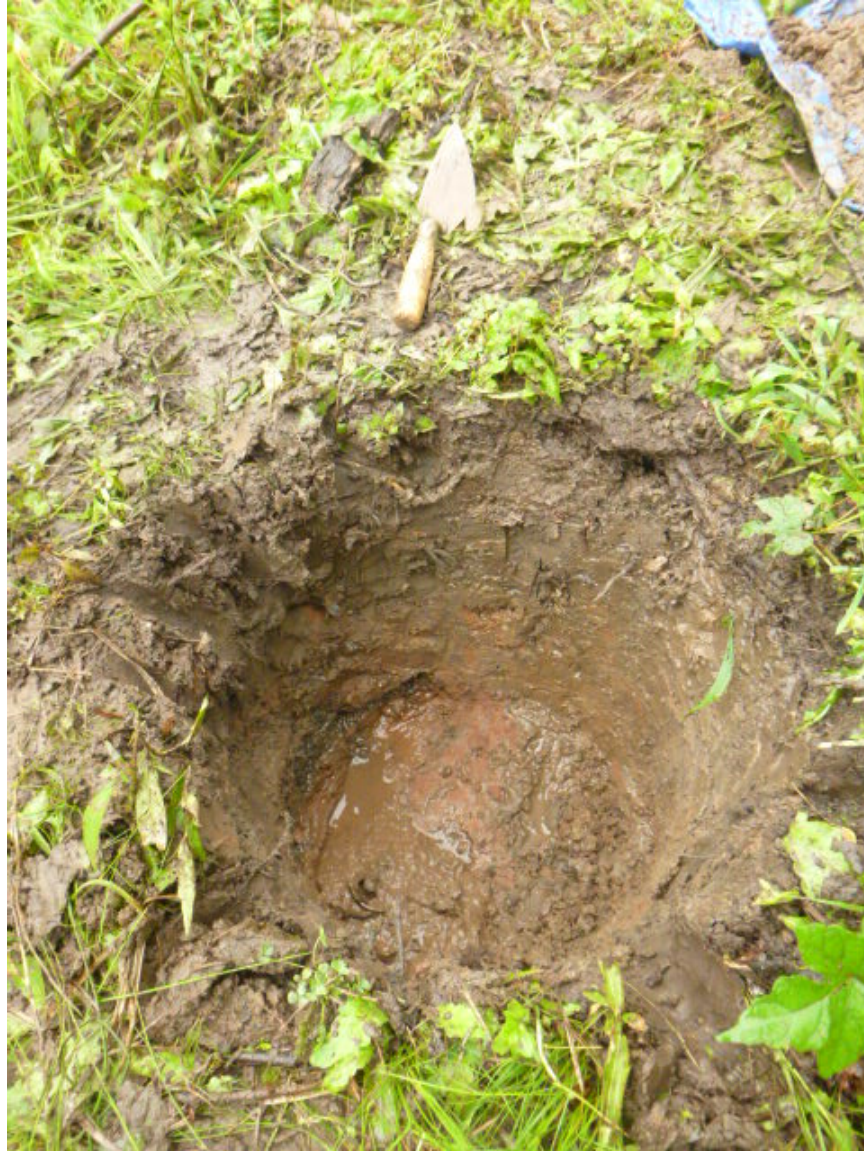
Image 06: B-02 east profile.

None of the Transect B STPs were able to be excavated to the maximum depth of 3.3' (1m) below ground surface due either to a shallow water table or ground compaction. The soils encountered were highly disturbed save for B-02, which featured a thick hydric layer over compacted and clay-rich subsoil (Btx) (Image 06).

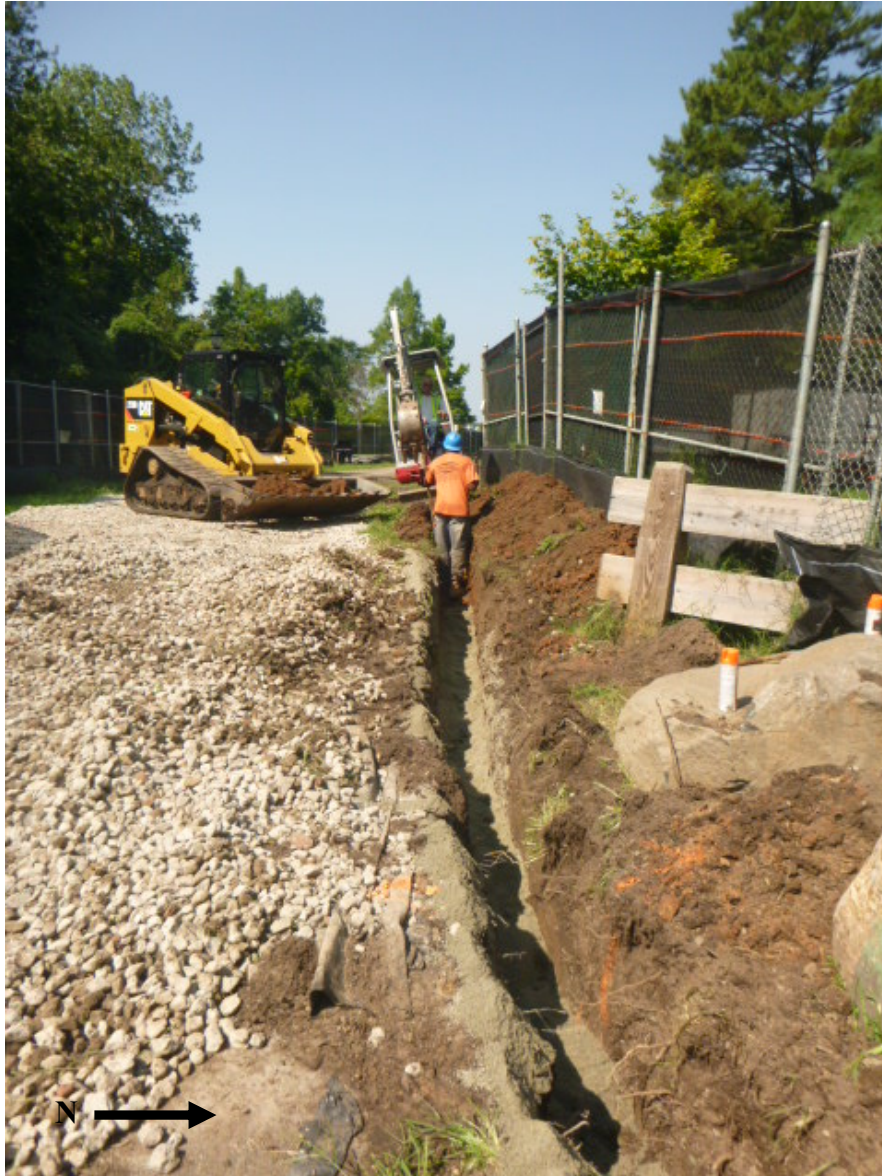
Image 07: Eastern section of Trench 02, excavation in progress.

The eastern third of the trench closely followed the contours of the Hylan Boulevard extension, running for 54.5' (16.6m) at 258° (Image 07). This section of the trench exhibited the most disturbed stratigraphy, as numerous utilities and roadway elements were encountered, including a buried electrical pipe near the construction gate (Image 08) (Table 04).

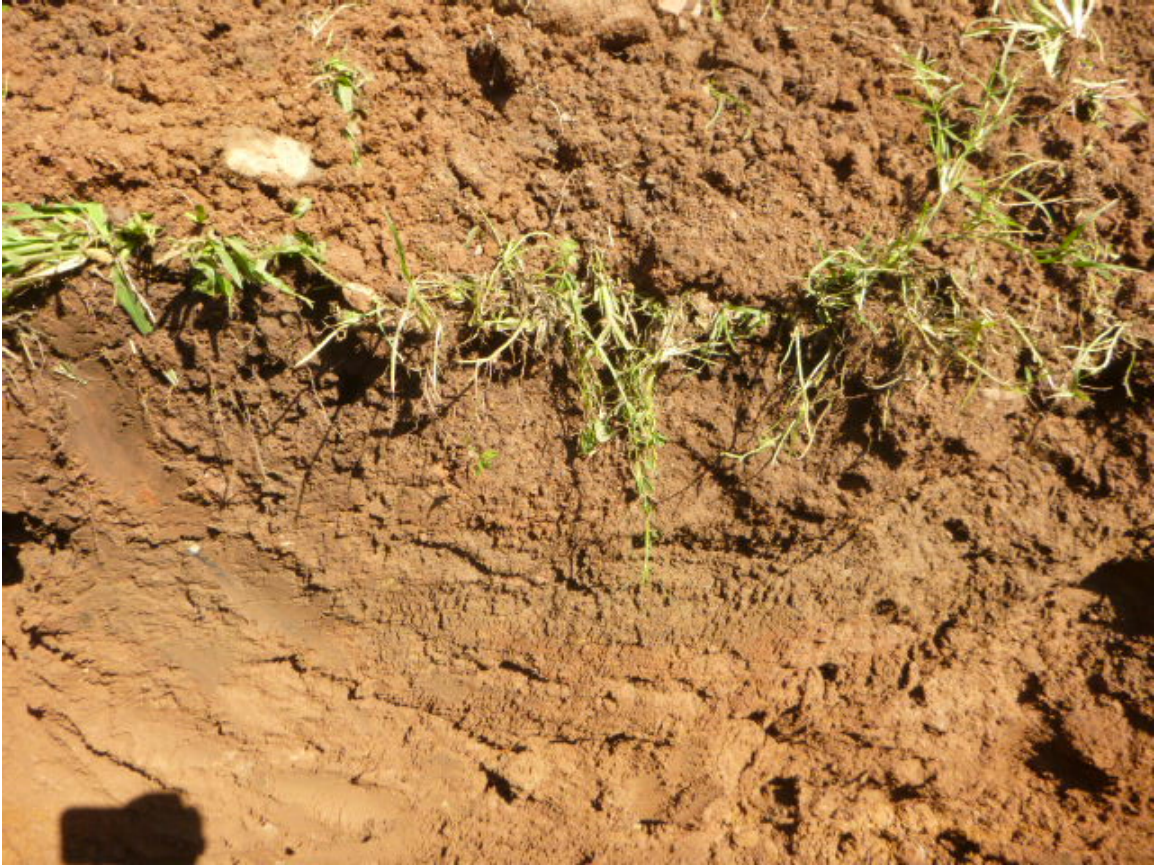
Image 08: Stratigraphic profile, Section 1, north wall, Trench 02.

STRAT	NAVD 88 DEPTH (BGS)	MUNSELL	SOIL TYPE	COMMENTS
Developing Ao	32.66' – 32.46' (0' – 0.20' bgs)	10YR 2/2 very dark brown	Fine Sandy silt	
Redeposited B soils I	32.46' – 31.66' (0.20' – 1.00' bgs)	7.5YR 3/2 dark brown mottled with 7.5YR 4/6 strong brown	Sandy loam	Occasional semi-rounded, medium-to-small rocks.
Redeposited B soils II	31.66' – 30.26' (1.00' – 2.40' bgs)	7.5YR 4/3 brown mixed with 7.5YR 4/4 brown and pockets of Gley 1 5/10GY greenish gray	Sandy clay	Very compact with oxidation.

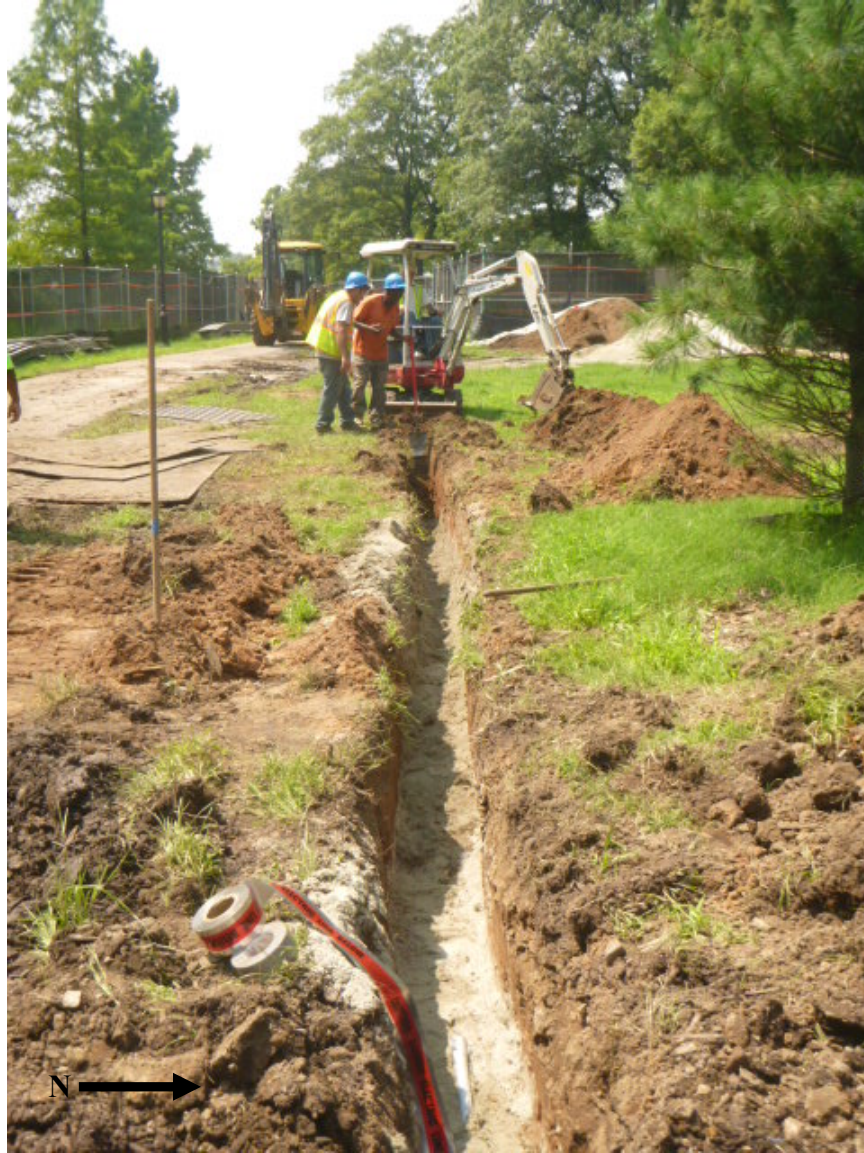
Image 09: Trench 02, Section 2, excavation in progress.

The second distinct profile was consistent across the western two-thirds of Trench 02, which cut into an adjacent open field starting at 54.5' (16.6m) west of the eastern edge of the trench at 285° for the remainder of its excavation (Image 09) (Map 05). The stratigraphy in this location was characterized by modern disturbance horizons overlaying intact subsoils (Image 10) (Table 05).

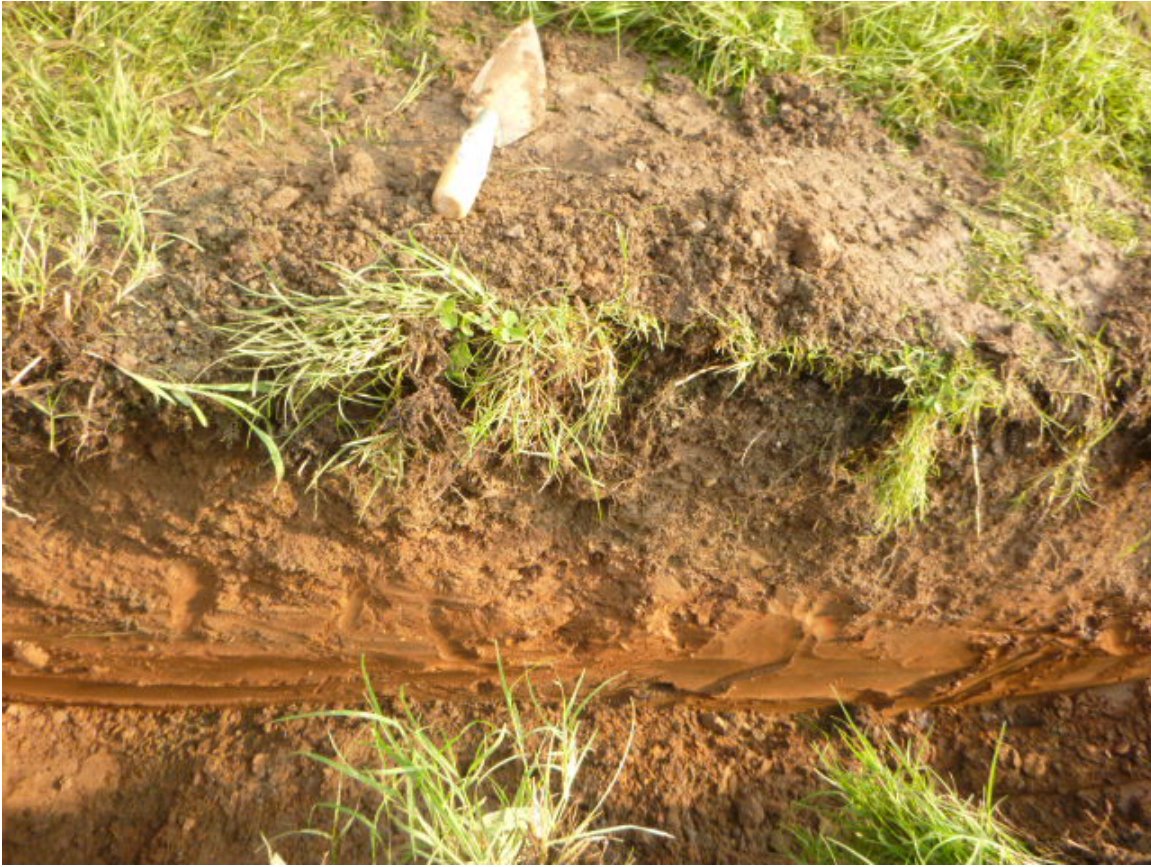
Image 10: Stratigraphic profile, Section 2, north wall – Trench 02.

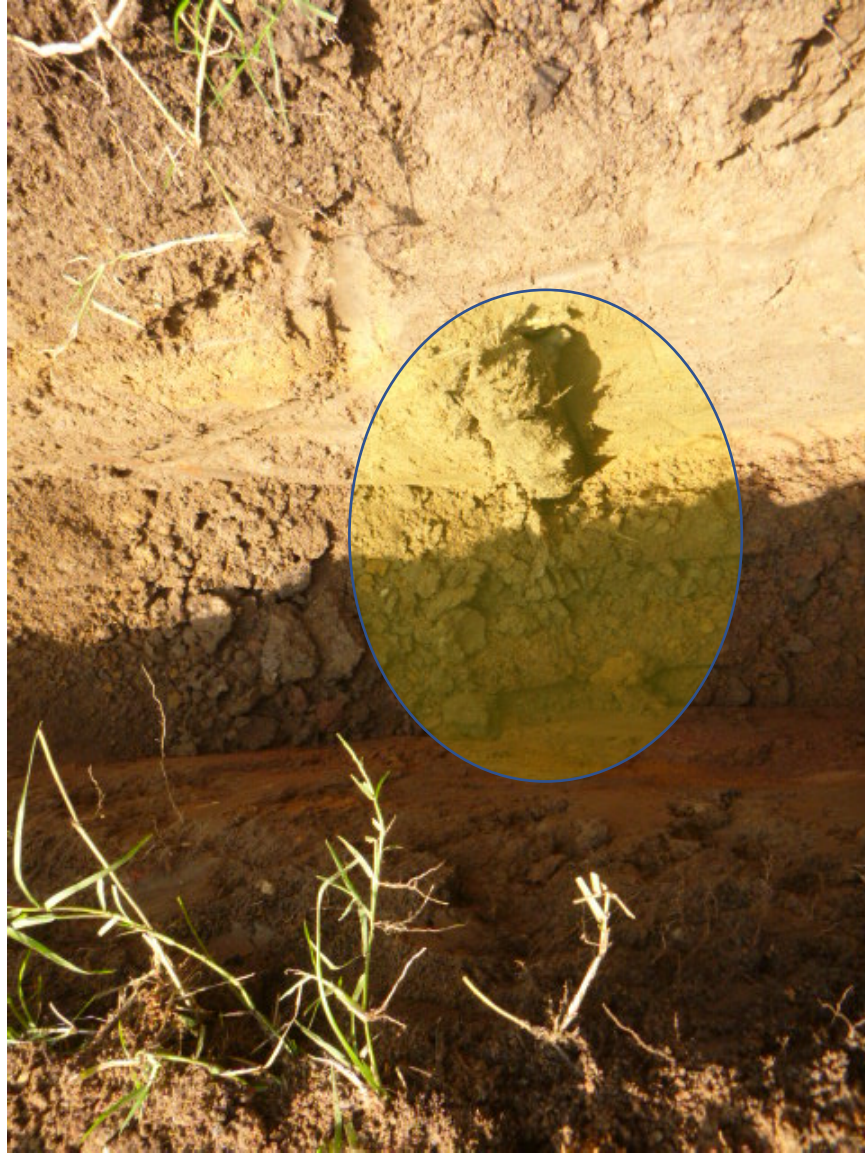
Feature 01 was discovered in the Trench 02 north wall, within the open field cut by this trench, at 122.7' (37.4m) from the eastern edge of Trench 2. Feature 01 was an in situ, buried wooden post and associated builder's trench of indeterminate age that was discovered along the northern wall of Trench 02 in the area farthest from the road (Image 11) (Figure 01).

Image 11: Feature 01 (highlighted) in situ, facing north.

However, future construction projects in the open field in which Feature 01 was found should be subject to archaeological investigations, as intact stratigraphy and/or cultural resources may exist to the north.

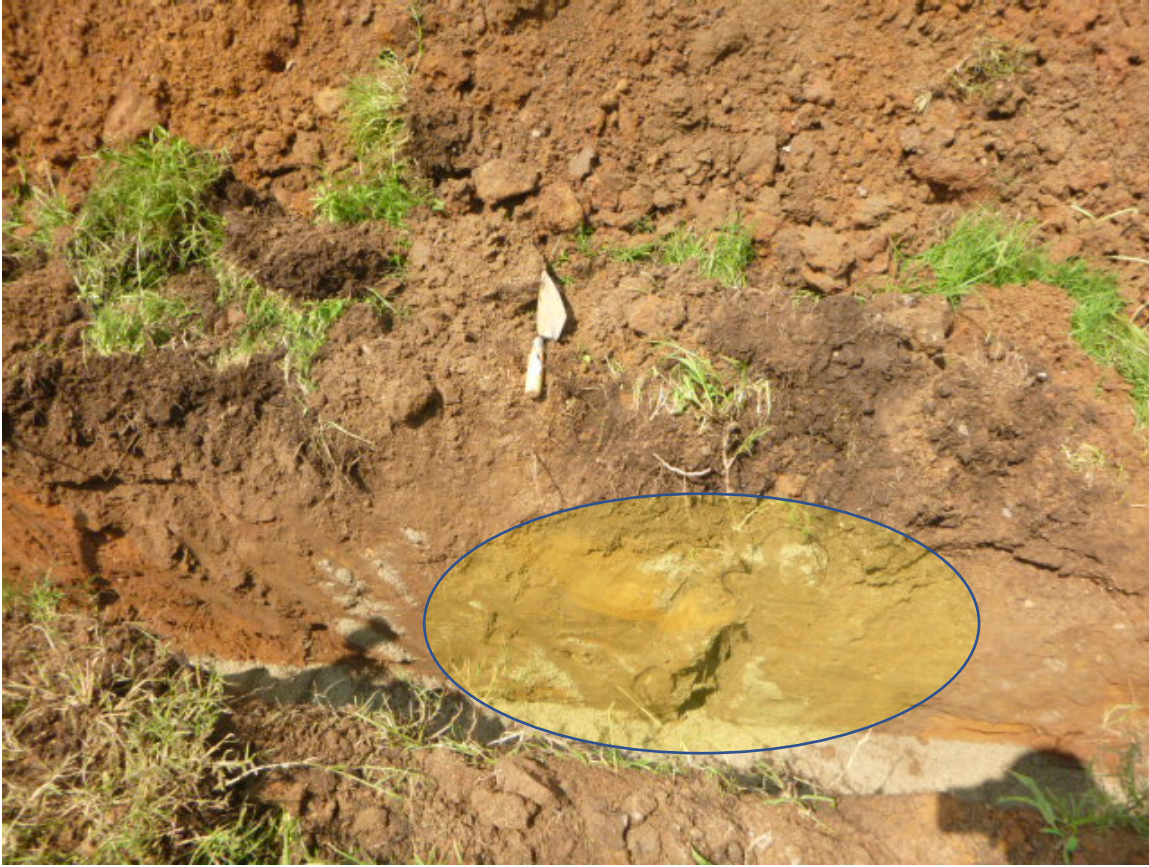
The post extended from 31.31' NAVD 88 (28cm bgs) to 29.04' NAVD 88 (72cm bgs) and was 0.33' (10cm) in width. The post was surrounded by a much larger bowl-shaped builder's trench measuring 6.9' (2.1m) in length by at least 2.1' (0.63m) in depth, with the bottom at 29.04 NAVD 88. The builder's trench began immediately underneath the developing A₀ horizon and cut into disturbed B soils. Pockets of B soil was evident in profile directly atop the wooden post and outside of the builder's trench to the west (Image 12). No artifacts were uncovered in or around the feature. The feature was recorded, mapped, and photographed.

Image 12: Feature 01 (highlighted) in profile, Trench 02.

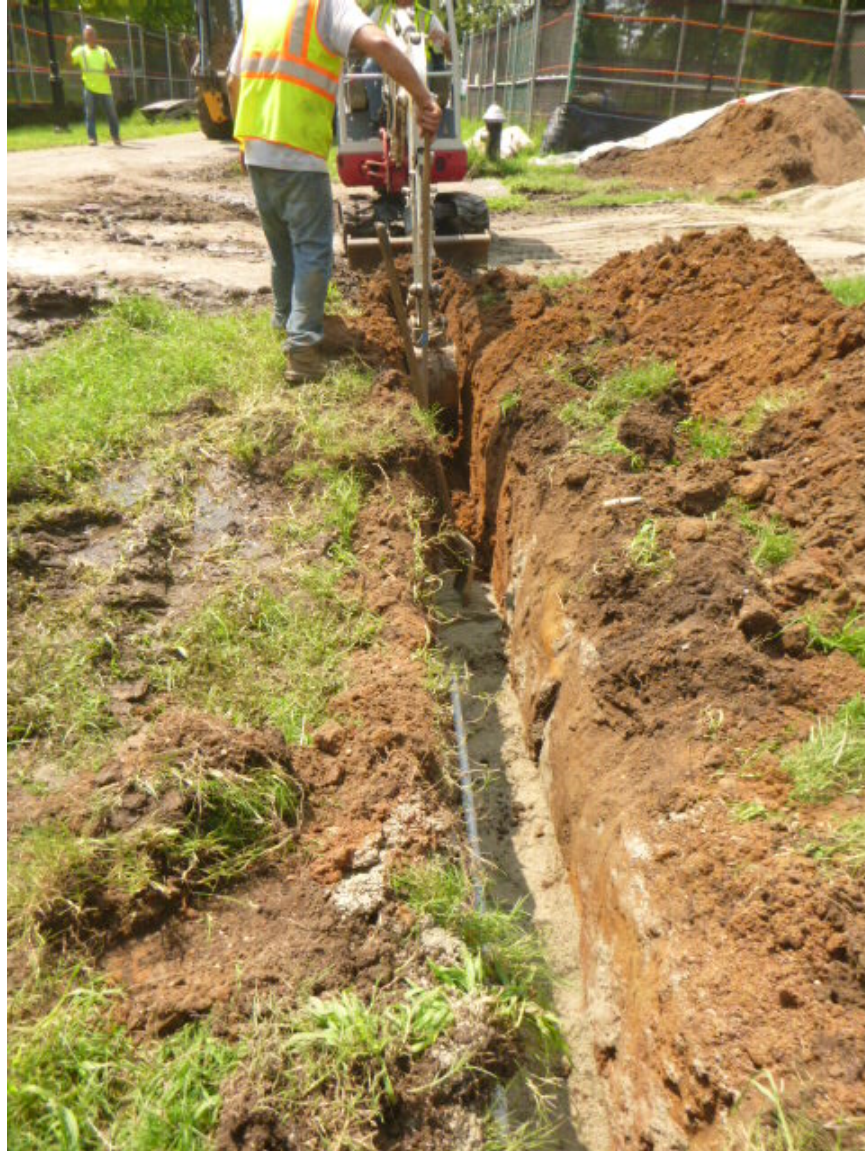
Image 13: Trench 02, excavation in progress to the west of Feature 01.

The stratigraphy of Trench 02 in the area to the east and west of the Feature 01 wooden post was highly disturbed, indicating low probability that additional fence posts exist intact in the area (Image 13). Additionally, a disarticulated segment of wooden fence post was discovered in construction fill just to the west of Feature 01, suggesting that the fence in this area was destroyed by modern construction (Image 14). No other features or cultural resources were recovered in Trench 02.

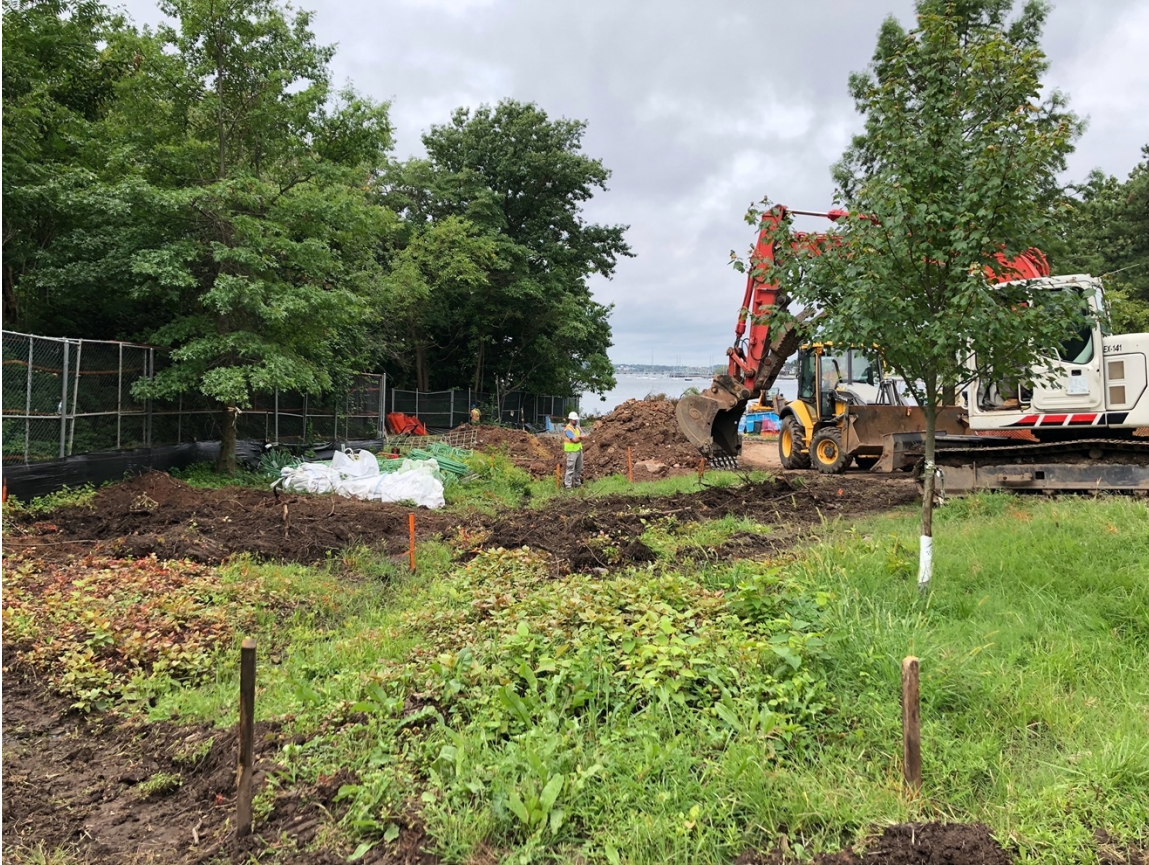
Image 15: Weir area pre-excavation, looking west.

Trenches 03-05 were excavated for the installation of new weirs (Weirs A-C): Trench 03 corresponds to Weir A, Trench 04 to Weir C, and Trench 05 to Weir B (Map 05). Trenching for a new drainage pipe was placed along the course of the existing drainage system (Trenches 09A and 09B) (Image 15).

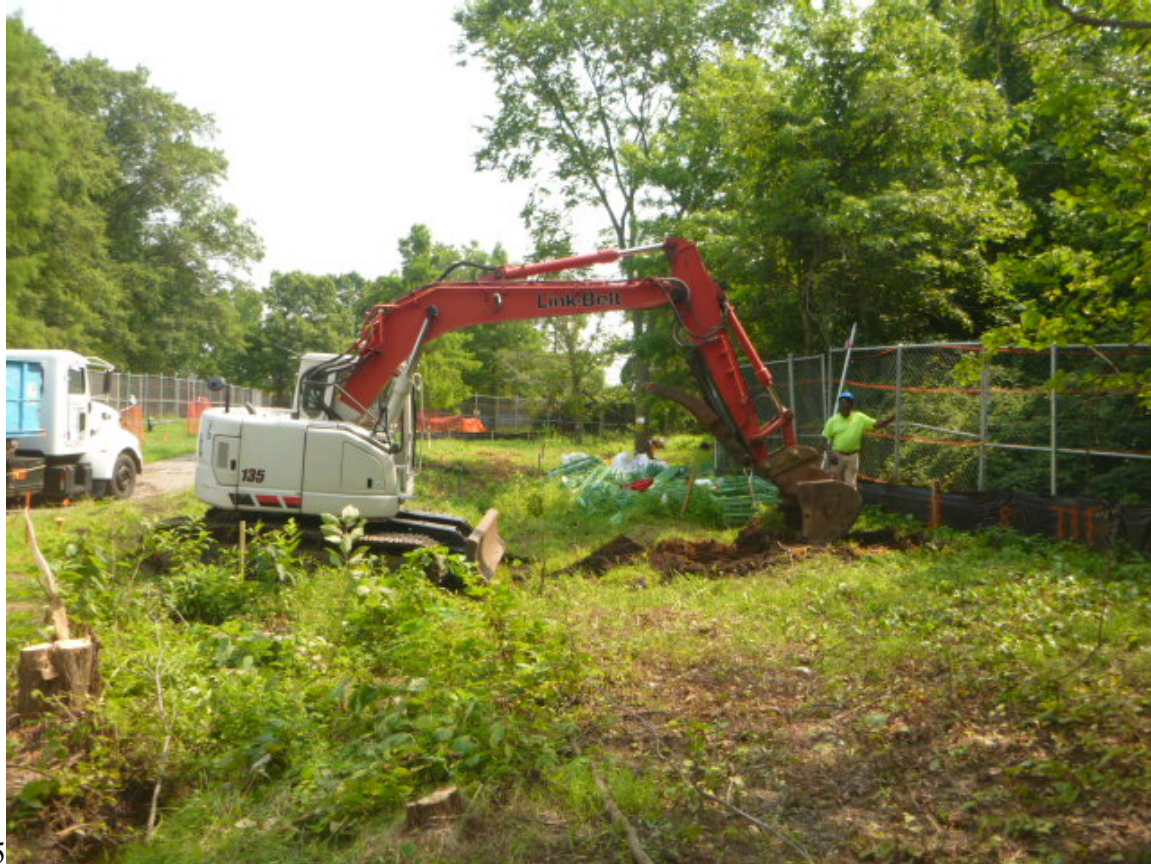
Image 16: Excavation in progress, Trench 03, looking east.

Trench 03 was a north-south oriented rectangular trench measuring 12' by 32' (3.6m by 9.75m) at the surface, its large width due to safety stepping. It was excavated to 11.34' NAVD 88 (7' bgs). At 17.34' NAVD 99 (1' bgs), the trench measured 6' by 32' (1.8m by 9.75m). Trench 03 was placed in between the Hylan Boulevard extensions and the construction fencing surrounding the site (Image 16). An existing drainage system bisected the trench.

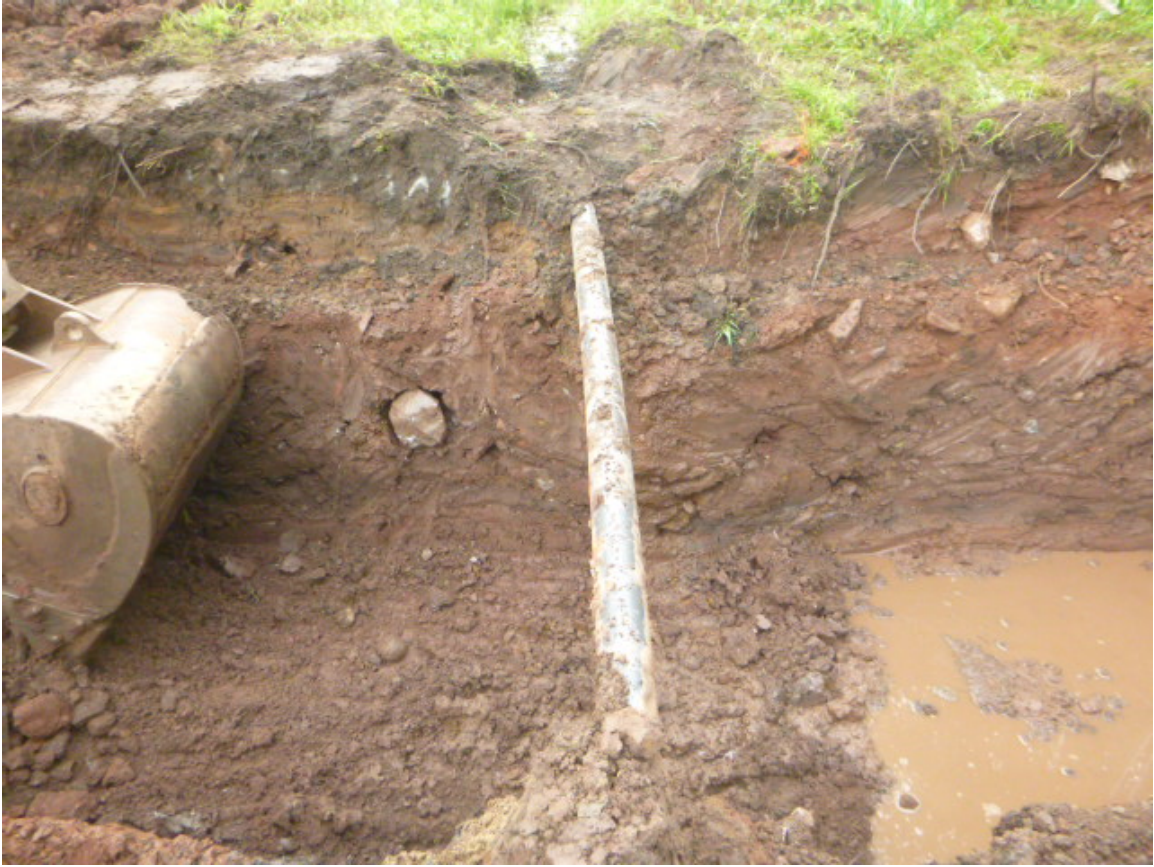
Image 17: Stratigraphic profile, west wall – Trench 03.

The stratigraphy of Trench 03 was variable and exhibited obvious disturbances, especially in the northern half due to the Hylan Boulevard extension roadway and existing drainage system. In the southern half, redeposited subsoils and fill layers overlaid intact substratum. What would have been the topmost intact subsoil layers in Trench 03 appear to have been previously stripped, some redeposited, possibly as a result of the construction of the existing weir and road (Image 17). The existing drainage system bowled out as much as 1' below the surrounding ground surface to 16.50' NAVD 88. The drainage included a rectangular concrete slab in a checked pattern to a depth of about 16.74' NAVD 88 (1.6' bgs) and an associated pipe (Image 18).

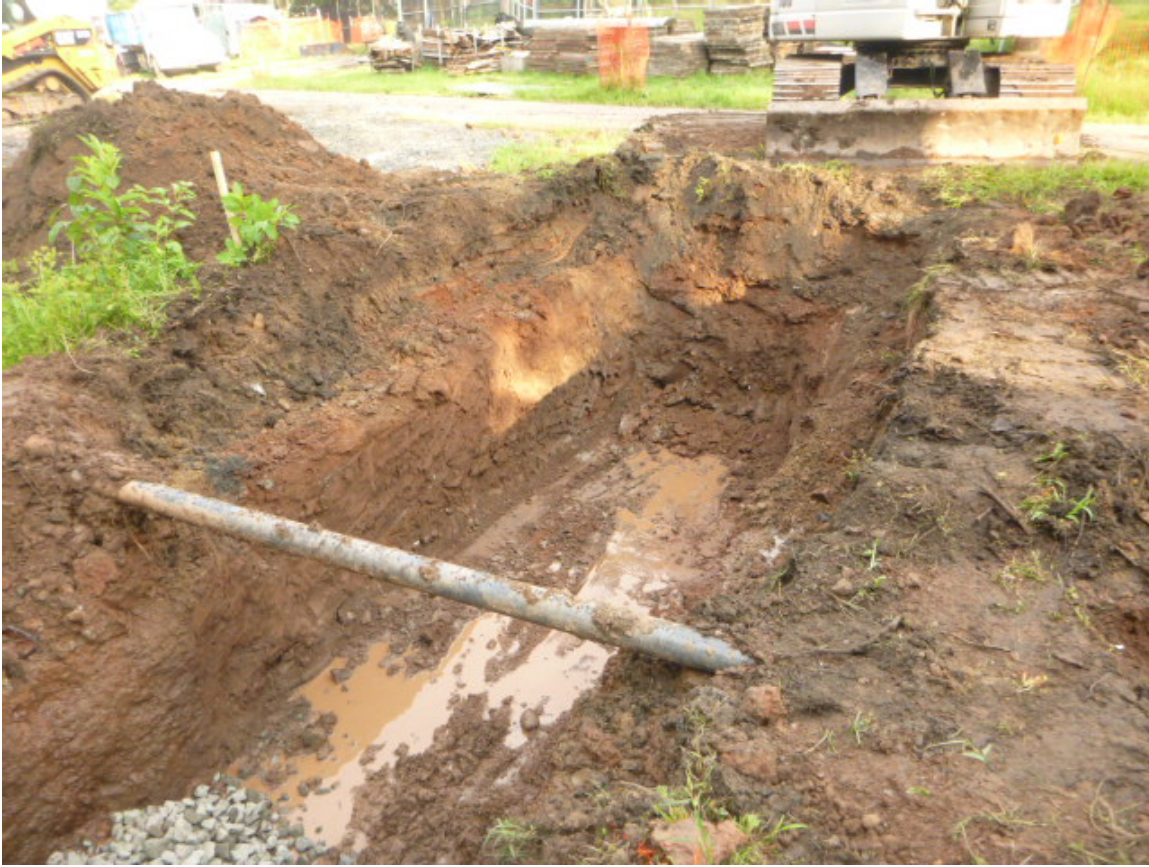
Image 18: Trench 03, post-excavation, looking north.

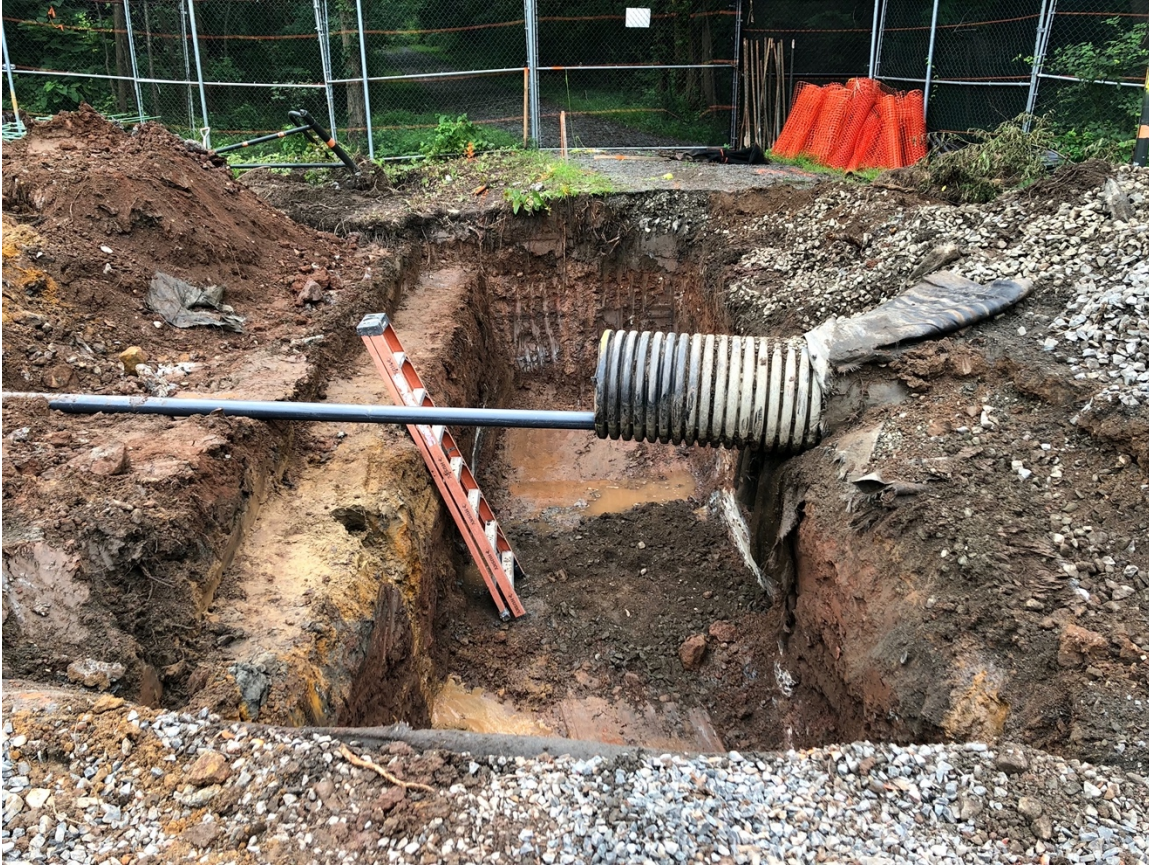
Trench 04 was located west of Trench 03 and was the westernmost weir trench. The trench measured 11' by 24' (3.35m by 7.3) and was excavated to a depth of 9.0' NAVD 88 (8' bgs). Like Trench 03, a 1.5' long and 1.8' (15.20' NAVD 88) deep safety step was utilized along the eastern wall to prevent caving, making the dimensions of the interior of the trench slightly smaller, at 8' (2.4m) in width. The stratigraphy of Trench 04 was highly disturbed in its northern half due to the weir and roadway, characterized by fill and redeposited B soils overlaying subsoil (Table 06). Like Trench 03, intact stratigraphy was evident in Trench 04's southern half (Image 19).

Image 19: Trench 04 post excavation, looking south.

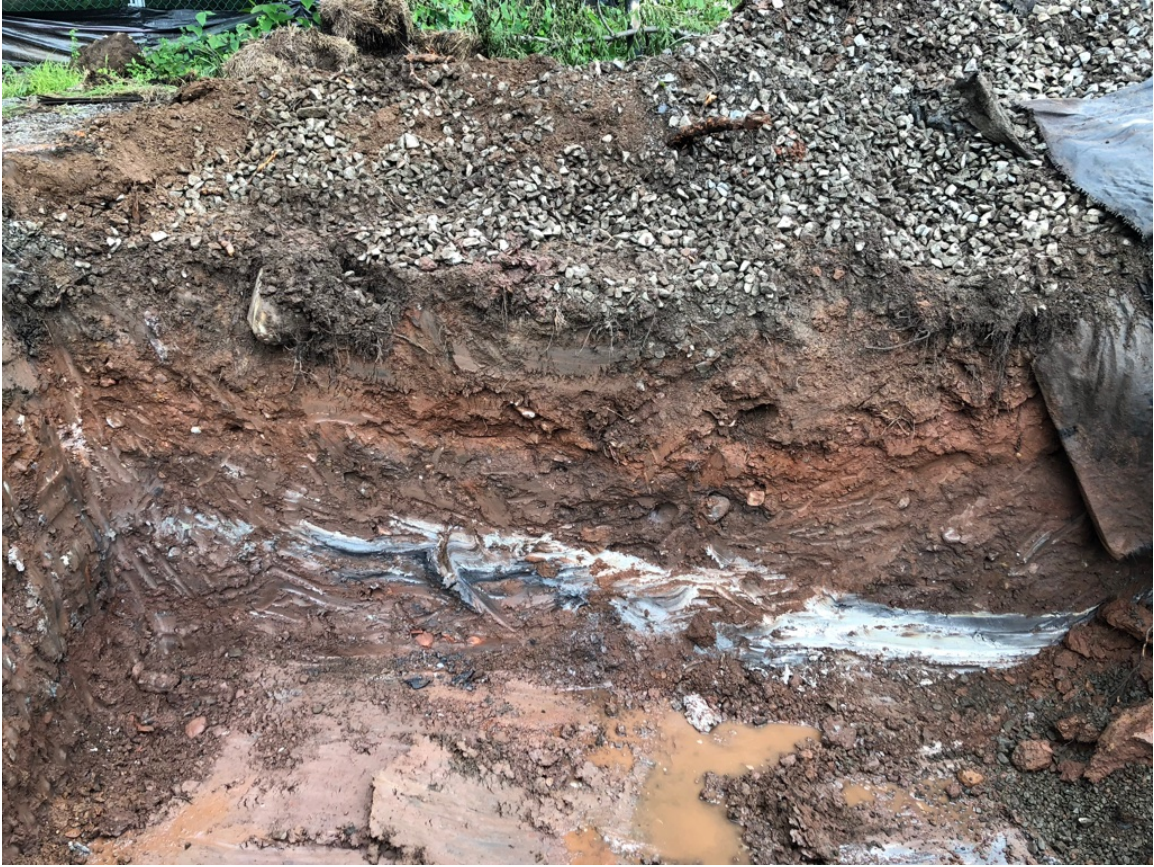
Stratigraphical differences were also evident between the eastern and western walls of Trench 04, as the western half of the trench was within the footprint of the gravel pathway that connects the Park's interior with the Hylan Boulevard extension. The western wall was more demonstrably disturbed than its eastern counterpart and included a large drainage pipe in the northwest section of the wall (Image 20). No Ao or A1 horizons were evident. Along the eastern wall, intact stratigraphy was encountered in the southern portion of Trench 04. Highly disturbed stratigraphy was present in the northern half, as the trench approached the roadway.

Image 20: Western wall profile – Trench 04.

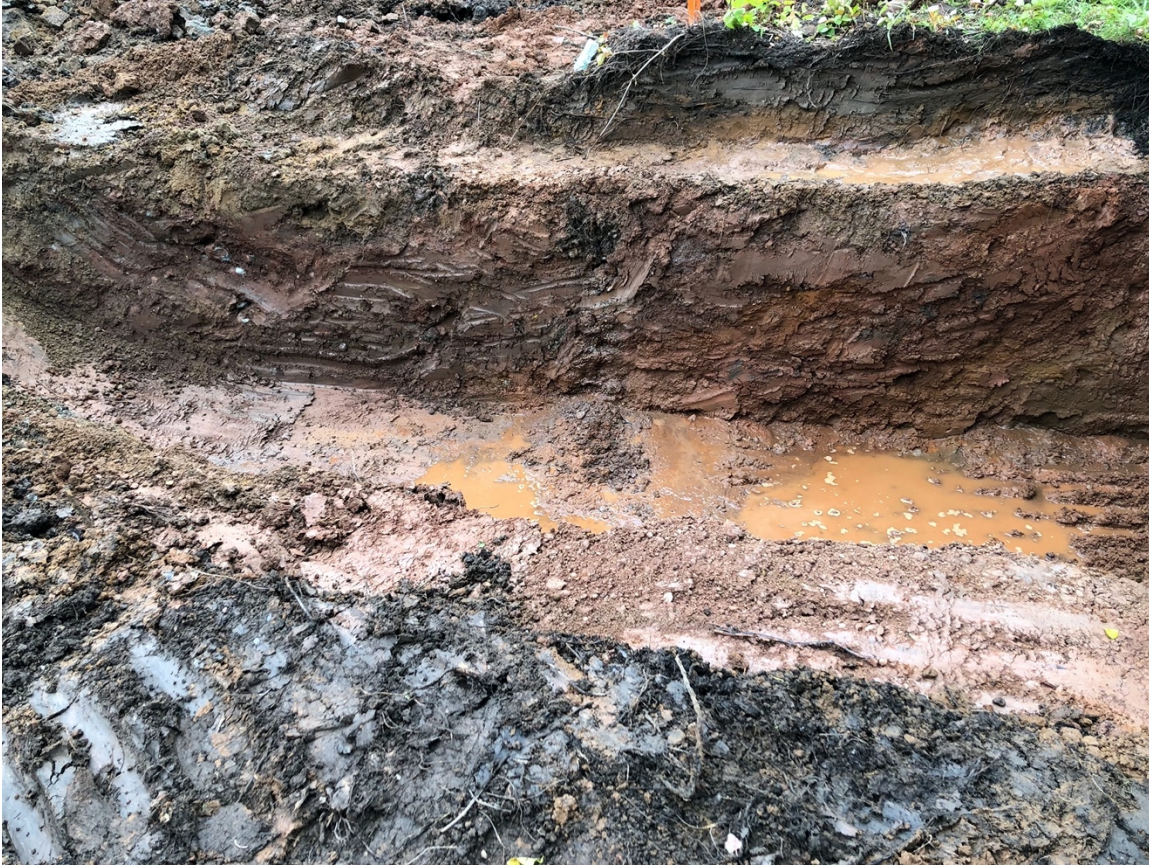
As with the other two weir trenches, the stratigraphy of Trench 05 was increasingly disturbed in the northern half, with fill and redeposited subsoils proliferating (Table 07). In the southern half, intact subsoil horizons were mixed and banded due to continual water action as a result of the shallow water table. No significant cultural resources were encountered during the excavation of Trench 05.

Image 21: East wall profile, Trench 05.
