**Reconstruction of the Pavilion at the end of Hylan Boulevard
Adjacent to Satterlee Street in Conference House Park, Staten
Island, Richmond County, New York Project (Contract Number
R006-213M; E-PIN: 8461780040001)**

EXECUTIVE SUMMARY TABLE

EXECUTIVE SUMMARY TEXT

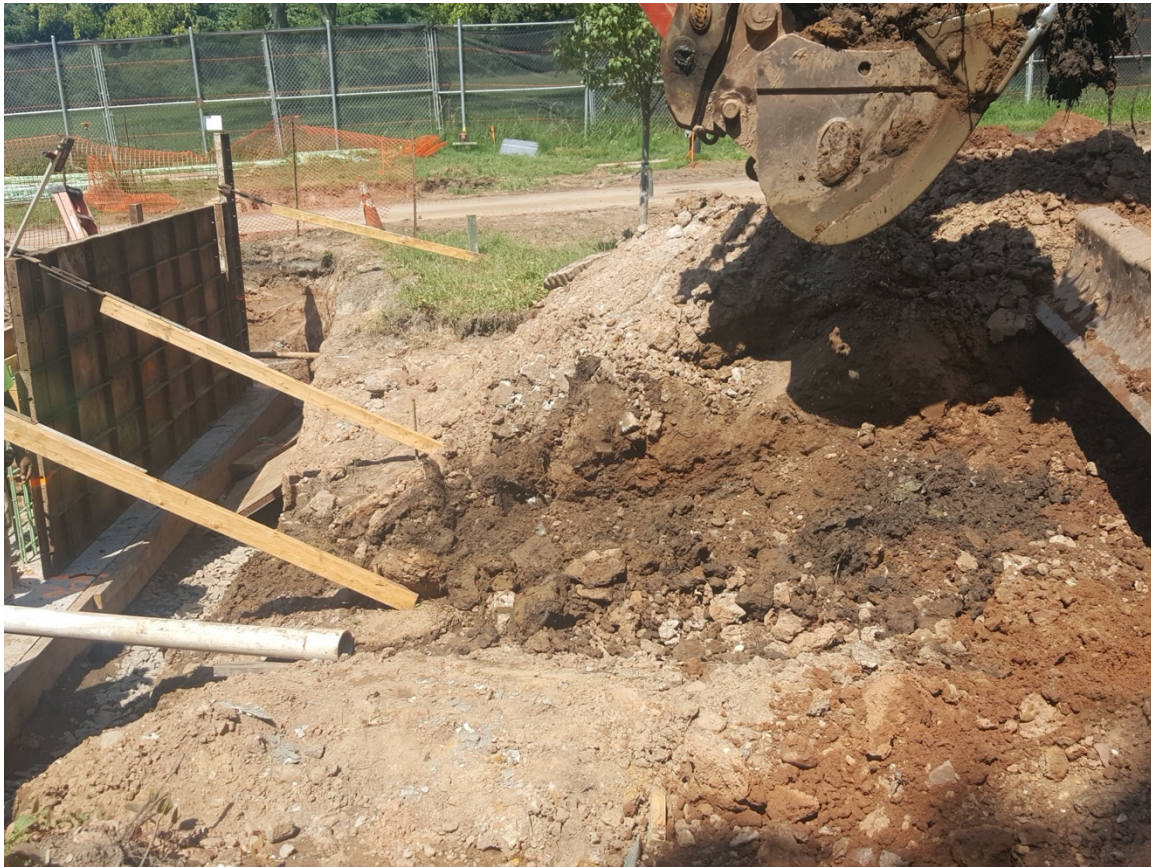
Image 22: Excavation-in-progress, Trench 09A, looking north.

Trench 09A measured 3.75' by 28' (1.1m by 8.5m) and was excavated to a depth of 18.6' NAVD 88 (3.4' bgs) on its eastern end and 16.1' NAVD 88 (4.4' bgs) on its western end. The area was already disturbed down to 2.5' bgs on its western end up and at the ground surface on its eastern end, as its course roughly corresponded to the existing drainage ditch (Image 22). Trench 9A connected to Trench 05 roughly halfway up its eastern wall, at 18' (5.5m) north of the southeast corner.

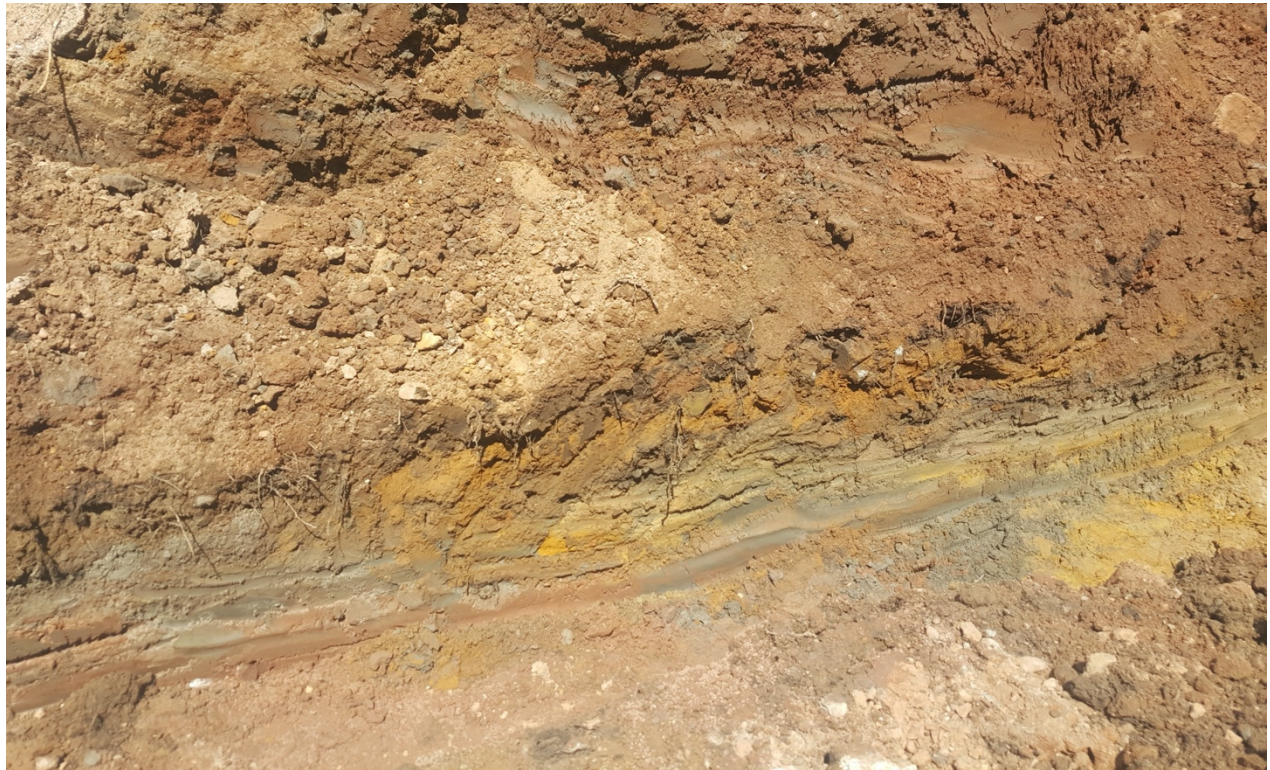
Image 23: Stratigraphic profile, North wall, center section – Trench 09A.

The stratigraphy of Trench 09A varied considerably along its northern wall, though a top layer of modern disturbance extended across the trench to a depth of 2.5' bgs, which corresponds to 19.50' NAVD 88 on the eastern end and 18.0' NAVD 88 in the western end. The stratigraphy underneath the disturbance was different in three segments: from 0' at the trench's northwestern corner to 15'

(4.5m) to the east, from 15' to 21' (4.5m to 6.4m) east, and from 21' (6.4m) east to its northeastern corner (Image 23) (Table 08).

STRAT	NAVD 88 DEPTH (BGS)	MUNSELL	SOIL TYPE	COMMENTS
Fill 1	21' – 18.5' (0' – 2.5' bgs)	10YR 4/2 dark grayish brown	Loamy sand	Pebbles, cobbles and architectural debris.
Redeposited Sub I	18' – 16.1' (2.5' – 4.4' bgs)	7.5YR 4/6 strong brown mottled with 10YR 5/2 grayish brown	Sandy clay loam	Western edge to 15' east. Pebbles, cobbles and architectural debris.
Redeposited Sub II	18.5' – 17.1' (2.5' – 3.9' bgs)	5YR 4/4 reddish brown mottled with 10YR 5/2 grayish brown	Sand	15' to 21' east. Pebbles and cobbles.
Subsoil	19.5' – 18.6' (2.5' – 3.4' bgs)	5YR 4/4 reddish brown	Sand	21' to eastern edge. Pebbles and cobbles.

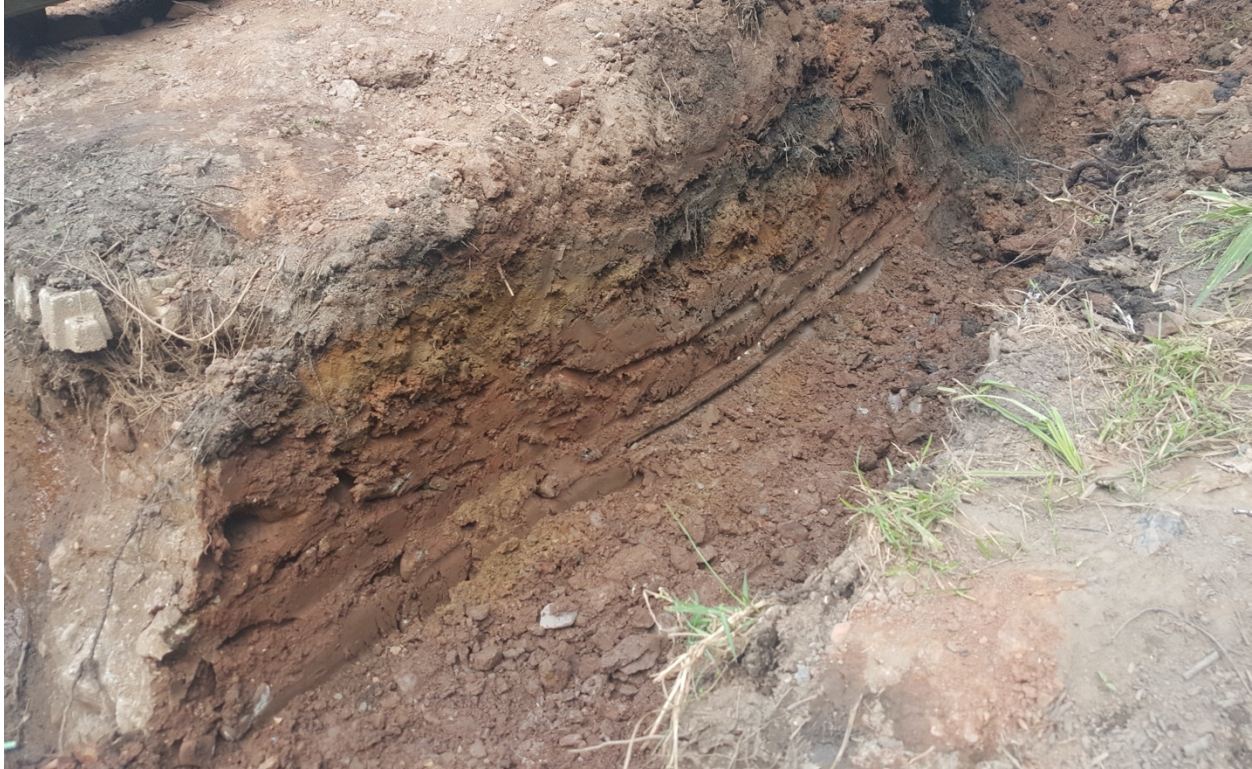
Image 24: Stratigraphic profile, North wall, western section – Trench 09B.

14.0' NAVD 88 (3.5' bgs) in the west to 18' NAVD 88 (2.5' bgs) in the east. Similar to Trench 09A, 09B exhibited differing stratigraphy along its course, although much of it was disturbed (Image 24) (Table 09). However, a layer of intact subsoil was extant in the eastern half of the trench. No significant cultural resources were encountered during the excavation of Trench 09B.

STRAT	NAVD 88 DEPTH (BGS)	MUNSELL	SOIL TYPE	COMMENTS
Developing Ao	17.5' – 17.0' (0' – 0.5' bgs)	10YR 2/2 very dark brown	Loamy sand	Western section.
Developing A1	17.0' – 16.5' (0.5' – 1.0' bgs)	10YR 3/2 very dark grayish brown	Sandy loam	Western section.
Fill I	16.5 – 14.0' (1.0' – 3.5' bgs)	7.5YR 4/3 brown	Clay sandy loam	Western section. Pebbles, cobbles, architectural debris, and ceramic sewer pipe fragments.
Fill II	16.7' – 15.8' (2.3' – 3.2' bgs)	7.5YR 4/6 strong brown	Sand	18' to 36' east. Pebbles, cobbles, architectural debris, and ceramic sewer pipe fragments.
C	20.0' – 18.0' (0.5' – 2.5' bgs)	5YR 4/4 reddish brown	Sand	36' to 65'. Pebbles and cobbles.

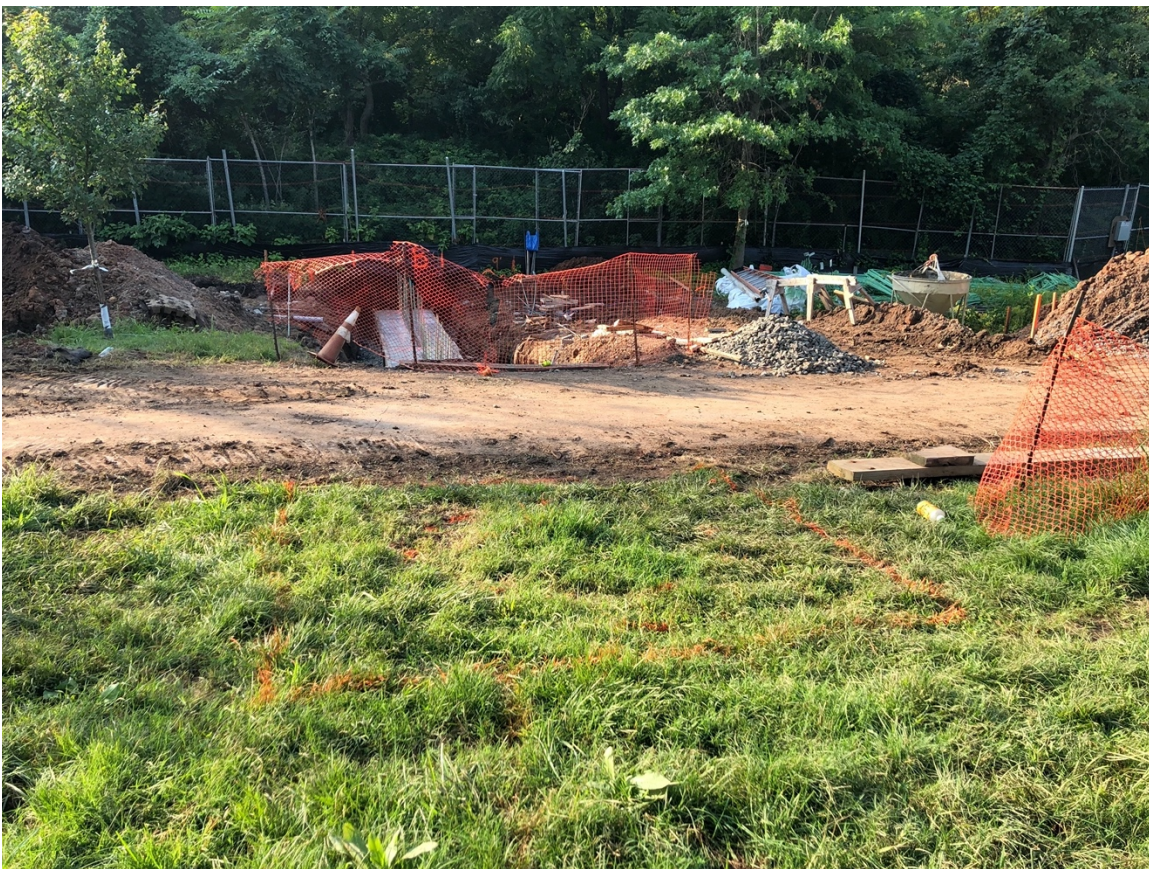
Image 25: Catch Basin 1/TP 1 pre-excavation, looking south with Trench 05 in background.

TP 1 corresponded to Catch Basin 1 and was a 9' by 9' (2.7m by 2.7m) square pit located north of the Hylan Boulevard extension and Trench 05 (Image 25). The pit was highly disturbed, likely the result of its proximity to the roadway (Table 11). Two distinct layers of redeposited subsoil were observed in the northern wall of the trench, indicating that this area was subject to soil stripping and redeposition of materials at some point, likely when the roadway was constructed in the 1920s (Image 26). The trench was excavated to a depth of 16.5' NAVD 88 (6.5' bgs).

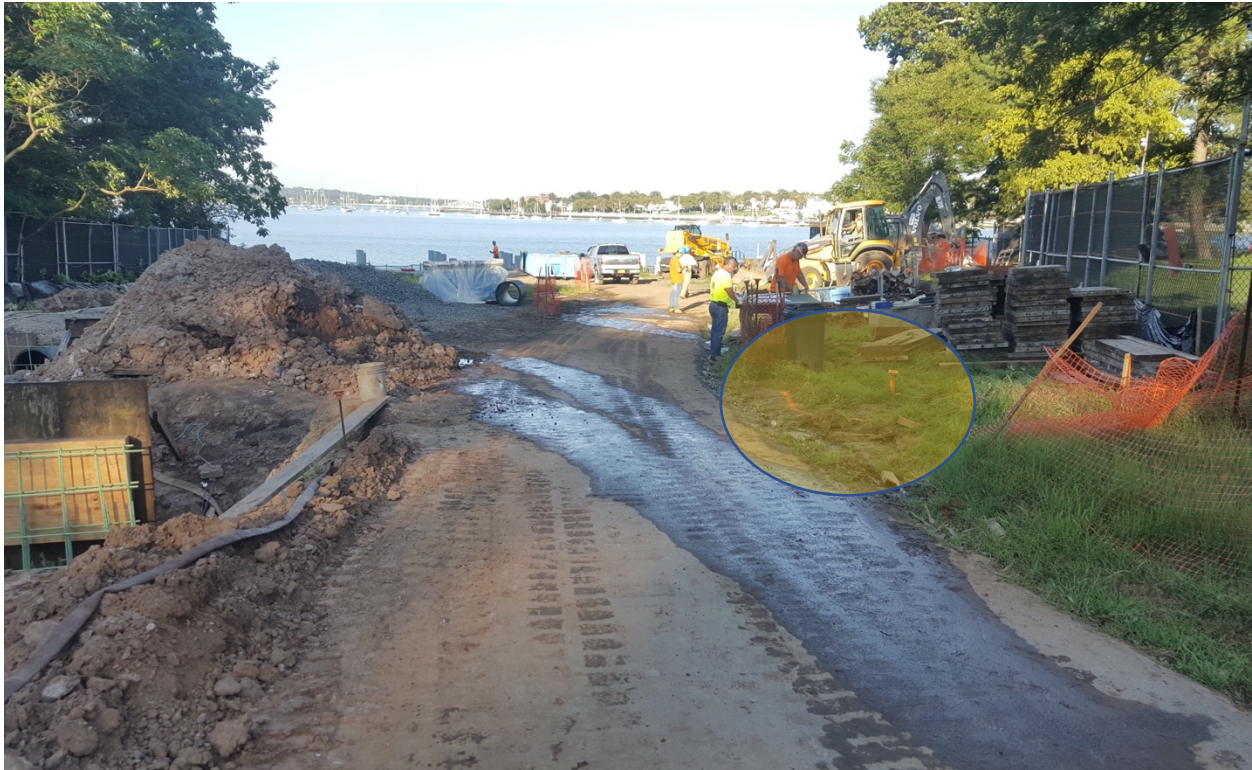
Image 27: Location of TP 2 (highlighted) with Trench 03 on left, looking west.

TP 2 was excavated for the installation of Catch Basin 2 on the north side of the roadway and just north of Trench 03 (Image 27). The trench measured 7.3' (2.2m) on its east-west axis and 9.6'

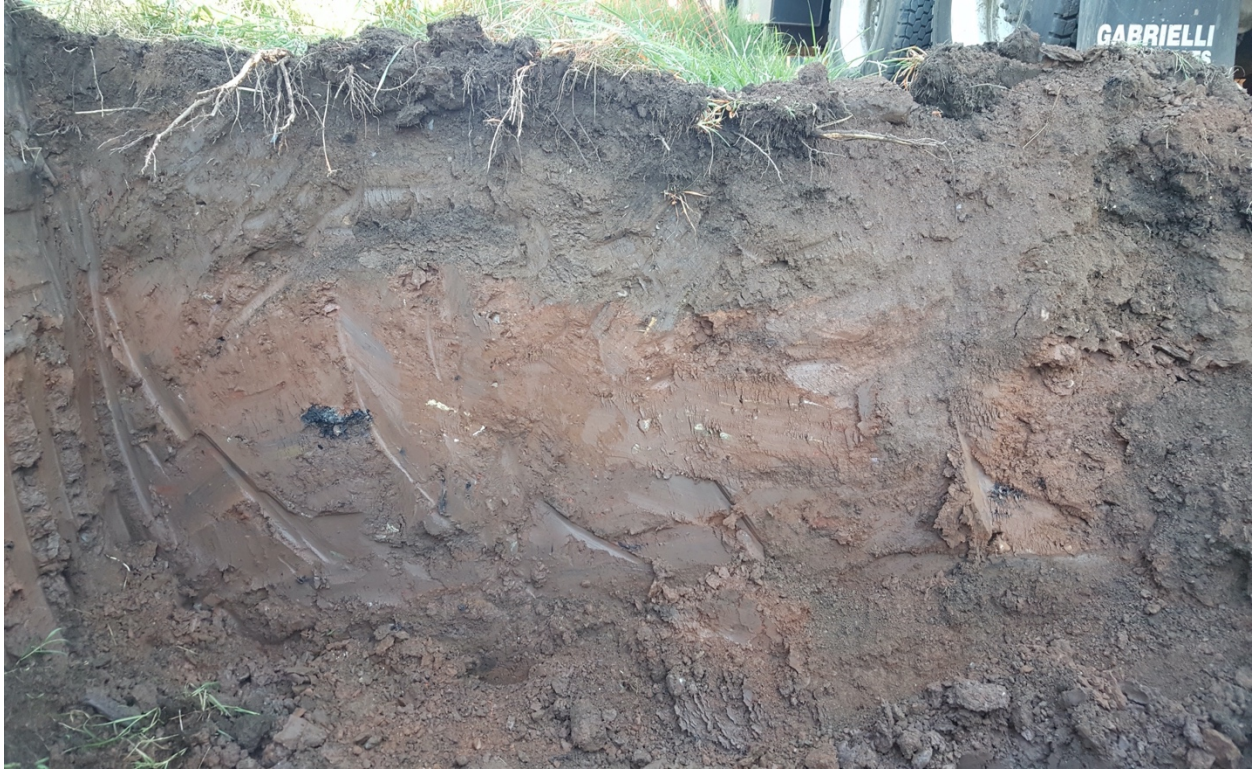
Image 28: Stratigraphic profile, east wall – TP 2.

(2.9m) on its north-south axis. The trench was excavated to a depth of 14.85' NAVD 88 (4' bgs), all disturbed soils with modern trash (Image 28) (Table 12).

STRAT	NAVD 88 DEPTH (BGS)	MUNSELL	SOIL TYPE	COMMENTS
Developing Ao	18.85 – 18.55' (0' – 0.30' bgs)	10YR 2/2 very dark brown	Sandy loam	
Developing A1	18.55' – 17.45' (0.30' – 1.40' bgs)	10YR 3/2 very dark grayish brown	Sandy loam	Modern trash, asphalt and timber chunks, plastic, pebbles and cobbles.
Fill I	17.45' – 16.55' (1.40' – 2.30' bgs)	7.5YR 4/6 strong brown	Sandy loam	Modern trash, asphalt and timber chunks, plastic, pebbles and cobbles.
Fill II	16.55 – 14.85' (2.30' – 4.0' bgs)	7.5YR 4/3 brown	Sandy loam	Modern trash, asphalt and timber chunks, plastic, pebbles and cobbles.

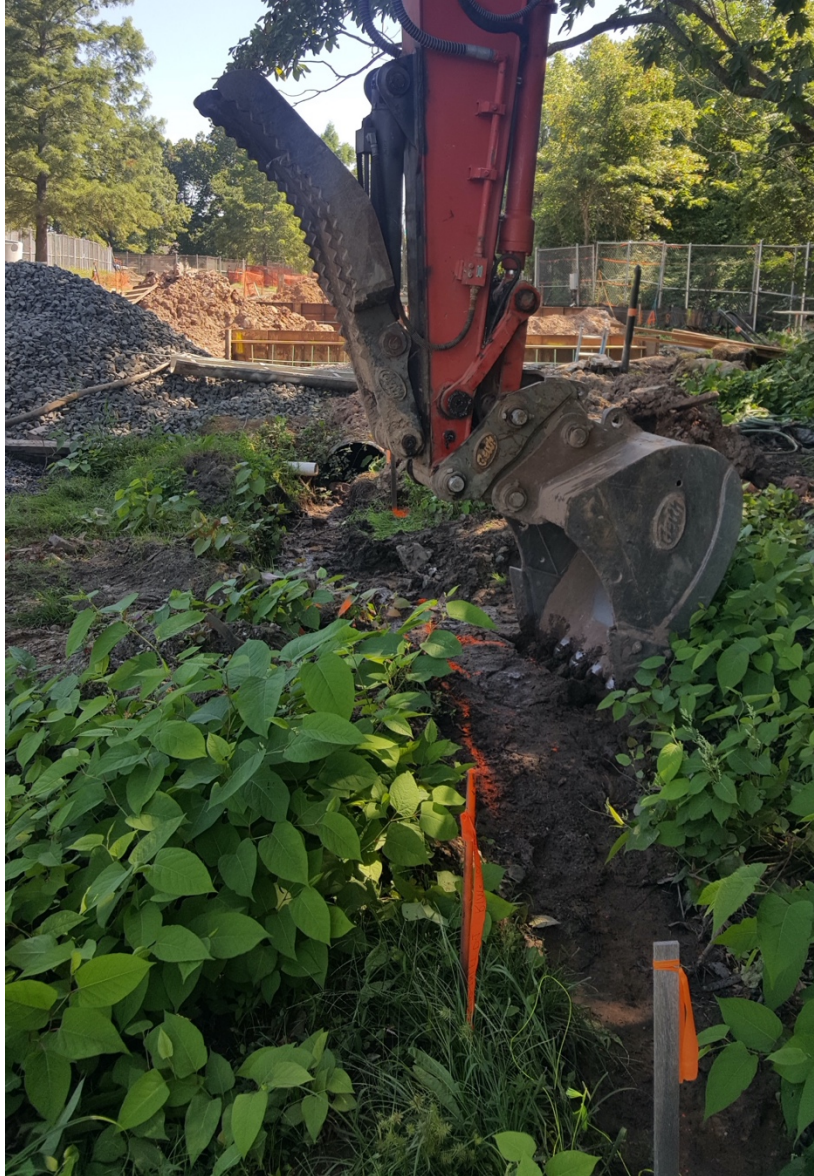
Image 29: Location of TP 3, looking east.

TP 3 was located on the southern side of the roadway and 35' (10.6m) west of the western wall of Trench 04 (Image 29). The trench was oriented northwest by southeast, measuring 4.5' by 8' (1.4m by 2.4m) and was excavated to a depth of 7.9' NAVD 88 (4.8' bgs). Intact stratigraphy was encountered at 2' bgs, though no significant cultural materials were recovered (Image 30) (Table 13).

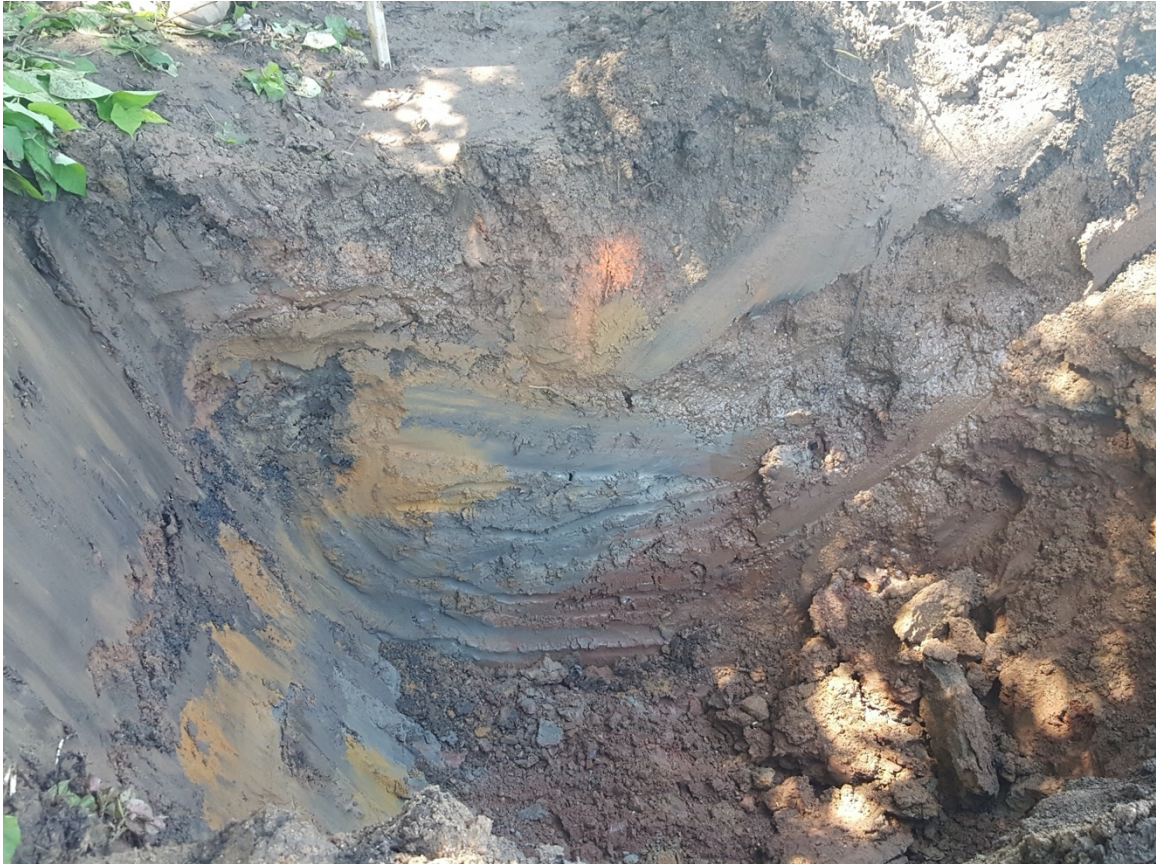
Image 30: Stratigraphic profile, west wall – TP 3.

STRAT	NAVD 88 DEPTH (BGS)	MUNSELL	SOIL TYPE	COMMENTS
Developing Ao	12.7' – 12.4' (0' – 0.30' bgs)	10YR 2/2 very dark brown	Loamy sand	
Redeposited Subsoil	12.4' – 10.7' (0.30' – 2.0' bgs)	7.5YR 3/3 dark brown	Loamy sand	Stone slab fragments and architectural debris; cobbles and pebbles.

Fill I	10.7' – 9.7' (2.0' – 3.0' bgs)	7.5YR 3/1 very dark gray with 7.5YR 5/8 strong brown and Gley 2 6/5B bluish gray	Sandy clay	
Truncated Bt	9.7' – 7.9' (3.0' – 4.8' bgs)	5YR 4/4 reddish brown	Clay loam

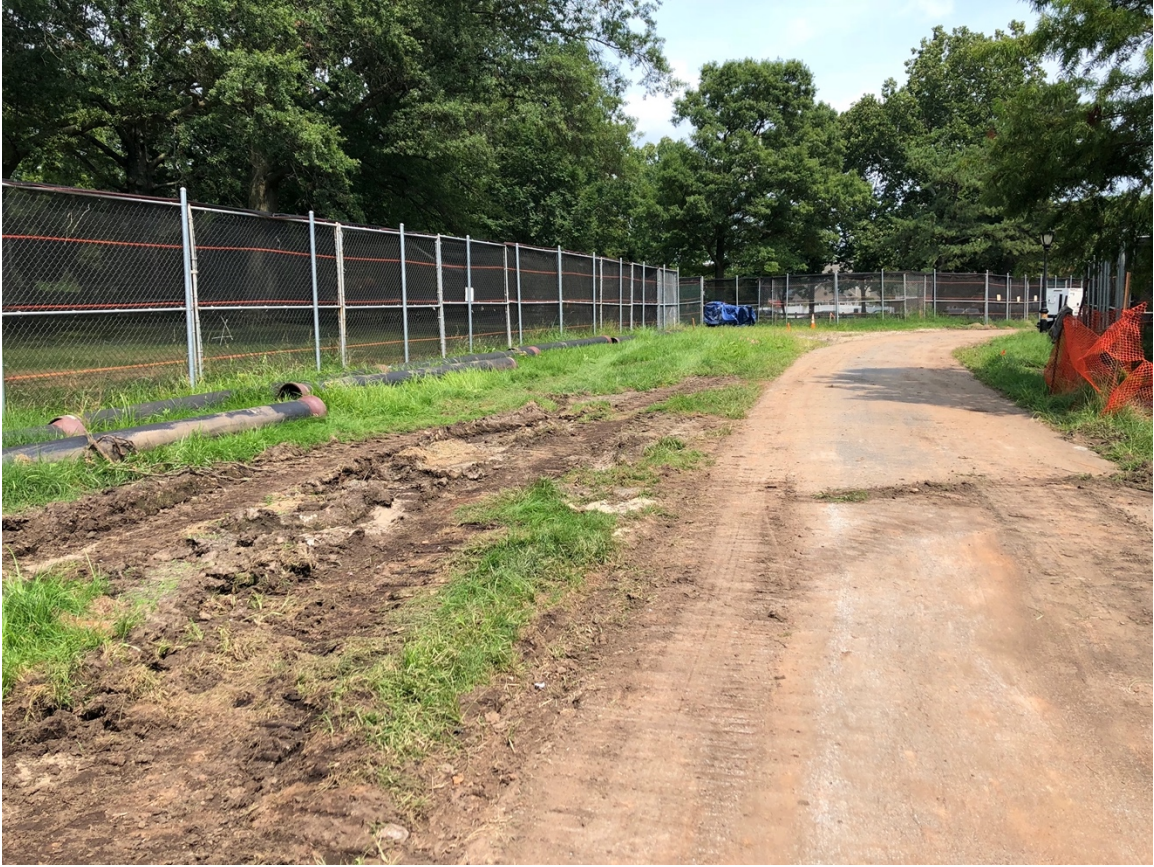
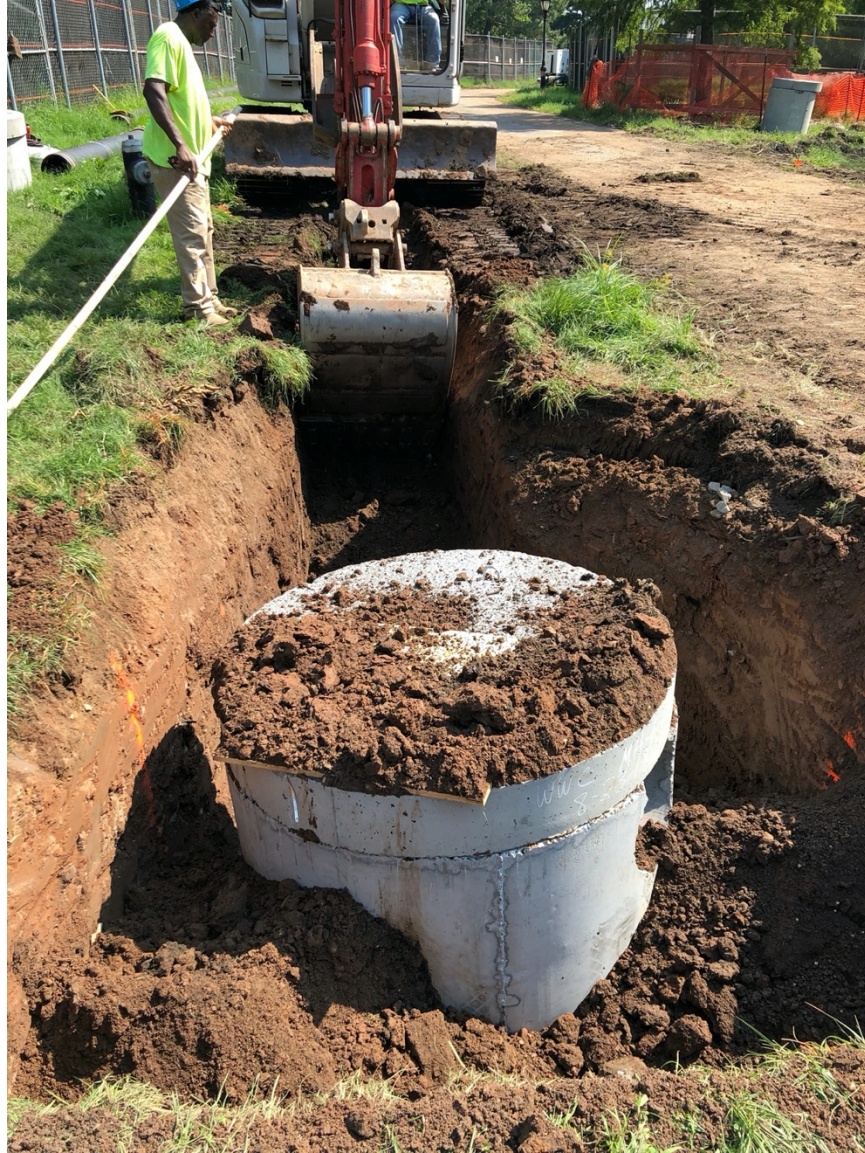
Trench 06 was a long and thin east-west running trench excavated for the installation of a 1” water pipe and a 12” drainage pipe connecting Catch Basin 1 (TP 1) to Trench 02 on the north side of the roadway (Images 31 and 32) (Map 05). The trench measured 4’ by 150’ (1.2m by 45.7m) and was excavated to a depth of 4.5’ bgs, which corresponded to 24.24’ NAVD 88 on the eastern end and 18.5’ NAVD 88 on the western end. No intact stratigraphy or significant cultural resources were encountered in Trench 06 (Image 33) (Table 14).

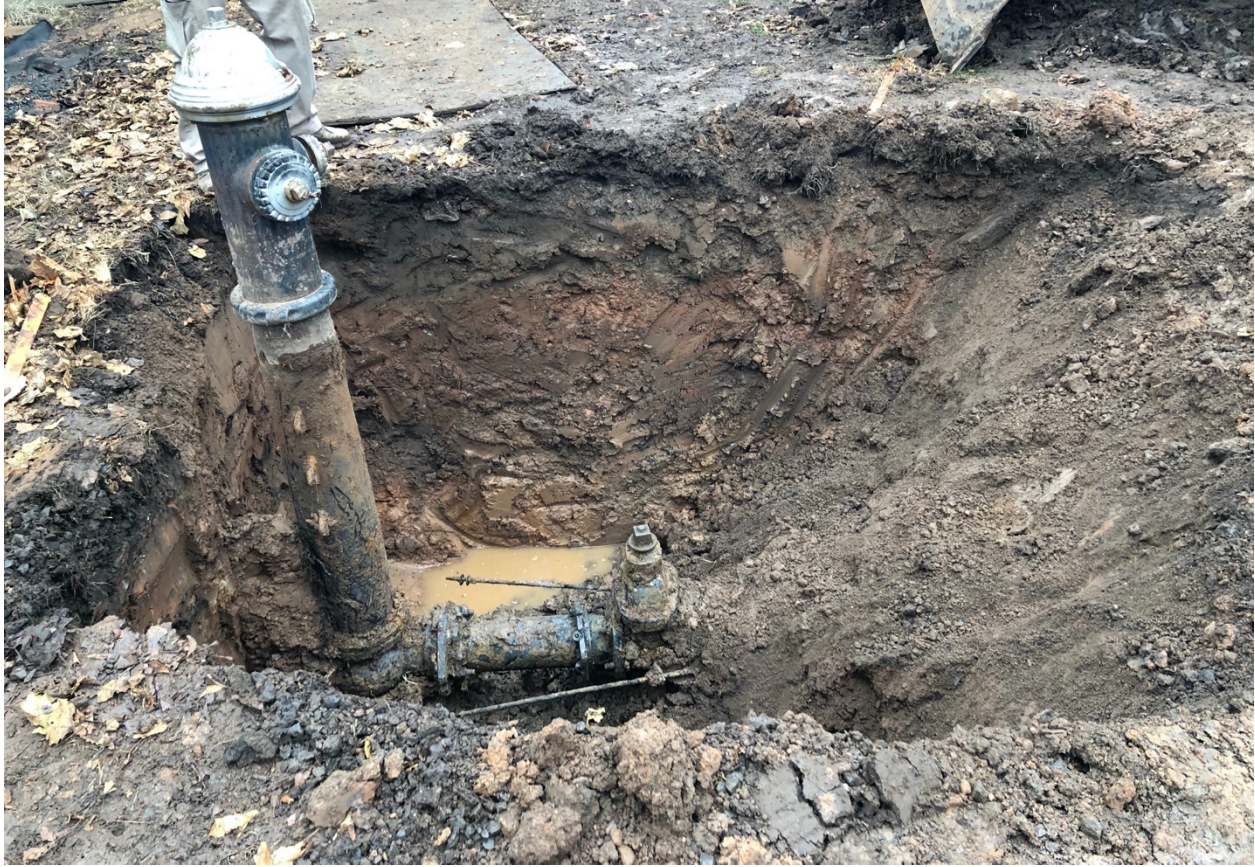
Trench 13, measuring 7.67' by 12' (2.3m by 3.7m), was excavated to the west of Trench 12 to expose piping and elements associated with the existing fire hydrant (Image 47). A valve was uncovered 3' (.9m) east of the hydrant at a depth of 11' NAVD 88 (3.5' bgs), and a series of supporting tie-ins that anchored the fire hydrant against water pressure was uncovered to the east of the valve at a depth of 10.16' NAVD 88 (4.34' bgs). The water main exposed in Trench 12 was also found in Trench 13 as it connected to the fire hydrant elements (Image 48). No intact stratigraphy or significant cultural resources were encountered during Trench 13 excavation (Image 49) (Table 19).

Image 48: Fire hydrant elements exposed, Trench 13.

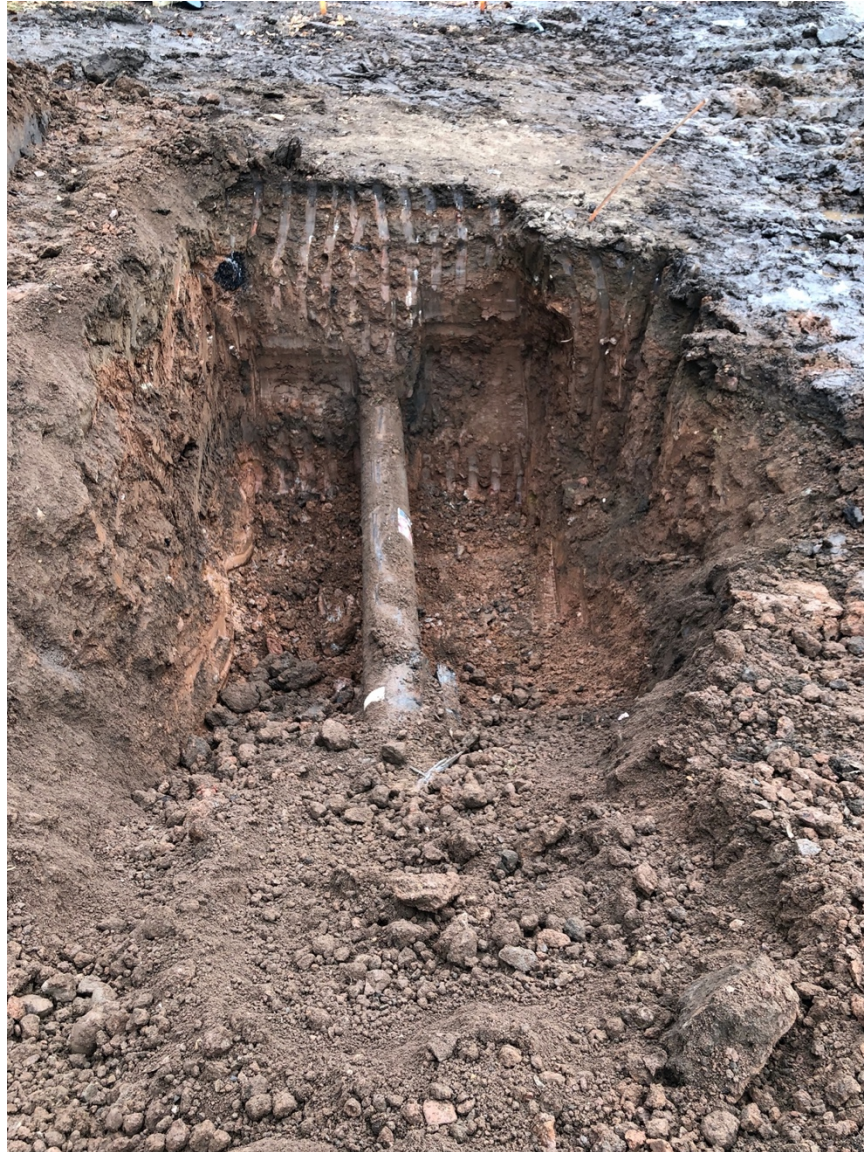
The stratigraphy near the surface of Trench 14 outside of its overlap with Trench 12 was highly disturbed, in part because this area was used as a staging location for construction vehicles and supplies (Image 50). Subsurface disturbances were also noted, though a truncated Bt subsoil layer with remnants of old beach was found underneath the water main at a depth of 10.16' NAVD 88 (4.84' bgs) (Image 51) (Table 20). However, the stratigraphy in this location has been obviously

Image 50: Trench 14, post-excavation, looking east.

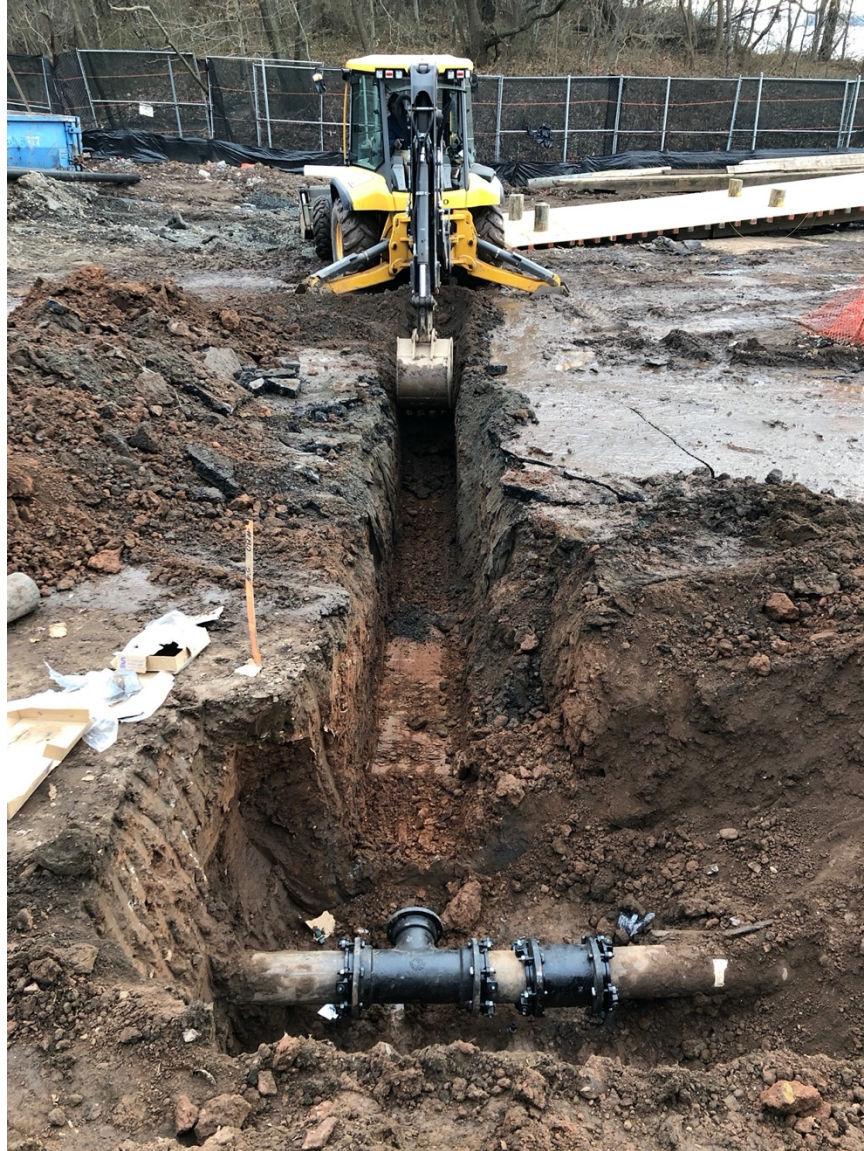
Image 52: Trench 15, excavation in progress, looking south with Trench 14 in foreground.

Trench 15 was the only north-south oriented trench associated with the relocation of the existing fire hydrant (Image 52). The trench was excavated to connect the new location of the fire hydrant in Trench 14 to the main drainage line (Trench 07) on the south side of the roadway. The trench eventually connected with Trench 07, although Chrysalis was not on hand to monitor this activity. The dimensions of the portion of Trench 15 that was monitored were 3.67' by 32' (1.1m by 9.75m).

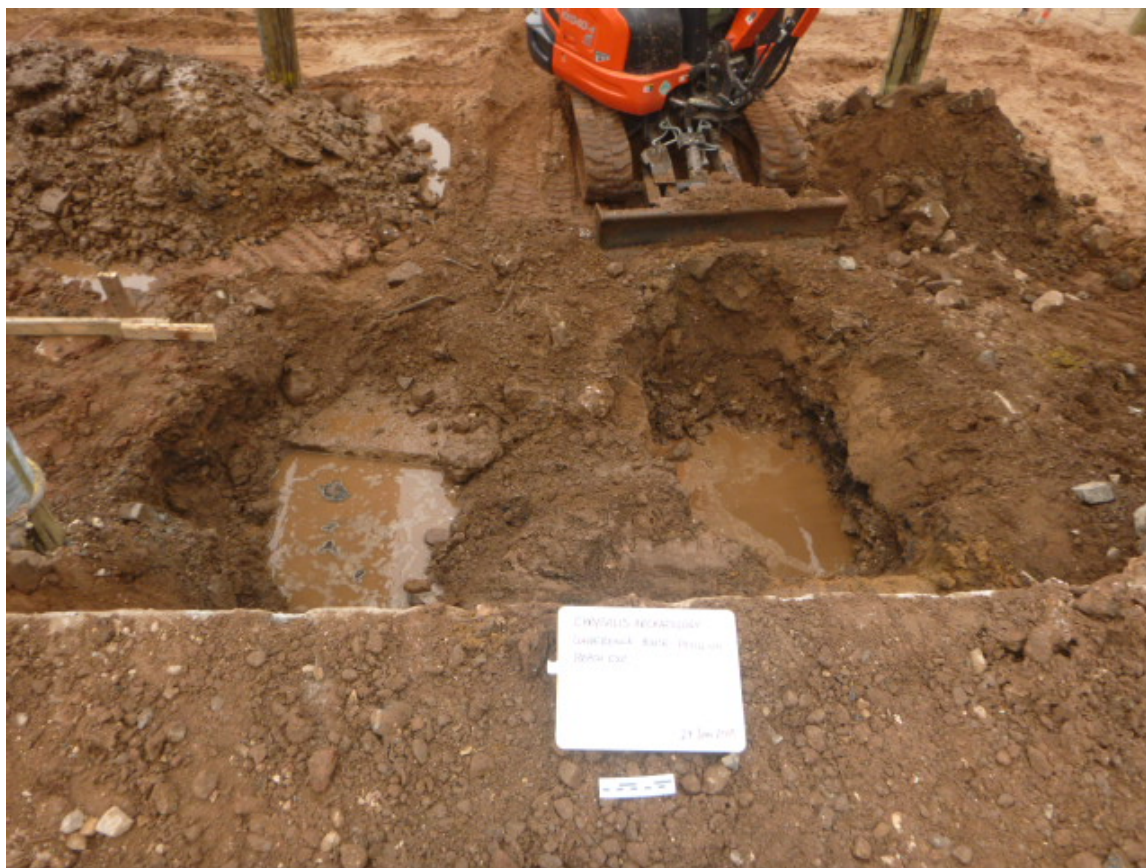
Image 61: High water table in Trenches 19 and 20.

Both trenches exhibited similar stratigraphy, although the maximum depth achieved in both was obscured due to a shallow water table encountered at 1.92' NAVD 88 (4.5' bgs) (Table 23). A shallow water table obscured the stratigraphy of many Sonotube installation trenches at around 4 to 4.5' bgs (Image 61).

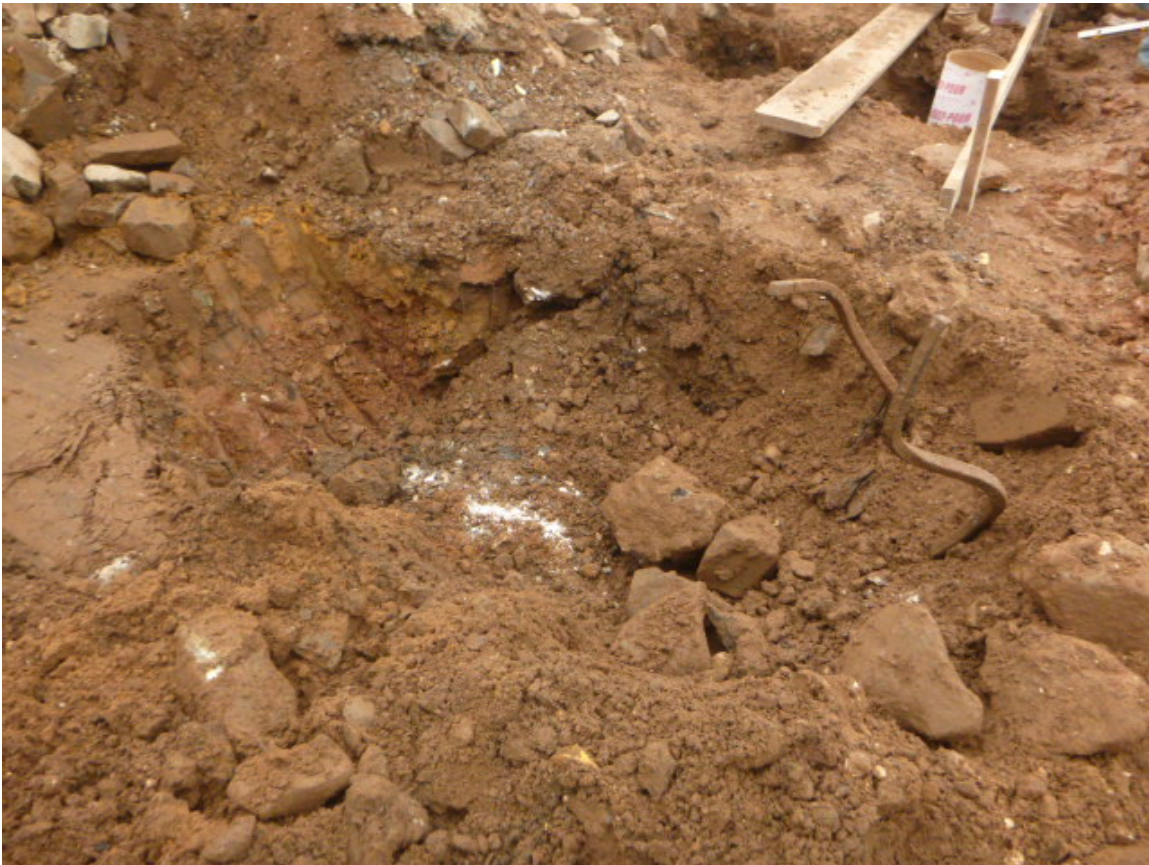
Image 62: Old rebar and concrete slab in Trench 19.

Trench 19 measured 5' by 8' (1.5m by 2.4m) and was placed 4.5' (1.4m) north of the northern wall of Trench 18. The stratigraphy was all modern fill, and the buried remnants of a concrete slab embedded with old, square rebar was discovered in the western half of the trench at 7.84' (2.38m) west of the concrete wall separating the beach from the upper level of the APE (Image 62). The concrete slab was not anticipated by the construction crew, and Trench 19 was discontinued after its discovery at a depth of 2.22 NAVD 88 (4.2' bgs). Additionally, the water table was encountered at 2.42' NAVD 88 (4.0' bgs), slightly obscuring the stratigraphy.

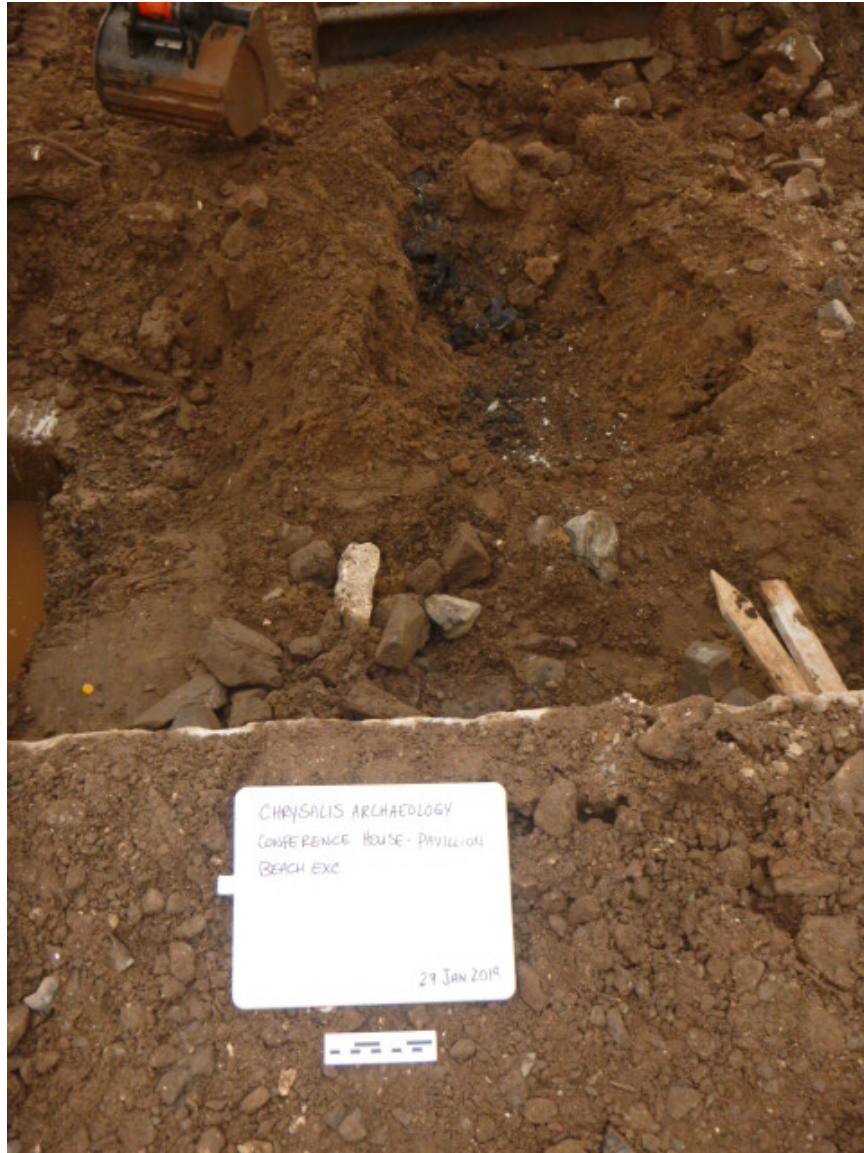
Image 63: Asphalt layer, Trench 20.

Trench 20 was also abandoned due to unanticipated concrete impediments. A layer of unanticipated asphalt was discovered in Trench 20 at a depth of 5.42' NAVD 88 (1' bgs) (Image 63). The excavator was able to cut through this layer, although a second, impenetrable cement floor was encountered at 2.25' NAVD 88 (4.17' bgs) (Image 64).

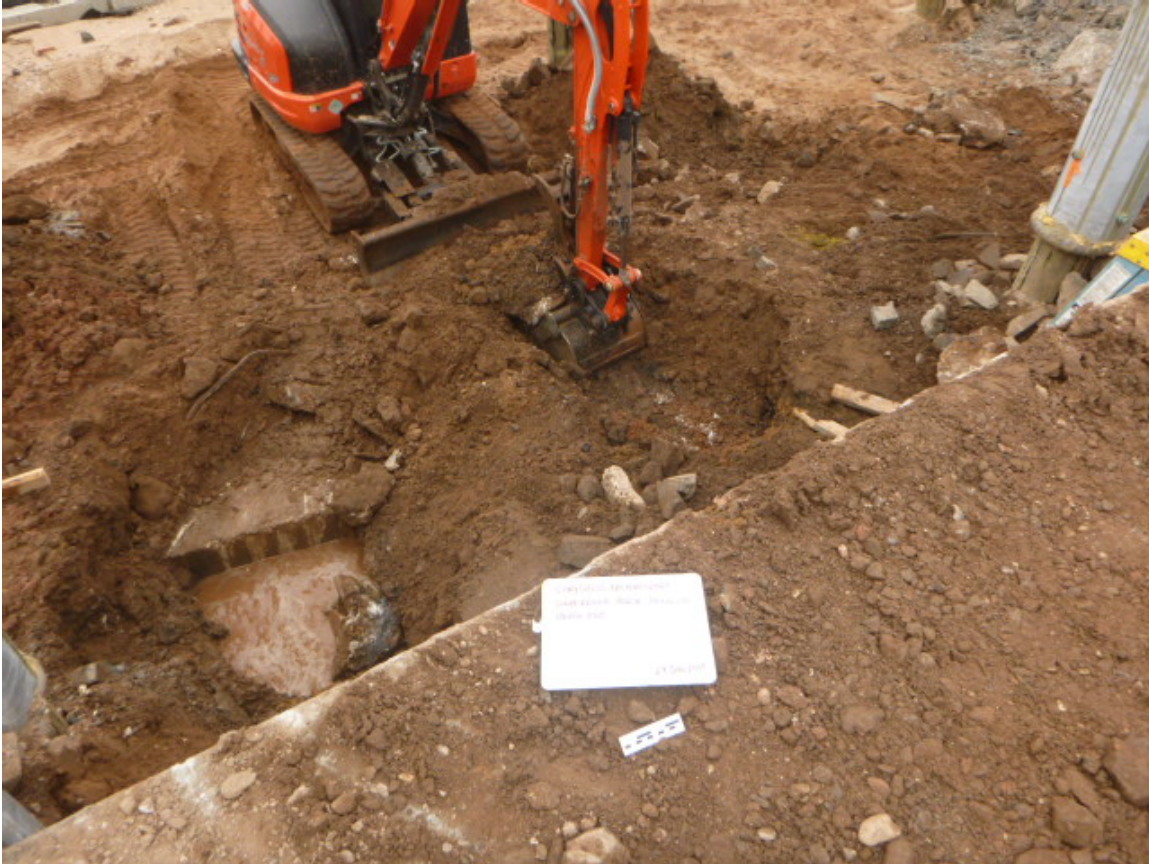
Image 64: Discovery of second concrete layer during excavation of Trench 20.

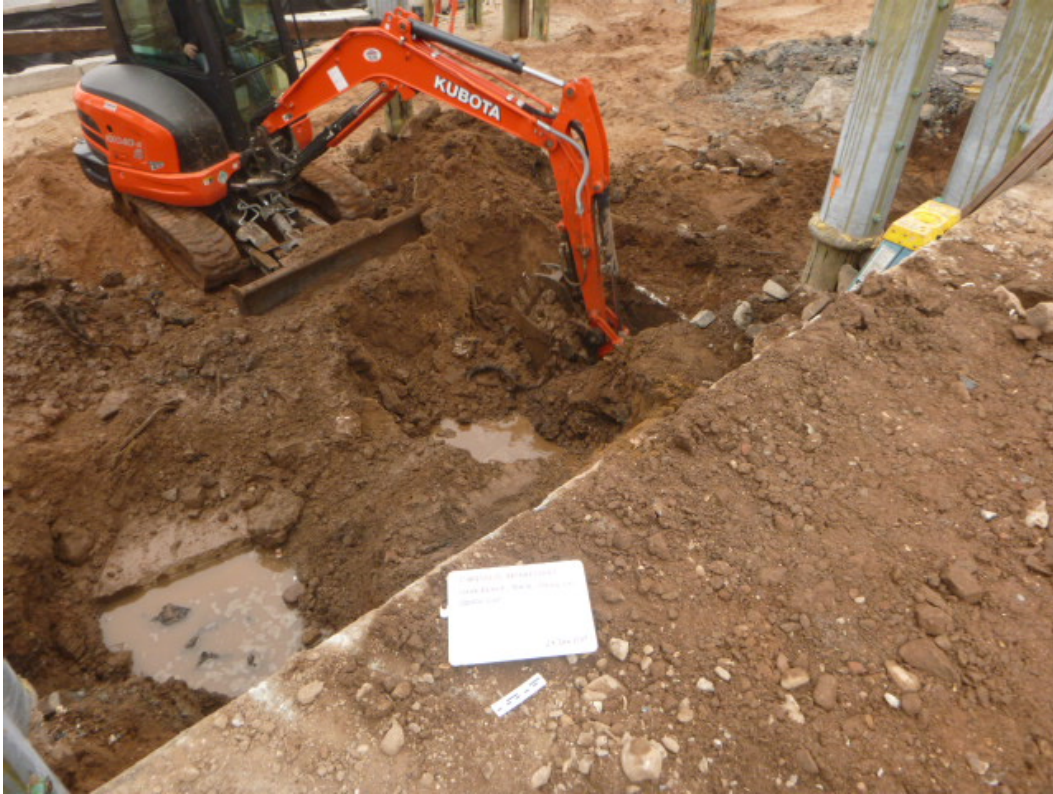
Image 65: Widening of Trench 20.

The dimensions of the trench were widened further north to try and find the edges of the second cement floor (Image 65). Though slightly amorphous, the trench's final dimensions generally measured 10' by 7' (3m by 2.1m). Another buried concrete slab was discovered 8' (2.4m) north of the southern wall of Trench 20 at a depth of 5.17' NAVD 88 (1.25' bgs) as the trench was being widened (Image 66). Ultimately, the edges of the second cement floor were not found in Trench 20, and its excavation was discontinued. No intact stratigraphy or significant cultural resources were encountered in Trench 20.

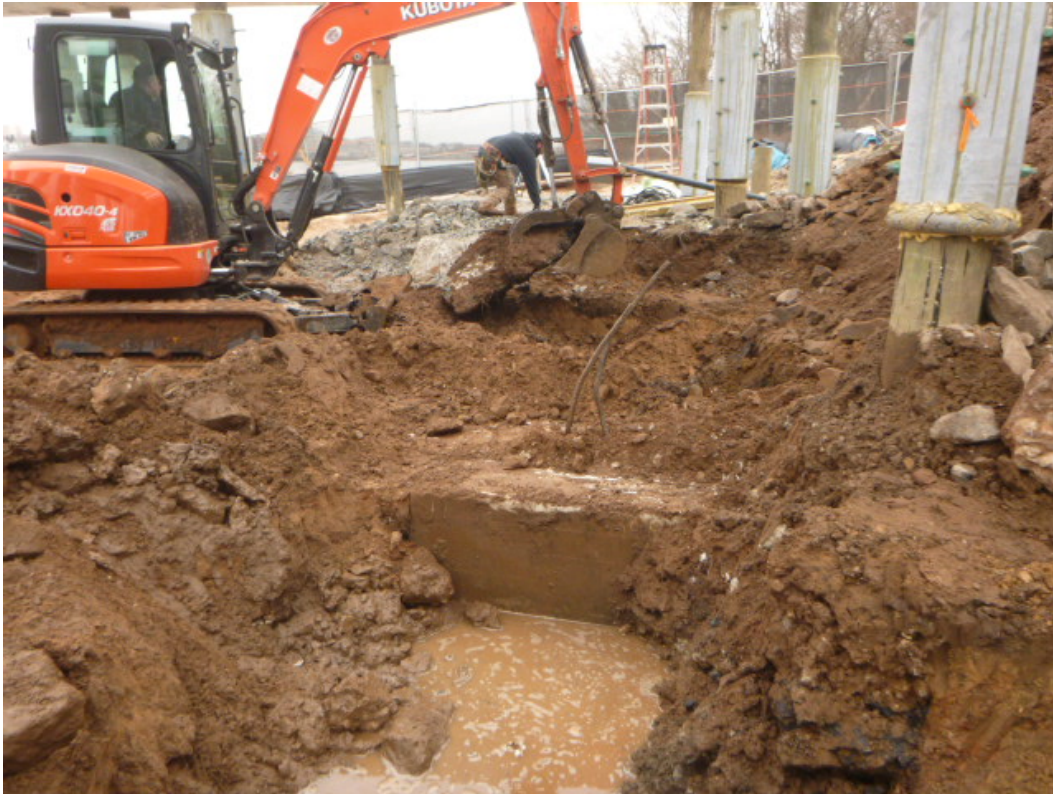
Image 66: Concrete slab found in widened portion of Trench 20.

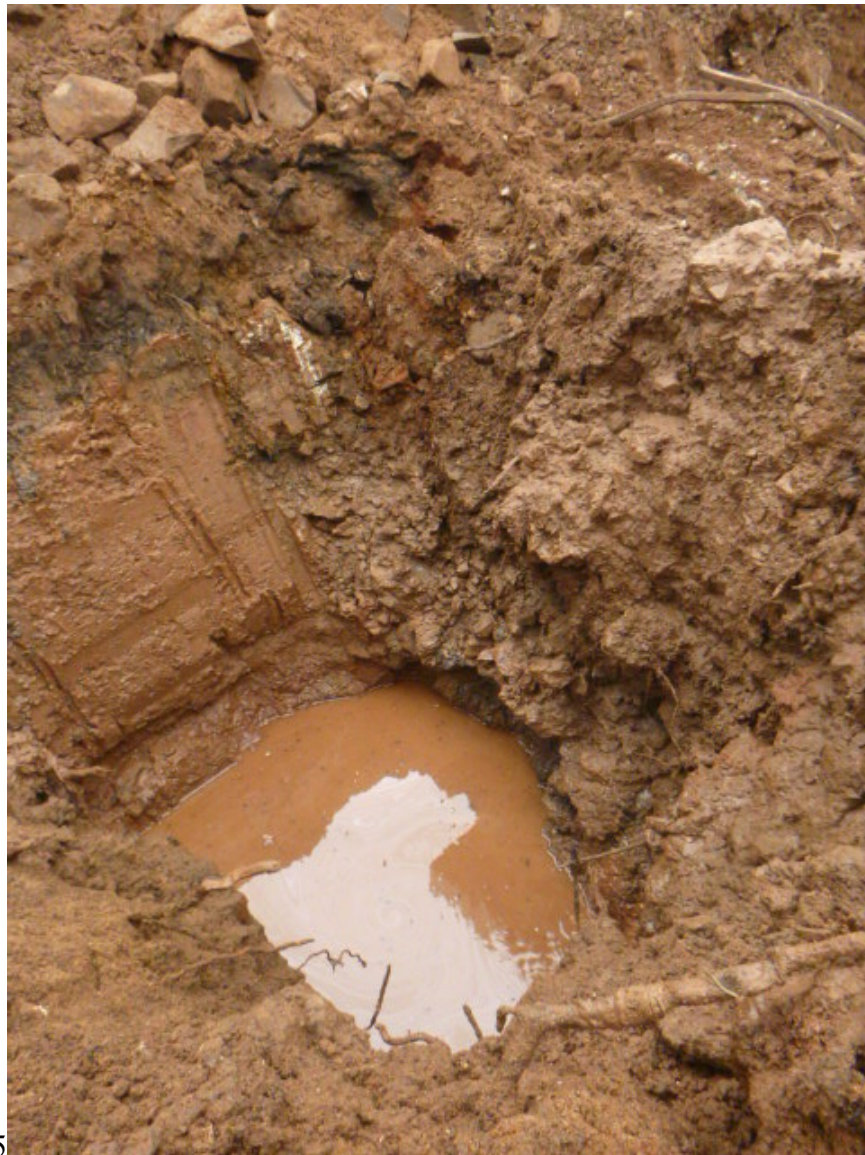
Image 67: Trench 21, post-excavation.

The first asphalt layer found in Trench 20 was also encountered in Trenches 21 and 22, although the second, impenetrable layer was not. As a result, both trenches were able to be excavated to -0.37' NAVD 88 (6.42' bgs), although the stratigraphy was obscured by the water table (Images 67 and 68). In both Trenches 21 and 22, several layers of disturbed beach fill sat atop a layer of intact beach sand (Table 24). No significant cultural resources were encountered during the excavation of Trenches 21 and 22.
