**Reconstruction of the Pavilion at the end of Hylan Boulevard
Adjacent to Satterlee Street in Conference House Park, Staten
Island, Richmond County, New York Project (Contract Number
R006-213M; E-PIN: 8461780040001)**

EXECUTIVE SUMMARY TABLE

EXECUTIVE SUMMARY TEXT

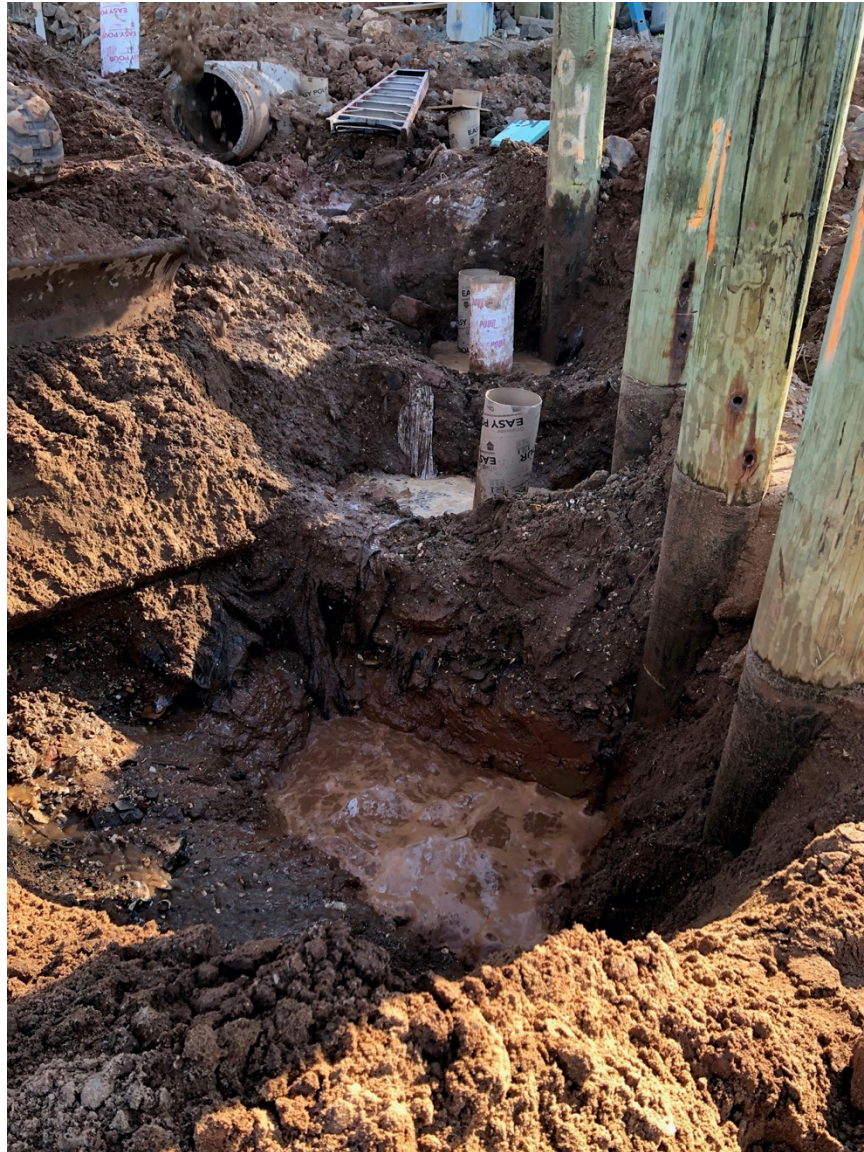
Nine trenches (Trenches 23-31) were excavated in the interior of the beach, interspersed between the main wooden support beams and directly underneath the raised concrete foundation of the new pavilion for the installation of secondary supports (Map 06). Trenches 23-25 were placed along the southernmost line of east-west oriented main wooden support beams (Image 69). Trenches 26-

Image 69: Trenches 23-25, along the southernmost line of east-west oriented main wooden support beams.

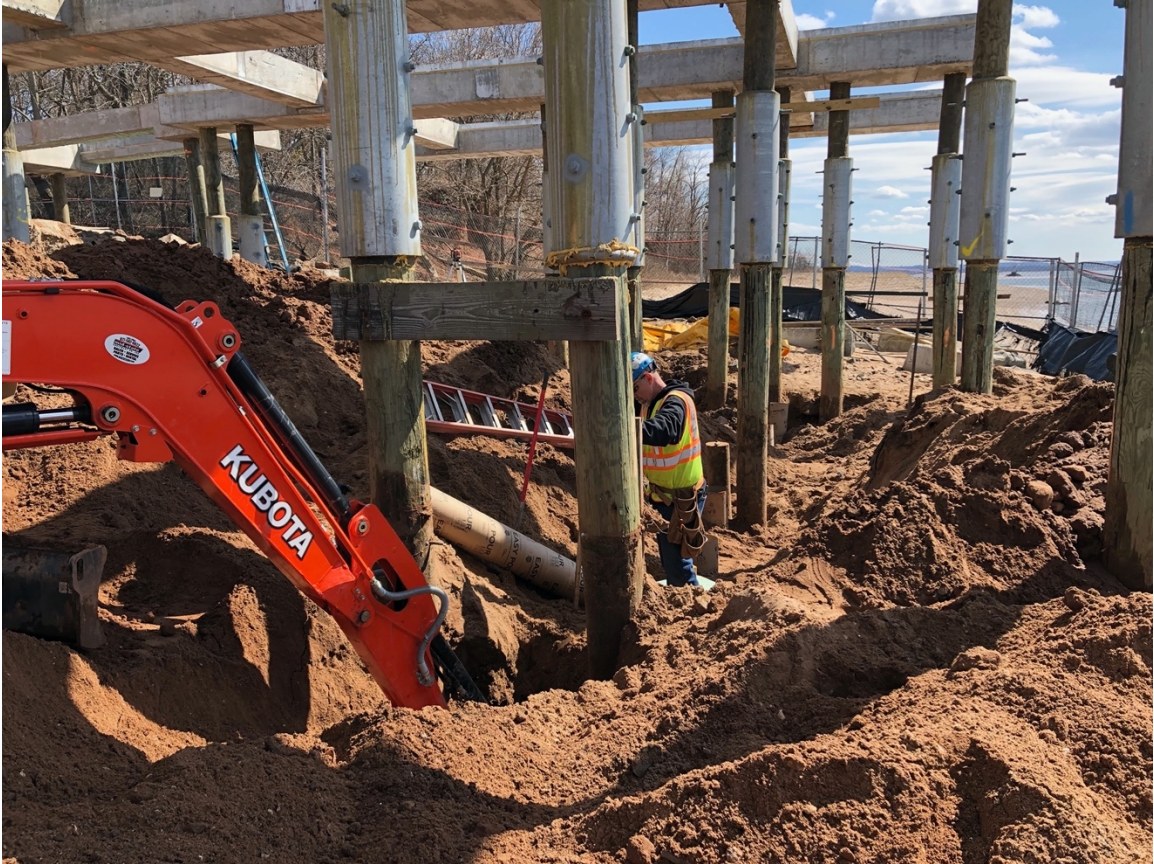
31 pivoted direction and ran south to north along the western edge of the main support beams (Image 70). Additional trenches were planned along the northern section of the east-west oriented Sonotubes (Image 71), though excavation was discontinued in this area after the discovery of an impenetrable concrete flooring in Trench 31.

Image 70: Trenches 26-31, running south to north along the western edge of the main support beams.

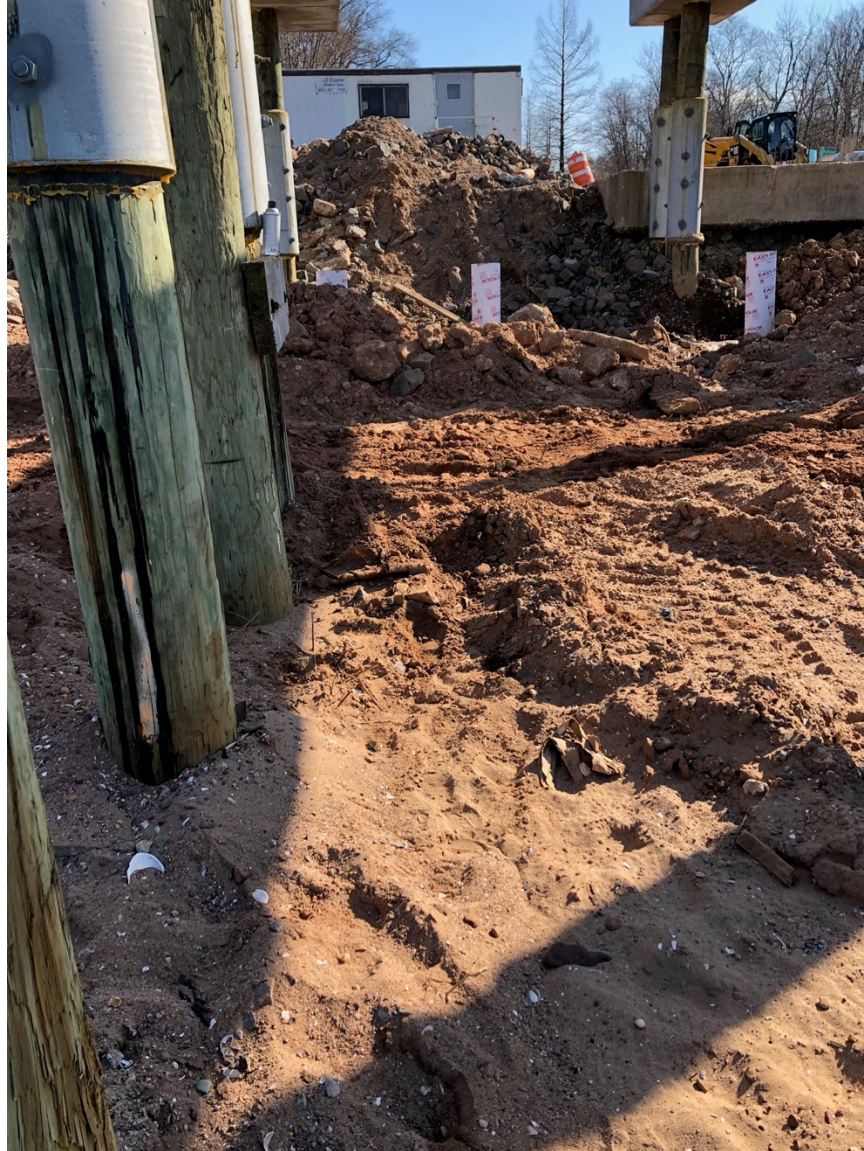
Image 71: Unexcavated area due to concrete flooring.

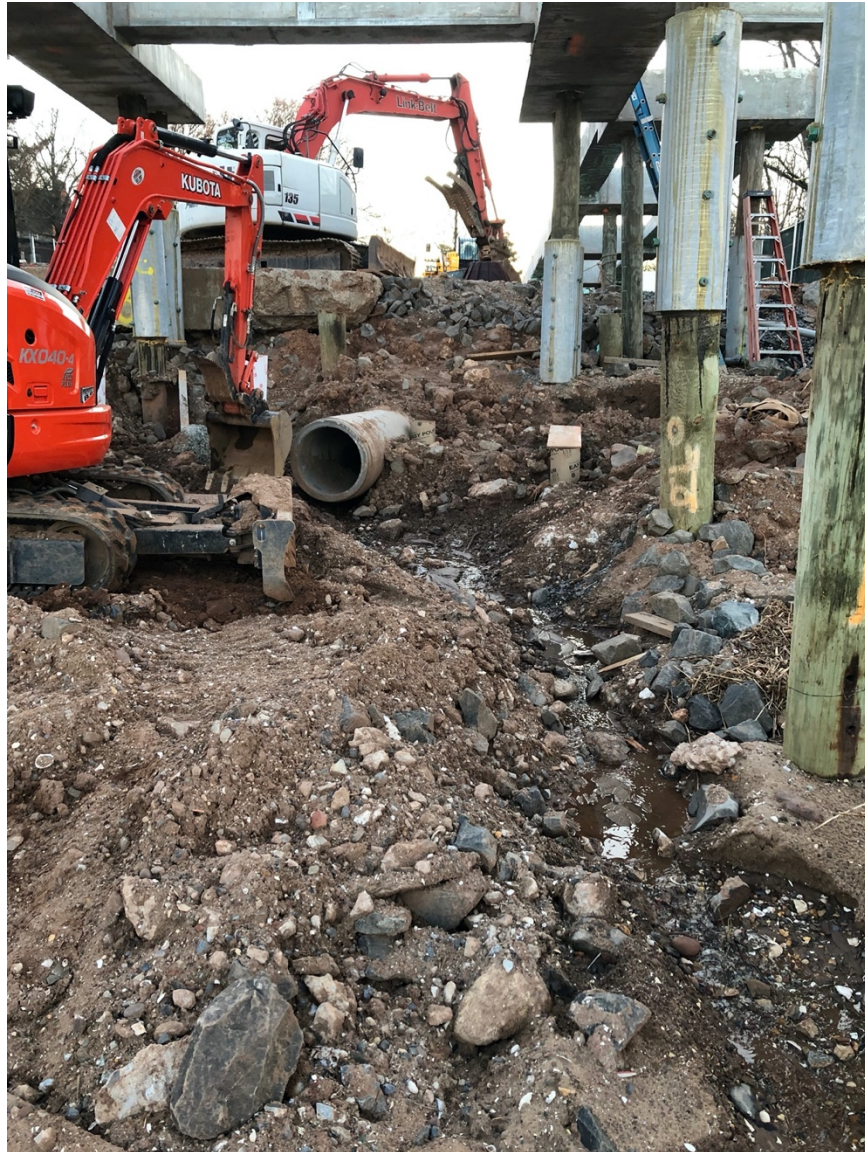
Trench 23, which measured 7' by 4.5' (2.1m by 1.4m), was the first to be excavated in the interior of the beach and was located west of the site's main drainage pipe and northwest of Trench 16 (Image 72). The southeast corner of Trench 23 abutted the first line of main wooden support beams (Image 73). A concrete slab visible on the surface of the beach was also visible in profile to a depth of 2.4 NAVD 88 (3.5' bgs) in the west wall of Trench 23 (Image 74). Fill layers surrounded the concrete slab, though intact beach deposits were encountered starting at 2.4 NAVD 88 (3.5' bgs) and extending to the bottom of the trench at -2.6' NAVD 88 (8.5' bgs) (Table 25). The tide was low during excavations for Trenches 23 and 24 in this area, allowing for deeper excavation and a more complete stratigraphic profile to be observed. Trench 24, which was placed directly west of Trench 23, shared a similar stratigraphy, though without the concrete slab.

Image 72: Terrain of the beach prior to excavation of Trench 23, looking east.

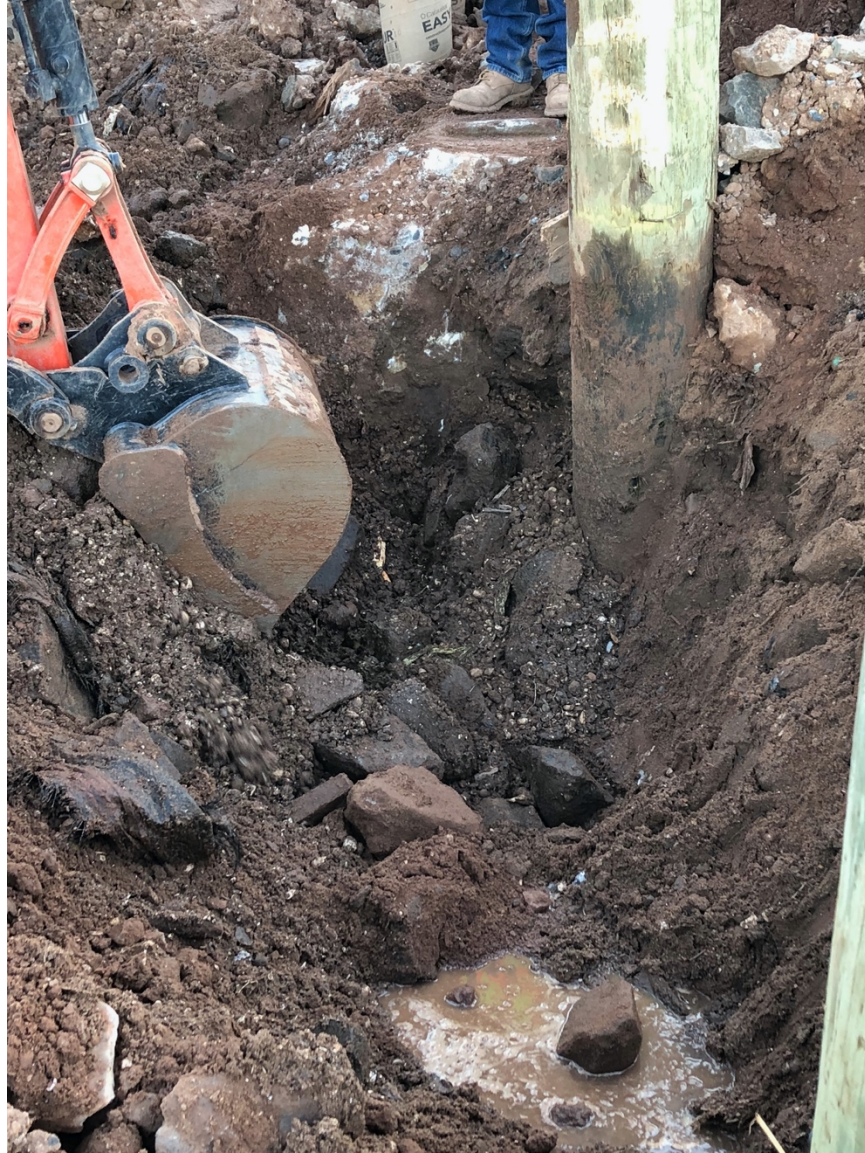
Image 73: Trench 23, excavation-in-progress with wooden support beam, looking east.

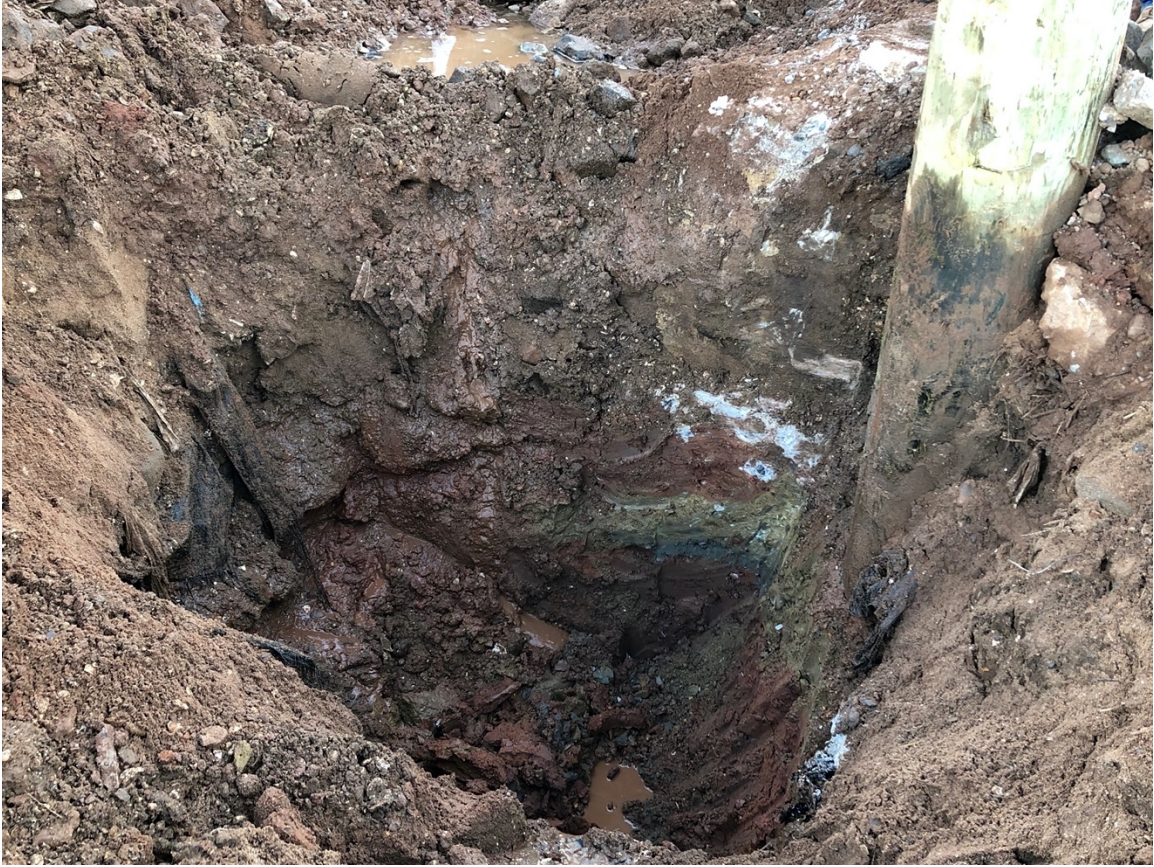
Image 74: Stratigraphic profile, east wall – Trench 23.

STRAT	NAVD 88 DEPTH (BGS)	MUNSELL	SOIL TYPE	COMMENTS
Fill I	-1.0' – -5.0' (0.0' – 4.0' bgs)	NA	NA	In profile in area north of concrete slab. Modern trash, construction debris, shell, gravel, pieces of drainage matting and wooden beams, plastic, angular rocks.
Concrete slab	-1.0' – -2.5' (0.0' – 3.5' bgs)	NA	NA	Along southern 2/3 of east wall.
Remnant Beach I	-2.5' – -1.10' (0.0' – 4.0' bgs)	5YR 4/6 yellowish red	Medium sand	Directly underneath concrete slab
Beach II	0.10' – -1.10' (4.0' – 5.0' bgs)	Gley 1 5/5GY greenish grey with Gley 2 3/5B very dark bluish grey	Very fine sand	
Beach III	1.10' – -0.6' (5.0' – 6.5' bgs)	5YR 4/4 reddish brown	Fine sand with clay	
Beach IV	-0.6' – -1.6' (6.5' – 7.5' bgs)	5YR 3/1 very dark grey	Sand with clay	Pebbles
Beach V	-1.6' – -2.6' (7.5' – 8.5' bgs)	5YR 3/3 dark reddish brown	Sand with clay	Pebbles

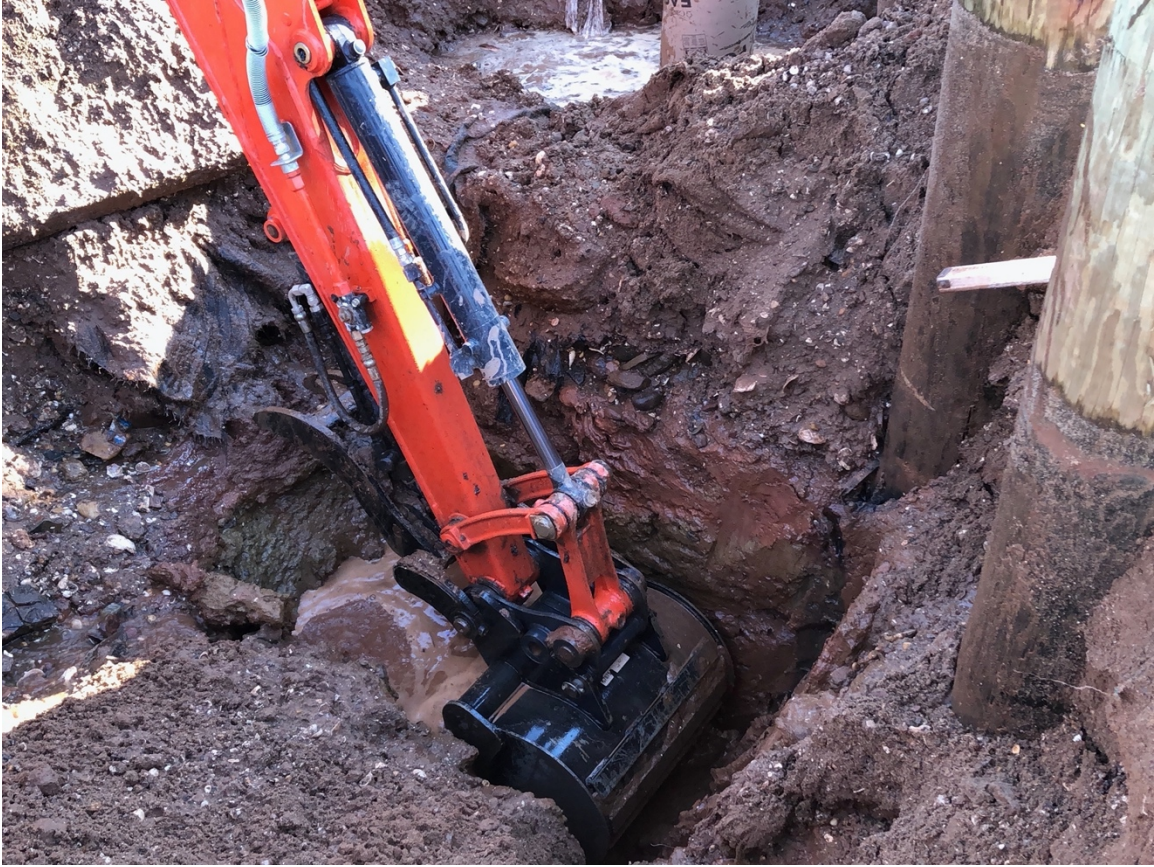
Image 75: Trench 25, excavation-in-progress, looking east.

Trench 25 was the last east-west oriented trench in the interior of the beach; all subsequent trenches were oriented north-south. The eastern wall of Trench 25 almost directly abutted the western wall of Trench 24 (Image 75). The stratigraphy of Trench 25 was slightly obscured by a shallow water table, which was encountered at 1.5' NAVD 88 (3' bgs) (Table 26) (Image 76). A layer of shell and poorly sorted rocks, pebbles and cobbles was found between 1.5' NAVD 88 (2.5') and 0.5' NAVD 88 (3.5' bgs) in Trench 25. This may be the result of water action from the tides and/or from continual drainage from the upper level of the site. Trenches 26 and 27 had very similar stratigraphy and water table depths.

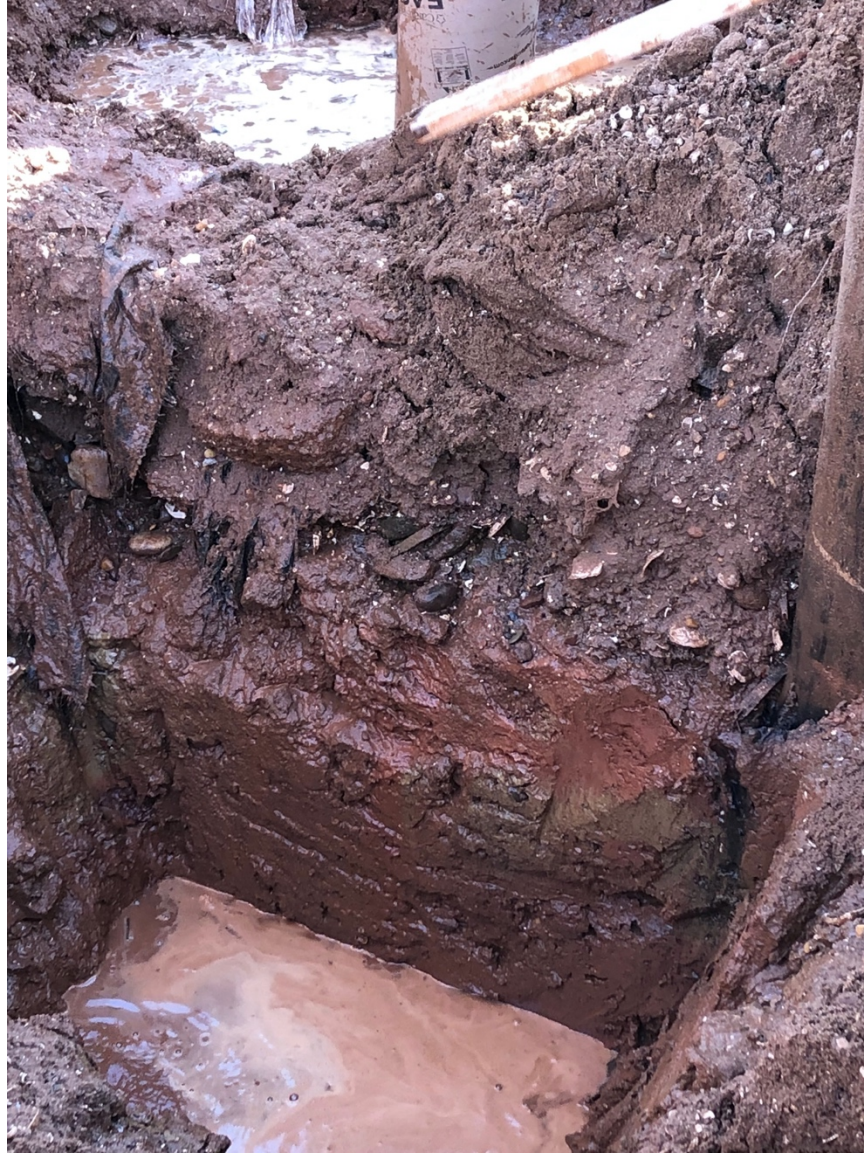
Image 76: Stratigraphical profile, east wall – Trench 25.

STRAT	NAVD 88 DEPTH (BGS)	MUNSELL	SOIL TYPE	COMMENTS
Fill I	4.5' – 2.0' (0' – 2.5' bgs)	NA	NA	Modern trash, construction debris, increased shell, gravel, pieces of drainage matting and wooden beams, plastic wrap, angular rocks.
Drainage I	2.0 – 1.5' (2.5' – 3.0' bgs)	NA	NA	Shell and poorly sorted rocks, pebbles and cobbles.
Beach III	1.5 – -1.5' (3.0' – 6.0' bgs)	5YR 4/4 reddish brown	Fine sand with clay	
Beach IV	-1.5 – -2.0' (6.0' – 6.5' bgs)	5YR 3/1 very dark grey	Sand with clay	Pebbles
Beach V	-2.0 – -4.0' (6.5' – 8.5' bgs)	5YR 3/3 dark reddish brown	Sand with clay	Pebbles

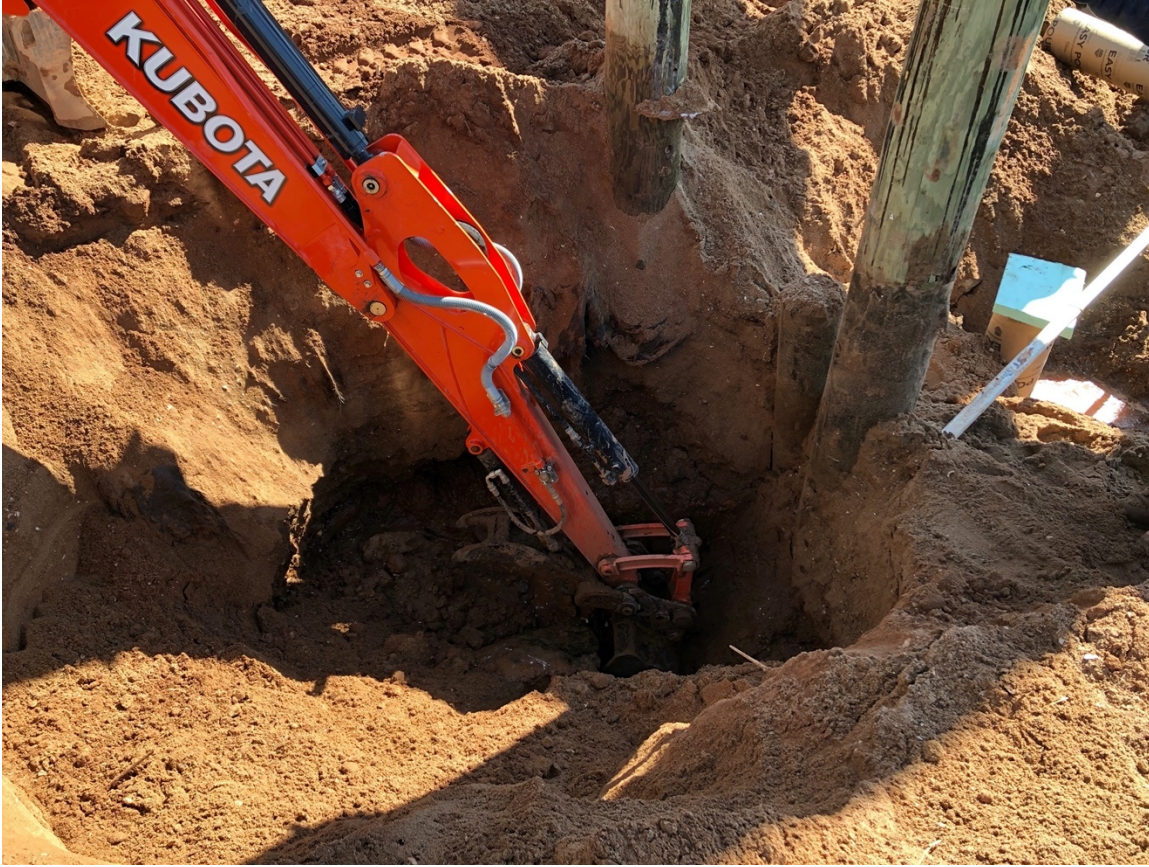
Image 77: Trench 28, excavation-in-progress, looking south.

The topmost fill layer, present in all trenches in the interior of the beach, and the water table were both slightly deeper in Trench 28 than surrounding trenches, though this may have been the result of a change in the tide. Trench 28 was excavated to -4.5' NAVD 88 (9' bgs), making it the deepest trench in the interior of the beach (Image 77). The top layer of fill had an increased amount of modern trash in it, including Styrofoam, and the remnants of a drainage matt were found at 2.5' NAVD 88 (2' bgs) (Table 27) (Image 78). The water table was encountered at -0.5' NAVD 88 (5' bgs), at which point a thin layer of poorly sorted shell, rocks, pebbles, and cobbles was encountered. Once the water table was encountered, precise measurements and observations of the trench's stratigraphy were made impossible. Trenches 29 and 30 shared similar stratigraphy and water table depth with Trench 28.

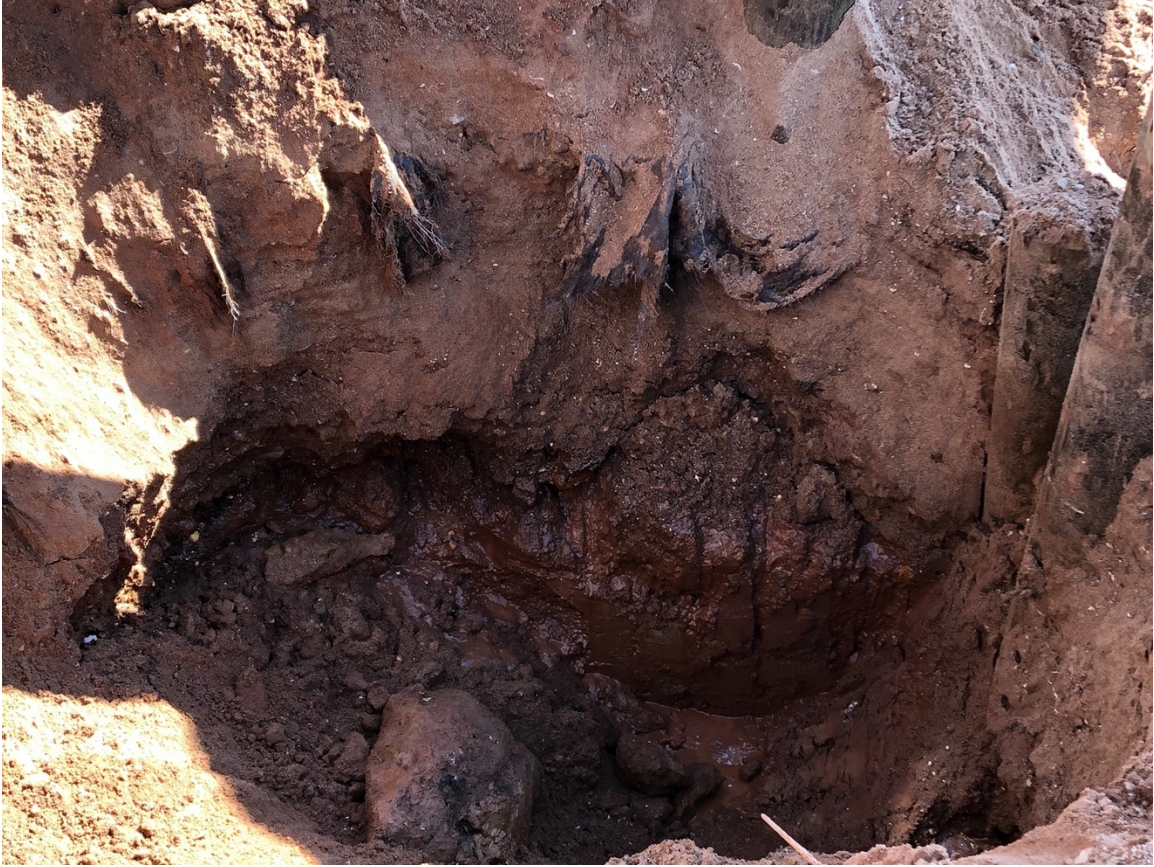
Image 78: Stratigraphic profile, east wall – Trench 28.

STRAT	NAVD 88 DEPTH (BGS)	MUNSELL	SOIL TYPE	COMMENTS
Fill I	4.5' – -0.5' (0' – 5.0' bgs)	NA	NA	Modern trash and drainage matting. Water table found at 5' bgs.
Beach I	-0.5' – (5.0+ bgs)	5YR 4/6 yellowish red	Coarse sand	Wet

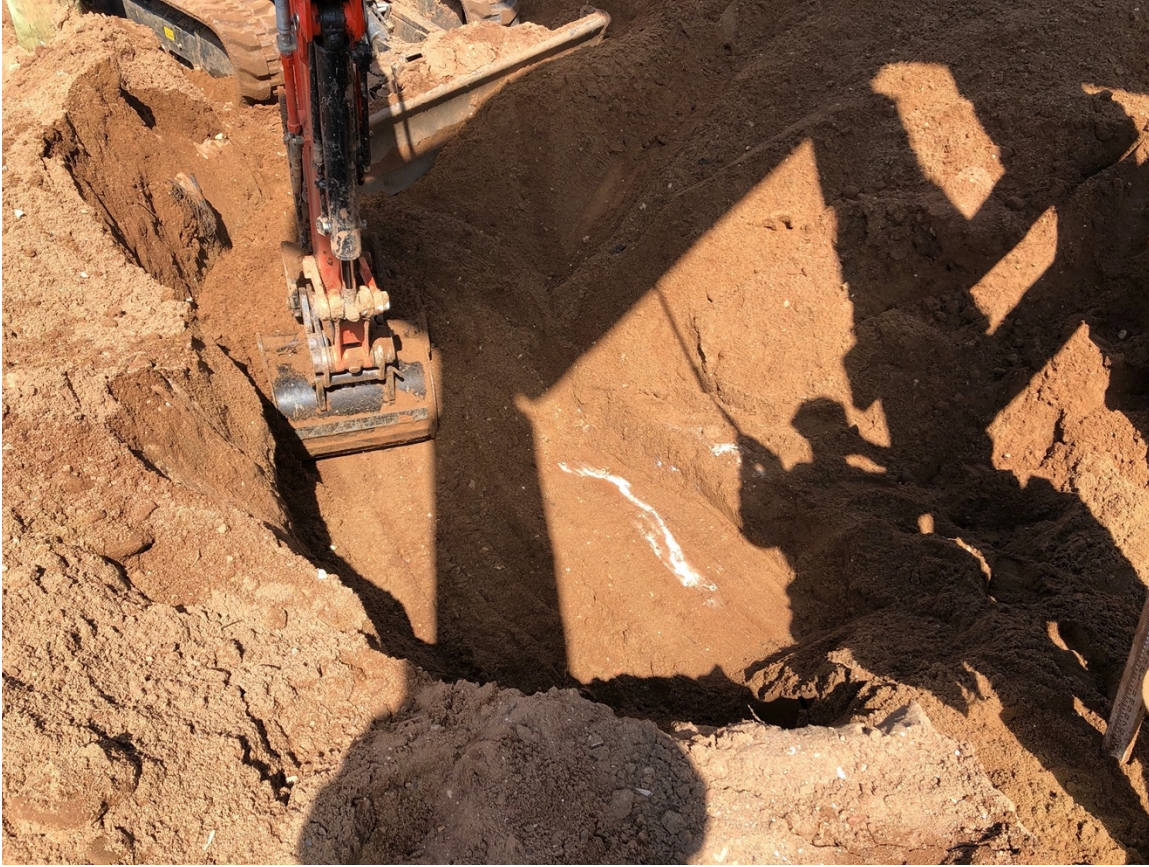
Trench 31 was the northernmost trench excavated for this round of Sonotube installations, although more were planned further north. Trench excavations were halted due to the presence of impenetrable concrete flooring found in Trench 31 at a depth of 0.0' NAVD 88 (4.5' bgs) (Image 79). Trench 31 actually had two concrete layers. The first layer, found at 1.5' NAVD 88 (3' bgs), was able to be removed. Both concrete layers were similar to those found in Trench 20. The stratigraphy above and between the concrete floors was all fill or disturbed beach deposits. No intact stratigraphy or significant cultural resources were encountered during the excavation of Trench 31.

Image 79: Concrete flooring in Trench 31.

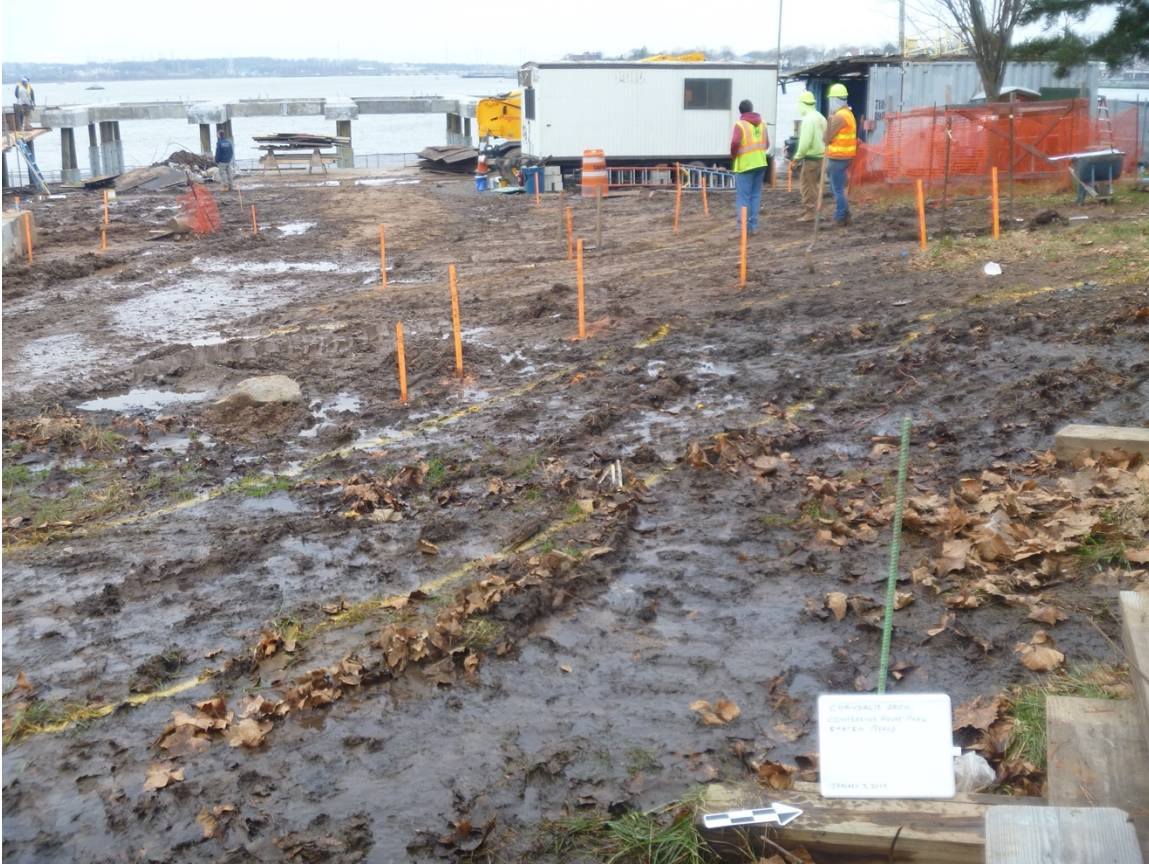
Image 80: Seawall locations laid out, looking west.

Trenches 32-36 were excavated in the northwestern section of the APE for the installation of seawalls A-H to prevent flooding (Map 05). The seawalls were located within the less sensitive historic swale area on the AWP map (Map 04). Trench 32 corresponds to Seawall A, Trench 33 to Seawall B, Trench 34 to Seawall C, Trench 35 to Seawall D, Trench 38 to Seawall E, Trench 36 to Seawall G, and Trench 39 to Seawall H. No significant cultural resources were encountered during the excavations of the seawall trenches.
