Phase IB Archaeological Testing

**New York City Department of Design and Construction
Capital Project SER-002317:
BMP AH-3 Halpin Avenue and Legate Avenue
Arden Heights Woods Watershed
Staten Island, Richmond County, New York
19PR06668**

March 2020

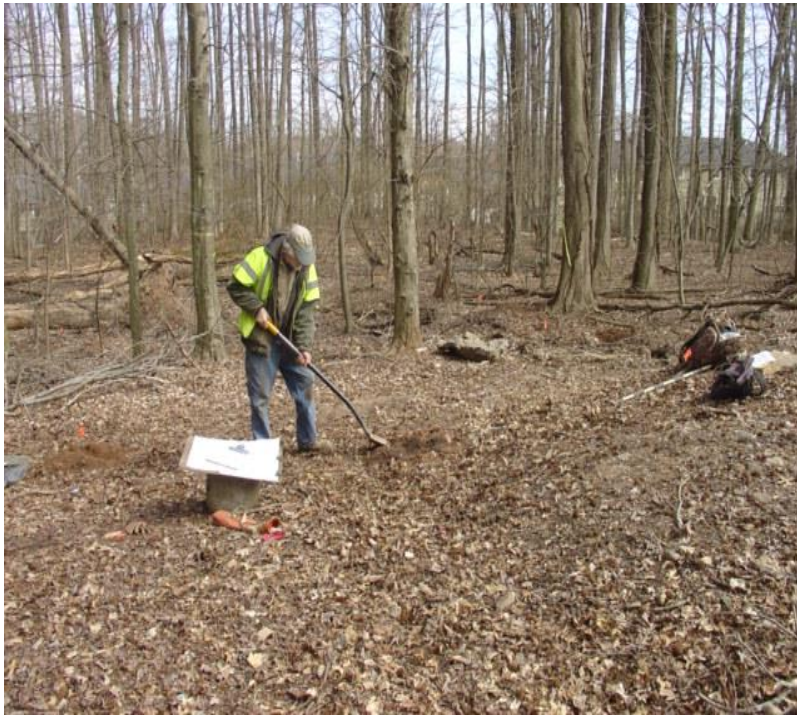
Photograph 1. View looking north at BMP AH-3 Shovel Test 2 on the south end of the Area of Potential Effect.

The STs were nearly evenly divided between the five (5) that had natural profiles, with an A horizon over a B horizon and sometime a C horizon (STs 1, 6, 7, 8, and 9), and the six (6) STs that had profiles with some or all fill. Two had profiles composed entirely of fill, ST3 and ST2. See the following field Photos 1-2.

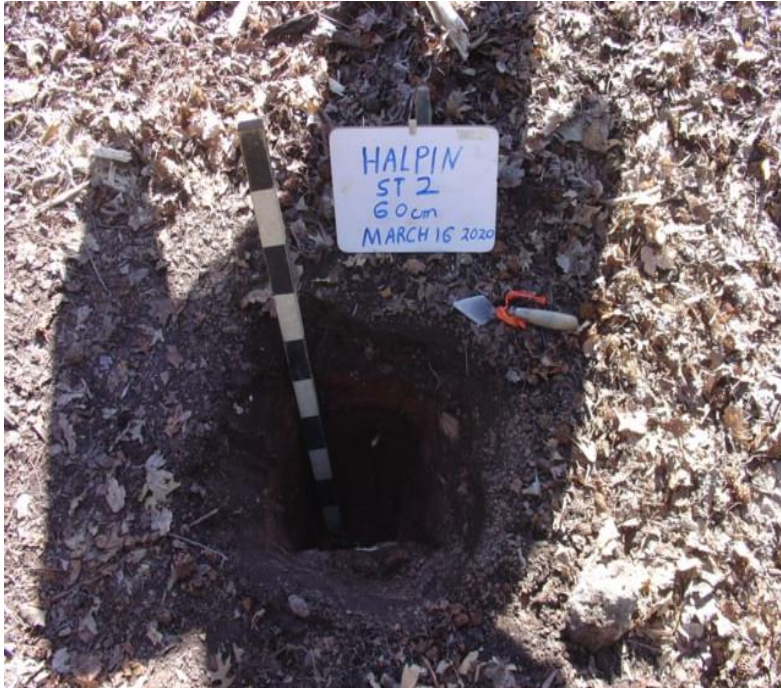
Photograph 2. BMP AH-3 Shovel Test 2 east profile. Note: Entire profile consisting of fill.

TABLE 1: Soil Stratigraphy of ST2 / N5E15

<i>Depth</i>	<i>Soil type</i>	<i>Color</i>	<i>Artifacts</i>	<i>Interpretations</i>
0-10cm	Loam	Very Dark Grayish Brown	Styrofoam*, Mod. bottle glass*	Fill
-27cm	Clay Loam	Reddish Brown Mottled Very Dark Grayish Brown	NCM	Fill
-30cm	Clay Loam	Reddish Brown Mottled Very Dark Grayish Brown	NCM	Fill
-60	Clay Loam	Reddish Brown	NCM	Fill?

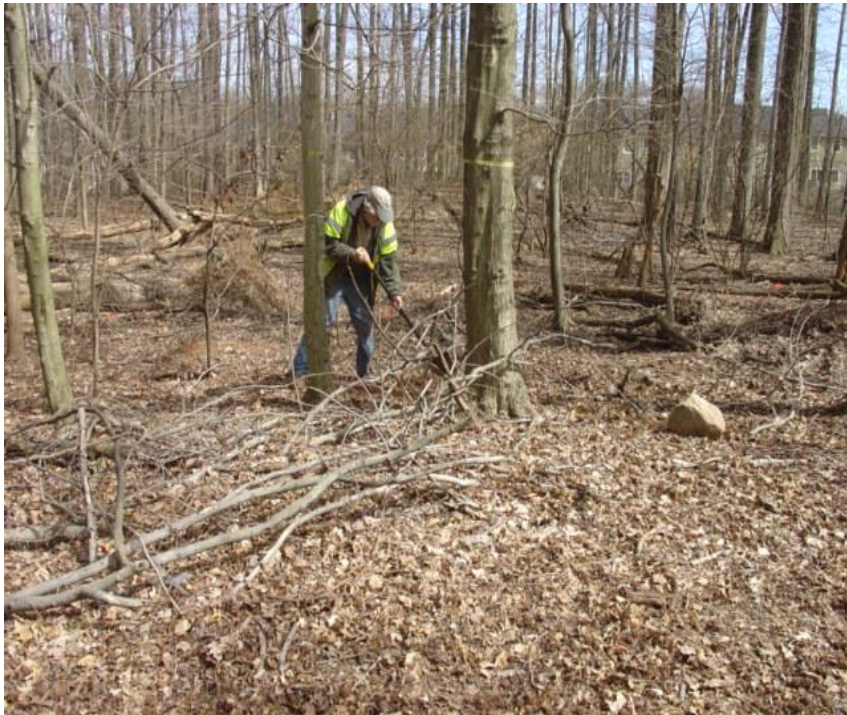
Photograph 3. View looking north at BMP AH-3 Shovel Test 7 in the center of the Area of Potential Effect.

ST4 was truncated; it had fill directly atop a C horizon. Fill sat atop a B horizon in ST5, ST10 and ST11. ST11 also had a dark gray basal stratum, likely indicative of wetlands. ST7 was near the center of the APE and had a natural profile (Photos 3 and 4).

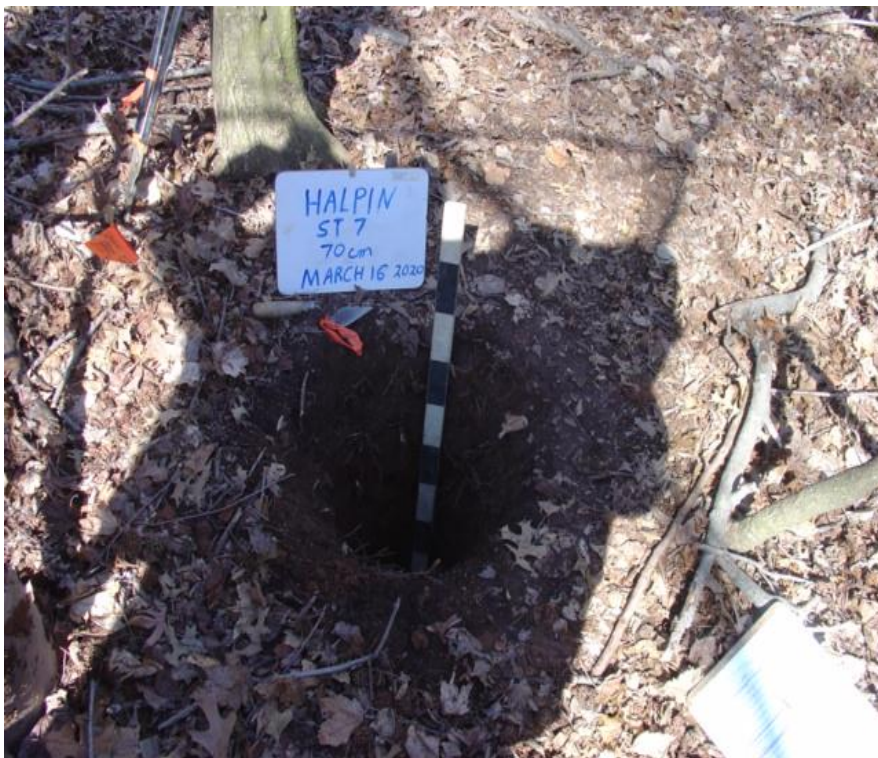
Photograph 4. BMP AH-3 Shovel Test 7 west profile. Note: Showing a natural profile in the center of the Area of Potential Effect.

TABLE 2: Soil Stratigraphy of ST7 / N10E10

<i>Depth</i>	<i>Soil type</i>	<i>Color</i>	<i>Artifacts</i>	<i>Interpretations</i>
0-25cm	Loam	Dark Brown	NCM	A
-70cm	Loam	Dark Gray	NCM	B/Sterile Subsoil
